Detection and characterization of impact damage in carbon fiber aircraft fuselage structure

**DETECTION AND CHARACTERIZATION OF IMPACT
DAMAGE IN CARBON FIBER AIRCRAFT FUSELAGE
STRUCTURE**

THESIS

**Master of Science
Civil Engineering**

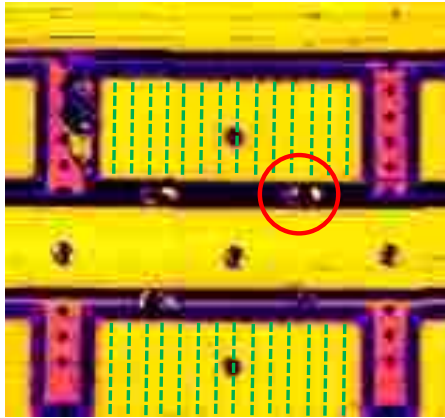
26 – B3-SK4-ST4B-110

Edge of Stringer Flange (Not Stringer Side)
Impact Energy: 105 Ft lbs
Damage Area: 2.43 in²
Type of Damage: Flange delamination, visible crack on surface paint
Strain Indication: Yes, compressive strain indication

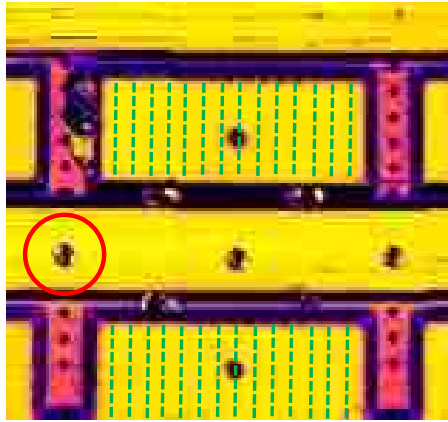
27 - B2/3

Damage Area: 1.07 in²

Type of Damage: Near surface fiber crushing and interply delamination

Strain Indication: No

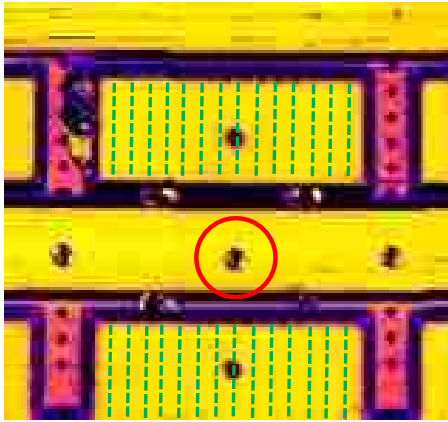
28 – B3-S

Center of Stringer Between Flanges
Impact Energy: 90 Ft lbs
Damage Area: 1.17 in²
Type of Damage: Interply delamination
Strain Indication: Increased compressive strains at fibers nearest to the stringer flange, not detectable

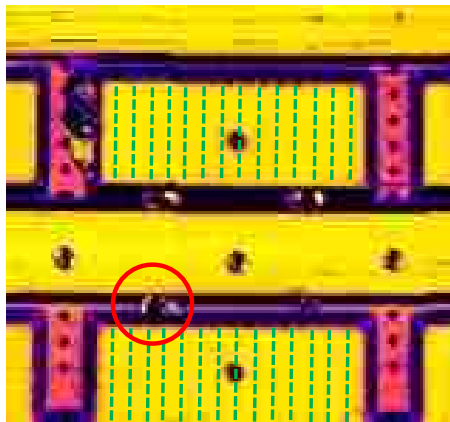
Center of Stringer Flange
Impact Energy: 105 Ft lbs
Damage Area: 3.89 in²
Type of Damage: Interply delamination
Strain Indication: Yes, compressive strain indication

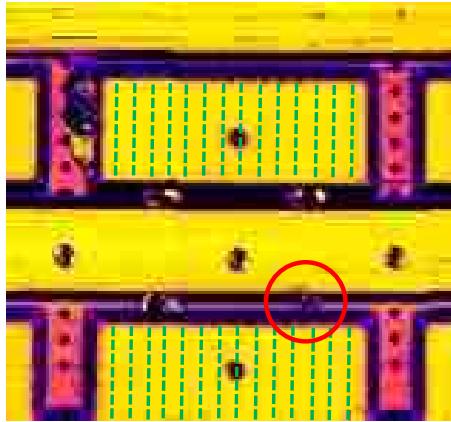
31 - B3-S

Center of Stringer Flange
Impact Energy: 97.5 Ft lbs
Damage Area: 1.63 in²
Type of Damage: Interply delamination
Strain Indication: Yes, clear negative strain peak

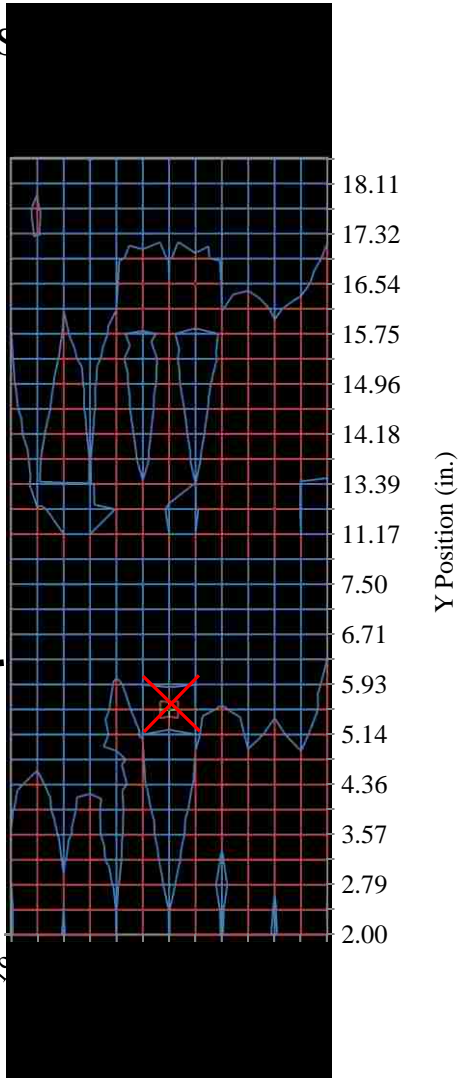
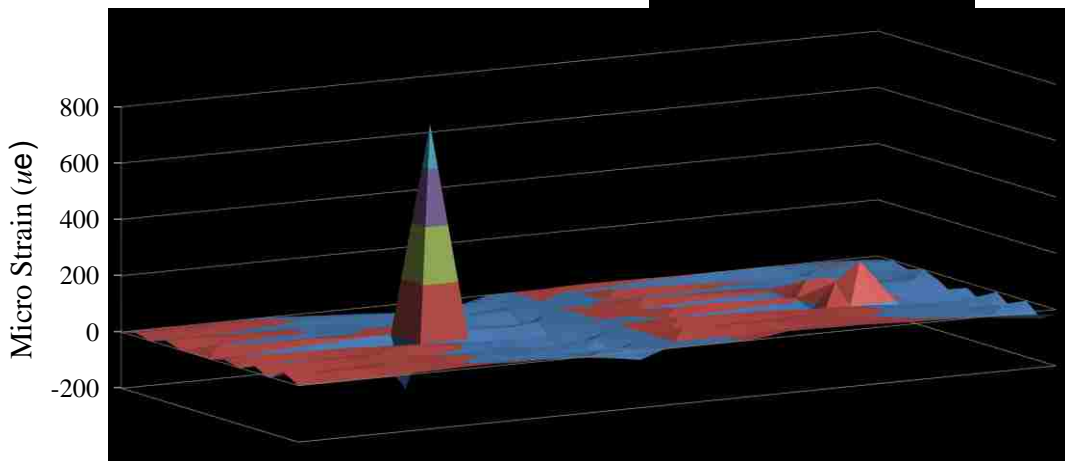
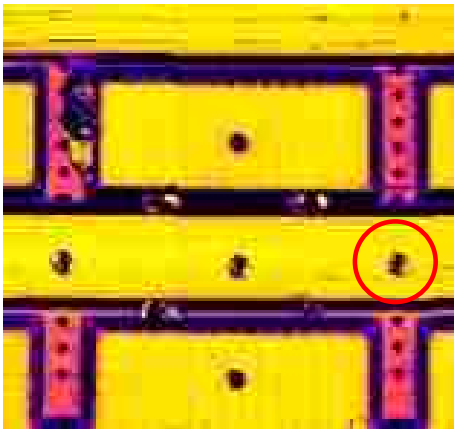
29 – B3/4-SK0-ST4-H3

Center Bay Over Skin
Impact Energy: 105 Ft lbs
Damage Area: 0.81 in²
Type of Damage: Near surface fiber crushing
Strain Indication: Yes, high strains at impact location

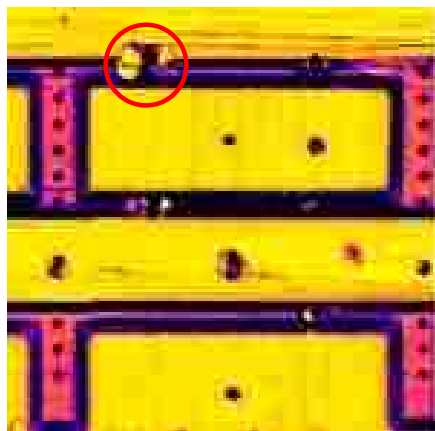
33 – B4-SK4-ST3L-H2c

Damage Area: 5.14 in²

Type of Damage: Interply delamination

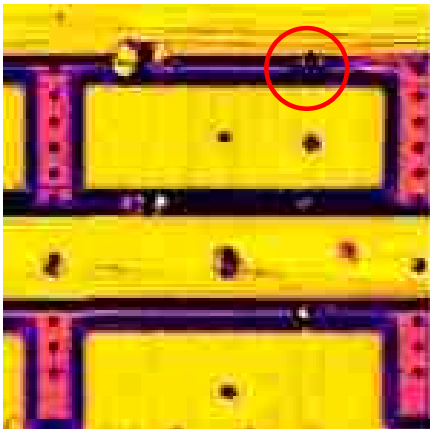
34 – B4-SK4-ST3R-H2c

Damage Area: 2.55 in²

Type of Damage: Interply delamination

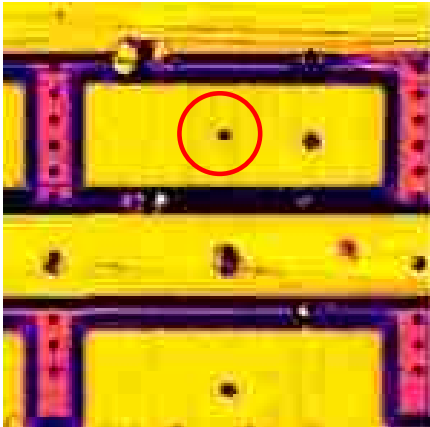
35 – B4-SK4-ST0-H1

Center Bay Over Skin
Impact Energy: 20 Ft lbs
Damage Area: 0.25 in²
Type of Damage: Near surface crushed fibers

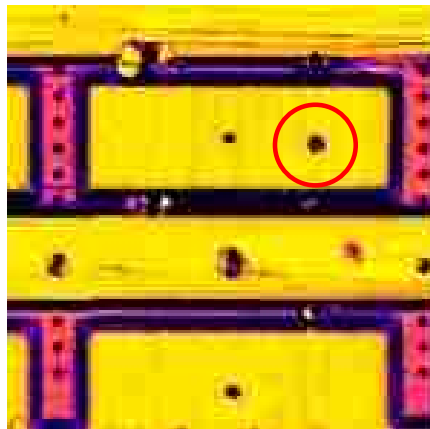
36 – B4-SK4R-ST0-H1

Center Bay Over Skin
Impact Energy: 20 Ft lbs
Damage Area: 0.55 in²
Type of Damage: Near surface fiber crushing

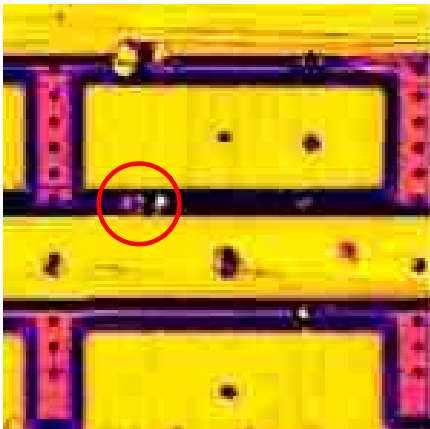
37 – B4-SK4-ST4L-H2a

Edge of Stringer Flange (Not Stringer Side)
Impact Energy: 90 Ft lbs
Damage Area: 2.26 in²
Type of Damage: Interply delamination

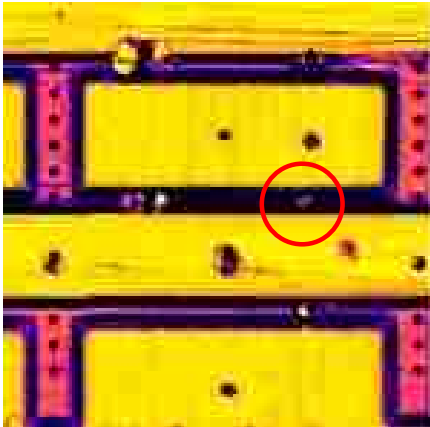
38 – B4-SK4-ST4R-H2a

Damage Area: 0.85 in²

Type of Damage: Interply delamination

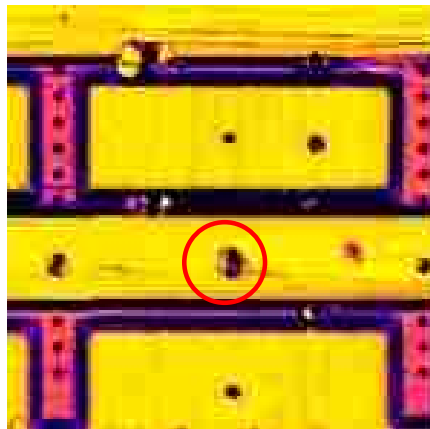
39 – B4-SK0-ST4-H3

Damage Area: 1.77 in²

Type of Damage: Interply delamination

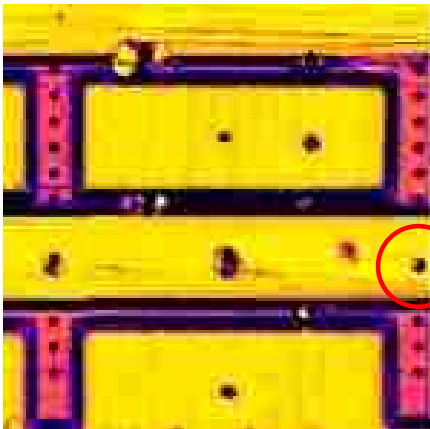
40 – B4-SK0-ST4R-H3

Damage Area: 0.31 in²

Type of Damage: Near surface fiber crushing

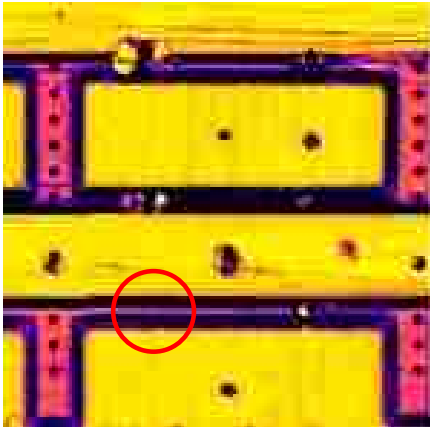
41 – B4-SK5-ST4L-H2b

Center of Stringer Flange
Impact Energy: 60 Ft lbs
Damage Area: 0 in²
Type of Damage: No damage

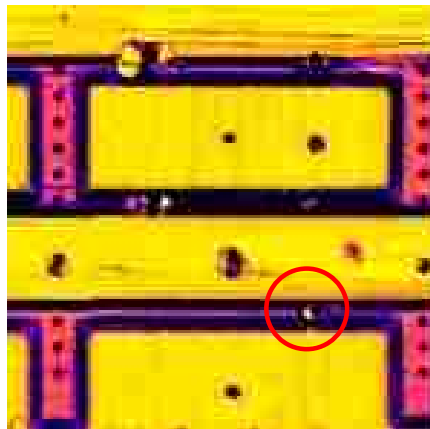
42 – B4-SK5-ST4R-H2b

Center of Stringer Flange
Impact Energy: 82.5 Ft lbs
Damage Area: 1.68 in²
Type of Damage: Interply delamination

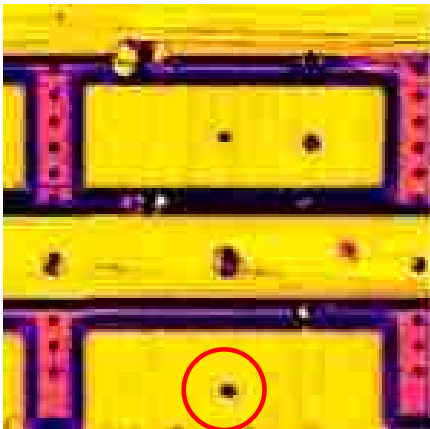
43 – B4-SK5-ST0-H1

Center Bay Over Skin
Impact Energy: 75 Ft lbs
Damage Area: 0.51 in²
Type of Damage: Near surface fiber crushing
