Fatigue Failure Evaluation of Tie Plates due to Secondary Deformations on Steel Plate Girder Bridges

Xiang Li
Lehigh University

A Thesis

In Candidacy for the Degree of
Master of Science
In
Civil Engineering

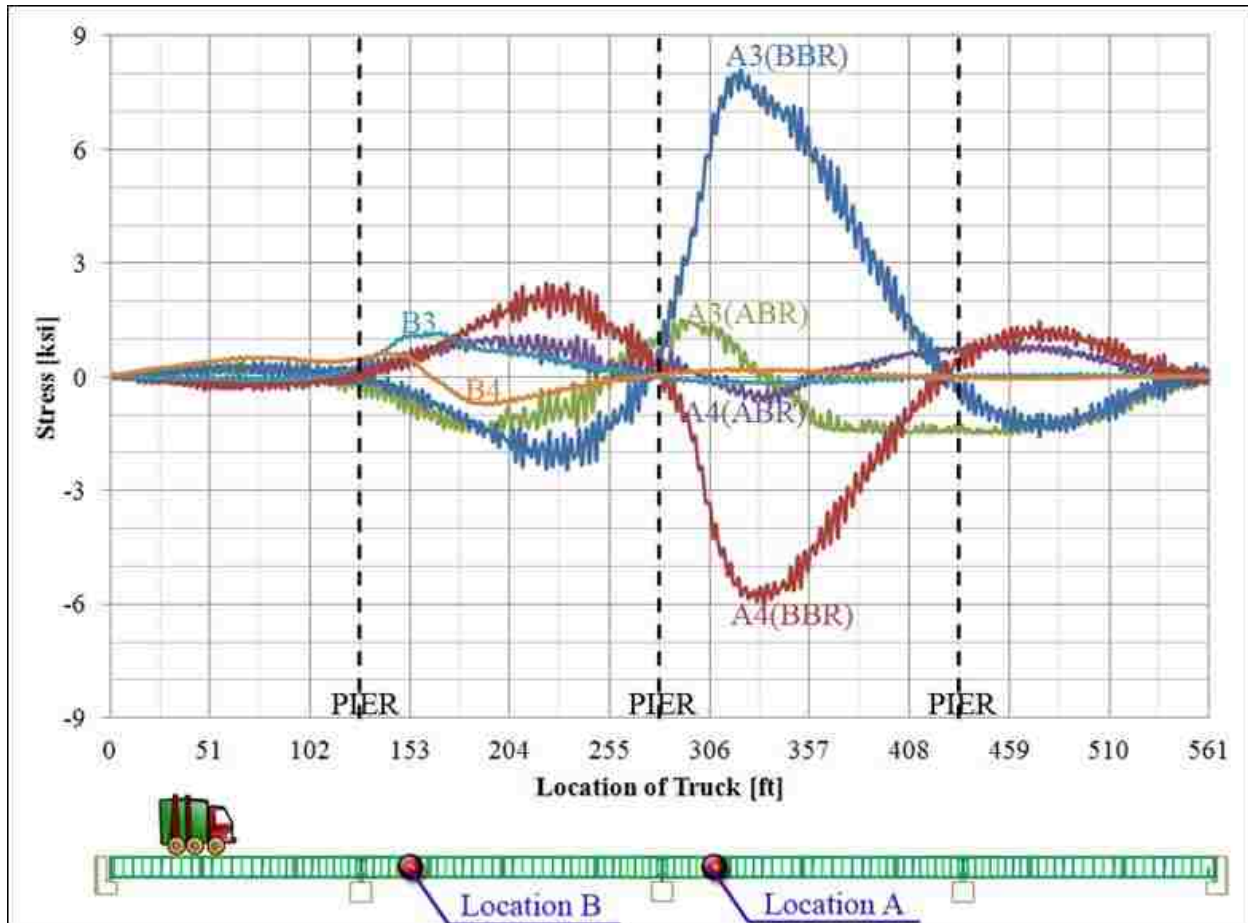
Figure 3-2: Stress location-history plot for strain gages installed on the tie plates at Location A before bolt removal (BBR), after bolt removal (ABR) and at Location B

To assess stress changes in the tie plate at Location A before and after bolt removal (BBR/ABR), stress location-history data is gathered in Figure 3-2. Comparing A3 (ABR) and A4 (ABR) to A3 (BBR) and A4 (BBR), it can be seen that removal of the bolts resulted in significantly reduced stresses in the tie plate as well as displacement of the tie plate. After bolt removal, peak stresses of 1.5 ksi were measured (compared to 8 ksi prior to bolt removal).

To evaluate the retrofit strategy operated on the tie plate at Location B, Figure 3-2 also presents the stresses in the tie plate for the same load test. After tie plate being replaced with a new identical one without bolt-connect, the girder is free to move longitudinally relative to the tie plate, the stresses are significantly reduced from the as-built condition (A3 (BBR) and A4 (BBR) in Figure 3-2). The maximum measured stress was just over 1.0 ksi.

It is also worth mentioning that stresses in the tie plate at Location B are in the same stress range as the ones in the tie plate at Location A after bolt removal, which provides a practical evidence that the “softening method” (removal of the bolts) can effectively reduce high stress in the tie plates regardless of their locations.

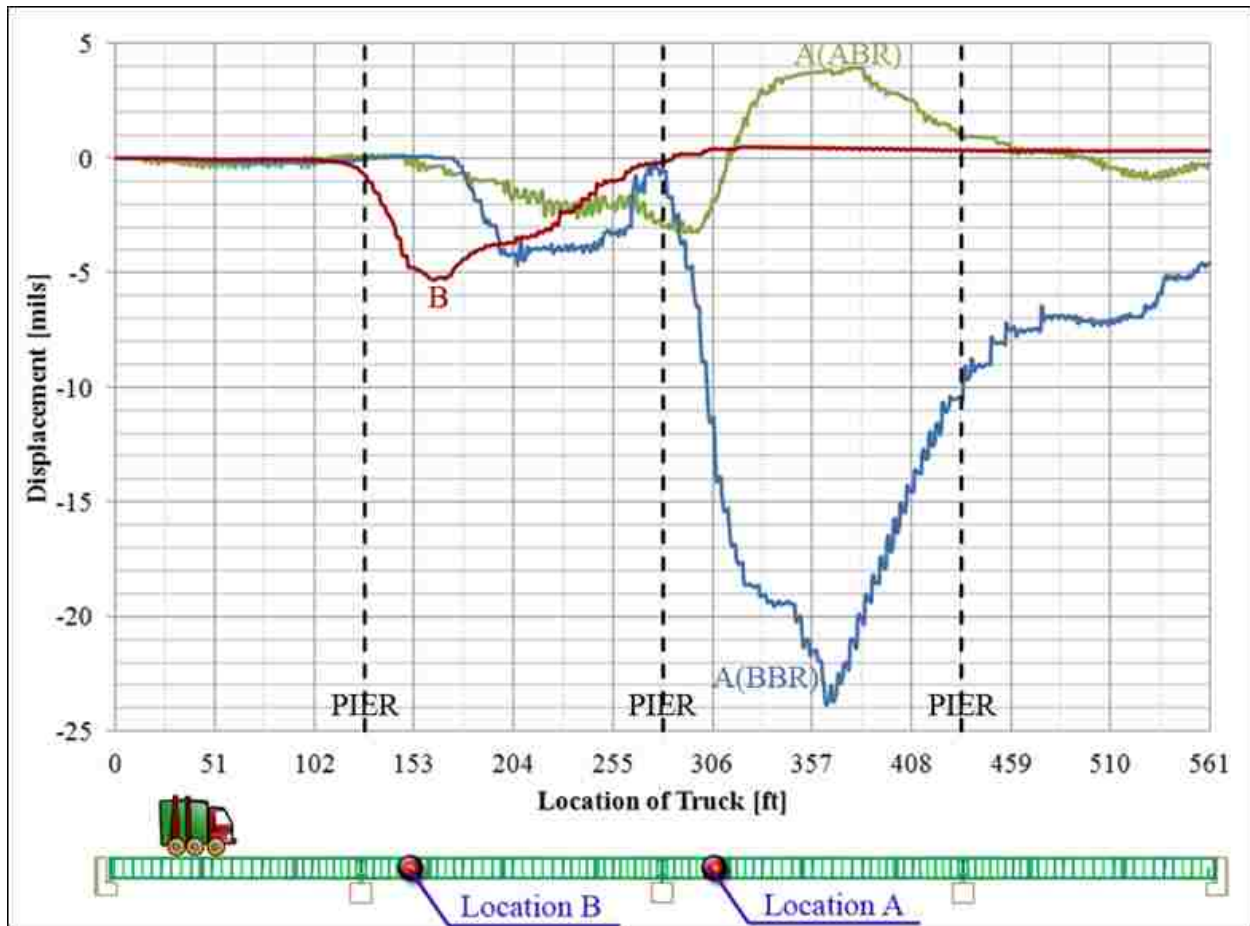
Figure 3-3: Displacement location-history plot for LVDTs installed at Location A before bolt removal (BBR), after bolt removal (ABR) and at Location B

comparison, performance at Location B, with the same loading as Location A before bolt removal, is also provided in the same figure. The maximum relative displacement of the tie plate prior to bolt removal was about 24 mils (0.024 in.), compared to 4 mils (0.004 in.) after unbolting. It is proved that removal of the bolts resulted in significantly reduced stresses in the tie plate as well as displacement of the tie plate. Peak displacement at Location B was 5 mils (0.005 in.), which was similar to A (ABR), but with a reversed sign. Plotted in blue, the relative displacement between tie plate and its adjacent stringers at Location A when tie plate still connecting to girder reveals poor coordination between tie plate and stringers, especially when test truck passing above (span three and four). It might be imposed by longitudinal girder action. It is also suspected that the sensor wasn't well-attached to structural components.

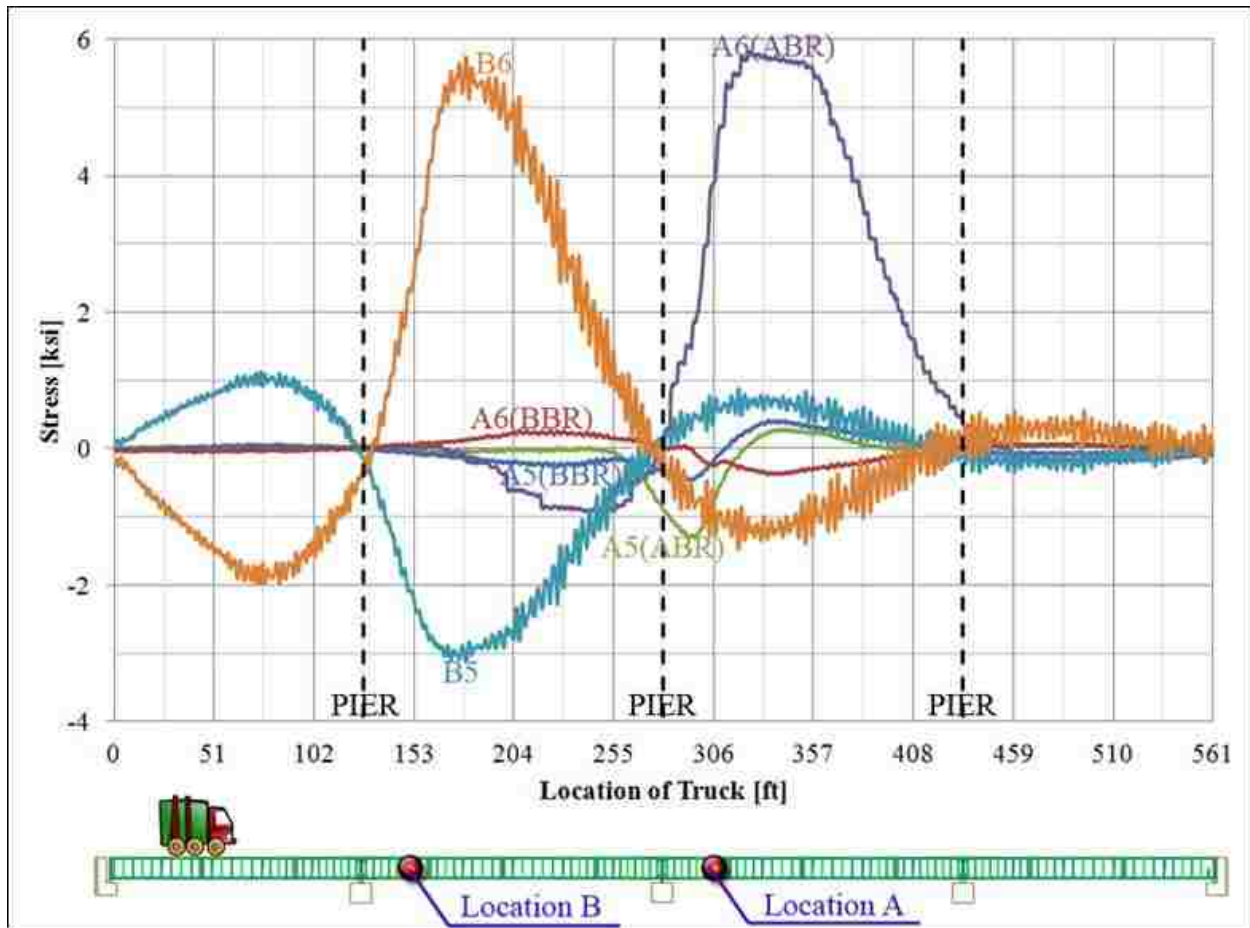
Figure 3-4: Stress location-history plot for strain gages installed on cantilever bracket web at Location A before bolt removal (BBR), after bolt removal (ABR) and at Location B

With the tie plate connected, it can be seen in Figure 3-4 that the stresses are low, with highest measured stresses at all locations of less than 1 ksi. Peak stresses occur when the test truck is directly over the instrumented location, and are in the horizontal direction (gages A6). Out-of-plane bending dominates the response of the web. Figure 3-4 also presents stress location-history plots after seven of the eight tie plate-to-girder connection bolts were removed. By comparing with A5 (BBR) and A6 (BBR), it can be seen that removal of the bolts resulted in a significant increase in the stresses in the web. The largest stress was nearly 7 ksi with a maximum stress range of over 8 ksi.

Based on observation and comparison, a conclusion can be drawn that fatigue cracking can initiate in this region as a result of relative displacements between the deck/stringers and girder. Stress location-history from sensors A5 and A6 have provided enough information about stress changes in the cantilever bracket web for the study of web stresses, thus, data from sensors A9 and A10 is no longer listed in study scope.

stresses in the web of the cantilever bracket since it is connected to the girder but restrained by the stringers. It can be seen in Figure 3-4 that the stresses in the web are significantly higher than those measured at A5 (BBR) and A6 (BBR). This is due to the release of the tie plate from the girder flange. The highest stresses were horizontal (B6) with a magnitude of nearly 6 ksi. The response of the web is dominated by out-of-plane bending, which is consistent with that of web at Location A after bolt removal.

Shown in plots colored pink and purple, data from horizontally oriented Strain gages A6 reveals a reversal in the stress before and after disconnecting girder to the tie plate (A6 (BBR) and A6 (ABR)). This is imposed by the change in longitudinal deformations as girder is freed to move without constrain from tie plate.

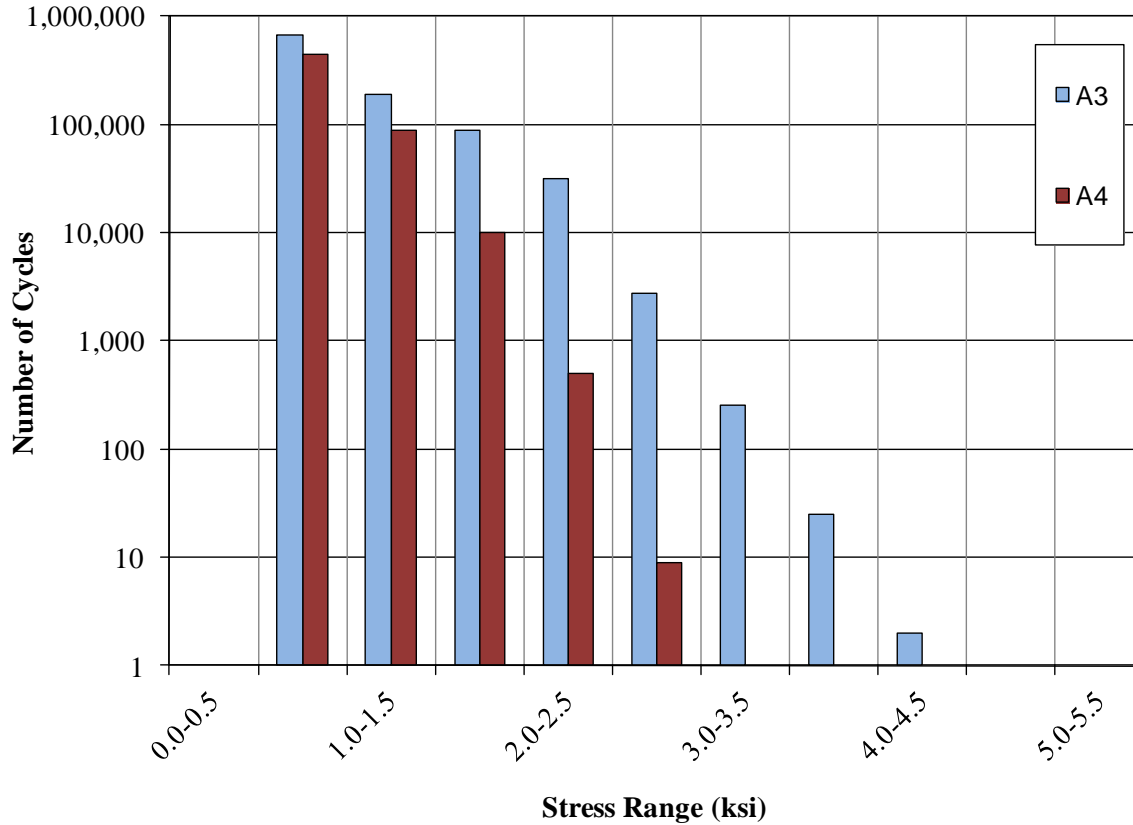
Figure 3-5: Stress-range histogram for strain gages installed on the tie plate at Location A

Plot in Figure 3-5 provides the stress-range histograms for the two strain gages installed on the tie plate at Location A after 7 of the 8 tie plate-to-girder flange bolts being removed from the connection. It can be seen in the figure that the measured stress ranges were similar at A3 and A4. Similarly, the stress-range histograms for the six strain gages installed on the web of the cantilevered floor beam bracket at Location A (strain gage installation details are shown in Figure 2-8 and Appendix A) were developed.

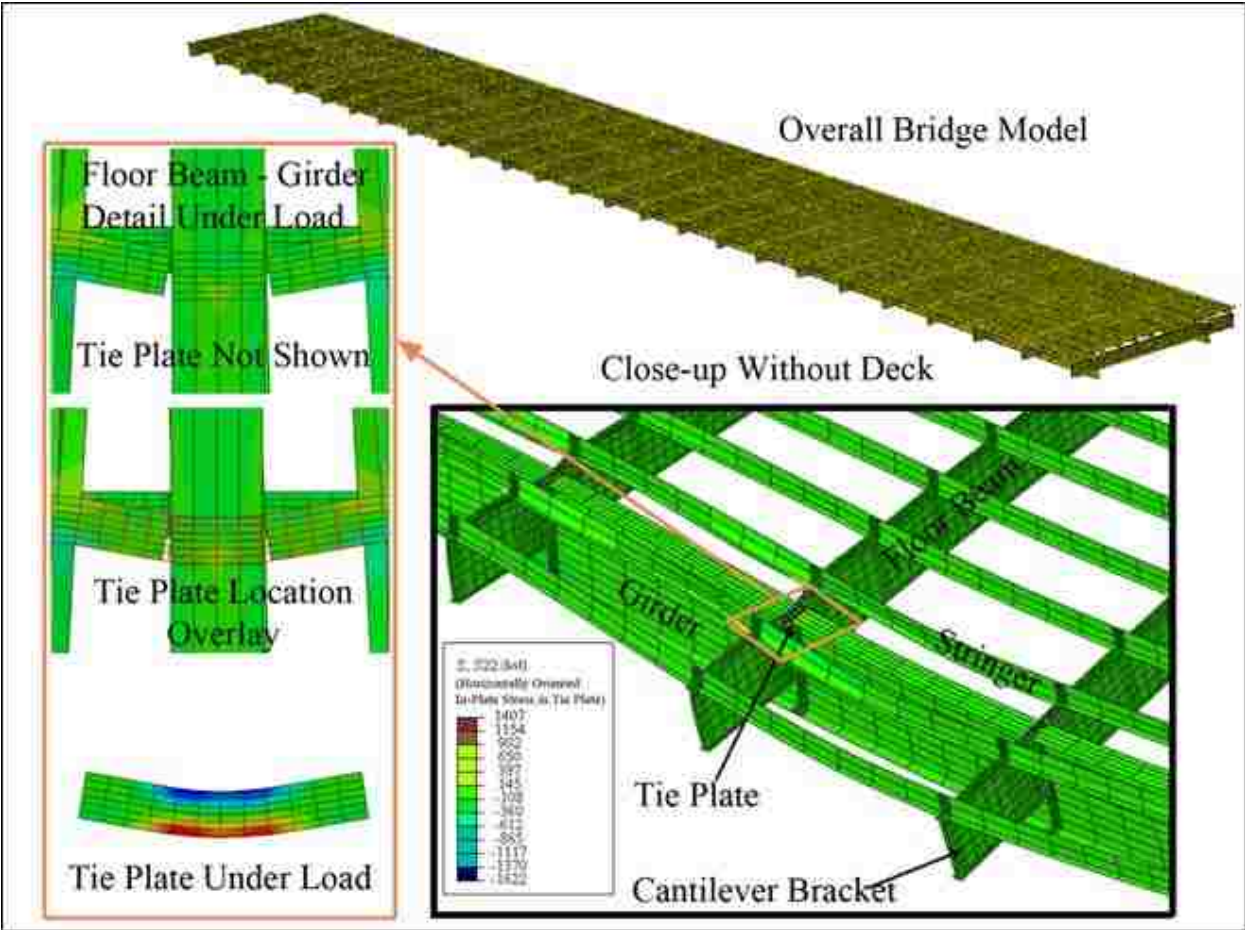
Figure 4-3: Bridge deformation and structural components' interaction

Shown in Figure 4-3 is an exaggerated deflected shape of the structure when the loads are applied on far right lane. View cut has been made at approximate half height of the stringers, leaving the lower structural components exposed. By uncovering the understructure, deformations caused by compatibilities in displacement as the members transfer loads in three dimensions can be examined. Figure 4-3 demonstrates that the longitudinal girder deflects in bending when the load is applied on the span. This deflection causes the end of the girder to rotate toward the center of the span, about the bearing located at the bottom flange of the girder. As the longitudinal girder rotates inward, the top of the transverse floor beam's web, which is

enhanced by angles and connected to the longitudinal girder, is pulled toward the center of the span. The stringers, which are connected to the top flange of the transverse floor beam, provide lateral bracing restraint and resist the inward movement of the transverse floor beam. This forces the tie plate to bend in the horizontal plane, creating tension on the leading edge of the tie plate and compression on the trailing edge of the tie plate.

The comparison of the two details indicates that the high cyclic stresses in tie-plate are caused by in-plane displacement of the tie-plate, which generated by flexural bending of the girder as well as out-of-plane bending of floor beam and cantilever bracket.

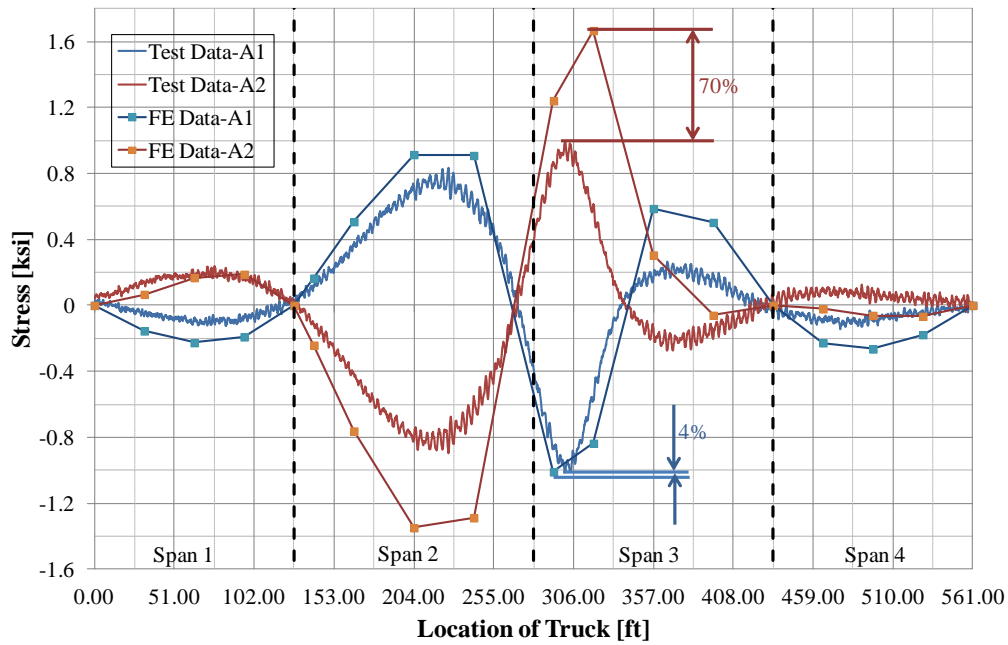
Figure 4-5: Computed and measured stress in the top and bottom girder flange at locations at Location A

The comparison of stress in top and bottom flange of the girder at Location A is plotted in Figure 4-5. The two results are in the same stress range and with the similar shapes of curvature, both of which reverse in sign once in the third span, almost at the same location. This is consistent with the expected influence line for a four-span bridge and the given sensor location. The peak stress for each plot is achieved at identical location, which is closed to the interior pier 2 (the one in the middle). The selecting of locations to apply truck load on ABAQUS model is proved to be effective.

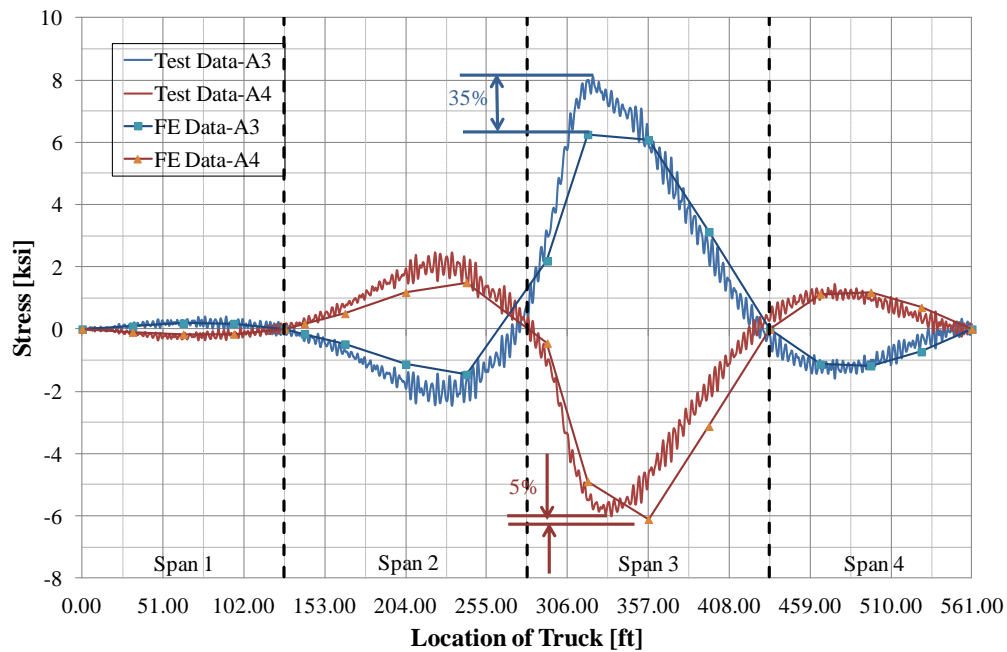
Figure 4-8: Computed and measured stress in the tie plate at locations at Location A before bolt removal

Shown in Figure 4-8 are estimated and measured stress on the tie plate at Location A, when the test truck/simulated load was applied on the eastbound right lane, prior to removal of the tie plate-to-girder flange bolts. The errors (35% of peak tensile stress and 5% of peak compressive stress) are measured near Location A, which are relatively small compared to the girder case (e.g. Figure 4-5). Recall that to simulate the loading condition, all together the six concentrated loads in ABAQUS are applied at twelve locations along the bridge spans with the same order as truck travelling direction in each case. The locations are almost evenly distributed in order to cover most of case scenarios, which include loading near piers and abutments, loading closed to instrumented tie plates, loading at mid-spans, etc. Based on observation, it is believed that the correlation would improve (i.e. the curve will be smoother) if more loading cases were examined as part of the ABAQUS model.

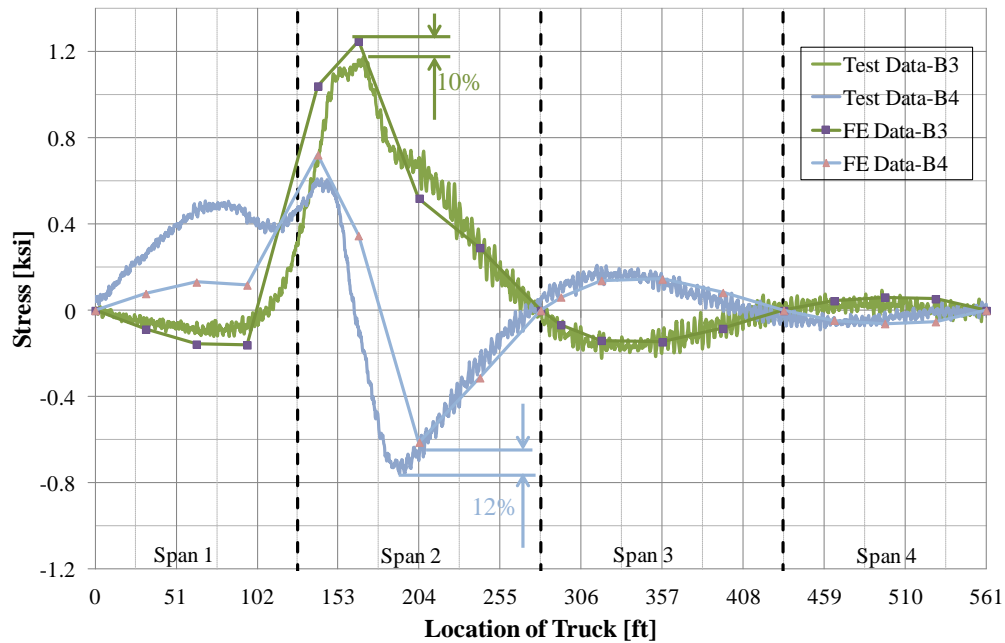
Figure 4-9: Computed and measured stress in the tie plate at locations at Location B

A similar procedure for comparison has been conducted for Location B, with the load on eastbound far right lane. As shown in Figure 4-9, after the tie plate was replaced, the girder is free to move longitudinally relative to the tie plate, the stresses are significantly reduced from the as-built condition (shown in Figure 4-10). The estimated result successfully catches the peak tensile and compressive stress, both of them occurred when load was applied near Location B. The analytical plot generally matches well with field measurement result along the bridge span, with a small margin of error. The error rate is as low as 10%.

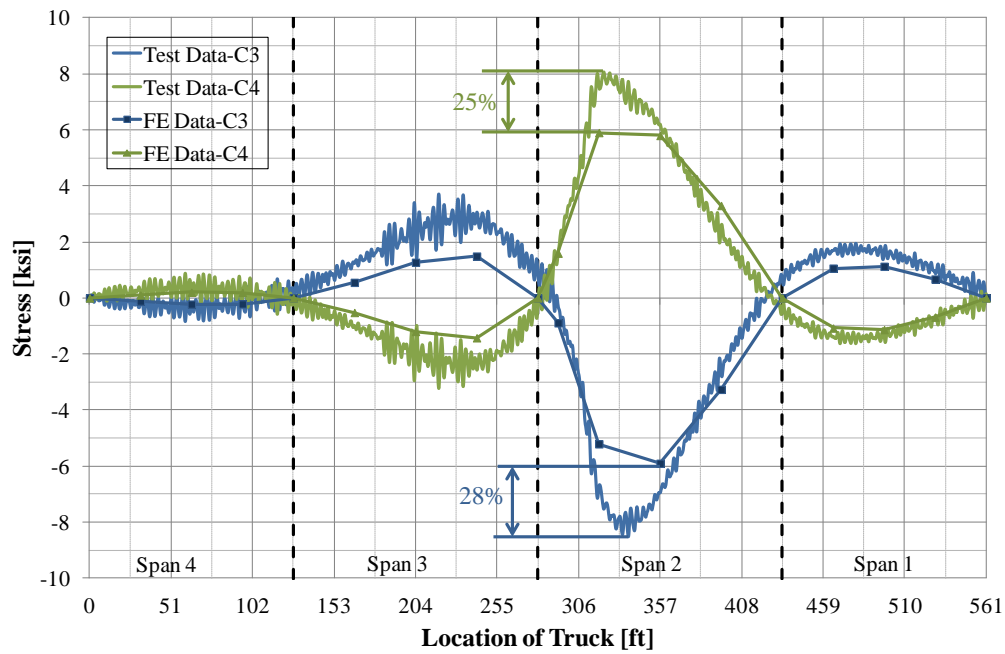
Figure 4-10: Computed and measured stress in the tie plate at locations at Location C

Figure 4-10 provides correlation between finite element model and strain gage results, which is similar as Location A. The load was on westbound right lane, passing span 4 through 1 in an order. Again, the model agrees well with field data, it also provides evidence that reducing the interval of loading cases would more precisely predict the peak stress.

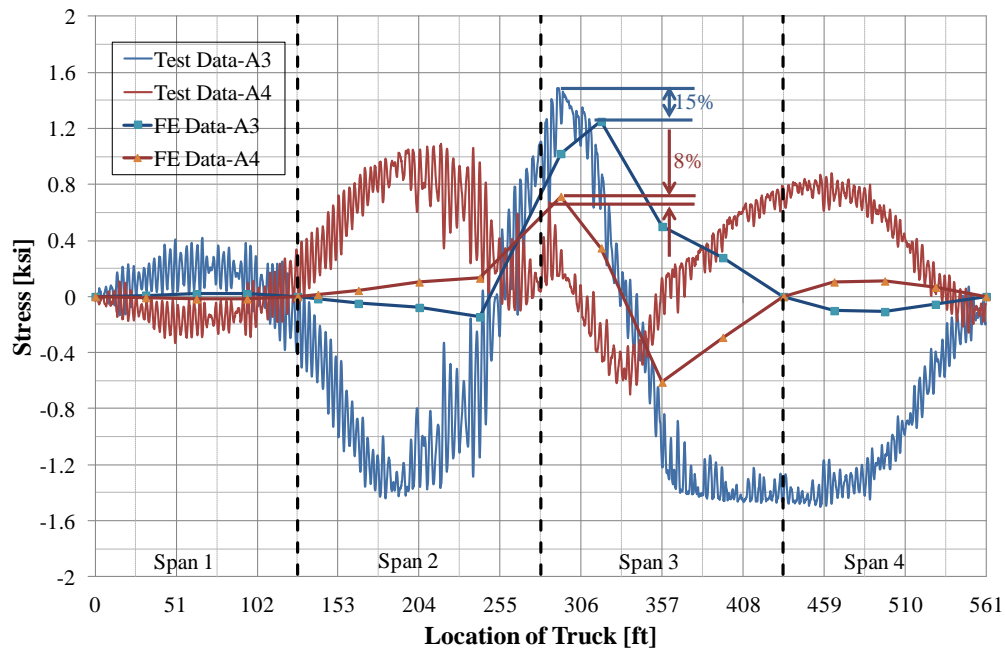
Figure 4-11: Computed and measured stress in the tie plate at locations at Location A after bolt removal

Above figure shows unstable correlation between computed and measured stresses in tie plate at Location A after seven of eight tie plate-to-girder flange bolts were removed from the connection. The stresses in both plots are significantly reduced due to release of the constraint. The error recorded when load was passing Location A are 15% of actual stress on the east side of the tie plate, and 8% on the west side, which are significantly lower than the average error rate.

The failure of estimation could be attributed to the difference between in-situ condition of tie plate connection and constraint in ABAQUS model. Although the incompleteness of unbolting was modeled as well in FE model, by leaving one tie constraint at similar location, the in-situ condition was suspected to be somewhat between complete unbolted and fully connected, given the fact that the nut on the bolt was removed however the bolt itself remained in place.

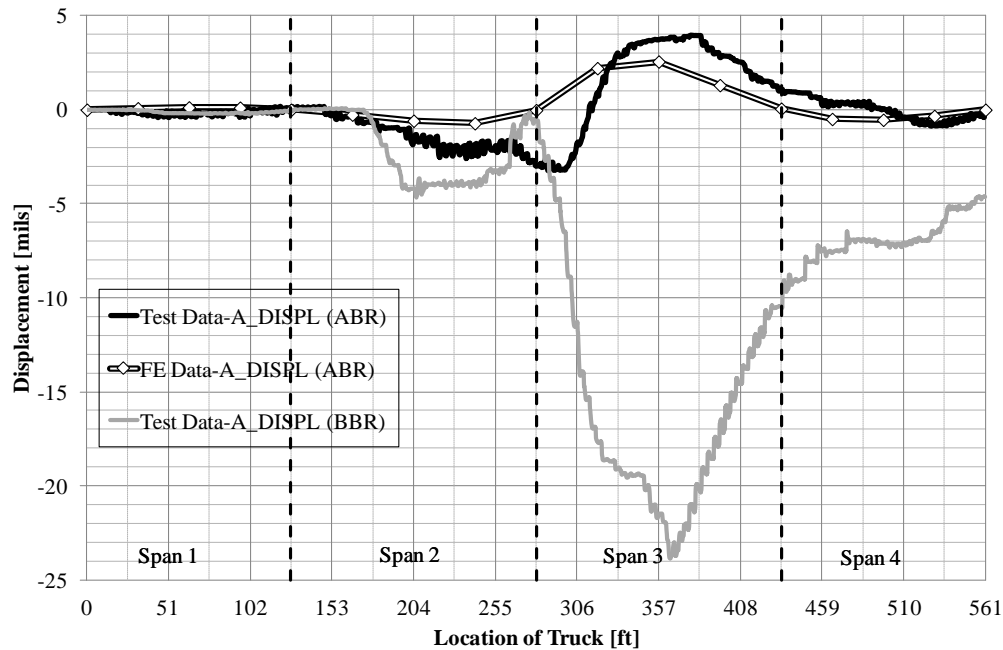
Figure 4-12: Displacement location-history plot for test data and FEA of tie plate at Location A before bolt removal (BBR), after bolt removal (ABR)

FEA shows agreeable match of displacement location-history of tie plate at Location A after bolt removal (ABR) compared to LVDT data (shown in Figure 4-12). The theoretical analysis succeeded in catching the slope, though the predicted maximum and minimum value of the relative longitudinal displacement between the centerline of the tie plate at the girder and the connection points at the stringers on either end are conservative. The plots of LVDT results of both before and after unbolting cases show some levels of deflection when the load applied right above the interior support. Since the sensor was attached to the stringer it is suspected that the relative deflection was not properly measured.

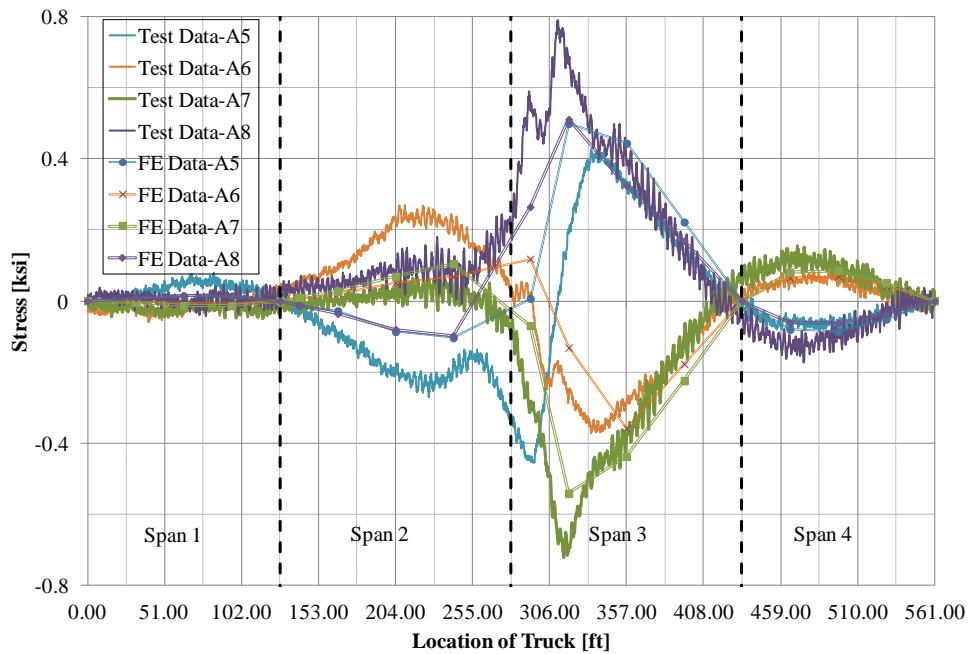
Figure 4-13: Computed and measured stress in the cantilever bracket web at locations at Location A before bolt removal

Shown in Figure 4-13 are the comparison plots for the four sets of data. The twelve loading cases cover most of the critical stress changes along the overall bridge span and precisely catch the locations where peak tensile and compressive stress occurred. Furthermore, a better correlation between the finite element model and the test results was obtained for vertically oriented stress (presented by A5 and A7). Higher error rate of data comparison for horizontal stress could be attributed to the discrepancy in connection angle simulation of cantilever bracket web region, which is originally modeled to accommodate the potential stress concentration.

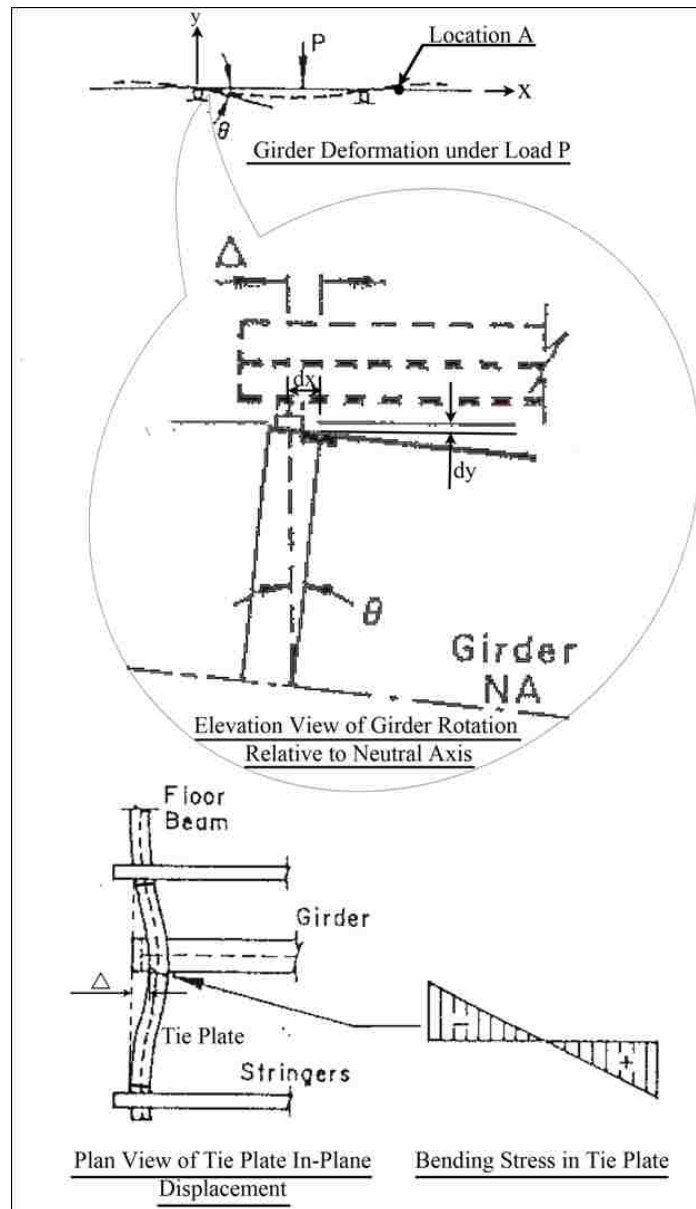
Figure 5-1: Sketch of tie plate bending due to global action [Fisher 1984, Page 188]

Studies in field measurement and FEA indicate that the tie plates are subjected to in-plane bending stresses. Figure 5-1 shows schematically that the high cyclic stresses in tie-plate are caused by in-plane displacement of the tie-plate, which generated by flexural bending of the girder. X-axis is parallel with longitudinal girder, the positive direction represents truck traveling direction on eastbound. Y-axis indicates vertical deflection; its positive direction is opposite to load applying direction. Both axes in this 2-D sketch are consistent with global coordinates in FE model. Correspondingly, dx and dy are considered as longitudinal and vertical deflection of girder, respectively. After taking the height of girder cross-section into consideration and assuming that the neutral axis of girder cross-section and the axis of zero

rotation of girder coincide with each other, the first sketch of girder major deformation can be magnified at one floor beam (the second sketch in Figure 5-1). Δ is the displacement at tie plate with respect to its associated girder.

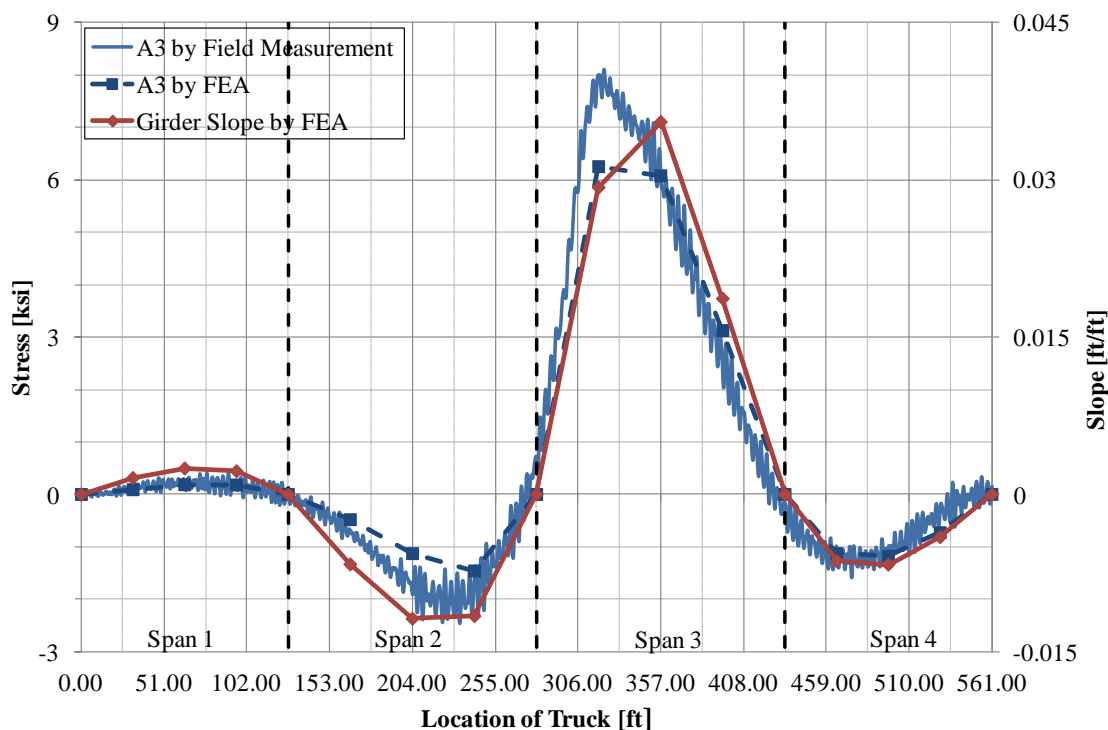
Figure 5-2: Comparison of stress history in tie plate with influence line for girder slope for Location A (floor beam 13)

As shown in Figure 5-2, the in-plane bending of tie plate is compatible with the change in slope of the main longitudinal girder. The influence line for Location A agrees with the measured stress response. As predicted, the primary cracking occurred at locations that experienced the largest changes in rotation.

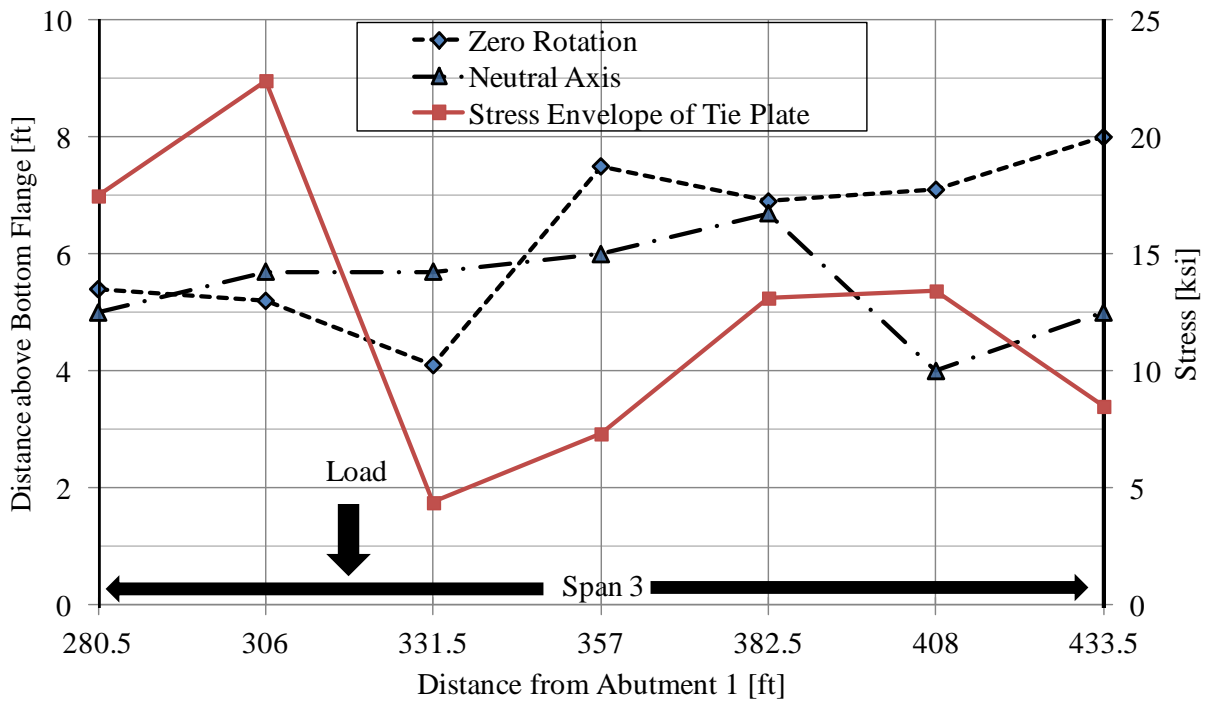
Figure 5-3: Neutral axis and zero rotation location of south girder and stress envelope of the associated tie plate

This typical case indicates opposite to sketch in Figure 5-1, the neutral axis and the axis of zero rotation do not coincide with each other due to actual boundary condition in practice. The non-composite cross-section of girder is symmetric, with the height of 10 ft, the neutral axis of girder over two end piers is the same as the geometric center of girder cross-section. The locations of zero rotation of girder, however, are variable at different floor beams. Recall that the tops of girder and floor beam are at the same elevation (shop drawing in Figure 2-3) and the floor beam height is 6 ft, which sum up to 4 ft between the bottom flanges of floor beam and girder. When girder rotates with respect to its geometry center, large rotation is produced resulting high bending stress at tie plate. When floor beam interferes with girder rotation causing girder rotating relative to floor beam bottom flange, the connecting tie plate becomes less vulnerable to girder rotation. Then when the center of floor beam becomes the new center of rotation, the relative movement between girder top flange and tie plate continues to induce in-plane bending, though the magnitude is not as large as the one controlled by main girder rotation.

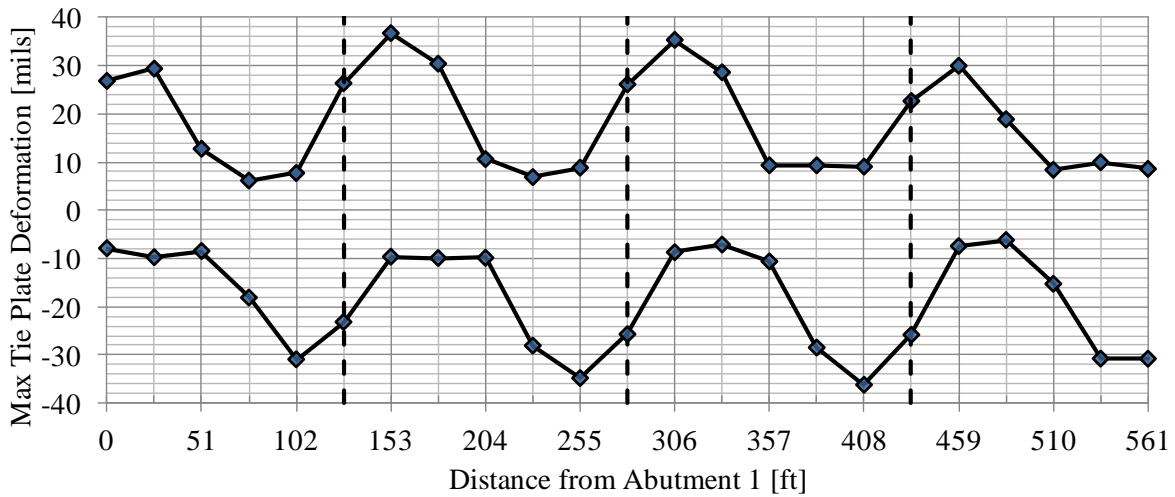
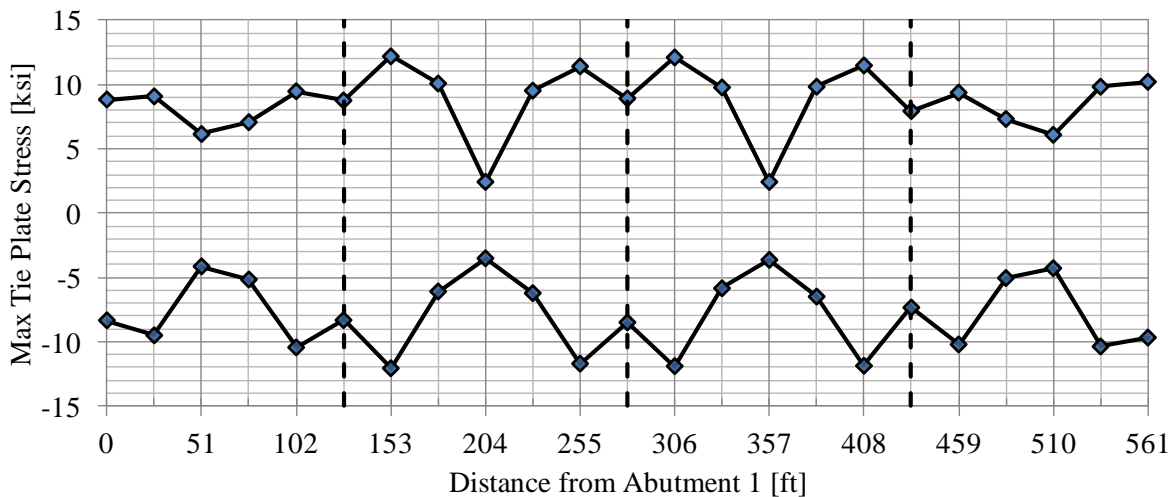
Furthermore, the data of stresses and displacements at tie plates along the entire length of the south girder were collected from all eastbound replicated test load positions. Figure 5-4 and Figure 5-5 provide the envelopes of the maximum and minimum in-plane displacements and bending stresses at each tie plate. The in-plane displacements of the tie plates in the middle of each span are relatively small. Correspondingly, the more highly stressed tie plates are near the piers and abutments. These behaviors can be seen to be compatible with the change in slope of the main longitudinal girder.

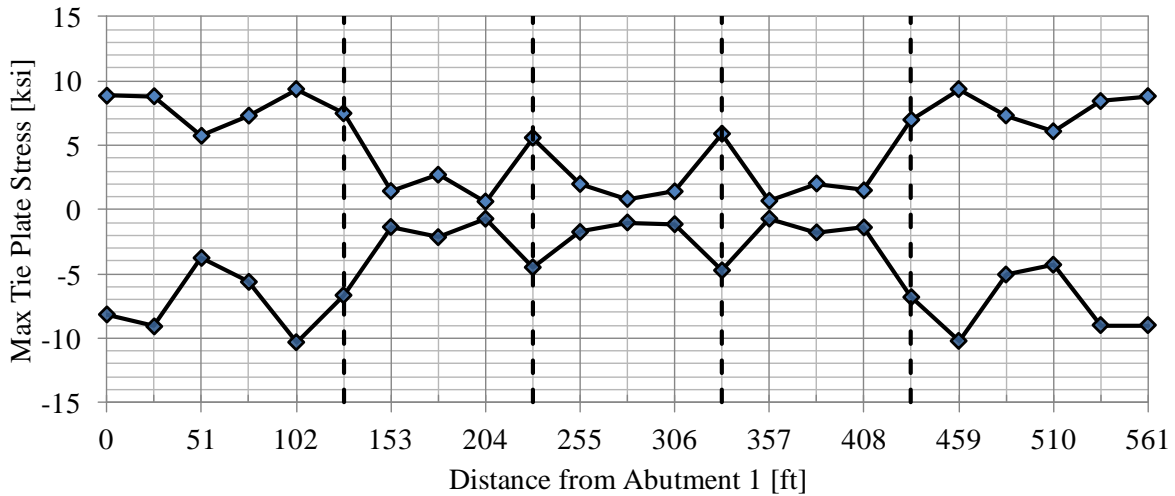
Figure 5-6: Envelope of normal stress at each tie plate after shortening the span length

As shown in Figure 5-6, decreasing the length of interior spans reduces the girder slope therein and consequently the bending of the tie plate. The stresses in tie plate have reduced dramatically, while the one along exterior span remains in the same stress range.

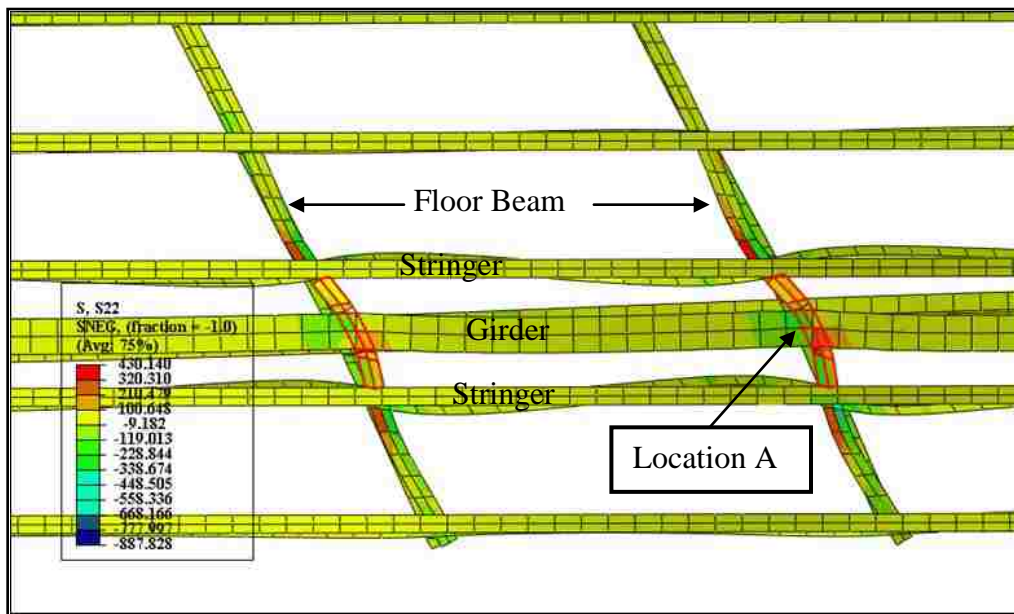
Figure 5-9: Magnified plan view of floor beam system deformation and structural components' interaction

A bridge model of the same dimension and geometry as the existing one but with all floor beams parallel to the end ones is developed in ABAQUS program. The modified FE model sustains the same level of accuracy by remaining the mesh sizes and tie constrains at connection region. Figure 5-9 demonstrates that as the longitudinal girder rotates inward, the top of the transverse floor beam's web, which is enhanced by angles and connected to the longitudinal girder, is pulled toward the center of the span. The stringers, which are connected to the top flange of the transverse floor beam, provide lateral bracing restraint and resist the inward movement of the transverse floor beam. This forces the tie plate to bend in the horizontal plane, creating tension

on the leading edge of the tie plate and compression on the trailing edge of the tie plate. Compared with Figure 4-3, floor beam is susceptible to torsion, resulting higher in-plane bending demand. The legend at the lower right corner presents in-plane bending stress at girder top flange, with the unit of ksf. The stress at the corresponding tie plate at Location A plotted in Figure 5-8 is revealing of significant increase when truck load is travelling nearby, due to the contribution of torsion of floor beam system.

The qualitative and some quantitative comparison might provide reference to future design and examination of skewed steel plate girder system. Torsion of floor beam system should be eliminated in order to secure the maximum value of stress range being kept at a level which is less than the fatigue limit of the structural detail.

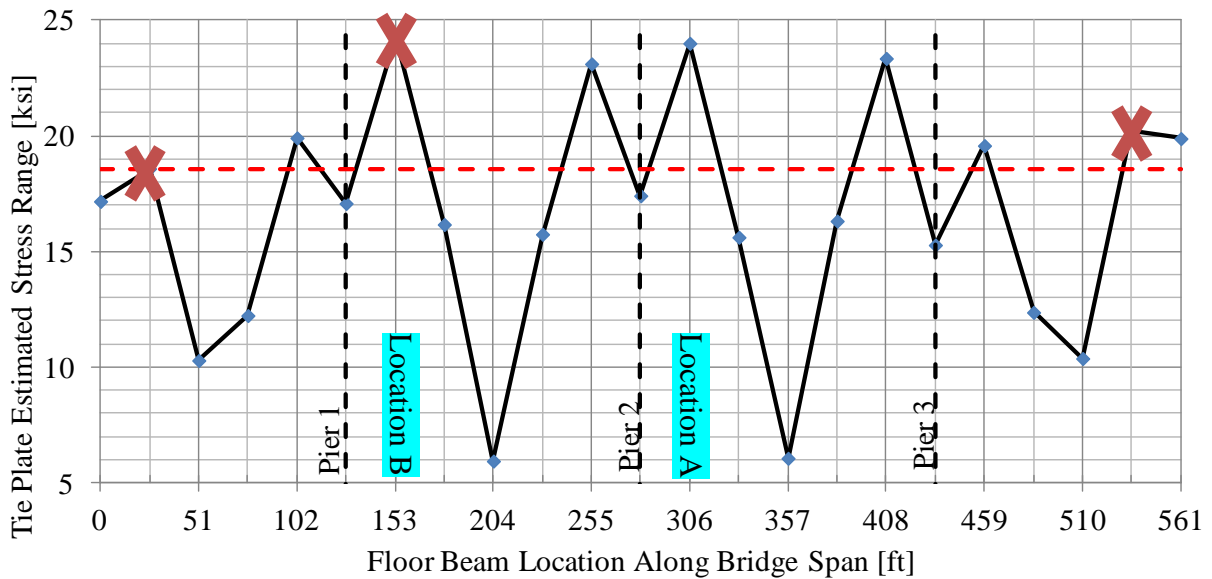
Figure 6-1: Estimated stress range for tie plates over south girder

To evaluate the likelihood of cracking at each tie plate on the bridge, Figure 6-1 illustrates the predicted stress ranges for the tie plates over south girder under the replicated test truck load. The estimated stress range of each tie plate is obtained by adding the absolute values of maximum and minimum in-plane bending stresses plotted in Figure 5-5. The locations marked with red crosses have already exhibited cracking, which are floor beam #2, #7 (Location B) and #22. The stresses at location B is the higher stress location predicted by analysis, providing confirmation of field inspection results. Other locations of potential crack formation can be identified, such as Location A and Location C. Note that the tie plate at Location A was over the south girder at the first floor beam east of Pier 2, and the tie plate at Location C was over the north girder at the first floor beam west of Pier 2, those two tie plates were located symmetrically at two sides of the center of Pier 2.

Recall in section 3.2.3, the field evaluation revealed that fatigue cracking of Location C should have already occurred at tie plate. Note that the tie plate at Location C was over the north girder at the first floor beam west of Pier 2. Again, the FE model gives accurate prediction of location where tie plate with high risk.

Validated by field inspection and long-term monitoring program, tie plates with potential fatigue failures are identified by the parametric study. Shown in Figure 6-1, the dividing line illustrated as the red dashed line is representing the cracked region. As a minimum, all tie plates with stress ranges higher than the cracked regions should be unbolted. Based on these results a minimum of nine tie plates are likely to have fatigue failures in the near future.
