Rapid repair of severely damaged RC columns under combined loading of flexure, shear, and torsion with externally bonded CFRP

RAPID REPAIR OF SEVERELY DAMAGED RC COLUMNS UNDER
COMBINED LOADING OF FLEXURE, SHEAR, AND TORSION
WITH EXTERNALLY BONDED CFRP

A DISSERTATION

CIVIL ENGINEERING

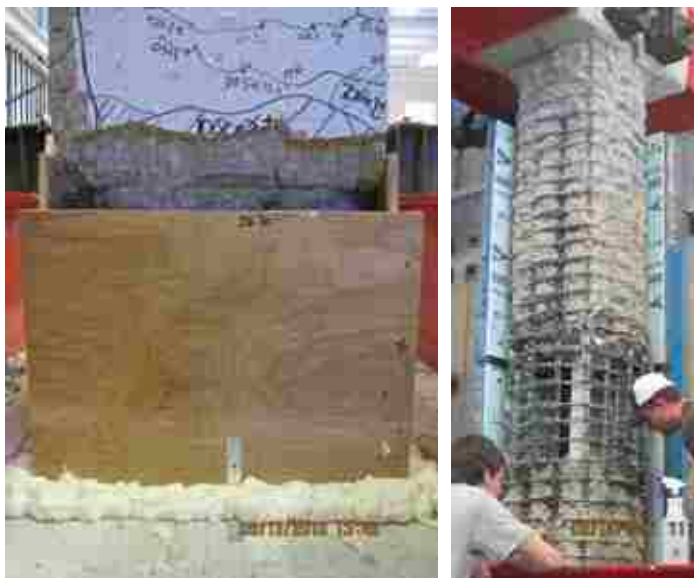
(a) Plywood Formwork

(b) Metal Formwork

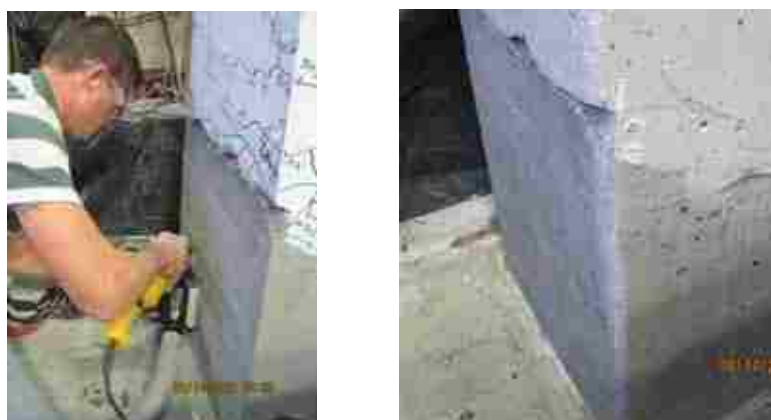
Figure A.5. Concrete Surface Smoothing

(a) Smoothing Concrete Surface

(b) Smoothed Concrete Surface with Corner

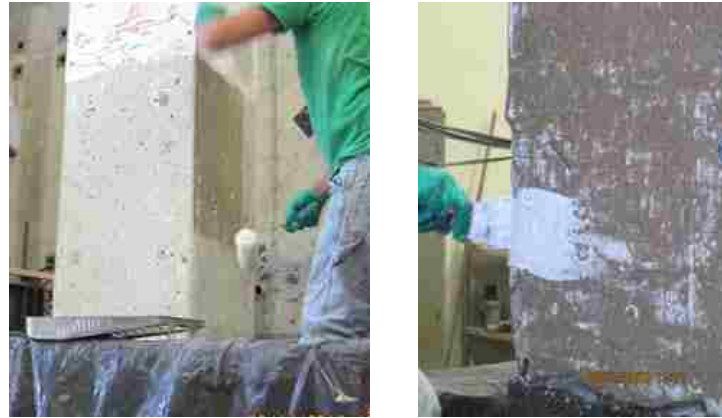
Figure A.6. Concrete Surface Preparation

(a) Application of MBrace® Primer (b) Application of MBrace® Putty

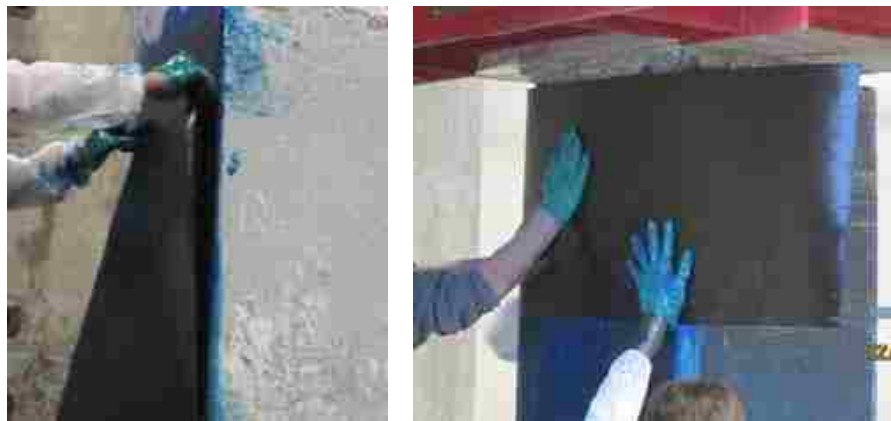
Figure A.7. Application of MBrace® CFRP System

(a) Application of Longitudinal CFRP (b) Application of Transverse CFRP

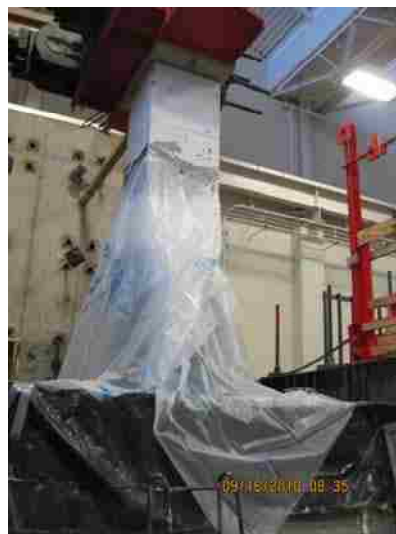
Figure A.8. Curing of the CFRP System

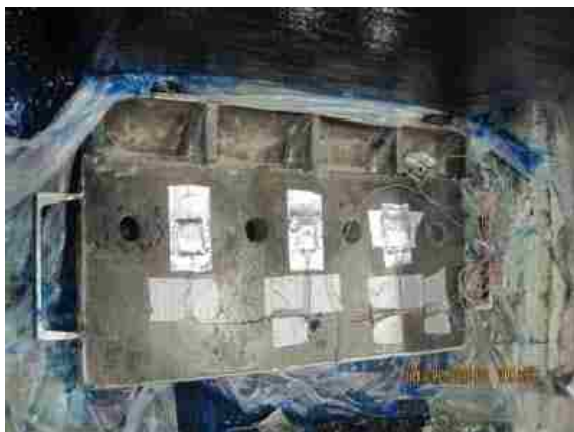
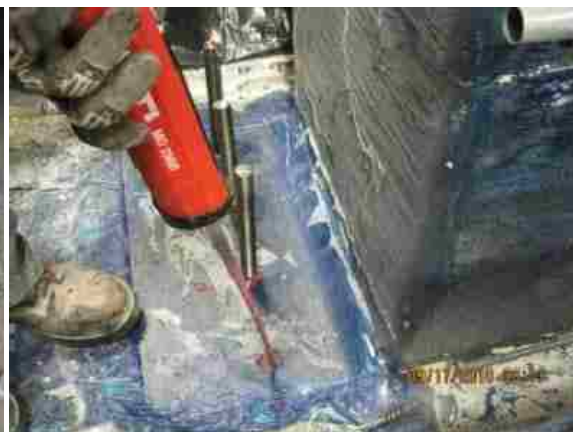
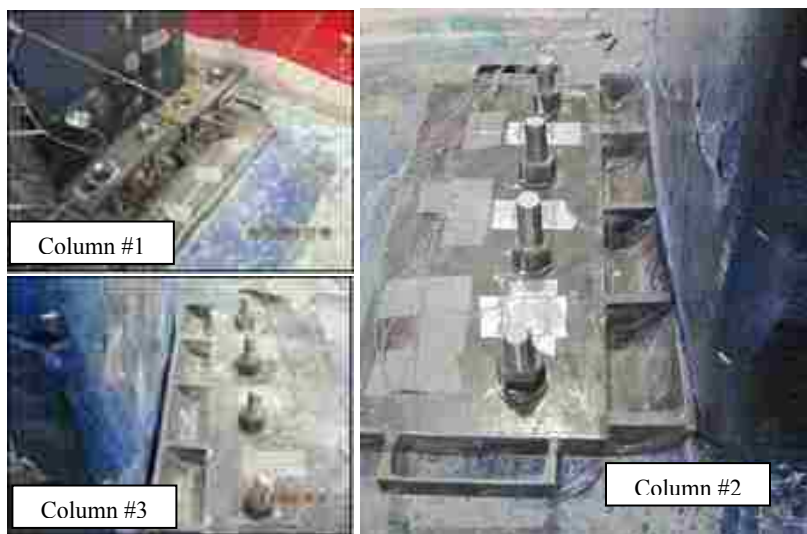
Figure A.9. Novel Anchorage System (Grelle 2010)

(a) Temporary Placement of Anchorage Over “Wet” Saturant

(b) Injecting Epoxy Into Anchor Rod Holes

(c) Installed Novel Anchorage System
