Bridge deck condition assessment using destructive and nondestructive methods

BRIDGE DECK CONDITION ASSESSMENT USING DESTRUCTIVE AND
NONDESTRUCTIVE METHODS

BRANDON TYLER GOODWIN

MASTER OF SCIENCE IN CIVIL ENGINEERING

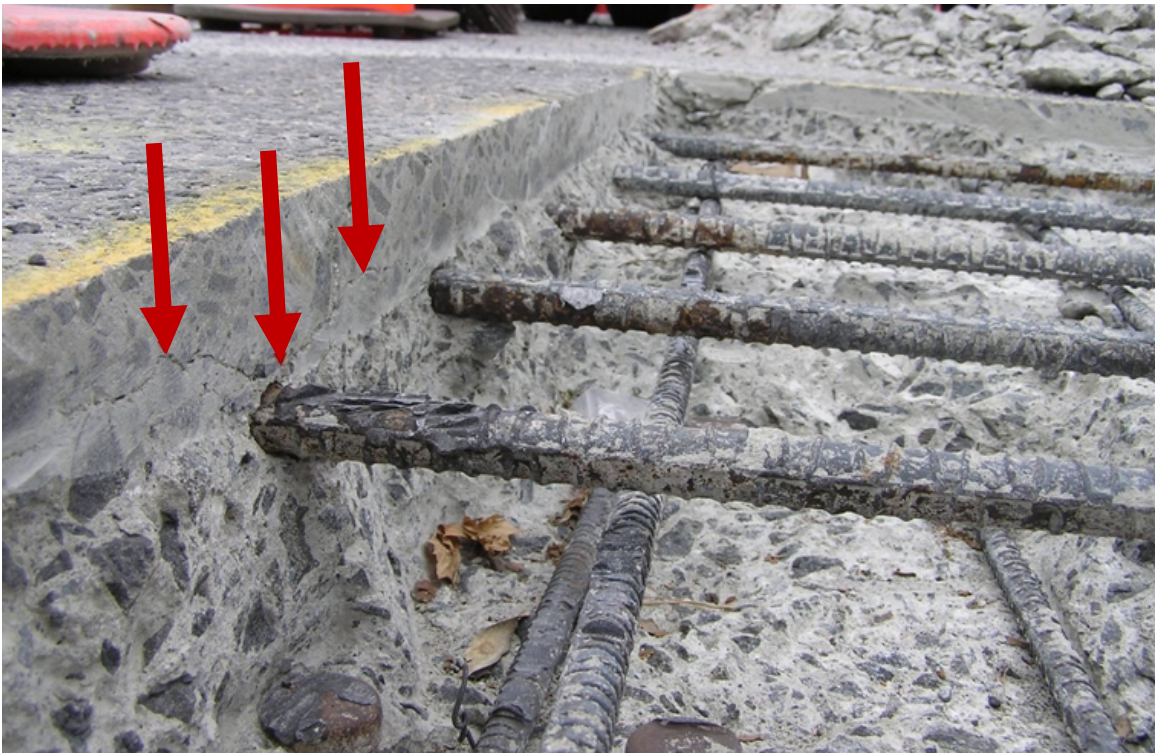
Figure 2.2. Delamination in Bridge Cross Section [6]

oxygen and water can reach the steel allowing corrosion to occur. Corrosion products from the steel occupy a volume between three to six times that of original steel, inducing large tensile stresses in the concrete [4]. If the tensile strength of the concrete is exceeded, a horizontal crack called a delamination will occur. According to the American Concrete Institute (ACI), a delamination is defined as “a horizontal splitting, cracking, or separation within a slab in a plane roughly parallel to, and generally near the upper surface” [5]. Delaminations can cause an increased rate of corrosion as well as visible deterioration on the bridge deck surface such as spalling and potholes. Figure 2.2 below shows a delamination present in a bridge deck cross section [6].

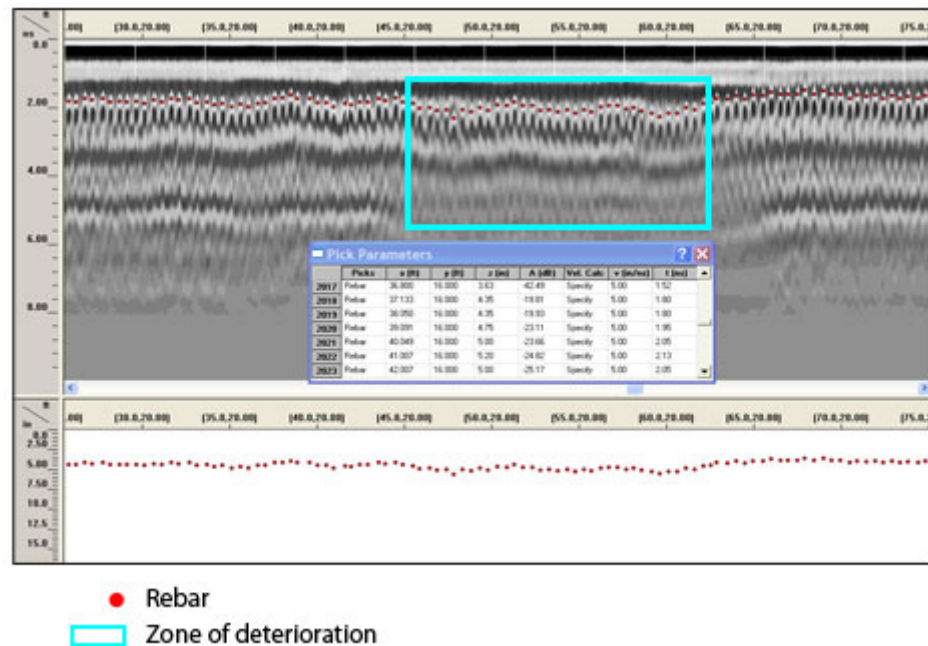
Figure 2.8. GPR Results from a Bridge Deck [30]

sample GPR results from a bridge deck [30]. The hyperbolas in the image represent reflections from the reinforcing bars. The boxed area shows a section of the bridge deck that is predicted to be deteriorated, as indicated by signal attenuation and varying apparent depths of reinforcing bars.

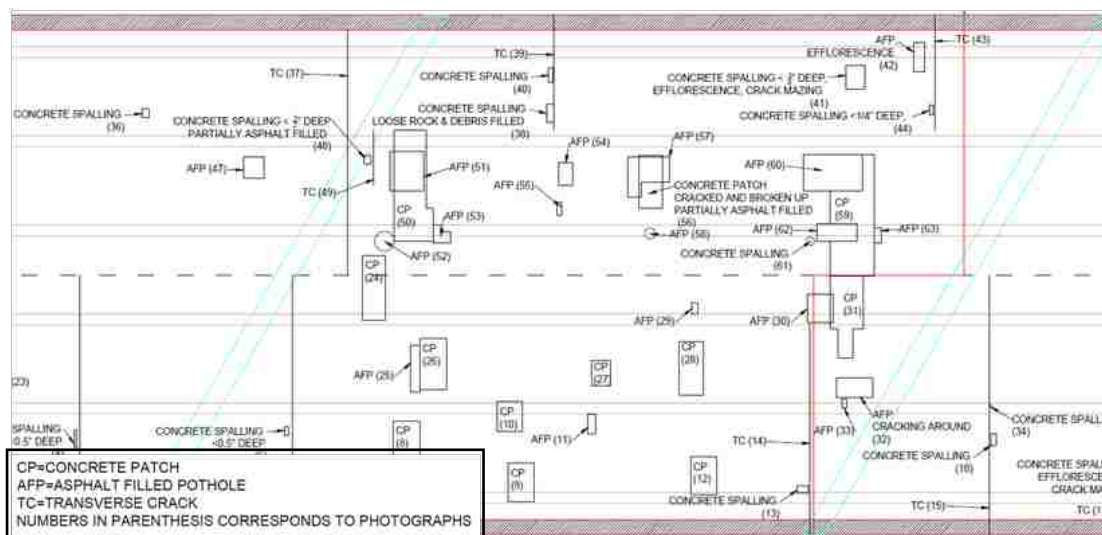
Figure 3.3. Sample Visual Inspection Results

3.1.1. Visual Inspection. Each bridge was carefully examined for defects and deterioration by the researchers on site. The top of each bridge deck was thoroughly examined for signs of defects and deterioration including asphalt and concrete patches, cracks, unfilled spalls, and efflorescence. Where time and access allowed, the underside of the deck was quickly examined for concrete spalling, rust marks, efflorescence, and any other signs of deterioration. Each noted item on the top of the deck was numbered, measured, and photographed. These notes were later incorporated into CAD drawings of the bridge, showing the exact size, location, and type of defect or deterioration as shown in Figure 3.3 below.

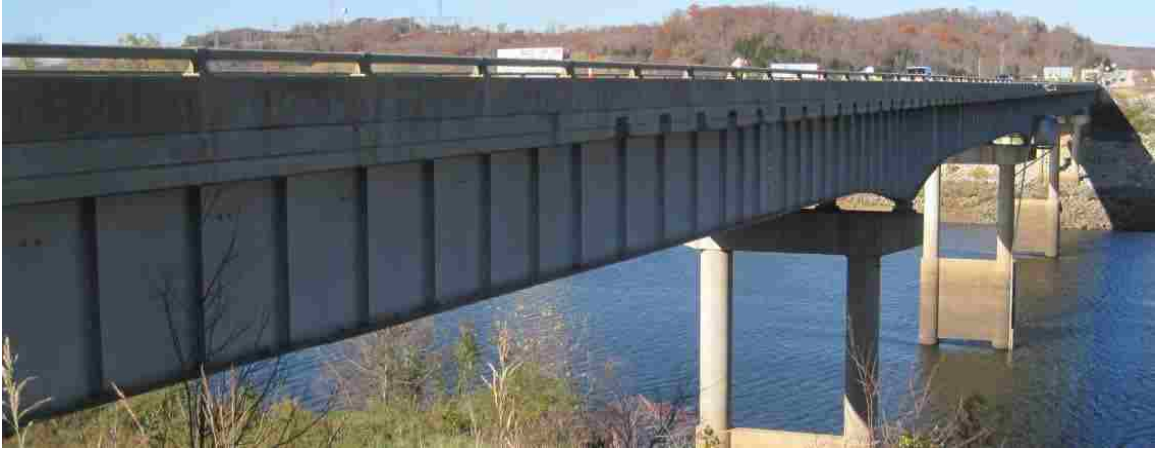
Figure 3.14. Bridge A1479 Side View

Bridge A1479 is located near Lake Ozark City, in Miller County, Missouri. The bridge carries U.S. 54 West Bound traffic over the Osage River. Figure 3.14 below shows a side view of the bridge. In November 2012, the initial bridge investigation took place, which included visual inspection of the deck, PSPA, GPR, and coring. Eight researchers assisted in the seven hour long initial investigation. Approximately 0.25 in. of rain was reported in the area within the seven days prior to the investigation. The reported high and low temperatures for the day of the investigation were 64°F and 32°F, respectively. The deck was not prepared in any way prior to the investigation. Debris was minimal in the area of the GPR scan, which only included the two driving lanes.

Rehabilitation of the bridge commenced in March 2013 and was completed in May 2013, with a total project cost of \$835,000 [49]. Hydrodemolition was used to remove loose and deteriorated concrete on the outside (West) lane in March 2013, and in April 2013 for the inside (East) lane. Each lane was scanned with lidar before and after the hydrodemolition process to document the concrete removal.

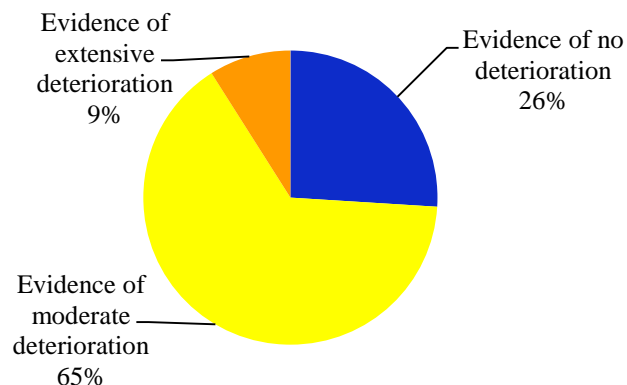
Figure 3.21. Bridge A1479 Deck Deterioration Levels Based on GPR

Of the 27,776 sq. ft. inside curb-to-curb area of the bridge deck, 20,760 sq. ft., or 75%, was scanned with GPR. Based on the GPR estimates, 5,398 sq. ft. or 26% of the scanned portion had no evidence of deterioration. 13,494 sq. ft. or 65% of the deck was estimated to have evidence of moderate deterioration, and 1,868 sq. ft. or 9% was estimated to have evidence of extensive deterioration. These values are illustrated in Figure 3.21 below.

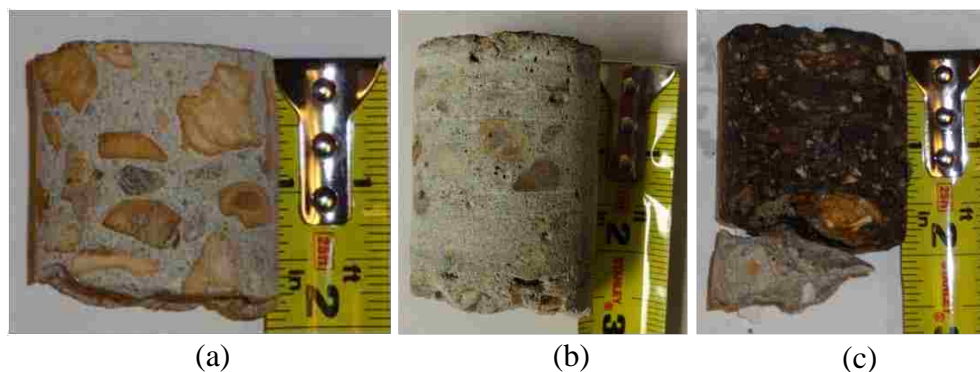
Figure 3.22. Material Types of Extracted Cores from Bridge A1479, (a) As-Built Concrete, (b) Concrete Patch, (c) Asphalt Overlaying As-Built Concrete

3.2.2.3 Cores. Nine cores were extracted from the deck of Bridge A1479. Of the nine cores, five were rated good based on visual evaluation, three fair, and one bad. Refer to Section 3.1.4.1 for the core rating criteria. Seven of the cores were composed of the as-built concrete, one of the cores was taken from a concrete patch as determined by the difference in aggregate, and one core was mostly asphalt, with a 0.5 in. piece of as-built concrete on bottom as shown in Figure 3.22 below. Figure 3.23 shows all nine cores extracted from Bridge A1479, along with the visual rating assigned to each during the visual evaluation. Complete core visual evaluation results are included in the Appendix B.

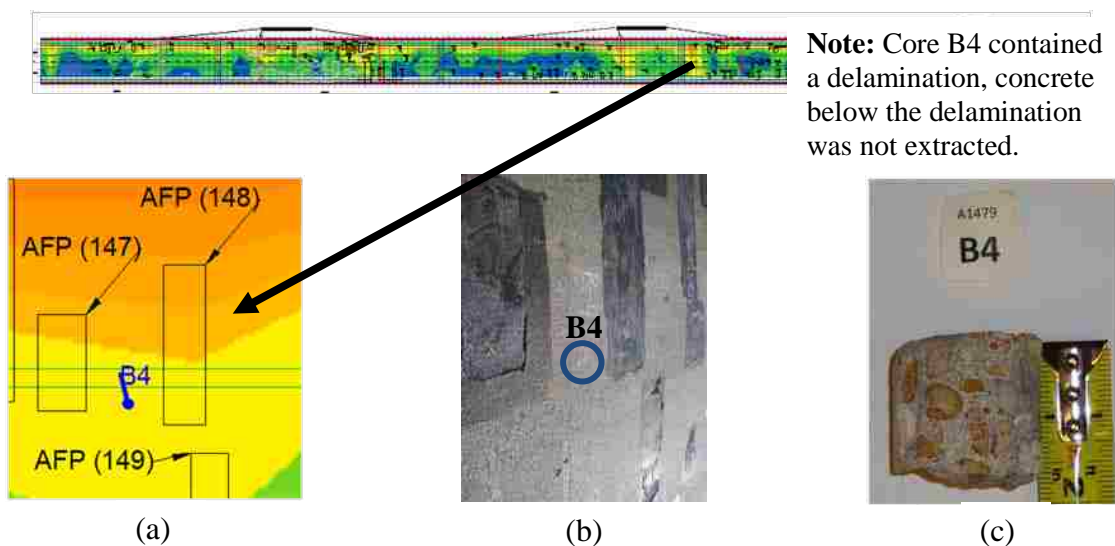
Figure 3.25. Bridge A1479 Core B4, (a) On Bridge Drawing, (b) Deck Image at Core Location, (c) Extracted Core

Figure 3.30 shows Core B3 on the GPR and lidar maps. As mentioned in Section 3.2.2.3, Core B3 was rated good in the visual evaluation and was located in an area where there was no evidence of deterioration based on the GPR results. Figure 3.31 shows Core B4 on the GPR and lidar maps. Core B4 was rated fair in the visual evaluation due to a delamination at an approximate depth of 1.75 in. Based on the GPR results, the area where Core B4 was extracted from showed evidence of moderate deterioration.

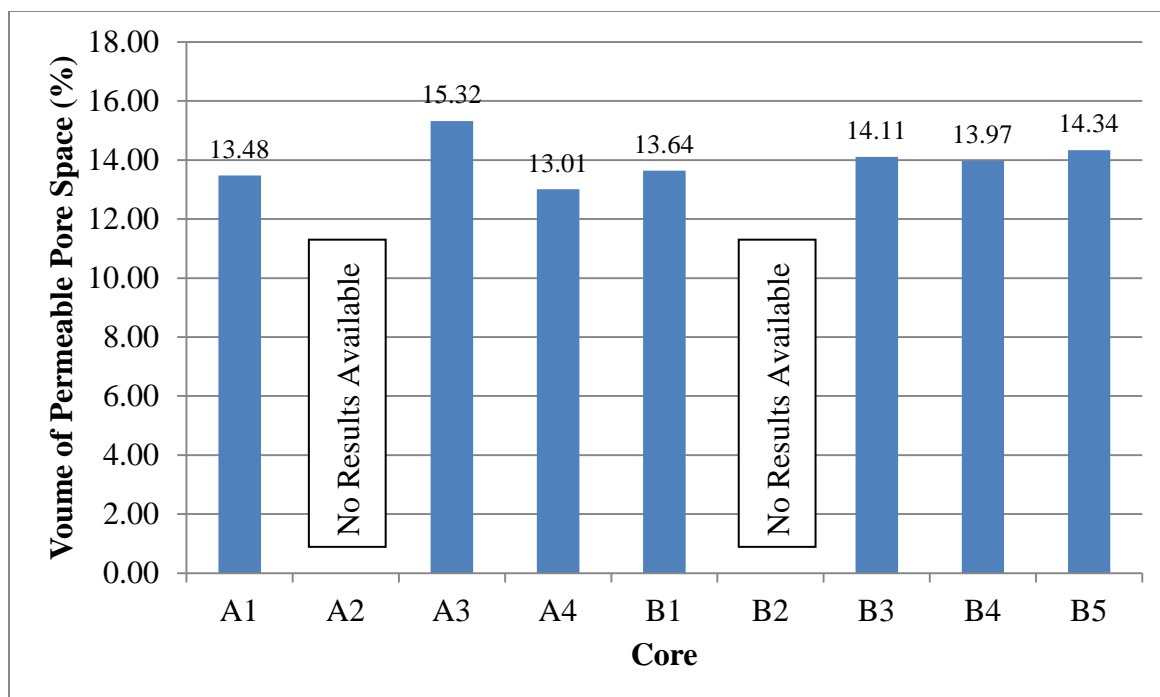
Figure 3.26. Bridge A1479 Volume of Permeable Pore Space Results

The volume of permeable pore space was determined for seven of the nine extracted cores. Volume of permeable pores space ranged from 13.01% to 15.32%. Core A2, which was composed of the concrete patch material, split apart during the testing for volume of permeable pores. Core B2 was asphalt, so it was not tested for the volume of permeable pores. Core A3, which was rated fair during the visual evaluation, had the highest volume of permeable pores at 15.32% and Core A4, which was rated good during the visual evaluation, had the lowest volume of permeable pores at 13.01%. Core A3 was extracted from an area with evidence of moderate deterioration based on GPR results, and Core A4 from an area with no evidence of deterioration. Figure 3.26 below illustrates the volume of permeable pore space for the cores. Complete results from the volume of permeable pore space test are included in Appendix E.

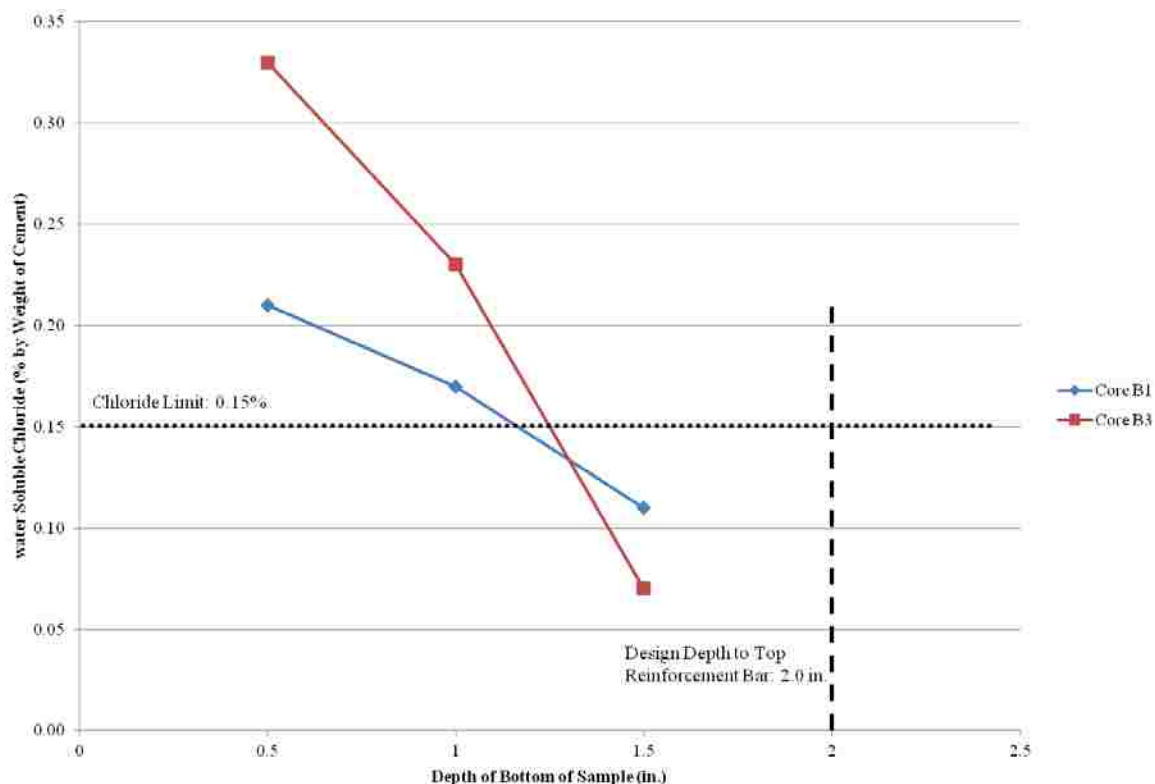
Figure 3.27. Bridge A1479 Chloride Ion Content Results

Chloride ion concentration test results were obtained for two cores from Bridge A1479, Cores B1 and B3. Both cores were rated good in the visual examination, however B1 showed evidence of moderate deterioration based on the GPR results, and B3 showed no evidence of deterioration. The chloride ion concentration results are illustrated in Figure 3.27 below. Core B3 had a higher initial chloride ion concentration than Core B1, but at a depth of 1.5 in., B1 has a slightly higher percent chloride. The bridge design specifies that the reinforcing bars have a clear cover of 2 in. As discussed in Section 2.3.2, a threshold value of 0.15% water-soluble chloride by weight of cement is used in this thesis as the threshold for the initiation of corrosion. Chloride ion concentrations at or above this level indicate the potential for corrosion of the steel reinforcing bars.

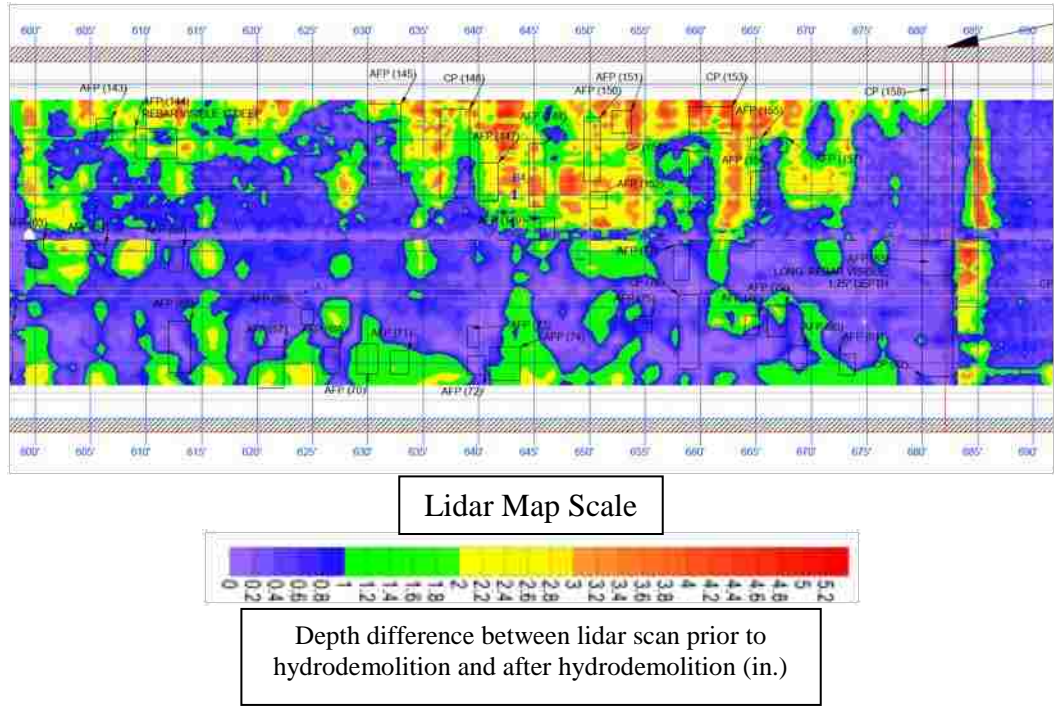
Figure 3.28. Section of Bridge A1479 Drawing Including Lidar Rehabilitation Survey and Visual Investigation Results

3.2.2.4 Hydrodemolition. Hydrodemolition was used as a method to remove loose and deteriorated concrete from the entire inside curb to curb area of Bridge A1479. The rehabilitation of the bridge deck was conducted one lane at a time, with the other lane remaining open to traffic during rehabilitation. When the first lane was finished being rehabilitated, it was reopened, and the second lane was closed to traffic. Lidar data were acquired before and after the hydrodemolition of each lane. All results given below were generated using the difference between the before and after hydrodemolition lidar scans. Three feet from the East and West edge of the lidar map was removed because of inaccurate data due to construction debris along the curbs during scanning. Therefore, all lidar images in this thesis cover only a 26 ft. width of the bridge. Figure 3.28 below shows a section of the bridge drawing with the lidar and visual inspection results.

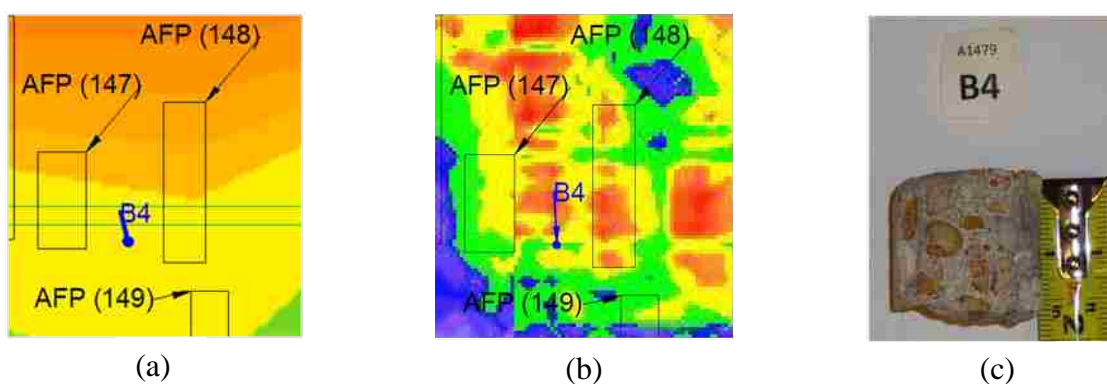
Figure 3.31. Bridge A1479 Core B4 on GPR Map (a), Lidar Map (b), and Core Photograph (c)

Note: Core B4 contained a delamination, concrete below the delamination was not extracted.

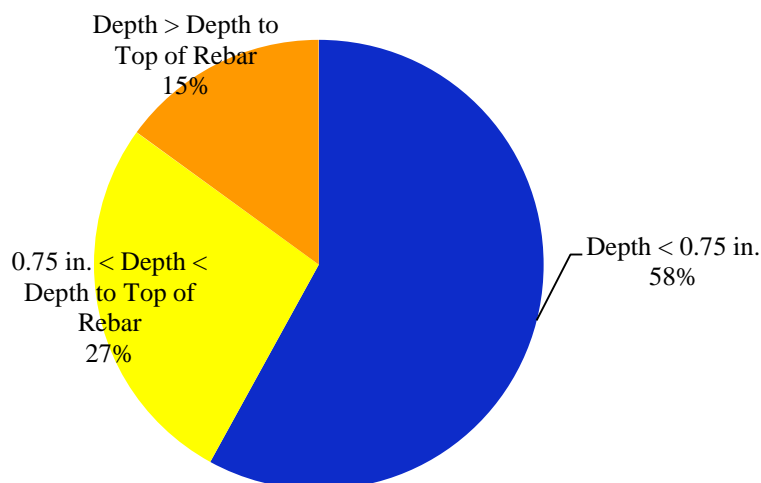
Figure 3.32. Bridge A1479 Lidar Depth of Concrete Removal Results

From the lidar results, it was possible to categorize the concrete removal into three categories based on depth, as discussed in Section 3.1.5. The categories include 0.75 in. depth or less, greater than 0.75 in. to the top of reinforcing bar, and deeper than the top of reinforcing bar. For this bridge, it is important to note that the top reinforcing bar is in the longitudinal direction, and the GRP data is based on the reflection amplitude from the top traverse rebar, which is 0.625 in. below the top of the top longitudinal bar. From this analysis, 58% of the deck was determined to have 0.75 in. or less concrete removed. Twenty seven percent of the deck had concrete removal depths greater than

0.75 in., but not below the top of reinforcing bar. Approximately 15% of the deck had concrete removal deeper than the top of reinforcing bar. The 0.75 in. category includes the milling of the entire bridge deck surface as discussed in Section 3.1.5. Figure 3.32 below summarizes the lidar results.

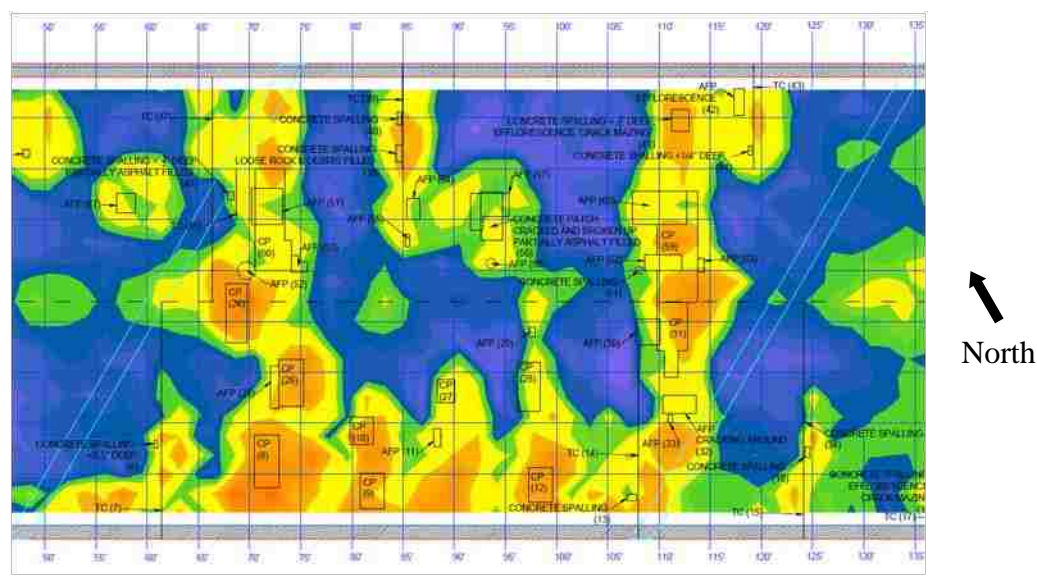
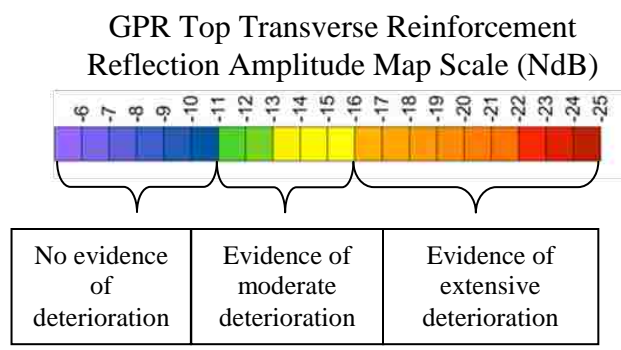
Figure 3.37. Section of Bridge A1297 GPR Results

Similar to the GPR results of Bridge A1479 in Section 3.2.2.2, the GPR results of A1297 show a correlation with the documented visual defects. Sections of the deck that showed no evidence of deterioration on the GPR results had few documented visual defects. In areas where many visual defects were documented, the GPR results indicate higher levels of deterioration.

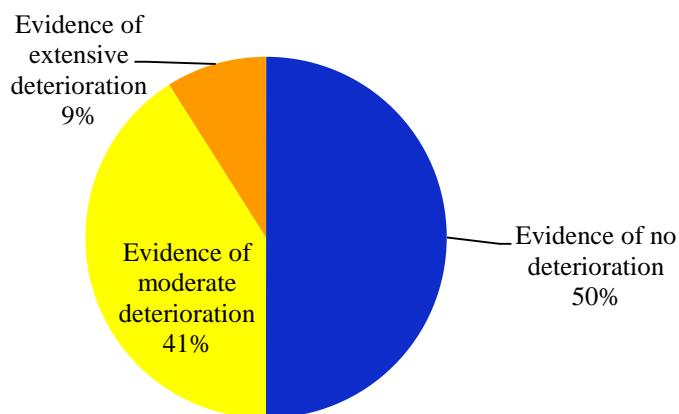
Figure 3.38. Bridge A1297 Deck Deterioration Levels Based on GPR

Of the 6,908 sq. ft. inside curb-to-curb area of the bridge deck, 6,515 sq. ft., or 94%, was scanned with GPR. Based on the GPR estimates, 3,258 sq. ft. or 50% of the scanned portion had no evidence of deterioration. 2,671 sq. ft. or 41% of the deck was estimated to have evidence of moderate deterioration, and 586 sq. ft. or 9% was estimated to have evidence of extensive deterioration. These values are illustrated in Figure 3.38 below.

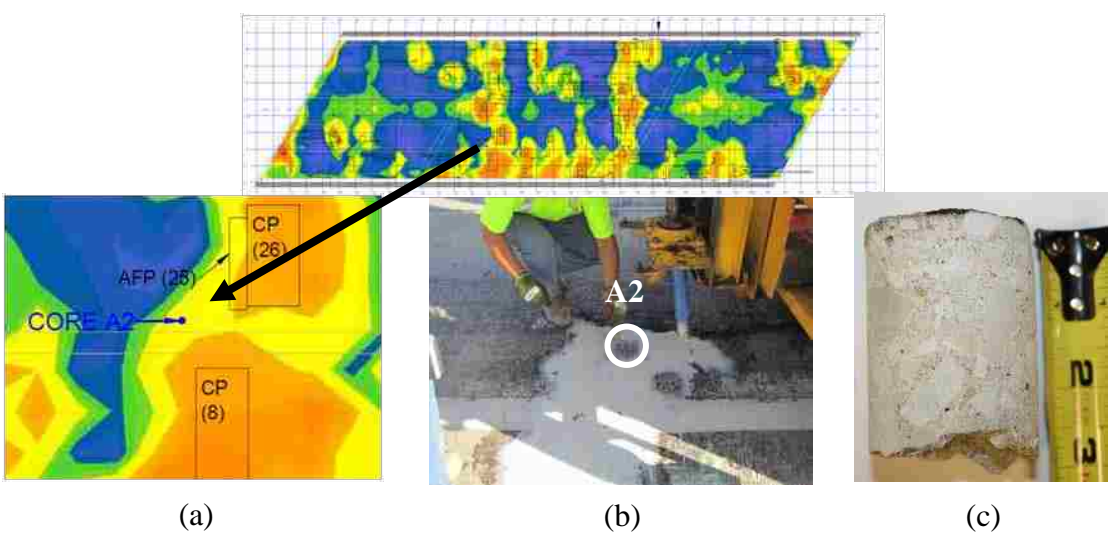
Figure 3.41. Bridge A1297 Core A2, (a) On Bridge Drawing, (b) Deck Image at Core Location, (c) Extracted Core

Based on the GPR results, one core was extracted from an area of the bridge deck that had no evidence of deterioration, and five cores from areas with evidence of moderate deterioration. Figure 3.40 below illustrates the locations of Core A1 on the bridge deck drawing containing the visual investigation and GPR. Core A1 is located in an area with no evidence of deterioration based on GPR and no documented visible deterioration. Core A1 was rated good in the visual examination. Figure 3.41 illustrates Core A2, which is located in an area that has evidence of moderate deterioration based on GPR results. The core has a visual evaluation rating of good.

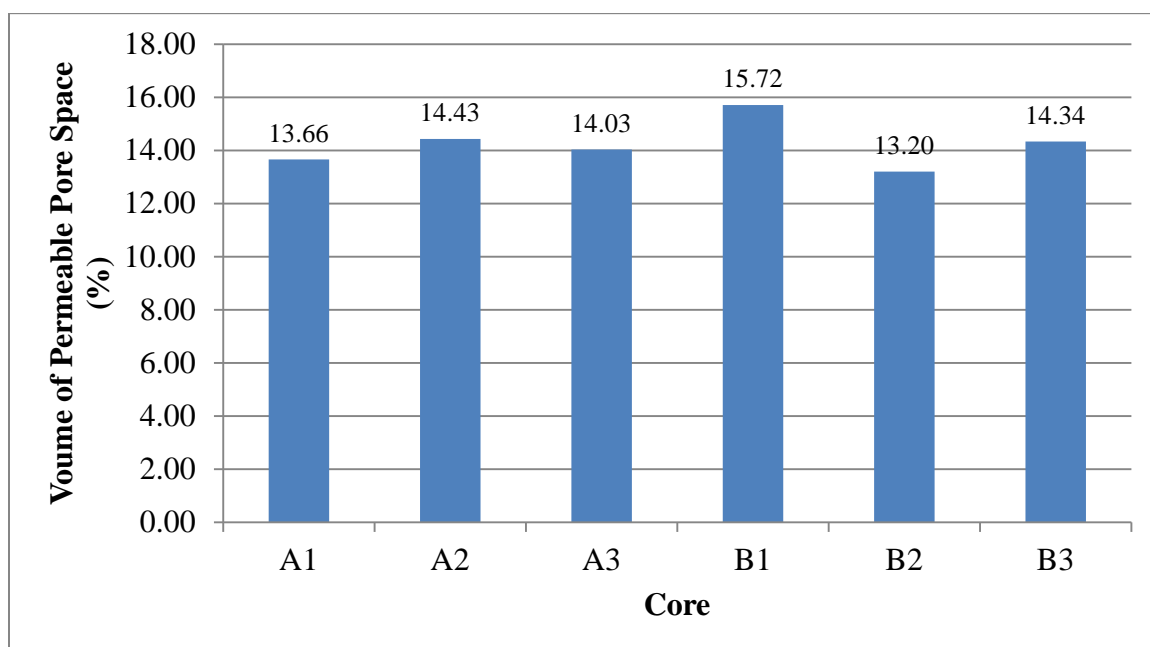
Figure 3.42. Bridge A1297 Volume of Permeable Pore Space Results

The volume of permeable pore space was determined for all six of the extracted cores. Volume of permeable pore space ranged from 13.20% to 15.72%. Core B1, which was rated bad during the visual evaluation, had the highest volume of permeable pores at 15.72% and Core B2, which was rated fair during the visual evaluation, had the lowest

volume of permeable pores at 13.20%. Both Cores B1 and B2 were extracted from areas with evidence of moderate deterioration based on GPR results. Figure 3.42 below illustrates the volume of permeable pore space for the cores. Complete results from the volume of permeable pore space test are included in the Appendix E.

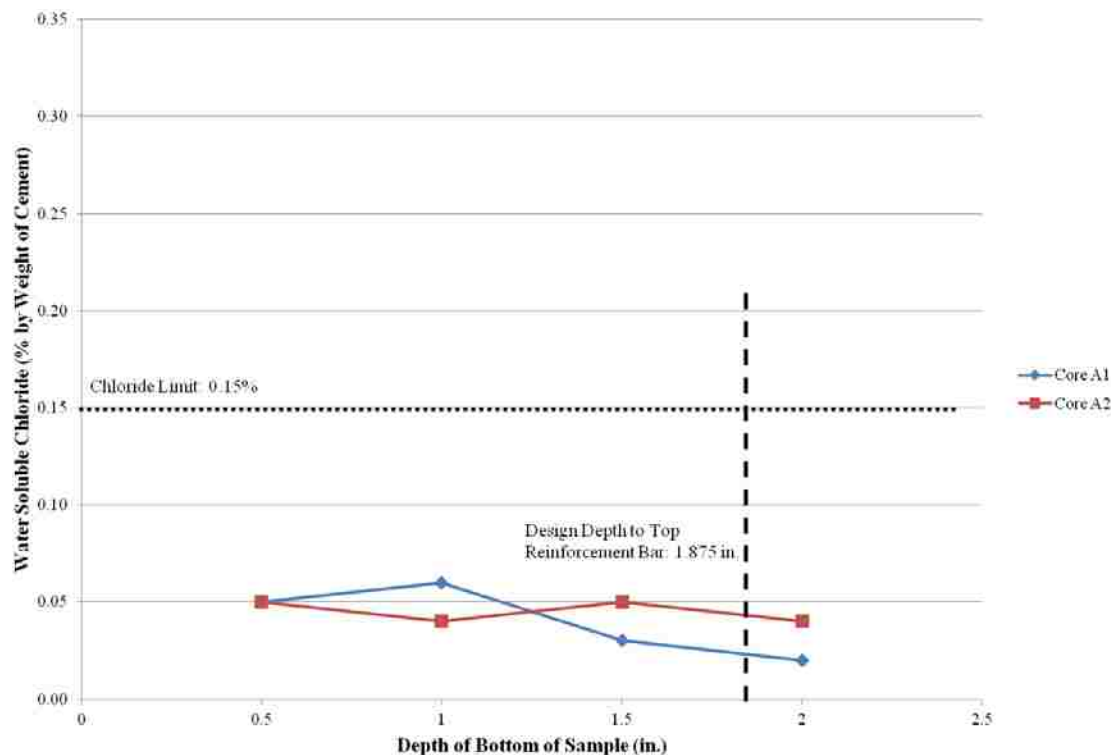
Figure 3.43. Bridge A1297 Chloride Ion Content Results

Chloride ion concentration test results were obtained for two cores from Bridge A1297, Cores A1 and A2. Both cores were rated good in the visual examination, however Core A1 showed no evidence of deterioration based on the GPR results, and Core A2 showed evidence of moderate deterioration. The chloride ion concentration results are illustrated in Figure 3.43 below. Both cores had low values of percent chloride, all values were below 0.06%. The bridge design specifies that the reinforcing bars have a clear cover of 1.875 in. As discussed in Section 2.3.2, a threshold value of 0.15% water-soluble chloride by weight of cement is used in this thesis as the threshold for the initiation of corrosion. Chloride ion concentrations at or above this level indicate the potential for corrosion of the steel reinforcing bars.

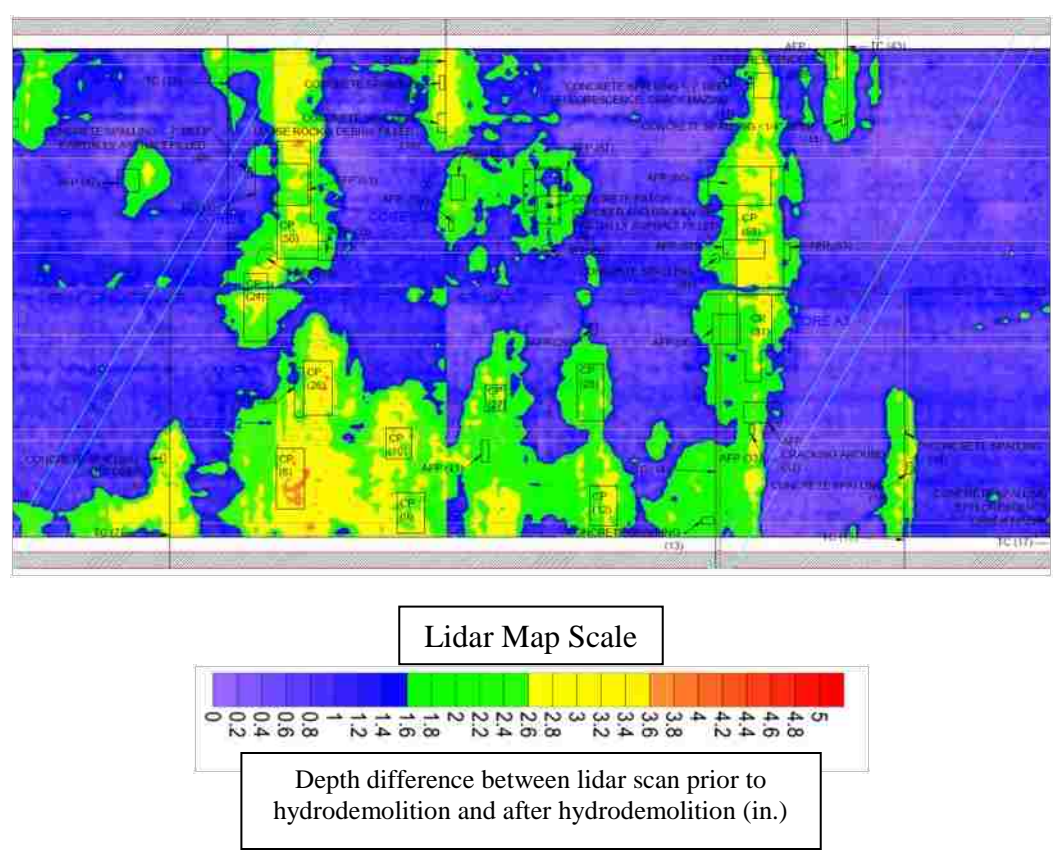
Figure 3.44. Section of Bridge A1297 Drawing Including Lidar Rehabilitation Survey and Visual Investigation Results

Therefore, all lidar images in this thesis cover only a 41.5 ft. width of the bridge. Figure 3.44 below shows a section of the bridge drawing with the lidar and visual inspection results.

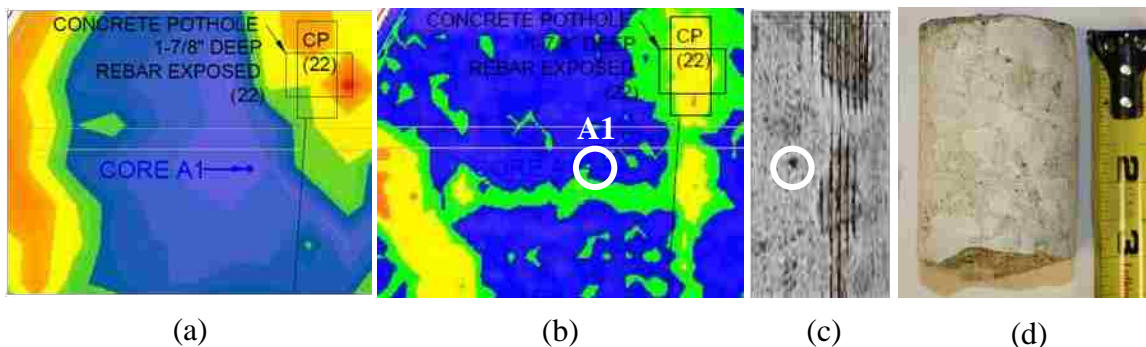
Figure 3.45. Bridge A1297 Core A1 on GPR Map (a), Lidar Map (b), Image of Deck Around Core Location after Hydrodemolition (c), and Core Photograph (d)

Figure 3.45 below shows Core A1 on the GPR and lidar maps, as well as the core hole after the hydrodemolition. As mentioned in Section 3.2.2.3, Core A1 was rated good in the visual evaluation and was in an area where there was no evidence of deterioration based on the GPR results. Approximately 1.6 in. of concrete was removed during the hydrodemolition process in the deck where Core A1 was extracted. Figure 3.46 shows Core A2 on the GPR and lidar maps. Core A2 was rated good in the visual evaluation. Based on the GPR results, the area where Core A2 was extracted from

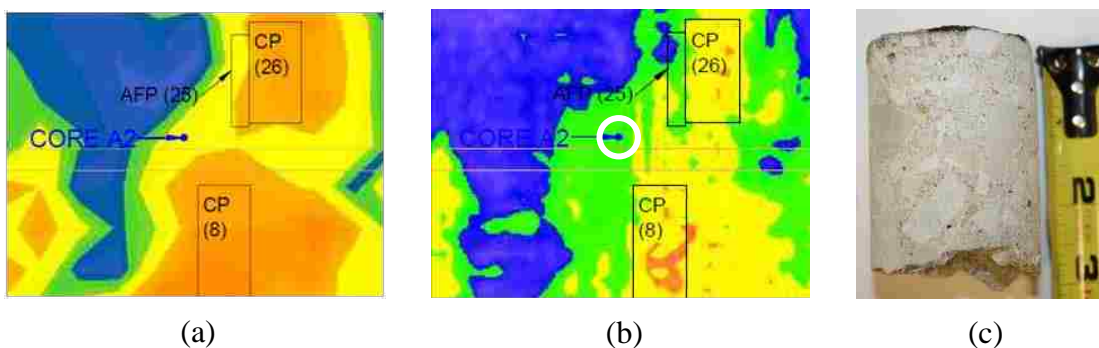
Figure 3.46. Bridge A1297 Core A2 on GPR Map (a), Lidar Map (b), and Core Photograph (c)

showed evidence of moderate deterioration. Approximately 2.3 in. of concrete was removed from the hydrodemolition process in the area where Core A2 was extracted.

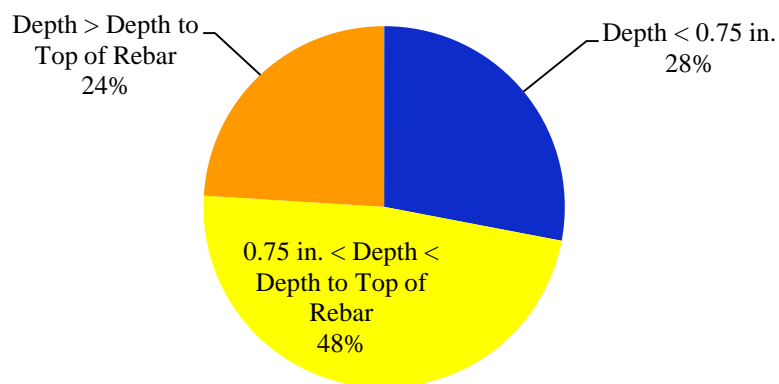
Figure 3.47. Bridge A1297 Lidar Depth of Concrete Removal Results

As discussed in Section 3.1.5, the lidar survey results were placed into three categories. The categories include 0.75 in. depth or less, greater than 0.75 in. to the top of reinforcing bar, and deeper than the top of reinforcing bar. From this analysis, 28% of the deck was determined to have 0.75 in. or less concrete removed. Forty eight percent of the deck had concrete removal depths greater than 0.75 in., but not below the top of reinforcing bar. Approximately 24% of the deck had concrete removal deeper than the

top of reinforcing bar. The 0.75 in. category includes the milling of the entire bridge deck surface as discussed in Section 3.1.5. The average depth to the top of the reinforcement bars was 1.80 in. Figure 3.47 below summarizes the lidar results.

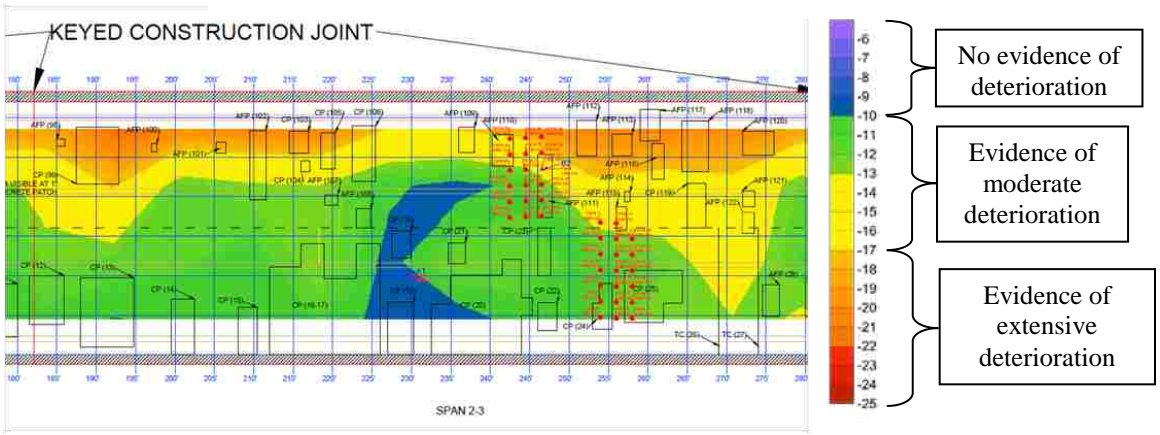
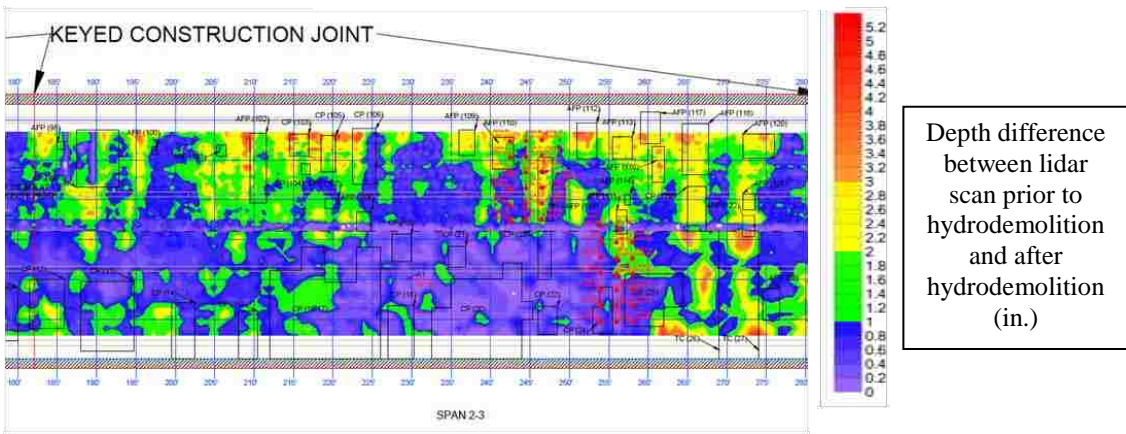
Figure 4.6. Visual Comparison Between GPR Results (a) and Rehabilitation Lidar Survey (b) From Bridge A1479

Figure 4.6 below shows the GPR results and rehabilitation lidar survey for a section of Bridge A1479. Due to the size of the bridge, only a 100 ft. section of the 868 ft. long bridge is shown. Complete results are located in the Digital Appendix discussed in Appendix F. In the figure, a strong correlation between the GPR results and rehabilitation lidar survey is visible. Areas where the GPR estimated higher evidence of deterioration correspond to areas where more material was removed during the rehabilitation process. And likewise, areas where the GPR estimated lower evidence of deterioration correspond to areas where less material was removed during the rehabilitation process.

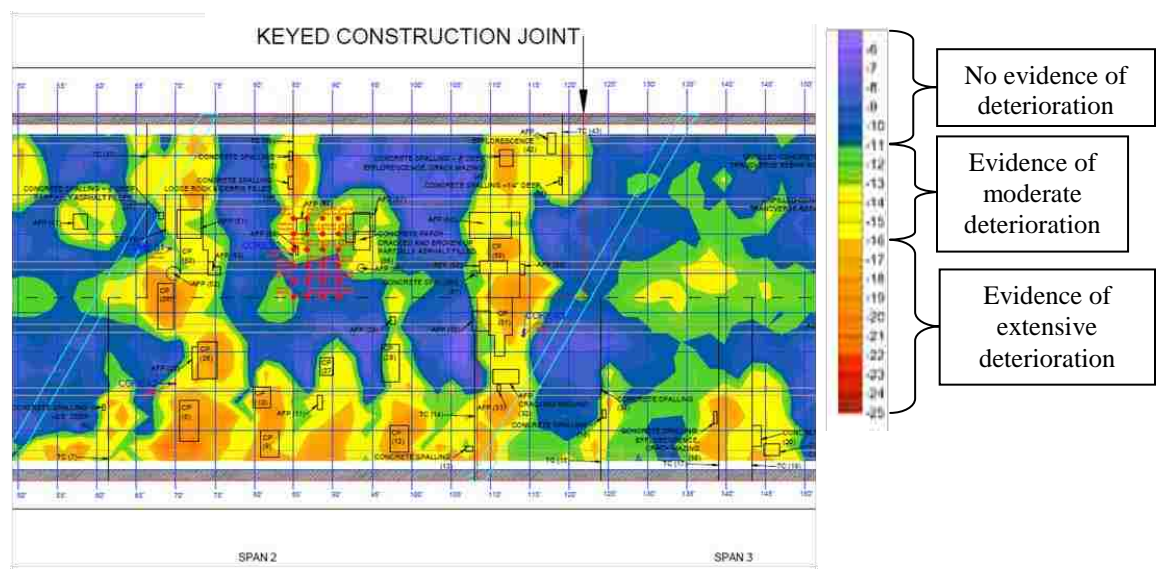
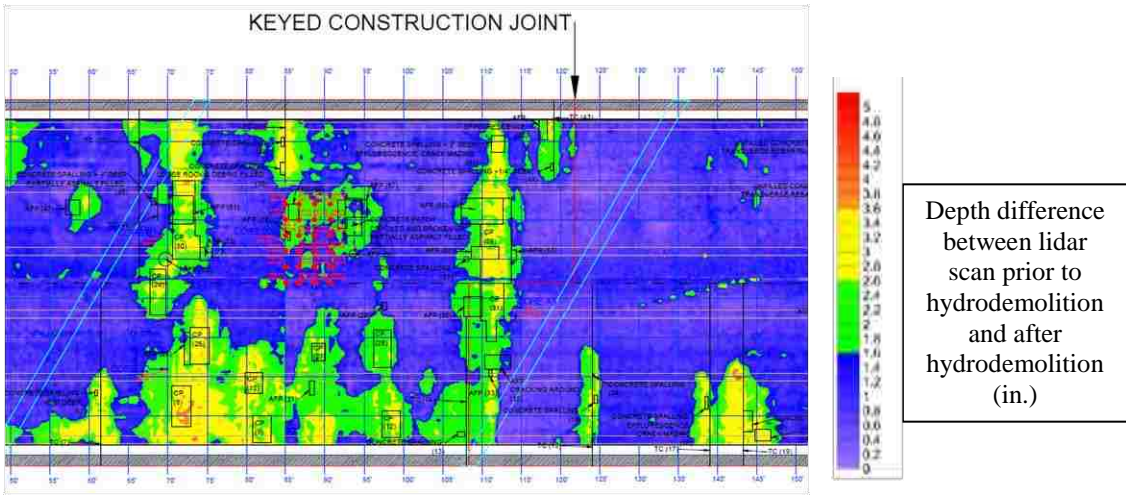
Figure 4.7. Visual Comparison Between GPR Results (a) and Rehabilitation Lidar Survey (b) From Bridge A1297

The GPR results and rehabilitation lidar survey for Bridge A1297 are shown in Figure 4.7 below. Results are show for 100 ft. of the 157 ft. long bridge. Complete results are available in the Digital Appendix described in Appendix F. Similar to Bridge A1479, the GPR and lidar results for Bridge A1297 have a visual correlation. Areas where the GPR estimated higher evidence of deterioration correspond to areas with greater material removal depths from the lidar survey of the rehabilitation. Similarly, areas where the GPR estimated lower evidence of deterioration correspond to areas with lower material removal depths from the lidar survey.

The correlation between GPR results and the rehabilitation lidar scans was expected. The GPR responds to areas of saline moisture present in the deck, and for the moisture to ingress into the deck, some form of degradation of the concrete has to be taking place.

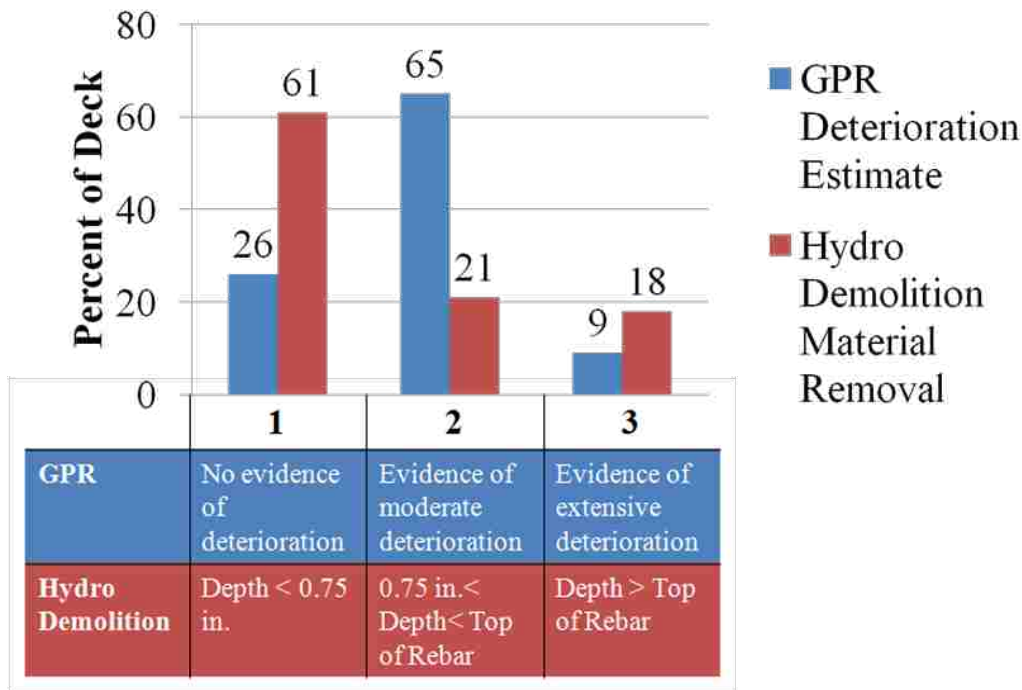
Figure 4.8. Percentage of Deck Area for Bridge A1479 Categorized by GPR Results and Rehabilitation Lidar Survey

In order to better understand the visual correlation between the GPR results and rehabilitation lidar survey, both data sets were grouped into three categories, and the percentage of the deck area that fell into each of these categories was determined. The three categories for the GPR results are: no evidence of deterioration, evidence of moderate deterioration, and evidence of extensive deterioration. The rehabilitation lidar survey data was also placed into three categories based on the depth of material removal. The three rehabilitation material removal categories are: material removal depths less than or equal to 0.75 in., material removal depths greater than 0.75 in but less than the depth to the top of the topmost reinforcement bar, and material removal depths greater than or equal to the depth to the top of the topmost reinforcement bar. The results for Bridges A1479 and A1297 are illustrated in Figures 4.8 and 4.9 respectively.

Figures 4.8 and 4.9 above were expected to show a trend between the GPR results and the rehabilitation lidar survey because of the visual correlation noted in Figures 4.6 and 4.7. However, no trend between the three different categories of GPR results and rehabilitation lidar surveys is visible.

While interpreting the results shown in Figures 4.8 and 4.9 above, there are several crucial factors that need to be acknowledged. As discussed in Section 3.2, the GPR results used in this thesis are the reflection amplitude from the top transverse layer of reinforcement, therefore these results do not represent the condition of the concrete below the top transverse reinforcement. Because of this, category 3 of the rehabilitation lidar survey is not reflected in the GPR results, because the GPR results presented in this thesis do not extend deeper than the top transverse reinforcement bar. It is also important to note that the topmost layer of reinforcing bars in Bridge A1479 is in the longitudinal direction, which is what the percentages for the three depth removal categories are based on. However, the GPR results are based off of the top transverse reinforcement, which is located 0.625 in. below the top of the longitudinal bars. Also, the GPR results presented
