Mechanical Characterization Of Composite Repairs For Fiber-Glass Wind Turbine Blades

A Dissertation

for the degree of
Doctor of Philosophy

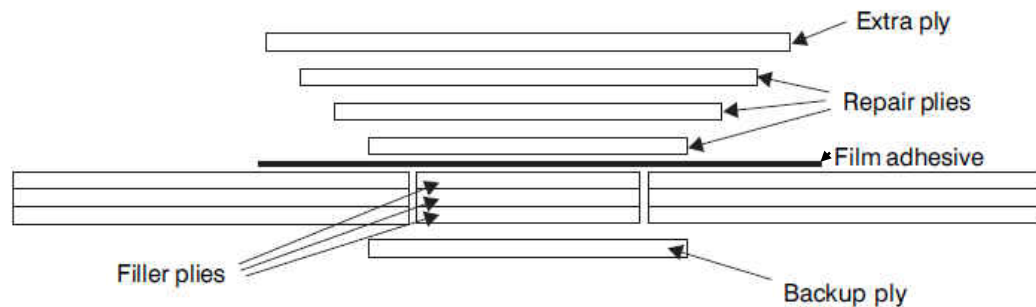
Figure 1.1. Patch repair [4]

Patch repairs involve the use of filler plies (Figure 1) to make up for the thickness of the original laminate and repair patches are either bonded adhesively or mechanically fastened to the laminate surface externally.

Different types of lay-ups may be used for repairs in this case. Pre-preg plies may be used and cured simultaneously with the adhesive. Application of pre-cured plies alternating with epoxy based paste adhesive layers is another alternative. Parts may also be manufactured by preforming and later bonded to the repair area to fit the repair contour [5]. Repair contours possessing double curvatures may be repaired by wet lay-ups consisting of plies similar to parent laminate with two-part (resin and initiator) systems. Though patch repairs are practically very easy and require minimum preparation, the disadvantages are that the repaired laminate is heavier and thicker than the original and the surface has to be very carefully prepared for proper adhesion [5].

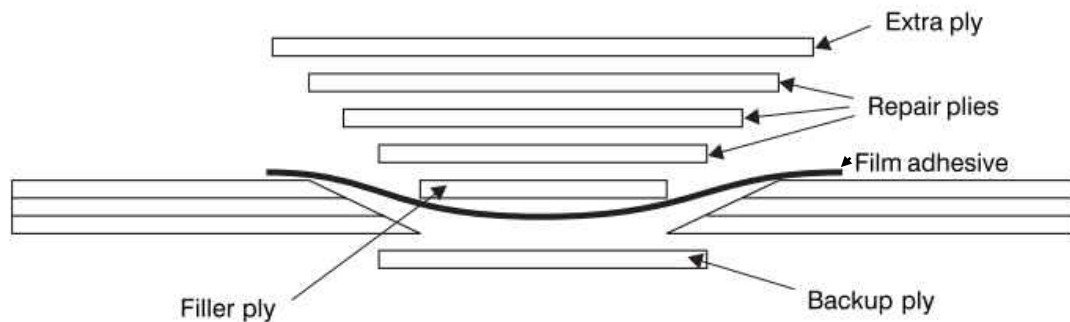
Figure 1.2. Scarf repair [4]

Scarf repairs are time-consuming and more difficult than patch repairs due to high skill and precision needed for accurate machining of the damaged structure. In this type of repair, the area of the damaged portion and that around it is sanded to expose each layer

of the laminate (Figure 2). Sometimes a filler ply may be added in addition to the repair plies to have a flatter surface. A wet lay-up is preferred as there might be fitting problems with the pre-cured ones. As in the case of patch repairs, the stacking sequence of the repair plies is the same as that of the parent laminate and an extra ply is added at the top of the repair plies to increase the overall strength and reduce creep as much as possible [3].

Curing of the lay-up is carried out by keeping the repair portion at room temperature under atmospheric pressure or by vacuum bagging in an autoclave or simply vacuum bagging in the open [3]. The advantage over patch repair is that the laminate repaired by this technique is only a little thicker than the original and a straighter load path is produced as each ply overlaps the corresponding ply being repaired resulting in a uniform shear stress distribution. The amount of strength restored to the original part varies with changes in parameters such as scarf angles, material used and depth of repair, etc.

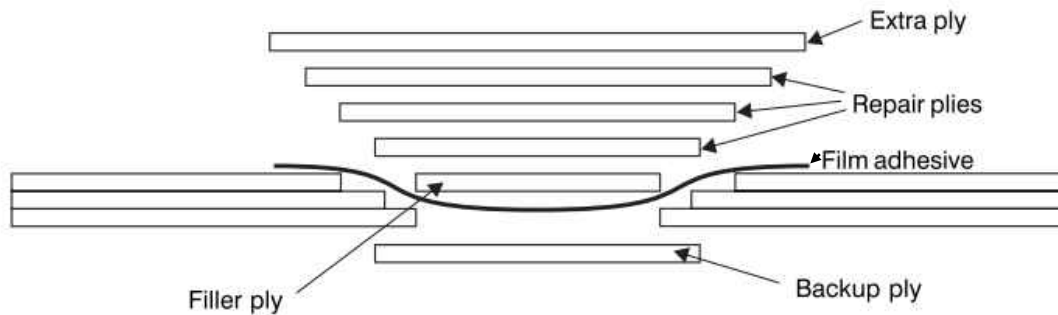
Figure 1.3. Step repair [4]

In step repair, as the name suggests, the damaged plies are sanded such that a flat face of the ply is exposed giving the laminate a 'stair-like' appearance (Figure 3). The steps are

typically 25-50 mm per layer and the sanding increases the roughness of surface to be bonded thus increasing adhesion with the repair resin.

The resultant laminate is almost the same as that produced in scarf repairs as good bonds are achieved due to exposure of fibers to the resin but this method requires considerable skill.

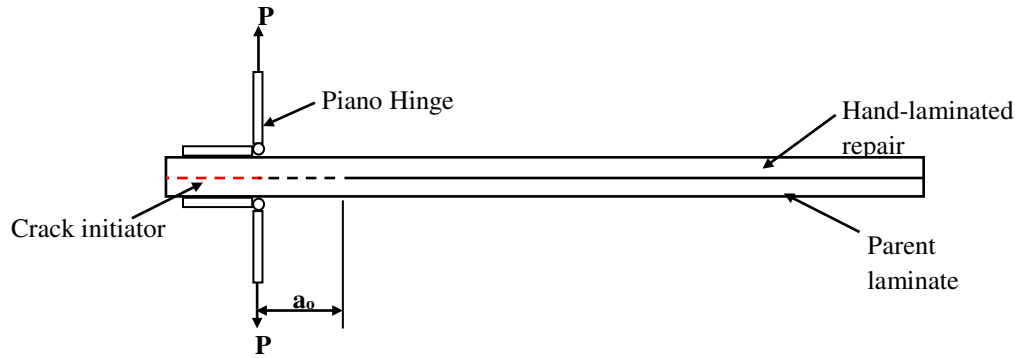
Figure 2.1. DCB Specimen

For repair resin screening, DCB specimens (Figure 2.1) were manufactured in accordance with ASTM D 5528 and consisted of two separate parts: the lower adherend or parent plate, representing the blade, and the upper adherend or repair plate, simulating the flat part of a one-sided scarf repair. Both adherends consisted of an even number of plies. A description of the lay-up and the materials used is given in Table 2.2. The company uses a different polyester resin (MB-B) for repairs currently than is used to fabricate the shell of the blade (MB-A). The parent plates for the DCB specimens were made using the current blade shell resin. Simulated repairs were fabricated using each candidate repair resin. Simulated repairs using the current repair resin (MB-B) were tested to serve as a baseline for comparison.

surface. The final DCB specimen dimensions were 350 mm in length and 30 mm in width. The parent laminate adherend had a thickness of 7.7 ± 0.3 mm whereas the repair laminate was 10.2 ± 0.7 mm thick. Both edges of the specimens were coated with a water-based white typewriter fluid and thin lines were marked every 1 mm on either edge for a distance of 100 mm from the end point of the pre-crack. The coating and markings were added to aid in the observation of crack propagation during testing. To compare the toughness of the repairs with that of the main blade, a batch of DCB specimens was made in which the main blade resin (MB-A) was used for both adherends. These specimens were manufactured with both adherends together under vacuum using VARTM followed by a room temperature cure for 24 hours, a post-cure at 60°C for 24 hours, and then a final cure at 95°C for 3 hours. The lay-up was the same as that of the DCB specimens made with repair resin candidates and the adherends had a thickness of 8.35 ± 0.04 mm.

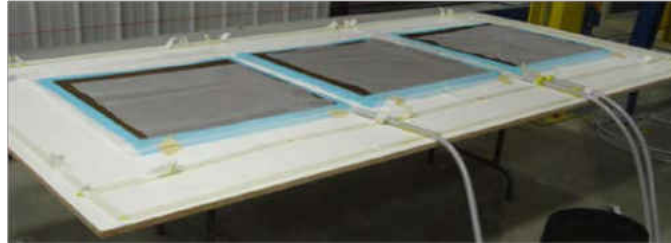
Figure 2.2. VARTM set-up before infusion

The parent plate representing the blade was manufactured using Vacuum Assisted Resin Transfer Molding (VARTM). A VARTM setup, before vacuum bagging and infusion of resin, is shown in Figure 2.2. After the gelling of the resin, the parent plates were cured at room temperature for 24 hours, and then further post-cured at 60°C for 24 hours and then at 95°C for 3 hours. This was done to fully cure the parent plates and also to have low residual styrene content by minimizing incomplete polymerization through high curing temperature. All parent plates were made continuously one after the other and each plate was then assigned to a repair resin candidate. Care was taken that the time lapse between

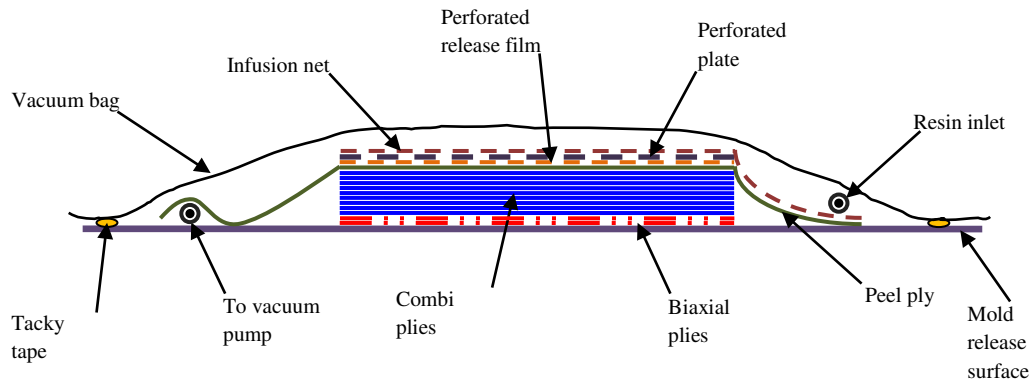
Figure 2.3. VARTM infusion package

Each parent plate initially consisted of nine, 0.88 mm thick plies with unidirectional glass fibers and a chopped strand mat attached on one side (called Combi plies hereafter) and two biaxial plies (plies with glass fibers at $\pm 45^\circ$) at the bottom (Figure 2.3). Since the lay-up of the parent plate was not symmetric, some warp was observed in the parent plates perpendicular to the direction of the unidirectional fibers in the Combi plies. The extent of warp is depicted in Figures 2.4 and 2.5. The reading on the scale (depth of warp) in Figure 2.4 is 1.25 cm. The total width of the plate was 60 cm. As the specimens were to be cut along 1-direction (direction along fibers), it was decided that the warp would not have a significant effect on the test results.

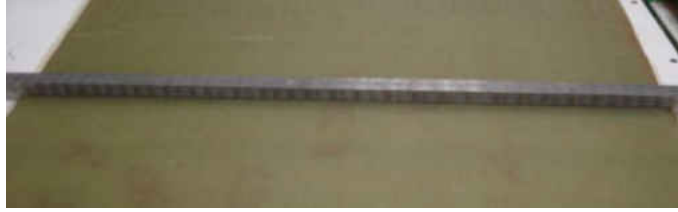
Figure 2.4. Straight rule along Combi plies' 0° direction (1 – direction)

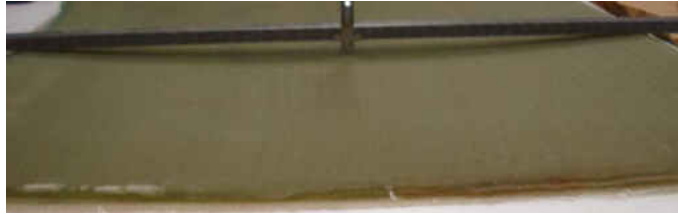
Figure 2.5. Straight rule along Combi plies' 90° direction

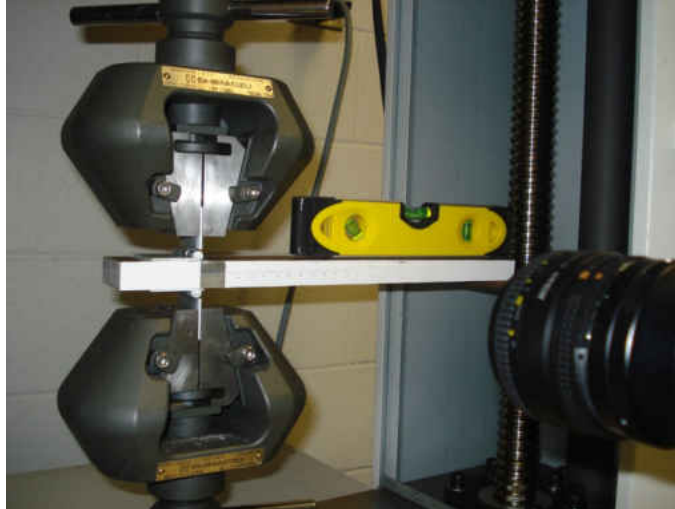
Figure 2.6. Experimental set-up for DCB testing

Testing of the DCB specimens was conducted on the Shimadzu AG-IS Universal Testing Machine under displacement control at a crosshead rate of 0.1 mm/min. Higher rates were tried but at those rates crack propagation was too fast for collection of adequate data for fracture toughness calculations. The specimens were aligned and centered with the help of a level when the hinges were being mounted in the load grips with the parent laminate down as shown in Figure 2.6. The end of each specimen, opposite to the end where the hinges were attached, was supported before loading. It was noticed that the supported end lifted (less than 1.0 mm) off the support as the load was applied. Crack propagation was monitored and recorded with the help of a Retiga 1300 camera (Figure 2.6).

Load data was recorded using TRAPEZIUM 2 control software linked to the universal testing machine and images of the loaded samples were captured and analyzed for displacements using Vic-Snap digital image and Vic 2D correlation software respectively. Initially, testing was conducted with the adherends of the specimen being pulled apart continuously. It was noticed that the crack growth was primarily run-arrest extension in which the delamination front jumped ahead abruptly rather than being a slow, stable extension [18]. In order to be able to monitor crack growth effectively, following each 15 mm crack growth increment, the load was reduced by 30% and then the specimens were reloaded to continue the test; this procedure was repeated at least five times for each specimen. In order to procure statistically significant data, five specimens were tested for each of the resin samples.

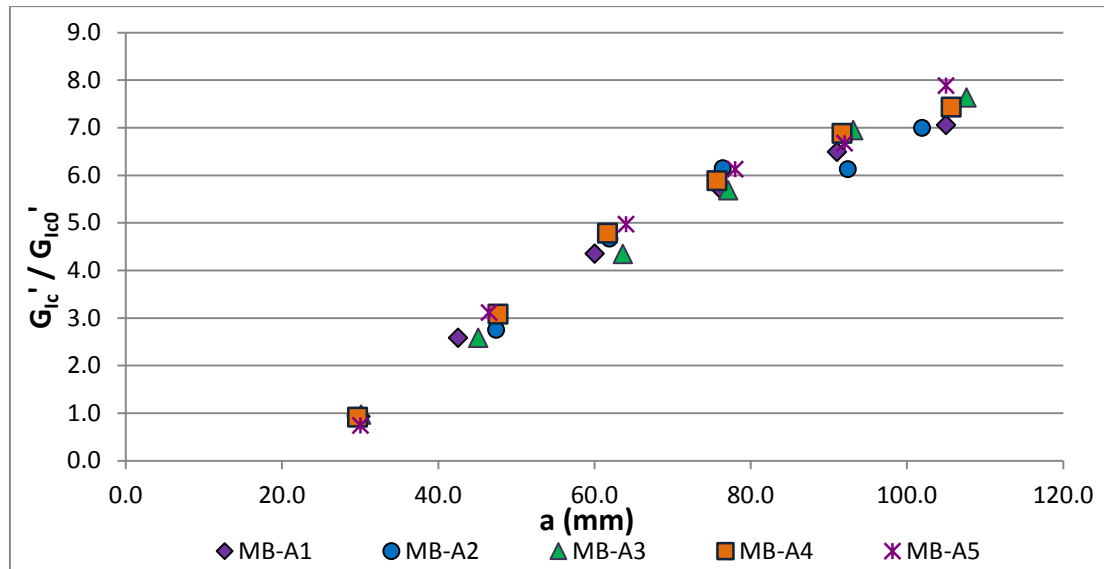
The ratios of corrected values of interlaminar fracture toughness, G_{Ic}' , to the fracture toughness value for main blade resin at crack initiation, G_{Ic0}' , were calculated using Equation 2.2 for each increment in every batch of specimens tested and plotted against a, the crack length. Figure 2.7 and Figure 2.8 show the resulting curves for the main blade

Figure 2.7. G'_{Ic}/G_{Ic0}' vs crack length for main blade resin, MB-A.

These curves indicate the toughness of the main blade at a crack length of approximately 105 mm to be four times more than that of the repairs made by the current repair resin.

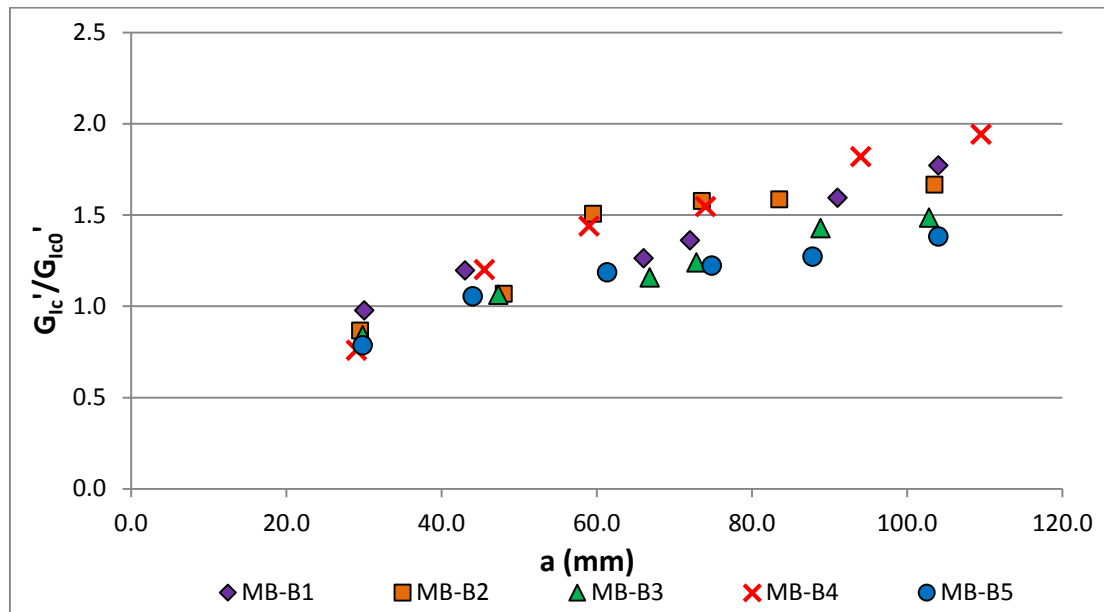
Figure 2.8. G'_{Ic}/G_{Ic0}' vs crack length for current repair resin, MB-B.

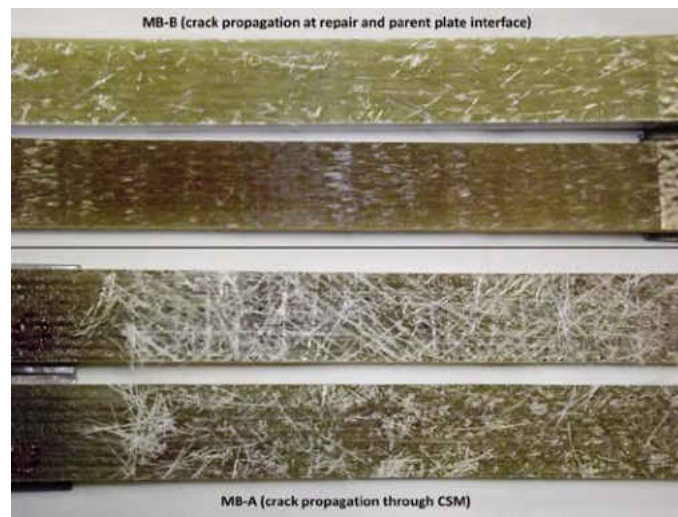
specimens made completely with MB-A, the crack propagated through the CSM (Figure 2.9) whereas in the case of the specimens repaired with MB-B, crack propagation was at the interface of the two adherends with the upper adherend (including the CSM) being completely removed from the lower one that represented the blade (adhesive failure). Significant fiber bridging was observed (Figure 2.10) when specimens fabricated completely of the main blade resin (MB-A) were being pulled apart. Little-to-no fiber bridging was observed in specimens made with the currently used repair resin (MB-B). This concurs with post-fracture surface observations. Reduced fiber bridging relative to the main blade specimens was observed during testing of all repair resin candidates. However, several resins exhibited more bridging than the current repair resin. It is evident from the experimental results that there exists a positive correlation between the fracture toughness values and fiber bridging.

Figure 2.9. Surface morphologies after crack propagation

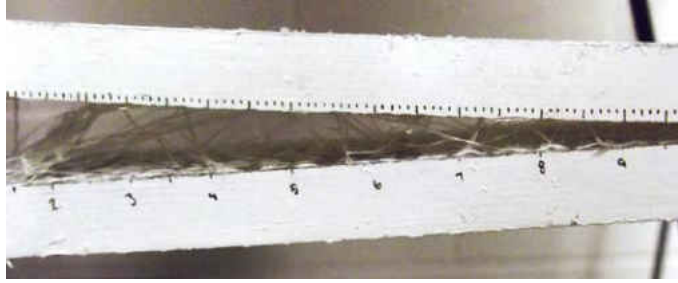
Figure 2.10. Fiber bridging in case of MB-A (main blade resin)

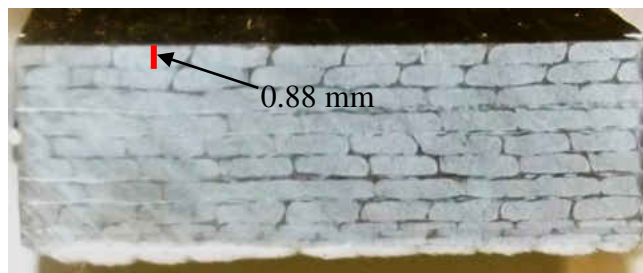
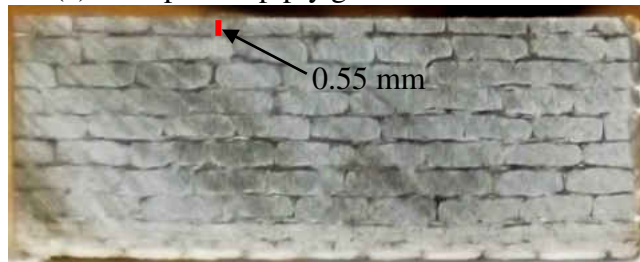
Figure 2.11. Grinding difference in case of NRR1, NRR4 and NRR5 resins

While testing the set of specimens consisting of repairs carried out with repair resins NRR1, NRR4 and NRR5 it was observed that the fracture toughness values obtained were markedly high. Examination of the fractured specimens revealed that the top plies of the parent plates of these specimens had been ground to about half the depth (Figure 2.11) instead of one complete top ply. The specimens for these three resins were manufactured again with the complete top plies ground off so as to get a correct comparison with the other repair resins.

(a) Complete top ply ground off

(b) Partial top ply ground off

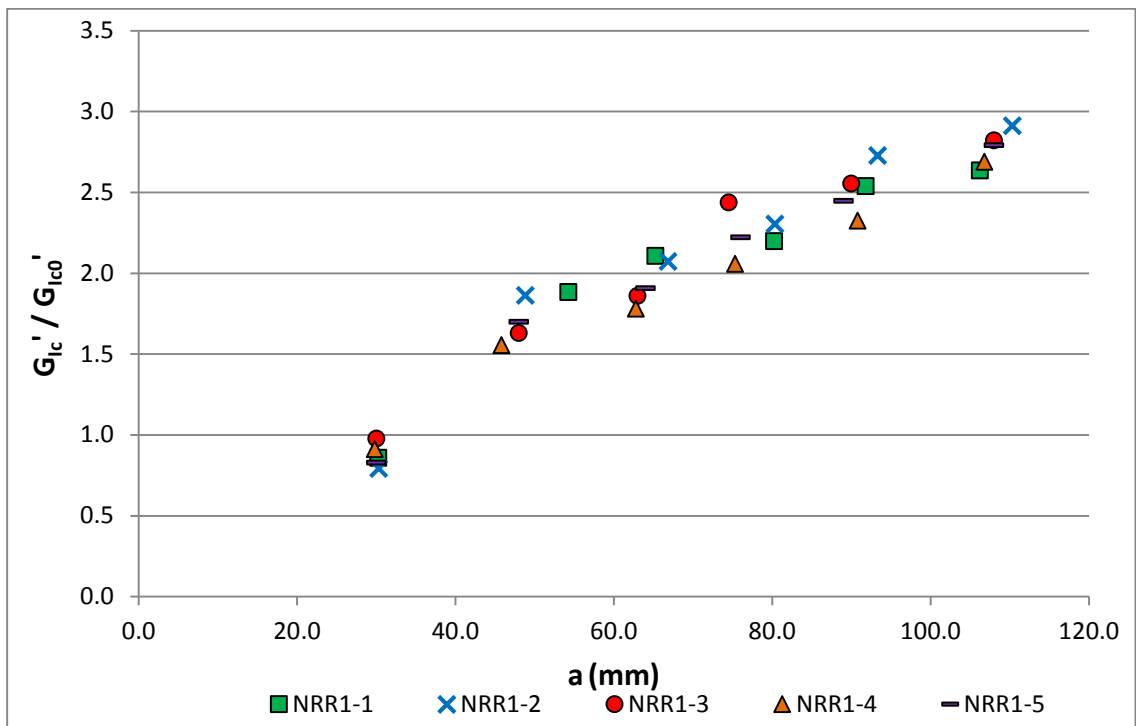
Figure 2.12. G'_{Ic} / G'_{Ic0} vs crack length for candidate resin, NRR1

candidates (Figures 2.12 to 2.17) to compare with the baseline data obtained from the current repair resin. The profile of almost all the plots was as expected but there was an anomaly in the graph for two specimens of new repair resin candidate three (NRR3) (Figure 2.14). The surfaces of these specimens were examined and patches of dry glass were noticed in the CSM on the repair adherend (Figure 2.18); the positions of these patches corresponded to the spikes in fracture toughness values in the plot. The remaining three specimens also had similar patches though much smaller in size. It was not clear whether the patches were manufacturing defects or due to some property of the resin. However, due to the patches and the erratic nature of fracture toughness values obtained this resin (NRR3) was no longer considered to be a viable candidate even though it gave almost 1.5 times higher fracture toughness values than the current repair resin at crack length of approximately 105 mm.

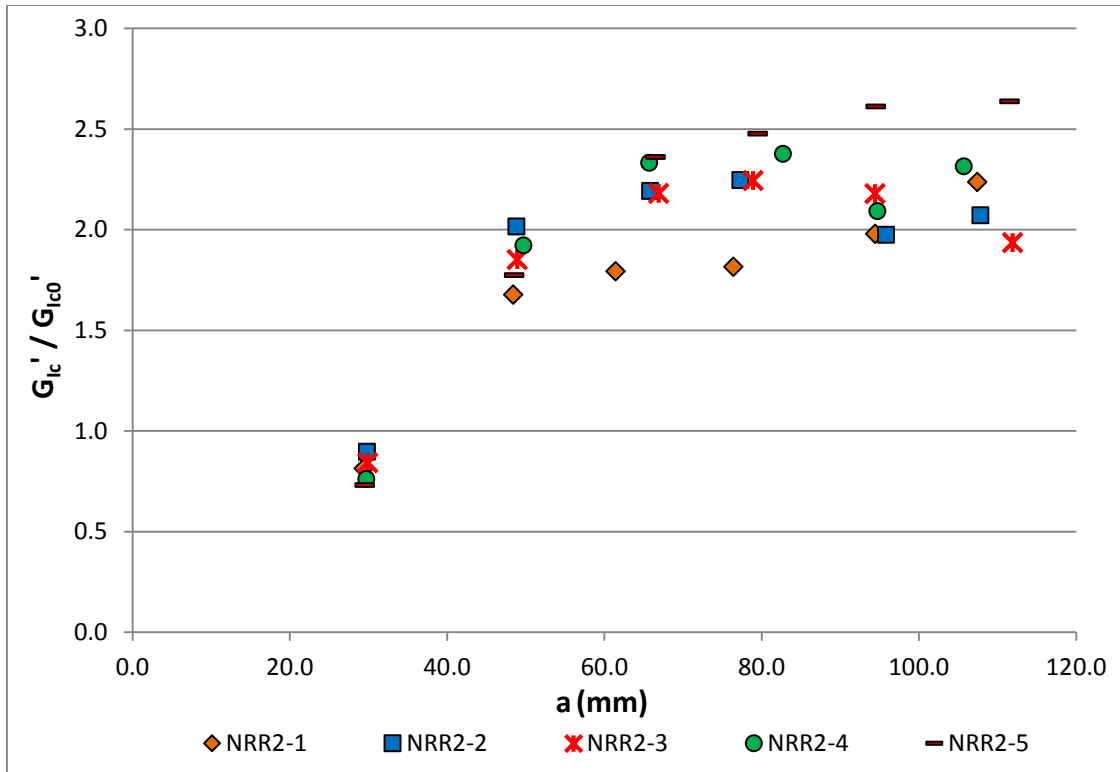
Figure 2.13. G'_{ic}/G'_{ic0} vs crack length for candidate resin, NRR2

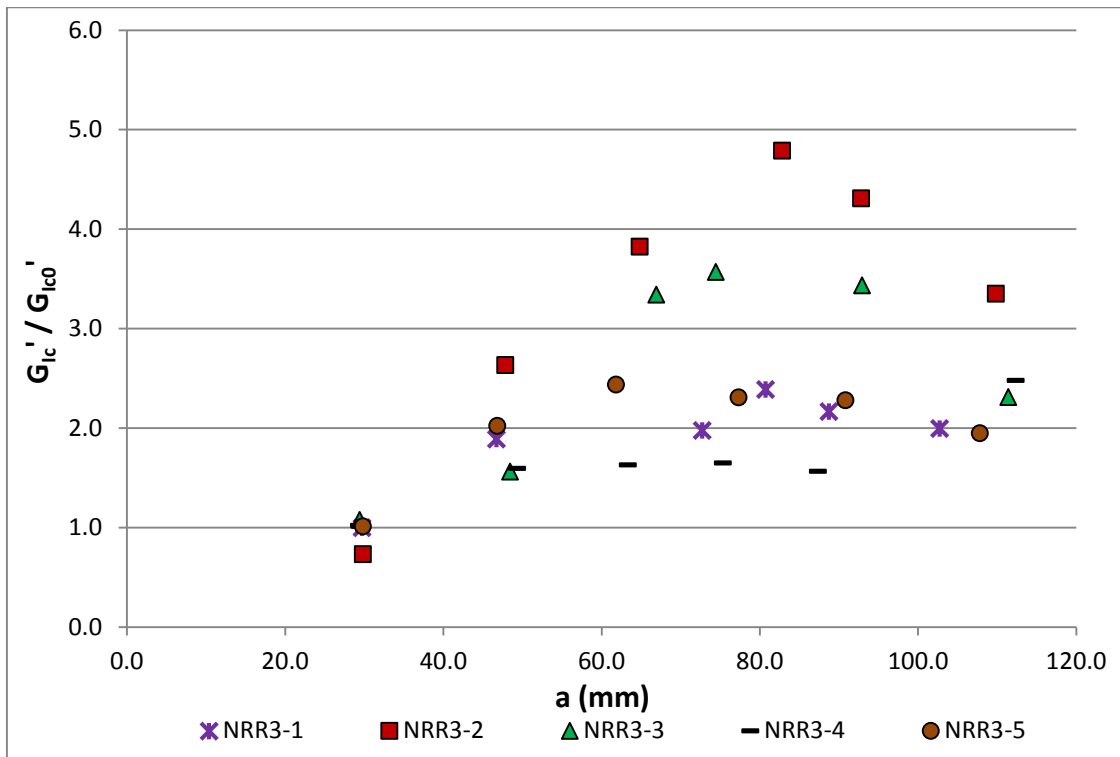
Figure 2.14. G'_{ic}/G'_{ic0} vs crack length for candidate resin, NRR3

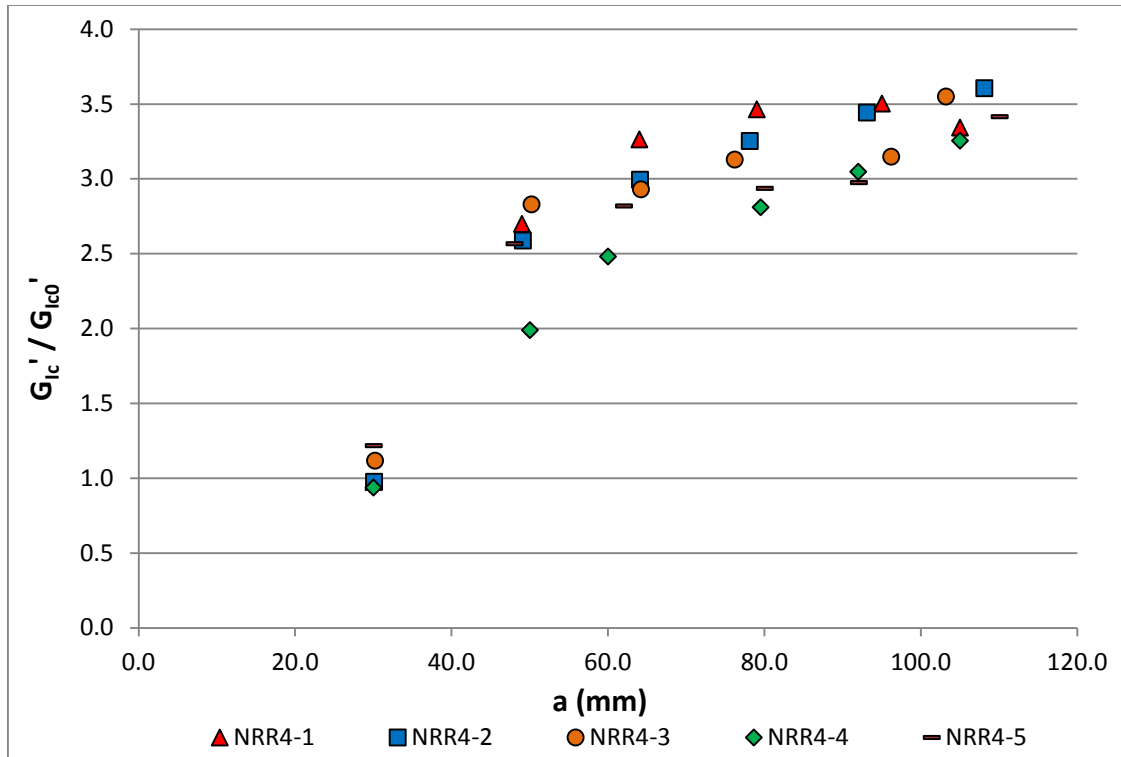
Figure 2.15. G'_{ic}'/G'_{ic0}' vs crack length for candidate resin, NRR4

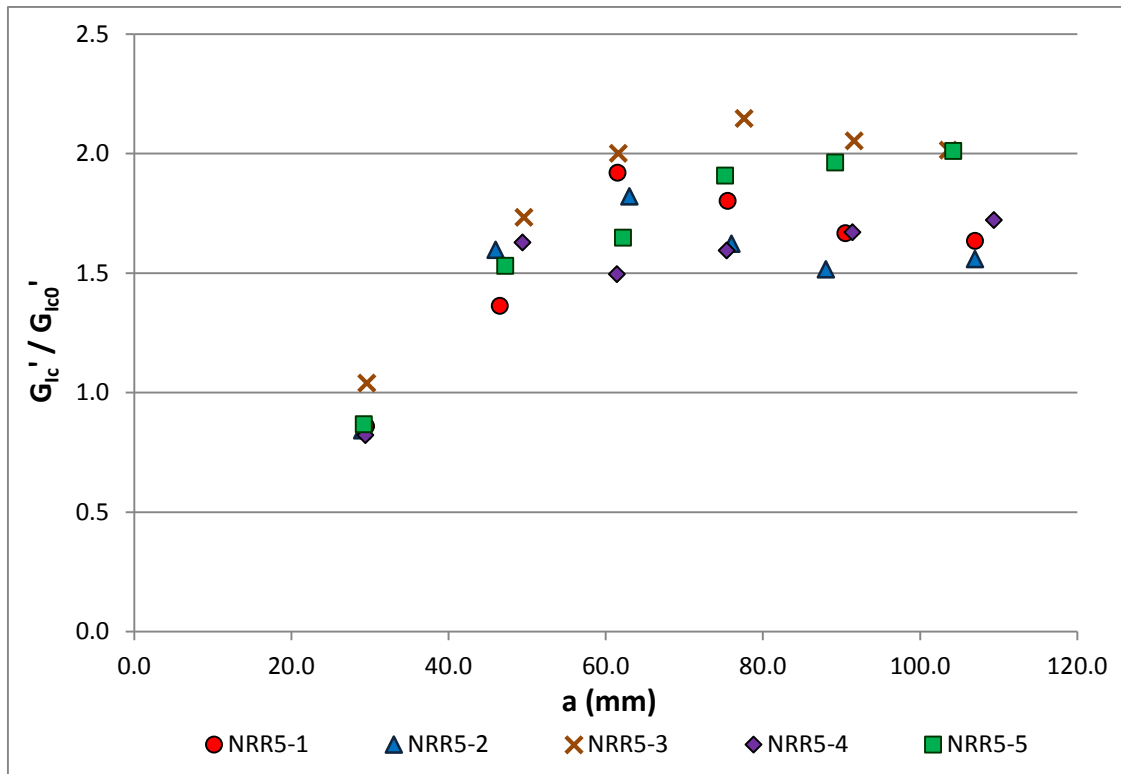
Figure 2.16. G'_{ic}'/G'_{ic0}' vs crack length for candidate resin, NRR5

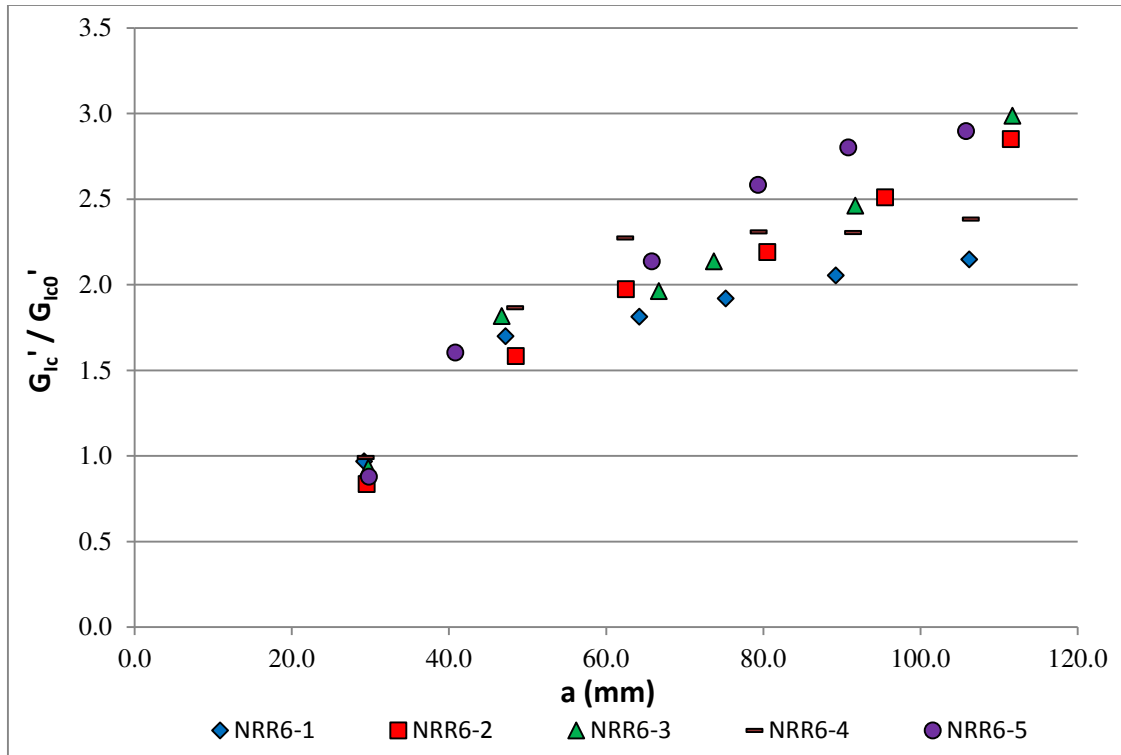
Figure 2.17. G'_{ic} / G'_{ic0} vs crack length for candidate resin, NRR6

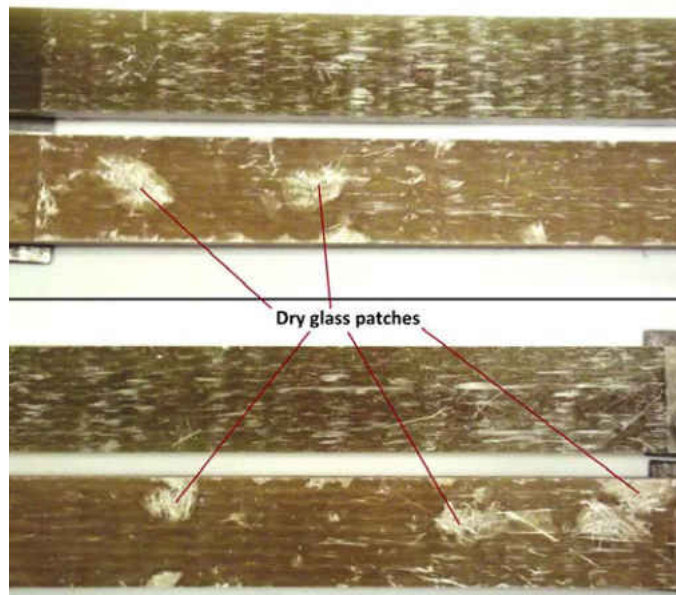
Figure 2.18. Fractured surfaces of NRR3 specimens with dry patches in CSM

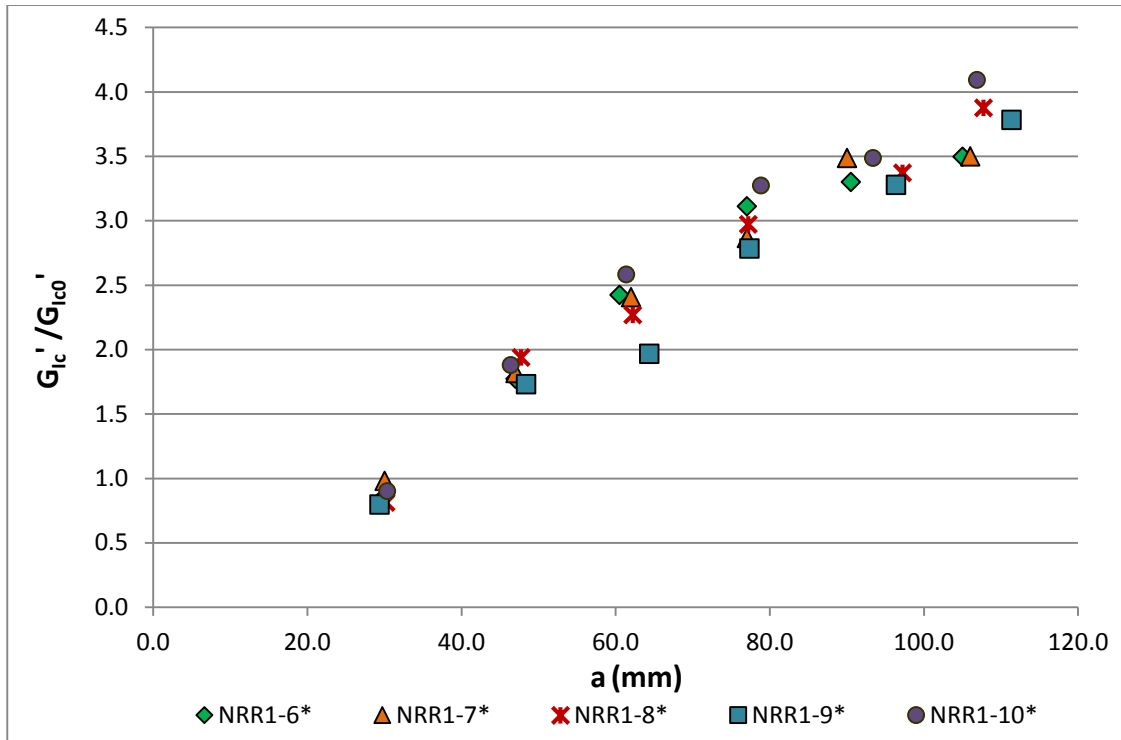
Figure 2.19. G'_{Ic} / G_{Ic0}' vs crack length for resin NRR1 with partial top ply ground off

The specimens with the top plies partially ground off and repaired with repair resins NRR1, NRR4 and NRR5 were also tested to examine the fracture toughness difference due to grinding variation. The normalized fracture toughness values for these are plotted against crack length in Figure 2.19 to Figure 2.21.

In all of the specimens with the top plies partially ground off the fracture toughness values were much higher (Table 2.5) than those obtained from specimens made with same repair resins but with their top plies ground off completely. When the top plies are ground off completely, the resulting exposed surface on which the repairs are carried out comprises mainly main blade resin, MB-A. Whereas, when the top plies are ground off partially, the resulting surface has a mixture of exposed fibers and resin. These exposed fibers bond with the repair resin and this results in pronounced fiber bridging while the specimens are being tested, thus leading to high fracture toughness values. Figure 22 to Figure 24 depict a comparison of the normalized fracture toughness values obtained from specimens with top parent plies completely ground off (numbered NRR#-#) to those with the top parent plies partially ground off (numbered NRR#-#*).

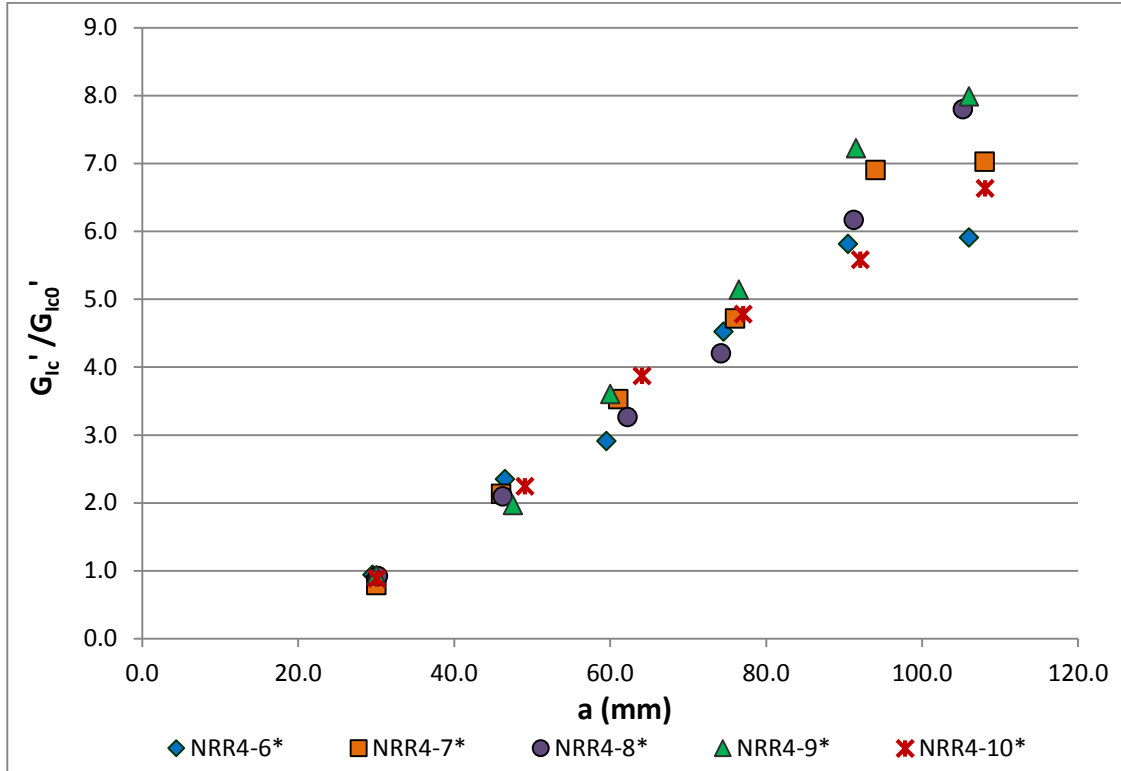
Figure 2.20. G'_{Ic} / G_{Ic0}' vs crack length for resin NRR4 with partial top ply ground off

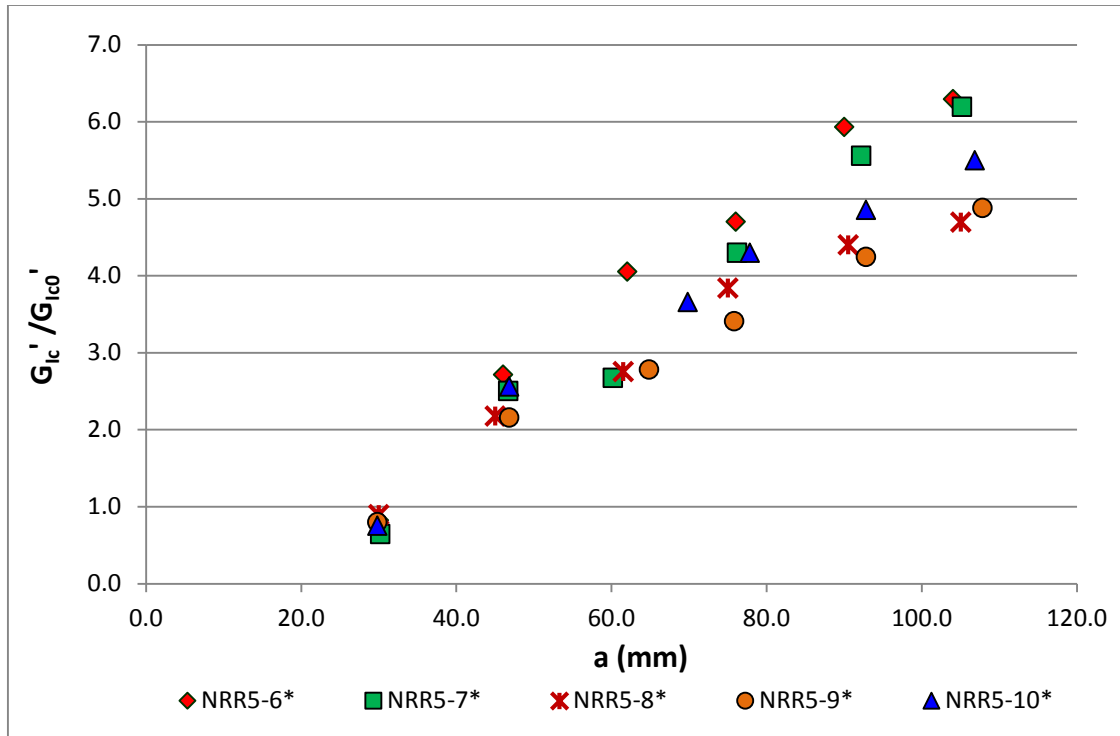
Figure 2.21. G'_{Ic}/G_{Ic0}' vs crack length for resin NRR5 with partial top ply ground off

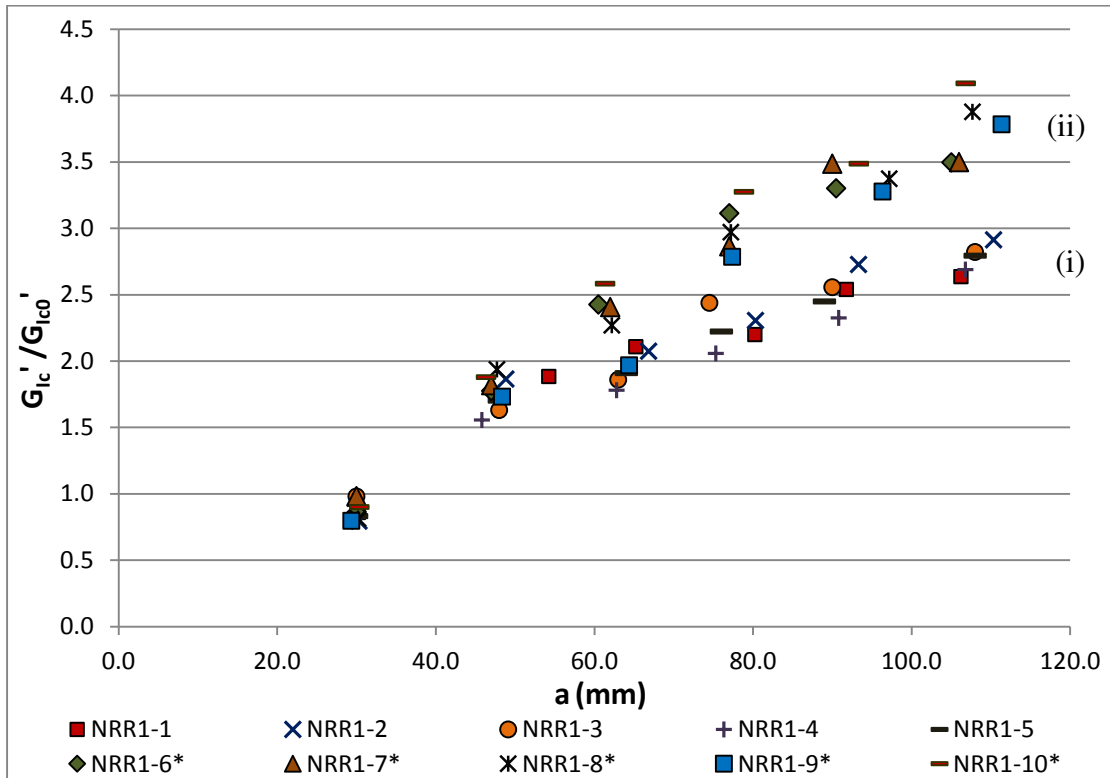
Figure 2.22. Comparison of fracture toughness values of NRR1 specimens with (i) whole top ply ground off (NRR1-#) (ii) partial top ply ground off (NRR1-#*)

From the graphs plotted in Figures 2.22 to 2.24 it is evident that there is little variation in the fracture toughness values at first crack initiation at $a = 30$ mm for the two cases. A closer look reveals that the fracture toughness values, when the specimen first cracks open at the tip of the insert, are higher for the repairs carried out on parent plates with the complete top plies ground off (Figure 2.25). This might be due to the differences in the crack propagation paths in the two cases. For crack initiation at the end of the insert, the fracture toughness values primarily depend upon the bond morphology at the crack tip. The fiber bridging effect comes into play later as the crack propagates along the bondline between the two adherends. In the case of parent plates with the top plies partially ground off the surface at crack tip comprises partial exposed resin and exposed fibers. On the other hand the surface of parent plates with complete top plies ground off comprises mainly resin.

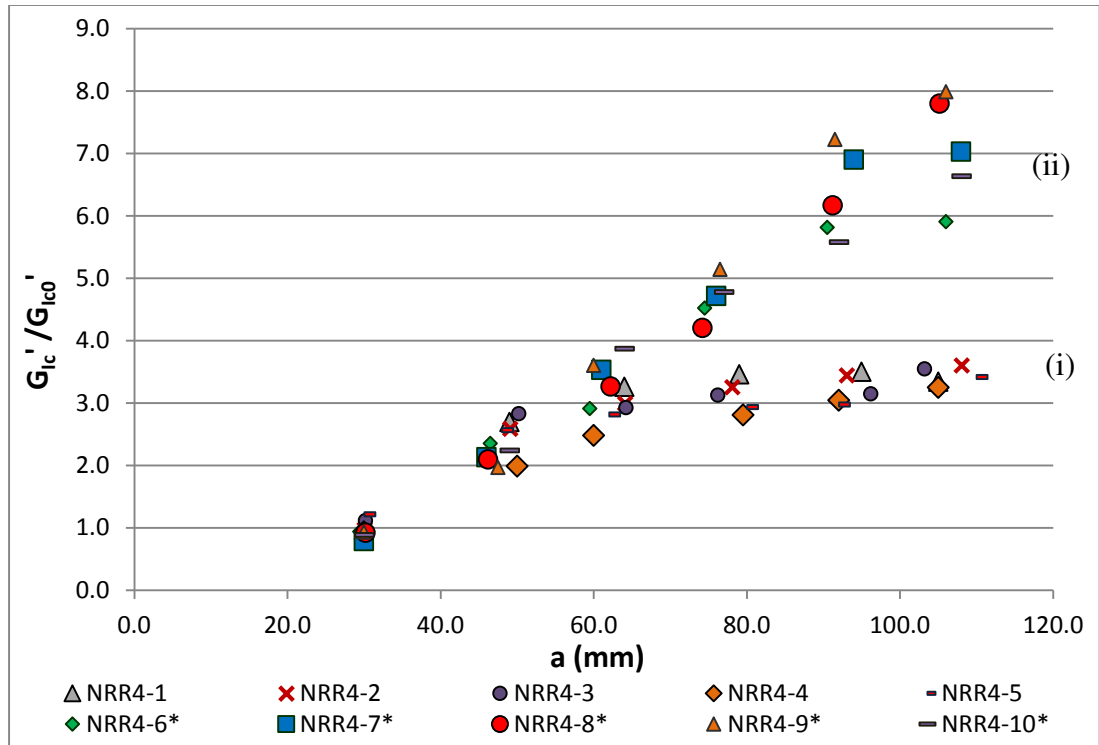
Figure 2.23. Comparison of fracture toughness values of NRR4 specimens with (i) whole top ply ground off (NRR4-#) (ii) partial top ply ground off (NRR4-#*)

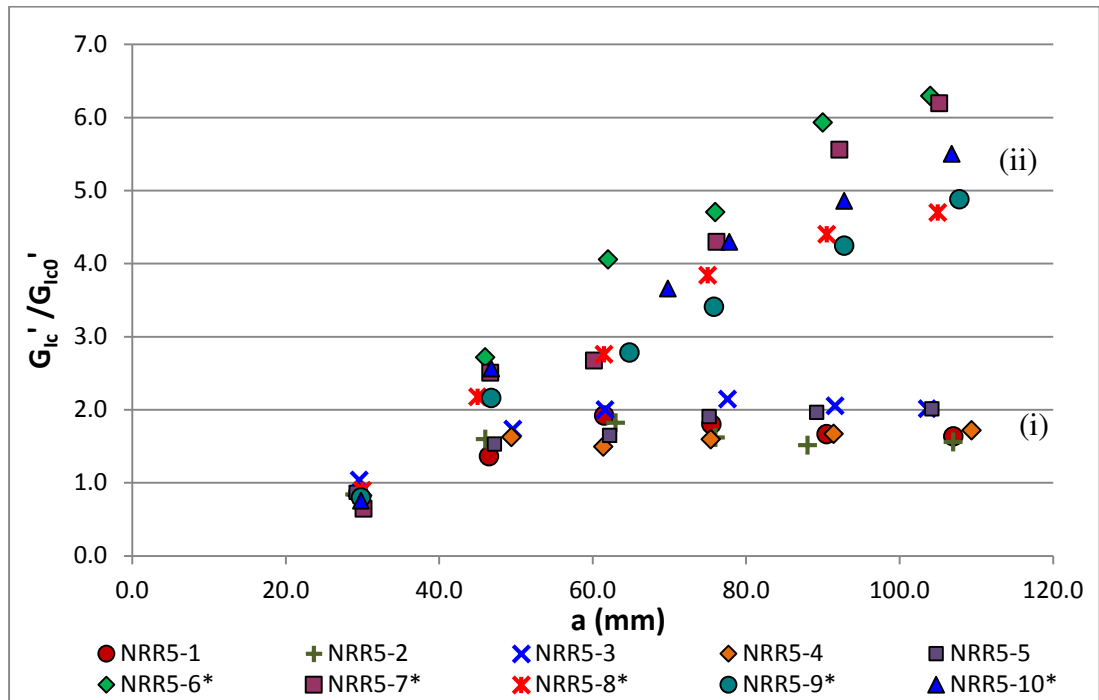
Figure 2.24. Comparison of fracture toughness values of NRR5 specimens with (i) whole top ply ground off (NRR5-#) (ii) partial top ply ground off (NRR5-#*)

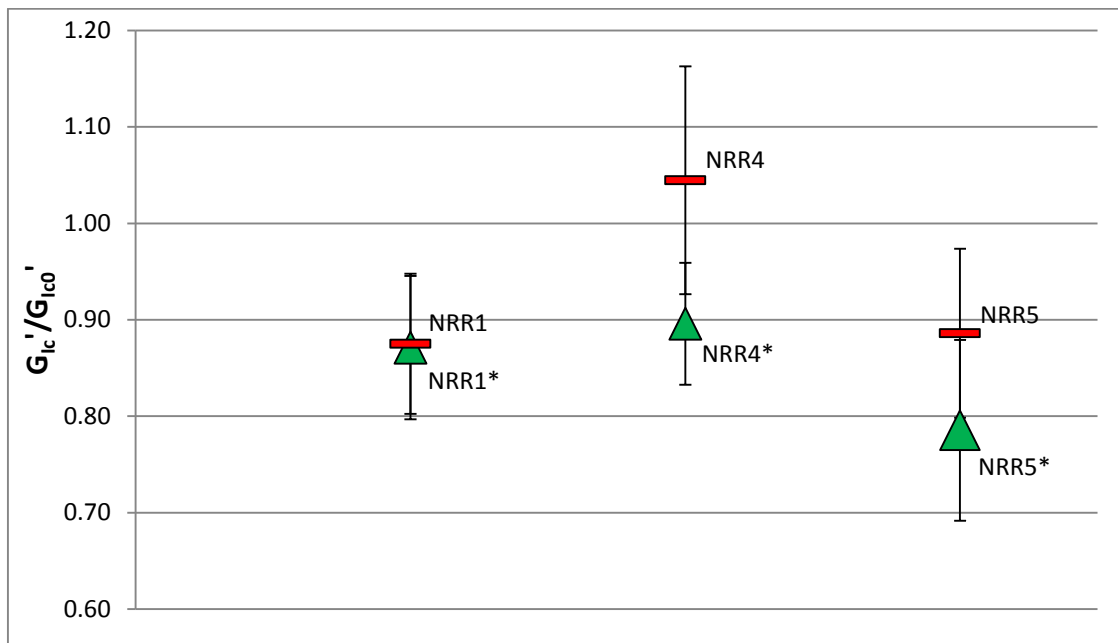
Figure 2.25. Normalized fracture toughness values from crack initiation at $a = 30$ mm for (i) complete top ply ground off case, NRR# (ii) partial top ply ground off case, NRR#*

In all three cases, the specimens consisting of repairs carried out on parent plates with the top plies ground off completely, depicted higher crack initiation toughness values at the insert tip. For repair NRR1, a significant difference was not observed.

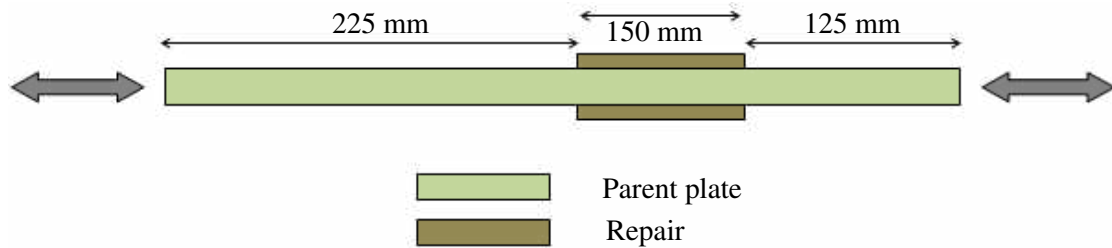
Specimens for fatigue tensile testing consisted of a parent laminate with a strip of repair on either side (Figure 3.1). Eight parent plates (60 cm X 60 cm) were manufactured following same manufacturing technique (VARTM) as used for mode I testing specimens. The sequence of lay-up, curing and post curing details are listed in Table 3.1. As the lay-up was symmetric for these parent plates, no warping was observed.

Following post curing, surfaces of four of the parent plates were ground off at the regions where the repair strips were to be laid before conducting the hand lay-up with MB-B and the three chosen candidate repair resins. The repair regions were ground to one ply depth in these plates. Repairs on the other four parent plates were conducted without any grinding.

Figure 3.1. Fatigue tensile test specimen configuration (side view, not to scale)

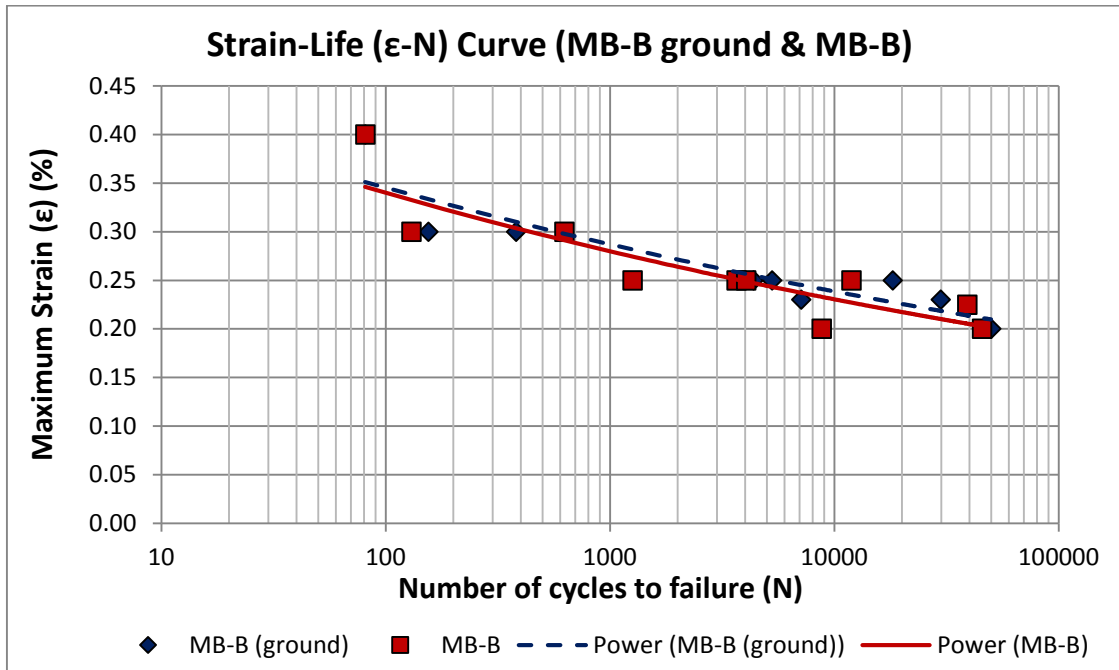
Figure 3.4. Strain-Life plot for ground (MB-B ground) and unground (MB-B) specimens

In the first round of testing, specimens repaired with MB-B repair resin and with and without grinding were tested. The resulting Strain-Life (ϵ -N) and Stress-life (S-N) curves are presented in Figure 3.4 and Figure 3.5 respectively.

Though MB-B ground specimens do perform a little better under fatigue loads, these plots show that there is little difference in the fatigue properties of ground and unground specimens repaired by the same resin. When the region of repair on a parent plate is ground down to remove one complete ply as in the case of MB-B ground specimens, the layer of resin between the top and the second glass plies is exposed. The repair ply is then hand laminated on this freshly exposed resin layer. In the case where the top ply is not ground the repair ply is hand laminated on the resin layer present on the top surface of the parent plate. This similarity in the composition of the repair surfaces accounts for the similar fatigue characteristics in these two repair cases. Since, the ground and unground specimens did not behave very differently under fatigue, fatigue results of specimens repaired without grinding were only considered in order to avoid the effects of variation in grinding depths as those observed on fracture toughness values in mode I testing.
