Mechanical Characterization Of Composite Repairs For Fiber-Glass Wind Turbine Blades

A Dissertation

for the degree of
Doctor of Philosophy

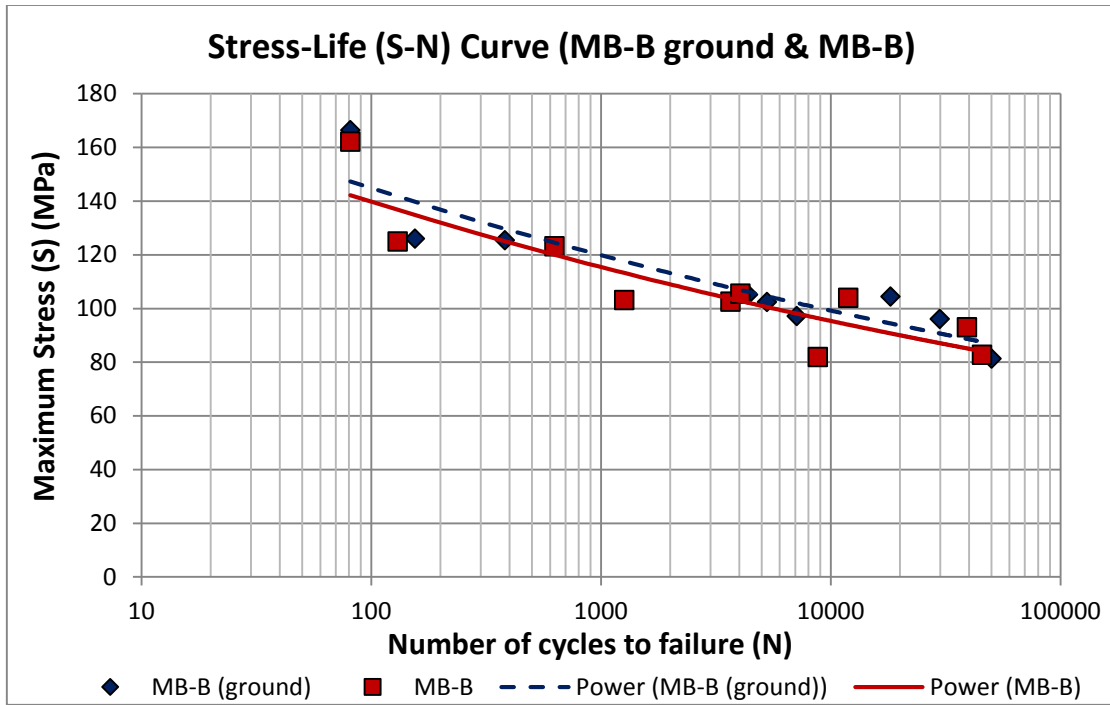
Figure 3.5. Stress-Life plot for ground (MB-B ground) and unground (MB-B) specimens

In the first round of testing, specimens repaired with MB-B repair resin and with and without grinding were tested. The resulting Strain-Life (ϵ -N) and Stress-life (S-N) curves are presented in Figure 3.4 and Figure 3.5 respectively.

Though MB-B ground specimens do perform a little better under fatigue loads, these plots show that there is little difference in the fatigue properties of ground and unground specimens repaired by the same resin. When the region of repair on a parent plate is ground down to remove one complete ply as in the case of MB-B ground specimens, the layer of resin between the top and the second glass plies is exposed. The repair ply is then hand laminated on this freshly exposed resin layer. In the case where the top ply is not ground the repair ply is hand laminated on the resin layer present on the top surface of the parent plate. This similarity in the composition of the repair surfaces accounts for the similar fatigue characteristics in these two repair cases. Since, the ground and unground specimens did not behave very differently under fatigue, fatigue results of specimens repaired without grinding were only considered in order to avoid the effects of variation in grinding depths as those observed on fracture toughness values in mode I testing.

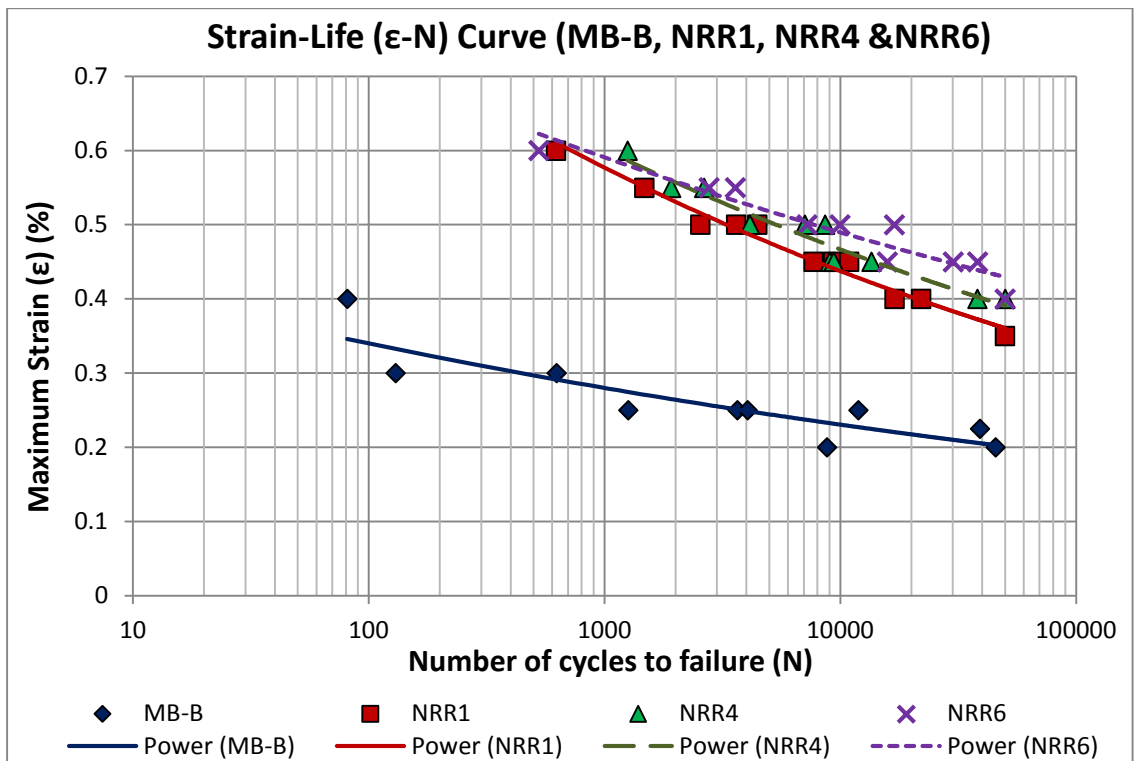
Figure 3.6. Strain –Life plot for unground specimens repaired with MB-B, NRR1, NRR4 and NRR6 repair resins

Strain-Life (ϵ -N) and Stress-life (S-N) curves for the repair resin candidates NRR1, NRR4 and NRR6 and their comparison with base repair resin MB-B are presented in Figure 3.6 and Figure 3.7 respectively. These depict that all three new repair resins shortlisted from mode I testing performed better than the base repair resin MB-B when loaded in tension-tension fatigue. The peak stress in NRR1 repairs at a life of about 50,000 cycles was 147 MPa which was less than the peak stresses for NRR4 (167 MPa) and NRR6 (166 MPa) at a similar life.

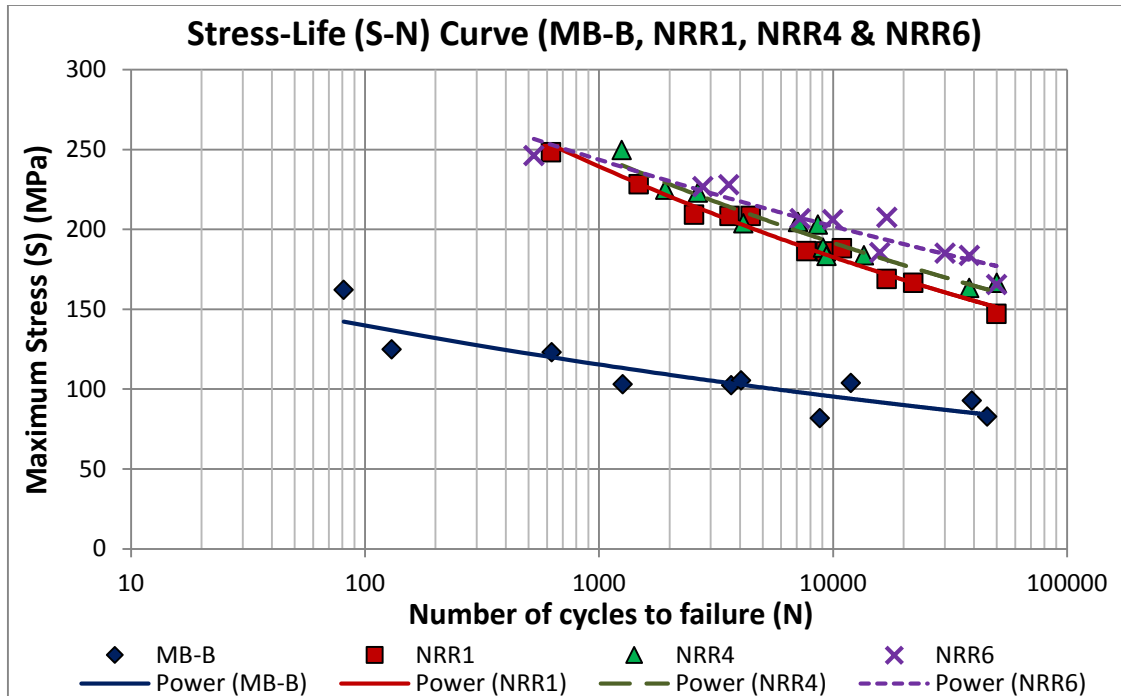
Figure 3.7. Stress –Life plot for unground specimens repaired with MB-B, NRR1, NRR4 and NRR6 repair resins

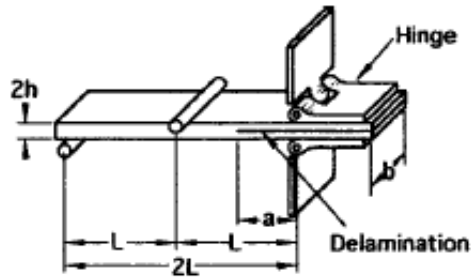
Figure 4.1. Specimen details for mixed mode I – mode II test [61]

For initial testing, specimens were made with the same materials and average thickness of $h \sim 9$ mm (Figure 4.1) as the DCB specimens for mode I testing. Mixed-mode ratios (G_{II}/G_c) of 0.2, 0.5 and 0.8 were used. It was found that the adhesive bond of the piano hinges with the specimen was not able to bear the loads (1.5 ± 0.15 kN) incurred at 0.5 and 0.8 values of G_{II}/G_c . The range of the thickness h of each adherend (Figure 4.1) was recalculated for the required maximum load < 1.5 kN, keeping in consideration that the displacements were not so large as to cause geometric nonlinear errors [61]. The final specimen thickness obtained from the results of the initial mixed mode I – mode II testing and calculations from ASTM D 6671/D 6671M – 06 using estimated critical load and load point deflection values was $h \sim 5$ mm, a reduction of approximately 4 mm from the thickness of each adherend of a mode I testing specimen.

and E_{11} = longitudinal modulus of elasticity measured in tension (MPa), E_{22} = transverse modulus of elasticity (MPa) and G_{13} = shear modulus out of plane (MPa). The half-span length, L , (Figure 4.1) of the mixed mode I – mode II testing fixture was kept 50 mm for all mode mixity ratios. Thus, crack propagation was observed to a distance of 25 mm from the pre-crack tip i.e. to a distance of 50 mm from the load line. After testing had been conducted the flexural modulus was calculated as:

where a_0 = the initial delamination length (mm), m = slope of load displacement curve (N/mm), b = width of specimen (mm), C_{sys} = system compliance (mm/N), and L = half span length of the test apparatus (mm) (Figure 4.1). The fracture toughness and mode mixture were calculated using the equations given below:

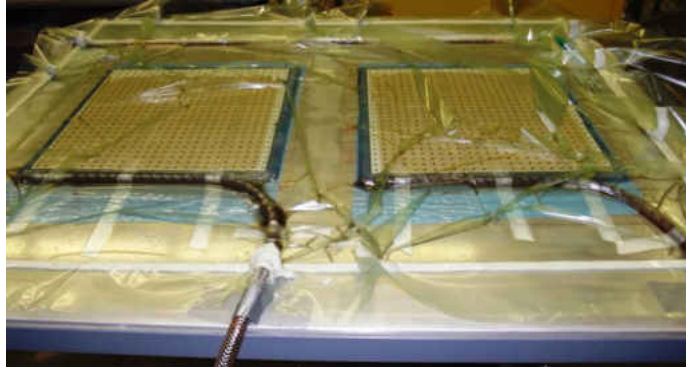
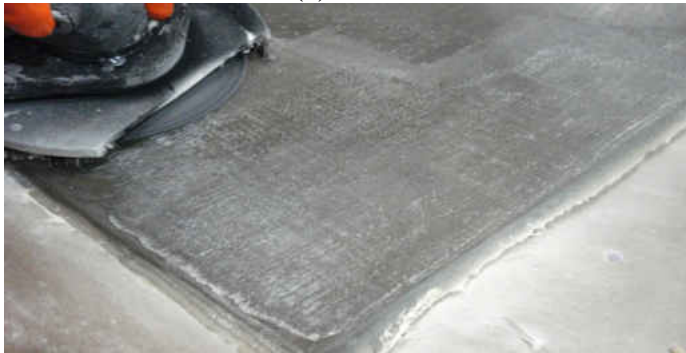
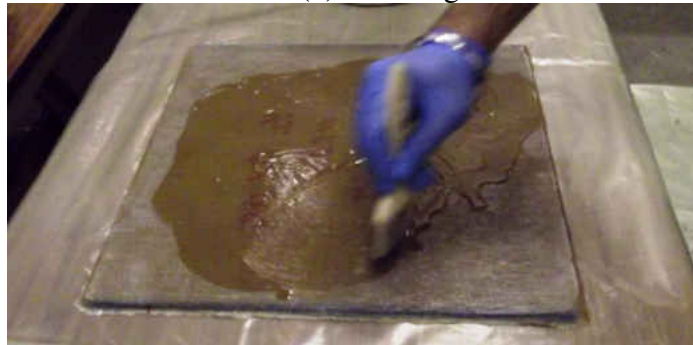
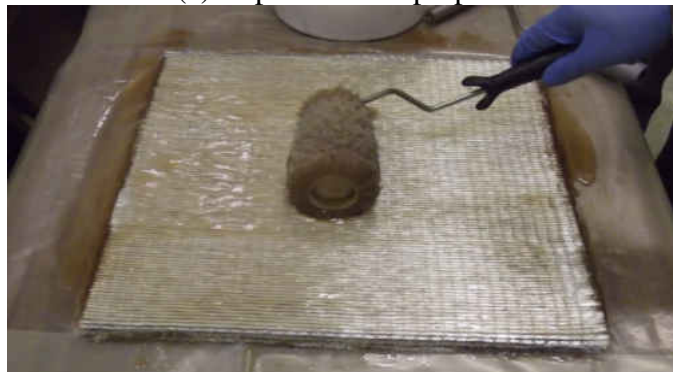
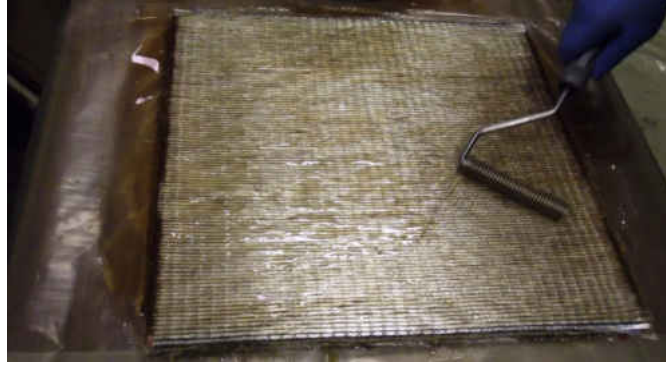
4.2 (a) VARTM

4.2 (b) Grinding

4.2 (c) Repair surface preparation

4.2 (d) Resin application

4.2 (e) Removal of voids

Figure 4.2. Mixed-mode specimen manufacturing

4.2 depicts, (a) the methods of manufacturing of the parent plates, (b & c) surface preparation for repairs and (d & e) repairs being conducted. The repairs were carried out in a similar fashion to that in the case of mode I testing and were allowed to cure at room temperature for 24 hours. Then, post-curing was carried out for 16 hours in the oven at 40° C. After the parent plates had been repaired and cured, they were found to be slightly warped in a direction perpendicular to the unidirectional fibers. This was most probably due to the difference in the composition of the parent plate and repair resins and the shrinkage of the repair resin while in contact with the pre-cured parent plate resin. Again, as in the mode I testing, it was assumed that this warp would not have a significant effect on the test results since the specimens were to be cut in a direction along the unidirectional glass fibers.

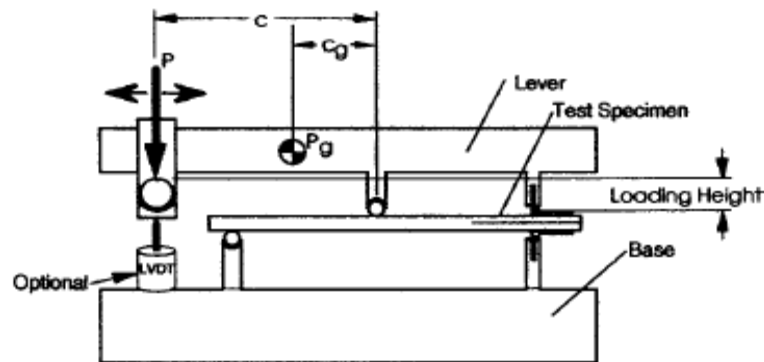
Figure 4.3. Test fixture and parameters of mixed-mode test [61]

mixed mode I – mode II bending test apparatus shown in Figure 4.3 is used to pull apart the two adherends of the DCB specimens in order to calculate the mixed-mode delamination fracture toughness values at different ratios of mode I to mode II loading. The specimen is supported at the base by the hinge attachment at the delaminated section and by a roller at the other end. The roller attached to the lever arm bears on the top surface of the specimen at a distance midway between the base roller and the hinges. Loads are applied to the delaminated part of the specimens (that contains the pre-crack) by pulling at the hinges and also through rollers that bear against the specimen in the non-delaminated section of the specimen. This setup results in application of mode I load at the hinges and mode II load at the fulcrum formed by the roller attached to the lever arm.

Before testing, the length, c (Figure 4.3), of the lever of the mixed mode I – mode II test fixture was calculated and set to produce the desired mode mixture ratio G_{II}/G in accordance with Equation 4.1 as given in (ASTM D 6671/D 6671M – 06):

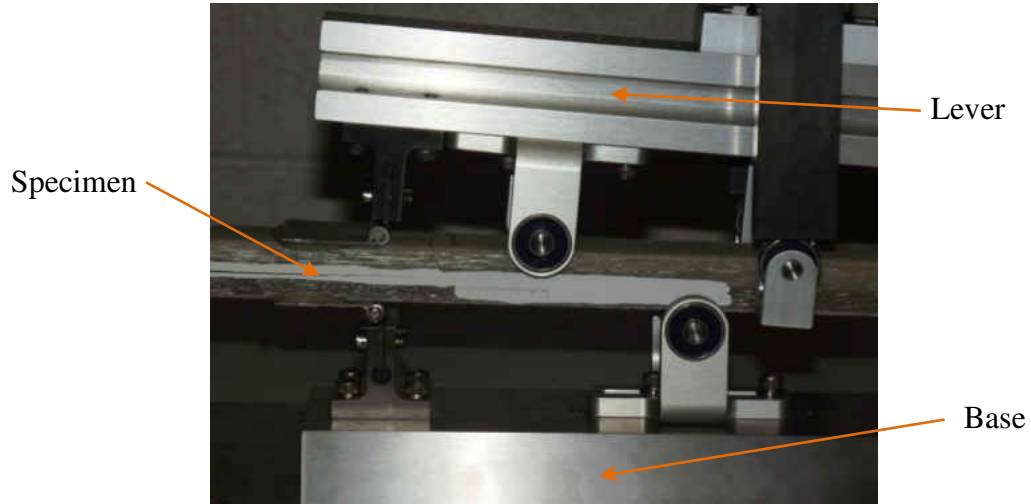
Figure 4.4. Mixed mode I – mode II test snapshot

software. These images were analyzed for stroke displacements using Vic-2D Digital Image Correlation Software. A picture of a specimen being tested in the (ASTM D 6671/D 6671M – 06) fixture is given in Figure 4.4.

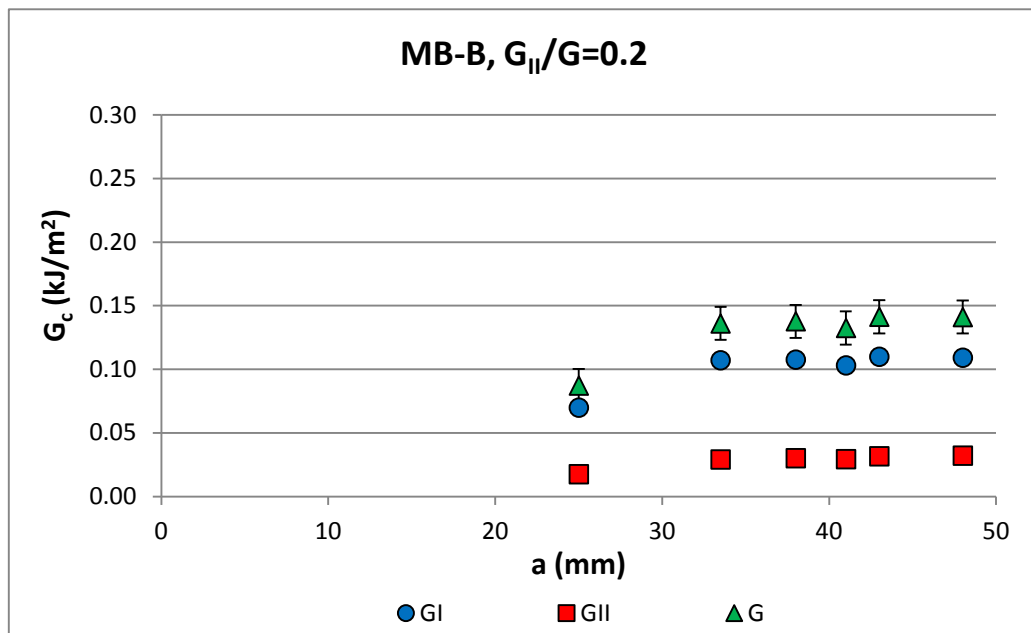
Figure 4.5. (a) Preliminary mixed mode I – mode II testing results for current blade repair resin MB-B

From the initial mixed-mode testing for mixed mode load ratio $G_{II}/G = 0.2$, fracture toughness values of crack propagation for the repair resins MB-B and NRR4 were plotted against crack length (Figures 4.5 (a) – (b)). Preliminary results show that fracture toughness values obtained with delamination growth in accordance with ASTM D 6671/D 6671M – 06 are higher for NRR4 as compared to MB-B. This corroborates with the results obtained from mode I and fatigue testing for these two repair resins.

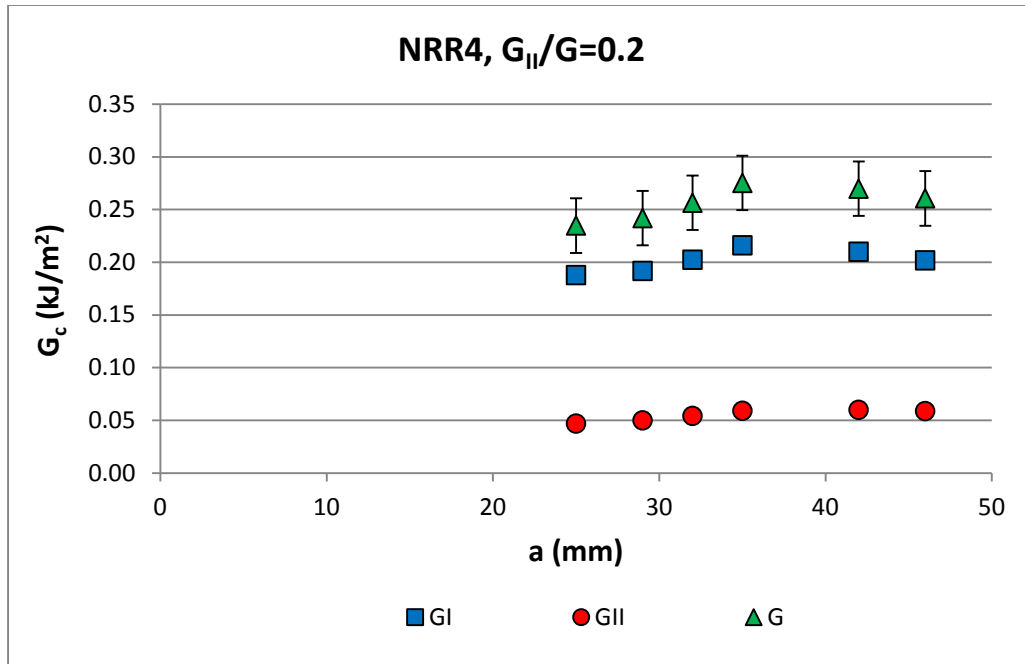
Figure 4.5. (b) Preliminary mixed mode I – mode II testing results for new repair resin candidate NRR4

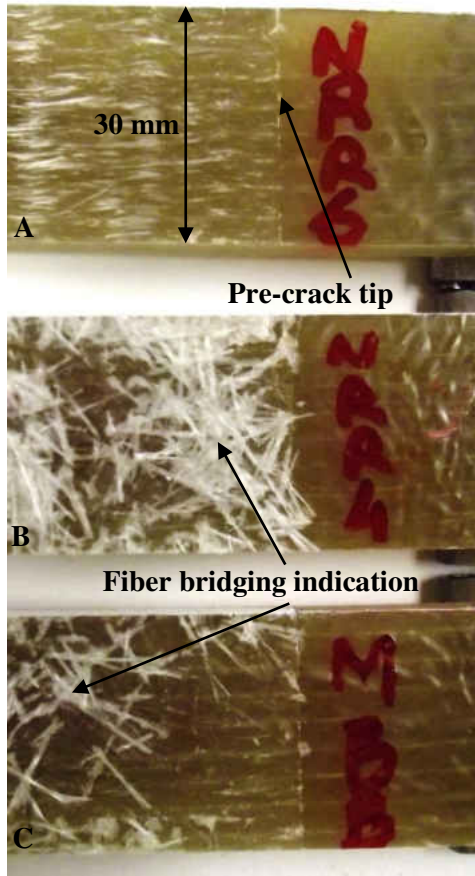
Figure 4.6. Fiber bridging in NRR6 (specimen A), NRR4 (specimen B) and MB-B (specimen C) in mixed mode I – mode II ($G_{II}/G_c = 0.2$) test

In the case of mixed mode I – mode II testing of specimens repaired with repair resin NRR6, the crack propagation was very fast and the camera was not able to capture the crack length values between the 25 mm and 50 mm marks. Thus it was not possible to record the propagation fracture toughness values for this resin. The reason for the fast crack growth can be the lack of fiber bridging as can be seen in Figure 4.6. NRR6 showed better crack initiation fracture toughness values than the repair resin MB-B (Figure 4.7) but they were less than those for NRR4.

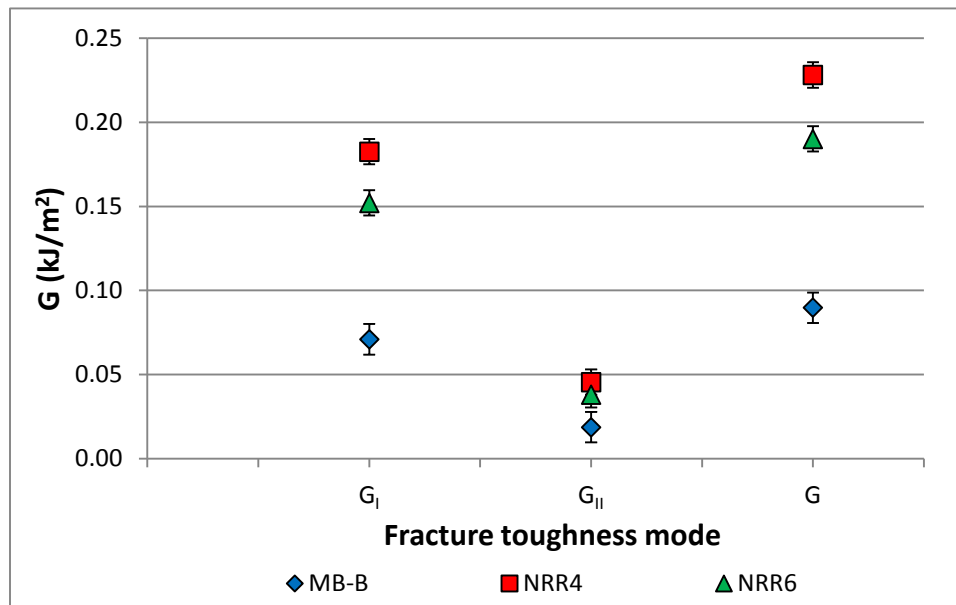
Figure 4.7. Fracture toughness values at crack initiation for MB-B, NRR4 and NRR6

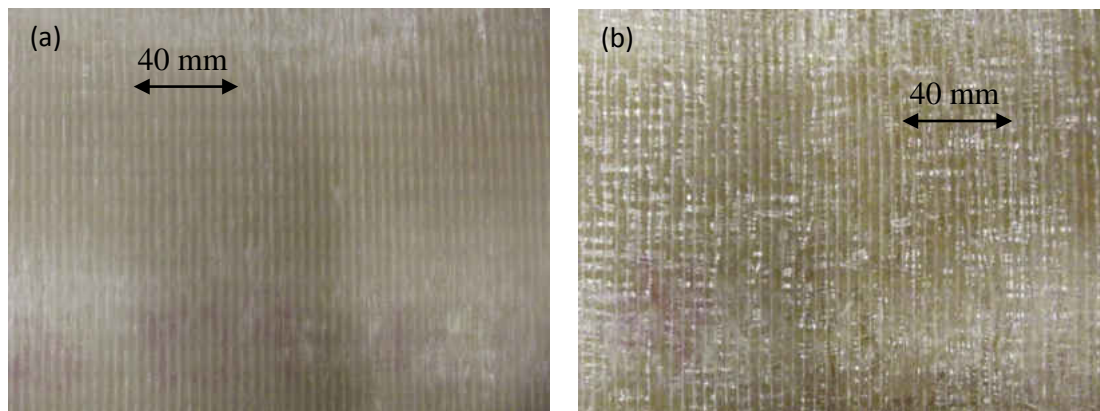
Figure 4.8. Parent plate with (a) complete top ply ground off (b) partial top ply ground off

Specimens consisting of parent plates manufactured with MB-A' and H-glass and repaired with MB-B and NRR4' repair resins were tested after the initial mixed mode I – mode II testing. The length of the lever arm, c , of the mixed mode I – mode II testing apparatus was varied for each of the mode mixtures ($G_{II}/G = 0.2, 0.5$ and 0.8) before testing. Two levels of grinding of the top ply of the parent plate were evaluated. In mode I testing it was seen that difference in grinding depth of the top surface of the parent plate while preparing it for repairs does affect the fracture toughness values of the repairs. For this testing one set of plates was repaired with the top unidirectional glass-fiber ply completely ground off, thus exposing a surface comprising mainly of cured resin as shown in Figure 4.8 (a). The top unidirectional glass-fiber ply of the other set was partially ground off to expose a surface comprising of a mixture of glass fibers and cured resin (Figure 4.8 (b)).

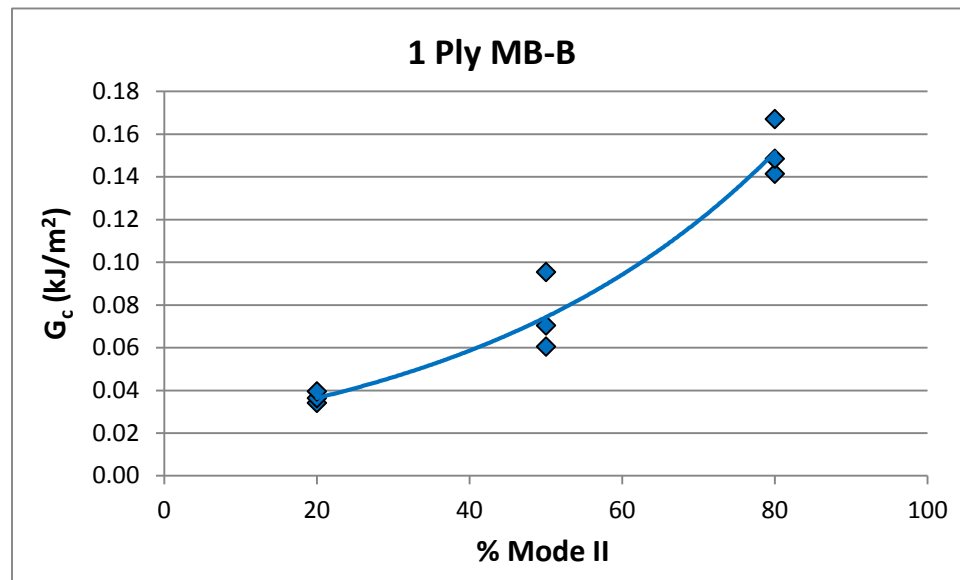
Figure 4.9. Delamination fracture toughness values for MB-B with whole top ply of parent plate ground off

as the crack growth was very fast in mixed-mode testing. A typical fracture toughness contour is shown in Figure 4.9 for the repair carried out using repair resin MB-B after grinding off the top ply of the parent plate completely. The delamination fracture toughness values increase with an increase in the percentage of mode II loading from 20% to 80% as expected.

The scatter in the toughness values does not bear a linear relation with the increase in mode II percentage. As shown in the plot, the mixed mode fracture toughness values obtained at different mode II ratios can be generally fitted by an exponential curve. Similar trend was found by Benzeggagh and Kenane [66] and further corroborated by other researchers like Dharamawan et al [70].

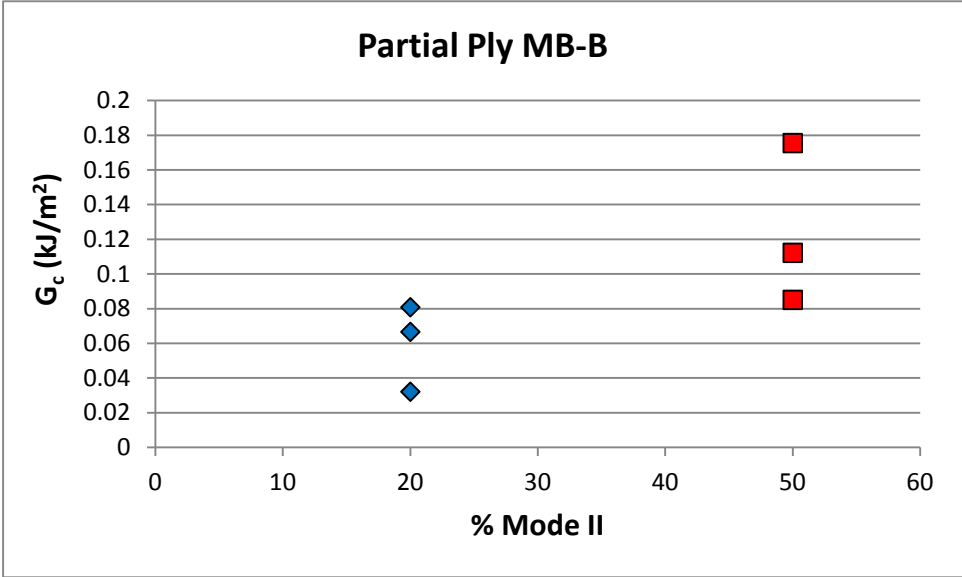
Figure 4.10. Delamination fracture toughness values for MB-B with partial top ply of the parent plate ground off

Similar fracture toughness contours are shown in Figures 4.10 – 4.12 for resin MB-B with partial top ply ground off, and resin NRR4' with complete top ply ground off and resin NRR4' with partial top ply ground off, respectively.

In all of these three cases (Figures 4.10 – 4.12) the methacrylate adhesive used to bond the hinges to the composite specimens was not able to bear the high shear loads at mode mixity ratio $G_{II}/G = 0.8$ and the hinges came off the specimens before crack initiation. The values of delamination fracture toughness for the mode mixity ratio $G_{II}/G = 0.8$ for these specimens were not recorded. The loads at which the hinges came off were of the order of 1.55 ± 0.15 kN. These loads were similar to the loads experienced by the initial mixed mode I – mode II testing specimens (with each adherend thickness ~ 9 mm) when they were tested at mode mixity ratio $G_{II}/G = 0.5$. Equation 4.11 from ASTM D 6671/D 6671M – 06 that was used to estimate the thickness of the specimens so that they would be able to bear the $G_{II}/G = 0.8$ loads does not take into account the fracture toughness of the bond between the composites and the methacrylate adhesive. It takes into account only G_c^{est} which is the estimated value of the composite total mixed mode fracture toughness.

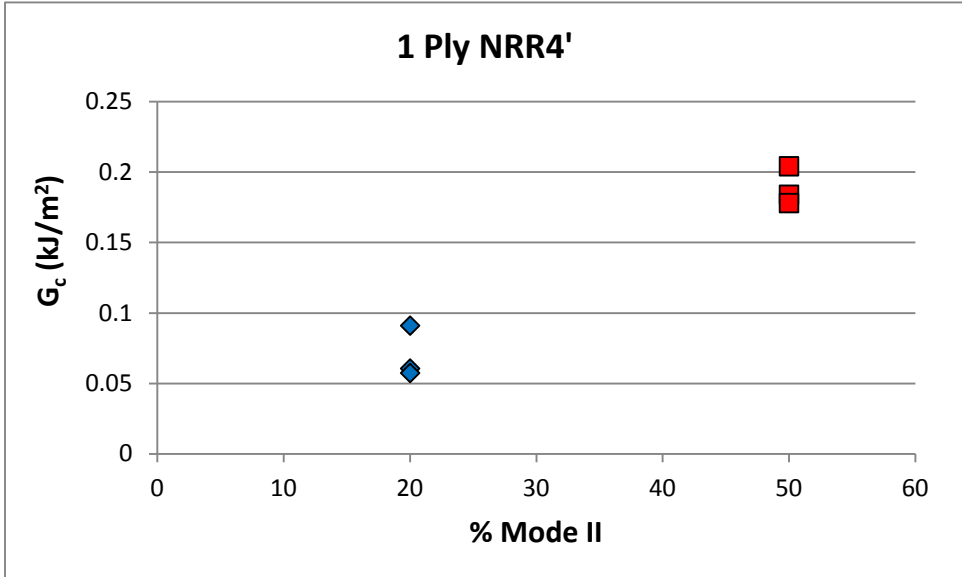
Figure 4.11. Delamination fracture toughness values for NRR4' with whole top ply of parent plate ground off

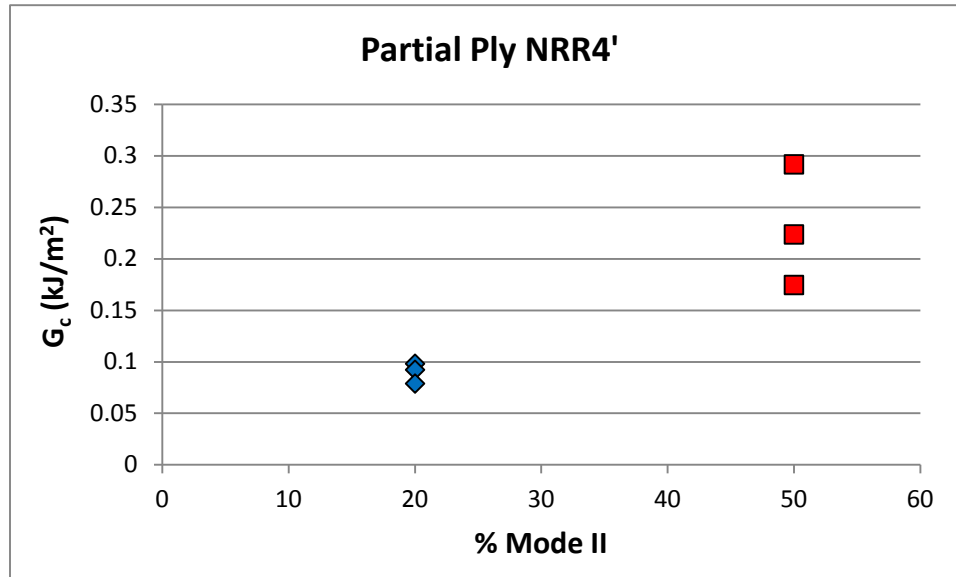
Figure 4.12. Delamination fracture toughness values for NRR4' with partial top ply of the parent plate ground off

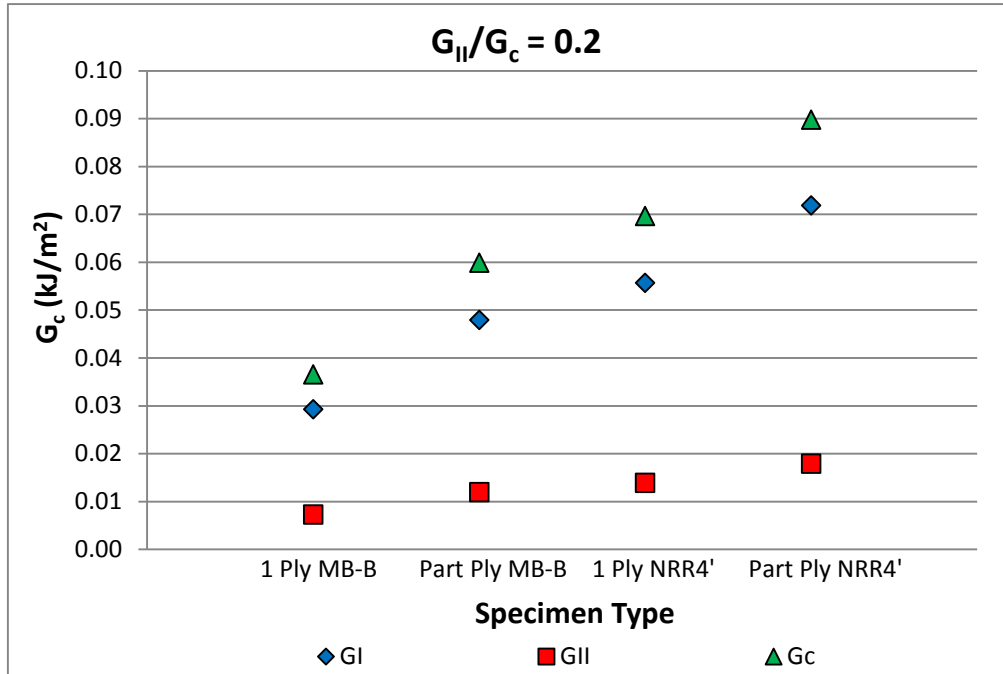
Figure 4.13. Fracture toughness values for MB-B and NRR4' at different grinding levels under mode II 20% loads (1 Ply ~ Complete top ply ground off, Part Ply ~ Partial top ply ground off)

Results from the mixed mode G_{II}/G_c ratios of 0.2 and 0.5 (Figure 4.13 and Figure 4.14) show that specimens repaired with NRR4' exhibit higher delamination fracture toughness values in mixed mode I – mode II testing as compared to those repaired with MB-B. In case of both repair resins, specimens repaired with partial top plies of the parent plates ground off have better fracture toughness values than the repairs with the complete top plies of the parent plates ground off. Similar phenomenon was observed in the case of mode I testing.

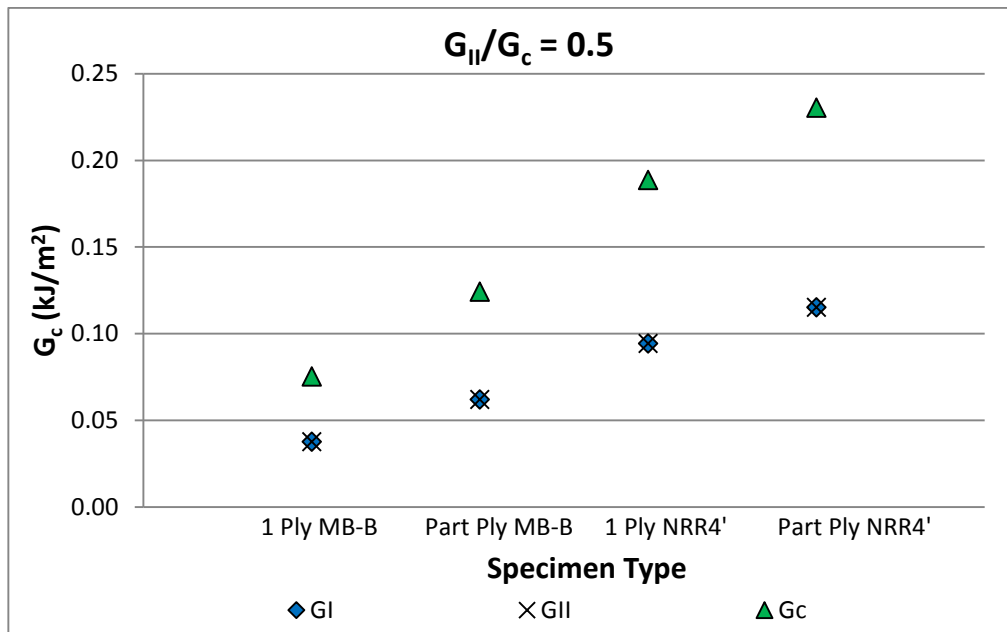
Figure 4.14. Fracture toughness values for MB-B and NRR4' at different grinding levels under mode II 50% loads (1 Ply ~ Complete top ply ground off, Part Ply ~ Partial top ply ground off)

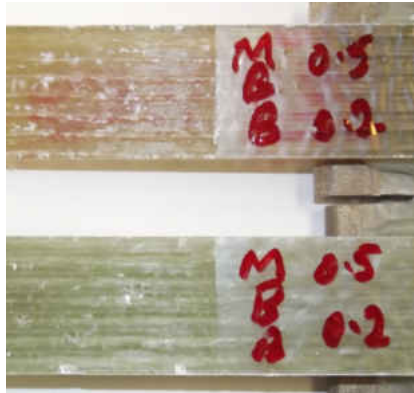
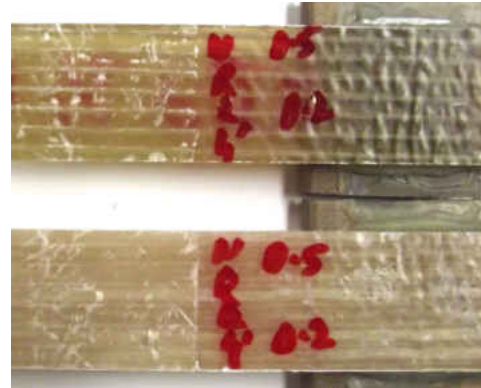
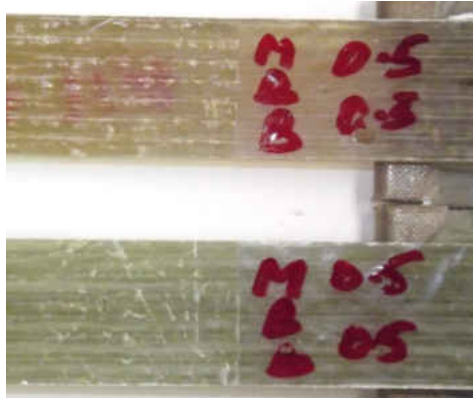
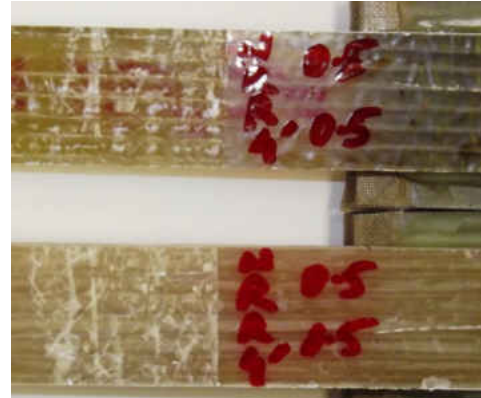
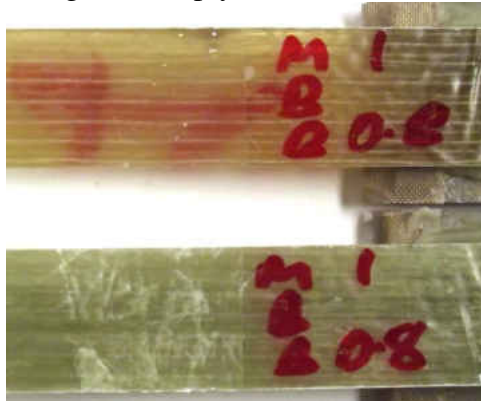
Figure 4.15. Images of surfaces fractured under different mixed mode I – mode II loads

(e) Partial ply MB-B $G_{II}/G=0.2$

(f) Partial ply NRR4' $G_{II}/G=0.2$

(g) Partial ply MB-B $G_{II}/G=0.5$

(h) Partial ply NRR4' $G_{II}/G=0.5$

(i) 1 ply MB-B $G_{II}/G=0.8$

Images of the fractured surfaces of specimens tested under various mixed mode ratios are shown in Figure 4.15. The MB-B specimens that were tested with mixed mode ratio $G_{II}/G = 0.2$, do not show significant signs of fiber bridging or effects of mode II load (Figure 4.15 (a) and (e)). In the case of MB-B specimens tested with mixed mode ratio $G_{II}/G = 0.5$, there are some signs of plastic deformation of the repair resin (depicted by white regions) under shear loads (Figure 4.15 (b)). For mode II 80% loads the MB-B specimens have more pronounced signs of fiber bridging as well as deformation of the repair resin due to shear loads.

The fractured surfaces of all specimens repaired with NRR4' resin show marked regions of fiber bridging and shear deformation of the repair resin under mode II loads. This is reflected in the higher fracture toughness values obtained for the NRR4' repair resin. In

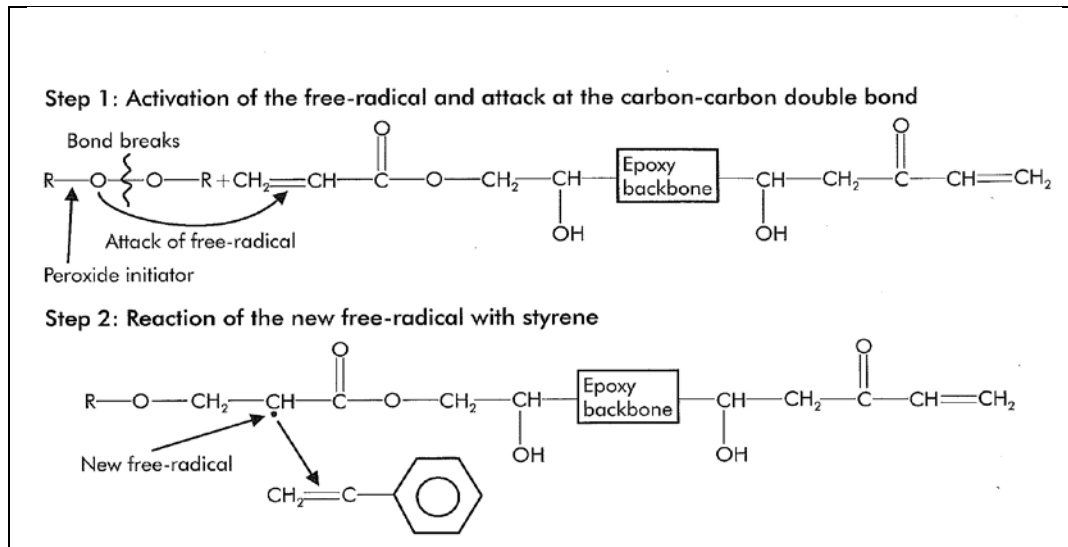
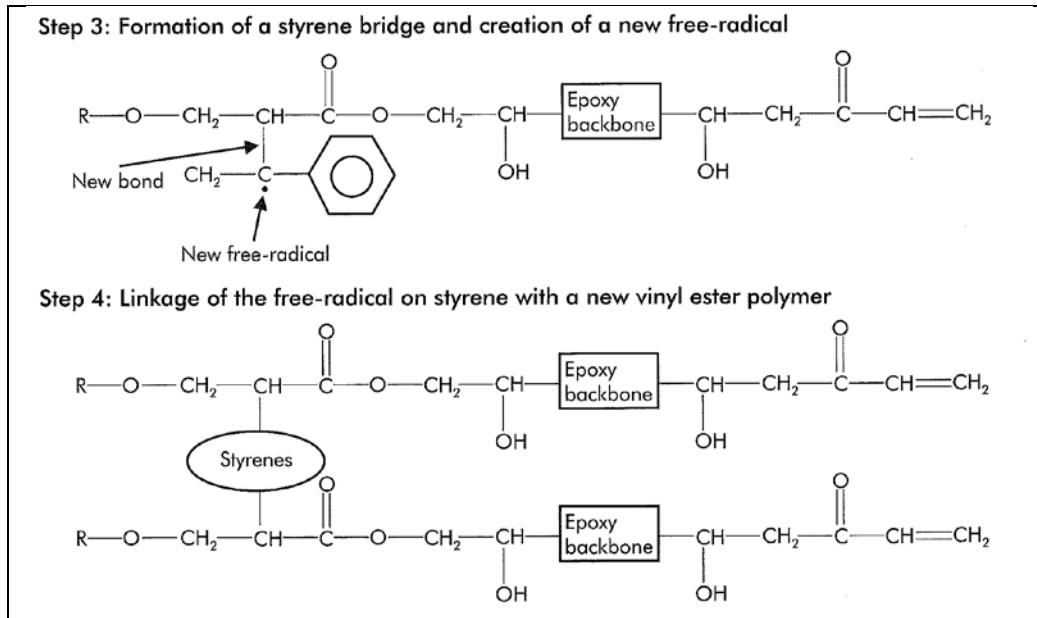
Figure 5.1. Crosslinking in vinyl ester resins [84]

In the first part of this work, mechanical characterization was conducted to select a new repair resin for a global wind turbine blade manufacturing company. It was found that NRR4, the vinyl ester resin with a higher amount of styrene, performed better than the polyester and other vinyl ester options that were selected as new repair resin candidates. A typical vinyl ester molecule consists of a main epoxy chain with unsaturated carbon – carbon double bond groups connected to its two ends with the help of ester groups. Just as in the case of unsaturated polyesters, these carbon – carbon double bonds are potential sites for crosslinking. Initiators like methyl ethyl ketone peroxide (MEKP) provide free radicals during cross linking that react at the double bond site (Figure 5.1) to form a new

free radical at that site. These free radicals further react with styrene molecules that are dispersed in the vinyl ester resin as shown in Step 3 in Figure 5.1. Depending on the relative concentration of styrene molecules in the resin, short or long chains consisting of styrene molecules are formed before they attach themselves to another vinyl ester molecule. The carbon – carbon double bond groups that have not yet reacted may join to other similar unsaturated parts of vinyl ester molecules through similar styrene bridges thus resulting in a large cross – linked system. The extent of cross linking depends upon the temperature at which the resin is cured. Usually, at room temperature after initial crosslinking, mobility of the polymer chains gets limited and the rate of crosslinking reduces. Some unsaturated (carbon – carbon double bond) groups that do not react at all are still left in the system. Post curing is carried out to fully cure the resin. The composite is generally post cured at a temperature that is higher than the glass transition temperature of the resin. As the polymer chains become more mobile, the rate of crosslinking
