# Low velocity impact testing and computed tomography damage evaluation of layered textile composite

Changpeng Song  
*University of Iowa*

A thesis submitted in partial fulfillment  
of the requirements for the Master of  
Science degree in Mechanical Engineering  
in the Graduate College of  
The University of Iowa

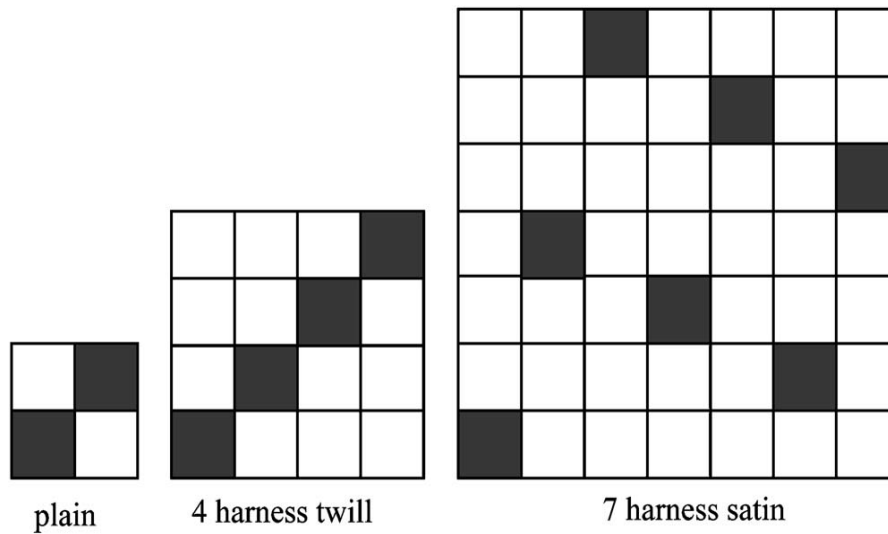
Figure 1. 1: Three fundamental ways to weave for woven fabric composites (Onal, 2007)

Usually, there are three kinds of textile composite materials: woven fabric composites, knitted fabric composites, and braided fabric composites (see Figure 1.1). For general woven fabric composite materials, two orthogonal yarns, known as warp and weft, are interlaced. Usually the warp yarns go vertically and weft yarns go horizontally.

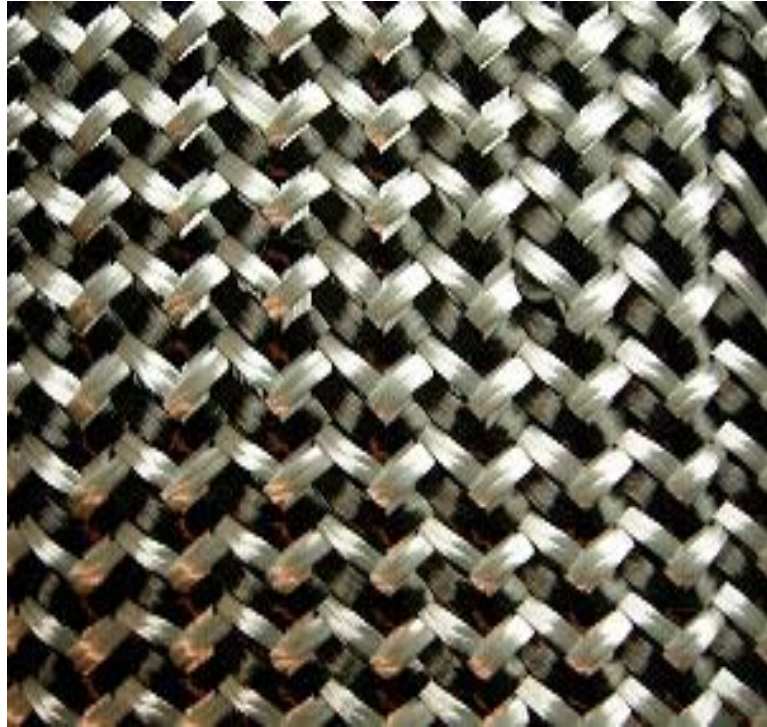
Figure 1. 7: Braided carbon fabrics (A&P Technology, 2013)

Braided fabric composite materials are often characterized by intertwining or orthogonally interlacing three or more threads when they cross one another to form an integral structure. There are two kinds of yarns in this kind of fabric: axial yarns and braided yarns. Generally, sets of parallel axial yarns interconnect with the braided yarns, which follow the  $+0$  and  $-0$  pattern. The braided fabrics are shown in Figures 1.6 and 1.7 (P. Tan, 1997).

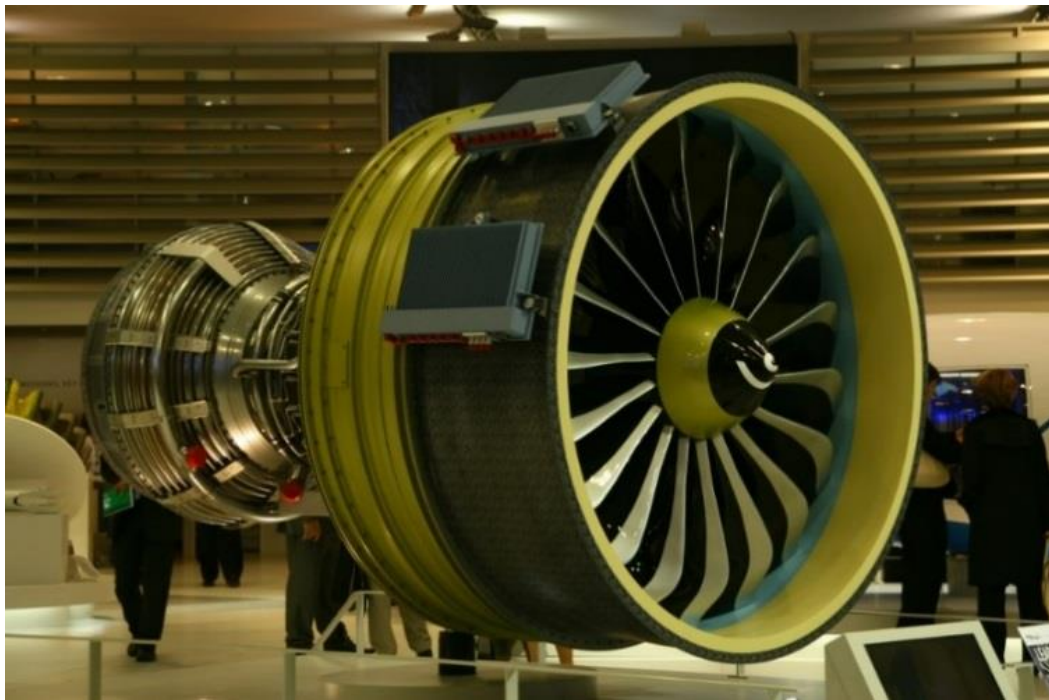
Figure 1. 12: CFM International new LEAP engine with 18 blades made from 3D woven composite (Composites Manufacturing Online, 2013)

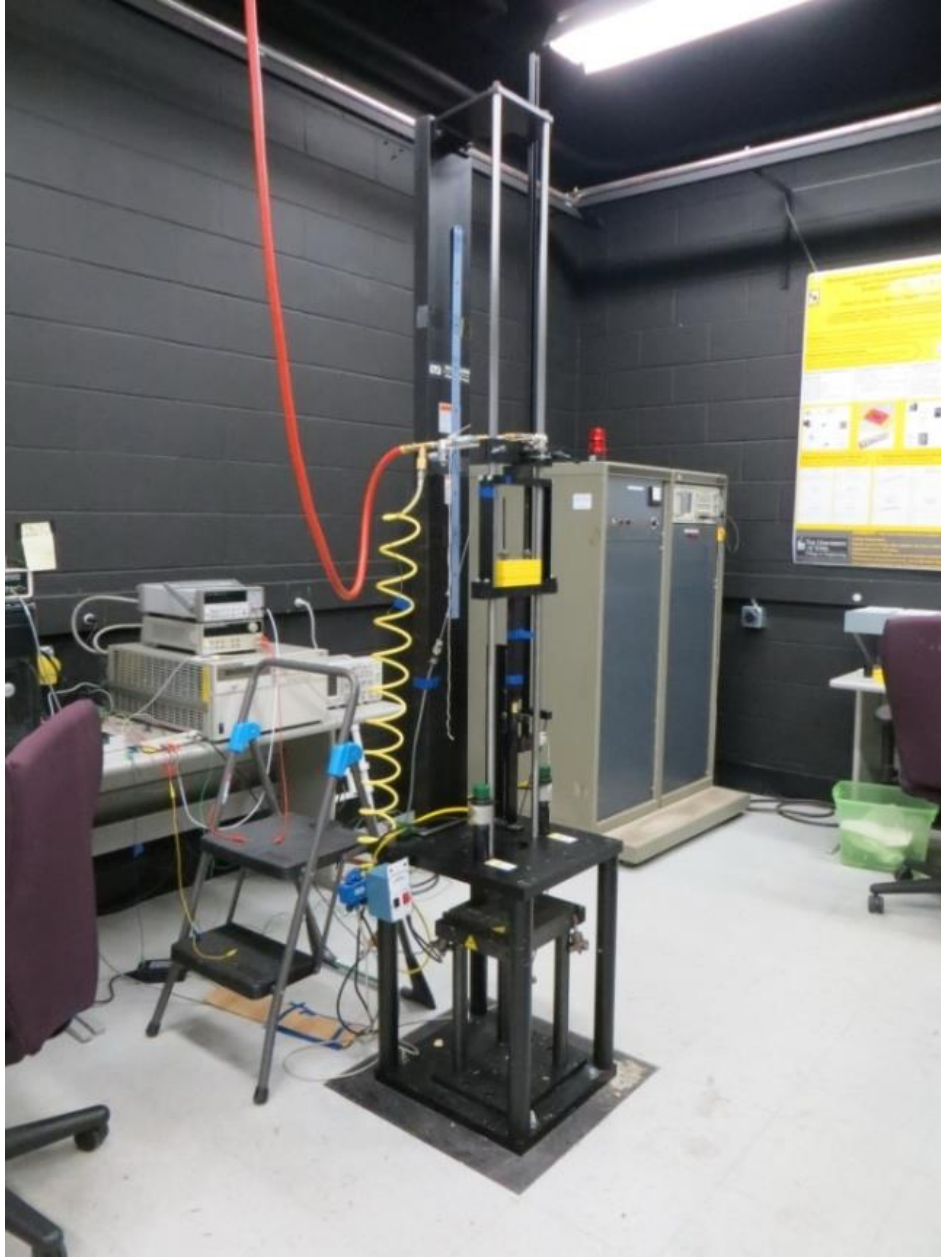
Figure 2. 1: Instron 8200 Impact Tester

In this work, an Instron 8200 Dynatup impact tester was used for low velocity impact testing of textile composites. The Instron 8200 Dynatup is designed to test the thin brittle plastics and composites in the numerous standards, like ASTM 3763 and NASA ST-1. Figure 2.1 shows us the Instron 8200 Dynatup impact tester (Dynatup, 2008).

The weight of the cross head of the impact tester can be adjusted from 1.1 to 13.6 Kg (6.7-25 lbs) with the single 1.1 Kg (2.4 lbs) increment for the falling carriage. The maximum drop height is 39.37 inch (1 m), which allows to achieve a maximum impact velocity of 4.4 m/s (14.5 ft/sec). The impact energy range is 1.356 to 132.8 Joules (Dynatup, 2008). Instron 8200 impact tester dimension are 90.8 inch (2305 mm) in height, 16 inch (406 mm) in width, and 18 inch (457 mm) in depth. The tester is equipped with two pneumatic self-rebounding stoppers that help to stop the falling carriage to avoid more than one contact of the impactor with a tested specimen. Figure 2.2 shows the two pneumatic self-rebounding stoppers of the tester. The tester is also equipped with a data acquisition system that records the impact load, deflection, absorbed energy, and the duration of impact data. Figure 2.2 shows the two pneumatic self-rebounding stoppers of the tester.

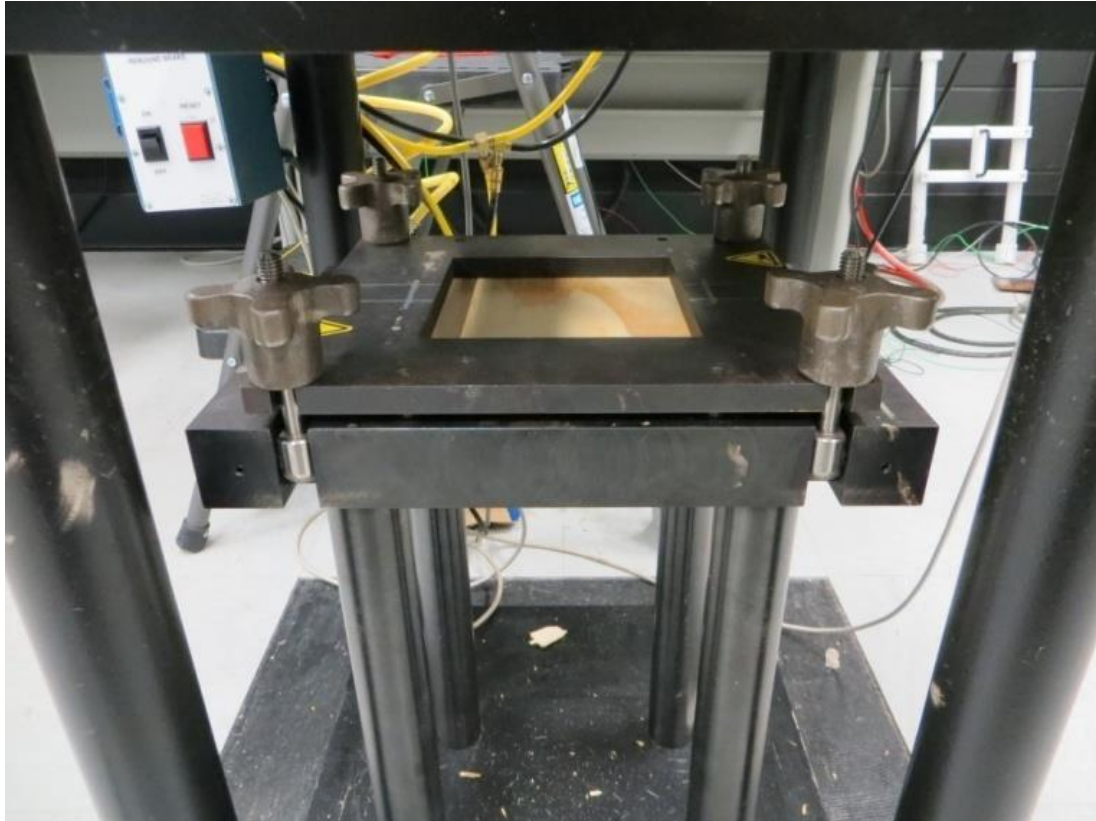
Figure 2. 3: The Clamping Fixture

A standard square clamping fixture (Dynatup, 2008) was used in the experiments performed in this study. The specimens were clamped around the entire perimeter with about half of inch. The fixture opening is five by five inches. Figure 2.3 shows the clamping fixture.

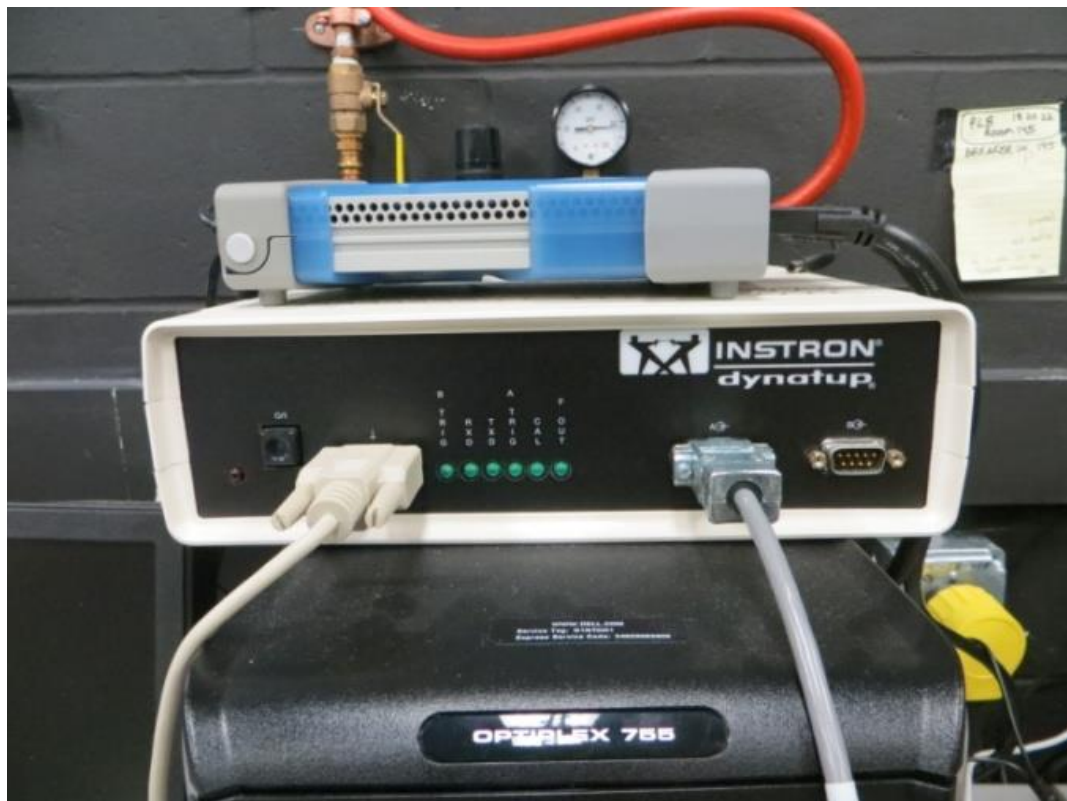
Figure 2. 6: Impact Tester Signal Conditioning Box

A signal conditioning box was also assembled for the Instron 8200 Dynatup impact tester. When the flag breaks the photo gate beam, the data signals of the impact load, deflection, absorbed energy and the duration of impact would be transferred to the signal conditioning box and then be transferred to the computer for analysis. The signal conditioning box is two-channel to maintain sampling rates from 1.25 and 5 MHz. It can be used for isolation, signal amplification and direct transducer conditioning functions. The Instron software was installed in the computer to handle all the conditioned signals (Dynatup, 2008). Figure 2.6 shows the signal conditioning box of the tester.

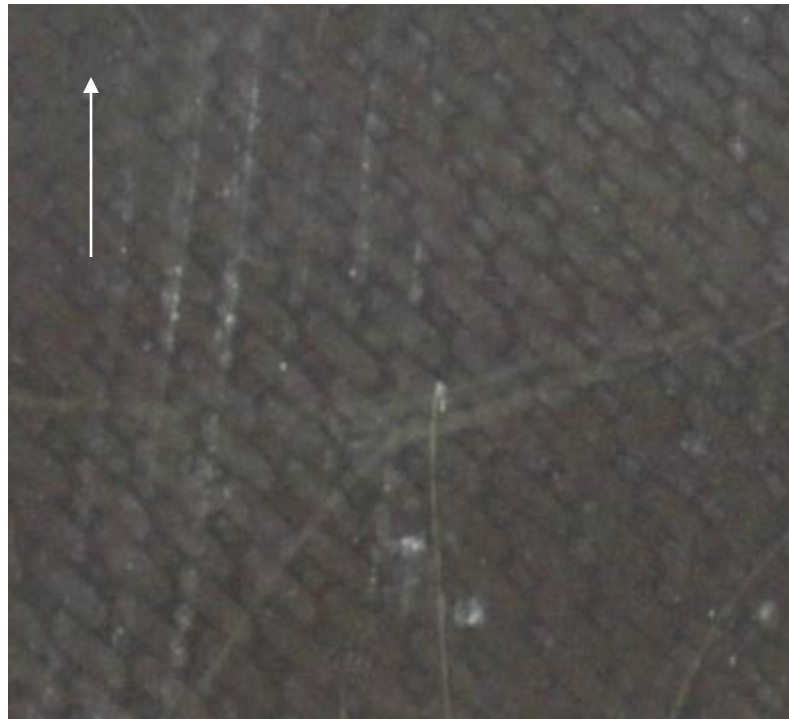
Figure 2. 7: Textile of the Specimen (the arrow indicates a  $0^\circ$  direction)

In this study a low velocity impact damage of carbon fiber polymer matrix textile composites has been studied. The composite specimens are layered five harness satin composites as seen in Figure 2.7. The laminate is symmetric with orientation of layers in  $0^\circ$ ,  $90^\circ$ ,  $45^\circ$ , and  $-45^\circ$  directions. The top and bottom layers are oriented in  $45^\circ$  directions, as shown in Figure 2.7

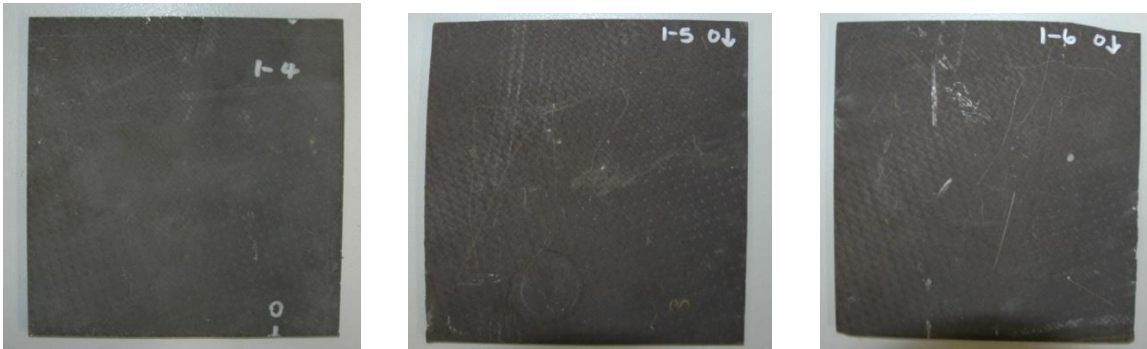
Figure 2. 10: Impact Test Samples (1-4, 1-5, 1-6)

Figure 2.10 shows the specimen after cutting. A two number identification system was used to track specimens. The first number represents the panel, from which the specimen was cut, and the second indicates the specimen number. An identification

number and an arrow indicating a 0° direction were written on each specimen. Table 2.1 shows dimensions of each square specimen used in this study.

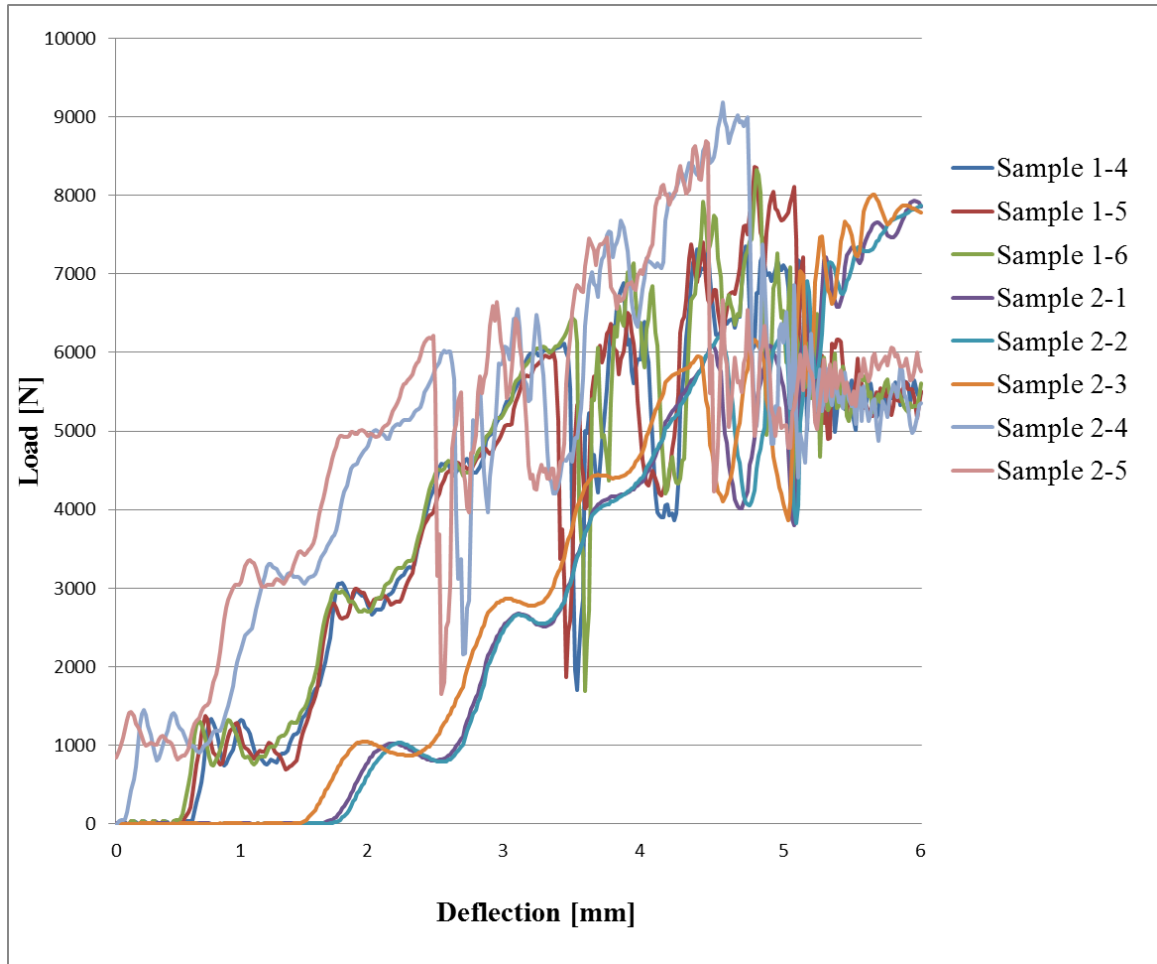
Figure 2. 12: Impact Load vs. Deflection

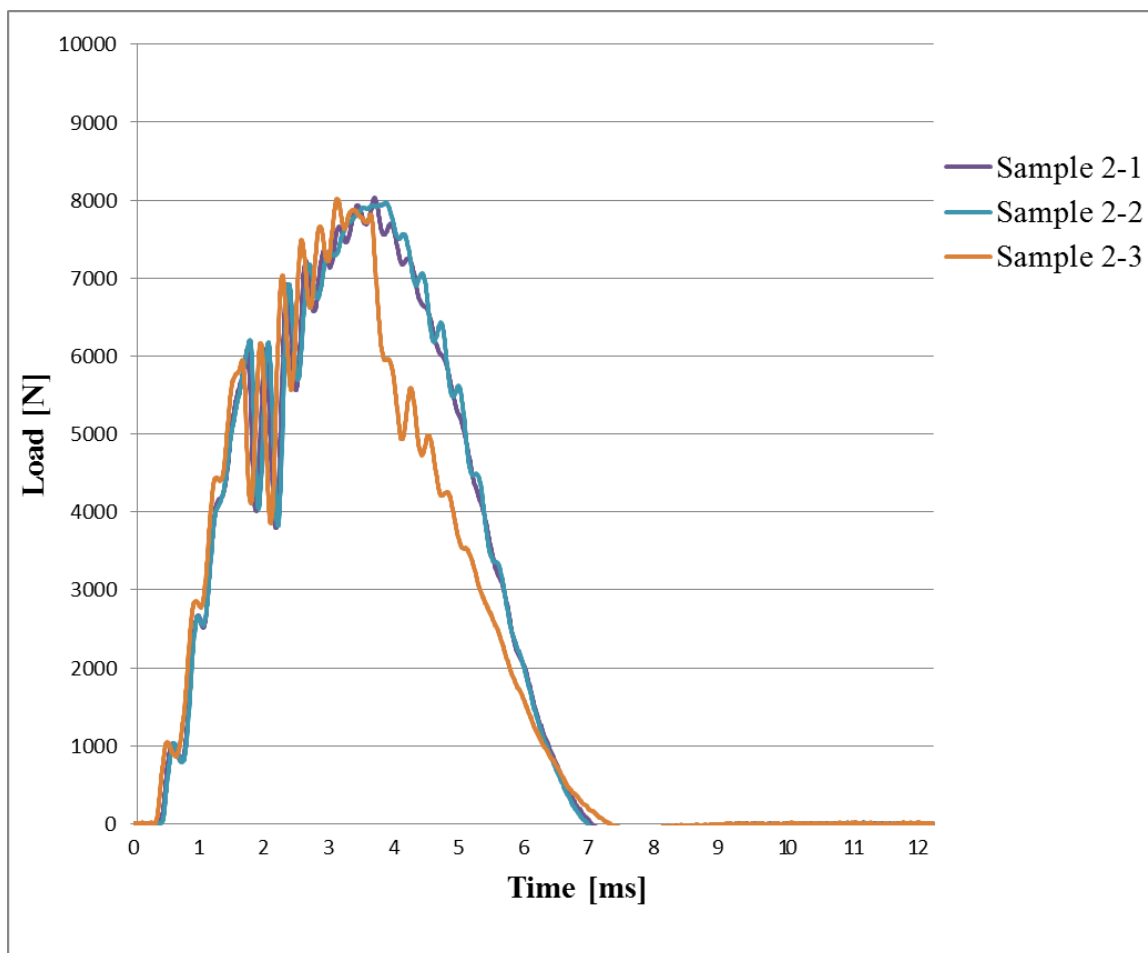
Figure 2. 14: Impact Load vs. Time for the Specimens Impacted at the Lowest Energy, 16 J.

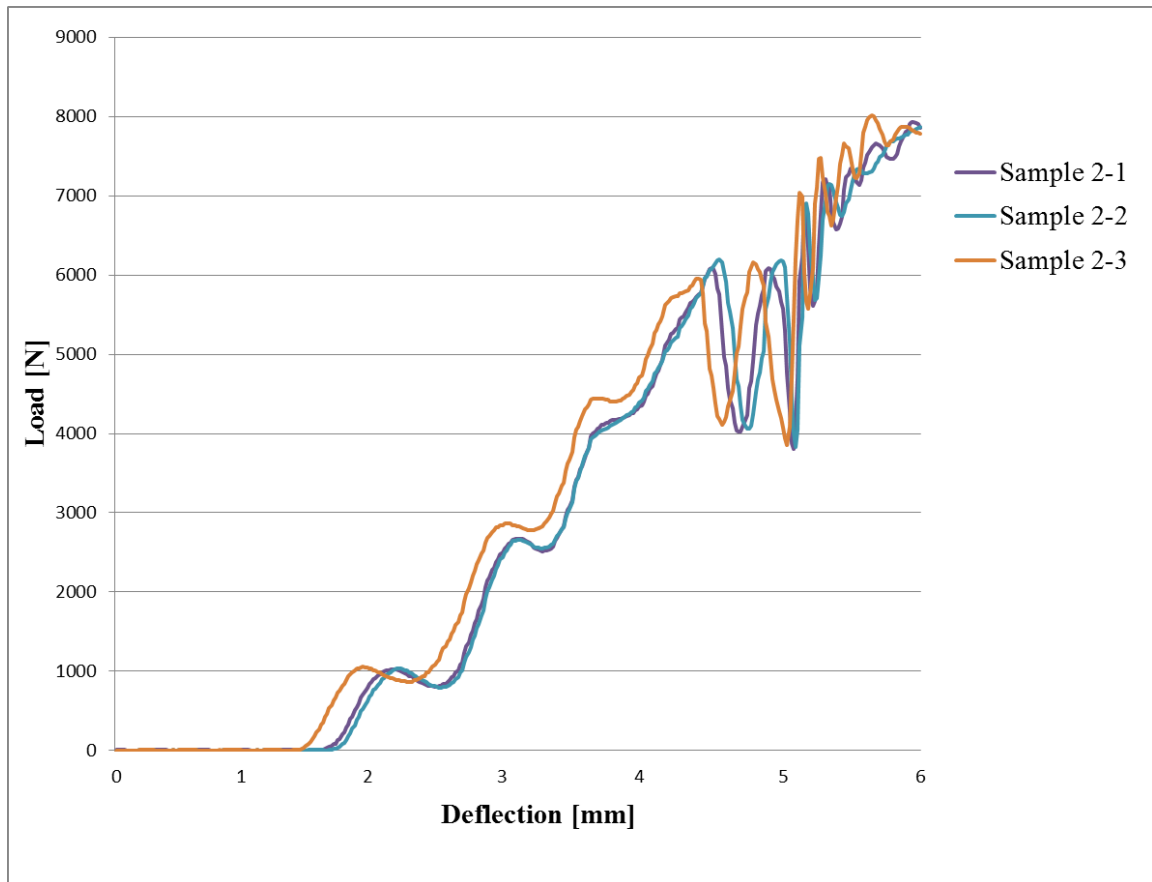
Figure 2. 15: Impact Load vs. Deflection for the Specimens Impacted at the Lowest Energy, 16 J.

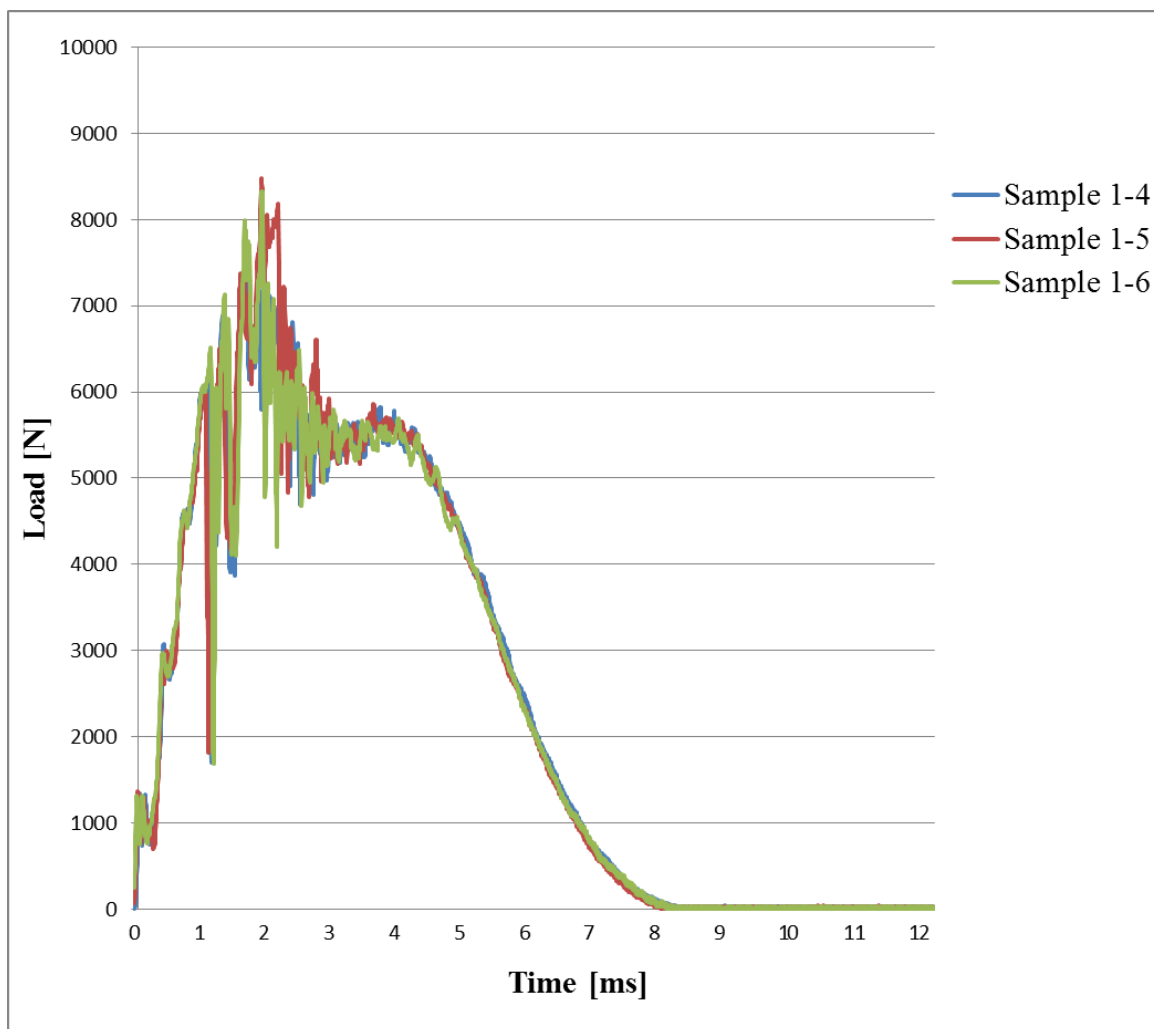
Figure 2. 17: Impact Load vs. Time for the Specimens Impacted at the Intermediate Energy, 22.5 J.

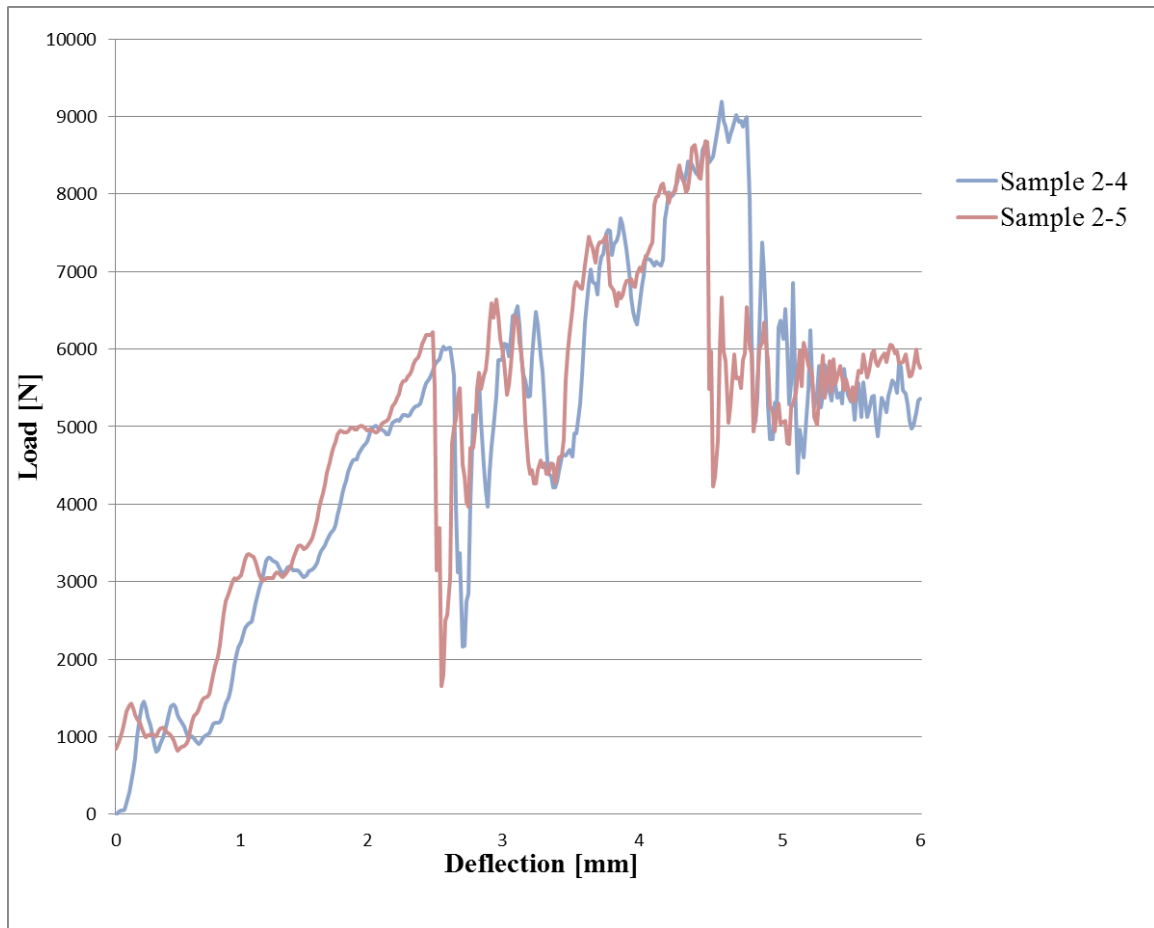
Figure 2. 21: Impact Load vs. Deflection for the Specimens Impacted at the Highest Energy, 26 J.

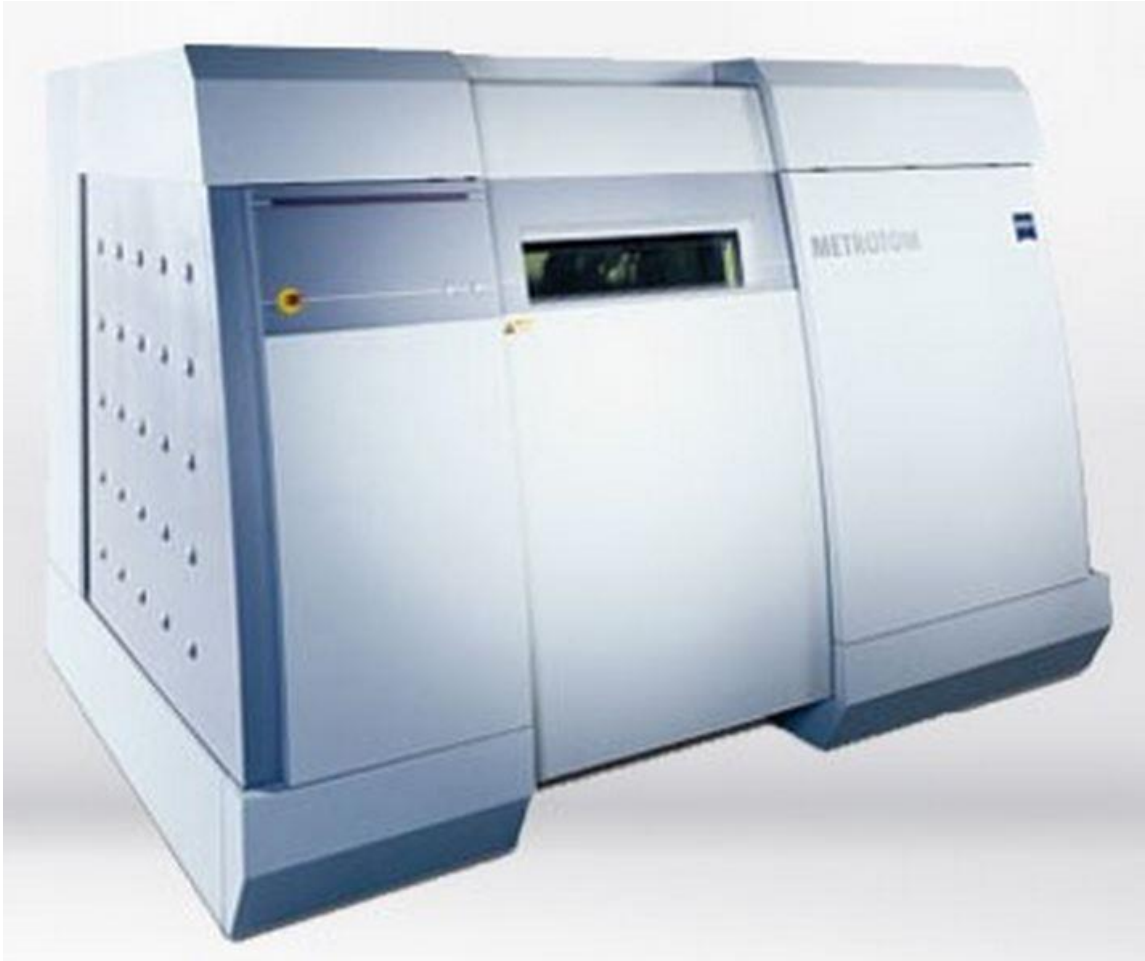
In the METROTOM 1500 system, the measuring, inspection processes, and objectification of measuring results are automatic. The METROTOM 1500 system is often used for inspection of new lightweight materials. It also can be applied to precisely measure the smallest parts and mounted components like ESP sensors and electric toothbrushes. With the METROTOM 1500 system, coordinate measuring and non-destructive inspection can be achieved. The system can also help to optimize the volume production processes for precision-manufactured and injection-mold work pieces in industries (Lettenbauer, 2007). Figure 3.3 and Figure 3.4 show the ZEISS METROTOM 1500 system and its internal structure.

Figure 3. 3: ZEISS METROTOM 1500 System (Lettenbauer, 2007)

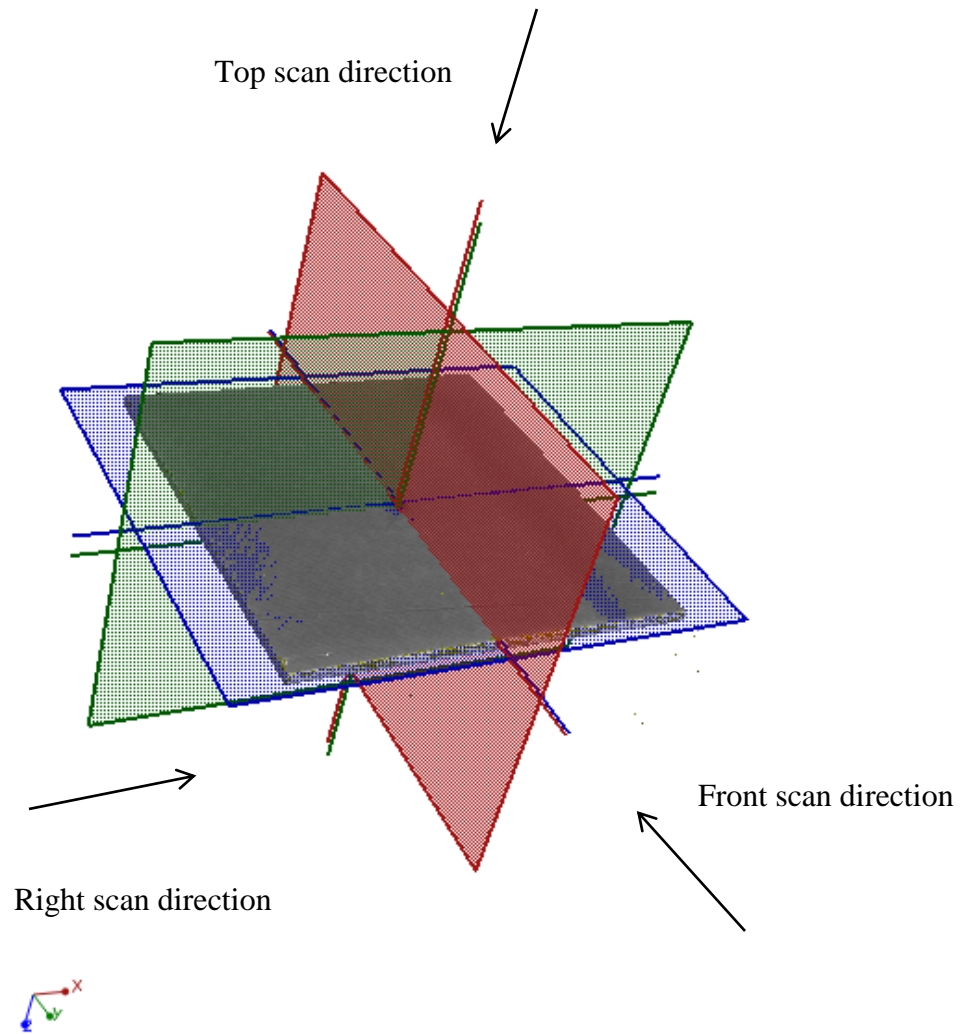
With the assistance of this software, the 3D volume inside the sample can be visualized. In addition, it provides the windows to detect the sample defects from the x, y, and z directions. The directions of each scan plane are shown in Figure 3.5.

Figure 3. 5: Scan Direction of Each Scan Plane

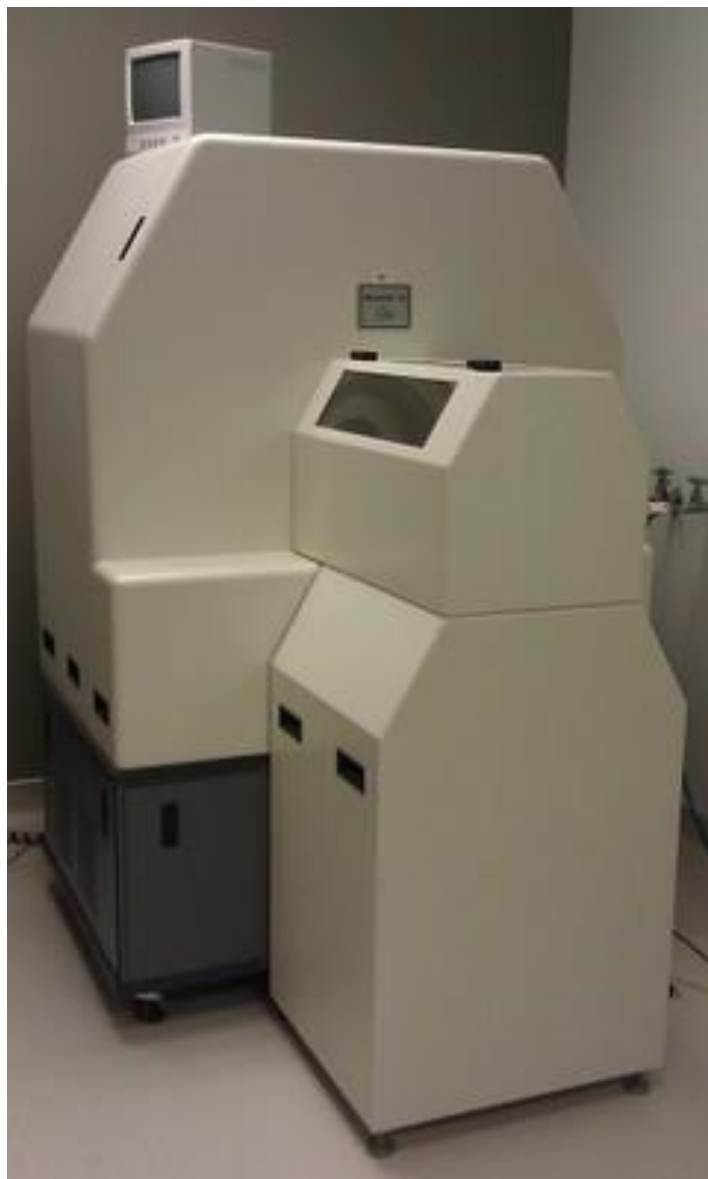
By rotating the X-ray detector and sources, the object is scanned, and Micro-CT images are acquired (MicroCAT II, 2014). The MicroCAT II scanner that was used in this work has an X-ray source with maximum operating energies of 140 kVp and 500 micro-amperes. During high-magnification scanning, high photon flux is provided by the X-ray source with large cone-beam angles in order to improve spatial resolution. The small-pixel CCD detector provides isotropic resolution of 28 microns at an image size of  $1536 \times 1536 \times 1024$  pixels at a binning of 2. In other words, it can go as low as 14 micron resolution, but due to increased image noise in most specimens, the 28 micron resolution was set. With the Siemens software, the reconstructed images can be easily transferred and visualized. The scanner and reconstructed image are shown in Figures 3.6 to 3.8

Figure 3. 6: Siemens MicroCAT II Scanner (MicroCAT II, 2014)

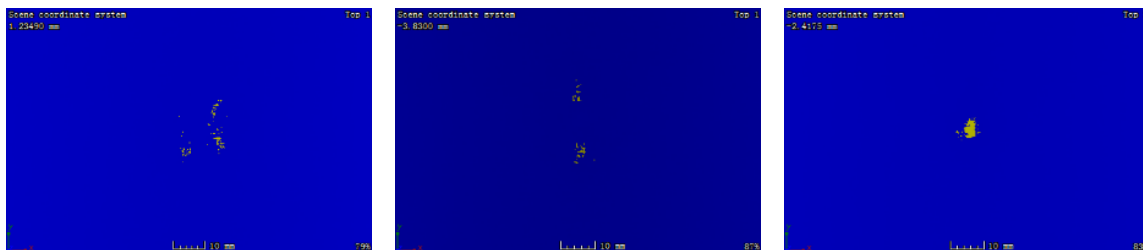
Figure 3. 20: CT image at the plane located 2.37 mm away from the impacted surface

Figures 3.11-3.26 show damage zones at different depths from the impacted surface of samples 2-1, 2-2, and 2-3. As one can see, damage was detected inside the samples at about 2 mm depth from the impacted surface. Sample 2-3 received the largest damage. This was confirmed by the analysis of the surfaces of the samples (see Figure 2-26).

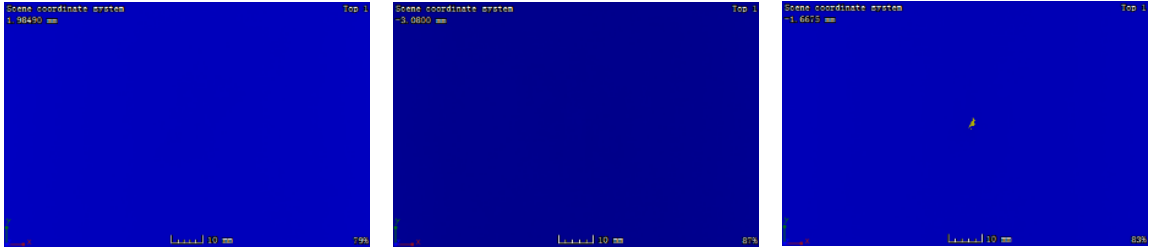
Figure 3. 22: CT image at the plane located 2.92 mm away from the impacted surface

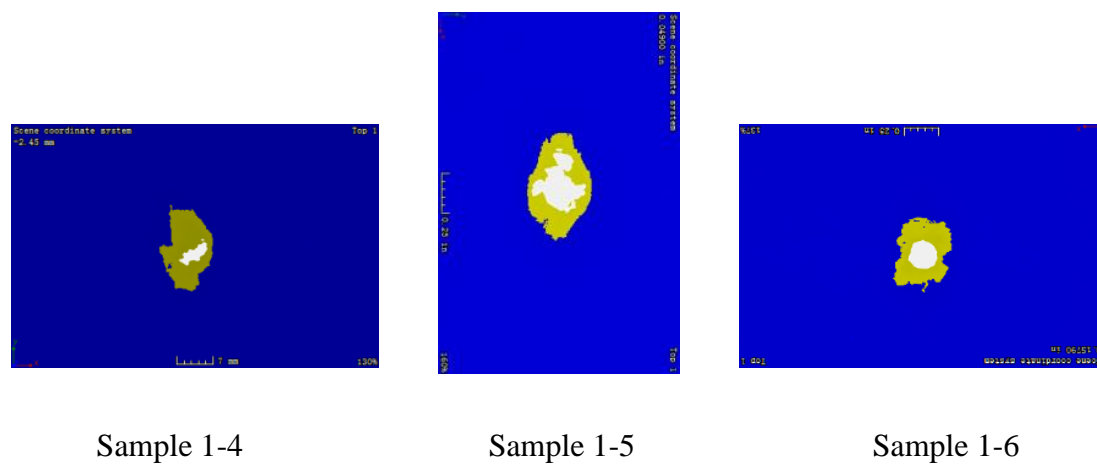
Figure 3. 28: CT image at the plane located 0.47 mm away from the impacted surface

In this section, the results of the image analysis of CT scans of the specimens impacted at the intermediate impact energy, 22.5 J, are discussed. The CT scans were obtained using a ZEISS METROTOM 1500 CT scanner. Figures 3.27-3.42 show damage zones at different depths from the impacted surface. As one can see, the damage in the samples impacted at the energy level of 22.5 J was present through the entire thickness of the samples. Moreover, the damage zone size increased with depth.

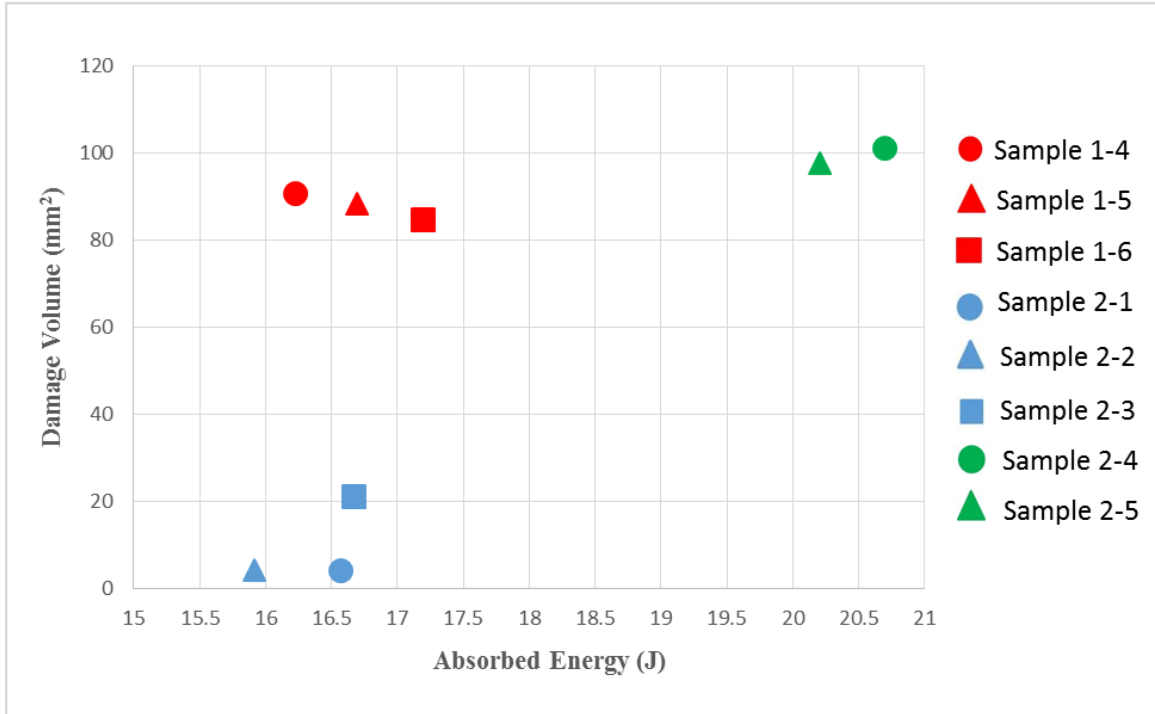
Figure 3. 66: Damage Volume vs. Absorbed Energy

last figures. After that, the damage areas were summed up and multiplied by the thickness of each slice to calculate the damage volumes. Table 3.3 shows damage volumes, impact energy, max impact force and total absorbed energy. Figure 3.64 shows damage volume versus impact energy for all eight specimens tested. Figure 3.65 shows damage volume versus max impact force for all eight specimens tested. Figure 3.66 shows damage volume versus total absorbed energy for all eight specimens tested.

As one can see, there is a strong nonlinear correlation between the impact energy and damage volume that needs further investigation. There is also some correlation between the absorbed energy and the damage volume. Figure 3.66 shows existence of some threshold, above which the delamination is limited and failure mode is mostly related to the fiber breakage within the impact zone. Below the threshold the damage zone increase is mostly driven by delamination. This is also confirmed by the analysis of the Micro CT results.

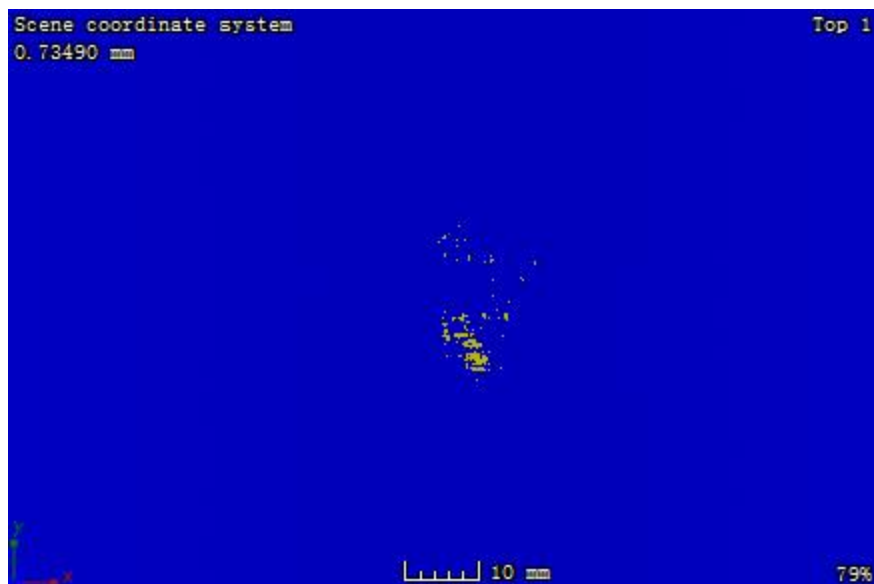
Figure A. 3: CT image at the plane located 1.87 mm away from the impacted surface of sample 2-1

For samples 2-1, 2-2, and 2-3, the impact energy level was 16 J. Figure A.1 shows pictures of Sample 2-1 after the impact test. The arrow on the left indicates the 0° direction. Figures A.2- A.6 show damage zones at different depths from the impacted surface of sample 2-1. As one can see, the extent of the damage zone increases with depth. The arrow on the left of Figure A.2 indicates the 0° orientation.

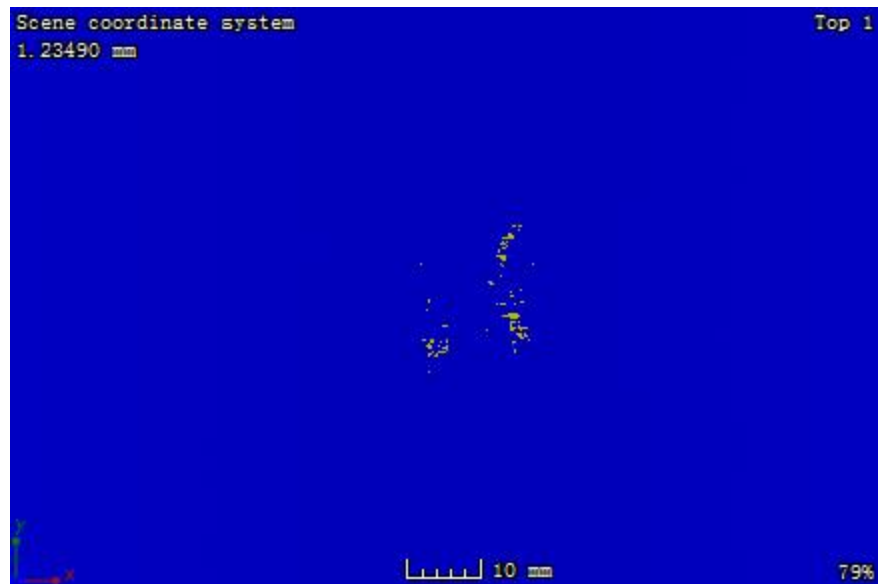
Figure A. 5: CT image at the plane located 2.37 mm away from the impacted surface of sample 2-1

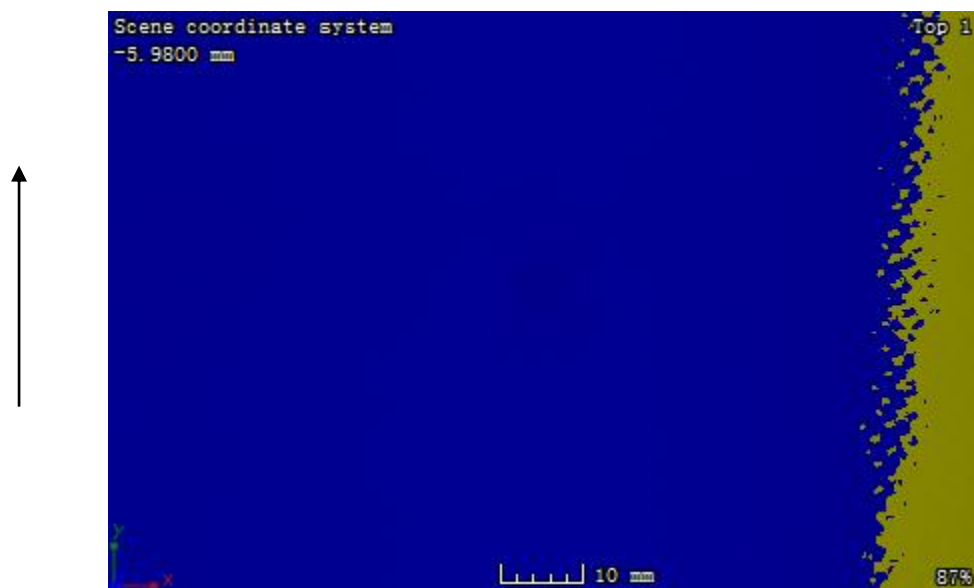
Figure A. 8: CT image at the plane located 0.22 mm away from the impacted surface of sample 2-2

Figures A.7- A.13 show damage zones at different depths from the impacted surface of sample 2-2. As one can see, the extent of the damage zone increases with depth. The arrow on the left of Figures A.7 and A.8 indicates the 0° orientation.

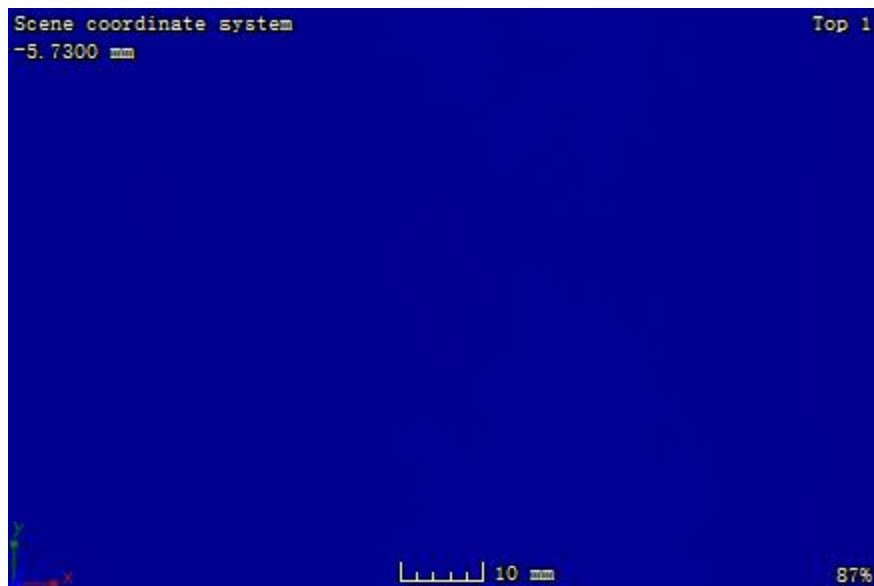
Figure A. 9: CT image at the plane located 0.47 mm away from the impacted surface of sample 2-2

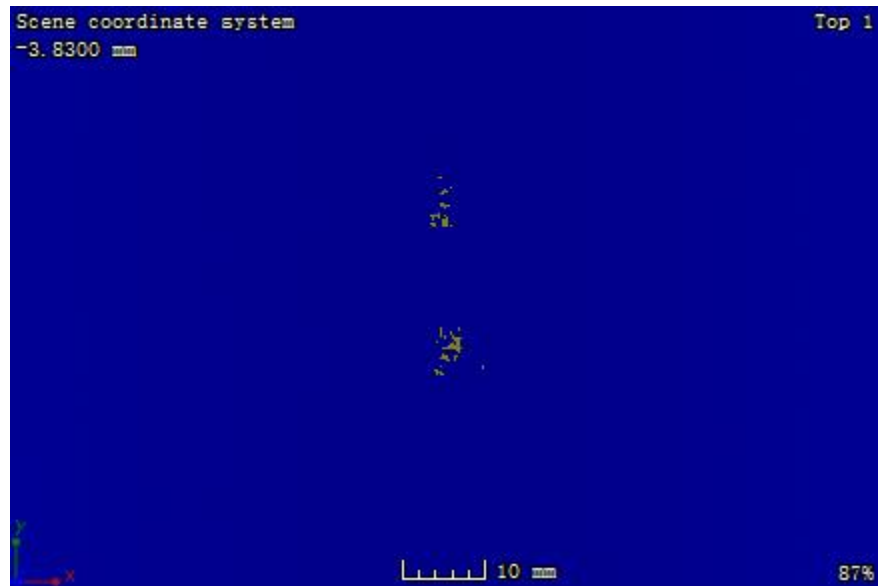
Figure A. 11: CT image at the plane located 2.37 mm away from the impacted surface of sample 2-2

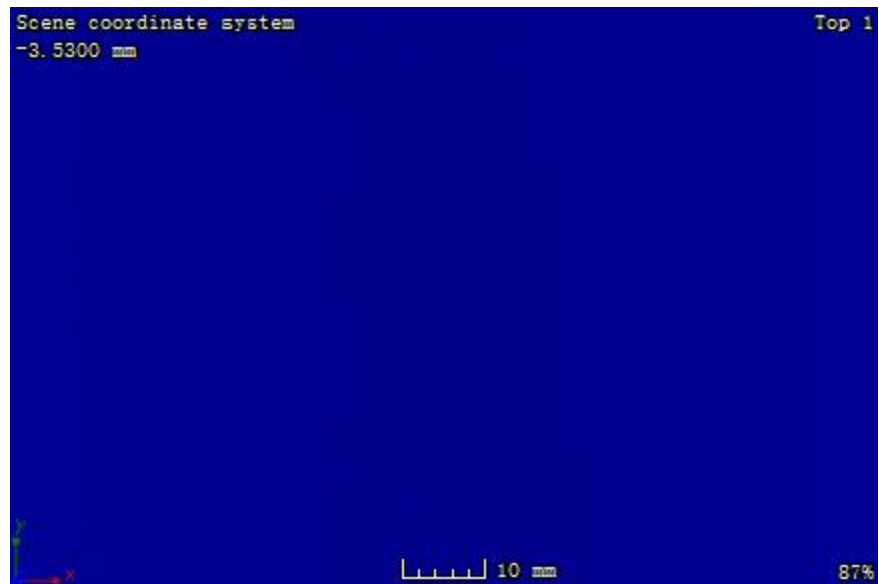
Figure A. 12: CT image at the plane located 2.67 mm away from the impacted surface of sample 2-2

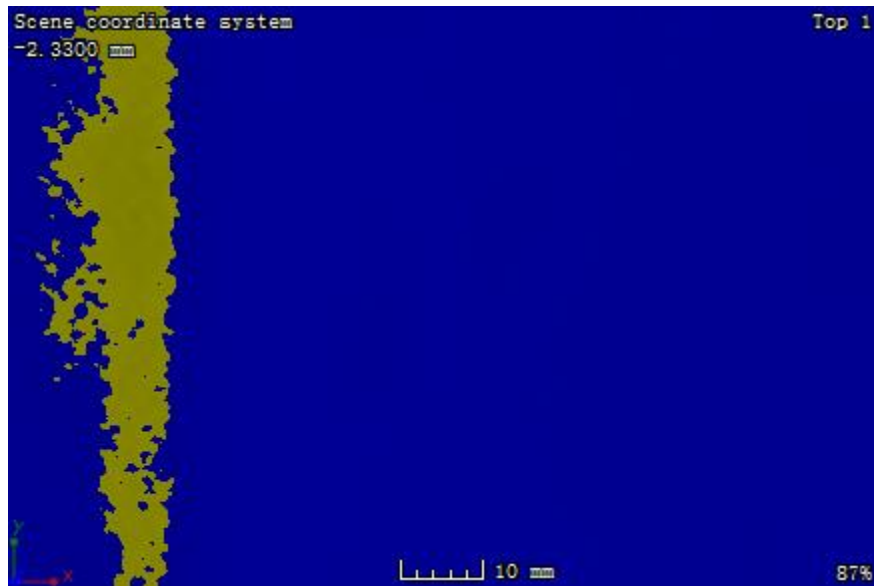
Figure A. 13: CT image at the plane located 3.87 mm away from the impacted surface of sample 2-2
