# Low velocity impact testing and computed tomography damage evaluation of layered textile composite

Changpeng Song  
*University of Iowa*

A thesis submitted in partial fulfillment  
of the requirements for the Master of  
Science degree in Mechanical Engineering  
in the Graduate College of  
The University of Iowa

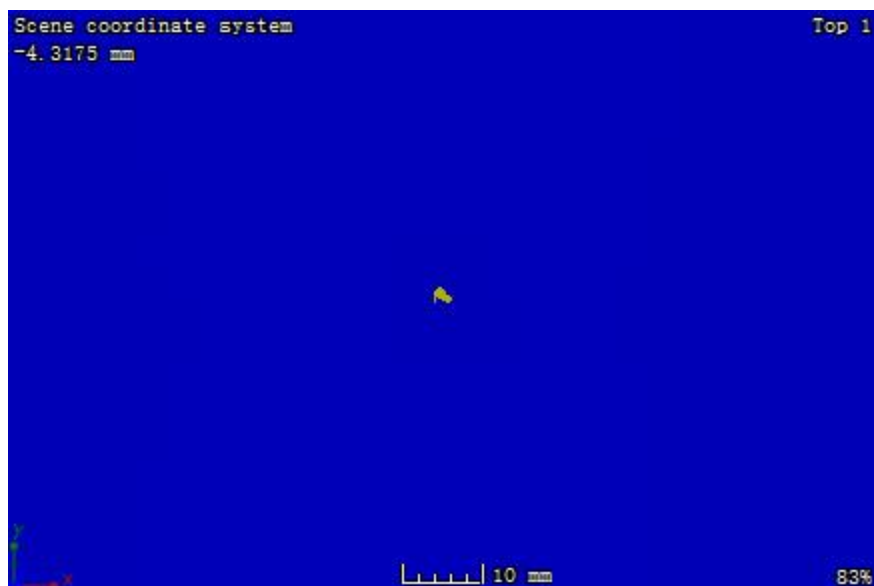
Figure A. 16: CT image at the plane located 0.47 mm away from the impacted surface of sample 2-3

Figures A147- A.24 show damage zones at different depths from the impacted surface of sample 2-3. The arrow on the left of Figures A.14 and A.15 indicates the  $0^\circ$  orientation.

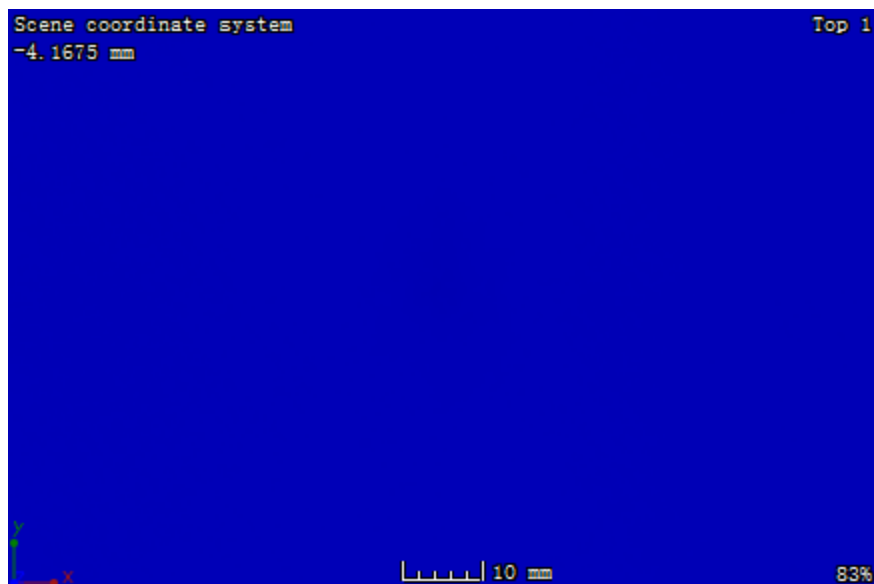
Figure A. 17: CT image at the plane located 0.62 mm away from the impacted surface of sample 2-2

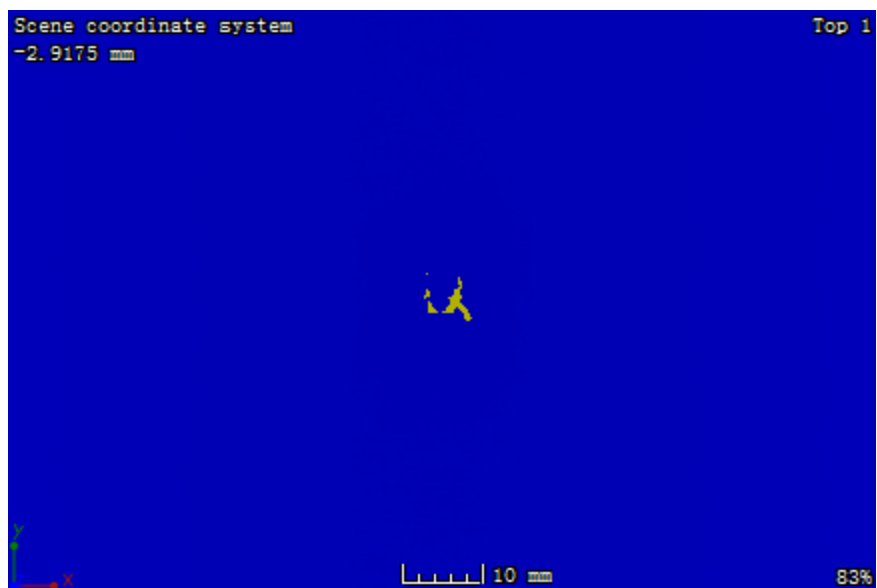
Figure A. 18: CT image at the plane located 1.87 mm away from the impacted surface of sample 2-3

As one can see, damage was detected inside sample 2-2 at about 1.87 mm depth from the impacted surface. This was also confirmed by Siemens MicroCAT II CT results. Sample 2-3 received the largest damage comparing with samples 2-1 and 2-2. This was confirmed by the analysis of the surfaces of the samples (see Figures A.14, A.7, and A.1). The impact energy for sample 2-3 was 16.2049 J, which is slightly higher than for sample 2-1 (impact energy was 15.9917 J) and sample 2-2 (impact energy was 15.8658 J).

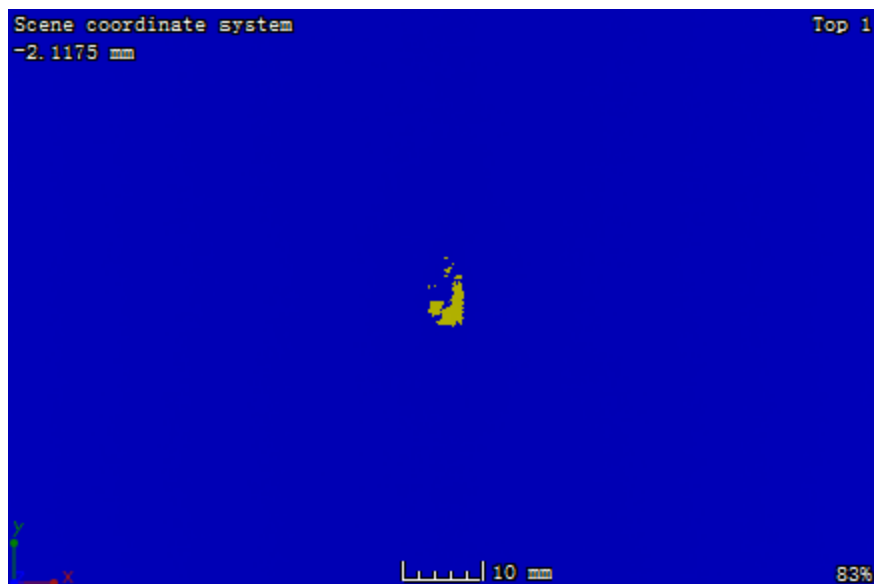
Figure A. 21: CT image at the plane located 2.67 mm away from the impacted surface of sample 2-3

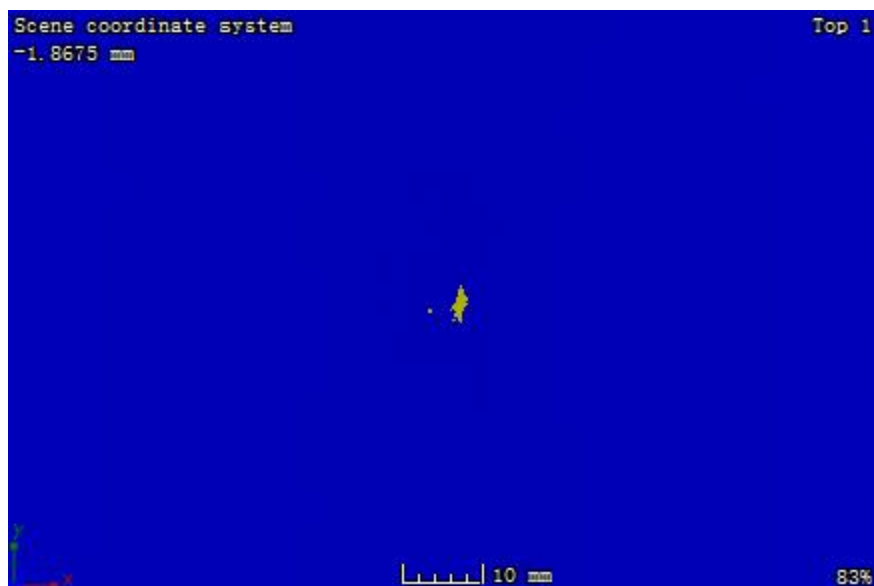
Figure A. 22: CT image at the plane located 2.97 mm away from the impacted surface of sample 2-3

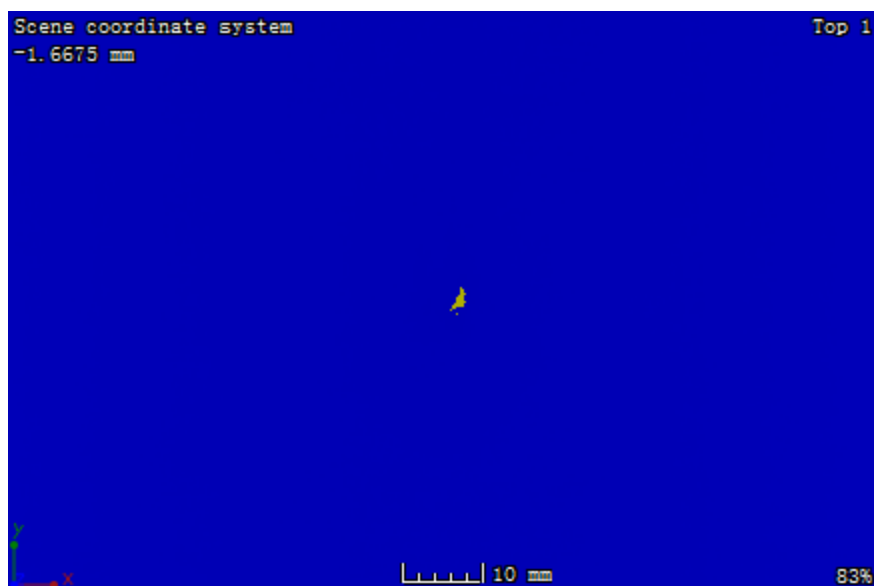
Figure A. 23: CT image at the plane located 3.12 mm away from the impacted surface of sample 2-3

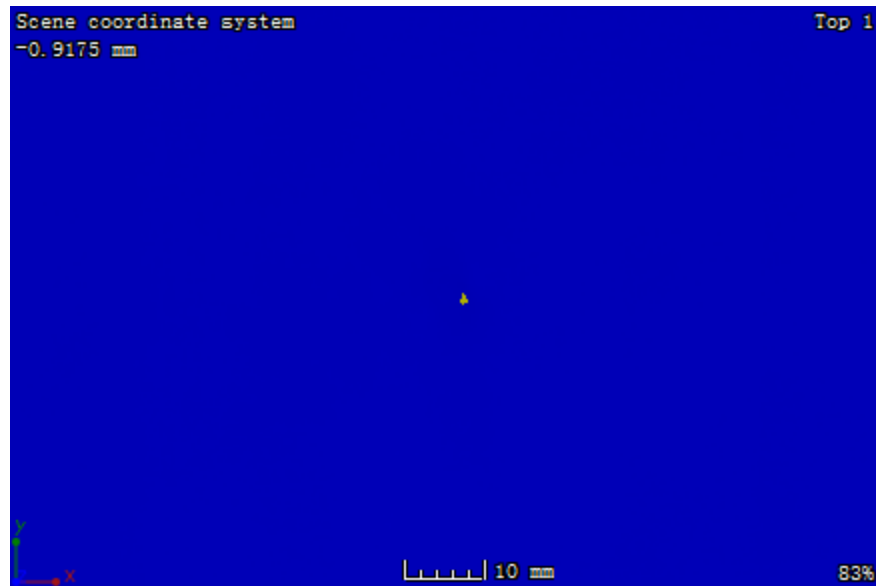
Figure A. 24: CT image at the plane located 3.87 mm away from the impacted surface of sample 2-3

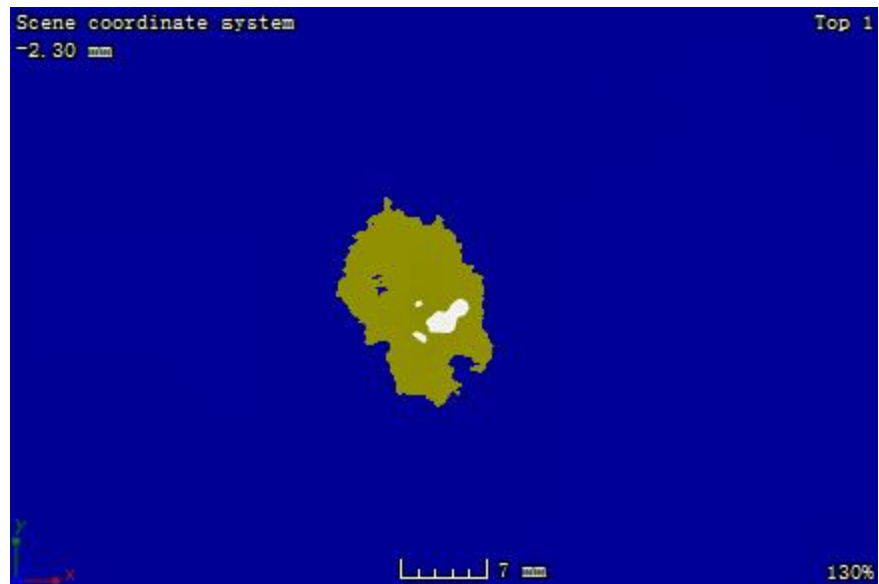
Figure B. 6: CT image at the plane located 0.62 mm away from the impacted surface of sample 1-4

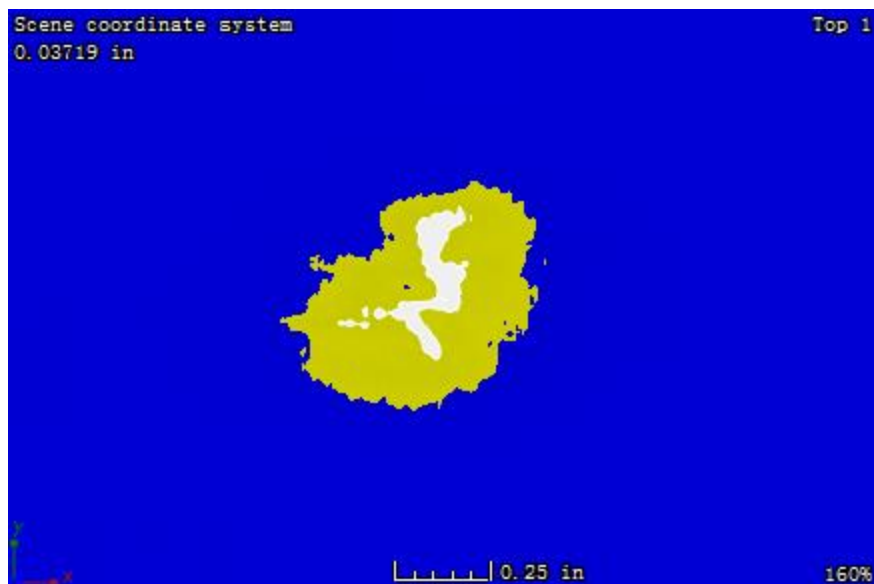
Figure B. 27: CT image at the plane located 0.77 mm away from the impacted surface of sample 1-5

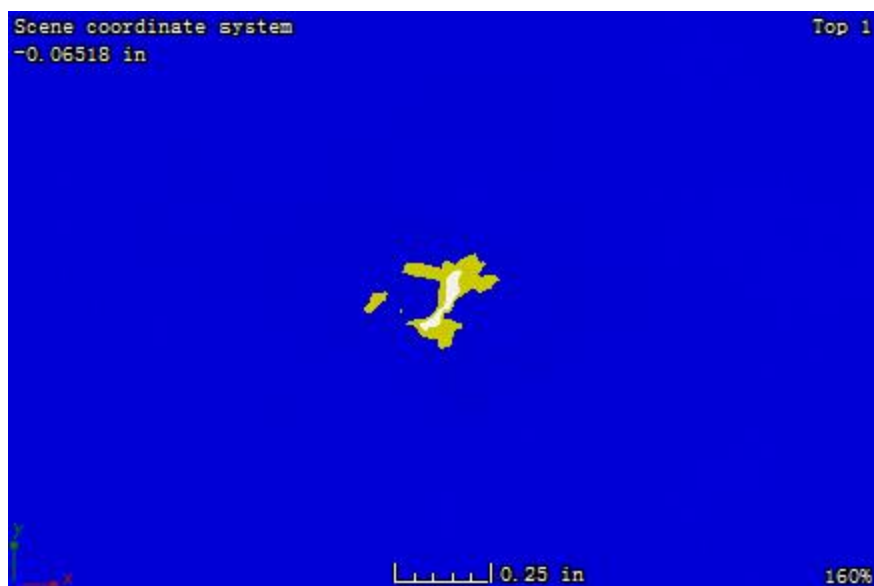
Figure B. 37: CT image at the plane located 3.37 mm away from the impacted surface of sample 1-5

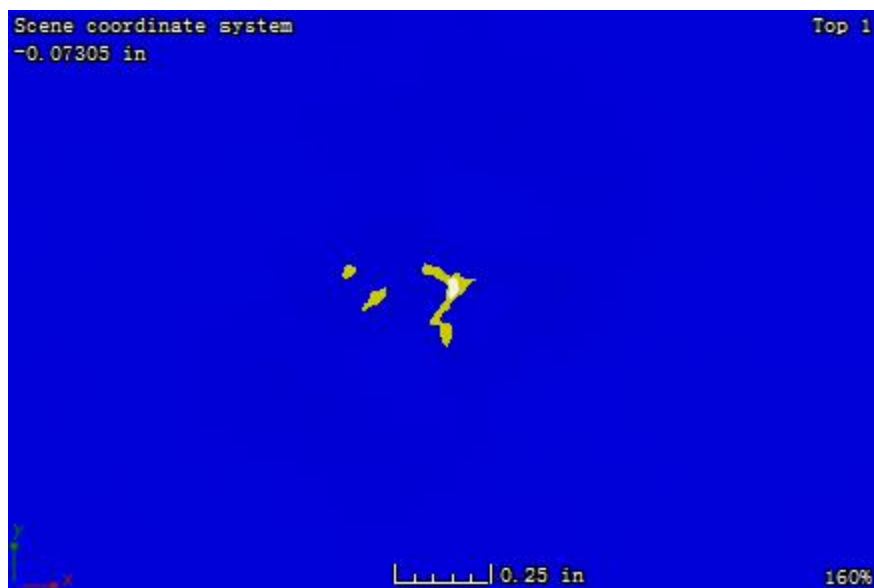
Figure B. 38: CT image at the plane located 3.57 mm away from the impacted surface of sample 1-5

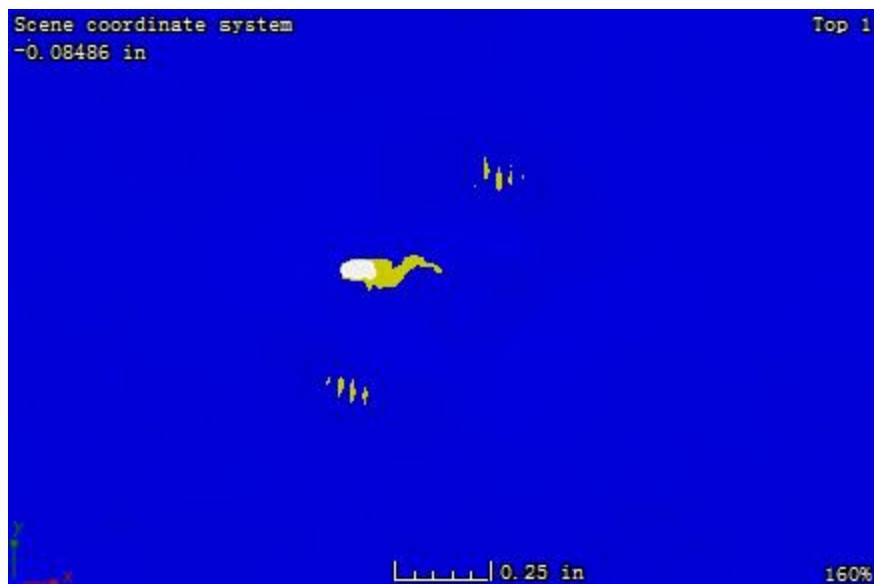
Figure B. 39: CT image at the plane located 3.87 mm away from the impacted surface of sample 1-5

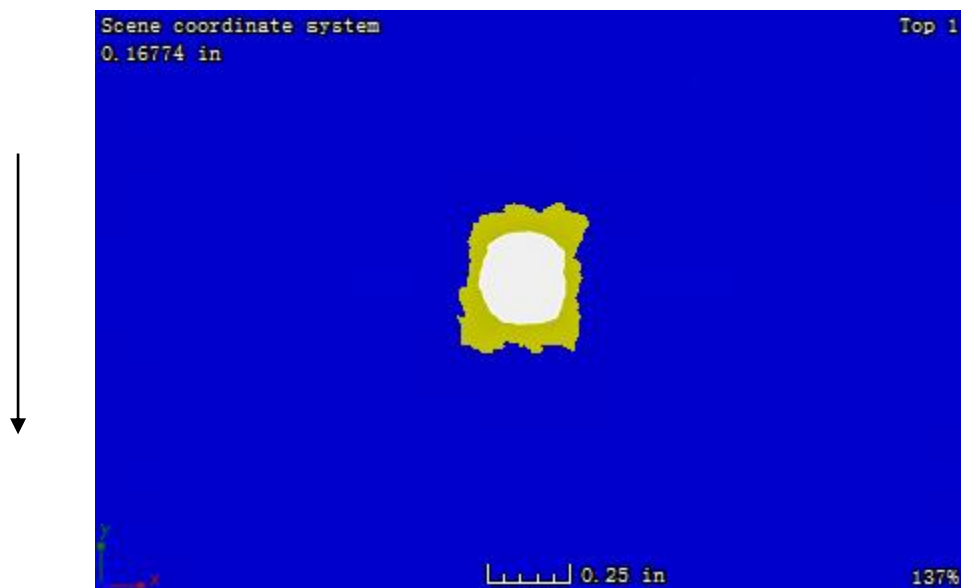
Figure B. 42: CT image at the plane located 0.22 mm away from the impacted surface of sample 1-6

It was determined from these images that for sample 1-6 the scan direction was the same as the direction of the impact. Figures B.42- B.58 show damage zones at different depths from the impacted surface of sample 1-6. The arrow on the left of Figure B.42 indicates the  $0^\circ$  orientation.

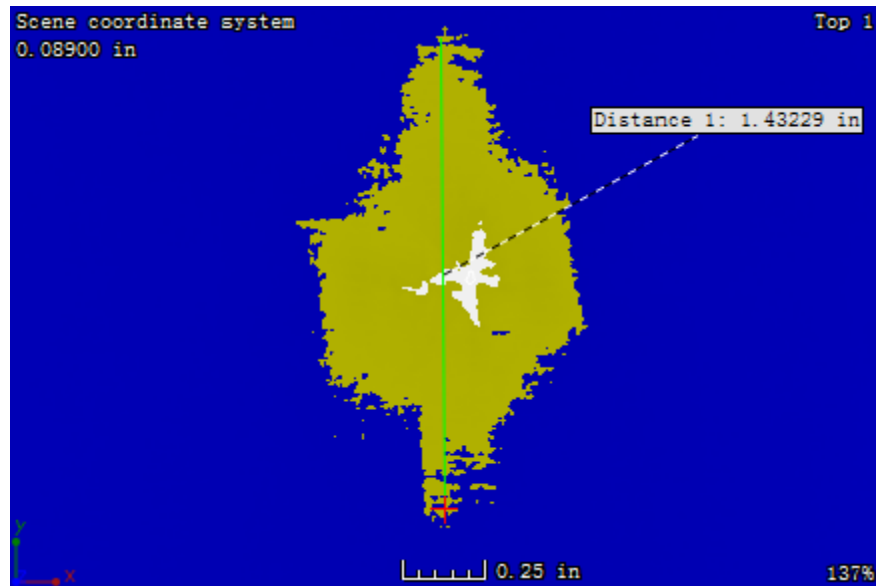
Figure B. 58: CT image at the plane with the largest damage size in sample 1-6 (located 2.22 mm away from the impacted surface)

As one can see, the extent of the damage zone increases with depth, and damage size reaches its maximum at the depth of 2.22 mm away from the impacted surface. Note that the thickness of sample 1-5 was 4.61mm. The size of the largest damage area was measured by the software MyVGL and was 36.38 mm (see Figure B.58). It is also important to notice that the view side of the slices shown in Figure B.42- B.58 is the same as in Figures B.24- B.40, but that it is different from the view side of the slices shown in Figures B.4- B.20, and the images are shown at the same depth from the impacted surface. In samples 1-5 and 1-6, the scan direction was the same as the impact direction, and in sample 1-4, the scan direction was opposite that of the impact direction. This also explains the similarity in the damage orientation in samples 1-5 and 1-6 and the

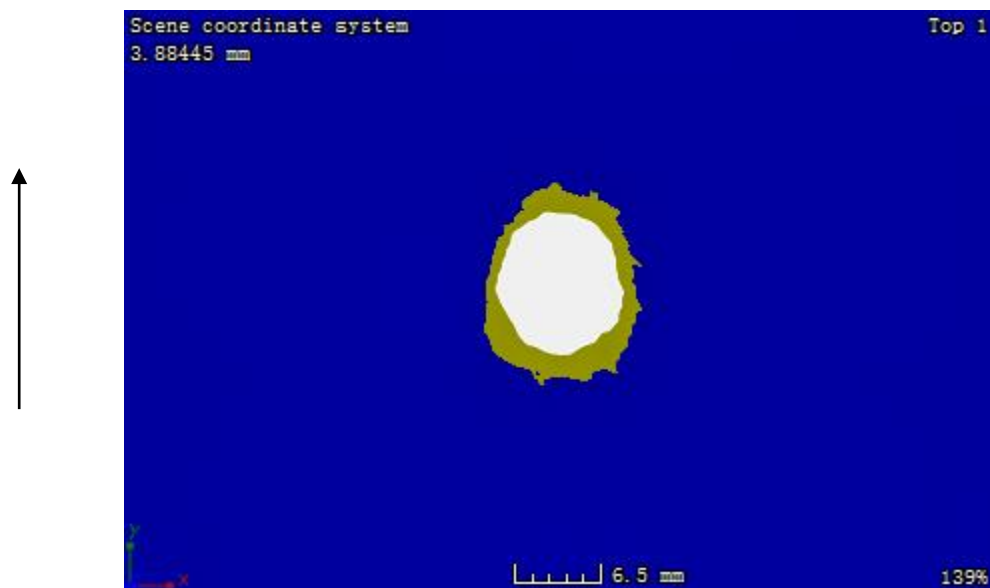
Figure C. 2: CT image at the plane located 0.22 mm away from the impacted surface of sample 2-4

For samples 2-4, 2-5, the impact energy level was 26 J. Figure C.1 shows pictures of Sample 2-4 after the impact test. The arrow on the left of Figure C.1 and C.2 indicates the 0° orientation. Figures C.2- C.18 show damage zones at different depths from the impacted surface of sample 2-4. As one can see, the extent of the damage zone increases with depth.

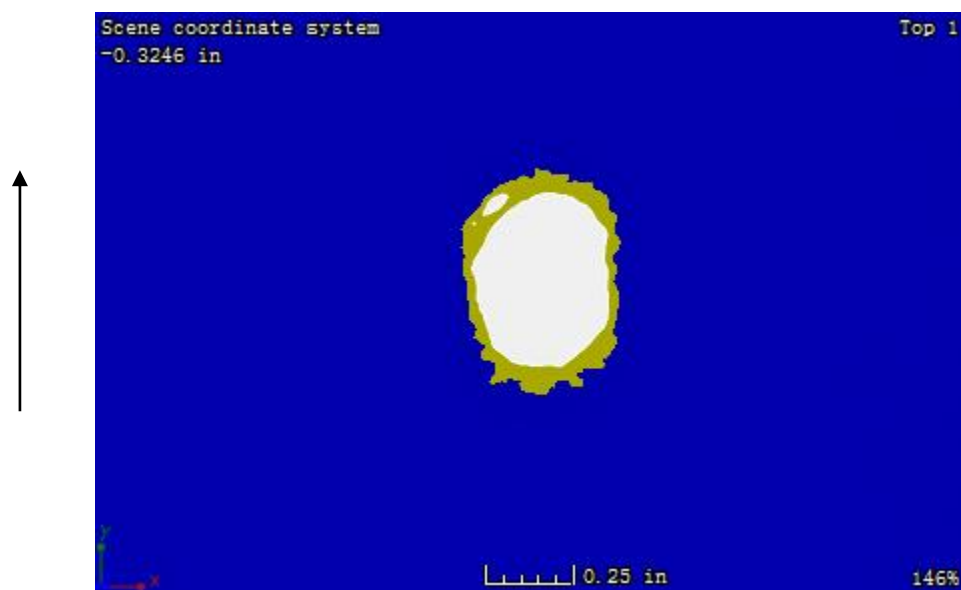
Figure C. 20: CT image at the plane located 0.22 mm away from the impacted surface of sample 2-5

Figure C.19 shows the impacted surface and a close view of the front (impacted side) and back surfaces of sample 2-5. The arrow on the left of Figure C.19 and C.20 shows 0 degree orientation. . Figures C.20- C.36 show damage zones at different depths from the impacted surface of sample 2-5. As one can see, the extent of the damage zone increases with depth.

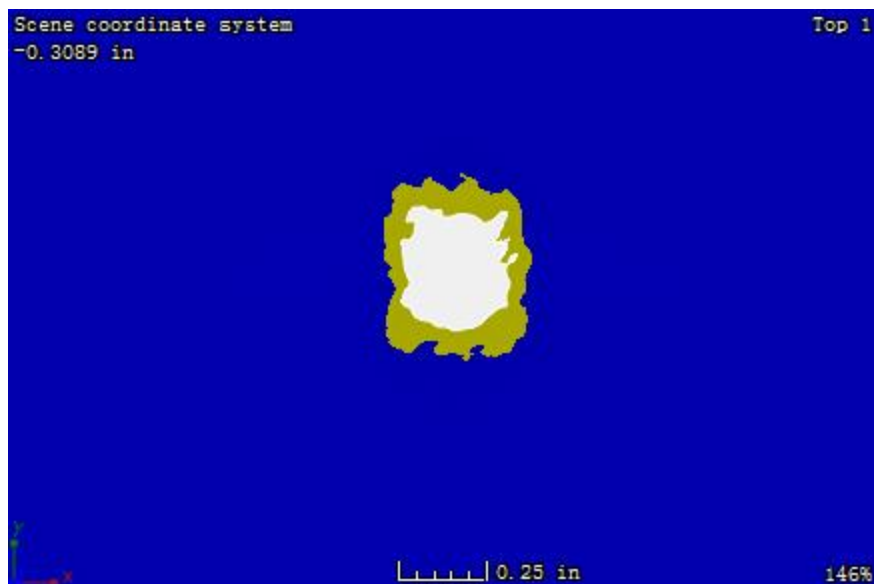
Figure C. 22: CT image at the plane located 0.62 mm away from the impacted surface of sample 2-5
