Self-centering bridge pier columns with structural fuses

MASTER OF SCIENCE

Major: Civil Engineering (Structural Engineering)

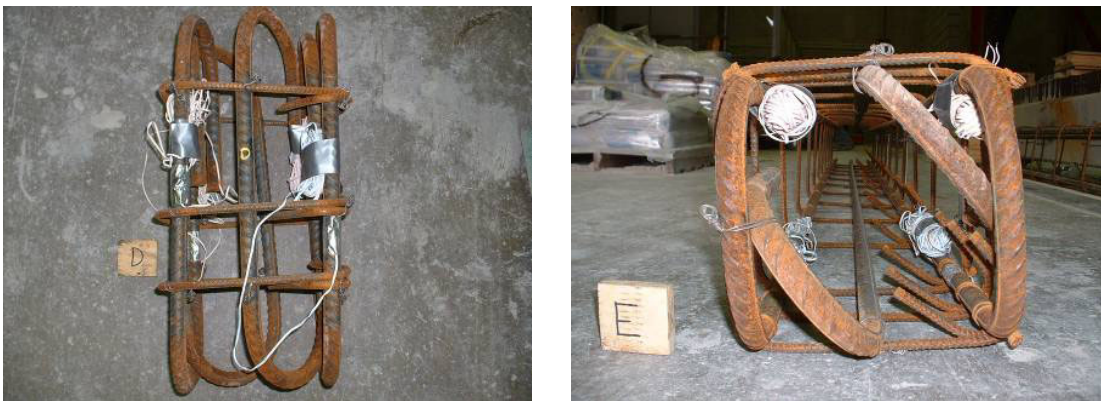
Figure 16. Photographs of column 2-4 reinforcement.

a.) Columns 2-4, 2 ft. segment reinforcement

b.) Columns 2-4, 12 ft. segment reinforcement

The first three segmented columns (Columns 2-4) had reinforcement details similar to those used in the unjointed control column (Column 1). U-bars were used on the construction-joint ends of the column segments for the corner bars as they were for the control column (Column 1). Similarly, the interior bars in each segment had one-hundred-eighty hooks on the construction-joint end. These U-bars and hooks were wrapped around the ducts in the steel collars in an attempt to prevent the through-bolts from pulling out of the ends of the column segments when the columns were loaded. For the 2 ft. column segment, hooks were used at the base of the reinforcement to provide anchorage. Similar transverse ties were used in these columns as in the first column. Additional column details for Columns 1-4 are shown in Figures 16-18.

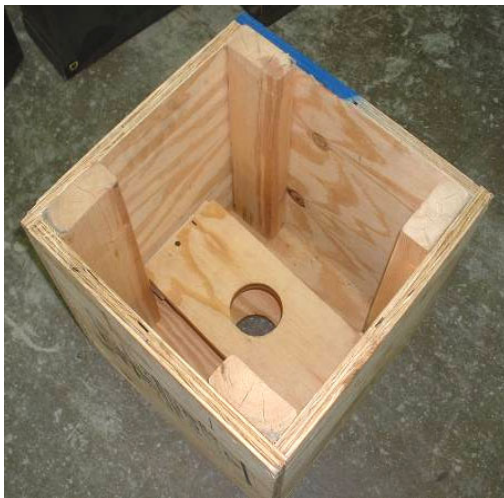
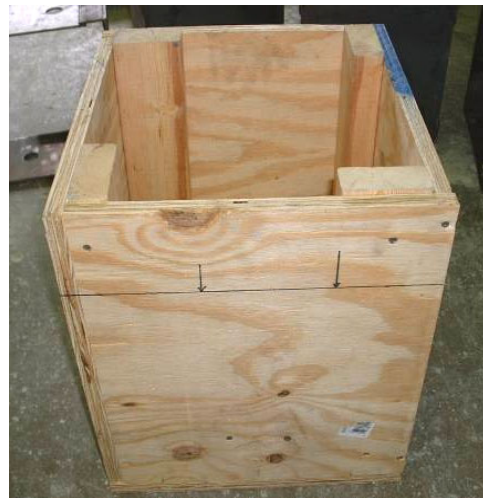
Figure 27. Photographs of center socket boxout.

a.) Top view

b.) Inside view

After construction of the reinforcement cage, the boxout for the center socket (shown in Figure 27) was tied in place. As previously mentioned, this socket allowed the bottom column segment to be epoxy grouted in the foundation block. A 2.5 in. diameter hole was drilled in the center of the socket boxout to allow for the center post-tensioning duct. Two additional 2.5 in. ducts (shown in Figure 24) were spaced 3 ft. on either side of center to align with the holes in the strong floor, permitting two post-tensioned tie-down bars to secure the foundations to the lab floor. A photograph of these ducts can be seen in Figures 28.

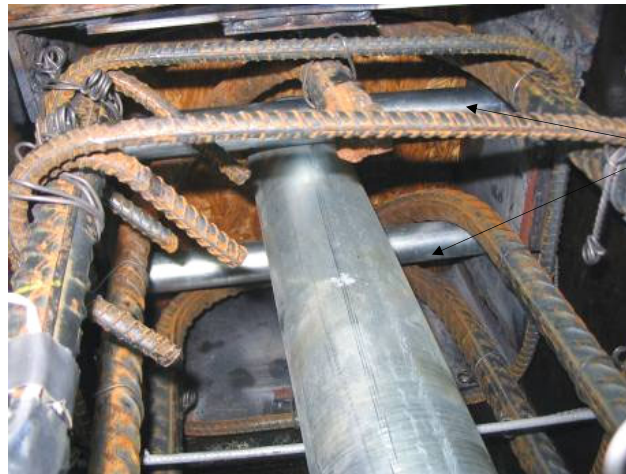
Figure 35. Photograph of Column 2 collar end.

Through-ducts
used for fuse
plate bolts

The 12 ft. column segment for Column 2 was constructed in a similar manner as the control column. However, several alterations were made to allow for segmented construction. As with the control column (Column 1), four internal strain gages were used in this column. They were placed 12 in. from the bottom of the column on the four corner longitudinal bars. A central duct for the unbonded post-tensioning bar was included in this segment. The steel collar was placed in the forms on the base end of the 12 ft. column. Plywood bulkheads, as seen in Figure 34, were used to cap the end of the forms and securely position the post-tensioning duct. Details of the 12 ft. Column 2 segment in the forms are shown in Figures 34-37.

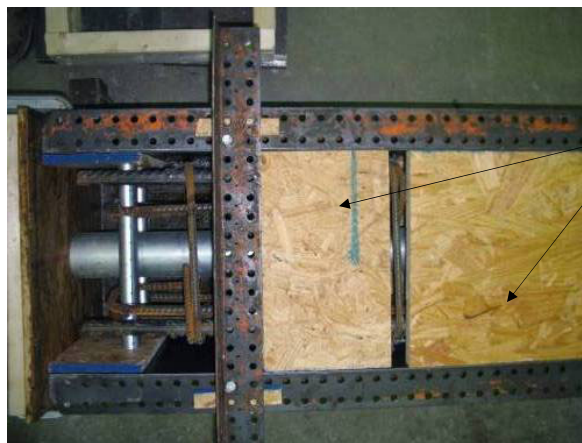
Figure 36. Photograph of top of Column 2.

Boxouts for
actuator
through-bolts

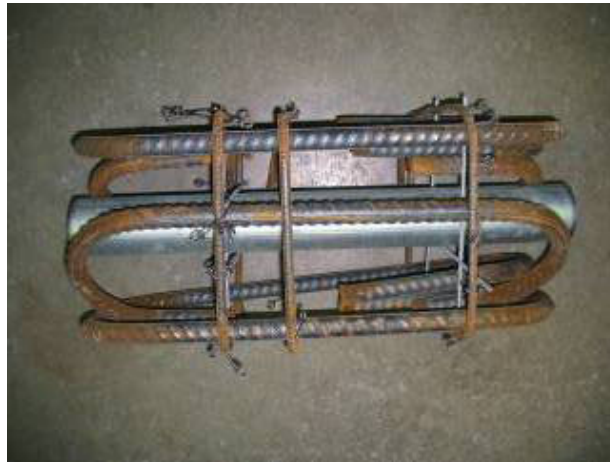
Figure 38. Photograph of reinforcement of Column 2 (2 ft. column segment).

The 2 ft. column segment shown in Figures 38 and 39 was constructed in a similar manner as the 12 ft. column segment. Strain gages were placed in the longitudinal direction at midheight of all four corner bars. Additionally, a steel collar identical to the one used on the 12 ft. column segment was placed on the top end of the segment.

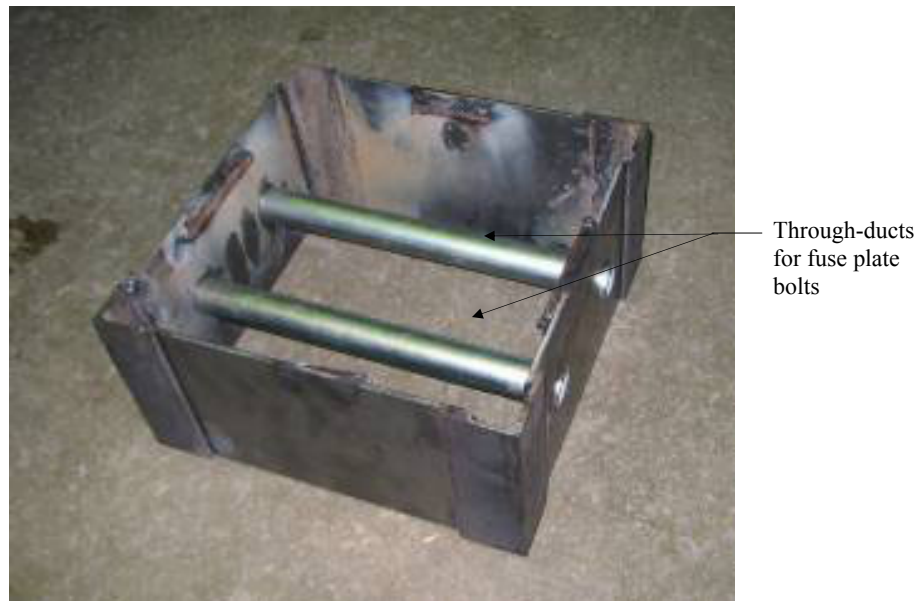
Figure 40. Photograph of Column 2 steel collar with bolt through-ducts.

A typical collar used for Columns 2–4, shown in Figure 40, was constructed by welding 3/16 in. angles with 3/16 in. plates. Holes for the ducts were drilled in two of the side plates to secure bolt ducts that connected the fuse plates to each column segment. Additional information about the collars and reinforcement details was presented in Chapter 3.

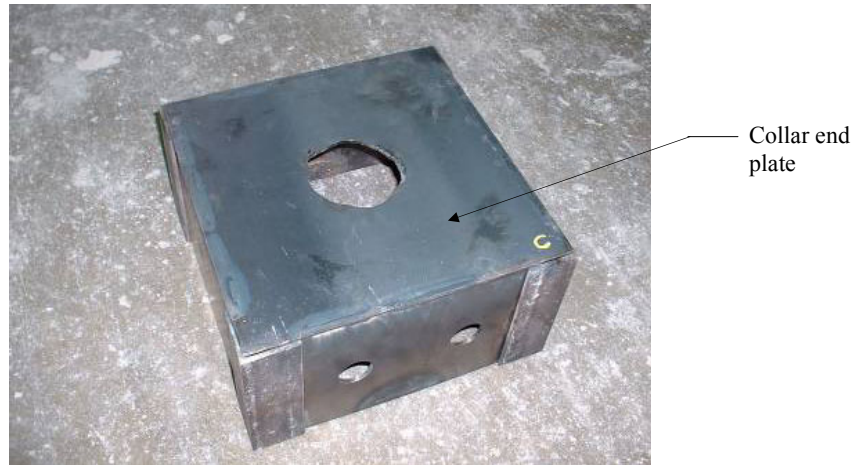
Figure 41. Photograph of Column 3 collar and end plate.

The third and fourth segmented columns (Columns 3 and 4) had a similar construction process as the first segmented column with one major difference. A steel plate was welded to the end of the collars for Column 3 to assist in confining the concrete near the construction joint. A 2.5 in. hole was cut in the center of this plate to accommodate the post-tensioning duct. Due to the experimental nature of this plate, it was not included for the Column 4 collars at the time of casting. The collar used for Column 3 is shown in Figure 41; construction details of the column segments used for Columns 3 and 4 are shown in Figures 42-50.

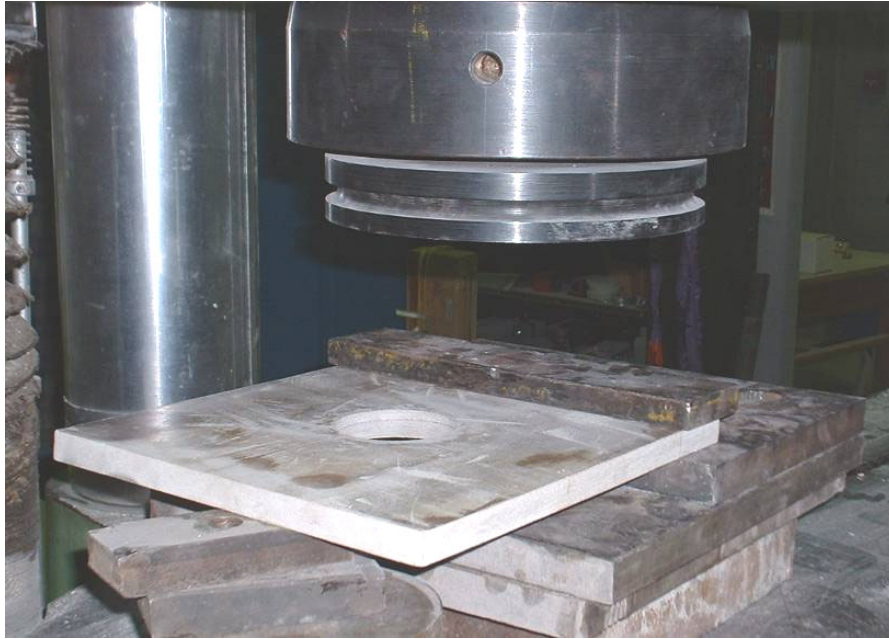
Figure 61. Photograph of edge compression test.

In addition to the cylinder breaks, an edge compression test was performed on each type of plate to obtain a realistic stress-strain relationship. To simulate the loading applied during column tests, a 2 in. wide strip on the edge of the plates was tested in compression. From these tests, an estimate of the elastic modulus of each plate was calculated by measuring the slope of the stress-strain relationship. The GFRP plate exhibited the highest modulus during the edge compression test, while the epoxy grout plate saw the lowest modulus. While the modulus of the GFRP plate was 20% higher than the epoxy grout plate modulus, the effect of the different modulus of the three plates during column testing could not be determined,

because each plate performed satisfactorily during the tests. The edge compression test is shown in Figure 61 and the results from the tests are shown in Figure 62.

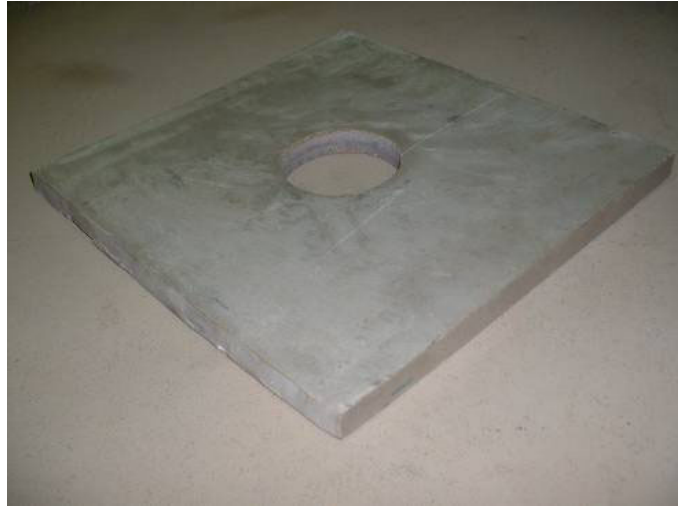
Figure 63. Photograph of epoxy grout plate.

To form the epoxy grout bearing plate, Sikadur 32, a high modulus, flowable epoxy, was mixed with Grade 37 silica sand in a 1:1 ratio. This mixture was also used to grout each column base into its foundation socket. The average compressive strength of the epoxy grout used was 12 ksi in fifteen 3 in. diameter by 6 in. long cylinder breaks, while the elastic modulus of the epoxy grout plate was 1,300 ksi. It should be noted that the elastic modulus for this material can easily be adjusted by altering the sand-to-epoxy ratio. When tested in compression, this material exhibited large plastic strains without cracking. A prefabricated epoxy grout bearing plate, shown in Figure 63, was used for Columns 2 and 3.

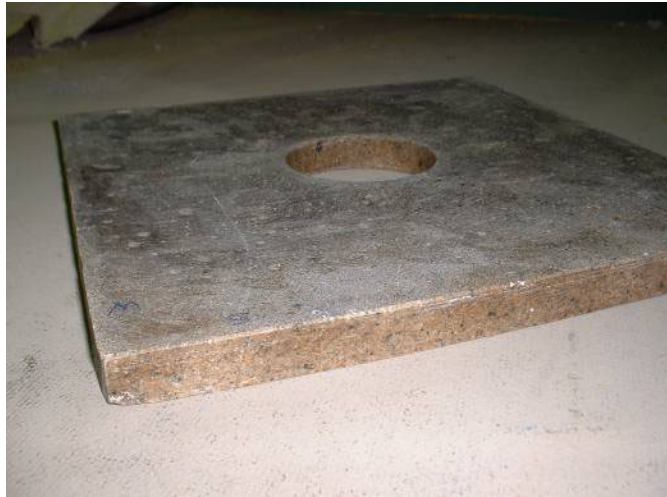
Figure 64. Polymer concrete bearing plate.

A steel-reinforced polymer concrete bearing plate was used in Column 4. In polymer concrete, a high strength, corrosion resistant, thermosetting resin acts as the binding agent. Three-eighths in. aggregate was used in the bearing plate, and a 2 in. square welded wire grid was cast into the plate to reinforce against splitting. The modulus of elasticity of the polymer concrete was approximately 1,500 ksi, while its compressive strength averaged 9.85 ksi in four cylinder breaks. The Column 4 plate is shown in Figure 64.

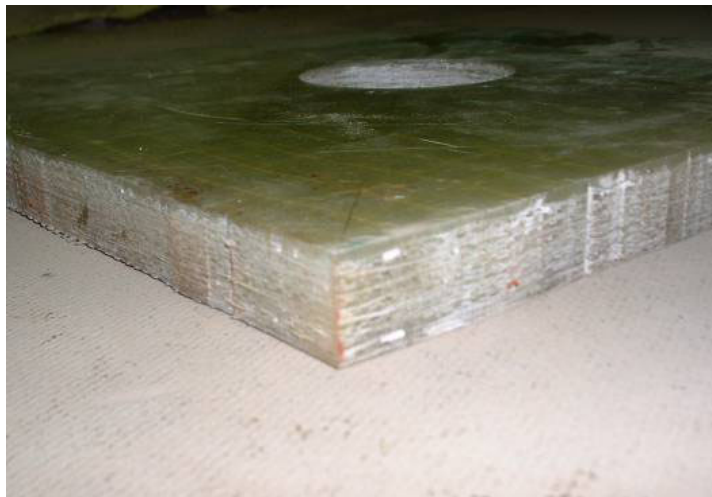
Figure 65. GFRP plate.

A GFRP bearing plate was used in Columns 5 and 6; an epoxy resin served as the matrix for GFRP, while glass fiber layers provided tensile reinforcement against lateral splitting. Seventeen layers of woven fiber fabric were laid up in alternating 90° orientations to construct the 0.75 in. thick plate. The elastic modulus for the GFRP bearing plate perpendicular to the fibers was approximately 1,600 ksi, and the average compressive strength of the epoxy matrix determined from 3 cylinder breaks was 13 ksi. The GFRP bearing plate is shown in Figure 65.

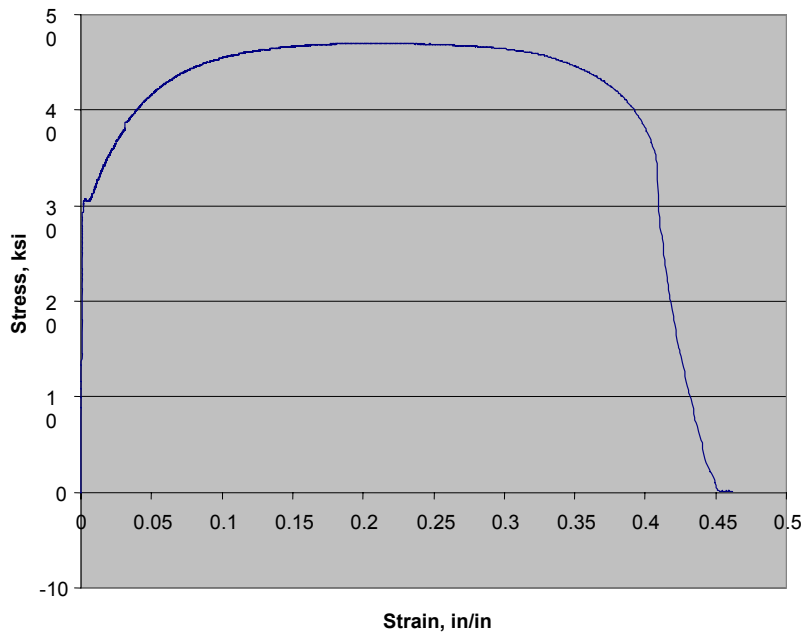
Figure 67. Typical stress vs. strain for 1018 carbon steel used in fuse plates.

Fuse plates in Column 3 were fabricated from 1018 carbon steel. In three tests, the 1018 carbon steel strips had an average yield stress of 30.5 ksi, an ultimate stress of 48 ksi, an ultimate elongation greater than 30%, and an approximate elastic modulus of 29,000 ksi. A

representative stress versus strain relationship for the 1018 carbon steel plates is presented in Figure 67.

As shown by Figures 66-68, the properties of the three tested materials varied significantly. The yield stress of the A36 steel was tested to be 6-7 ksi higher than the 1018 carbon steel, while the yield stress of the SMA was higher than both but not well defined. Ultimate elongations in the 1018 carbon steel and the A36 steel were found to be above 30%, which

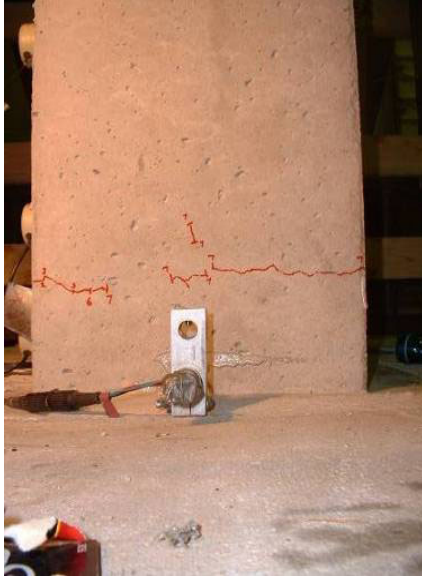
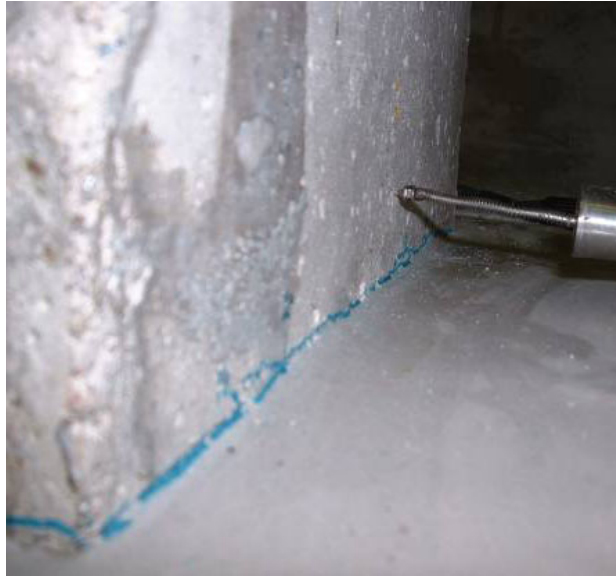
Figure 71. Photographs of Column 1 - Cycle 8.

Testing of Column 1 commenced and continued to a ± 9.0 in. lateral displacement. No post-tensioning was applied to this column to replicate the behavior of a conventional, cast-in-place column. Incremental damage accrued over the imposed displacement regimen is presented in Figures 71-84. Cracking across the east and west column faces was first observed on Cycle 7 (displacement = ± 0.40 in.). On the positive (push) half-cycle, cracking was observed 3 in. above the base on the east face; on the negative (pull) half-cycle, three full cracks across the column face were noted 3 in., 16 in., and 24 in. above the base on the west face. These initial cracks are shown during Cycles 8 and 11 in Figures 71 and 72, respectively.

a.) East face initial cracking

b.) West face initial cracking

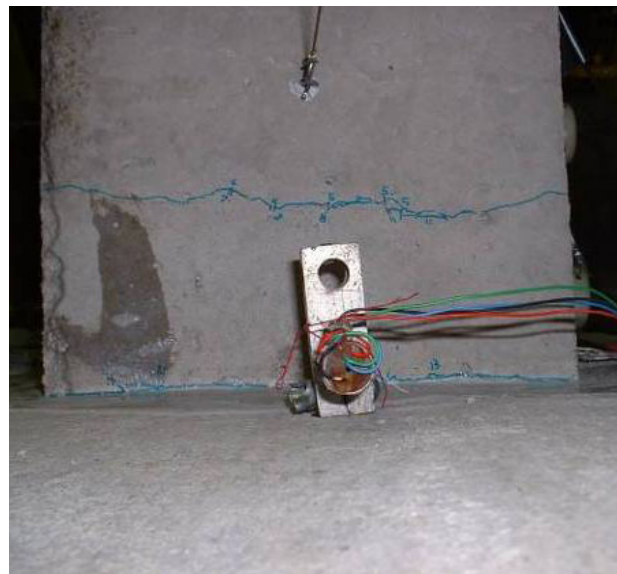
Figure 72. Photographs of Column 1 - Cycle 11 base cracking.

a.) East face

b.) West face

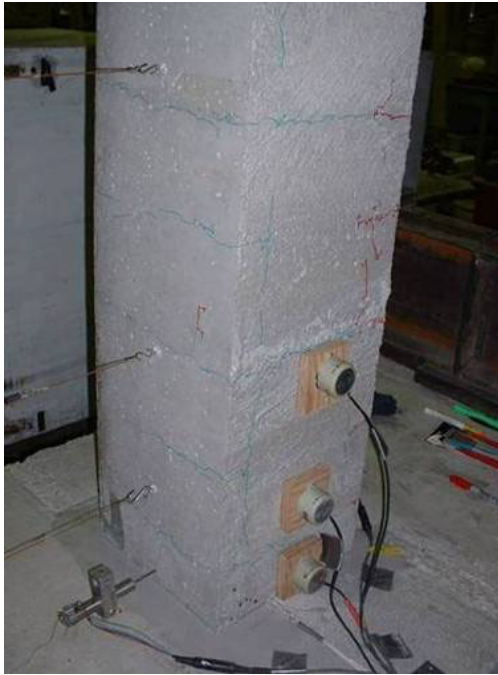
Figure 73. Photographs of Column 1 - Cycle 11 progressive cracking.

Cracks continued to expand and develop further up the column as cycles continued and lateral loads increased (see Figures 73 and 74). From Cycles 20 to 22, several areas on the compression face of the column began to exhibit localized compression damage and are denoted by hatched areas drawn on the column faces (see Figures 75 and 76). Major compression damage that localized in the southwest corner of the column was observed on Cycle 20 (displacement = ± 5.0 in.) (see Figures 77a and 78). As the previously observed damage increased on subsequent cycles, the column began to tilt to the south, perpendicular to the axis of loading. On Cycle 21 (displacement = ± 5.0 in.), Column 1 attained its maximum lateral load of + 9.7 kips.

a.) Southwest corner view of progressive cracking

b.) Progressive cracking on the east face

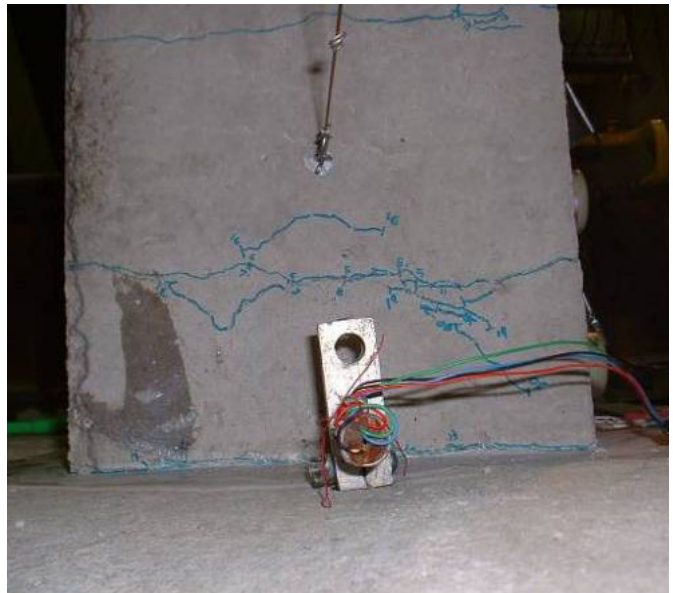
a.) East face cracking

b.) West face cracking

Figure 74. Photographs of Column 1 - Cycle 14.

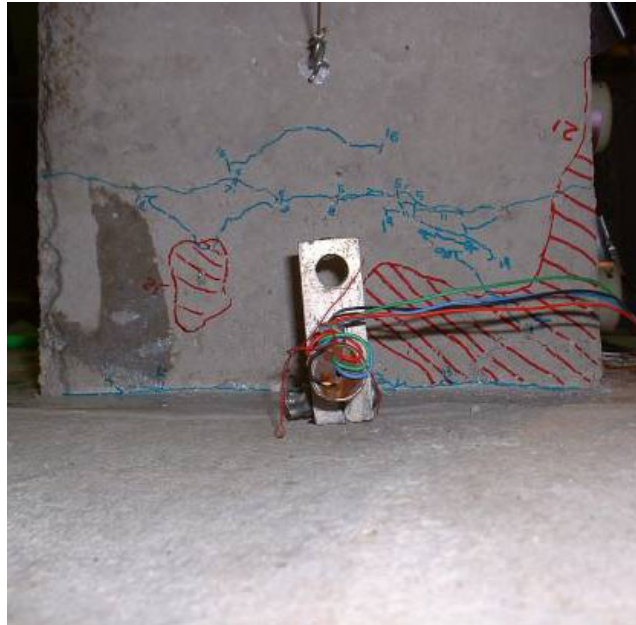
a.) West face initial compression damage

b.) Localization of compression damage on southwest corner

Figure 75. Photographs of Column 1 - Cycle 20.

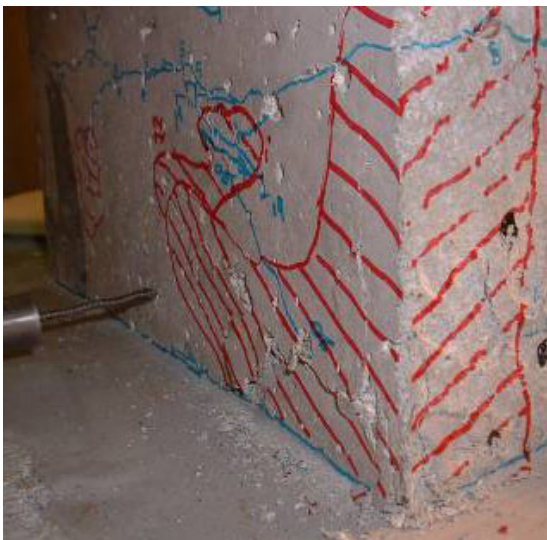
a.) Southwest corner compression damage

b.) East face initial compression damage

Figure 76. Photographs of Column 1 - Cycle 22.

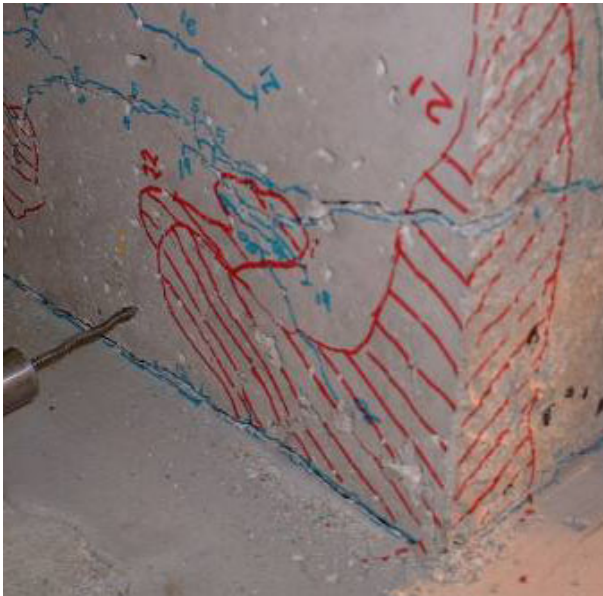
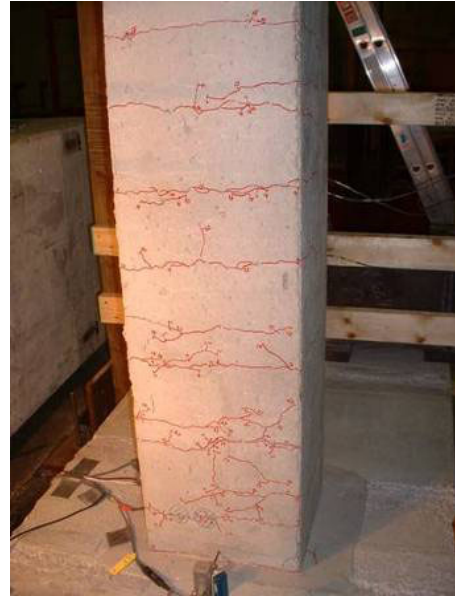
a.) Southwest corner compression damage

b.) East face crack progression

Figure 77. Photographs of Column 1 - Cycle 23.

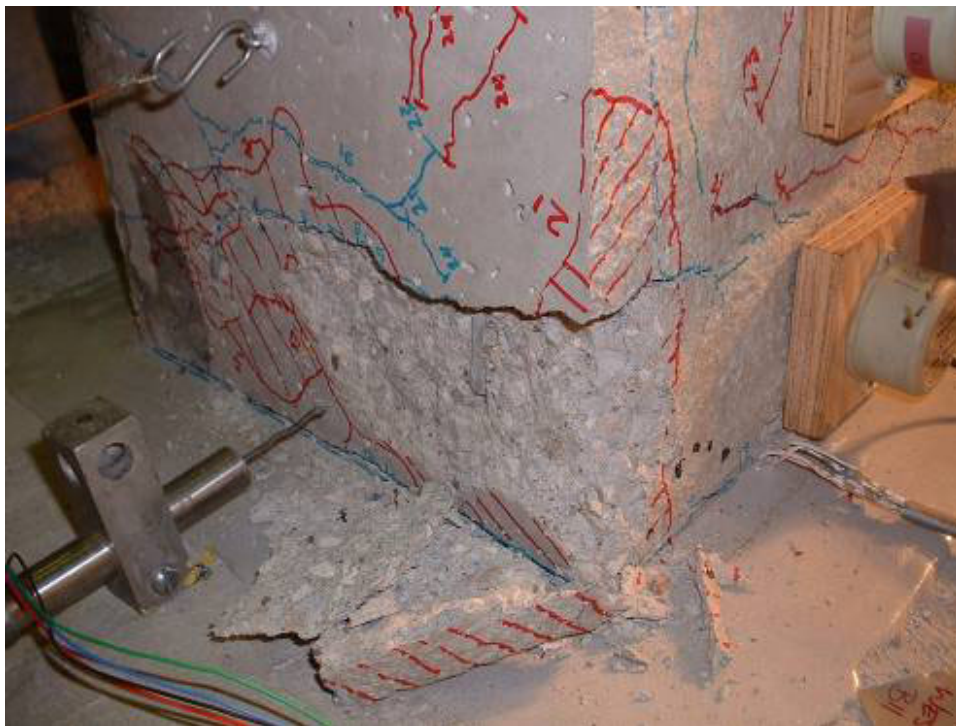
Figure 78. Photograph of Column 1 – Cycle 24 damage to southwest corner

Additional cycles produced more spalling of concrete, most notably on the southwest corner of the column near the base (see Figures 79-81), a reduction in lateral load, and further tilting of the column to the south (see Figure 82). It was observed during Cycle 25 that the load beam was in contact with the testing frame (see Figure 82a). On Cycle 27 (displacement = ± 9.0 in.), the damage was severe enough that the longitudinal reinforcement in the column was visible and exhibited clear signs of buckling (see Figures 82-84). Furthermore, the lateral load applied to the column had fallen off sharply, and the column was in danger of becoming

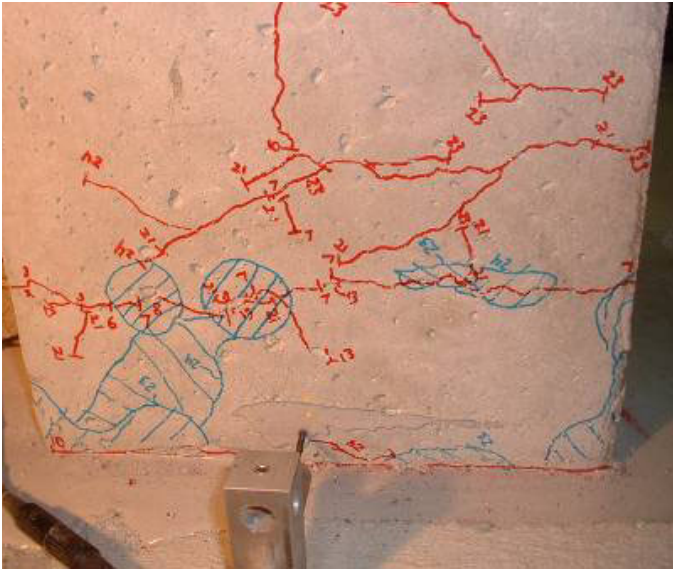
a.) East face damage

b.) North face crack progression

Figure 79. Photographs of Column 1 - Cycle 24.

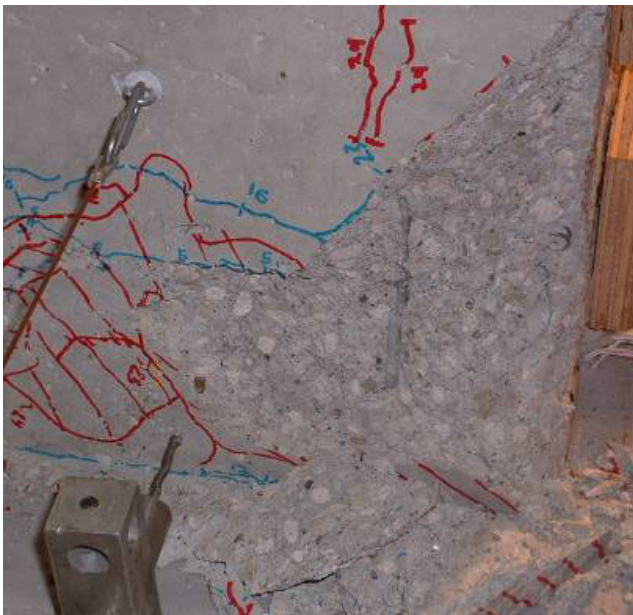
a.) Southwest corner damage

b.) East face damage

Figure 80. Photographs of Column 1 - Cycle 25.

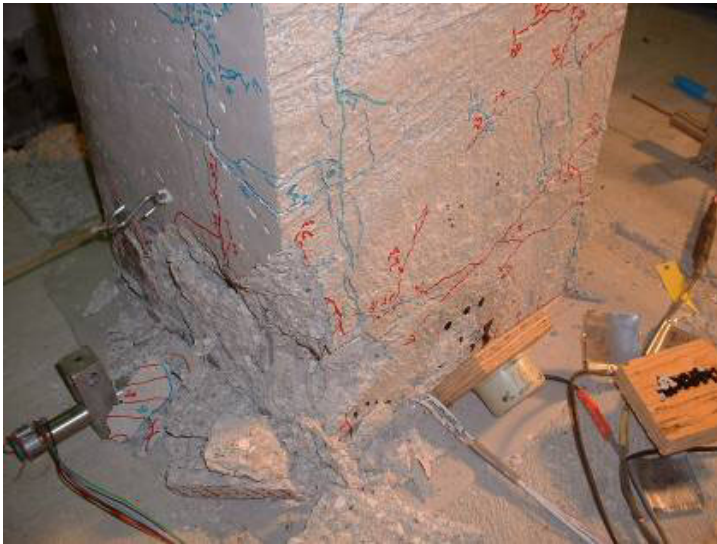
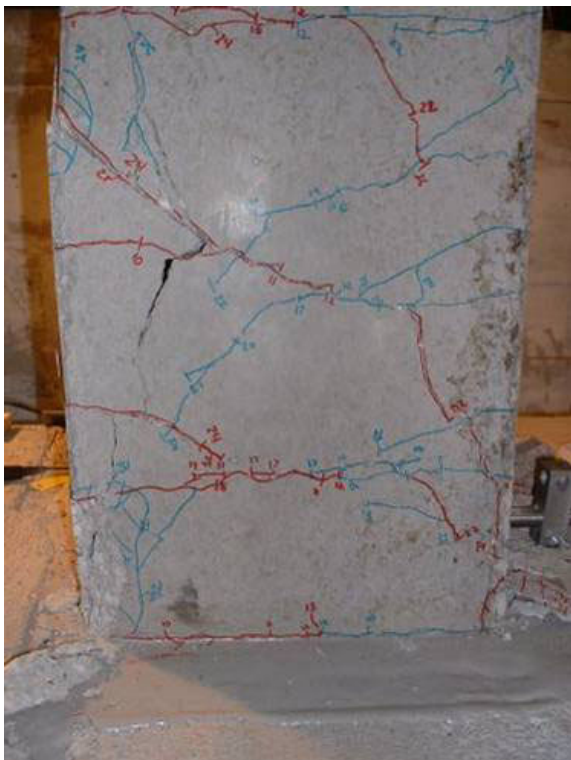
a.) Severe spalling of southwest corner

b.) Visible southwest corner reinforcement

c.) North face cracking/spalling

d.) East face bulging due to buckled reinforcement

Figure 81. Photographs of Column 1 - Cycle 26.

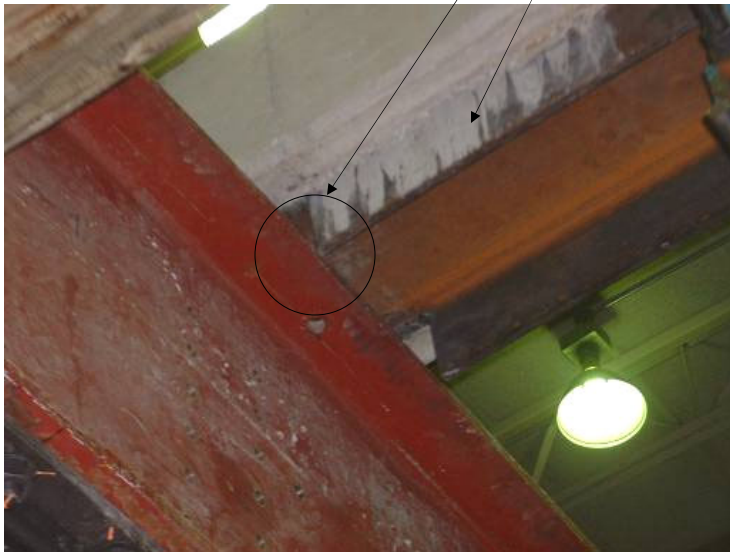
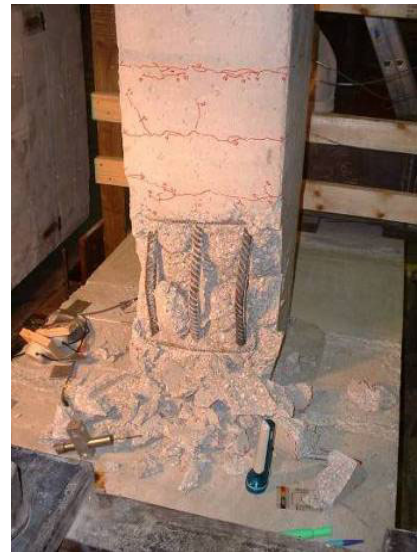
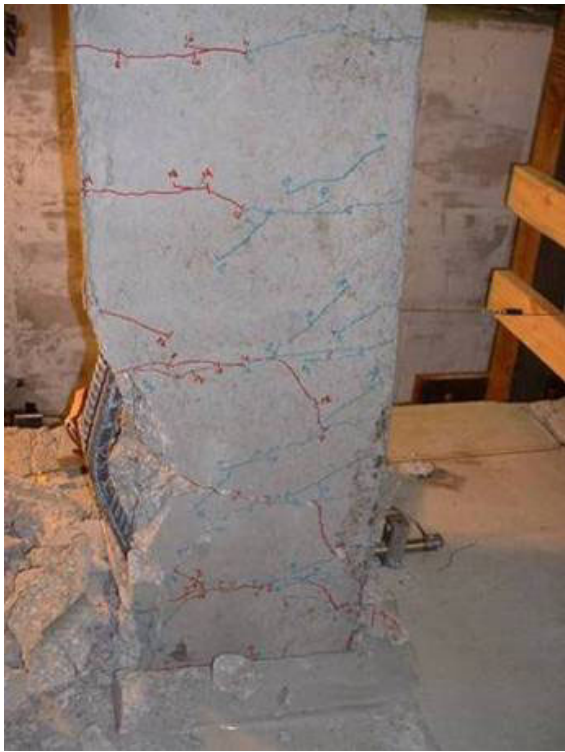
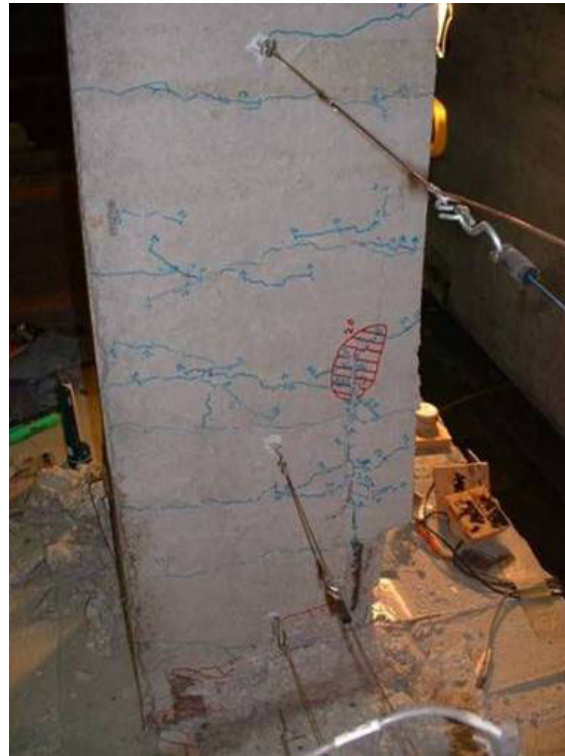
Contact between load frame and load beam — Flange of load beam

a.) Frame impingement with underside of load beam

b.) East face reinforcement exposed

c.) North face cracking/bulging

d.) West face damage

Figure 82. Photographs of Column 1 - Cycle 27 damage/frame impingement.

During the last three positive (push) half-cycles of + 7.0 in., + 8.0 in., and + 9.0 in. displacements, the load beam impinged on the load frame when displacements exceeded + 7.0 in. This impingement and the associated tilting to the south occurred only on the positive portions of the loading cycles. This caused spuriously high lateral load readings on these half-cycles. Testing was continued beyond the + 7.0 in. displacement, because the problem did not occur on the negative (pull) half-cycles. Thus, testing was continued until failure occurred on the negative half of Cycle 27. Due to this occurrence, only the data collected for negative half-cycles for the three largest displacement cycles were considered reliable and indicative of typical column behavior.

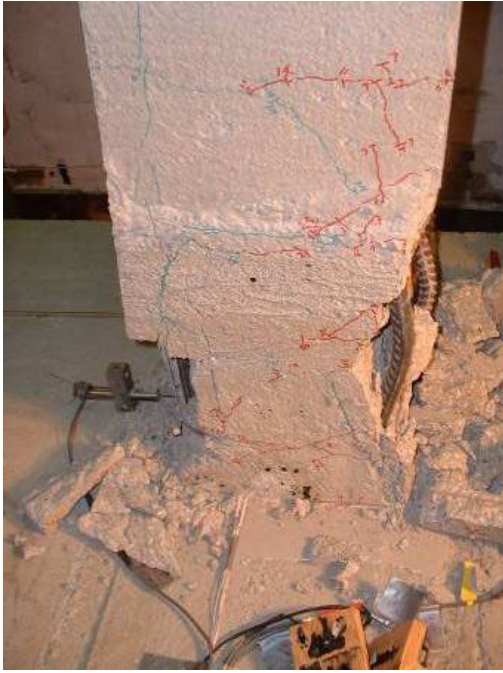
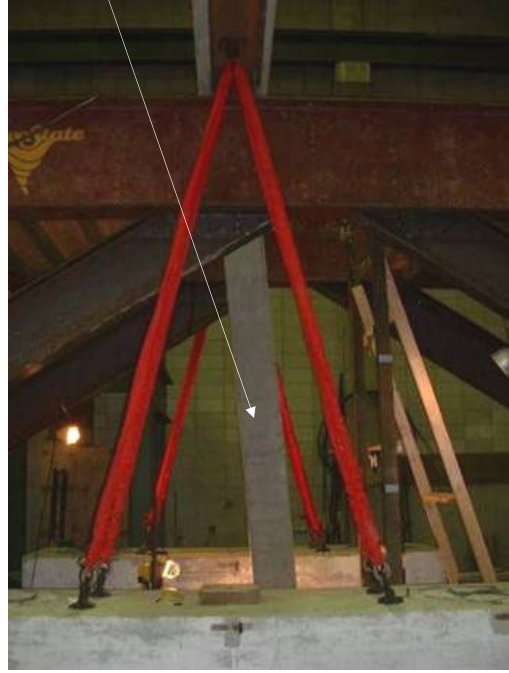
a.) South view of damage

b.) Column deformation on pull half-cycle

Figure 83. Photographs of Column 1 - Cycle 27 damage and deformation.

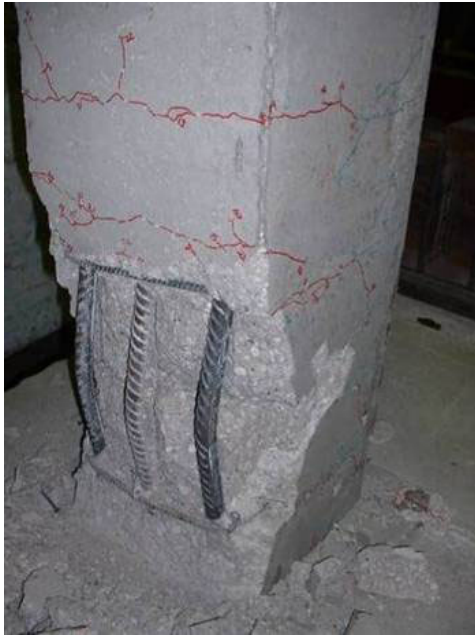
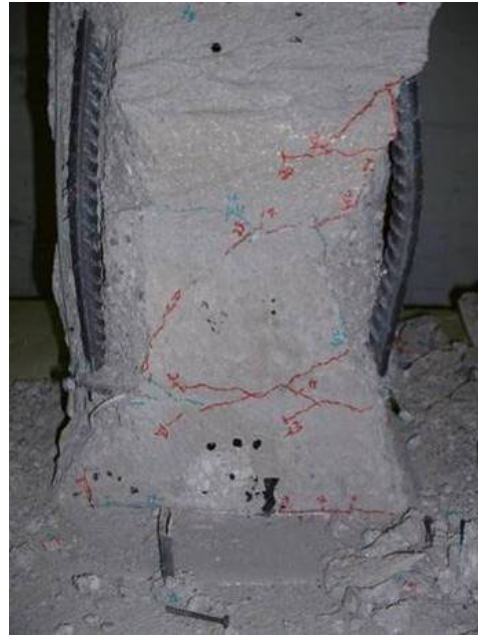
c.) Final damage to east face

d.) Final damage to south face

Figure 84. Photographs of Column 1 – After testing

Behavior of the control column closely matched that expected of a conventional, cast-in-place column in the field with the exception of the localized failure at the southwest corner (see Chapter 7 for quantitative comparisons). Cracking initially occurred near the base of the column and spread upward as lateral loads and deflections increased. Peak loads occurred near the time that yielding of the bonded reinforcement occurred and was followed by a period of increasing lateral displacements at or near the peak load. This continued until rotational capacity near the base of the column was reached and ultimate failure, marked by buckling of longitudinal bars and crushing of core concrete, occurred.

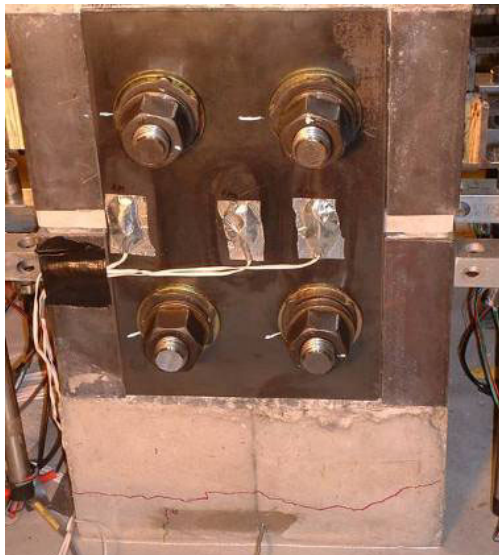
a.) East face

b.) West face

Figure 85. Photographs of Column 2 – Cycle 11a initial cracking.

Testing of Column 2 commenced and continued to a +/- 6 in. displacement. The incremental damage accrued over the imposed displacement regimen is illustrated in Figures 85-92. Cracking across the entire column was first observed on Cycle 10a (displacement = +/- 0.75 in.) (see Figure 85). On the positive (push) half-cycle, cracking occurred 2 in. above the base of the column on the east face; on the negative (pull) half-cycle, cracking occurred at the base of the west face of the column. Also during Cycle 10a, "pinging" in the fuse plate on the tension side of the column was heard, indicating slippage in the slip-critical connection between the fuse plate and the steel collar. "Pinging" was heard on each consecutive cycle in the tension fuse plates throughout the remainder of Test a. During Cycles 11a to 16a, small

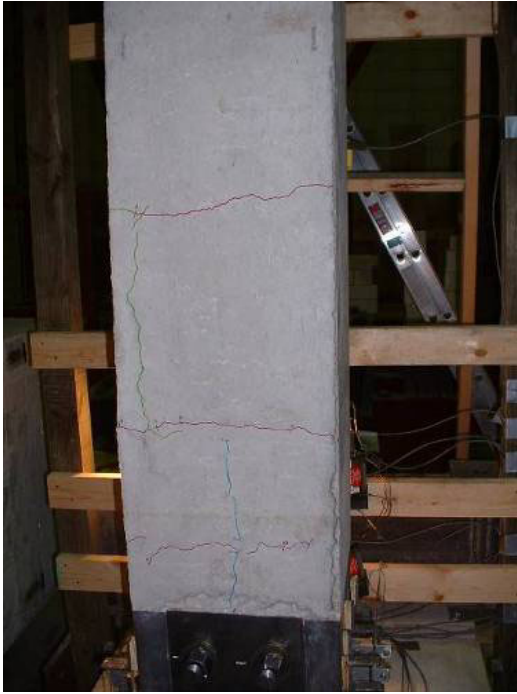
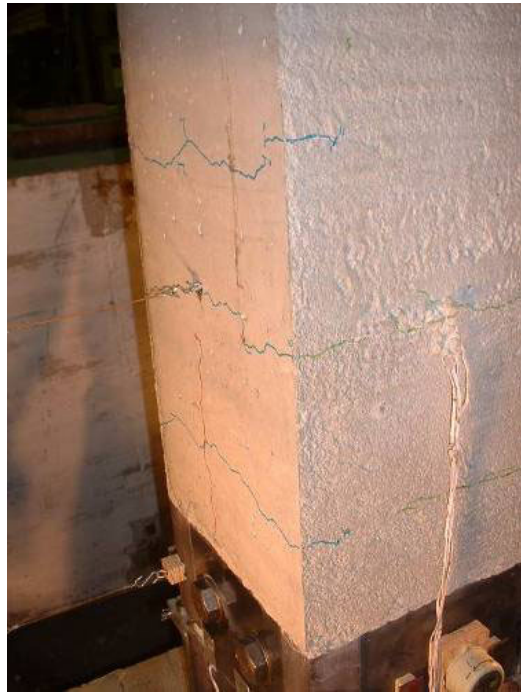
a.) East face crack progression

b.) Southwest corner crack progression

Figure 86. Photographs of Column 2 – Cycle 11a upper column crack progression.

cracks formed every 8 in. to 12 in. across the column for several feet above the construction joint (see Figures 86 and 88). The fuse plate in compression began to buckle on Cycle 13a (displacement = +/- 1.5 in.) and is shown buckling during Cycle 14a in Figure 87b. During Cycle 15a, the crack that formed between the upper column collar and the concrete grew noticeably (see Figure 88). Since Cycle 16a was the predetermined cycle to replace fuse plates, testing was stopped and new plates were mounted on the column. At this juncture, a peak load of + 6.39 kips had been applied to the column.

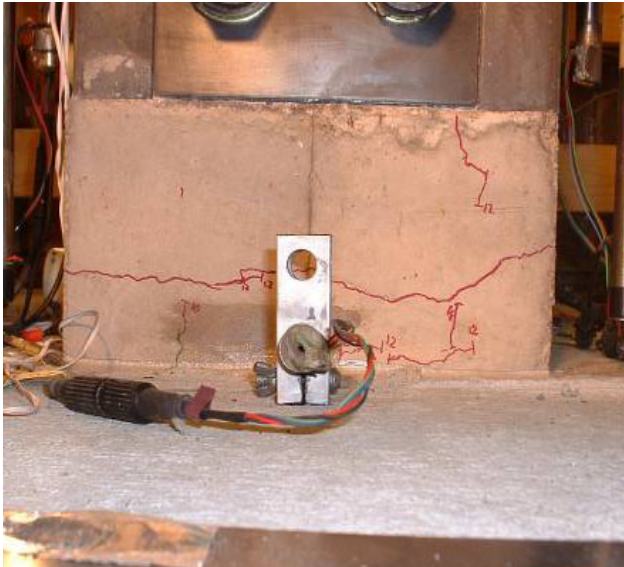
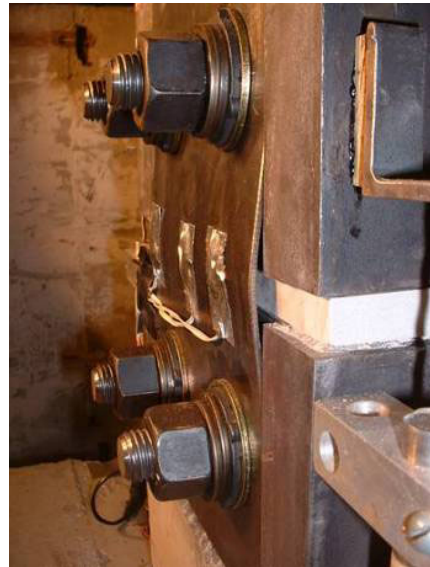
a.) East base cracking

b.) Initial buckling of east plate

Figure 87. Photographs of Column 2 – Cycle 14a.

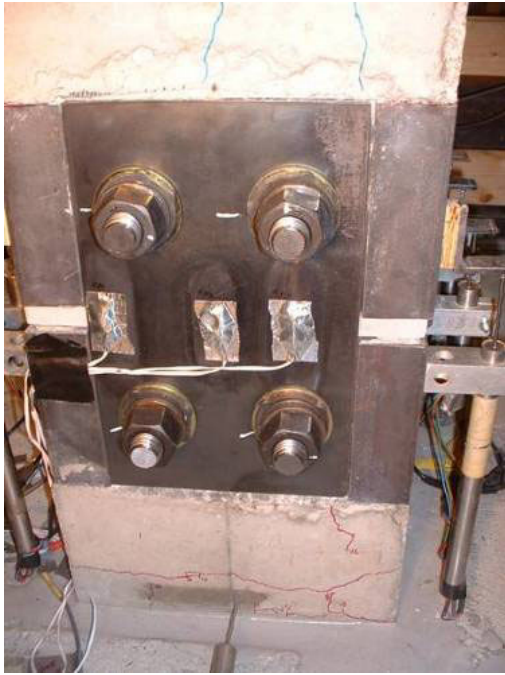
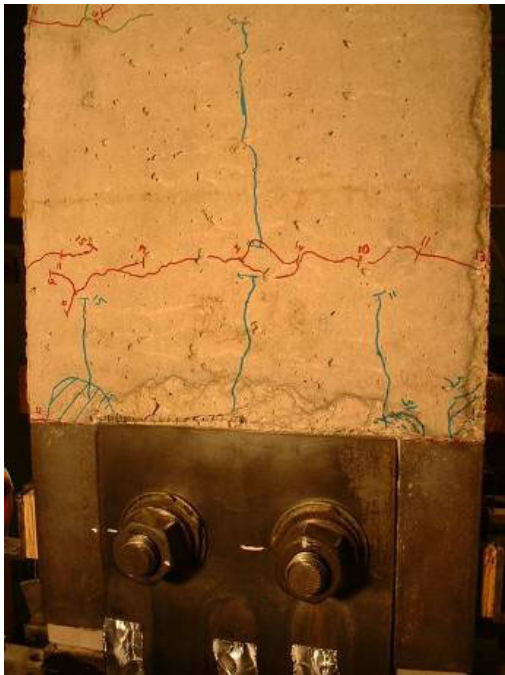
a.) East face

b.) East face crack progression

c.) East face cracking above top collar

d.) Southwest corner collar/column interface

Figure 88. Photographs of Column 2 – Cycle 15a.

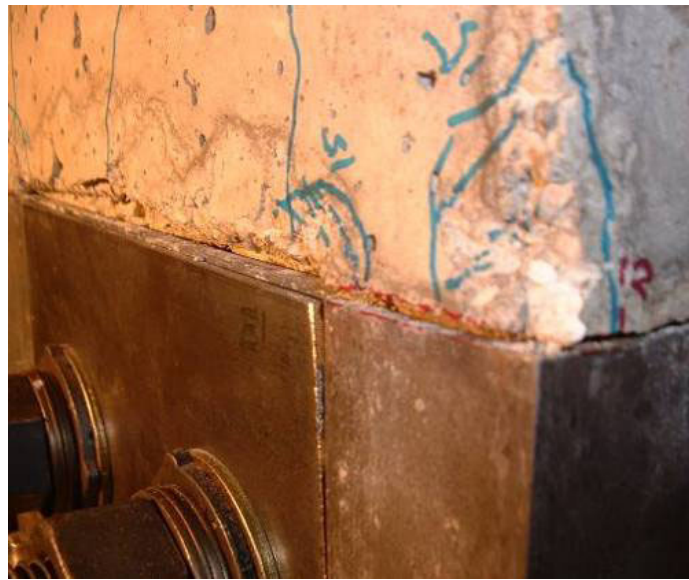
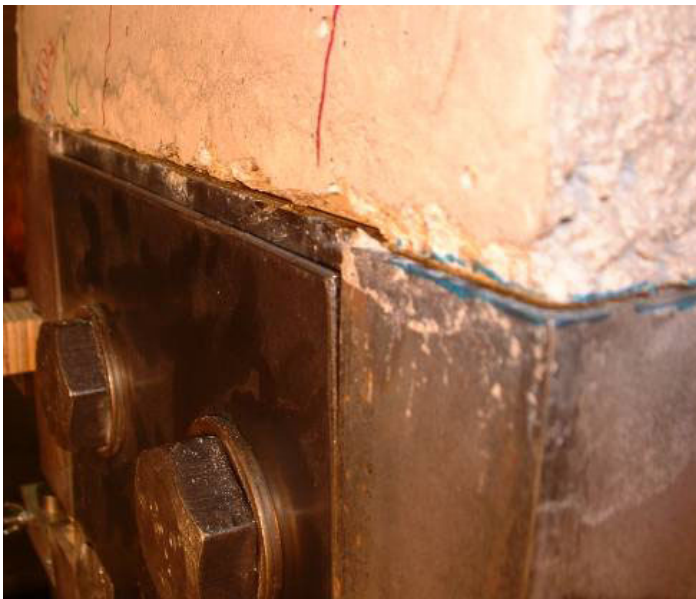
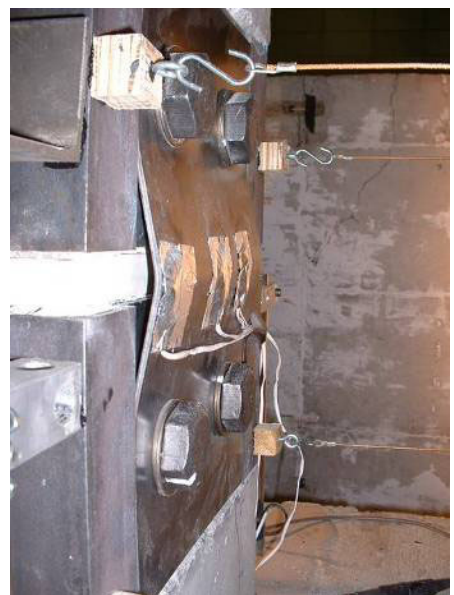
a.) East face

b.) Northeast corner collar/column interface

c.) West collar/column interface

d.) Buckling of replaced west plate

Figure 89. Photographs of Column 2 – Cycle 16b.

Following replacement of the fuse plates, testing was restarted and continued without additional cracking until Cycle 11b (displacement = +/- 1.0 in.), when several cracks were found at the base of the column. Slippage of the fuse plates was again noted during Cycle 12b (displacement = +/- 1.0 in.). During Cycle 15b (displacement = +/- 2.5 in.), the segment joint began to open significantly. Reverse curvature in the fuse plates at the top and bottom edges (see Figure 89) was also noted on the negative (pull) half of Cycle 15b indicating bolt bearing at the slip critical connection.

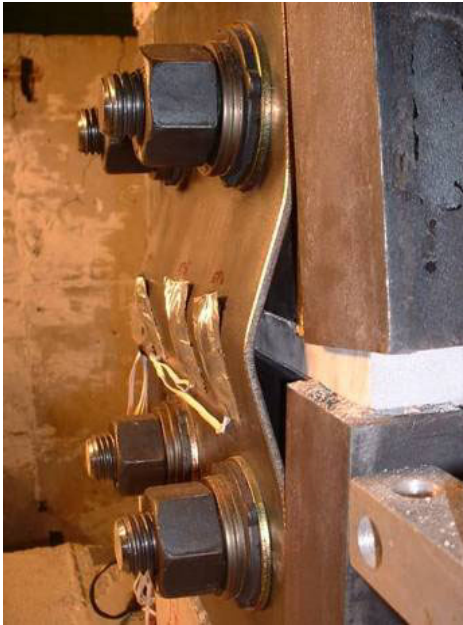
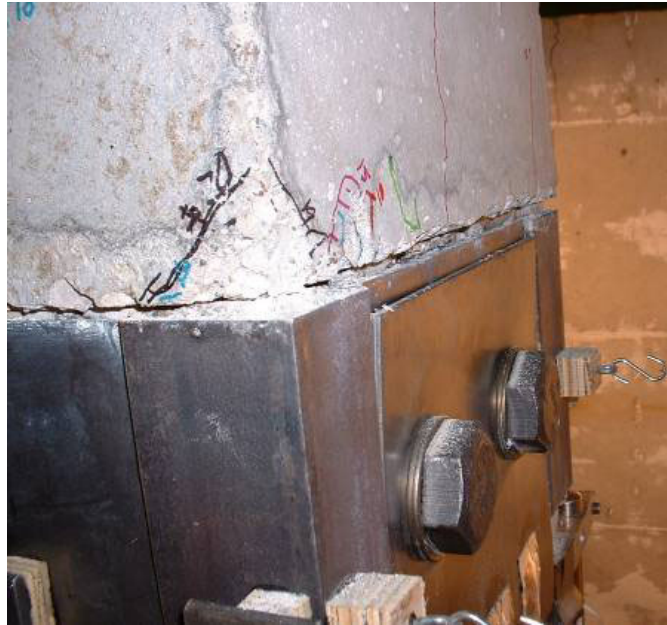
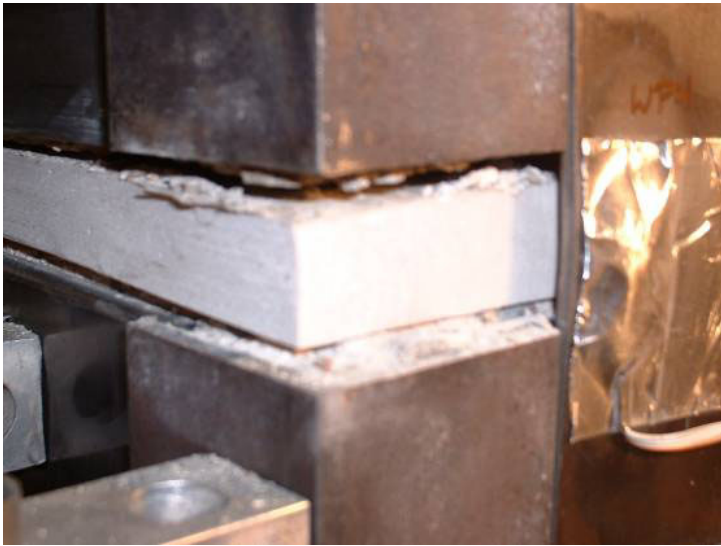
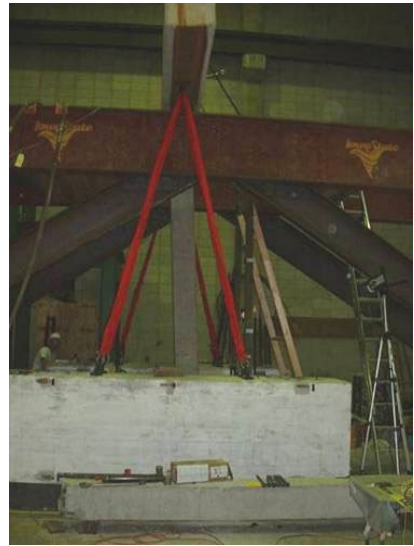
a.) East plate buckling during last cycle

b.) West collar/column interface final crack width

c.) Northwest corner of bearing plate

d.) Column tilt during negative half-cycle

Figure 92. Photographs of Column 2 – Cycle 23b.

Compression damage above the top collar was noted on Cycle 19b (displacement = +/- 3.5 in.) on the northwest and northeast corners of the column. On Cycle 20b (displacement = +/- 4.0 in.), the actuator control problem occurred at + 1.5 in. displacement on the positive (push) half cycle. An increase in gap width at the upper segment's collar interface, as well as a fractured weld on the upper steel collar (see Figure 91), was also noted on Cycle 20b. On the remaining cycles, the crack at the failed weld in the collar continued to widen. On Cycle 22b (displacement = +/- 6.0 in.), the crack between the upper collar and column segment began to open significantly, clearly causing rotation that was designed to occur at the segment joint. This indicated that the upper collar and through-bolts were pulling off the upper column segment, causing irreparable damage to the segment. This phenomenon is shown during

Cycle 23b in Figure 92b. Also during Cycle 22b, a crack was observed on the northwest corner of the bearing plate. The test was stopped after Cycle 23b due to the opening of the crack between the collar and column; it was evident that the decrease in load at each displacement was due to this phenomenon. A maximum load of + 6.64 kips was observed during Column 2's test on Cycle 14a (displacement = +/- 2.0 in.), while a maximum displacement of 6.0 in. was recorded for the test. At + 6.0 in., a load of + 4.48 kips was achieved, while a - 3.27 kip load was achieved at - 6.0 in. Quantitative lateral load versus displacement is shown in Chapter 7.
