Self-centering bridge pier columns with structural fuses

MASTER OF SCIENCE

Major: Civil Engineering (Structural Engineering)

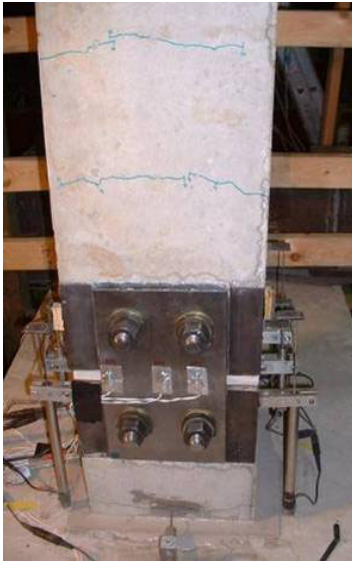
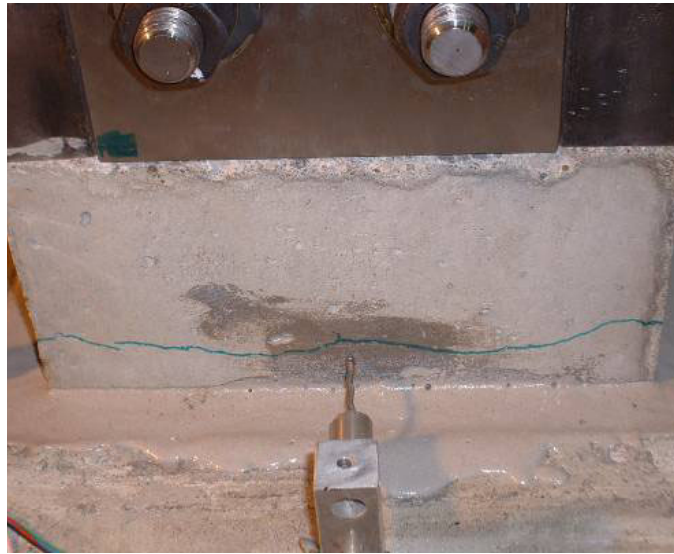
a.) East face crack progression

b.) East base initial cracking

Figure 94. Photographs of Column 3 – Cycle 10a east face.

Testing of Column 3 commenced and continued until ± 9.0 in. displacements were reached. The incremental damage accrued over the imposed displacement regimen is illustrated in Figures 93-105. Cracking across the entire column was observed on Cycle 10a (displacement = $\pm .75$ in.) (see Figures 94 and 95). On the positive (push) half-cycle, cracking occurred at the base of the column on the east face, as well as 1 ft. above the top collar; on the negative (pull) half-cycle, cracking occurred 1 in. above the base on the west face of the column. During the next several cycles, small cracks formed every 6 in. to 10 in. up the column face for several feet above the construction joint (see Figures 97a and 97b).

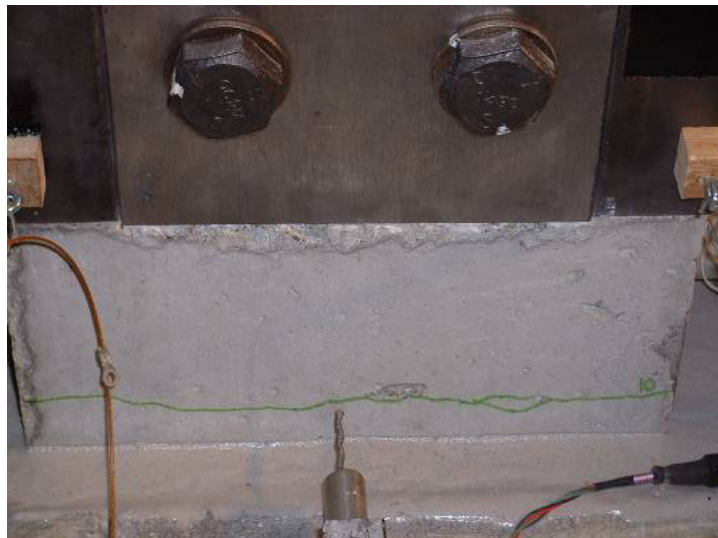
a.) West face crack progression

b.) West base initial cracking

Figure 95. Photographs of Column 3 – Cycle 10a west face.

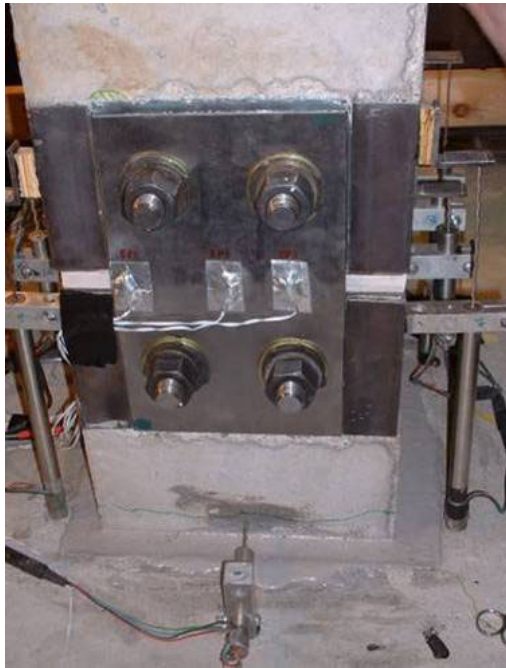
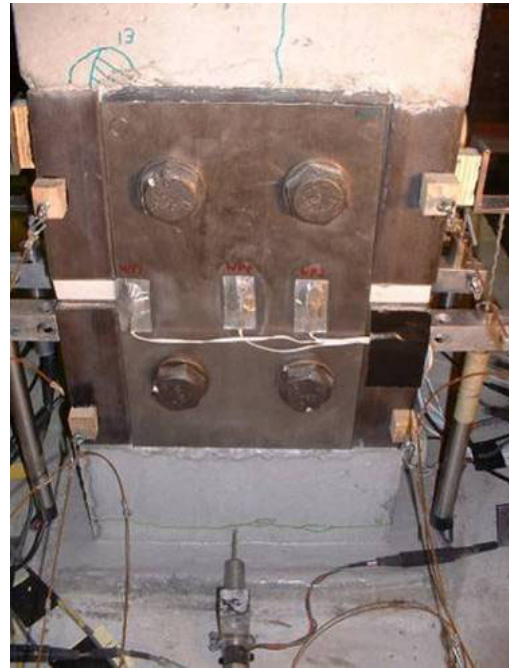
a.) East plate and column face

b.) West plate and column face

Figure 96. Photographs of Column 3 – Cycle 14a fuse plates.

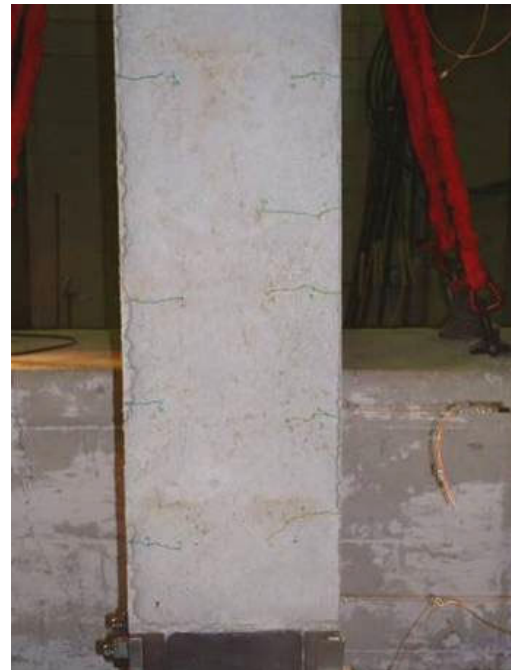
a.) West face cracking above collar

b.) North face crack progression

Figure 97. Photographs of Column 3 – Cycle 14a.

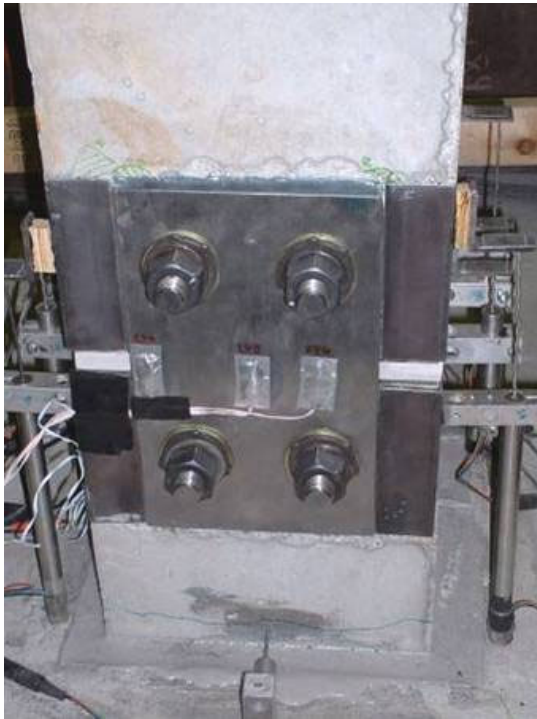
a.) East replacement fuse plate

b.) West replacement fuse plate

Figure 98. Photographs of Column 3 – Replacement fuse plates.

On Cycle 13a, a loss of control of the actuator occurred at a $- 0.59$ in. displacement. Also, on Cycle 13a, minor compression damage was observed around the collar. Buckling could be seen in the compression fuse plates, and a small amount of compression damage was noted in the bearing plate on the west side on Cycle 14a (displacement = ± 2 in.) (see Figure 98).

After replacing the fuse plates (see Figure 98), the displacement regimen was restarted. "Ticking" was heard in the east plate on Cycle 15b indicating slippage between the fuse plate and the collar. On Cycle 16b (displacement = ± 2.5 in.), the crack opening was noted between the top collar and the column segment (see Figure 99). Actuator problems occurred again on Cycle 17b (displacement = ± 3.0 in.) at $- 0.30$ in. At this point, the gain control was turned down in an attempt to regain control of the actuator.

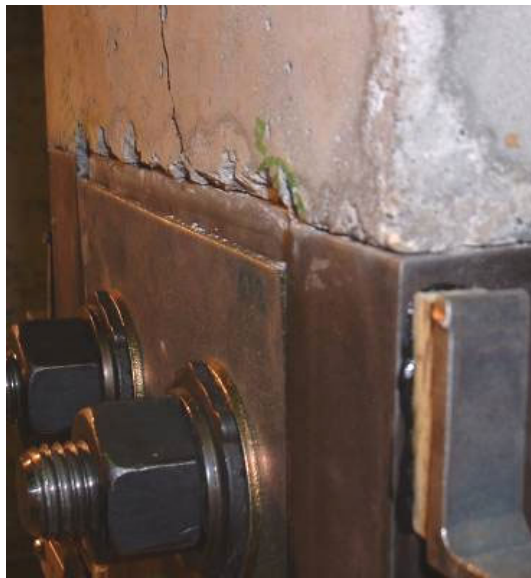
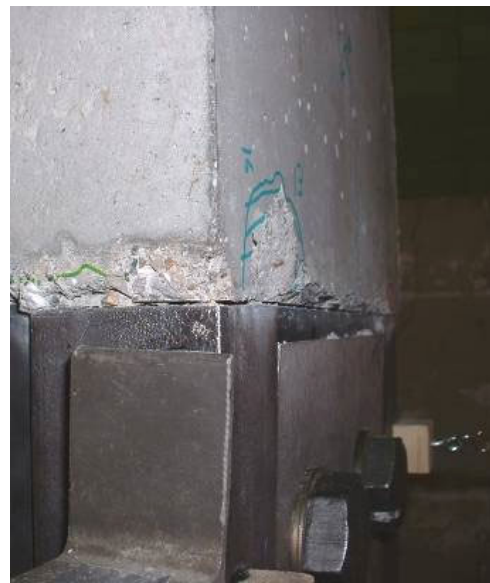
a.) Northeast corner interface opening

b.) Northwest corner interface opening

Figure 99. Photographs of Column 3 – Cycle 16b.

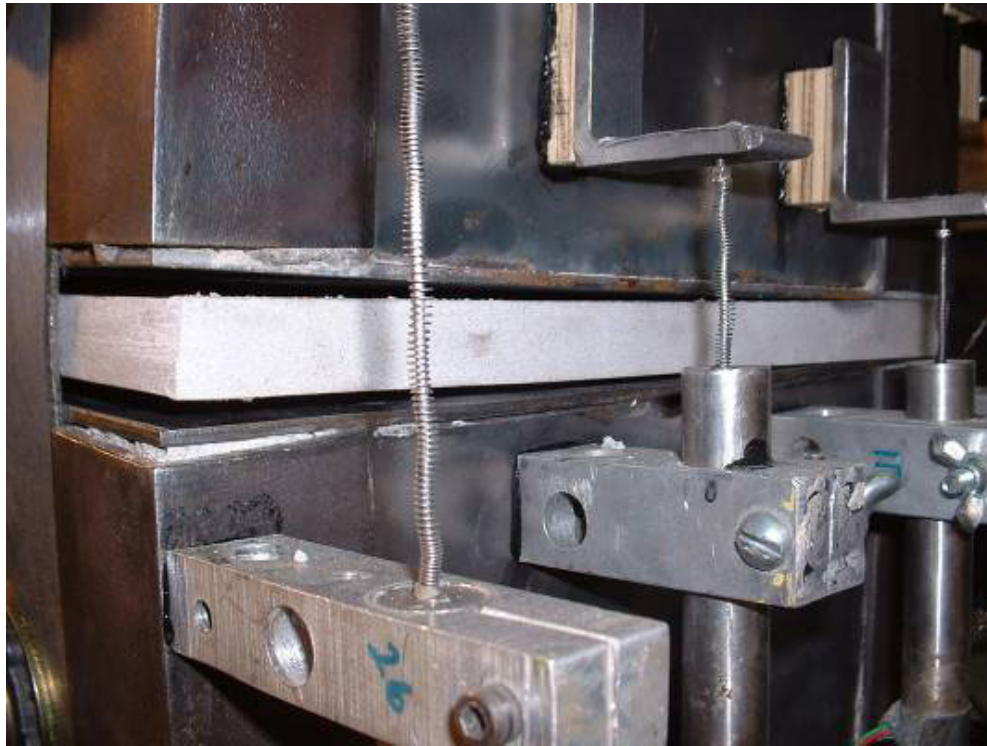
Figure 102. Photograph of Column 3 – Cycle 21b joint opening during push half-cycle.

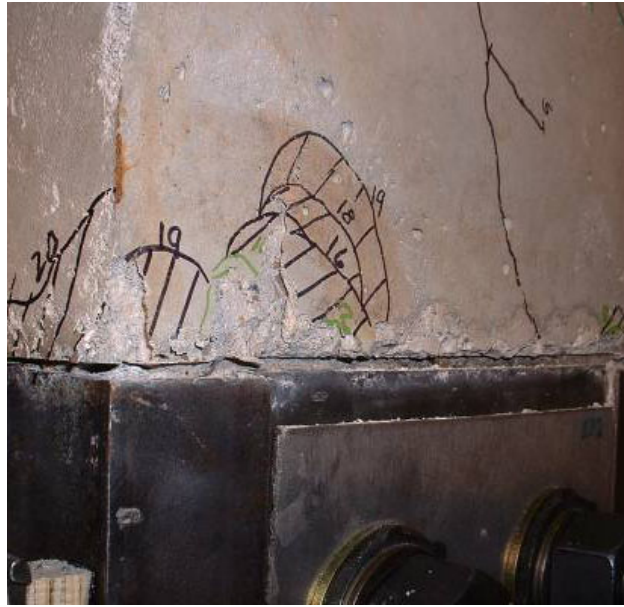
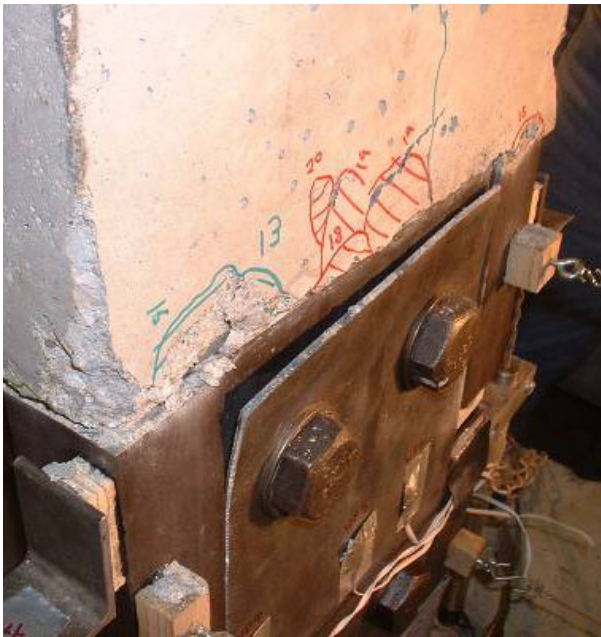
a.) Southeast corner joint opening

b.) Southeast corner interface opening

c.) West bolt bearing causing plate curling

d.) East fuse plate buckling

Figure 104. Photographs of Column 3 – Cycle 21b pull half-cycle.

During the next several cycles, additional slippage at the fuse plate was observed, and, as during Column 2 testing, the crack between the top collar and column continued to open. This concentrated the rotation at that location instead of at the construction joint. The fuse plate buckling and opening gap at the segment joint can be seen for several cycles in Figures 100-103. Additionally, curling of the top of the west fuse plate can be seen in Figure 104a, providing further evidence of the slippage and bearing of the fuse plates on the collar through-bolts.

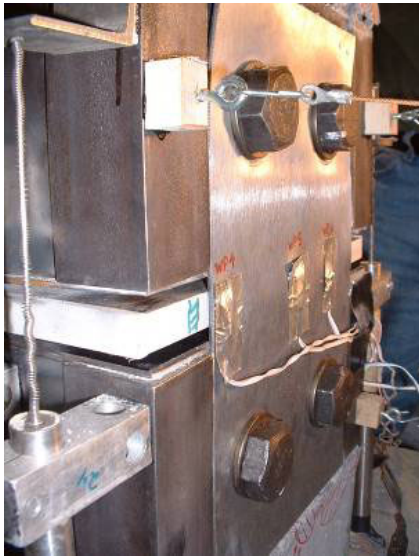
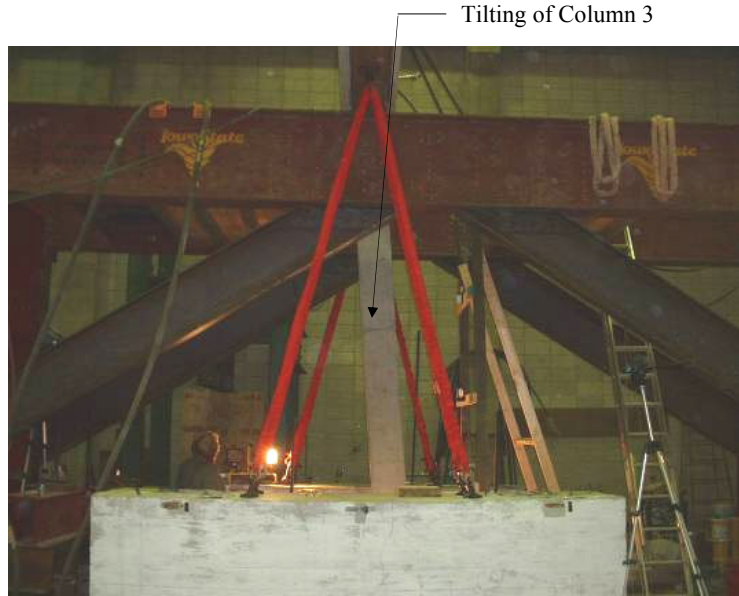
a.) Northeast corner joint opening

b.) Pull half-cycle column deformation

Figure 105. Photographs of Column 3 – Cycle 22b.

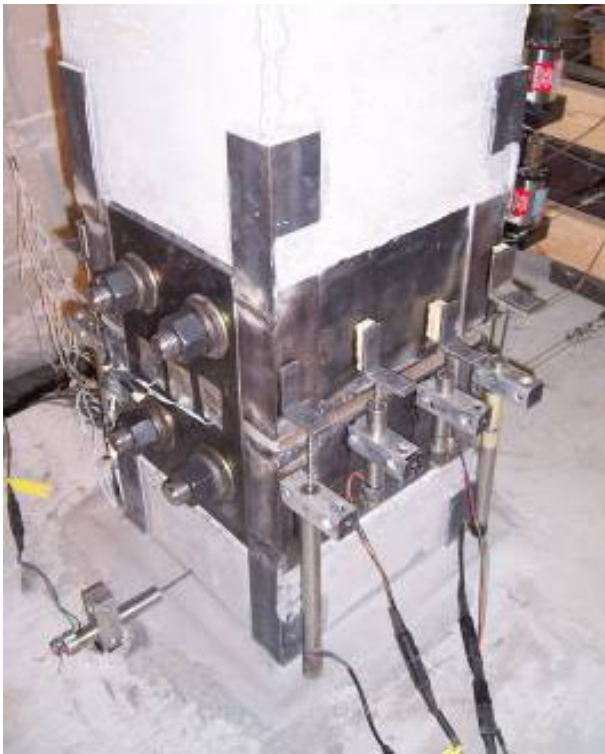
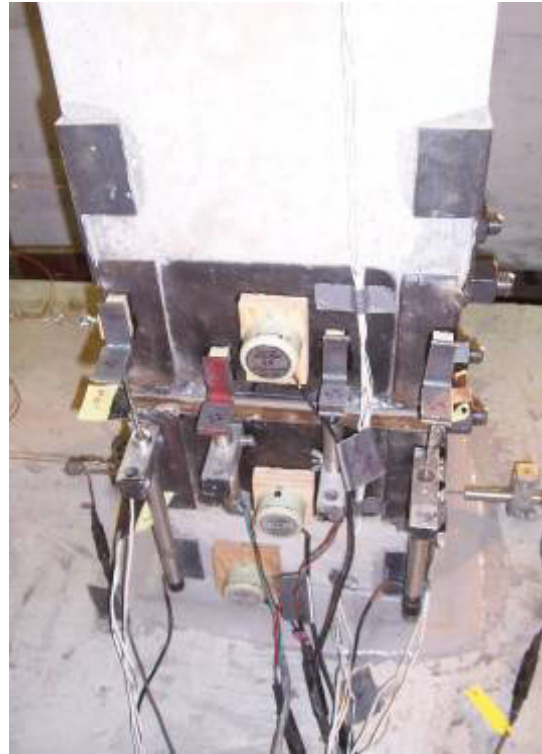
a.) Northwest corner of column

b.) South side of column prior to testing

Figure 106. Photographs of Column 4 – Column prior to testing.

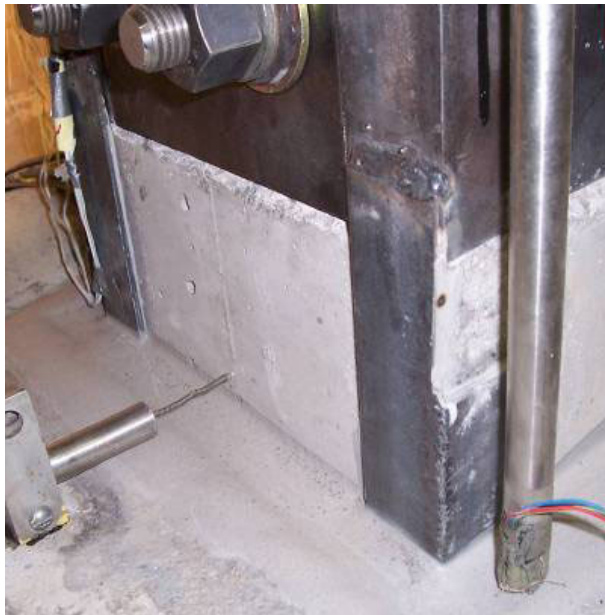
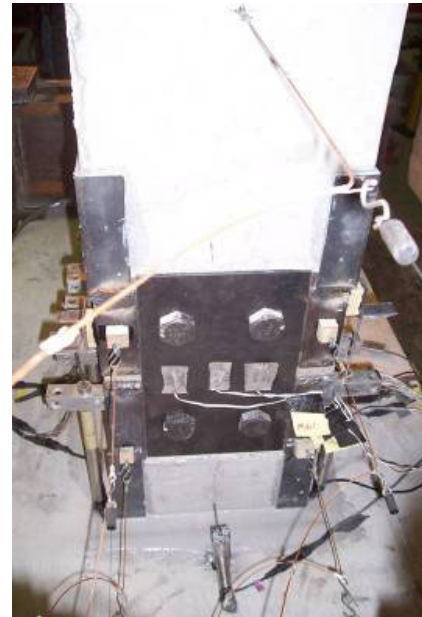
a.) Northwest retrofit angle on bottom column segment

b.) West face prior to testing

Figure 107. Photographs of Column 4 – Cycle 7a.

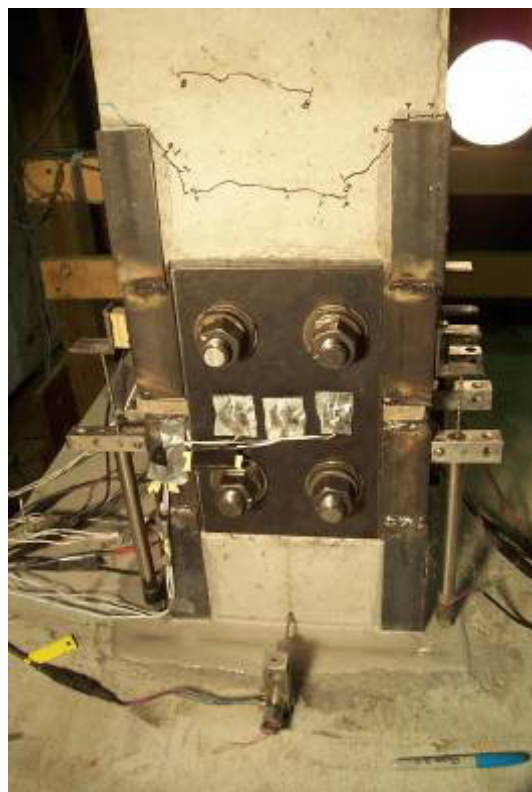
Figure 108. Photograph of Column 4 – Cycle 7a east face.

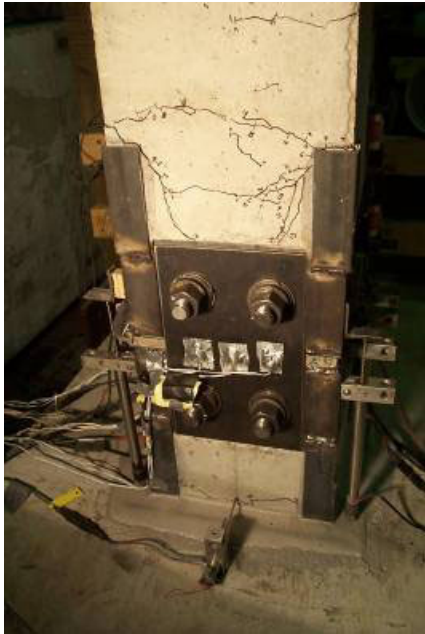
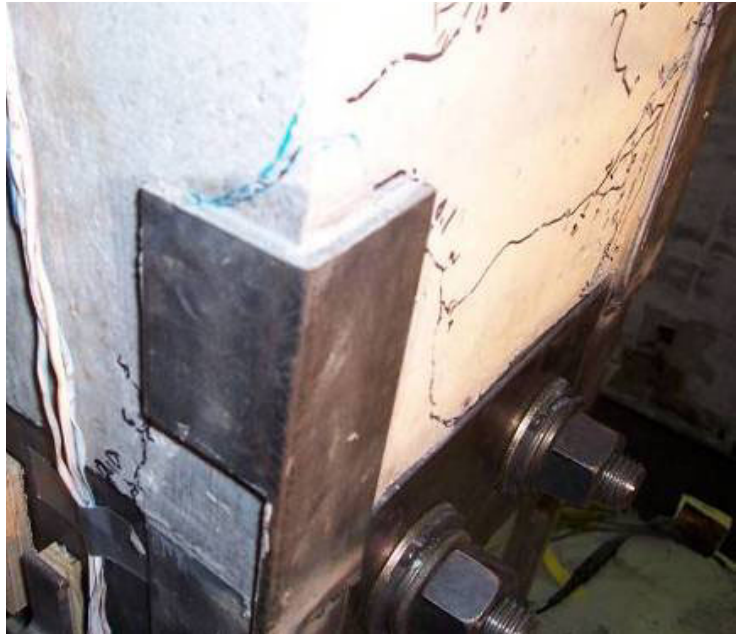
a.) East face crack progression

b.) Incipient cracking at southeast retrofit angle

Figure 109. Photographs of Column 4 – Cycle 11a.

Testing of Column 4 commenced and continued out to a ± 6.0 in. displacement. Because Column 4 was cast with the same internal reinforcement details that led to premature failure in the previous two columns, external retrofit angles were attached to the collars in an attempt prevent the same failure mechanism from occurring (see Figure 106). The added reinforcement is described in detail in Chapter 4. The incremental damage accrued over the imposed displacement regimen for the Column 4 test is illustrated in Figures 107-118. The first signs of damage to Column 4 were cracks that formed around the repair angles on Cycle 5a and 6a (displacements = $\pm .26$ in. and $\pm .30$ in.). A horizontal crack 3 in. above the top collar was noted on Cycle 7a (displacement = $\pm .40$ in.) on the east face (see Figure 108). Cycles 10a and 11a (displacements = $\pm .75$ in. and ± 1.0 in.) produced more cracking above the top collar, as well as a full crack across the base on the east and west sides (see

Figure 109). Small cracks were noted on the corner of the bearing plate on Cycle 15a (see Figures 110b and 111a). On Cycle 14a (displacement = ± 2.0 in.), several "pinging" sounds were heard from the west fuse plate during the negative (pull) half-cycle, indicating the onset of slippage. Slippage between the tension fuse plate and the collar was observed on Cycle 15a (displacement = ± 2.5 in.) as well. Actuator control problems then occurred on Cycle 15a at + 0.42 in. displacement and on Cycle 16a at + 0.40 in., - 0.46 in., - 1.71 in., and - 1.09 in. Also, on Cycle 16a, the upper segment exhibited severe cracking around the external retrofit angles (see Figure 112), and the fuse plates in compression had clearly buckled. Since this was also the predetermined cycle to replace fuse plates, testing was stopped and new plates were mounted on the column. At this time, a peak horizontal load of + 6.32 kips had been applied to the column.

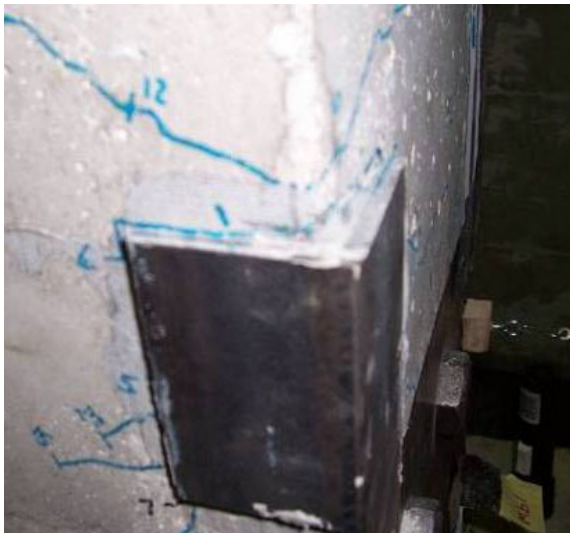
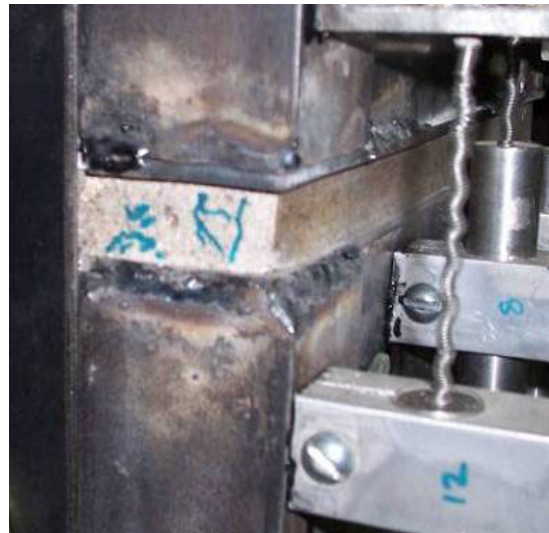
a.) Cracks forming around southeast retrofit angle

b.) Northeast corner bearing plate compression damage

Figure 110. Photographs of Column 4 – Cycle 15a.

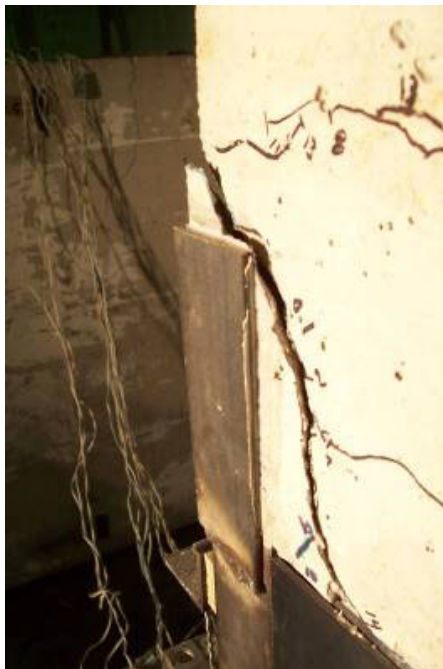
Figure 112. Photograph of Column 4 – Cycle 16a southeast retrofit angle damage.

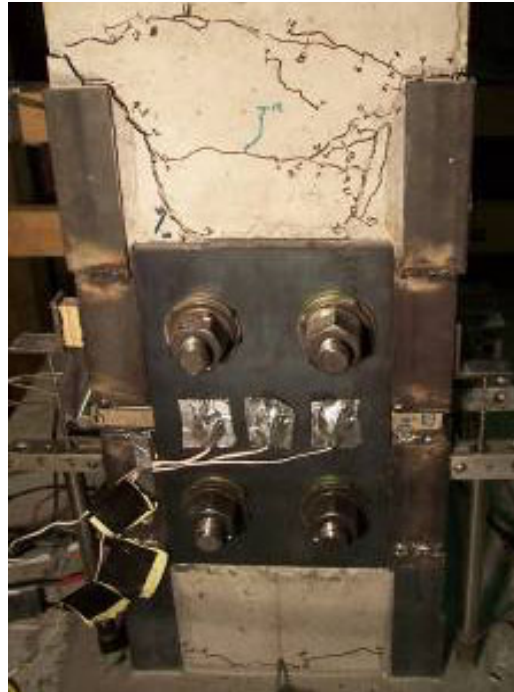
Figure 113. Photographs of Column 4 – Start of test 4b.

After replacing the fuse plates, the displacement regimen was restarted. The damage accrued in the column up to this point can be seen in Figure 113. Actuator control problems continued to increase in frequency and magnitude throughout the remainder of the Column 4 test. From Cycles 19b to 22b, damage to the upper column segment increased and the upper

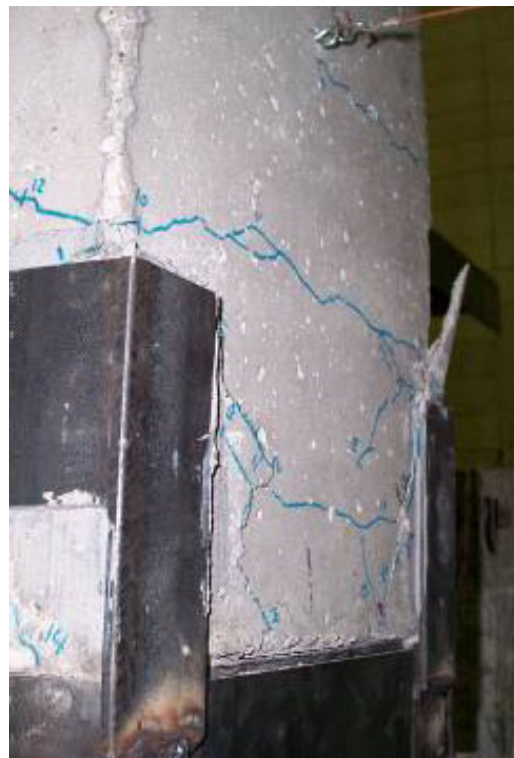
Figure 114. Photograph of Column 4 – Cycle 19b west face of upper column segment.

repair angles became detached from the column face (see Figures 114-117). By this point, rotation of the column concentrated almost exclusively at this location as the collar again pulled off the end of the segment. Testing of Column 4 was stopped after Cycle 23b, as it was again evident that the decrease in load at each displacement was due to this pull-off phenomenon. A maximum horizontal load of + 6.39 kips was observed on Cycle 19b (displacement = +/- 4.0 in.) and a maximum displacement of 6.0 in. was observed for the test. At + 6.0 in., a load of + 4.45 kips was achieved, while a - 5.16 kip load was achieved at - 6.0 in. Quantitative lateral load versus displacement data from the testing of Column 4 are presented in Chapter 7.

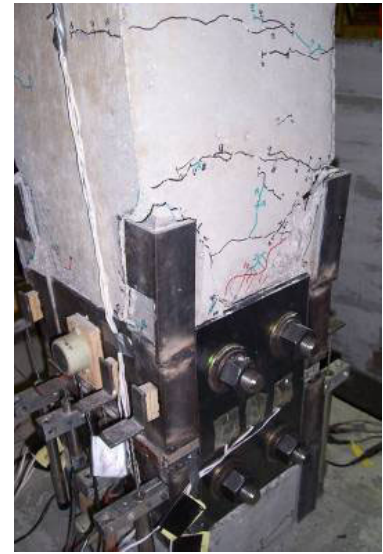
a.) North face joint opening during push half-cycle

b.) East face column damage

Figure 115. Photographs of Column 4 – Cycle 21b north and east faces.

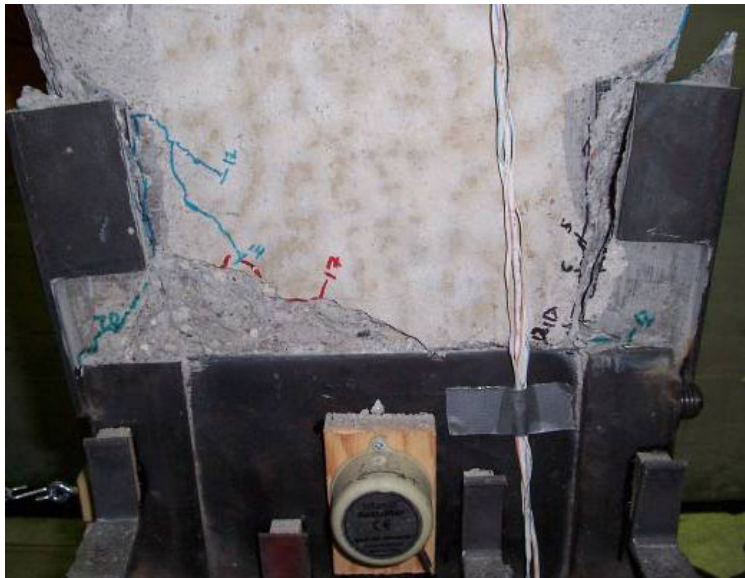
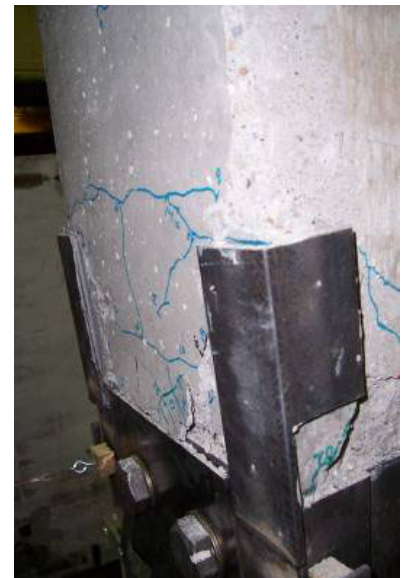
a.) South side view of retrofit angle failure

b.) Upper column segment damage

Figure 116. Photographs of Column 4 – Cycle 21b south and west faces.

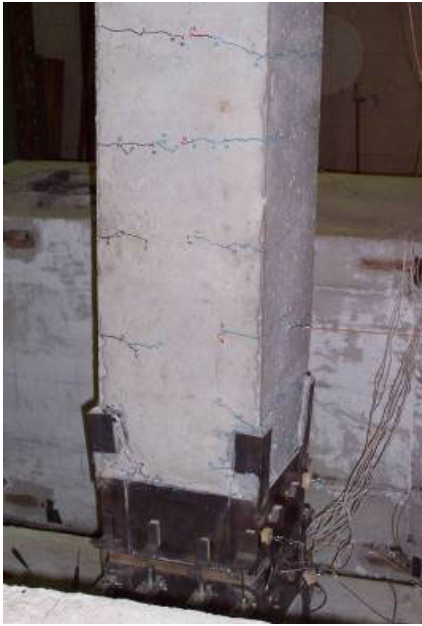
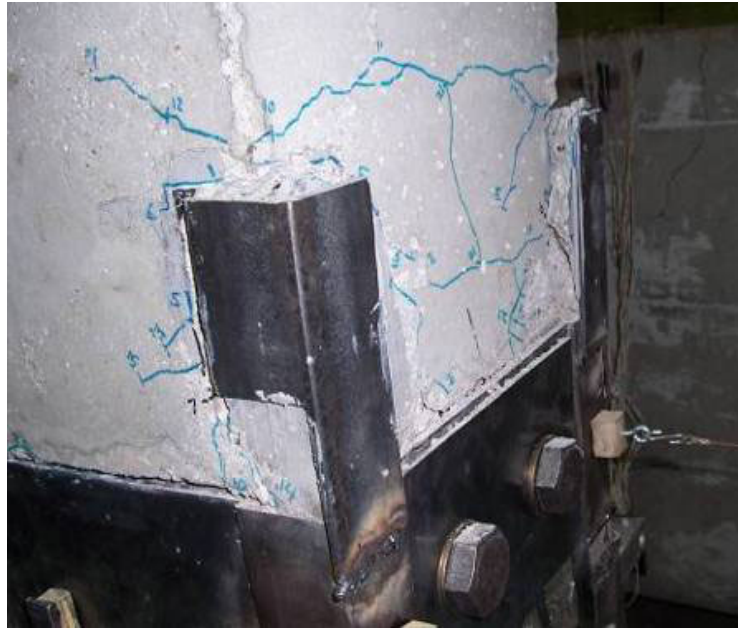
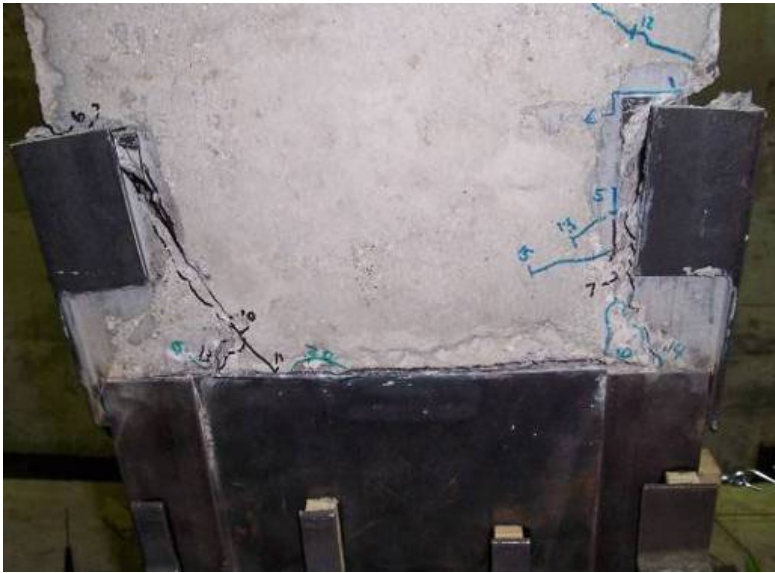
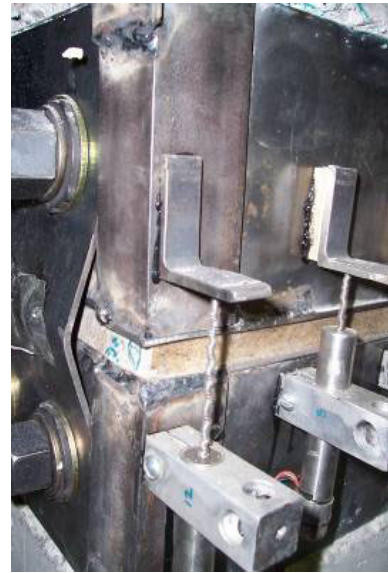
a.) Northwest corner damage

b.) Upper segment damage and retrofit failure

c.) North face damage and retrofit angle failure

d.) Northeast corner fuse plate buckling

Figure 117. Photographs of Column 4 – Cycle 22b.

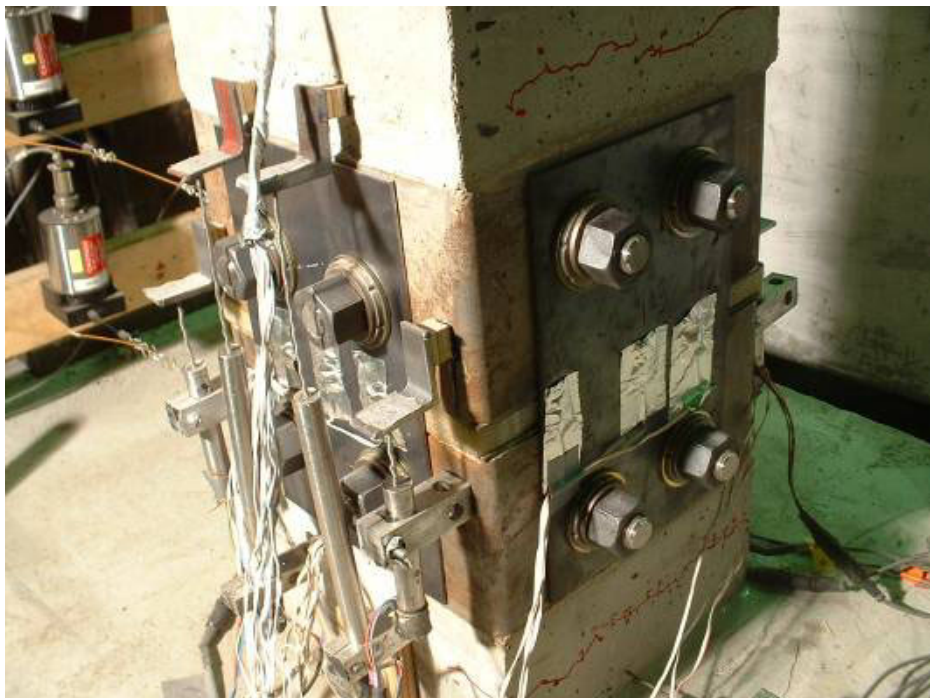
Figure 120. Photograph of Column 5 – Cycle 10a southeast corner view of cracking.

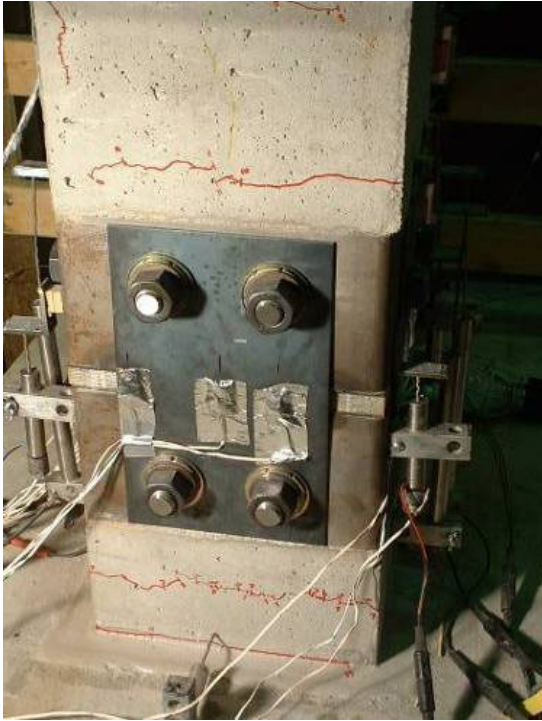
a.) Cracking around column joint

b.) Upper segment crack progression

Figure 121. Photographs of Column 5 – Cycle 13a east face.

After restarting the test, additional cracks formed across the column on Cycle 13a (displacement = +/- 1.5 in.) (see Figures 121 and 122). On Cycle 14a (displacement = +/- 2.0 in.), a small amount of compression damage was noted under the collar on the west face of the column (see Figure 123). This minute chipping was observed on previous specimens and was caused by the collar bearing on the surface of the concrete column. The depth of chipping was limited to the thickness of the collar and could be eliminated in the future by placing a small gap or indentation in the concrete at this location. Additional small regions of compression damage were marked on the positive (push) cycles of Cycles 15a and 16a (see Figure 125). By Cycle 16a, the fuse plates were visibly buckling. Since this was also the predetermined cycle to replace fuse plates, testing was stopped and new fuse plates were mounted on the column. At this time, a peak horizontal load of + 7.45 kips had been applied to the column during the positive (push) half-cycle, while a horizontal load of - 8.53 kips had been applied during the negative (pull) half-cycle.

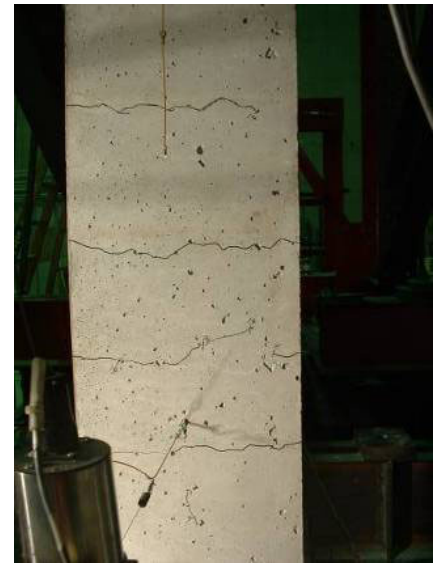
a.) Cracking at the base of the west face

b.) Upper segment crack progression

Figure 122. Photographs of Column 5 – Cycle 13a west face.

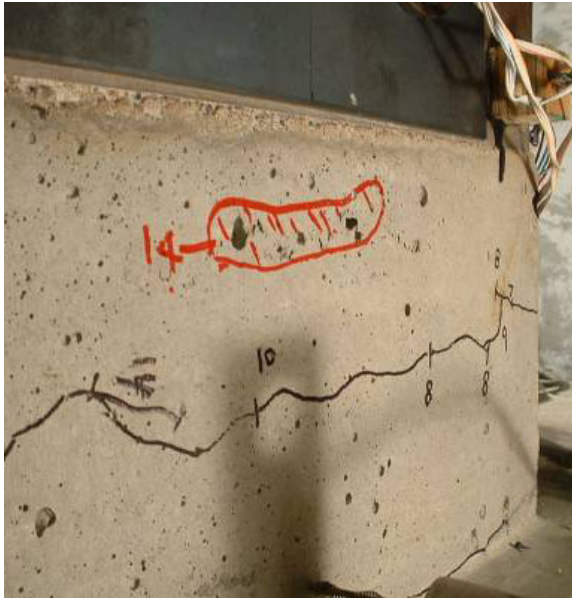
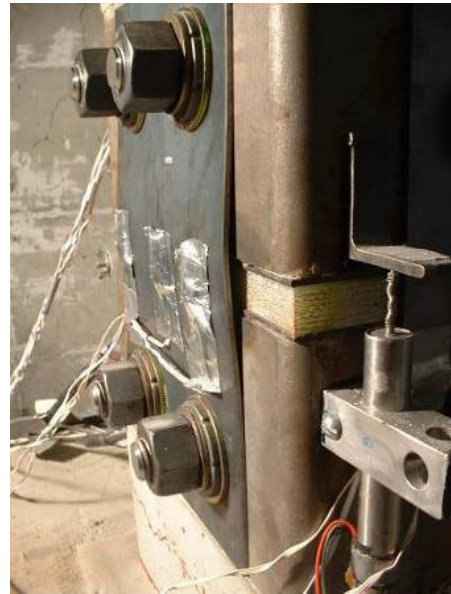
a.) West face at base

b.) East plate initial buckling

Figure 123. Photographs of Column 5 – Cycle 14a west face.

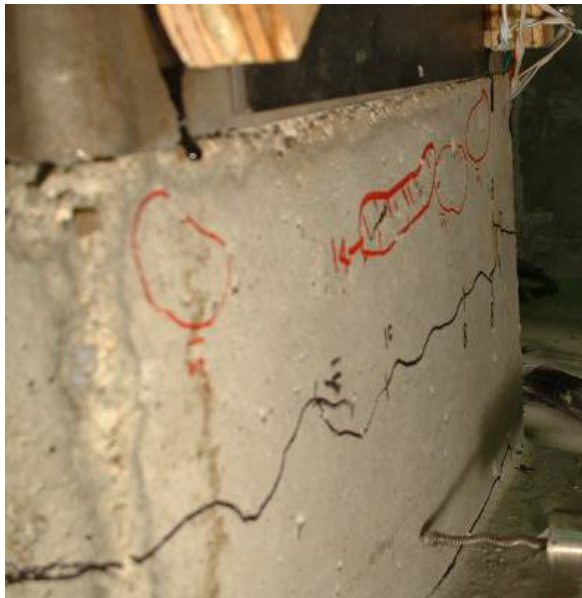
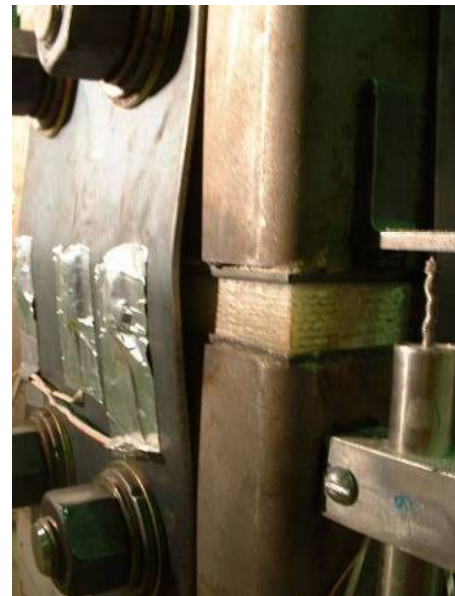
a.) West face compression damage and cracking at base

b.) East fuse plate buckling

Figure 124. Photographs of Column 5 – Cycle 15a.

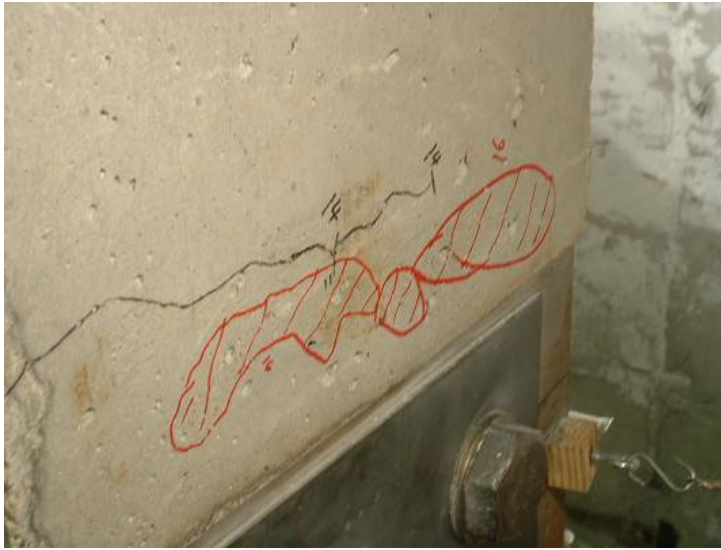
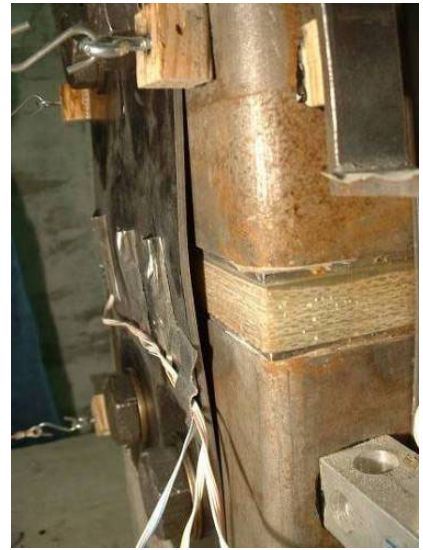
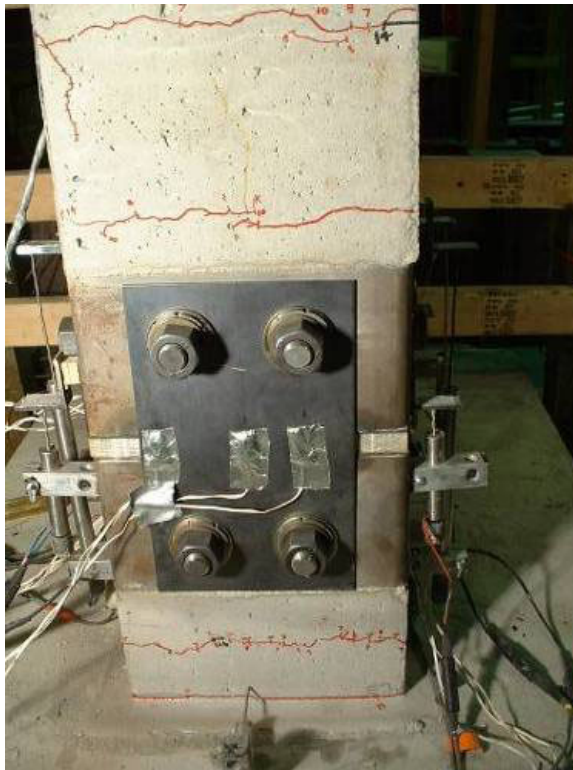
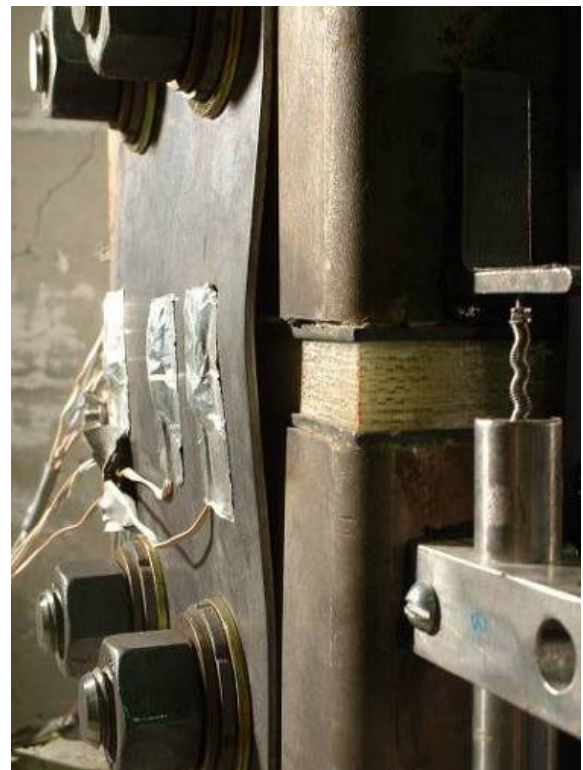
a.) Upper segment compression damage

b.) West fuse plate initial buckling

a.) West face cracking at the end of Test 5a

b.) East plate buckling in compression

Figure 125. Photographs of Column 5 – Cycle 16a.

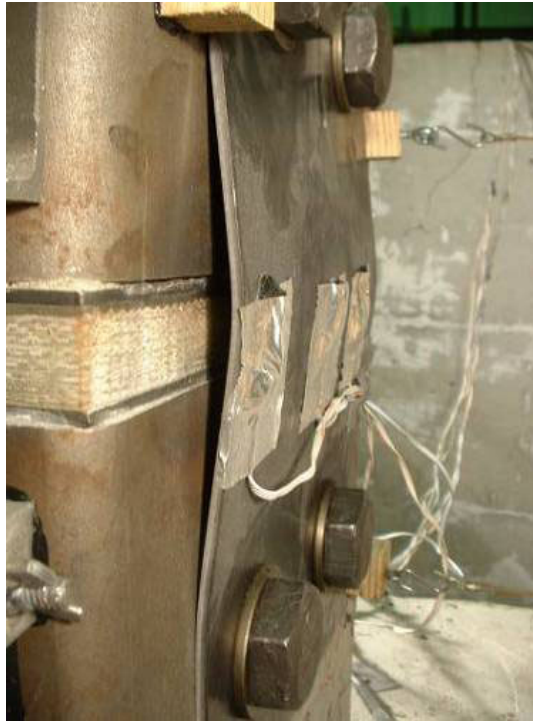
Figure 126. Photographs of Column 5 – Cycle 18b west fuse plate buckling.

The displacement regimen was then restarted with the second set of fuse plates. Testing continued without incident or additional cracking until Cycle 17b (displacement = +/- 3.0 in.) when the actuator control was lost briefly. Fuse plate buckling that occurred during Cycle 18b can be seen in Figure 126. Testing was stopped again after Cycle 18b due to several large actuator incidents and was resumed the following day after several adjustments were made to the control system. Cycles 19b and 20b (displacements = +/- 3.5 in. and 4.0 in.) were completed before another actuator incident halted testing again. A lateral load during this incident was recorded at 15 kips, possibly causing internal damage to Column 5 and initiation of slip in the fuse plate connections.

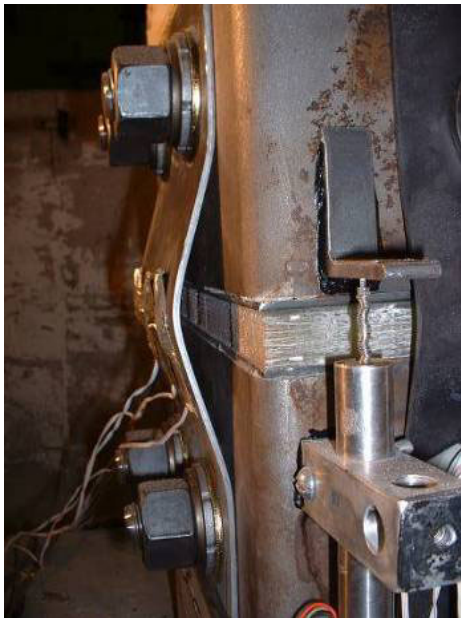
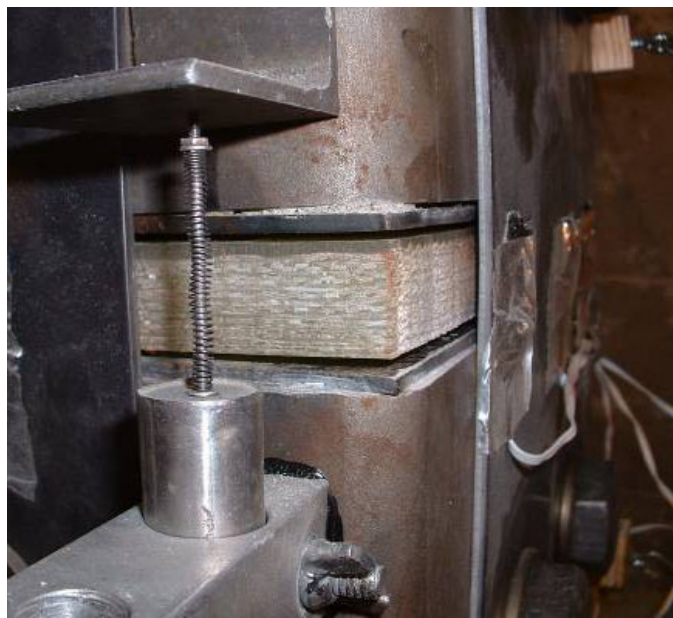
a.) East fuse plate buckling

b.) West joint opening during pull half-cycle

Figure 127. Photographs of Column 5 – Cycle 21b.

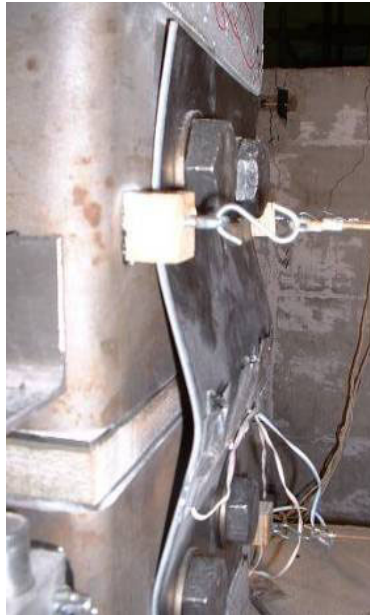
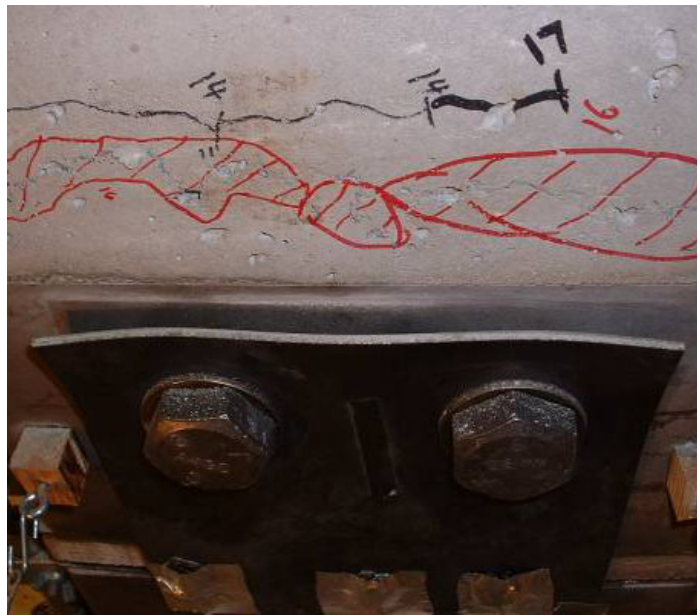
a.) West fuse plate buckling

b.) Bolt bearing on west fuse plate causing plate curling

Figure 128. Photographs of Column 5 – Cycle 23b.

of Cycle 21b, the top of the west plate began to curl due to this slippage and subsequently began bearing on the through-bolts. This condition continued on each cycle and can be seen during Cycle 23b in Figure 128b. With each significant "pinging" noise, a loss of load was also observed while displacement of the column continued. Slippage and the resulting bearing condition continued during each cycle until the full stroke of the actuator was reached (see Figures 128b, 130a, 130b, 133, 134c). Despite this slippage, the gap opening at the column segment continued to widen throughout the remainder of the test (see Figures 127b, 131a, 132c, 135a, 136c, 137b) and the crack width at the interface between the upper column segment and collar remained small. The final condition of the west fuse plate and the condition of Column 5 are shown after Cycle 30 in Figure 138. Post-test damage for all sides of Column 5 can be seen in Figure 139.

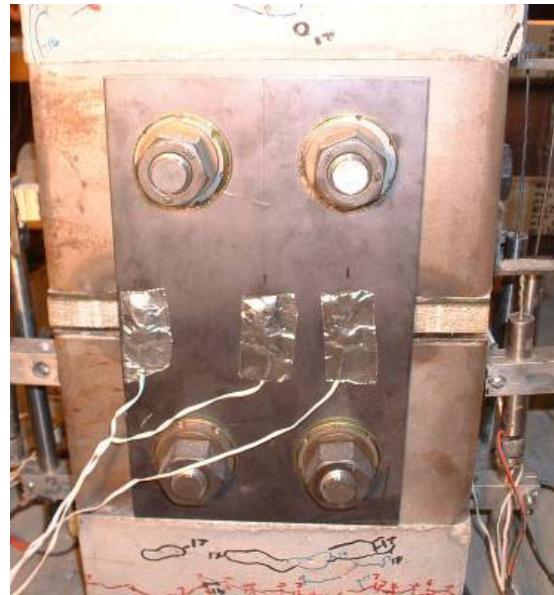
a.) Southeast corner joint opening

b.) East joint opening during push half-cycle

Figure 129. Photographs of Column 5 – Cycle 24b joint opening.

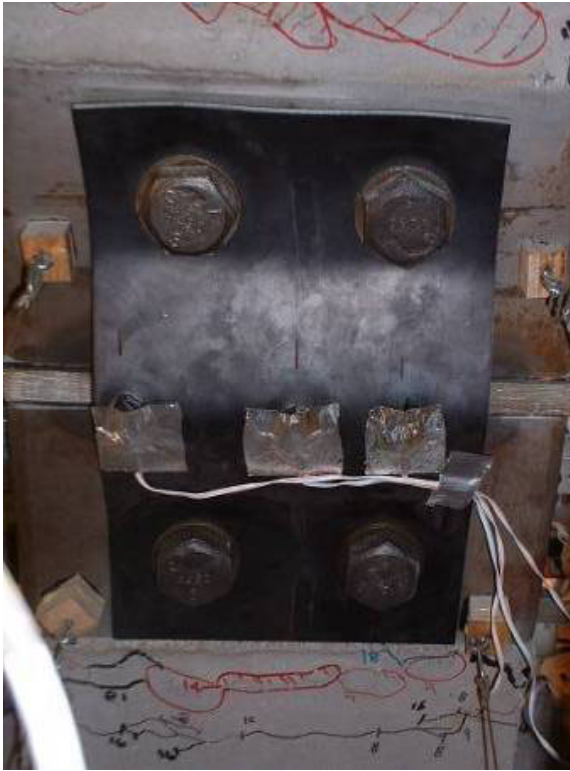
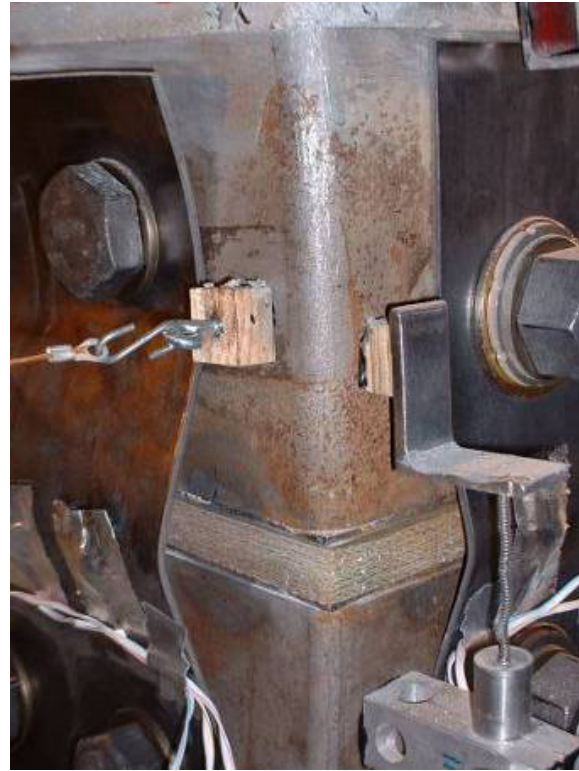
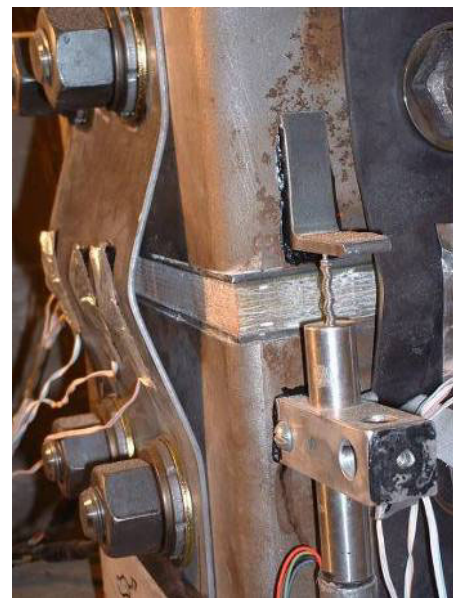
a.) West face damage and fuse plate buckling

b.) Southwest corner fuse plate buckling

c.) East fuse plate buckling

d.) Northeast corner fuse plate buckling

Figure 130. Photographs of Column 5 – Cycle 24b.
