Self-centering bridge pier columns with structural fuses

MASTER OF SCIENCE

Major: Civil Engineering (Structural Engineering)

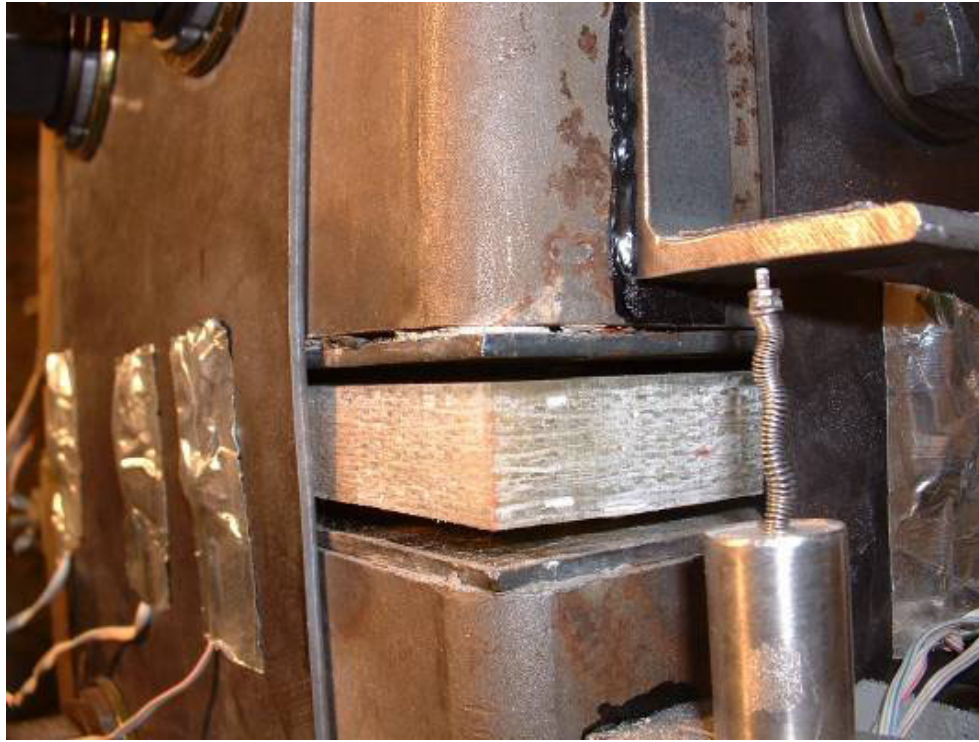
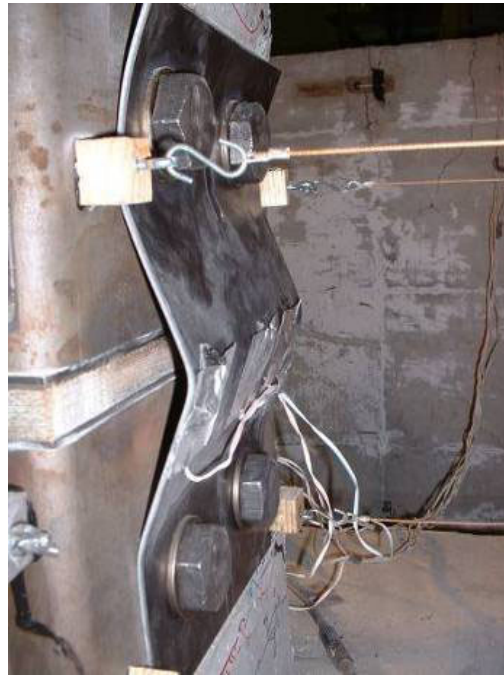
a.) Northeast corner joint opening

b.) East fuse plate buckling and segment damage

c.) West fuse plate buckling

Figure 131. Photographs of Column 5 – Cycle 26b.

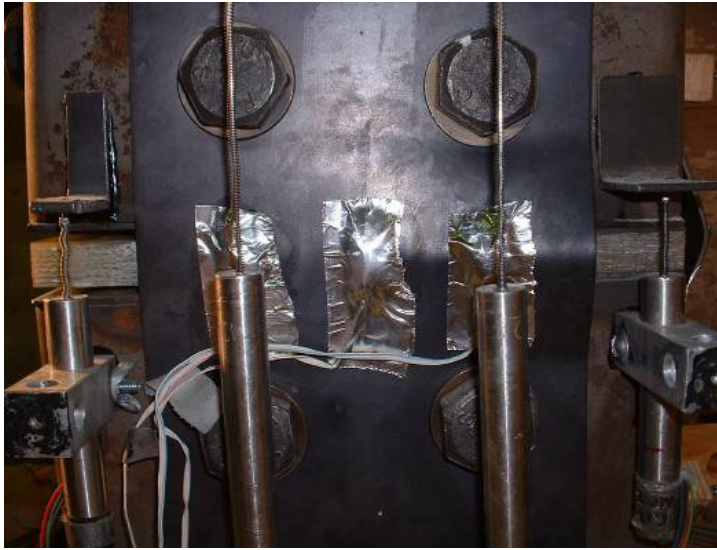
a.) Differential buckling in north fuse plate buckling

b.) West fuse plate buckling

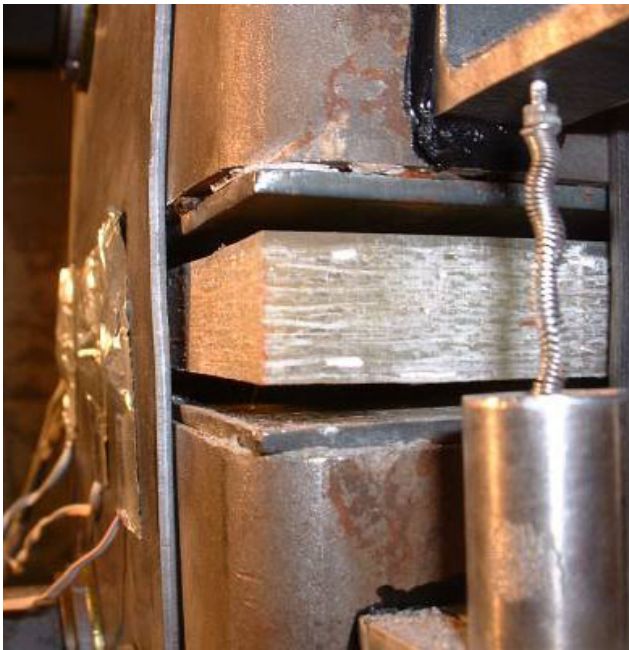
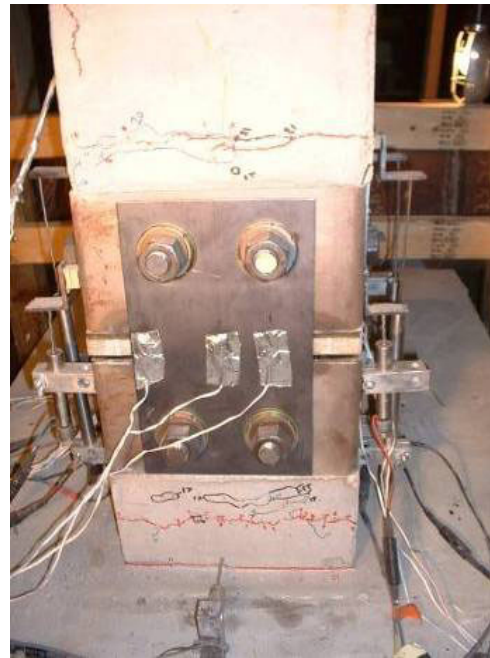
Figure 132. Photographs of Column 5 – Cycle 27b push half-cycle.

c.) East joint opening

d.) East joint opening and segment damage

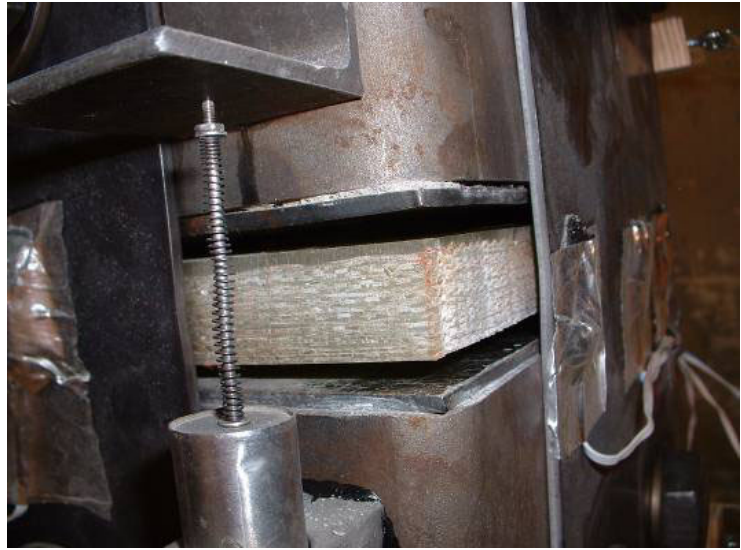
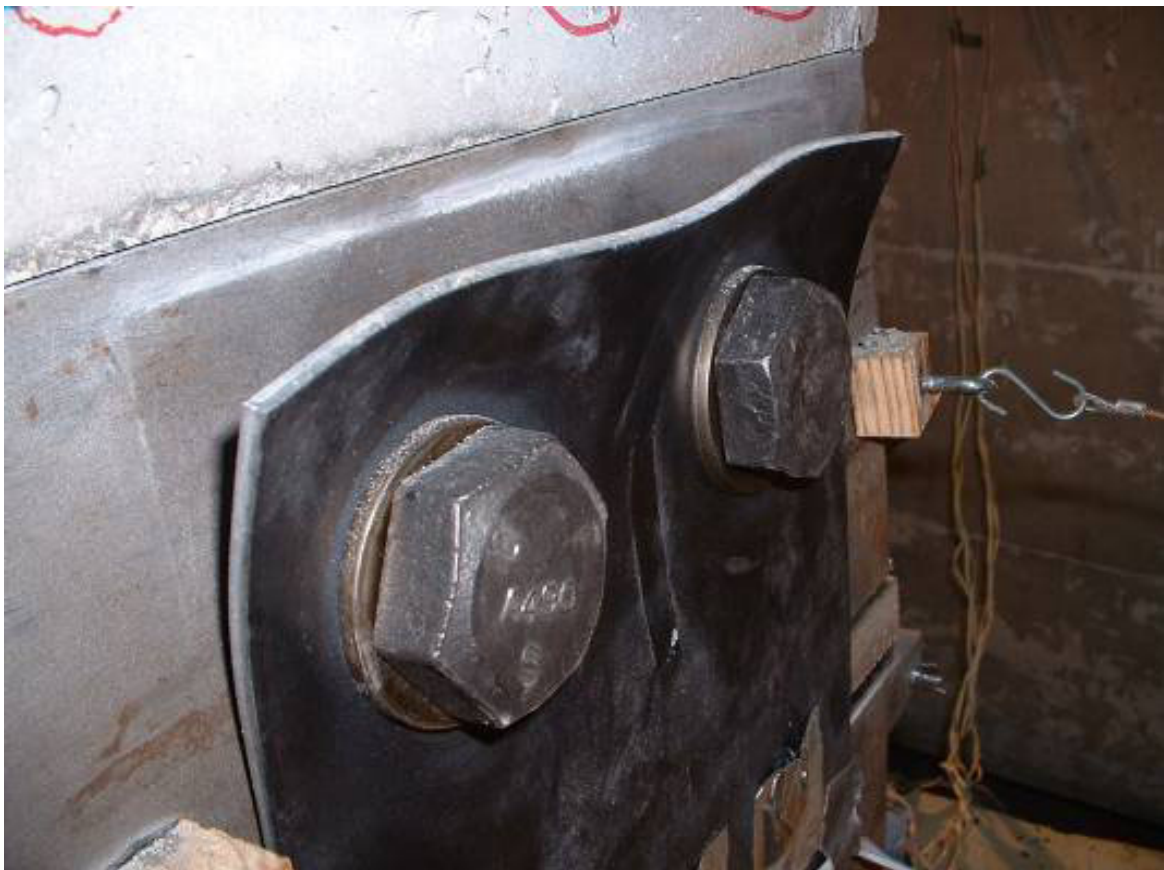
Figure 133. Photographs of Column 5 – Cycle 27b pull half-cycle.

a.) East face under compression

b.) West joint opening

c.) Curling of west plate

of Cycle 21b, the top of the west plate began to curl due to this slippage and subsequently began bearing on the through-bolts. This condition continued on each cycle and can be seen during Cycle 23b in Figure 128b. With each significant "pinging" noise, a loss of load was also observed while displacement of the column continued. Slippage and the resulting bearing condition continued during each cycle until the full stroke of the actuator was reached (see Figures 128b, 130a, 130b, 133, 134c). Despite this slippage, the gap opening at the column segment continued to widen throughout the remainder of the test (see Figures 127b, 131a, 132c, 135a, 136c, 137b) and the crack width at the interface between the upper column segment and collar remained small. The final condition of the west fuse plate and the condition of Column 5 are shown after Cycle 30 in Figure 138. Post-test damage for all sides of Column 5 can be seen in Figure 139.

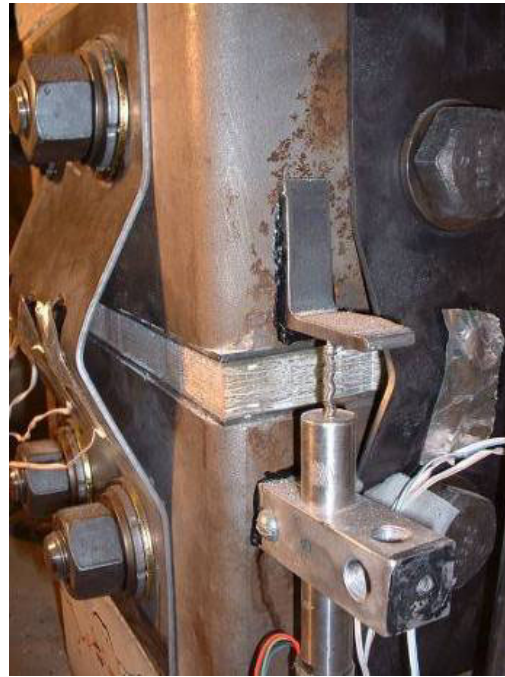
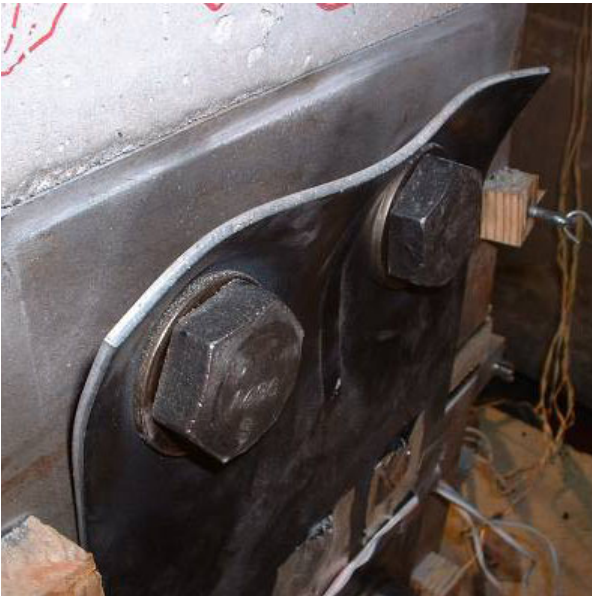
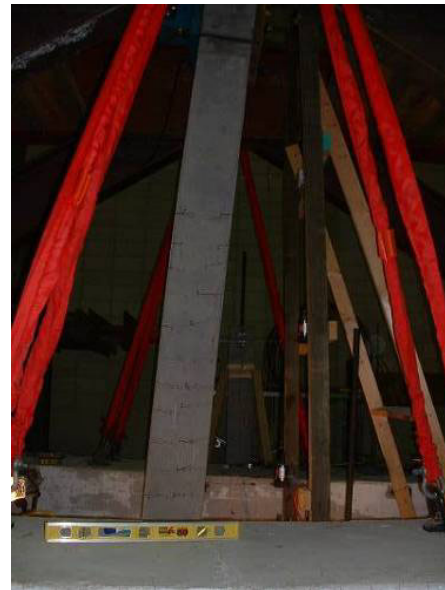
Figure 134. Photographs of Column 5 – Cycle 28b.

a.) East fuse plate buckling and column damage

b.) East fuse plate buckling

c.) Curling on top of the west plate

d.) Column deformation during push half-cycle

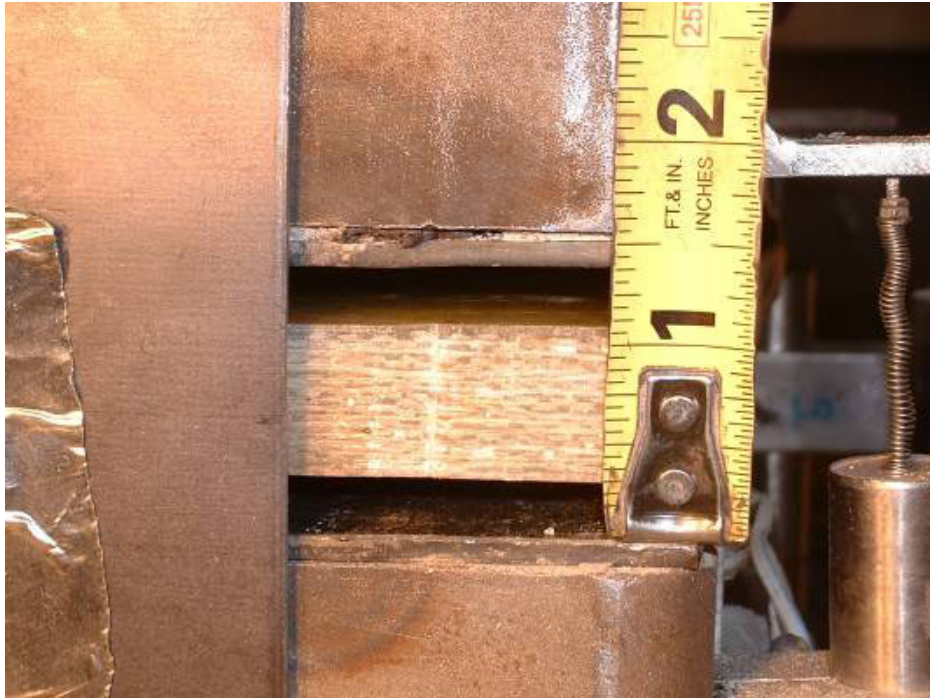
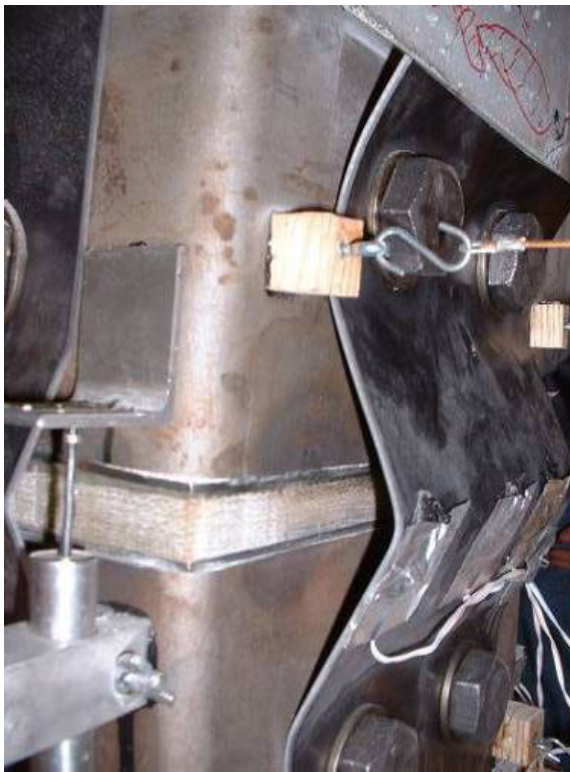
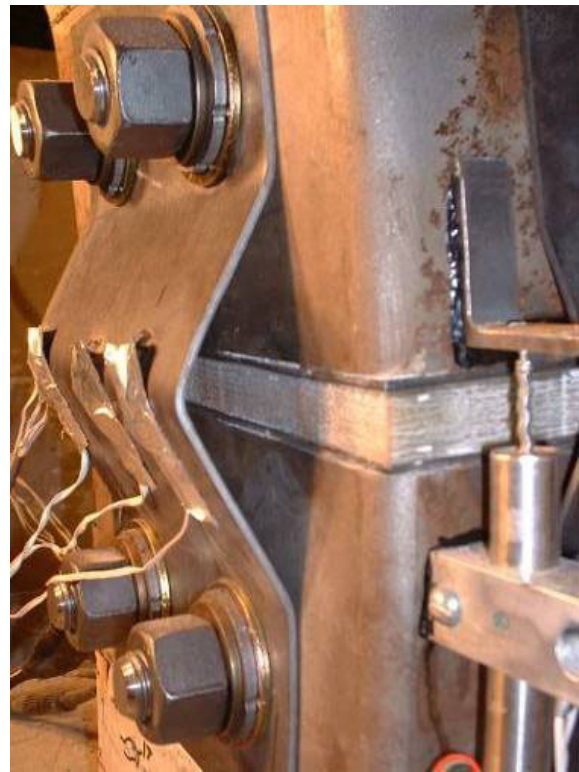
Figure 135. Photographs of Column 5 – Cycle 29b.

a.) East joint opening during push half-cycle

b.) West fuse plate buckling during push half-cycle

c.) East fuse plate buckling during pull half-cycle

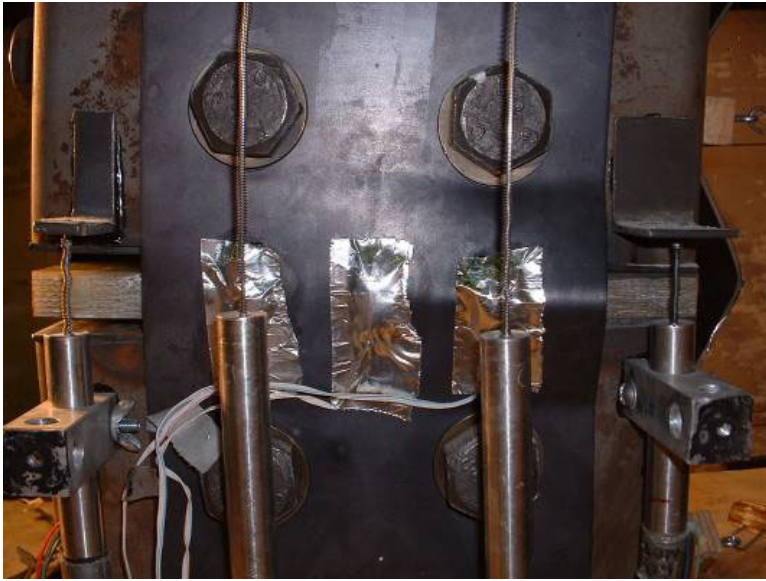
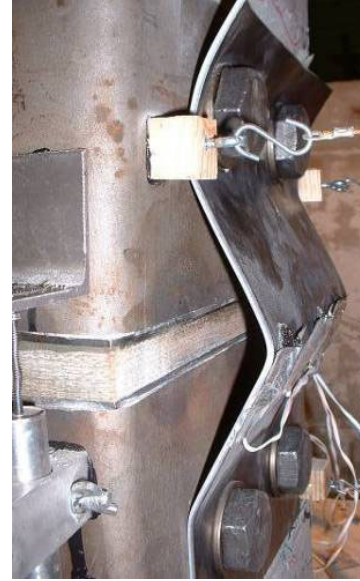
Figure 136. Photographs of Column 5 – Cycle 30b push half-cycle.

a.) North fuse plate differential buckling

b.) West fuse plate buckling

c.) East face damage and joint opening

d.) East joint opening

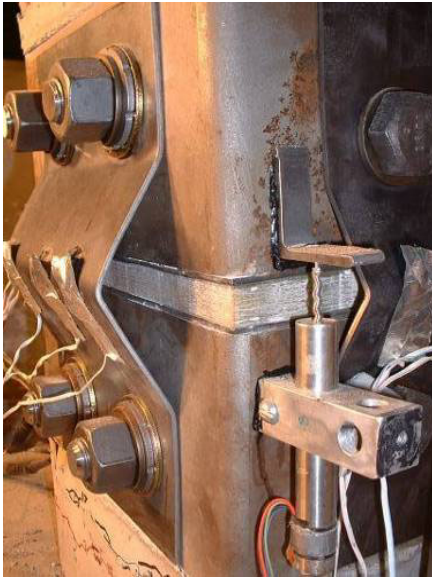
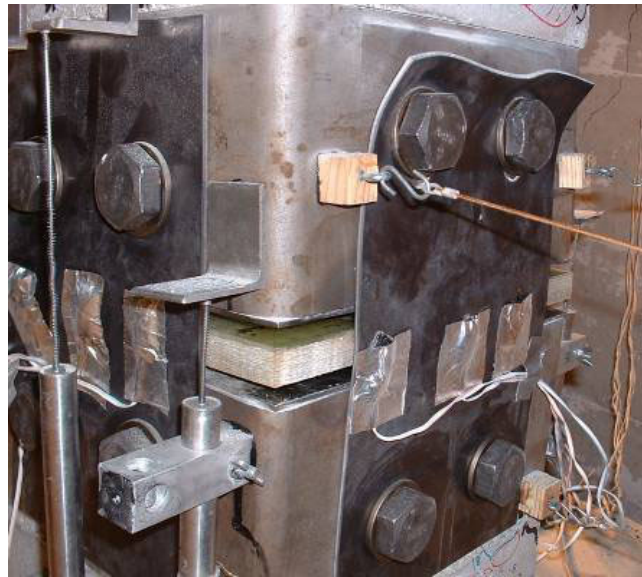
Figure 137. Photographs of Column 5 – Cycle 30b pull half-cycle.

a.) East fuse plate buckling

b.) West joint opening and bearing of west fuse plate on bolts

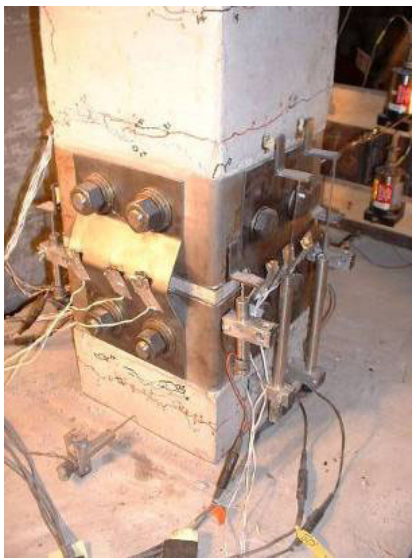
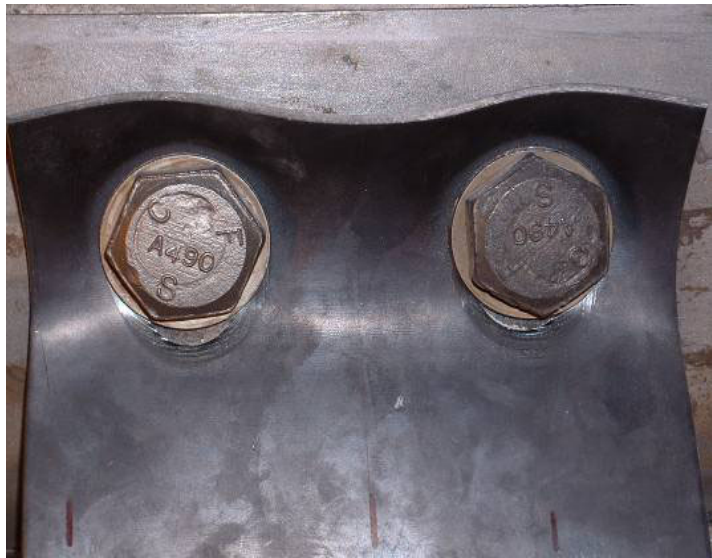
Figure 138. Photographs of Column 5 – After test.

a.) Residual fuse plate buckling

b.) Residual curling on top of west plate

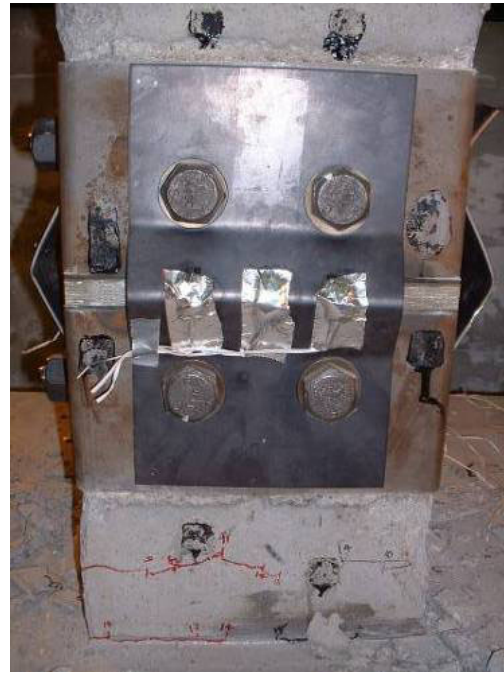
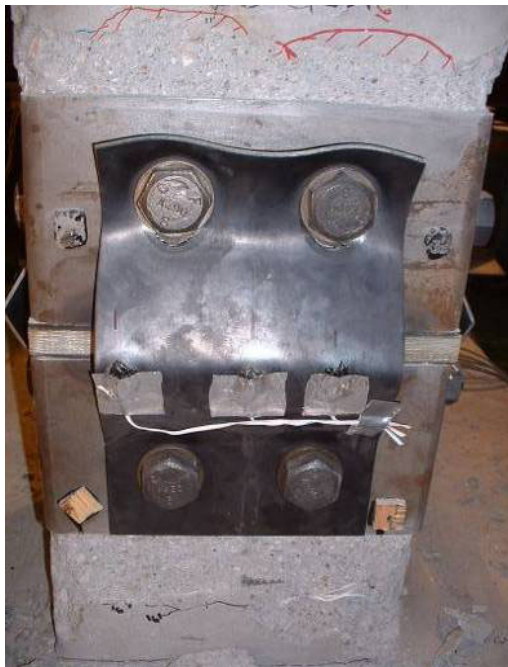
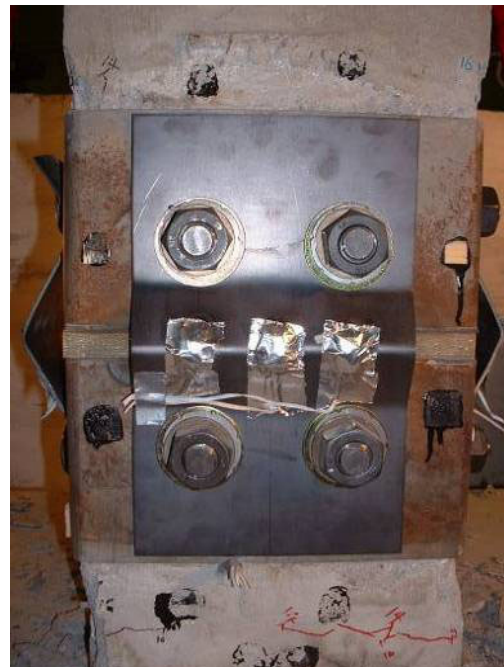
Figure 139. Photographs of Column 5 – Final damage after test.

a.) East face after test

b.) North face after test

c.) West face after test

d.) South face after test

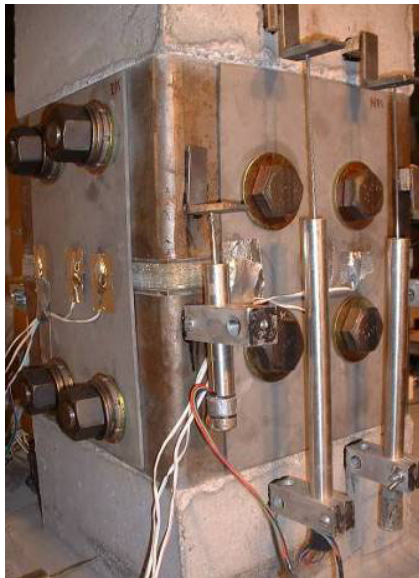
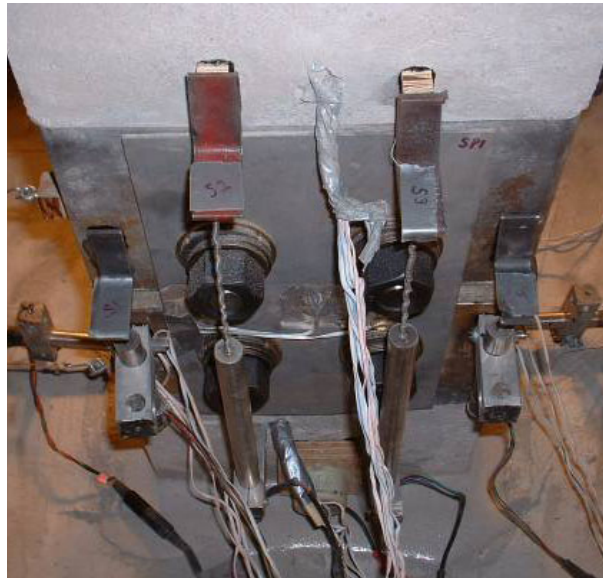
Figure 140. Photographs of Column 6 – Segment joint prior to testing.

a.) Northeast corner

b.) South face

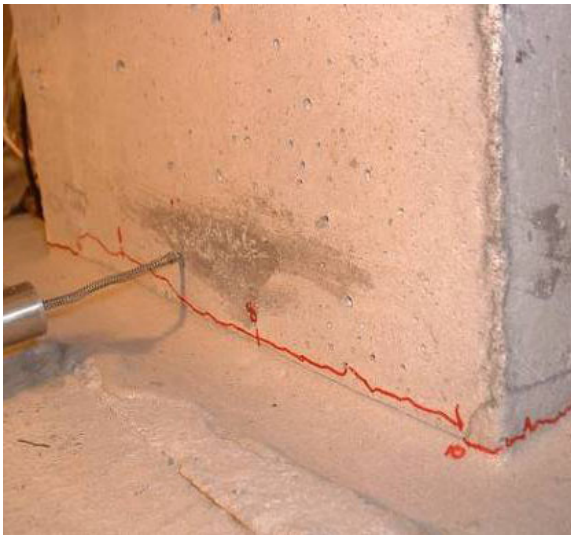
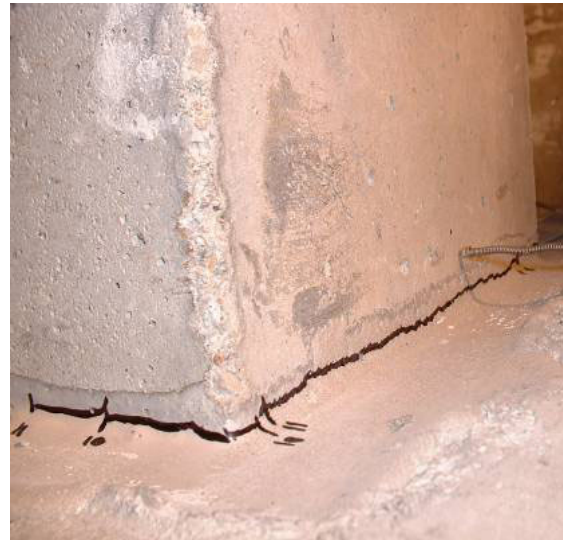
Figure 142. Photographs of Column 6 – Cycle 11a.

a.) East face initial cracking

b.) West face initial cracking

Cycle 8a (displacement = +/- 0.5 in.). Cracking across the entire base of the column (see Figure 142a), as well as cracks 6 in. and 18 in. above the base of the column, was observed on Cycle 10a (displacement = +/- 1.0 in.) on the east face of the column. Cracking across the west face was noted at the base on Cycle 11a (displacement = +/- 1.0 in.) (see Figure 142b). Additional cracking of Column 6 was noted on subsequent cycles until replacement of the fuse plates took place (see Figure 143). Relative to Column 5, Column 6 had a narrower opening of the construction joint up to this point. On Cycle 16a (displacement = +/- 2.5 in.), buckling in the plates was barely detectable due to the shape recovery of the SMA material. However, this was the predetermined cycle to replace fuse plates, so testing was stopped and new SMA fuse plates were mounted on the column. Up to this point, a peak horizontal load of + 7.22 kips had been applied to the column.

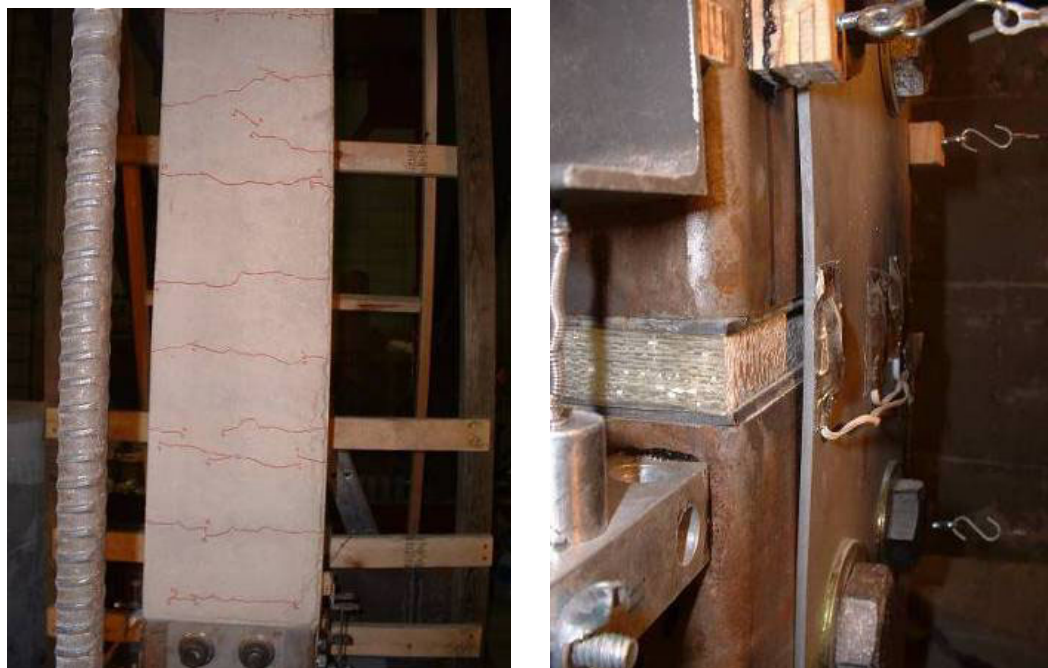
Figure 144. Column 6 – Cycle 16a.

a.) East face of upper segment crack distribution

b.) West fuse plate initial buckling

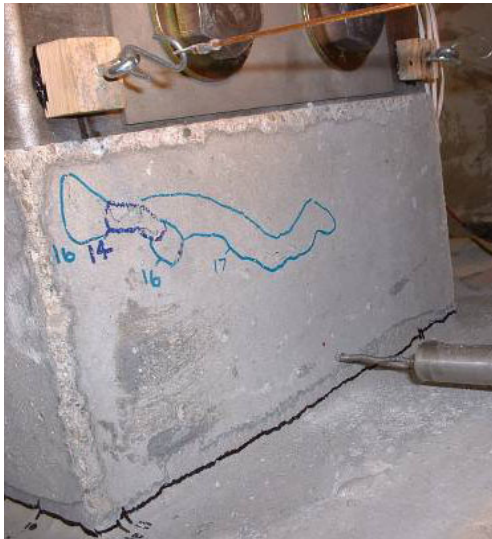
Figure 146. Photographs of Column 6 – Cycle 17b.

a.) West face initial compression damage

b.) East face initial compression damage

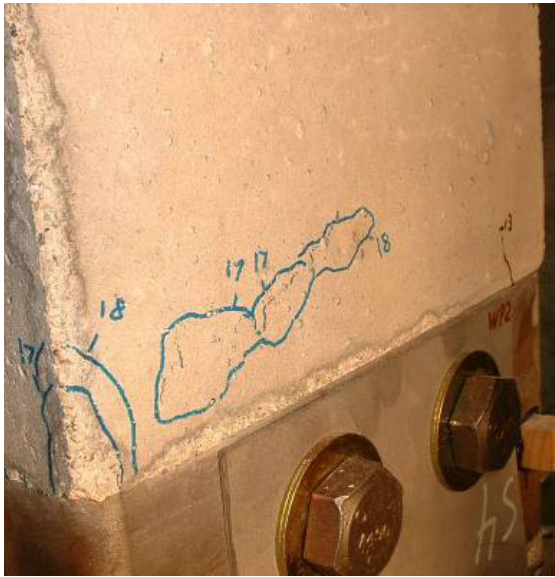
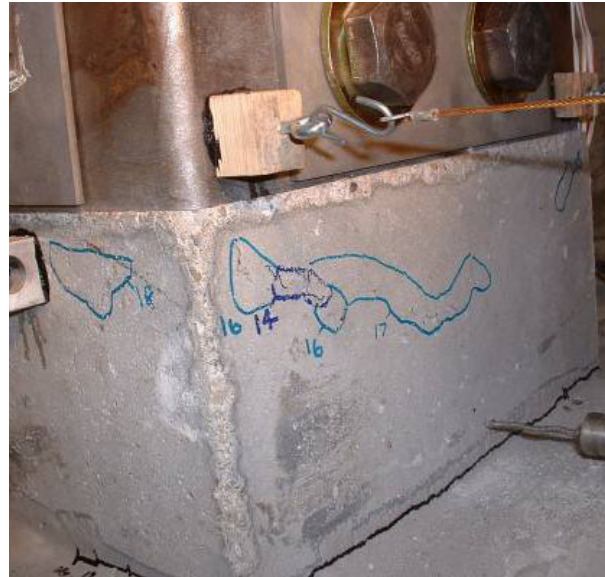
Figure 147. Photographs of Column 6 – Cycle 18b.

a.) Upper west column segment compression damage

b.) Northwest corner compression damage

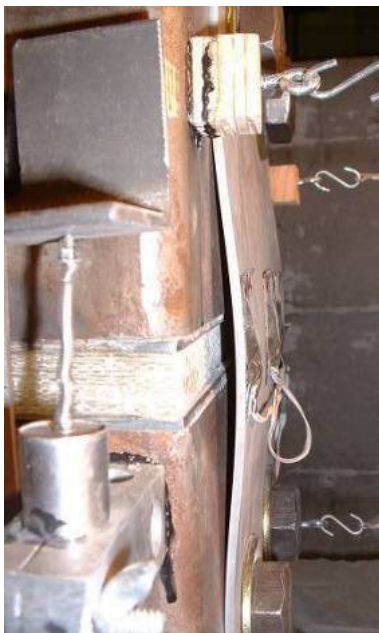
Figure 148. Photographs of Column 6 – Cycle 19b.

a.) West fuse plate buckling

b.) East face compression damage

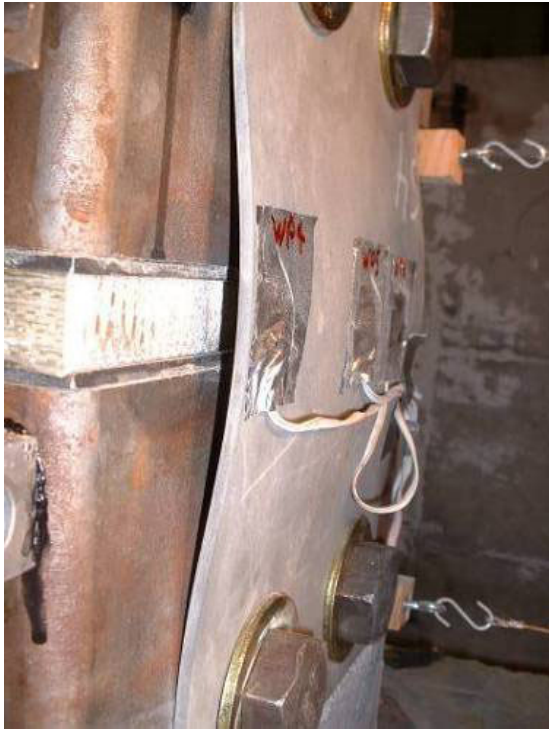
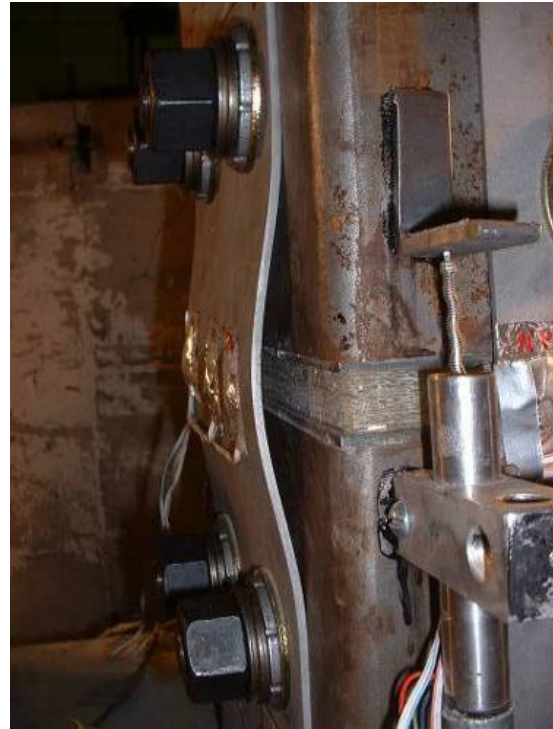
Figure 149. Photographs of Column 6 – Cycle 20b.

a.) West fuse plate buckling

b.) East fuse plate buckling

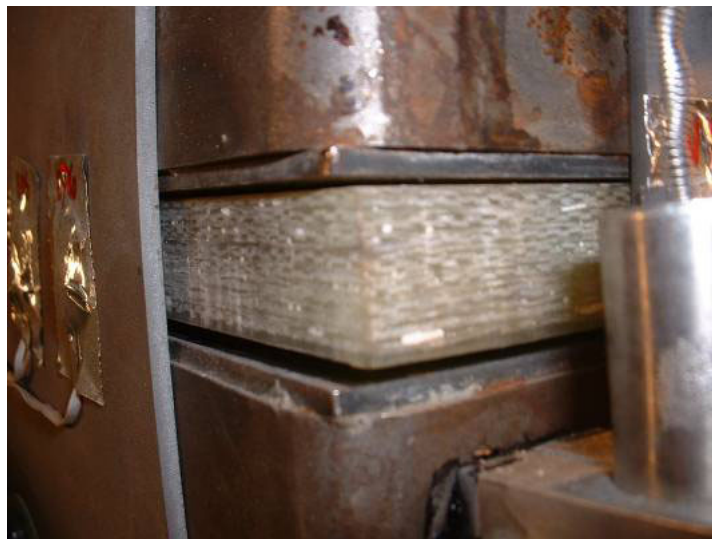
Figure 150. Photographs of Column 6 – Cycle 21b, joint opening.

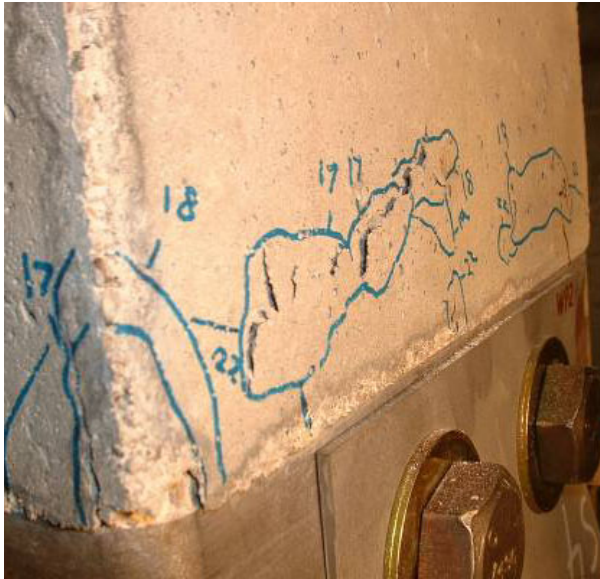
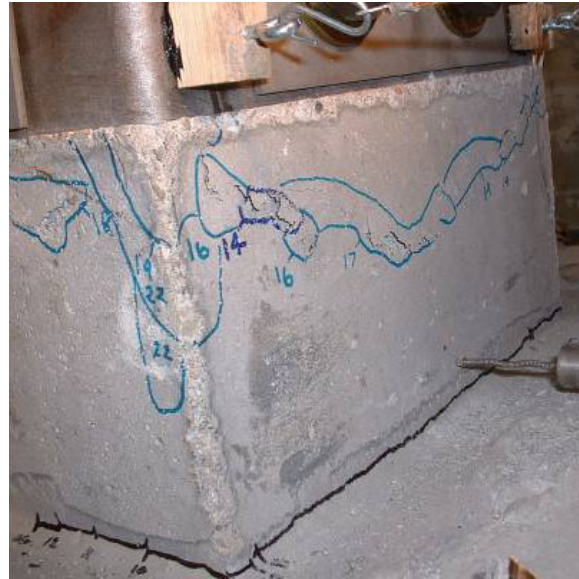
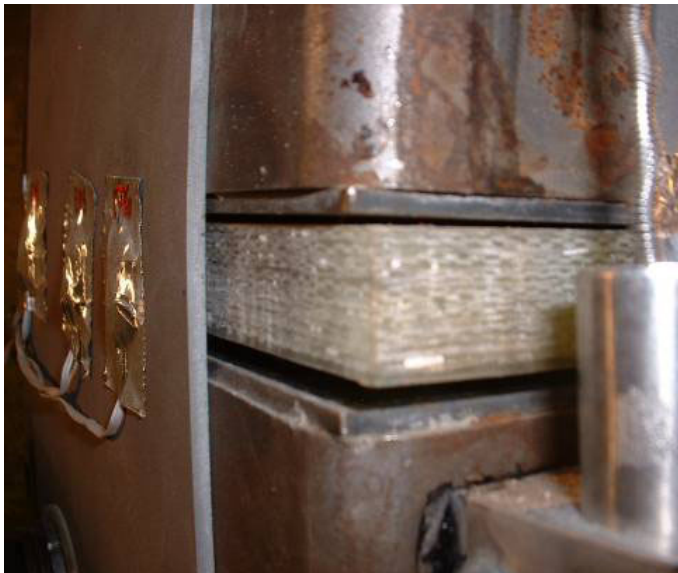
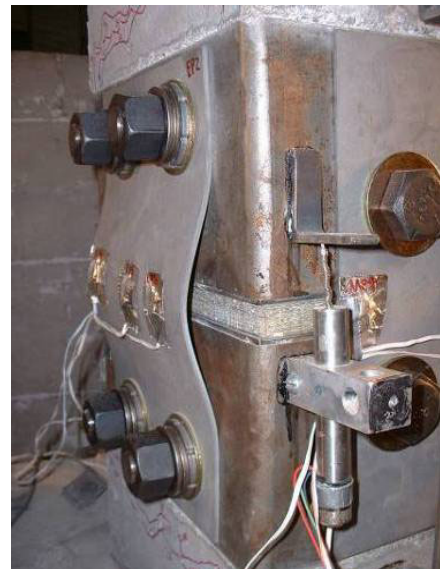
Figure 151. Photographs of Column 6 – Cycle 23b, push half-cycle.

a.) Upper segment west face compression damage

b.) Lower segment west face compression damage

c.) Northwest corner joint opening

d.) West fuse plate buckling

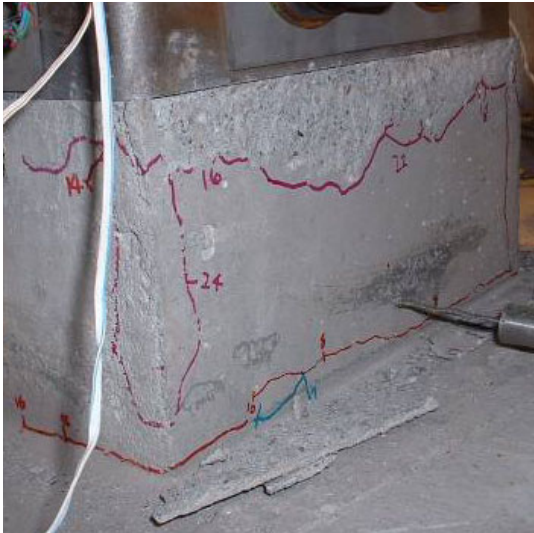
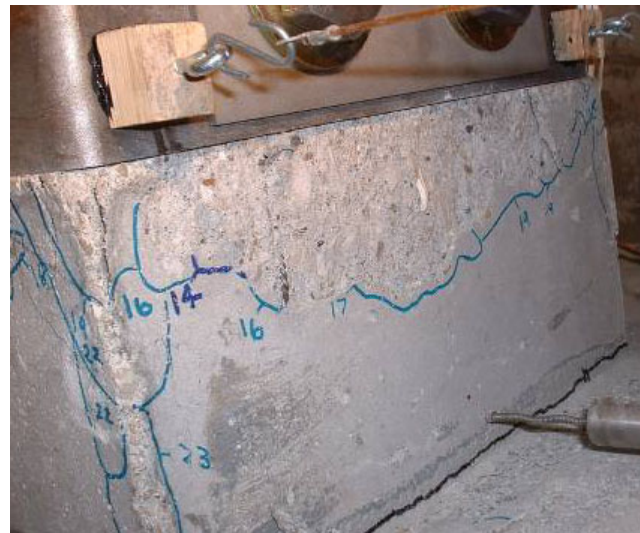
Figure 153. Photographs of Column 6 – Cycle 26b.

a.) Lower segment east face spalling

b.) Lower segment west face spalling

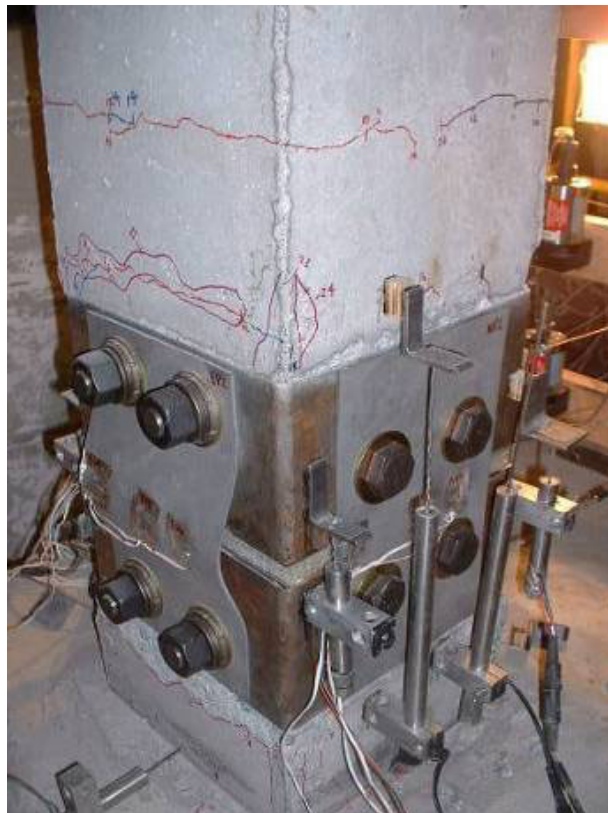
Figure 155. Photograph of Column 6 – Cycle 26b, column damage.

The damage to Column 6 up to Cycle 26b can be seen in Figure 155. Fuse plate buckling and joint opening that took place during Cycle 28b is illustrated in Figure 156. On Cycle 29b, the south fuse plate fractured below the top left bolt and washer at a displacement of -5.22 in. (see Figure 157a). This fracture was likely caused by the small-radius bending of the lateral plates due to buckling on previous cycles. Testing was continued until the -9.0 in. displacement on Cycle 29b (see Figure 157b), when testing was terminated; the column began to tilt perpendicular to the axis of loading due to the fractured fuse plate, and it caused the load beam to impinge on the load frame (see Figure 158).

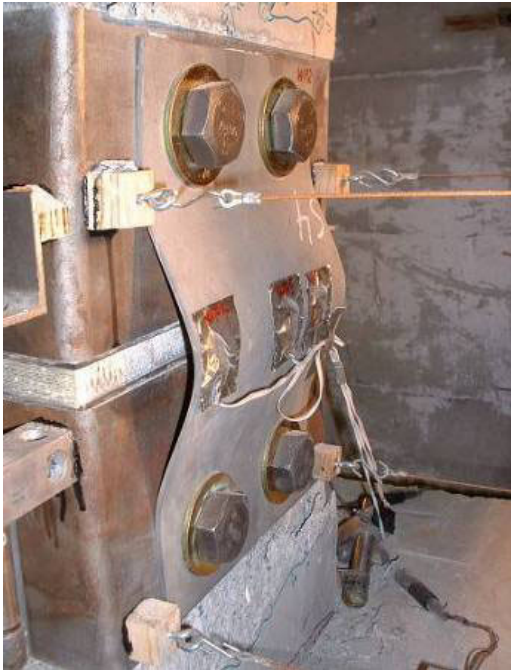
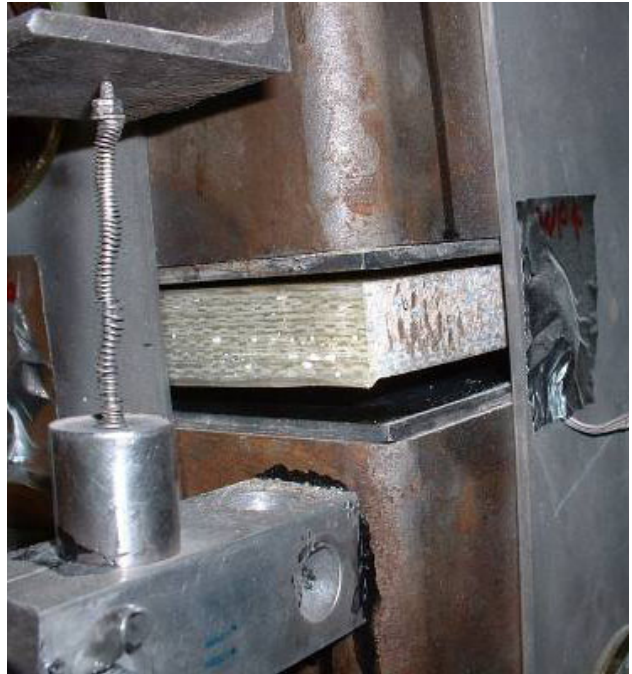
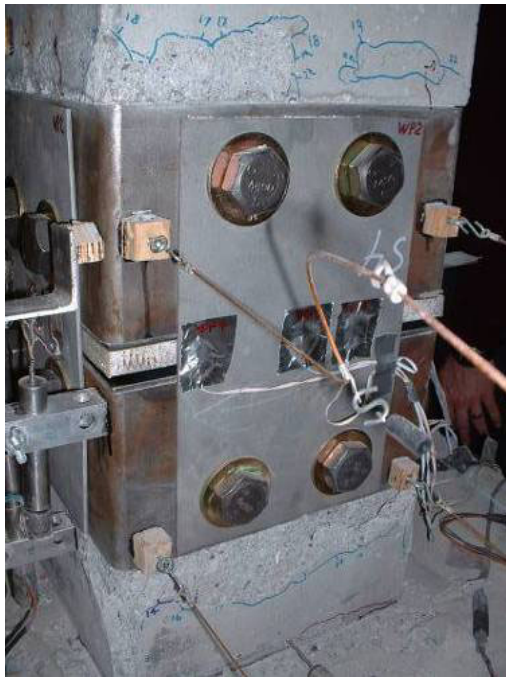
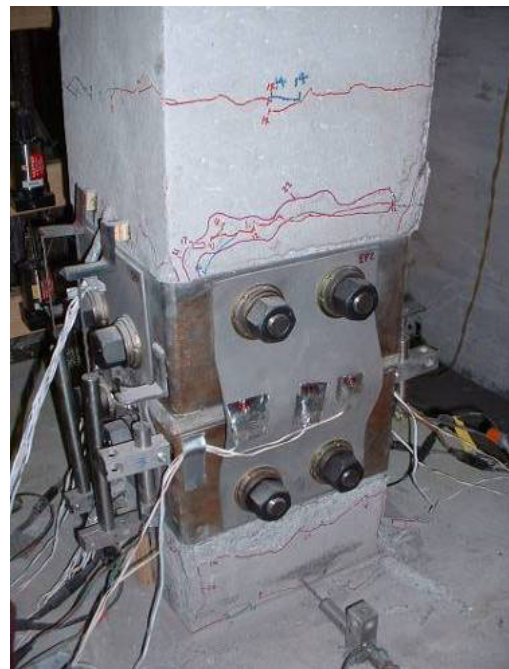
Figure 156. Photographs of Column 6 – Cycle 28b.

a.) West fuse plate buckling

b.) Northwest corner joint opening

c.) West face under tension

b.) East face under compression

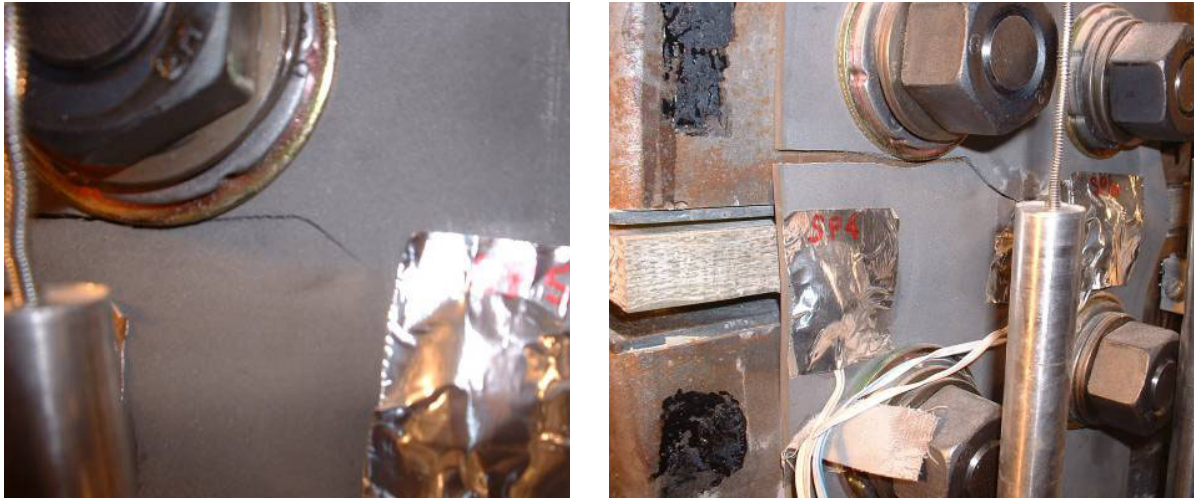
Figure 157. Photographs of Column 6 – Cycle 29b fuse plate crack.

a.) Initial fracture of south fuse plate at -5.22 in. displacement b.) Fuse plate crack at -9.0 in. displacement

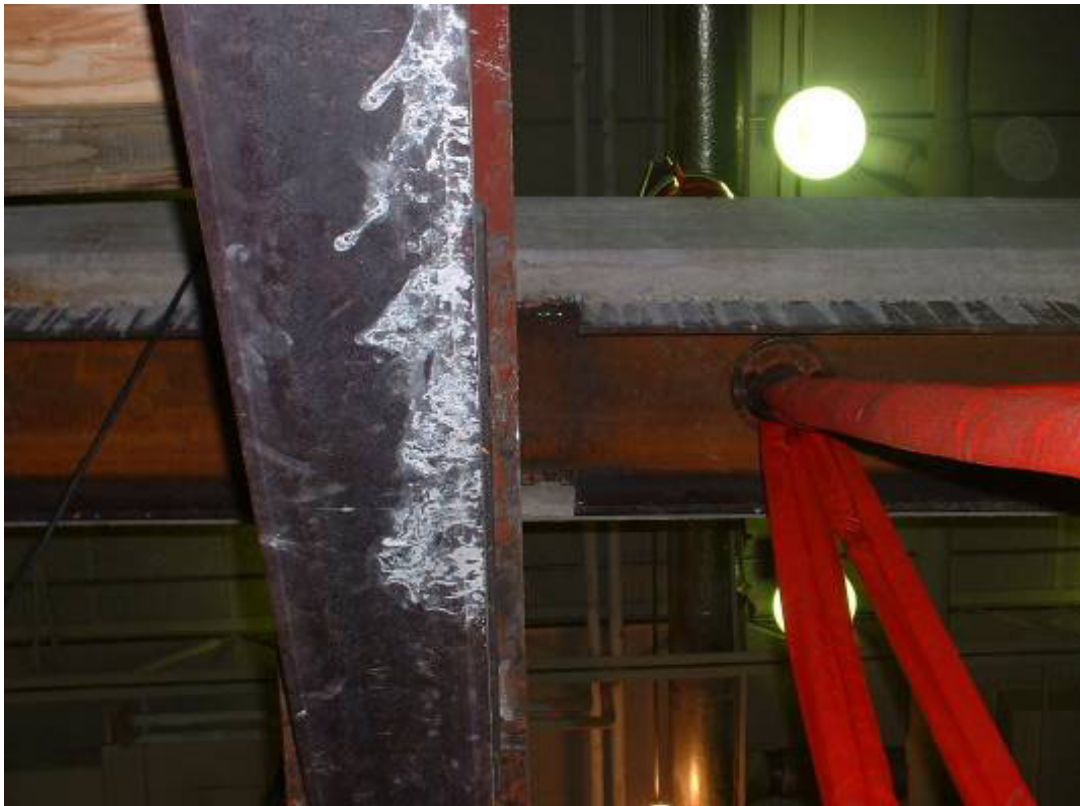
Figure 158. Photographs of Column 6 – Cycle 29b.

c.) Load beam impinging on load frame

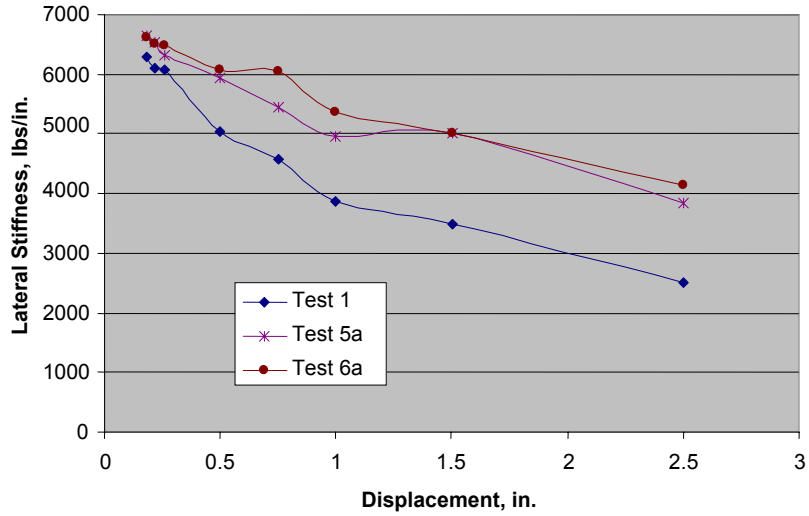
Figure 171. Test “a” lateral stiffness comparisons between Columns 1, 5, and 6.

As illustrated in Figure 171, the initial lateral stiffness values of Columns 5 and 6 for displacement cycles out to +/- 2.5 in. were both notably higher than those of Column 1. Furthermore, the stiffness values of these columns had smaller reductions in stiffnesses than Column 1 on each subsequent cycle during Test a. Comparing stiffness values presented in Figure 172 for Test b shows that Column 5 had the highest residual lateral stiffness values during larger displacement cycles. The stiffness values of Column 6 at larger displacements, while lower than those achieved by Column 5, were still significantly higher than the stiffness values of Column 1. Additional column stiffness data are presented in Table 5.

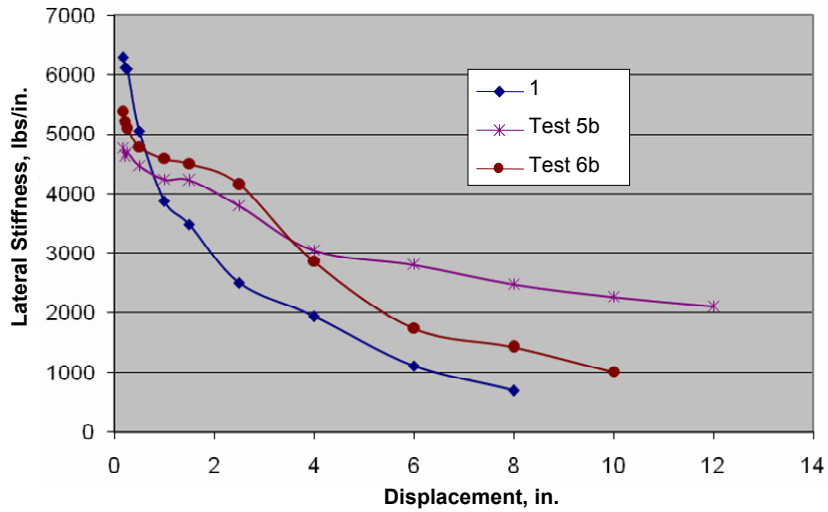
Figure 172. Test “b” lateral stiffness comparisons between Columns 1, 5, and 6.
