Laboratory testing of precast bridge elements, verification of post-tensioning forces and construction documentation of the Boone County IBRC accelerated bridge replacement project

**Laboratory testing of precast bridge elements, verification of post-tensioning forces
and construction documentation of the Boone County IBRC accelerated bridge
replacement project**

A thesis submitted to the graduate faculty
in partial fulfillment of the requirements for the degree of
MASTER OF SCIENCE

Major: Civil Engineering (Structural Engineering)

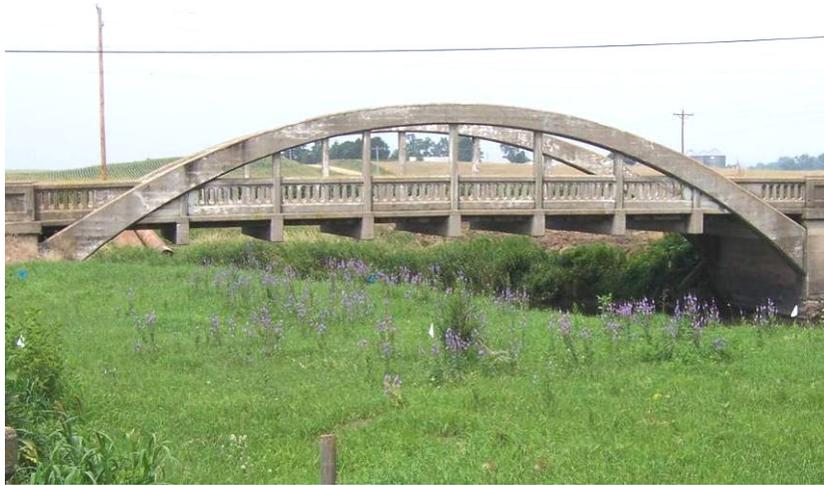
Figure 1. Marsh Arch bridge previously on 120th Street.

This research focused on the bridge constructed on 120th Street in Boone County over Squaw Creek; the bridge replaced an existing Marsh Arch bridge at the site, which can be seen in Figure 1. The new bridge is a continuous, four-girder, three-span bridge with a full-depth, precast deck and can be seen in Figure 2. Bridge dimensions are 151 feet and 4 inches long and 33 feet and 2 inches wide. Deck panels were 8-inches thick, half the width of the bridge, and prestressed in the transverse direction. Each panel had two full-depth channels, located over the prestressed girders, for post-tensioning. Once the panels were erected, the entire bridge deck was post-tensioned in the longitudinal direction, after which the post-tensioning channels were grouted. Precast pier caps and precast abutments were also used in the bridge substructure. Although this exact design had not been previously constructed, a similar partial-depth deck system has been constructed and tested in Nebraska (Badie *et al.*, 1998).

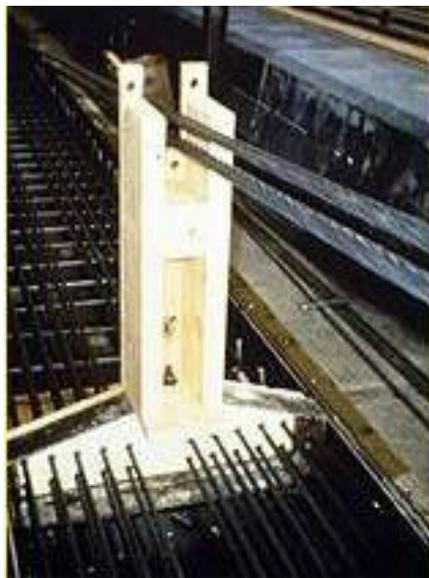
Figure 3. Bulkhead in a prestressed concrete casting bed.

are threaded through the formwork and then stressed. The stressed tendons are anchored to bulkheads located outside the concrete forms. After the concrete is cast and has reached an appropriate strength, the wires or strands are cut, compressing the concrete. A bulkhead located on a precasting bed can be seen in Figure 3.

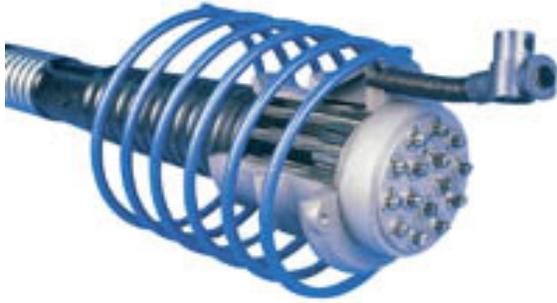
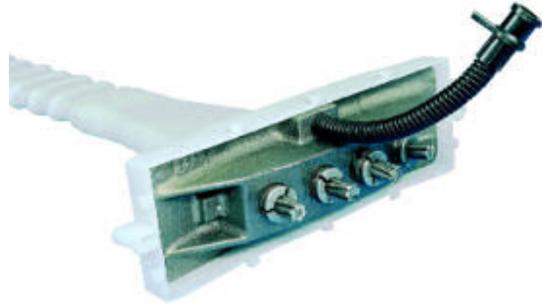
Figure 4. Common post-tensioning anchorages (Bonded Strand Post-Tensioning System, 2007) (VSL Post-Tensioning Systems, 2007).

There are several different types of proprietary post-tensioning anchors that can be used, depending on the strand or bar being post-tensioned. The type of anchorage used also depends on the size and strength of the concrete element, the number of strands used, and other design constraints. Several common post-tensioning anchors are shown in Figure 4.

a) DSI bonded multi-strand anchorage

b) DSI bonded multi-strand flat anchorage

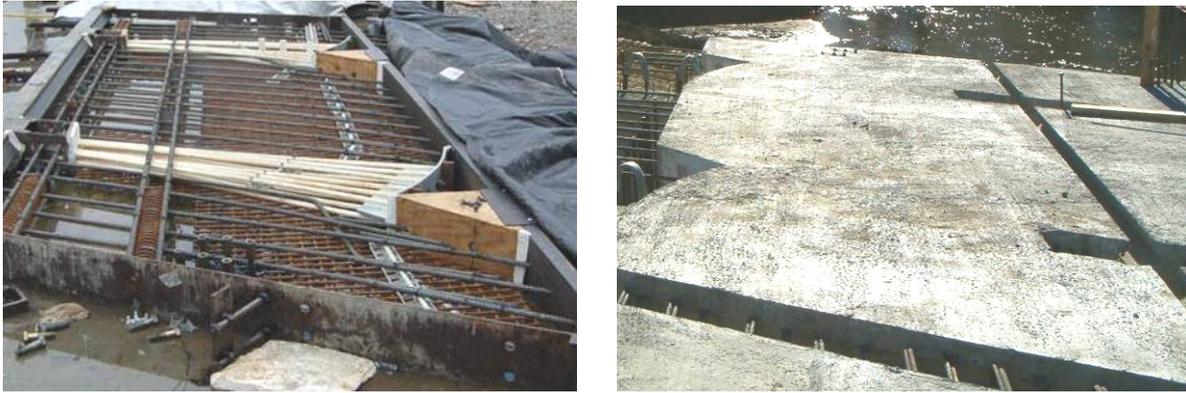
Anchorage zones in post-tensioned concrete are an area of concrete subjected to high levels of stress. Anchorage zones can be congested and difficult to design and construct due to the size of the anchorages and the amount of mild reinforcing required. To prevent cracking and bursting of concrete in the anchorage zone, secondary reinforcement such as spirals and closed stirrups can be used, and recently fiber-reinforced concrete has been used to reduce congestion (Haroon *et al.*, 2006). The Boone County project did not require abnormally high amounts of post-tensioning strand, but the end panels with the anchorage plates were still congested. Fabrication of one of the end panels is shown in Figure 5a while one of the completed end panels is shown in Figure 5b.

a) end panel reinforcement

b) complete end panel in the field

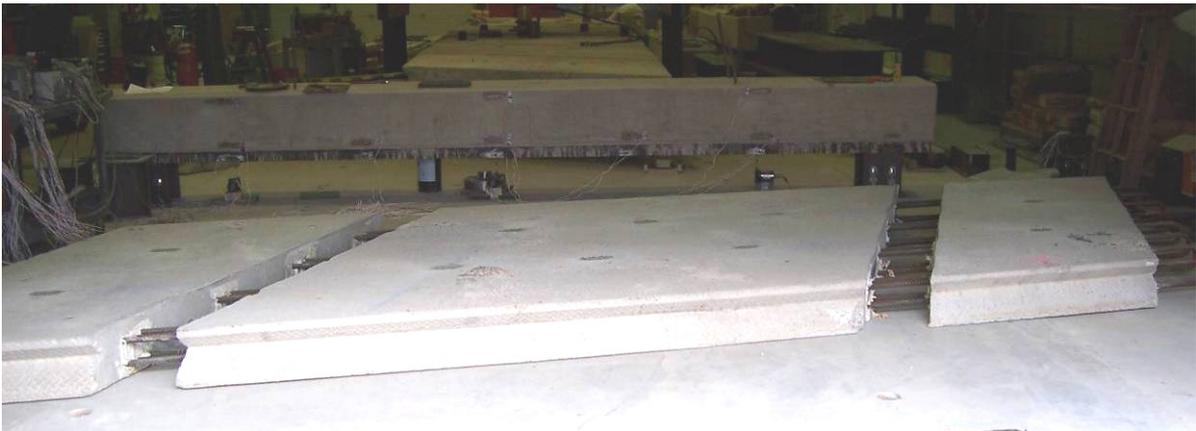
Figure 6. Boone County replacement bridge deck panel.

Post-tensioning channels used in the Boone County project avoided the corrosion protection issues related to the type of post-tensioning ducts and the presence of air voids in the ducts by eliminating the ducts all together. Open channels allowed the strands to be inspected as grout was placed and prevented the formation of air voids around the tendons. The channels in one of the deck panels can be seen in Figure 6.

A specialty concrete, designed to have low-permeability and low shrinkage to further prevent cracks near the tendons, was used in the channels. Details of the specialty concrete mix can be found in Chapter 3.

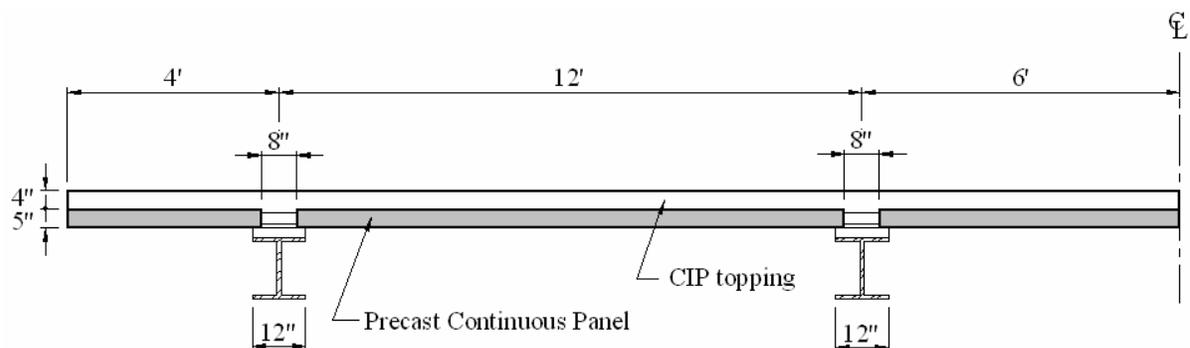
Figure 7. Typical cross-section of the NUDECK panel.

The NUDECK system is a stay-in-place precast, prestressed system developed to solve the problems in the existing stay-in-place (SIP) systems. This system uses partial-depth panels with a CIP composite deck. NUDECK can be constructed significantly faster than CIP systems and slightly faster than other SIP systems. Shown in Figure 7 is a section view of a typical NUDECK panel; the panel is symmetric about the bridge's longitudinal centerline (Badie *et al.*, 1998).

There are several block outs in each panel, located longitudinally over the each beam line. Block outs serve as post-tensioning channels, are positioned to avoid interference with the shear studs, and also simplify the post-tensioning process (Fallaha *et al.*, 2004).

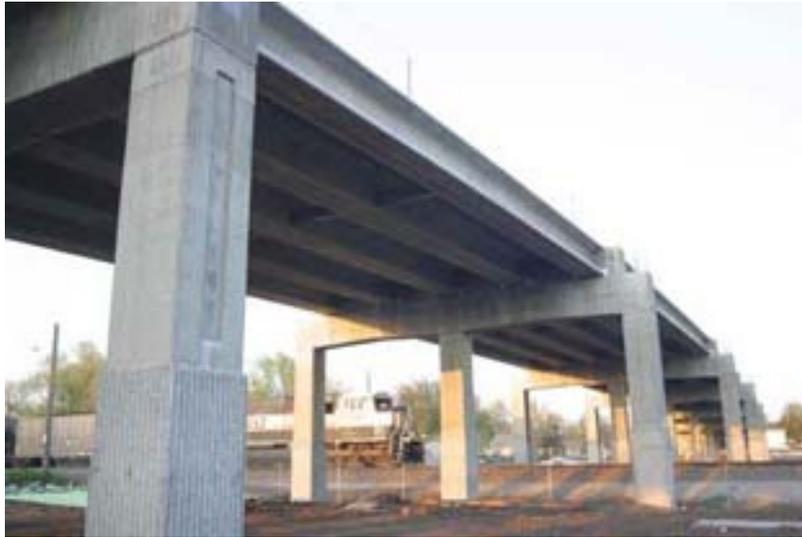
Figure 8. Bridge pier cap located Lincoln, Nebraska.

Precast concrete pier systems use precast piles and a precast pier cap to create a pier. Precast piers are compatible with a number of different foundation and substructure types. For larger bridges, precast pier caps, also called bent caps or cap-beams, may be necessary. A picture of a bridge in Nebraska using precast girders and precast pier caps is shown in Figure 8. Pier caps allow twin-span bridges to use the same piers for foundations. Precast, prestressed or post-tensioned caps can significantly reduce the cap size, which reduces the weight of the substructure. For extremely large bridges, pier caps may be fabricated and transported in two pieces and post-tensioned together on site (Billington *et al.*, 1999).

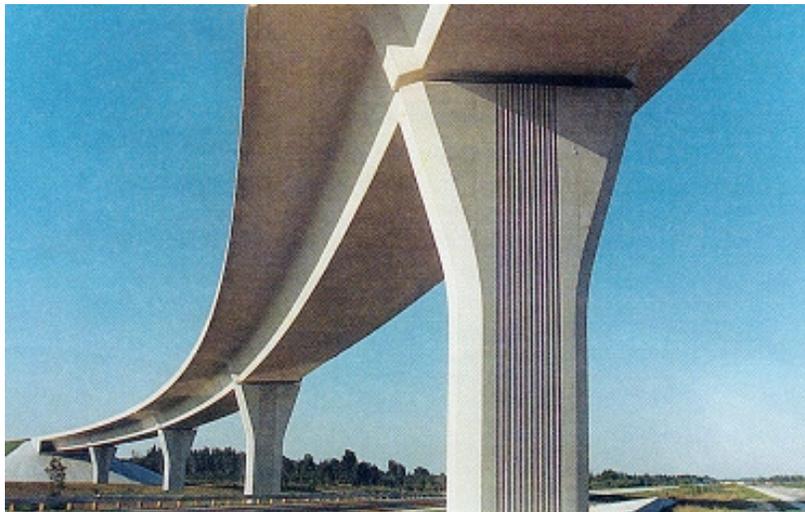
Figure 9. Slender pier design of the Florida Turnpike in Miami, Florida.

Precast elements also have the advantage of using high performance concrete, which typically increases the strength and durability of precast elements. The use of high-performance concrete also results in more slender substructure designs, as can be seen in Figure 9, which also results in significant material savings for a project (Billington *et al.*, 2001).

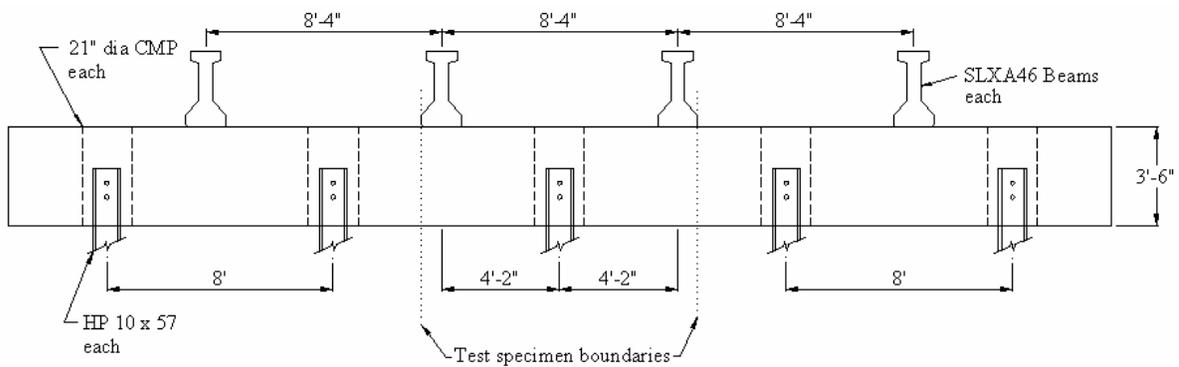
Figure 10. Side view of the Boone County replacement bridge abutment.

The abutment system consisted of a precast abutment cap that used corrugated metal pipe (CMP) as a 'block out' for the piles. During construction, the abutment cap was placed over H-piles already driven in the field after which a special concrete mix was used to fill the void and thus connect the piles and the abutment. Specimens were designed to represent the worst-case load condition on the actual abutments. Tests were performed using the prestressed girder spacing around the center pile; this provided the maximum moment to which the abutment would be subjected. The side view of the entire abutment, along with the sections of the abutment used in the various test specimens, can be seen in Figure 10. In this figure, the four precast girders and five piles can be seen.

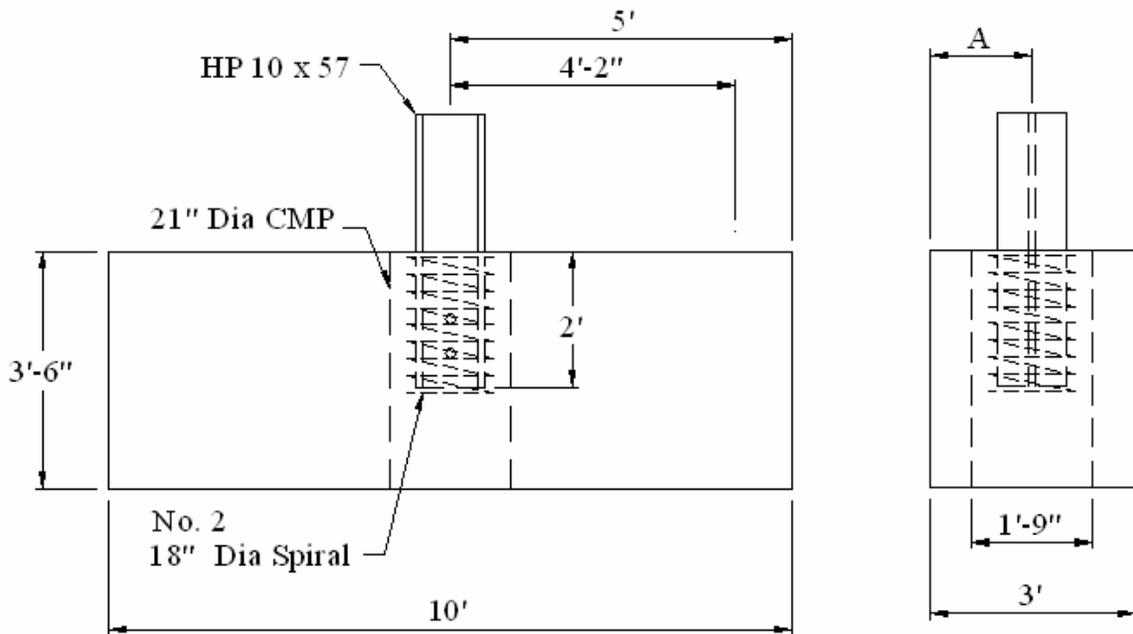
Figure 11. Single pile abutment test specimen.

During fabrication and testing, the abutment specimens were inverted. This provided the safest, most stable configuration for testing, and also made grouting the piles in place easier. The external details of the abutment test specimen are presented in Figure 11. There were two different single pile abutment tests specimen fabricated: one test with the pile centered in the CMP (i.e. the "C" designation in Table 1) and one with the pile offset the maximum distance in the CMP (i.e. the "O" designation in Table 1), designated by dimension "A" in Figure 11. Actual values for "A" and a top view of the centered and offset pile are shown in Figure 12.

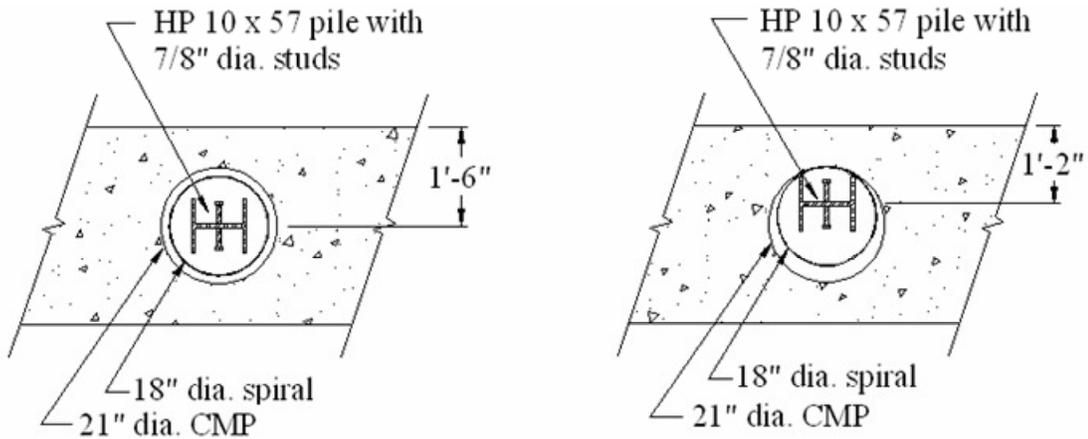
Figure 12. Abutment pile locations.

a) centered pile location

b) offset pile location

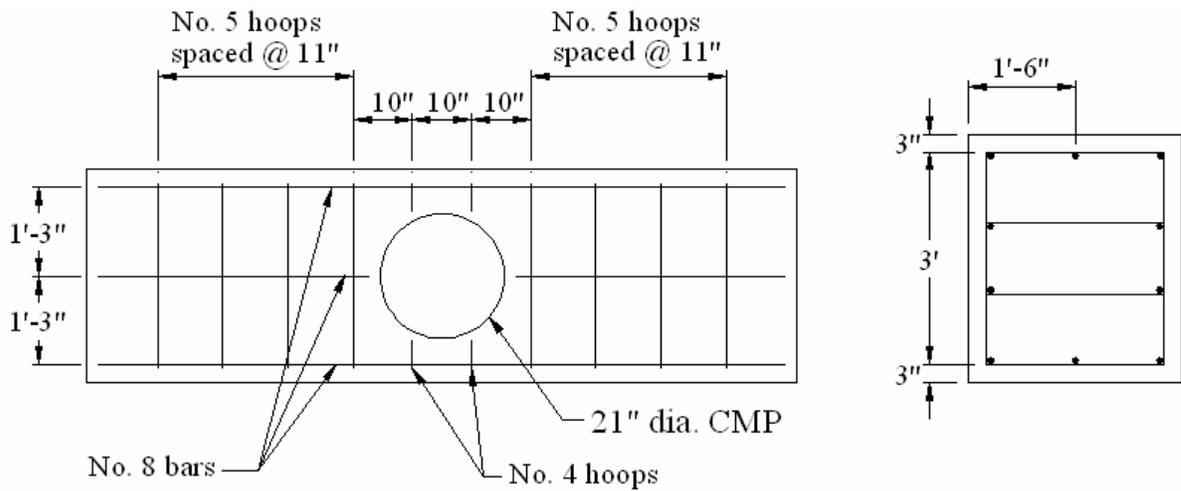
Figure 13. Single pile abutment reinforcement.

specimens was taken from the project plans and adapted for a ten-foot long section of the abutment. In the abutment, the No. 8 longitudinal bars were continuous; bars were lap spliced where necessary. In the test specimens, the longitudinal bars were limited to nine-feet and ten-inches in length, to provide one inch cover at the end of the bars; this provided sufficient bar length to ensure full development. A top view of the specimen, as well as an end view, showing the reinforcement is presented in Figure 13.

a) top view

b) end view

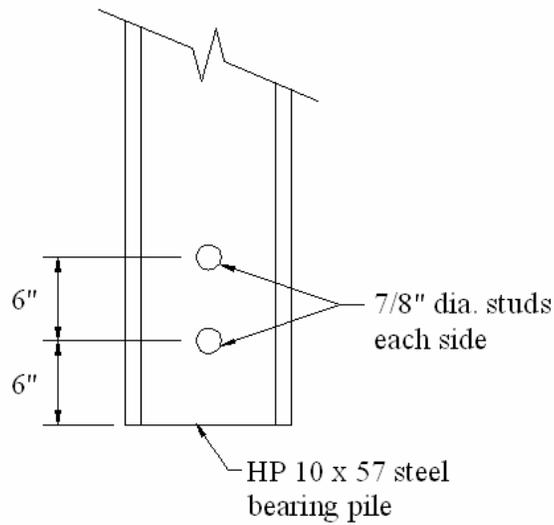
Figure 14. H-pile stud connection detail.

Each H-pile in the abutment specimens had four 7/8-inch diameter studs, five inches in length, welded to the pile web six inches apart, two of which can be seen in Figure 14. A No. 2 bar, bent in an 18-inch diameter spiral with a 3-inch pitch was designated in the bridge plans to complete the connection between the abutment and the pile. A portion of the CMP, spiral, and pile section with the studs is shown in Figure 15.

H-piles used in the double pile specimen had the same welded studs on the pile web as shown in Figure 14. Internal straps were increased from three straps for the single pile specimens to four straps for the double pile specimens; external straps were also increased from two straps for the single pile specimens to three straps for the double pile specimens. Lifting hooks used in the double pile specimens were the same number and layout as were used in the single pile specimens. The reinforcement in the formwork for a double pile test specimen, along with the external straps and lifting hooks, can be seen in Figure 32.

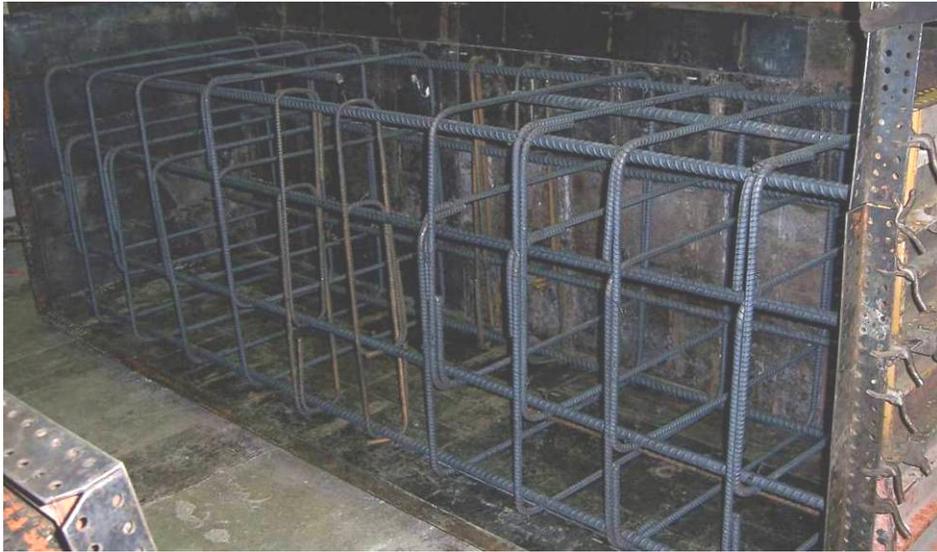
Figure 16. Single pile abutment specimen reinforcement placed in the formwork.

All of the reinforcing steel used was ordered through a local contractor's supply store and was pre-cut and bent to the appropriate dimensions except for the No. 4 ties, which were cut and bent in the laboratory. The reinforcement was assembled in the laboratory and placed in the partially assembled formwork, which had been previously coated with a release agent. One of the reinforcement cages in the formwork before the last side of the forms was attached is shown in Figure 16.

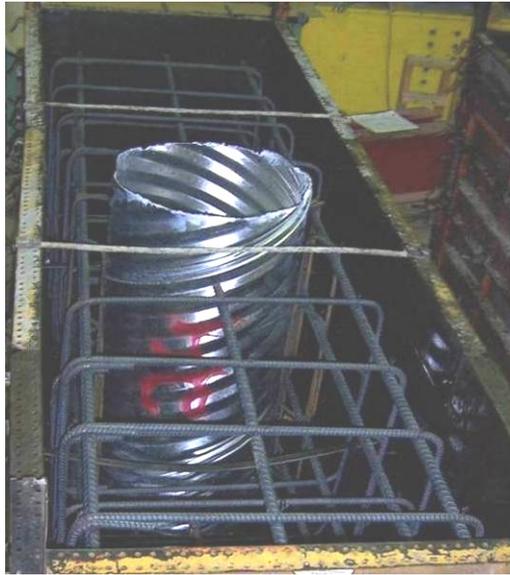
Figure 17. Completed formwork with the CMP for the first abutment test specimen.

After the formwork was partially assembled, the CMP was placed in the reinforcement cage and secured with wire ties, after which the formwork was completed. To give the forms more stability during concrete placement, internal and external steel straps were used. Internal straps were placed at three of the joints in the formwork, one foot from the bottom of the forms. Two external straps were used on top of the formwork. The CMP, external straps, and the completed formwork for one test specimen are shown in Figure 17.

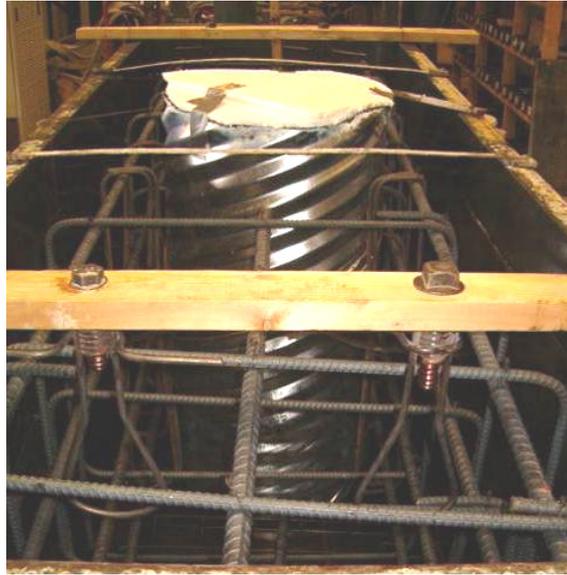
Figure 18. Lifting hooks and styrofoam cover before placing concrete.

The estimated weight of each individual specimen was 7.8 ton. To facilitate lifting and moving the specimens, four lifting hooks were embedded in each specimen. Lifting hooks were attached to wooden “two-by-fours” with bolts and positioned to provide at least two inches of concrete cover for the top of the hooks. Each bolt was greased before the

concrete was placed so after the concrete had cured, the bolts and two-by-fours could be easily removed. Styrofoam was used to cover each CMP to keep concrete out during the casting of the abutment specimens. A view of the lifting hooks attached to the formwork and the styrofoam is presented in Figure 18.

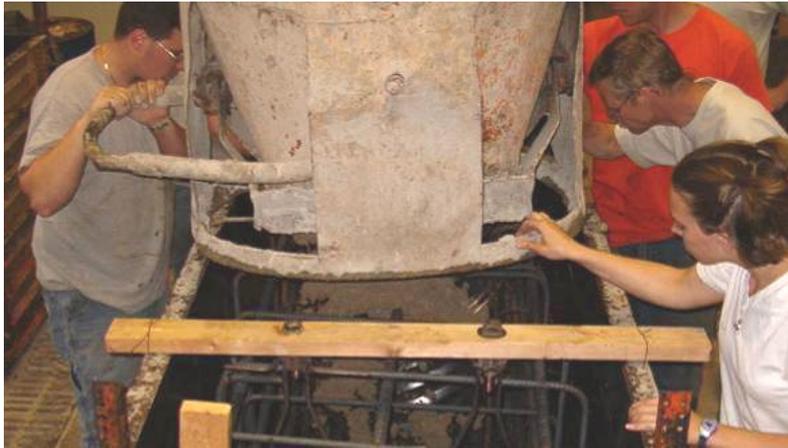
Figure 19. Concrete being placed in the first series of abutment specimen.

crane were used for placing the concrete. Several electric concrete vibrators were used throughout the pour to consolidate the concrete, especially in the area surrounding the CMP. Concrete was placed in approximately four lifts and vibrated between each lift; placement in one of the specimen is shown in Figure 19. While the concrete was being placed, twelve control cylinders were made using the concrete from a particular truck.

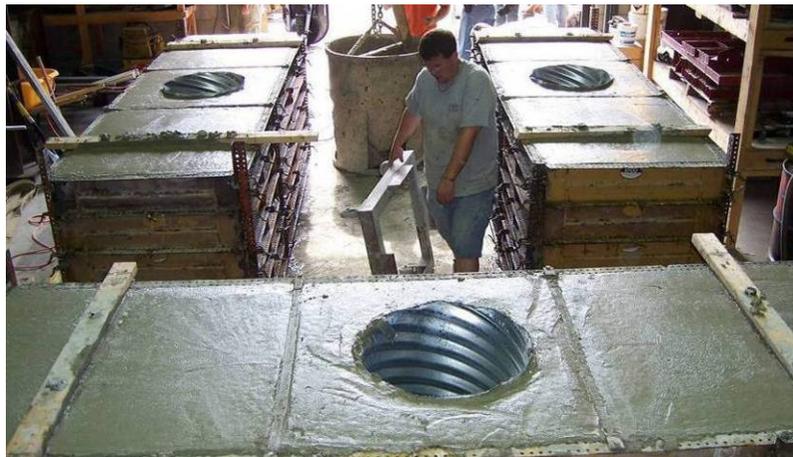
Figure 20. Hand-finished specimen before initial set.

A screed was used to strike off the concrete even with the formwork, after which trowels were used to hand-float the surface. The first finished series of test specimens can be seen in Figure 20. In total, thirteen cubic yards of concrete were required to fabricate the three specimen and control cylinders. Once the concrete reached initial set, the surface was covered with wet burlap and plastic sheets for curing. Each specimen remained covered with the plastic and wet burlap, which was removed after seven days and the formwork was ‘stripped’.

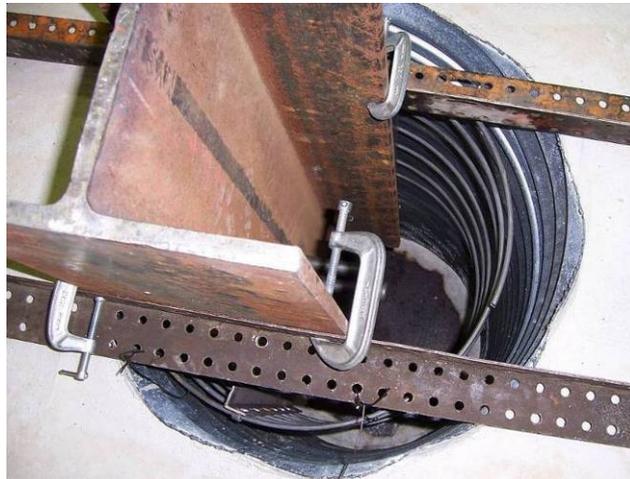
Figure 21. H-pile in place before placing grout.

specimens. To obtain the desired embedment length, the piles were attached to steel angles using C-clamps, which in turn were supported by the CMP. One of the piles offset in the CMP, before the special concrete mix was placed, is shown in Figure 21.

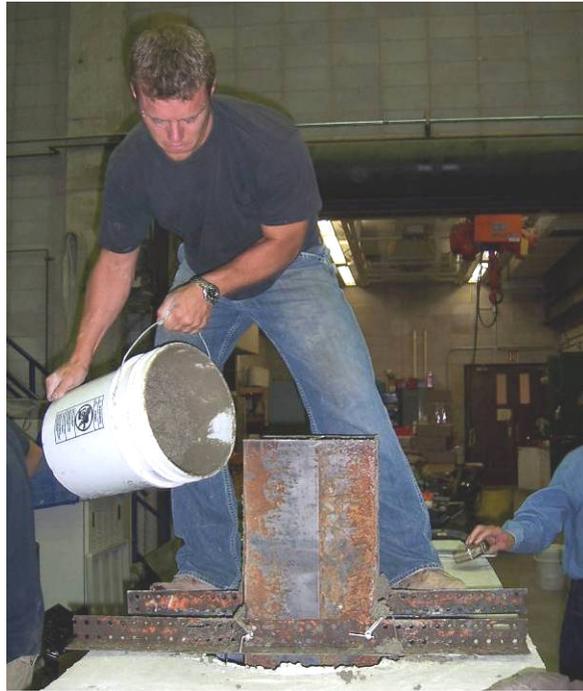
Figure 22. Concrete being placed in the CMP around the H-pile.

Placing concrete in the CMP was challenging. The opening was too small to use the concrete bucket without wasting large amounts of concrete. Thus the concrete was placed by hand using shovels and buckets; a student can be seen placing concrete around the H-pile in Figure 22. Vibrators were again used to ensure adequate compaction, and to eliminate voids under the ends of the piles and around the shear studs. Fifteen control cylinder were made using the grout concrete mix.

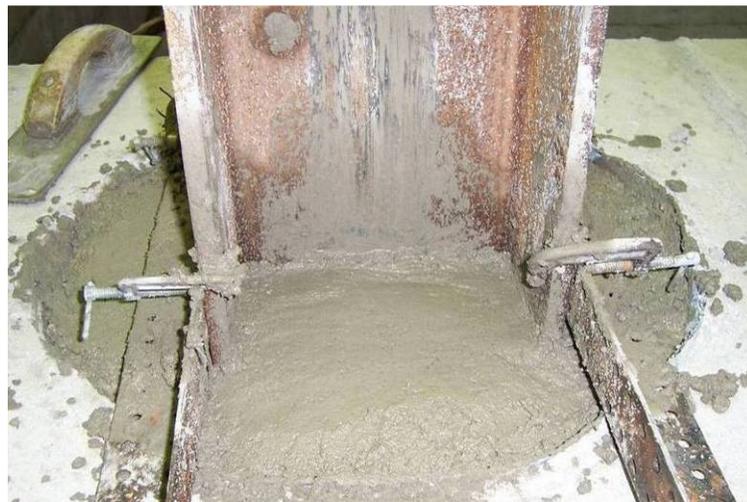
Figure 23. H-pile after being grouted in place.

Grouted concrete was finished by hand, however, because of the small space between the CMP and piles, a straight edge or trowel could not be used. A pile grouted in place can be seen in Figure 23. After the grouted concrete reached initial set, since each CMP was approximately one half inch longer than the depth of the added grout, water was ponded on top of the grout for curing. After 24 hours, the C-clamps and angles previously described were removed. Water was kept on the surface of the grouted concrete for seven days.

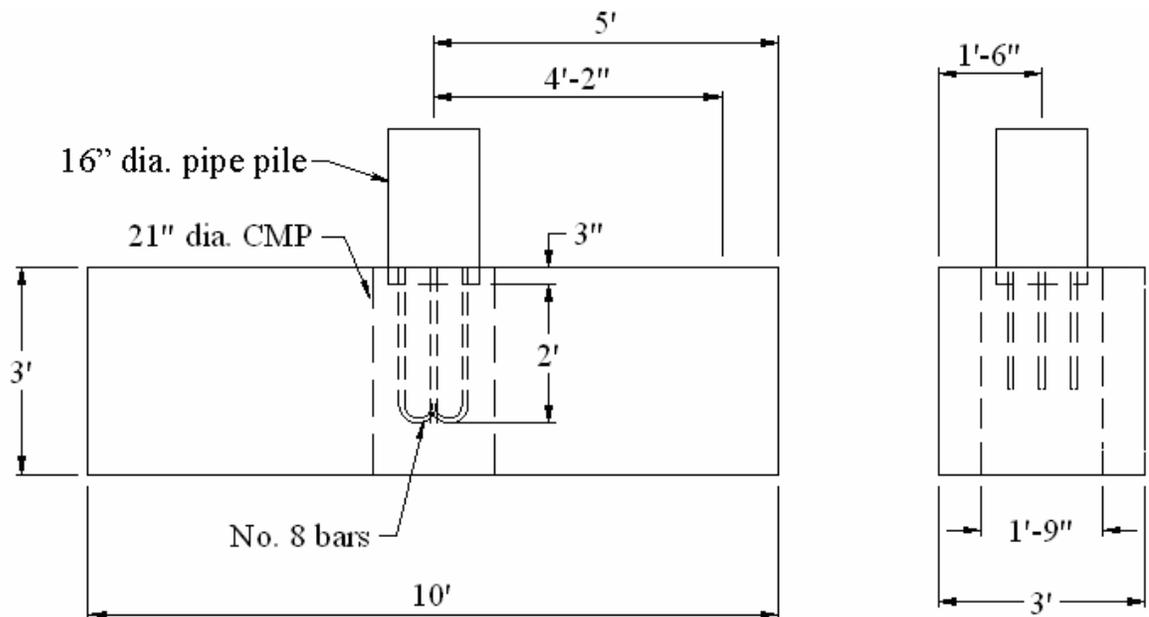
a) side view

b) end view

Figure 24. Single pile pier cap test specimen.

reached sufficient strength. In the single pier cap test specimen, the pipe pile was centered in the CMP. Each test specimen replicated the pier cap used in the field, including the dimensions and reinforcement. Similar to the abutment specimens, the pier cap specimens were inverted during fabrication and testing. External details of the pier cap specimens are shown in Figure 24.

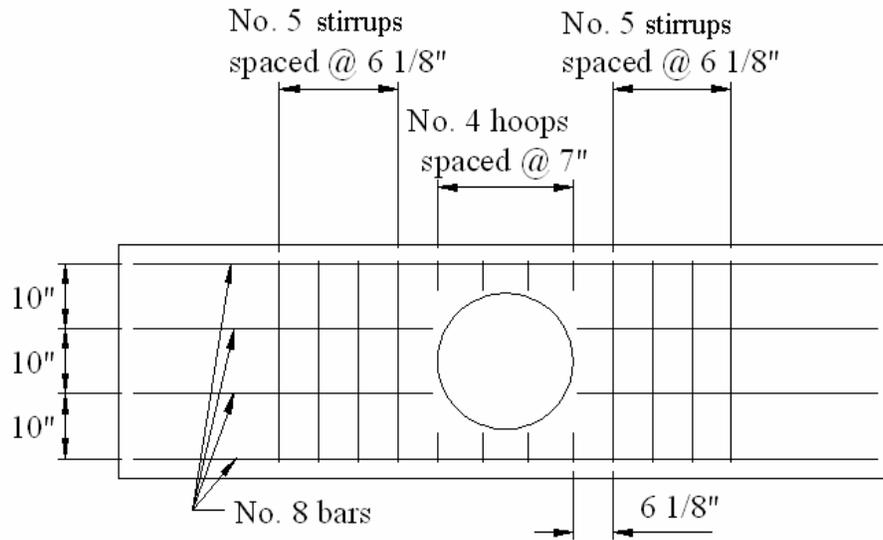
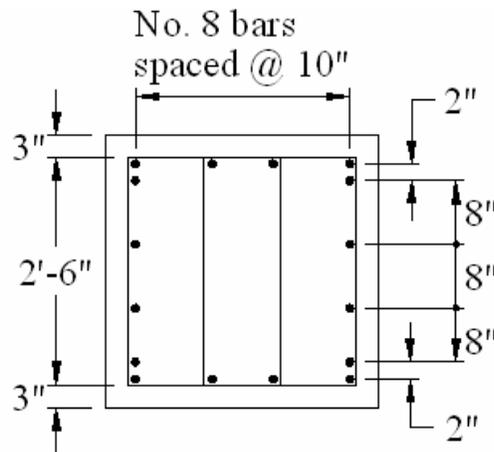
a) top view of pier cap reinforcement

b) cross-section view of pier cap reinforcement

Figure 25. Pier cap reinforcement.

The reinforcement in the specimens was the same as that specified the project plans (size and spacing), which was adapted for a ten-foot long section of the pier cap. As previously described for the abutment, the pier cap longitudinal bars were continuous, lap spliced where needed and cut to provide one inch of cover for the ends of the No. 8 bars. A top view and cross-section of the pier cap reinforcement can be seen in Figure 25.

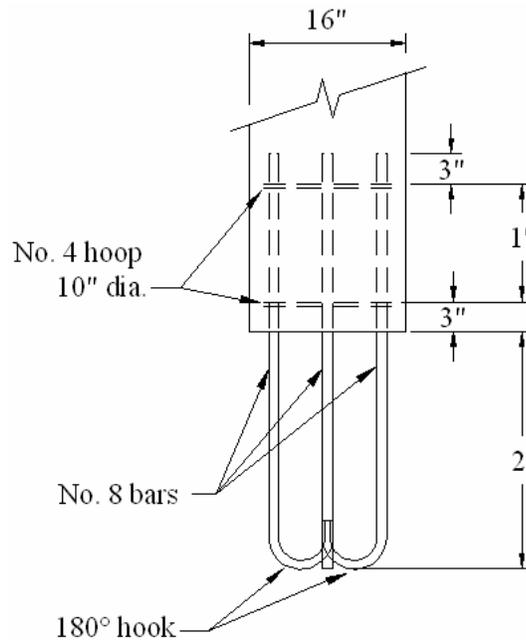
Figure 26. Pipe pile connection detail.

The reinforcement connection between the pipe pile and the pier cap consisted of four No. 8 bars, two straight bars and two bars with 180° hooks, shown in Figure 26. Additional No. 4 hoops, 10-inches in diameter, were also used in the connection. As the concrete in the pipe piles was placed, the reinforcement connection was embedded in the fresh concrete.

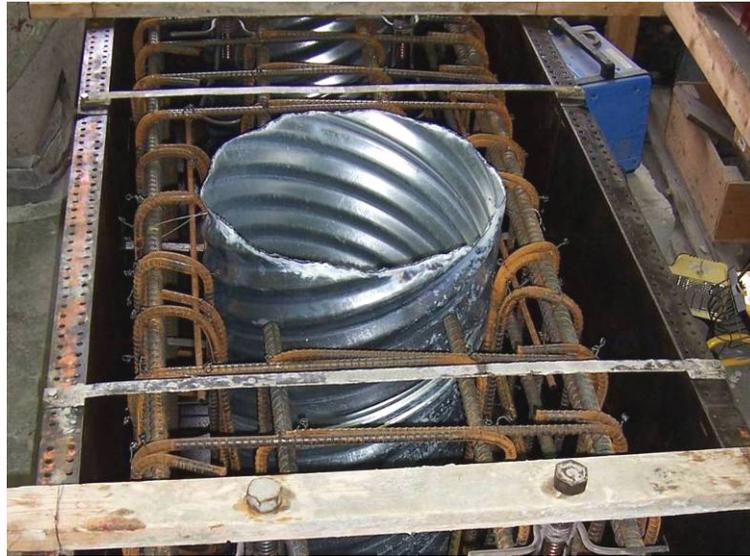
Figure 27. Pier cap reinforcement.

The same formwork used for casting the abutment specimens were used in the pier cap specimens. After the formwork was partially assembled and a release agent applied, the reinforcement cages were placed in the formwork on metal chairs, and the CMP was placed in the reinforcement and secured. Since the abutment specimens and pier cap specimens were the same size, the same lifting hooks and internal and external strap arrangements were used. One of the finished pier cap forms, with the CMP, reinforcement, and external straps is shown in Figure 27.

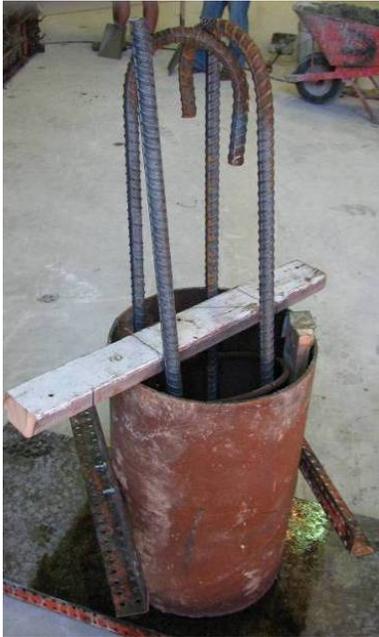
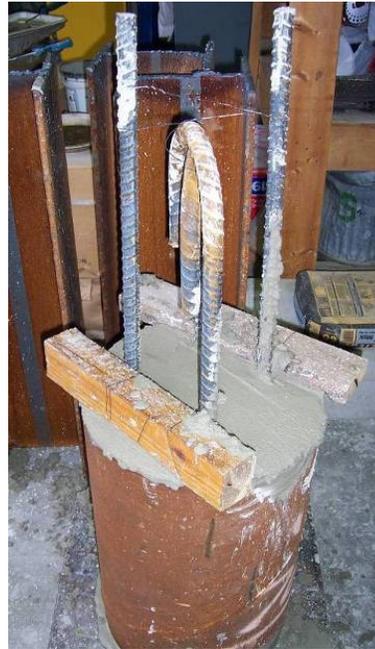
a) pipe pile before placing concrete

b) pipe pile after placing concrete

Figure 28. Pipe pile connection before and after placing concrete.

The pipe pile connection before and after placing concrete is shown in Figure 28. A wooden shim was used to hold the reinforcing steel in place at the correct embedment length. Another wooden shim was used inside the pipe to obtain the desired cover for the No. 4 hoop. Shims were removed after sufficient concrete was placed to keep the reinforcement stable.

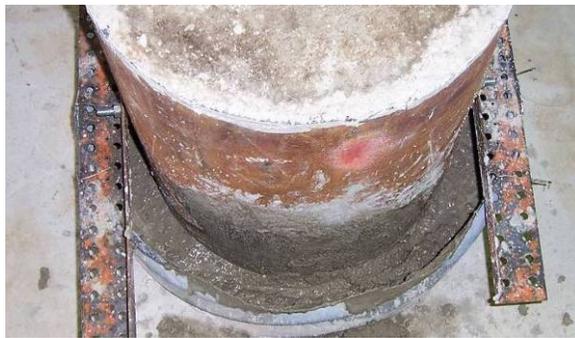
Figure 29. Pipe pile after being grouted in place in PSC1.

Pipe piles were grouted into place seven days after the specimen and pipe pile concrete was placed. The pipe pile was grouted in using the same method as was described for grouting the H-piles into place. Steel angles were bolted to the side of the pipe pile, which in turn was supported by the CMP to provide the desired embedment length for the pile; a pipe pile grouted in place can be seen in Figure 29.

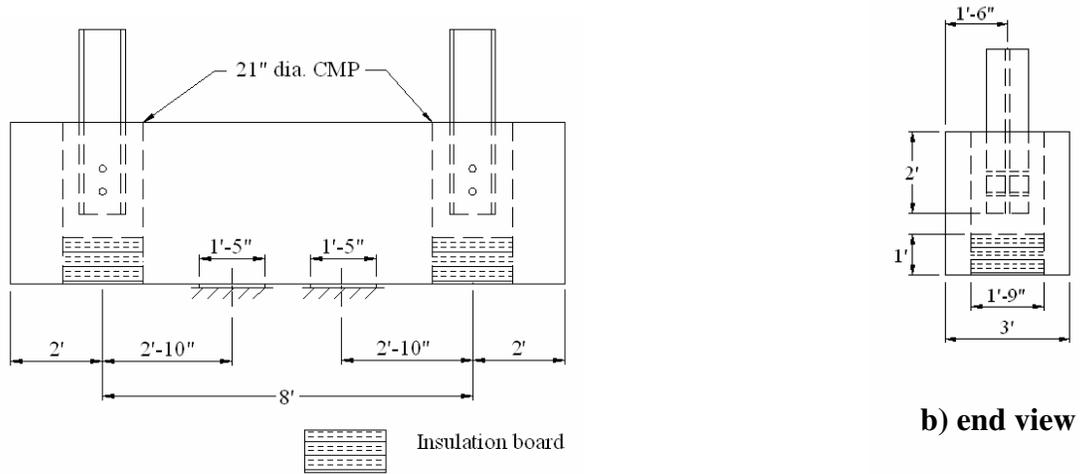
a) top view

b) end view

Figure 30. Double pile abutment test specimen.

Another change was made to the double pile connection detail. Based on the results from the single pile tests, the depth of concrete inside the CMP was decreased to reduce the capacity of the connection, which should lead to failure at a lower applied force. In order to decrease the depth of concrete in the pipe while keeping the pile connection intact, 12 inches of insulation board was placed in the bottom of the CMP, resulting in a concrete depth of two and a half feet. As with the single pile abutment specimens and pier cap specimens, the double pile abutment specimens were inverted during fabrication and testing. The external details of the double pile specimens are presented in Figure 30.

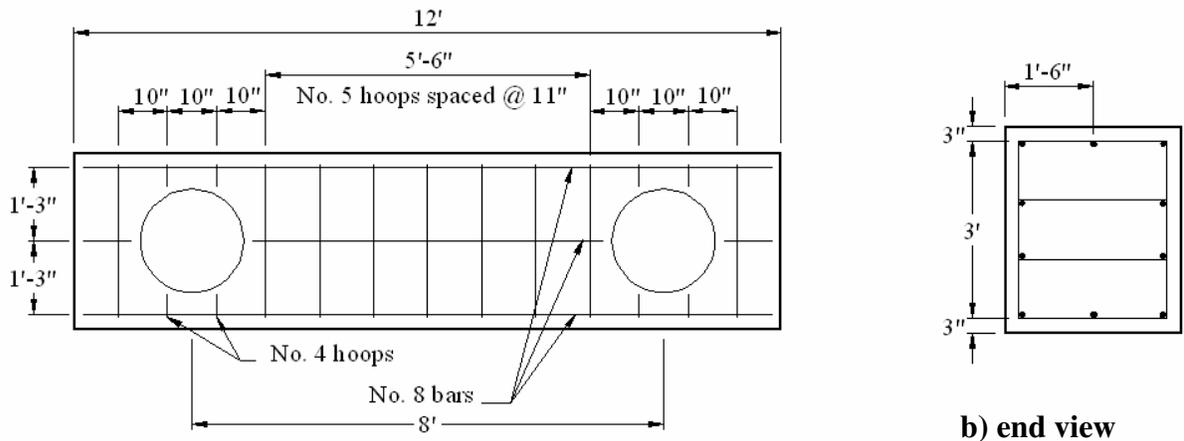
a) top view

b) end view

Figure 31. Double pile abutment specimen reinforcement.

Specimen size was limited to twelve feet for handling and constructability purposes. The reinforcing cages used in the double pile specimens were adapted from the bridge plans and thus had reinforcement similar to that used in the single pile abutment specimens. However, the reinforcement was designed and constructed to fit two CMP in the formwork; all other construction details remained the same. The top view as well as the end view of the reinforcement are presented in Figure 31.

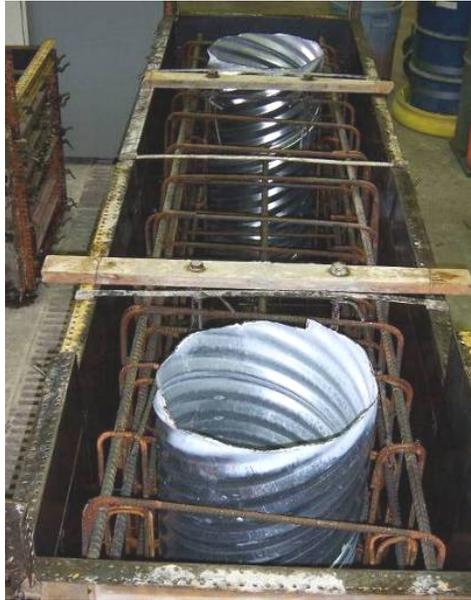
Figure 32. Finished reinforcement and formwork for ADC1.

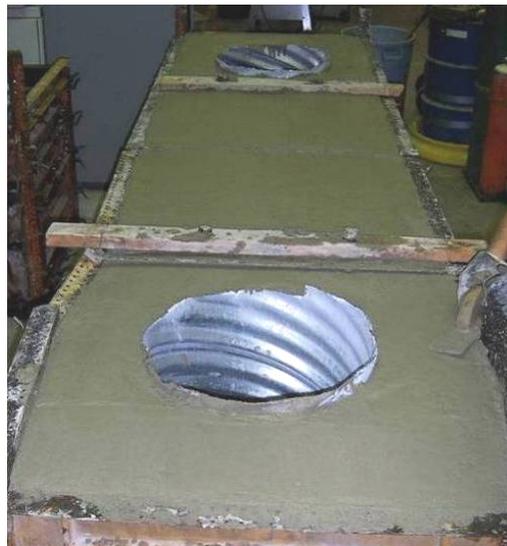
Figure 33. Abutment 6 after hand-finishing.

Concrete used in the double pile abutment specimens was the same mix used in the single pile abutment and pier cap specimens. As with the previous specimens, styrofoam was used to cover the CMP to keep concrete out of the void. Concrete was placed using the overhead crane and concrete bucket, vibrated, and finished by hand. A finished double pile specimen before initial set was reached is shown in Figure 33.

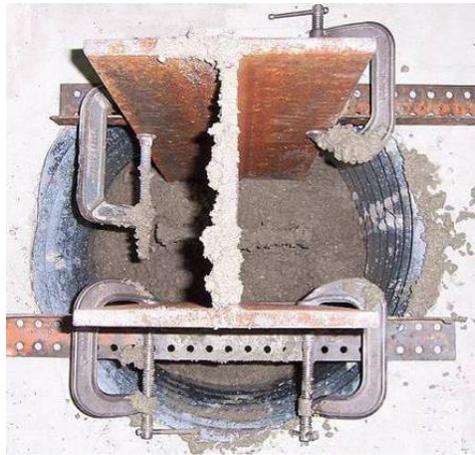
Figure 34. Double pile abutment specimen H-pile before being fully grouted.

Before the H-piles were grouted into place, as previously noted, twelve inches of insulation board were placed at the bottom of the CMP, leaving six inches of concrete cover below the tip of the H-piles. Steel angles and C-clamps were used to support the H-piles, which in turn were supported by the CMP during concrete placement. One of the H-piles being held in the desired position before placing concrete was complete is shown in Figure 34. Note the absence of the spiral reinforcement in the CMP.

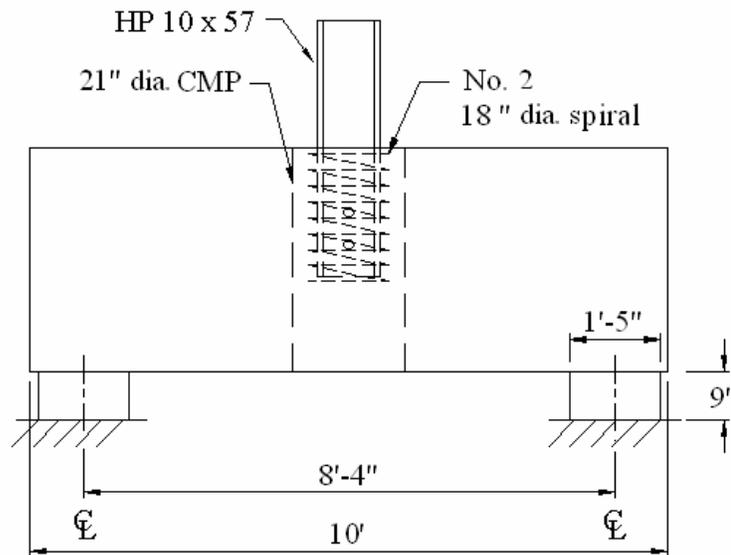
Figure 35. Single pile abutment test support details.

The single pile abutment and pier cap tests had two simulated beams spaced on eight-feet, four-inch centers, according to the bridge plans. This beam spacing provided the maximum negative moment in the substructure sections at the pile location. Beam spacing and support dimensions are presented in Figure 35.

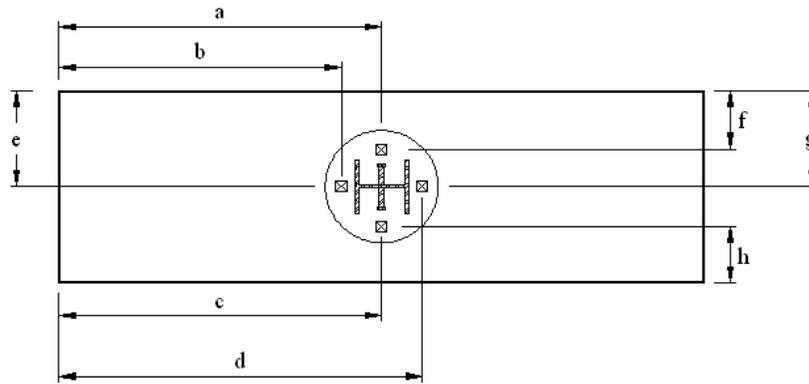
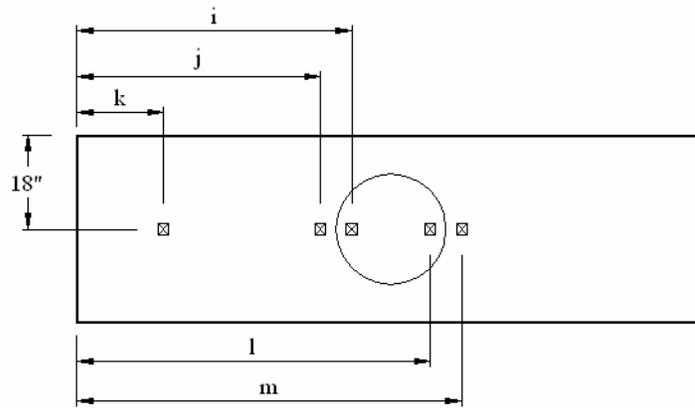
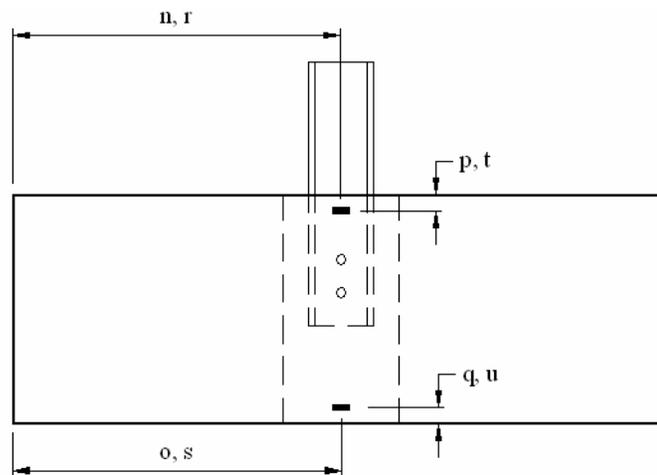
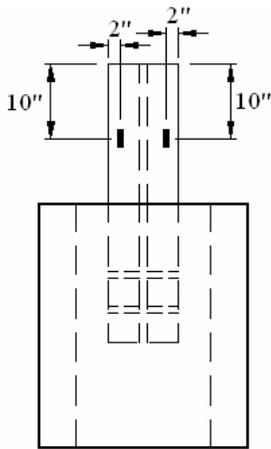
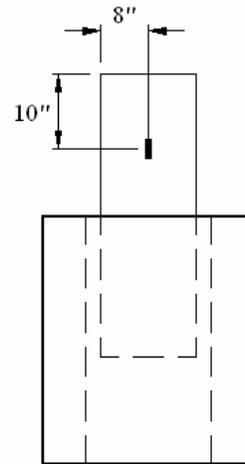
a) location of the deflection transducers used in the single H-pile and pipe pile tests, top view

b) location of the deflection transducers used in the single H-pile and pipe pile tests, bottom view

c) location of the strain gages used in the single pile tests (north face, south face)

Figure 36. Single pile abutment test instrumentation plan.

d) location of H-pile strain gages

e) location of pipe pile strain gages

Figure 36. (continued).

The pier cap specimens were tested using the same arrangement as the abutment test shown. Each specimen was instrumented with linear variable deflection transducers (LVDT) and strain gages. Transducers were placed on the top and bottom faces of the specimen to measure differential deflection between the precast concrete and the grouted concrete in the CMP, and total deflections during testing. A total of nine deflection transducers were used: four on the top surface of the specimen and five on the bottom surface. On the bottom

Strain gages were used on the pile flanges to determine if there was uniform loading. Each H-pile was instrumented with four strain gages, one gage on each flange of the pile; each pipe pile had two gages placed opposite each other. The concrete was also instrumented with four strain gages. Each of the transverse sides of the specimen had two strain gages attached, one at the top and one at the bottom. Placement of the gages varied slightly for each specimen, depending on the quality of the concrete surface. The instrumentation plan for the single pile specimens is presented in Figure 36 (spirals and pipe pile steel not shown for clarity); instrumentation used on the pier cap specimens was the same as that was used on the single pile abutment specimens, with the exception that only two strain gages were used on the pipe piles.

The variable dimensions for the deflection transducers and strain gages are labeled with letters in Figure 36; deflection instrumentation dimensions for each specimen are given in Table 2 and strain gage location dimensions are given in Table 3. Some of the instrumentation on ASC1 can be seen in Figure 37.

During testing, four parameters were measured: strains in the steel pile, concrete strains, differential movement between the concrete in the CMP and the precast concrete, and the total deflection of the specimen (see Figure 36 for location of instrumentation). Strains in the steel pile were examined first to ensure the pile was loaded uniformly. Steel

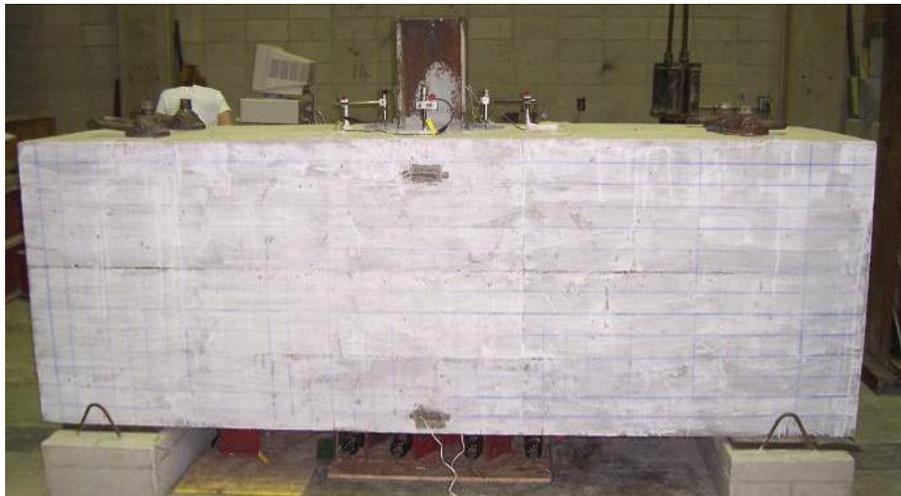
Figure 37. Instrumentation on ASC1 prior to testing.

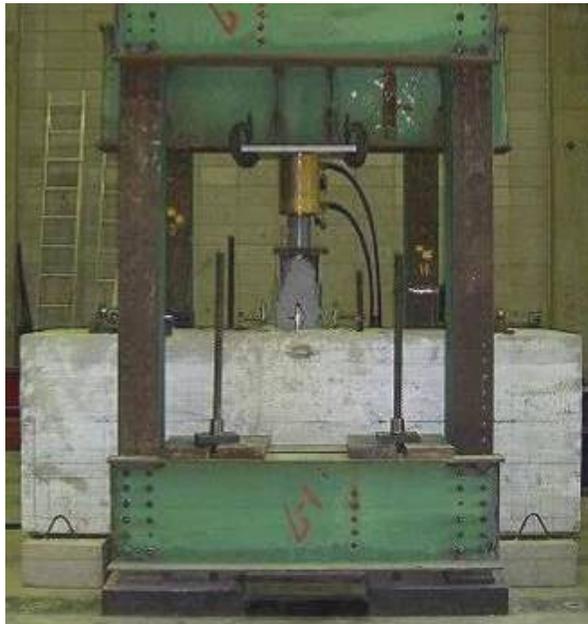
Figure 38. Laboratory test arrangement for ASC1.

As previously noted, the specimens were inverted for testing due to stability concerns. The simulated beams rested on the floor, the specimens were placed on neoprene pads on top of the beams, and the protruding pile was then loaded. An actual test arrangement for one of the abutment specimen is shown in Figure 38.

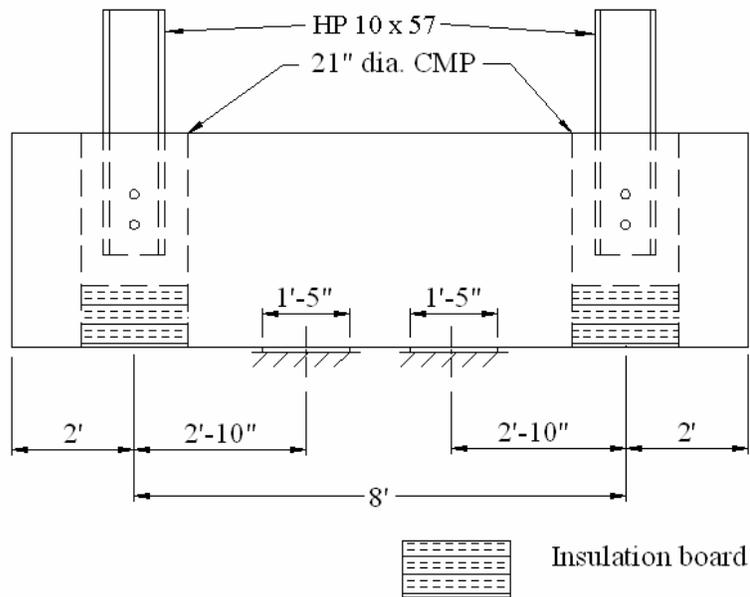
Figure 39. Double pile abutment test support details.

Double pile abutment specimens were tested to measure the effects of the combination of shear and positive moment on the abutment and to determine if this loading condition could produce a punching shear failure between the precast concrete and the concrete in the CMP. Support conditions were adjusted from the plans to produce a maximum positive moment in the abutment section between the piles. In the field, the abutment section can never be subjected to the same loads as in the laboratory tests because of the support conditions (i.e. continuous spans); the loads in the laboratory (i.e. simple spans) were more severe than actual field conditions. Double pile specimens were inverted and tested in the same manner as the single pile specimens; the support conditions for the double pile specimens are presented in Figure 39.
