Laboratory testing of precast bridge elements, verification of post-tensioning forces and construction documentation of the Boone County IBRC accelerated bridge replacement project

**Laboratory testing of precast bridge elements, verification of post-tensioning forces
and construction documentation of the Boone County IBRC accelerated bridge
replacement project**

A thesis submitted to the graduate faculty
in partial fulfillment of the requirements for the degree of
MASTER OF SCIENCE

Major: Civil Engineering (Structural Engineering)

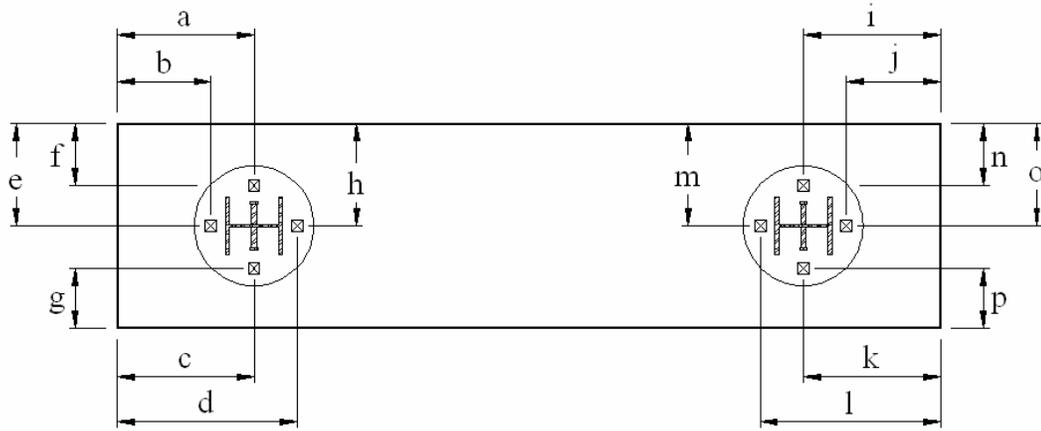
a) location of deflection transducers, top view

Each test specimen was instrumented using twelve strain gages on the concrete, eight strain gages on the H-pile, four deflection transducers at each pile connection (eight LVDTs total), and six deflection transducers along the bottom of the specimen. Deflection transducers were placed on the top and bottom faces of the specimen to measure total deflection and differential deflection during testing; the eight LVDTs on the top surface of the specimen were used for differential deflection measurements while the six transducers on the sides of the specimen were used for measuring total deflections.

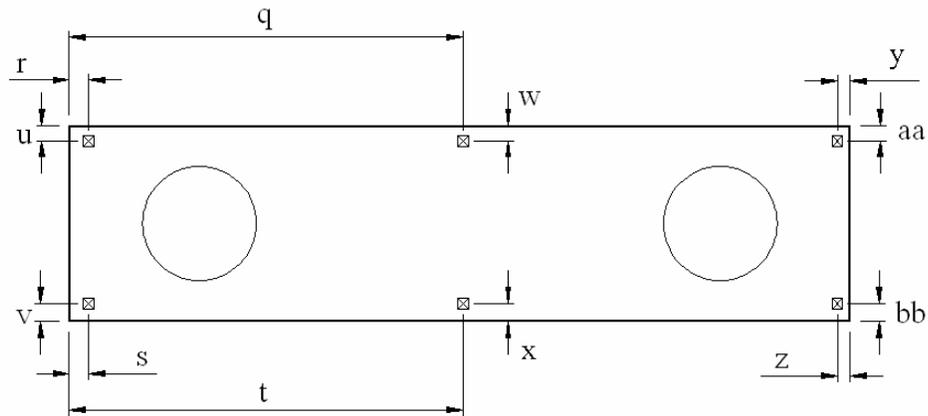
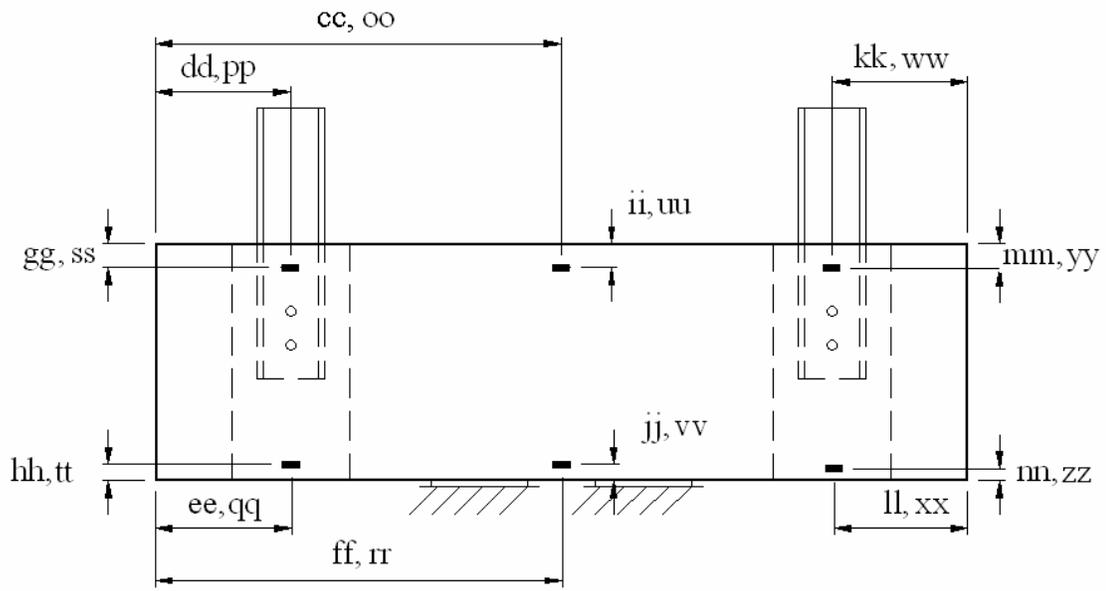
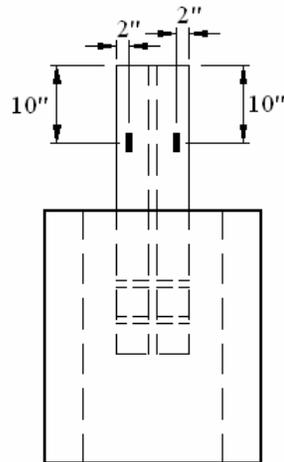
Figure 40. Double pile abutment test instrumentation plan.

b) location of deflection transducers, bottom view

c) locations of the strain gages (north face, south face)

d) location of the strain gages on the H-piles

Figure 40. (continued).

The instrumentation plan for the double pile specimens is presented in Figure 40 (the insulation board is not shown for clarity). Variable dimensions for the location of the top deflection transducers, the bottom deflection transducers, the strain gages on the north face of the specimens, and the strain gages on the south face of the specimens are presented in Table 4, Table 5, Table 6, and Table 7, respectively.

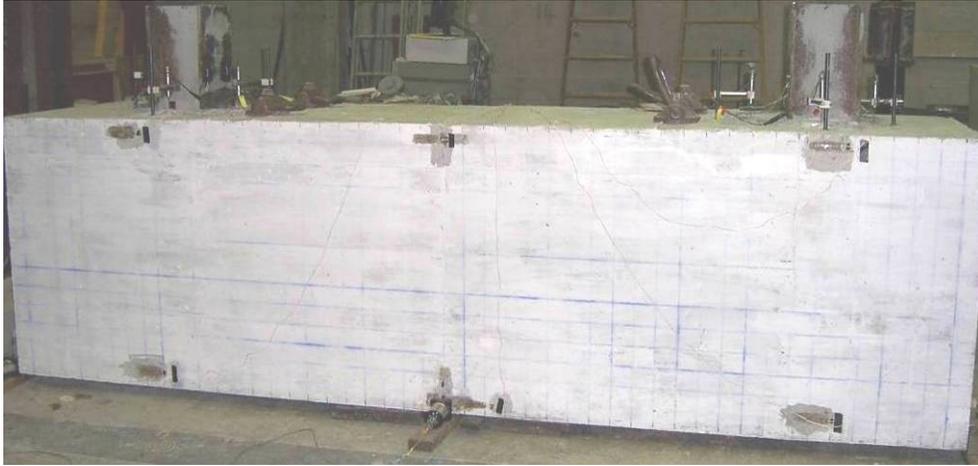
Figure 41. Instrumentation on a ADC1 prior to testing.

Complete instrumentation on the north face of ADC1 can be seen in Figure 41 prior to testing. Laboratory testing arrangements were similar to that used in the single pile

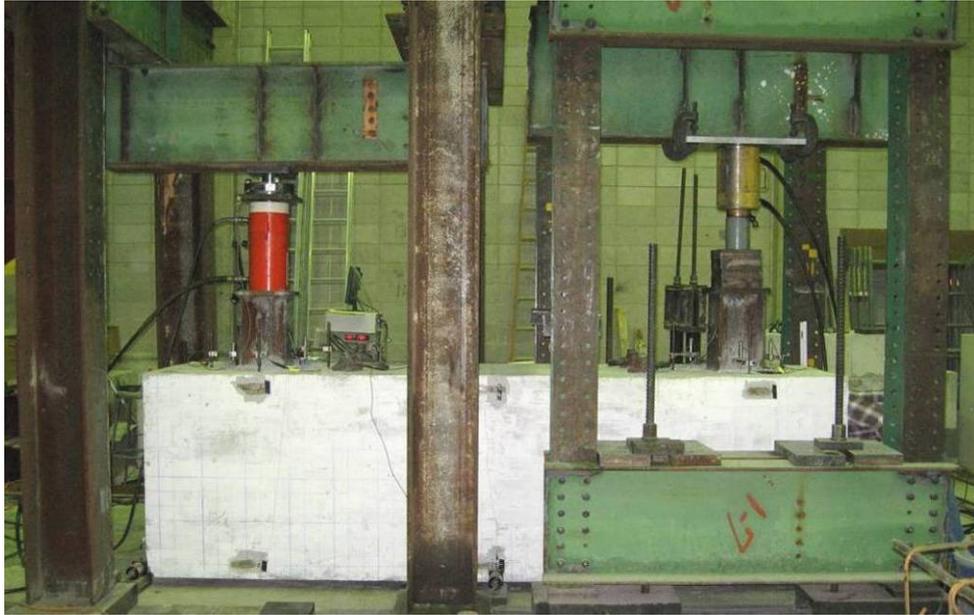
Figure 42. Laboratory test arrangement for ADC2.

specimen tests, however, the double pile test required two load frames so that both piles could be loaded simultaneously; Load Frame 2 had a capacity of 150 kips. The laboratory testing arrangement for ADC2 is shown in Figure 42.

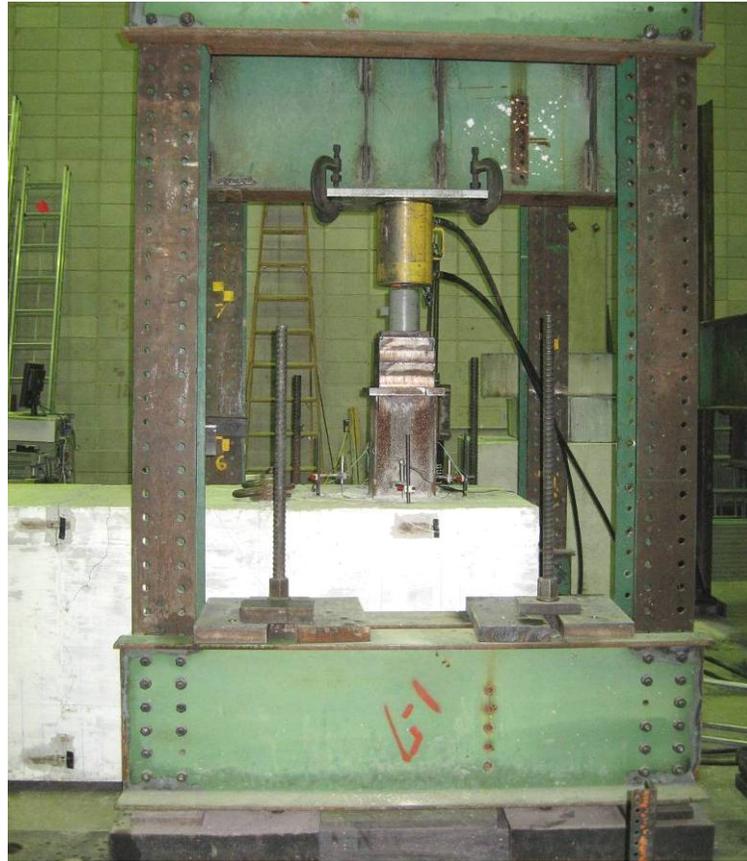
Figure 43. Double pile abutment shear Test 1.

After the combination shear and positive moment tests were complete, the double pile abutment specimen had not completely failed. The area of concrete around the CMP had not cracked, so additional tests were performed on the specimen. Each abutment was adjusted to center one of the piles under the larger load frame. Support conditions were moved so there were two supports located adjacent to the CMP around the pile being tested. A third support was placed under the opposite end of the abutment for stability. The load frame and test arrangement for one of the pile shear test can be seen in Figure 43.

Since the abutments were already instrumented, the same instrumentation was used in the shear test. The bottom deflection gages were omitted since the bottom of the concrete in the CMP could not be instrumented for comparison; also the four strain gages on the concrete located at the center of the specimen were omitted since the center gages were beyond the area of interest. Thus in the shear tests, data measured by the four strain gages on the concrete at the pile location, the four strain gages on the H-pile being tested, and the four LVDTs located adjacent to the pile were recorded.

Each pile was loaded to 400 kips, measurements being recorded approximately every 10 kips with the load cell in place (up to 300 kips), and every eight kips after the load cell was removed. The differential deflections were monitored and the specimen was checked for cracks throughout the loading. Since there were no cracks on the specimens visible to the naked eye, none were marked.

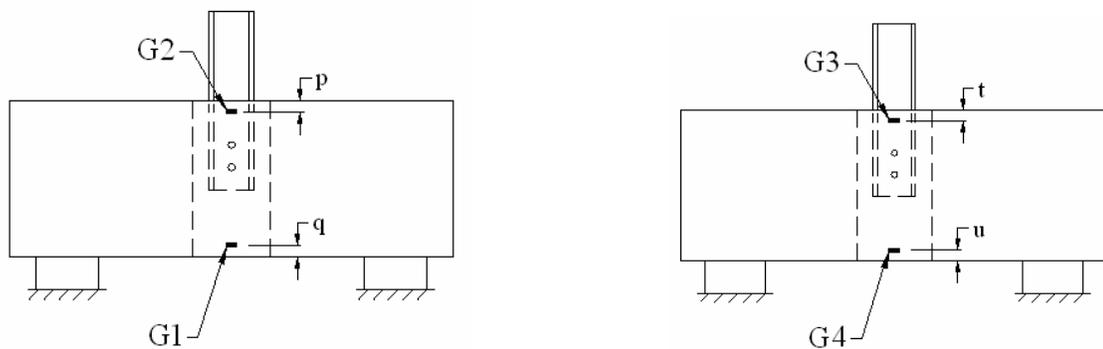
a) strain gage locations on the north face

b) strain gage locations on the south face

Figure 44. Single pile specimens: locations of strain gages on concrete.

To simplify the comparison of results, the instrumentation numbering for the single pile specimens was kept consistent. The following instrumentation labels and locations apply to all of the single pile tests. Labels and locations for the strain gages applied to the concrete are shown in Figure 44. As previously noted, the location dimensions for all of the gages which vary on each specimen can be found in Table 2 and Table 3.

Concrete tensile strength was estimated based on the assumption that tensile strength is approximately 8-10% of the compressive strength. Concrete compressive strength, a range of the tensile strength, and the modulus of elasticity for each centered single pile abutment specimen are presented in Table 10. Concrete stresses in ASC3 are presented in Figure 47. Locations of the stresses (strains) in the figure were presented in Figure 44.

Concrete strains in the pier cap were measured at the same locations as the abutment specimen, shown in Figure 44. Hooke's Law was used to convert concrete strains into stresses. Tensile strength was approximated as eight to ten percent of the compressive strength. The compressive strength, a range of the tensile strength and modulus of elasticity are presented in Table 14 and the concrete stresses are presented in Figure 57.

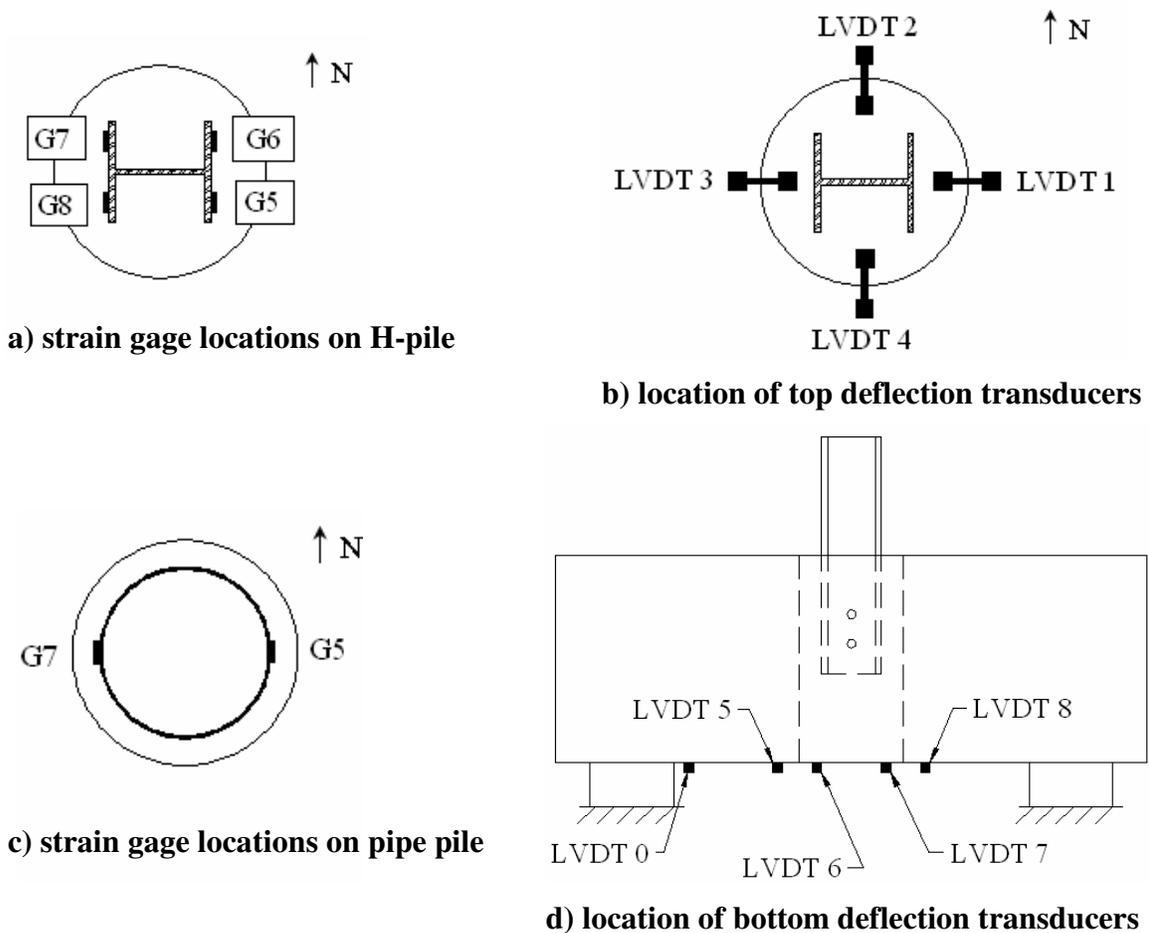
Figure 45. Single pile specimen instrumentation locations.

each other on the pipe pile. Locations of the strain gages on the H-pile for the abutments are shown in Figure 45a, the locations for the top deflection transducers are shown in Figure 45b, locations of the strain gages on the pipe pile are shown in Figure 45c and the locations for the bottom deflection transducers are shown in Figure 45d. This instrumentation labeling will be used throughout the results section.

Strain gages were applied to the pipe pile to measure strains during loading; G5 was located on the east side of the pile and G7 was located on the west side of the pile (see Figure 45c); steel strains measured during the testing of PSC1 are shown in Figure 56. Since strain gage G7 was not working properly during the test, only the results from G5 are presented in the figure. Because results from G7 were invalid, strains were recorded from only one gage, and therefore load eccentricity could not be determined.

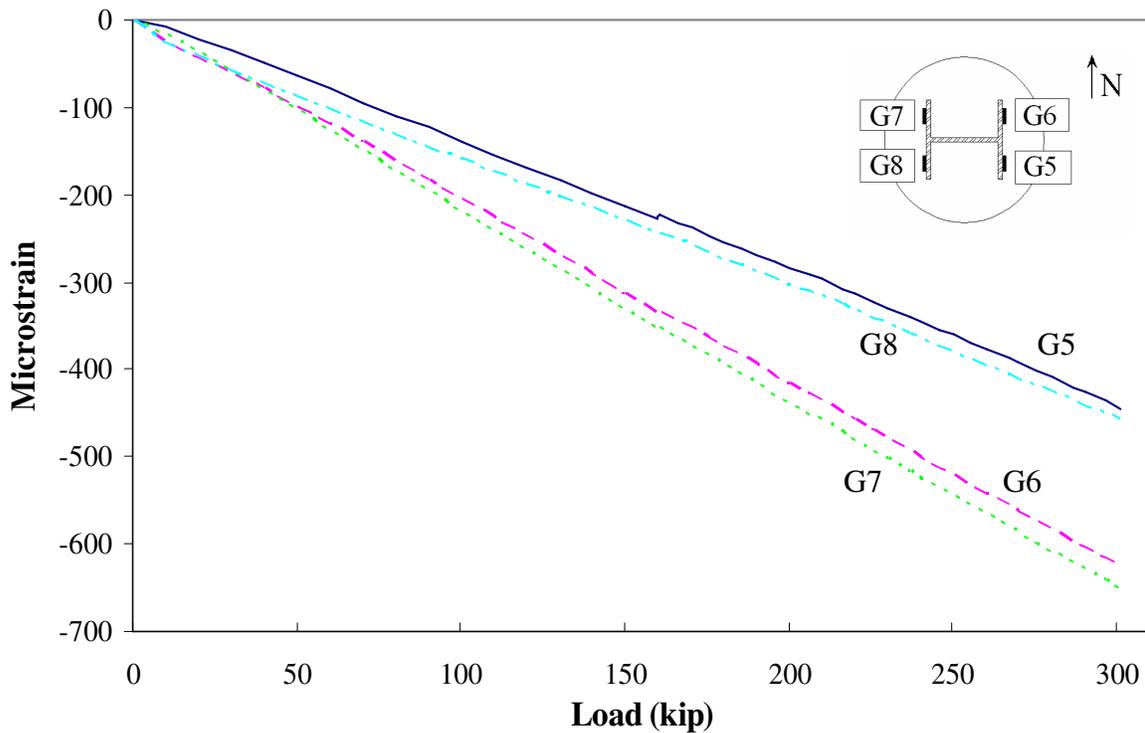
Figure 46. Steel strains for ASC3.

pile strains measured during the testing of ASC3 are presented in Figure 46. The behavior of the H-piles is represented by the measured strain data. Stress data for the pile will not be presented since the stress-strain relationship remains linear throughout testing (i.e. the piles did not yield). For this report, compressive strains and stresses are negative, tensile strains and stresses are positive.

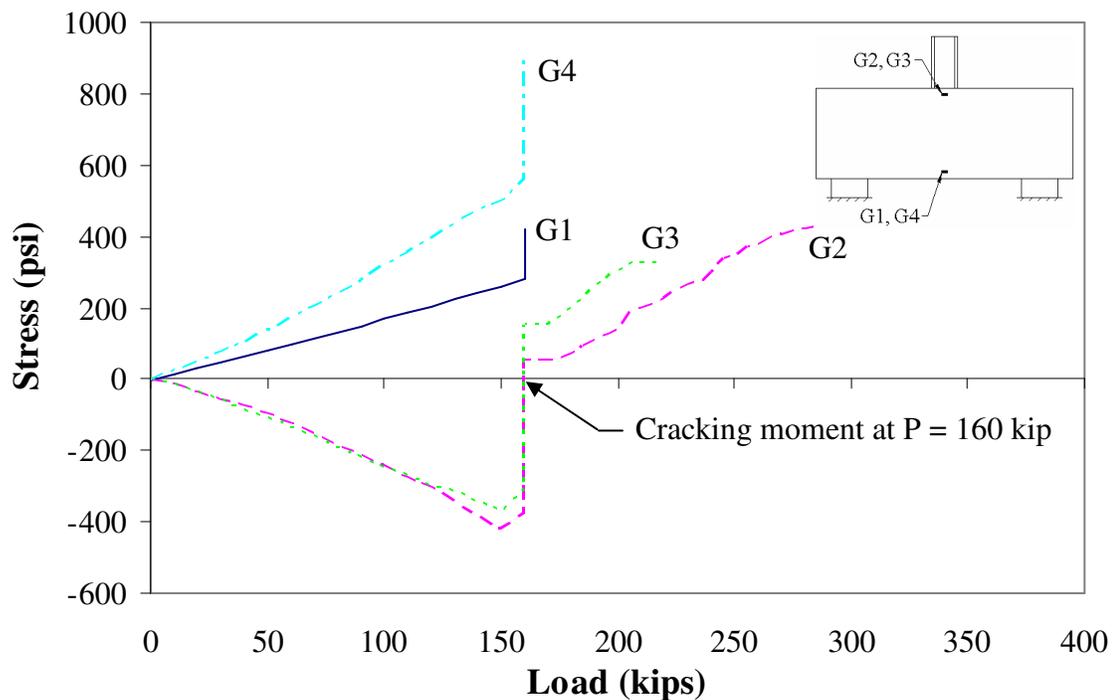
Figure 47. Concrete stresses in ASC3.

There are two distinct trends in the top and bottom specimen stresses that can be seen in Figure 47. At the bottom of the specimen, G1 and G4 indicate only tensile forces in the

concrete at that location for all loads applied. The gages at the top of the specimen, G2 and G3, indicate the concrete is initially in compression, which agrees with simple beam theory. At a load of approximately 160 kip, ASC3 reached the cracking moment capacity of the section and the initial cracks in the sides of the specimen were noticed.

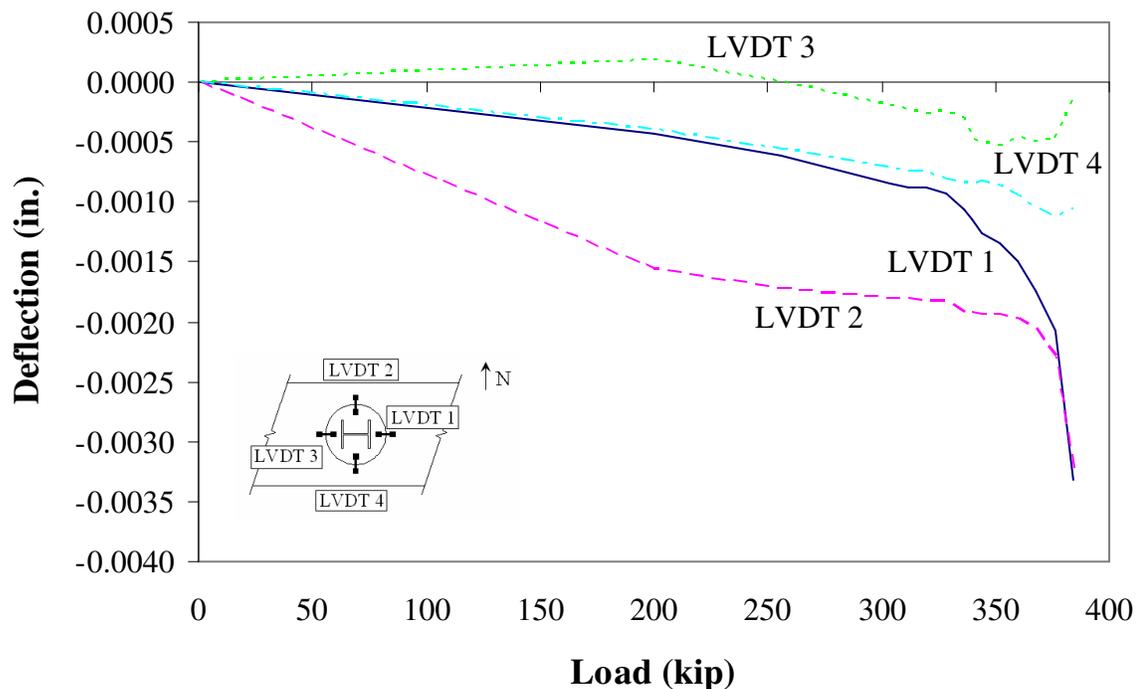
Figure 48. Differential deflection for ASC3.

precision was 0.0005 inches); differential deflections measured during the testing of ASC3 are presented in Figure 48. Note for the LVDTs, negative movement was downward movement. The maximum differential deflection measured on top of ASC3 was -0.0033 inches at the east transducer and slightly less at the north transducer. The transducers at the west and south locations measured -0.001 inches or less.

shown in the two figures, there is a large difference in the magnitude between the differential deflections (Figure 48) and the total deflections (Figure 49). Based on the small magnitude of the measured differential deflection and possible experimental error, shear failure between the precast concrete and the concrete in the CMP was not detected.

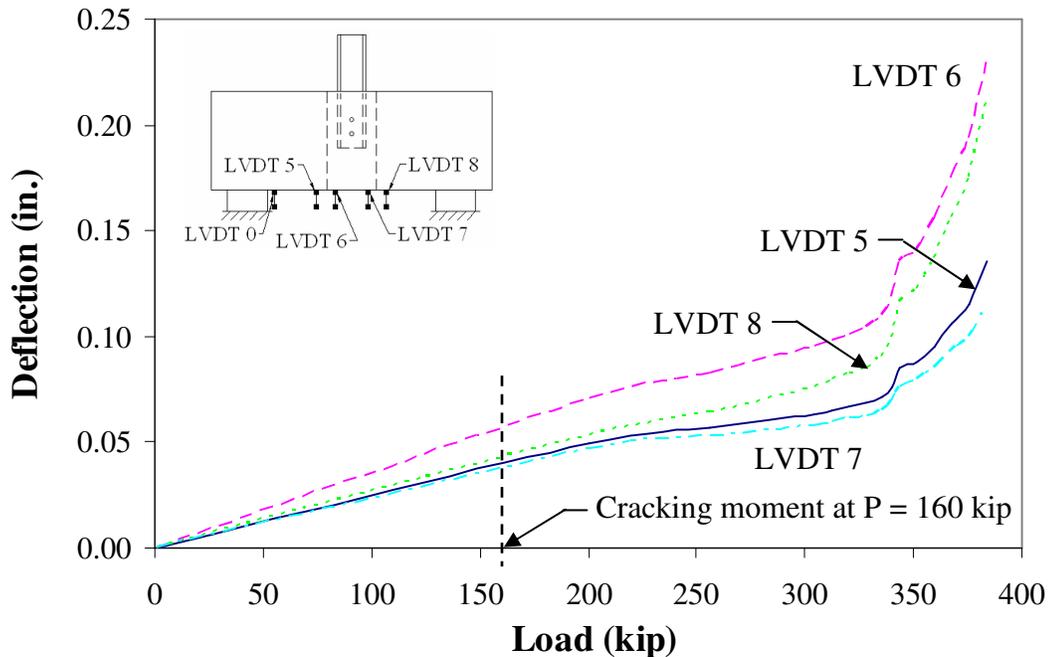
Figure 49. Bottom deflection for ASC3.

Deflections on the bottom of the specimen were found by subtracting the compression of the neoprene bearing pads, measured by the transducer located adjacent to the support (LVDT 0) from the four deflections measured near the center of the specimen. As shown in Figure 49, the largest deflections measured during testing were from LVDT 6 and LVDT 7, the two transducers located closest to the center of the specimen. Deflections measured by LVDT 5 and 8 were further from the center of the specimen and as would be expected, were also smaller than the deflections measured LVDT 6 and 7. As

As shown in Figure 49, the total deflection was linear before the cracking moment was reached. The deflection continued to increase essentially linearly up to an applied load of 340 kip, when the deflection behavior changed. After 340 kip, deflections increased rapidly under a small change in applied load, most likely due to yielding of the tension reinforcement in the specimen. In comparison, the stiffness of the uncracked specimen was approximately 3830 kip/inch, while at failure the stiffness was approximately 400 kip/inch. Based on the criteria that failure occurs when the specimen stiffness decreases by 50% or more, ASC3 failed at the applied load of 384 kip. The specimen failed in flexure, not due to

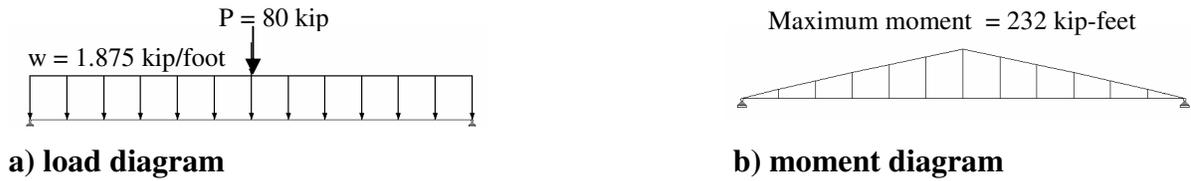
Figure 50. Load and moment diagrams for laboratory tests.

Due to the fact the laboratory specimens were simply supported and the abutments in the field are continuously supported, the loading conditions in the laboratory are more severe than actual conditions. Loading conditions (including self-weight) and moment diagrams for the laboratory specimens and the actual abutments are shown in Figure 50 and Figure 51, respectively. For comparison, the load and moment diagrams were based on a load of 80 kip and the self-weight of the abutment. As shown, the maximum moment resulting from an 80

kip load in the field was only eighty percent of the maximum moment induced by an 80 kip load in the laboratory. Note: moment diagrams are plotted on the compression side.

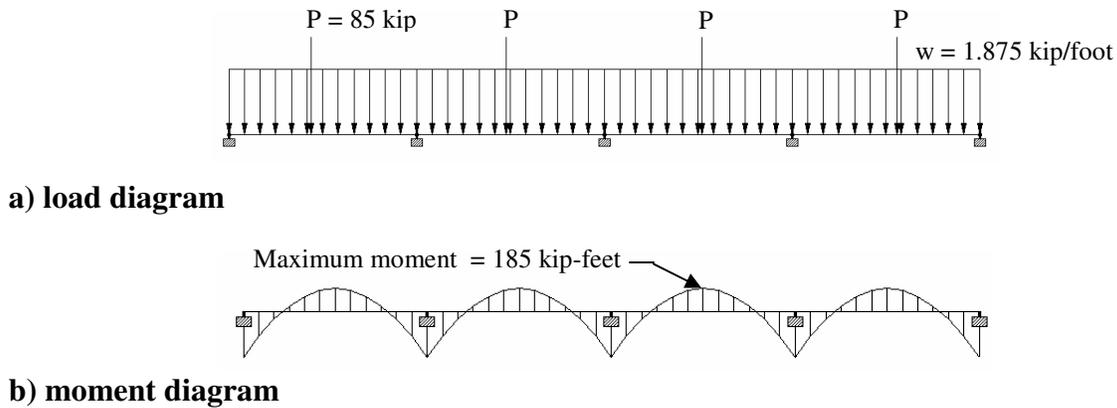
Figure 51. Load and moment diagrams for actual abutment.

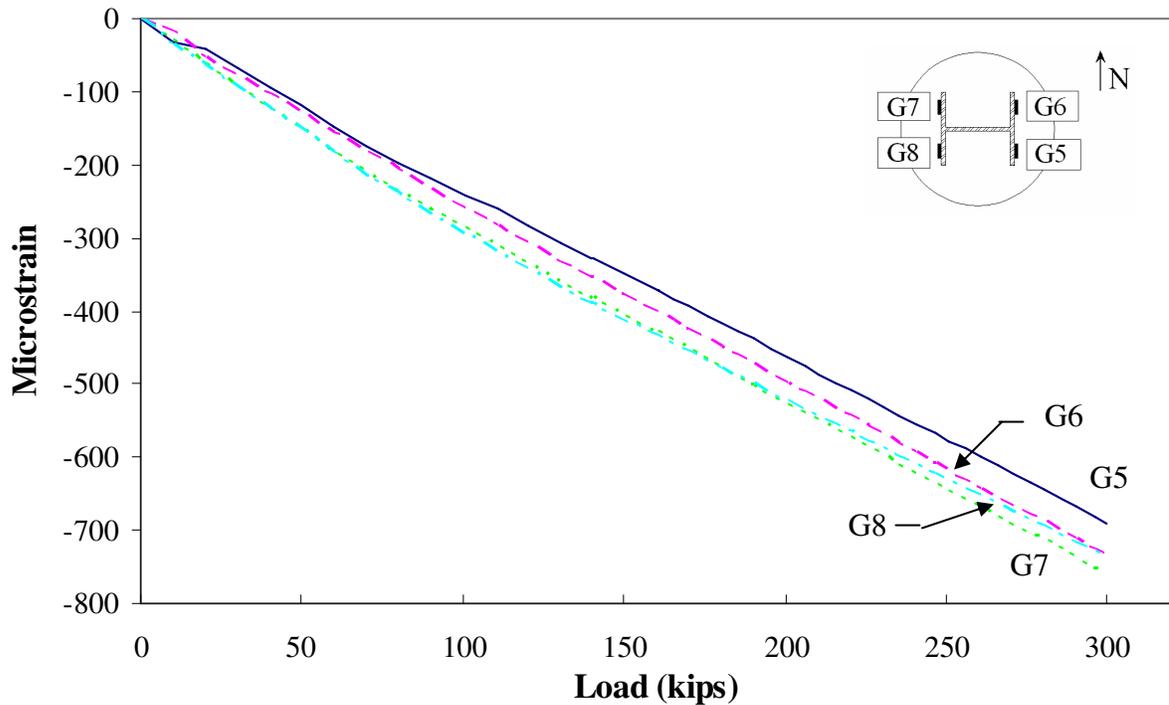
Figure 52. Steel strain for ASO2.

For the offset pile abutments, the steel strain data were analyzed first to ensure even loading; the strains in the steel pile for ASO2 are shown in Figure 52. The difference in strains was less than 100 μ -strain. As previously discussed, the difference in measured strains was due to a slight eccentricity in the axial loading applied to the pile.

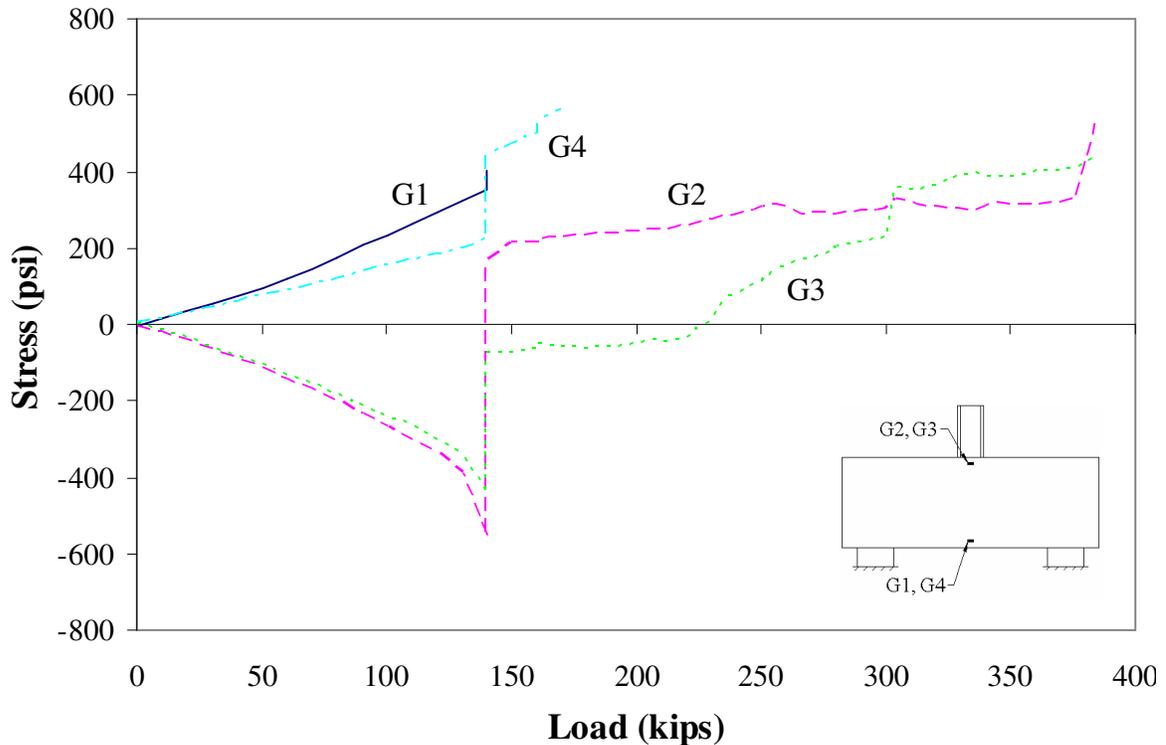
**Figure 53. Concrete stresses in ASO2.**

Hooke's Law was again used to convert concrete strains to stresses while the tensile strength of the concrete as before was assumed to be eight to ten percent of the compressive strength of the concrete. The concrete compressive strength, range of concrete tensile strength, and the calculated modulus of elasticity for each of the offset, single pile abutment tests are presented in Table 12. Concrete stresses for ASO2 are shown in Figure 53.

As can be seen in Figure 53, the stress behavior in the concrete for the offset single pile abutment is similar to the stress behavior in the centered pile specimen previously discussed. A difference in behavior can be seen between the top and the bottom of the specimen. In specimen ASO2, the cracking moment was reached at an applied load of approximately 150 kip. After the cracking moment was reached, the concrete at the top of the specimen displayed tensile stresses, the same as in the centered, single pile abutment.

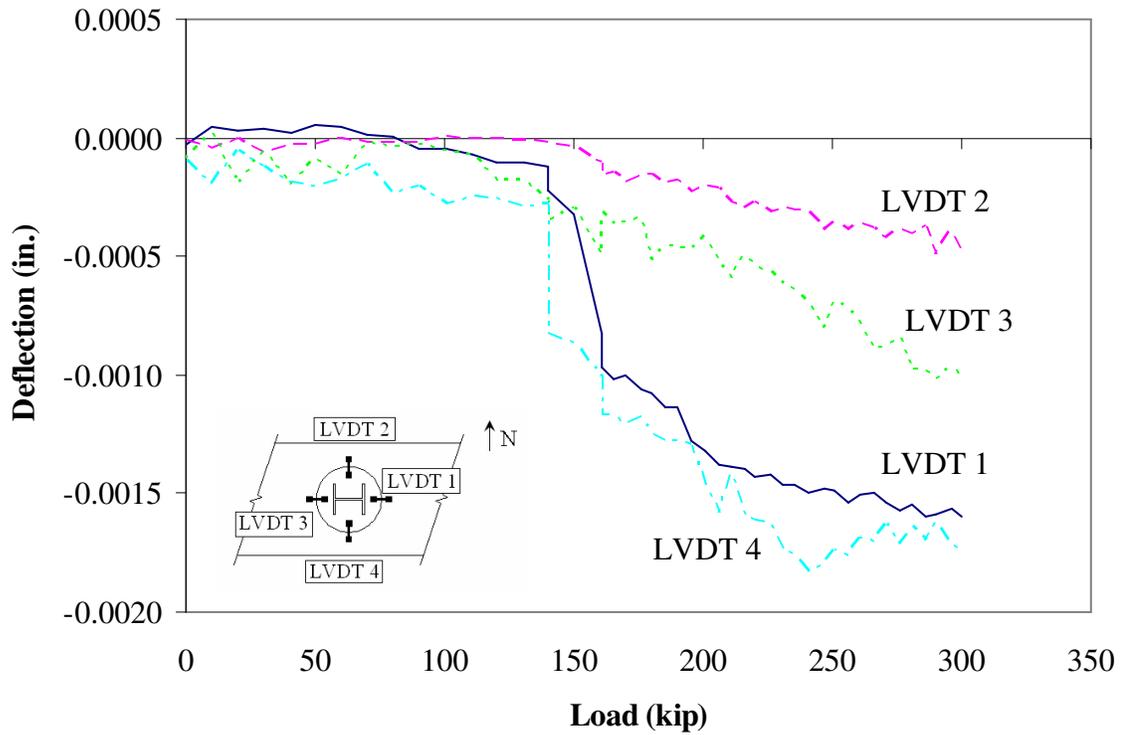
Figure 54. Differential deflection for ASO2.

Differential movements between the precast concrete and the concrete in the CMP were measured using the top deflection transducers in ASO2 and are presented in Figure 54. The maximum differential deflection measured was -0.0018 inches at the south transducer (the concrete in the CMP moved down) and slightly less at the east transducer; the north and west transducers measured less than -0.001 inches of differential movement. The total deflections were calculated using the same procedure as was used in the centered, single pile abutment deflections and are shown in Figure 55.

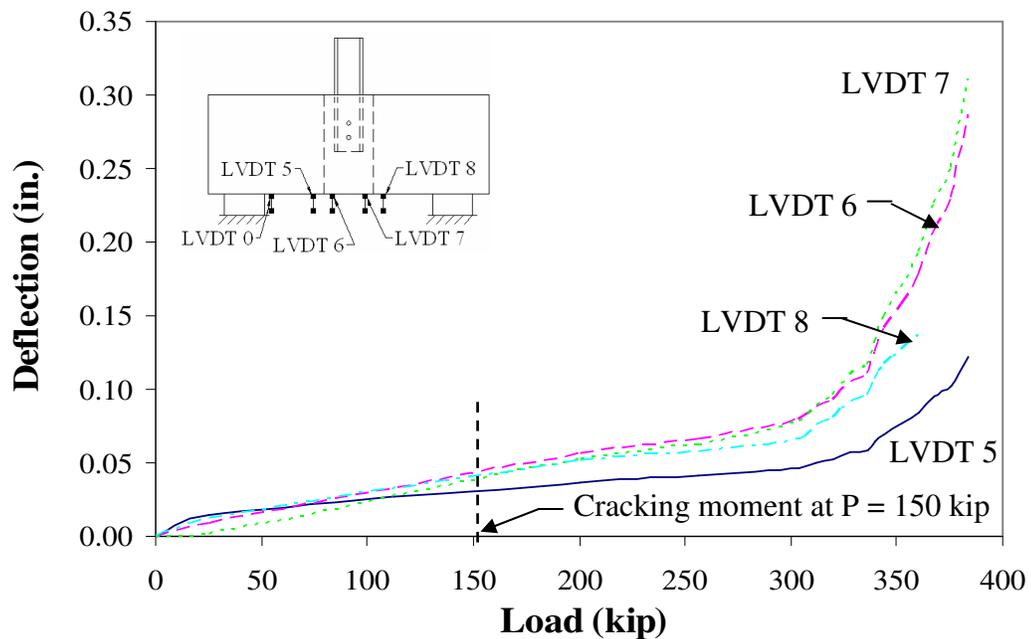
Figure 55. Total deflection for ASO2.

As shown in Figure 55, the total deflection was linear prior to the cracking moment. The linear behavior continued until the applied load approximately reached 300 kip. After

this point, the deflections increased rapidly with a slight increase in the load, similar to the deflection behavior discussed for the centered, single pile specimen. Based on the failure criteria discussed earlier, ASO2 failed at the final load of 384 kip. As with the centered pile specimen, total deflection was due to a combination of flexure and shear.

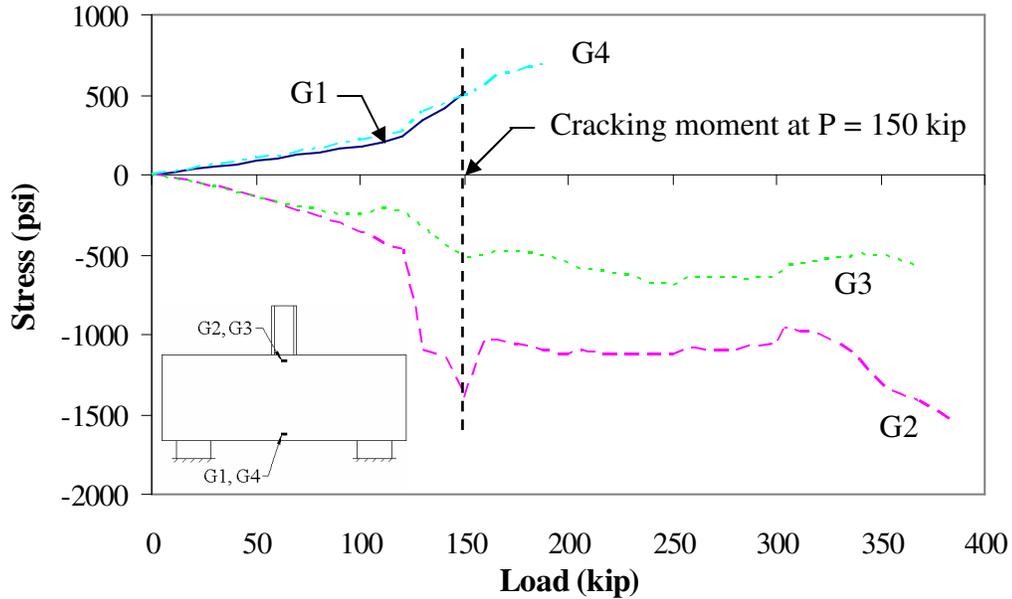
Figure 57. Concrete stresses in PSC1.

As with the abutment sections, the pier cap exhibited two distinctly different stress patterns in the concrete at the top of the specimen and at the bottom of the specimen. However, there is a noticeable difference in the behavior of the pier cap compared to the abutments. As with the abutments during initial loading, the stress at the top of the concrete is in compression and the bottom of the concrete is in tension. After the cracking moment is

reached, the concrete at the top of the pier cap remains in compression and the concrete at the bottom remains in tension, following the expected behavior of the specimen. In comparison, the concrete at the top of the abutment specimen was subjected to tensile stresses immediately after the cracking moment was reached. This indicates the CMP and pile connection had a different effect on the behavior of the section.

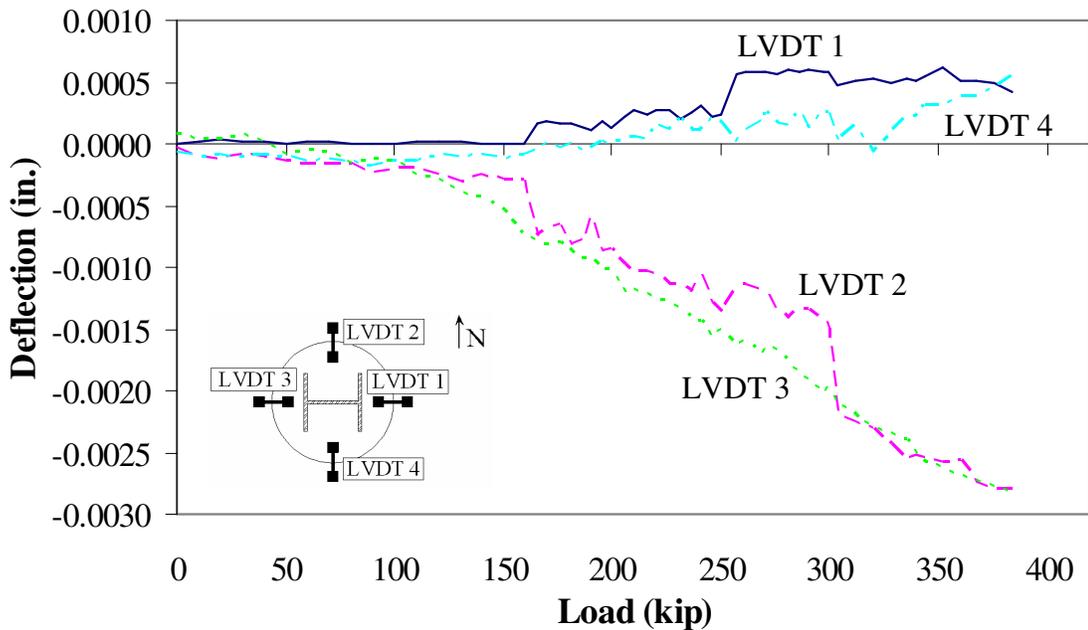
Figure 58. Differential deflection in PSC1.

During loading, the concrete in the CMP did not punch through specimen and there was no movement between the precast concrete and the concrete in the CMP that was noticeable. Deflection transducers on top of the specimen were used to measure any differential movement that may not have been visible; these differential deflections are presented in Figure 58.

The differential deflection measured in the pier cap was similar to the differential deflection measured for the abutments. A maximum deflection of -0.003 inches was measured by the west transducer and was slightly less at the north transducer; the south and

east transducers measured less than 0.0005 inches of total movement, which is the LVDT precision and therefore most likely noise.

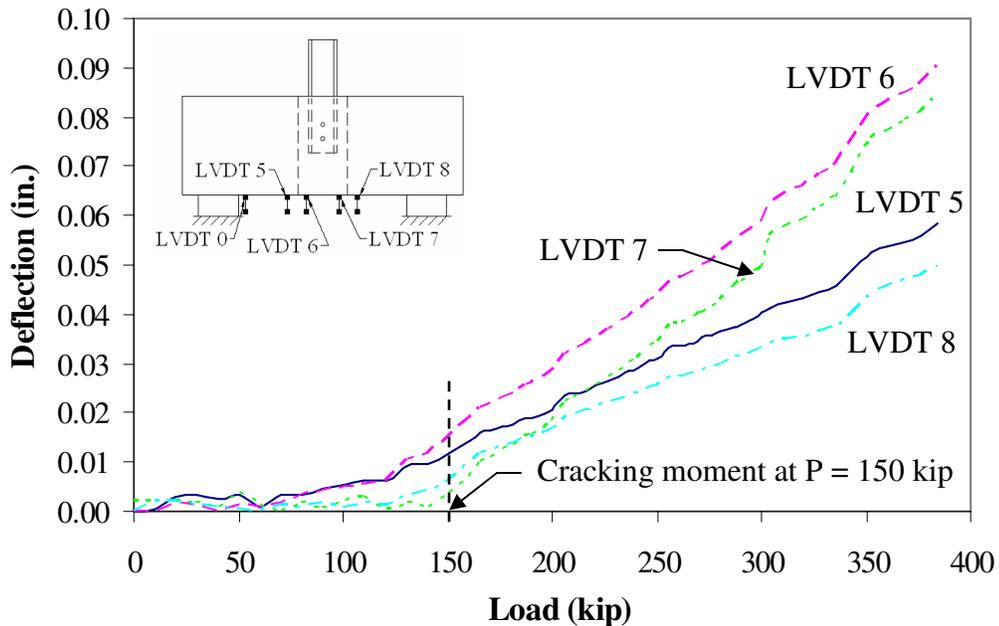
Figure 59. Total deflection in PSC1.

Total deflections were also measured and are presented in Figure 59. To obtain the total deflection of the specimen, the deflection of the neoprene pad was subtracted from the original deflection data taken at the center of the specimen. As Figure 58 and Figure 59 have shown, the differential movement was several orders of magnitude smaller than the total deflections measured.

As shown in Figure 59, the total deflection of PSC1 was relatively small before the cracking moment was reached. After the specimen cracked, the deflection was linear until the maximum load was applied, indicating the reinforcing bars did not yield. The difference in deflections between the abutments and the pier caps will be discussed later in this chapter.

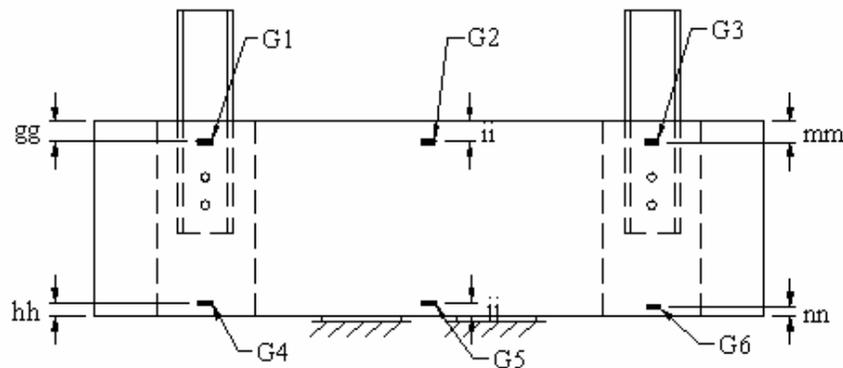
a) north face (nf) strain gage locations

Figure 60. Double pile specimen strain gage instrumentation plan.

Instrumentation was increased for the double pile abutment specimen, requiring a change to the labeling system previously used in the single pile tests. The labels and locations of the strain gages on the concrete are shown in Figure 60. As previously noted, the dimensions for the concrete gages varied slightly based on the quality of the surface of the concrete; those dimensions are presented in Table 6 and Table 7.

As would be expected, the stress data show the concrete at the bottom of the specimen was subjected to compressive stress and the concrete at the top of the specimen was under tensile stress. However, at the center of the specimen, there was no pile connection or CMP, which was the connection and area of interest. Stresses at the east and west piles were examined next and are shown in Figure 67 and Figure 68; see Figure 60 for the strain gage locations applied to the concrete.

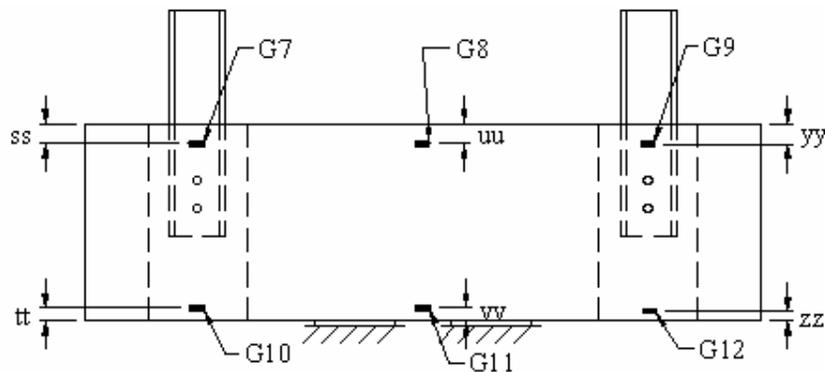
b) south face (sf) strain gage locations

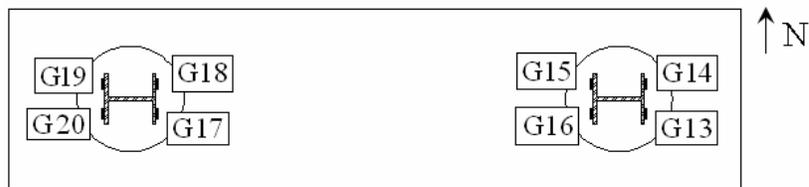
Figure 61. Double pile specimens: identification and location of pile strain gages.

Both piles were instrumented with strain gages, and the pile connection was instrumented with LVDTs to measure differential movement between the precast concrete and the concrete in the CMP. The labels and location of the strain gages on the H-pile and deflection transducers are shown in Figure 61 and Figure 62, respectively. Based on the testing system and support conditions, the total deflection transducers were placed on the bottom outside perimeter of the test specimens. The labels and locations of the total deflection transducers are shown in Figure 63.

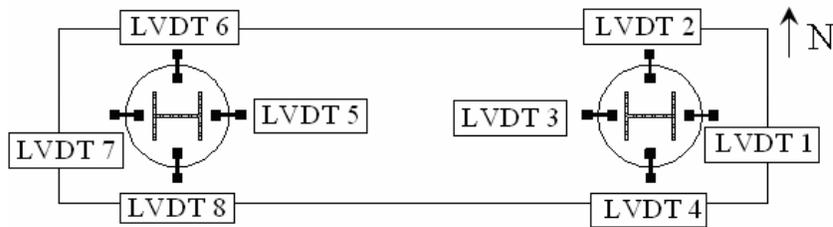
Figure 62. Double pile specimens: identification and location of top deflection transducers.

Deflection transducers were placed near each pile to measure differential movement between the precast concrete and the concrete in the CMP (see Figure 62). Differential movements for the east and west piles are shown in Figure 69 and Figure 70, respectively. The largest movements were measured from LVDT 3 and LVDT 5, the two gages located closest to the supports. Most likely, these two gages were measuring the flexural bending of the specimen along with differential movement. Even if these transducers were measuring differential movement, the maximum deflection measured was approximately 0.001 inches. The other six gages measured less than 0.005 inches, which is the tolerance of the LVDTs and therefore most likely picking up noise.

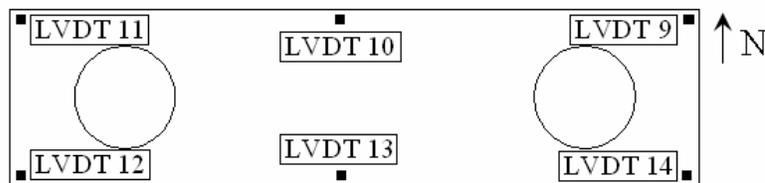
Figure 63. Double pile abutment specimens: identification and location of bottom deflection transducers.

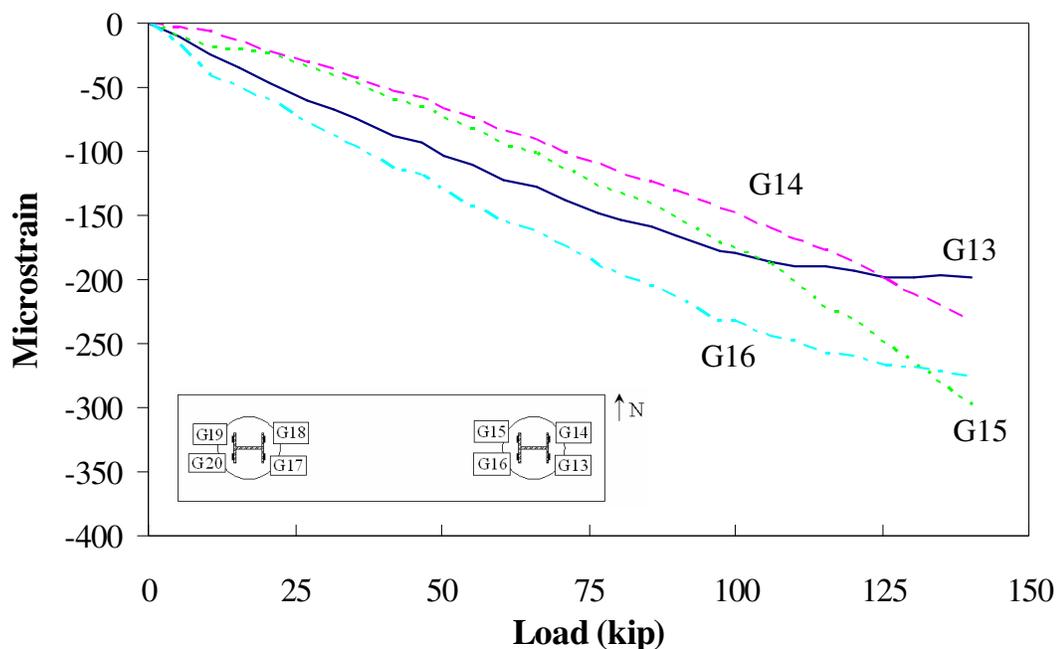
Figure 64. East pile steel strains in ADC1.

One of the difficulties encountered with the double pile test was using two different hydraulic jacks to load the piles at the same rate. The measured strains in the H-piles were analyzed first to ensure even loading between the piles and even load distribution through each pile. Results from the steel pile strain gages for ADC1 are presented in Figure 64 and Figure 65, respectively.

When compared, the magnitude of the strains in the H-piles are relatively similar. The west pile had slightly lower strains, indicating a lower load than the east pile. This agrees with the recorded loads; the east pile had a maximum load of 140 kip and the west pile had a maximum load of 138 kip. The difference in strains in each pile was also analyzed. As previously discussed, the difference in strains was caused by an eccentricity in the pile load.

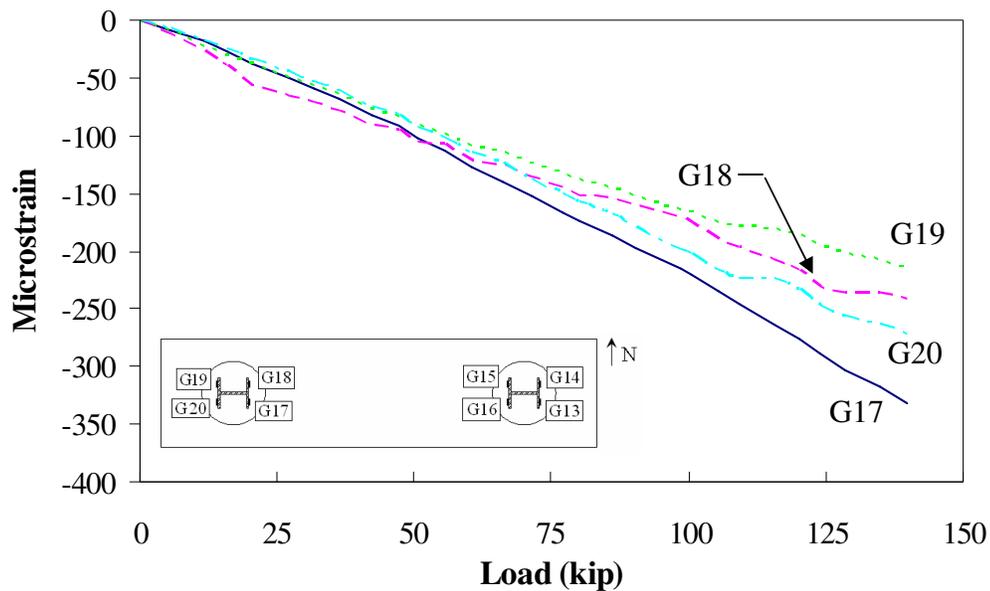
Figure 65. West pile steel strain in ADC1.

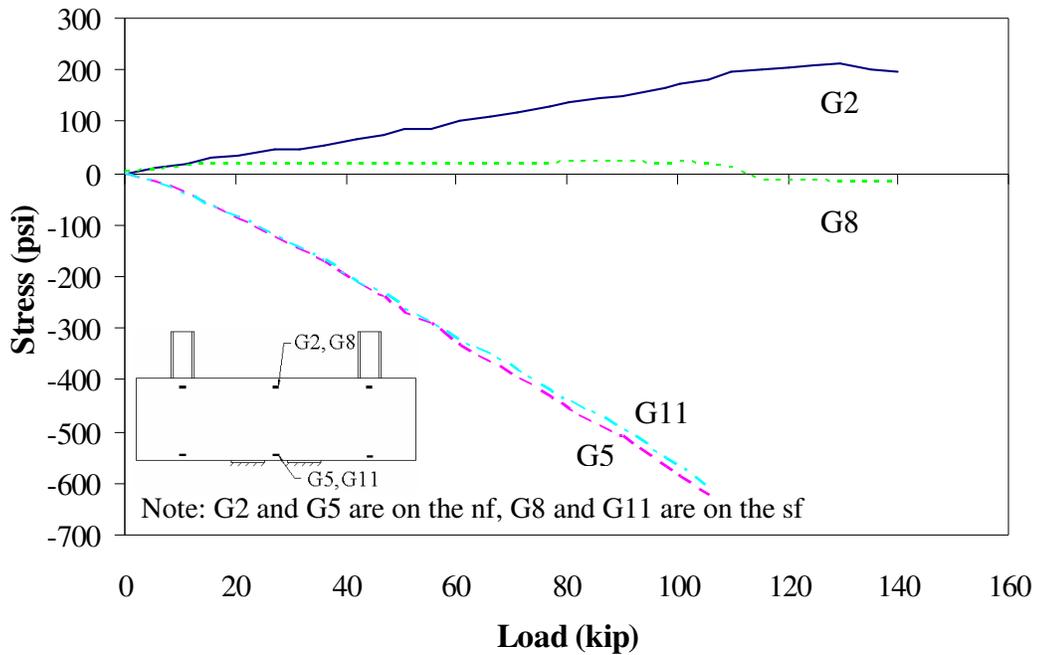
Figure 66. Concrete stresses at the center of ADC1.

Stresses measured in the concrete were examined at three different locations: the center of the specimen, the east pile connection, and the west pile connection. Since both piles were loaded simultaneously, the maximum moment in the abutment occurred between the supports at the center of the specimen; obviously the maximum stresses occurred at this location as well. Concrete stresses at the center of the specimen are shown in Figure 66.
