Laboratory testing of precast bridge elements, verification of post-tensioning forces and construction documentation of the Boone County IBRC accelerated bridge replacement project

**Laboratory testing of precast bridge elements, verification of post-tensioning forces
and construction documentation of the Boone County IBRC accelerated bridge
replacement project**

A thesis submitted to the graduate faculty
in partial fulfillment of the requirements for the degree of
MASTER OF SCIENCE

Major: Civil Engineering (Structural Engineering)

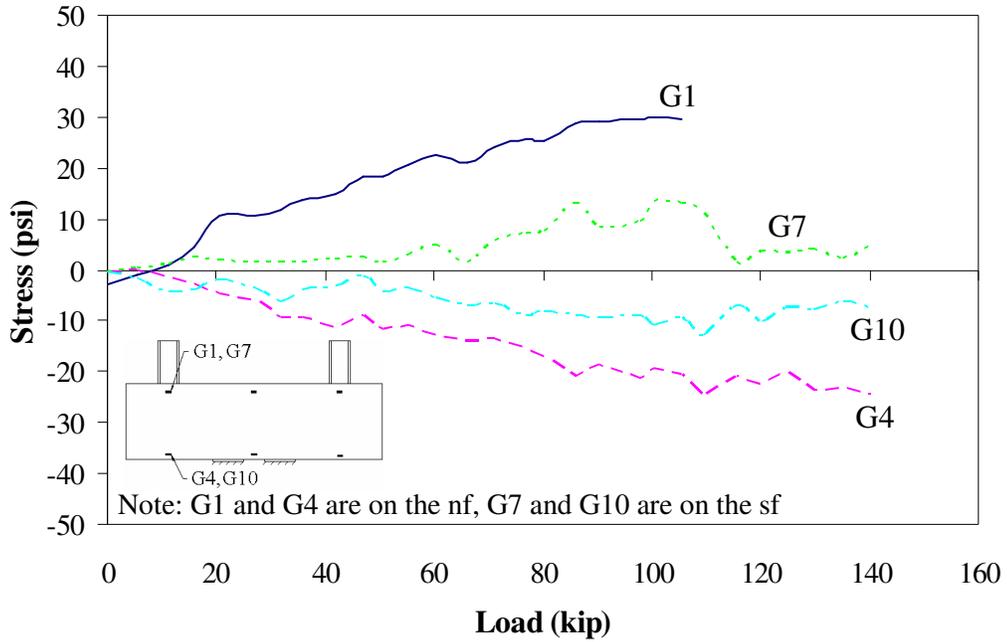
Figure 67. Concrete stresses at the east connection in ADC1.

As would be expected, the stress data show the concrete at the bottom of the specimen was subjected to compressive stress and the concrete at the top of the specimen was under tensile stress. However, at the center of the specimen, there was no pile connection or CMP, which was the connection and area of interest. Stresses at the east and west piles were examined next and are shown in Figure 67 and Figure 68; see Figure 60 for the strain gage locations applied to the concrete.

When comparing the stresses measured at the center of the specimen to the stresses measured at the pile locations, there is one noticeable difference. The levels of stress measured at the pile locations are at least ten times less than the stresses measured at the center of the specimen. Maximum stress measured at the pile locations was approximately 30 psi, for tension and compression. This level of stress is six percent of the tensile strength of the concrete and less than one-half of one percent of the compressive strength of the

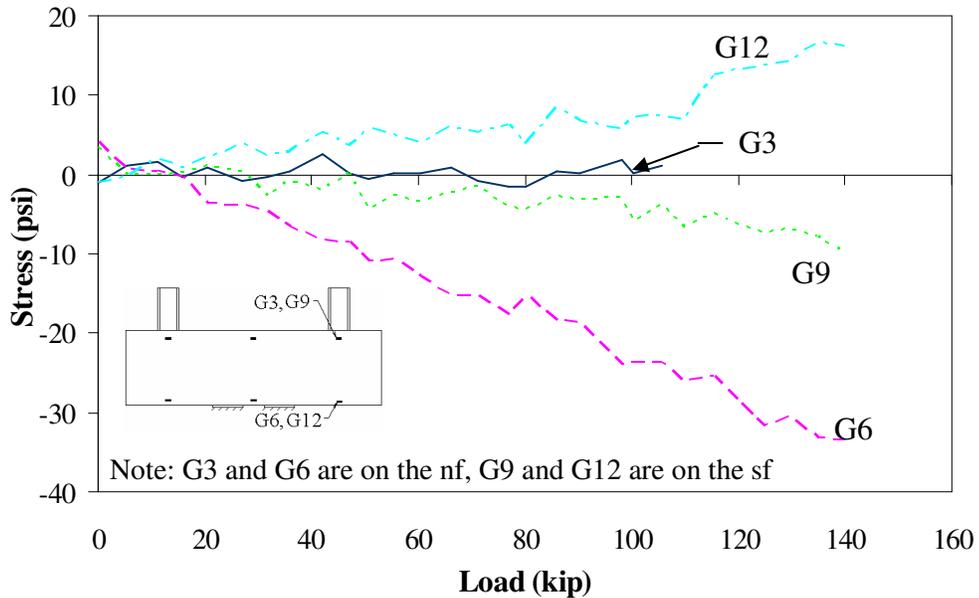
Figure 68. Concrete stresses at the west connection in ADC1.

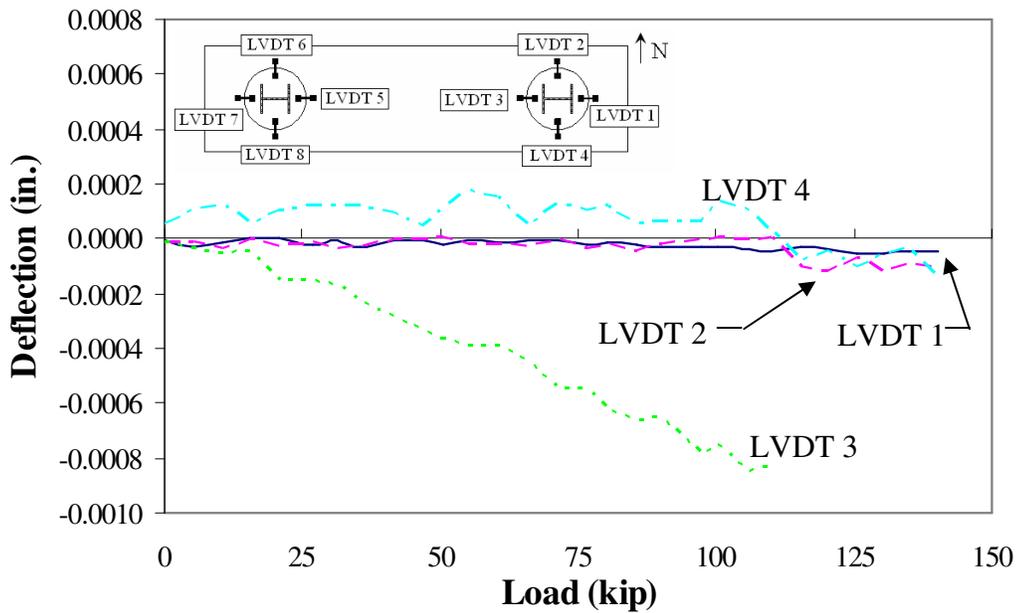
Figure 69. East pile differential deflections for ADC1.

Deflection transducers were placed near each pile to measure differential movement between the precast concrete and the concrete in the CMP (see Figure 62). Differential movements for the east and west piles are shown in Figure 69 and Figure 70, respectively. The largest movements were measured from LVDT 3 and LVDT 5, the two gages located closest to the supports. Most likely, these two gages were measuring the flexural bending of the specimen along with differential movement. Even if these transducers were measuring differential movement, the maximum deflection measured was approximately 0.001 inches. The other six gages measured less than 0.005 inches, which is the tolerance of the LVDTs and therefore most likely picking up noise.

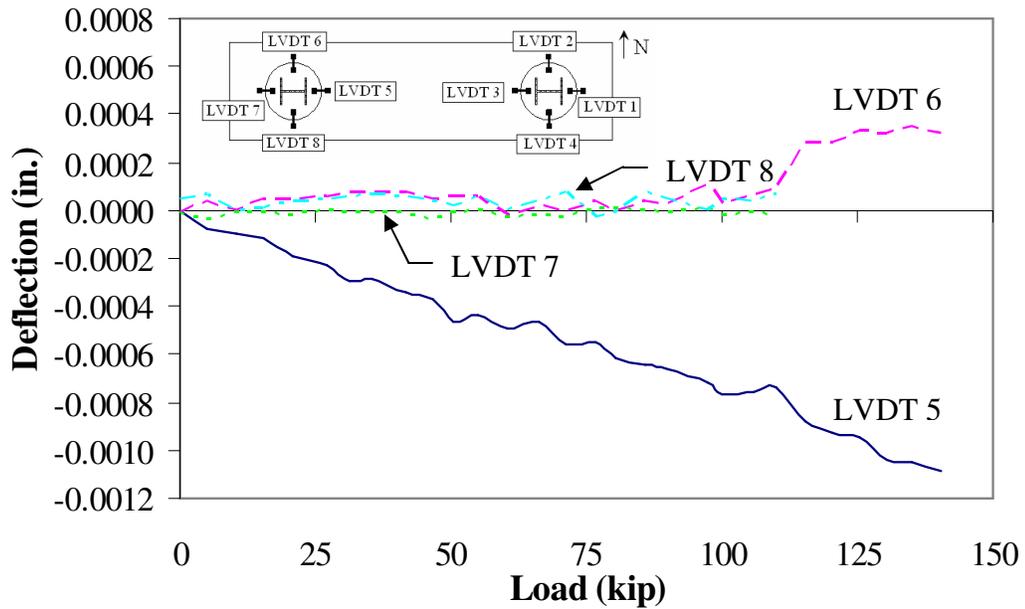
Figure 70. West pile differential deflections for ADC1.

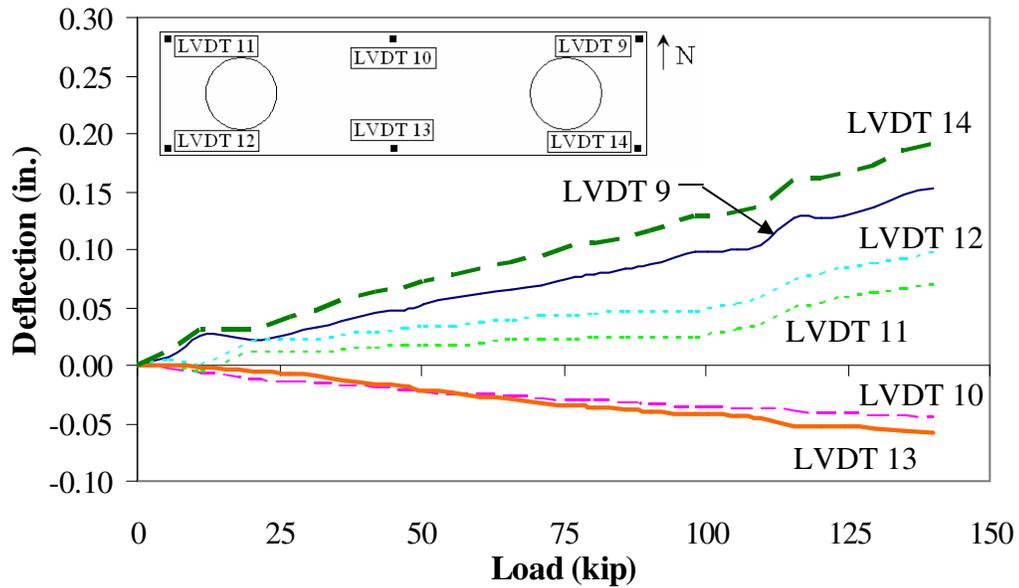
Figure 71. Total deflection of ADC1.

Total deflections of the specimen were also measured and are presented in Figure 71. Total deflection measurements are as expected: at the center of the specimen the specimen deflected upward (positive deflections) and the ends of the specimen deflected downward (negative deflections). In comparison with the total deflections, the magnitude of the differential movements are very small, less than the LVDT precision in six of the transducers. As the figures have shown, the total deflection is two-hundred times greater than the differential movement.

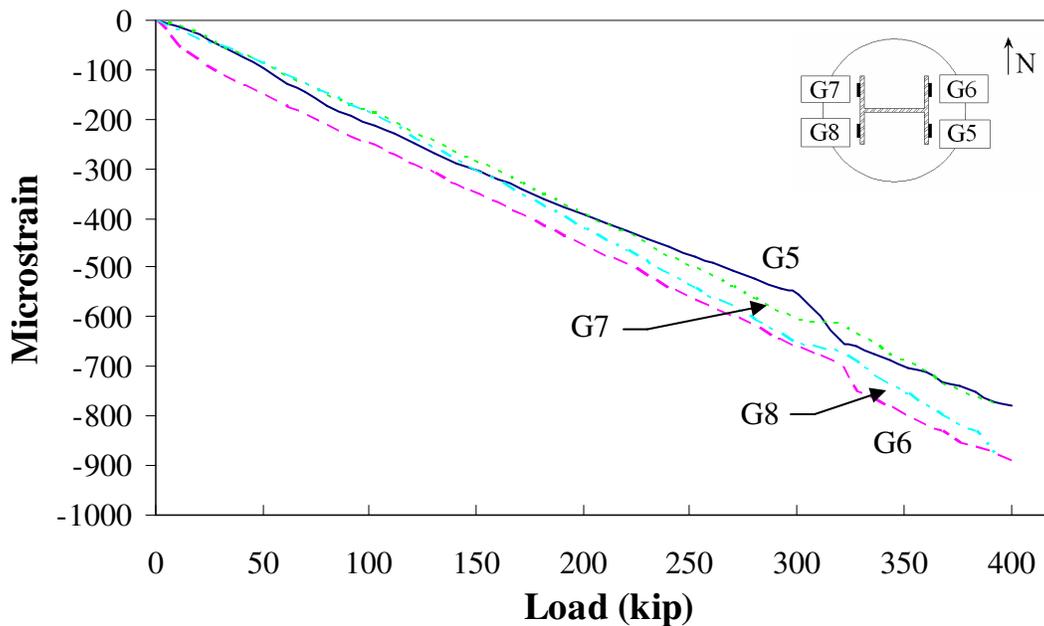
Figure 72. H-pile steel strains for Test 1, specimen ADC1.

Steel pile strains were first analyzed; strains for Test 1 are relatively linear as can be seen in Figure 72. There was a slight anomaly that occurred around 300 kip in two gages, which was likely due to unloading and reloading required since the load cell only had a capacity of 300 kip. Shortly after the load was reapplied, the strains stabilized and continued with the previous trend. There was a slight difference in the strains measured; the greatest difference was less than 150 μ -strain between gages G5 and G6. This was due to an eccentricity in the pile load, which has been previously discussed.

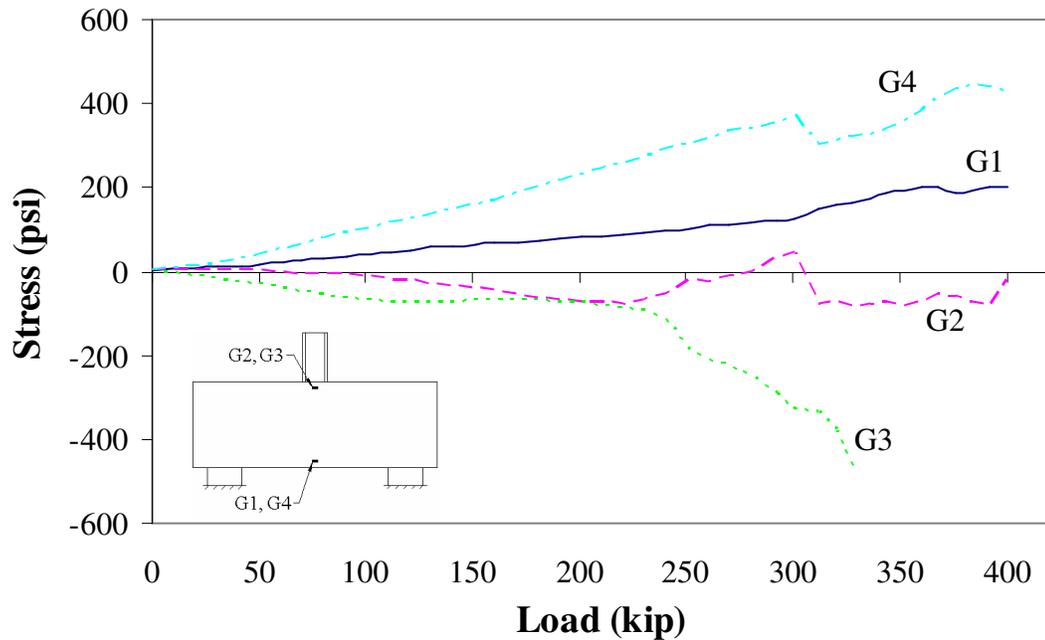
Figure 73. Concrete stresses for Test 1, specimen ADC1.

The strain gages on the concrete used in the double pile testing were reused for the shear testing. Strain data were converted into stresses using Hooke's law; ADC1 strength parameters and modulus of elasticity were used for shear Tests 1 and 2 and ADC2 strength parameters and modulus of elasticity were used for shear Tests 3 and 4. Concrete stresses occurring in shear Test 1 are shown in Figure 73.

Concrete located at the top of the specimen experienced low levels of compressive stresses - less than one-tenth of the compressive strength of the concrete. At the bottom of the specimen, the concrete was subjected to tensile stresses less than the tensile strength of the concrete (650 psi), thus the concrete did not crack. This is consistent with the fact no cracks were observed during the shear test in any of the connections. Even though no visible sign of differential movement were noticed during testing, the differential movements measured by the top deflection transducers, presented in Figure 74, were analyzed.

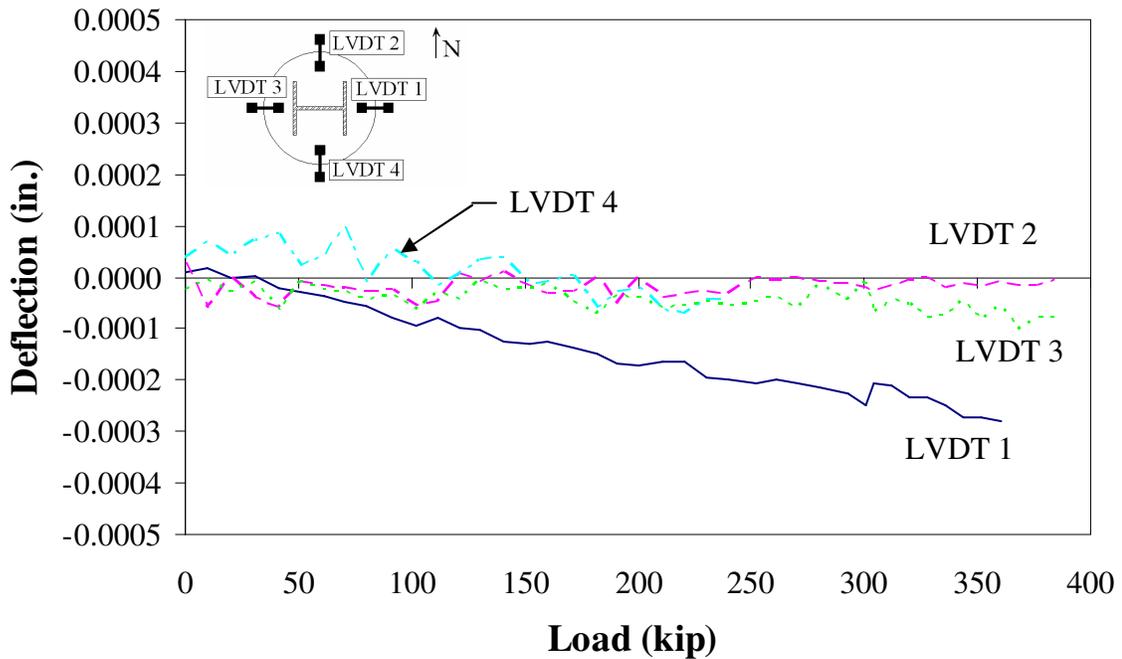
Figure 74. Top deflection for Shear Test 1, specimen ADC1.

Differential deflections measured during Test 1 were less than 0.0003 inches for all transducers, which were less than the precision of the LVDT (0.0005 inches). Since the differential deflections measured were less than the transducer precision, the measurements

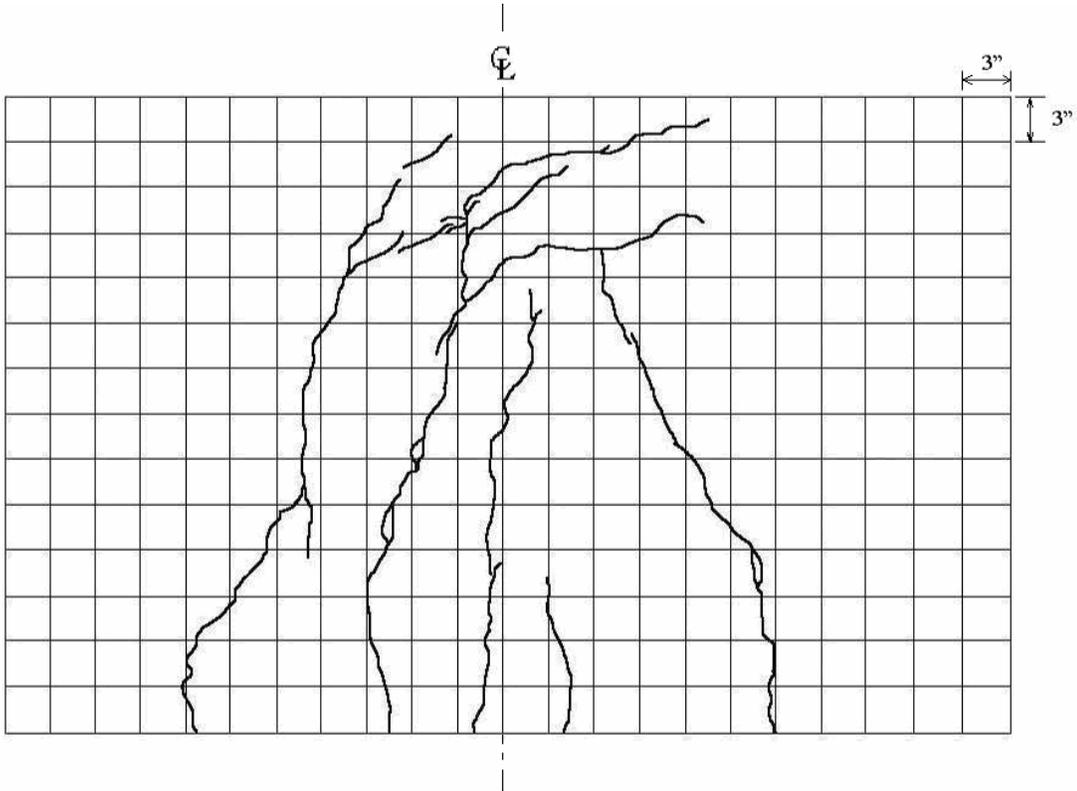
Figure 75. ASC3 crack pattern, north face.

While the pier cap specimen and the abutment specimens were loaded to approximately the same load, the stresses in the concrete and the crack patterns in the tested specimens indicate different behaviors. The crack pattern for ASC3 is shown in Figure 75 while the crack pattern for the PSC1 is presented in Figure 76. Note the cracks were scaled off the actual specimens using a three inch by three inch grid; thus the crack patterns shown are to scale.

When comparing the two crack patterns, one sees two main differences in the way each specimen cracked under load. Cracks in the abutment (shown in Figure 75) started as flexural cracks, but as the cracks progresses to the top twelve inches of the concrete, the cracks changes direction. Instead of pure flexural cracks, the cracks become almost horizontal, and appear to follow the same slope as the CMP cast in the concrete. The angle of incline of the CMP was measured to be approximately twenty-five degrees; the abutment crack pattern is compared to the angle of incline of the CMP in Figure 77.

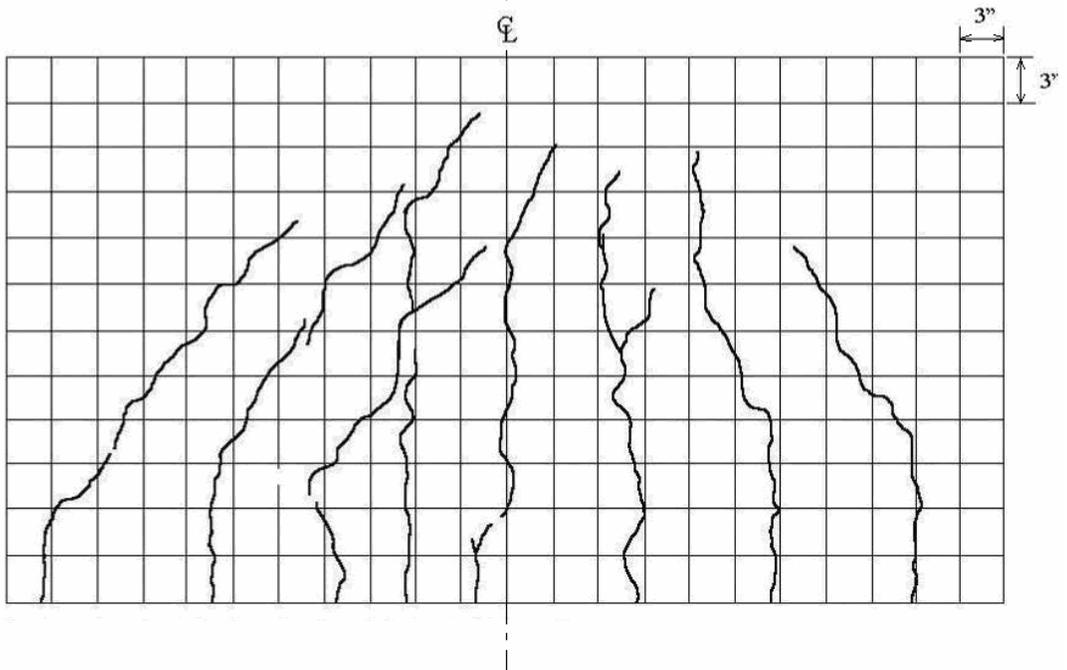
Figure 76. PSC1 crack pattern, north face.

In the pier cap, there are no cracks that followed this angled behavior. The pier cap crack pattern reflects flexural bending, which agrees with the stresses measured in the concrete. As shown in Figure 57, the concrete at the top of the specimen was subjected to compressive stresses while the concrete at the bottom of the specimen was subjected to compressive stresses, which correlate with flexural bending.

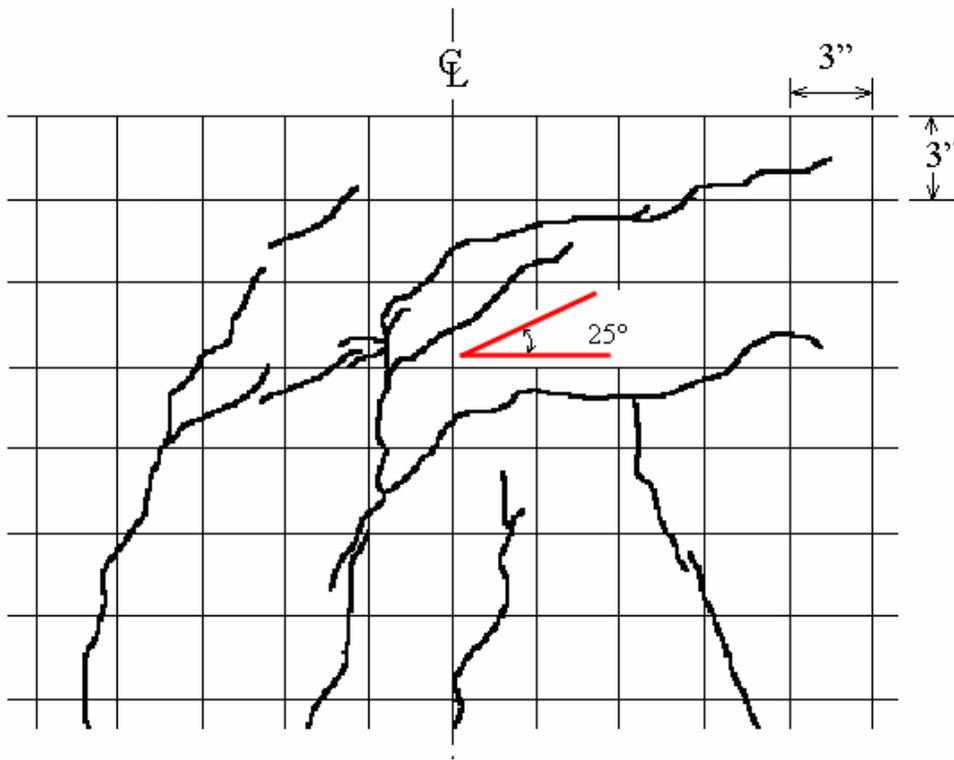
Figure 77. Abutment crack pattern compared with the CMP angle of incline.

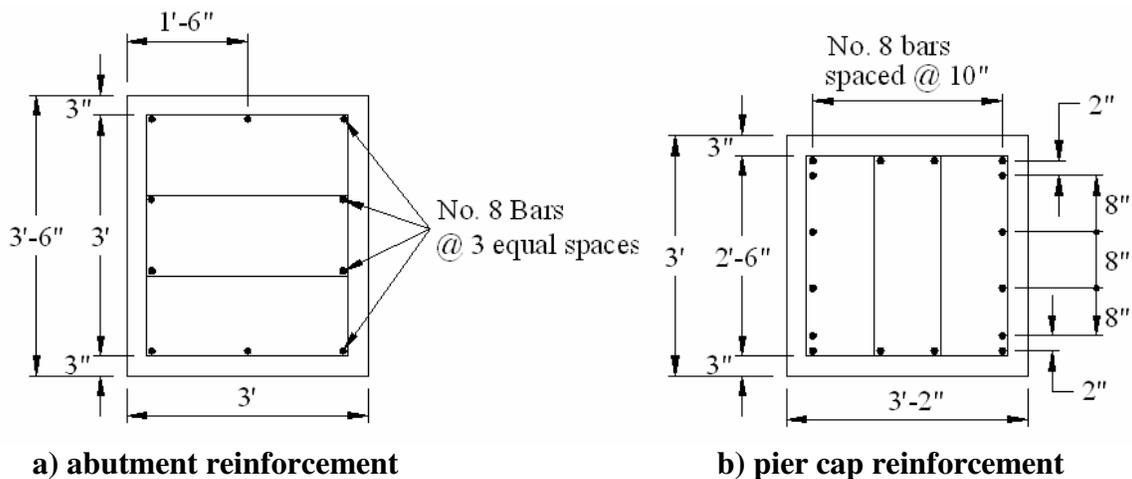
Figure 78. Comparison of the reinforcement used in the abutments and the pier caps.

The abutment specimens and pier caps were close in size and were loaded to approximately the same maximum load. To determine the reason for the differences in the behaviors of the abutment and pier cap, the reinforcement used in each specimen (shown in Figure 78) was compared.

As shown in Figure 78, the pier cap has a slightly smaller gross area of concrete ($1,368 \text{ in}^2$ versus $1,512 \text{ in}^2$) than the abutment, but it has six additional No. 8 longitudinal bars. Spacing for the transverse reinforcement in the pier cap was almost half that in the abutment transverse reinforcement. To better compare the reinforcement in each section,

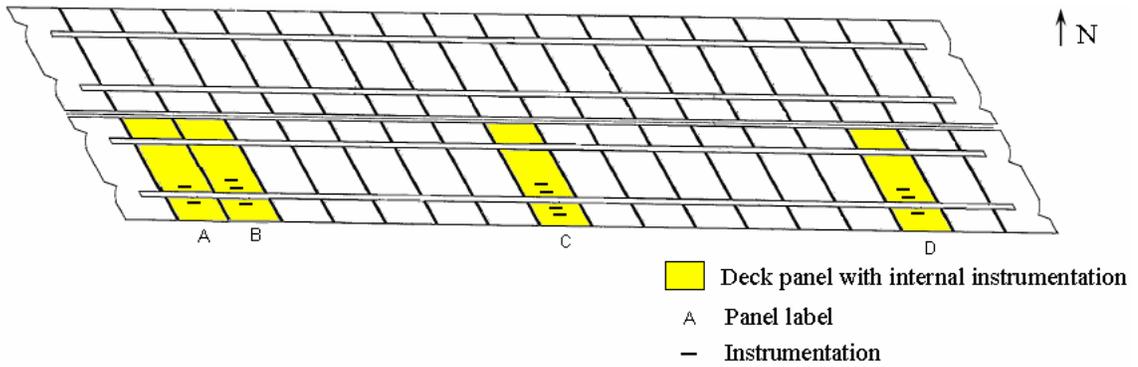
Figure 79. Location of instrumented panels.

Before the deck panels were cast, a total of twelve vibrating wire gages (VWG) were embedded in four of the deck panels so that strains in each of the panels could be measured during the post-tensioning operation. The strain data were then converted to deck panel stresses using Hooke's law. Location of the instrumented panels (Panels A, B, C, and D) and the number of gages in each panel are shown in Figure 79.

to see how the stresses were distributed, twelve gages as shown in Figure 79, were placed in four deck panels located in the south half of the bridge. Strain data recorded directly with the hand-held data collector were obtained for each of the VWGs and were converted to stresses using the modulus of elasticity of the concrete deck panels. To determine the modulus of elasticity, the average compressive strength of the deck panels prior to delivery was used. The modulus of elasticity, calculated using a concrete strength of 6,800 psi and the relationship provided in Section 5.4.2.4 of the AASHTO LRFD Bridge Design Specification (1996), used for all of the stress calculations was 4,700 ksi.

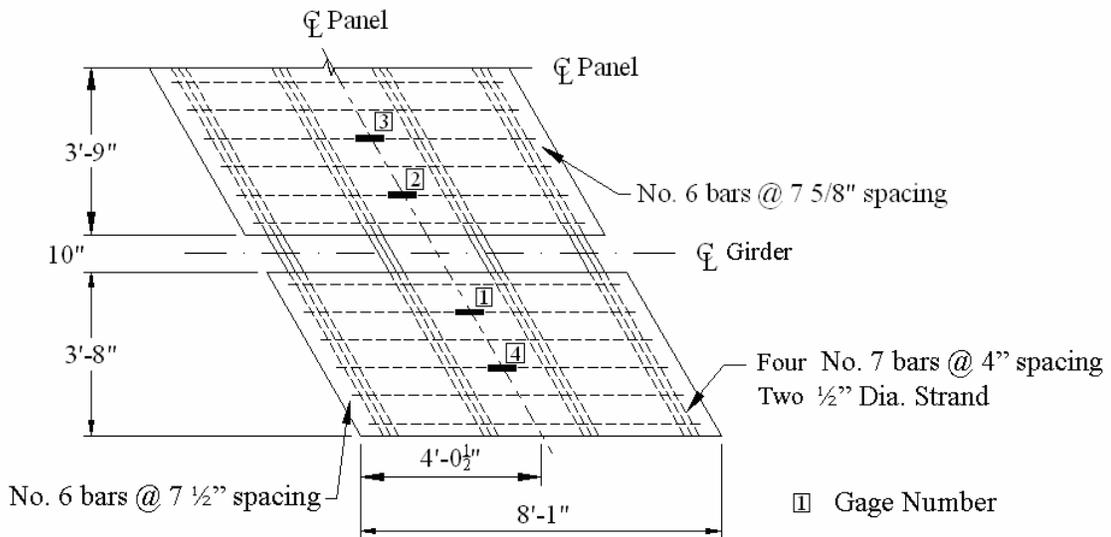
Figure 80. Deck panel internal instrumentation.

The instrumentation was concentrated around the southern-most post-tensioning channel. Gage identification and location is presented in Figure 80; the number of gages in each deck panel varied with the location of the panel. To simplify the comparison of the deck results, the numbering system for the deck panel gages was kept consistent between the panels. For example, gages A1, B1, C1 and D1 were all located at Position 1. Number and location of the gages embedded in each of the four panels are presented in Table 21; the gage number corresponds to the positions shown in Figure 80.

highest in the panel closest to the post-tensioning operation. To compare the stress distribution between the instrumented panels, Gage locations 1, 2 and 3 (see Figure 80) were compared; since there was only one gage at Location 4, no comparison was made.

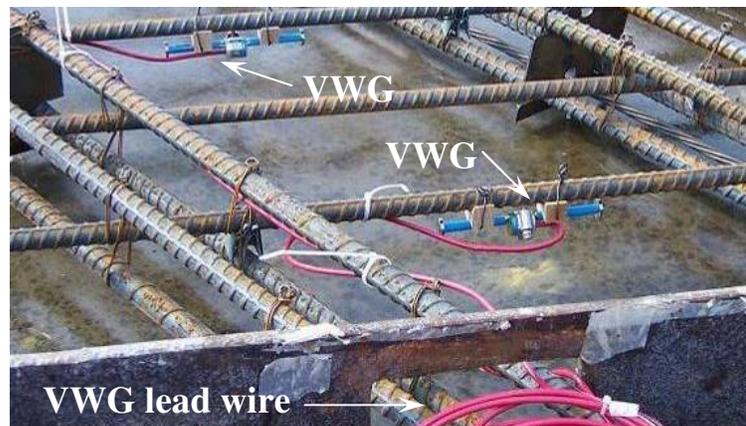
Figure 81. Deck panel vibrating wire gages.

The lead wires for the gages were threaded through the panel formwork and secured in the post-tensioning channel during casting and transportation of the panels. This allowed access to the wires from the deck for testing. Two of the VWGs attached to the panel reinforcement are shown in Figure 81 before the panel was cast. The gage lead wires can also be seen threaded through the formwork and secured in a channel in this figure as well.

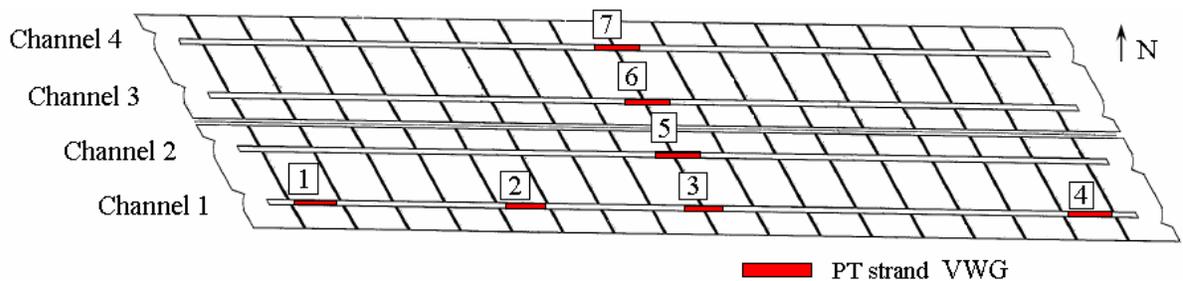
Figure 82. Post-tensioning VBG locations.

As shown in Figure 82, seven VWGs were used on the post-tensioning strand. Gages (No. 3, 5, 6, and 7) were placed on the top center strand in each of the post-tensioning channels at the center of the bridge, approximately three and one half inches below the

surface of the deck panel. Three additional gages (No. 1, 2, and 4) were placed along the strand previously instrumented in Channel 1. A VWG was placed one foot from the exterior edge of the first interior panel at both ends of the bridge. Another VWG was placed directly over the west pier, closest to the ‘live’ end of the jacking operation.

The corrected change in length was calculated and then converted into strain based on a gage length of 7 ½ inches; strains were converted in stresses using an elastic modulus of 28,500 ksi, based on the PCI Design Handbook (2004) elastic modulus for 0.6-inch diameter strand with a yield stress of 270 ksi. Finally, the stress was converted into force using the area of the 0.6-inch diameter strand (0.217 in²). The corrected change in length, strain, stress and force in each strand for each of the gages (Gage 1 – Gage 7) are presented in Table 23 through Table 29. Recall the location of the strand gages were identified in Figure 82.

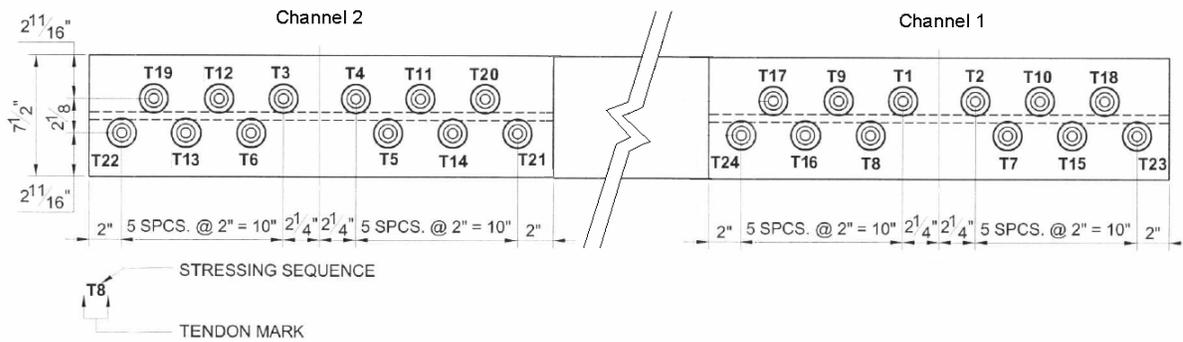
Figure 83. Post-tensioning stressing sequence (looking east).

for the south half of the bridge deck is presented in Figure 83. Instrumenting the initial strand stressed provides post-tensioning loss data throughout the entire stressing sequence.

While stressing the north half of the bridge, a construction error was noticed. The anchor plates shown in Figure 83 were inverted during fabrication at the precast plant in Channel 3 and Channel 4. Thus, instead of post-tensioning the top interior strands first, the bottom interior strands were initially stressed; the stressing sequence used for the north half of the bridge is shown in Figure 87.

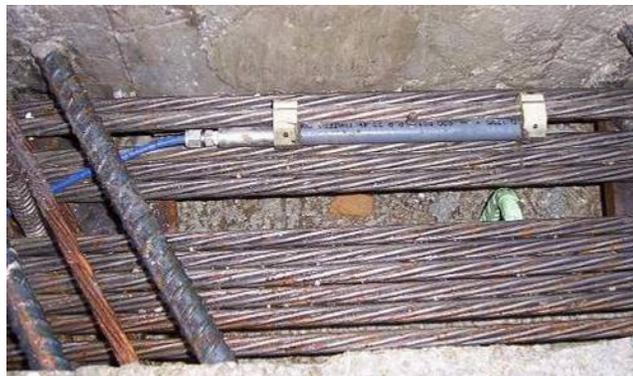
Figure 84. PT strand vibrating wire gage.

The south half of the bridge (Channel 1 and Channel 2), which contained the majority of the panel and strand instrumentation, was stressed first. Since a single jack was used for all of the stressing, the contractor had to alternate between channels while post-tensioning (i.e. T1 and T2 in Channel 1, T3 through T6 in Channel 2, etc.). One of the VWGs attached to the post-tensioning strand is shown in Figure 84.

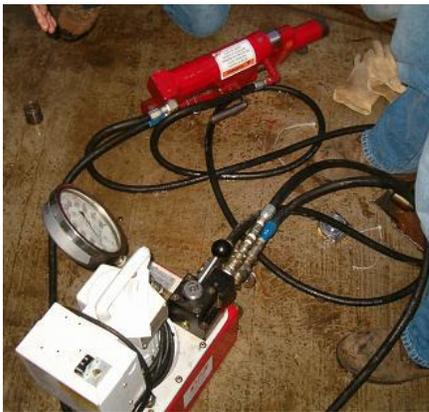
a) Mono-strand jack and hydraulic pump

Figure 85. Mono-strand jack used for post-tensioning.

The entire post-tensioning process took approximately four hours. The mono-strand jack used for post-tensioning can be seen in Figure 85. The two halves of the bridge, which were post-tensioned separately, acted independently since the longitudinal joint connecting

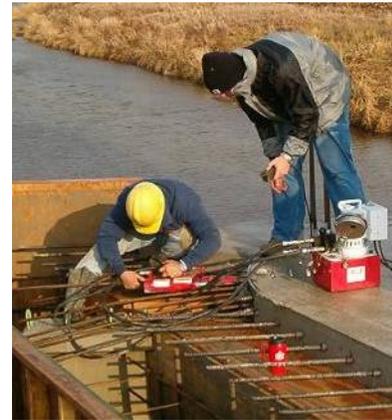
b) Mono-strand jack in use

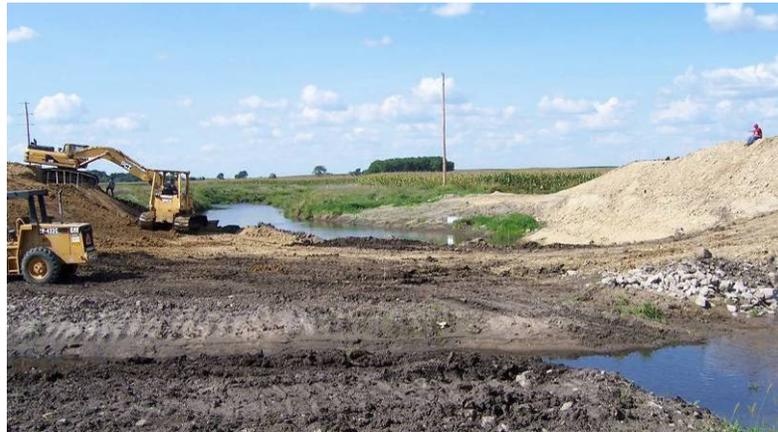
Figure 107. West bridge abutment site prepped for pile driving, September 5.

When the access road was replaced, the contractor removed the original sixteen-inch culvert pipe that was placed under the access road and replaced it with large rock overlaid by sand and gravel. Grading and earth work continued until the bridge abutment locations were properly prepared for pile driving; the bridge site on September 5, 2006 with the west end of the bridge site graded and leveled for pile driving is shown in Figure 107.

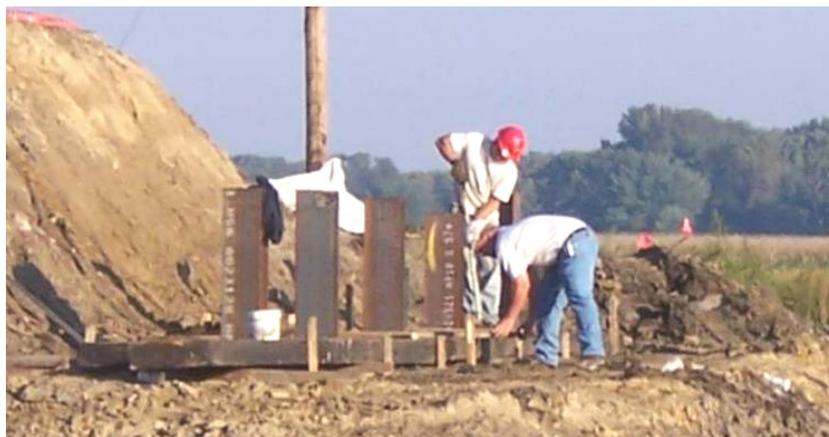
Figure 109. West abutment piles, driven and channels being blocked, September 15.

surface for placement of the precast abutments. To ensure the channels were welded at the correct elevation, survey equipment was used. One of the piles on the west bank was driven incorrectly; the pile (which will be shown later) was rotated 90° from what the plans specified. Steel channels on the west end of the bridge before being blocked up to the correct elevation are shown in Figure 109.

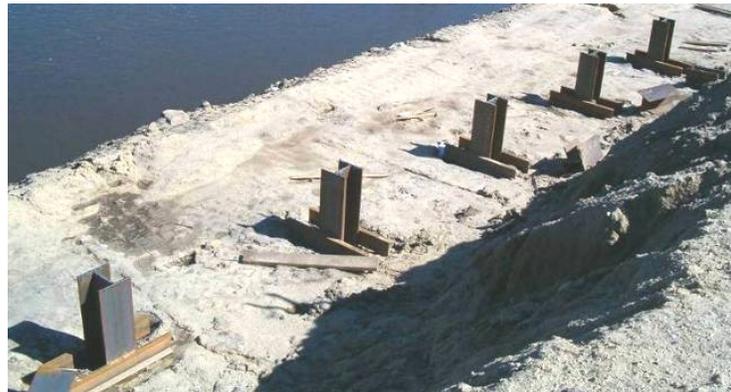
Figure 112. West abutment piles after wood blocking was removed, September 20.

were welded in place, the wooden blocking was removed (see Figure 112). Note in Figure 112 the north-most pile, as previously noted, was driven incorrectly; this error required the channels to be positioned parallel to the longitudinal axis of the abutment, instead of perpendicular.

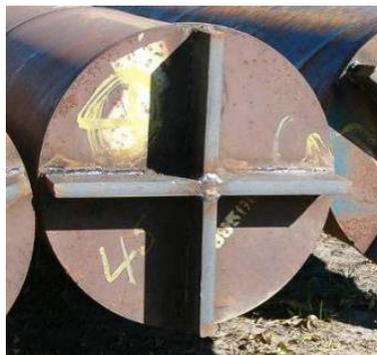
Figure 113. Steel pipe pile driving point, September 28.

The pipe piling for the west pier was driven on September 27 and 28. Each of the piers had nine, 16-inch diameter, closed-end steel pipe piles which were fitted with a pile point (shown in Figure 113) to make driving the piles easier and to prevent damage to the pile.

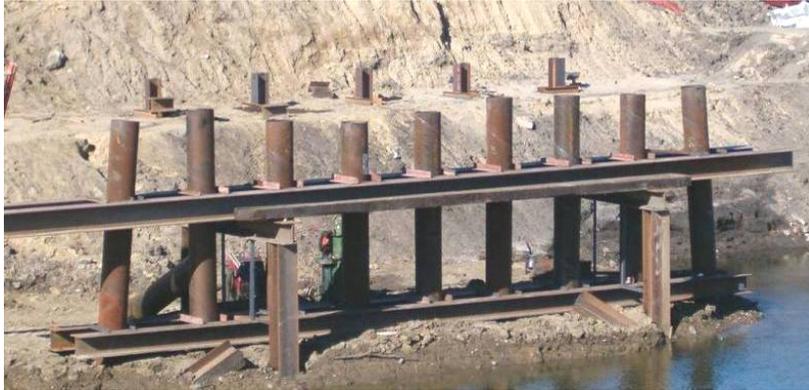
Figure 114. West pier and west abutment piling, September 28.

to provide a support for the precast pier cap, until it was installed and permanently grouted in place. The west pier as well as the west abutment piles can be seen in Figure 114.

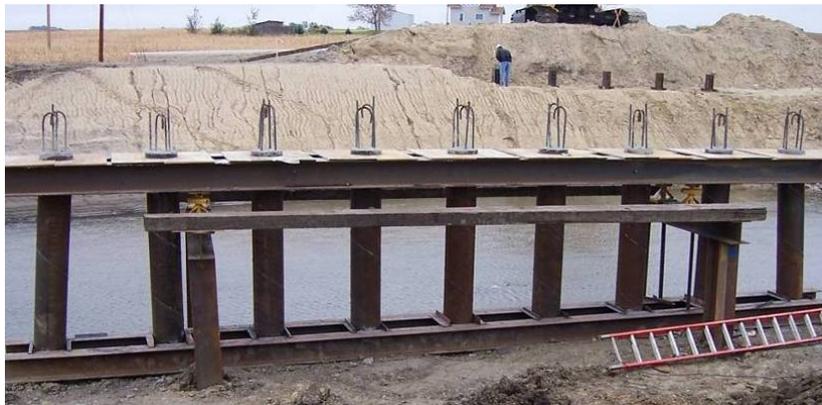
Figure 115. Pipe pile reinforcement for pier cap connection, October 4.

After the pipe piling was in place and secured with steel falsework, the piles were filled with concrete and the reinforcement connections were embedded in the pier cap as the concrete was placed. Pipe piles with the embedded reinforcement can be seen in Figure 115, after concrete was placed inside the pipe piles. The H-piles for the east abutment were driven, cut to length, and had the studs and channels welded in place on October 10 and 11. H-piles for the east abutment can be seen in the background in Figure 115.

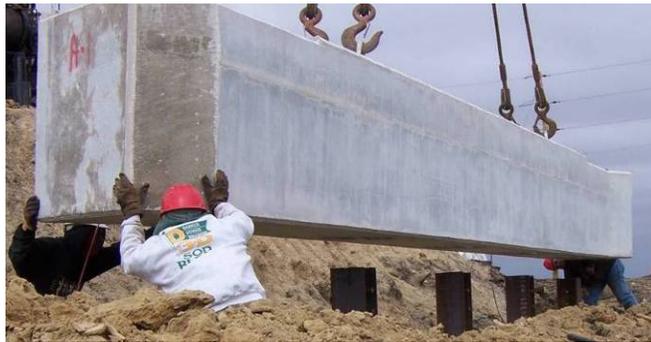
Figure 116. West abutment being lowered in place, October 4.

On October 4, the precast abutment and pier cap for the west side of the bridge were transported to the site and placed; the abutment was delivered and set into place first. Unloading and setting the abutment in place, shown in Figure 116, took the contractor approximately fifteen minutes. There were no clearance issues with the H-piles, thus the operation went smoothly. To connect the precast portion of the abutment with the CIP portion, mechanical splicers were embedded in the precast portion to connect No. 5 reinforcing bars. In Figure 117a, the west abutment can be seen in place as well as the No. 5 reinforcing bars; in Figure 117b, one of the H-piles in the abutment is shown.

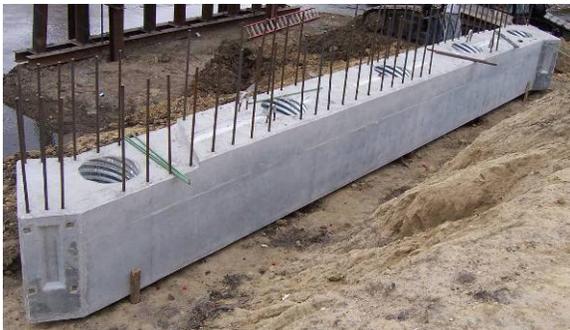
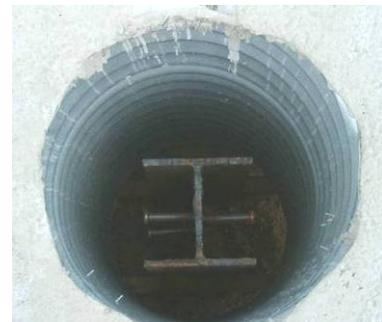
a) abutment in final position

b) H-pile in the abutment

Figure 117. West precast abutment in place, October 4.

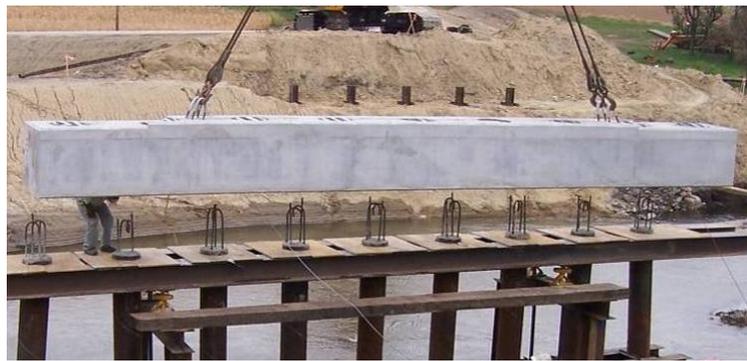
Figure 118. West pier cap being lowered into place, October 4.

Next, the west pier cap was delivered, unloaded, and lowered into place on the falsework in approximately fifteen minutes as well. As shown in Figure 118, the pier cap

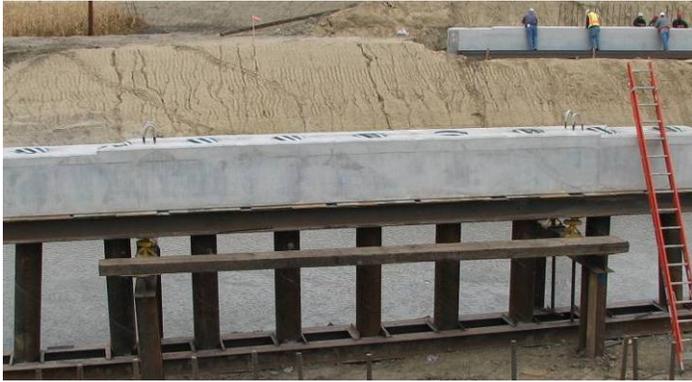
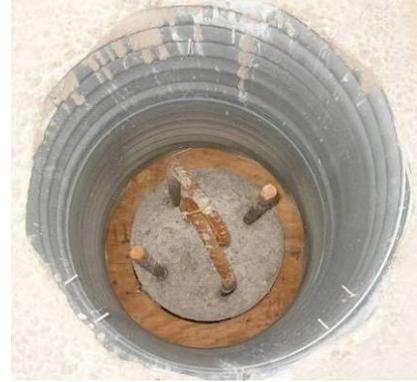
a) pier cap in place

b) pipe pile in the pier cap

Figure 119. West pier cap in place, in the field, October 4.

was set on the falsework without any clearance issues with the pipe piles; the west pier cap is shown in place (Figure 119a) along with one of the pipe piles in the pier cap (Figure 119b).

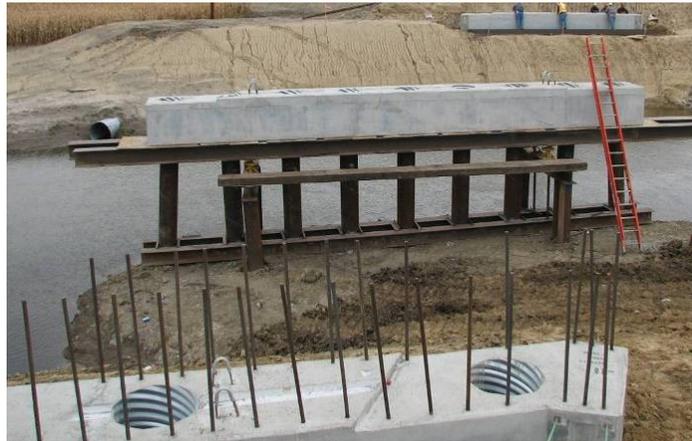
Figure 120. Precast abutments and pier cap in place, October 4.

The east abutment was delivered, unloaded, and set in place on October 4, in the same manner as the west abutment. Both abutments and the west pier cap were placed in approximately fifteen minutes each, and all were placed in the same day (October 4); the only delay in setting each element was waiting for the delivery truck. The east pier cap was the only precast substructure member that was not placed that day, due to the fact the site was still too wet to move the crane into place to drive the east pier piles. Shown in Figure 120 are the two abutments and the west pier cap on October 4, after all three were in place; the external reinforcement attached to the west abutment can be seen in this figure as well.

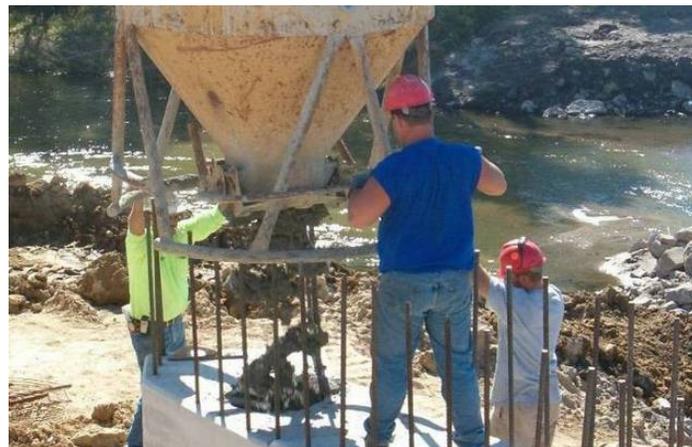
Figure 121. Concrete being placed in the east abutment, October 5.

The following day, the contractor grouted the nineteen piles into place (five in the east abutment, five in the west abutment, and nine in the west pier cap). There were difficulties with the special concrete mix meeting the slump and entrained air requirements and the first mix was rejected. The mix was corrected in the second truck and the contractor used a concrete bucket and crane to place the concrete in the CMP; the concrete was vibrated and finished by hand. Concrete being placed in the east abutment is shown in Figure 121; the finished concrete can be seen in Figure 122.

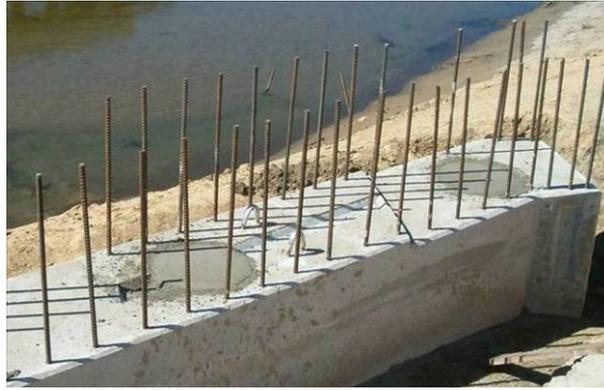
Figure 122. Finished specialty concrete in the east abutment, October 5.

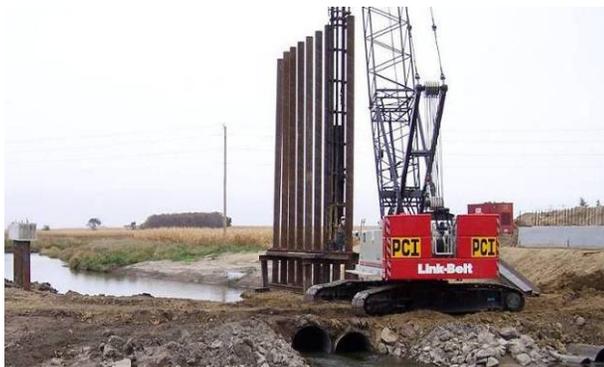
Figure 123. East pier pipe piles being driven, October 10.

By this time (October 5), the construction site had dried sufficiently for the contractor to rebuild the access road to the east side of the bridge. This time, the contractor used one sixteen-inch culvert pipe, one twelve-inch culvert pipe, and two twenty-four-inch culvert pipes, under the access road to increase the flow under the road to hopefully prevent another wash out. Once the road was finished, the crane was moved onto the access road (as shown in Figure 123) and pile driving for the east pier began on October 10.

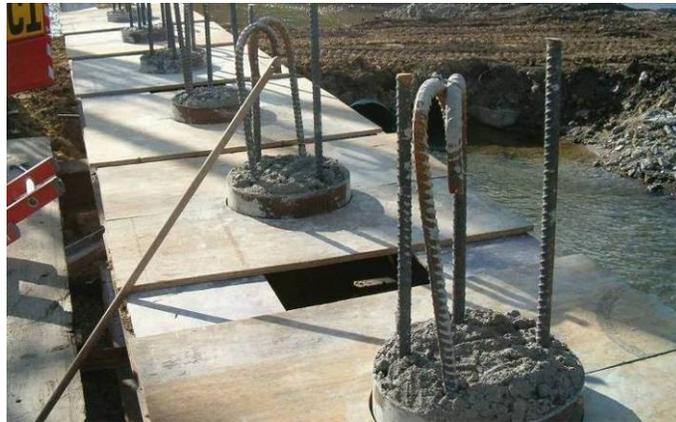
Figure 124. East pier pipe piles filled with concrete, October 12.

west pier. The east pier cap pipe piles are shown in Figure 124, after being filled with concrete. Later that same day (October 12), as shown in Figure 125, the east pier cap was delivered, unloaded, and set in place without difficulty.

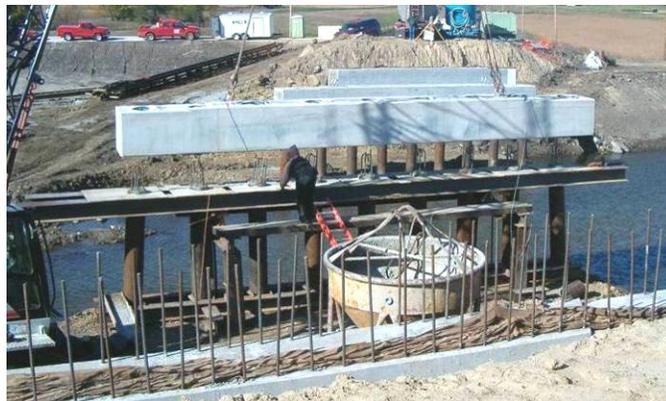
Figure 125. East pier cap being set, October 12.

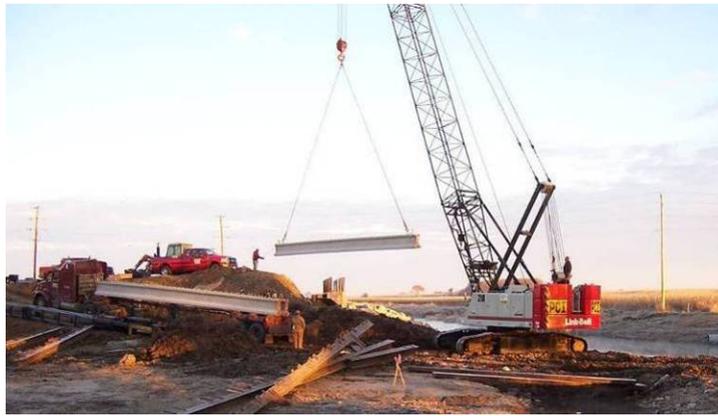
Figure 126. The first bridge girder being lifted into place, October 24.

girder was unloaded and set in place in approximately ten minutes; the first girder of the center span is shown being lifted into place in Figure 126.

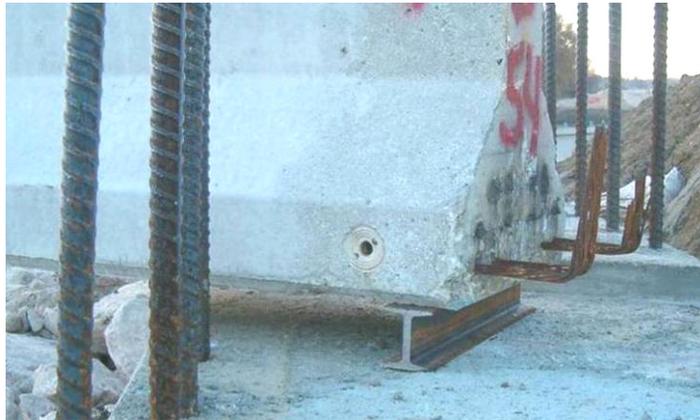
Figure 127. Steel beams used to support the girders, October 24.

All of the bridge girders were set in place on October 24. Small steel beams, shown in Figure 127, supported the girders on top of the pier caps and abutments to keep the girders at the correct elevation until the pier cap diaphragms and the CIP portion of the abutment caps were placed. A view of all of the erected bridge girders (looking east) is presented in Figure 128.

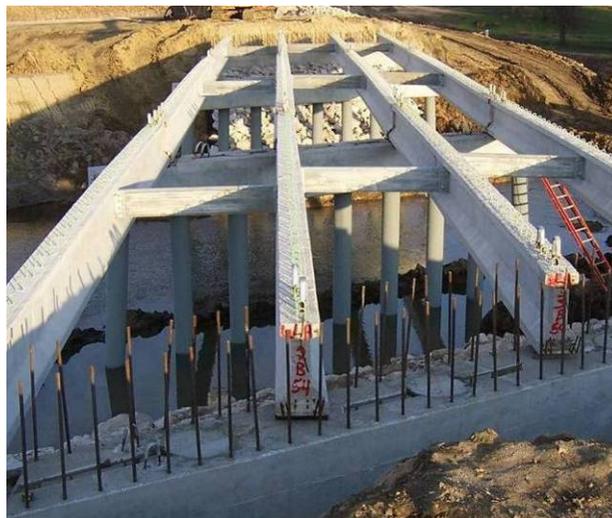
Figure 128. Erected bridge girders, October 24.

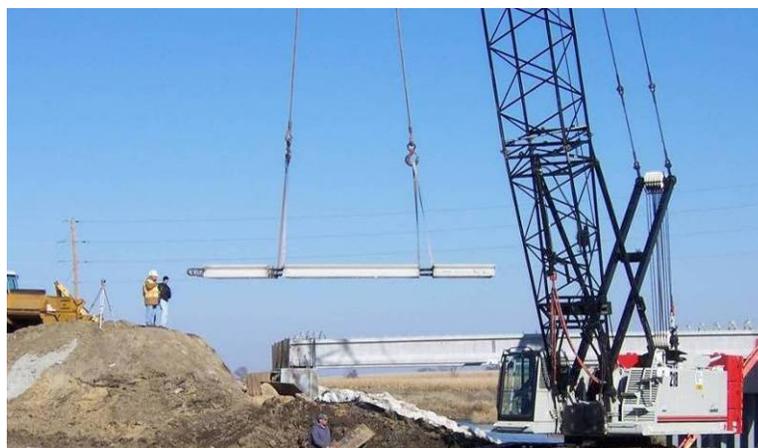
Figure 129. Deck panel being reset on the bridge girders, October 25.

The first of the interior deck panels were delivered on October 25, four panels per truck, and erection thereof began that morning. The first two deck panels set were the panels at middle of the center span of the bridge. However, the panels were not set in the correct location; this error was not noticed until after eight panels had been set. Since the panels had to be set from midspan outwards, the contractor had to remove all eight panels and reset the first two panels. After the initial two panels were correctly positioned, the rest of the panels were then reset. One of the deck panels can be seen being lifted and placed on the girders in Figure 129.

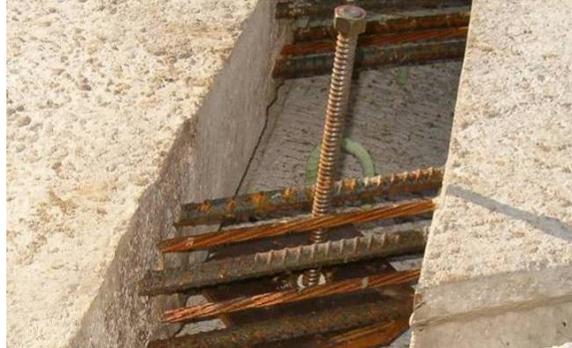
Figure 130. Deck panel leveling screw, October 26.

Over half of the bridge deck panels, sixteen in total, were set on October 25. The remaining panels were delivered and set the next day, with the exception of the four end panels. Four sets steel plates and screws, one of which is shown in Figure 130, were used by the contractor to level the interior deck panels.
