Laboratory testing of precast bridge elements, verification of post-tensioning forces and construction documentation of the Boone County IBRC accelerated bridge replacement project

**Laboratory testing of precast bridge elements, verification of post-tensioning forces
and construction documentation of the Boone County IBRC accelerated bridge
replacement project**

A thesis submitted to the graduate faculty
in partial fulfillment of the requirements for the degree of
MASTER OF SCIENCE

Major: Civil Engineering (Structural Engineering)

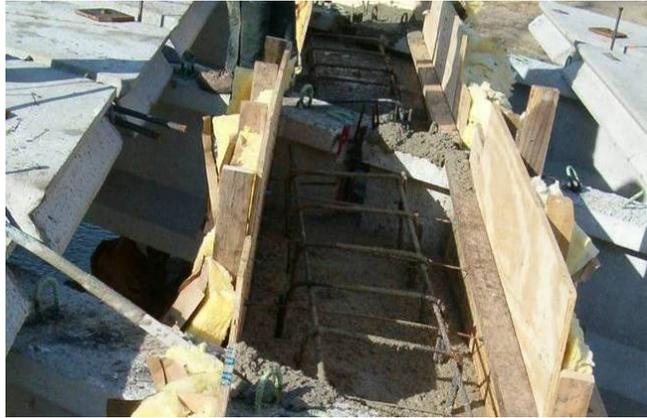
Figure 131. Pier diaphragm before concrete placement was complete, November 3.

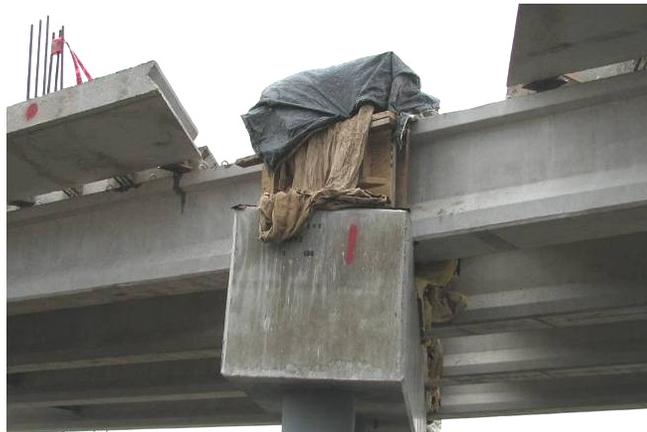
Figure 132. West pier diaphragm covered with burlap and plastic, November 4.

Once all of the deck panels were leveled to the correct elevation, the panels located over the piers were removed so the pier diaphragms could be cast. All of the panels had to be at final elevation so the contractor could form the diaphragms under the panels to the correct height. The diaphragms for both east and west piers were placed on November 3, as shown in Figure 131. After the concrete was placed, the diaphragms were covered in wet burlap and plastic for curing; the west pier diaphragm can be seen in Figure 132, a day after the concrete was placed.

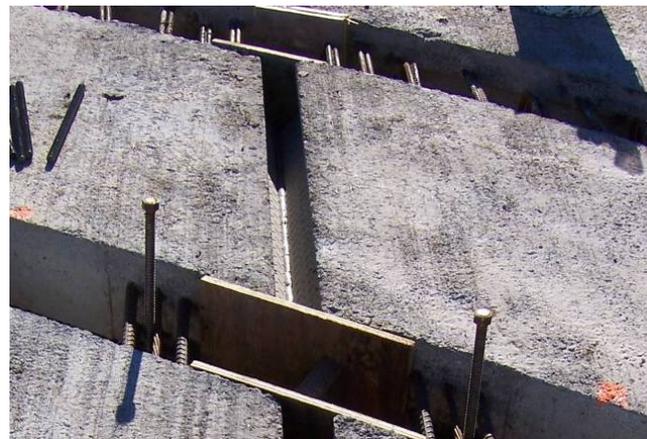
Figure 133. Transverse joint formwork, November 5.

The panels over the piers were replaced after the pier diaphragm concrete had gained sufficient strength and the diaphragm formwork had been ‘stripped’. While waiting for the diaphragm concrete to cure, the contractor formed the transverse joints between the deck panels, as shown in Figure 133. On November 8, all four of the end panels were delivered to the site and placed on the bridge; one of the east end panels being lowered into place is shown in Figure 134.

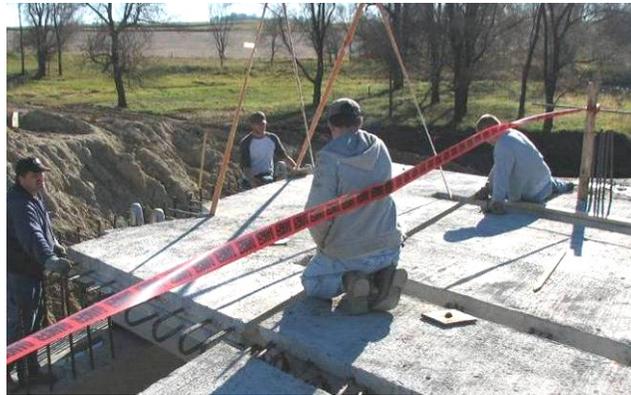
Figure 134. End panel being placed at the east end of the bridge, November 8.

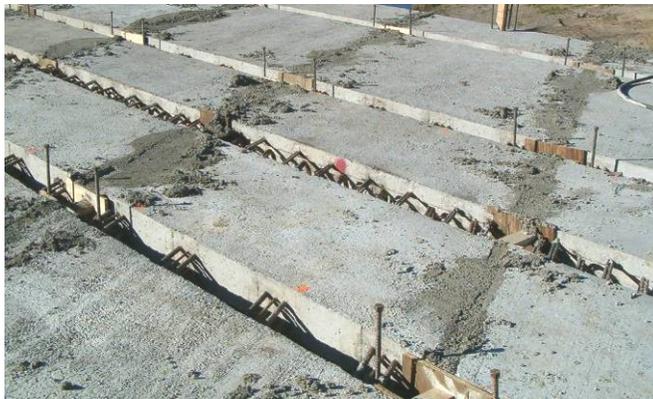
Figure 135. Several transverse joints before finishing, November 8.

The transverse joints between the end panels and the adjacent panels were not formed and cast with the rest of the transverse joints, since the end panels had not reached the required 28-day strength. On November 8 the remaining transverse joints were placed. Several transverse joints can be seen in Figure 135, before being finished; a finished transverse joint is shown in Figure 136.

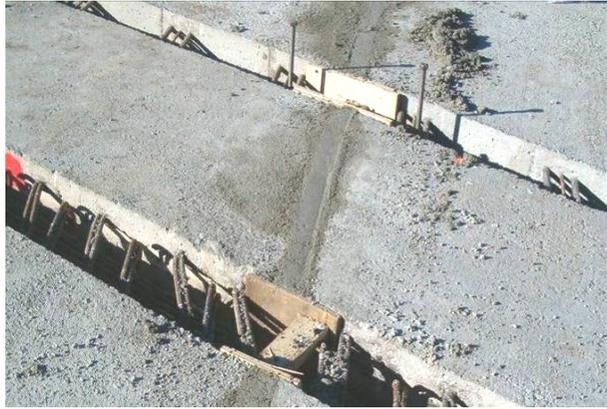
Figure 136. Finished transverse joint, November 8.

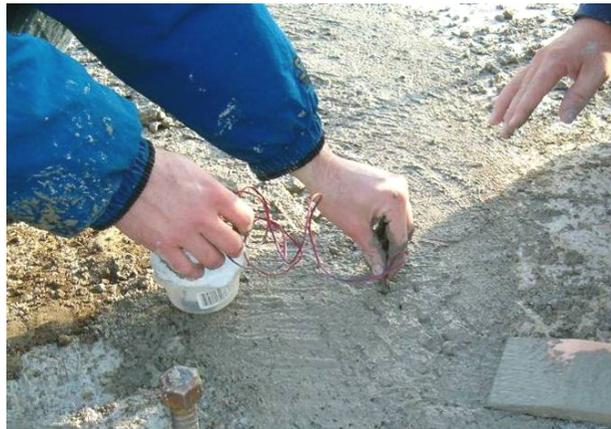
Figure 137. Thermal couple being inserted into end panel joint, November 16.

Post-tensioning the bridge deck could not take place until the end panel transverse joints had reached a minimum strength of 3,500 psi. Since the temperature was dropping, the contractor used heating coils and thermal blankets to heat the joints and decrease the amount of time needed for the concrete in the joints to cure and reach strength. The Iowa DOT placed thermal couples in the transverse joint concrete, shown in Figure 137, so the internal temperature of the concrete could be monitored. Temperature data from the transverse joints are presented in Appendix II. One of the finished end transverse joints can be seen in Figure 138 covered with burlap and heating coils, before the thermal blankets were put in place.

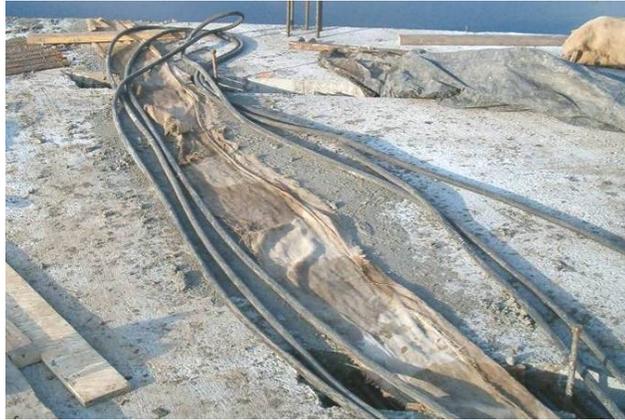
Figure 138. Burlap and heating coils on the west end panel joint, November 16.

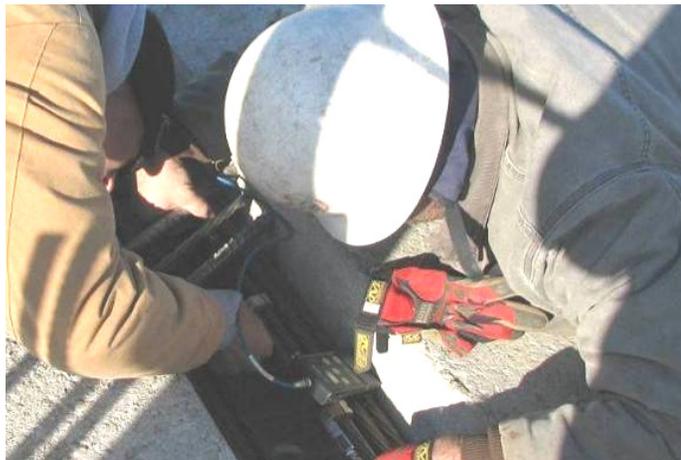
Figure 139. Calibration of one of the vibrating wire gages, November 21.

The contractor was originally going to post-tension the bridge deck on November 21; the VWGs for monitoring some of the post-tensioning forces were attached to four of the tendons and calibrated that morning. One of the gages is shown being calibrated in Figure 139. However, there were problems keeping the joints sufficiently warm; around 2:00 a.m. on November 18, the generator for the heating coils lost power. Power was not restored until around 7:00 a.m. later that morning. Since the strength of the concrete in the end panel transverse joints was not at the required strength, post-tensioning had to be delayed one week for the concrete to cure sufficiently to meet the minimum strength requirements.

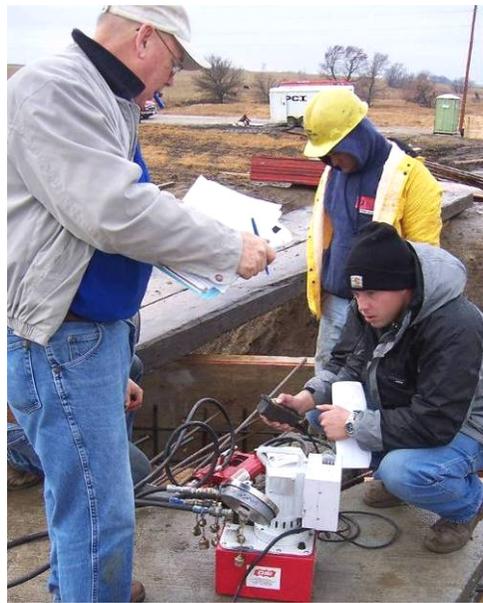
Figure 140. Post-tensioning in progress, November 28.

The following week, the concrete in the joints had gained sufficient strength and the post-tensioning operation, shown in Figure 140, began approximately at 8:00 a.m. on November 28. The order of post-tensioning the various tendons was presented earlier in Section 5.1 of Chapter 5. The entire post-tensioning operation took less than four hours, including the time post-tensioning had to stop for data collection.

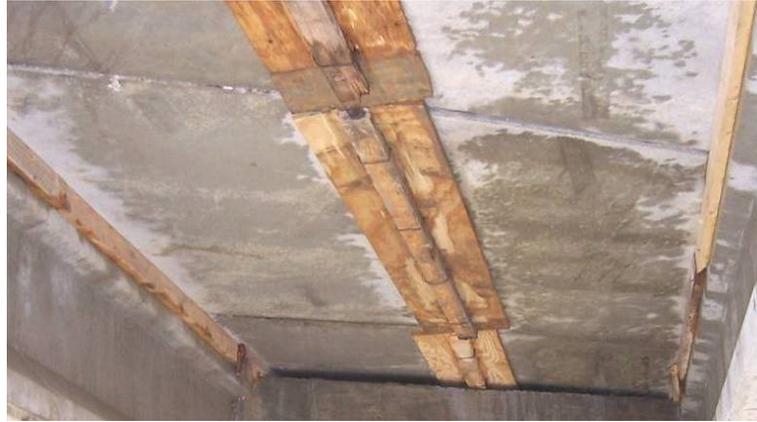
Figure 141. Longitudinal joint formwork, November 28.

During the time spent waiting for the transverse joint concrete to reach the required strength, the contractor formed the longitudinal joint between the north and south half of the bridge and put up formwork for the four post-tensioning channels. Longitudinal joint formwork can be seen in Figure 141 from below the bridge deck. Formwork was attached to the deck using U-bolts.

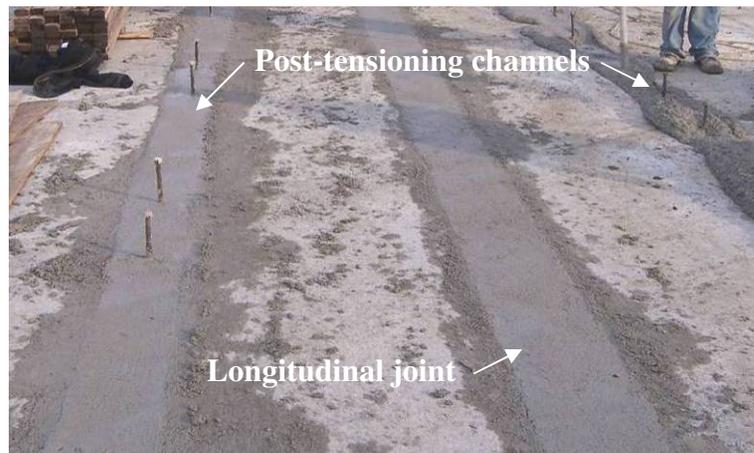
Figure 142. Longitudinal joint and one channel finished, November 28.

from the deck and the holes were filled with grout in accordance with the Iowa DOT Materials Instructional Memoranda 491.13 Hydraulic Cement Grouts criteria. A finished post-tensioning channel, the finished center longitudinal joint, and an unfinished post-tensioning channel can all be seen in Figure 142; note the leveling screws in the post-tensioning channels.

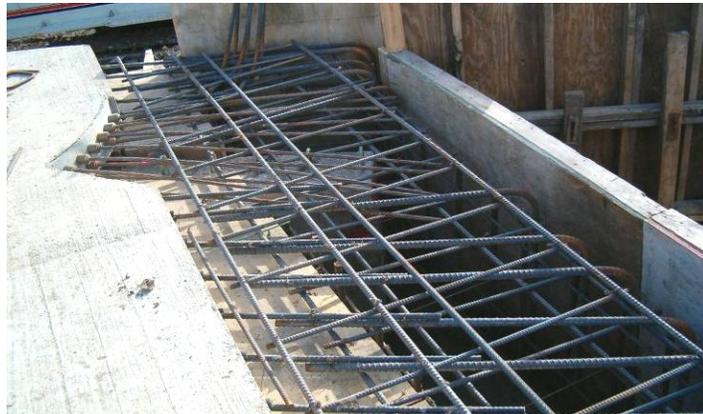
Figure 143. Reinforcement in the west abutment cap, November 29.

cold temperatures. The next day, November 29, the contractor fabricated the formwork for the abutment cap and wing walls and placed the reinforcement in the formwork; both sets of abutment caps and wing walls were placed on November 29. Next, external reinforcement for the barrier rail was added to the deck panels using embedded mechanical splicers. The reinforcement for the CIP portion of the abutment can be seen in Figure 143 and the finished abutment cap is shown in Figure 144. Note the No. 5 reinforcing bars for the guard rail system attached to the deck panels can also be seen in Figure 144.

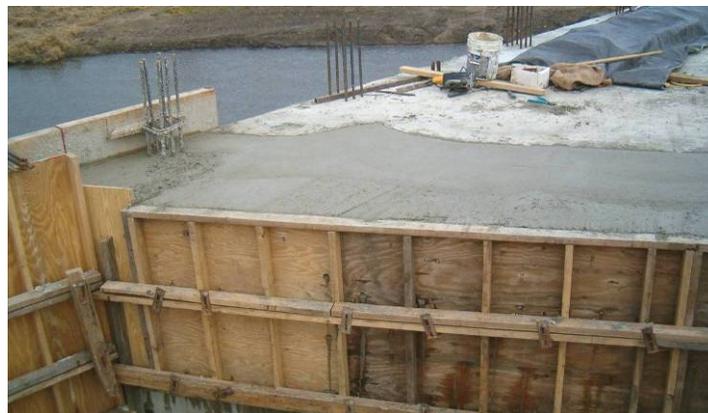
Figure 144. West abutment and wingwall, placed and finished, November 29.

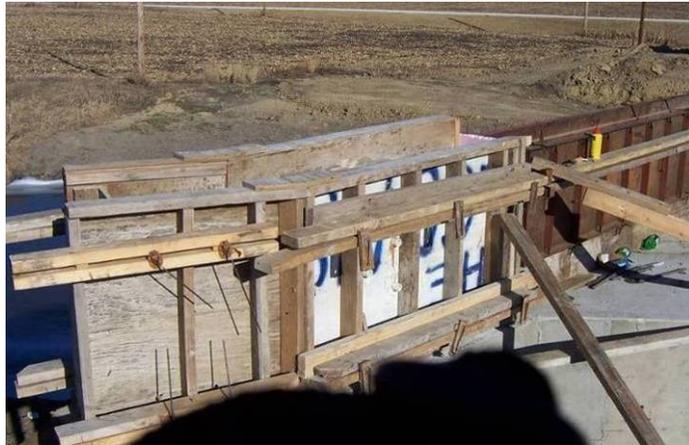
Figure 145. Barrier rail formwork, December 8.

Next, the contractor fabricated the formwork for the CIP barrier rails, (shown in Figure 145), tied the reinforcement cages to be placed in the formwork, and connected the

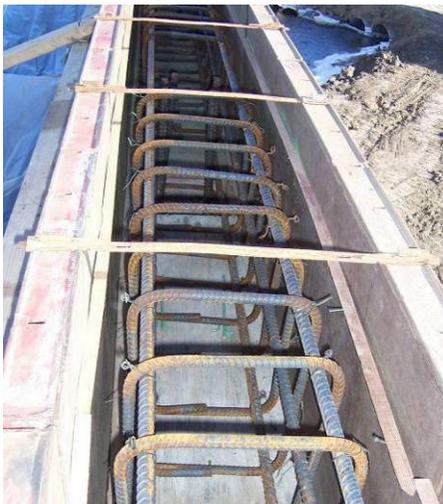
Figure 146. Barrier rail reinforcement, December 8.

external reinforcement to the deck panels using the embedded mechanical splicers. The reinforcement cage for the barrier rail in the formwork is shown in Figure 146. Both barrier rails were placed and finished on December 8; the barrier rail can be seen after being placed, before final finishing in Figure 147. After finishing, the barrier rails were covered with wet burlap and plastic for curing.

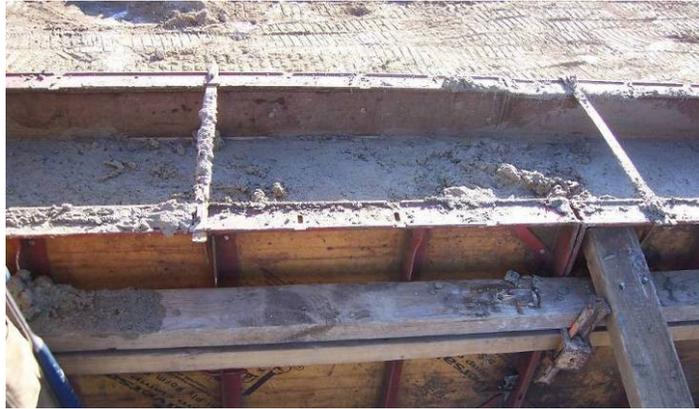
Figure 147. Barrier rail before final finishing, December 8.

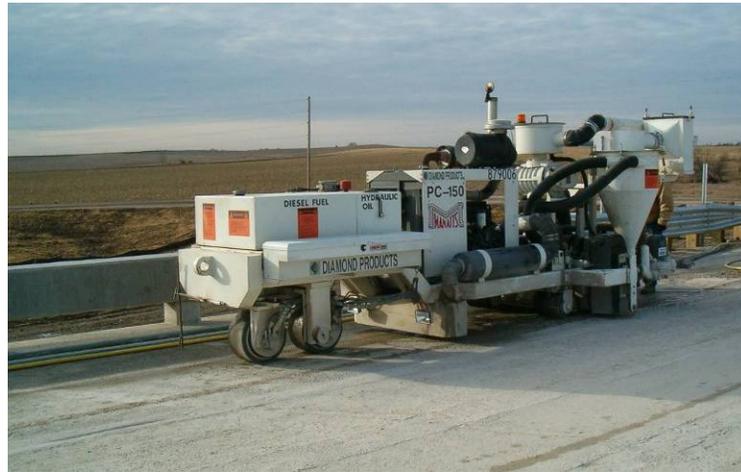
Figure 148. Bridge deck grinding equipment on site, December 27.

The last construction task for the bridge was to grind the surface of the bridge deck. On December 27, the surface of the deck was ground, however, due to equipment breakdown, grinding wasn't completed until December 28. Due to clearance issues with the grinding equipment, shown in Figure 148, the three feet adjacent to the barrier rails were not ground. Figure 149 shows the surface of the bridge deck after the surface was ground.

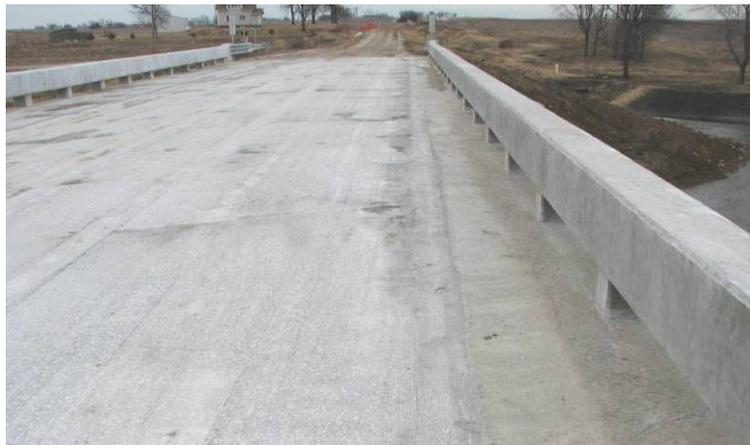
Figure 149. Bridge deck after the surface was ground, December 27.

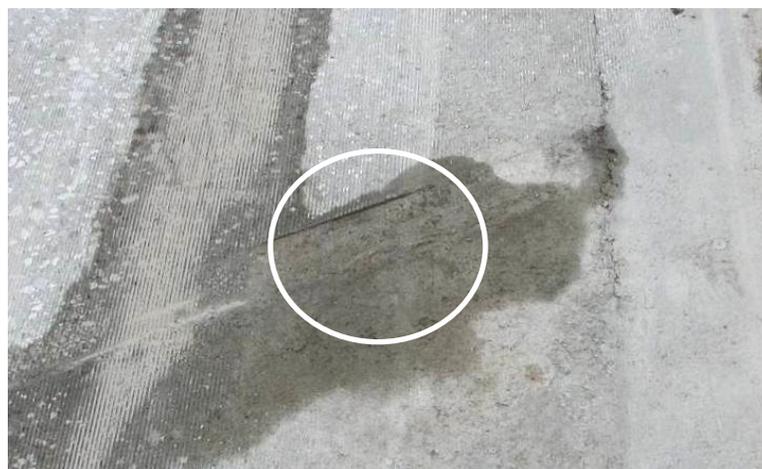
Figure 150. Low area in one transverse joint after deck grinding, December 27.

There were some difficulties encountered with the deck grinding process. Several areas of the transverse joints were not finished high enough, causing low and uneven areas on the deck. Even after grinding, there were several areas where the transverse and longitudinal joints had noticeable low areas. One such area between the transverse joint and the precast panels can be seen in Figure 150. After the bridge deck was ground, the completed bridge shown in Figure 151 was officially opened.

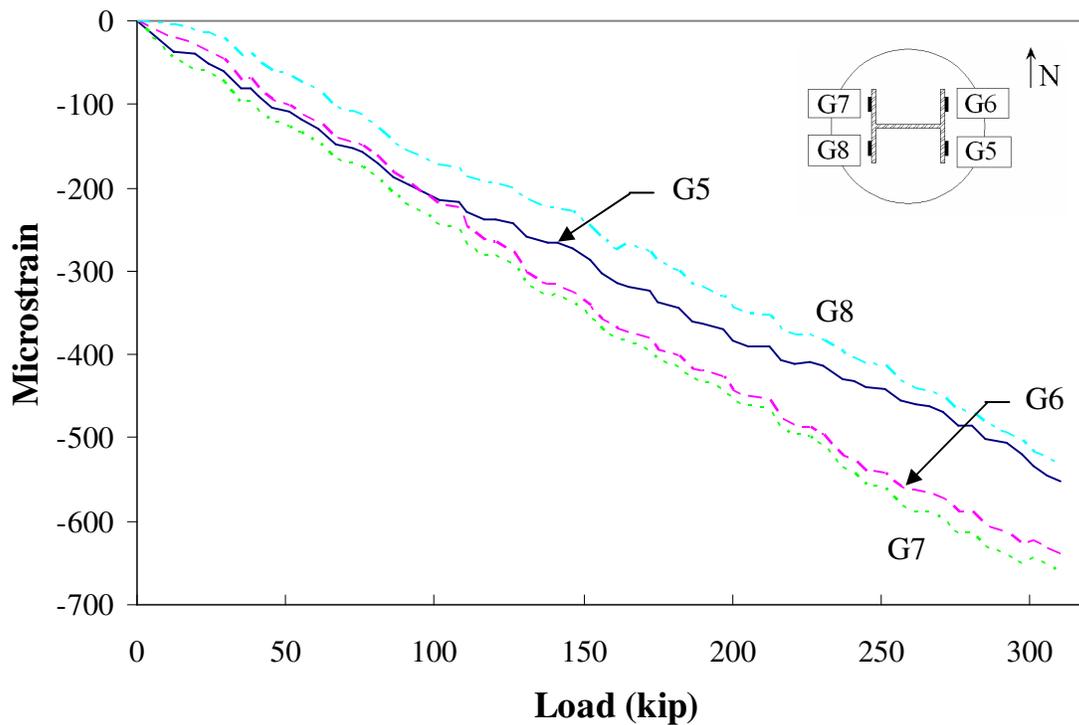
Figure 152. Steel strain for ASC1.

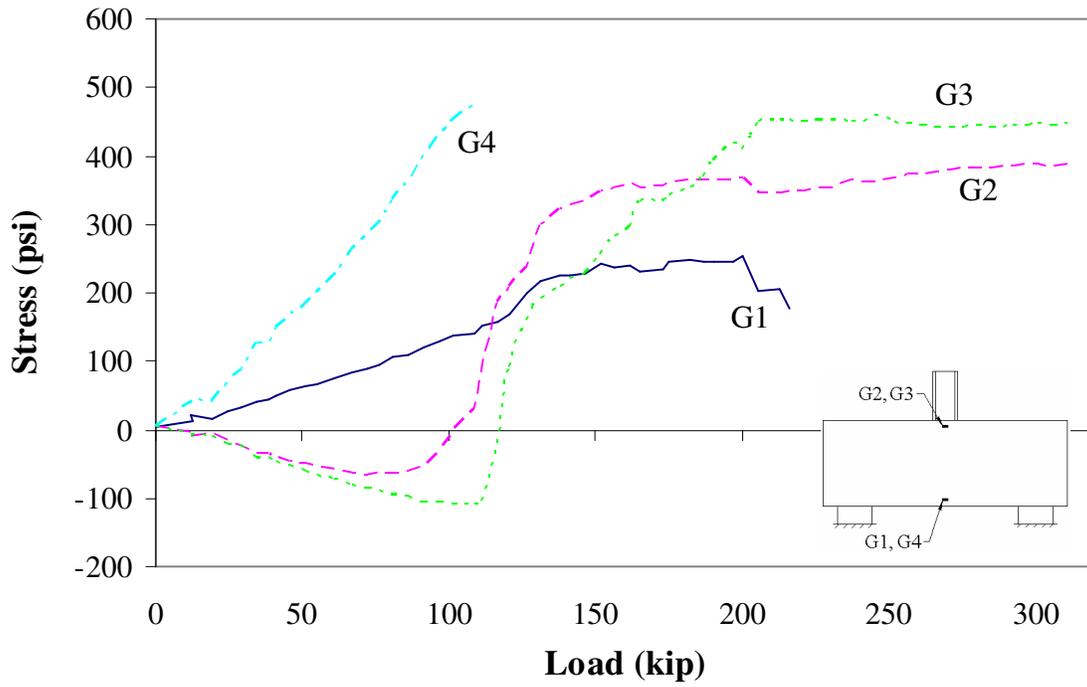
Figure 153. Concrete stress in ASC1.

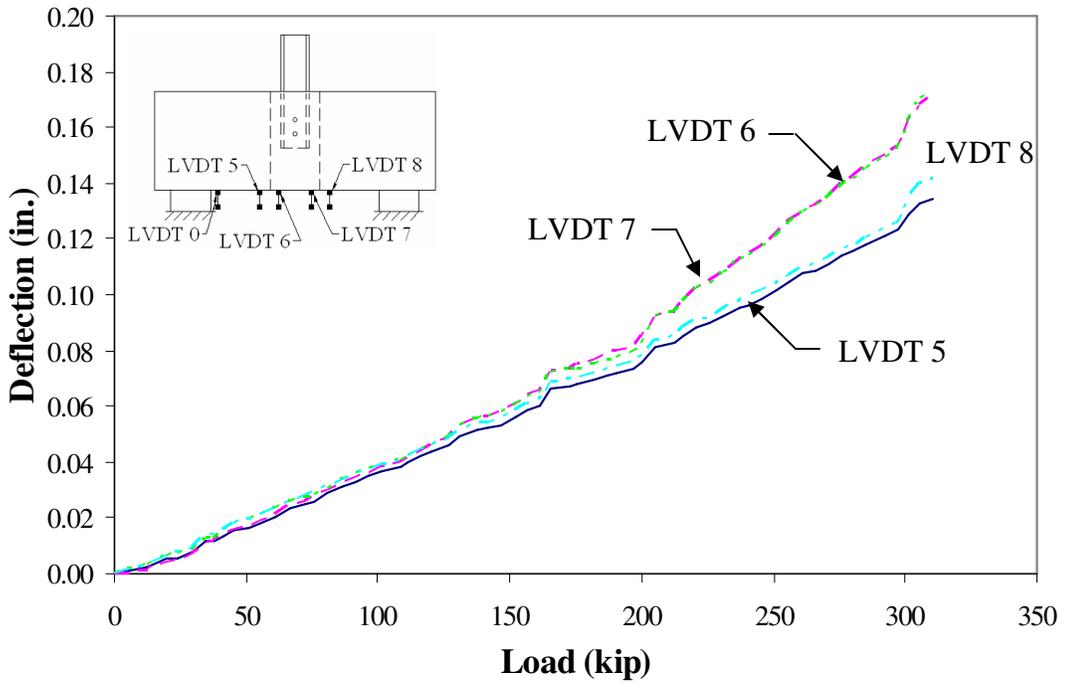
Figure 154. Total deflection for ASC1.

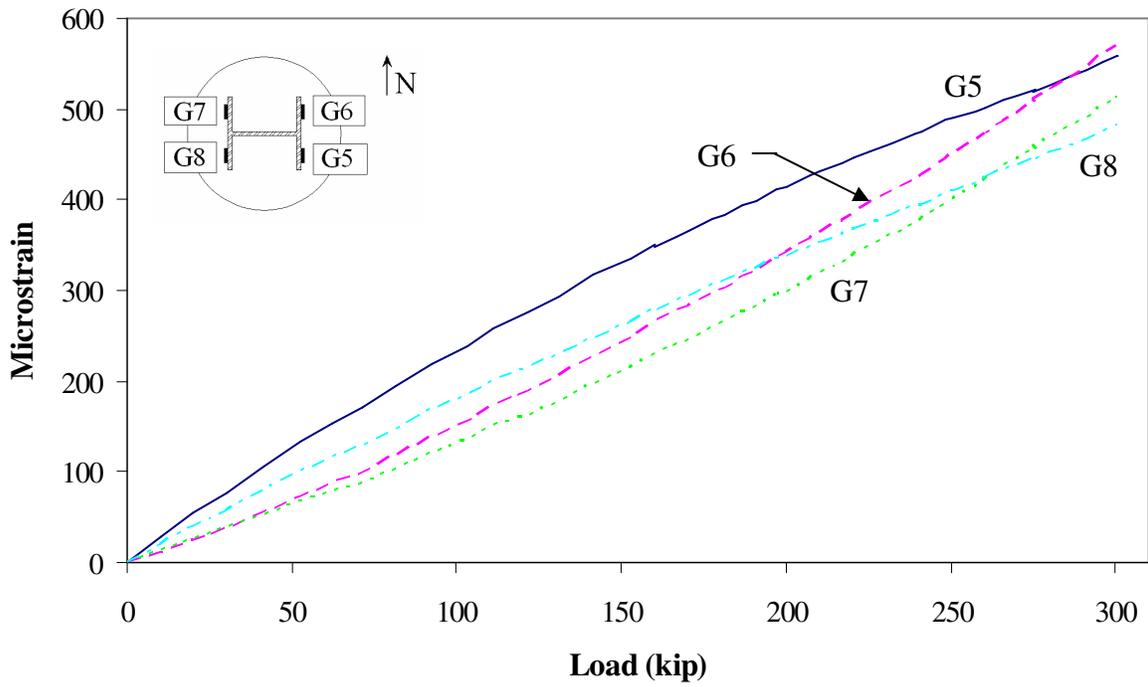
Figure 155. Steel strain for ASC2.

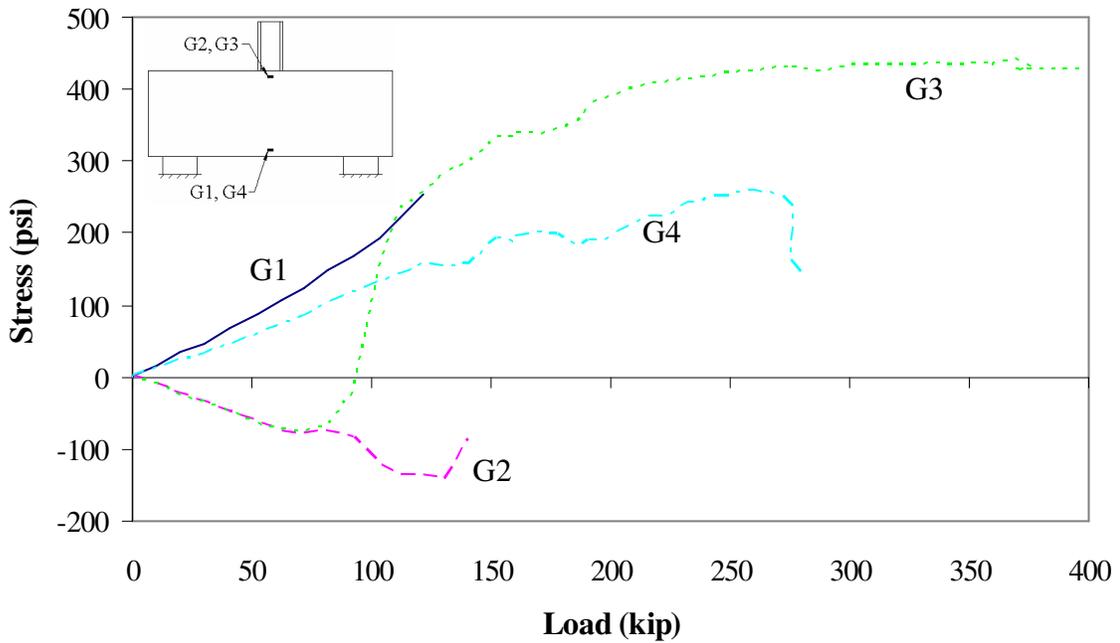
Figure 156. Concrete stress in ASC2.

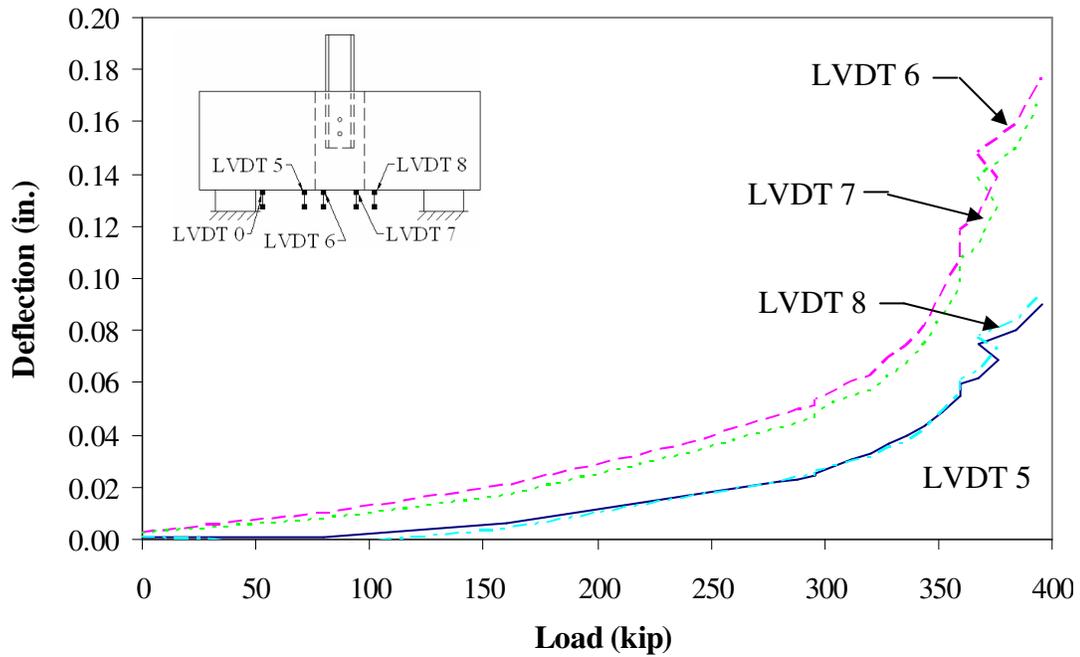
Figure 157. Total deflection for ASC2.

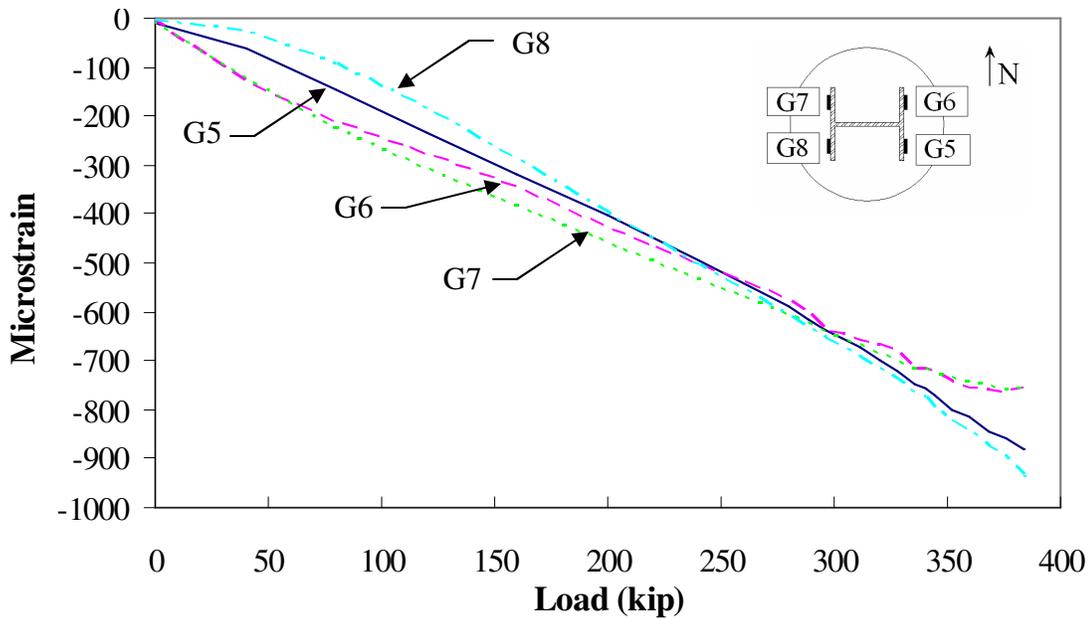
Figure 158. Steel strain for ASO1.

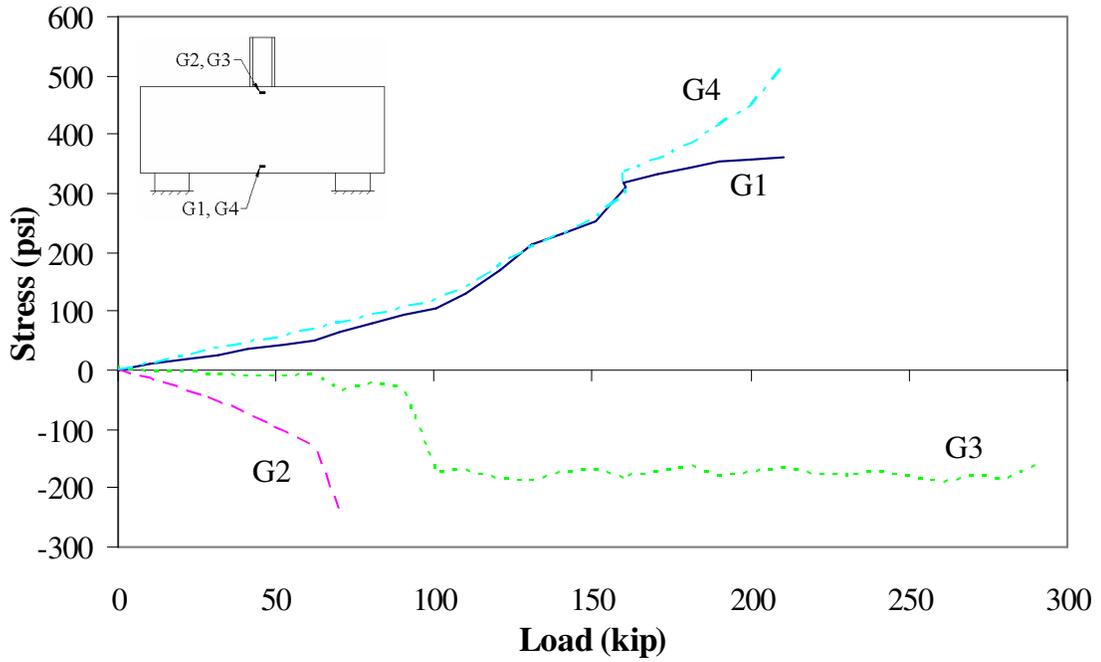
Figure 159. Concrete stress for ASO1.

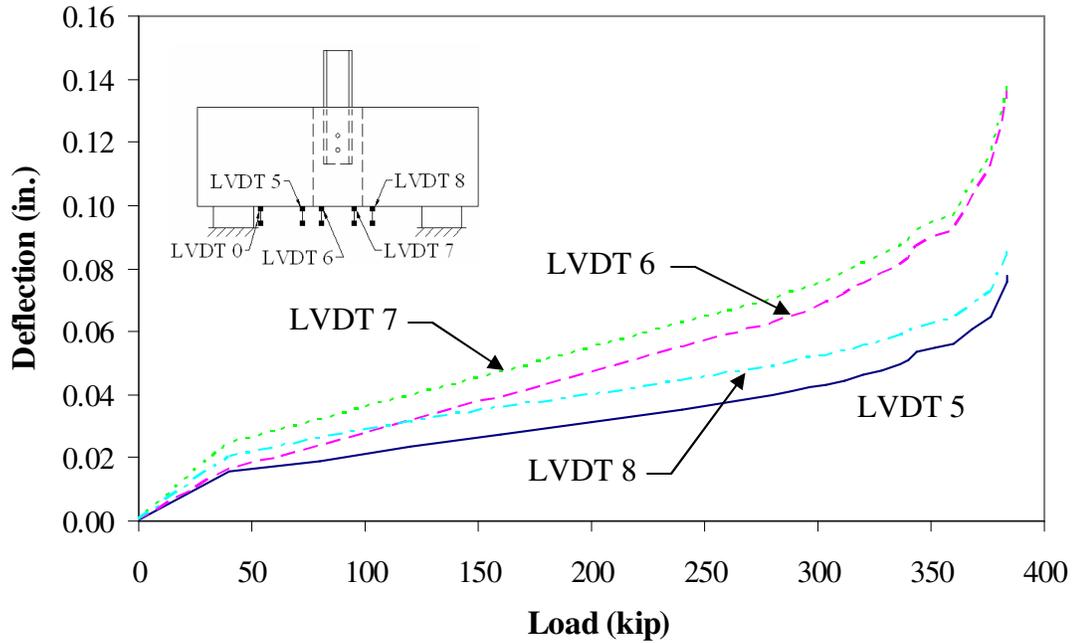
Figure 160. Total deflection for ASO1.

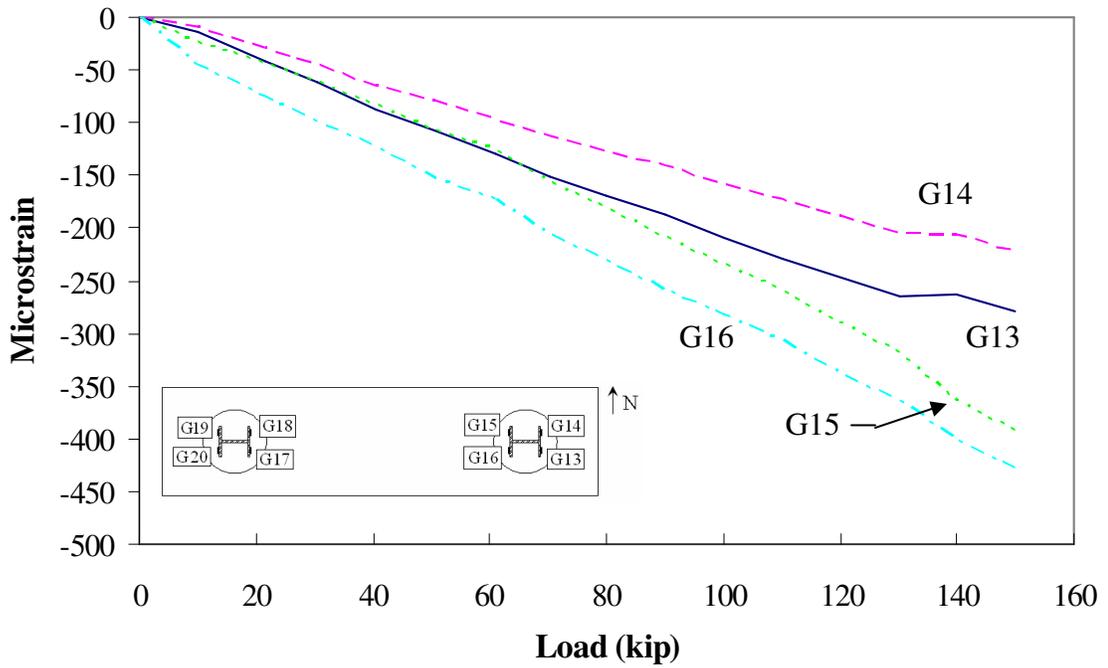
Figure 161. East pile steel strain for ADC2.

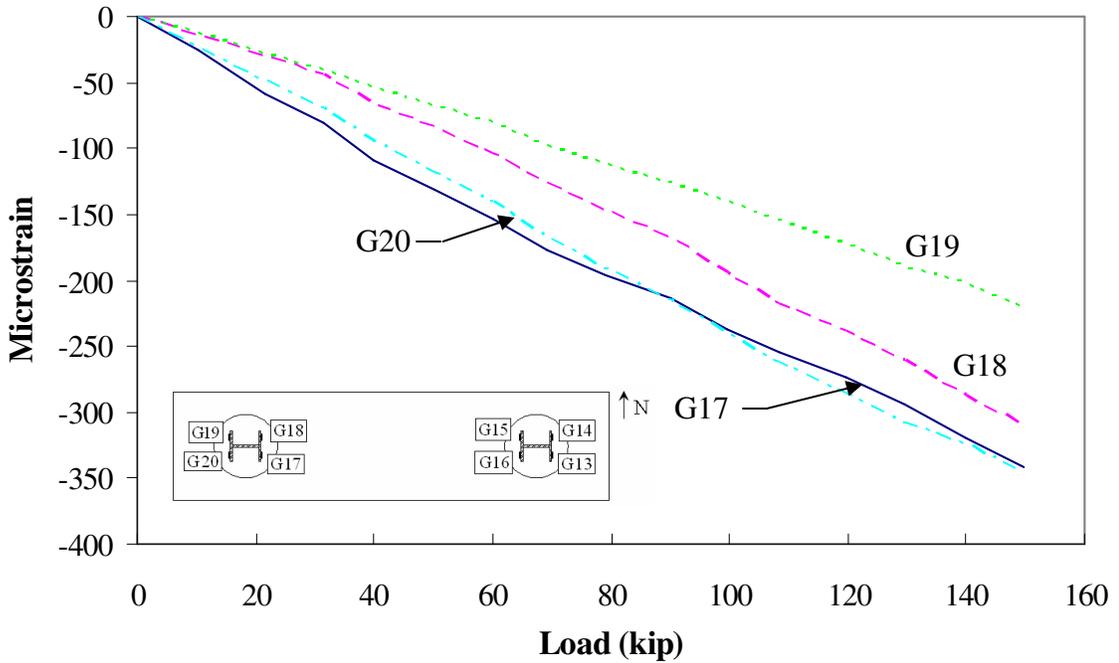
Figure 162. West pile steel strains for ADC2.

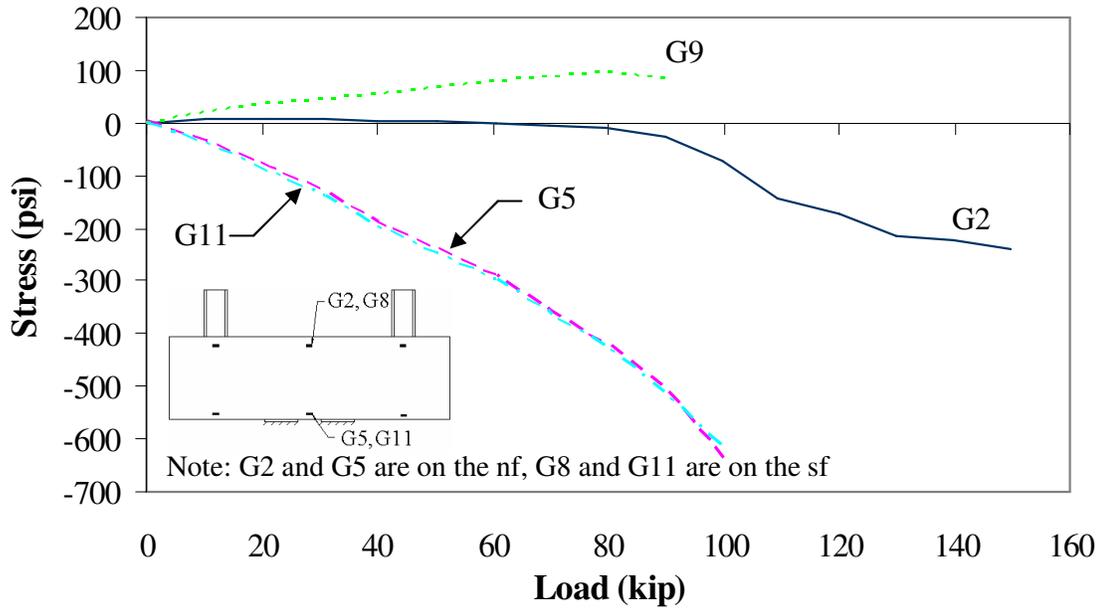
Figure 163. Concrete stresses at the center of ADC2.

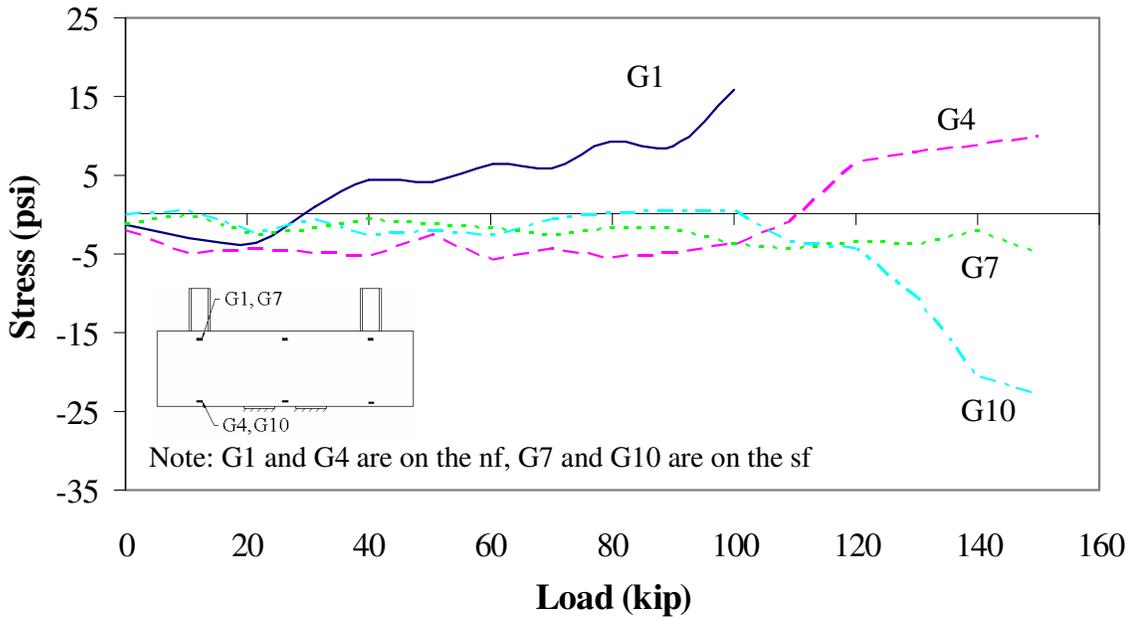
Figure 164. Concrete stresses at the east pile of ADC2.

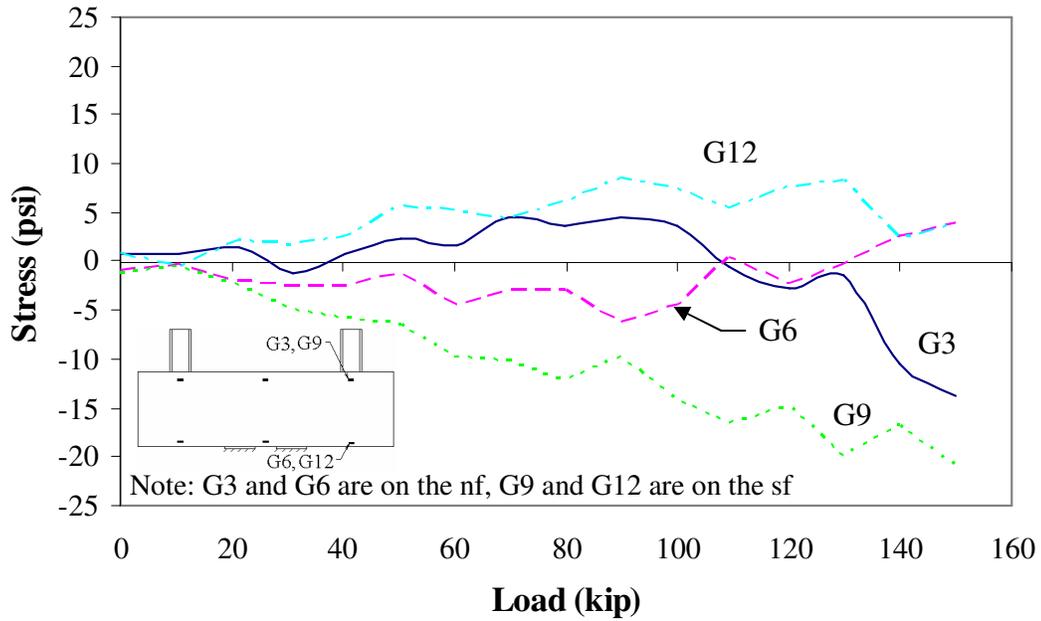
Figure 165. Concrete stresses at the west pile of ADC2.

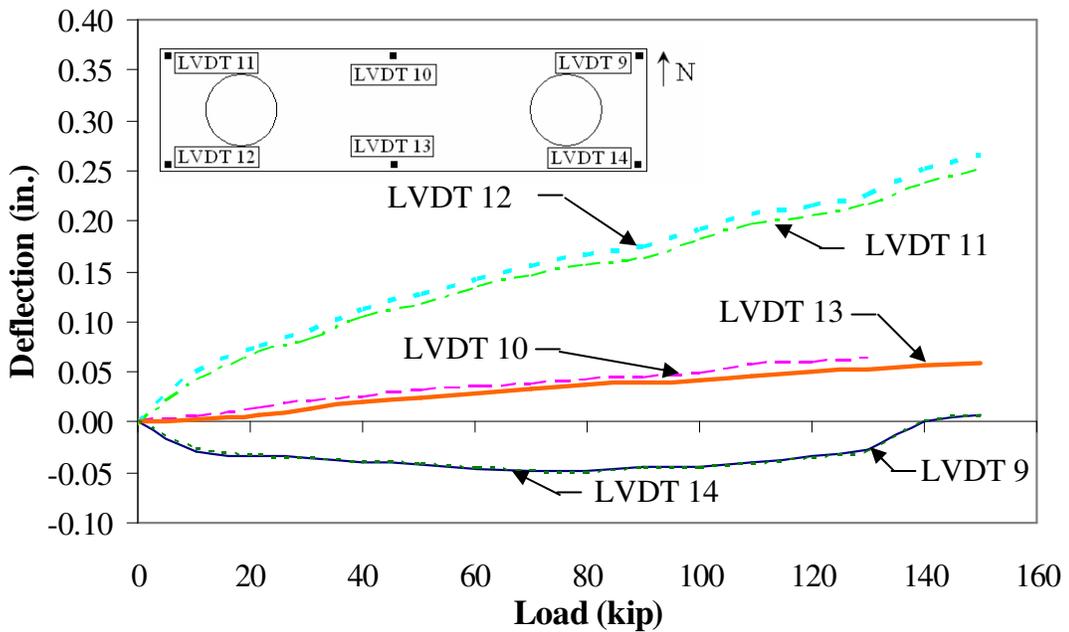
Figure 166. Total deflections for ADC2.

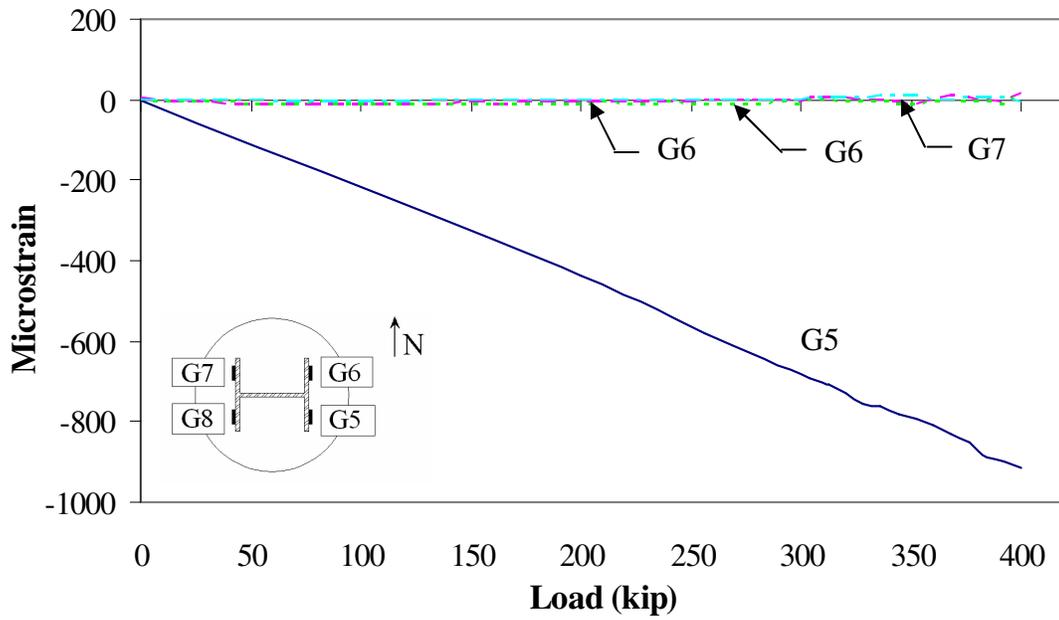
Figure 167. Steel strain for Shear Test 2.

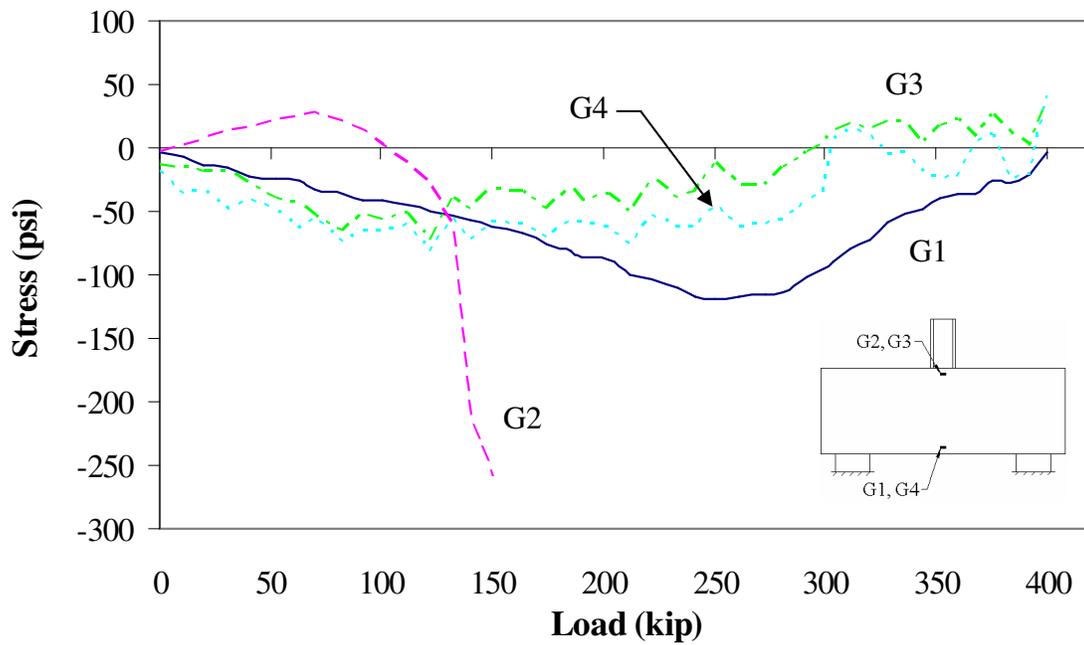
Figure 168. Concrete stress for Shear Test 2.

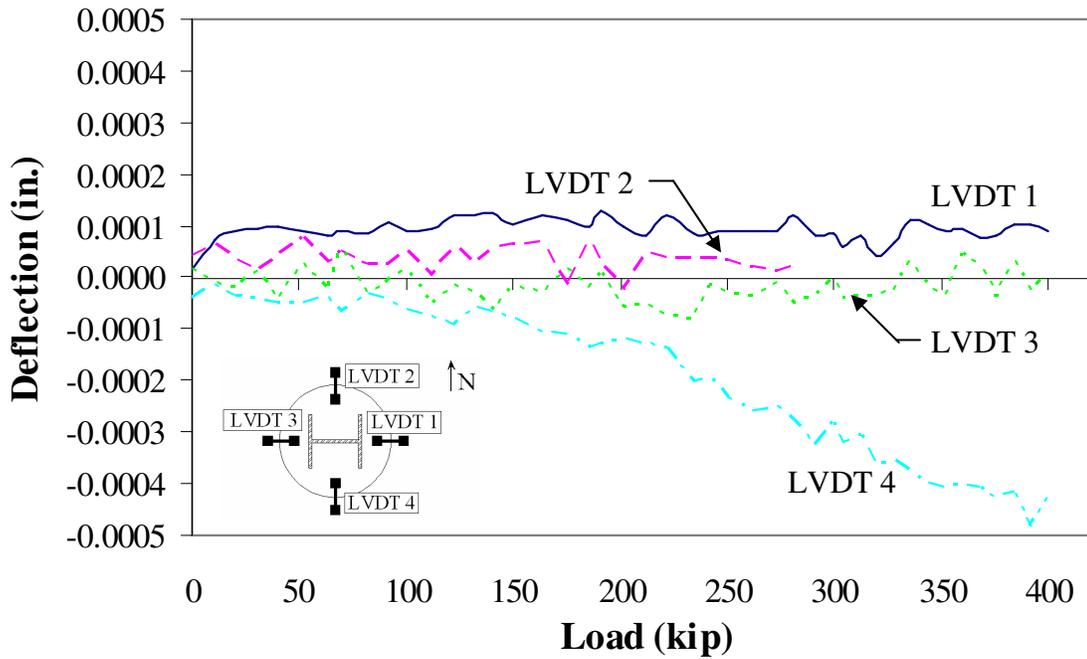
Figure 169. Top deflection for Shear Test 2.

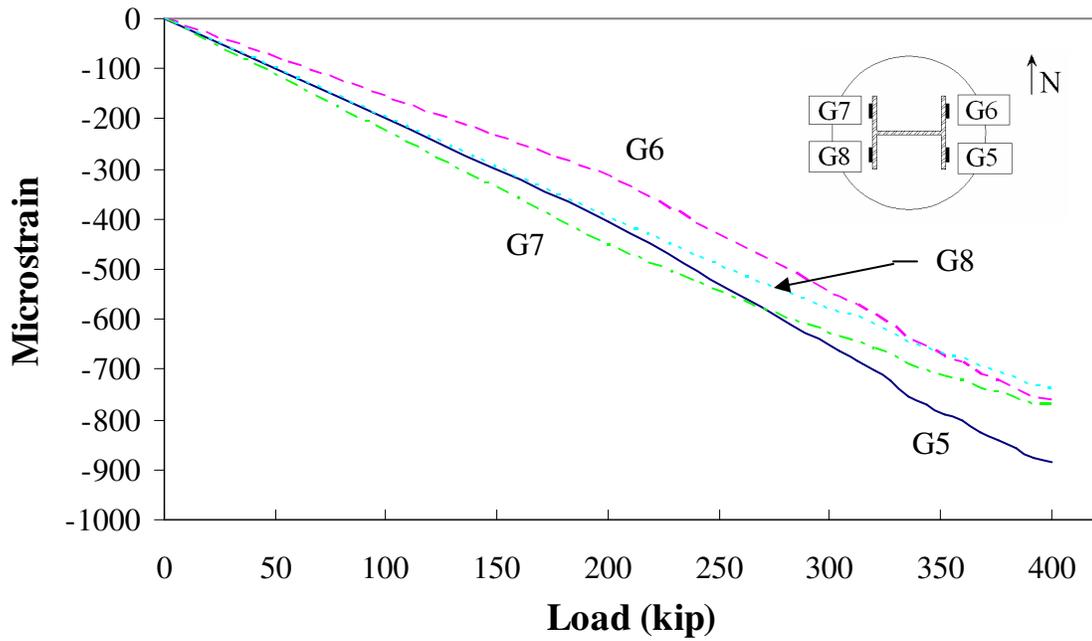
Figure 170. Steel strain for Shear Test 3.

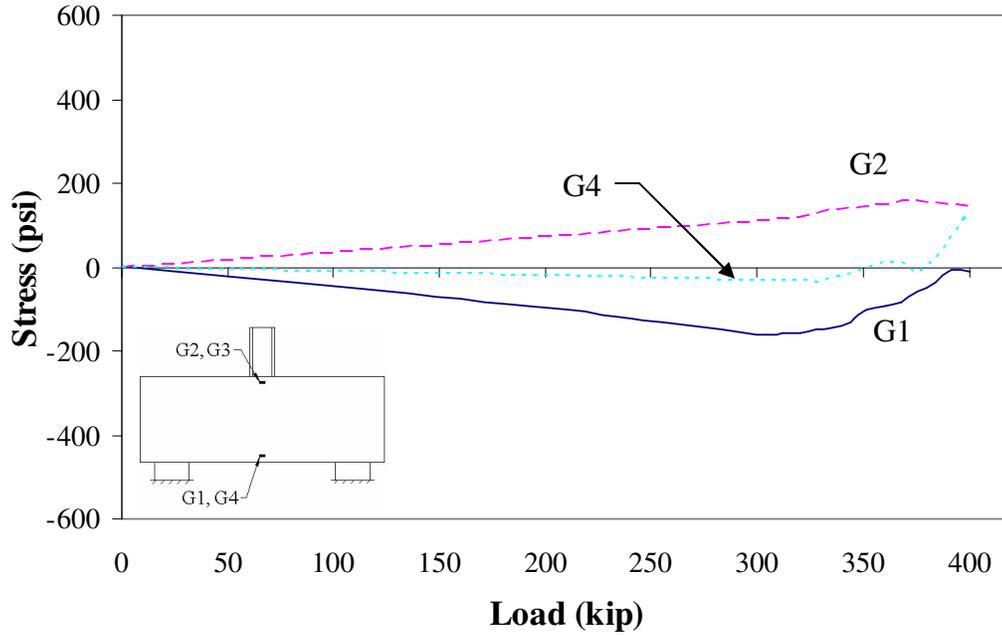
Figure 171. Concrete stress for Shear Test 3.

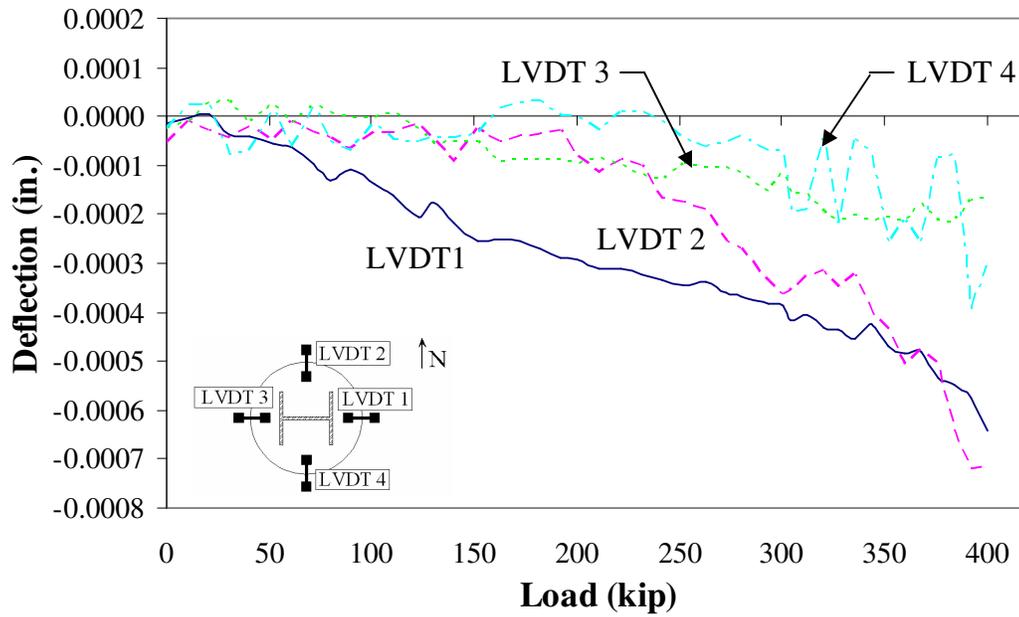
Figure 172. Top deflection for Shear Test 3.
