Laboratory testing of precast bridge elements, verification of post-tensioning forces and construction documentation of the Boone County IBRC accelerated bridge replacement project

**Laboratory testing of precast bridge elements, verification of post-tensioning forces
and construction documentation of the Boone County IBRC accelerated bridge
replacement project**

A thesis submitted to the graduate faculty
in partial fulfillment of the requirements for the degree of
MASTER OF SCIENCE

Major: Civil Engineering (Structural Engineering)

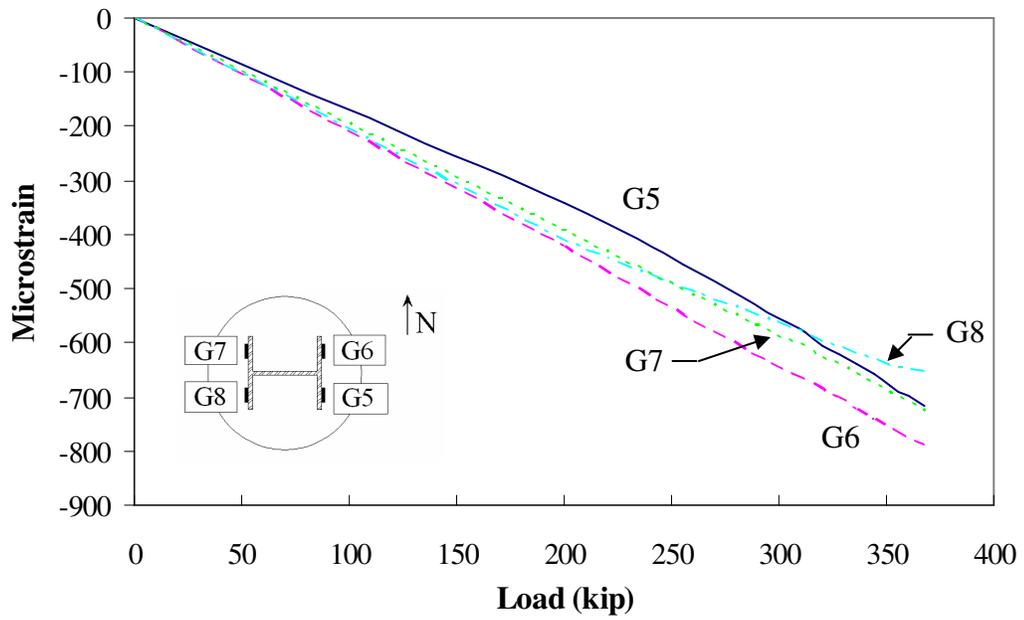
Figure 173. Steel strain for Shear Test 4.

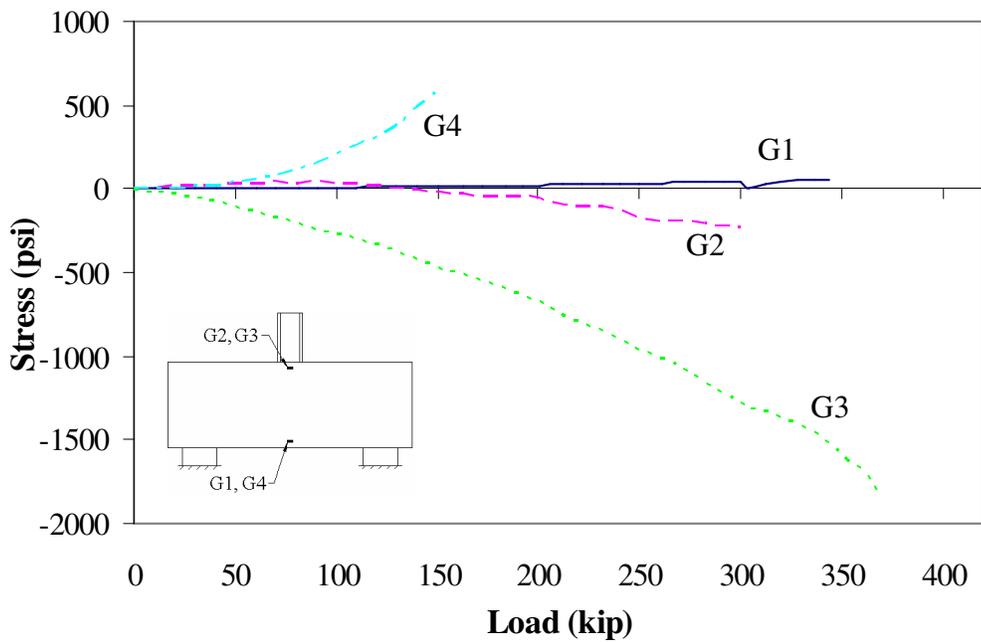
Figure 174. Concrete stress for Shear Test 4.

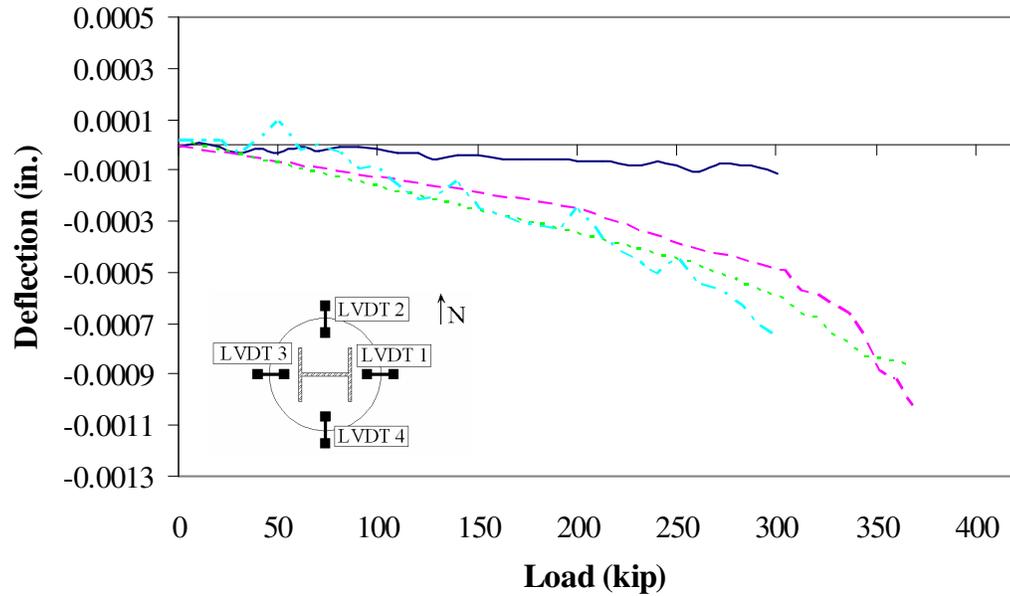
Figure 175. Top deflection for Shear Test 4.

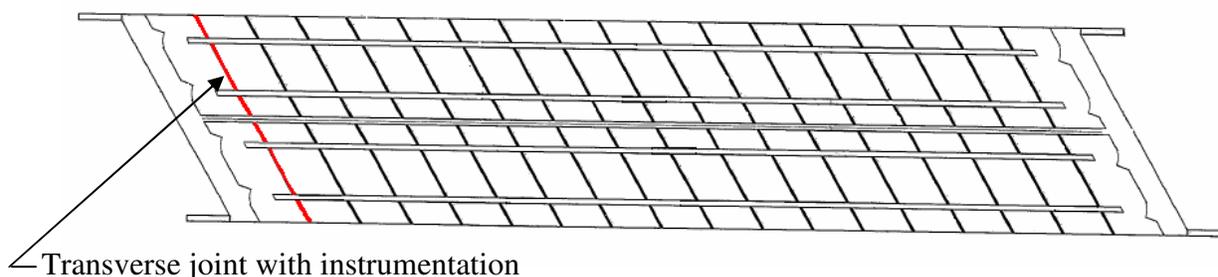
**Figure 176. Location of west transverse joint with temperature instrumentation.**
