Geotechnical remediation of transportation infrastructures: nondestructive evaluation of bridge substructures and stabilization of soft foundation soils

A dissertation submitted to the graduate faculty
in partial fulfillment of the requirements for the degree of
DOCTOR OF PHILOSOPHY

Major: Civil Engineering (Geotechnical Engineering)

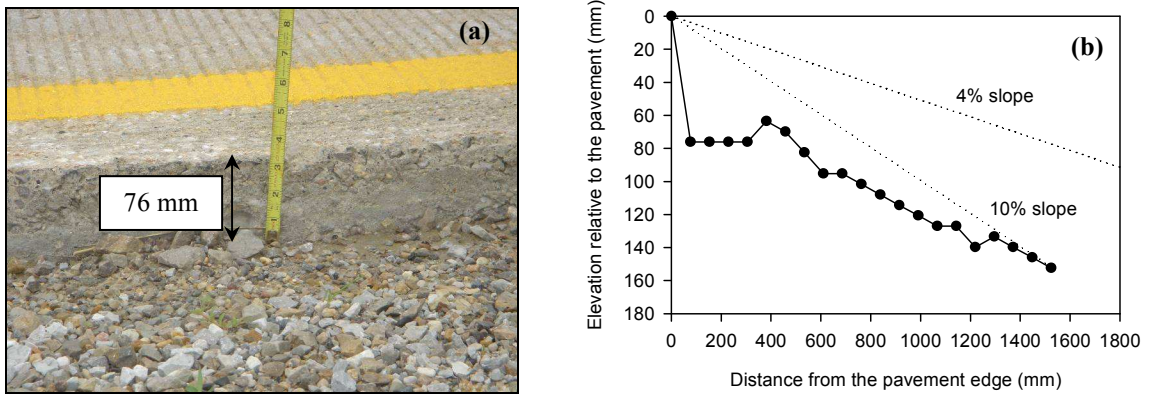
FIG. 2.3 — *Edge drop-off along the pavement edge (a) shoulder drop-off = 76 mm (b) elevation profile relative to the pavement edge*

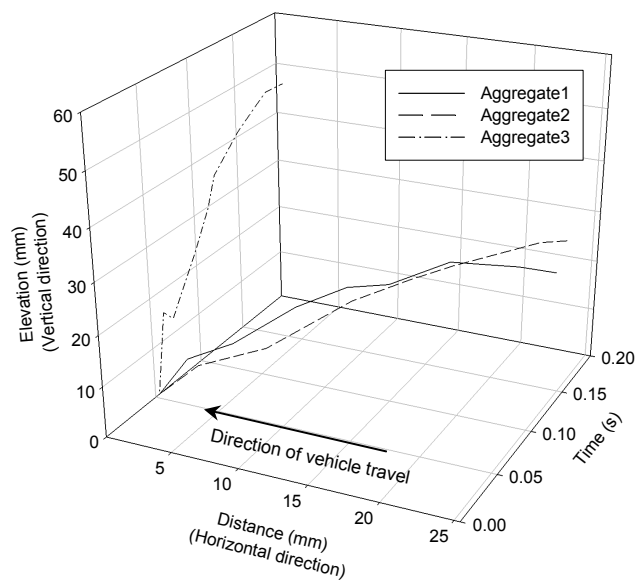
FIG. 2.7 — *Aggregate trajectory relative to the direction of vehicle travel*

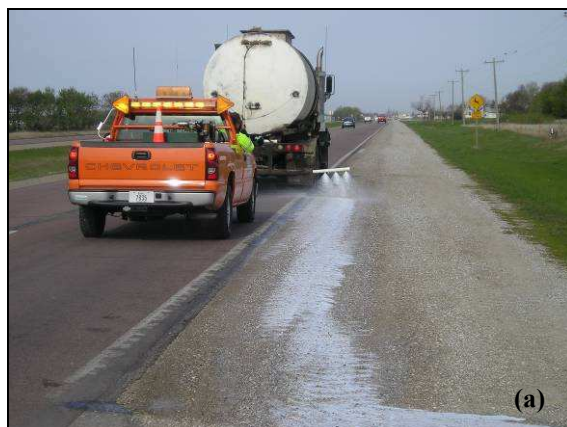
FIG. 2.8 — *Test section No. 1 (a) topical application of the polymer emulsion product (b) delamination of the stabilized granular material after 1 month (c) elevation profiles with time showing redevelopment of edge drop-off*

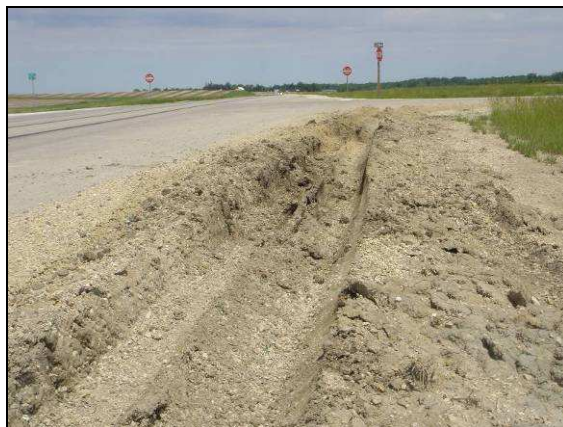
FIG. 2.14 — *Severe rutting extending to the underlying clay layer*

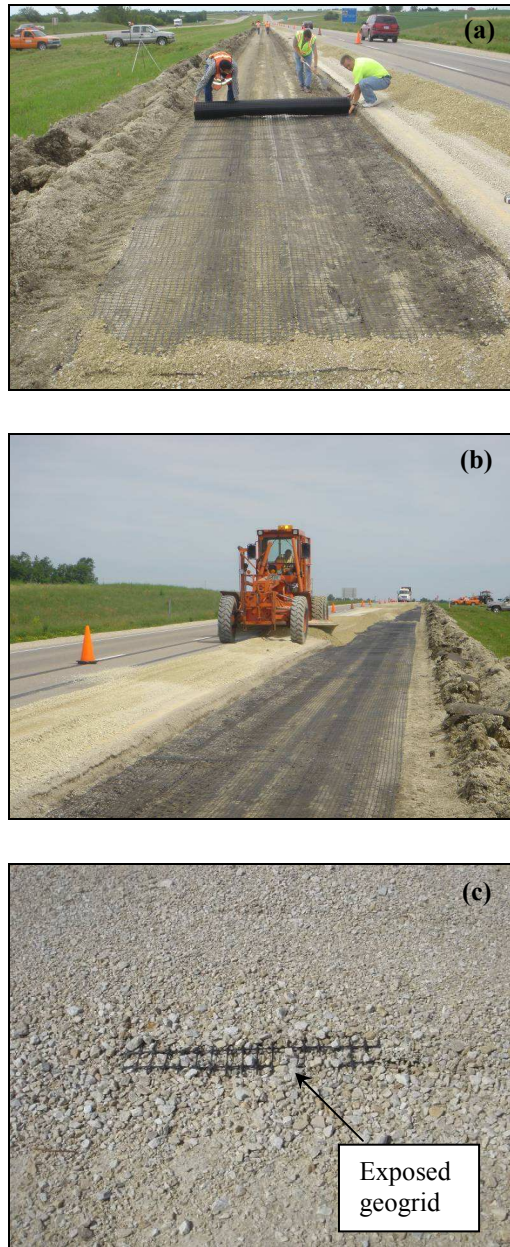
FIG. 2.15 — *Geogrid stabilization (a) rolling the BX1200 geogrid over the soft subgrade layer (b) spreading crushed limestone over the geogrid (c) exposed BX1200 geogrid at about 2.4 from the pavement edge after 10 months*

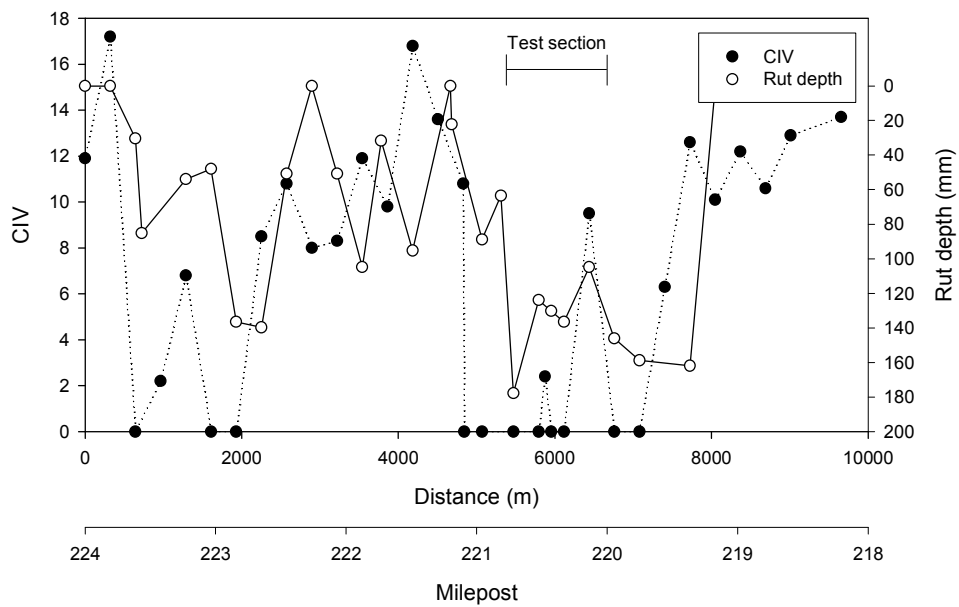
FIG. 3.2 — Profile of the rut depth measured inside the wheel path and CIV measured at 0.6 m from the pavement edge

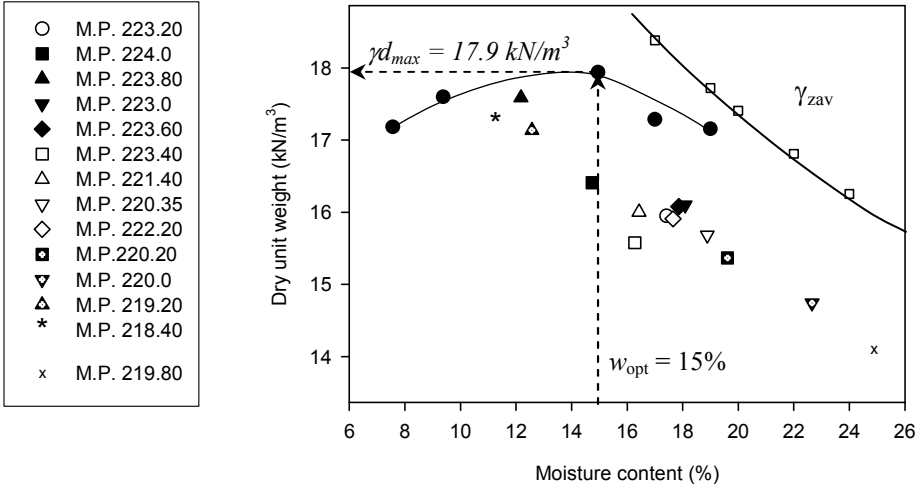
FIG. 3.3 — Moisture-density relationship for the subgrade material

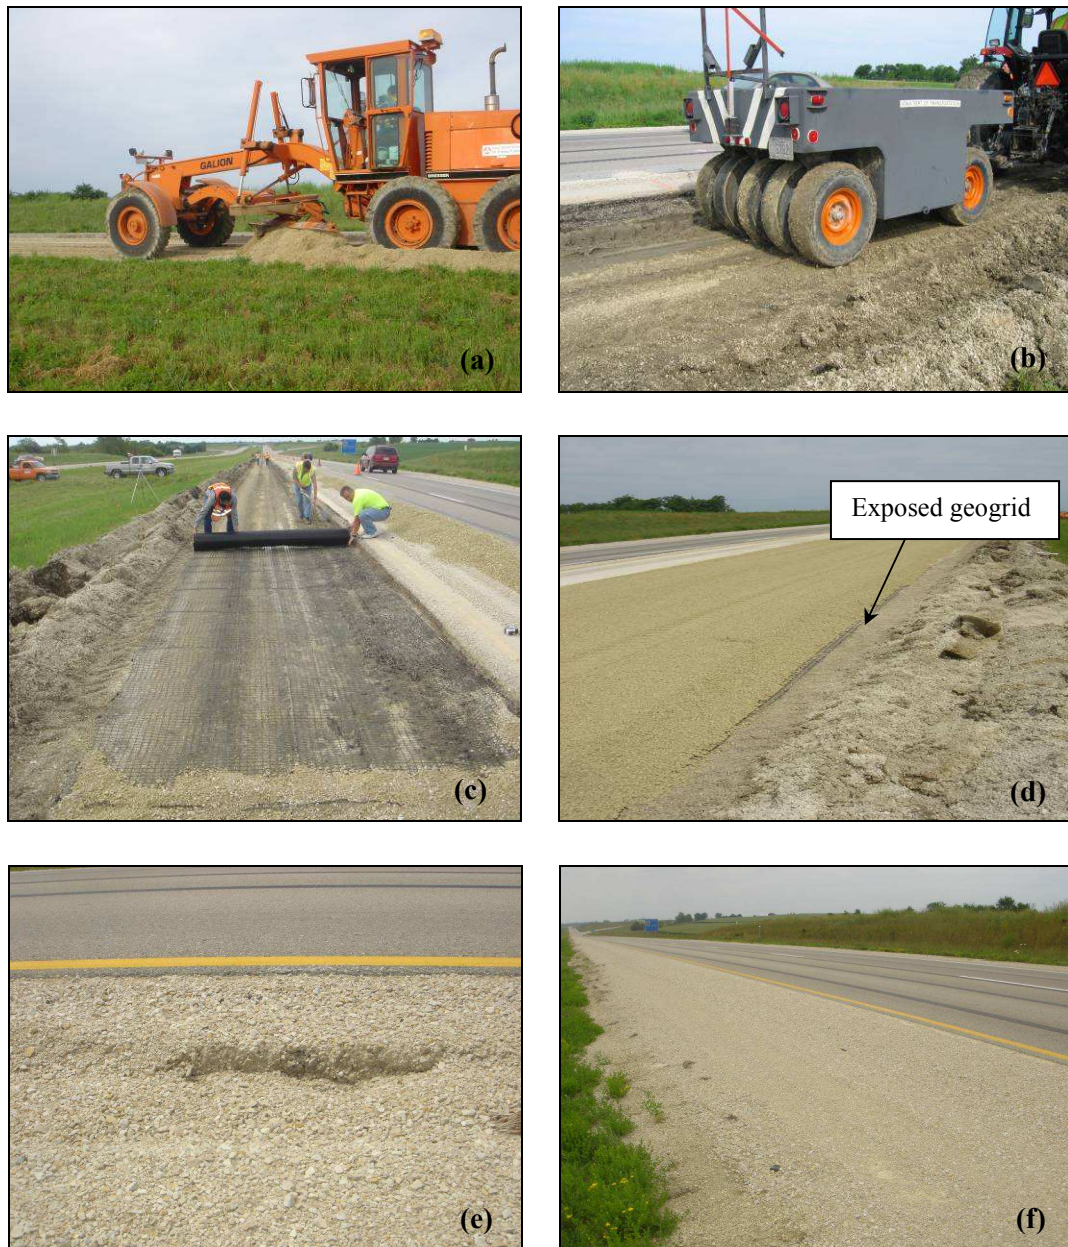
FIG. 3.5 — *Shoulder reconstruction using geogrids (a) motor grader removing the contaminated granular layer (b) pneumatic roller used to compact the subgrade (c) rolling the geogrid over the subgrade (d) spreading the aggregate over the geogrid (e) rutting developed at the control section after one month (f) no rutting at the geogrid stabilized section after one month*

As shown in Figure 3.5a, the existing granular layer was stripped using a motor grader and discarded because of its contamination with the underlying subgrade soil. About 450 tons of crushed limestone were delivered to the site and placed on the pavement adjacent to the test section. The subgrade was leveled using a skid loader and then compacted using a pneumatic roller (See Figure 3.5b). Using a power saw, the geogrids were cut to 2.4 m wide to match the width of the stabilized area. The geogrids were rolled over the soft subgrade starting with Geogrid1 followed by Geogrid2 then Geogrid3 (See Figure 3.5c). The shoulder beyond approximately 300 m was not included in the test section because Geogrid3 was damaged during transportation. The defective grid, denoted by Geogrid3*, was placed without alteration to document the effect of improper geogrid installation. . A motor grader followed by a pneumatic roller were used to spread and compact the aggregate. At the end of construction, it was noted that parts of the geogrids were not adequately covered with aggregate (2.4 m away from pavement) and the edges of the geogrids were exposed (See Figure 3.5d). The entire process of excavation of contaminated material, geogrid placement, aggregate placement, and compaction took approximately five hours. Upon construction completion, the section was opened to traffic. Unlike some chemical stabilization, a geogrid are quickly installed and does not require curing time, which reduces disturbance to traffic.

The first inspection was performed after one month from the date of construction. Edge rut of about 127 mm rut was observed at the control section as shown in Figure 3.5e. The stabilized sections showed no signs of rutting (See Figure 3.5f).

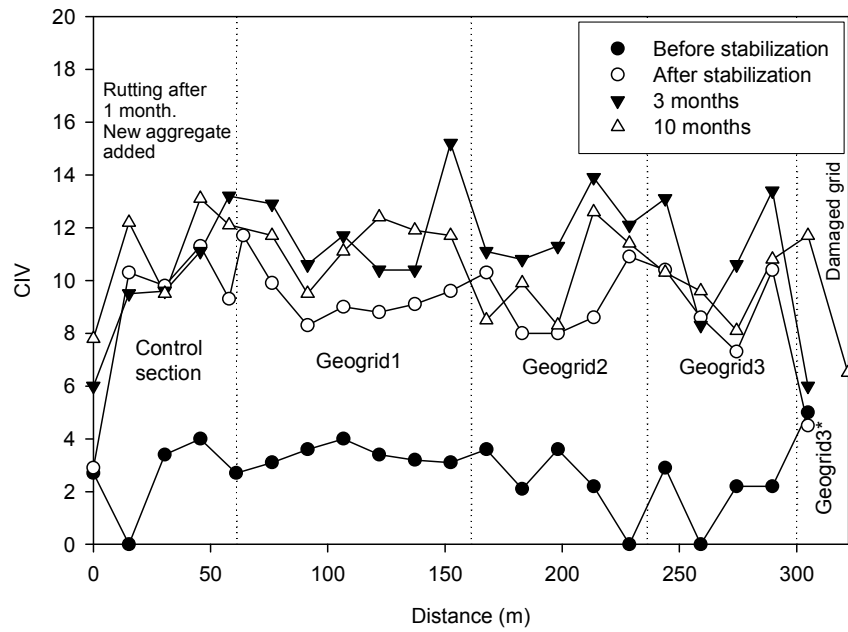
FIG. 3.7 — Profile of CIV with time at 1.2 m from the pavement edge

Using a 20 kg hammer, CIV tests were performed every 15 m as shown in Figure 3.7. Immediately after geogrid installation, CIVs increased. CIVs also increased at the control section as a result of subgrade compaction during the geogrid installation procedure and the addition of virgin rock material. After three months, additional strength at the stabilized sections was measured as indicated by the further increase in CIVs. CIVs measured at the control section did not increase. There was no significant difference between the CIVs measured at the geogrid sections even though the aperture stability modulus, and thus stiffness, varied for each geogrid type. It is possible that the CIV value for the 20 kg Clegg hammer is influenced by a relatively shallow depth and thus was unable to detect different degrees of confinement. At 10 months, CIVs were reduced in all the stabilized sections. Relative loosening of the granular layer after the freeze-thaw period may be the reason behind this reduction.

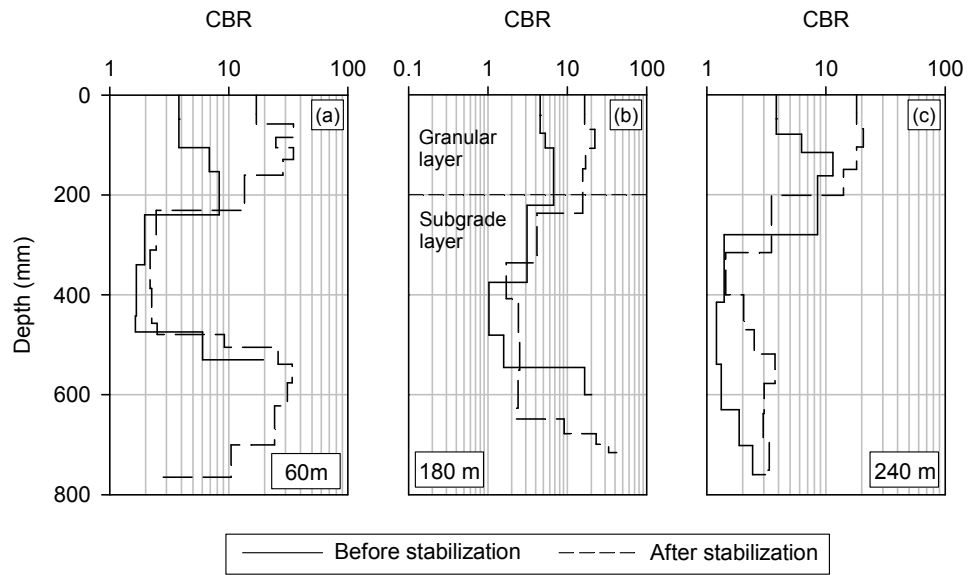
FIG. 3.8 — DCP results before and after stabilization (a) Geogrid1 (b) Geogrid2 (c) Geogrid3

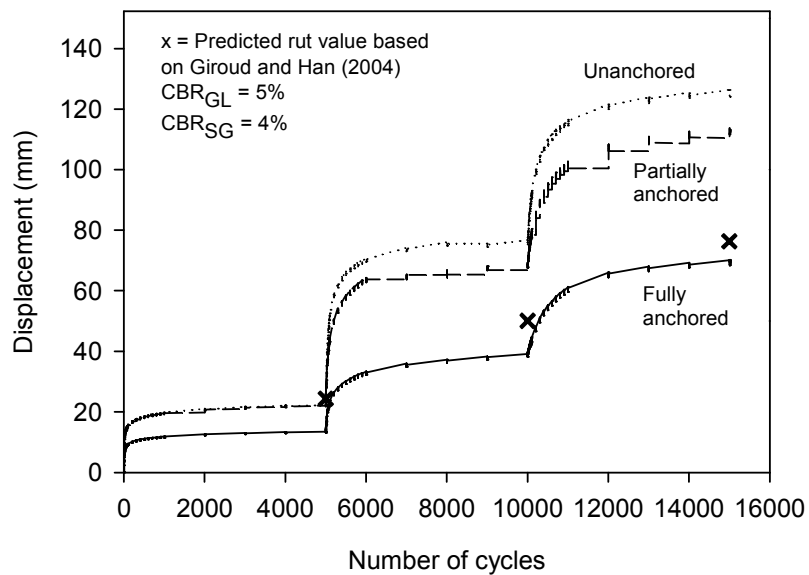
FIG. 3.13 — Measured and predicted soil displacement for Geogrid I tests

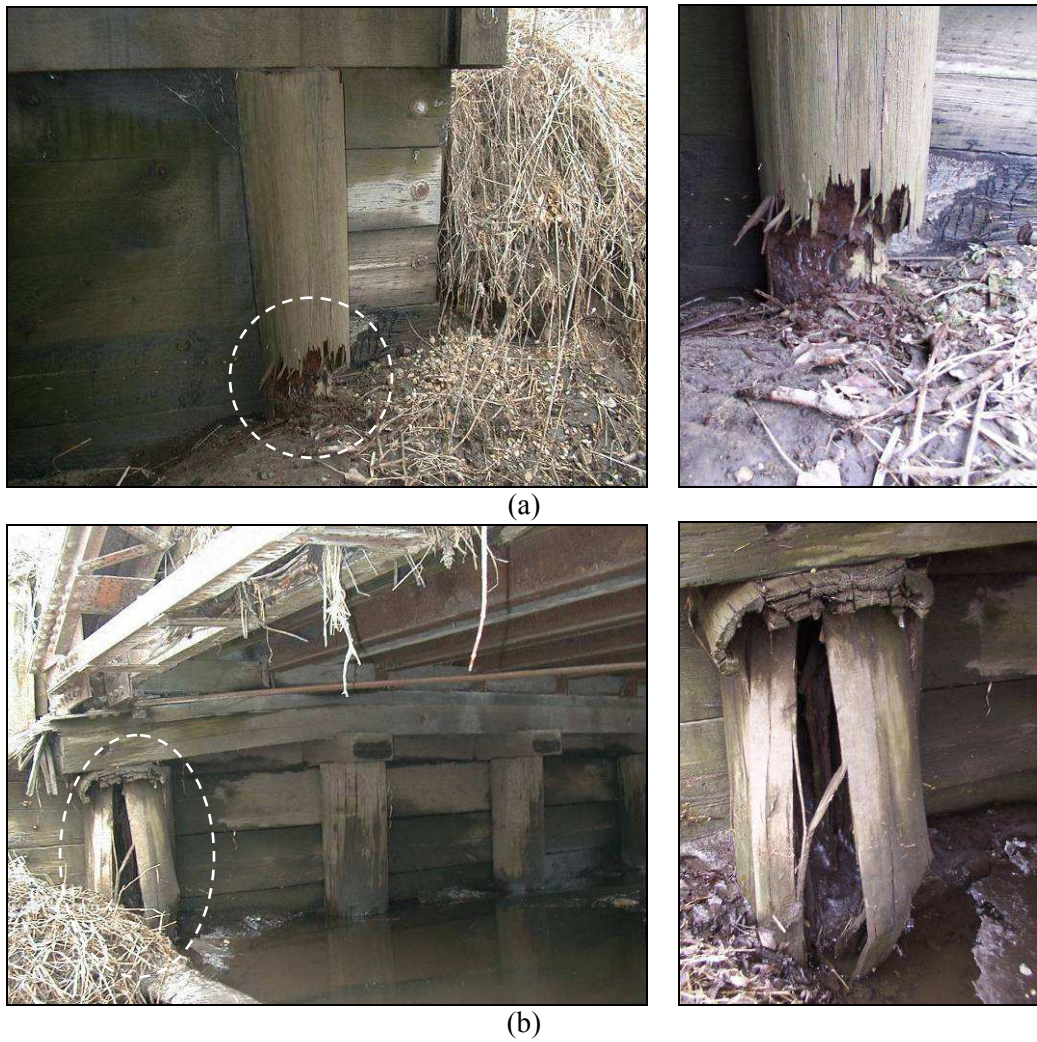
FIG. 4.1 — *Timber pile biological deterioration (a) reduction of pile cross section (b) complete deterioration of pile section*

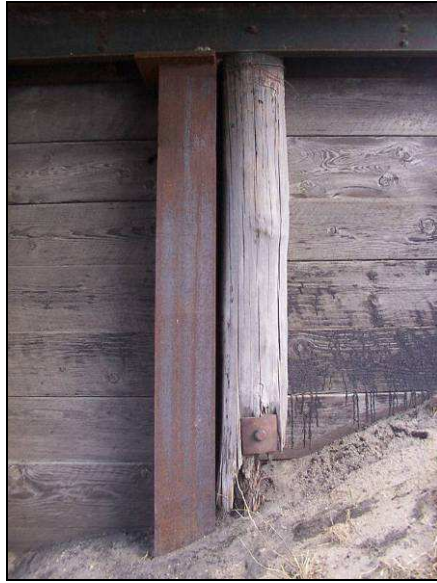
FIG. 4.3 — *New steel pile driven adjacent to a defective timber pile*

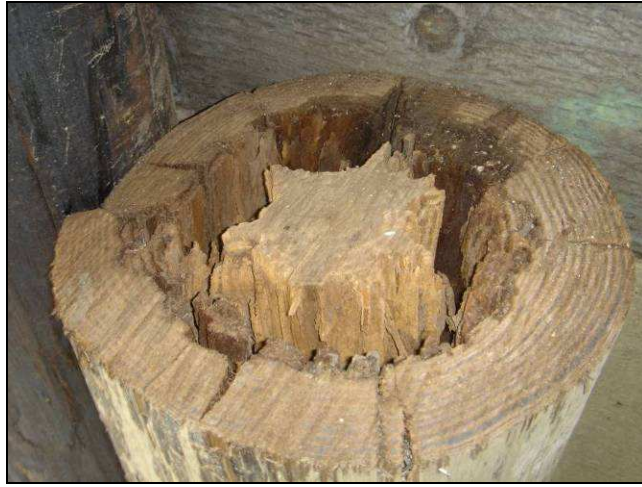
FIG. 4.6 — *Internal pile deterioration that is difficult to detected using the stress wave technique*

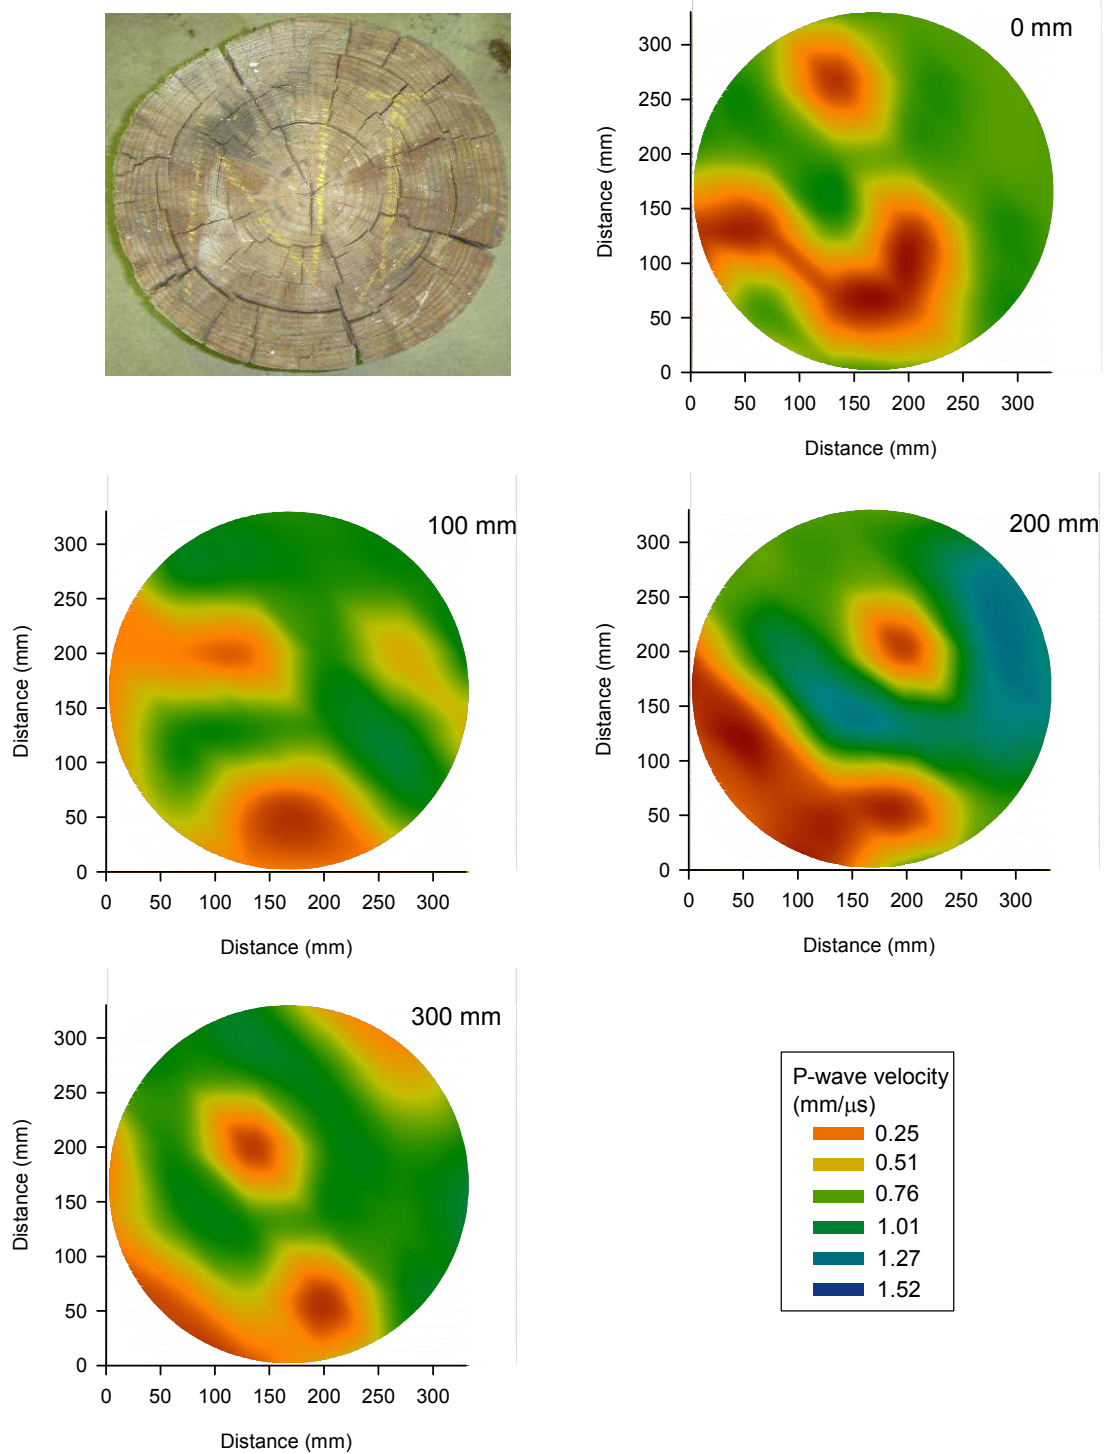
FIG. 4.12 — *Generated tomography images of a timber pile specimen*

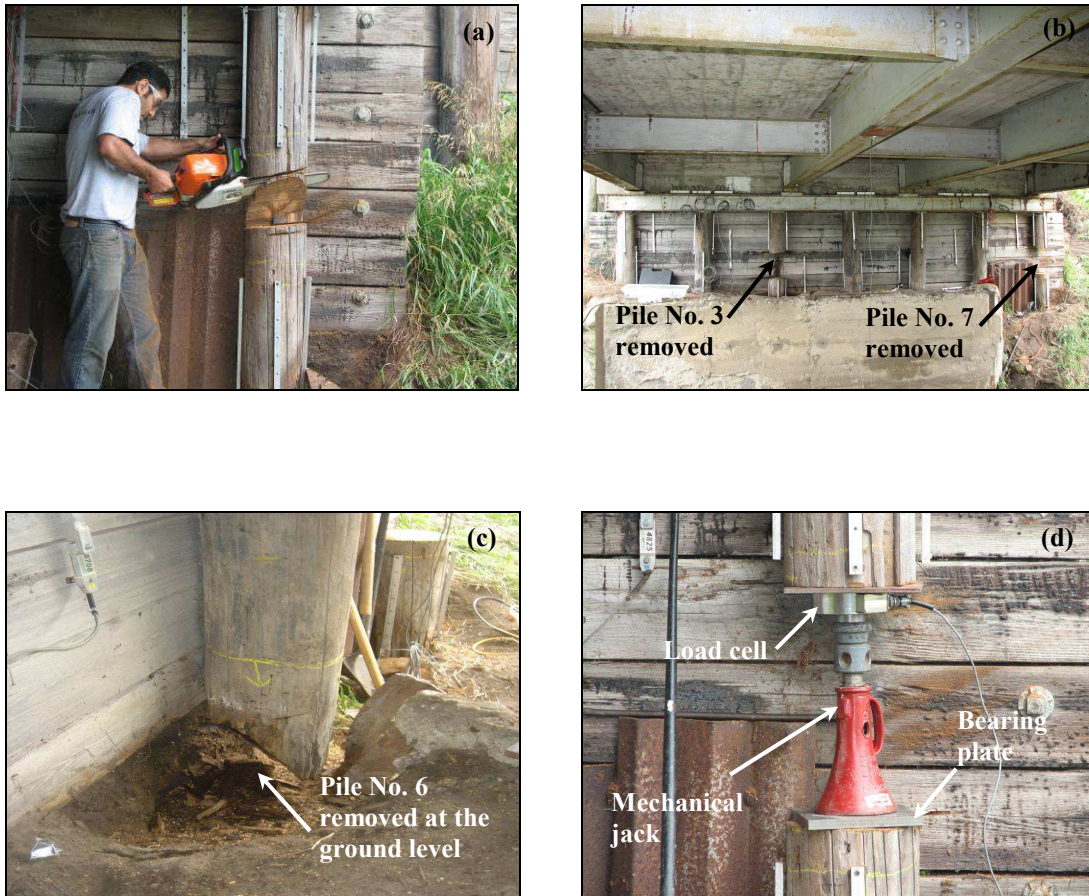
FIG. 5.7 — *Destructive static load tests (a) removing pile No. 7 (b) a section from pile Nos. 3 and 7 removed (c) a section near the ground level is removed from pile No. 6 (d) mechanical jack and load cell used to restore the dead load carried by pile No. 7*

FIG. 5.7 — Destructive static load tests (a) removing pile No. 7 (b) a section from pile Nos. 3 and 7 removed (c) a section near the ground level is removed from pile No. 6 (d) mechanical jack and load cell used to restore the dead load carried by pile No. 7

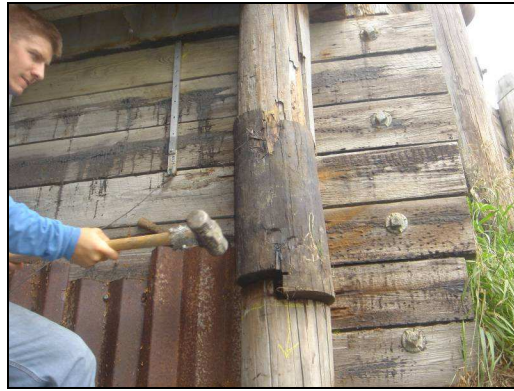
FIG. 5.10 — *Repairing pile No. 7 using the splicing technique*

FIG. 5.10 — Repairing pile No. 7 using the splicing technique
