Lead Hazard Control in Henderson, Nevada: Identifying Critical Areas and the Associated Costs

LEAD HAZARD CONTROL IN HENDERSON, NEVADA: IDENTIFYING
CRITICAL AREAS AND THE ASSOCIATED COSTS

Master of Public Health

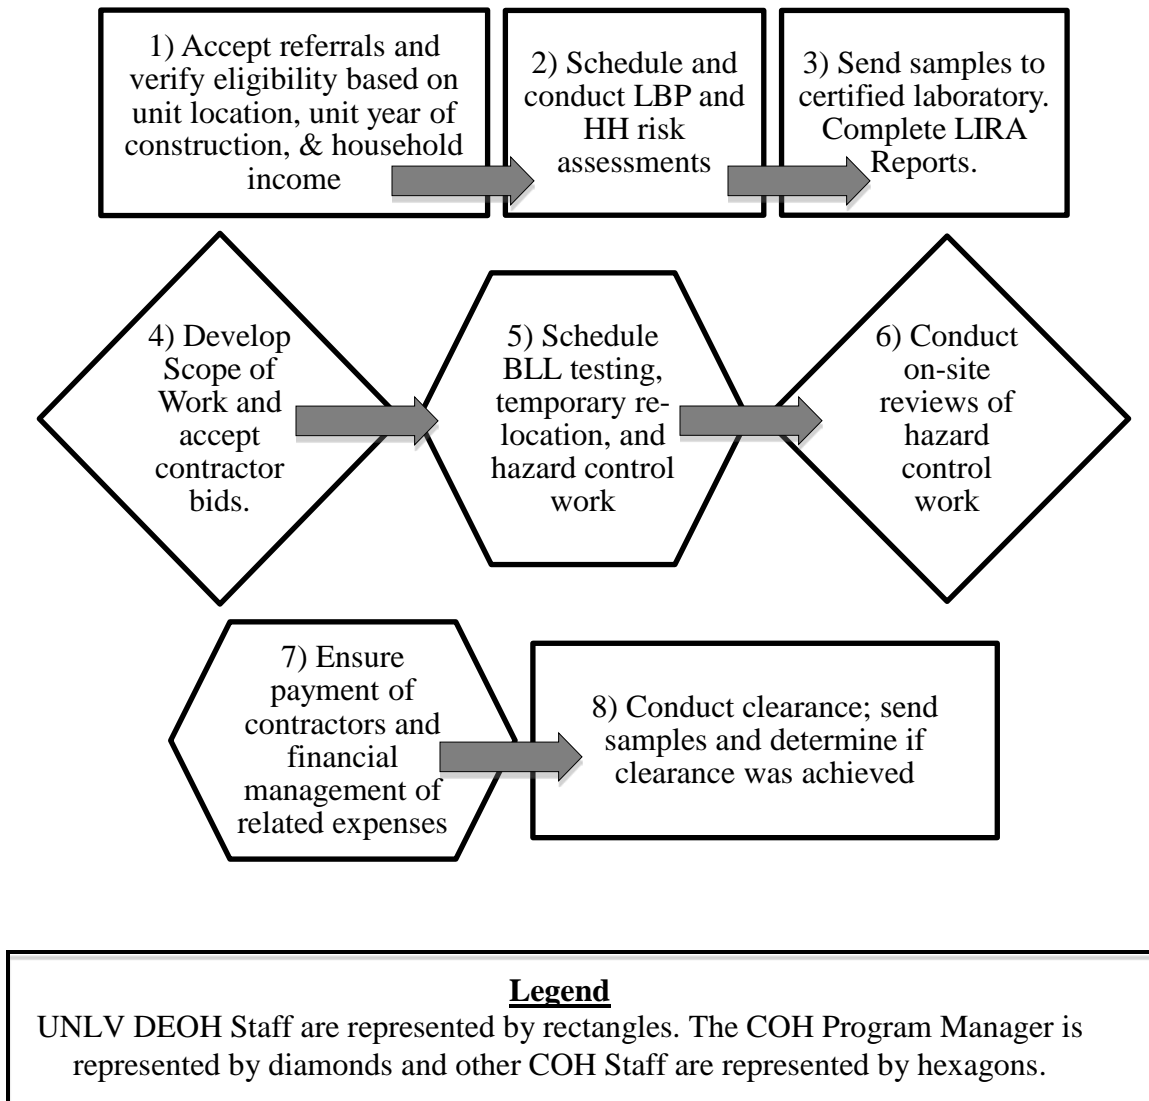
Figure 4: Flow Chart Process of Staff Position Duties for The Henderson Lead Hazard Control and Healthy Homes Program Protocol

UNLV staff conducted the Lead Inspection Risk Assessments after qualifying a targeted housing unit. Grant employees at the COH worked in tandem with UNLV staff once the LIRA was completed and after receiving the report of the house inspection. If the unit was found to contain LBP, the COH staff members conducted a walk-through of the home and discussed LHC options with the landlord/homeowner/renter. A landlord was defined as a person or organization that rented land, a building, or an apartment to a tenant.

The Program Manager at the COH was responsible for the walk-through of the homes and created the scope of work. Once the COH determined the cost estimates of the specified work to be done, which could either be interim control or abatement, the COH staff members released bids to certified and trained contractors that were chosen to help with the construction process. The bid was then awarded to the lowest "responsible bidder", which was the contractor who submitted the lowest price on time, without errors, and the cost was realistic aligning with appropriate work measures.

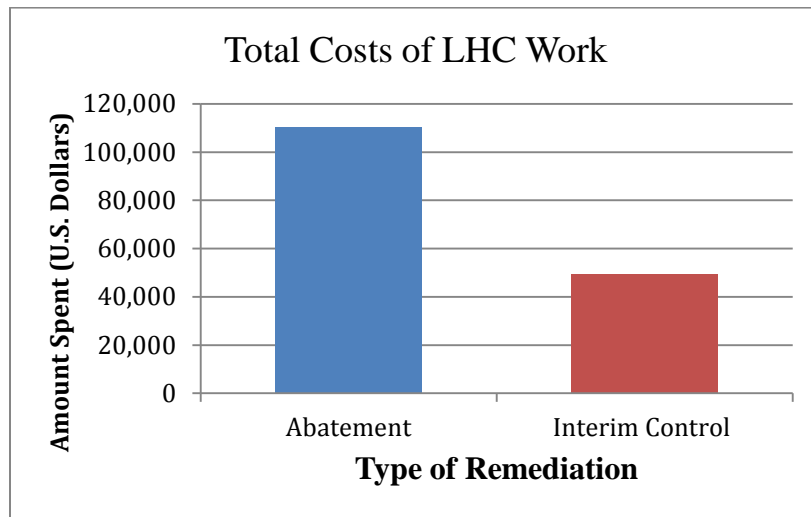
Figure 6: Total Costs of LHC Work (Abatement vs Interim Control) in U.S. Dollars

instances of remediation done on both exterior and interior of the home. All of the instances describing which components, substrates, and type of remediation utilized per case are detailed in APPENDIX I. A total of \$159,672 was spent on LHC work only with \$88,942 spent on abatement measures and \$70,730 was spent on interim controls as seen in Figure 6. The pricing per remediation ranged from \$90 - \$14,500.

A Mann-Whitney U test was run to determine if there were differences in pricing between abatement methods and interim controls. Distributions of the pricing for abatement methods and interim controls were not similar, as assessed by visual inspection of the pyramid graph (Fig. 6). Pricing for abatement (Mean rank = 51.54) and interim controls (Mean rank = 43.34) were not significantly different, $U = 916$, $z = -1.435$, $p = .151$; therefore, the null hypothesis for question 4 for is retained – H_0 : There was not a difference between average costs of abatement methods compared to interim controls.
