## Remanufacturing of precision metal components using additive manufacturing technology

Department: **Mechanical and Aerospace Engineering**

**PAPER****I. EXPERIMENTAL CHARACTERIZATION OF A DIRECT METAL DEPOSITED COBALT-BASED ALLOY ON TOOL STEEL FOR COMPONENT REPAIR****Xinchang Zhang<sup>1</sup>, Tan Pan<sup>1</sup>, Wei Li<sup>1</sup>, and Frank Liou<sup>1</sup>**<sup>1</sup>Department of Mechanical and Aerospace Engineering,

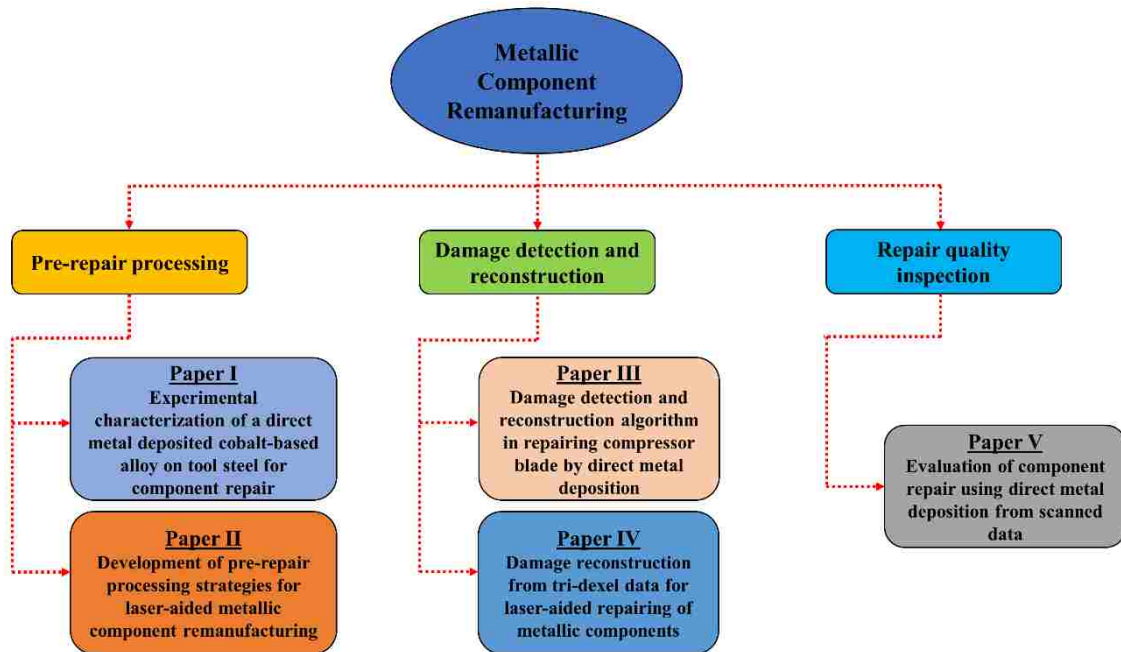
Figure 1.1. The framework of this dissertation

specific issue for realizing the overall objective. The organization of this dissertation is illustrated in Figure 1.1.

Discharge Machining (EDM). Pre-repair heat-treatment procedure for H13 tool steel that is widely used for manufacturing casting dies, molds and tools was presented to restore the nominal properties of damaged parts due to fatigue failure after a large number of thermal cycles. Mechanical properties of re-hardened samples were compared with the corresponding properties of damaged specimens to show the benefits and necessity of pre-repair heat-treatment. Paper III introduced a method for refurbishing damaged jet engine turbine and compressor blades, which has an immense value of remanufacturing. Algorithms for accurately aligning damaged blade models with their nominal models were investigated. Besides, repair volume reconstruction approach based on one-directional ray casting method was proposed. Paper IV further extended the damage reconstruction method by casting rays in three directions (Tri-dexel modeling). This approach is capable of generating three-dimensional repair volumes for a variety of metal parts. The accuracy of the reconstructed damage based on the proposed algorithm was further studied. This paper also introduced an automatic 3D scanning process by integrating a structured-light 3D scanner with a Nachi industrial robot. The integration intends to realize the scanning automation to benefit the automated part repair process. Paper V analyzed the repaired part quality by microstructure characterization and mechanical testing. The purpose of this paper is to validate the successful repair of damaged components by the AM process, confirming the feasibility of the repair framework illustrated in Figure 1.1.

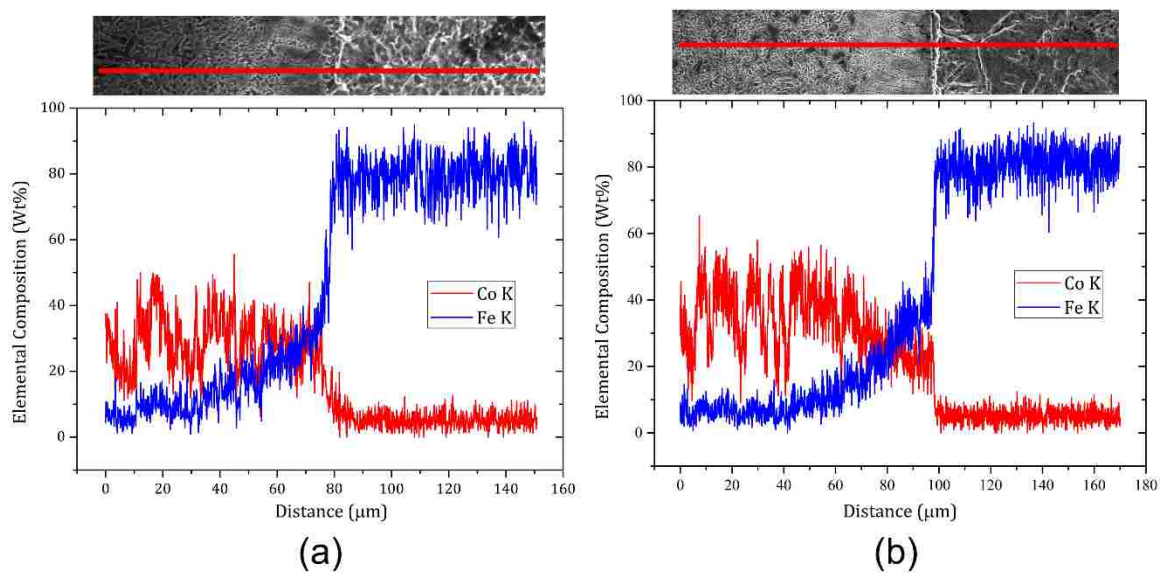
Figure 5. EDS line scan result for samples with 45° (a) and 75° (b) sidewall damage

An EDS line scan was performed on the repaired specimens to investigate elemental composition and distribution. The line scan was initiated from the as-deposited Wallex 50 and terminated in the area of the H13 tool steel, passing the bi-material interface. Major elements including Co and Fe were quantified along this route. Dwell time for each point was 200 ms. The acquired data are plotted in Figure 5.

The EDS line scan exhibits that the major elements like Co and Fe were quickly changed from the deposit region to the substrate. A diluted zone can be seen at the interface. In this region, the quantity of Co is gradually increasing while the amount of Fe is decreasing. This can be attributed to that when a melt pool was formed on the substrate, cobalt-based alloy Wallex 50 was injected in the melt pool and mixed with the melted H13 tool steel material. After solidification, mixture of Wallex 50 and H13 tool steel was formed at the interfacial area. This material mixture results in the transition of the elemental composition near the interface. A large amount of Fe exists in the first few layers of deposits, showing the dilution of Fe into Wallex 50 and contributes to the phase transformation over the interface. There is almost no influence of sidewall tilt angle on the transition of elements at the boundary. Therefore, once materials are fused together, similar elemental composition trend can be obtained. The EDS line scan also confirms that excellent metallurgical bonding was created along the interface. Both materials were metallurgically instead of mechanical joined, showing the mixing compatibility.

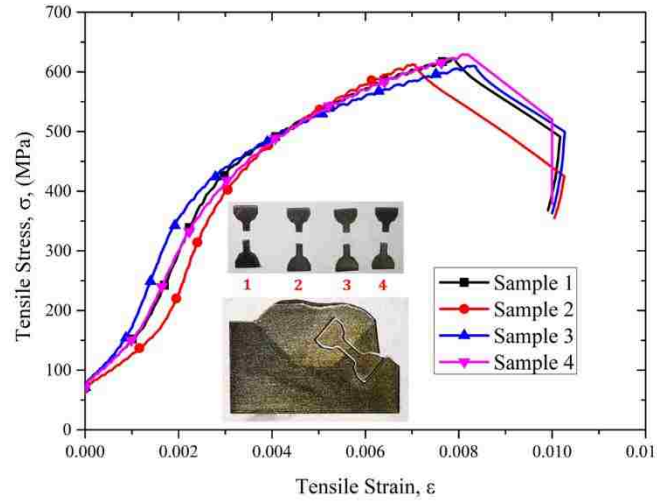
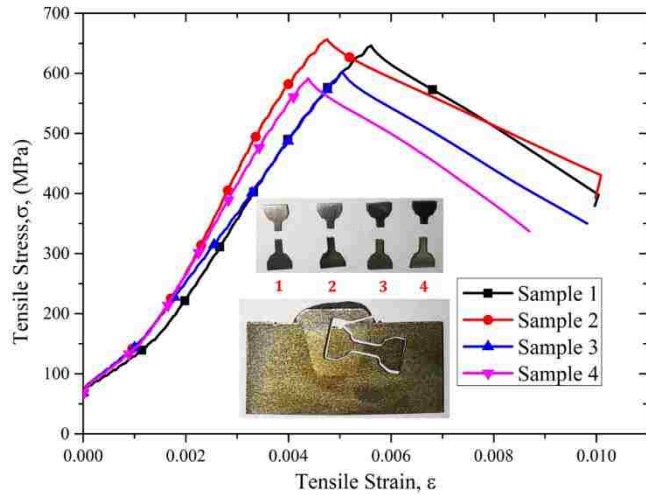
Figure 6. Tensile stress-strain curves for samples with  $45^\circ$  (a) and  $75^\circ$  (b) damage

Four tensile specimens were cut from each repaired sample. The tensile stress-strain curves were plotted in Figure 6, the ultimate tensile strength (UTS) is summarized in Table 3, and the tensile fracture surface is in Figure 7. The tensile stress-strain curves reveal that the tensile stress increased with the increase of tensile strain to a peak stress of approximately 620 MPa. Then the tensile samples fractured abruptly. The stress-strain curves did not reveal yielding phenomenon during the tensile testing. The ductility of the tensile samples was extremely low. Further investigation reveals all samples fractured at the as-deposited Wallex 50 region. Therefore, the as-deposited Wallex 50 alloy shows a brittle fracture mechanism.

The average UTS of the repaired samples with 45° and 75° V-shaped defects is approximately 618 MPa and 624 MPa, respectively. The tensile testing reveals the

influence of sidewall inclination angle on the UTS is barely recognizable. This result shows that as long as the deposited material bonded well with the substrate, the tensile strength of the repaired sample is relatively consistent. There is a substantial variation of UTS in the tensile result. This variation was possibly attributed to the unevenly located defects in the deposited regions. Some micropores in deposits may affect the UTS and result in the large standard deviation. The strain at UTS for 45° sample is slightly higher but not more substantial than the strain at UTS for 75° sample.

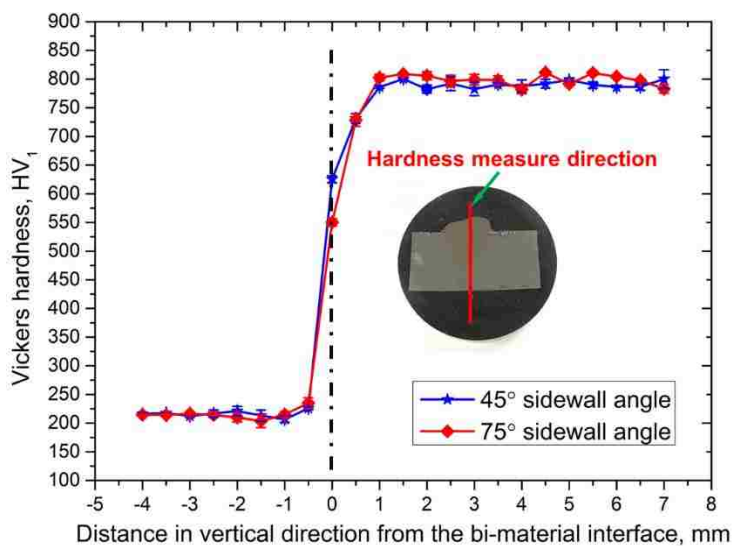
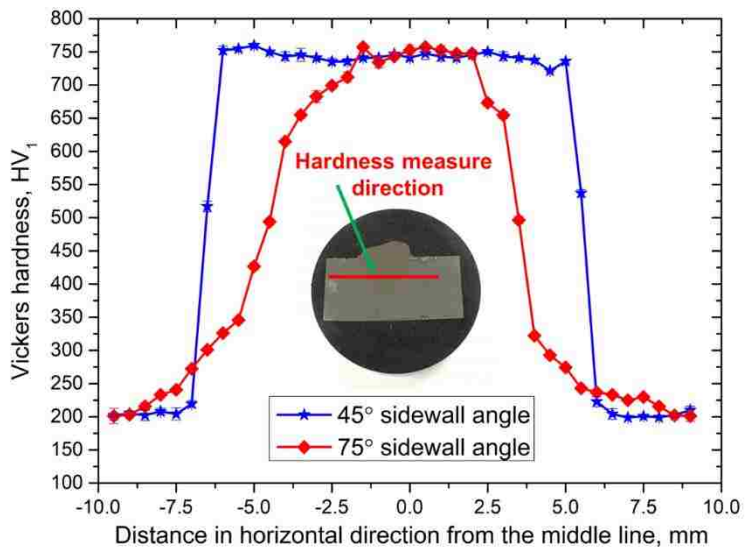
Figure 8. Vickers hardness distribution. (a) Microhardness measurement in a vertical direction; (b) Microhardness measurement in a horizontal direction

Vickers hardness along two paths was measured on the cross sections of the repaired samples. One is in the vertical direction from as-deposited Wallex 50 to substrate as shown in Figure 8a. Another one is in the horizontal direction passing through substrate, deposits, and substrate, which is shown in Figure 8b.

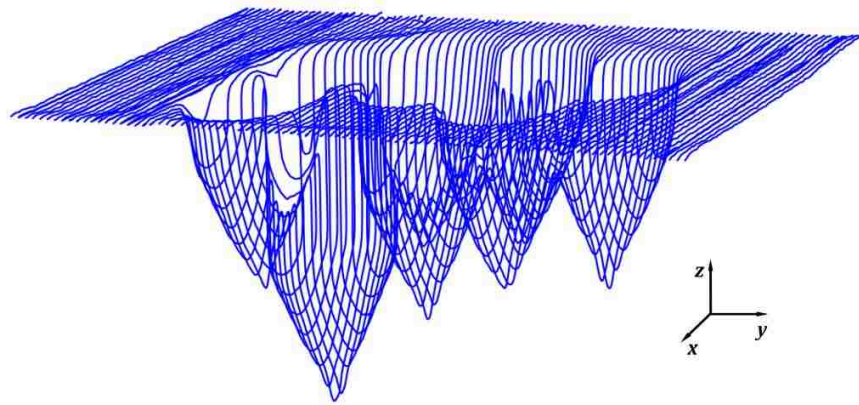
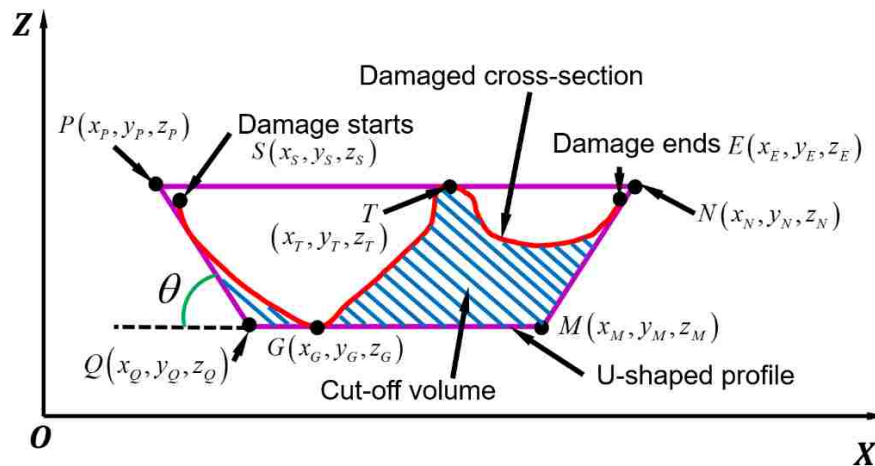
Figure 5. Model slicing and enveloping boundary determination. (a) Cross-sections of the damaged model; (b) U-shaped enveloping boundary

The model of the damaged part was sliced into a number of layers along the y-axis with a layer thickness of 0.5 mm as shown in Figure 5a. The slicing outputs a series of

**2.3.2. Convex-Hull Boundary Definition.** One can see in Figure 5b that for U-shaped boundary, the bottom connecting line  $QM$  is parallel to the x-axis, and this may result in extra material cut-off in the polygon  $GMETG$ . This material over-cut comes worse when one deep defect is presented while majority defects are shallow because the depth of the bottom line  $QM$  is determined by finding the minimum z-coordinate across the damaged cross-sections. If a deep damage was presented, materials located between the bottom plane and the shallow defects also need to be machined. Because such material has to be deposited back through additive manufacturing process, this machining methodology will consume more time and efforts.

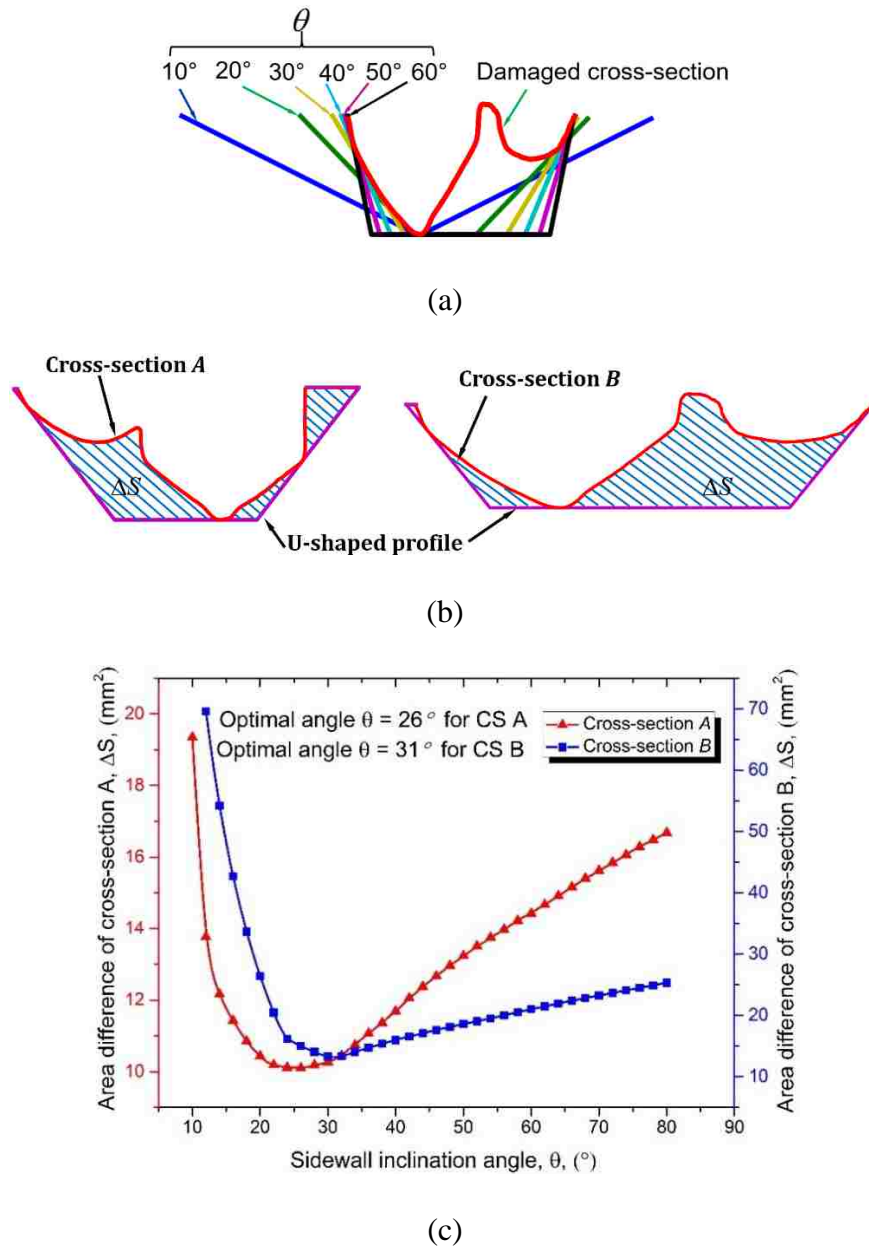
Figure 6. Sidewall inclination angle optimization for the U-shaped boundary. (a) U-shaped boundary with varied approaching lines; (b) U-shaped boundary for cross-sections A and B; (c) Relationship between area difference  $\Delta S$  and sidewall inclination angle  $\theta$

The inclination angle  $\theta$  of the two approaching lines can be operator determined and adjusted flexibly according to the specifications and performance of the AM system. It should be noted that  $\theta$  has a significant effect on the cut-off volume that should be machined in the pre-repair machining step. A small  $\theta$  can give good accessibility to the AM system but may result in a much more cut-off volume. An optimized  $\theta$  needs to be determined which not only reveals good accessibility but also holds a minimized cut-off volume. For this purpose, a series of approaching lines with varied inclination angle was adopted to intersect a cross-section shown in Figure 6a. Inclination angle  $\theta$  controls the accessibility and it shouldn't approach  $90^\circ$ .

A series of experiments were conducted that aim to refill slots with different sidewall inclination angles ( $45^\circ$ ,  $75^\circ$ ,  $90^\circ$ ) on H13 tool steel in Paper I and it was found that  $75^\circ$  tilt angle can still yield a sound bi-material bonding and good material properties. Therefore, the range of angle  $\theta$  was limited in  $[10^\circ, 75^\circ]$ . The area difference between the U-shaped profile and the cross-section,  $\Delta S$  shown in Figure 6b, can indicate the cut-off area. A series of approaching lines were processed on cross-sections A and B as shown in Figures 6a and 6b and the relationship between  $\Delta S$  and inclination angle  $\theta$  was plotted in Figure 6c.

It was observed from Figure 6c that for both cross-sections, the area  $\Delta S$  decreases and then increases with the increase of angle  $\theta$ . The curves indicate that neither a minimum

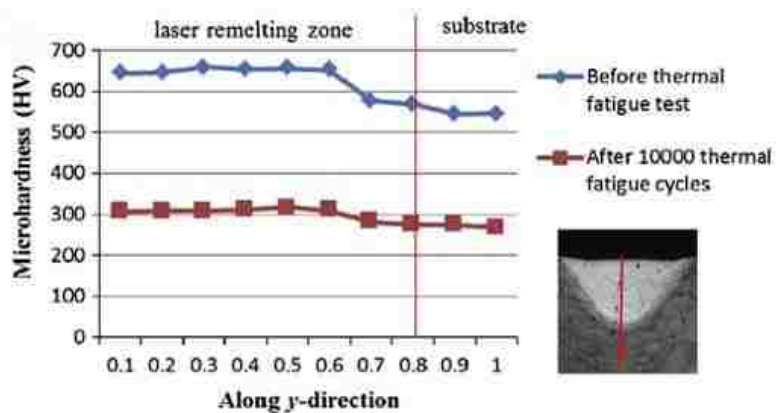
Figure 14. (a) The hardness of H13 tool steel before and after thermal fatigue cycles [41];  
(b) Microstructure of H13 tool steel after thermal fatigue cycles [41]

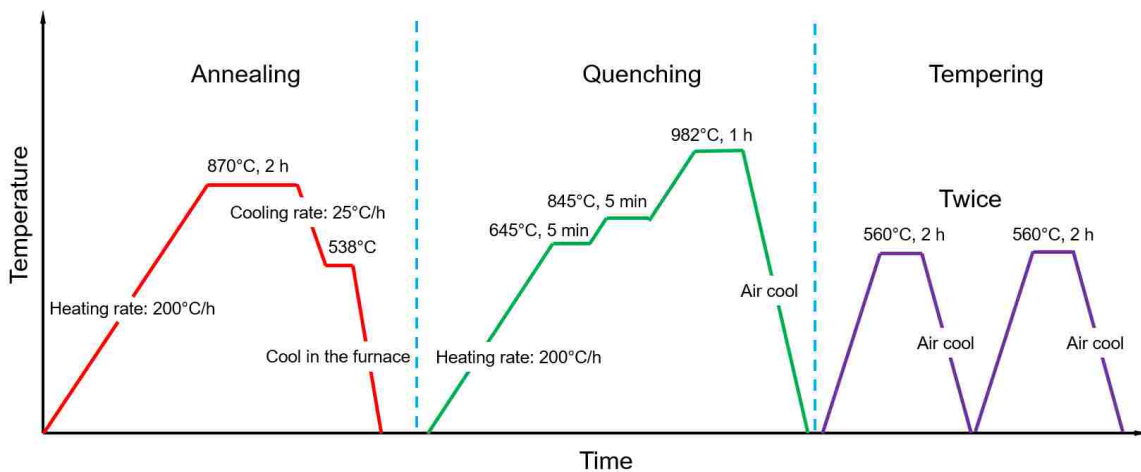
Figure 15. Schematic diagram of the re-hardening process for H13 tool steel

Figure 15 depicted the re-hardening procedure for H13 tool steel. It should be noted that H13 tool steel for die/mold applications is already in quenched and tempered condition. In order to re-harden it, annealing must be conducted at first.

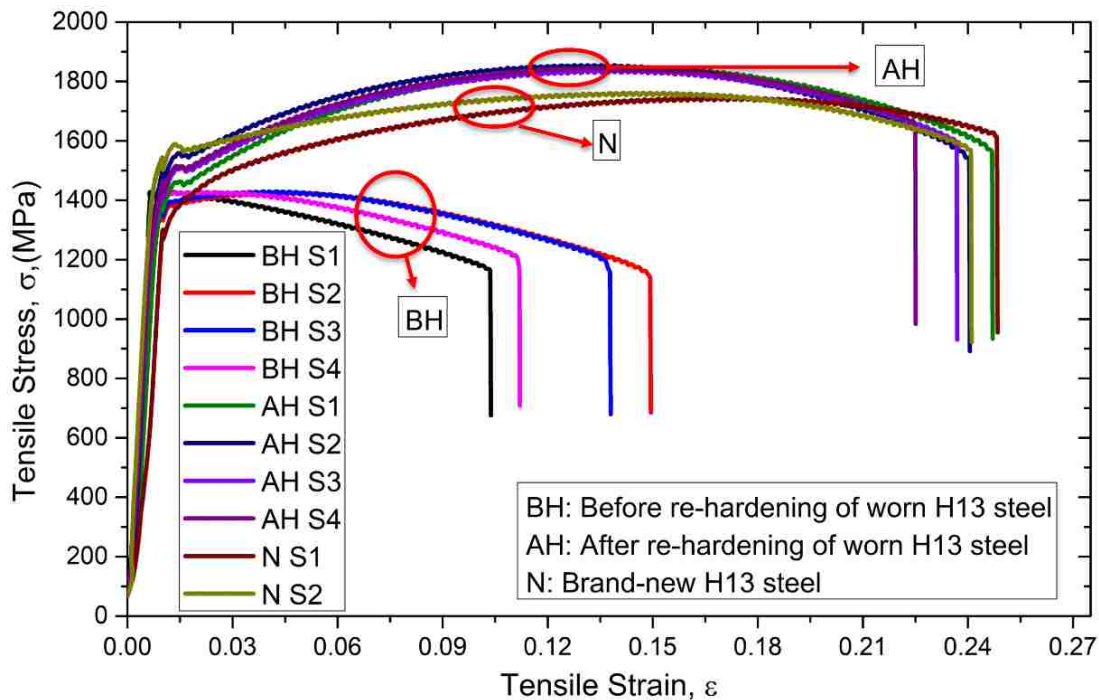
Figure 16. Tensile testing data of worn H13 tool steel (BH), re-hardened H13 tool steel (AH) and brand-new H13 tool steel in quenched and tempered condition

Figure 16 shows the tensile testing data of worn H13 tool steel (BH), re-hardened H13 tool steel (AH) and new quenched and tempered H13 tool steel (N). It can be observed that the UTS of worn H13 tool steel before re-hardening is 1427.9 MPa. By re-hardening it, the UTS can be increased to 1846.7 MPa and the ductility is also increased a lot. The tensile properties of re-hardened H13 tool steel are comparable with that of the new H13 steel in quenched and tempered condition. Therefore, it can be concluded that re-hardening can restore the tensile strength of worn H13 tool steel.

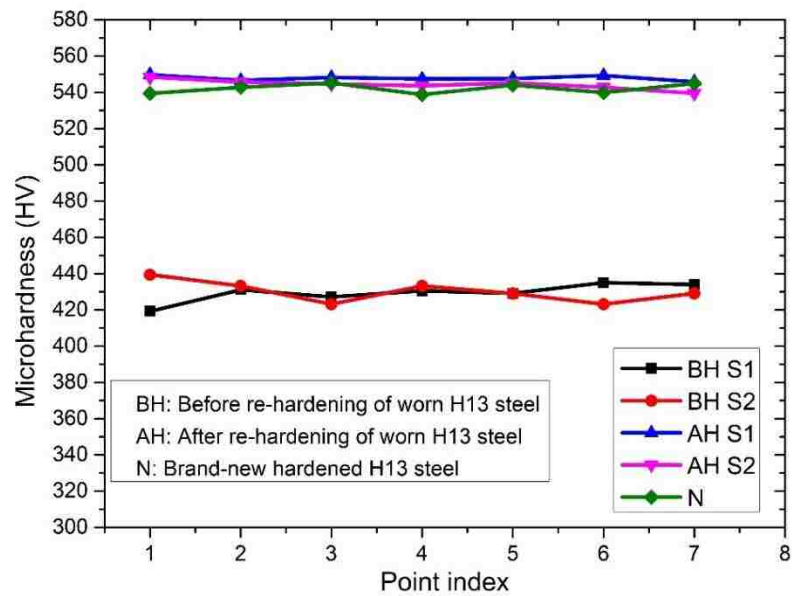
Figure 17. The hardness of worn H13 tool steel (BH), re-hardened H13 tool steel (AH) and brand-new H13 tool steel in quenched and tempered condition

Figure 17 shows the hardness measurements of worn H13 tool steel (BH), re-hardened H13 tool steel (AH) and new quenched and tempered H13 tool steel (N). In terms

of hardness, the worn H13 tool steel has a hardness of around 420 - 440 HV while the re-hardened H13 steel is about 540 - 550 HV which is similar to the hardness of new quenched and tempered H13 tool steel. Therefore, by re-hardening the worn H13 tool steel, its hardness can be increased.

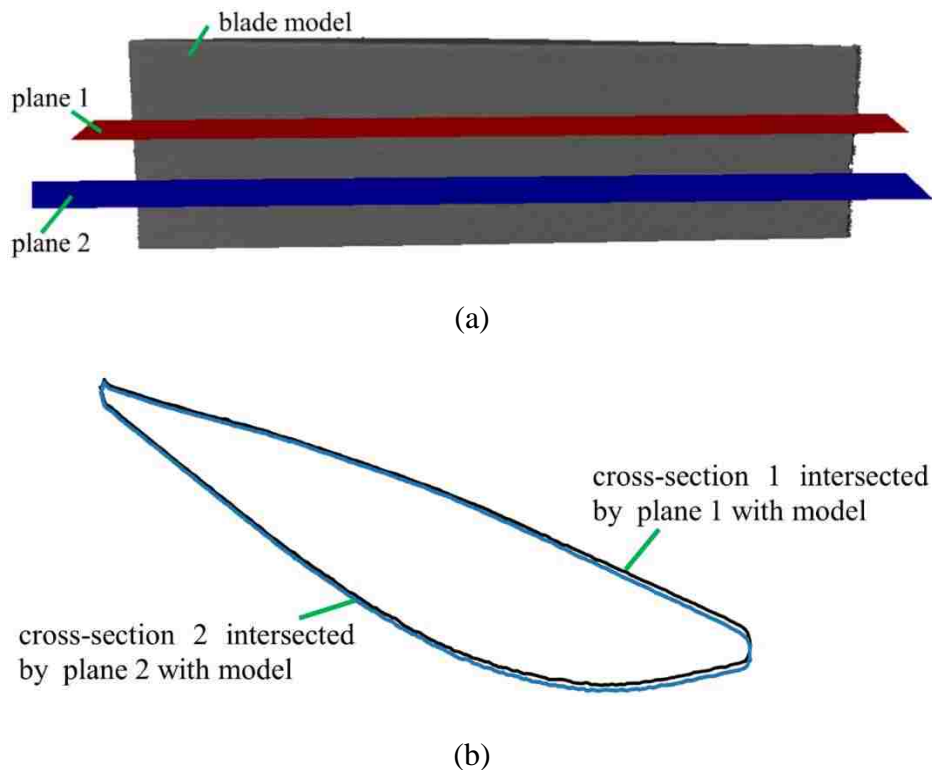
Figure 1. Cross-section comparison showing the curved profile of a blade. (a) The intersection of plane 1 and plane 2 with the blade; (b) Comparison of cross-section 1 with cross-section 2

Figure 1b shows a comparison of two cross-sections obtained by two parallel planes intersecting with the curved blade in Figure 1a. Because of a curved profile, the cross-sections at different levels are different and therefore, the model cannot be simply defined by one cross-section. Because of the complex shape of engine blades, an algorithm to automatically restore the damaged geometry is critical to provide accurate repair volume for repair.

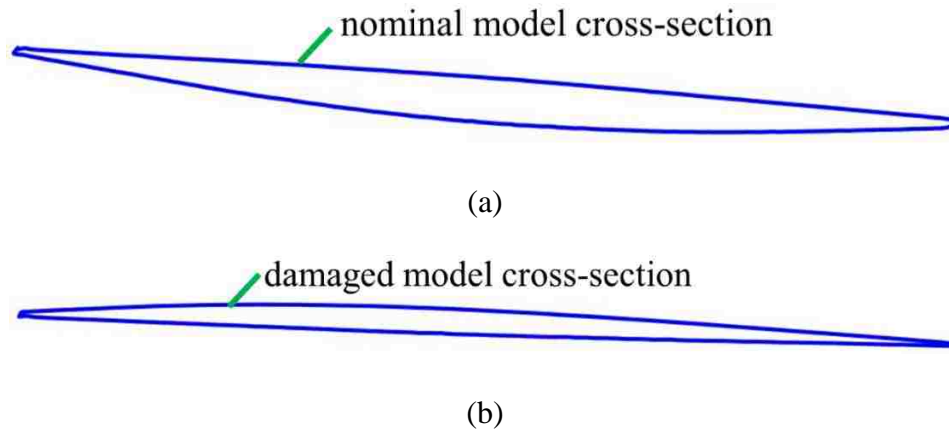
Figure 6. A cross-section of the nominal model (a) and damaged model (b)

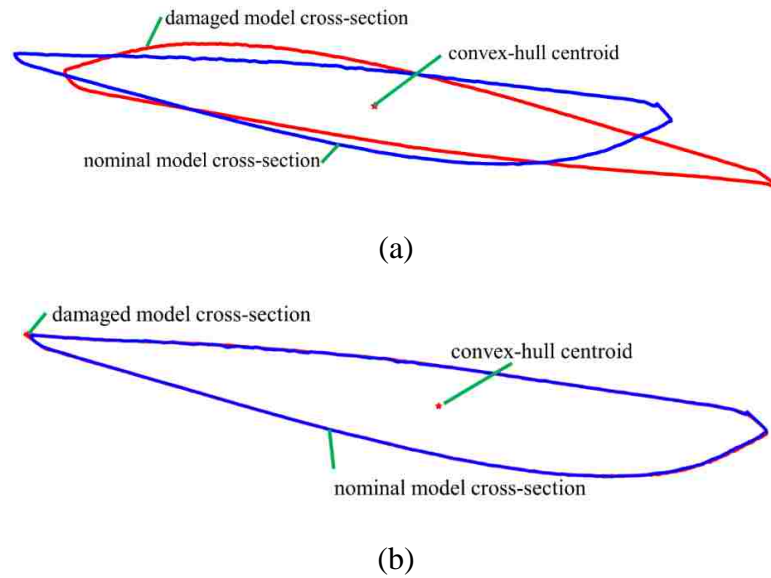
Figure 11. Nominal and damaged profiles before (a) and after (b) cross-section best-fit

Figures 11a and 11b show two cross-sections of nominal and damaged models before and after cross-section best-fit. It can be found that the cross-section of the damaged model was best-fitted with the cross-section of the nominal model after cross-section best-fit process.

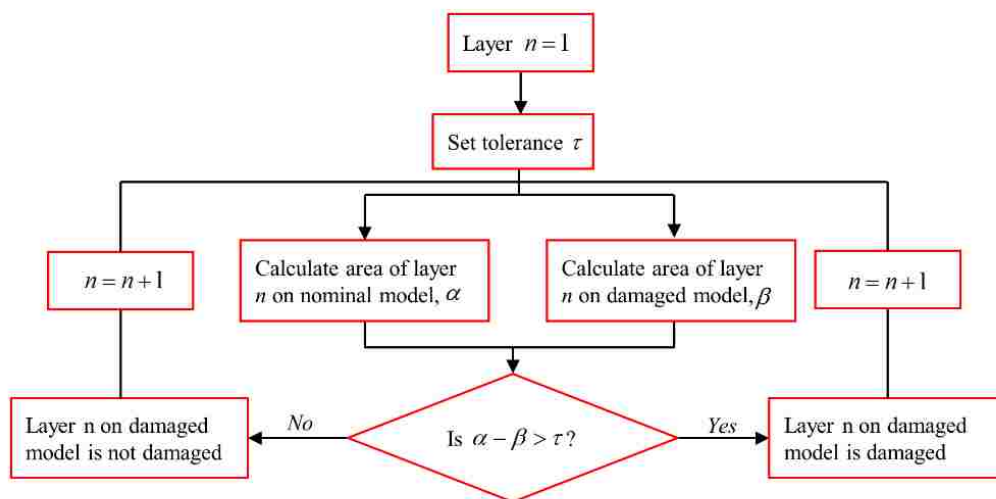
Figure 14. Defect detection process

For each layer, the area of the polygon of the nominal model was obtained as  $\alpha$  and the area of the corresponding layer of the damaged model was obtained as  $\beta$ . A tolerance  $\tau$  was set to deal with the error in the model reconstruction process. If the difference  $\Delta = \alpha - \beta$  was larger than the pre-defined tolerance  $\tau$ , this layer on the damaged model was defined as a defective layer. This process continues throughout all slices. Finally, the damaged layers of the damaged model were defined as shown in Figure 15.

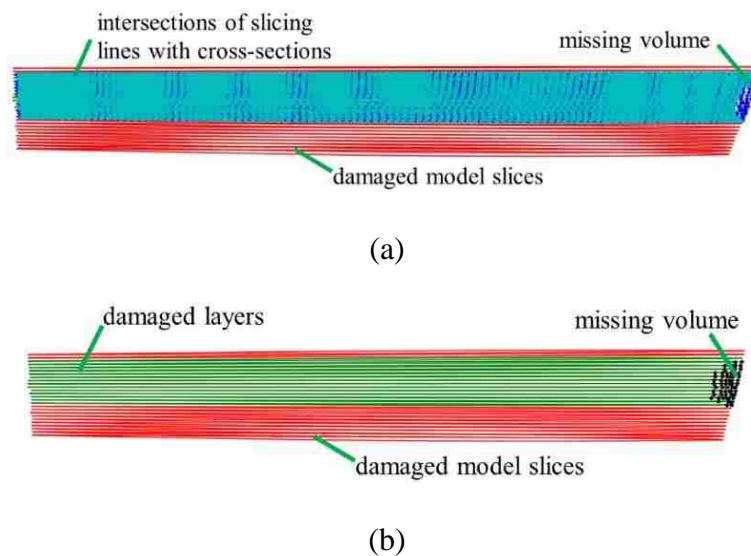
Figure 17. (a) Damage detection process; (b) Damage extraction processes

outer points on the blade surface. By reducing the slicing lines interval, more points on the defective region can be obtained. Figure 17a shows the intersections of a number of lines with the layered damaged model and the nominal model. The interval between two adjacent lines is set at 0.2 mm. By searching points in the damaged region, the point cloud that constructing the missing volume was obtained as shown in Figure 17b.

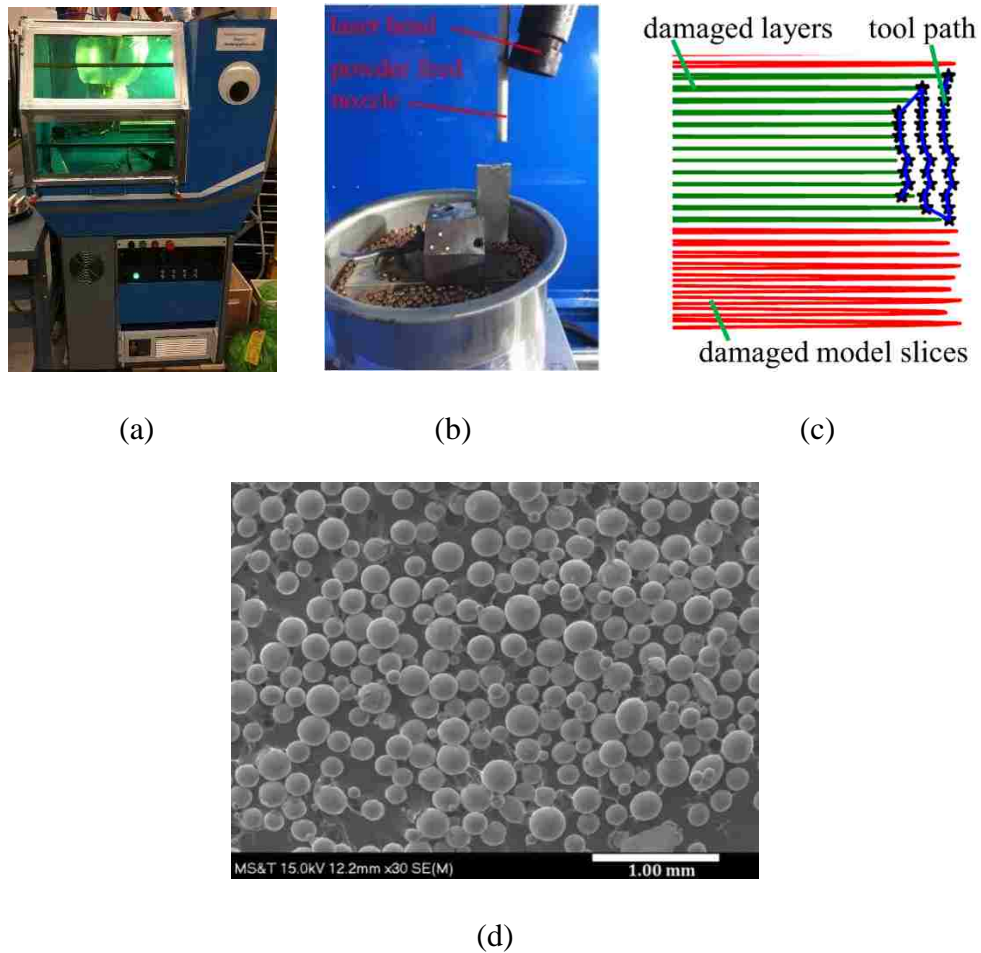
Figure 18. (a) DMD system; (b) DMD experimental setup; (c) Tool path generation for material deposition; (d) SEM images of Ti-6Al-4V particles

The DMD system as shown in Figure 18 employed in this study consists of a laser heat source (YLR-1000-MM-WC), powder feeder (Model 1200, Bay State Surface Technologies), 3-axis motion table, shielding gas units. Fiber laser with maximum power of 1000 W was used as the laser source. The laser head is tilted and the powder feed nozzle is vertical. The laser beam diameter which is focused on the damaged blade is 1.8 mm. The relative movement between the laser head and the blade was achieved by a 3-Axis motion table. Argon gas was used as the shielding gas to avoid oxidation to the titanium blade. Ti-6Al-4V particles were used as the deposited material. Micrograph of target particles was taken using a Field Emission Scanning Electron Microscopy (Hitachi S4700) and was shown in Figure 18d. It can be found that most powders were spherical although some irregularly shaped powders were detected. Table 1 summarizes the processing parameters used in the experiment. It should be noted that the highest thickness of the extracted missing volume geometry is 1.22 mm, which is smaller than the laser beam diameter. Therefore, only one track was planned for each layer. The tool path was shown in Figure 18c.

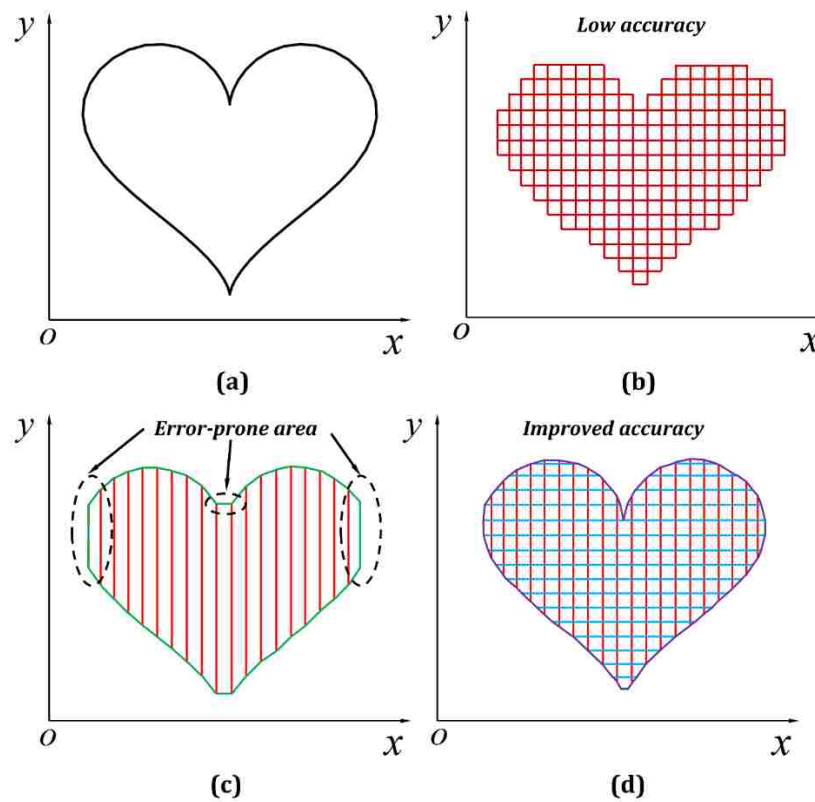
Figure 2. Comparison of a cross-section of a polyhedral model (a), voxel model (b), single-dexel model (c) and tri-dexel model (dexel along z-axis not shown) (d)

Compared with voxel model which represents an object with a large collection of small cubes (Figure 2b), the single-dexel model representation can yield a high accuracy except at certain locations where the normal is nearly perpendicular to the dexel direction (Figure 2c). Therefore, the accuracy of single-dexel model relies on the orientation of the model relative to casting rays. Tri-dexel model (Figure 2d) with rays along three orthogonal directions, i.e. x-, y-, and z-axis direction, could achieve good accuracy to precisely represent the polyhedral model. Tri-dexel model has been used for virtual sculpting [28-31] and geometric simulation of additive manufacturing [32-34].

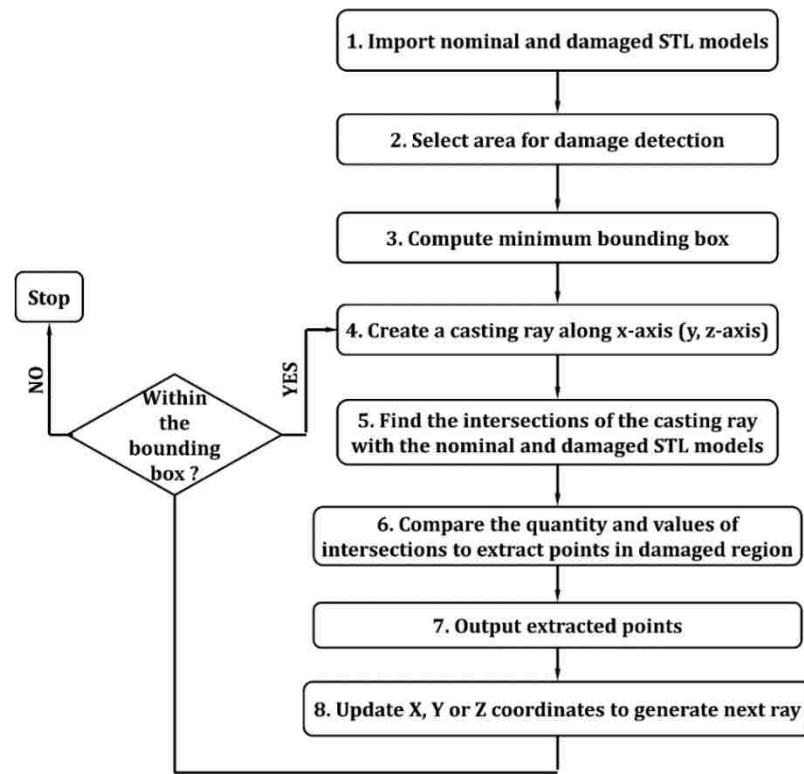
Figure 6. Flowchart of the damage reconstruction process from tri-dexel data

The flowchart of the proposed damage reconstruction algorithm is illustrated in Figure 6, which includes the following eight steps:

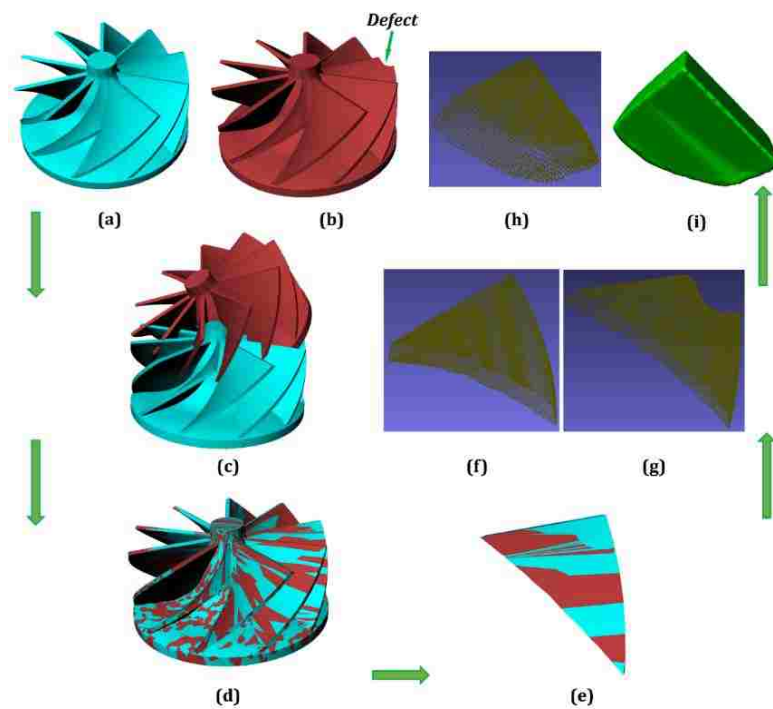
Figure 13. Damage reconstruction for a damaged turbine rotor. (a) Nominal CAD model; (b) Damaged CAD model; (c) Initial relative position of nominal and damaged STL models; (d) Aligned models; (e) Selected area for damage reconstruction; Intersections of casting rays with selected area of nominal (f) and damaged (g) models ( $\delta=0.2$  mm); (h) Extracted damaged points; (i) Reconstructed STL model of the damage

Two examples as shown in Figure 13 and Figure 14 were conducted to test the functionality and reliability of damage reconstruction from tri-dexel data. A defect was

created on a model as shown in Figure 13b. The damaged model was aligned with the nominal model (Figure 13d) and the damage was reconstructed as shown in Figure 13i.

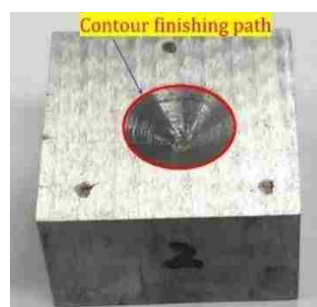
Figure 5. (a) Uncontinuous deposition pattern; (b) Continuous deposition pattern; (c) Repair tool path; Circular (d) and rectangular (e) finishing path

Three repair experiments (Namely, repair 1, 2 and 3, repair 1 stands for repairing sample 1 in Figure 2) were performed. For repair 1, tool path (Figure 5c) generated directly from the repair volume was used. For repair 2, an extra layer obtained by measuring the defect's edge was performed (Figure 5d). This contour tool path overlays the defect's

boundary. For repair 3, a rectangular tool path which covers the defective region was conducted (Figure 5e). The processing parameters were listed in Table 2.

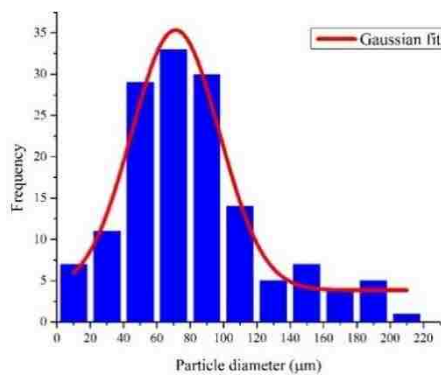
Figure 6. SEM micrograph (a) and particle size distribution (b) of Wallex 40 powder

particles exhibit spherical morphology although some irregular shaped powders were observed. Particle size distribution analyzed using ImageJ was depicted in Figure 6b and the average particle diameter was 71  $\mu\text{m}$ .

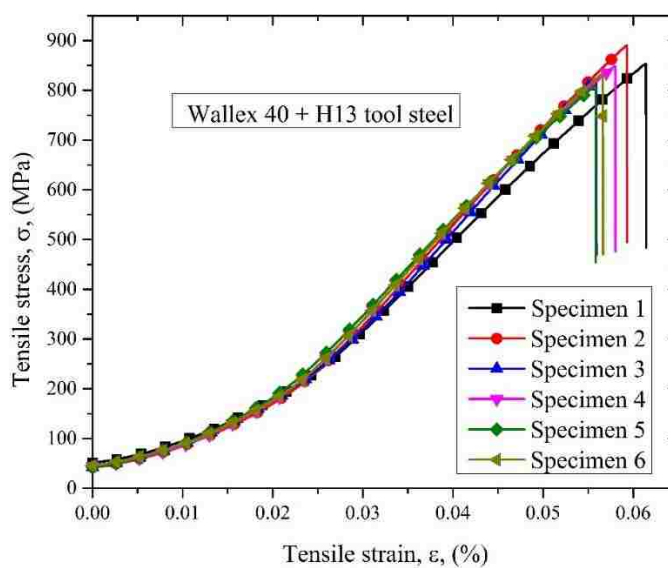
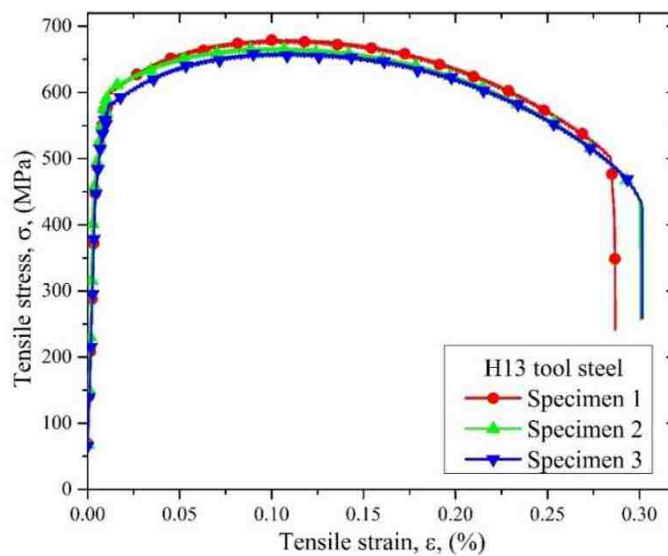
Figure 12. Tensile stress-strain curves obtained from the tensile test for (a) Wallex 40 + H13 tool steel samples, and (b) H13 tool steel samples

**4.3.1. Tensile Behavior.** The stress-strain curves obtained from tensile testing were shown in Figure 12 and the results were summarized in Table 3. Two groups of samples were tested, including combined samples which is made of Wallex 40 deposits and H13 tool steel substrate, and pure H13 tool steel samples. The tensile testing of the combined samples is shown in Figure 12a and of the pure H13 tool steel samples is shown in Figure 12b. The combined samples revealed largely consistent tensile properties. The tensile stress increased with the increase of tensile strain to a peak of around 850 MPa. Then the tensile samples fractured suddenly, and the stress decreased rapidly. No yielding regions were found from the stress-strain curves, showing that the samples repaired using DMD process reveal brittle fracture failure. The ductility of the tensile samples was very low (approximately 6%). A further investigation of fractured samples reveals that the combined

Tensile testing of samples consisting of pure H13 tool steel shows that the tensile stress increased with the increase of strain to yield stress (YS) of approximately 600 MPa. Then an extensive plastic deformation and energy absorption were followed to reach a UTS of around 660 MPa, and the samples finally fractured. The samples were very ductile with an elongation of up to 30%.

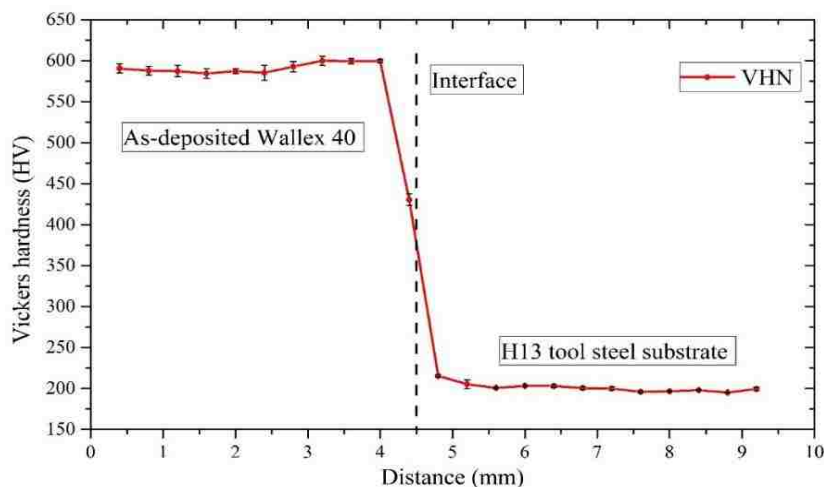
Figure 15. Vickers hardness distribution

**4.3.3. Vickers Hardness Analysis.** Vickers hardness was measured on the cross-section of the repaired sample from deposits to substrate and the result was plotted in Figure 15. A constant distance of 0.4 mm was applied between two indentations.

It was shown that the as-deposited material has a relatively constant hardness of around 580 HV. The hardness of deposits is much higher than that of the as-received H13 tool steel substrate in annealed condition (220 HV). The hardness increased rapidly from

220 HV on the substrate to approximately 600 HV on the deposits. The sharply increased hardness on deposits is because of the rapid cooling rate and fine microstructure obtained on deposits. Cobalt-rich matrix with carbides also contributes to the elevated hardness. The hardness measured approximately near the interface reveals transitional values between 220 HV and 600 HV, indicating the existence of a narrow region of dilution in the heat-affected zone. The dilution distance between deposit and substrate from the hardness analysis was approximately 1 mm. Another feature that can be seen is that the hardness of deposits decreases slightly during multi-layer deposition. This was due to the higher cooling rate during the first layer of deposition. In a multi-layer deposition, the pre-deposited material was re-melted and heated, causing coarse microstructure and slightly drop of hardness. The hardness at the substrate near the interface is slightly higher than the area away from the interface. Heating history in HAZ acts as a normalization process that increases the hardness in such area.

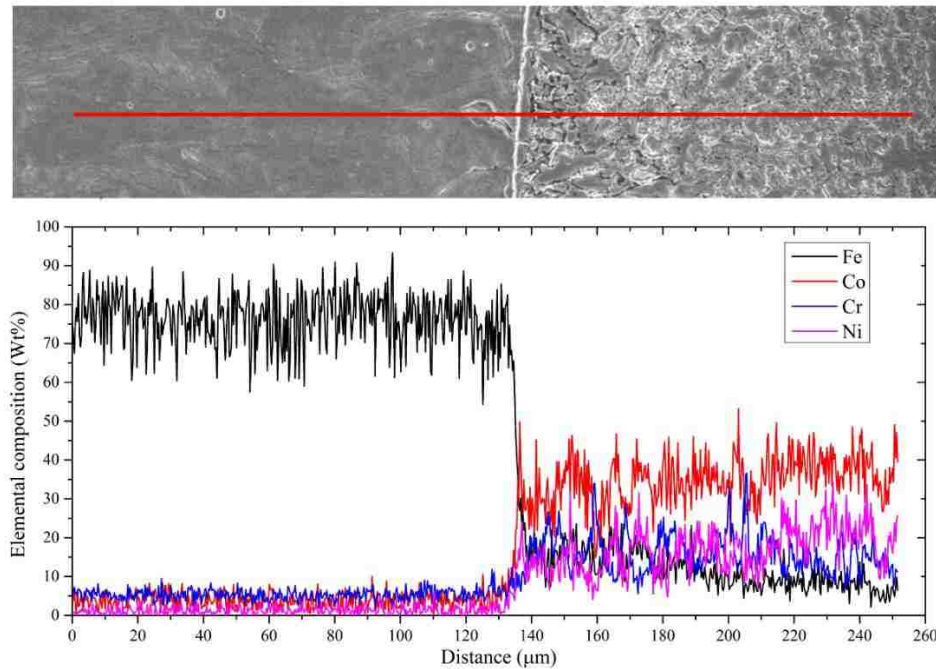
Figure 17. EDS line scan analysis from the substrate to deposits

The EDS line scan analysis in Figure 17 exhibits that the transition of major elements from the substrate to deposits is rapid. Fe is slightly higher in the deposits near the interface compared to the area away from the interface, showing the dilution of Fe into deposits. Fe contributes a lot to phase transformation over the interface. The result confirms that excellent metallurgical bond was formed along the interface after deposition.
