Geotechnical state-of-the-art in Guatemala -- Ground stabilization

GEOTECHNICAL STATE-OF-THE-ART IN GUATEMALA – GROUND
STABILIZATION

DOCTOR OF ENGINEERING
In
GEOTECHNICAL ENGINEERING

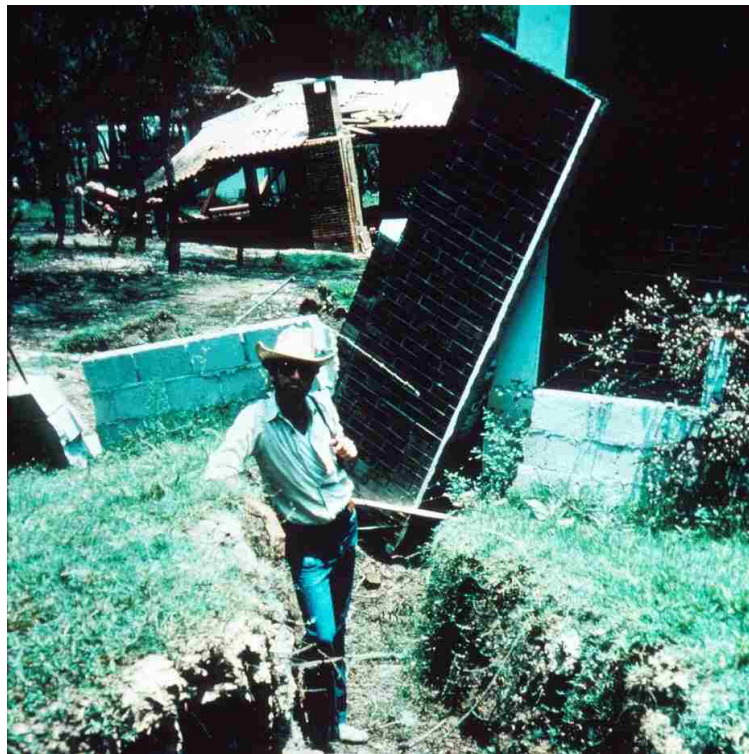
Figure 2.10. Cracks at Lake Amatitlan (Plafker, 1977)

The Figure 2.10. One of many large cracks in a delta at Lake Amatitlan (20 kilometers south of Guatemala City) opened as a result of Earthquake-induced liquefaction of a near surface layer of saturated pumice sand and lateral spreading of the surficial deposits towards the lake. Such cracks caused serious damage where they intersected structures such as the one in the foreground. The front portion of the house in the background sank into the liquefied sand, tilting the brick chimney. (Plafker, 1977)

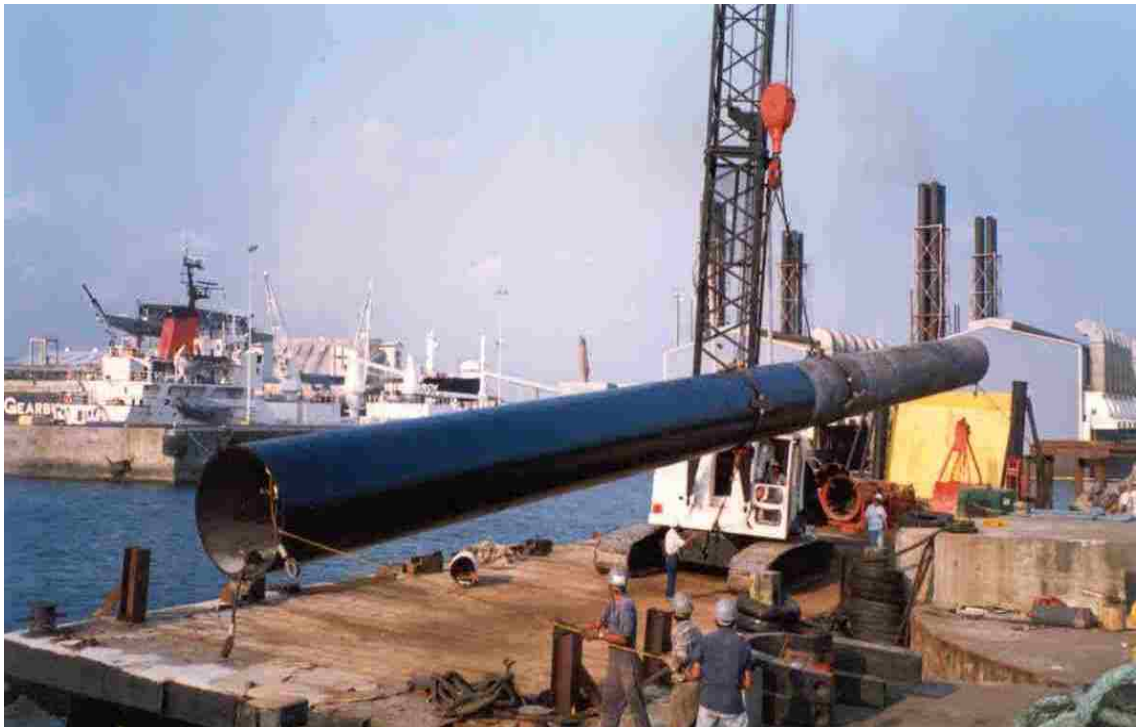
Figure 2.15. Steel piles of Barcaza Man

Puerto Quetzal is the most important marine project performed since 1955, according with the web site of Empresa Portuaria Quetzal. It was built from 1980 to 1983 by the French company Dragages Et Travaux Publics. The wharf consists of a sheet pile wall with a concrete slab in the top. It was the first time that a structure of this type was built in Guatemala. For its construction a small railroad was built in order to ease concrete blocks and rocks transportation. The other relevant projects are San Jose docking station and Barcaza Man Power Station this project are part of thermal electric power plants. Both were the first to use large diameter steel driven piles, 1.50 m. Both were performed from 1999 to 2000 in Puerto Quetzal harbor area by Swissboring Overseas Corp. Ltd. Figure 2.15 shows the handling of the steel piles of Barcaza Man and Figure 2.16 show the pile driving process of the steel pipe piles of San Jose Docking station.

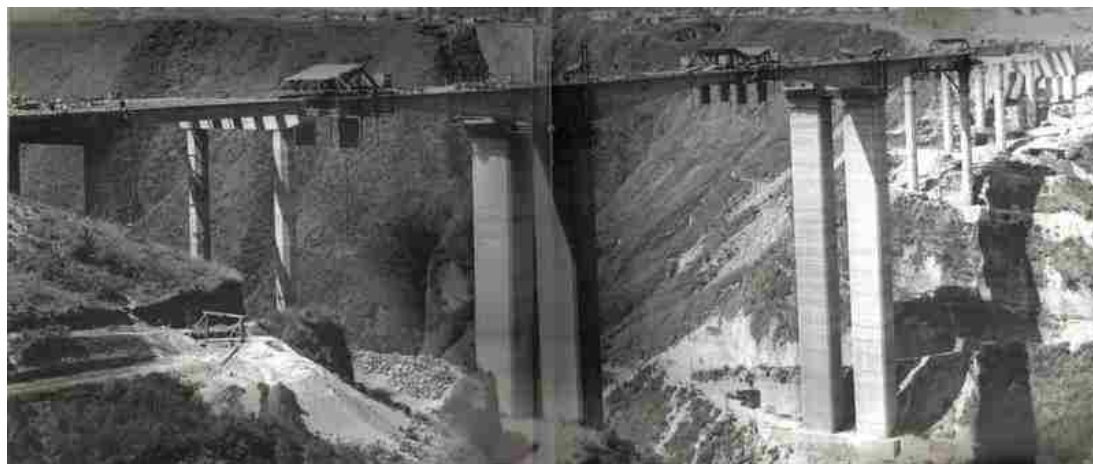
Figure 2.17. Construction of Incienso Bridge deck (Castillo, 2009)

The Incienso bridge, Ingeniero “Martín Prado Vélez” bridge, is the second largest bridge in Guatemala and was the first one to use a post-tensioned box girder system, its construction started in 1973 was inaugurated on June 1974. This is also one of the largest bridges in Central America with a total length of 390.00 m, a width of 25.00 m and height from the bottom of the creek to the deck of 135.00 m. It was built by Ingenieros Urruela y Sittendfeld, Cía. Ltda. from Guatemala, and Ingenieros Civiles Asociados, S. A., ICA, from Mexico (Arriola, J., 2007), Figure 2.17 and 2.18 shows different construction stages.

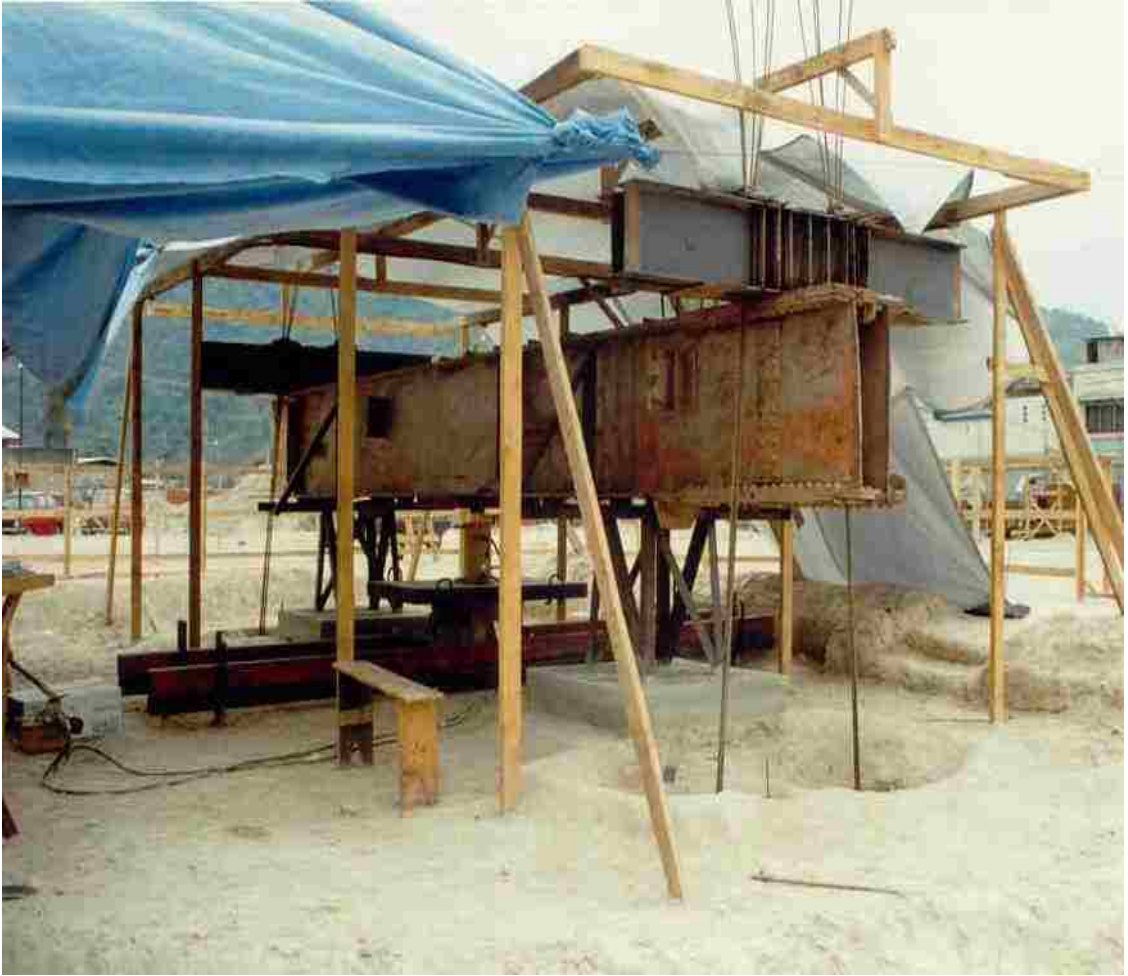
Figure 2.20. Pile load test in Cementos Progreso Cement Plant

The clinker silo construction in 2000 of the Cementos Progreso cement plant in Sanarate included the performance of the first loading test. The load test was a full scale test of 1.20 m diameter drilled pier, using posttensioned anchors as reaction, Figure 2.20 shows the test setup. The test, anchors and pile construction were performed by Swissboring Overseas Corp. Ltd with advice of CPK a Salvadorian consultant firm. Other milestone of piling is also provided by Cementos Progreso in its new San Juan cement plant where 7 load tests were performed using Osterberg Load Cells. The test were performed by the American company Load Test meanwhile the piles were performed by Rodio-Swissboring Figure 2.21 shows drilled shafts and load cells installation.

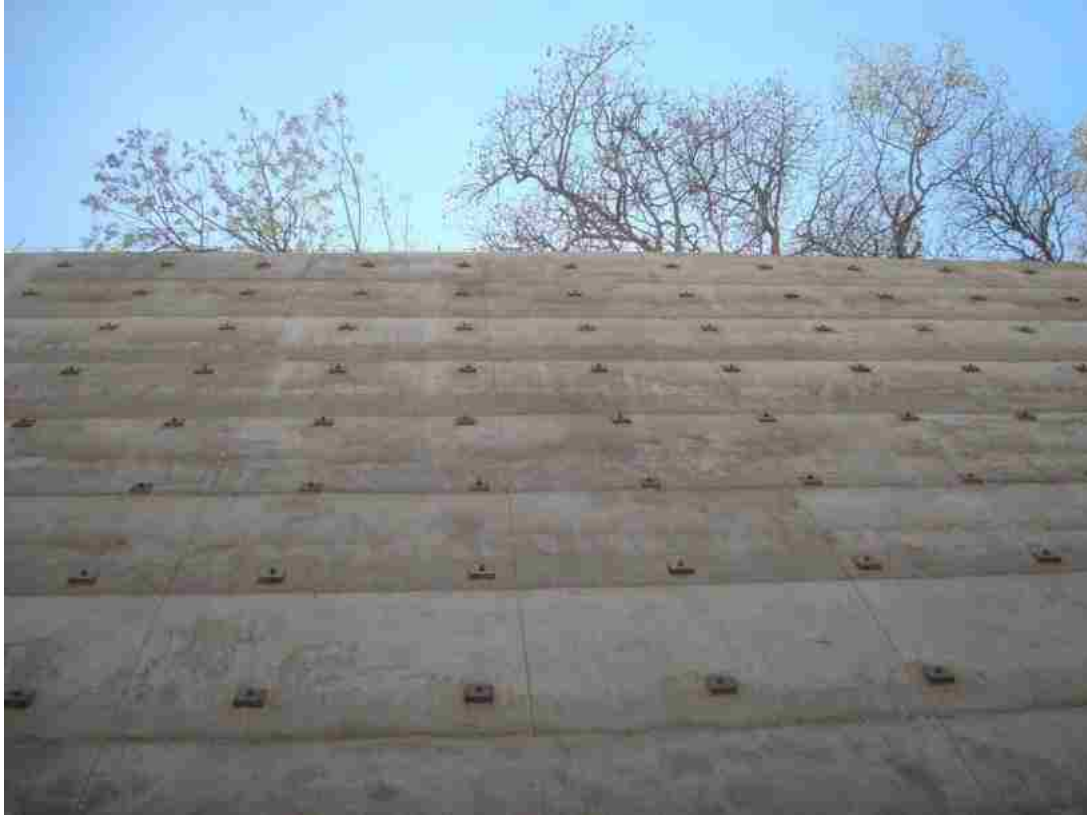
Figure 3.1. Vertical soil nailing wall for excavation stabilization

The Figure 3.1 shows a vertical soil nailing wall for a basement construction.

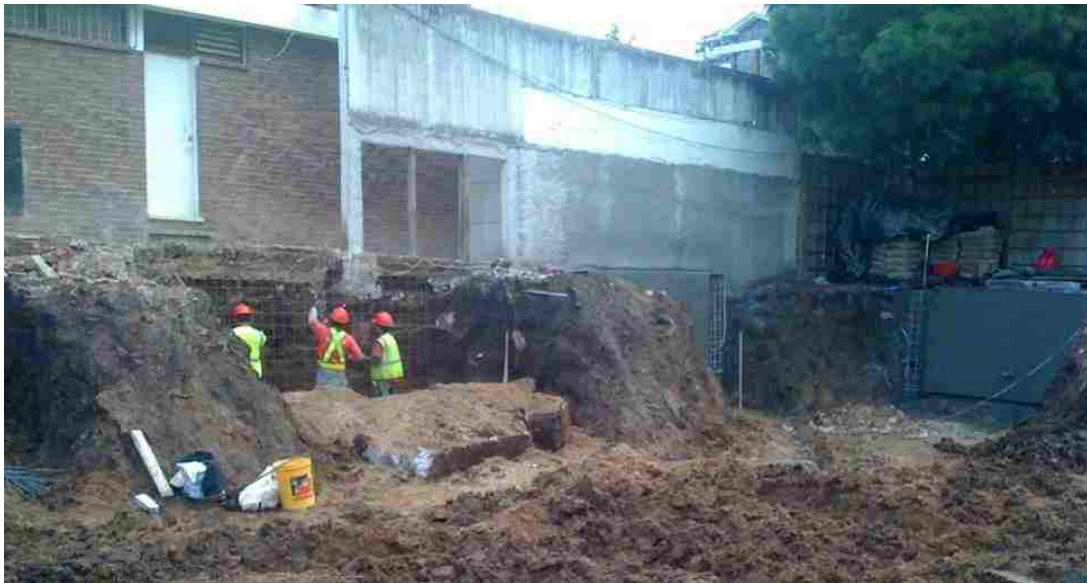
Figure 3.2. Berm utilization during construction

3.1.3.1. Ground conditions. The most important ground condition for soil nail walls performance is the temporary stability during each excavations stage, normally 24 to 72 hour. Is recommended do each stage with some alternates berms as shown in the Figure 3.2.

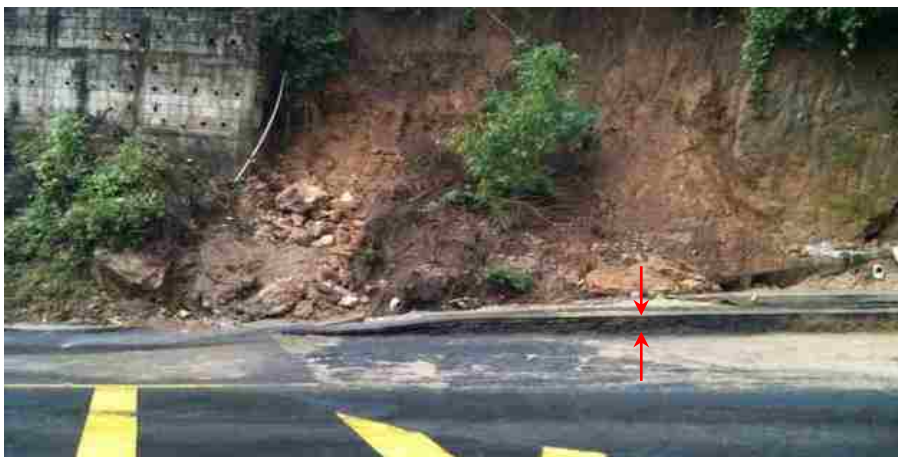
Figure 3.7. Ground heave due to active landslide

3.1.5.3.3. Bearing capacity. Bearing capacity failure is not common, soft layer underneath wall toe and at the same time a stiffer layer underneath this soft layer is the typical conditions that trigger this failure mechanism. Water flows, can also contribute to this kind of failure, arrows in the Figure 3.7 show slope toe heave.

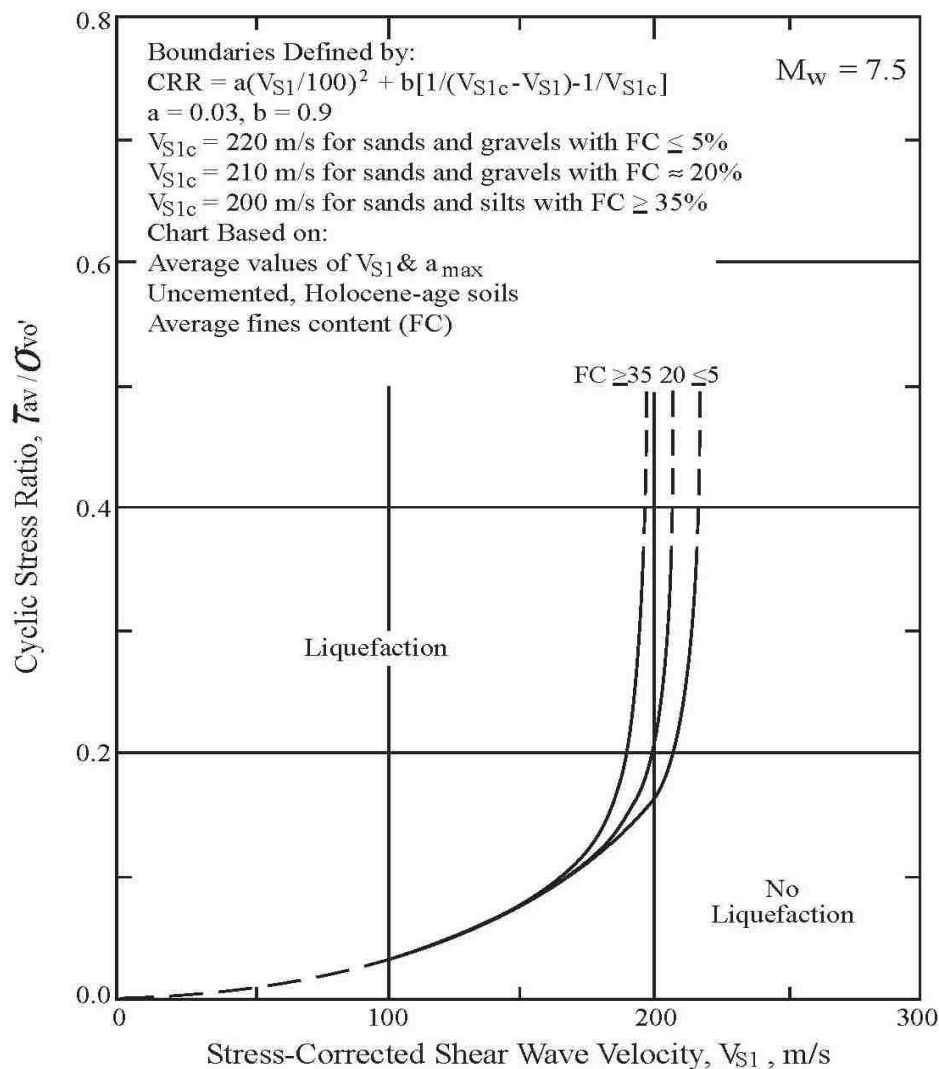
Figure 3.24. Liquefaction relationship recommended for clean, uncemented soils with liquefaction data from compiled case histories (Andrus and Stokoe, 2000)

The Figure 3.24 shows the liquefaction relationship recommended for clean, uncemented soils with liquefaction data from compiled case histories.

3.3.2.2. Magnitude Scaling Factors (MSFs). The clean-sand base or CRR curves in Figures 3.21 (SPT), 3.22 (CPT), and 3.23 (V_{S1}) apply only to magnitude 7.5 earthquakes. To adjust the clean-sand curves to magnitudes smaller or larger than 7.5, Seed and Idriss (1982) introduced correction factors termed “magnitude scaling factors (MSFs).” These factors are used to scale the CRR base curves upward or downward on

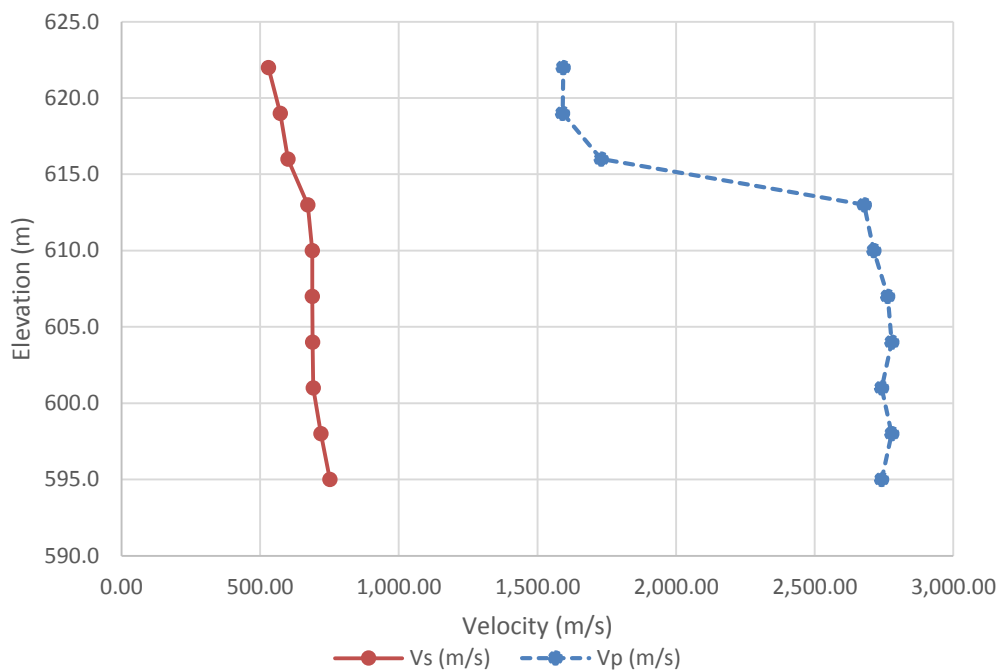
In order to evaluate shear wave velocities of the ground a cross hole test was performed. For the purpose of this test three boreholes were drilled on the right side of the Polochic River, upstream of the dam possible axis, approximately at elevation 625. Drill holes have a 114 mm diameter in order to allow the installation of 76.2 mm (3 inches) PVC pipe. Drilling was subsequently grouted to ensure that the tube walls having good adherence to the ground. The distance from the probe E2 (Transmitter 2) to survey R (receiver) is 5 m, distance from poll to poll E1 R (Transmitter 1) was 10 meters, Figure 4.26 shows the shear wave velocity, V_s , and compression waves velocity, V_p , versus depth.

Figure 4.26. Graphic of shear and compression wave velocity (Alvarado, 2004)

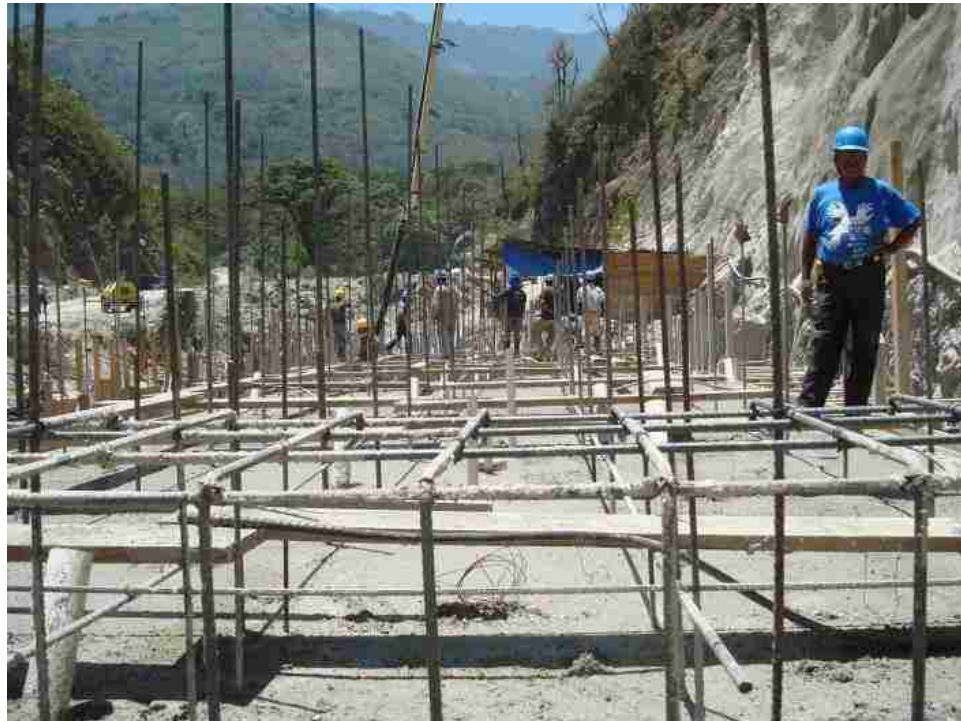
4.2.5.1. Sleeve installation. In order to reduce drilling and possible damage to the concrete of the dam a 10 cm diameter PVC sleeves were installed in the base of the dam during the initial construction stage. Figure 4.28 show PVC sleeve installed during construction.

Figure 4.28. PVC sleeves intalled during construction

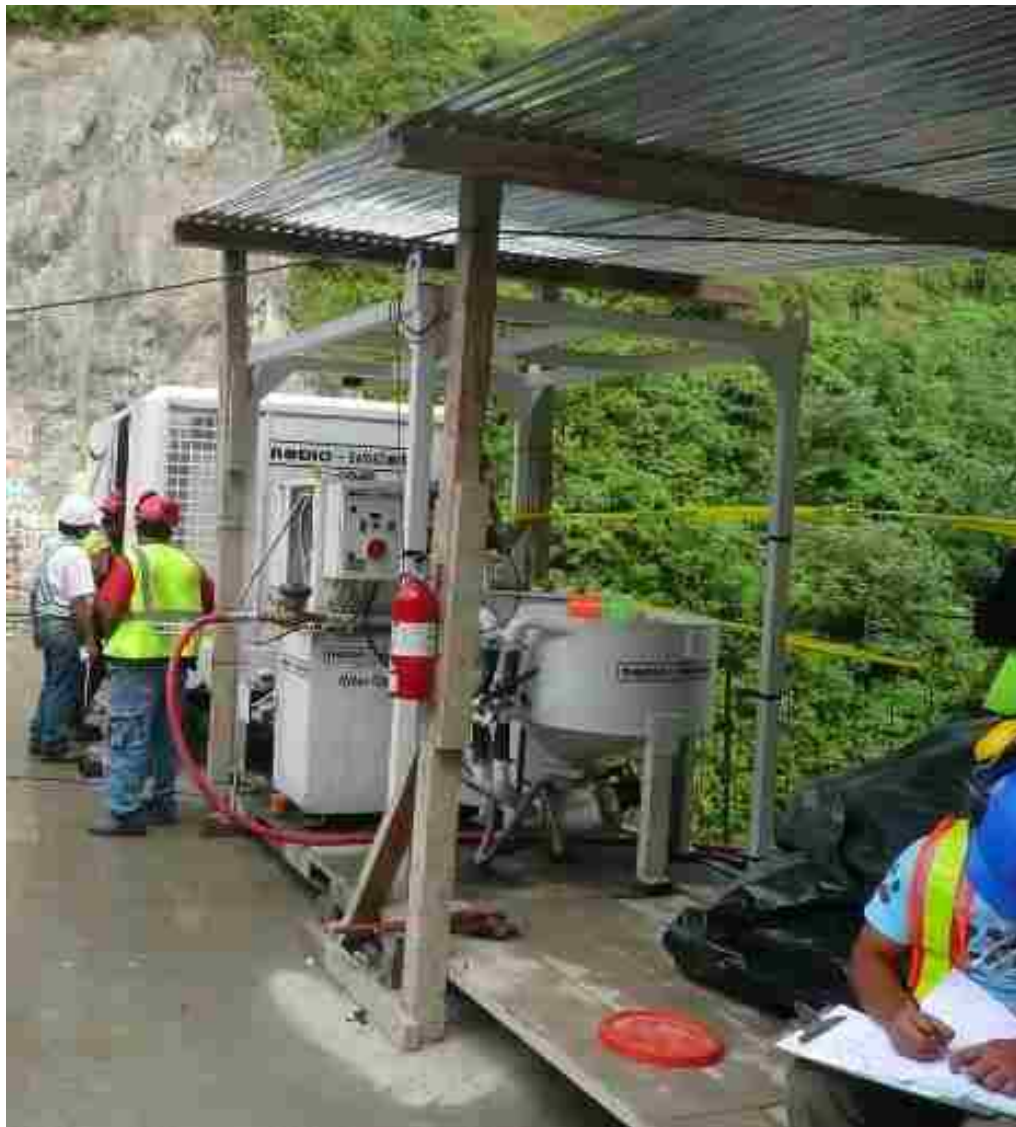
4.2.5.2. Grouting station set-up. Grouting stations were located in strategic points to reduce pumping distance as well as to ease grouting works. During the set-up of the grouting station a foreign technician from the grouting monitoring manufacturer, Jean Lutz, came to the project to perform the initial equipment calibration. This calibration included pressure, volume, grouting rate, stoppage parameters. Figure 4.29 shows one of the two grouting stations.

Figure 4.29. PVC sleeves installed during construction

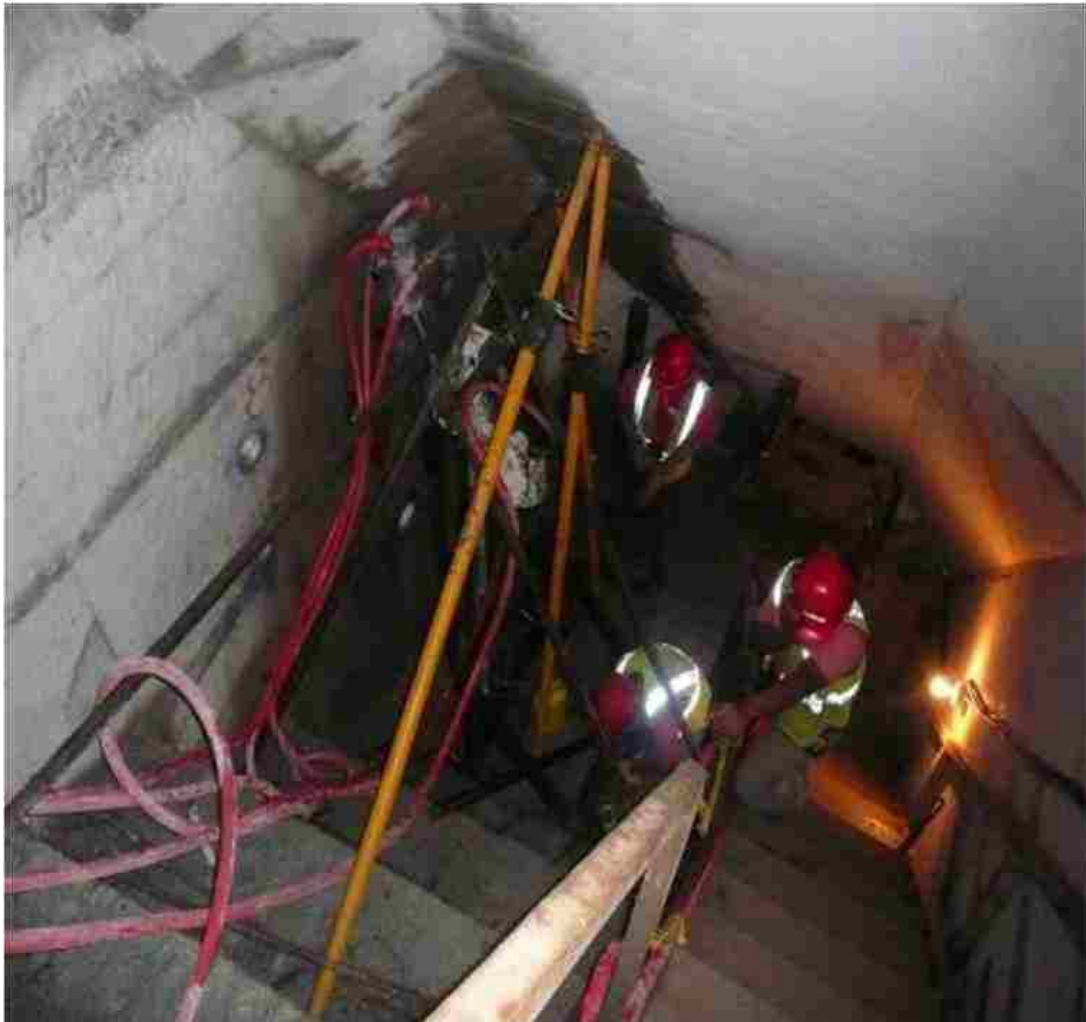
4.2.5.4. Grouting. The first step for grouting is mix preparing. The mix was prepared by two Cemix grout fabrication station manufactured by Atlas Copco. The grout station was equipped with a high speed mixer of 100 liters capacity a high turbulence agitator of 200 liters capacity and an endless screw type grouting pump capable to deliver 120 liters / min at pressures between 800 and 5,500 kPa. The equipment is driven by electric motors and the electro system is controlled by automatic

Figure 4.31. Grouting from access gallery using wire line system

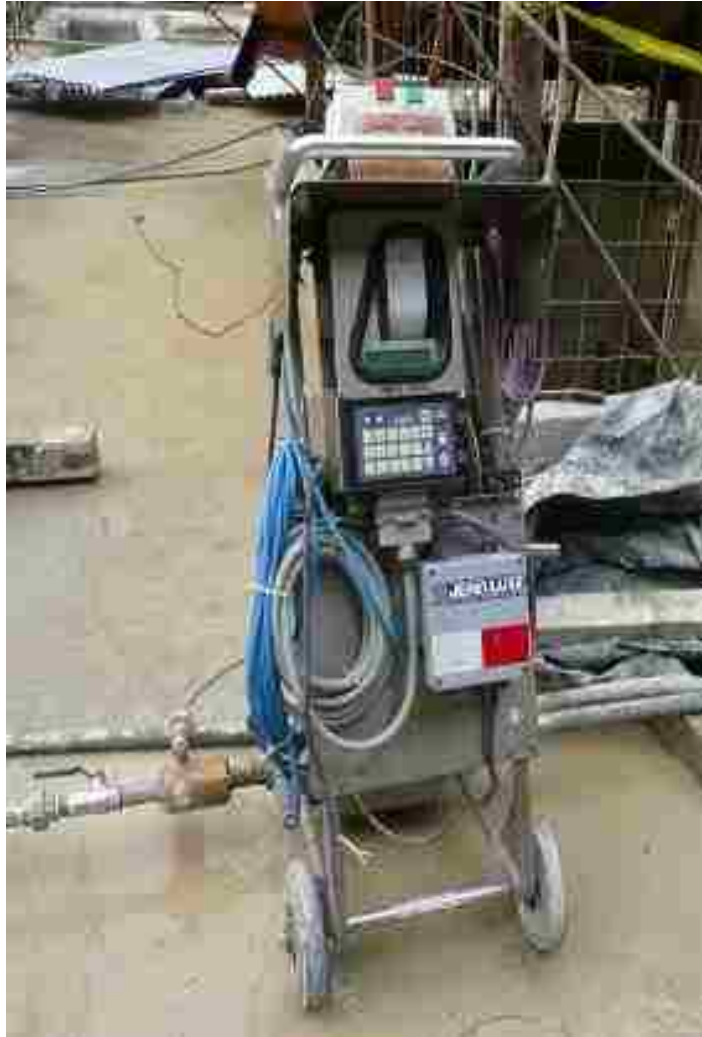
valves. An automatic recording equipment Lutin model NX-B53 manufactured by Jean Lutz was used to control the grouting pump. This unit was calibrated for recording pressure, volume and flow, being programmed to use three curves GIN system parameters. This type of recorder prints the results on paper and simultaneously recorded on a card that is used to download the information to a computer and graph the results of each step of injection. Grouting was performed in 3.00 m stretch using a single packer. A split-spacing method was used. Grouting sequence is first downstream line, upstream line and at the end the center line. Figure 4.31 shows grouting works within the service gallery and Figure 4.32 shows Lutin NX-B53 grouting control equipment.

Figure 4.32. PVC sleeves intalled during construction

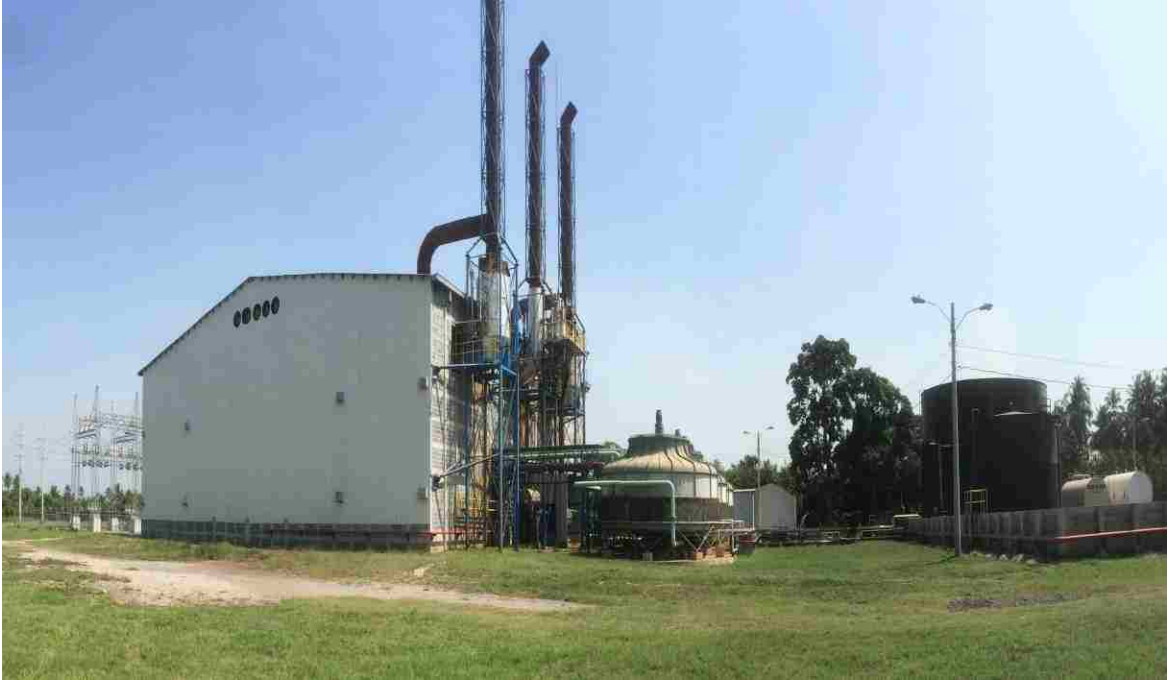
The power plant consists of a main structure with three engines, auxiliary structures as cooling tower, electrical substation and a storage tanks area, Figure 4.35 shows an actual view of the power plant.

Figure 4.35. Panoramic view of Genosa Power Plant

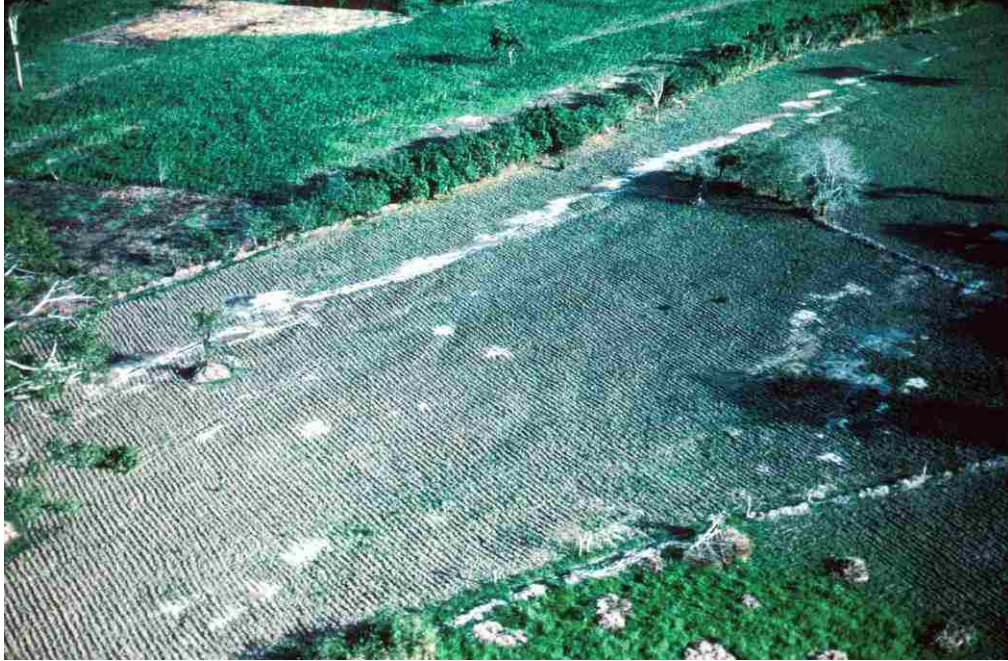
Figure 4.36. Sand blows located near to Motagua River during 1976 earthquake (Plafker, 1977)

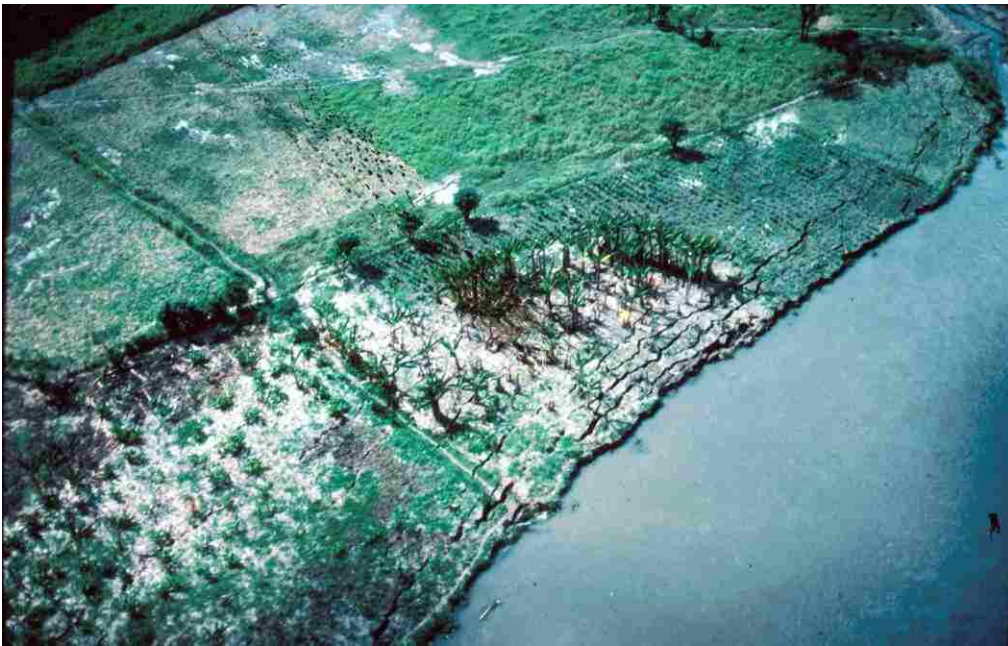
Figure 4.37. Flow liquefaction in a bank of Motagua River during 1976 earthquake (Plafker, 1977)

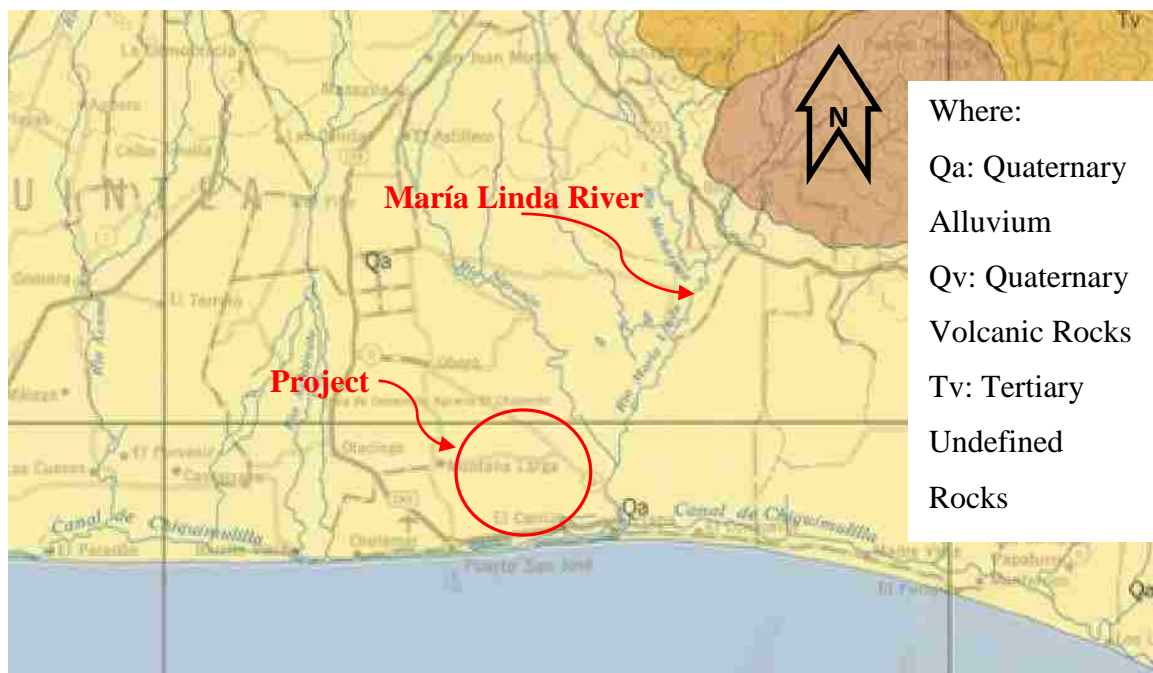
4.3.2.1. Local geologic context. The shallow regional geology consists of Quaternary alluvium (Qa) within the Maria Linda watershed. These soils, consisting of interbedded, underconsolidated and poorly drained layers of sands and silts, and to a lesser extent gravels and clays, having erratic depositional patterns typical of coastal plains. The Quaternary alluvium (Qa), about 1,000 m thick, is underlain by rocks of the Tertiary and rock and sands of the Cretaceous, followed by Ophiolitic Basement.

Figure 4.38. Area geological map (Instituto Geografico Nacional, 1970)

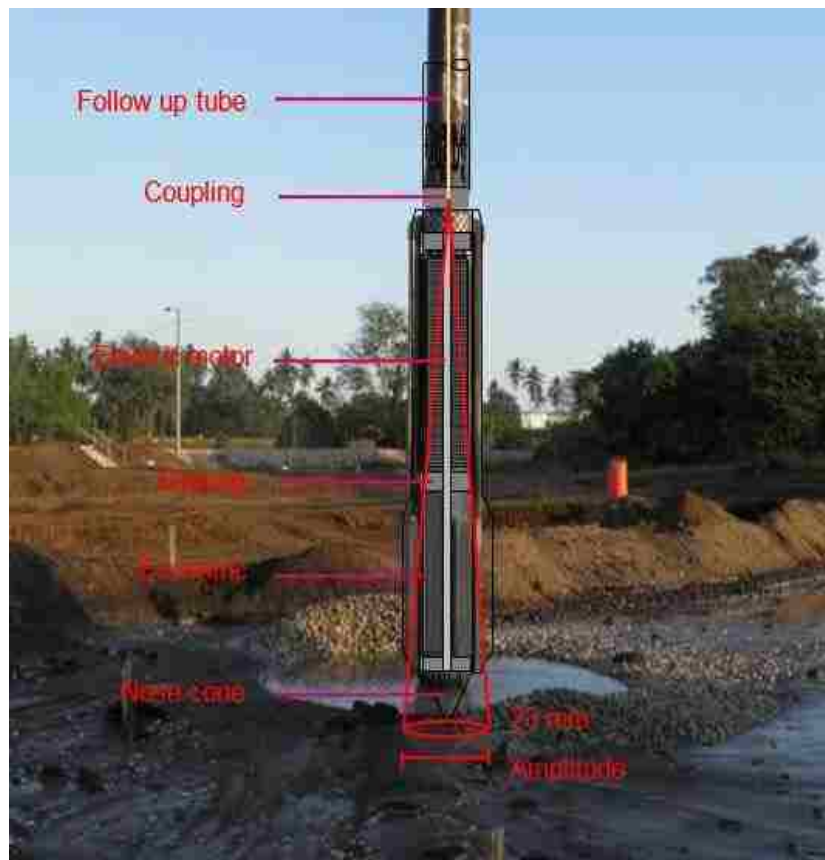
Figure 4.50. V23, Vibratroy probe schematic

The essential parts of the Vibroprobe are shown on the Figure 4.50. It is essentially a long slender steel tube with two parts: the vibrator and the follow-up tubes. The vibrator, the heart of the Vibratory Probe, consists of a hollow cylindrical body with 300-400mm diameter connected by means of a special elastic coupling to the follow-up tubes of a slightly smaller outside diameter. The characteristics of the V23 vibroprobe are summarized in Table 4.17.

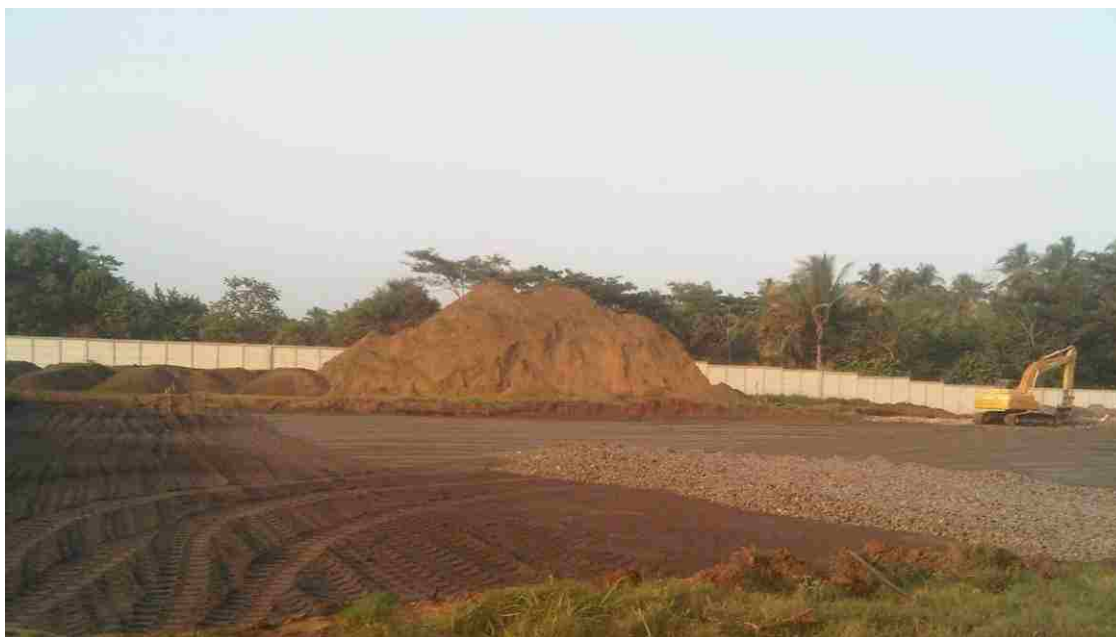
Figure 4.52. Working platform construction

The first step is prepare the working platform. This is very important in order to avoid accidents and allow a proper drainage of the area. The platform and accesses was compacted, drained and levelled in order to accommodate a crawler crane as well as the traffic of loaders required for stone delivery. The spoils and water generated by the stone column installation will be managed to maintain a clean working platform at all times. The working platform elevation was set at +0.50 m, at least 1.50 m above ground water elevation. The Figure 4.52 shows the work platform prior work start.

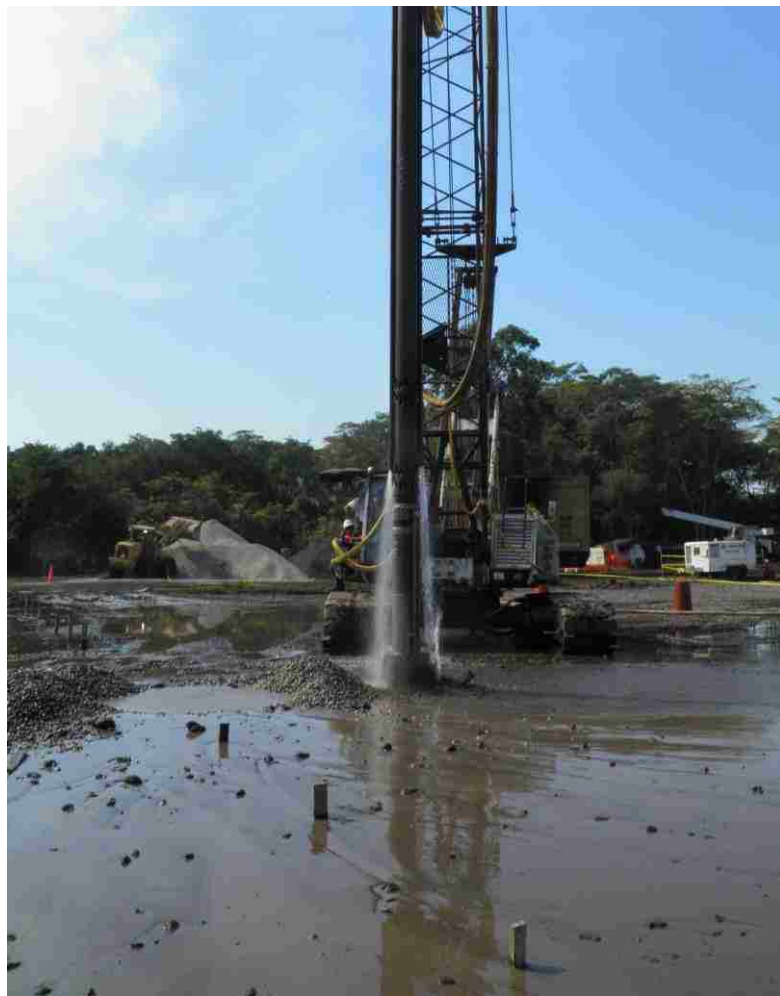
Figure 4.53. Vibroflot penetration

the maximum depth. When the vibroflot has reached again the full depth, the amount of water discharged from the tip of the vibroflot was adjusted so that the water level in the hole stays at about 1.50 m above ground water table or at working platform level. This ensures the stability of the hole. The figure 4.53 present de vibroflot penetration using water and air jet.

Penetration is stopped at the design depth or upon refusal on very dense sandy layers or very stiff clayey layers or big elements. Refusal was defined in the following way: the intensity in the electric motor of the vibroflot reaches values in excess of 200/250 A and/or penetration becomes slower than 0.50 m per minute, whichever comes first.

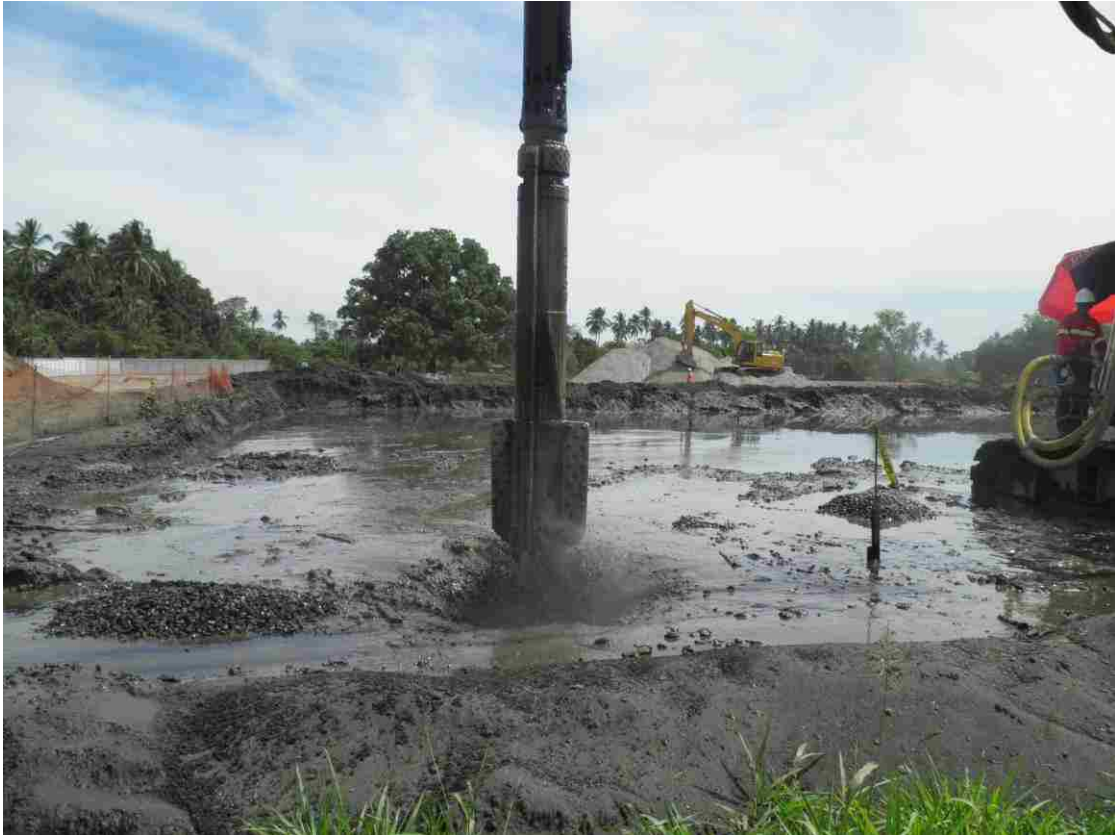
Figure 4.55. Final stage of the compaction process

3 - The filling / compaction cycle is then repeated in upward increments up to the working platform level or up to the upper level of the soft silty ground layers or lenses. During this operation, additional gravel or stone is added to the hole but without overfilling to avoid bridging of the gravel. In this manner dense granular material

interlocks with the surrounding ground and densifies it. The Figure 4.55 show final stage of the compaction process. Works were performed between 15th of January and 4th of February of 2012.

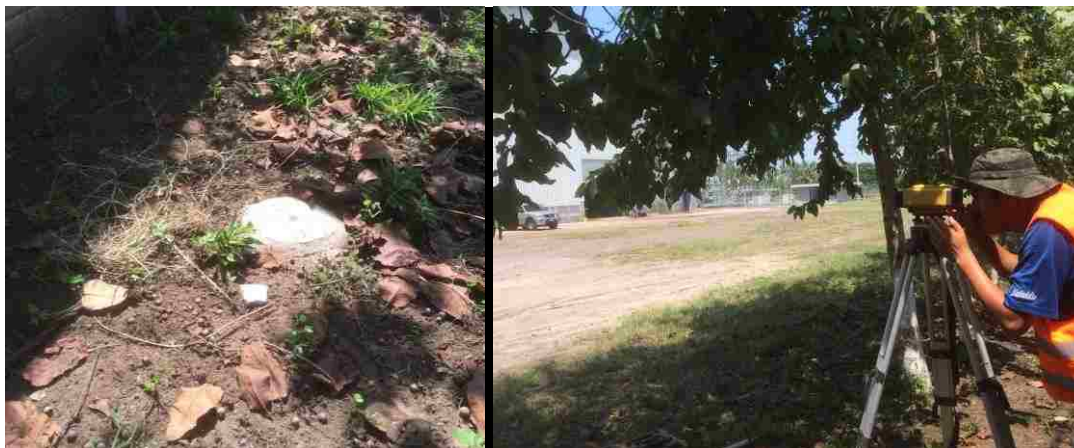
Figure 4.66. Survey monument and surveying works

Reading were performed using Topcon DL 102 Electronic Digital Level and a Nikon DTM 322 Total Station, Table 4.19 and 4.20 presents instruments characteristics, Figure 4.66 shows the survey monument and surveying works.
