Masters Theses

Stability of streambanks subjected to highly variable streamflows: the Osage River Downstream of Bagnell Dam

Kathryn Nicole Heinley

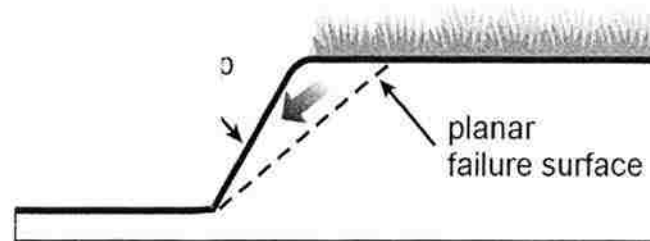
along a planar slip surface, and the failed block slides toward the toe of the bank before toppling into the channel [6]. It is common for deep tension cracks to appear before a planar failure occurs [12]. An example of a planar or slab-type failure is provided in Figure 2.1.

Figure 2.1 Example of Planar Bank Failure [3]

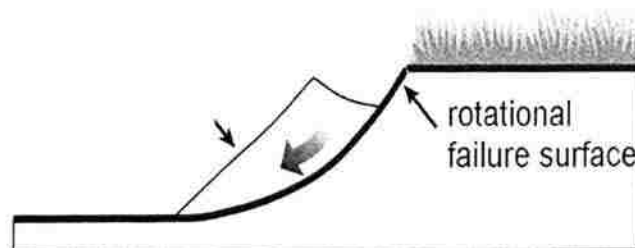
Rotational failures occur along a slightly curved slip surface, and are prevalent in streambanks with large bank heights and mild slopes. Generally a bank with a bank angle of less than 60 degrees is classified as mildly-sloped. The appearance of vertical tension cracks prior to a rotational failure is common. The failure block typically rotates toward the bank while it slides downward [6,12]. An example of a rotational failure is provided in Figure 2.2.

Figure 2.2 Example of Rotational Bank Failure [3]

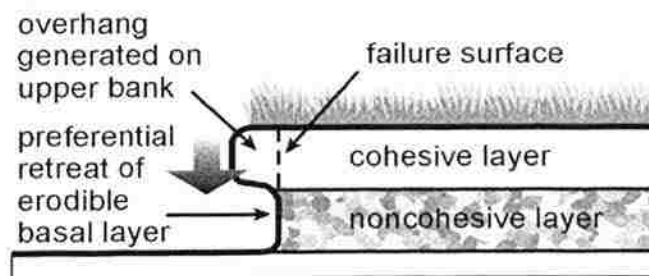
Cantilever failures are typically seen in streambanks that are composed of a layer of noncohesive material underlying an upper layer of cohesive material. Cantilever, or overhanging, banks form when the bank toe material is noncohesive and is significantly eroded, resulting in a loss of the material that had been supporting the cohesive layer. This loss of material is also referred to as undercutting. When the magnitude of the downward force of gravity on the overhanging bank exceeds its strength, a portion of the bank will break off and fall downward into the eroded area [7]. An example of a cantilever failure is provided in Figure 2.3.

Figure 2.3 Example of Cantilever Bank Failure [3]

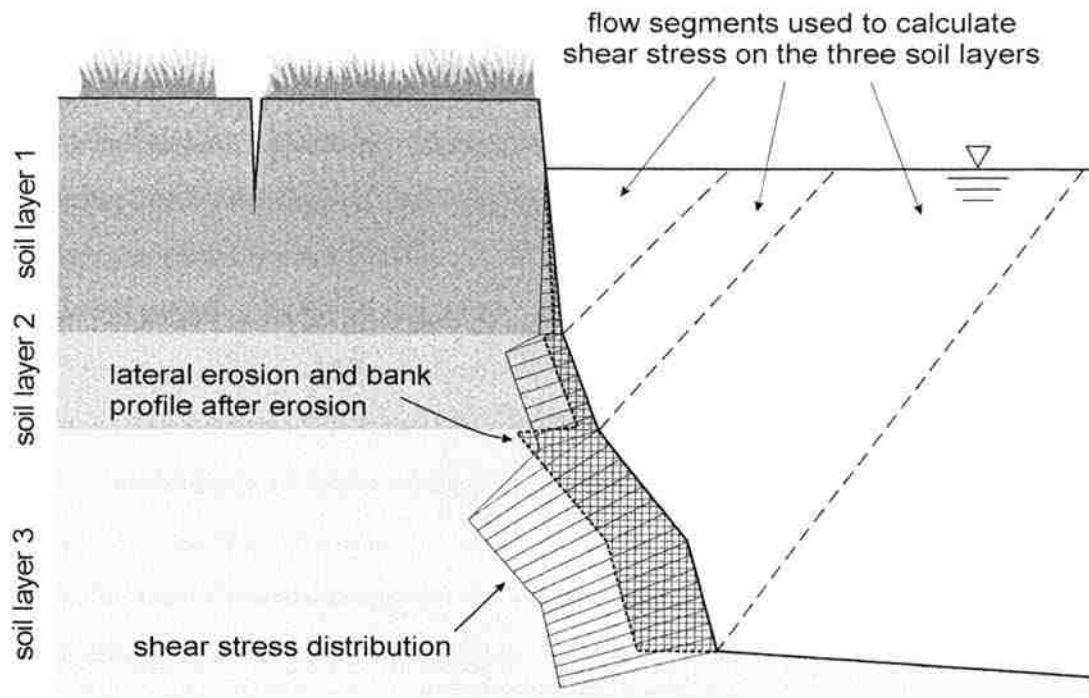
Figure 3.1 Example of Shear Stress Distribution in BSTEM [3]

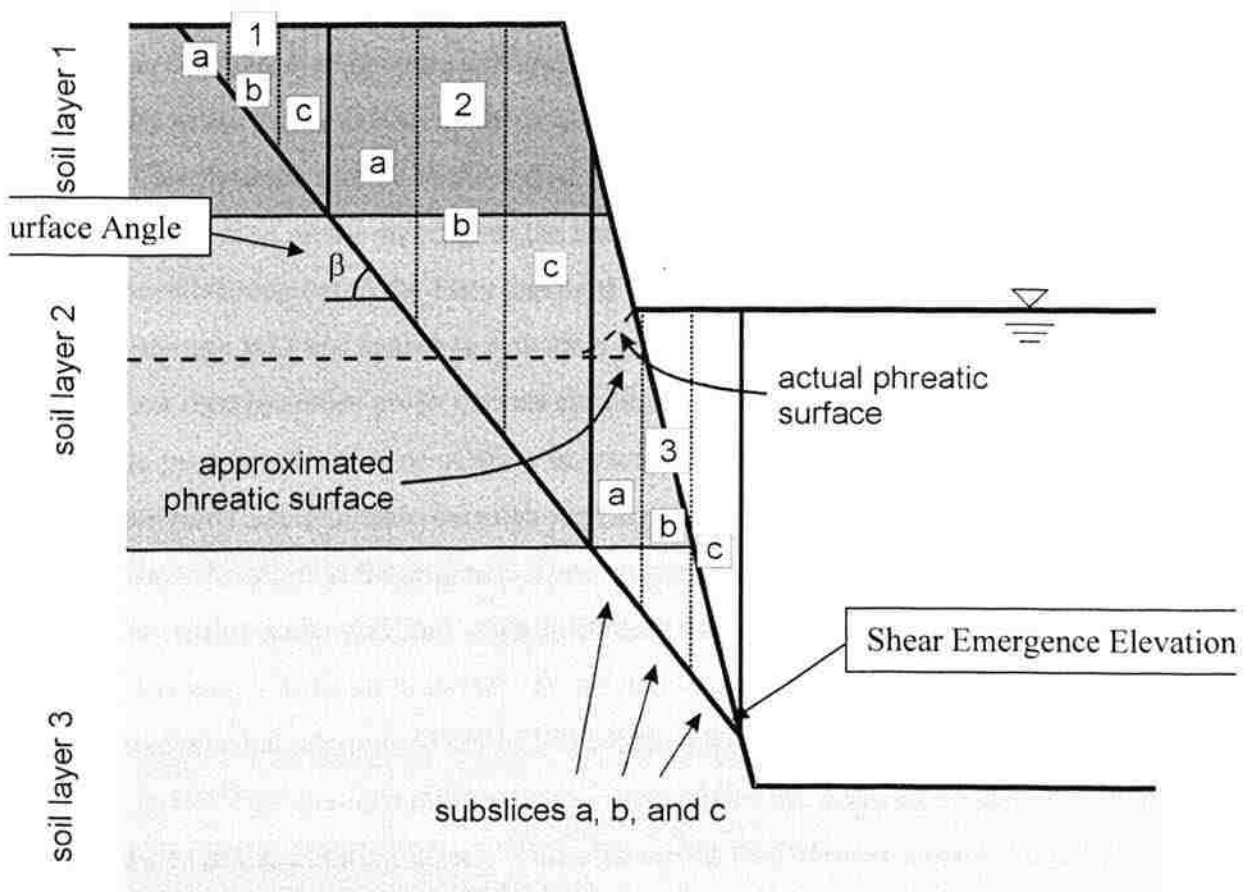
The program has a built-in algorithm that iterates over multiple failure scenarios to determine the scenario that results in the lowest FS. The iterations cover many different combinations of shear emergence elevations and shear angles. The shear emergence elevation is the elevation on the bank where the failure plane will intersect the cross-section face. The shear angle is the angle of the failure plane. Figure 3.2 illustrates the shear emergence elevation and angle.

Figure 3.2 Figure Showing Shear Emergence Elevation and Shear Surface Angle [3]

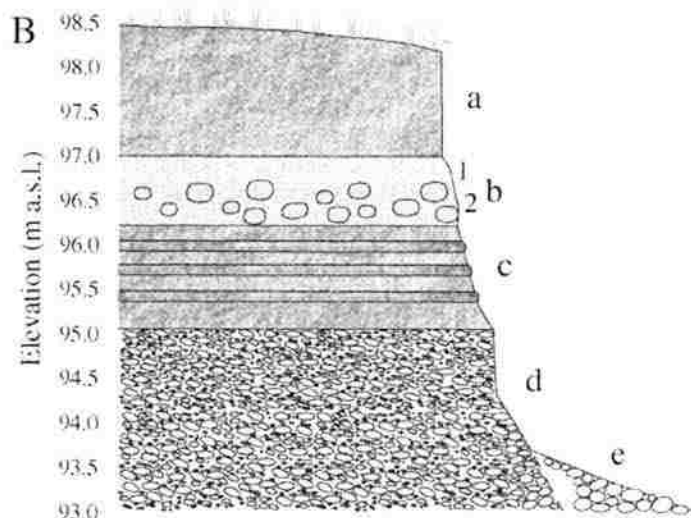
Figure 5.1 Bank Stratigraphy [13]

thick, and is comprised of silty sand, with silt sublayers throughout the upper and central portions of the layer. Layer *d* is a 2.0 m thick layer of packed and imbricated sand, gravel and cobbles. Layer *e* is the bank toe, and the soil type in this layer is described as loosely packed gravel and cobbles.

The geotechnical properties for layers *a* through *c* were determined through a series of triaxial tests and borehole shear tests. The values reported for these layers are provided in Table 5.1, and were used unchanged in the BSTEM model. In cases where the triaxial tests and borehole shear tests resulted in slightly different parameter values, the values were averaged before being used as input.
