Corrosion of epoxy-coated reinforcement in marine bridges with locally deficient concrete

A dissertation submitted in partial fulfillment of the requirements for the degree of Doctor of Philosophy Department of Civil and Environmental Engineering College of Engineering University of South Florida

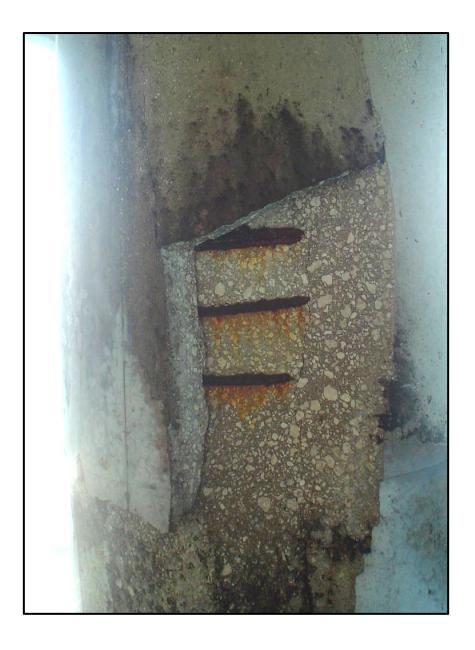
Figure 1. Large Concrete Spall Exposing Corroding Steel Reinforcement. Channel 2, Florida Keys (Photograph by author).

Reinforced concrete has been widely used in modern construction of civil infrastructure as it combines the mechanical resistance of concrete under compressive loads and steel reinforcement under tensile loads. In non-severe environments, reinforced concrete is known to have long service lives with minimal maintenance requirements. In severe environments however, with exposure to chlorides, carbon dioxide, sulfates, certain alkalis, and frost for example, concrete deterioration can occur with subsequent consequences on the serviceability of the structure. In the presence of chloride ions or carbonation of concrete pore water from atmospheric carbon dioxide, corrosion of the steel reinforcement can initiate. Reinforcing bars are normally made of hypoeutectoid plain carbon steel (ASTM A615M-09b, 2009), where iron constitutes >97% of the material. The iron corrosion product is larger in volume than the originating metal, creating expansive stresses in the surrounding hardened concrete. Given the low resistance of the latter to tensile stresses (Mindess et al., 2003), damage in the structure ensues in the form of cracking, delamination, and spalling of the concrete (Figure 1).

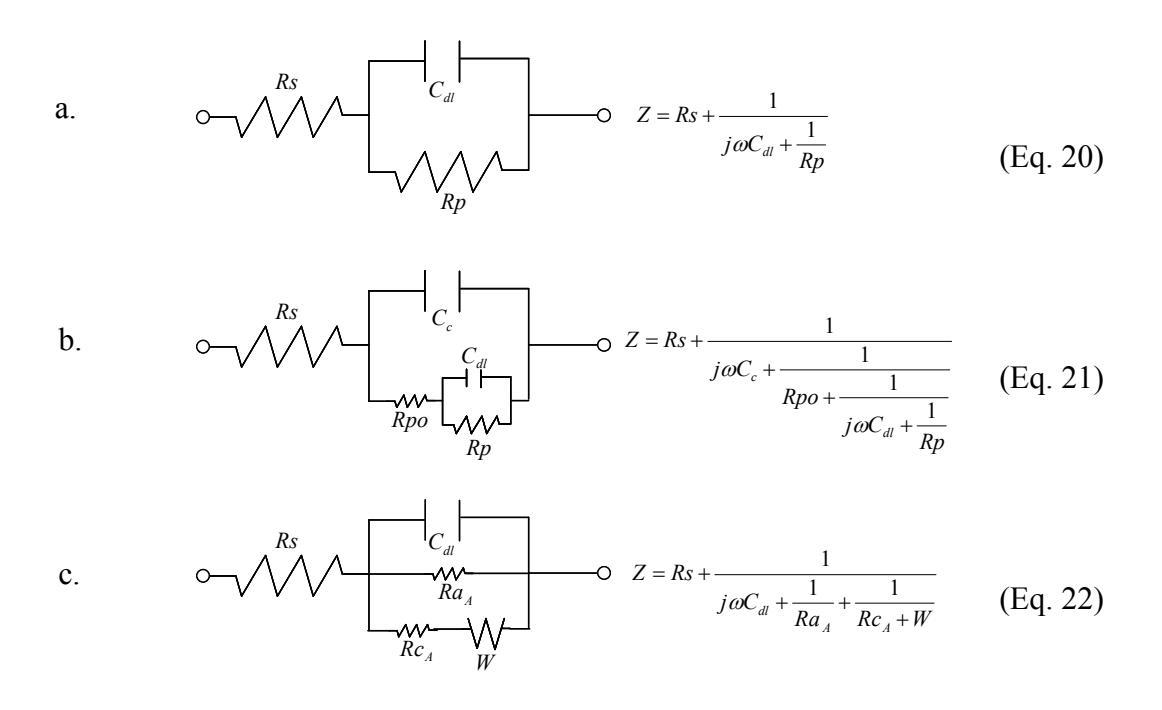
Figure 2. EIS Equivalent Circuit Analogs

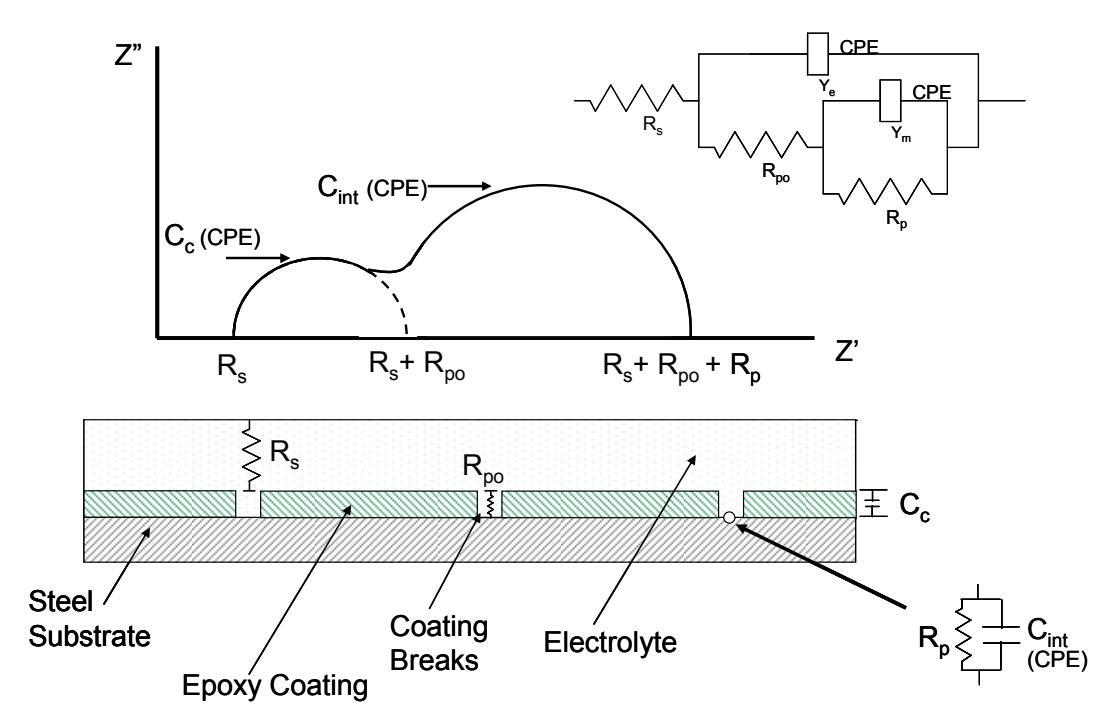
Figure 3. Idealized Impedance Diagram of Coated Metal System with Coating Breaks and Equivalent Circuit Analog.

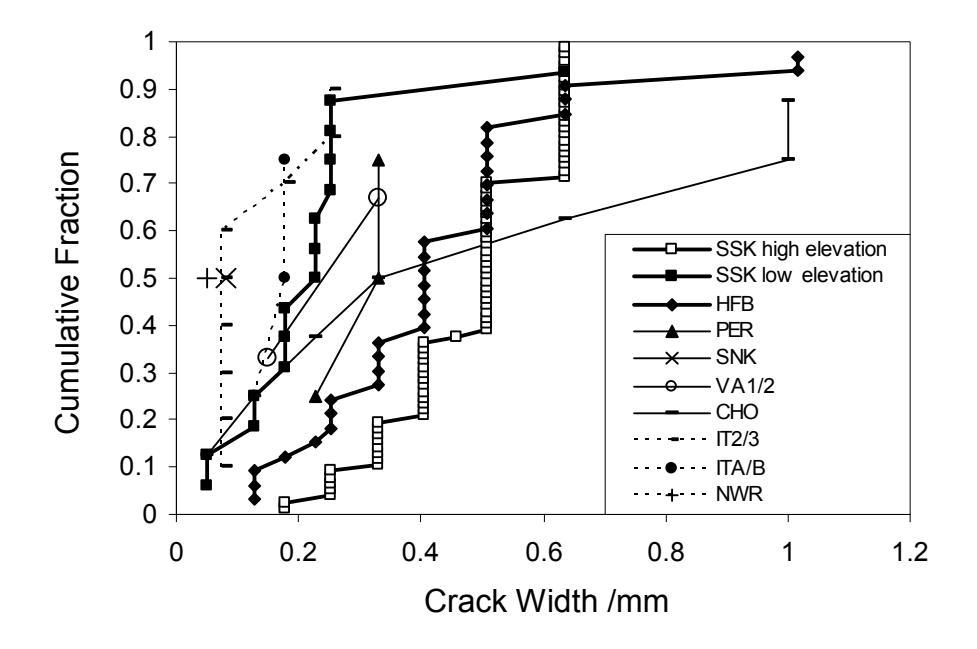
Figure 5. Widest Crack per Substructure Unit.

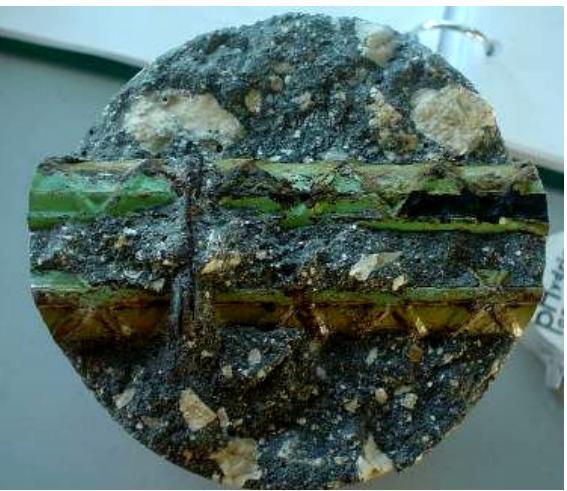
a) VA2 Drilled Shaft ~45 cm AHT on crack (0.33 mm).

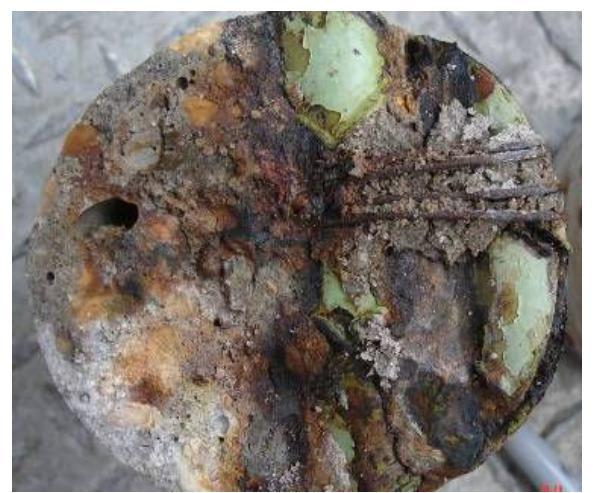
b) CHO. Footer. ~9 cm AHT.

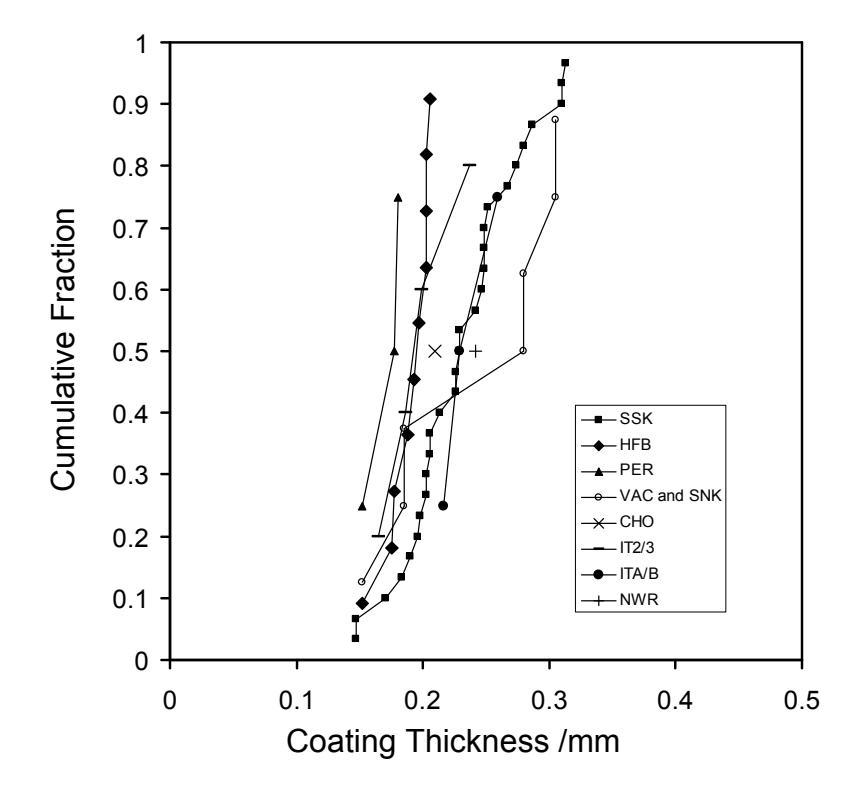
Figure 7. Epoxy Coating Thickness.

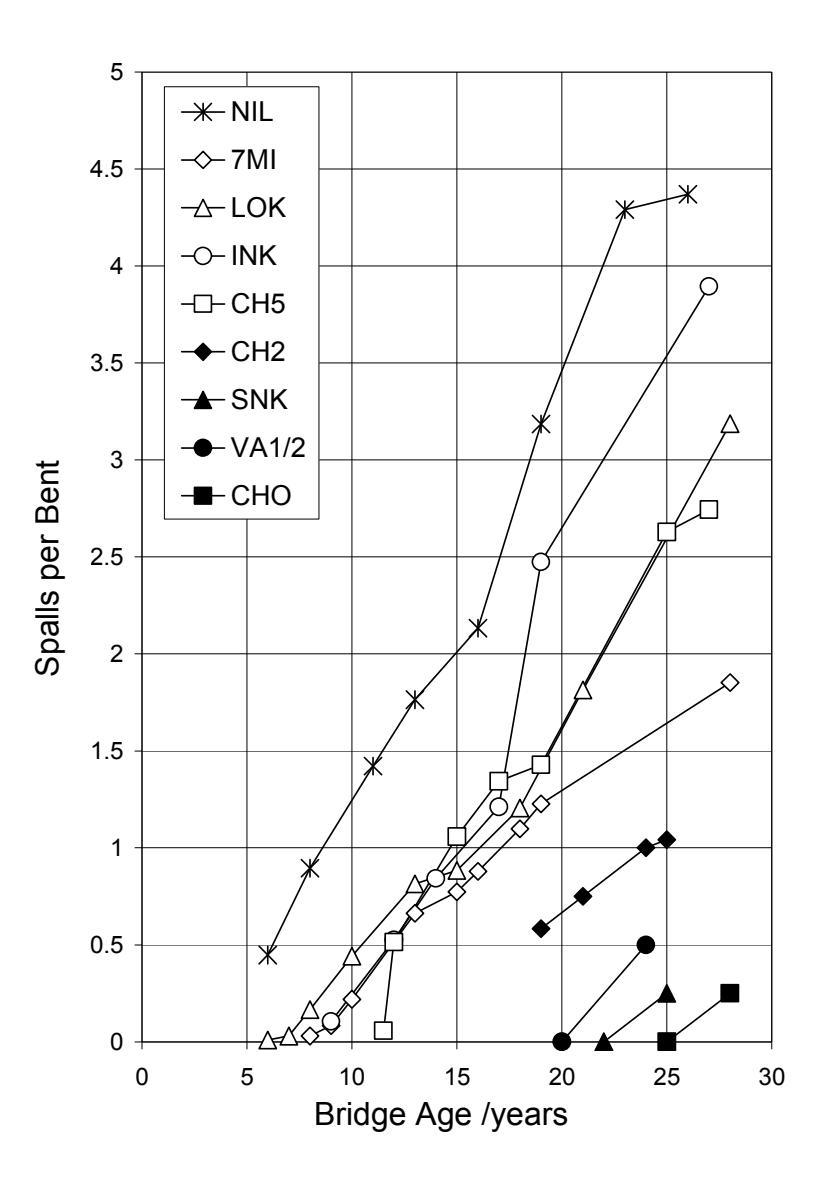
Figure 10. Progress of Concrete Corrosion Damage as Function of Time.

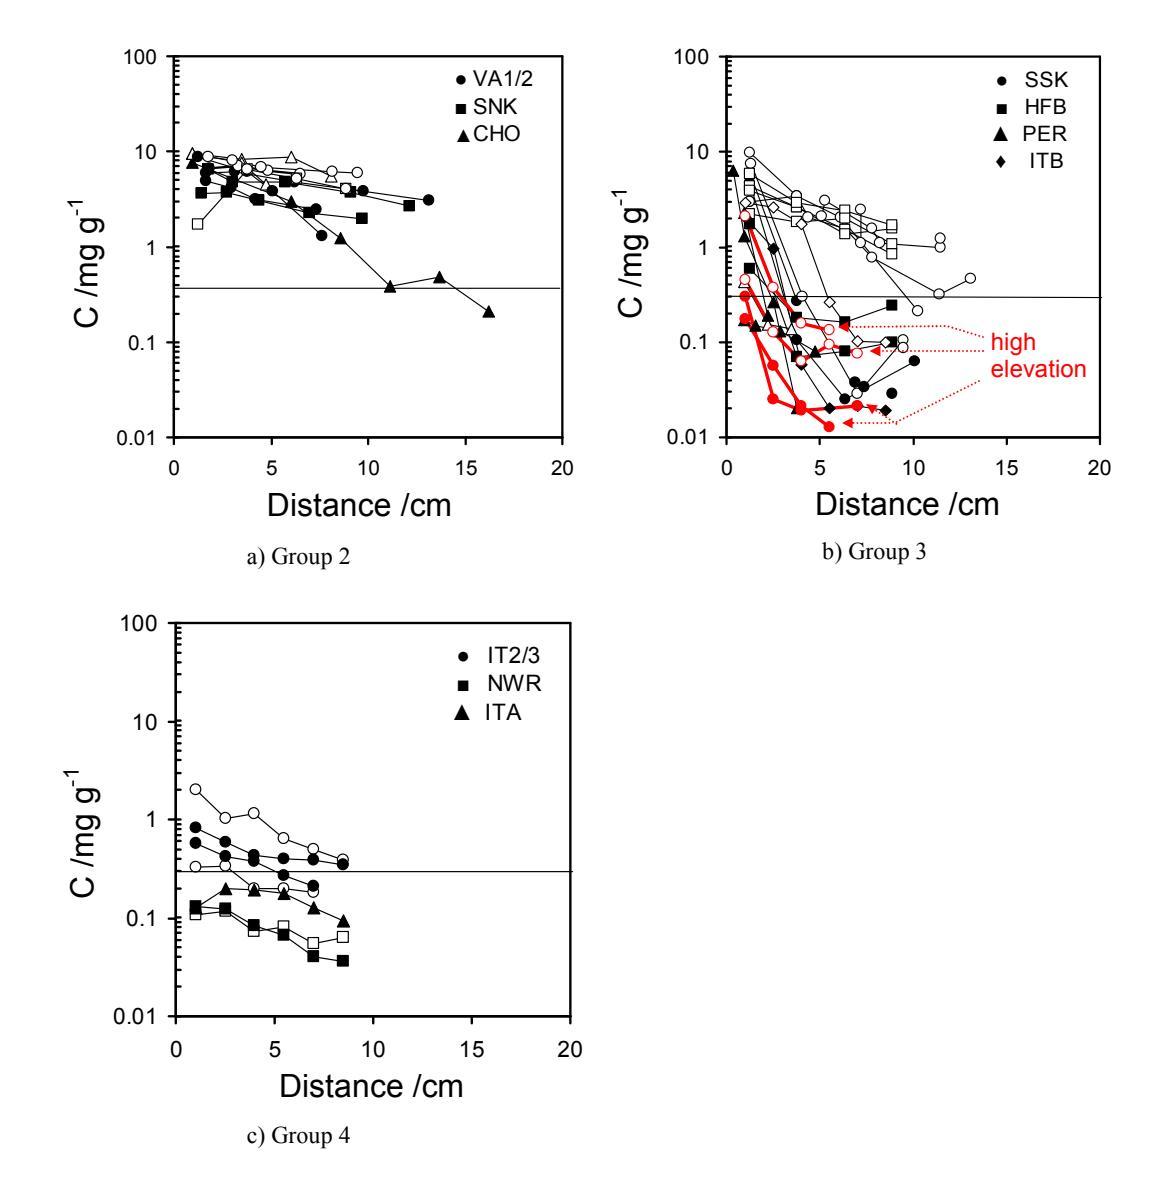
Figure 11. Chloride Penetration Profiles. Solid symbols: sound concrete. Open symbols: cracked concrete. Thick line, arrowed: high elevation trestle cap SSK locations. Horizontal line: conservative chloride threshold value $\sim 0.3 \text{ mg/g} (C_T \sim 0.7 \text{ kg/m}^3)$.

The profiles for on-crack locations in Groups 2 and 3 were on average higher than those for sound concrete confirming the expectation of preferential chloride penetration through cracks. In Group 2 the difference was moderate, indicating that the effect was overshadowed to some extent by fast bulk diffusion through the sound concrete in that group. In contrast the difference was dramatic for Group 3 where bulk diffusion in sound concrete is low, especially for SSK and HFB. The effect for those bridges was notable at the low elevations where the conservative threshold level was exceeded in most instances at the reinforcement depth. In the SSK higher elevation trestle caps the chloride penetration enhancement was less consequential, not markedly exceeding typical native chloride concentrations at depths greater than a few centimeters from the concrete surface. This lesser effect at high elevations likely reflects, as noted earlier, both a lower external surface concentration and drier conditions in the crack with consequentially less efficient transport. Enhanced chloride penetration was not observed in the limited number of samples extracted from PER, but there conditions similar to those encountered for SSK at the higher elevations may exist. Enhanced chloride penetration through cracks in ITB was moderate and may have been somewhat mitigated by low Cs, <10 kg/m³, reflecting presence of concrete surface coating, as noted also in Group 4 which is discussed next. The overall findings for Group 3 agree also with initial observations made by Sagüés et al., 2001.

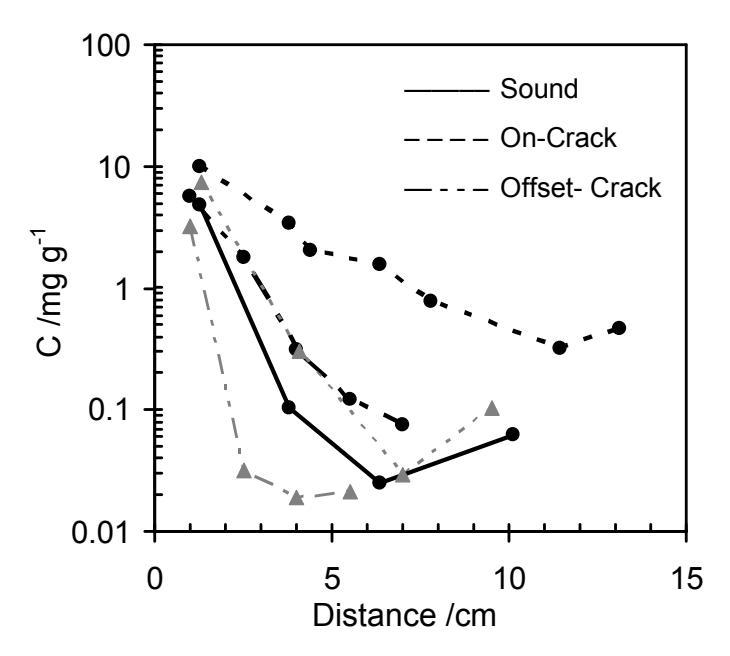
Figure 12. Chloride Penetration into the Side Walls of Cracks. On-crack profiles obtained following the usual procedure. Offset-crack profiles are for the same cores as On-crack but sampled ~1cm away from the approximate crack plane. A sound concrete profile from the matching core of one the on-crack locations is shown as well. Circle: cores SSK117E1-3. Triangle:SSK117E4.

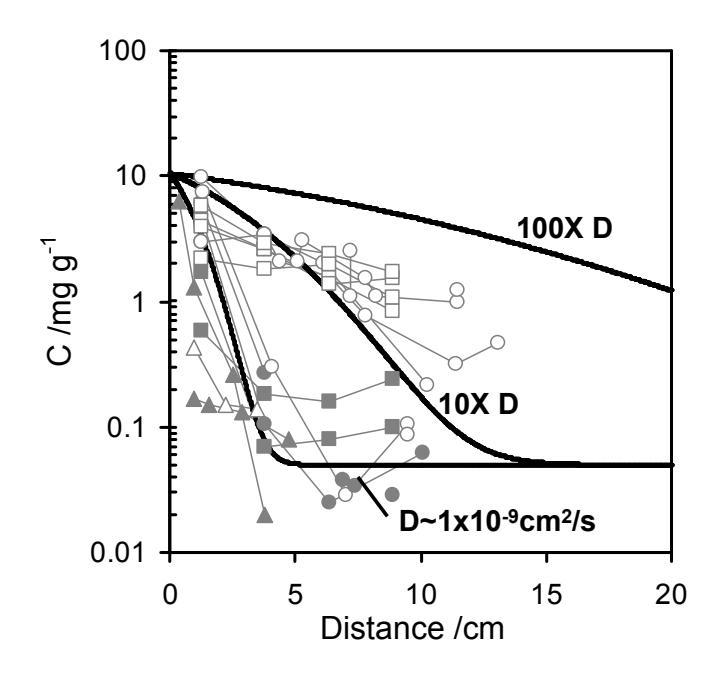
Figure 13. Comparison of Chloride Concentration Profiles with 10x and 100x Multiplier of D_{App} for Idealized Diffusion per Equation 3. Group 3 Case. Solid symbols: sound concrete. Open symbols: cracked concrete. (Data reproduced from Figure 11b)

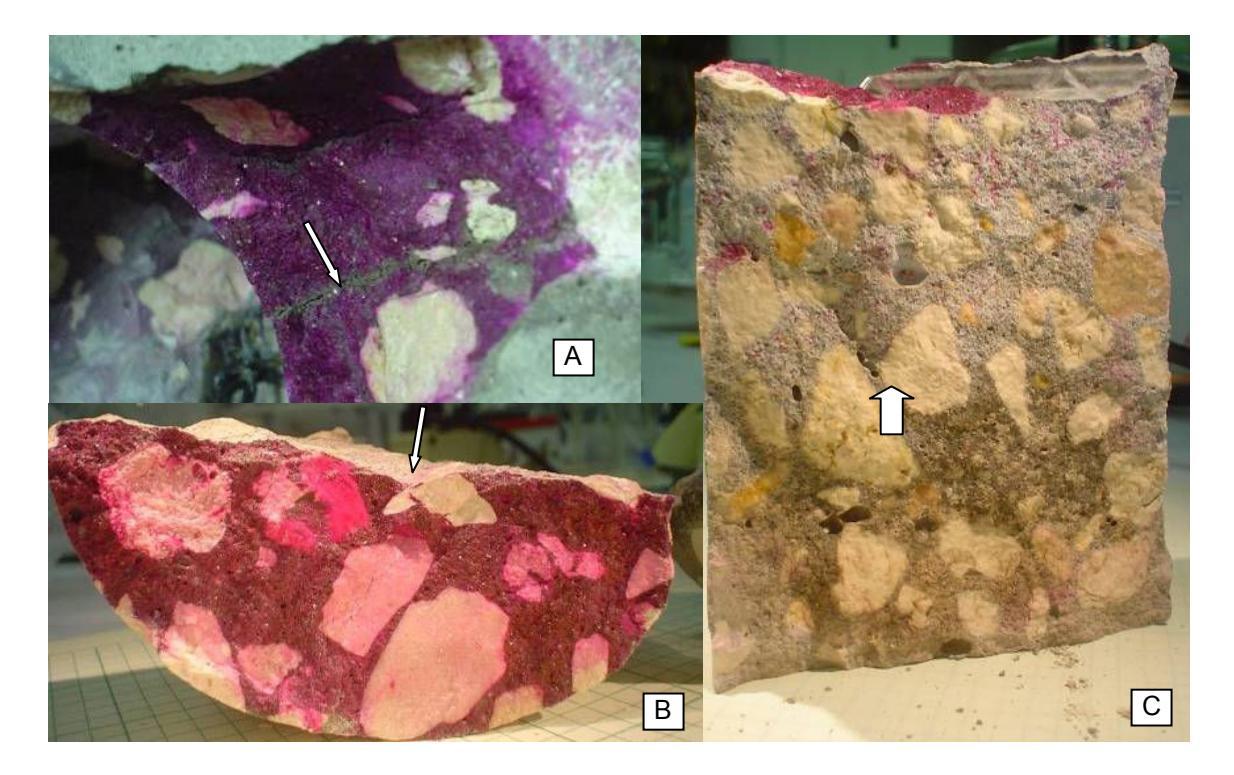
Figure 14. On Crack Carbonation Testing: SSK High Elevation Trestle Cap Concrete core. A) On site crack location, SSK140E1. B) Transverse cross section from crack surface, SSK33W1. C) On crack surface, SSK33W1.

The depth of concrete carbonation, from the external surface, was measured by lightly spraying 1% phenolphthalein in ethanol solution on freshly fractured concrete core samples. In concrete cores from cracked locations, the core was separated exposing the cracked surface, and phenolphthalein was sprayed on it. The depth, if any, from the external surface to which the crack surface remained colorless was recorded as the on-crack carbonation depth. In selected cores, the halves corresponding to each side of the crack were further broken transversely to the crack, to determine how carbonation had progressed into the sides of the crack.

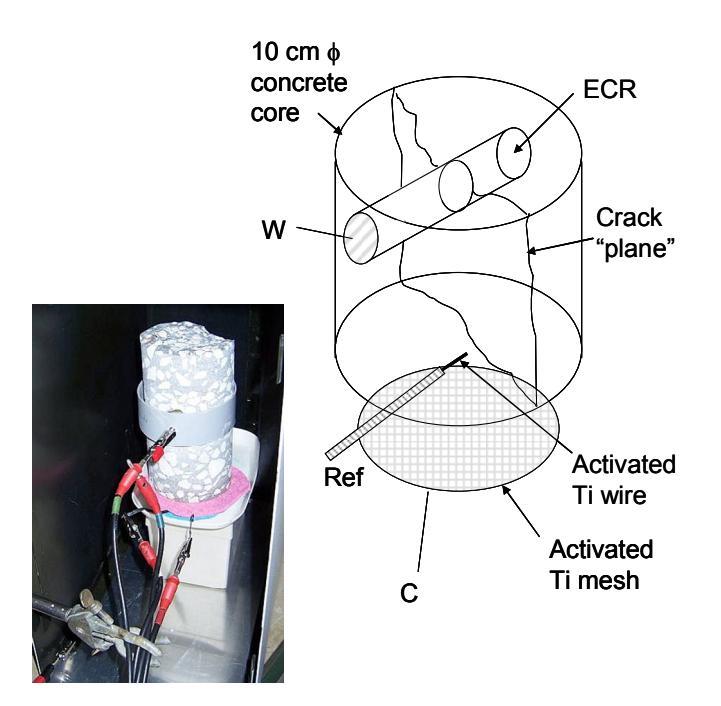
Figure 15. Field-Extracted ECR Concrete Core EIS Test Set-up.

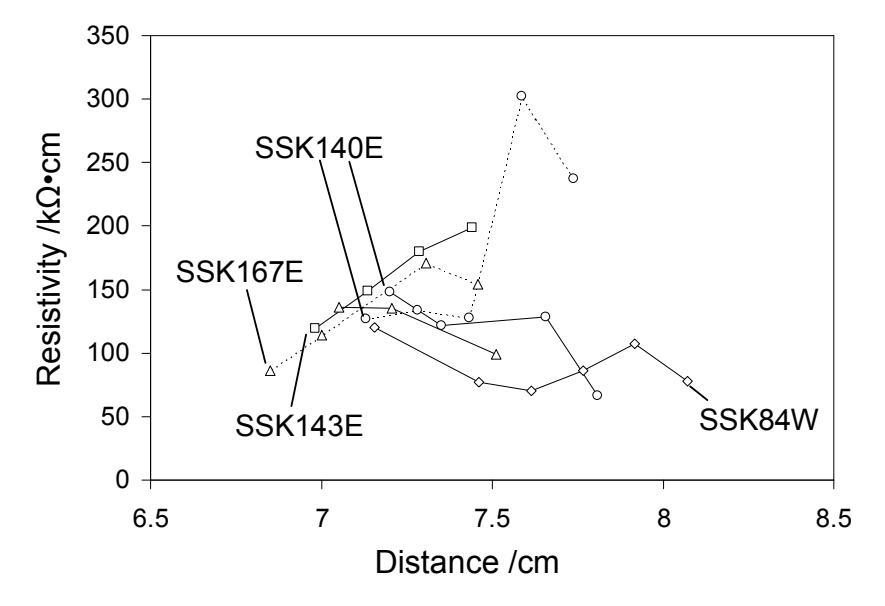
Figure 16. Concrete Surface Resistivity Comparison On and Off crack. SSK High Elevation Trestle Caps line: Sound concrete. Dotted line: Cracked concrete.

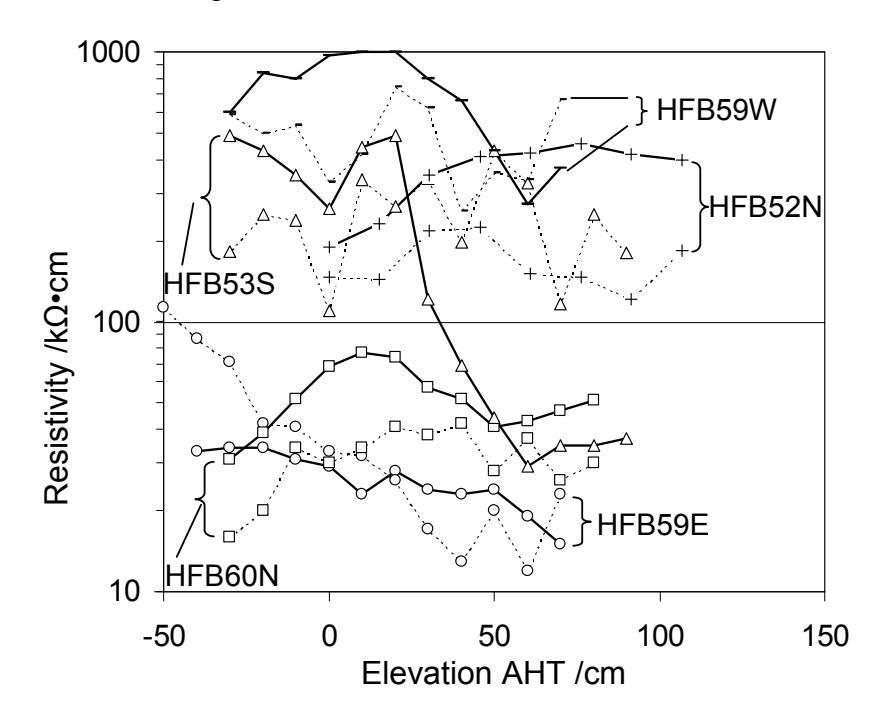
Figure 17. Concrete Surface Resistivity Comparison On and Off Crack. HFB footers. Solid line: sound concrete. Dotted line: cracked concrete.

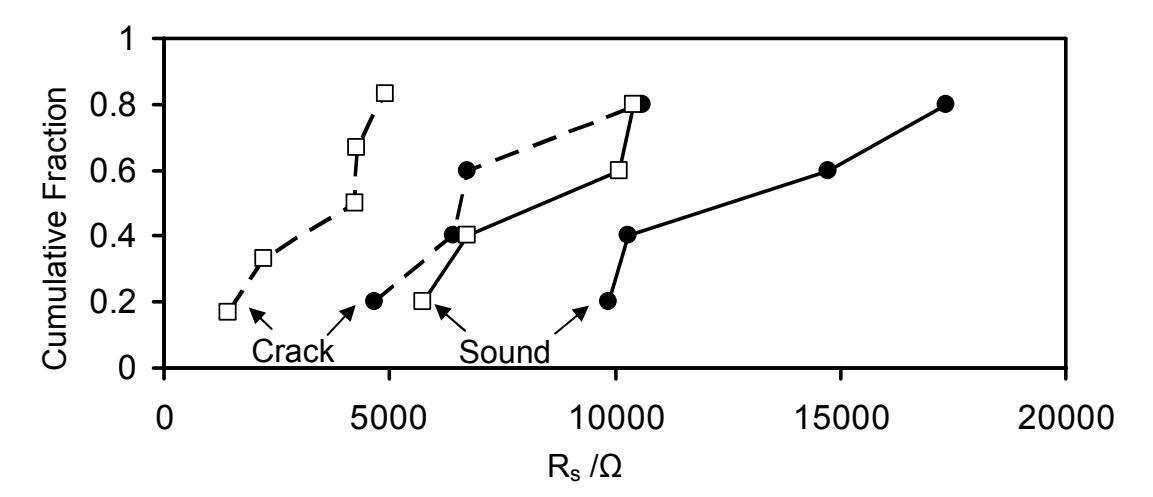
Figure 18. Solution Resistance Measured by EIS (SSK).● High elevations. □ Low elevations

The EIS measurements did show differentiation between both conditions, as shown in Figure 18. The solution resistance was smaller not only at low elevation locations —already observed in the surface resistivity tests— but also in cracked samples consistent with the increased moisture content and water penetration expected for the latter. For a typical EIS cell geometry, core diameter d=10cm, cover length L~10cm, the nominal concrete resistivity can be approximated by $\rho = R_s \pi d^2/4L$. The resulting value for sound concrete was in the range $\sim 40-140 \text{k}\Omega$ -cm, comparable to that obtained in the field surface resistivity measurements. The nominal ρ in cracked concrete was in the range \sim 8-80 k Ω -cm, smaller than in sound concrete and indicative of increased electrolyte presence in the cracks. The effect was stronger at low elevations, where ρ for cracked concrete was as much as 10 times smaller than for sound concrete. It is noted that some of the moisture in the crack in the EIS tests may have been recharged from the sponge used to enhance counter electrode contact. Nevertheless, the increased conductance of the cracked cores underscores the ability of that region to retain moisture and consequently facilitate chloride transport. The effect would be expected to be greater in bridges such as HFB where cracks were on average twice as large as in the others, and where the observation of corrosion of the ECR at crack locations was actually observed.

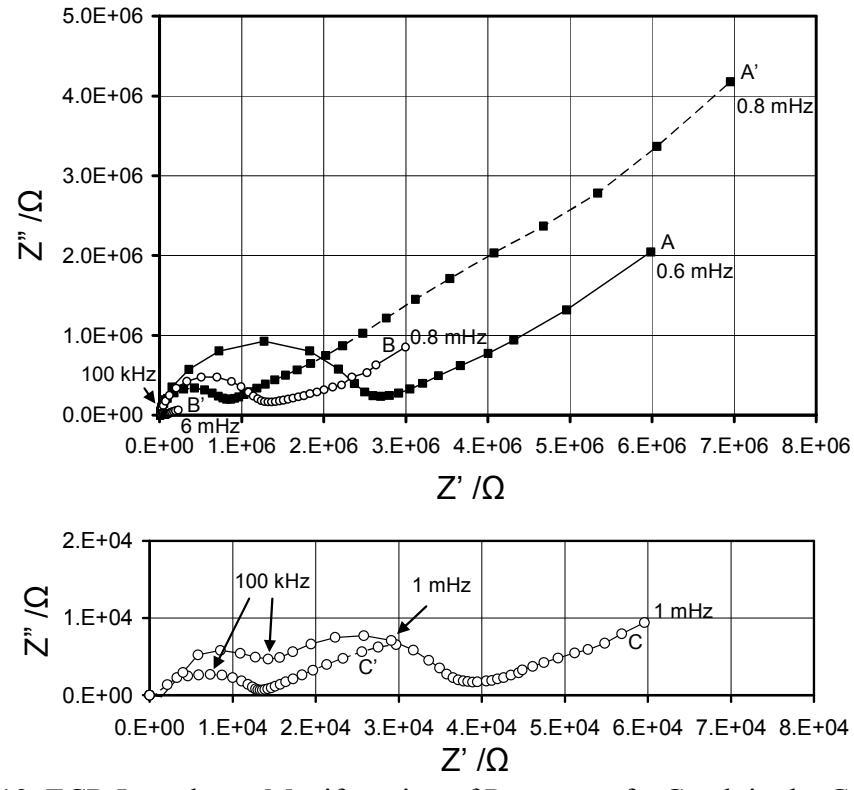
Figure 19. ECR Impedance Manifestation of Presence of a Crack in the Core (Low Elevation SSK Samples). A,B,C Sound concrete core; A', B', C' Companion on-crack core; crack widths were 0.13, 0.25 and 0.23 mm respectively. A, A':118W4,118W3. B, B': 118W2, 118W1. C,C': 117E3, 117E1.

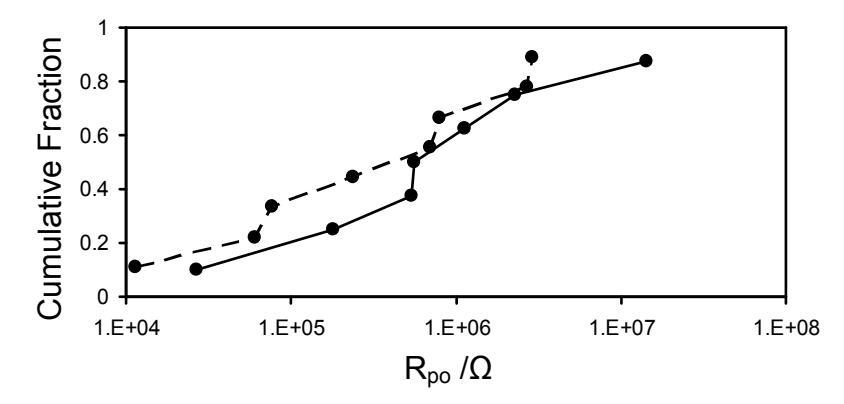
Figure 20. Pore Resistance in ECR from SSK Sound and Crack Concrete Locations. – sound concrete, -- crack concrete.

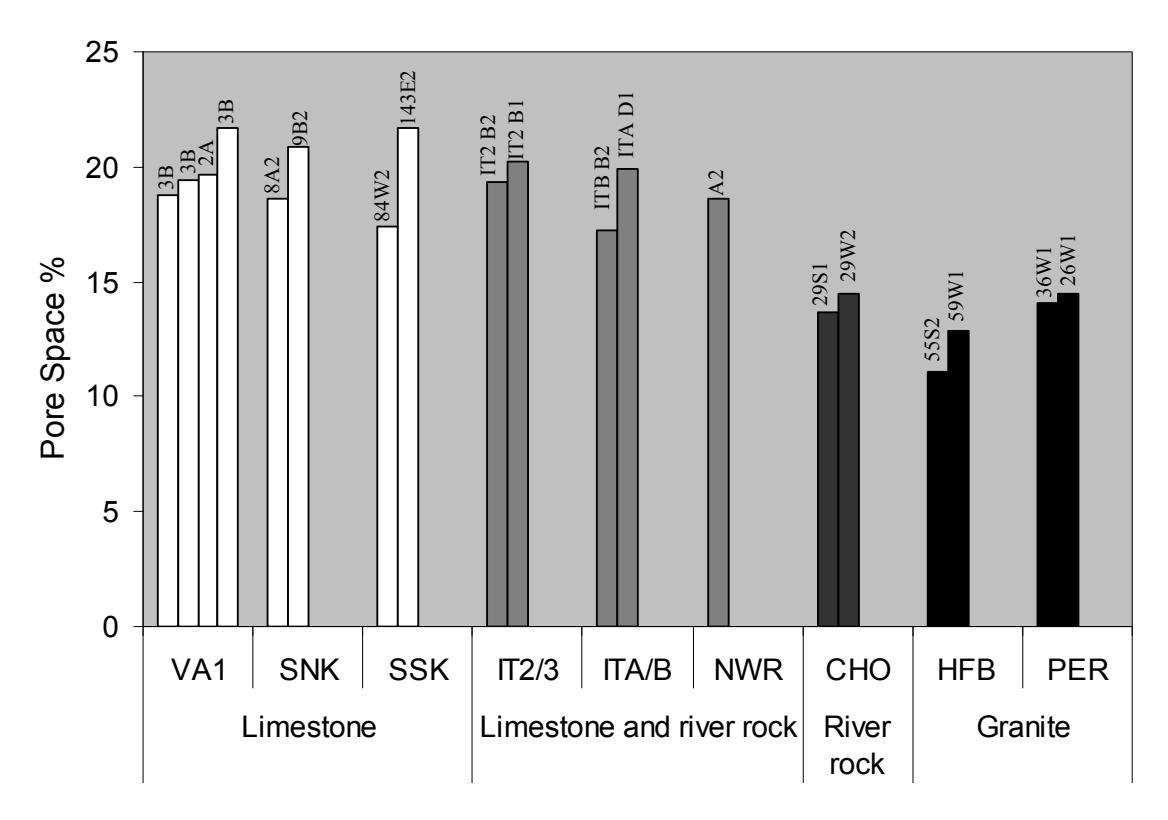
Figure 21. Concrete Porosity.

Concrete porosity was measured following ASTM C642, 1997. Figure 21 shows that concrete porosity results, while being generally in the range or values normally expected for concrete, did not have good correlation to other permeability factors, such as D_{App} or ρ , nor to extent of corrosion. Porosity instead was influenced by the type of coarse aggregate, tending to be smaller for concrete with denser aggregate such as granite. This overall behavior is not unexpected as chloride transport tends to be dominated by the connectivity of the pore network rather than the total porosity (ACI 2004). Coarse aggregate such as limestone contains large pores but relatively little of the chloride resides there (Yu and Hartt, 2007). These measurements were performed for completeness and to rule out extraneous factors that might have changed the interpretation of the other findings.

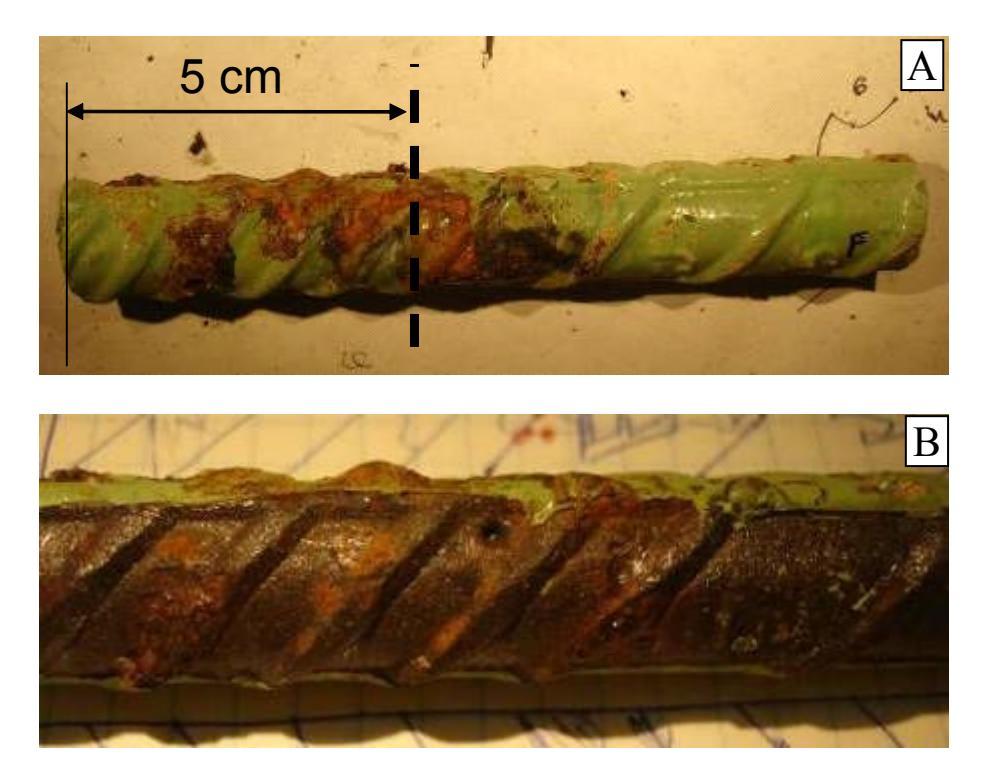
Figure 22. ECR Corrosion at Crack Location, HFB 59E1 A. Corrosion products on bar surface. The line represents the location of the crack intersection. B. Appearance after partially removing the coating and exploring into the corrosion products.

Corrosion products developed in four separate cracked concrete locations in the Group 3 bridge HFB, examples shown in Figure 22, were examined with metallographic cross sections by optical metallography; two of those samples were further analyzed by secondary and backscatter Scanning Electron Microscopy, SEM, supplemented by elemental analysis with Energy-Dispersive X-Ray Spectroscopy, EDS.

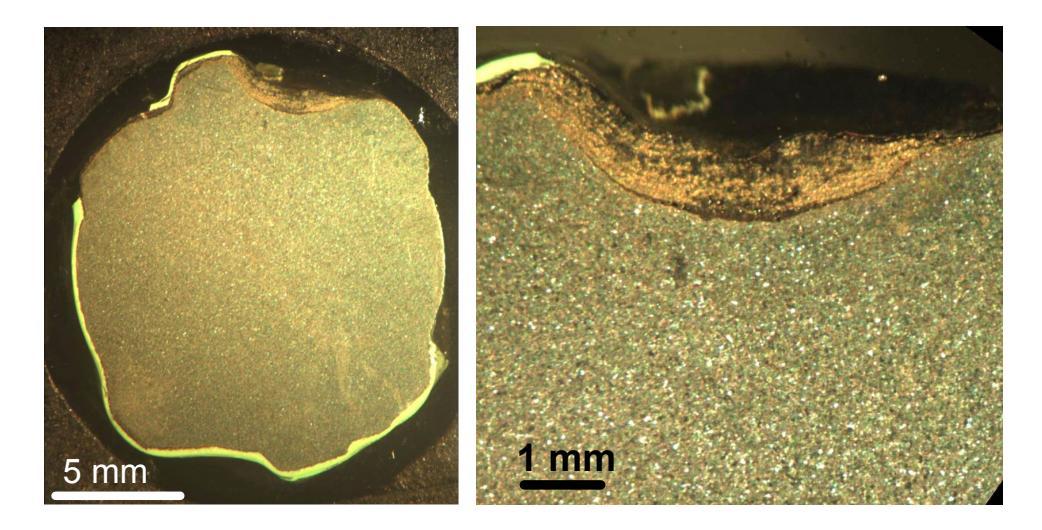
Figure 23. Cross Section of ECR Bar Showing Severe Corrosion at a Crack Location of HFB 59E1. Left: Entire Bar cross-section. Right: Close up of corrosion penetration.

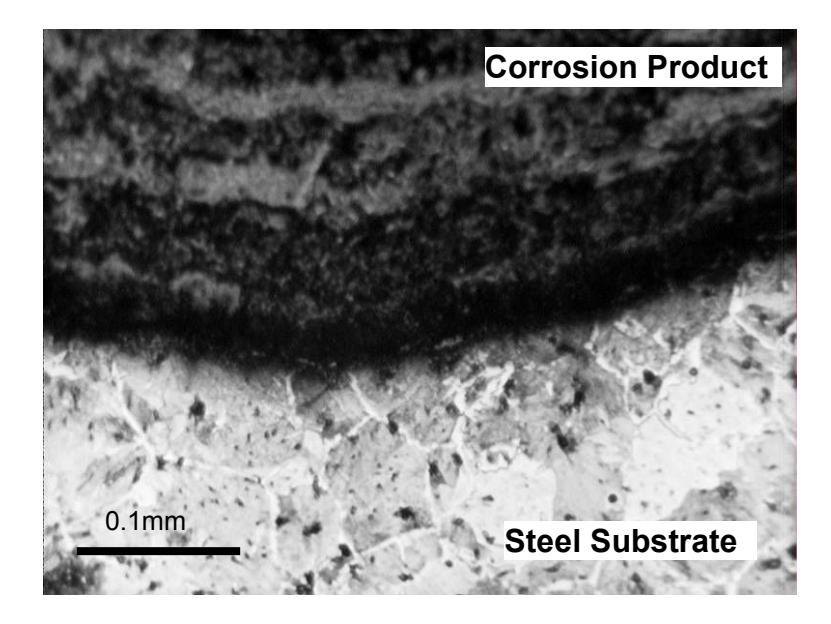
Figure 24. Corrosion Product - Base Metal Interface Showing Progression of Corrosion into the Microstructure of the Rebar Steel, HFB 59W1.

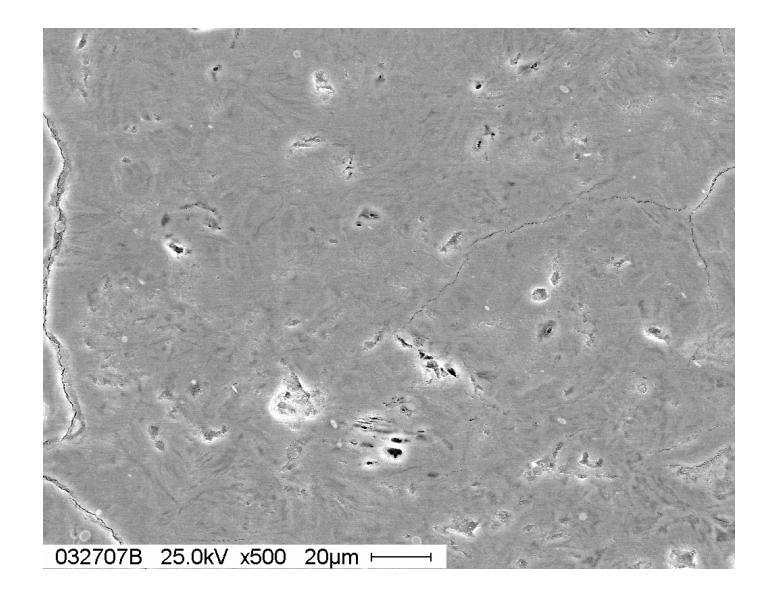
Figure 25. SEM Image of Corrosion Product (HFB59W1).

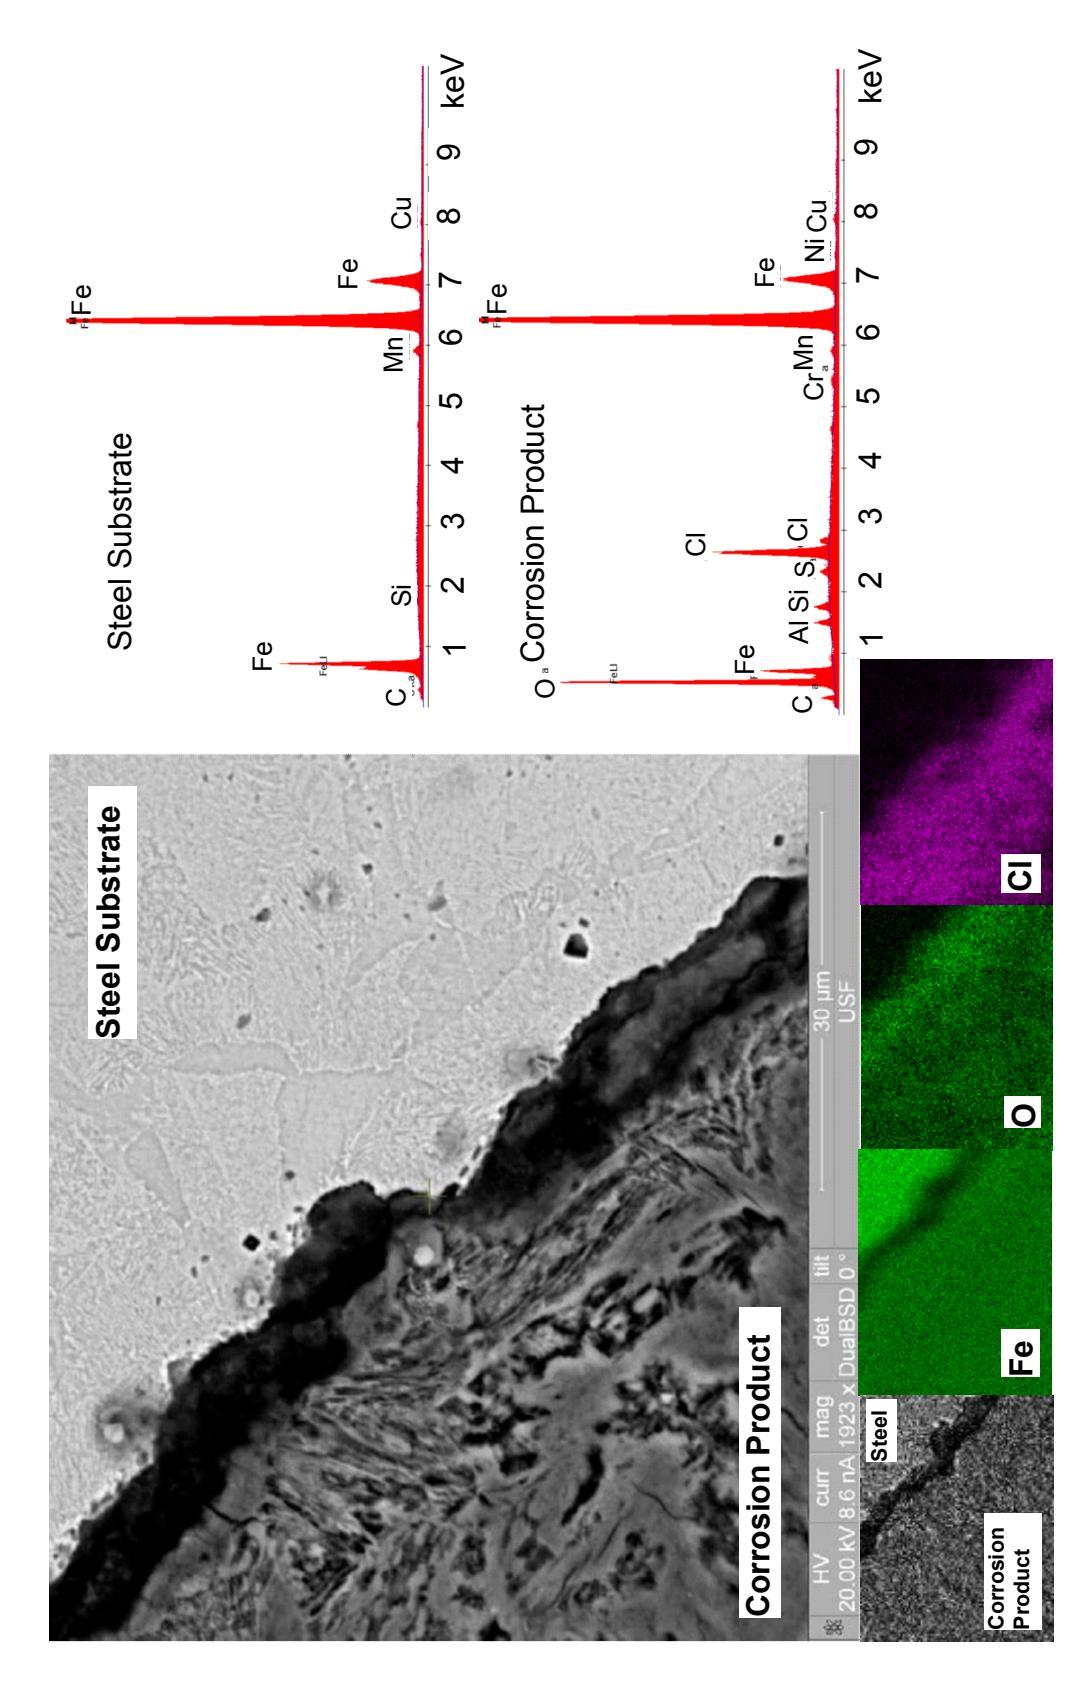
Figure 26. SEM/EDS Analysis of Corrosion Product Observed in HFB59E1.

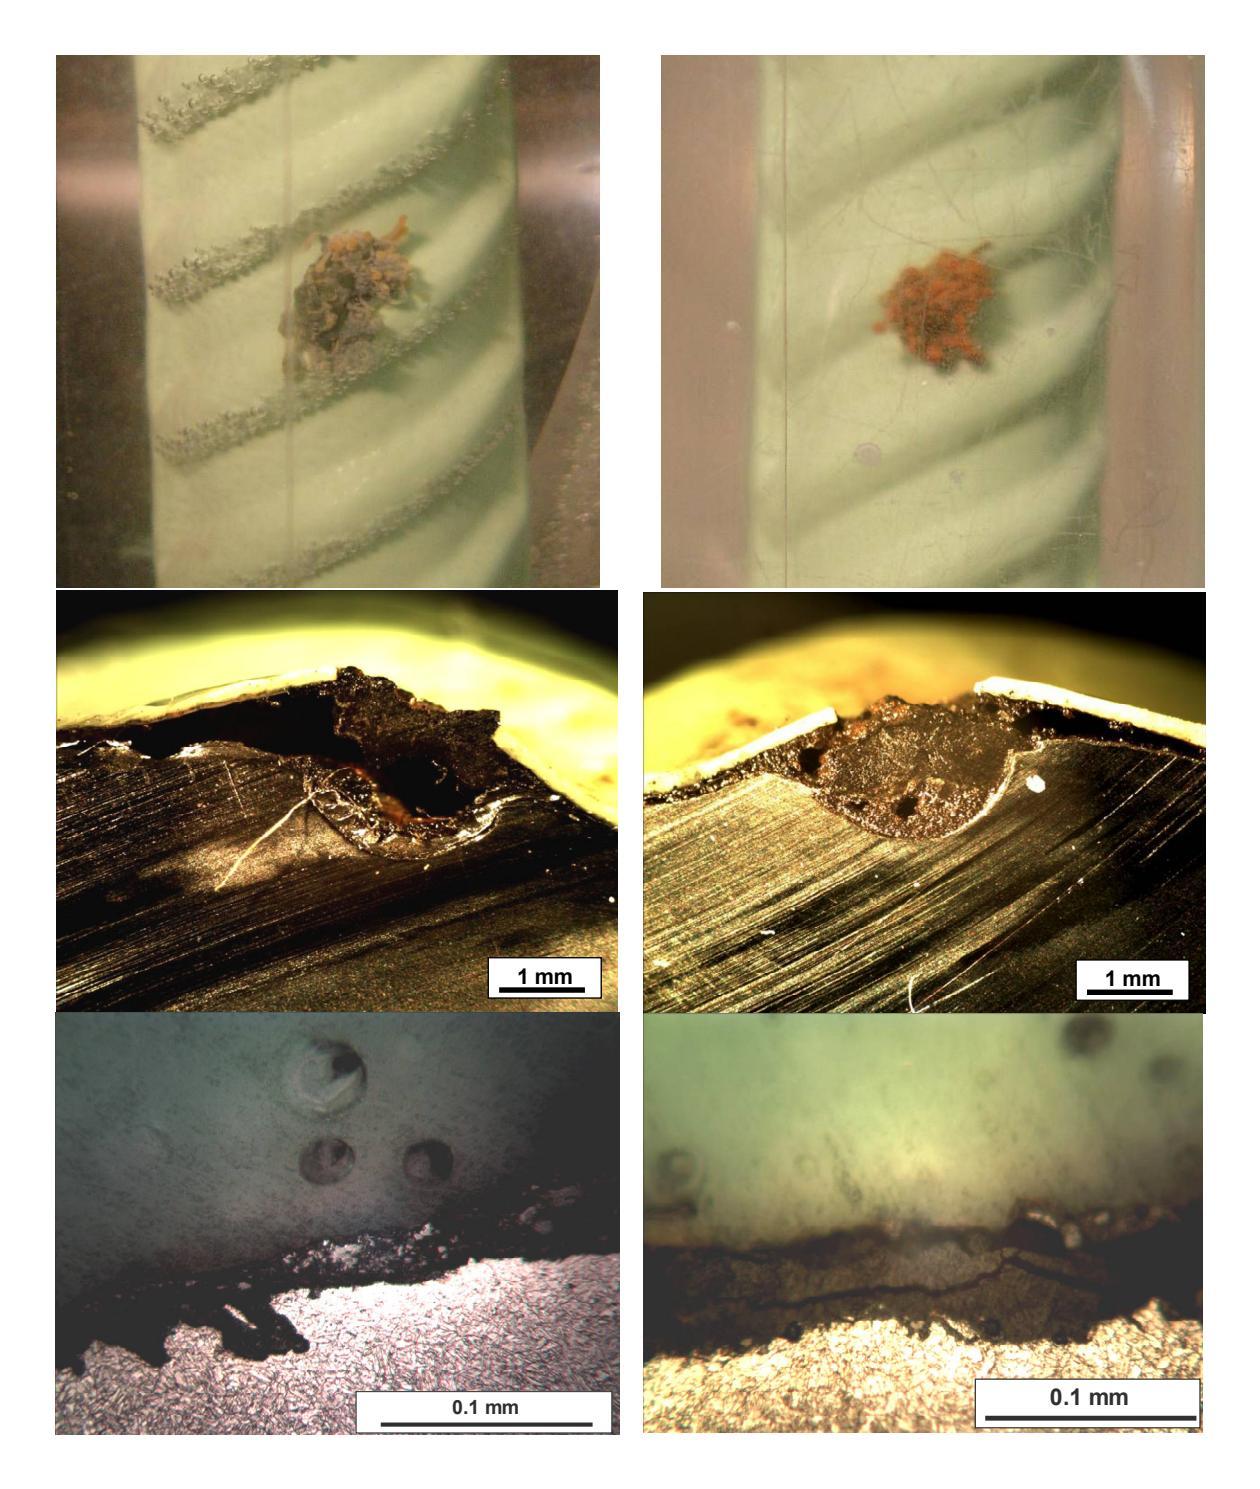
Figure 27. External and Undercoating Corrosion Development in De-aerated (left) and Aerated (right) Environments.

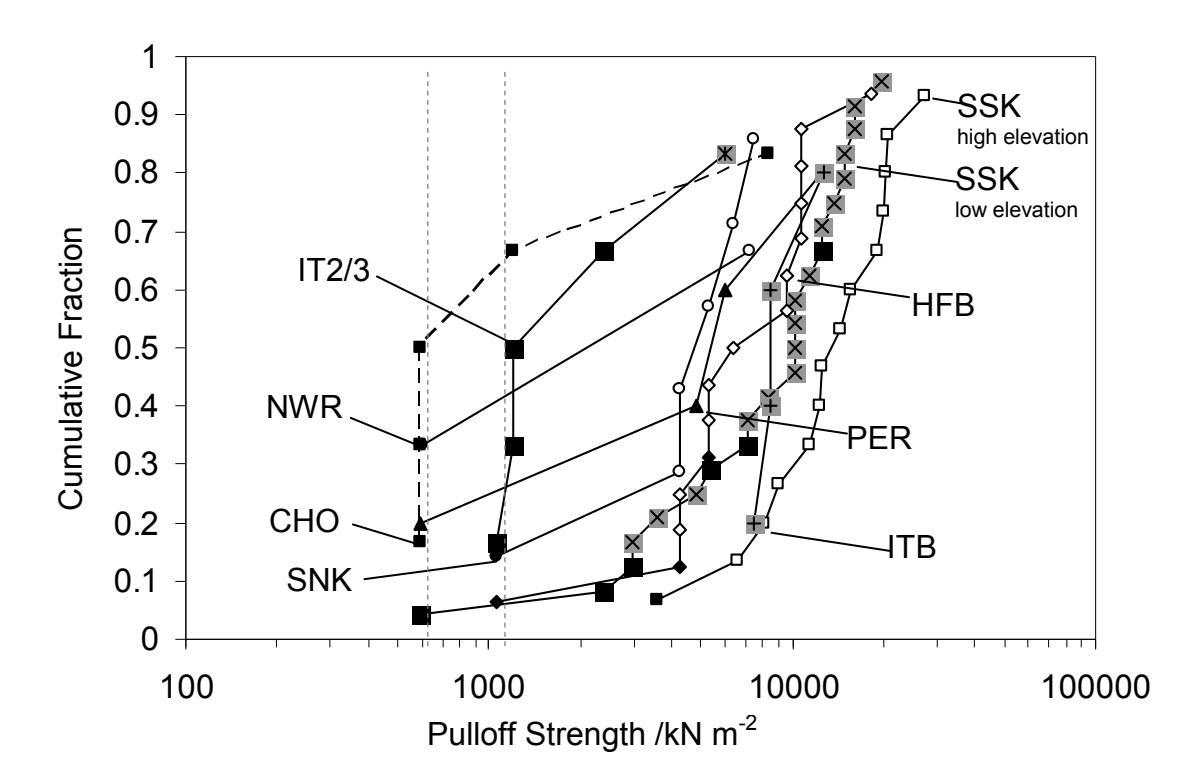
Figure 28. Epoxy Coating Pull-Off Strength. The pull-off strengths for Vaca Cut samples were negligible. Solid black symbols represent measured pull-off strengths. The other symbols represent lower bound pull-off strength failure at cyanoacrylate adhesive.
 Vertical lines represent minimum measurable strengths using metal dollys, nominal area 0.049 and 0.028 cm².

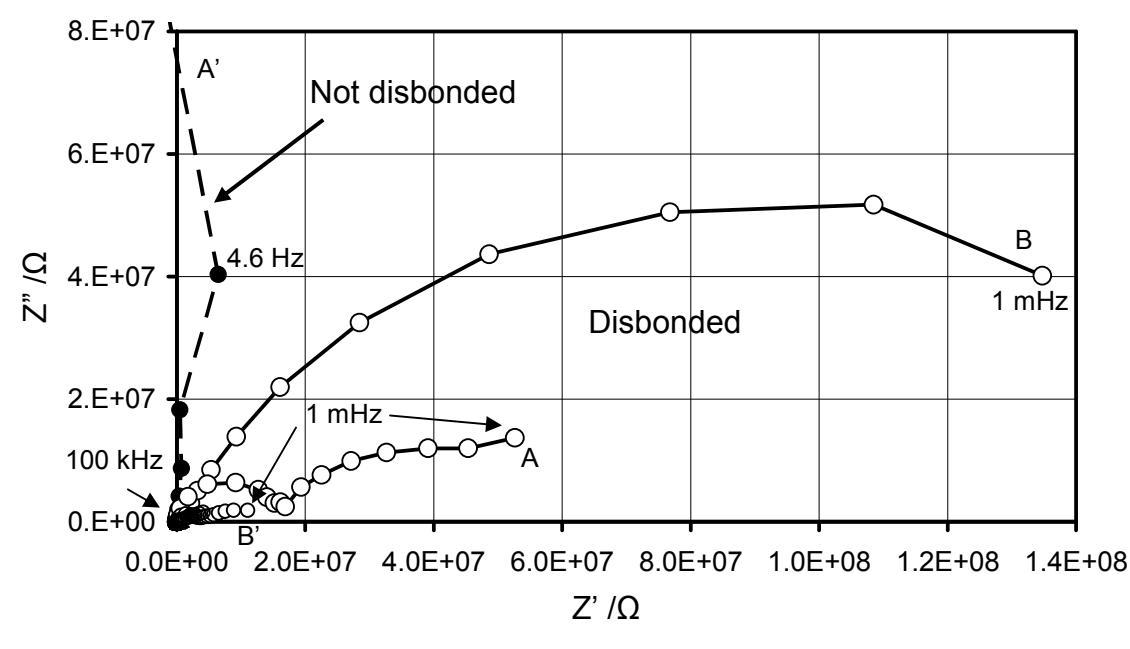
Figure 29. Impedance Manifestation of Disbondment. ECR from high elevations. A,B Sound concrete core. A',A' Companion on crack core. (A, A': 140E2, 140E1. B, B': 33W2, 33W1).
