Corrosion of epoxy-coated reinforcement in marine bridges with locally deficient concrete

A dissertation submitted in partial fulfillment of the requirements for the degree of Doctor of Philosophy Department of Civil and Environmental Engineering College of Engineering University of South Florida

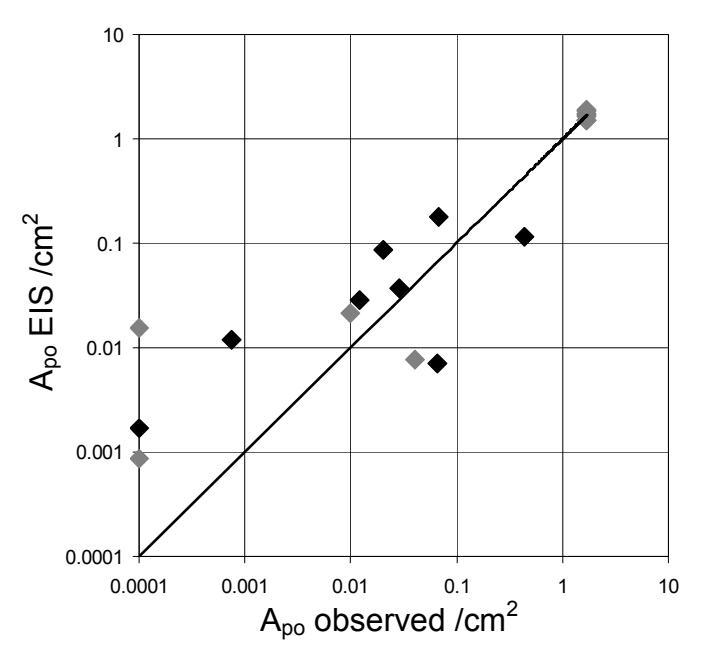
Figure 30. Comparison of Observed Coating Defects to Estimated Coating Defects. Black symbols represent SSK data. Grey data from Lau and Sagüés, tbp.

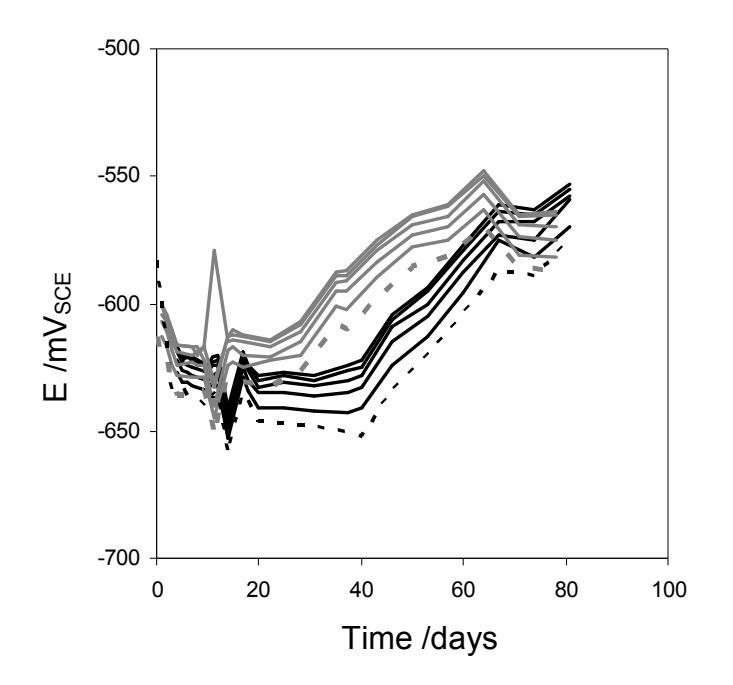
Figure 31. Polarization Behavior of ECR from Supplemental Test Setup of ECR Embedded in Concrete. All potentials are mixed-potentials while the system was connected to the steel bar anode. Dotted lines- steel bar anodes. Gray and black lines represent bars from duplicate concrete specimens.

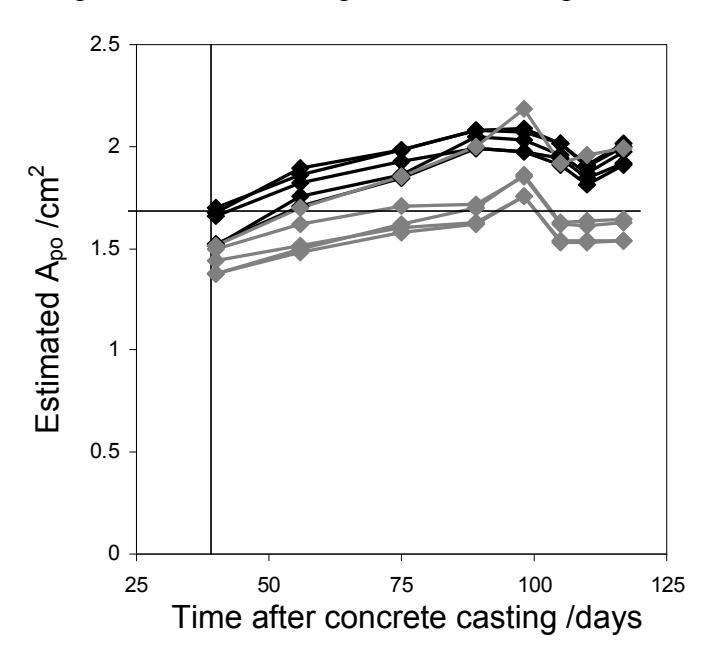
Figure 32. Estimated Apo as Function of Time After Initial Concrete Casting. Vertical line represents time of initial cathodic polarization. Horizontal line represents nominal intentional defect area. . Gray and black lines represent bars from duplicate concrete specimens.

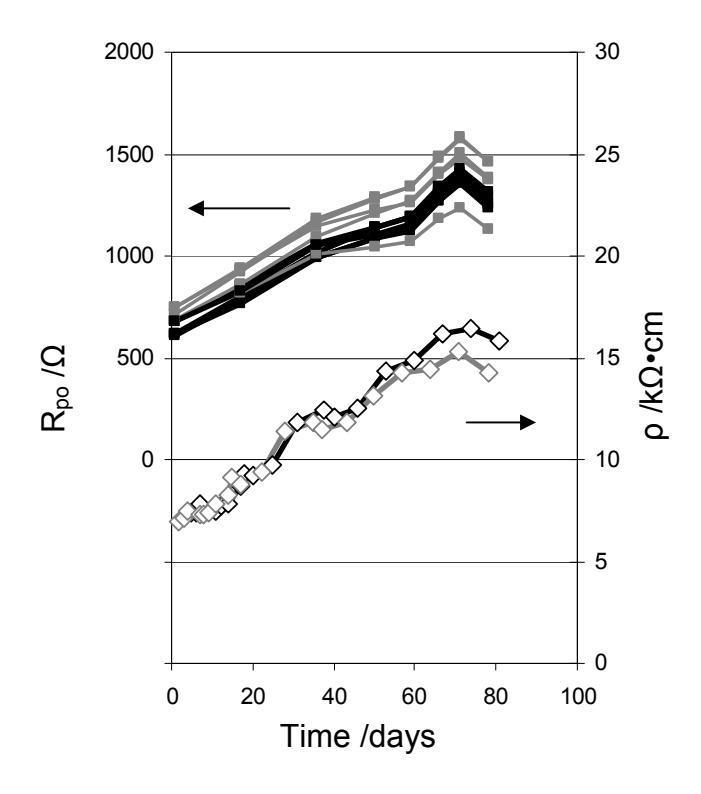
Figure 33. Pore resistance and Concrete Resistivity as Function of Time after Inital Cathodic Polarization, ~40 days After Concrete Casting.

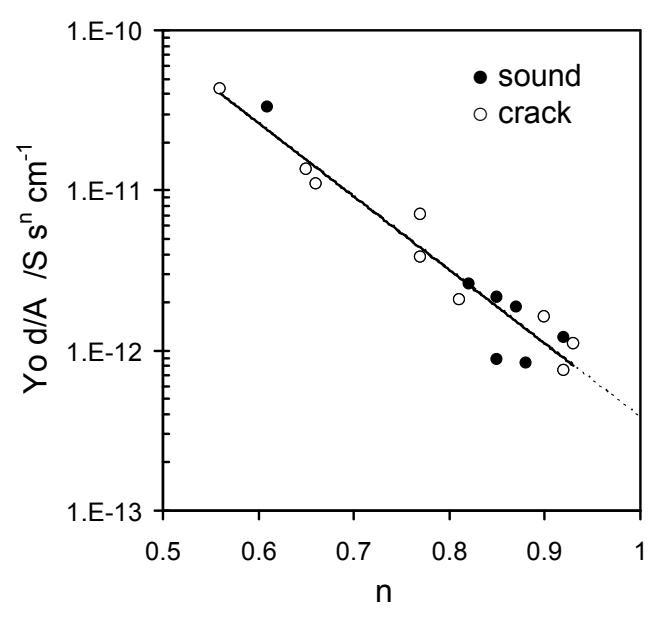
Figure 34. Correlation of Yo and n for Coating CPE Component.

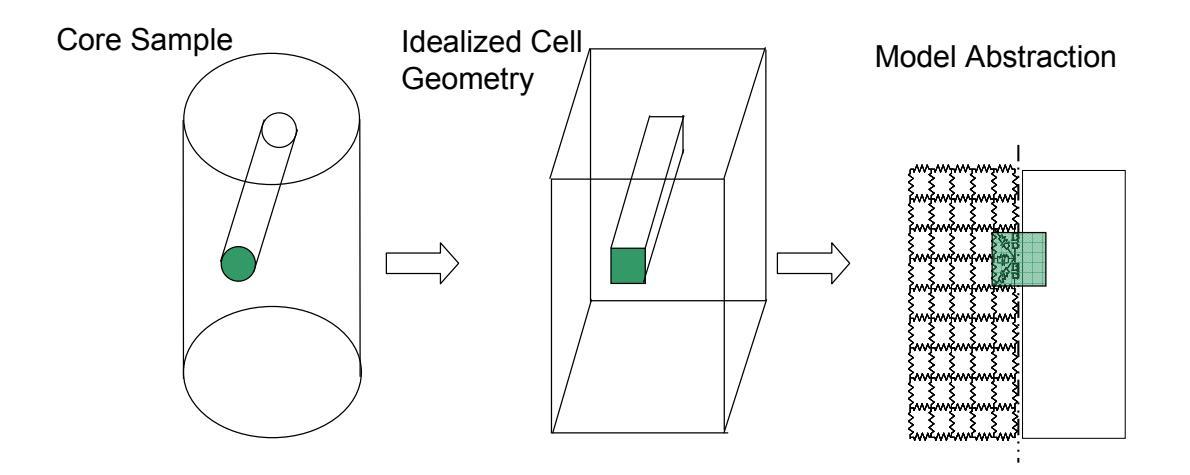
Figure 35. Idealized Extended Circuit Analog Model Abstraction.

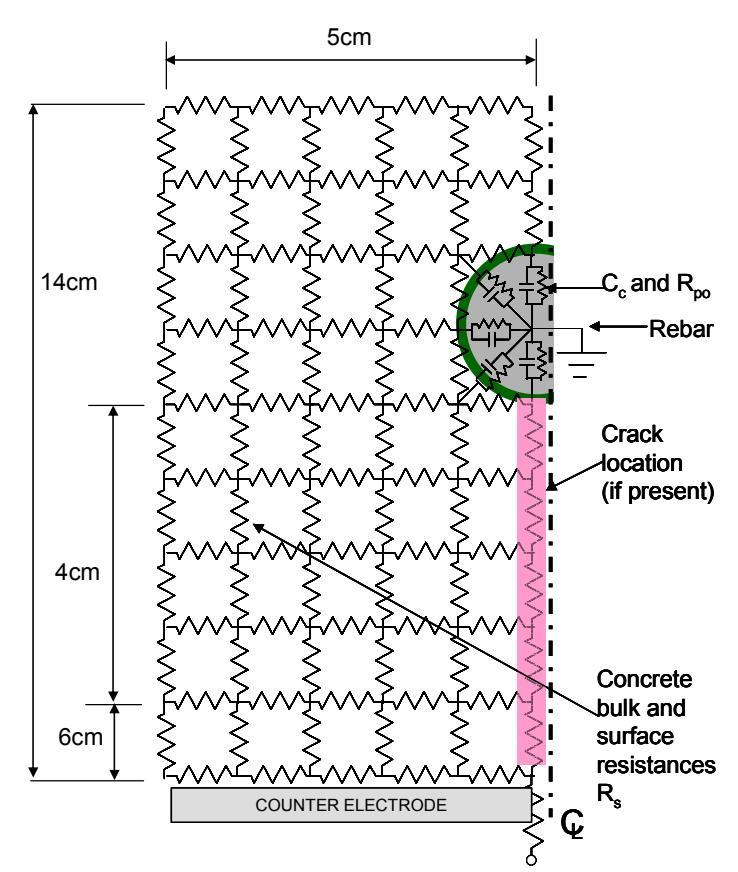
Figure 36. Detailed Schematic of Extended Circuit Analog Model Abstraction.

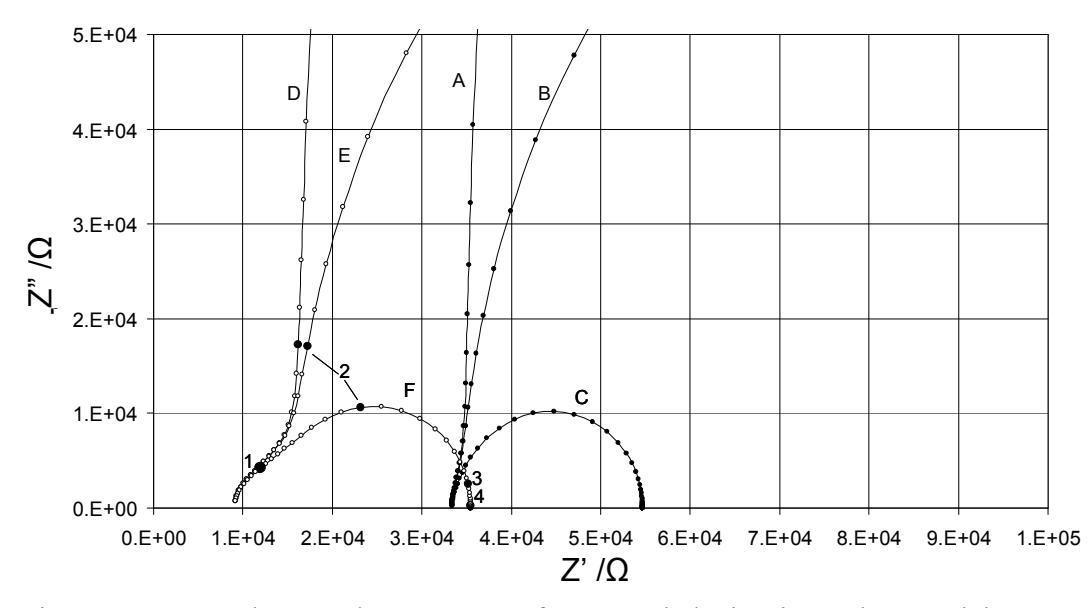
Figure 37. Example Impedance Spectra for Extended Circuit Analog Model Case A-F for ρ_B =300 k Ω -cm. Point 1, 100kHz; Point 2, 10kHz, Point 3, 1kHz, Point 4, 100Hz.

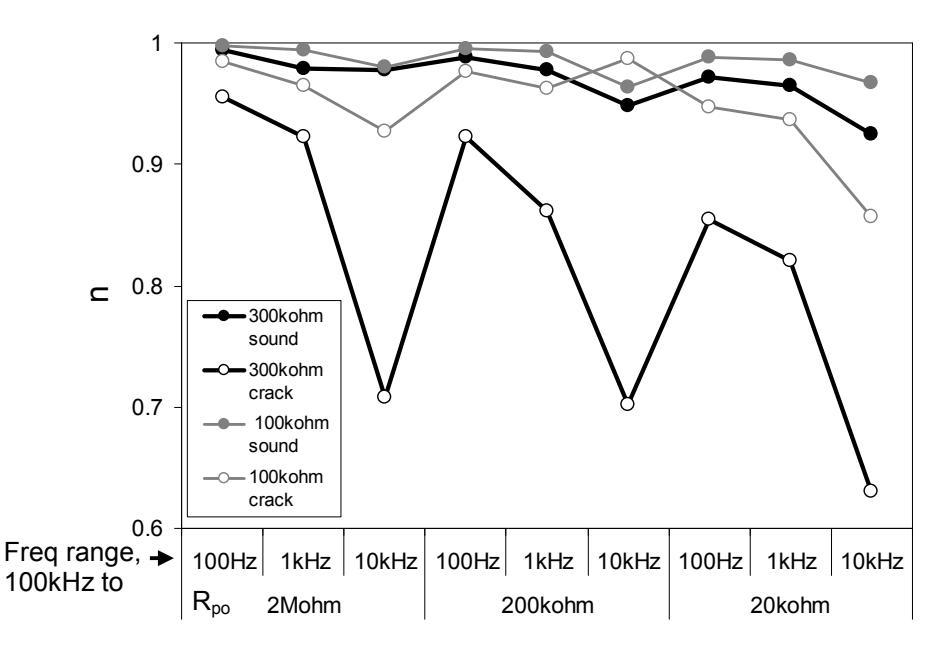
Figure 38. Frequency Dispersion Quantified by Coating CPE n Term for Idealized Extended Circuit Analog.

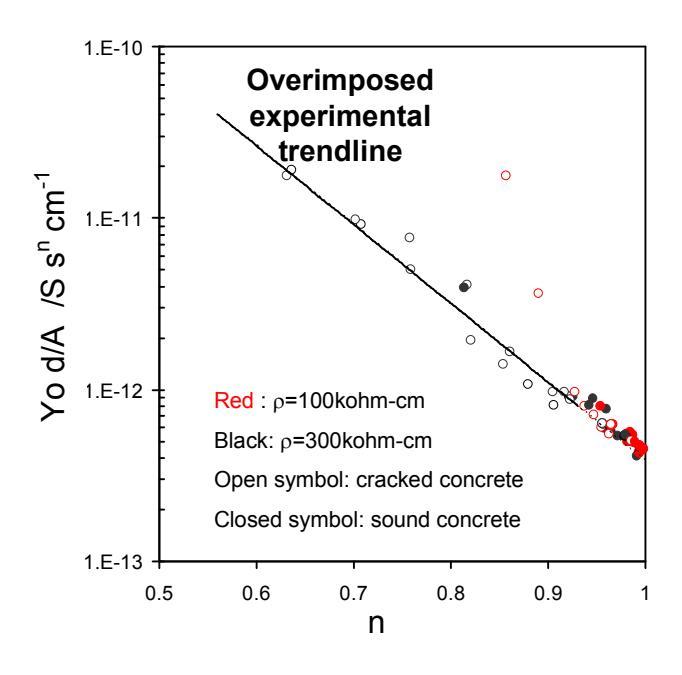
Figure 39. Yo-n Correlation from Idealized Extended Circuit Analog Model EIS Analysis. The trendline overimposes experimental Yo-n correlation.

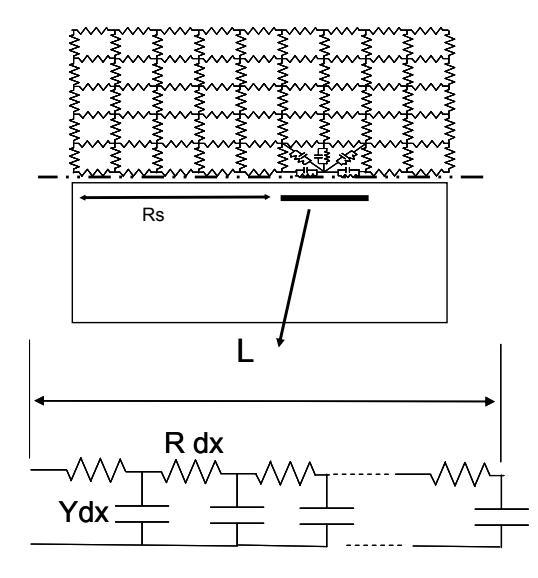
Figure 40. Transmission Line Extended Circuit Analog Abstraction.

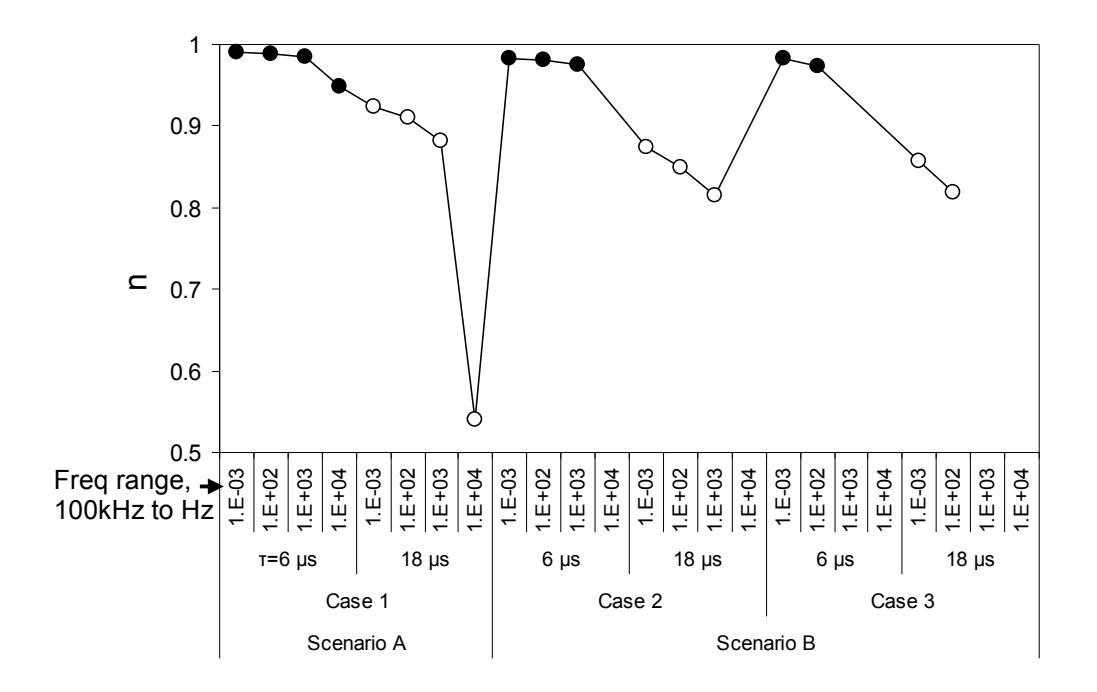
Figure 41. Frequency Dispersion Quantified by Coating CPE n Term for Truncated Transmission Line Extended Circuit Analog

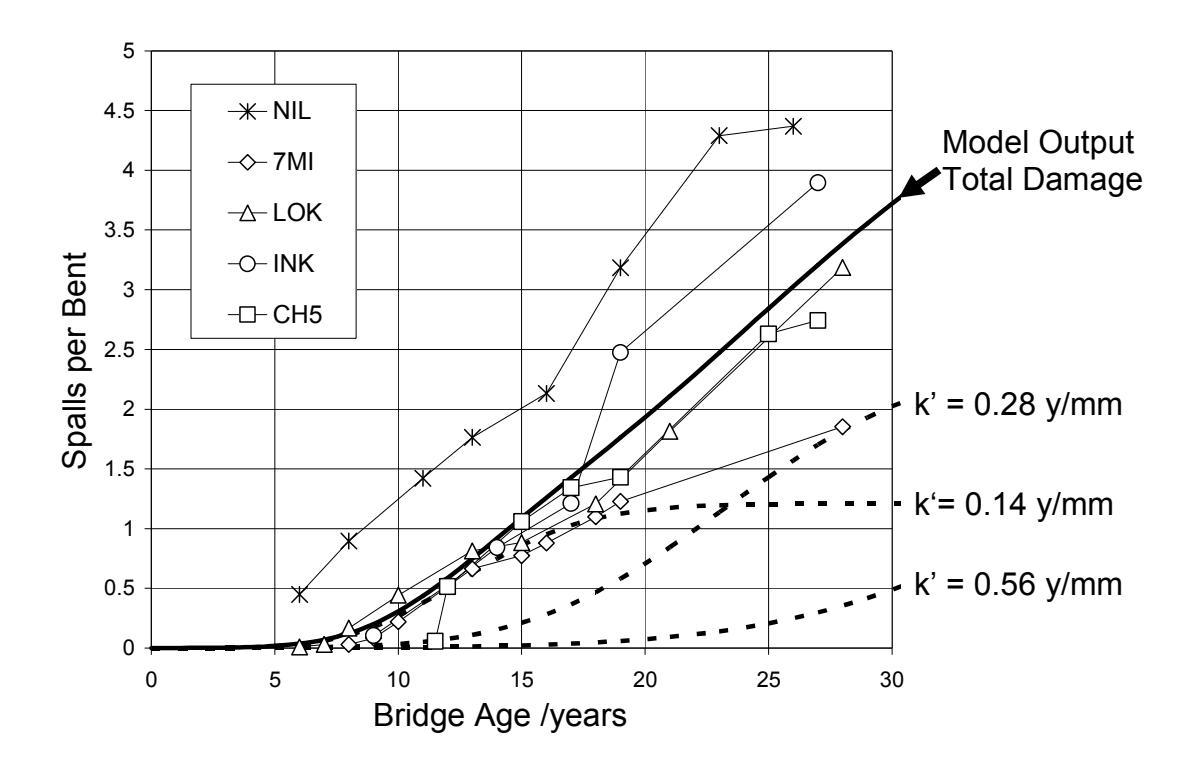
Figure 42. - Projected Damage Function for Group 1 Bridges. Thick bold line: total damage projection. Dashed lines: partial damage from each of the rebar assembly fractions considered: 2% of the rebar with k'=0.14 y/mm; 4% with k'=0.28 y/mm and 8% with k'=0.56 y/mm.

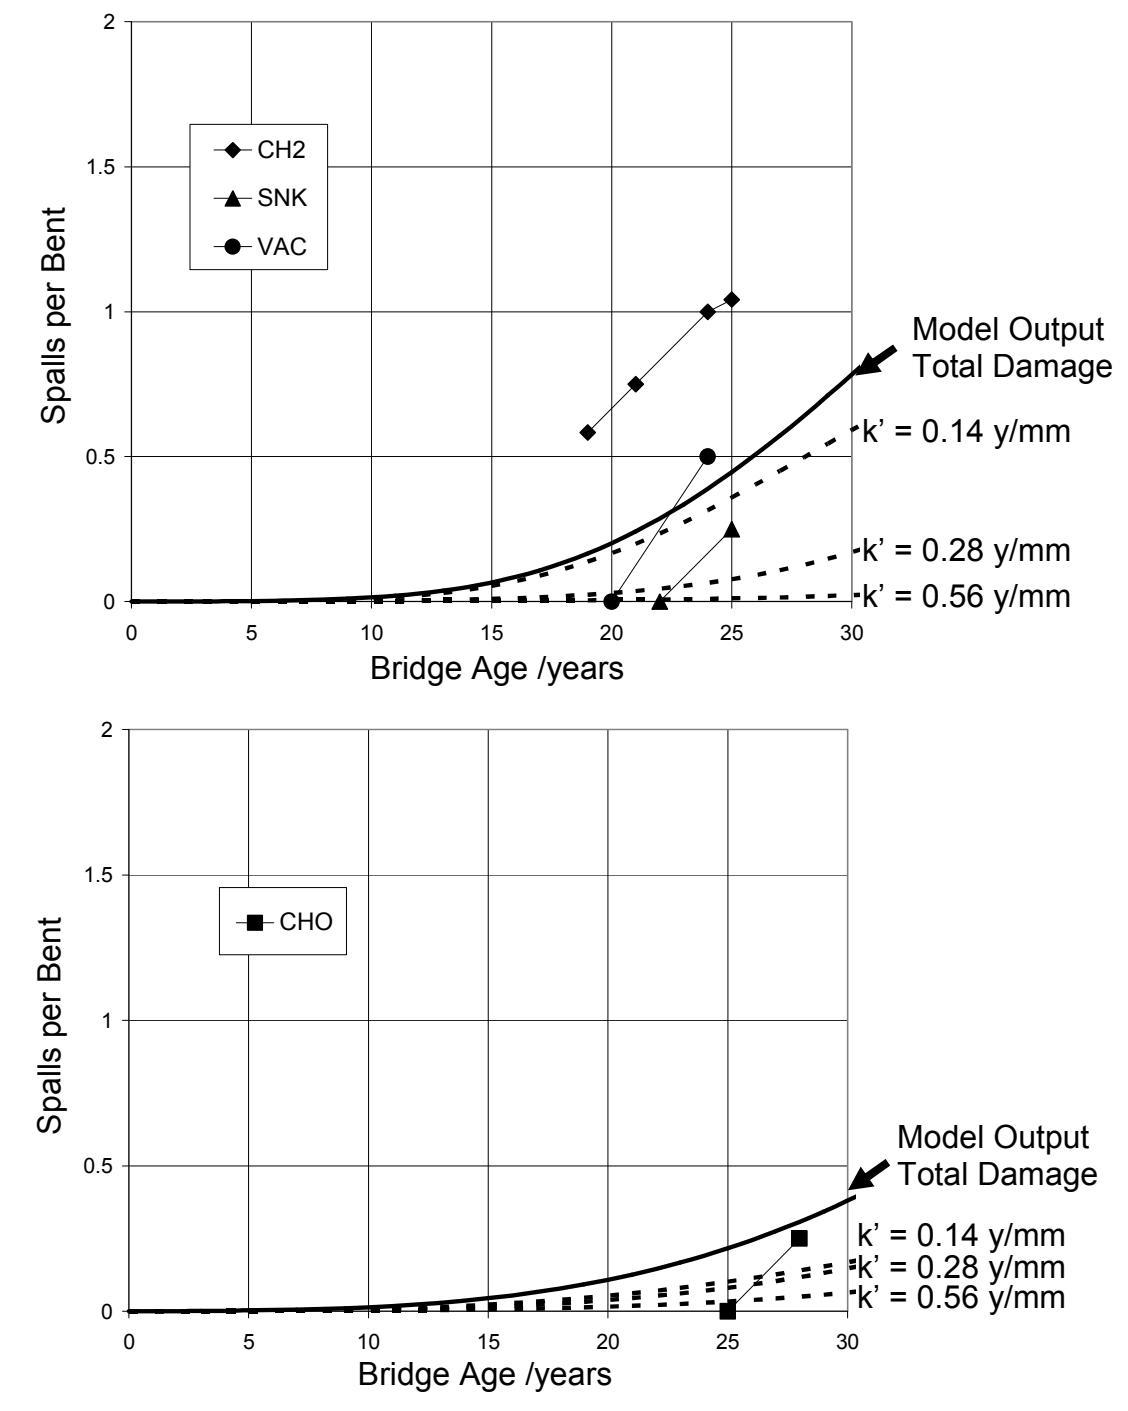
Figure 43. Projected Damage Function for Group 2 Bridges. Thick bold line: total damage projection. Dashed lines: partial damage from each of the rebar assembly fractions considered: 2% of the rebar with k'=0.14 y/mm; 4% with k'=0.28 y/mm and 8% with k'=0.56 y/mm.

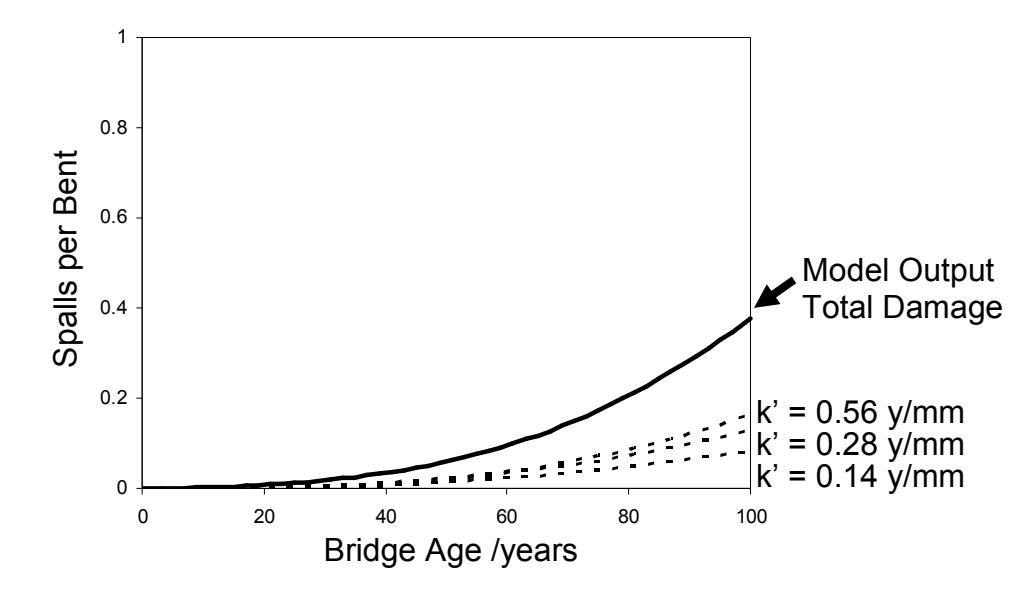
Figure 44. Projected Damage Function for Group 3 Bridges. Thick bold line: total damage projection. Dashed lines: partial damage from each of the rebar assembly fractions considered; 2% of the rebar with k'=0.14 y/mm; 4% with k'=0.28 y/mm and 8% with k'=0.56 y/mm.

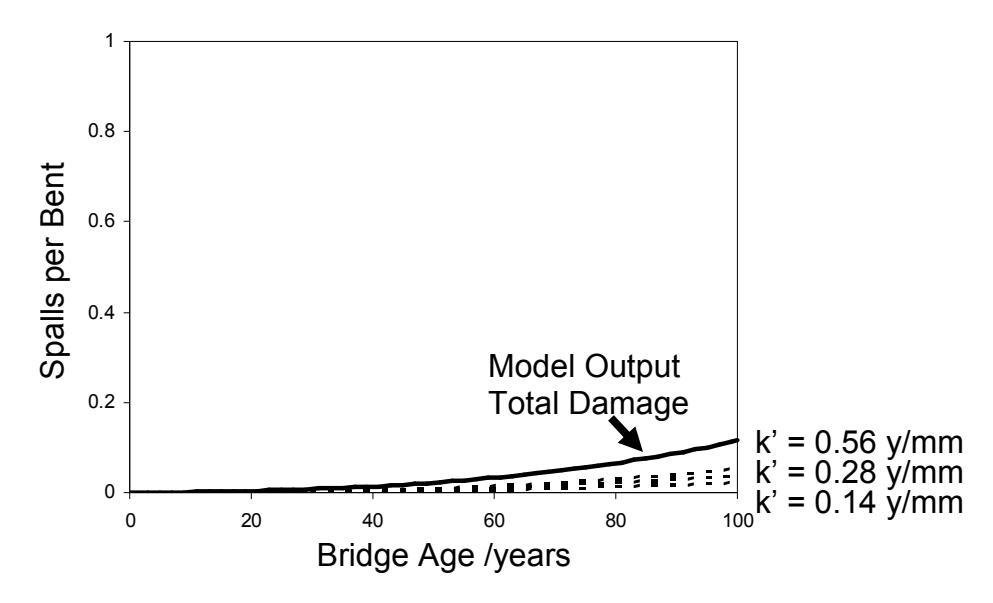
Figure 45. Projected Damage Function for Group 4 Bridges. Thick bold line: total damage projection. Dashed lines: partial damage from each of the rebar assembly fractions considered; 2% of the rebar with k'=0.14 y/mm; 4% with k'=0.28 y/mm and 8% with k'=0.56 y/mm.

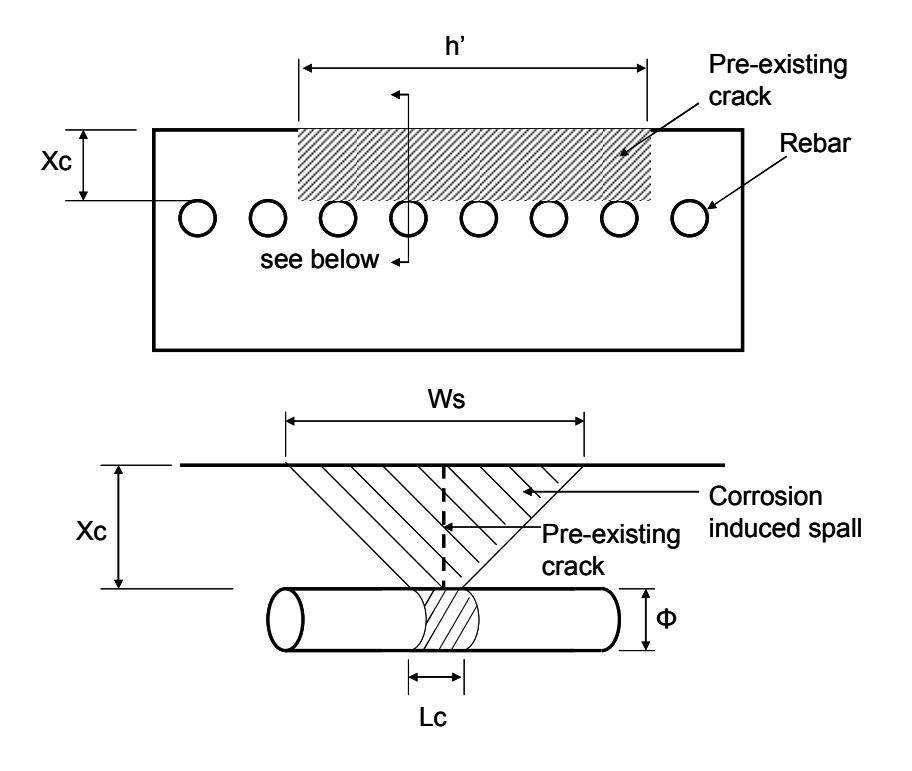
Figure 46. Schematic of Idealized Model Geometry.

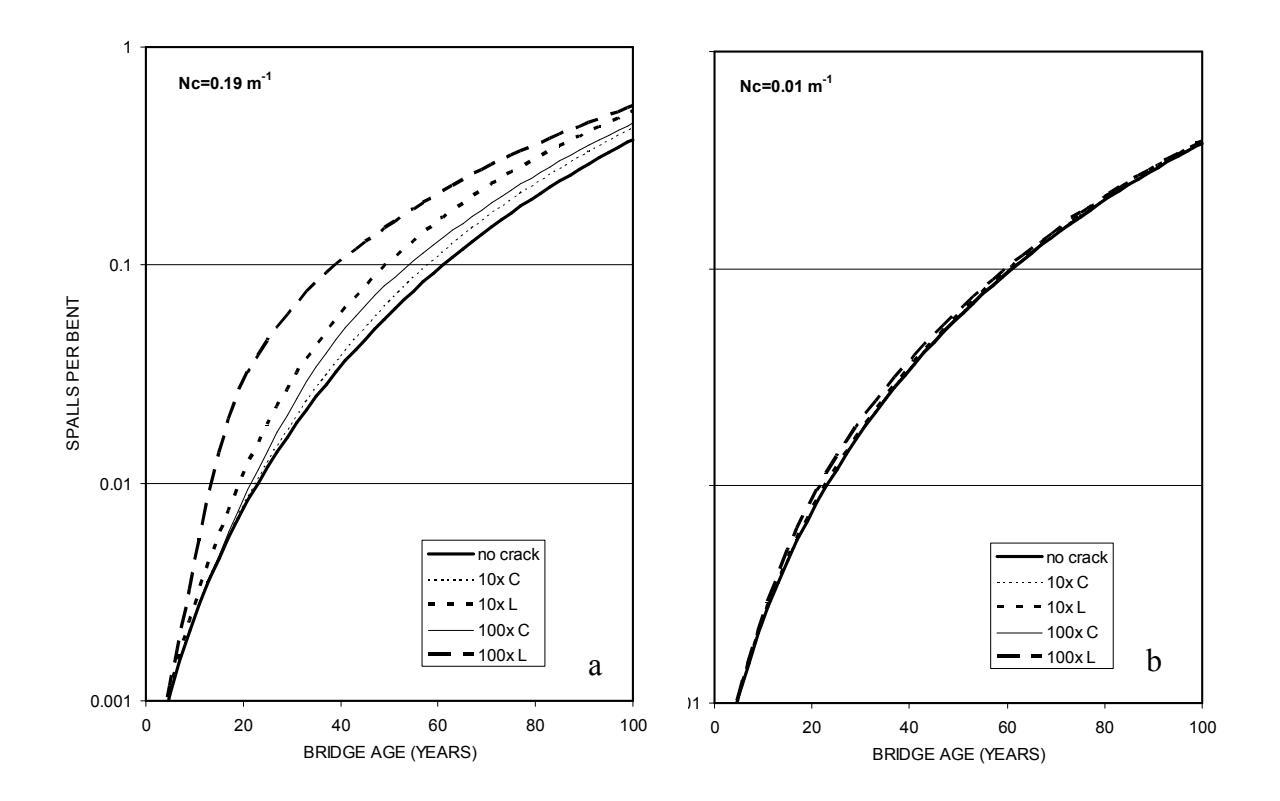
Figure 47. Model Projections for the a) High, Nc=0.19m⁻¹ and b) Low, Nc=0.01m⁻¹ Cracking Incidence Cases.
