The Impact of Septic Tank Systems on the Water Quality of Stream Reaches in the Oak Orchard Watershed

A Thesis

Presented to the Faculty of Environmental Science and Ecology
of the State University of New York College at Brockport
in Fulfillment for the
Degree of Master of Science

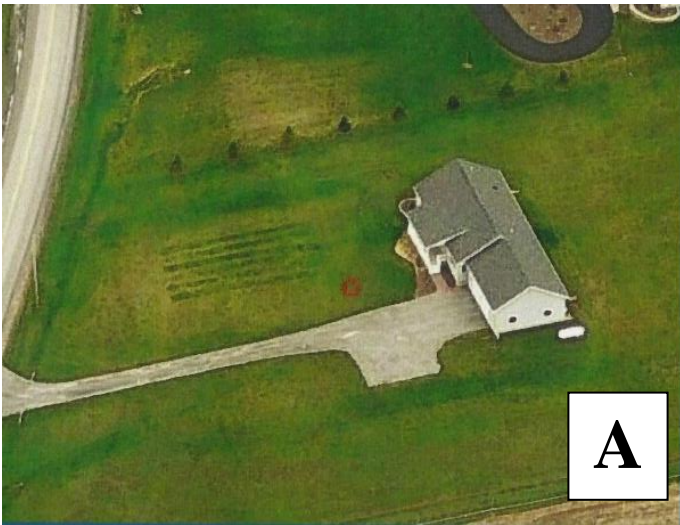
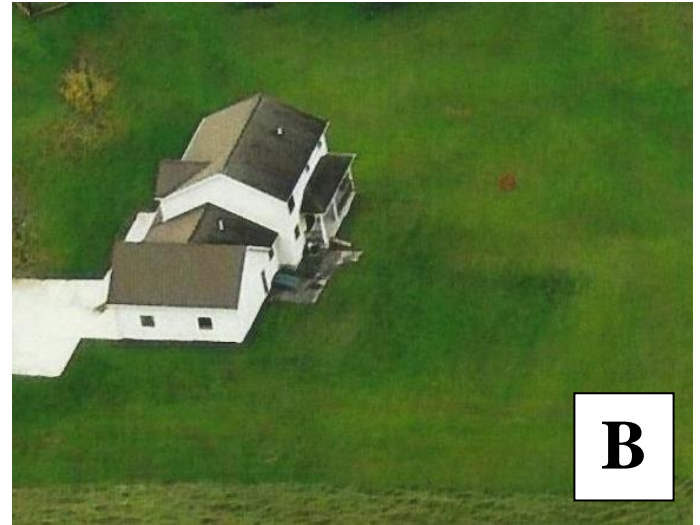
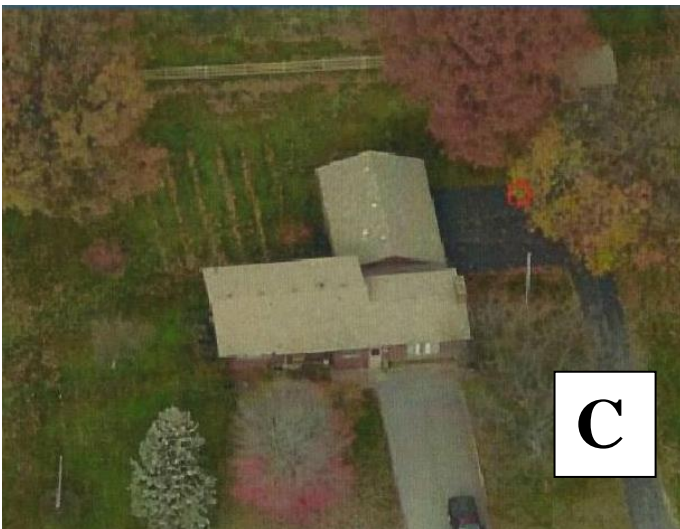
Figures 1A, 1B, and 1C. Images A and B show the darkening of grass where the septic field is. Image C shows the gathering of leaves over the septic field due to micro-relief.

Septic fields can be distinguished in aerial photography by 1) the hue of grass and 2) micro-relief. For example, Zhou et al. (2008) showed that color photography can be used to

identify differences in grass color due to fertilizer. Septic leachate can have the same effect on grass as fertilizer because leachate adds water and nutrients to the area around the leach field. Imagery taken in the late summer, especially after a period of no rainfall, should show a difference between the color of the grass over a leach field and the color of the grass everywhere else (Figures 1A & 1B). Furthermore, another way to identify septic fields through aerial photography is by observing the micro-relief over the septic field. Burial of septic tanks and pipes during installation will disturb the soil, causing a different micro-relief than that of the undisturbed soil. Often, the disturbed soil in the leach field will sink between the pipes in the leach field, forming small trenches. In fall imagery, this micro-relief can be observed by leaves gathering in the trenches between pipes (Figure 1C).

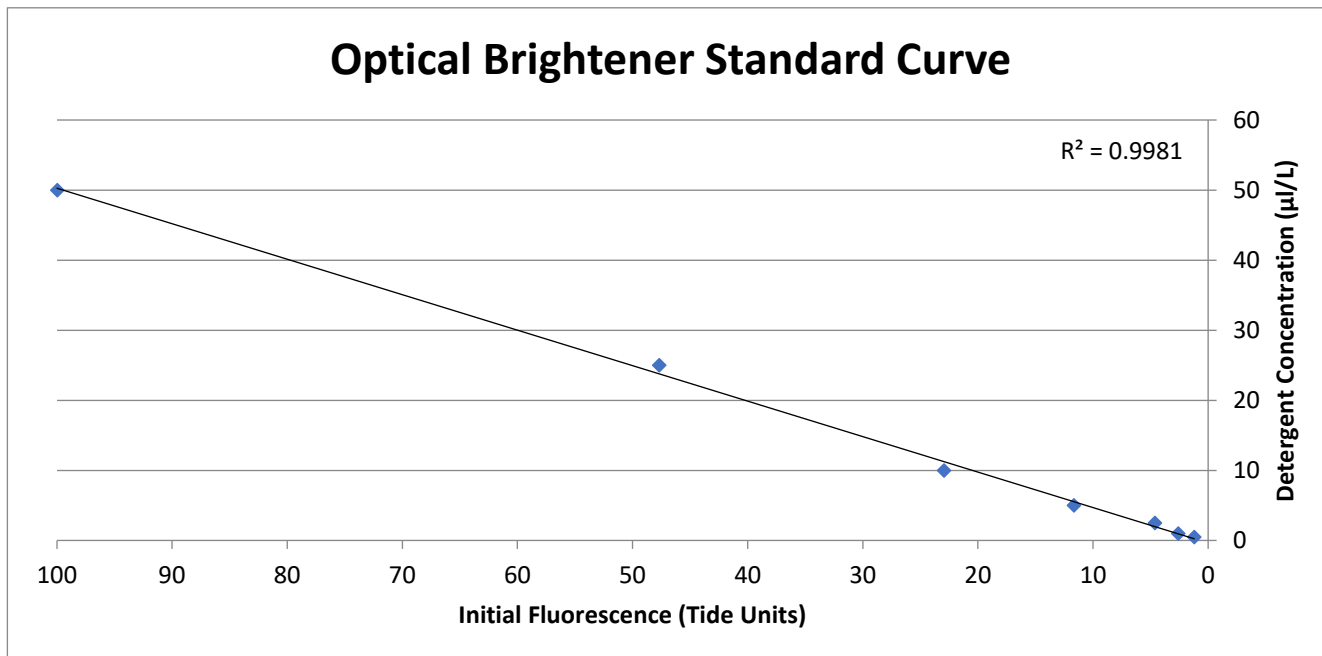
Figure 5. Initial fluorescence was measured for known concentrations of Tide 2X Original Scent detergent. From this graph, the amount of detergent in a water sample could be determined based on the initial fluorescence of a sample.

From the dilution curve created, it was determined that optical brighteners can still exist in a sample with an initial fluorescence value less than 10 (Table 3). As the standard was diluted, the ratio, which indicated the presence of optical brighteners (<1.5), remained constant while the initial fluorescence decreased. At initial fluorescence less than 10, the ratio still remained constant. Thus, a low initial fluorescence value that results in a ratio less than 1.5 can be considered positive for optical brighteners.

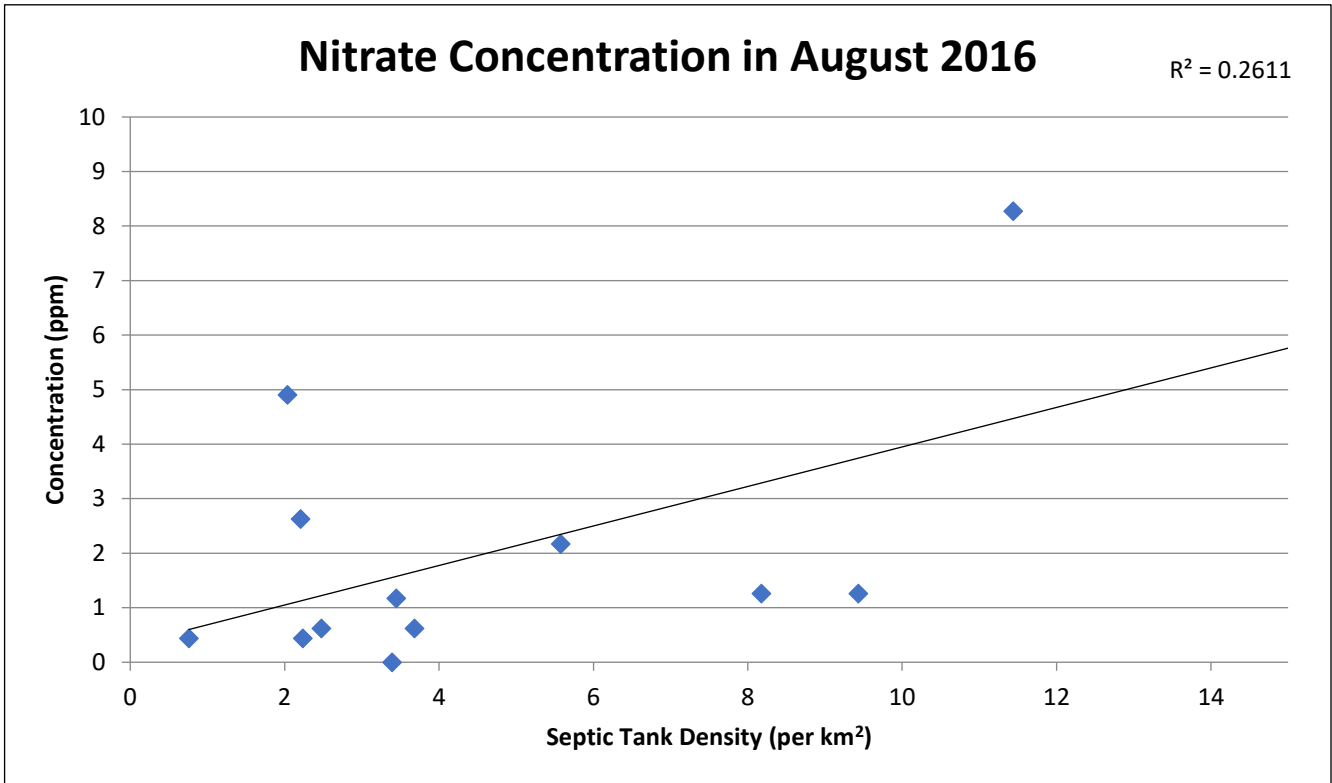
Figure 6. Nitrate concentrations were compared against the density of septic tanks within the watershed basin of the sample point. The R^2 is 26.1% and the p-value is 0.09.

A regressional relationship between septic field density and nitrate concentration shows a weak relationship between the two factors ($r\text{-sq}=26.1\%$) (Figure 6). The p-value is 0.09 meaning that 91% of the time the septic field density will predict the nitrate concentration. A regressional relationship between the number of septic fields within 200m of the sample site and nitrate concentration for August suggests that the amount of fields within 200m of the sample site do not predict the nitrate concentration ($r\text{-sq} = 12.5\%$) (Figure7). The p-value is 0.26 meaning that 74% of the time the number of fields within 200m will predict the nitrate concentration. Thus, the septic field density within the subbasin is a better predictor of nitrate concentration.

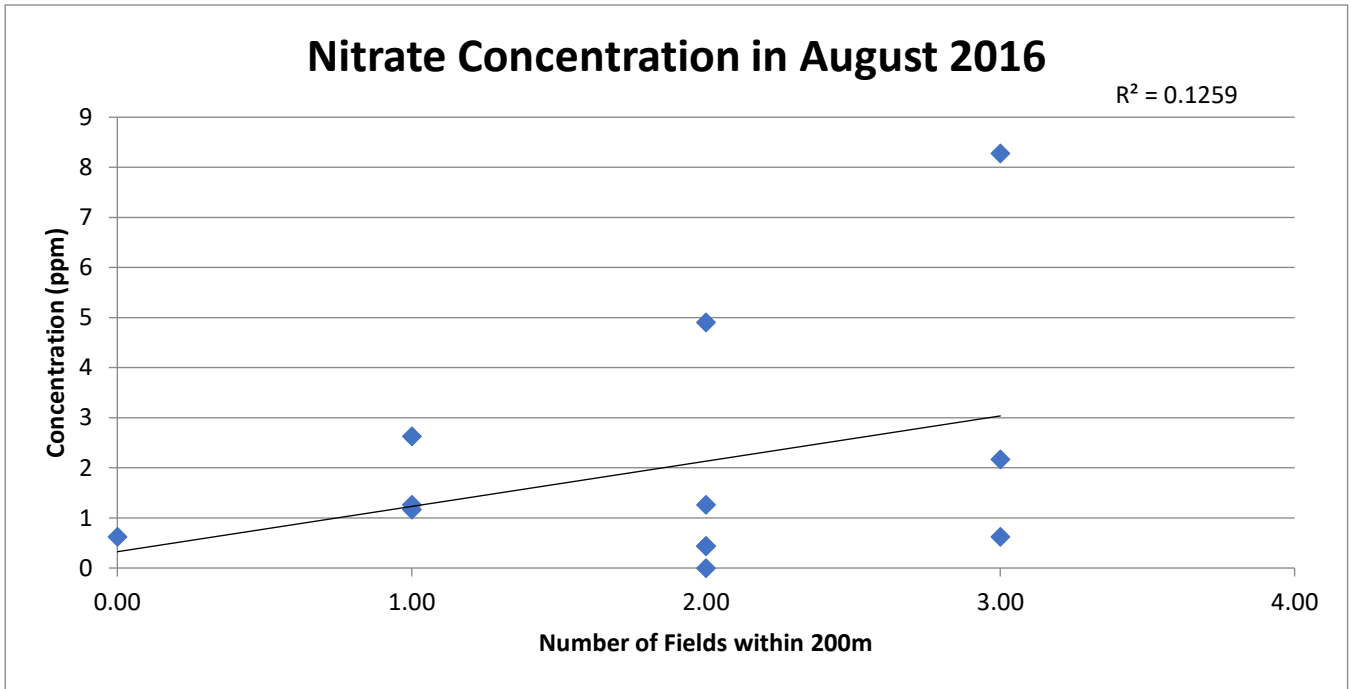
Figure 7. Number of septic fields within 200m of the sample site were compared to the concentration of nitrate in each sample site. The R^2 is 12.5% and the p-value is 0.26.

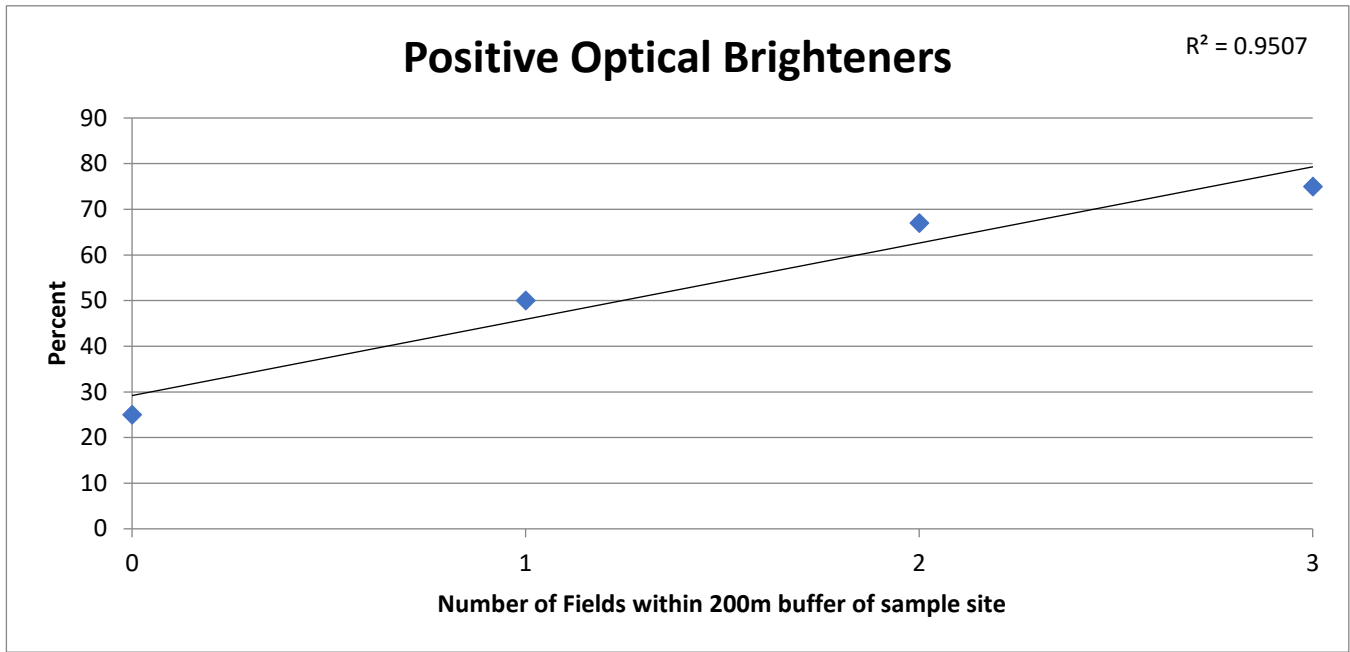
Figure 8. Number of septic fields within 200m of the sample site were compared to the percentage of samples that were positive for optical brighteners. The R^2 is 95% and the p-value is 0.02.

Optical brightener statistics consisting of either a “yes” or “no” for each sample site were used to assess the presence of OBs. The number of sites within 200m was compared to the percentage of yes’s and no’s. For sites with no septic fields within 200m of the sample site, 25% of the samples were positive for optical brighteners (Figure 8). For sites with one septic field

within 200m of the sample site, 50% of the samples were positive for optical brighteners. For sites with two septic fields within 200m of the sample site, 67% of the samples were positive for optical brighteners. For sites with three septic fields within 200m of the sample site, 75% of the samples were positive for optical brighteners. A regression analysis of this data had an r-sq of 95% and a p-value of 0.02. This means that as the number of septic fields close to a stream segment increase, more samples are going to contain optical brighteners. Thus, there is a relationship between number of fields close to streams and the chance of leachate pollution.

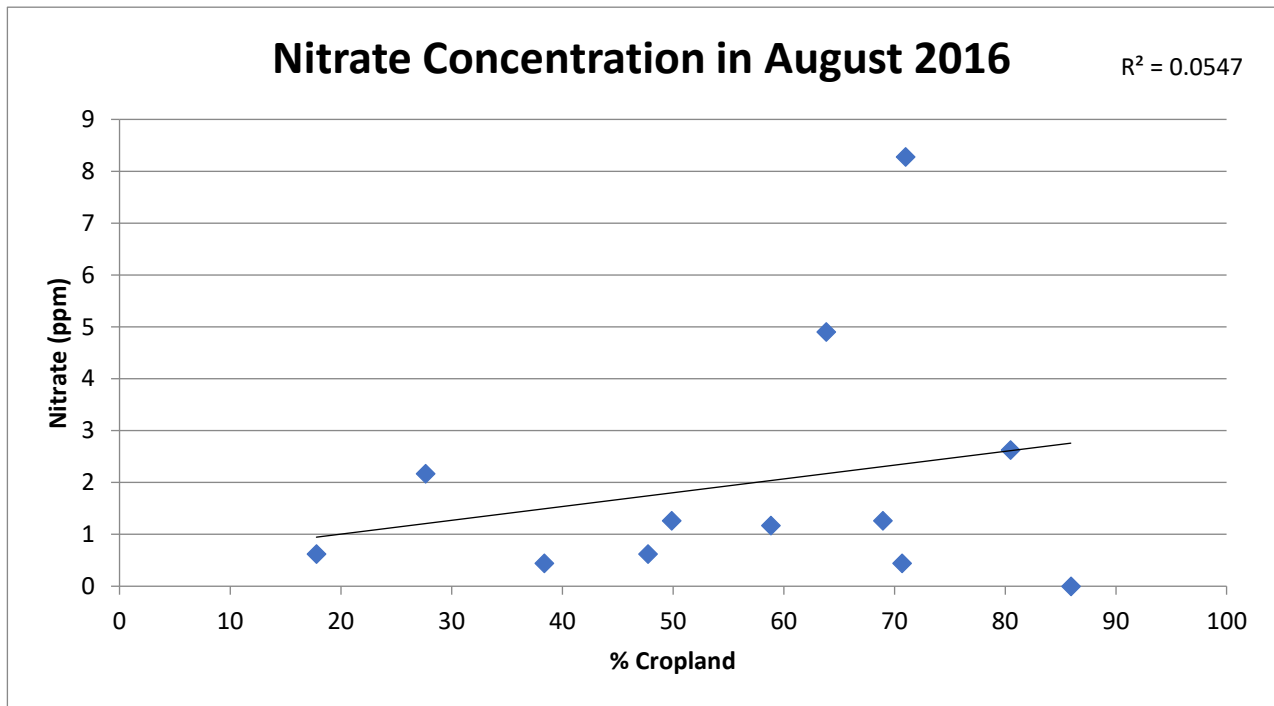
Figure 9. Nitrate concentrations were compared against the percentage of cropland within the watershed basin of the sample point. The R^2 is 5.4% and the p-value is 0.46. The weak relationship suggests that the amount of nitrate from agriculture is not the main contributor of nitrate to the surface water.

In contrast to septic field statistics, relationships between nitrate and percentage of cropland were not as well-defined. The regression analysis of percent cropland and nitrate concentration did not yield a strong relationship (r-sq = 5.5%) (Figure 9). The slope had a p-value of 0.46. Since septic field density had a stronger relationship to nitrate concentration, septic fields have a greater influence than cropland on nitrate concentrations found in the streams of the watershed.
