# Two integral girder connections for precast concrete bridges in seismic regions utilizing extended prestressing strands

**Two integral girder connections for precast concrete bridges in seismic regions  
utilizing extended prestressing strands**

Major: Civil, Construction and Environmental Engineering (Structural Engineering)

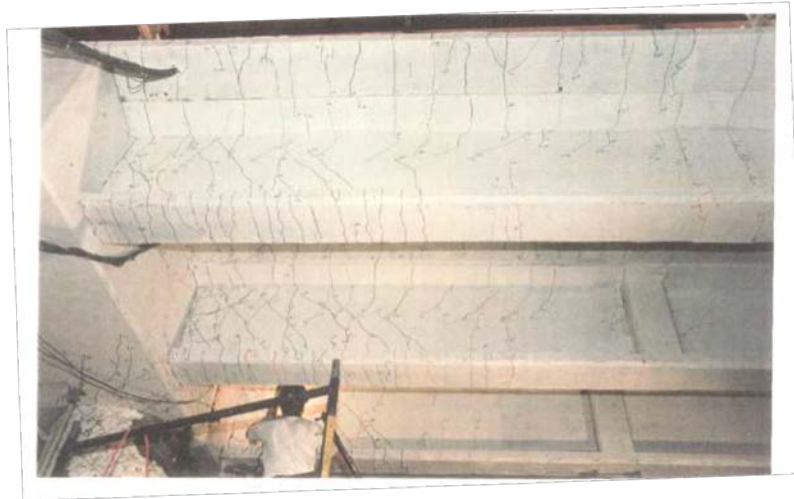
Figure 2.9: Bulb-tee test unit (Holombo, 1999)

In the horizontal displacement cycles, both the bathtub and bulb-tee units were able to reach a higher displacement ductility than the design ductility of  $\mu_{\Delta}=4$ . The bulb-tee reached a ductility of  $\mu_{\Delta}=8$  while the bathtub unit reached a ductility of  $\mu_{\Delta}=6$ . Only minor cracking was observed at the girder to cap interface and many of the cracks closed after the testing loads were removed. When the actuators were moved to the vertical position and the capacity of the superstructure was tested, the bulb-tee reached the actuator displacement limits of  $\mu_{\Delta}=2.5$  and  $\mu_{\Delta}=1.5$  in the push and pull directions without spalling any concrete around the section (Figure 2.9). The maximum positive

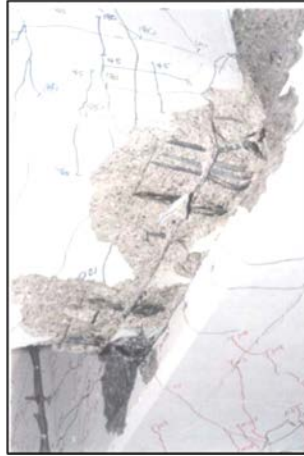
Figure 2.11: Spalling of bathtub girder at cap interface (Holombo, 1999)

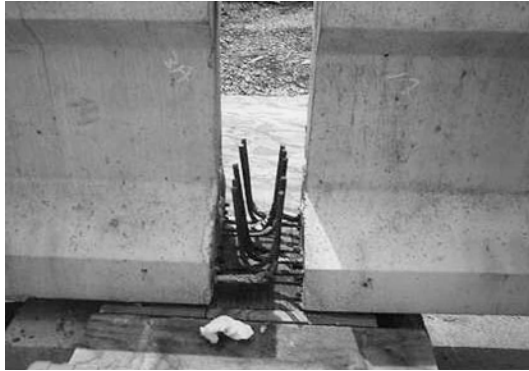
**Figure 2.27: Bent reinforcing bar connection (NCHRP, 2004)**

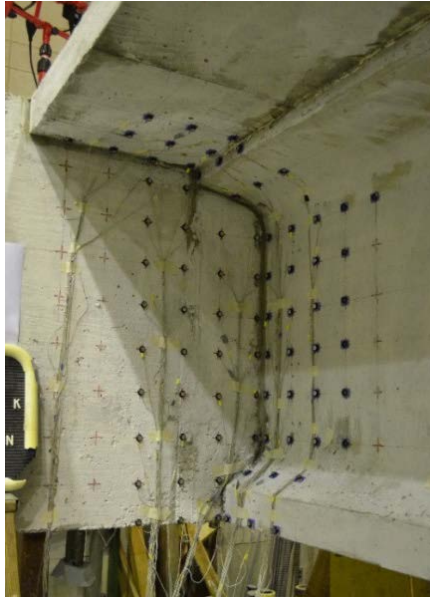
**Figure 3.34: LED configuration at connection region**

camera recorded the movement of the LED's which would allow surface displacements and cracking to be measured.

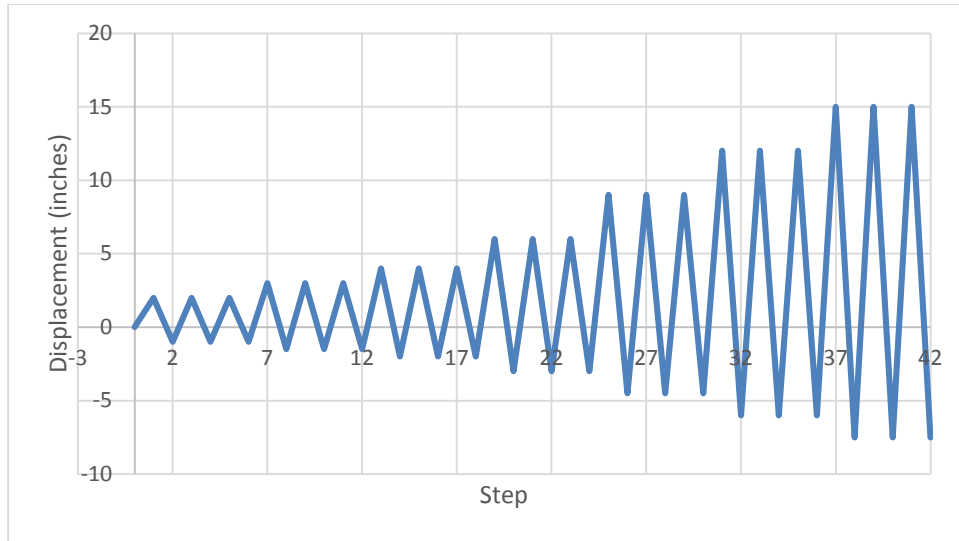
**Figure 3.44: Displacement control loading protocol**

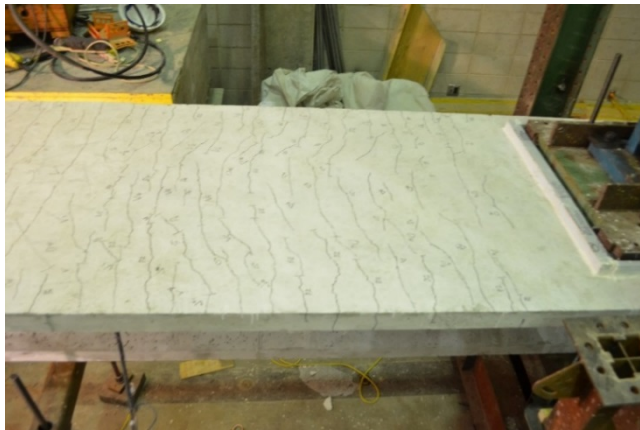
**Figure 4.7: Extended deck cracking**

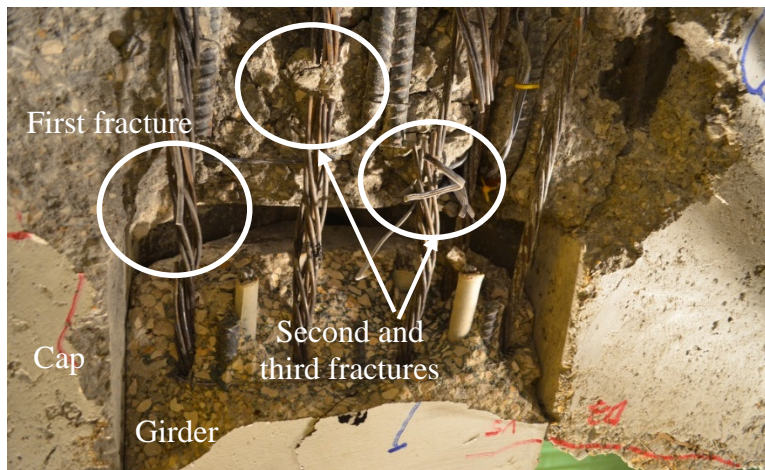
**Figure 4.10: Fractured extended strands**

testing was terminated since full capacity of the connection was reached. Figure 4-10 and Figure 4-11 show the final condition of the connection.

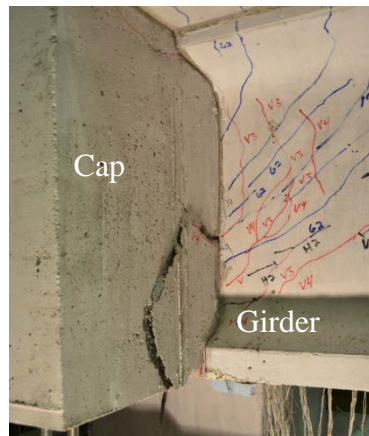
**Figure 4.16: Spalling of cap cover concrete**

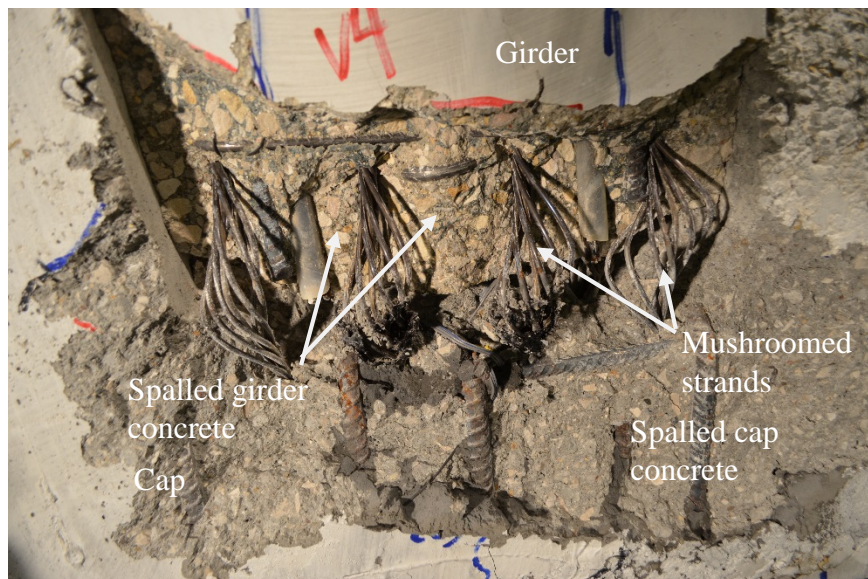
**Figure 4.19: Spalling of concrete and mushrooming of strands**

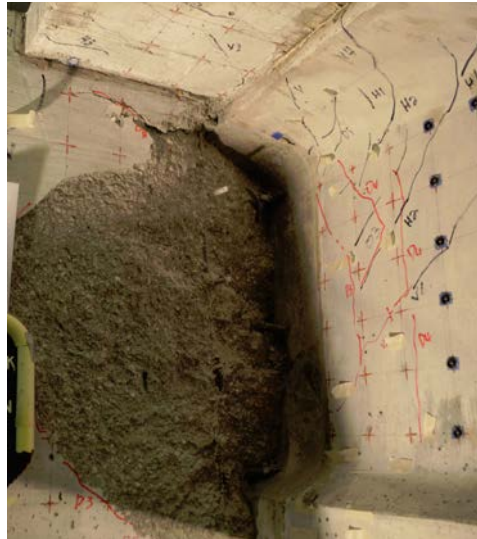
Figure 4.25: Spalling of cap cover concrete adjacent to girder

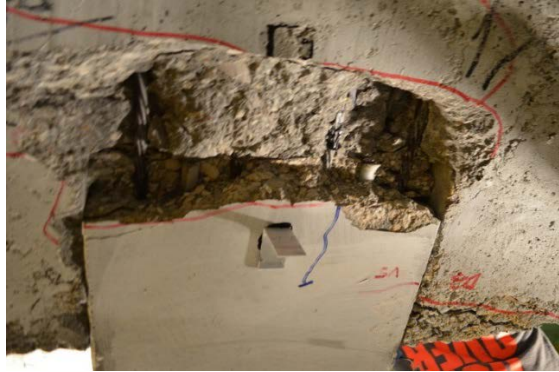
**Figure 4.28: Spalling at bottom of girder to cap interface**

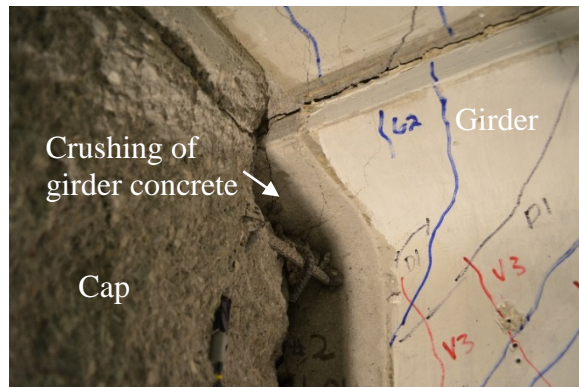
**Figure 4.31: Crushing of girder concrete**
