Assessment of embankment construction QC/QA procedures in Iowa

A thesis submitted to the graduate faculty
in partial fulfillment of the requirements for the degree of
MASTER OF SCIENCE

Major: Civil Engineering (Geotechnical Engineering)

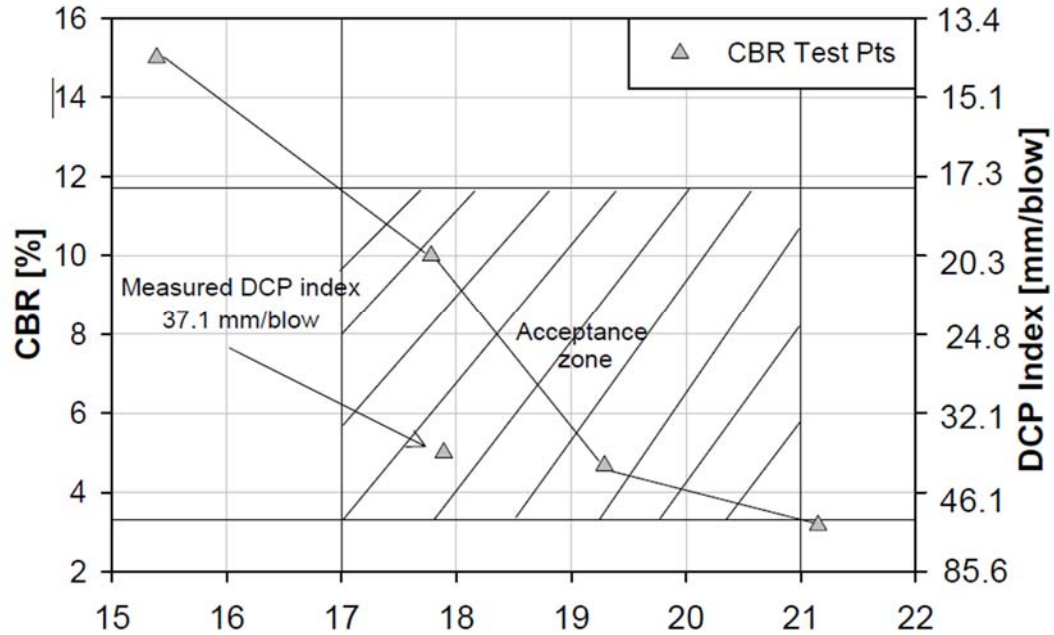
The results from Phase IV report shows the data collected from the field indicate DCP index control limits could be set more tightly. ISU developed an acceptable zone of DCP index values (Figure 3) which later was determined using the CBR-DCP index correlation for "all other soils," equation 3, in ASTM D 6951-03 for the moisture control limits specified by the QM-E. Use proposed CBR technique for the creation of soil specific DCP target values can addresses some of the shortcomings of using blanket control limits for broad ranges of soils classifications.

Figure 3. CBR testing results for unsuitable soil sample

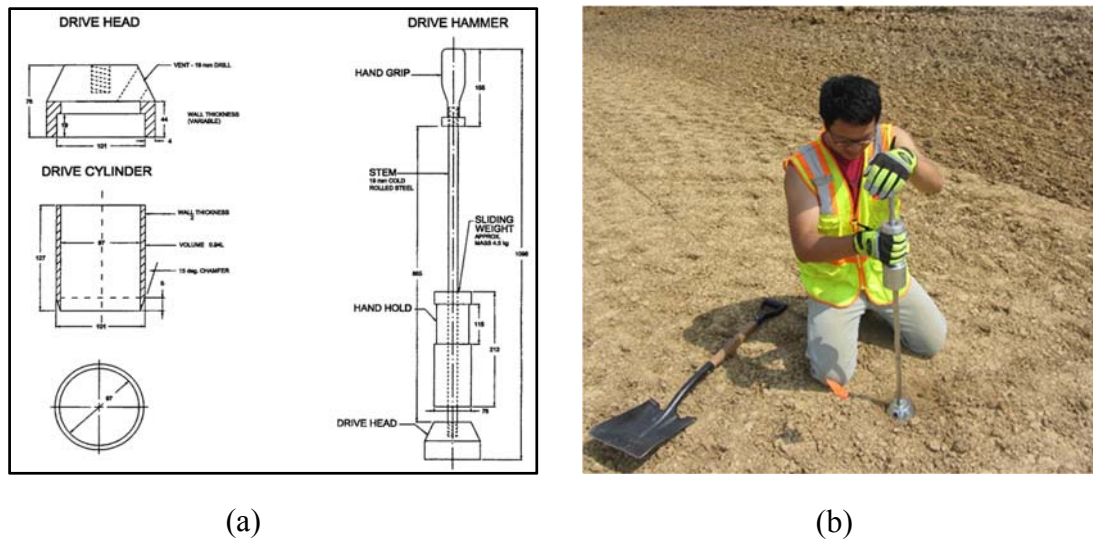
ASTM D2937-10 (ASTM 2010) drive cylinder test method was used to determine in situ moisture and dry density. Thin wall 4 in. diameter cylinder with a driving head were driven into the soil to obtain relatively undisturbed samples. The cylinders were then carefully excavated from the soil, sealed in a plastic bag, and placed in a humid cooler and transported back to the laboratory. The samples were processed in the laboratory to determine unit weight and moisture.

Figure 11. (a) Schematic of drive cylinder test (ASTM 2010) and (b) picture of drive cylinder test in situ

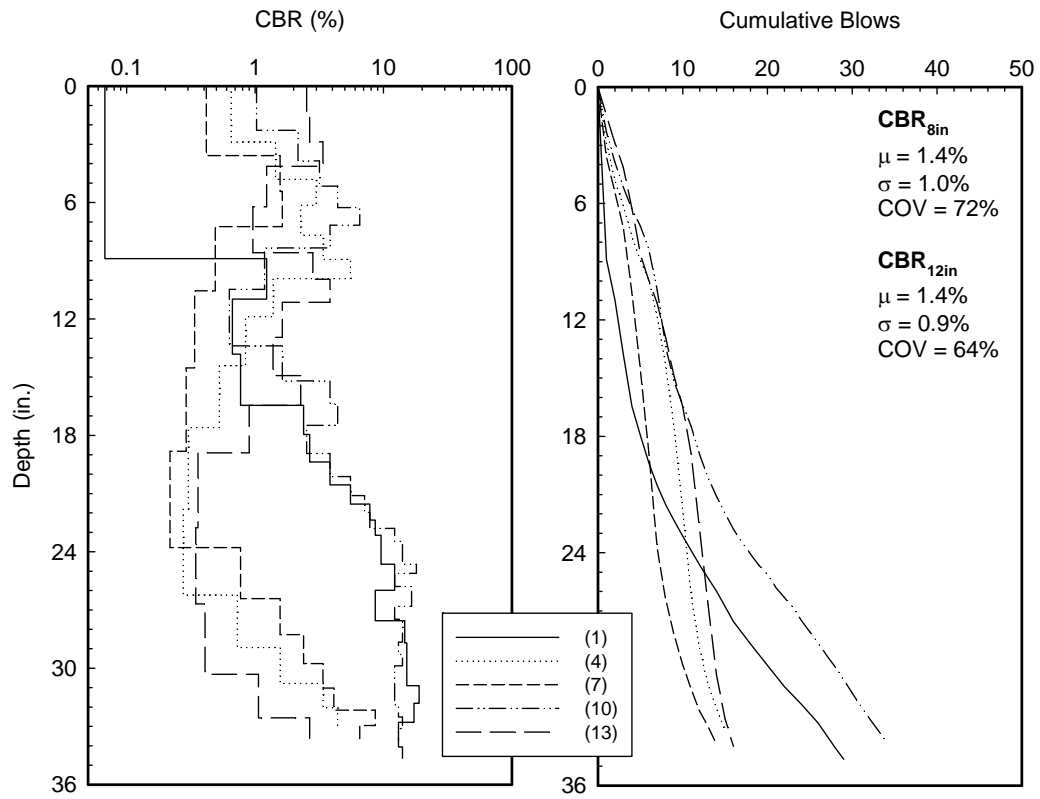
Figure 37. DCP-CBR profile at Polk County Project TB1

very low CBR values even when the depth goes deeper, that indicate this test bed have poor quality (Figure 37).

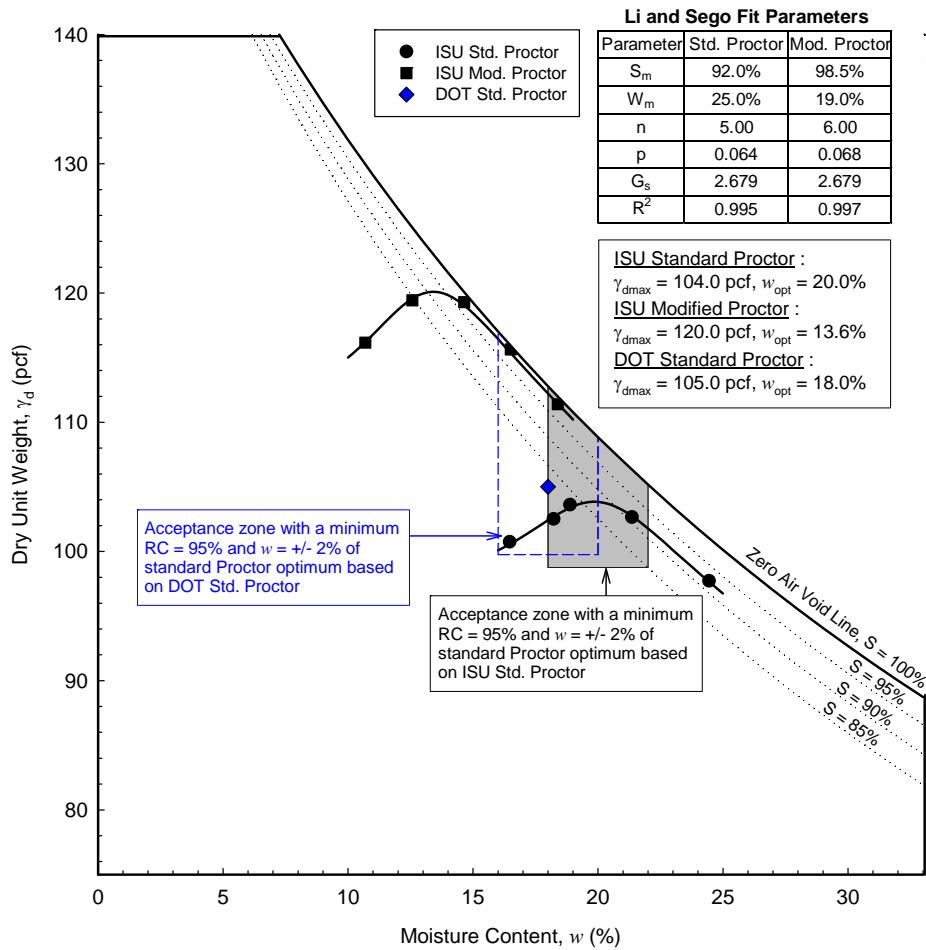
Figure 38. Comparison of in situ moisture-density measurements with laboratory Proctor compaction test results and Iowa DOT acceptance limits for Polk County Project TB2

TB2 does not have in situ drive core data (Figure 38).

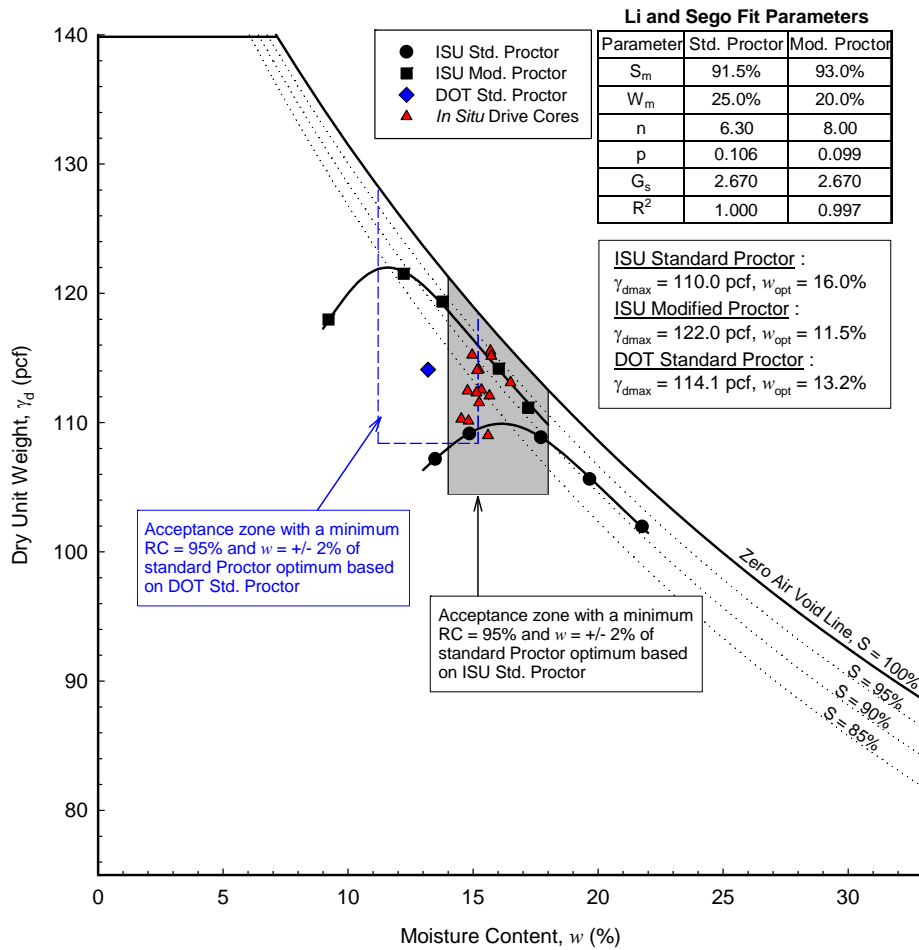
Figure 39. Comparison of in situ moisture-density measurements with laboratory Proctor compaction test results and Iowa DOT acceptance limits for Polk County Project TB3

Based on 15 drive core tests performed from TB3, all 15 fell in the acceptance zone identified from ISU Proctor testing. The moisture content of the material in situ varied from - 1.5% to +0.5% of w_{opt} , with an average of about -0.7% from all test points. The dry unit weight of the material varied from 99.1% to 105.1% of standard Proctor γ_{dmax} , with an average of about 103% from all test points (Figure 39).

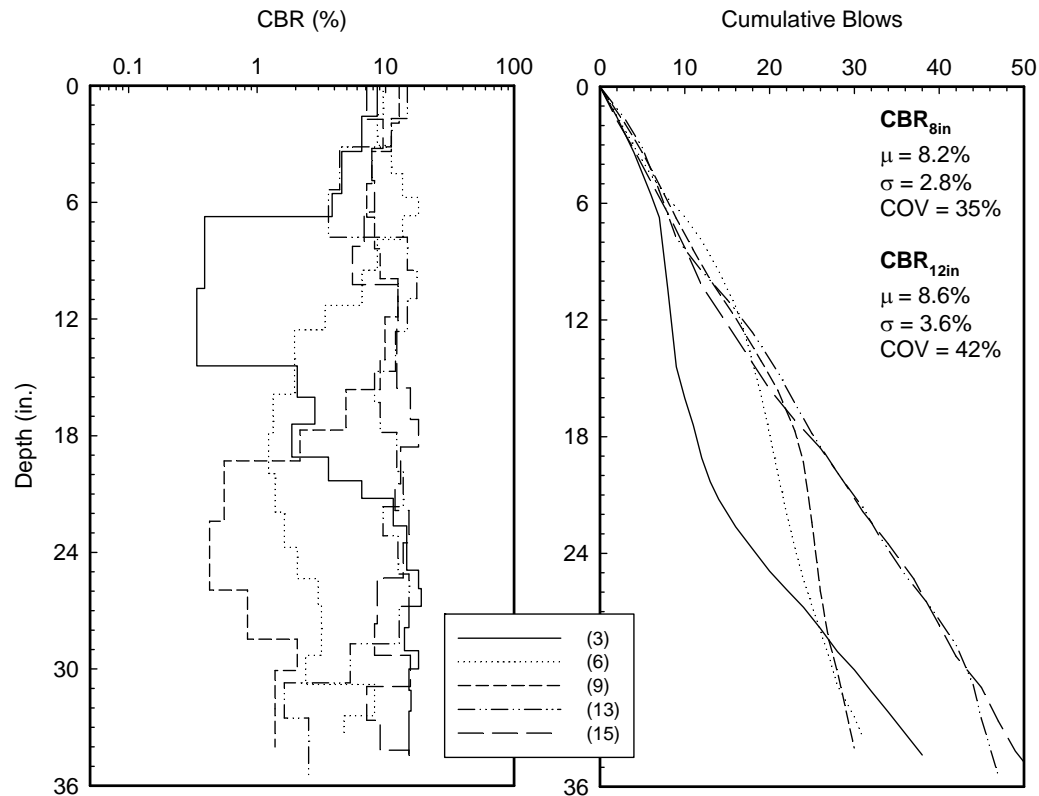
Figure 40. DCP-CBR profile at Polk County Project TB3

The results from TB3 showed an average DCP-CBR of 8.2 in top 8 in. and 8.6 in top 12 in, which is considered as poor according to SUDAS. Point 3 have a very low CBR from 7 to 14 inch, and point 9 have a very low CBR from 19 to 29 inch which is an indication of “uncompacted” fill or the oreo-cookie effect (Figure 40).

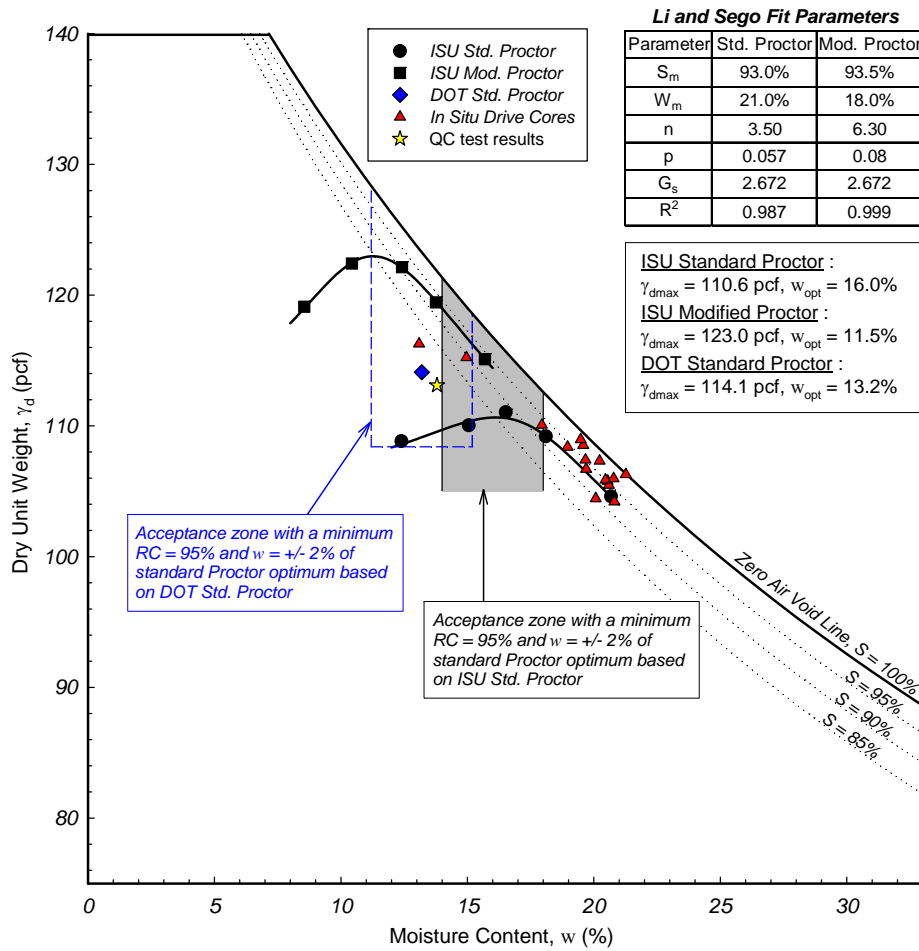
Figure 41. Comparison of in situ moisture-density measurements with laboratory Proctor compaction test results and Iowa DOT acceptance limits for Polk County Project TB4

Based on 15 drive core tests performed from TB4, only 2 fell in the acceptance zone identified from ISU Proctor testing. The moisture content of the material in situ varied from - 3.4% to +4.8% of w_{opt} , with an average of about +3.0% from all test points. The dry unit weight of the material varied from 94.2% to 105.1% of standard Proctor γ_{dmax} , with an average of about 96.8% from all test points. The QC test results which marked as a yellow star are qualified for Iowa DOT standard. (Figure 41Figure 39).

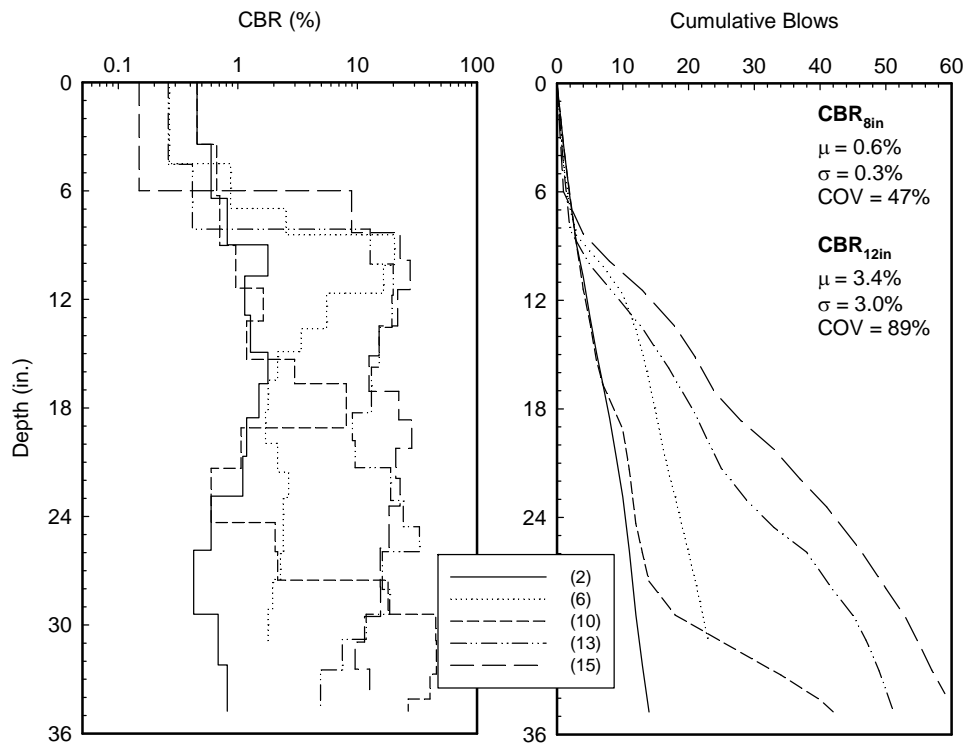
Figure 42. DCP-CBR profile at Polk County Project TB4

The results from TB4 showed an average DCP-CBR of 0.6 in top 8 in. and 3.4 in top 12 in, which is considered as poor according to SUDAS . Point 2 and top 5 inch of all points have very low CBR value which is an indication of “uncompacted” fill effect, the CBR value of point 6 and 10 varies a lot which indicate the compaction is poor and not uniform (Figure 42).

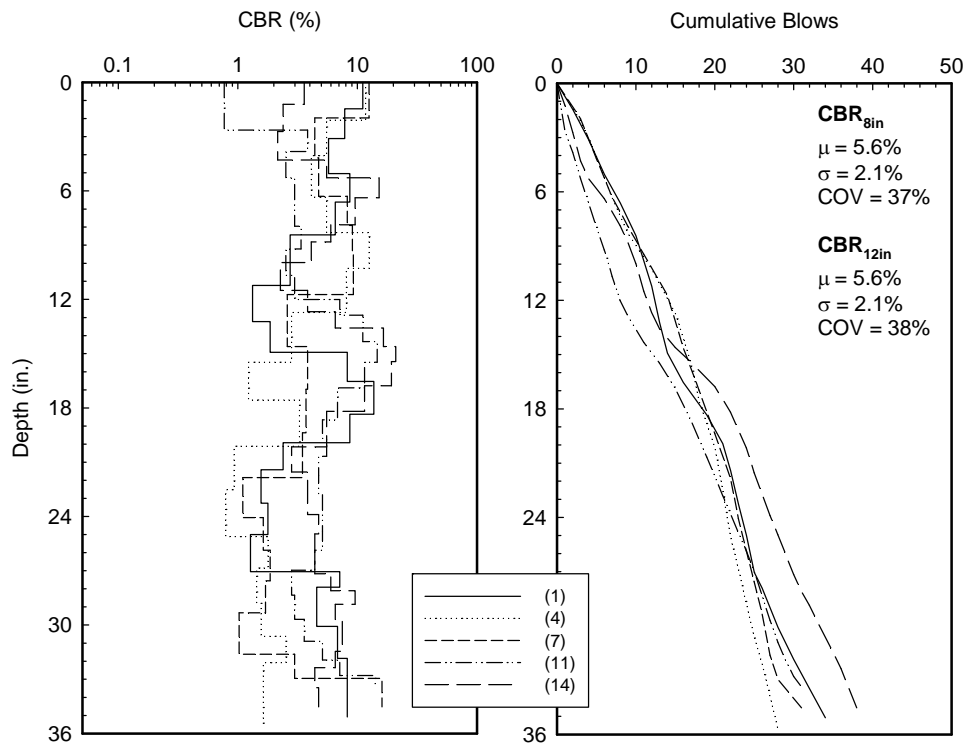
Figure 47. DCP-CBR profile at Warren County Project TB1

The results from TB1 showed an average DCP-CBR of about 5.6 in the top 8 in. and 12 in, which is considered as poor according to SUDAS. The CBR value does not varies a lot for each point, which indicate the compaction is relatively uniform (Figure 47).

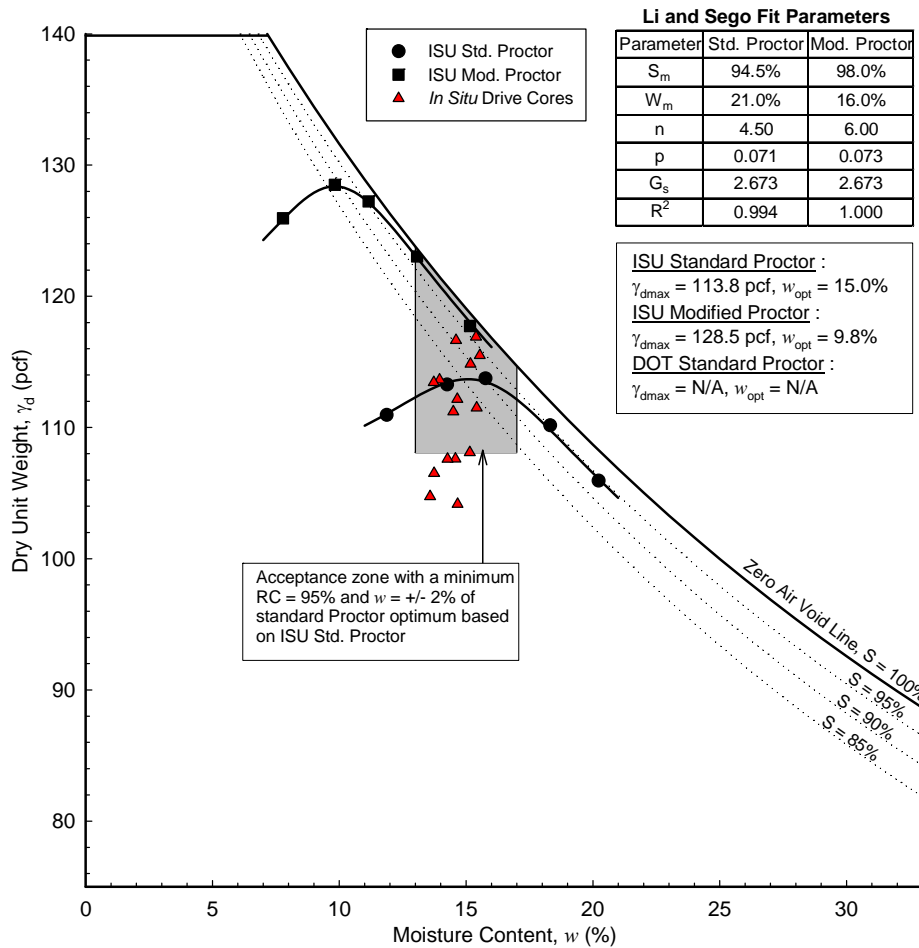
Figure 48. Comparison of in situ moisture-density measurements with laboratory Proctor compaction test results and Iowa DOT acceptance limits for Warren County Project TB2 (N/A: not available)

Based on 15 drive core tests performed from TB2, 9 fell in the acceptance zone identified from ISU Proctor testing. The moisture content of the material in situ varied from -1.4% to +0.5% of w_{opt} , with an average of about -0.4% from all test points. The dry unit weight of the material varied from 91.5% to 102.7% of standard Proctor γ_{dmax} , with an average of about 97.5% from all test points (Figure 48).

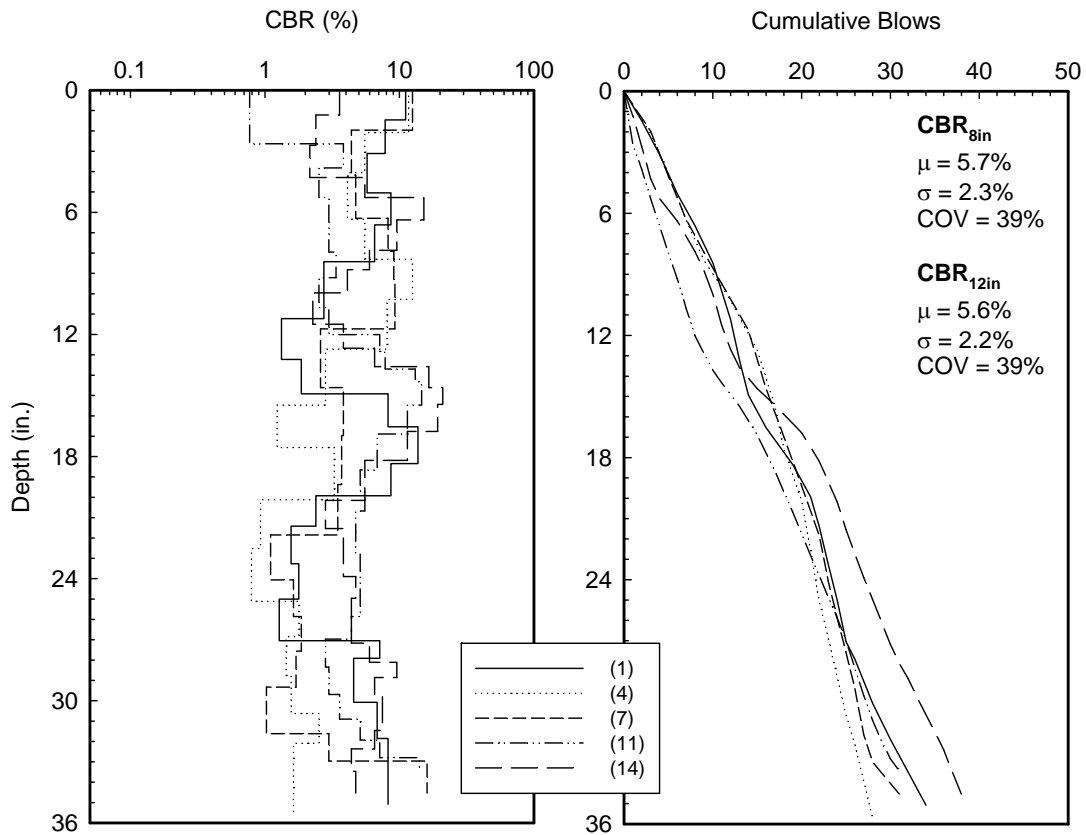
Figure 49. DCP-CBR profile at Warren County Project TB2

The results from TB2 showed an average DCP-CBR of 5.7 in top 8 in. and 5.6 in top 12 in, which is considered as poor according to SUDAS. Point 1, 4, and 7 have a low CBR below 20 in. deep, which is an indication of “uncompacted” fill or the oreo-cookie effect (Figure 49).

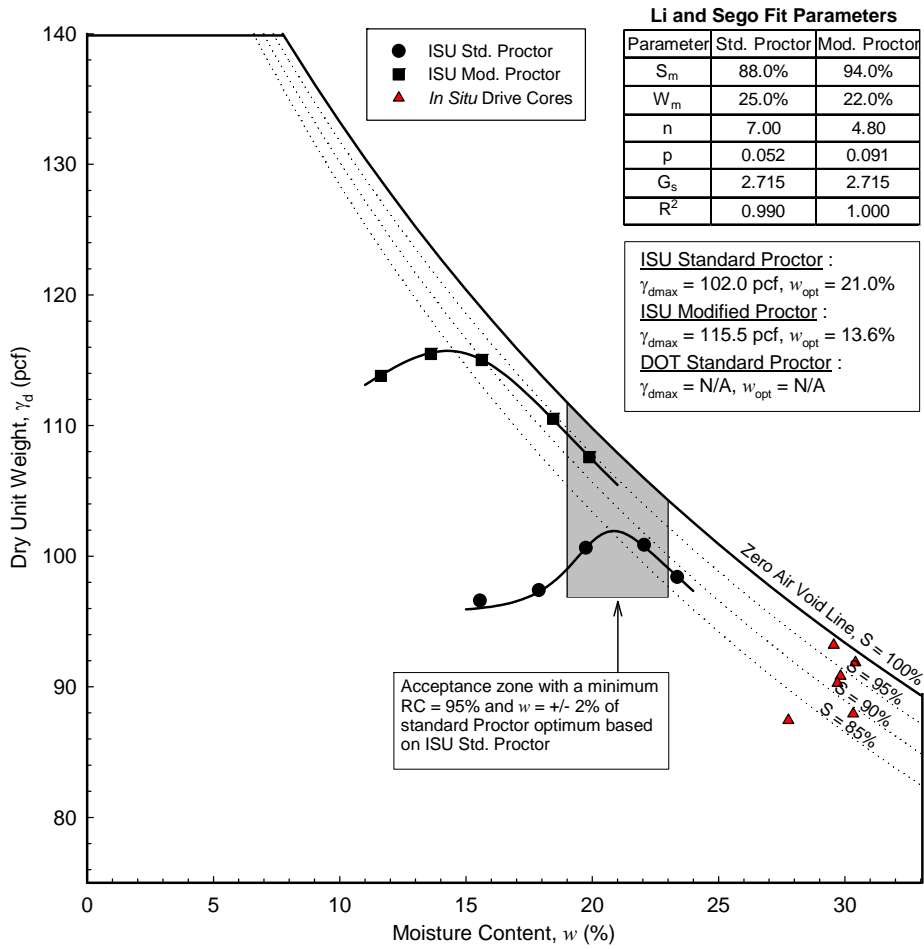
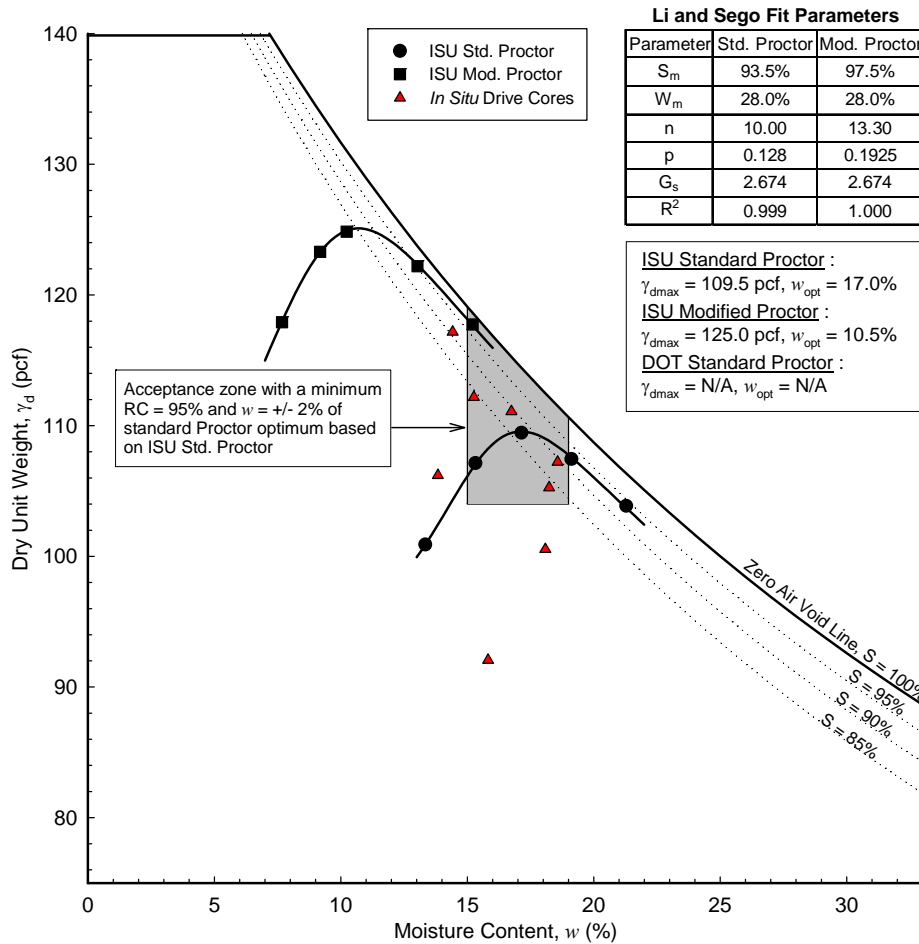
Based on 15 drive core tests, 4 out of 8 drive core results fell in the acceptance zone identified from ISU Proctor testing for brown clay. 0 out of 7 fell in the acceptance zone identified from ISU Proctor testing for grey clay. The moisture content of the material in situ varied from -3.2% to +9.4% of w_{opt} , with an average of about +3.3% from all test points. The dry unit weight of the material varied from 84.1% to 107.0% of standard Proctor γ_{dmax} , with an average of about 93.6% from all test points (Figure 50 and Figure 51).

Figure 50. Comparison of in situ moisture-density measurements with laboratory Proctor compaction test results and Iowa DOT acceptance limits for Warren County Project TB3 (Grey soil) (N/A: not available)

Figure 51. Comparison of in situ moisture-density measurements with laboratory Proctor compaction test results and Iowa DOT acceptance limits for Warren County Project TB3 (Brown soil) (N/A: not available)

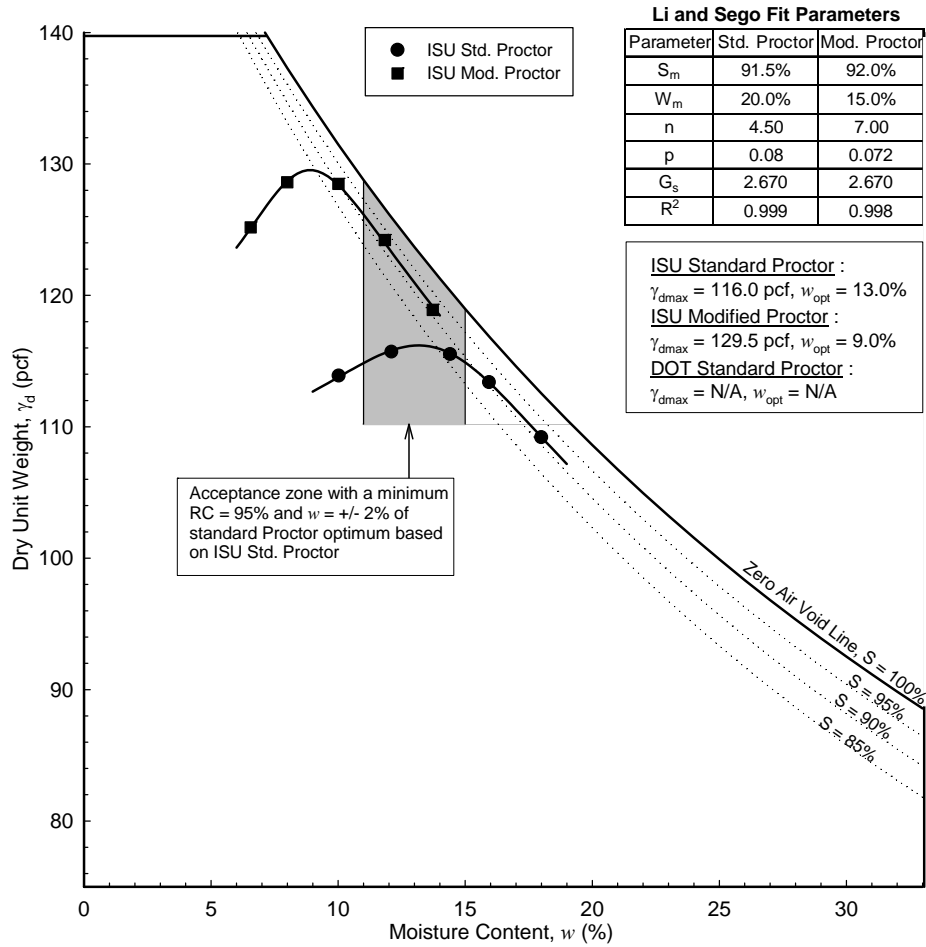
Figure 61. Comparison of in situ moisture-density measurements with laboratory Proctor compaction test results and Iowa DOT acceptance limits for Linn County #1 Project TB2

No in situ drive core test have been conducted at TB2 (Figure 61).

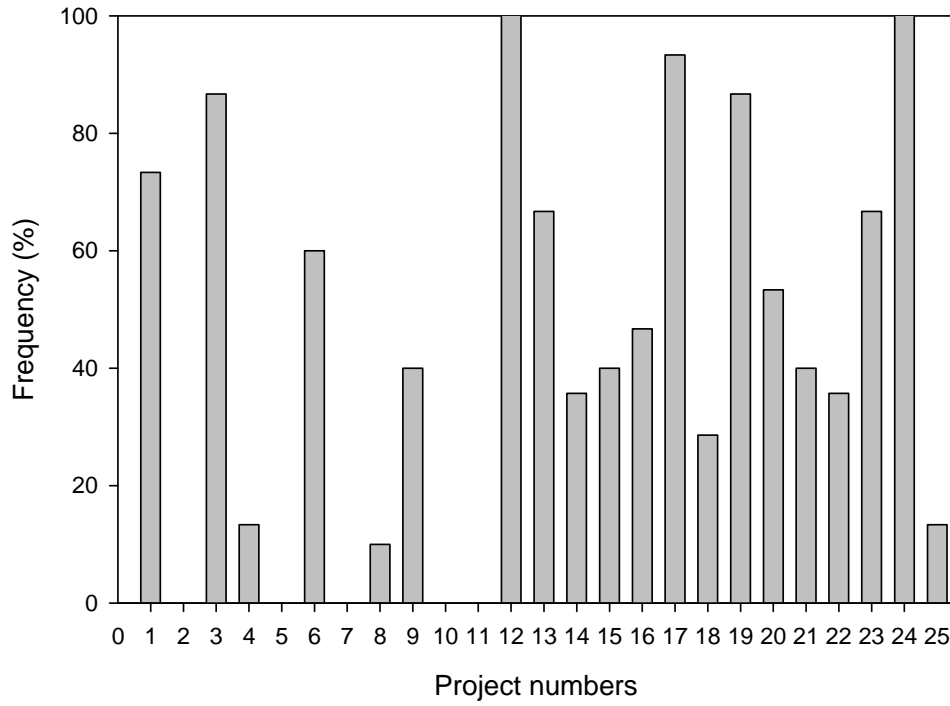
Figure 132. Percentage of test measurements were outside the accepted moisture limits

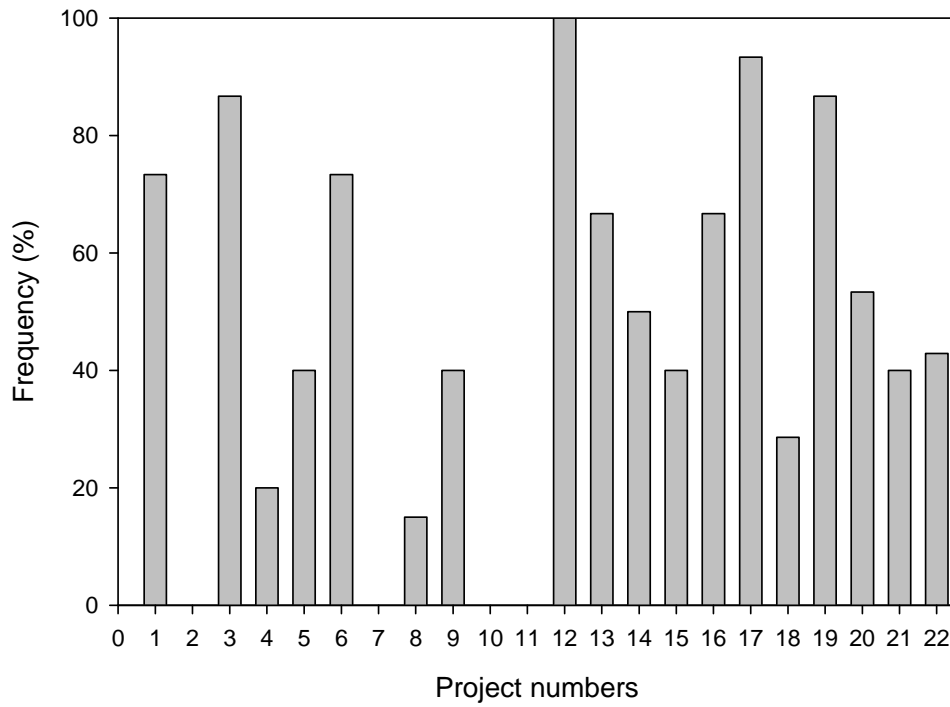
Figure 133. Percentage of test measurements were outside the accepted moisture and density limits

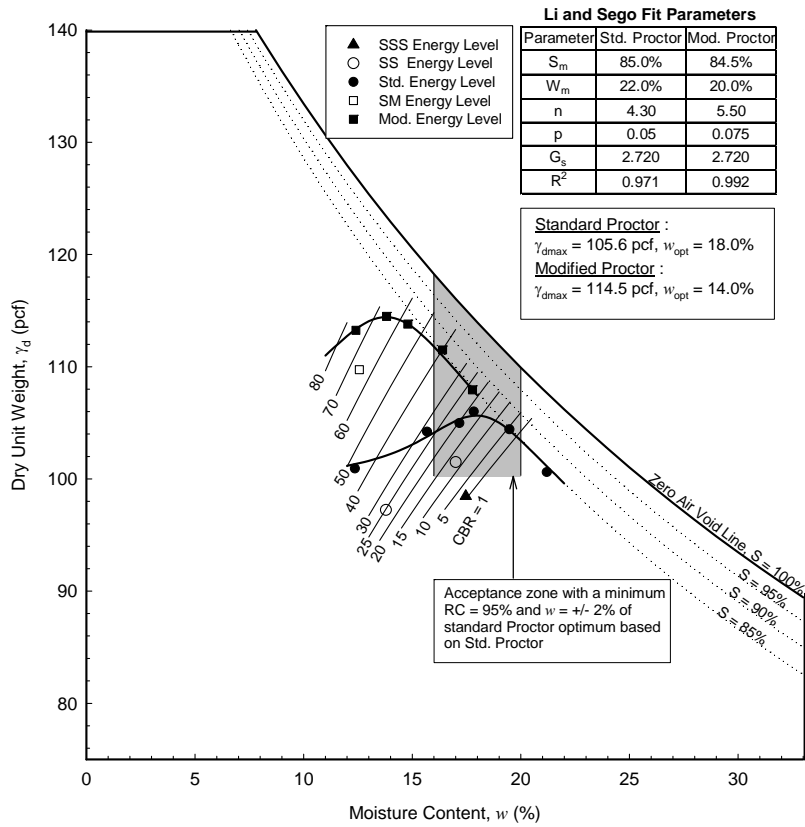
Figure 146. Relationship between w, γ_d, and laboratory CBR for western Iowa loess

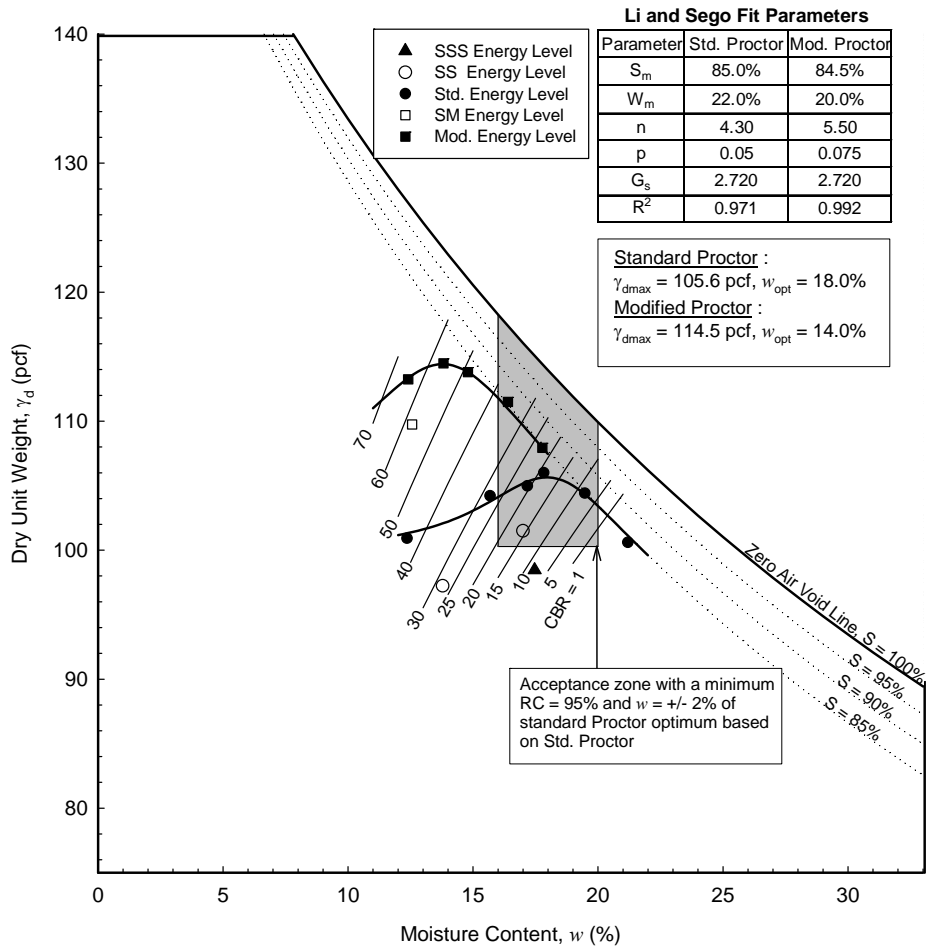
Figure 148. Relationship between w , γ_d , and DCP-CBR for western Iowa loess

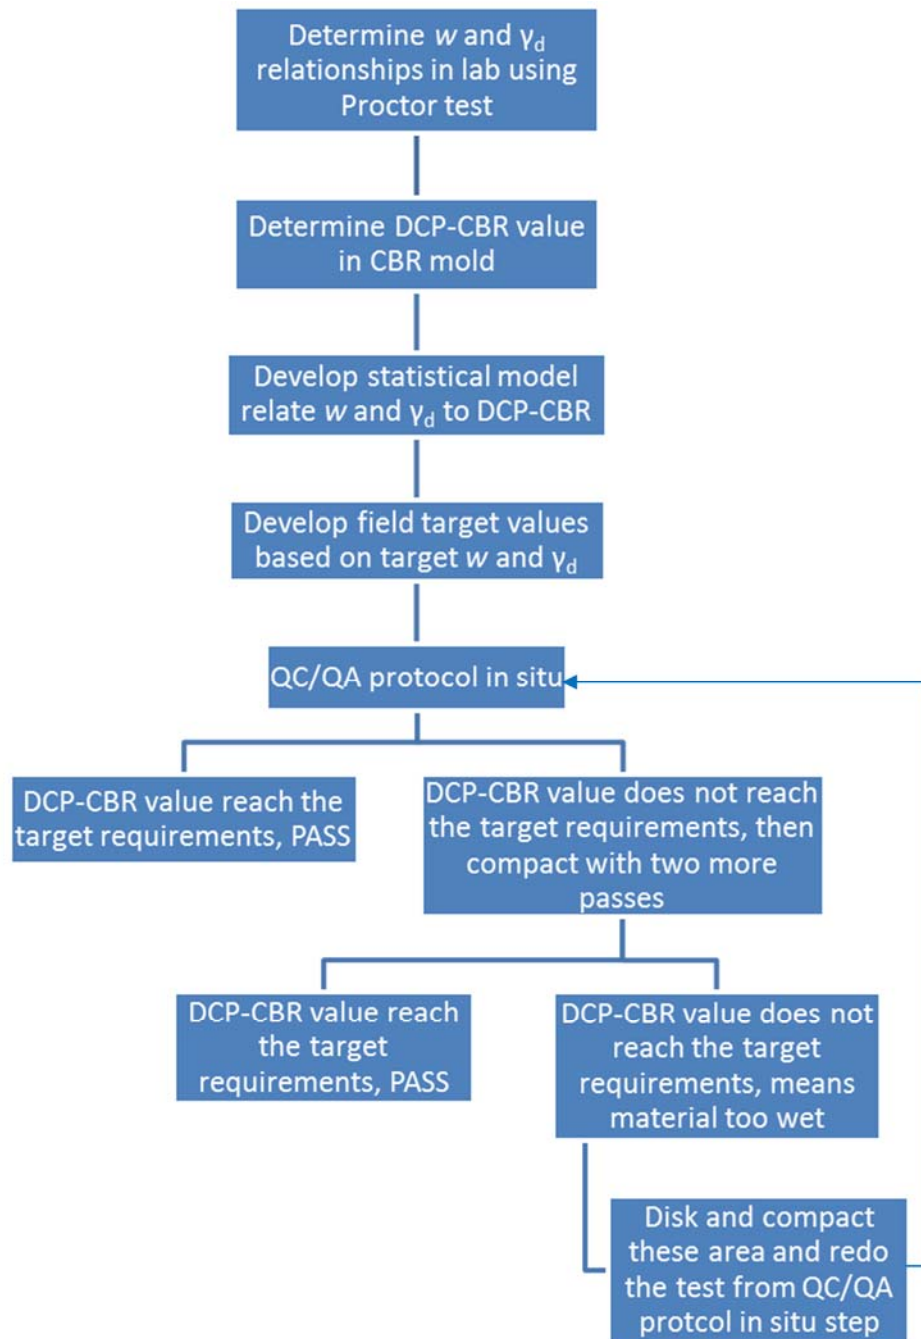
Figure 149. Proposed Iowa DOT flowchart for estimating field DCP-CBR target values in QC/QA program
