Use of UHPC piles in integral abutment bridges

A thesis submitted to the graduate faculty
in partial fulfillment of the requirements for the degree of
MASTER OF SCIENCE

Major: Civil Engineering (Structural Engineering)

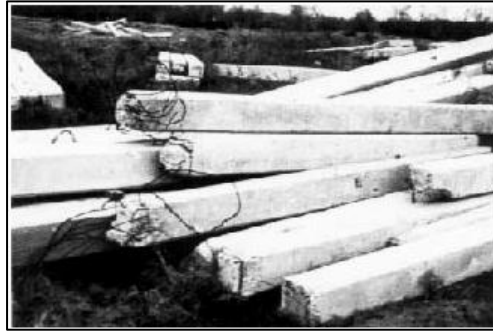
Figure 1-2: Concrete Piles Damaged by Difficult Driving Conditions (DiMillio 1998)

Concrete piles can fail as a result of large compressive stresses developed during driving. This can be attributed to an excessively large driving hammer used during installation or when driving through hard soil conditions. Figure 1-2 illustrates the crushing of concrete due to hard driving conditions for normal concrete piles. It is important to

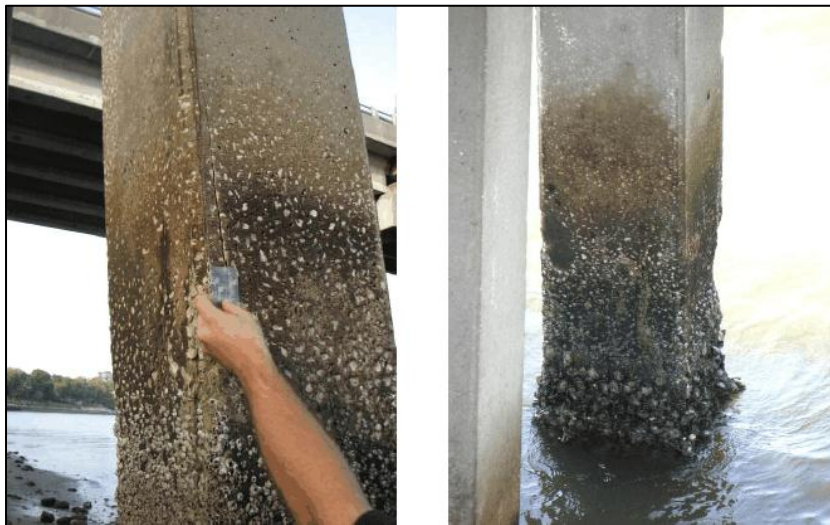
Figure 1-3: Damage to Prestressed Concrete Pile Due to Corrosion (Moser et al. 2011)

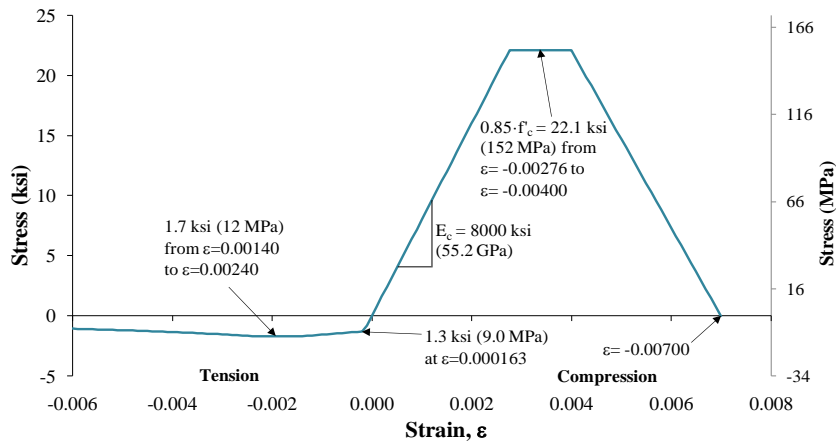
Figure 3-2: Assumed UHPC Monotonic Stress-Strain Behavior (Vande Voort et al. 2008)

During each step, the stresses and strains are calculated for each segment of the cross-section using a stress-strain relationship of UHPC and of prestressing strands that are described in Figure 3-2 and Figure 3-3, respectively. The forces and moments are then calculated for each segment of the cross-section by manipulating the strains. The spreadsheet solves a series of equations using the solver to calculate the appropriate curvature and neutral axis for each step. When the correct neutral axis is found for a curvature by satisfying the equilibrium condition, the sum of the moments in the section is equal to the total moment resistance associated with the input curvature (Vande Voort 2008).

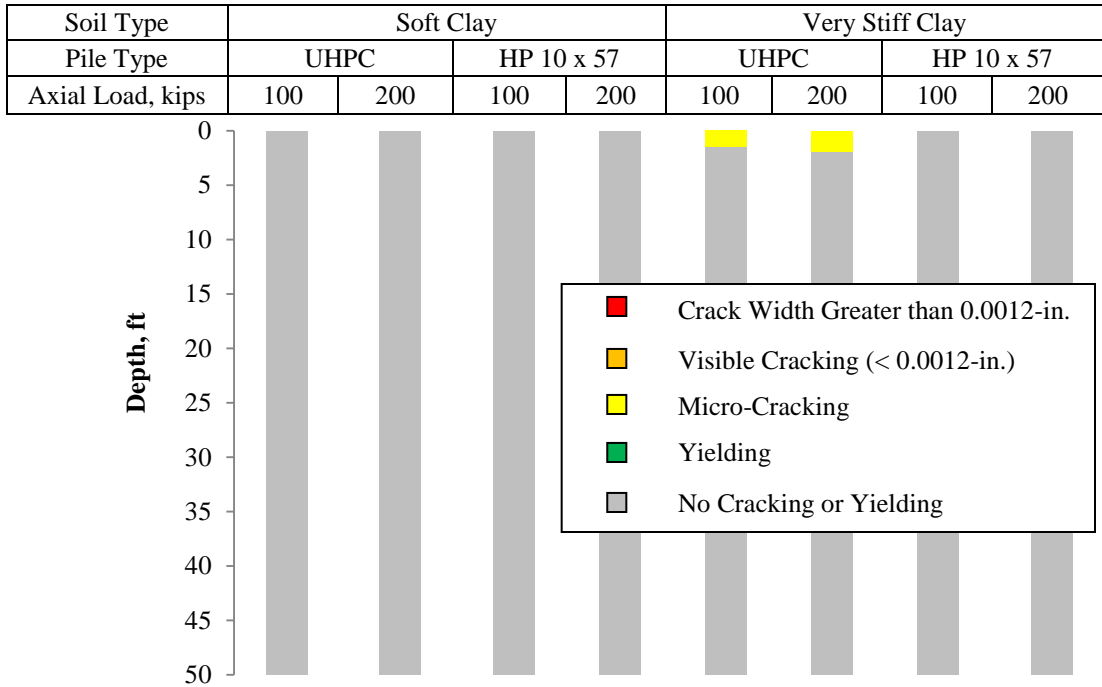
Figure 3-15: Cracking or Yielding along the Length of Piles Subjected to a 1.00 inch of Lateral Displacement with a 10-ft Deep Prebore Hole

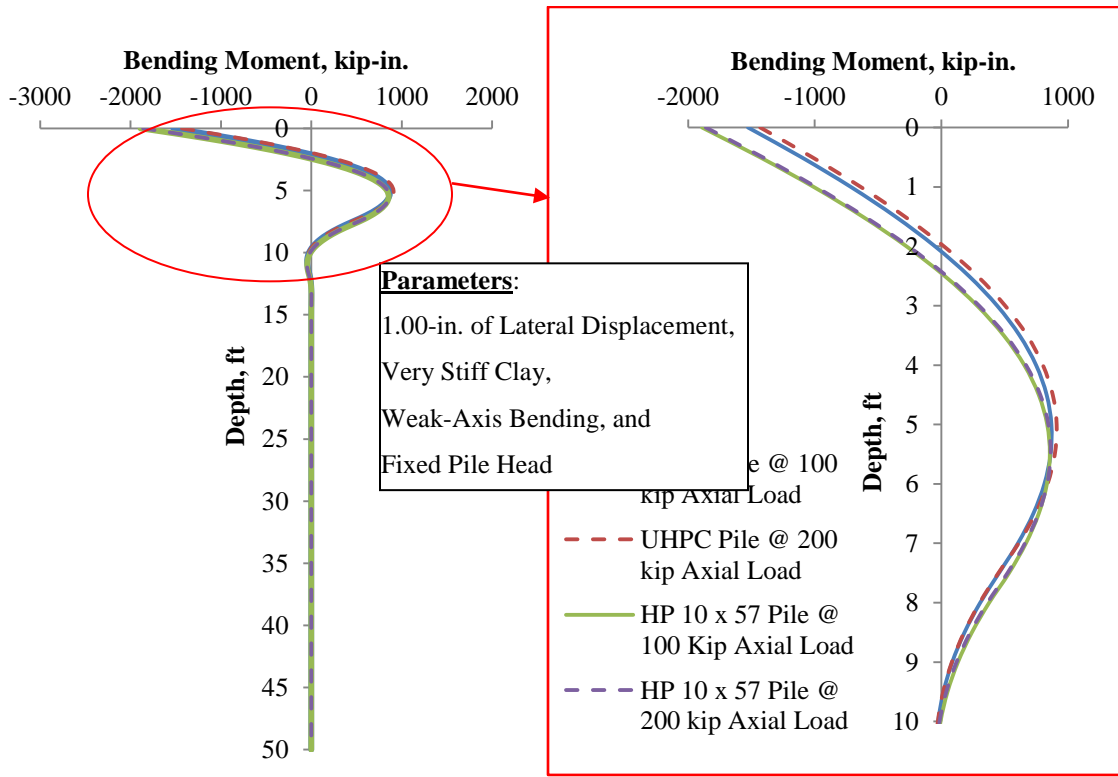
Figure 3-17: Performance Difference between a UHPC pile and an HP 10 x 57 Pile

When comparing the differences in performance between the UHPC pile and the HP 10 x 57 pile while keeping all of the parameters the same, the maximum moments and maximum shear forces induced in both piles are almost identical as shown in Figure 3-17. The steel pile has a slightly higher maximum moment and maximum shear as shown in Figure 3-17, which is caused by the slight difference in flexural rigidity (EI). The HP 10 x 57 pile has a slightly lower EI value than the UHPC pile by 1.0 percent.

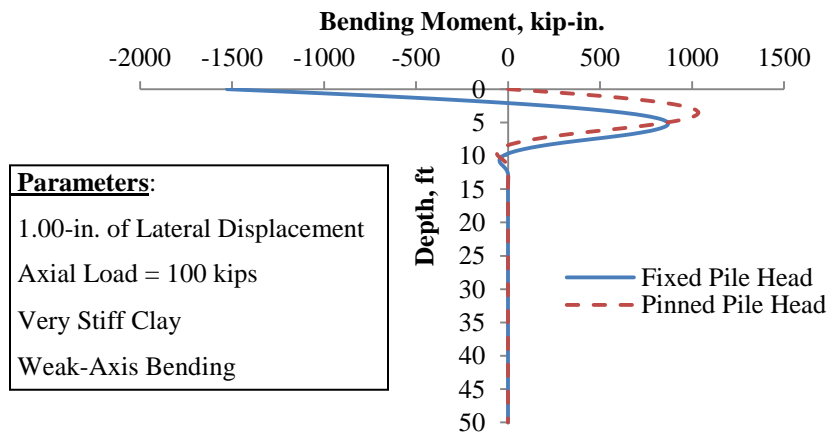
Figure 3-19: Effect of Fixed and Pinned Pile Head Boundary Condition on the Moment Profile for UHPC Piles

When varying the pile head boundary condition of UHPC and steel HP 10 x 57 piles from fixed to pinned condition the results were very different as can be expected, and are illustrated in Figure 3-19. There are three main differences in performance which are due to: 1) the magnitude of the maximum bending moments and shear forces are greater for the fixed pile head condition as compared to the pinned pile head condition; 2) the location of the second peak moment is much deeper for the pinned pile head condition than that of the fixed pile; and 3) the point of fixity for the pile with a fixed head connection is deeper than for the pinned connection.

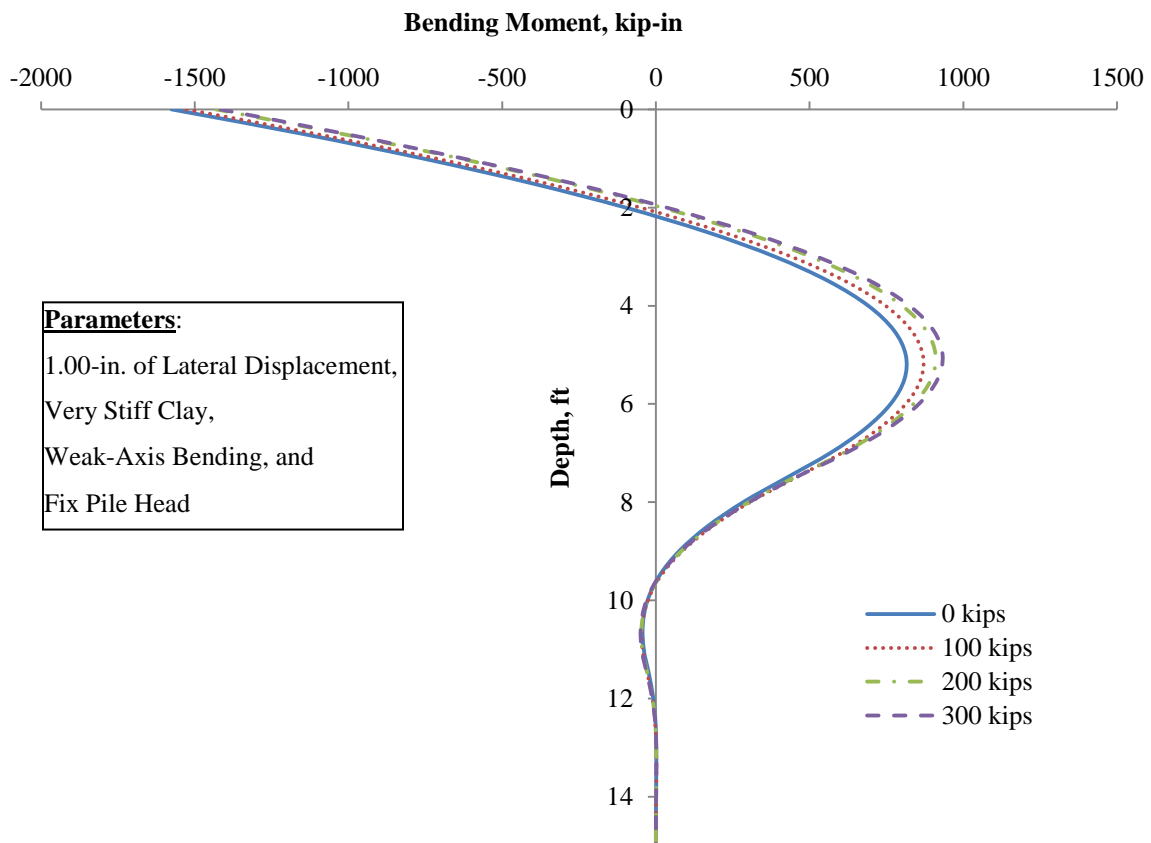
Figure 3-20: Comparison of Bending Moment When Varying the Axial Load for UHPC Piles

Furthermore, it was found that as the axial load was increased, the maximum bending moment and maximum shear forces decrease for the steel HP 10 x 57 piles and the UHPC piles subjected to weak-axis bending, but increased for the UHPC pile subjected to strong-axis bending. For strong-axis HP 10 x 57 piles, the maximum moment increased from 0 kips to 100 kips, but decreases for 200 and 300 kips. Also, the locations of the second maximum moment remains relatively constant, but the magnitude increases as the axial load increases for the weak-axis bending case as shown in Figure 3-20. The point of fixity stays relatively constant as the axial load increases for all the UHPC and HP 10 x 57 piles in all soil types.

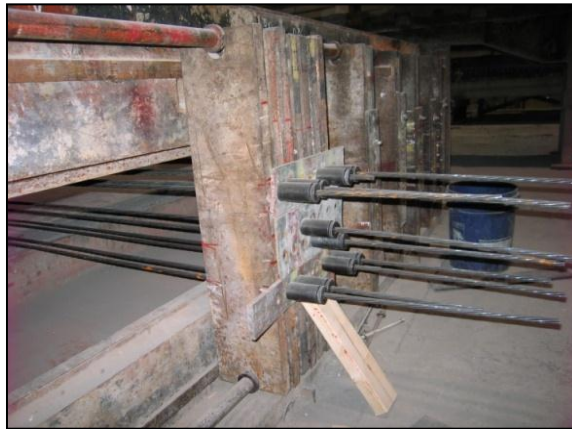
Figure 4-8: Prestressing Strands Layout at the Anchorage end

After the Styrofoam was in place, the final six prestressing strands were arranged and stressed to their initial prestress of 202.5 ksi, as shown in Figure 4-8. The rest of the gages were installed to the prestressing strands. Initial readings of the strain gages were taken and the side forms were locked in place. The mixing of the UHPC ensued at the precaster's batch plant in a 4.0 yd³ mixer.

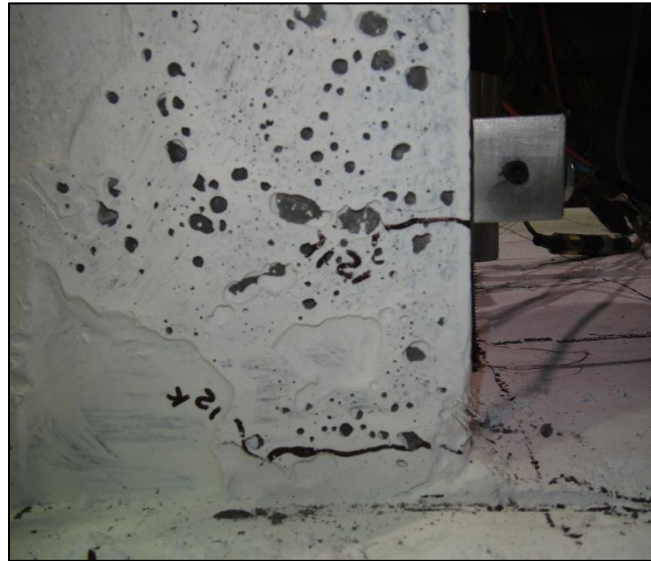
Figure 4-22: Hairline Tensile Cracks that Developed on the UHPC Pile in UPAC-2 at the 12 kip Lateral Load Step with a 100 kip Axial Load

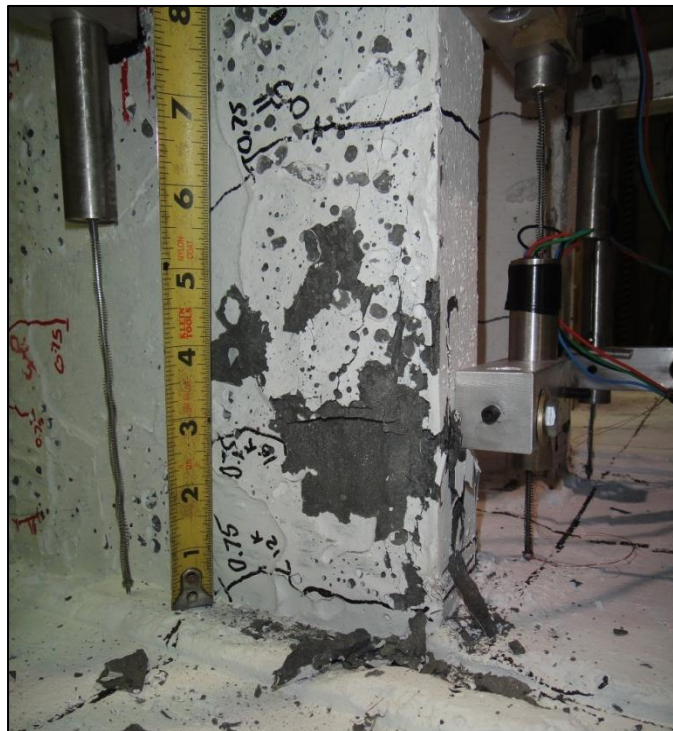
Figure 4-23: Spalled Region of the UHPC Pile Due to Crushing during the UPAC-2 Test after Completing of the 1.0-in. Load Displacement Cycles

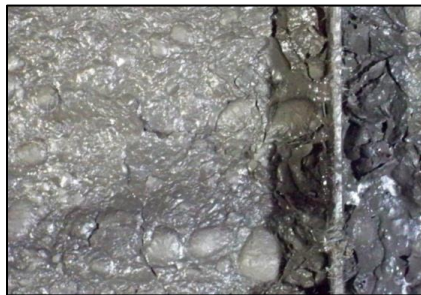
Figure 5-15: Clumps in UHPC after Batching for the 11/21/2011 Pour

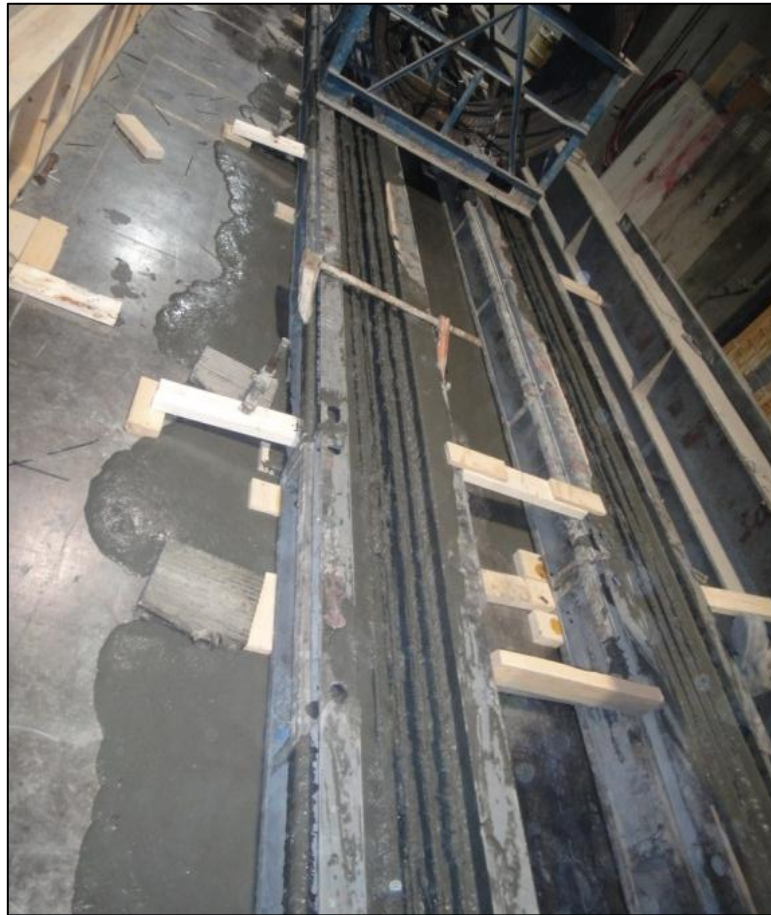
Figure 5-16: Steel Forms Beginning to Tilt Causing UHPC to Leak

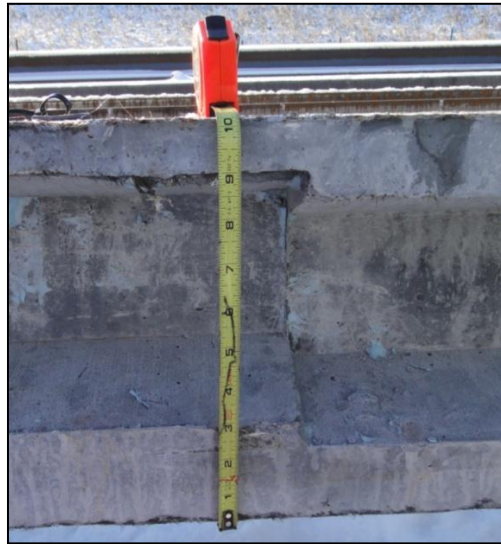
Figure 5-17: Change in the Flange Thickness of P3

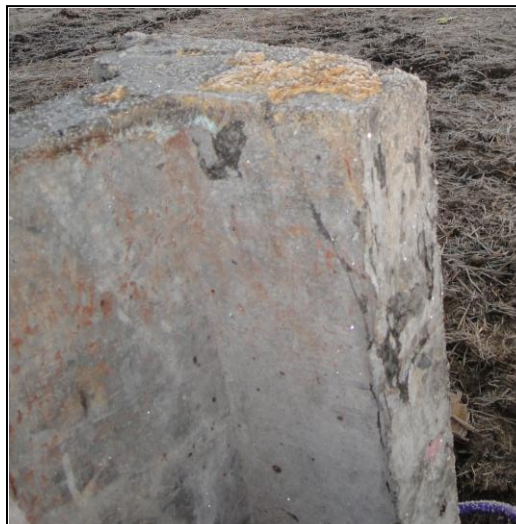
Figure 5-26: Slight Damage observed to P3 Pile Head after Driving the Pile in Place

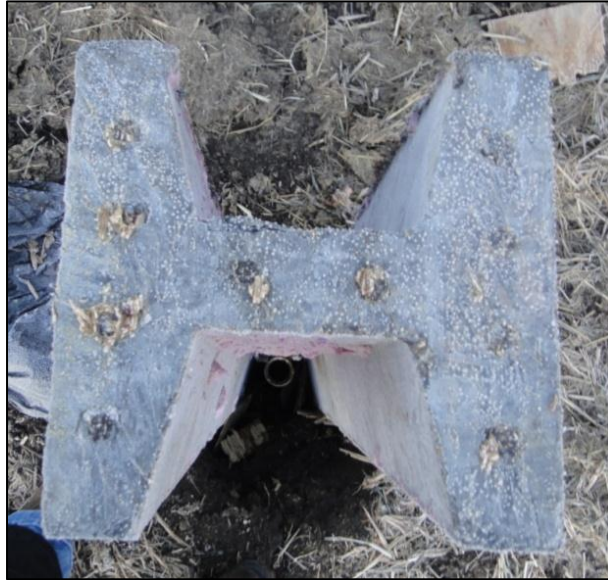
Figure 5-27: No Visible Damage on Pile P4 Head after Driving

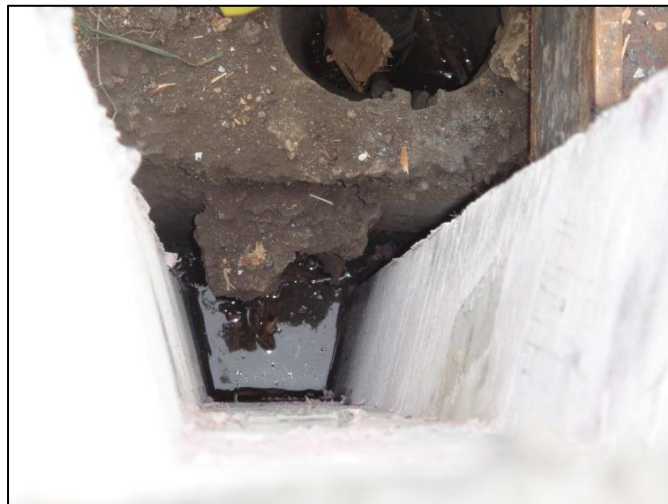
Figure 5-40: Void that Formed from Installation of P3

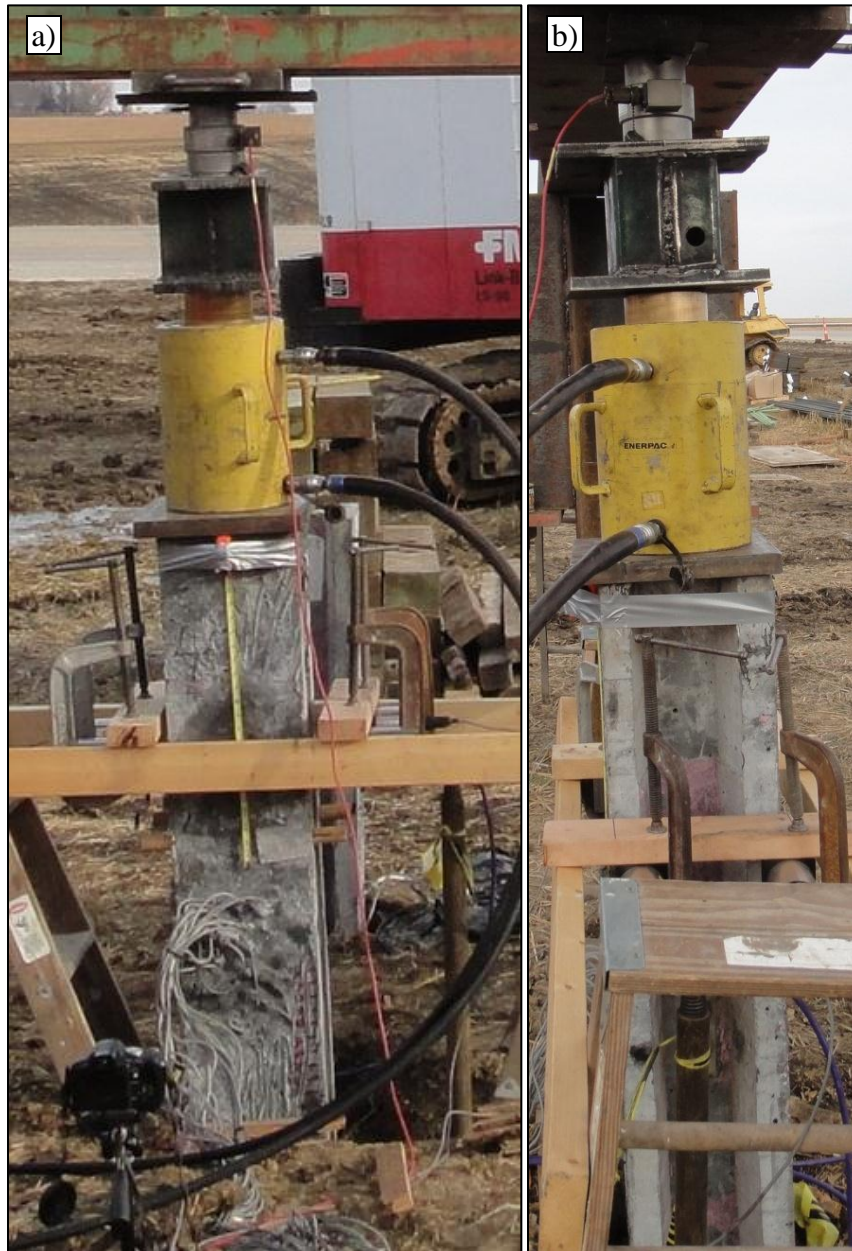
Figure 5-41: Tilt of P3 after Driving in the a) Weak-Axis Direction; and b) Strong-Axis Direction

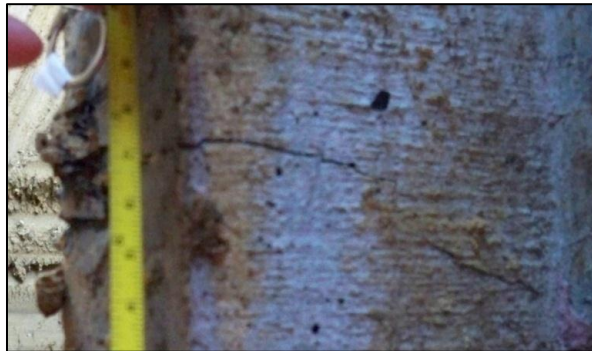
Figure 5-54: A Flexural Crack Found at a distance of 9 ft. from the Ground Surface on P4 due to the Lateral Load Test

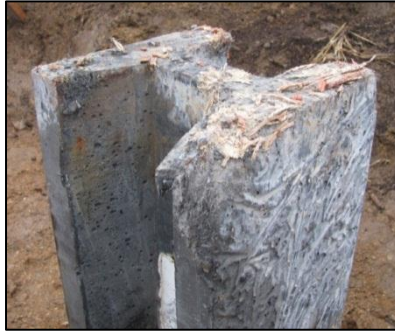
Figure 6-19: Damage to the Pile Head of UW1-2
