# Development and Testing of a Time-Resolved Personal Ozone Monitor

A thesis submitted to the  
Faculty of the Graduate School of the  
University of Colorado in partial fulfillment  
of the requirement for the degree of  
Master of Science  
Department of Civil, Environmental  
and Architectural Engineering  
2011

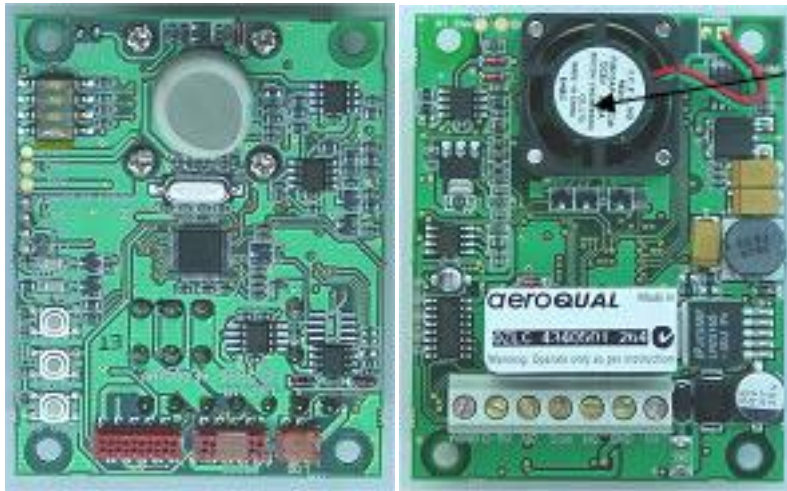
Figure 2.4: Aeroqual SM50 sensor (Aeroqual Ltd, 2011)

The Aeroqual SM50 sensor was designed to provide state of the art gas measurements. These sensors utilize “Gas Sensitive Semiconductor” GSS sensor technology to provide reliable, sensitive and quick response measurements for different gases. The GSS technology is exclusive to Aeroqual. The sensors exhibit an electrical resistance change when in the presence of the gas

it is meant to measure; in this case, ozone (Aeroqual Ltd, 2011). These sensors are calibrated to output linear gas concentrations between 0-150 ppb and are available in diffusion, fan and pump sampling versions (Aeroqual Ltd, 2009). The fan-sampling version with an 8 bit analog signal was chosen for this study.

The SM50 sensor requires an input voltage range of 11-24VDC. It is connected to power through the V+ and GND (ground) slots in the screw terminal. Though this sensor is designed to operate continuously, it should be allowed to operate in a clean environment for a couple of hours on its first use or its first use after a period of no use. The sensor requires a 3-10 minute warm-up period before it is fully operational.

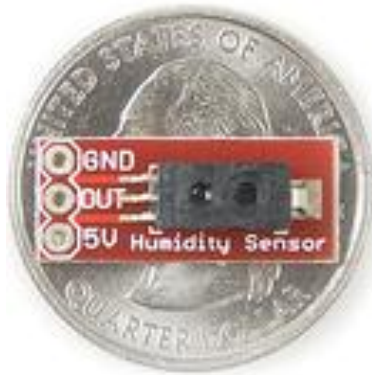
Figure 2.5a: RH sensor (Sparkfun Electronics, 2011)

The relative humidity (RH) sensor is a HIH-4030 Breakout board that measures %RH and outputs values as an analog output voltage. For temperature measurement, a thermistor was used. Both these sensors have linear outputs.

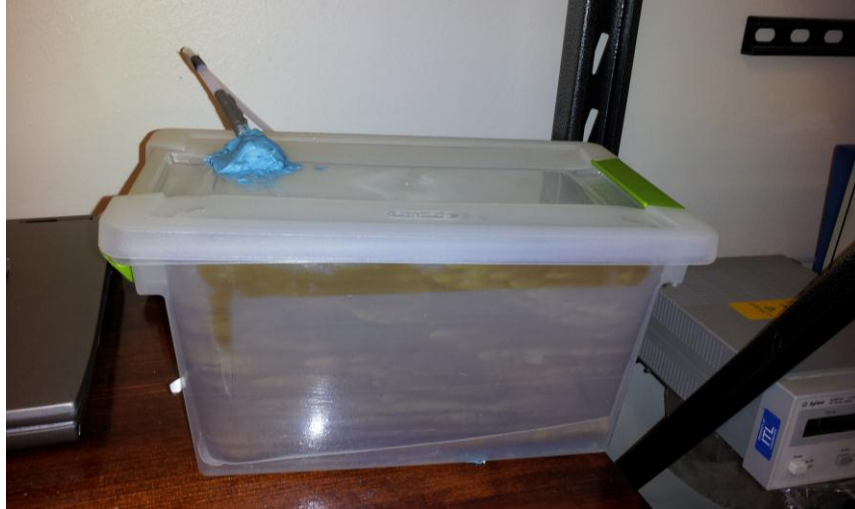
Figure 2.9: Calibration chamber

All calibrations were conducted inside a plastic box, referred to as the calibration chamber, which was lined with Teflon sheets as shown in Figure 2.9. The top of the box was not lined with Teflon to allow observation of monitor during calibrations. The ozone generator used for calibrating the ozone sensors was turned on at least an hour prior to the starting time of each calibration to allow the generator to properly warm-up. The ozone generator used was made by Thermo Electron Instruments, now known as Thermo Fisher Scientific, and it is a Model 49. The ozone generator was connected to the chamber by Teflon tubing. After the warm-up period, the SM50 ozone sensor, GPS shield and Arduino were placed inside the chamber, without any ozone flow, and allowed a ten-minute warm-up period as well. These components were placed inside the chamber without the monitor's outer case. Then, the ozone sensor was exposed to low levels of ozone for a ten-minute period before starting the calibration.

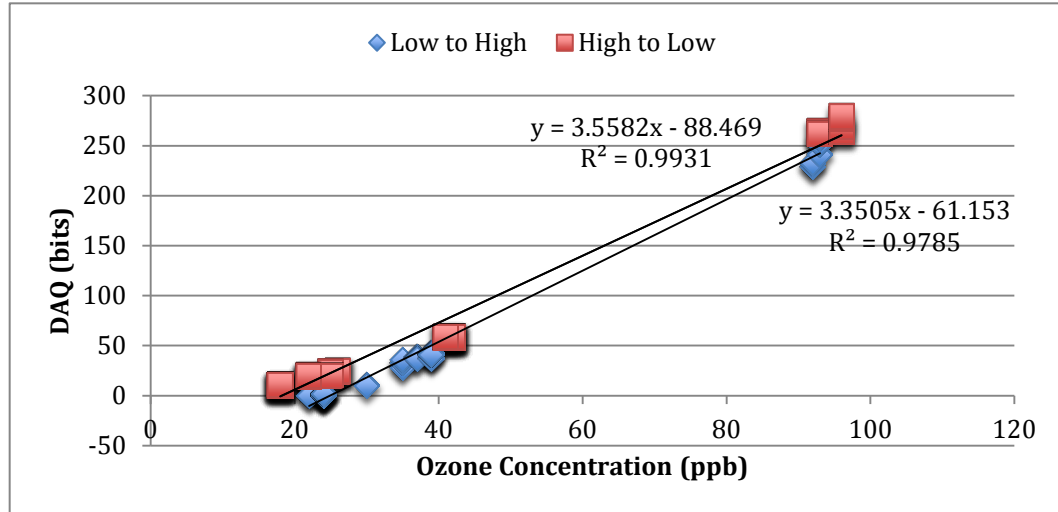
Figure 2.10: Example calibration

The calibrations consisted of exposing the ozone sensors to low, medium and high levels of ozone. Each calibration was broken into two parts: starting at a low concentration and moving to a high concentration, called low-to-high (LH), and starting at a high concentration and moving to a low concentration, called high-to-low (HL). The ozone sensor's response was plotted against the ozone concentration from the generator. Regression equations and correlations were found for both LH and HL readings to note differences between the two measurement sequences as shown on Figure 2.10. Some of the sensors were slightly more responsive to low ozone levels after being exposed to high ozone levels. Three calibrations were conducted on each monitor prior to the pilot study. Calibrations were also conducted after the pilot study, but the number of calibrations conducted on each monitor, post-study, depended on whether the monitor's sensor was suspected of drifting.

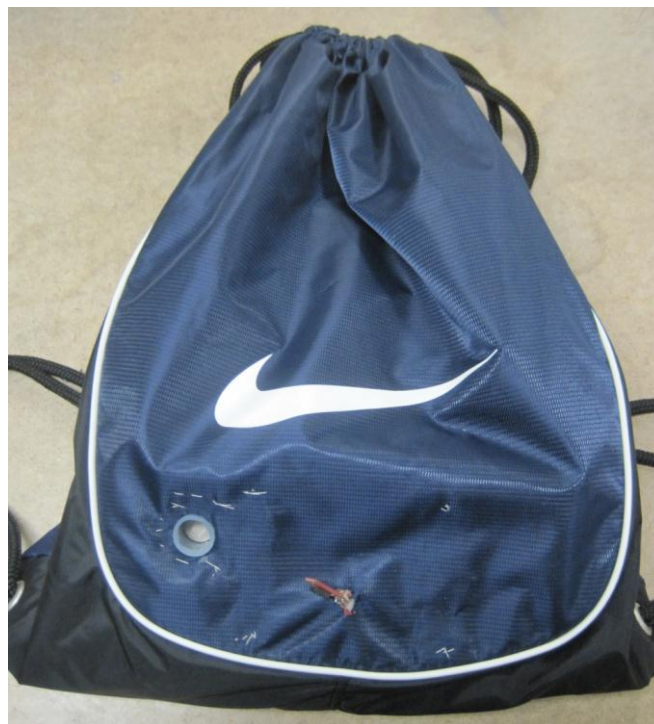
Figure 2.11: Carrying method 1

The first carrying method for the ozone monitor employed the use of drawstring backpacks. This method was believed to be comfortable and less likely to interfere with the volunteers' daily activities. The front of the ozone devices was attached to the inside of the backpack using Velcro. Holes were cut out for the ozone sensors' inlet and for the RH and temperature sensors. To keep the back of the backpack from blocking the ozone sensor's fan, a piece of cardboard was placed at the bottom of the backpack to ensure sufficient room for the fan. This design is shown in Figure 2.11.

This method was used during the first portion of the pilot study but after a couple of days; the ozone monitors began noticeably malfunctioning. Initially it was believed the drawstring backpacks were causing the monitors to overheat. Holes were cut out in the back of the backpack to allow for greater airflow in an attempt to solve the problem. However, this idea did not work. The monitors were then set side-by-side on a ledge outside to test if the bags were in fact causing the problem or not. First, all the monitors were tested outside of the bags for 30 minutes and then they were placed inside of the bags. This test showed a considerable decrease in the monitors' readings after they were placed in the bag. The Skywatch Observatory's ozone readings did not show a significant decrease in ozone during that time period. During outside tests, the monitors were located about 800 m from the Skywatch Observatory. More detailed analysis on these tests can be seen in Chapter 3.

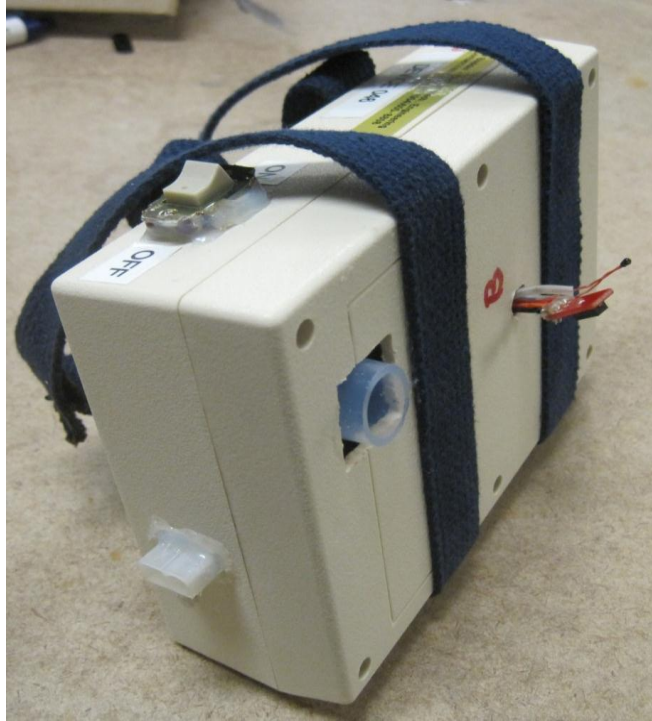
Figure 2.12: Second carrying method

A new carrying method was then devised. This method consisted of gluing two straps across the monitor and holding the monitor as a bag or purse. Since the monitor was believed to be more susceptible to movement with this new carrying method, all of the monitors were tested to see if movement had a negative impact on the ozone sensors' function. These test were conducted by carrying each instrument for an hour or more while walking. Movement did not cause the monitors to output error data or appear to have a significant affect their function; therefore, this carrying method was chosen for the second portion of the study.

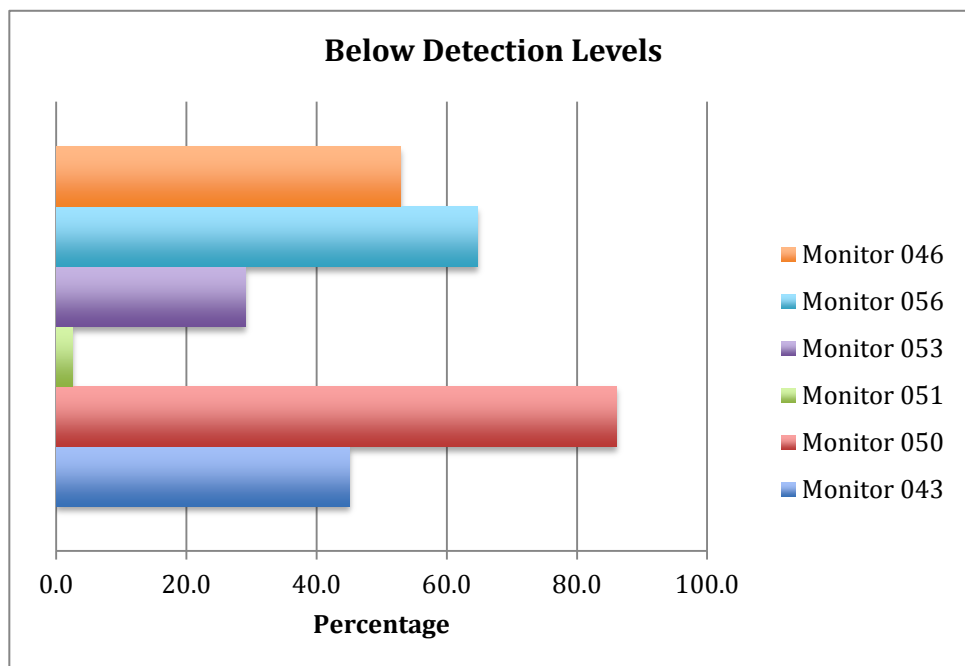
During the Study, Monitors 050 and 051 never malfunctioned; these two monitors never recorded error data. However, Monitor 050 recorded more below detection data than expected from Volunteer 3. The other three monitors mostly recorded data below detection levels or error data. This behavior led us to analyze the reliability of the monitors; which was done by pooling all the data points from each monitor and calculating the percentage of points that fell under the following categories: below detection levels, at or above detection levels, and error output. The results of this analysis are shown below.

Figure 3.1: Percentage of time monitors were below detection levels

As shown, the percentage of data when the monitors were measuring below detection limits is mostly high and the percentage of data at or above detection levels is mostly low. Out of all the monitors, Monitor 053 draws the most attention because approximately 75% of its data is

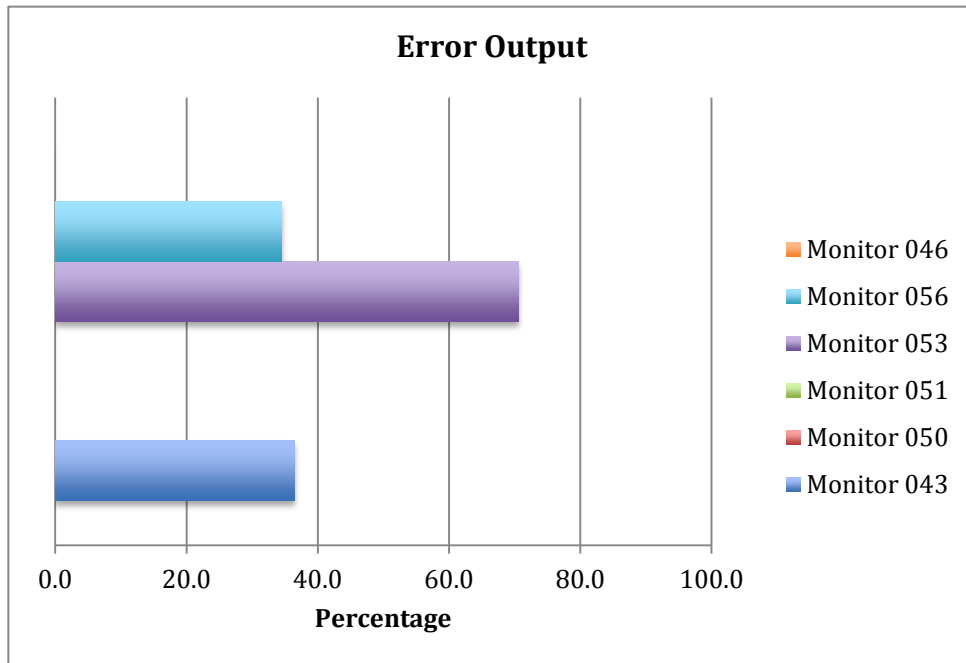
Figure 3.3: Percentage of time monitors recorded error data

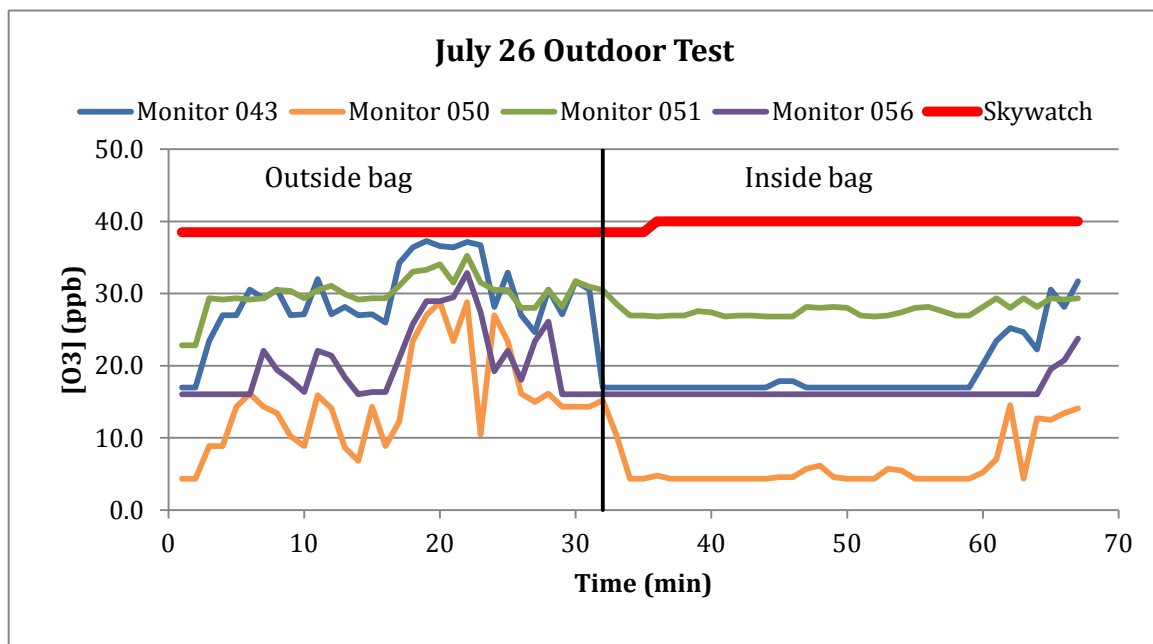
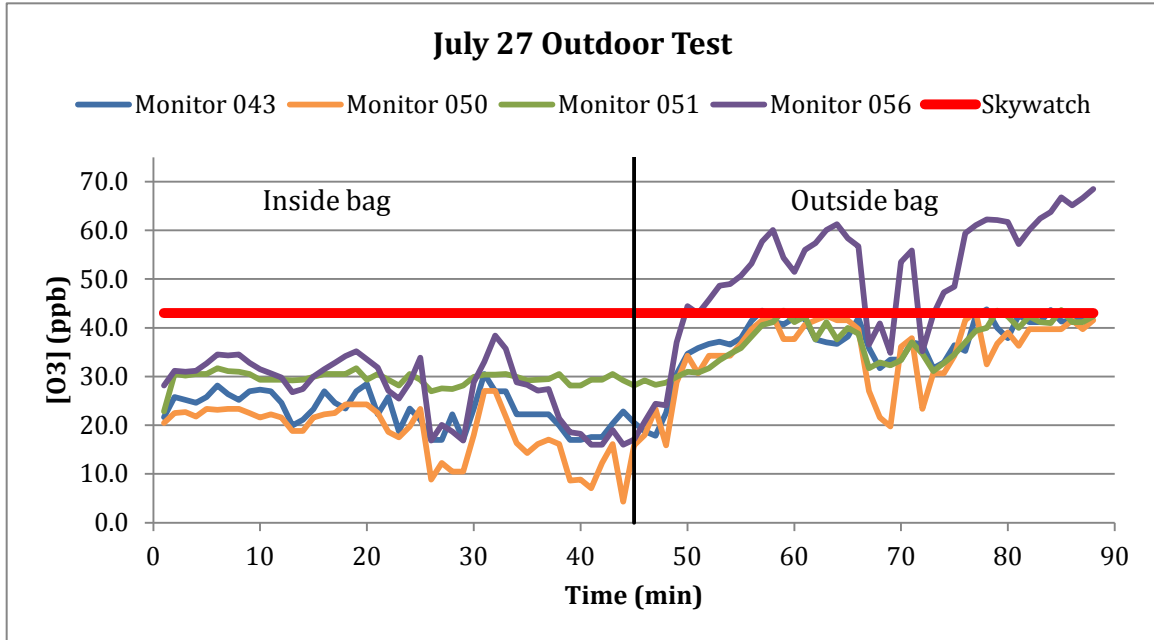
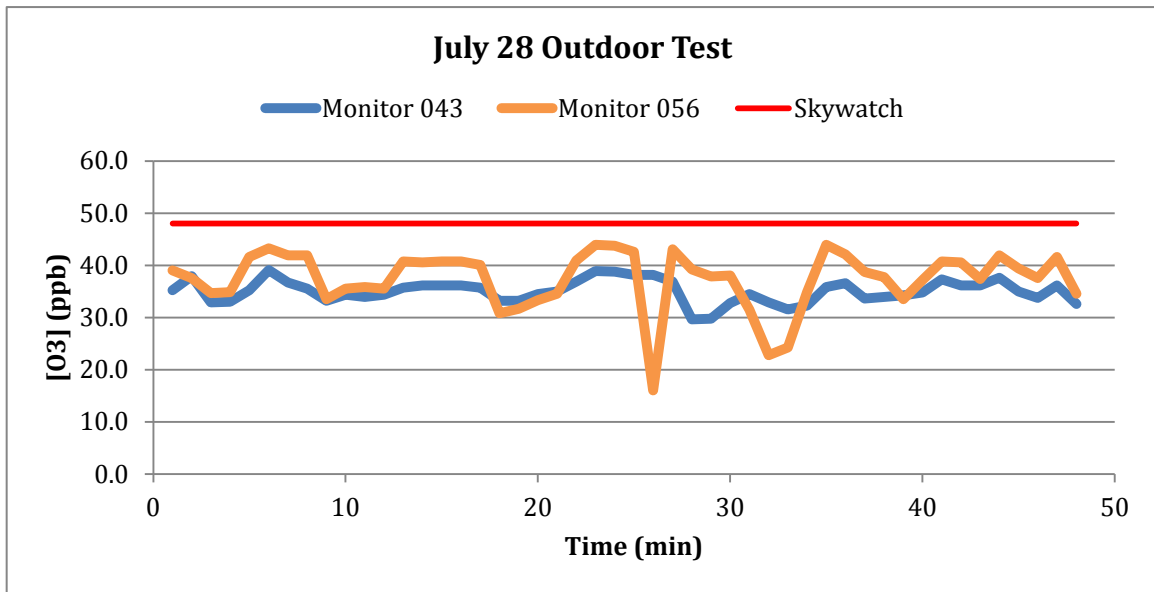
The July 27<sup>th</sup> test had the lowest bias among the other tests conducted in July. The correlation between the monitors is the highest and the difference between the monitors' and monitoring sites' average ozone concentration is the lowest. Though the July 28<sup>th</sup> test had the lowest correlation, the average ozone concentration measured by Monitors 043 and 056 only differ by 2.4 ppb.

Figure 3.4: Outdoor test started at 5:13pm

Figure 3.5: Outdoor test started at 11:28am

Figure 3.6: Outdoor test started at 2:50pm

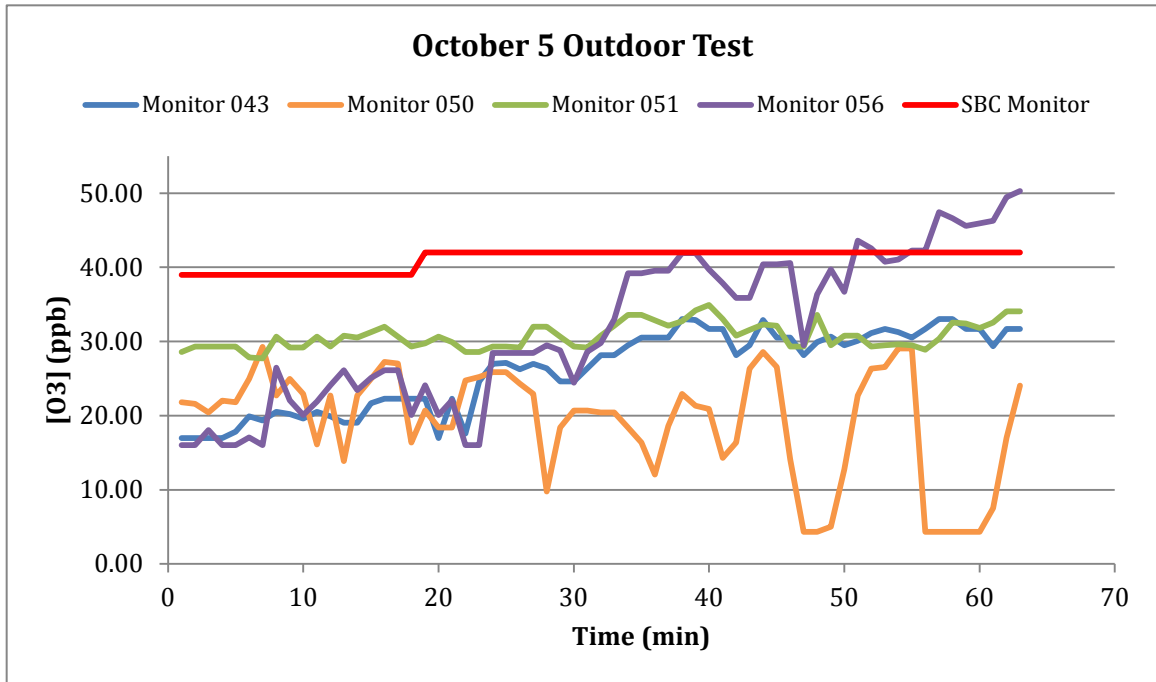
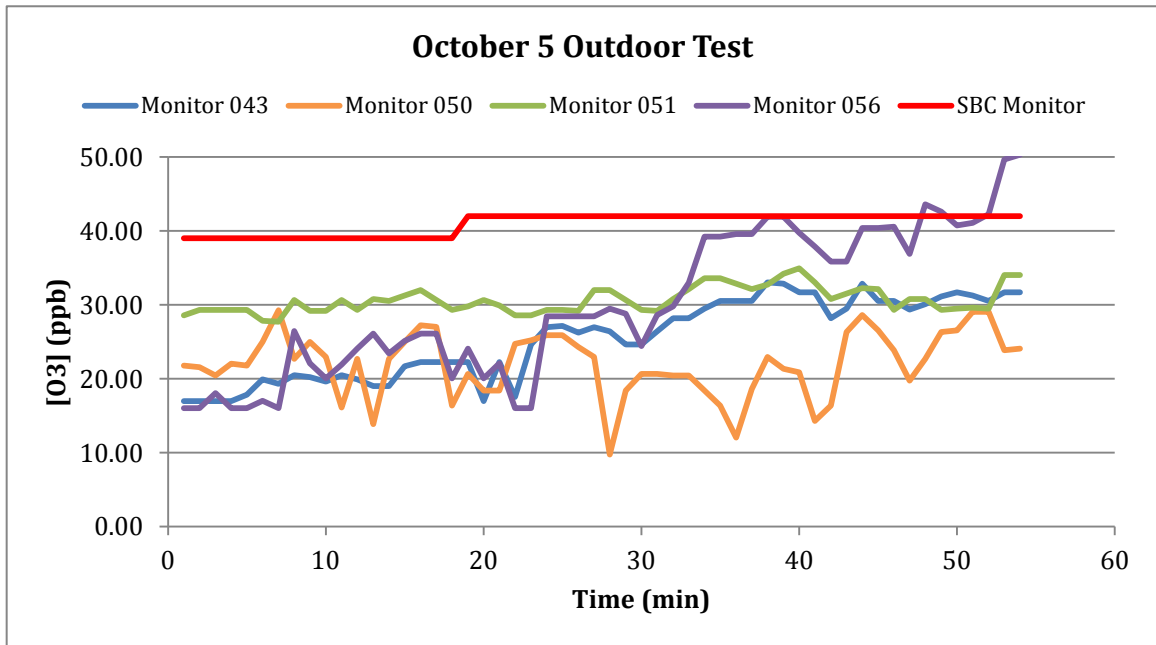
During the test, Monitor 050 fell off the ledge it was on twice. The first column under October 5<sup>th</sup> on Table 3.3 shows the results from the correlation analysis on all the data points recorded during the tests, including those recorded when Monitor 050 was on the ground. The second column results do not include the data points recorded while Monitor 050 was on the ground. The points from this fraction of time were discarded for all of the monitors for the second correlation analysis. The third column shows results from the correlation analysis on data points recorded before Monitor 050 fell. Data recorded after Monitor 050's first fall were excluded from the third analysis for all monitors.

The correlation between monitor pairs excluding Monitor 050 increases from the first to third analysis done for October 5<sup>th</sup>. For pairs in which this monitor is included, the correlation continues to be very low or negative throughout the analysis. This could be attributed to the monitor malfunctioning, even before it fell, or because the ozone sensor inside Monitor 050 is more sensitive to wind than the rest. The wind speed increased about halfway through the test. The ozone levels detected by the monitors were mostly about 10 ppb below the Skywatch monitor during the July tests. At the beginning of the October test, most of the monitors differed from the SBC monitor by more than 10 ppb. About halfway through the test, the monitors' response became more scattered and only Monitor 056 approached, but also surpassed, the levels recorded by the SBC Monitor. The ozone levels recorded by the SBC monitor slightly increased after the first 20 minutes of the test. A similar trend can be seen for the monitors, except for Monitor 050.

Figure 3.7: Outdoor test started at 1:42pm. Figure includes all data collected during test.

Figure 3.8: Outdoor test started at 1:42pm. Figure excludes data collected during fall of Monitor 050.

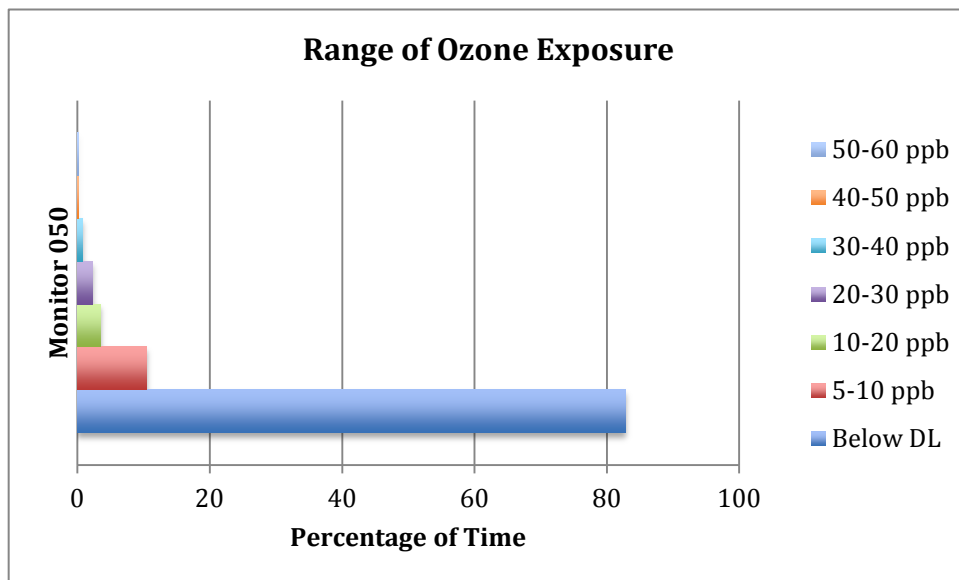
The percentage of time Volunteers 2 and 3 were exposed to different detectable ozone levels is shown below. The results for Volunteer 2 correspond with our expectation that she would have the highest ozone exposure, but her exposure range is very limited; her monitor only shows exposure between 20 to 40 ppb. Over 80% of the data recorded for Volunteer 2 is between

20 to 30 ppb. Volunteer 3 has a larger exposure range, between 5 and 60 ppb, though the percentage of time she was exposed to ozone levels above 40 ppb is very low.

Figure 3.10: Range of ozone exposure for Volunteer 2

Figure 3.11: Range of ozone exposure for Volunteer 3

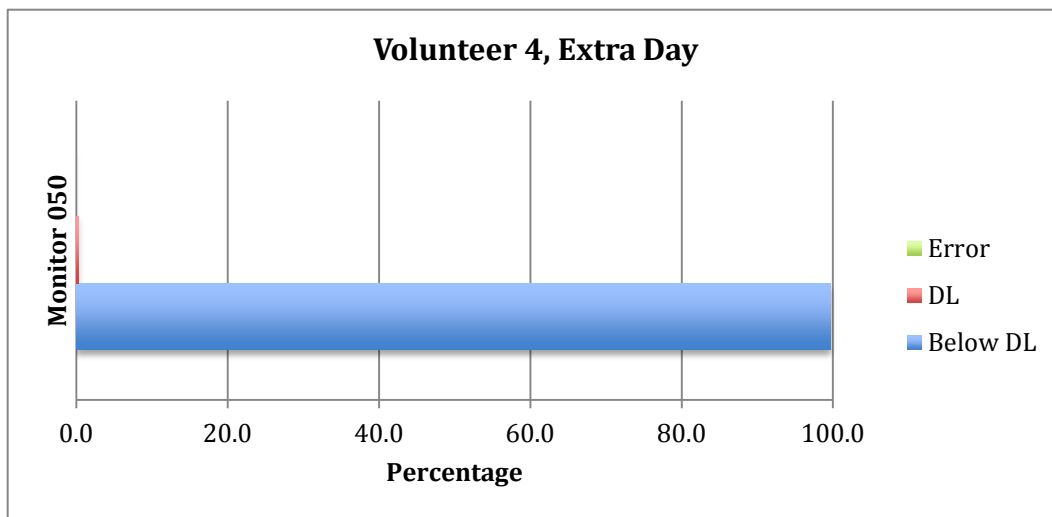
started. During the testing time frame, these two Volunteers were usually indoors with the AC on. Volunteer 4 agreed to do an extra day with Monitor 050 to ensure her exposure levels were indeed low. The results from the extra day in Figure 3.12 show a high percentage of below detection levels and a very low percentage of points at detection levels.

Figure 3.12: Reliability of results for Volunteer 4, Extra Day

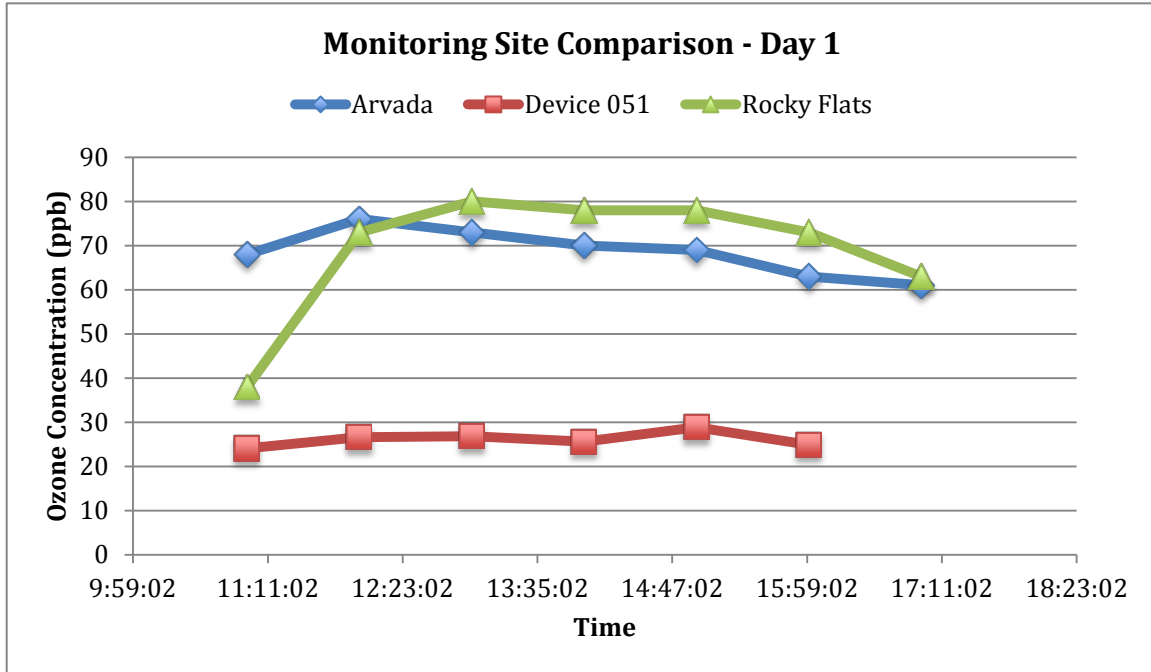
Figure 3.13: Comparison of hourly averages between Monitor 051 and monitoring stations for Day 1

Figure 3.14: Comparison of hourly averages between Monitor 051 and monitoring stations for Day 2

As shown in Figures 3.13 and 3.14, Monitor 051 was recording ozone concentrations around 50 ppb lower than those recorded by the stationary monitors. Monitors recording ozone concentrations below what stationary monitors recorded was common during the outdoor tests

Days 1 and 2 were the days with the highest ozone concentrations during the pilot study's testing time frame. Hourly averages from the Arvada and Rocky Flats monitoring stations were obtained for comparison between the monitors and monitoring stations. The Arvada monitor's latitude and longitude are 39°48'0.62" and -105° 5'57.35". The Rocky Flats monitor's latitude and longitude are 39°52'20.94" and -105° 9'55.79". The distance of these monitors to the volunteers' houses ranges from 3 to 10 km. The Arvada monitor is located in a residential area while the Rocky Flats monitor is located in a rural area. Both of these sites use Teledyne 400E ozone monitors and the monitors are 3 m above the ground. As shown below, Monitor 051's readings, which had the highest averages, were well below the levels recorded by the monitoring stations.

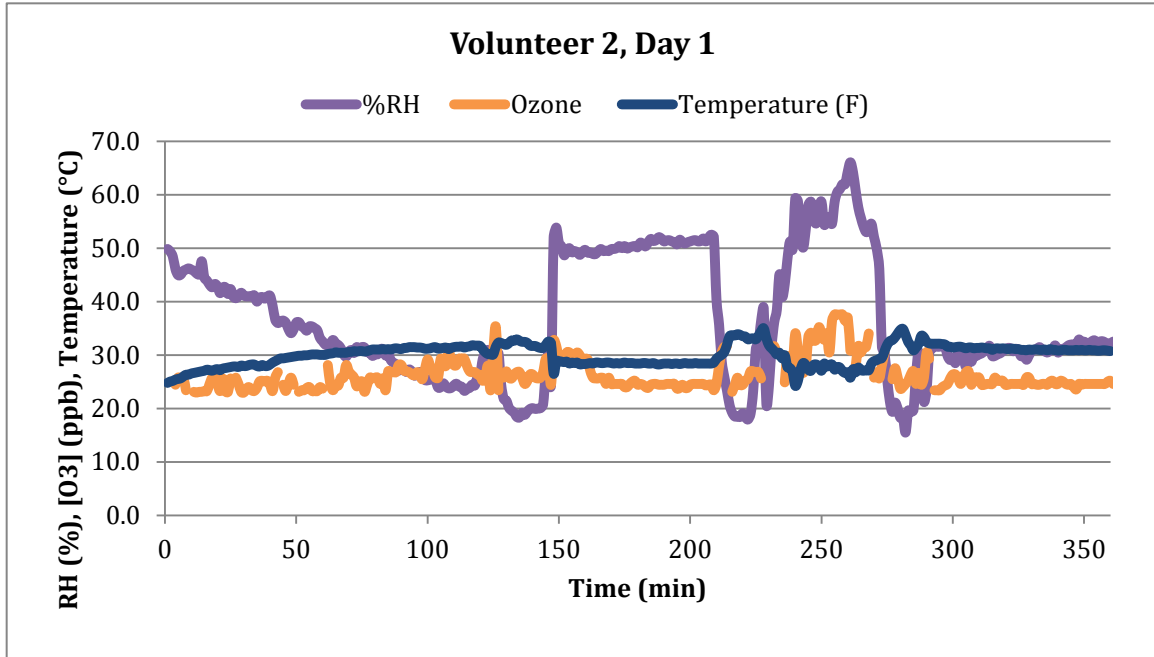
For the Day 1, as shown in Figure 3.15, Volunteer 2 was outside her house during the first 60 minutes of the testing time frame and in and out of her house between minutes 60 and 90. Then between minutes 90 and 150, the GPS data shows the volunteer to be in transit. During this period of time, %RH steadily decreased, spiked during minute 126 and then continued decreasing. Ozone slightly increased, also spiked during minute 126 and decreased again. Temperature remained constant. When Volunteer 2 reached her destination, she was indoors between minutes 150 and 210. The %RH increased and temperature and ozone levels decreased during this time. The volunteer was again in transit between minutes 210 and 225. Temperature increased, %RH decreased, but ozone levels spiked during minute 214, dropped below detection levels as shown by the gap in the series, and then decreased to levels similar to those recorded indoors. As the volunteer arrived at her second destination, a commercial greenhouse, %RH increased to the highest levels recorded for the day, ozone also increased and temperature decreased. The volunteer was at this location between minutes 225 and 270. Her movement at the commercial greenhouse is shown in Figure 3.16. The volunteer was in transit again between minutes 270 and 300. During this time, the temperature increased and ozone levels and %RH decreased. When the volunteer arrived at her house, she remained outdoors for the last hour of the testing time frame, between minutes 300 and 360. During this time, the ozone levels, temperature and %RH remained constant.

Figure 3.15: comparison of %RH, Temperature and ozone levels for Volunteer 2, day 1

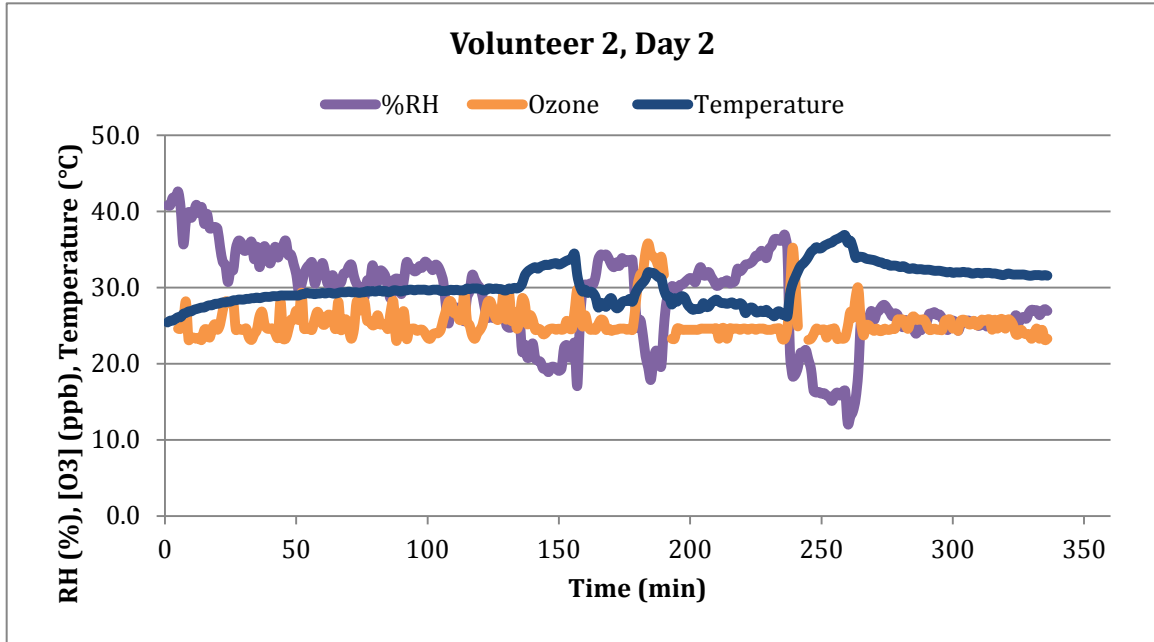
For Day 2, Volunteer 2 spent the first 34 minutes of the testing time frame in her front yard. At this time, temperature increased, %RH decreased and ozone levels fluctuated between 23 and 30 ppb. Between minutes 34 and 139, the volunteer was either in her front yard or inside her home. During this time, gaps are not seen in the ozone series; therefore, the ozone levels did not drop below detection levels when she was indoors. Also, %RH and temperature are consistent except for a drop in %RH during minutes 113 and 114. The volunteer was in transit between minutes 139 and 154. During this time %RH and ozone levels decreased and temperature increased. The volunteer was at her destination, a store, between minutes 154 and 244. While at the store, the %RH increased, decreased and increased again, temperature decreased, and ozone levels remained constant at first but then spiked, decreased to below detection levels and then remained constant at 25 ppb. As the volunteer was leaving the store, an increase in temperature and ozone levels and a drop in %RH can be seen. The volunteer was again in transit between minutes 244 and 259. During the transit period, %RH dropped to the lowest levels recorded for Day 2, temperature increased and ozone levels remained constant at 23 ppb. Volunteer 2 remained in her front yard or backyard for the remainder of the testing time frame for Day 2. When she arrived at her house, the ozone levels increased to 29 ppb for two minutes but then decreased 25 and remained constant for the remainder of the testing time frame. The %RH also remained constant and the temperature had a slight decrease during that time.

Figure 3.17: comparison of %RH, Temperature and ozone levels for Volunteer 2, day 2
