Consequences of four-point, strap-type wheelchair tiedown and occupant restraint system practices on wheelchair passenger safety in fixed-route transit.

CONSEQUENCES OF FOUR-POINT, STRAP-TYPE WHEELCHAIR TIEDOWN
AND OCCUPANT RESTRAINT SYSTEM PRACTICES ON WHEELCHAIR
PASSENGER SAFETY IN FIXED-ROUTE TRANSIT

A Dissertation
Submitted to the Faculty of the
J.B. Speed School of Engineering of the University of Louisville
in Partial Fulfillment of the Requirements
for the Degree of

Department of Mechanical Engineering
University of Louisville
Louisville, Kentucky

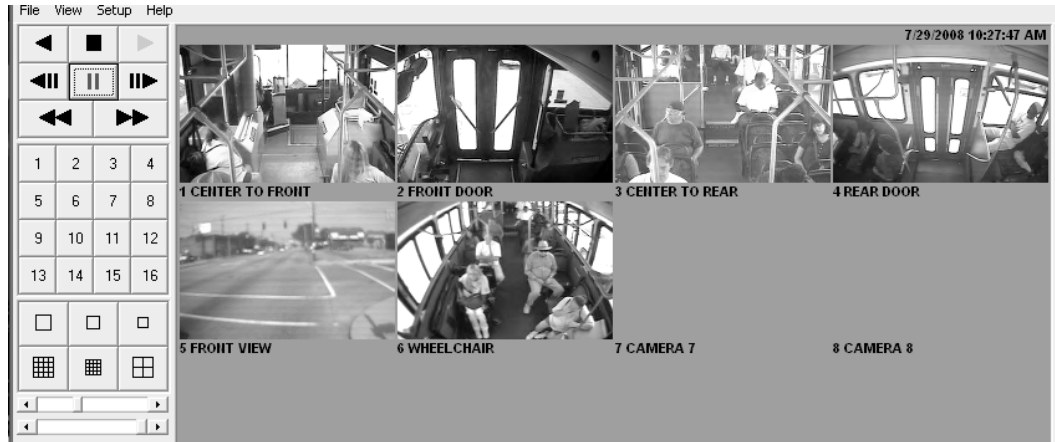
Figure 1. In-vehicle 6-camera LATV video surveillance system. This LATV was equipped with cameras to include views from the front windshield, front and rear of the LATV interior, and front and rear doors, as well as the wheelchair securement station.

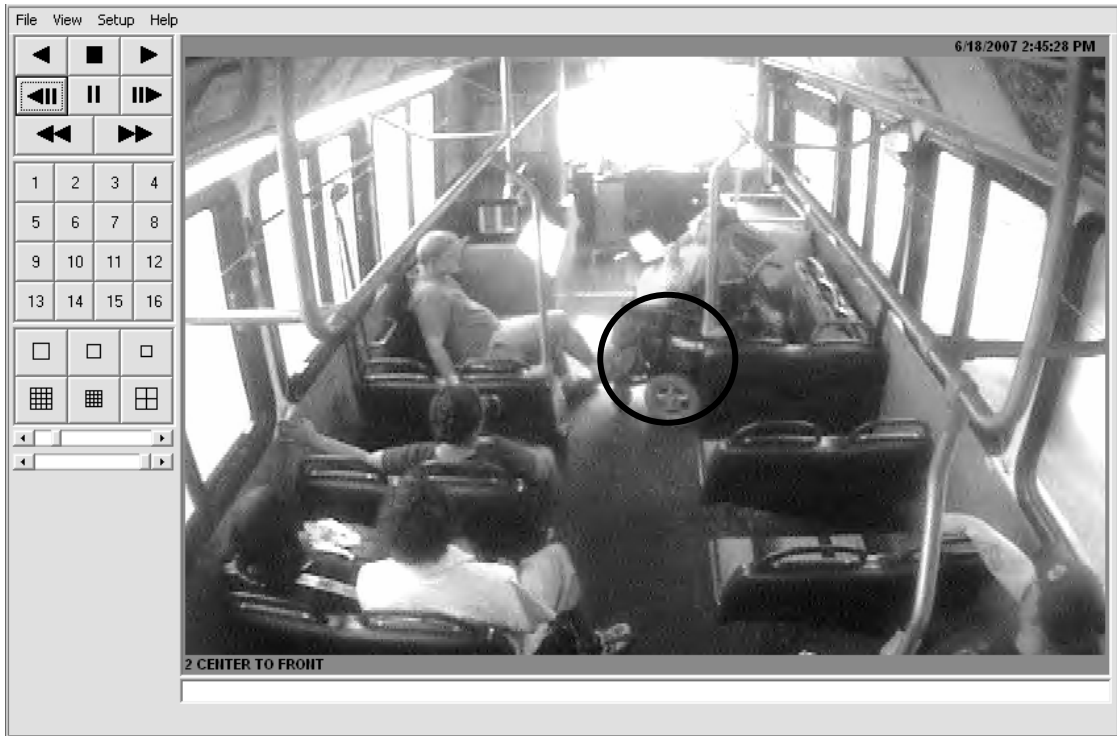
Figure 4. Case 1: Unsecured power wheelchair enters aisle during routine LATV transit, while sitting ambulatory passenger lifts foot to prevent injury and limit power wheelchair movement. (View from LATV rear).

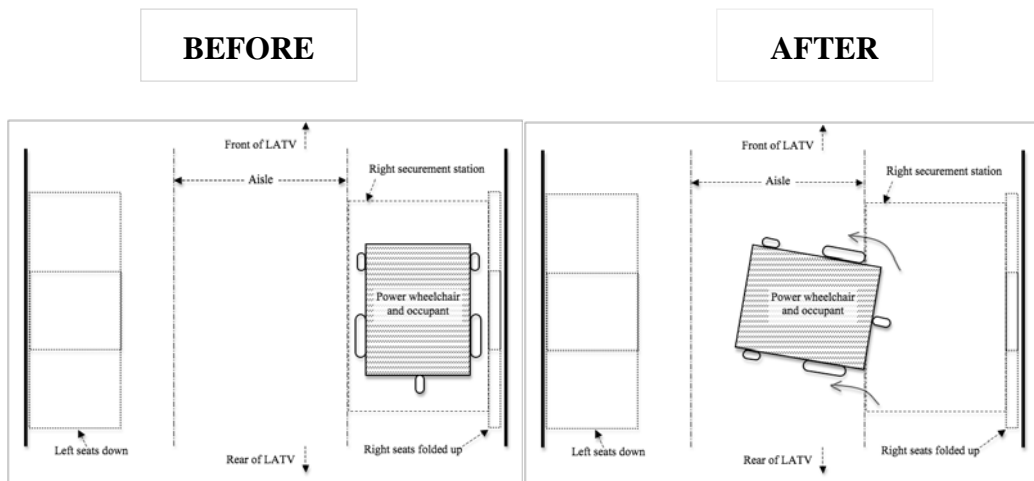
Figure 5. Diagram showing unsecured power wheelchair rotating laterally into aisle during routine LATV transit (Case 1).

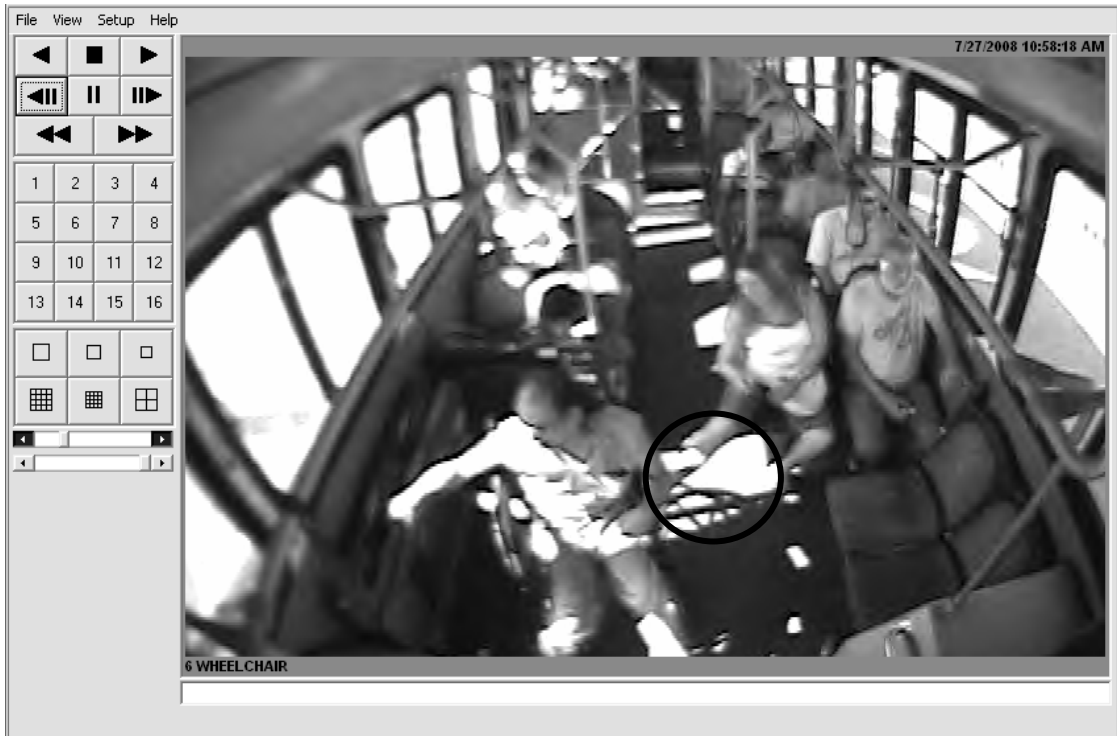
Figure 6. Case 2: Manual wheelchair passenger and wheelchair rotated into aisle as LATV performed a right turn. Wheelchair passenger stabilized himself by placing both feet on the floor and using his right arm to grab the folding-seat while an ambulatory passenger used her foot to prevent additional lateral excursion of the wheelchair. (View from LATV front).

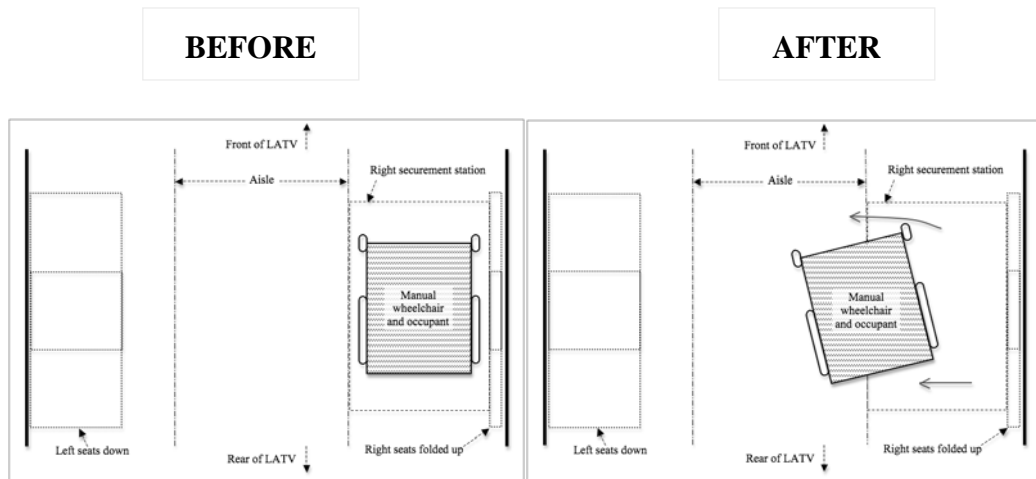
Figure 7. Diagram showing manual wheelchair and wheelchair passenger rotating laterally into the aisle during a routine right turn. Note: orientation of this diagram is 180° opposite of Figure 6 camera view.

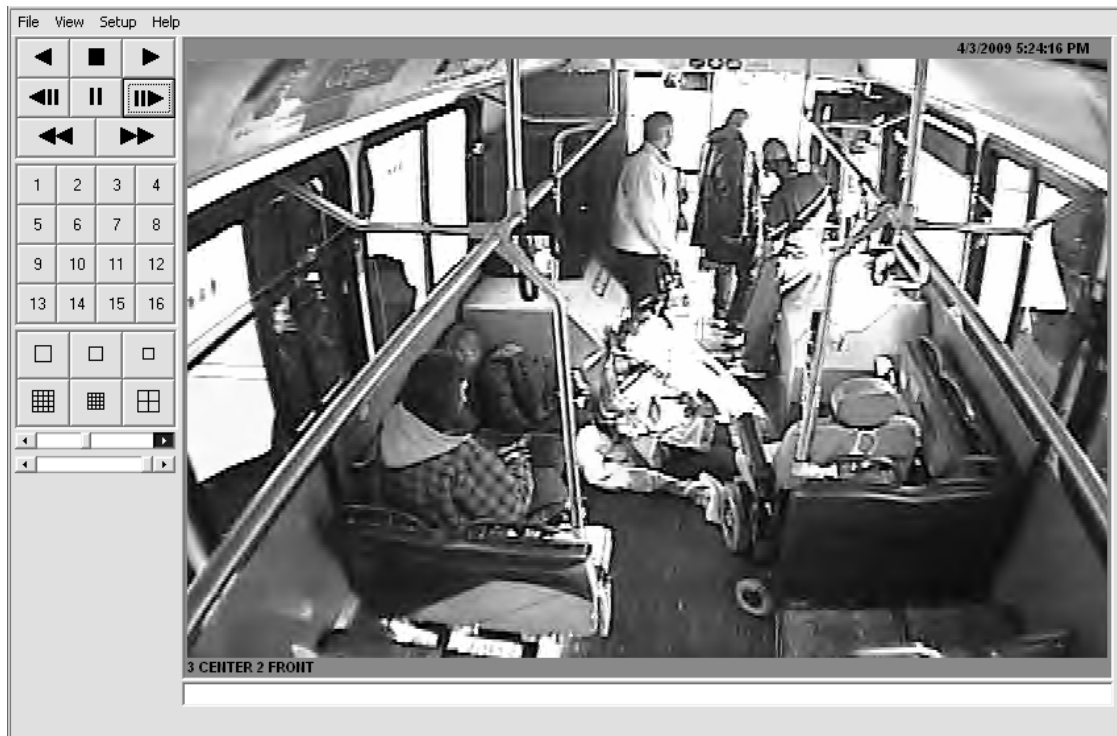
Figure 8. Case 3: Power wheelchair passenger ejected from wheelchair during normal LATV braking. Wheelchair passenger struck the bulkhead in front of the securement station and fell to the floor complaining of a fractured leg. (View from LATV rear).

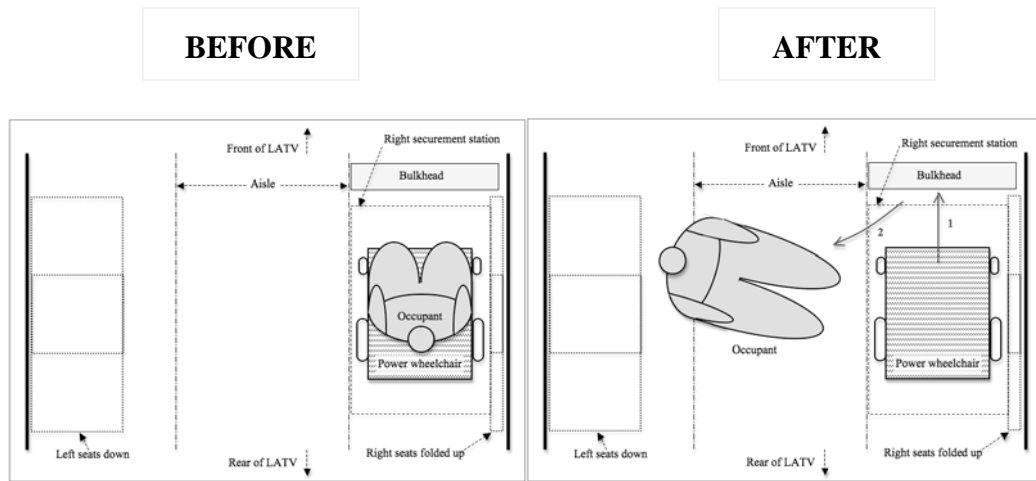
Figure 9. Diagram showing power wheelchair passenger ejected from power wheelchair during an apparent routine braking maneuver. During ejection, (1) the wheelchair passenger struck the LATV bulkhead directly in front of the right securement station, and then (2) fell to the floor in the aisle.

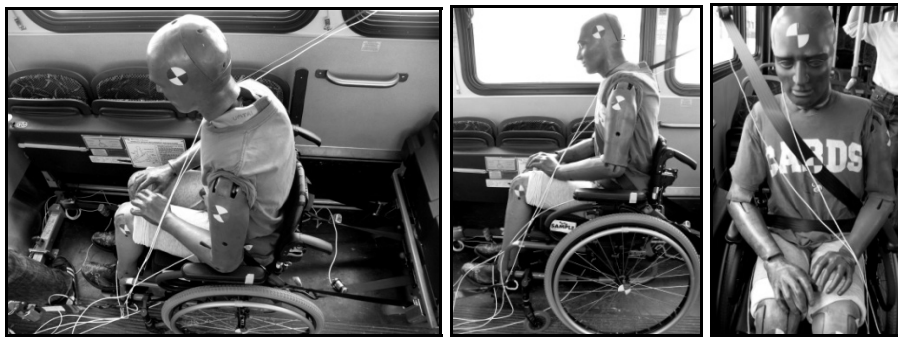
Figure 2A. Typical test setup of 50th percentile ATD seated in manual wheelchair with four tie-downs and lap and shoulder belt applied. Low-g accelerometers were mounted in the ATD head, chest, and pelvis as well as on the LATV floor (at securement station). Load cells were used to measure webbing tension in the tie-downs and lap and shoulder belts.

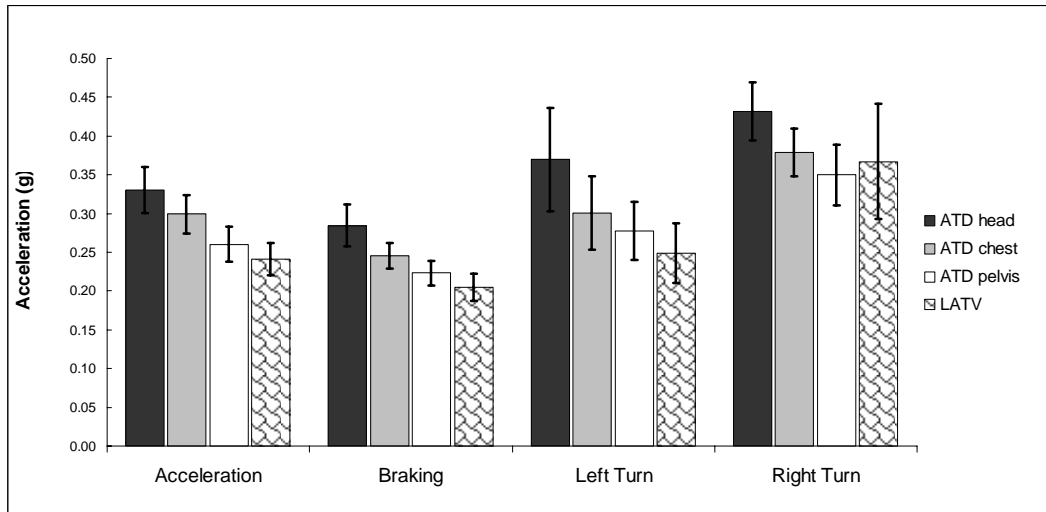
Figure 4. Mean peak resultant accelerations for ATD and LATV for acceleration (n=87), braking (n=81), left turn (n=10), and right turn maneuvers (n=10) under normal driving conditions. (Error bars indicate 95% confidence intervals).

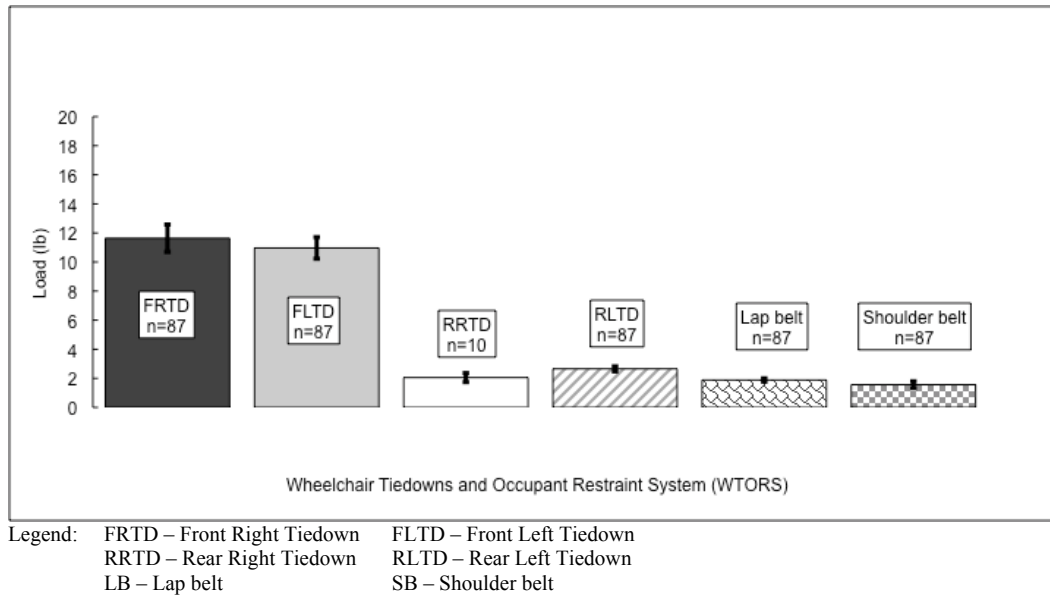
Figure 5. Mean peak WTORS loading for *acceleration* (from standstill) maneuvers under normal LATV driving conditions. (Error bars indicate 95% confidence intervals).

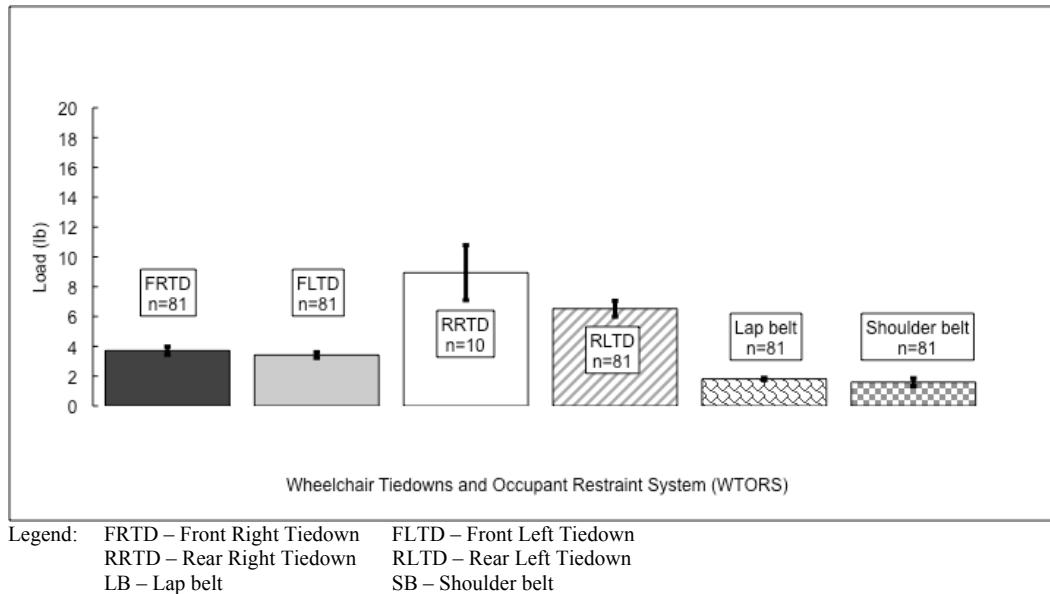
Figure 6. Mean peak WTORS loading for *braking* (to standstill) maneuvers under normal LATV driving conditions. (Error bars indicate 95% confidence intervals).

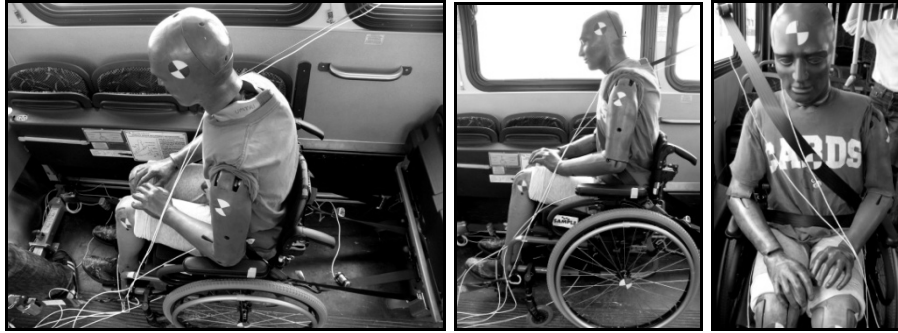
Figure 2A. Typical test setup of 50th percentile ATD seated in manual wheelchair with four tie-downs and lap and shoulder belt applied. Low-g accelerometers were mounted in the ATD head, chest, and pelvis as well as the LATV floor (at securement station) while load cells were used to measure webbing tension in the tie-downs and lap and shoulder belts.

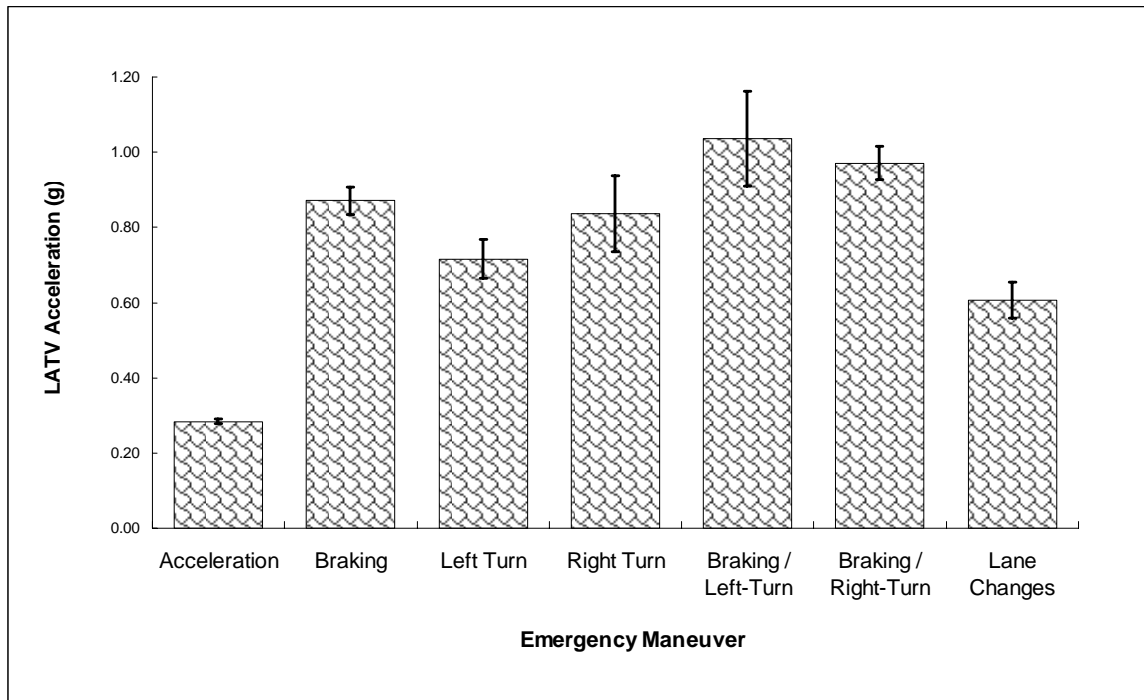
Figure 5. Mean peak LATV resultant accelerations (independent of WTORS configuration) for acceleration (n=7), braking (n=5), left turn (n=6), right turn (n=6), braking/left-turn (n=4), braking/right-turn (n=5), and lane change (n=4) maneuvers under emergency driving conditions. (Error bars indicate 95% confidence intervals).

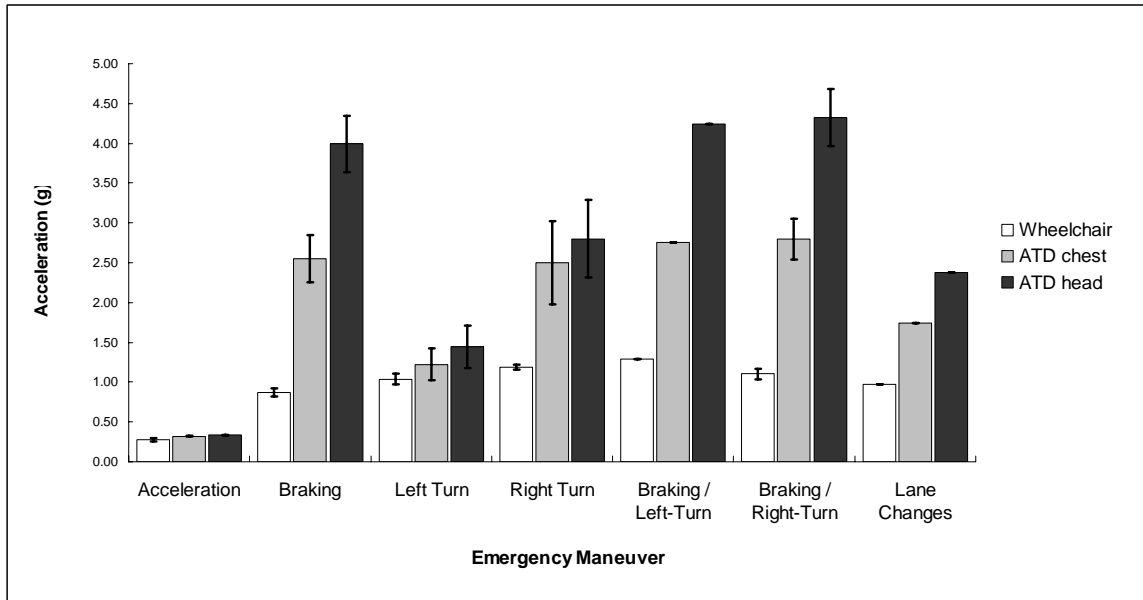
Figure 6. Mean peak resultant accelerations for ATD and wheelchair (proper WTORS use, configuration C) for acceleration (n=3), braking (n=3), left turn (n=3), right turn (n=3), braking/left-turn (n=2), braking/right-turn (n=3), and lane change (n=2) maneuvers under emergency driving conditions. (Error bars indicate 95% confidence intervals; error bars not shown for sample sizes $n < 3$).

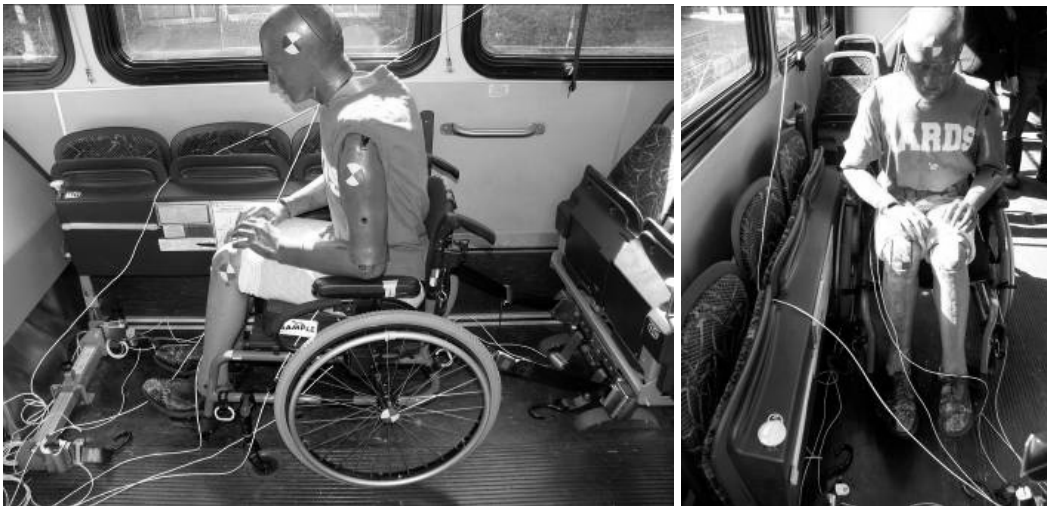
Figure 1A. Test setup of 50th percentile ATD seated in manual wheelchair within LATV securement station. The lap belt was used in an attempt to secure the wheelchair (routed around the seatback). The tiedowns and shoulder belt were not applied.

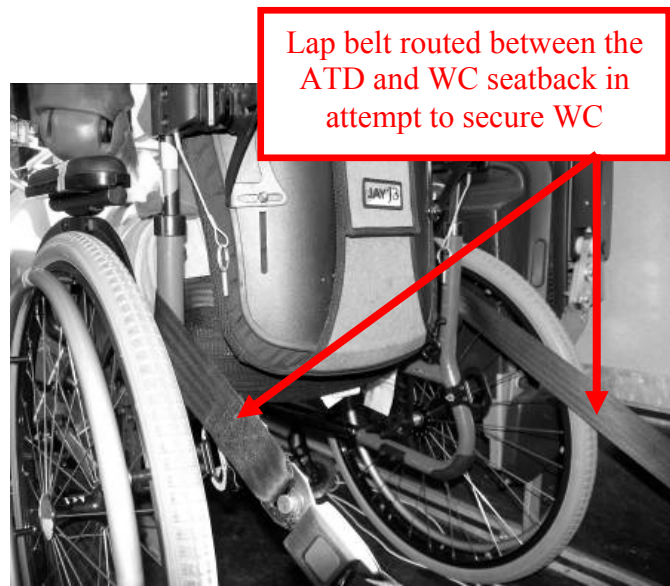
Figure 1B. Test setup of 50th percentile ATD seated in manual wheelchair with lap belt used in an attempt to secure the wheelchair (routed around the seatback). The tiedowns and shoulder belt were not applied.

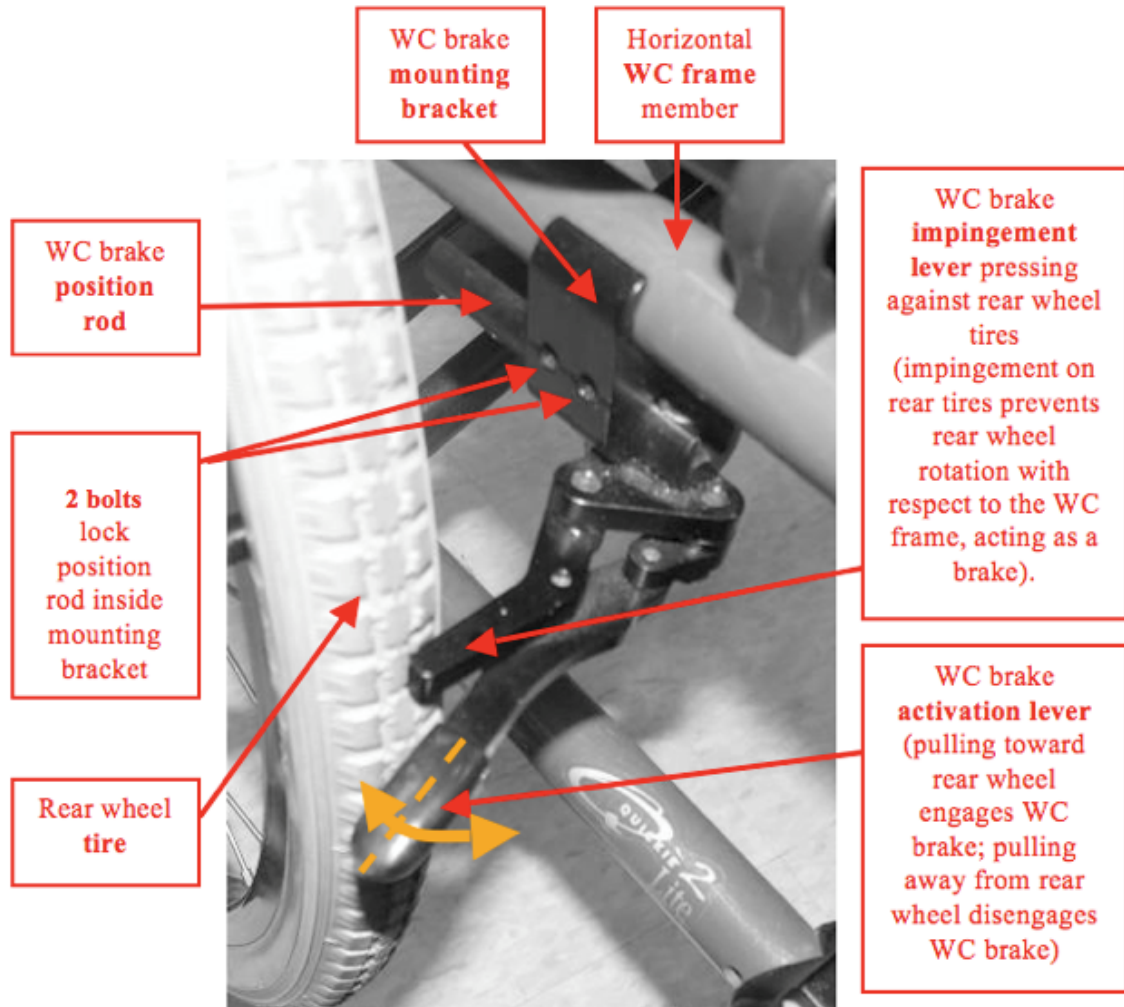
Figure 2. Design of manual wheelchair (compact scissor) brake. The brake is shown in the engaged position. To securely clamp the brake to the wheelchair frame, the two bolts were tightened to lock the position rod inside the mounting bracket. With the position rod fixed relative to the mounting bracket (and therefore the wheelchair frame), the impingement lever (attached to the position rod) was able to effectively impinge the rear wheel tire to prevent rear wheel rotation with respect to the wheelchair frame.

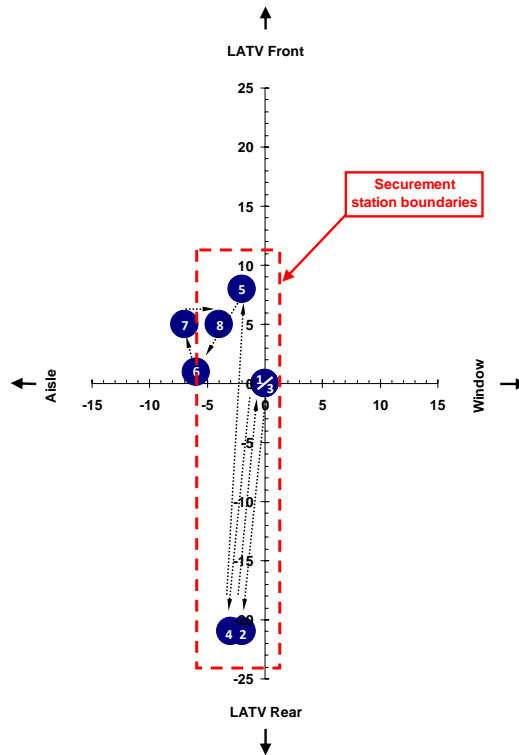
<u>Wheelchair Location</u>	<u>Event Observed</u>
①	Wheelchair starting position
②	Wheelchair seatback strikes rear barrier of securement station Wheelchair front wheels lift off as wheelchair tilts rearward
③	Wheelchair rolls back to initial position
④	Wheelchair seatback strikes rear barrier of securement station Wheelchair front wheels lift off as wheelchair tilts rearward
⑤	Wheelchair rolls forward
⑥	Wheelchair rear rotates clockwise into aisle
⑦	Wheelchair front rotates counter-clockwise into aisle
⑧	Wheelchair rear rotates clockwise, wheelchair nearly perpendicular to securement station

4. Wheelchair trajectory during trial 2 (brake mounting hardware loosely clamped to the wheelchair frame). The dark-shaded circular markers represent wheelchair locations (rear axle) at sequential points over trial duration. Dimensions are in inches.....	99

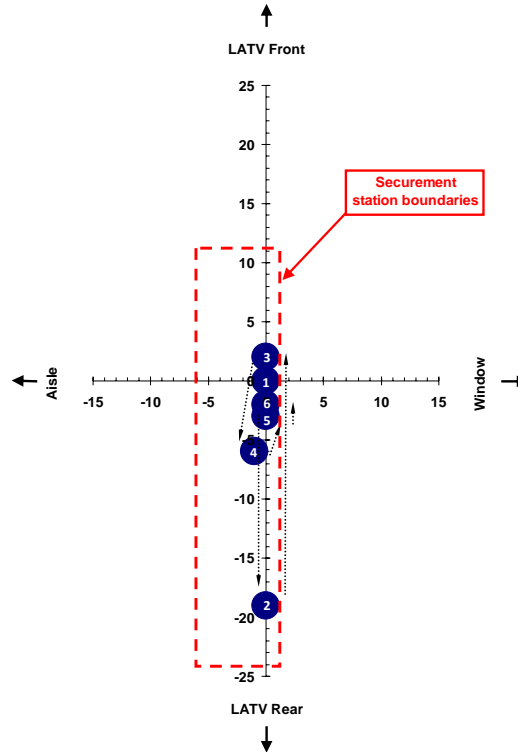
<u>Wheelchair Location</u>	<u>Event Observed</u>
①	Wheelchair starting position
②	Wheelchair seatback strikes rear barrier of securement station Wheelchair front wheels lift off as wheelchair tilts rearward
③	Wheelchair rolls within securement station
④	Wheelchair rear rotates clockwise
⑤	Wheelchair rolls within securement station
⑥	Wheelchair rolls within securement station

5. Wheelchair trajectory during trial 3 (brake mounting hardware loosely clamped to the wheelchair frame). The dark-shaded circular markers represent wheelchair locations (rear axle) at sequential points over trial duration. Dimensions are in inches.....	101

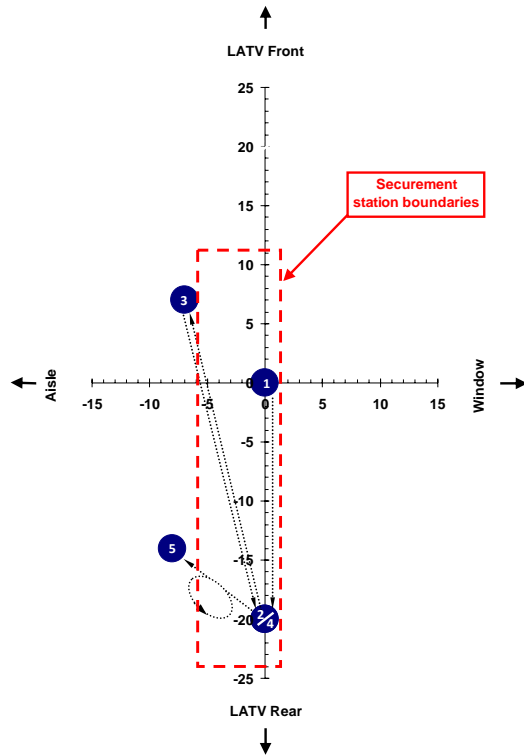
<u>Wheelchair Location</u>	<u>Event Observed</u>
①	Wheelchair starting position
②	Wheelchair seatback strikes rear barrier of securement station
③	ATD feet strike front barrier of securement station Wheelchair front rotates counter-clockwise into aisle
④	Wheelchair seatback strikes rear barrier of securement station Wheelchair front wheels lift off as wheelchair tilts rearward
⑤	Wheelchair front rotates counter-clockwise into aisle Wheelchair flips over completely; ATD head strikes rear sec station barrier

6. Wheelchair trajectory during trial 4 (brake mounting hardware loosely clamped to the wheelchair frame). The dark-shaded circular markers represent wheelchair locations (rear axle) at sequential points over trial duration. Dimensions are in inches.....	102

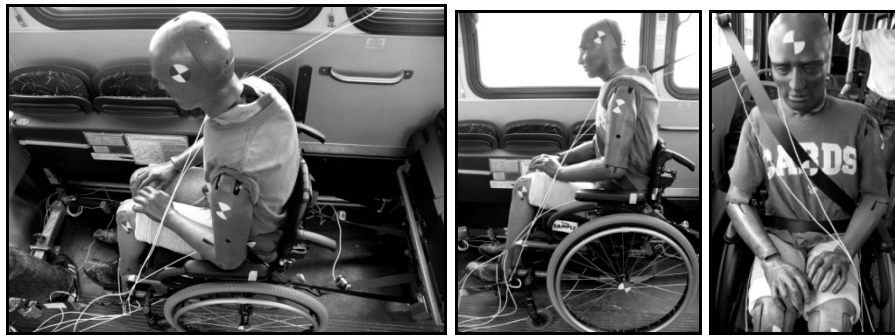
Figure 1. Test setup of 50th percentile ATD seated in manual wheelchair with four tiedowns and lap and shoulder belt applied. Low-g accelerometers were mounted in the ATD head and chest, the wheelchair CG, as well as on the LATV floor (at securement station). Load cells were used to measure webbing tension in the tiedowns and lap and shoulder belts.

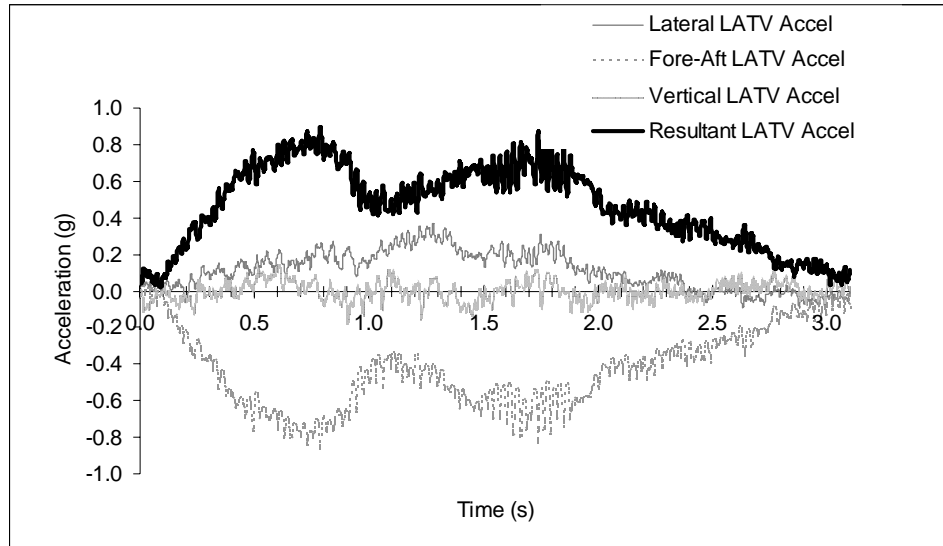
Figure 2. Experimental LATV acceleration pulse during a LATV emergency combination braking/left-turn maneuver.

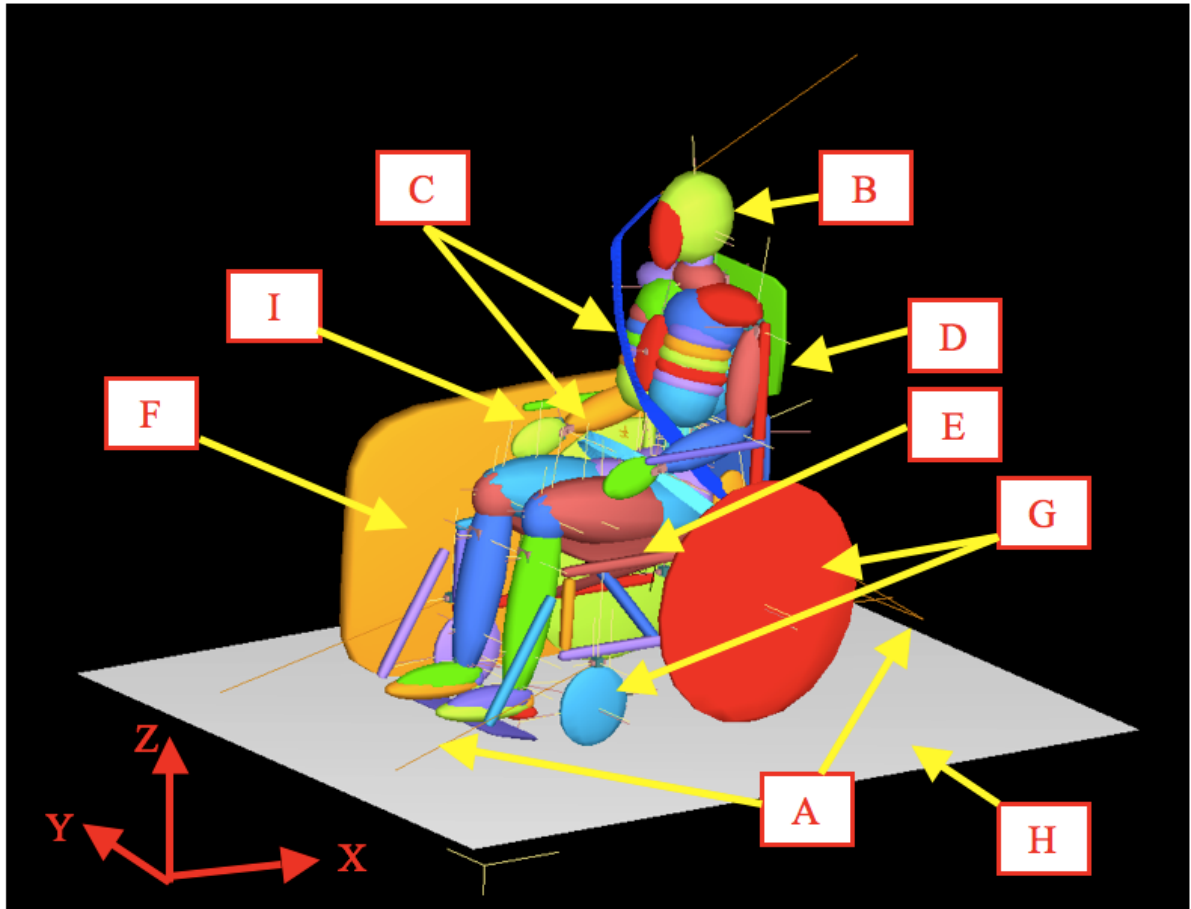
- Legend:
- A – front and rear tiedowns
 - B – 50th percentile male Hybrid II ATD representing wheelchair user
 - C – lap and shoulder belts
 - D – wheelchair seatback
 - E – wheelchair seat
 - F – wheelchair frame
 - G – front and rear wheels
 - H – LATV and LATV securement station
 - I – folding seat

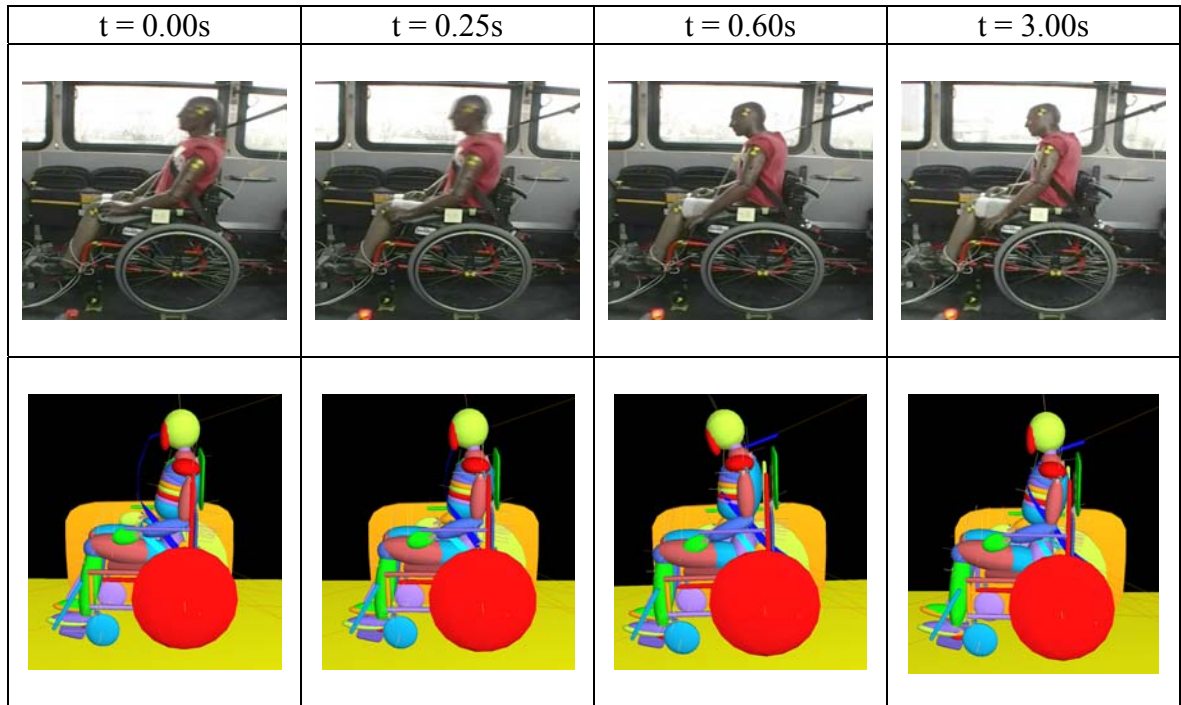
Figure 4. Frame Sequence of Experimental Test (Top) and Computer Simulation Model (Bottom).

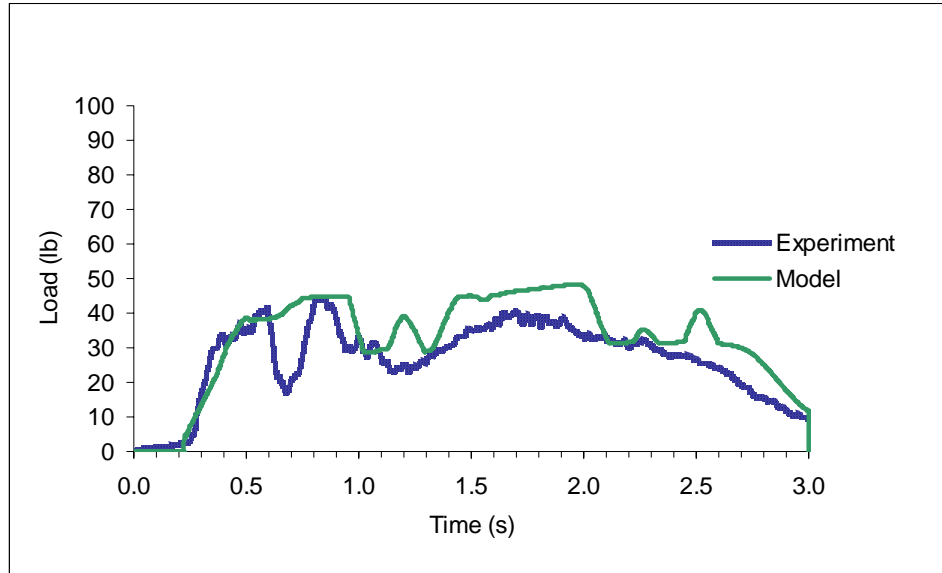
Figure 5. Right rear tiedown loading: model (solid line) vs. experiment (dashed).

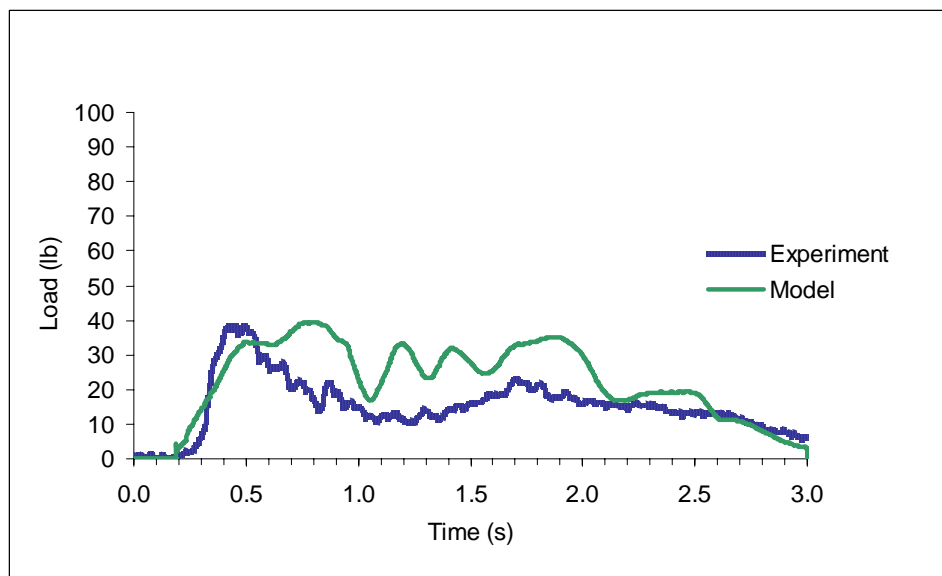
Figure 6. Left rear tiedown loading: model (solid line) vs. experiment (dashed).

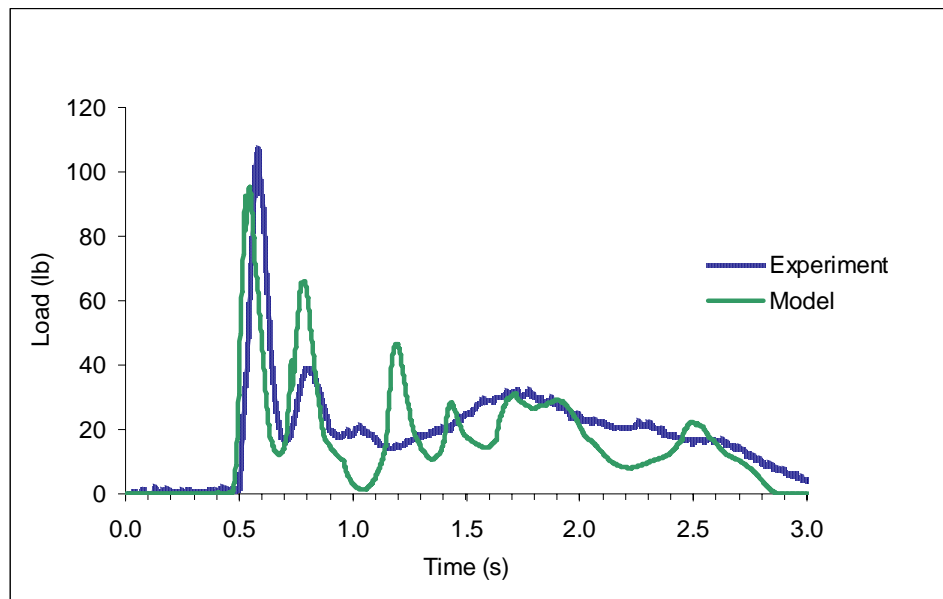
Figure 7. Shoulder belt loading: model (solid line) vs. experiment (dashed).

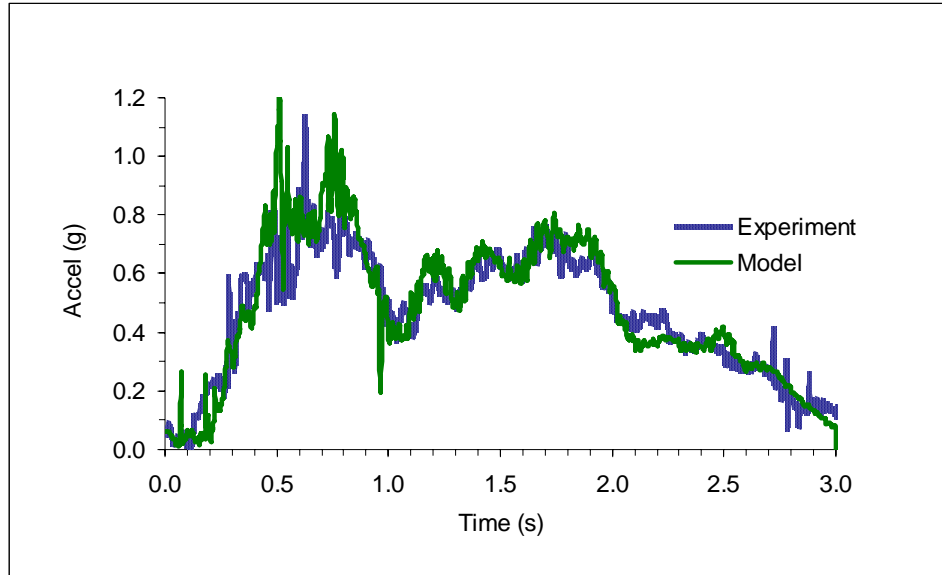
Figure 8. Wheelchair resultant acceleration: model (solid line) vs. experiment (dashed).

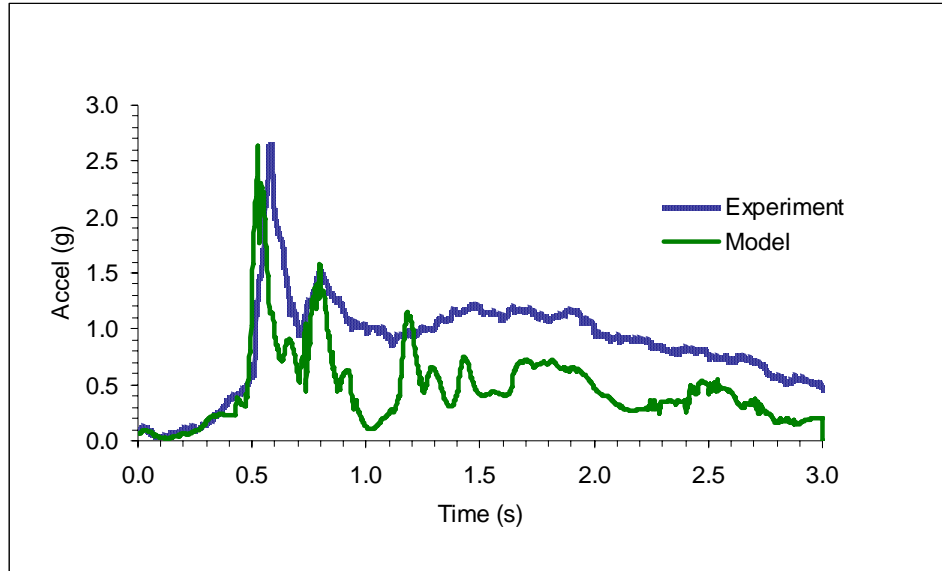
Figure 9. ATD chest resultant acceleration: model (solid line) vs. experiment (dashed).

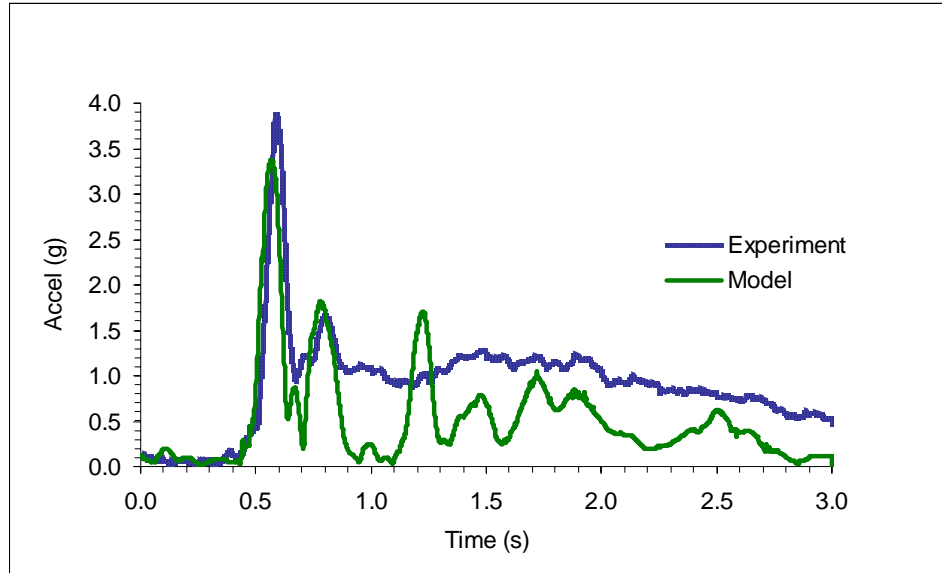
Figure 10. ATD head resultant acceleration: model (solid line) vs. experiment (dashed).

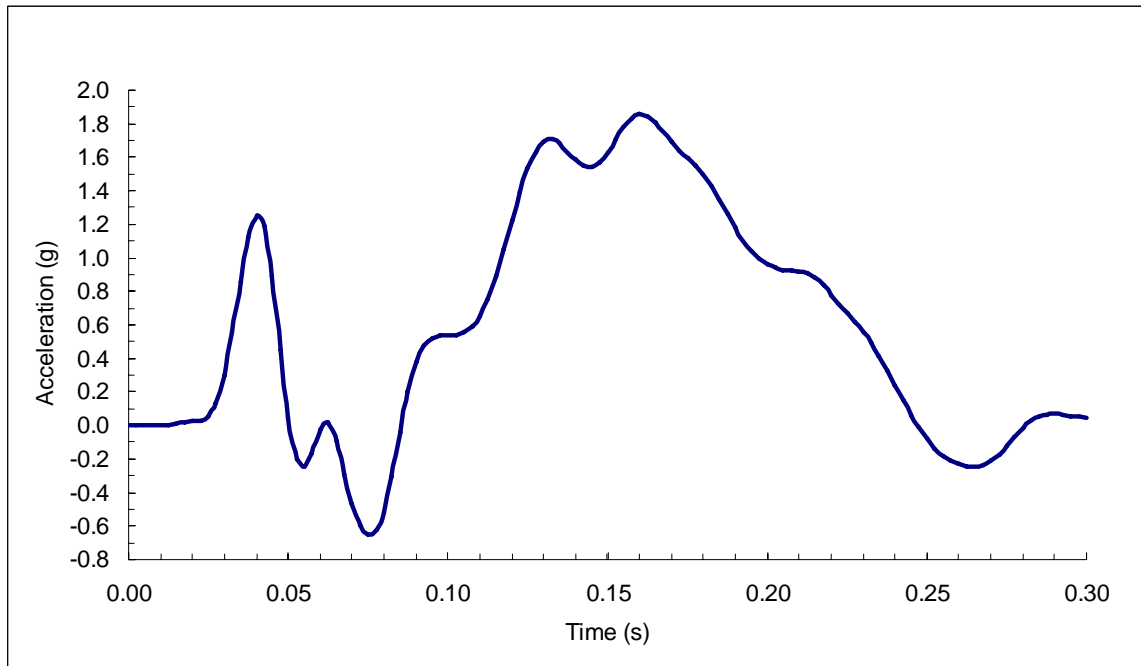
Figure 1. LATV deceleration pulse of sedan automobile frontal impact into LATV. Pulse peak is 2g (frontal crash).

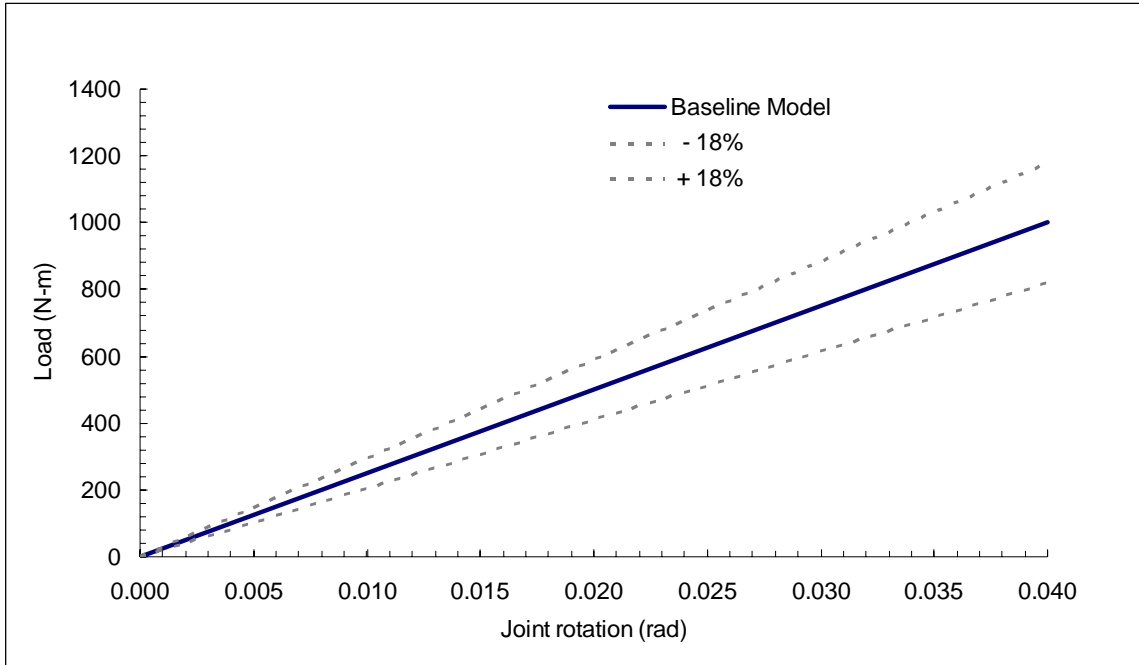
Figure 2. LATV suspension stiffness range in parametric sensitivity analysis. Computer model simulated LATV suspension during an emergency braking maneuver as a rotational joint positioned at the center of the securement station platform (allowing platform fore-aft tilt). Joint baseline stiffness in model is depicted with a solid line. The LATV suspension stiffness was varied $\pm 18\%$ (dashed lines) based on published acceleration differences associated with varying LATV suspensions.

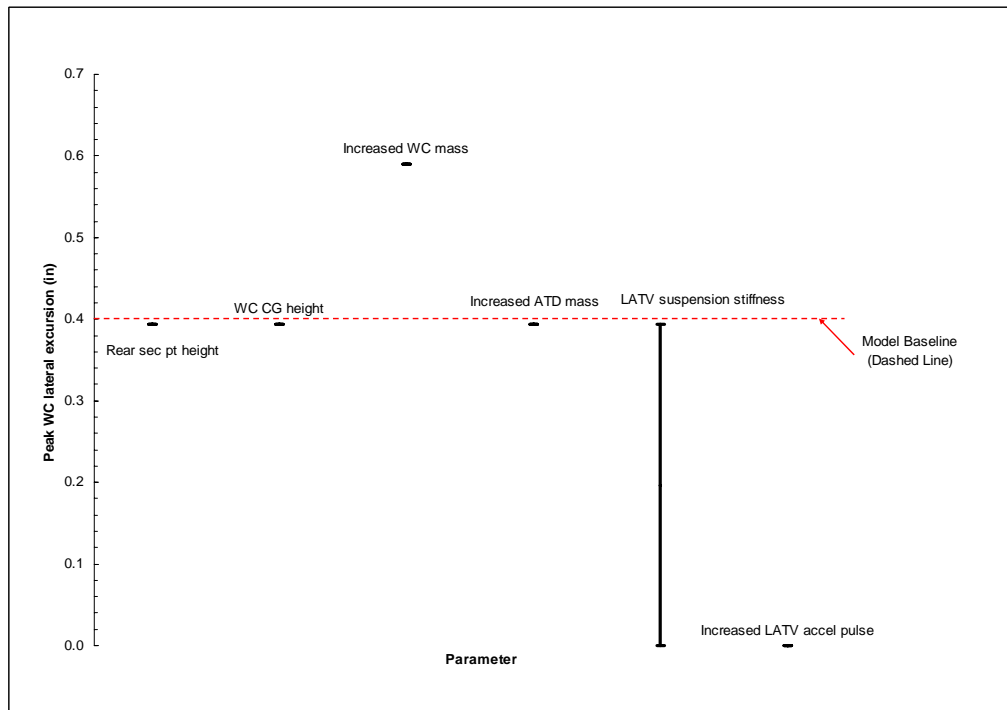
Figure 6. Range of peak wheelchair lateral excursion values for each parameter varied in the sensitivity analysis. Red dashed line shows model baseline value.
