Consequences of four-point, strap-type wheelchair tiedown and occupant restraint system practices on wheelchair passenger safety in fixed-route transit.

CONSEQUENCES OF FOUR-POINT, STRAP-TYPE WHEELCHAIR TIEDOWN
AND OCCUPANT RESTRAINT SYSTEM PRACTICES ON WHEELCHAIR
PASSENGER SAFETY IN FIXED-ROUTE TRANSIT

A Dissertation
Submitted to the Faculty of the
J.B. Speed School of Engineering of the University of Louisville
in Partial Fulfillment of the Requirements
for the Degree of

Department of Mechanical Engineering
University of Louisville
Louisville, Kentucky

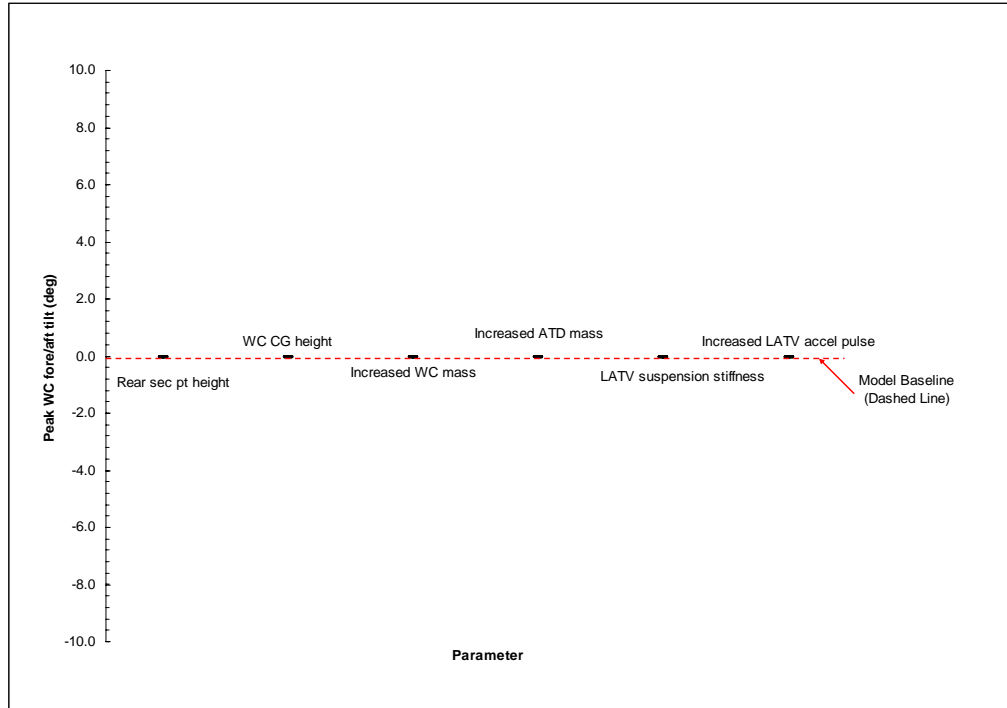
Figure 7. Range of peak wheelchair fore/aft tilt values for each parameter varied in the sensitivity analysis. Red dashed line shows model baseline value.

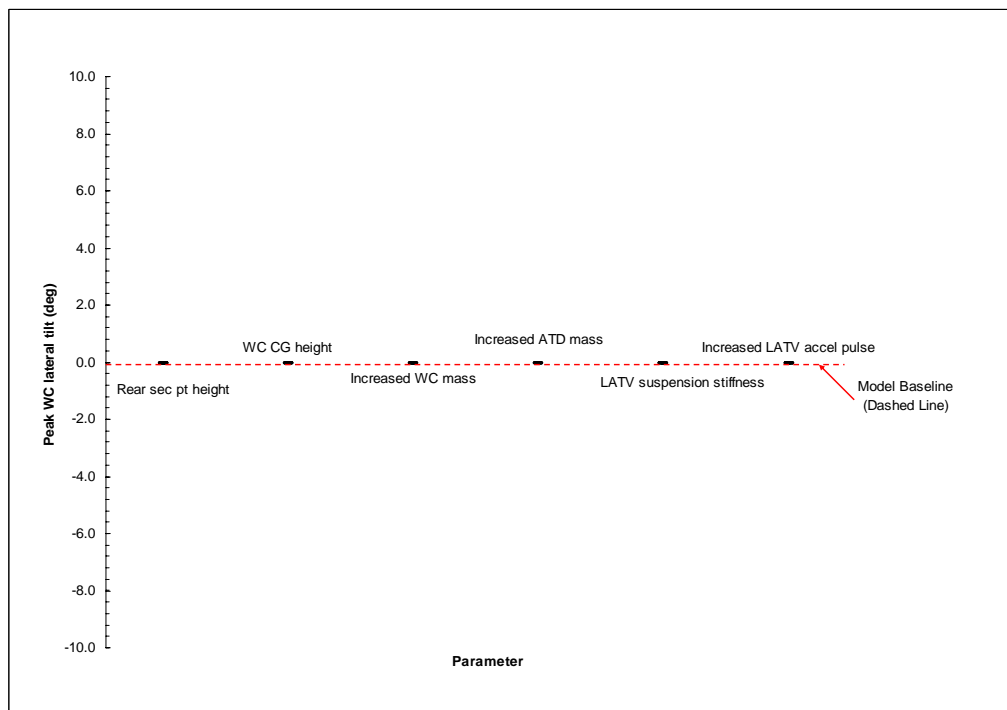
Figure 8. Range of peak wheelchair lateral tilt values for each parameter varied in the sensitivity analysis. Red dashed line shows model baseline value.

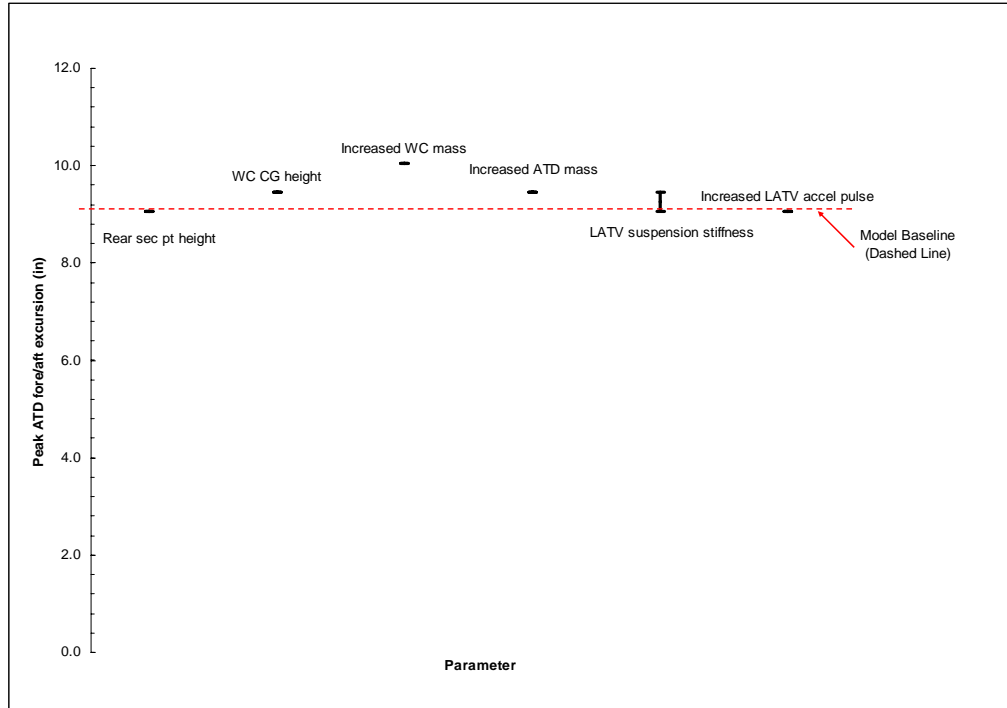
Figure 9. Range of peak ATD fore/aft excursion values for each parameter varied in the sensitivity analysis. Red dashed line shows model baseline value.
