Efficacy of Geosynthetic Separators and Filters: An Evaluation of Test Sections in Marked Tree, Arkansas

A thesis submitted in partial fulfillment
of the requirements for the degree of
Master of Science in Civil Engineering

May 2012
University of Arkansas

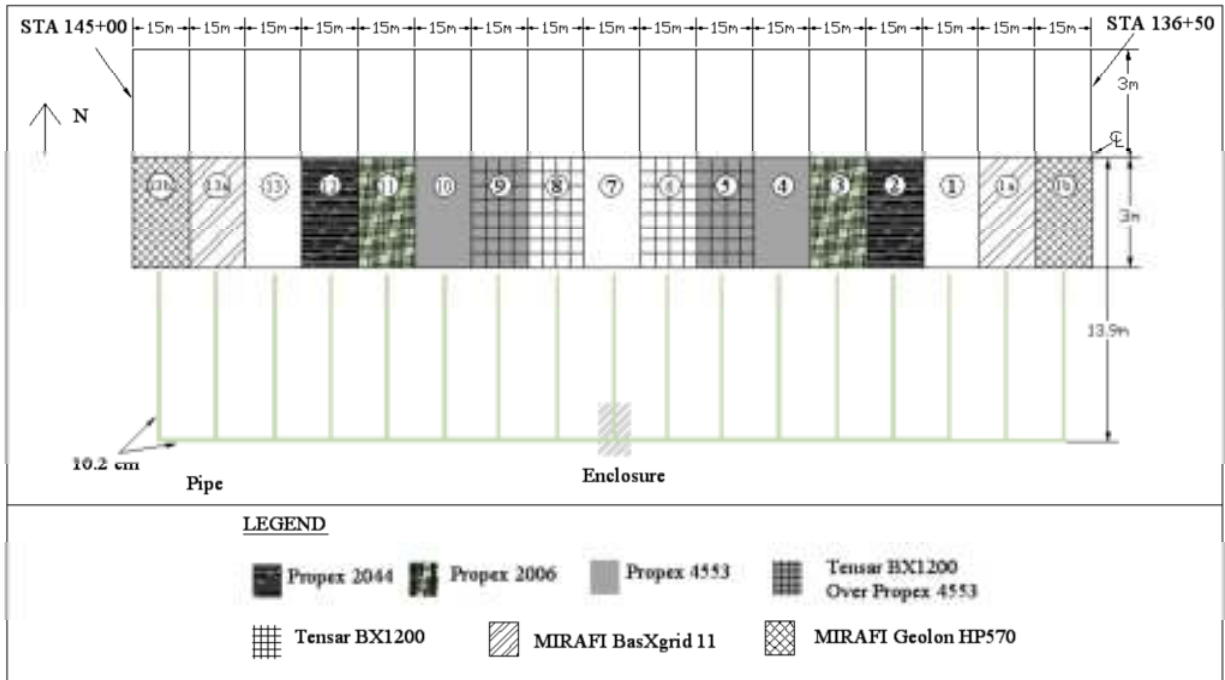
As presented in Figure 2.2a, these test sections contained control sections and various geosynthetic configurations including geotextile, geogrid, or geogrid on top of geotextile. These sections were heavily instrumented with asphalt strain gauge, earth pressure cells, geotextile strain gauges, geogrid strain gauges, moisture content probes, piezometers, and thermocouples (Figure 2.2b). The effects of including geosynthetics within the pavements of low volume roads constructed on poor subgrade soils encompassing different base course thicknesses and utilizing different types of geosynthetics was the focus of this research (Howard, 2006).

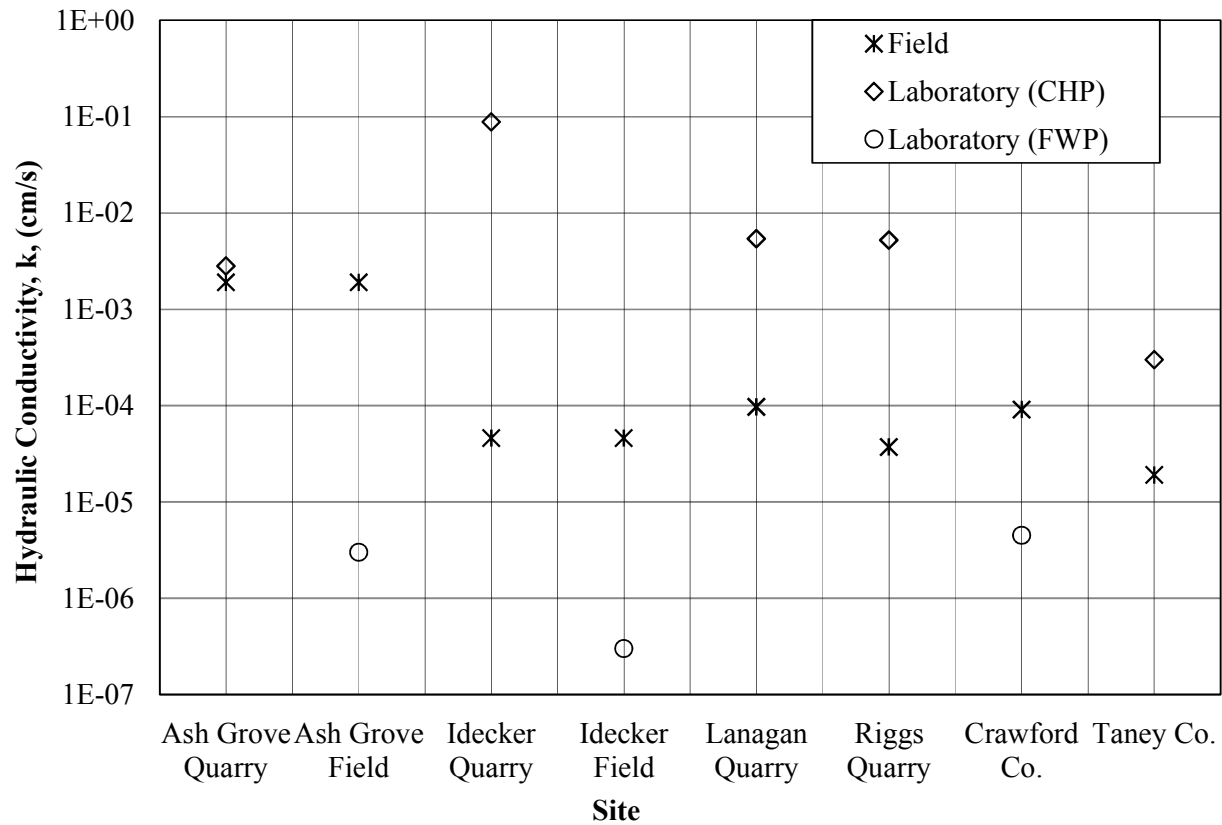
Figure 2.5. Field and laboratory measured hydraulic conductivities (modified from Blanco, 2003).

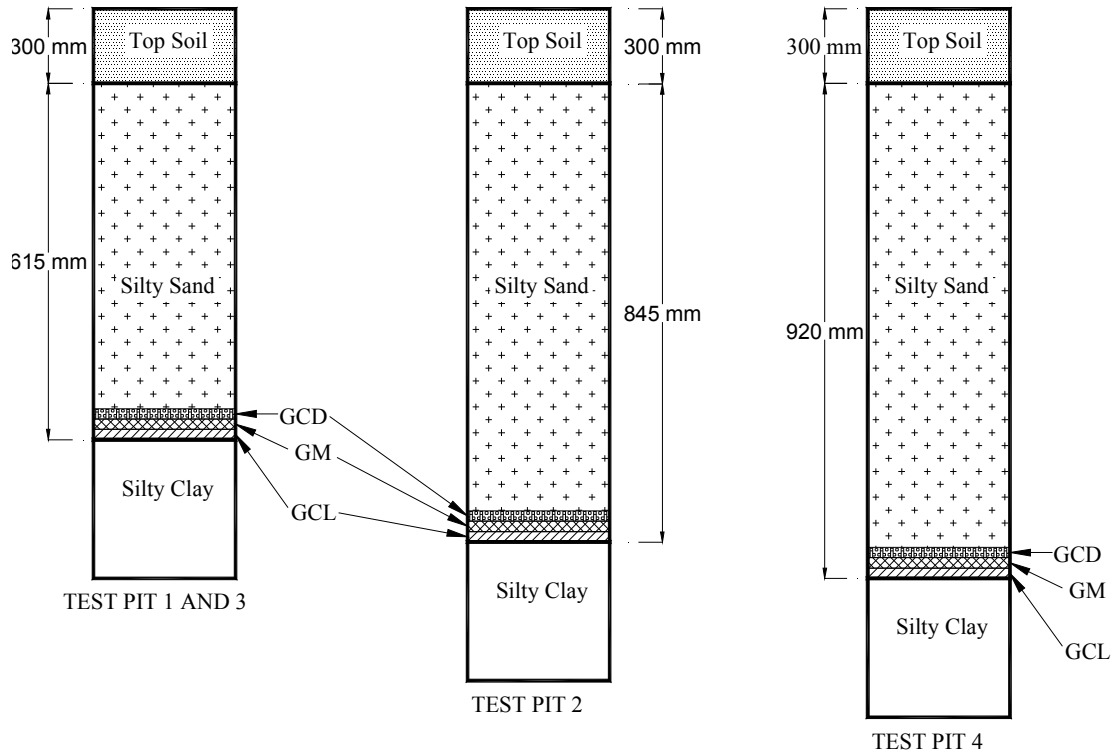
Figure 2.12. Profile of test pits 1 to 4 (from Benson et al., 2010).

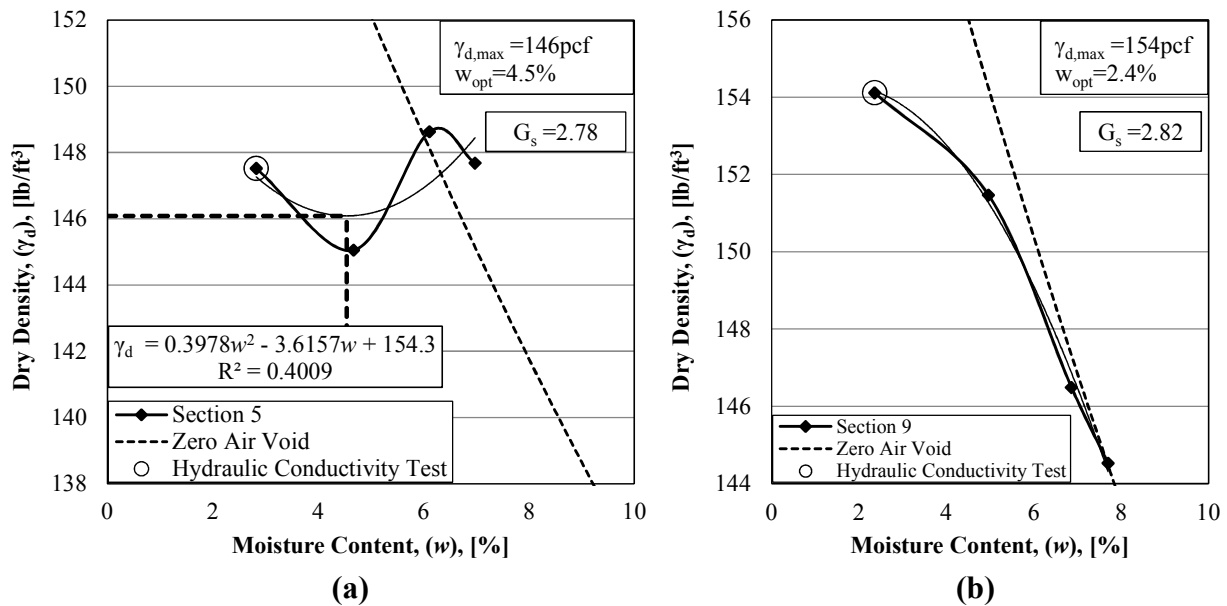
Figure 4.21. a) Proctor curve for Section 5 (ten-inch thick section), and b) Proctor curve for Section 9 (six-inch thick section).

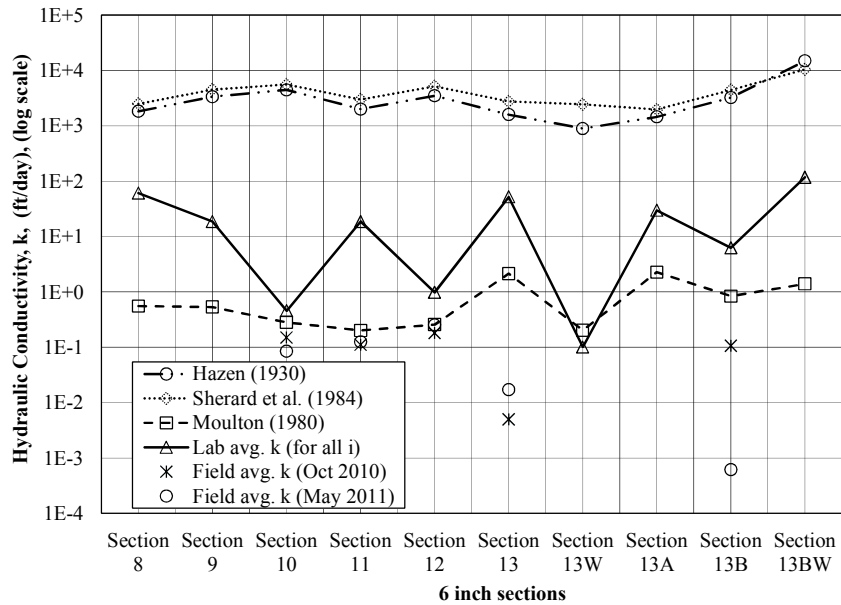
Figure 4.27. Estimated hydraulic conductivity, laboratory obtained average hydraulic conductivity (k) for interface base course sample, and in-situ average apparent hydraulic conductivity (Stage 1) for the six-inch thick sections.

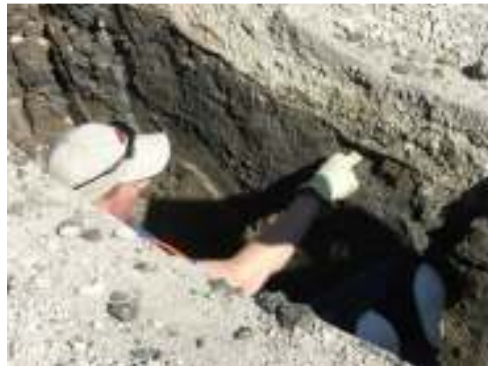
Figure 4.32. Void space observed (Section 13BW) underneath the geotextile.

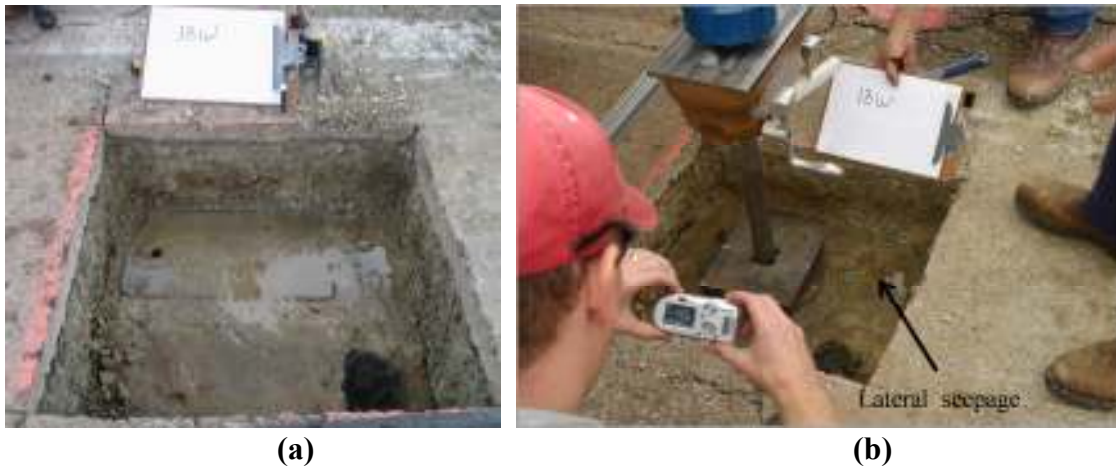
Figure 4.35. Lateral seepage observed in subgrade of Section 13W a) after DCP testing and b) after completion of CBR testing.
