Pavement Surface Distress Detection, Assessment, and Modeling Using Geospatial Techniques

**PAVEMENT SURFACE DISTRESS DETECTION,
ASSESSMENT, AND MODELING
USING GEOSPATIAL TECHNIQUES**

DISSERTATION

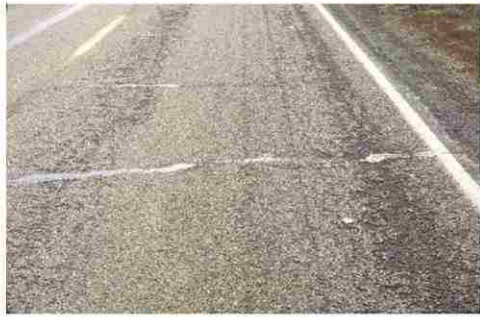
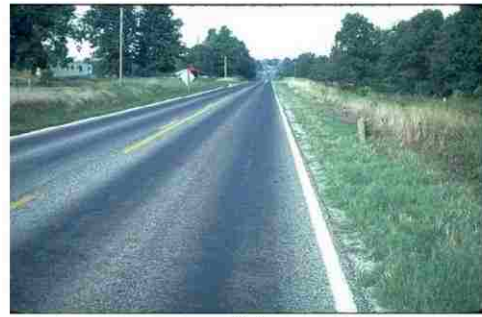
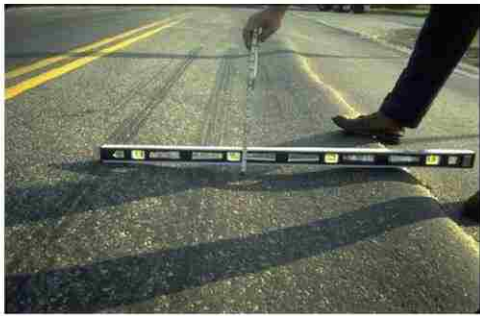
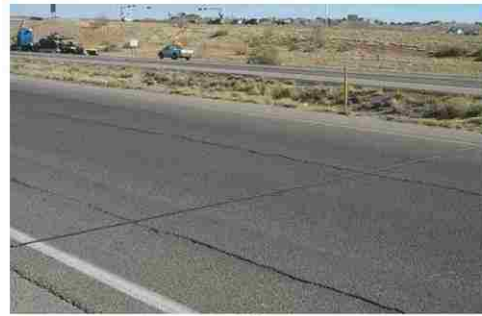
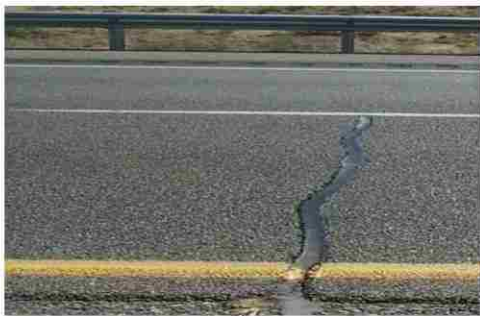
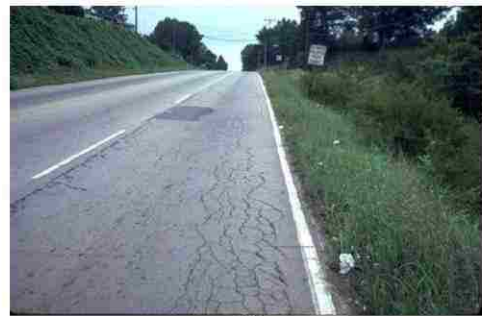
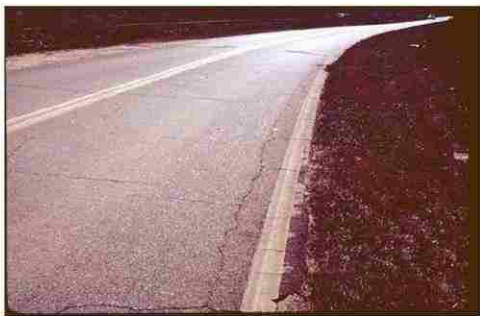
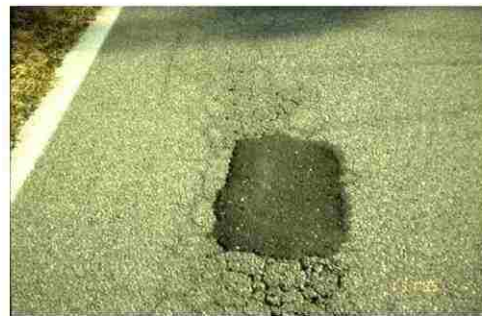
Figure 1. Illustration of flexible pavement surface distress; (a) raveling and weathering; (b) bleeding; (c) rutting and shoving; (d) longitudinal cracking; (e) transverse cracking; (f) alligator cracking; (g) edge cracking; (h) patching.

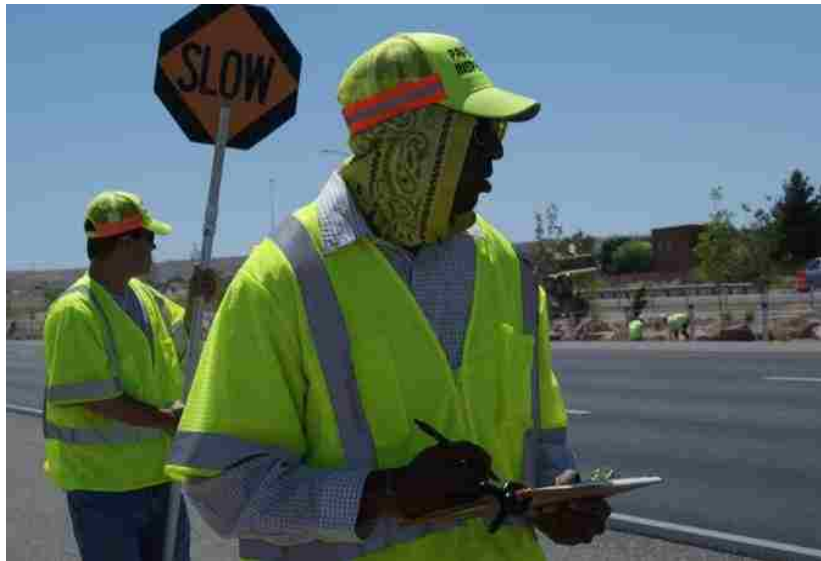
Figure 3. Illustration of manual evaluation walking along the shoulder.

In addition, manual evaluation relies on the subjective evaluation of distress type extent, and severity by a trained inspector based on visual observation (Hudson and Uddin 1987), which means the evaluation results are prone to subjective bias. Another problem with manual evaluation is that it is potentially dangerous to inspectors. Survey crews must walk along the side of the road to perform their evaluation and, despite safety precautions (e.g., safety training and high-visibility garments), are exposed to substantial risk of personal injury, especially in high traffic volume sections.

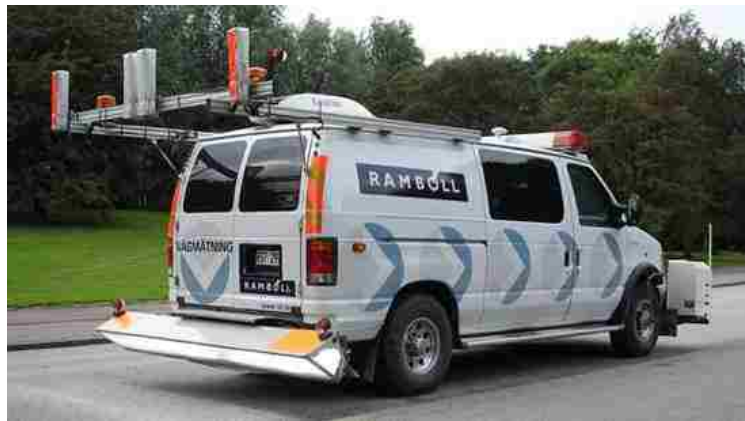
Figure 4. Automatic pavement surface distress evaluation system.

The application of video camera based automated evaluation became common in the 1980s (Hudson and Uddin 1987). The development of automated pattern recognition techniques for quantifying surface distress from video film or image frame has led to much wider application of video and image processing technology in pavement surface distress evaluation (Hudson and Uddin 1987; Curphey et al. 1985; Haas et al. 1985). Video cameras, which are mounted to mobile platforms such as survey vans, are used to record video films or image frames of the pavement surface, while pattern recognition techniques are used to analyze the collected videos or images and extract pavement surface distress information.

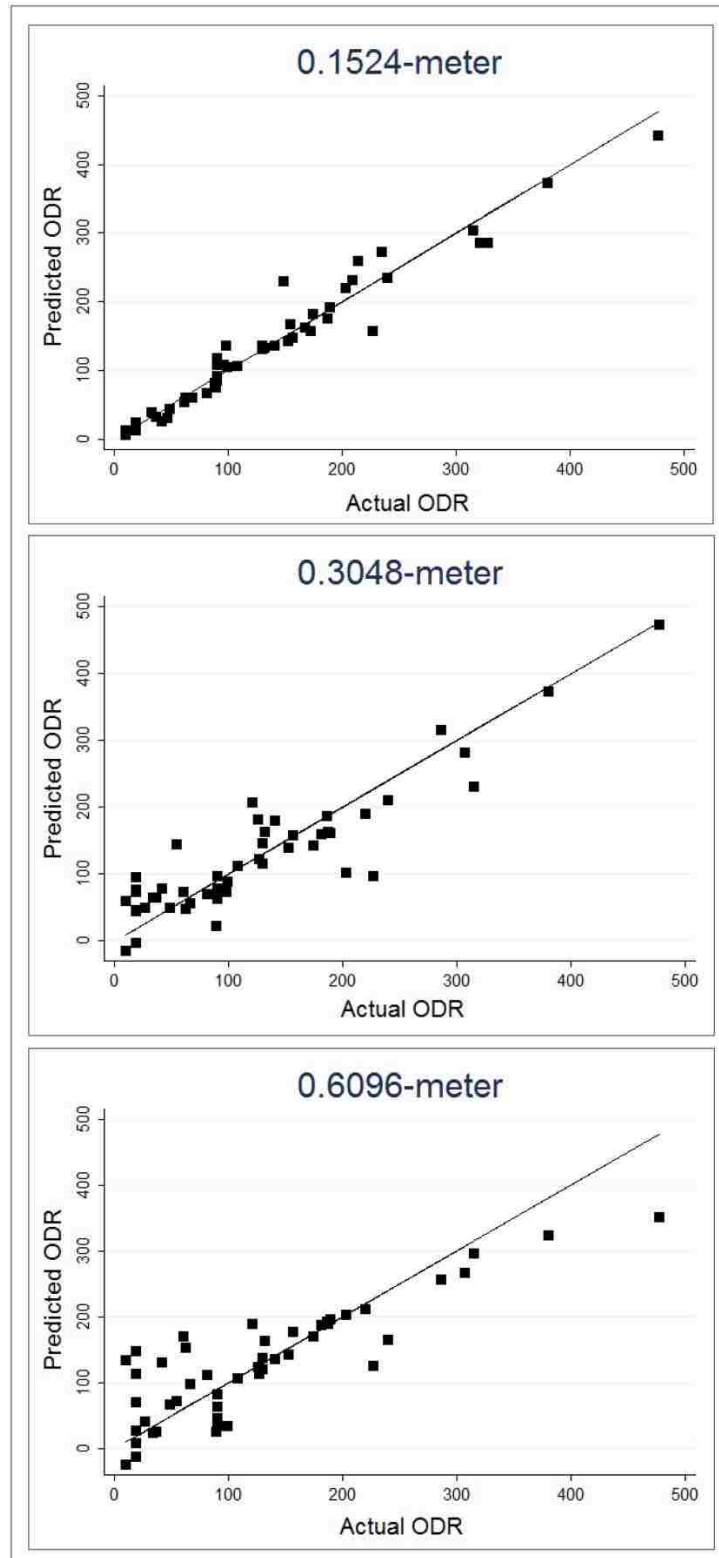
Figure 6. Correlation of predicted ODR versus actual ODR for (a) 6-inch, (b) 12-inch, (c) 24-inch natural color digital aerial photography.

The 24-inch linear regression model is valid at a 95% confidence interval (joint P -value (Prob > F) is less than 0.001). The adjusted R-squared value is 0.6771 and RMSE is 57.645. This implies that natural color aerial photographs with 24-inch resolution can still be used to assess and predict overall pavement surface distress rates, but with the highest error of the resolutions assessed. However, it is still better than the manual evaluation ($57.645 < 84$) and it has the advantage of lower cost when compared to higher spatial resolution datasets.

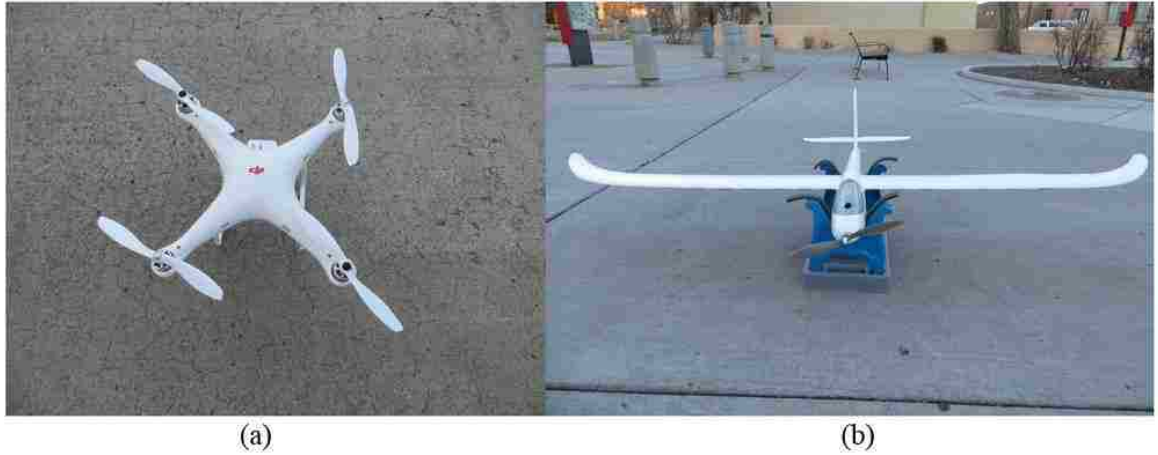
Figure 7. Examples of untethered low altitude AGL S-UAS; (a) rotary-wing S-UAS; (b) Fixed-wing S-UAS

A low-altitude AGL and low-cost S-UAS was constructed to simulate the collection of HySR-DAP from other untethered low altitude AGL S-UAS (Figure 7) that are now common in the marketplace. This system includes a tethered helium weather balloon with custom-designed rigging based on the Picavet suspension system, as suggested by the Public Lab (Balloons & Kite Mapping 2014). As mentioned in the previous section, a tethered helium weather balloon is permitted to fly in the United States as long as the flight meets the rules about location and altitude. The sensor affixed to the platform was an off-the-shelf small-format Canon SX260 HS digital camera. This camera has a 12-megapixel Complimentary Metal-Oxide Semiconductor (CMOS) detector array collecting in the visible blue, green, and red wavelength bands through Bayer array sampling and a built-in GPS unit. A firmware enhancement application known as the Canon Hack Development Kit (CHDK), was used to permit more control over the operation of the Canon SX260 HS camera, including shutter speed, shutter lag, aperture size, and intervalometer (Figure 8).

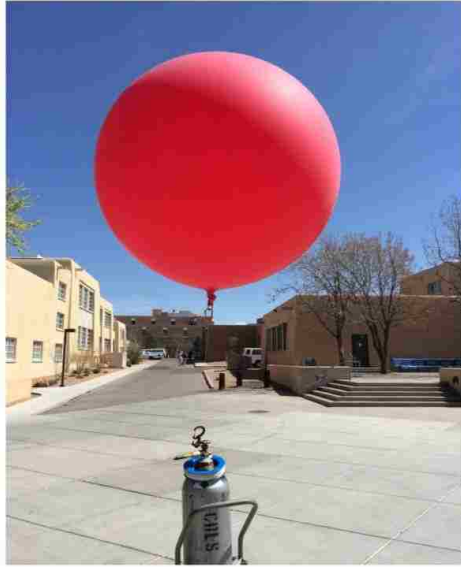
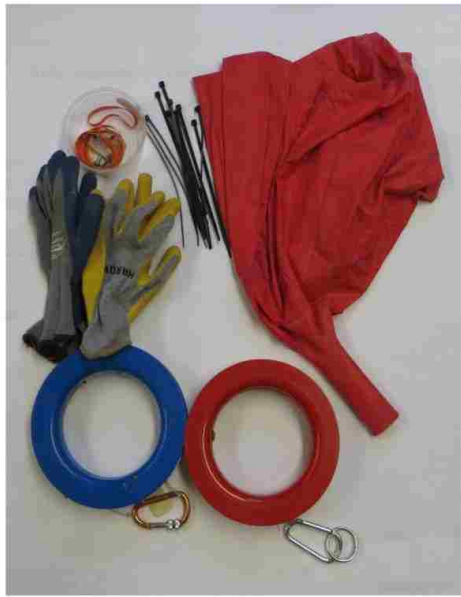
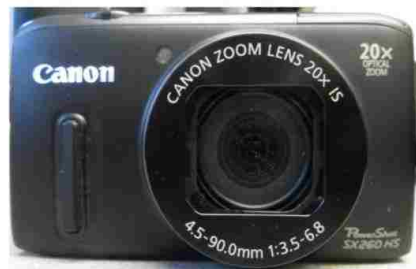
Figure 8. The helium weather balloon small-unmanned aircraft system (S-UAS); (a) a filled helium weather balloon and a helium tank; (b) customized rigging and mounted Canon SX260 HS digital camera; the characteristics of the rigging are lightweight, durable, resilient, capable of protecting the sensor, capable of removing the string in the aerial images and capable of dynamically adjusting the sensor position (i.e., the lens always facing down the nadir or principal point); (c) balloon mapping kit, including a balloon, reels, gloves, rubber bands, and zip ties; (d) front facet of Canon SX 260 HS digital camera and Canon Hack Development Kit (CHDK) graphical user interface (GUI).

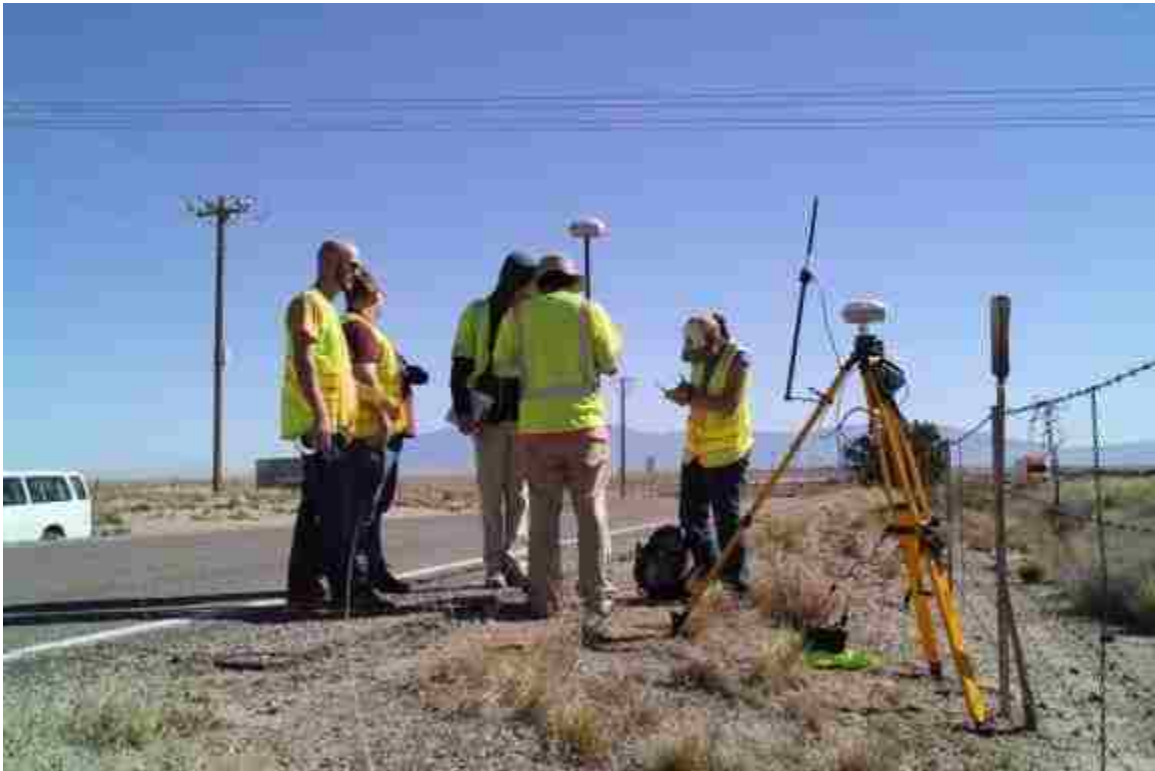
Figure 9. An illustration of the RTK system in a base/rover configuration.

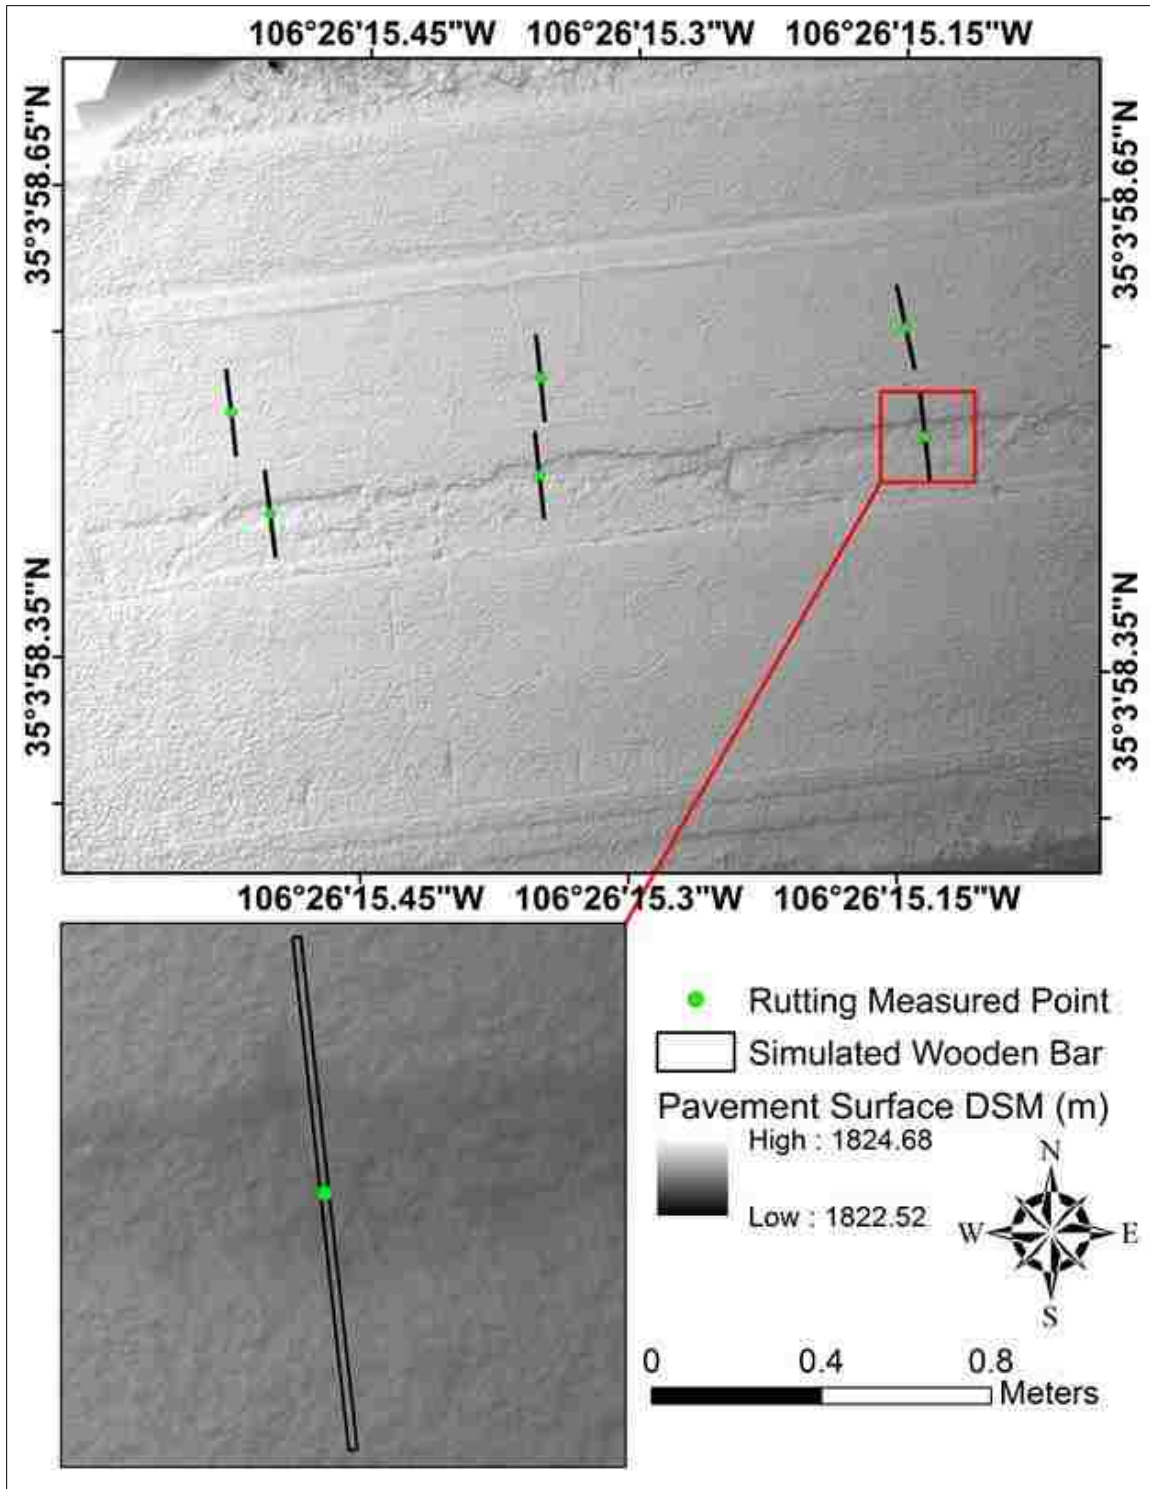
Figure 11. An illustration of the locations of rutting depth actual measured points and wooden bars.

Unlike ground-based manual measurement, it is not possible to directly identify the highest point at the bottom of the wooden bar. Therefore, the following method was used to identify the highest and lowest points of rutting. Using the polygon as the boundary, the DSM pixels within the boundary were extracted and reclassified to find the highest point on both sides of the actual field measured points. If there were multiple pixels having the same highest value, the one closer to the actual measured point in the field was used.

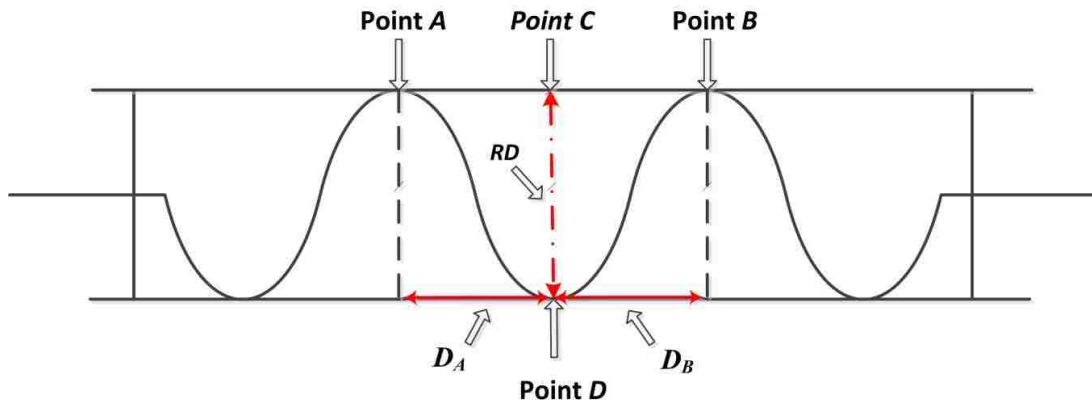
Figure 12. Rutting depth calculation process. D_A indicates the horizontal distance from Point A to Point D, while D_B is the horizontal distance from Point B to Point D. RD indicates the calculated rutting depth.

Then, as shown in Figure 12, the two highest points within the two polygons are considered as Point A and Point B, while the two measured points as Point C and Point D. The distance from Point C to Point D is the rutting depth. Points A, B, and C will have the same height if the heights of Points A and B are equal. However, under most circumstances the heights of Points A and B are different. Therefore, a weighted average method was used to calculate the height of Point C:

where H represents the height of a given point, and therefore H_A represents the height of Point A, and H_B represents the height of Point B. D_A represents the horizontal distance from Point A to Point D, while D_B represents the horizontal distance from Point B to Point D. RD represents the rutting depth. H_A and H_B were determined from the DSMs, while D_A and D_B were determined from the orthophotos.

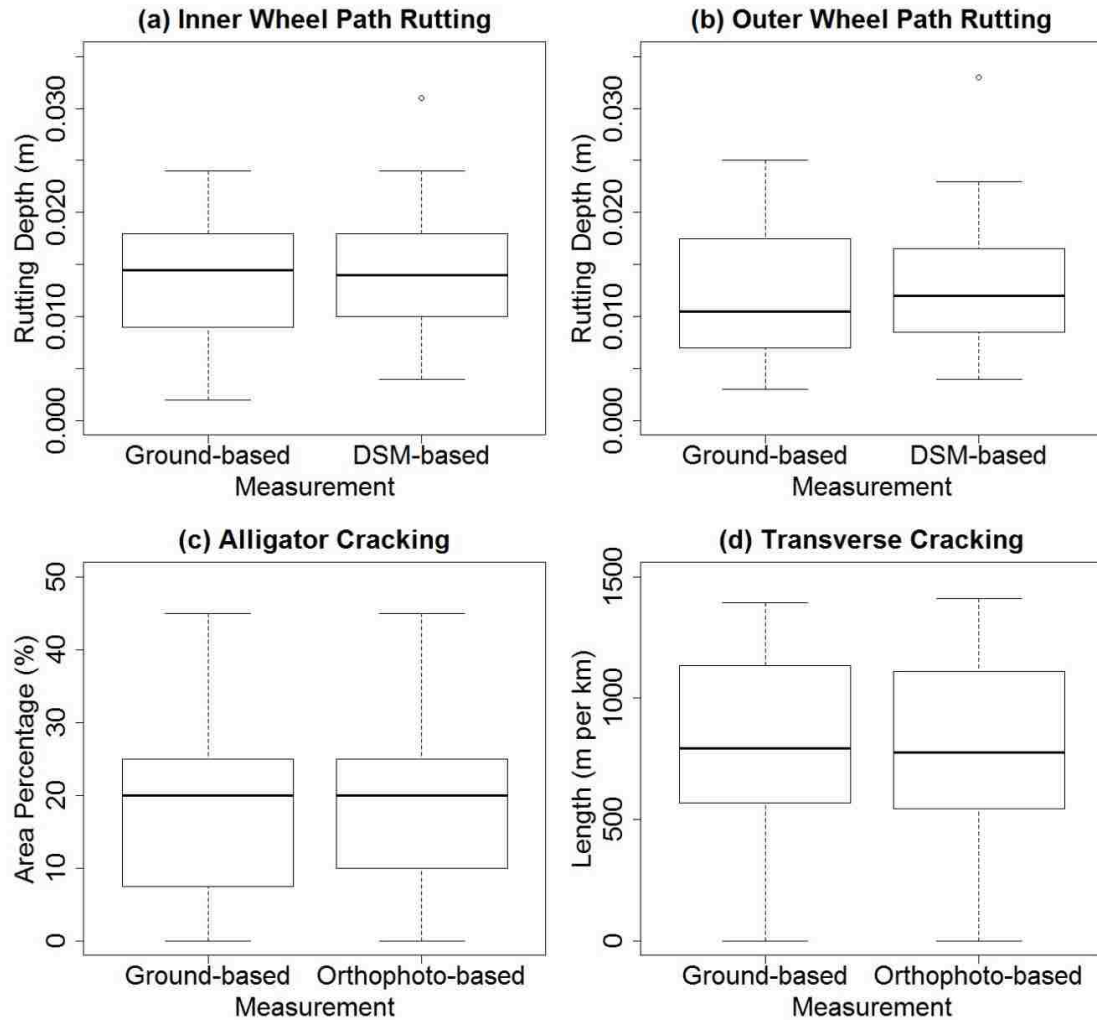
Figure 15. Box plot for each set of measurement. In each quadrant, the two boxes are ground-based measurement and HSR-AP derived products based measurement, respectively. (a) Inner wheel path rutting depth measurement; (b) outer wheel path rutting depth measurement; (c) alligator cracking area percentage measurement; (d) transverse cracking length measurement. The uppermost bar is the maximum measurement value, while the lowermost bar is the minimum measurement value. The bar inside of the box indicates the median. The dots in (a) and (b) indicate measurement outliers.

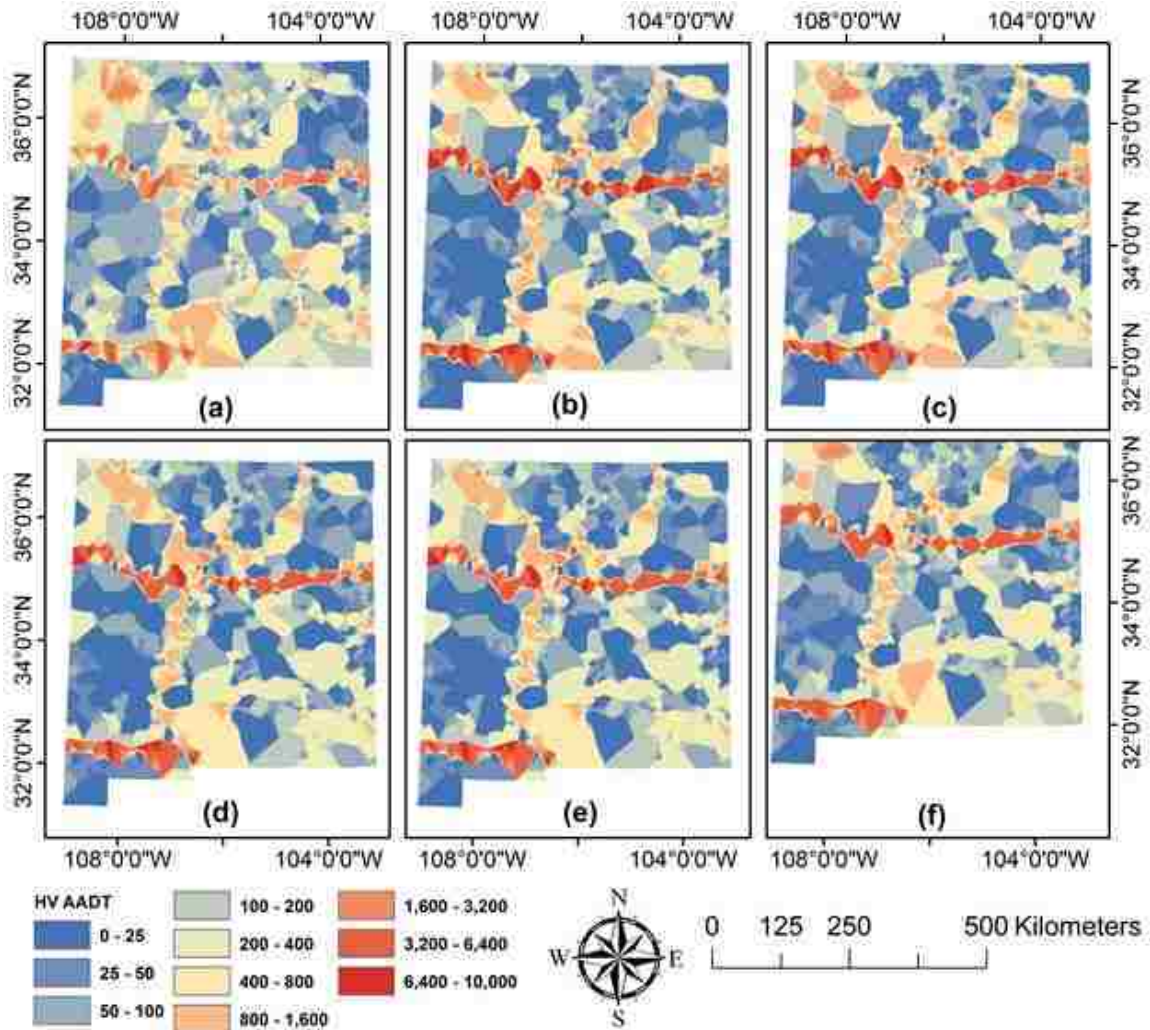
Figure 25. Data characterizing the heavy vehicle traffic volume of the State of New Mexico; HV indicates heavy vehicle; Inverse distance weighted (IDW) method was used for spatial interpolation; (a) Interpolated HV AADT for the year of 2005; (b) Interpolated HV AADT for the year of 2006; (c) Interpolated HV AADT for the year of 2007; (d) Interpolated HV AADT for the year of 2008; (e) Interpolated HV AADT for the year of 2009; (f) Interpolated HV AADT for 5 years from 2005 to 2009.

and the search radius for neighboring points is commonly limited to 12. The interpolated grids of traffic value and heavy vehicle traffic volume from 2005 to 2009 are showed in Figure 24 and Figure 25.
