The effect of mica on the aging of asphalt binder

**EFFECT OF MICA ON ASPHALT
BINDER AGING BEHAVIOR**

THESIS

May, 2012

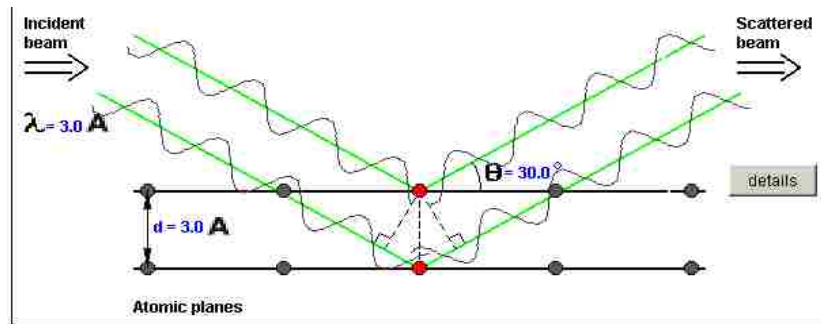
Figure 2.5: X-ray beams striking 2 layers of two different fictitious crystalline materials (Schields 2011)

(a) Waves reinforce each other exiting the crystal

(b) Waves interfere with each other exiting the crystal

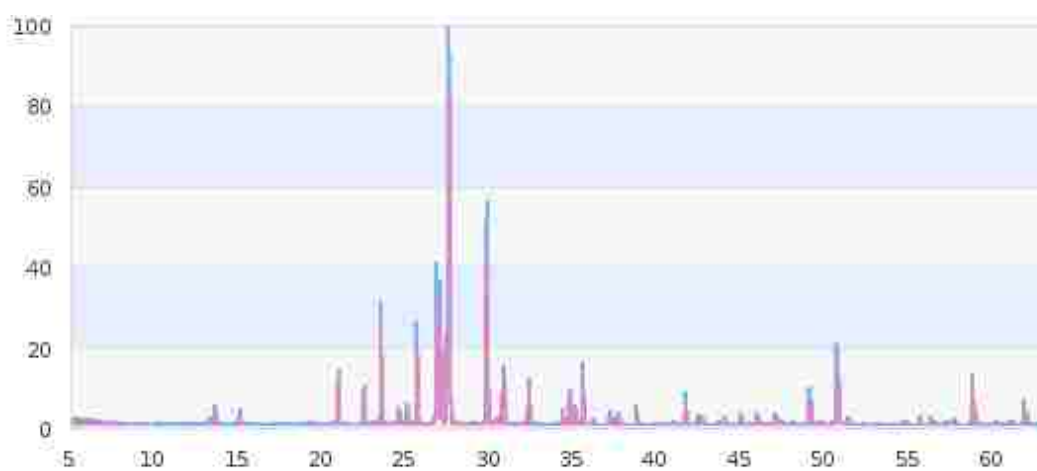
Figure 2.6. XRD Spectra for comparison (mindat.org)

(a). Spectrum of muscovite

(b) Spectrum of feldspar

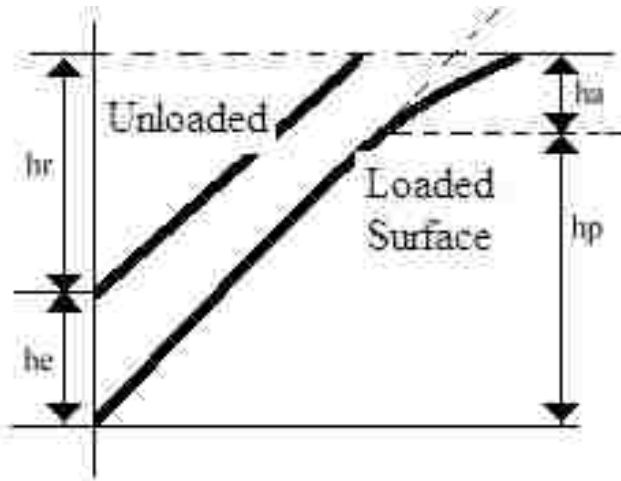
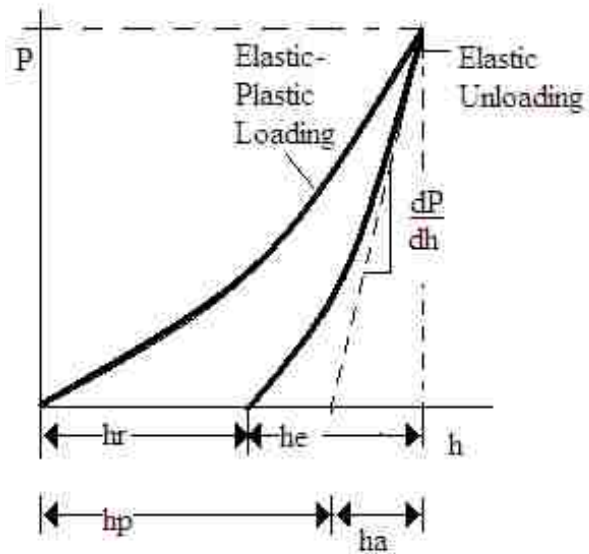
Figure 2.11: Cut-away view of an indentation and its load displacement curve

(a) One half of a split view of loading and unloading surfaces of an indentation

(b) Load displacement curve

The mean contact pressure is calculated by dividing the indenter load (P) by the projected area of contact (A). When this is determined under conditions of a fully developed plastic zone, this is the hardness of the material, H . Figure 2.9(b) (from Beake et al. 2006) shows the general concept behind the indentation process. An incrementally increasing load L (or P) is applied to the tip and pushes it into the sample to h_{max} (or h_{total}). Then the tip is withdrawn, leaving an indentation of the plastic depth (h_p). For a Berkovich

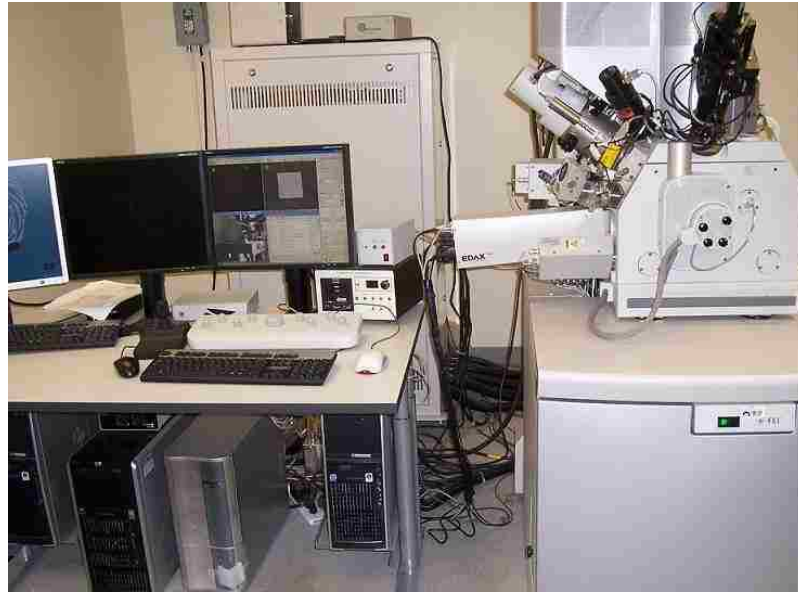
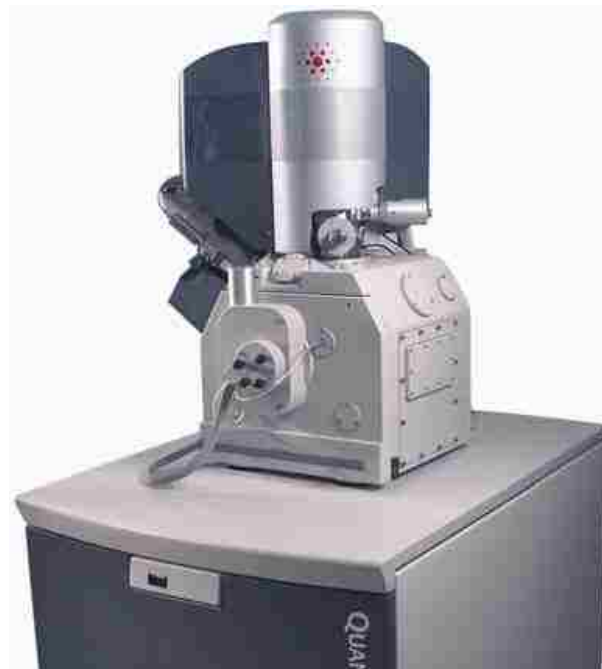
Figure 3.10: SEM Quanta 3D FEG SEM/FIB machine

(a) As configured at the University of New Mexico

(b) With no extraneous equipment attached

A small piece was broken off the end of a stick of each mastic mix. The broken pieces were then placed on the SEM sample platforms (called stubs) with the broken face exposed, as shown in Figure 3.9(a). The sample was attached to the stub with tape that is electrically conductive and sticky enough to prevent the vacuum in the Emitech from pulling the sample off the stub. The sample was carbonized with the Emitech sputtering machine shown in Figure 3.9(b) to provide an electrical grounding path from the sample to the body of the SEM. Figure 3.9(c) shows the inside of the lid of the Emitech and the graphite rod that is vaporized and deposited on the sample in the process. The sharpness and placement of the graphite rod in the lid is critical to controlling the amount of graphite deposited on the sample. If the sample was not sufficiently grounded to the stub, the electron beam would cause a charge to build up on the sample and the image would be obscured with white lines of electronic noise. If too much graphite was deposited, the detail of the surface features would be obscured. Figure 3.9(d) shows the samples mounted inside the drawer of the SEM. Figure 3.10(a) shows the Quanta 3D FEG

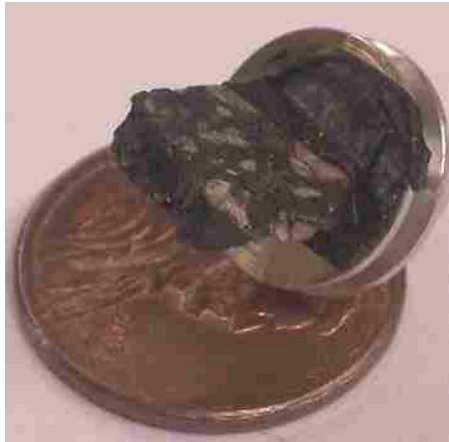
Figure 4.1: Original AC sample

(a): Sample on SEM stub

(b): SEM image of mica in AC

(c): SEM image of AC showing cracked mica

The original motivation for this study came from an SEM image of a random piece of commercial asphalt concrete (AC) that showed several pieces of uncoated mica in the mastic. Figure 4.1(a) shows this piece of AC after it was broken and mounted on an SEM stub for viewing. A penny is included in the photo for scale. Note that, while the sample is over a centimeter tall, the only part viewed in the SEM is the broken face, which is a much smaller area. Figure 4.1(b) shows the SEM image of one piece of mica about 50 micrometers wide that was found in the original sample. Figure 4.1(c) shows a much wider SEM image, nearly a half centimeter, of another area on the sample in which two large areas of mica can be seen. These images raised the question, “How does mica contribute to the mechanical properties of and wear and tear of asphalt on pavement?” In the next sections, the results of the SEM study will be explained.

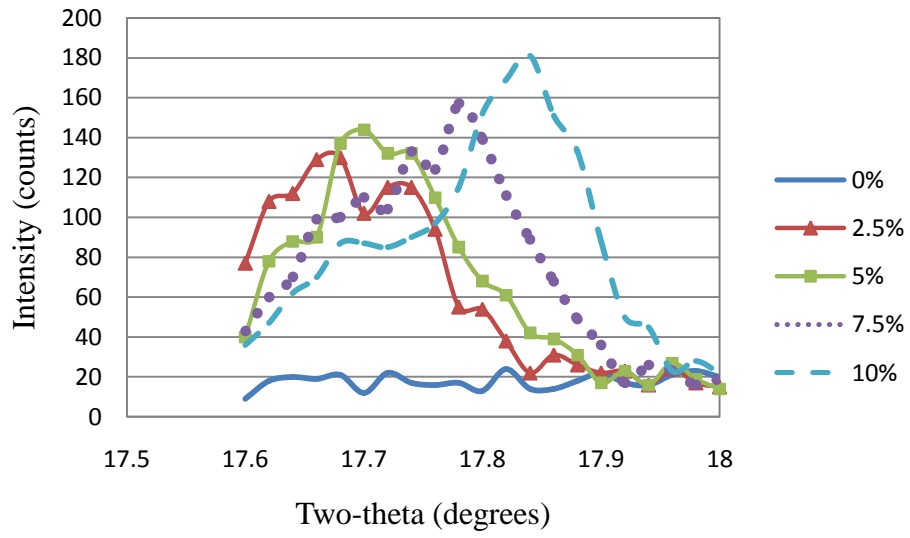
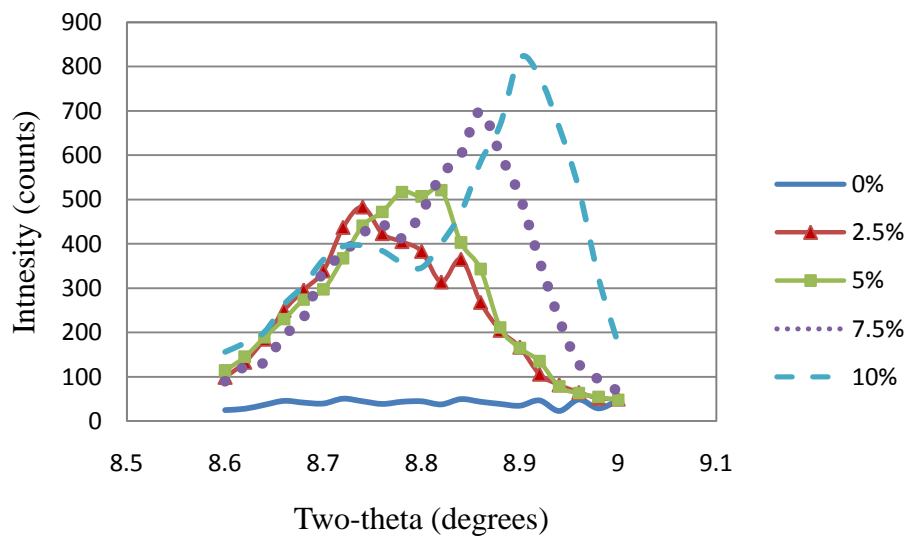
Figures 5.3: XRD Patterns comparing 5 different concentrations of mica in fines

(a) Two-theta between 17.6 and 17.9

(b) Two-theta between 8.6 and 8.9

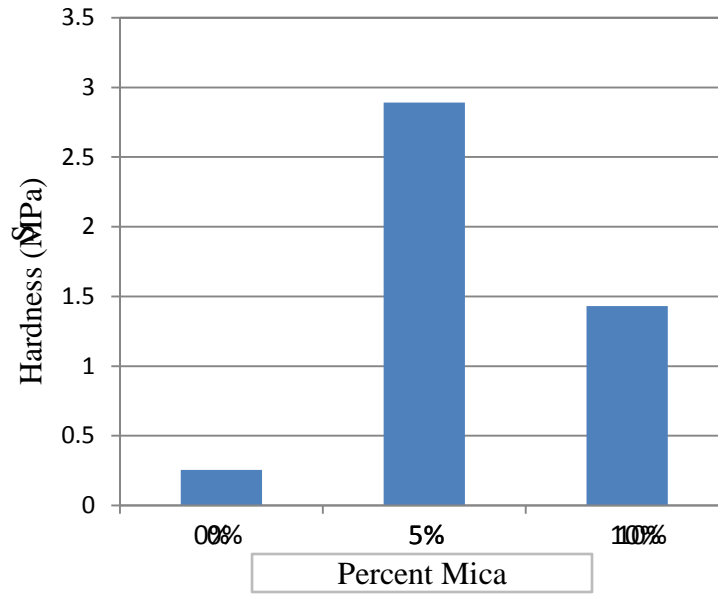
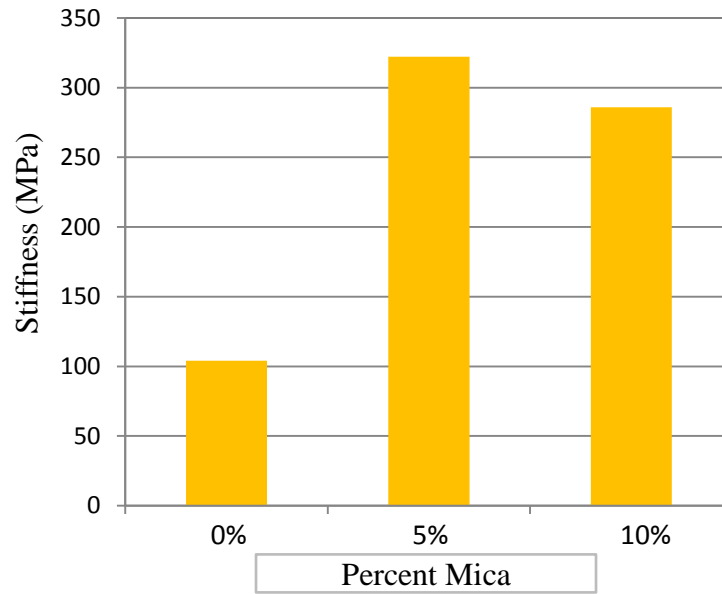
Figure 6.2: Hardness and stiffness vs. mica concentration in unmodified binder mastic

(a) Average Hardness

(b) Average Stiffness

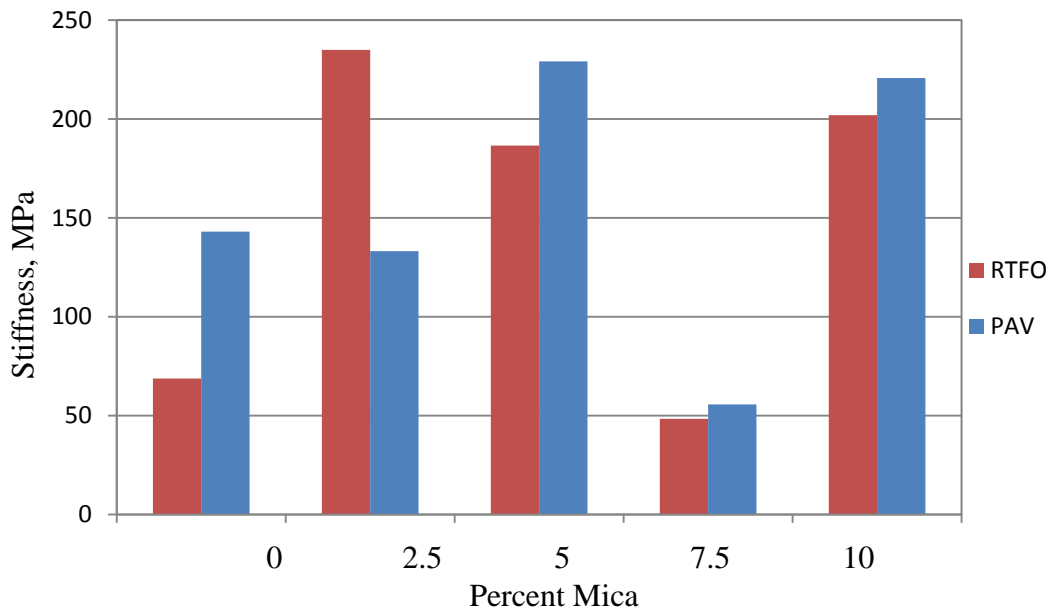
Figure 6.4: Average hardness and stiffness of SB4% polymer modified binder mastics after aging short term and long term

(a) Average hardness vs mica concentration

(b) Average stiffness vs mica concentration
