UNM Shock Tube Modernization

THESIS

Master of Science
Mechanical Engineering

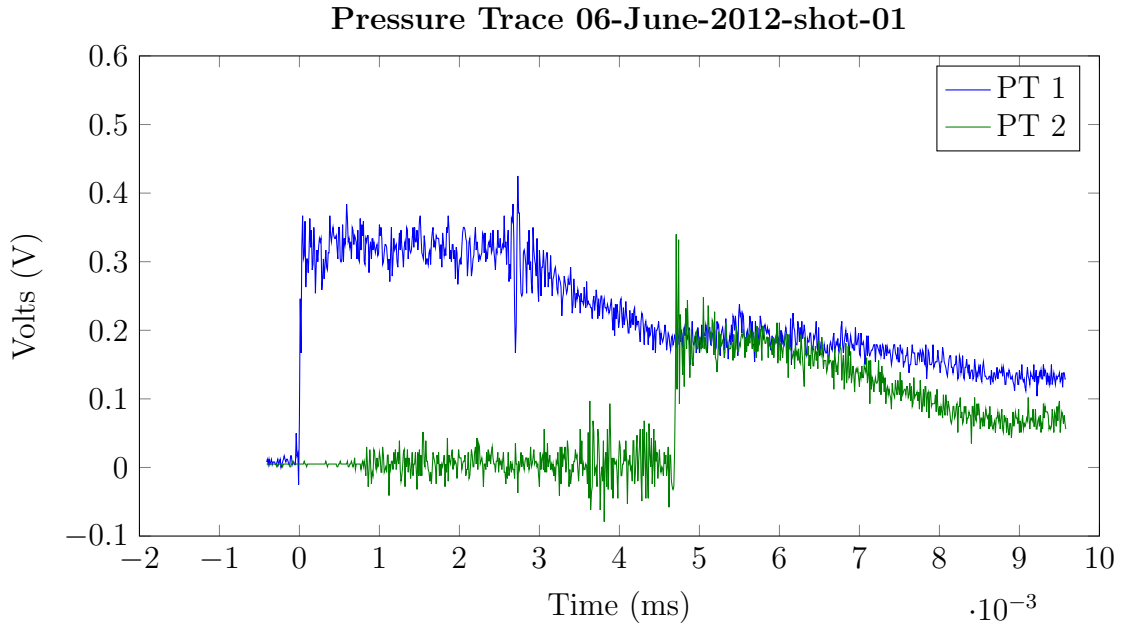
To get the shock timing data, we must interrogate the “pressure trace”, which is just a recording of the pressure transducer data captured by the oscilloscope for that “shot”. Figure 1.7 is a pressure trace of a shot taken on June 6, 2012. This was before the isolation of the pressure sensors discussed in a later section.

Figure 1.7: Pressure Trace, 2012-06-01-shot-01, pre isolation

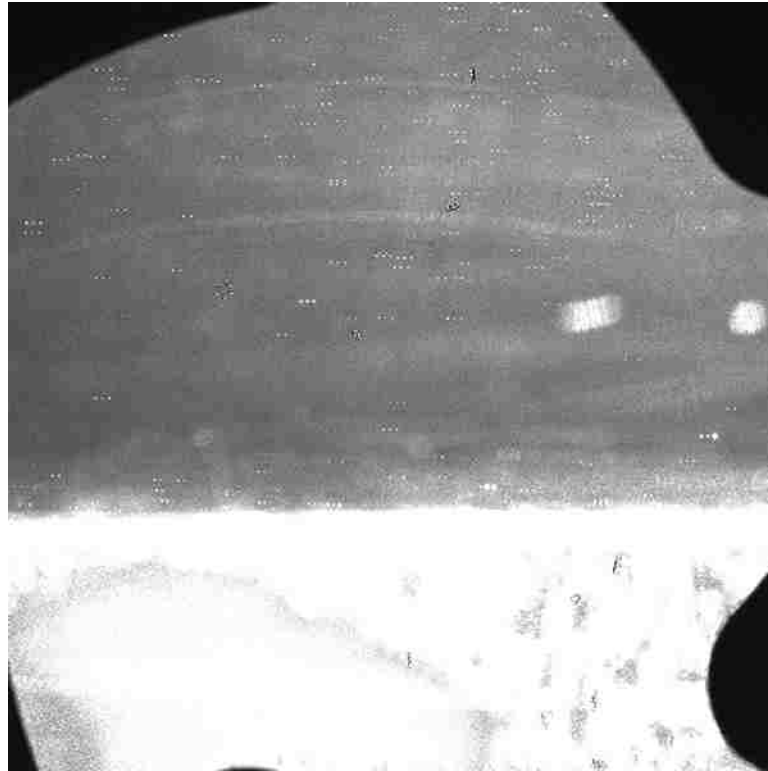
In Figure 1.8, you can also see the "triplets" used for particle velocimetry where we are working to determine the velocity and boundary layer profile of particles seeded in the stream. The spacing between the "triplets" is used to calculate the velocity of that particle at that location. The timing for these pulses is very critical and led to the discovery of another issue that we had to address. This specific issue is discussed in more detail in a later chapter.

Figure 1.8: Particle Image Velocimetry with the iris just opening and three laser pulses

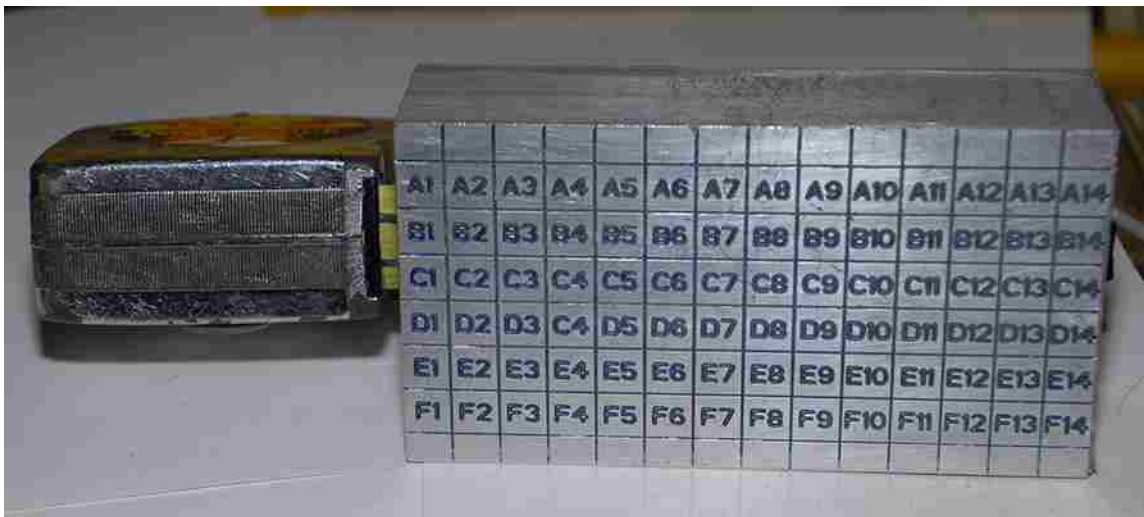
This target was very useful, but it was decided that additional improvements could be made. The Rev 3 target differed from the Rev 2 target in that it was nearly 7" long. This additional length was added to prevent the target from tilting up under the weight of the taper measure. In addition, testing had shown that a grid of identical 1cm x 1cm boxes makes it very hard to locate the physical center of the image relative to the target. To resolve this issue, labels were engraved into each block face. This allows instant identification of which block a person is looking at in the image. Figure 3.4 shows the Rev 3 target.

Figure 3.4: Focal target and tape measure

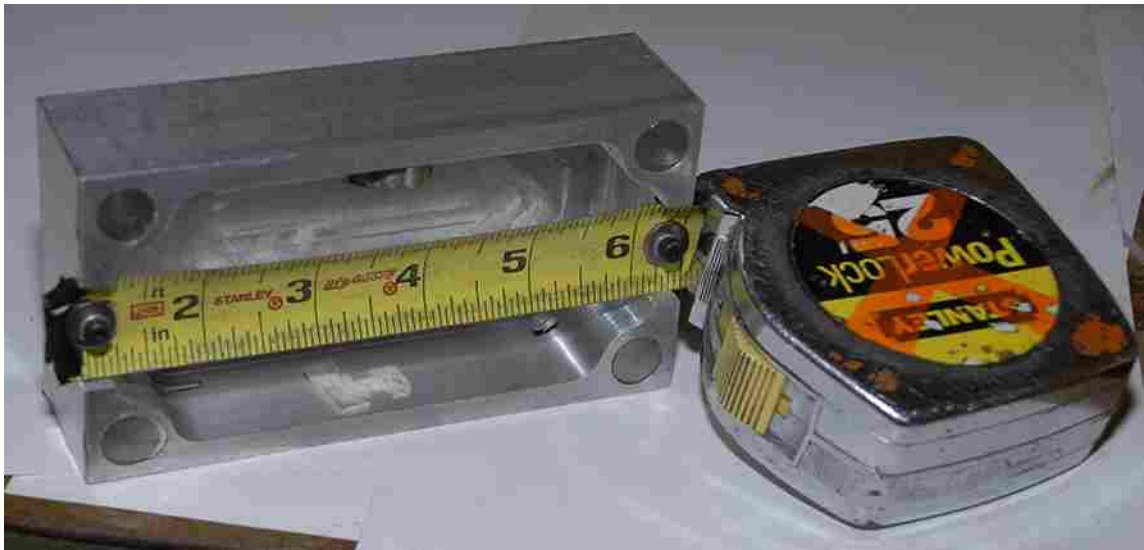
To improve the positioning issues, it was decided that strong rare earth magnets could be used to hold the target in position. The whole of the shock tube is non magnetic aluminum and polycarbonate, so rare earth magnets were embedded in the back of the new target as shown in Figure 3.5.

Figure 3.5: Focal target and tape measure, back view

Finally, the figure also clearly shows how the tape measure was attached to the target. Previously, the tape measure was actually attached to the target with double sided foam tape. Needless to say, this wasn't optimal as it had to be reattached from time to time and it was a messy job removing all the residue of the old foam tape. The screws that attached the tape to the current target do not have to be replaced as it does not come off. When the tape measure needs to be removed, it only takes seconds to remove the screws and remove the tape measure.

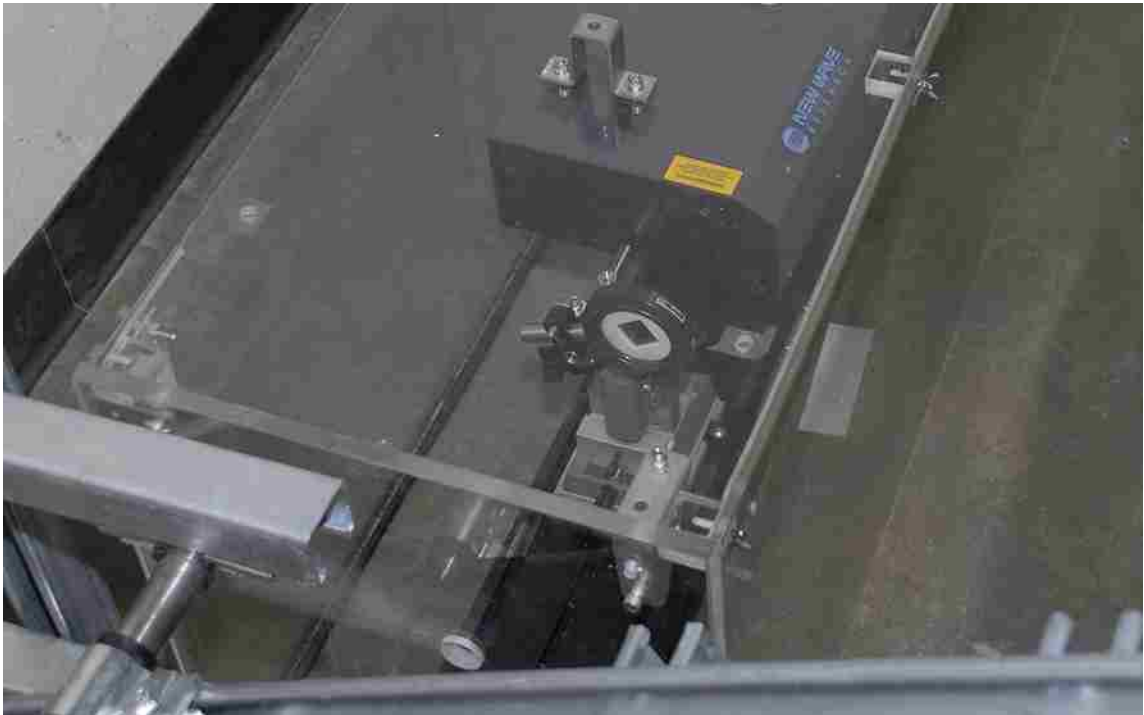
off a cleaning/digging session that uncovered many more mounts and rails. Most of them were incorporated in old pieces of equipment that had not been used in decades. These provided the raw material for the improved optical system for the acceptable price of free.

Figure 3.6: Optics on rail

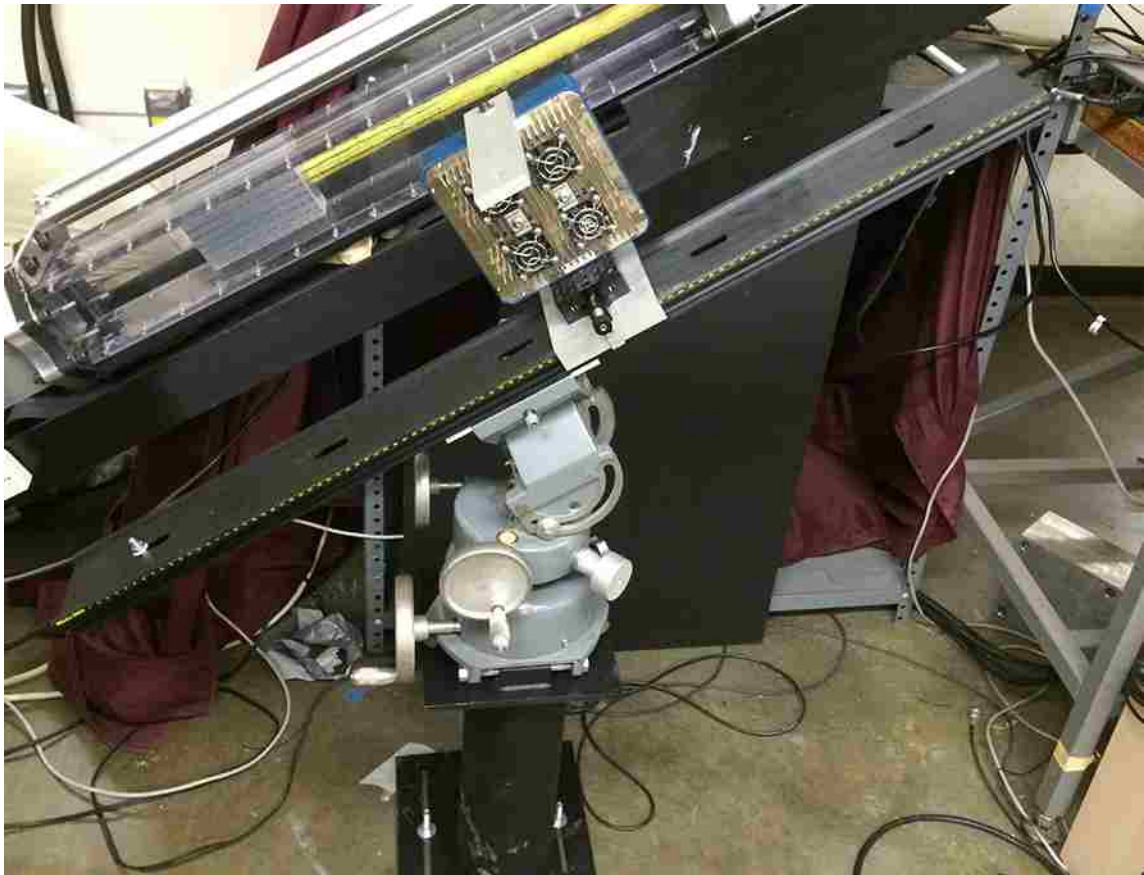
With the current tripod no longer able to accurately and repeatedly hold the camera in the correct position, a new camera mount was designed that basically used the tripod head of one of our very heavy duty tripods (that was too tall to be used for inclined shots) along with a custom base mount and a heavy duty optical rail to attach the camera. Figure 3.10 shows the final result.

Figure 3.10: New camera mounting system

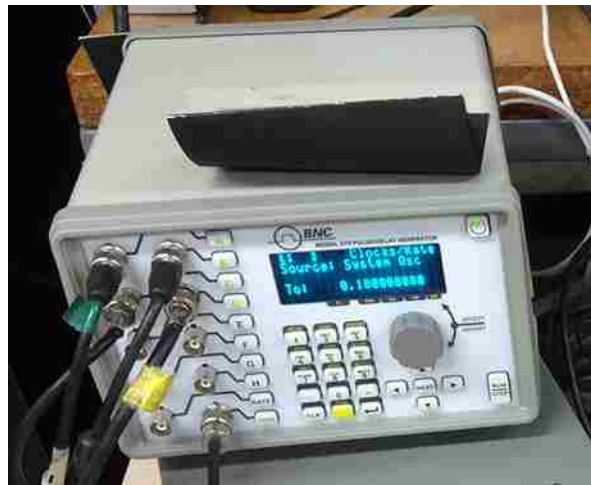
With the delay generators we had, we could not achieve the necessary delays and accuracy on all eight channels simultaneously. With the aging of the delay generators and their inability to accurately work with the current experiment, we received permission (and funds) to purchase a new, eight channel delay generator, a BNC Model 575. This model allowed us to control the on time and off time of each channel independently with a precision of $250ps$ on both the delay and duration of each pulse.

Figure 3.14: BNC 575 delay generator

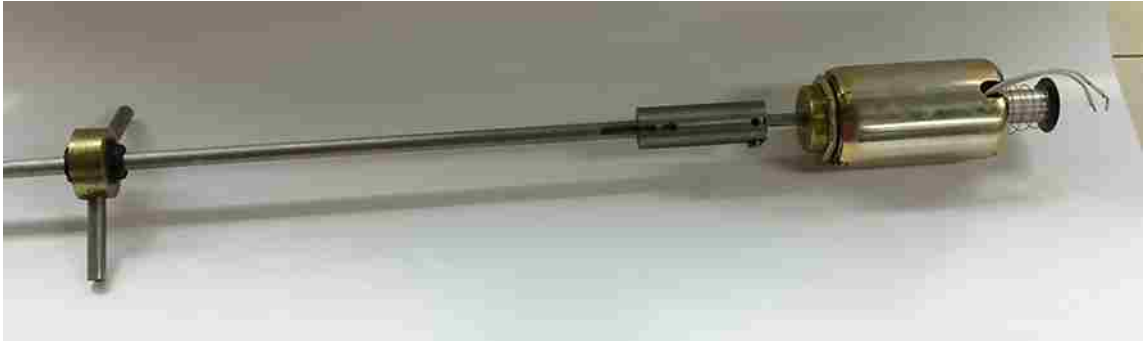
Our shock tube uses a type 1 polyester film as a diaphragm. They start life as commercially available 3M CG5000 and CG6000 transparency films. This film separates the driver section from the driven section to allow the helium to pressurize the driver section just like the burst diaphragm does. But these are not precision manufactured films and do not have specific pressure that they will burst at. Instead, inside the driver section, there is a cutter assembly. Figure 4.1 shows most of what is inside the driver.

Figure 4.1: Solenoid, coupler, rod and support bearing

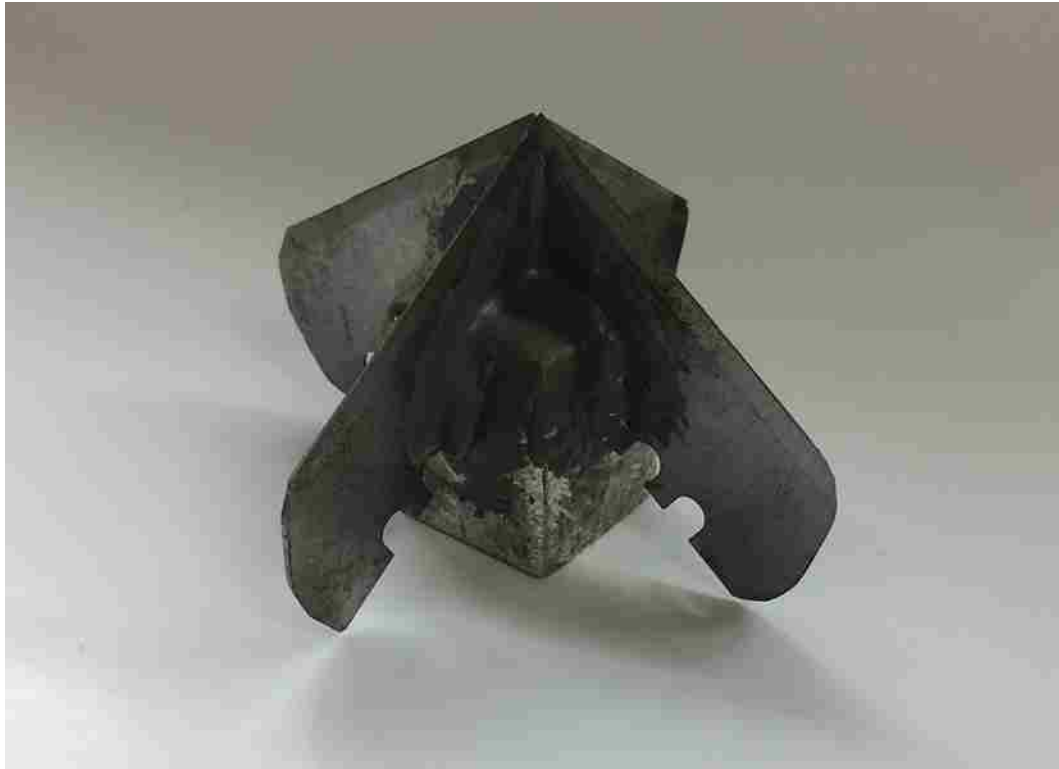
When the cutter head is retracted before a new diaphragm is installed, the bearings are pushed back slightly. But more importantly, they were also tilted backwards.

Figure 4.3: Closeup of the original cutter head.

Referring back to the cutter head Figure 4.3, you can see that the cutter head is

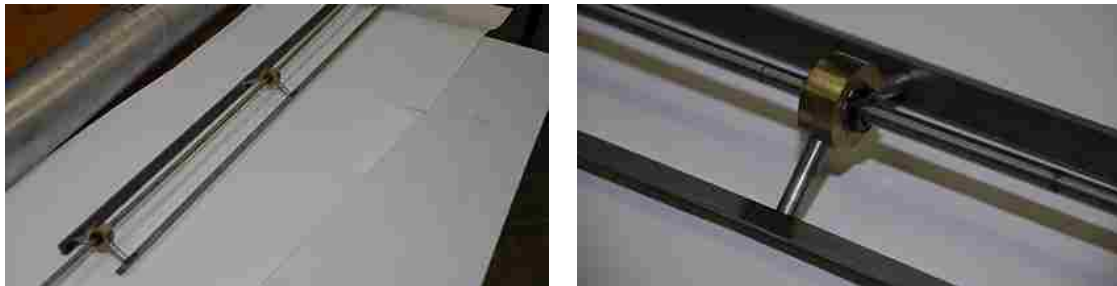
(a) Both bearings on rail

These issues led to the very first modification for the shock tube: a set of guide rails shown in Figure 4.4 to hold the linear bearings vertical and maintain the proper spacing between the bearings.

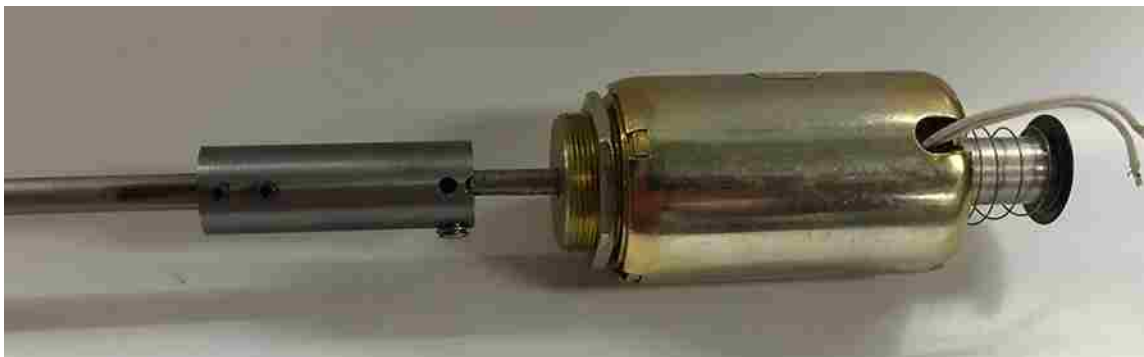
A partial solution was found in the solenoid coupler of all places! After all the low hanging fruit (such as adjusting the cutter head so it was less than 1mm from the back of the diaphragm to maximize the throw length) was consumed, additional investigations found that the original coupler sat over almost 3/4" of the output shaft on the solenoid! When the solenoid is fully retracted, the coupler is one of the limiting factors as the back of the coupler hits the front of the solenoid. Figure 4.7 shows the new coupler attached to the solenoid.

Figure 4.7: Close up of new coupler and solenoid, partially extended

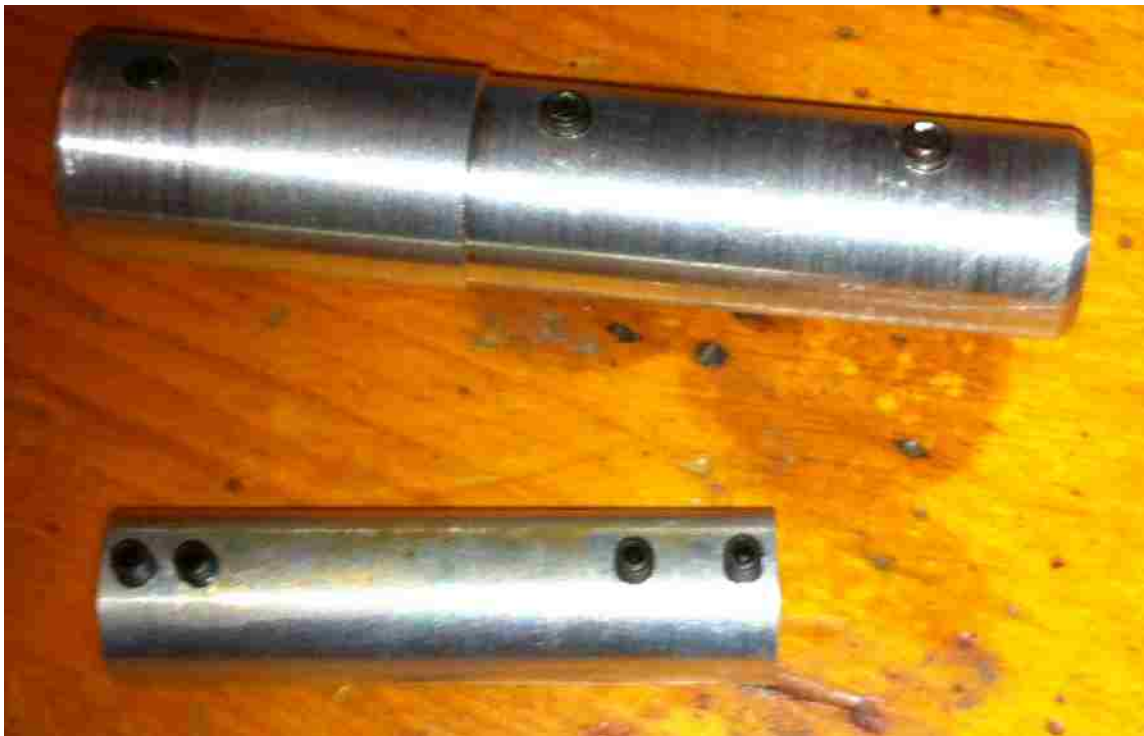
to 3/8", providing 3/8" more throw with this one change! In addition, the shorter length of the coupler along with its smaller diameter also produced a coupler that has significantly less mass than the original. Given that solenoids do not have a linear force curve, reducing the mass allows the solenoid to accelerate the cutter head to a higher speed before it impacts the diaphragm. The longer throw gives it a better chance of rupturing a severely yielded diaphragm as well. Figure 4.8 shows both the original and new coupler side by side.

Figure 4.8: Old and new couplers side by side

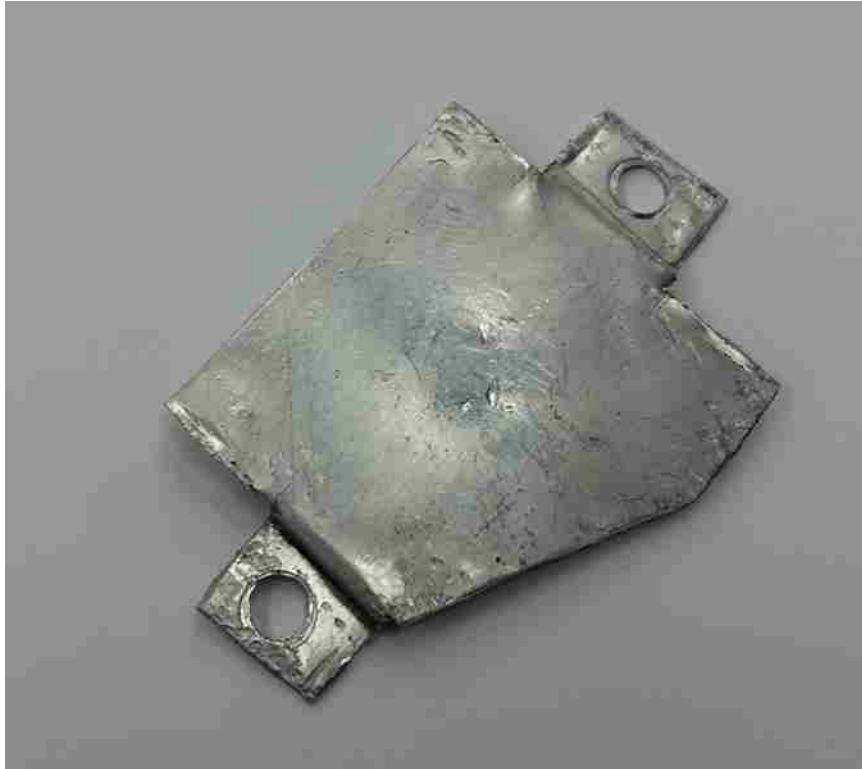
dolly, tin snips and a few other small hand tools, the part shown in Figure 4.9 was created.

Figure 4.9: Top view of helium baffle

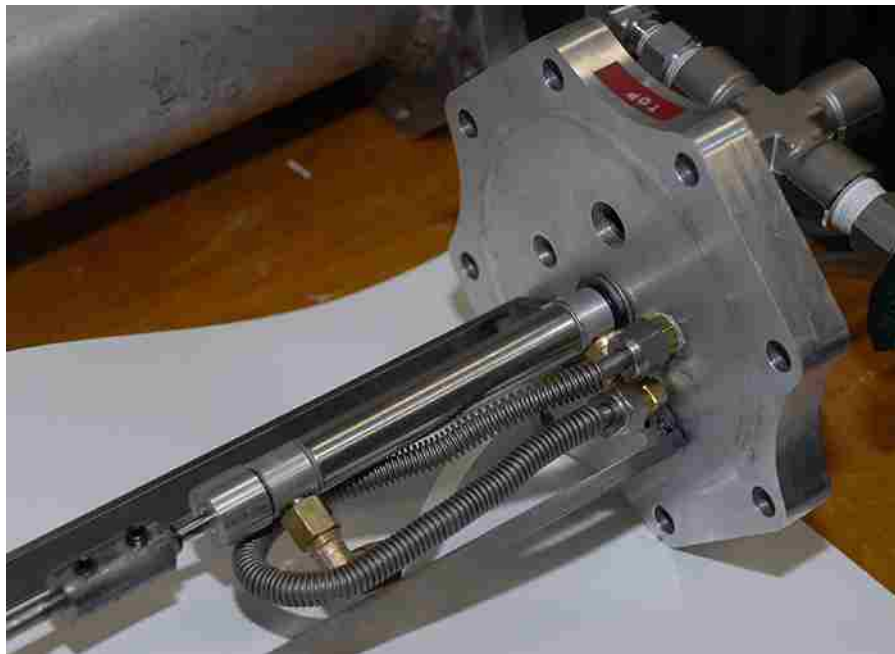
the new system. We also already had a source of 125 psi compressed air in the lab as well. The cylinder selected used a very small threaded port (10-32 to be exact) for the supply and vent lines. The only concern we had was if this system would actually work inside the driver section after it had been pressurized with helium. Eventually, we decided to give it a try, so parts were ordered and the new driver flange was machined. Figure 4.11 shows the new cylinder mounted to the driver flange.

Figure 4.11: Pneumatic cylinder mounted to driver flange

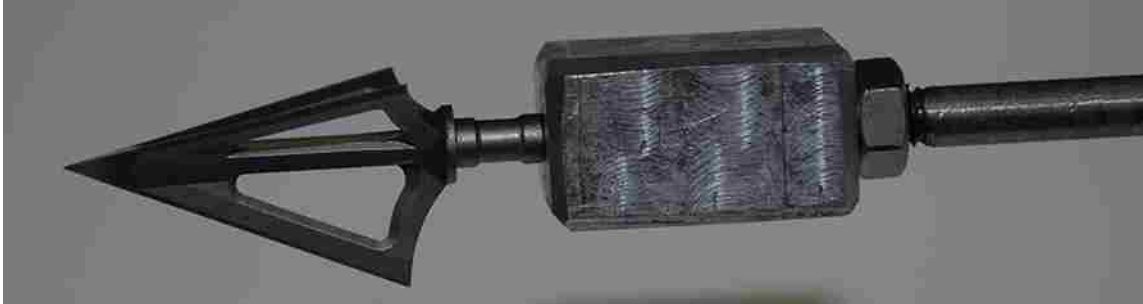
cutter from less than 1.5” of travel to 2.75” of travel, almost doubling it. Figure 4.12 is a picture the current, and actually original arrowhead cutter.

Figure 4.12: Original and now current arrowhead cutter

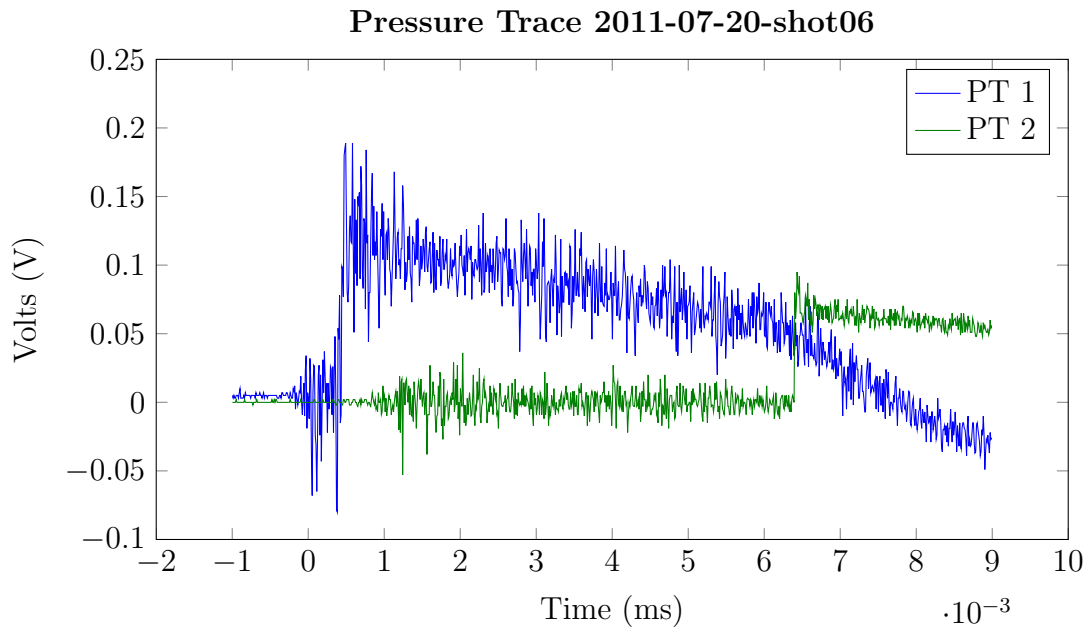
Pressure trace 4.15 shows a different case. The Mach number is lower so the signal level has decreased. The noise signal has also decreased, but not as much as the shock signal. In the worse case scenario, the signal disappears into the noise completely and it isn't possible to trigger the lasers on the shock. This is actually a very good preisolation pressure trace. The signal at PT 2 is peaking at 100mV, but the noise is only peaking at 50mV, giving a small 25mV window were the trigger level could be set to trigger on the signal but not the noise. Again, none of the "bad" shots pressure traces were kept as they are of no value to the experiment, but would have been great to have for this thesis.

Figure 4.15: Mach 1.20 shot, pre isolation

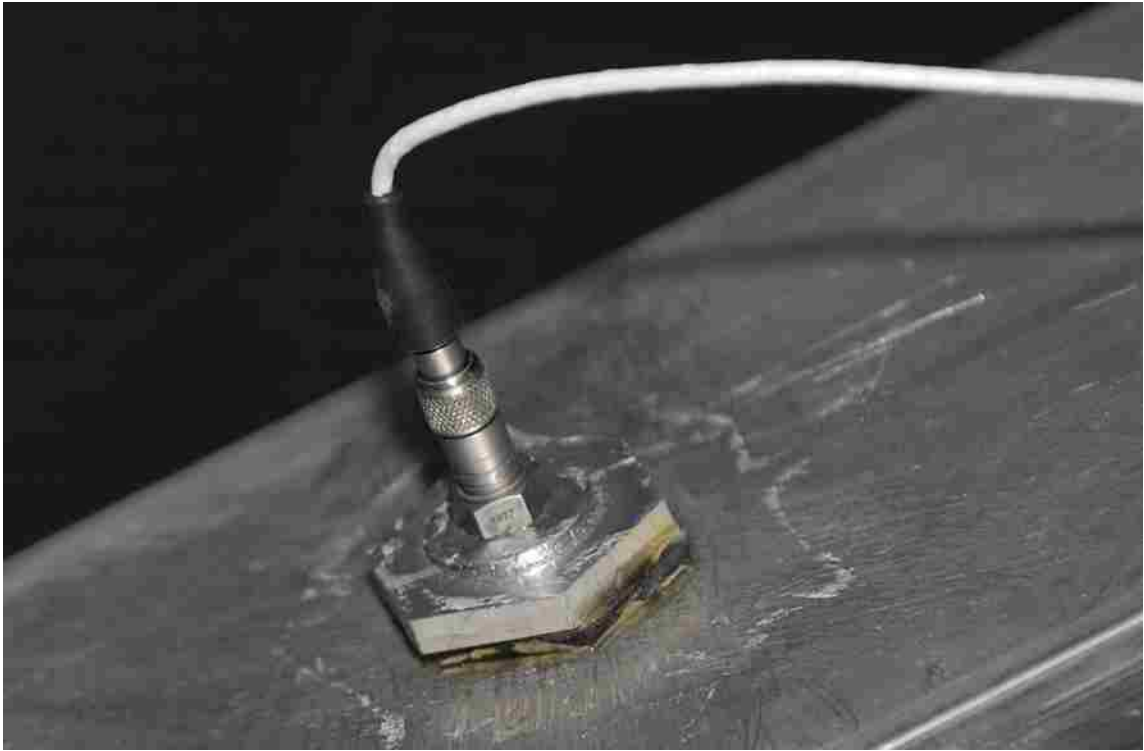
Figure 4.16 shows the small aluminum adapter that was designed that had a large, 1" diameter flange around a central cylindrical mounting area. The mounting area was designed so that with the adapter epoxied to the driver section and the pressure sensor torqued down, it would hold the sensor at the correct height. The driver section was then machined to provide positive clearance around the body of the adapter while providing minimal clearance around the tip of the pressure transducer. Any contact between the tip and the driver section would mitigate the effects of the isolation adapter. Finally, a torus shaped piece of 1/8" thick sorbathane was cut and bonded to the adapter and the driver section with structural epoxy. Weights were used to keep the adapter firmly in contact with the drive section while the epoxy cured.

Figure 4.16: Pressure transducer mounted to driver section in isolation adapter
