# Defect Growth Characterization in Modern Rail Steel

Sena Kizildemir

A Thesis

Structural Engineering

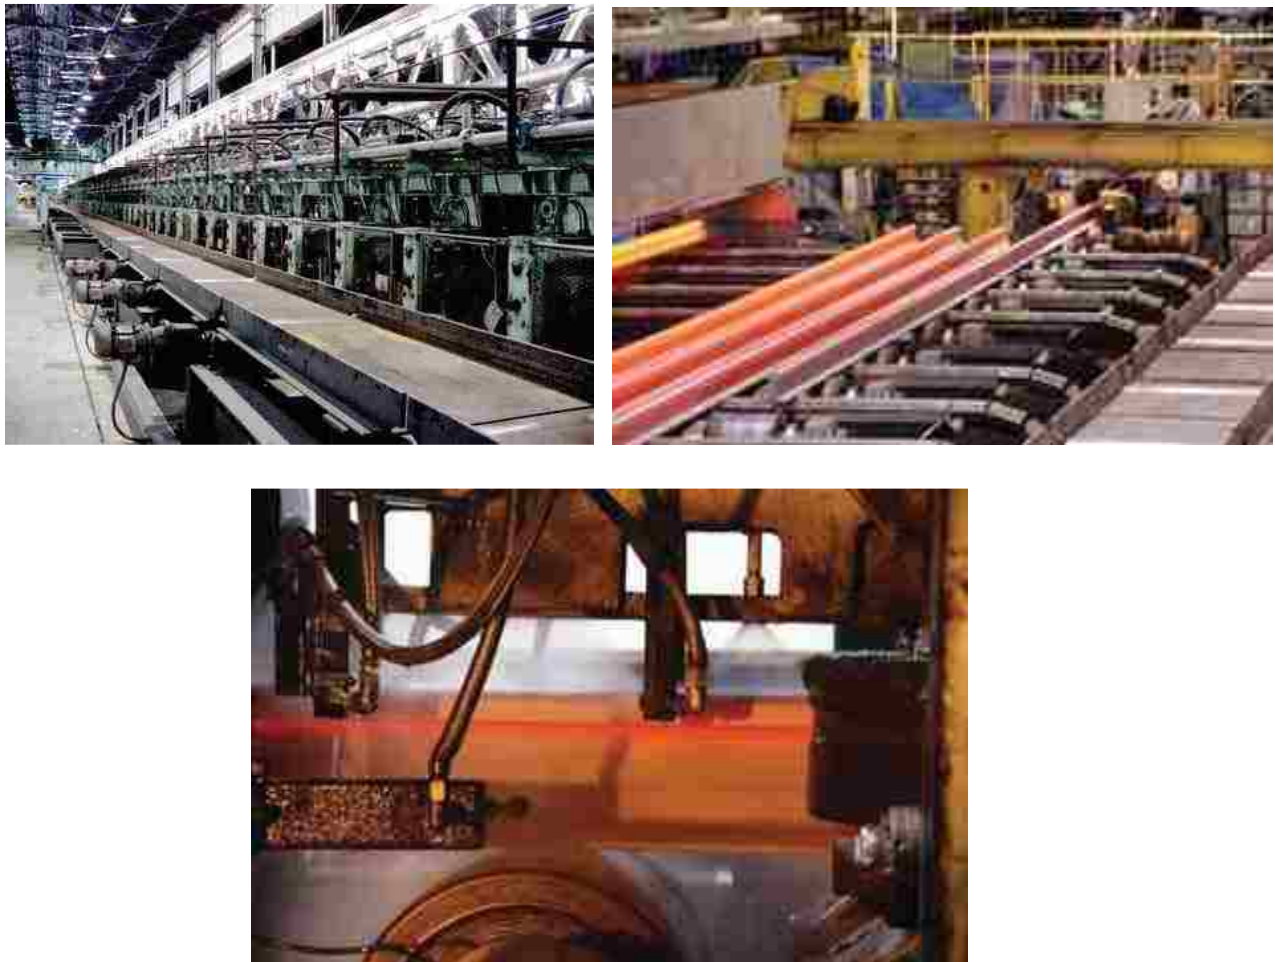
**Figure 3** – Head hardening facility at ArcelorMittal, Steelton.

The head hardening processes that briefly mentioned above, involves a 100 meter long system that sprays either water, mist or oil on to rails to cool them as they passes through the cooling zones[58]. The process introduces a microstructural gradient inside the head (Figure 4c), which can lead to variable crack growth rate inside the head. These processes has been developed and used since 1994 to produce intermediate strength head hardened (ISHH), head hardened (HH), and advanced head hardened (AHH) rails.

The head hardening process described previously [58] is done at the facility at Steelton, which is in-line with the rail mill. To describe it better, we can say that the rolled hot rails directly proceed to the facility. The picture of it can be found below.

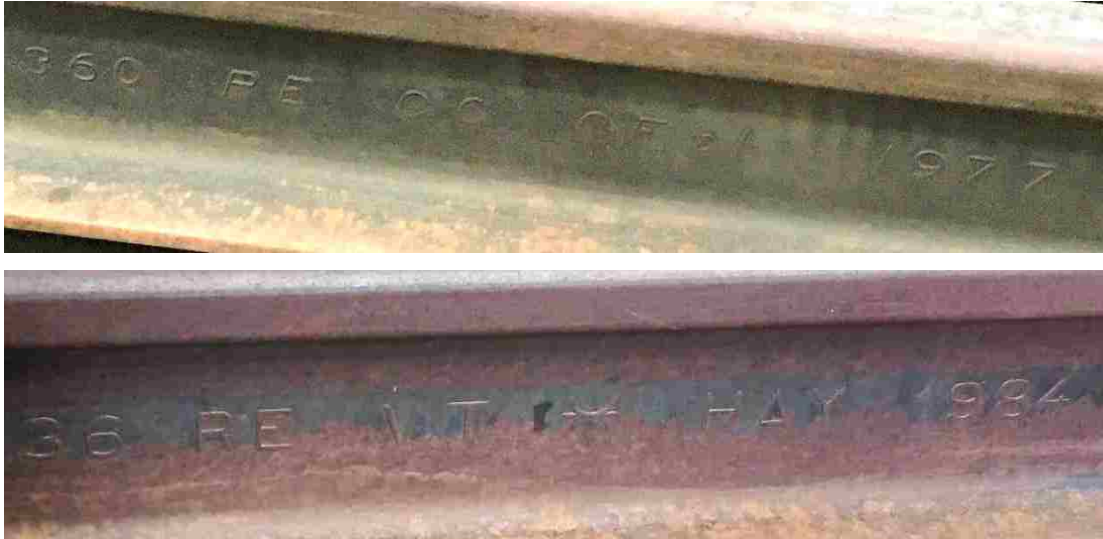
**Figure 7** – Photographs of legacy rails, CF&I77 (top) and HAY84 (bottom), used to develop baseline data for comparisons with modern head hardened rails.

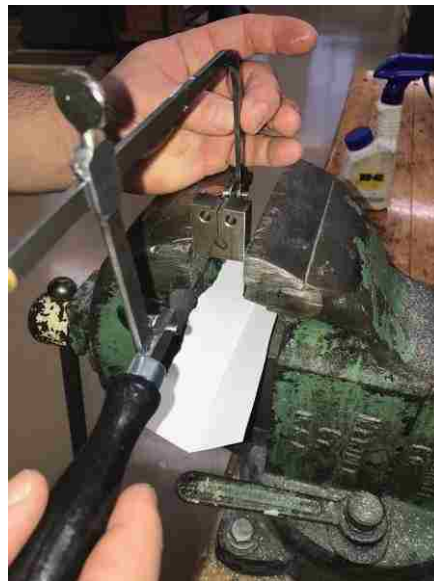
**Figure 52** – Cutting sharp notch at the base of waterjet cut notch using jeweler's saw.

Additional machining steps included milling the CT specimens to obtain flat surfaces, boring the pin loading holes, and cutting the notch. In the initial phases of the test program, notches were cut with a very fine (0.006 in.) diameter wire (EDM). However, it was determined that waterjet cut notches (notch widths between 0.020 – 0.030 in.) were perfectly acceptable for the precracking process, especially if a fine jewelers saw (blade width 0.012 in.) was used to make a fine saw cut at the base of the waterjet cut notch as shown in Figure 52. All CT fracture specimens were precracked in fatigue to obtain a precrack length of  $a = 12.5$  mm using a constant amplitude sine loading with a maximum load of 4000 N and a minimum load of 400 N at a frequency of 15 – 20 Hz. Figure 53 shows a polished CT specimen with a close-up image showing the fatigue crack growth from the tip of the notch. The photomicrograph in Figure 54 also clearly shows the precrack from the notch tip in a CT specimen.

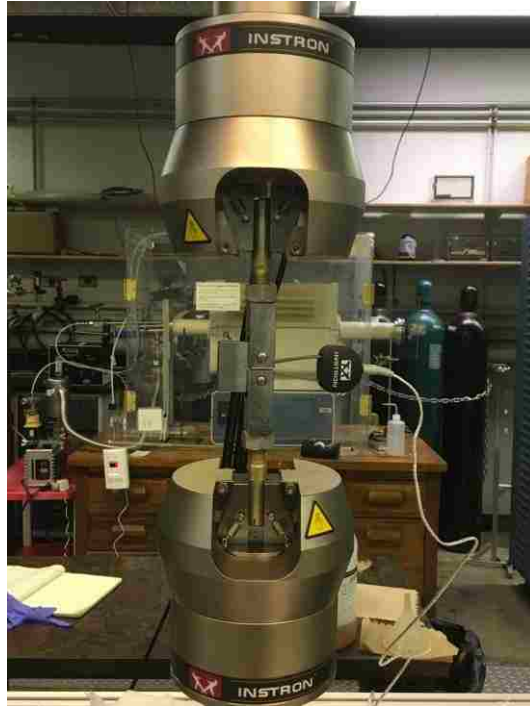
**Figure 55** – Compact tension fracture toughness test showing COD clip gauge.

with the attached COD clip gauge during fracture toughness testing. Appendix C contains sample load vs COD measurements taken from valid  $K_{Ic}$  tests for the different rail types. This Appendix also contains the CT formulas for  $K_I$  and crack opening displacement  $d_1$ . The formulas for  $K_I$  and  $d_1$  are given as a polynomial function of the crack length  $a$  and applied load  $P$ . Thus, the crack length  $a$  and the stress intensity factor  $K_I$  can be determined indirectly from the measured values of  $P$  and  $d_1$  during a test.

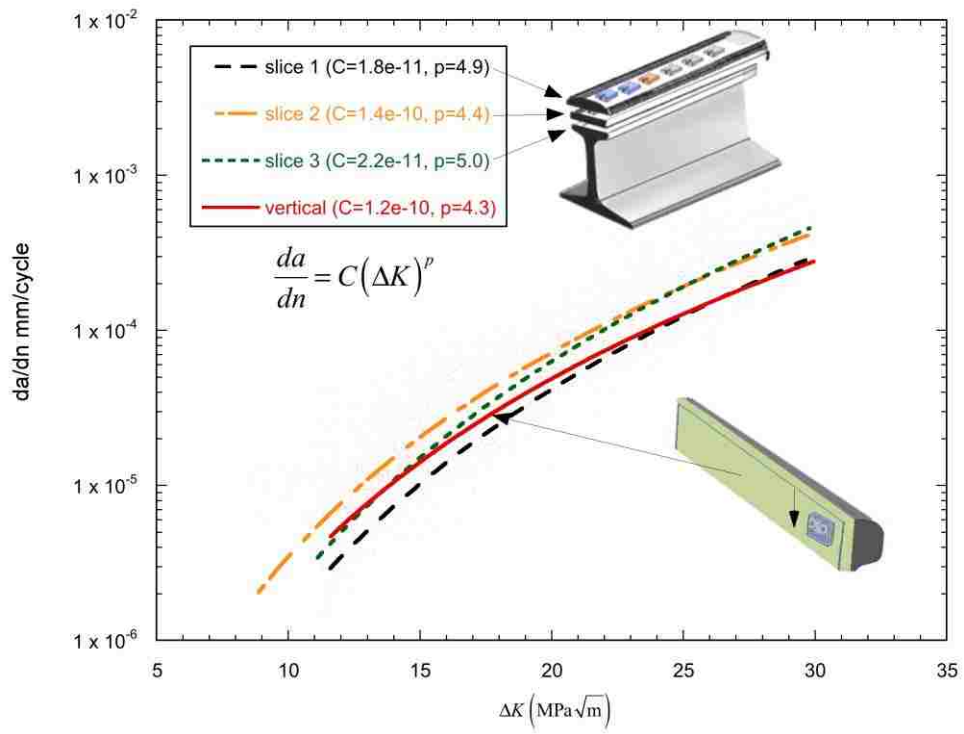
**Figure 69** – Comparison of average fatigue crack growth rates for horizontal and vertical cracking in AHH rail.  $R=0.1$ .

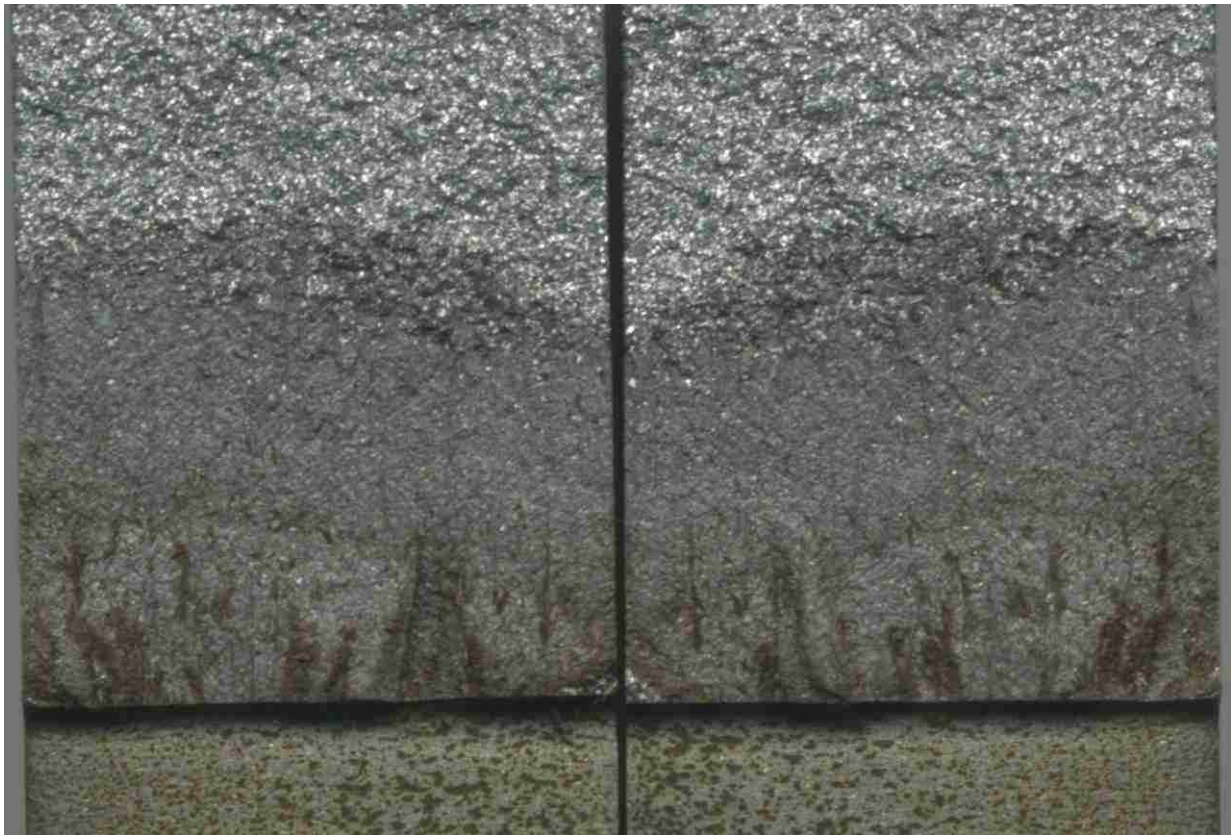
**Figure 75** – Fatigue/fracture surface for HH 3B tested at  $R=0.1$ .

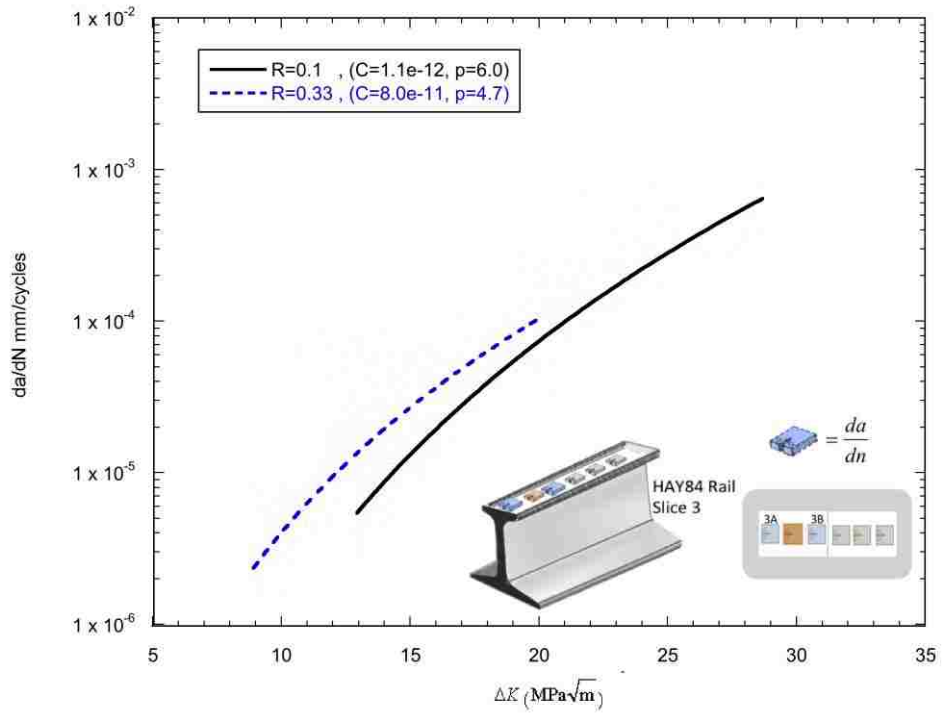
**Figure 79** — Comparison of horizontal fatigue crack growth rates at two different R-ratios in Slice #3 of HAY84 rail.  $R=0.1$  and  $R=0.33$ .

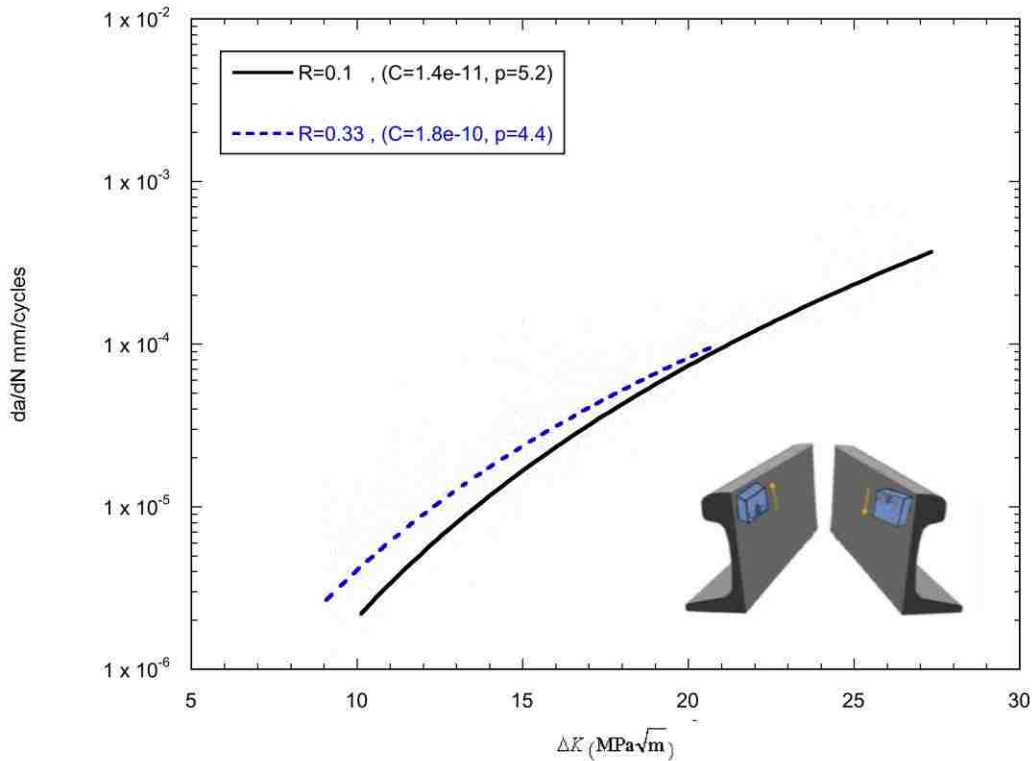
**Figure 83** – Comparison of vertical fatigue crack growth rates in CF&I77 rail for CT specimens at two different R ratios.  $R=0.1$  and  $R=0.33$ .

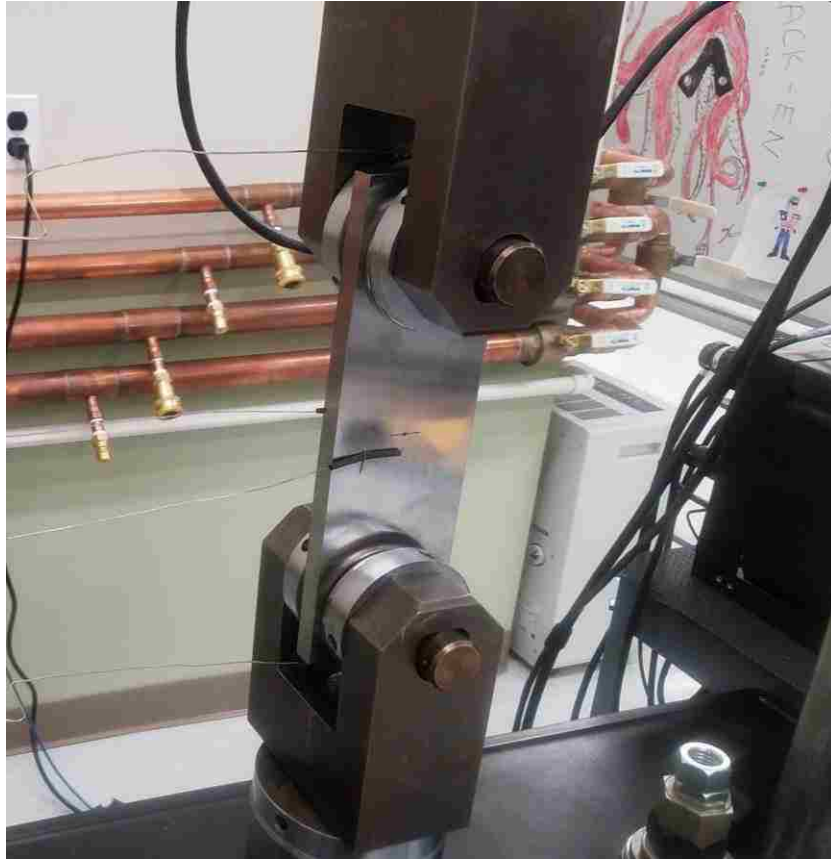
**Figure 86** – Testing of center cracked tension (CCT) specimen at LTI.

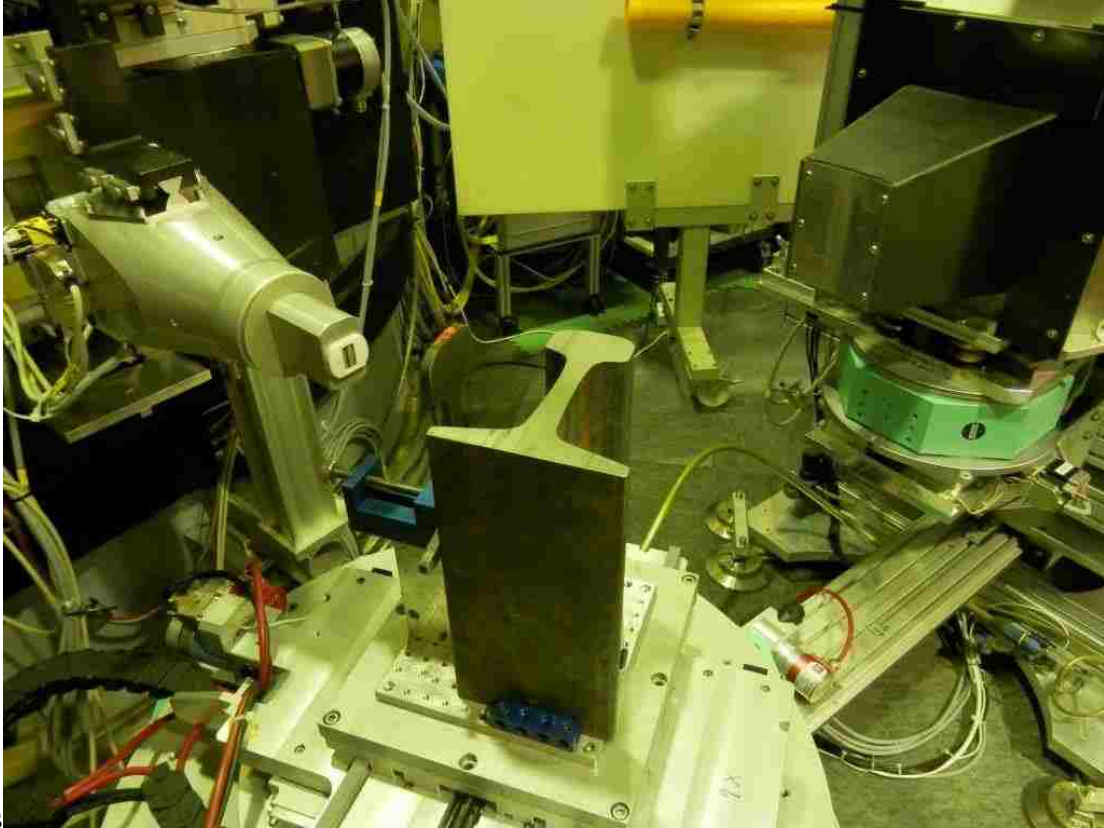
**Figure 109** – Residual stress measurements on a 300 mm section of the AHH rail using the neutron source at Helmholtz-Zentrum Berlin (HZB).

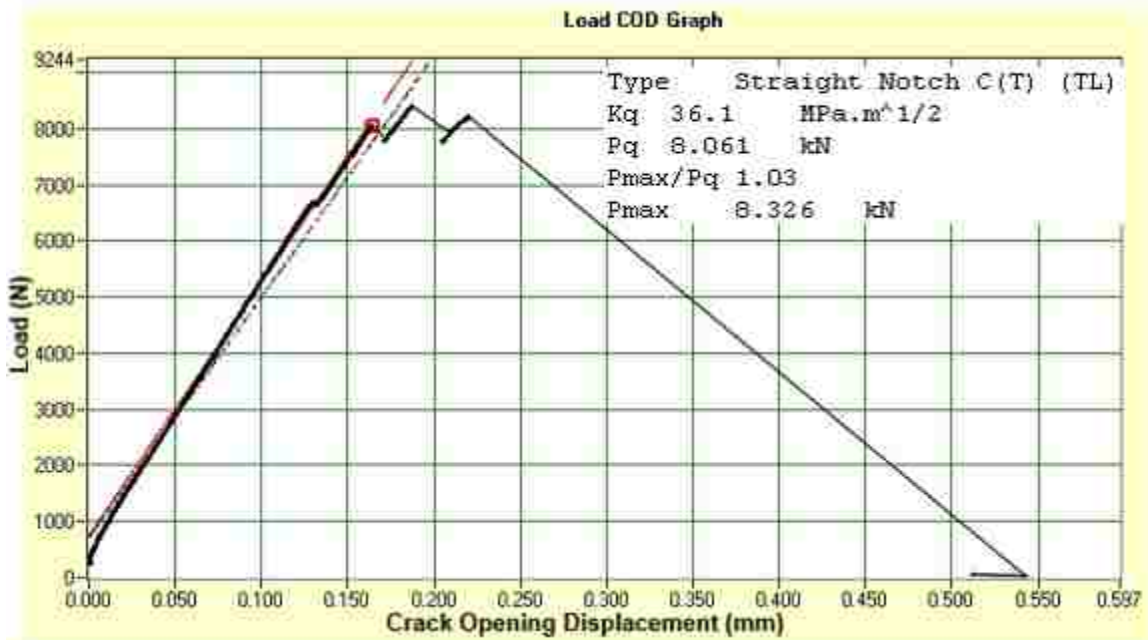
**Figure 128** – Load vs COD for SS Rail Fracture Toughness Test.
