THE IMPACT OF WATERS OF LOW QUALITY ON SOILING
REMOVAL FROM PHOTOVOLTAIC PANELS

Master of Science in Engineering - Civil and Environmental Engineering

University of Nevada, Las Vegas

May 2018

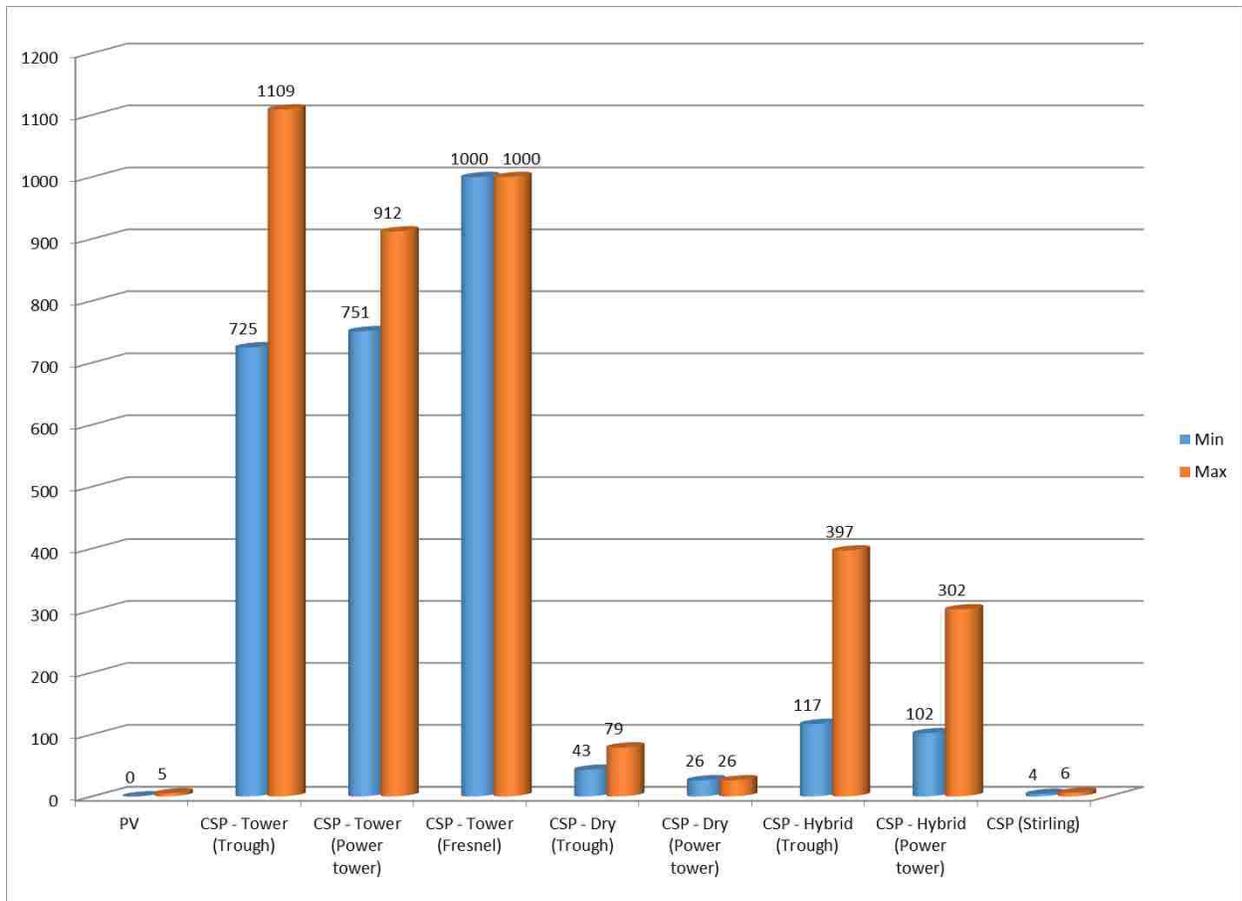
Figure 1. Water consumption for solar energy technologies based on the data from Macknick et al (2012), showing that PV and dry cooling consumes less energy than concentrating solar power that uses wet cooling

Macknick et al. (2012) provided an estimation of operational water withdrawal and water consumption factors for generating technologies in the United States. The authors concluded that concentrating solar power technologies that use a recirculating cooling system have the highest water consumption; non-thermal renewables such as PV (maximum of $5 \text{ gal MW}^{-1} \text{ h}^{-1}$) and wind have the lowest water consumption factors, along with thermal technologies that utilize dry cooling. PV systems may need water for panel washing; however, industry practices indicate that most PV system operators do not wash the panels. Figure 1 represents the water consumption for solar energy technologies ($\text{gal MW}^{-1} \text{ h}^{-1}$). The location and the climatic conditions can affect the efficiency and water use rate. Other factors that may impact water use concentrations are the age of the plant, thermal efficiency, age of the cooling system, and water source.

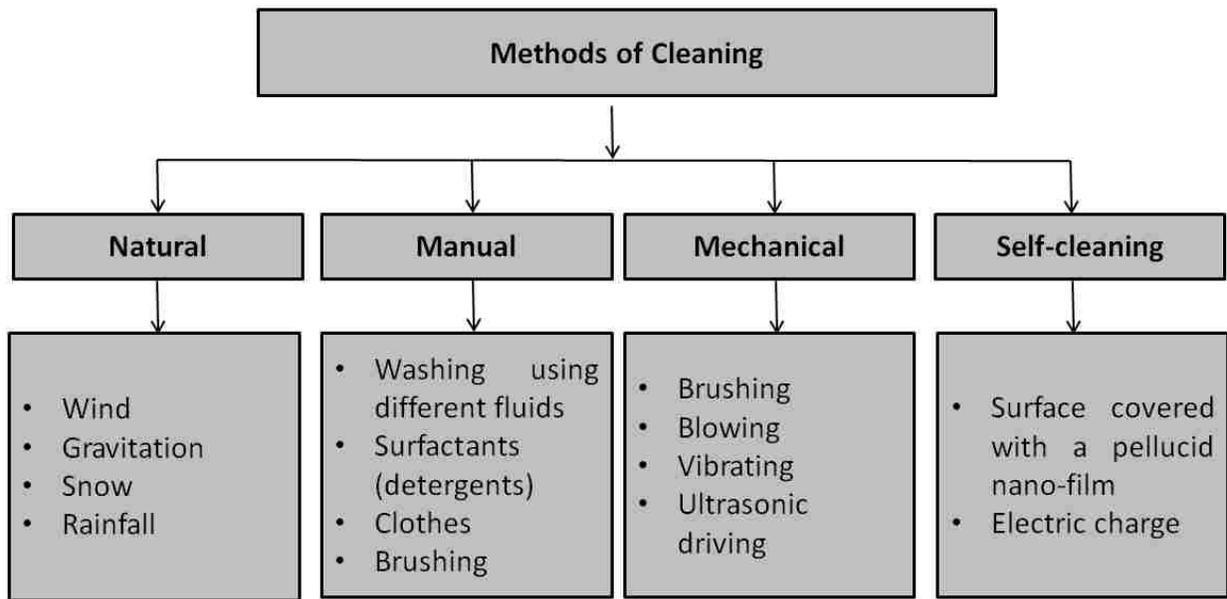
Figure 2. Different cleaning methods used to clean solar PV panels

In places where dust is a concern, the investment in cleaning techniques is important to restore the efficiency of the system. The restoration can be done by washing, mechanical removal, and hybrid techniques. Washing is the use of fluids to remove soiling and to clean modules' surfaces. This method should be applied with some effective recycling system to avoid waste water. The mechanical removal includes wiping, forced air, and brushing. These techniques tend to use less water, but require care due to abrasiveness of the dust particles that can damage the modules. The hybrid techniques are combinations of washing and mechanical, brushing, and wiping with forced air (Kazmerski, 2014). Figure 2 presents four different cleaning techniques.

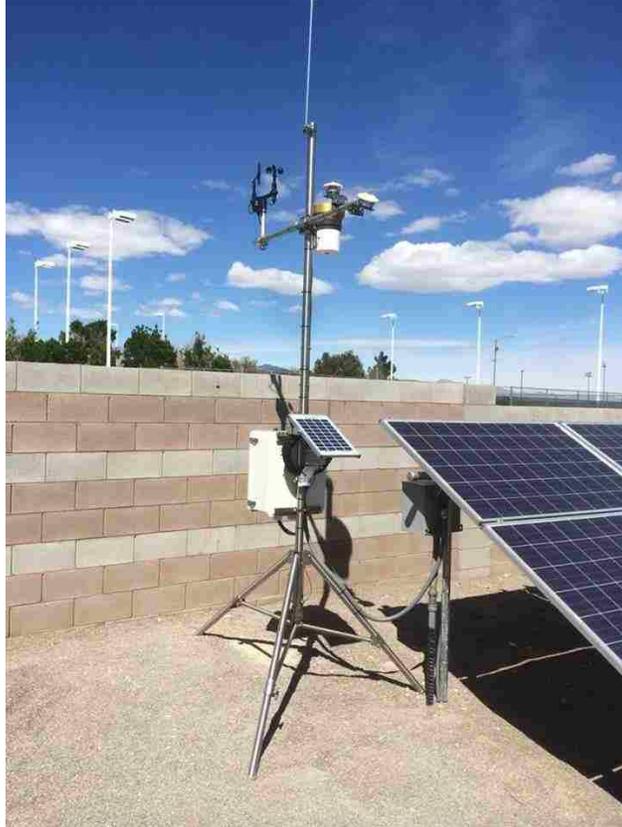
Figure 4. Weather Station installed at the City of Las Vegas West Maintenance Yard to assist in the data collection for the solar plant

A monitoring system for the solar panel was set up at the site that includes a Campbell Scientific Incorporated (CSI) model CR1000 datalogger (Figure 4). The sensors include a Vaisala model HMP45C-L Temperature and Relative Humidity Probe. For wind speed and direction, the system uses an R.M. Young model 03002 Wind Sentry Set. Two CMP3-L Pyranometers are used to measure the global horizontal radiation and the plane of array irradiance. A TE525WS-L Rain Gage to measure the rainfall, and a 10 thermocouple CS220-L type Es to measure temperature were installed at the back of the solar panels.

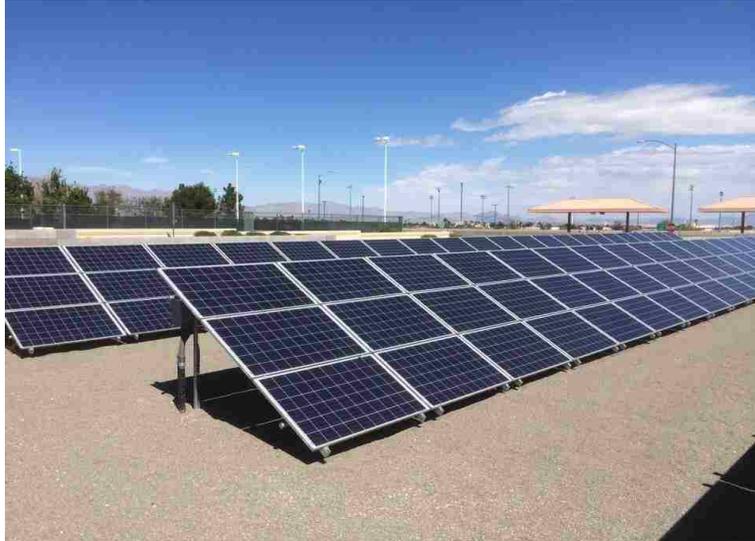
Figure 5. Instrumented 264 PV modules located at the West Maintenance Yard of the City of Las Vegas used in the study

The solar plant (Figure 5) has six inverters (Fronius IG Plus V 10.0-1 UNI, Portage, IN - USA) that are responsible for changing the direct current (DC) into alternating current (AC) and measuring the daily power output.

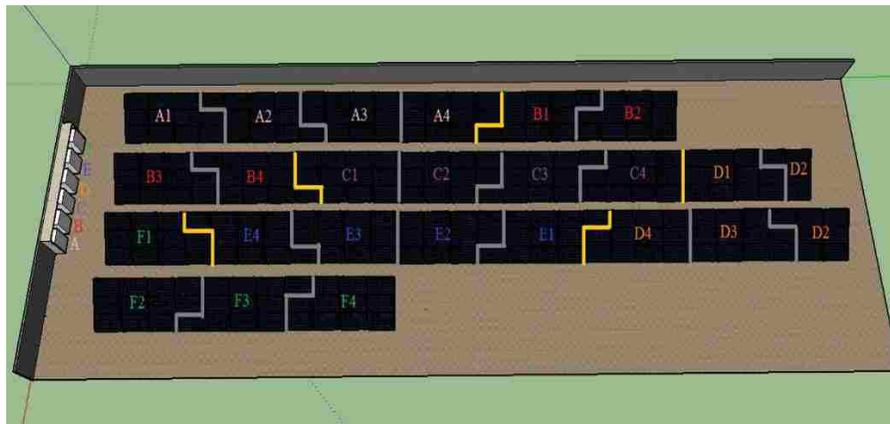
Figure 6. Design of the West Yard Solar site (each letter represents one group of panels)

The panels have been grouped into six independent sections (Figure 6), and each section was washed using different cleaning solution as presented in Table 4. Soiled panel cleaning was performed manually using a soft cleaning brush (Mr. LongArm 0405 Soft Flow-Thru Brush, Greenwood, MO – USA). Each solar panel group was cleaned early in the morning to avoid interferences in the power output.

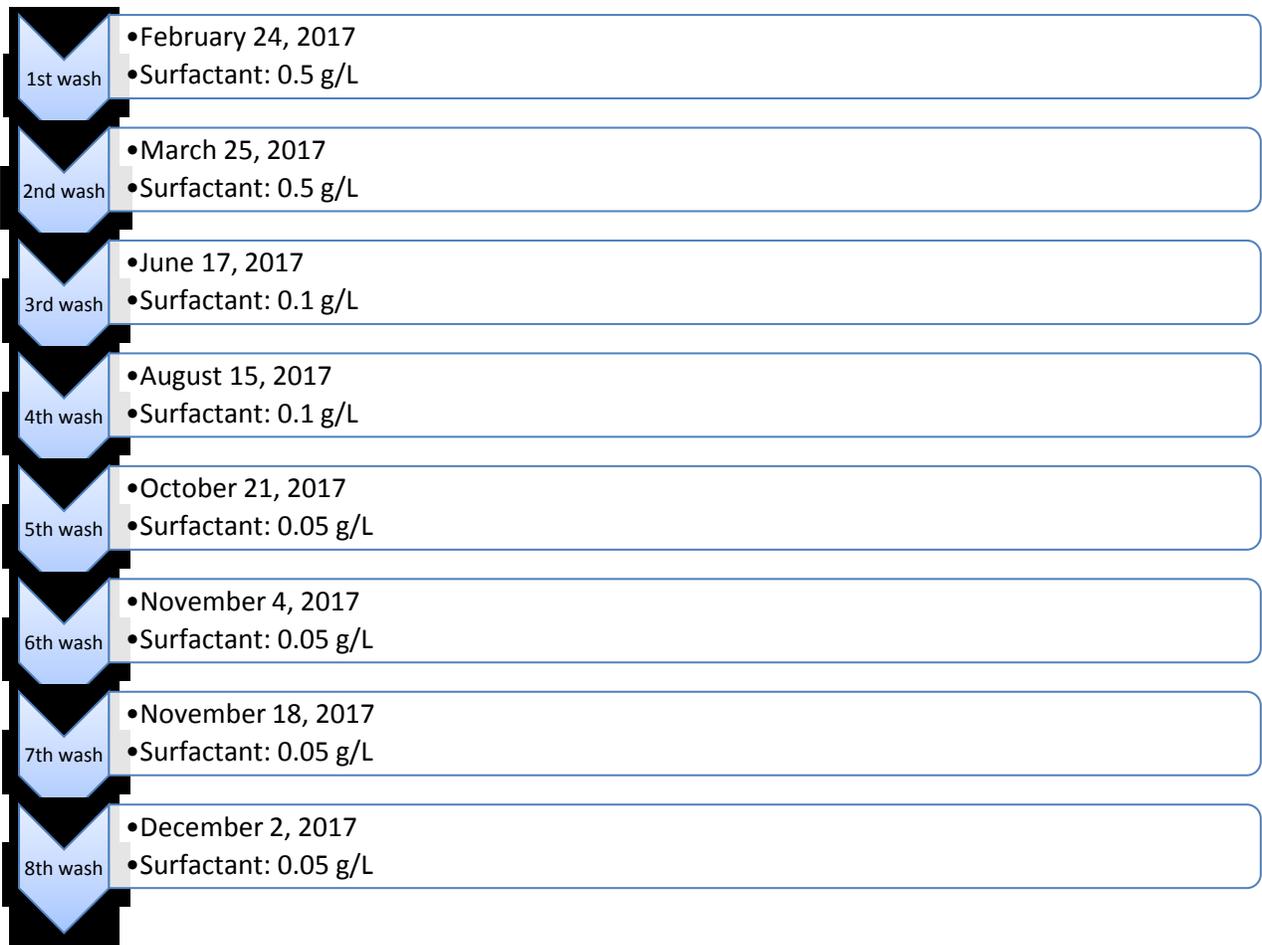
Figure 7. Cleaning schedule and the concentration of the anionic surfactant (Sodium Dodecyl Sulfate) utilized to wash solar panels

Determining the cleaning frequency for PV panels depends on different variables such as water accessibility, water transportation, water storage, labor work, cleaning time needed, field size, and costs. In this study, it was not possible to determine a cleaning schedule since the amount of dust accumulated on the panels was small and several rainfall events occurred during the study. The solar panels did not get as dirty as expected. Figure 7 summarizes the cleaning schedule and surfactant amount utilized in the study. The concentration of the anionic surfactant (Sodium Dodecyl Sulfate) was based on the study of Moharram et al. (2013).

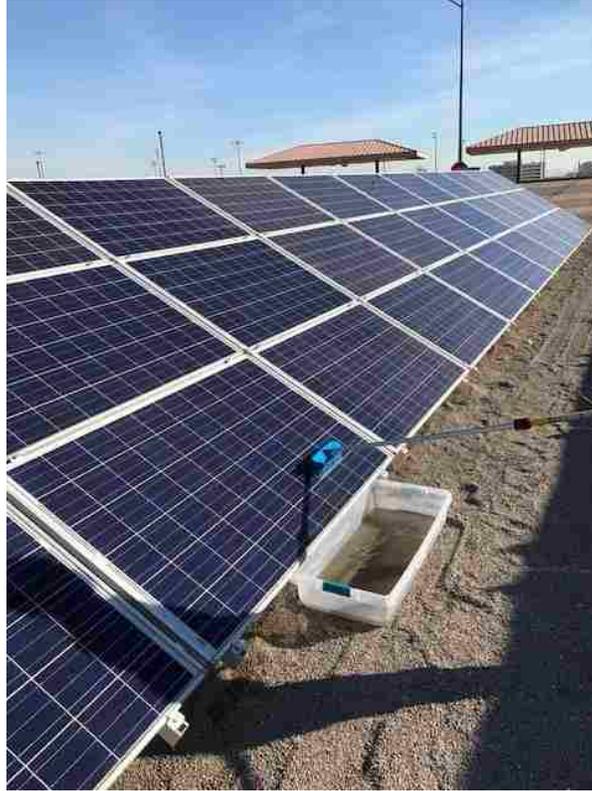
Figure 8. Panel cleaning process using a soft brush and long containers to collect the wash water for analysis

During cleaning, the wash water from each panel set was collected in long containers placed along the panels and the resulting water was reutilized to wash the same panel set (Figure 8). The wash water was analyzed for pH, Conductivity, Total Dissolved Solids (TDS), Total Suspended Solids (TSS), anions, and metals.

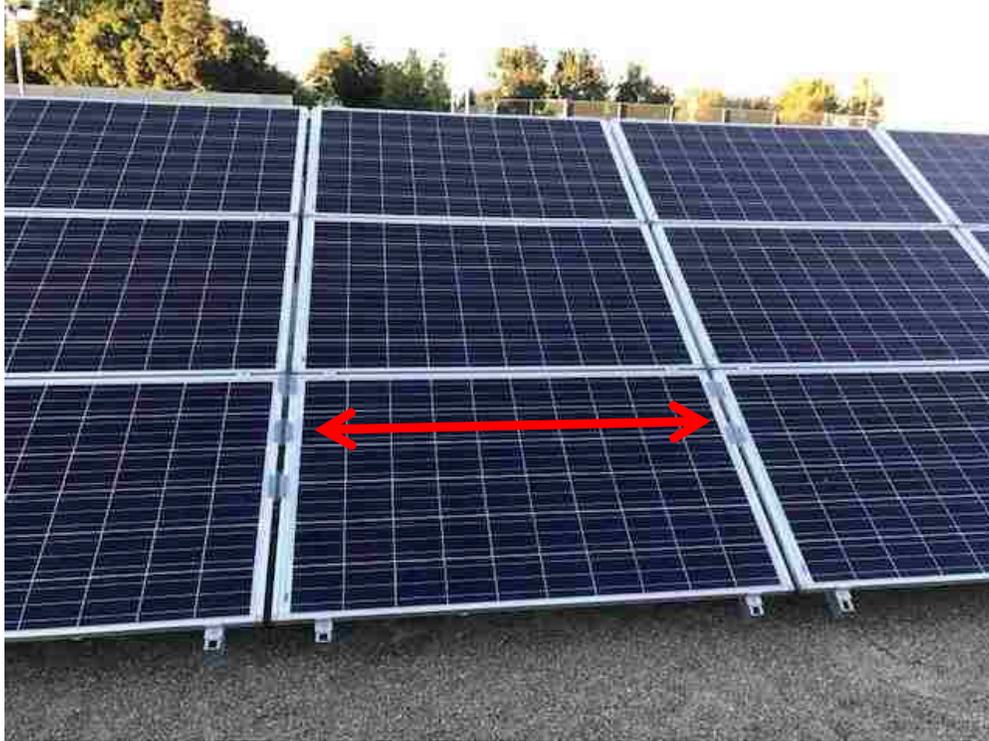
Figure 9. Tempered glass samples fixed to the solar panels to verify the amount of dust accumulated per cleaning, and the efficiency of cleaning

Tempered glass samples with dimensions of 16.51cm x 10.16 cm x 0.762 cm (width x Length x thickness) were fixed (Figure 9) to the solar panels for dust sample collection. The attachment of the tempered glass was needed to have a sample that could be brought to the laboratory for SEM-EDS and goniometer analysis.

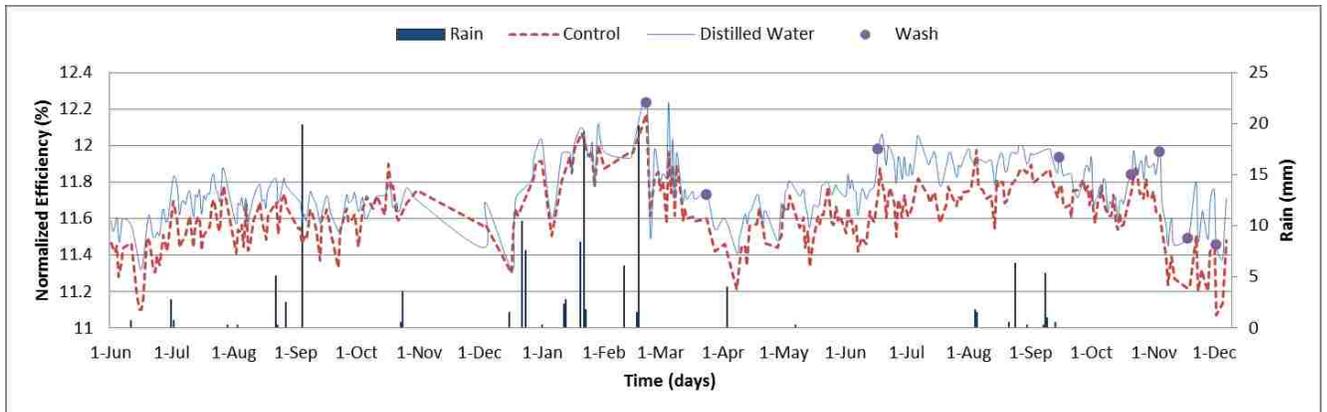
Figure 11. Normalized efficiency for the distilled water group versus the control group, amount of rainfall per day, and the date of panels washing during 18 months

After starting the cleaning schedule (8 total) on February 24, 2017, the highest normalized mean efficiency was observed in the distilled water (11.79%), followed by the treated wastewater (11.74%), treated wastewater with surfactant (11.72%), vacuum cleaner (11.67%), groundwater (11.66%), and the control group (11.64%).

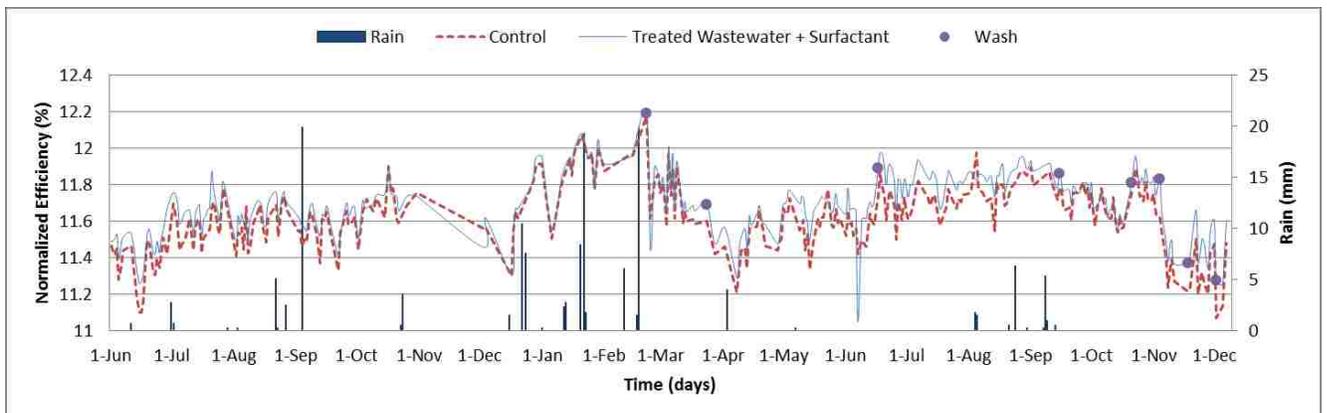
Figure 12. Normalized efficiency for the treated wastewater with surfactant group versus the control group, amount of rainfall per day, and the date of panels washing during 18 months

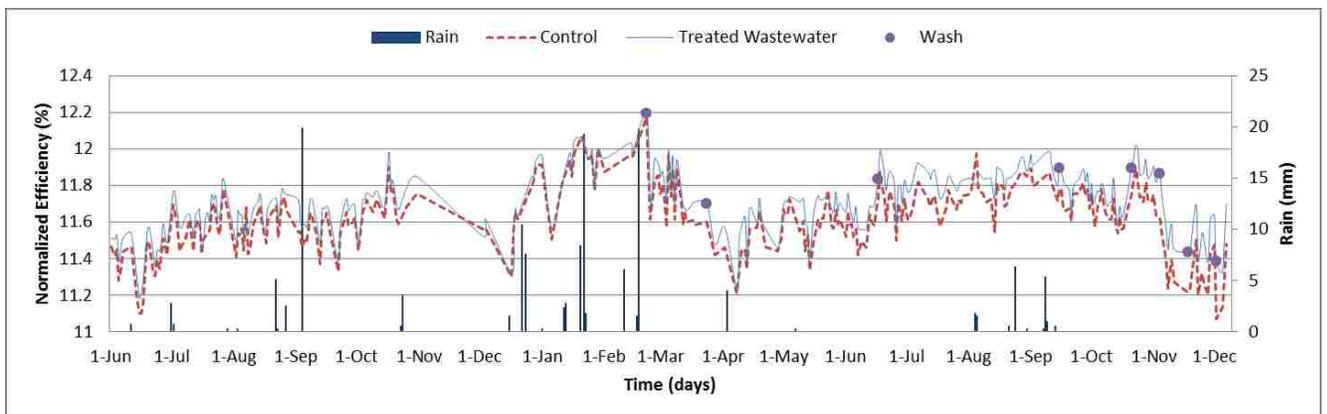
Figure 13. Normalized efficiency for the treated wastewater group versus the control group, amount of rainfall per day, and the date of panels washing during 18 months

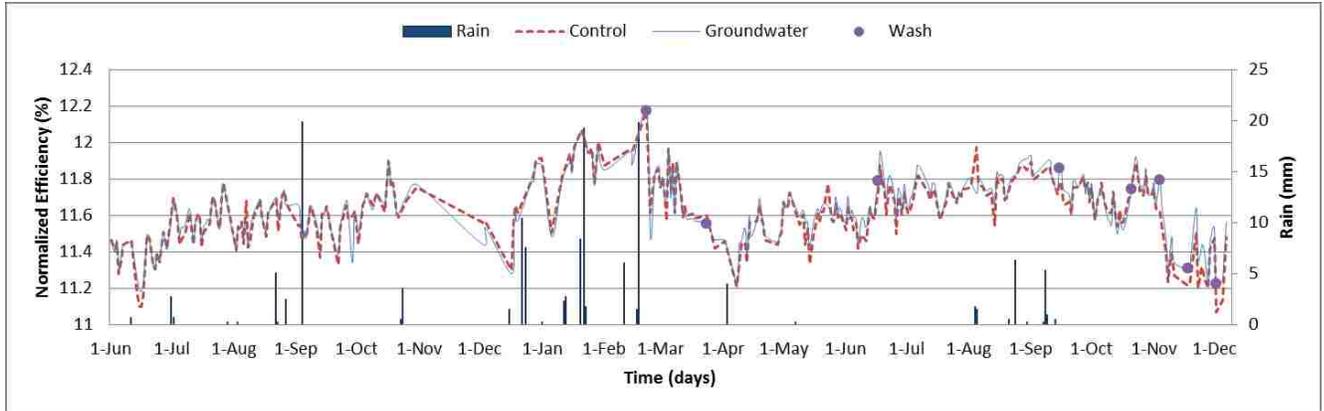
Figure 14. Normalized efficiency for the groundwater group versus the control group, amount of rainfall per day, and the date of panels washing during 18 months

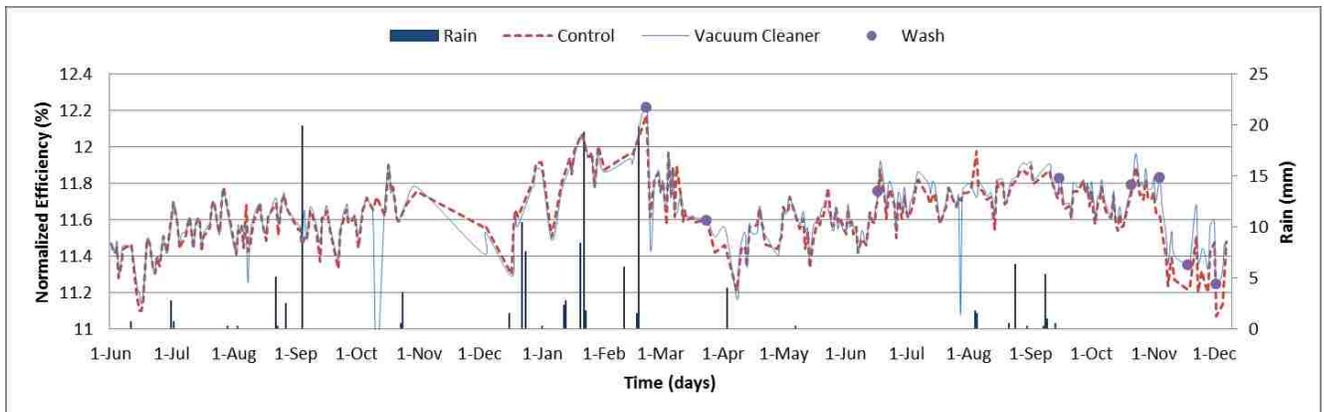
Figure 15. Normalized efficiency for vacuum cleaner group versus the control group, amount of rainfall per day, and the date of panels washing during 18 months

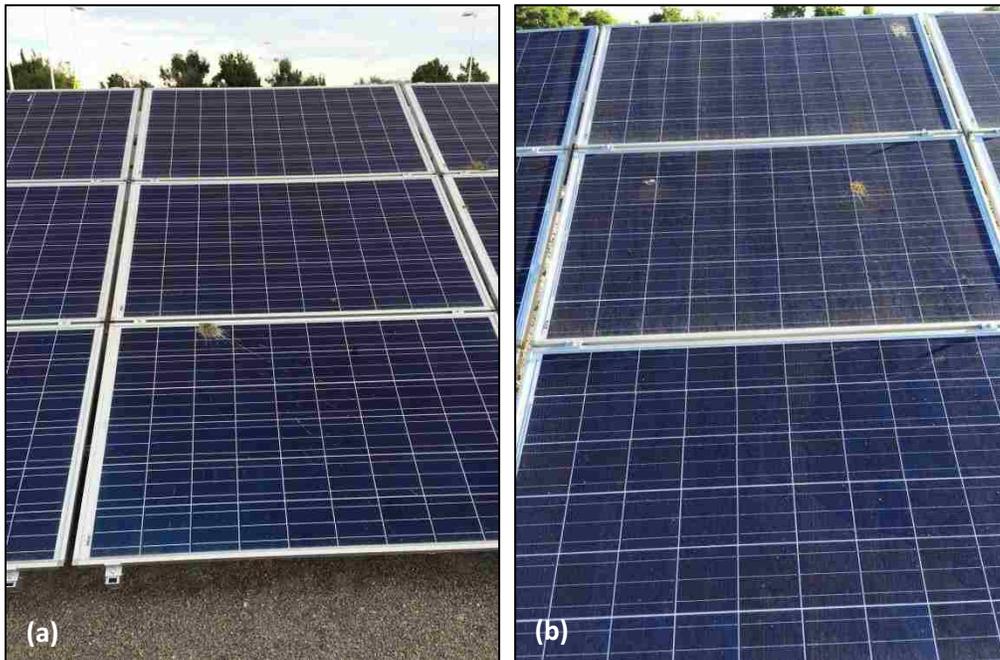
Figure 16. Bird droppings for (a) Group B on October 14, 2016, and (b) Group C on June 17, 2017

The presence of bird droppings (Figure 16) was not found uniformly in the groups of panels. In addition, cleaning those panels was the most time consuming part in the cleaning schedule. The vacuum cleaner was not able to remove the bird droppings, which contributed for the low mean normalized efficiency in this group.

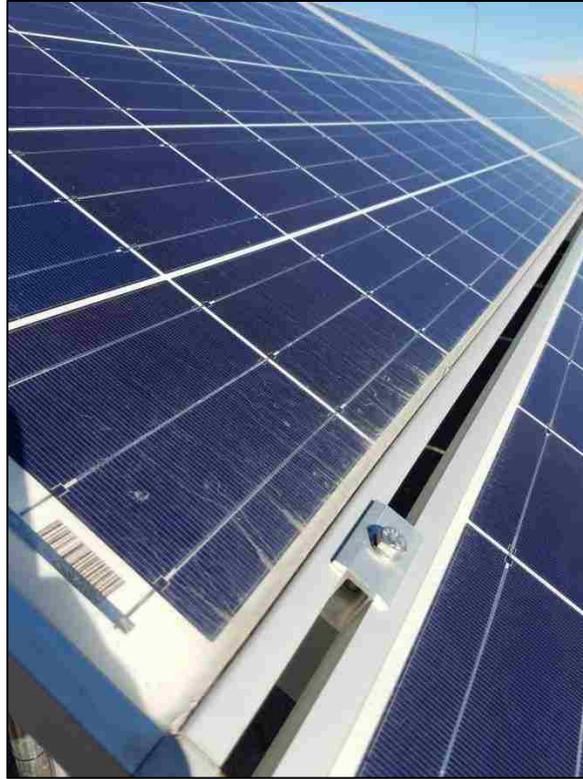
Figure 17. Presence of soiling near the edges

Even though the solar panels were exposed to same amount of rainfall, some panels still presented soiling near the edges (Figure 17). This event can explain the normalized efficiency difference for each group of panels. In similar study, Schill et al. (2015) observed that a light rainfall did not wash the soil off totally. The dust got accumulated in the lower area of the panels.

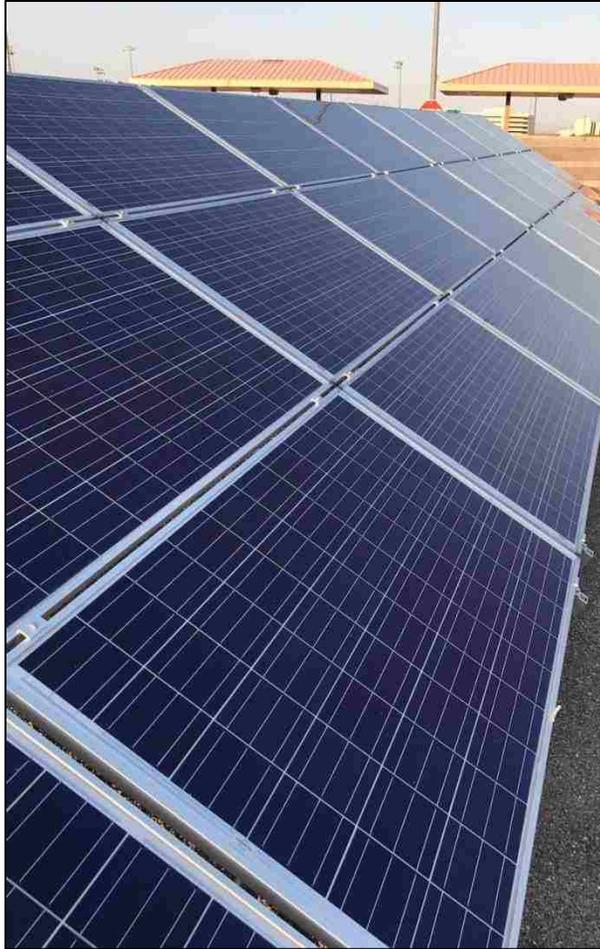
Figure 18. Clean surface after rainfall events that happened on August 2, 2017 (1.77 mm) and August 3, 2017 (1.52 mm)

Weekly or monthly cleaning was not justified in this research because the dust deposition on the glass of the PV modules did not considerably degrade the performance of the PV system. Furthermore, most of the rain events were enough to keep the solar panels clean. Inadequate or inefficient cleaning methods, such as the use of groundwater to clean PV panels, can end up consuming more time and increasing costs. The same result was reported by Sinha et al. (2014), which stated that cleaning schedules are not necessary when soiling is not a big concern and dust is regularly removed by the rainfall.

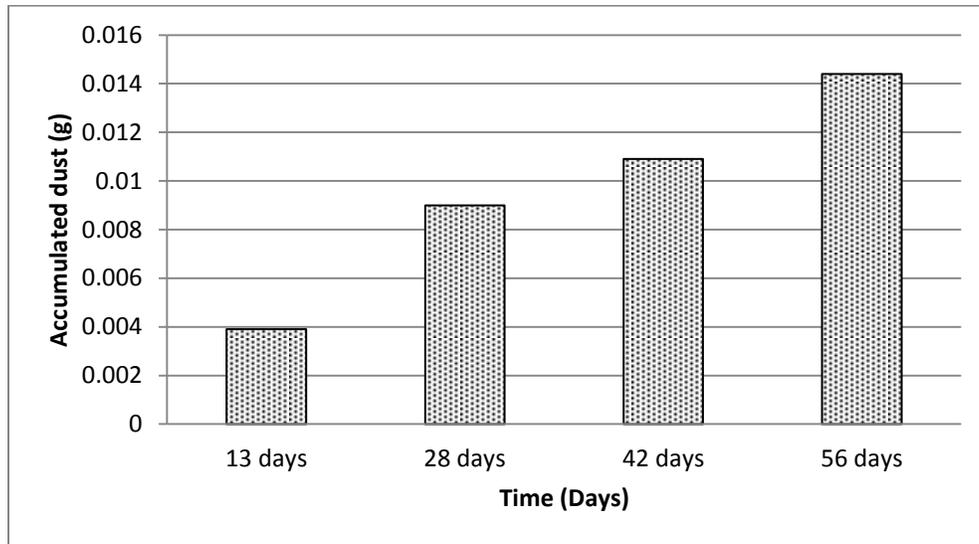
Figure 19. Accumulated dust on the panel's surface located at the West Maintenance Yard of the City of Las Vegas from October 8, 2017 to December 2, 2017

deposition increased over time. The accumulated dust on the surface of PV panels in 56 days ranged from 0.023 mg/cm² to 0.086mg/cm².

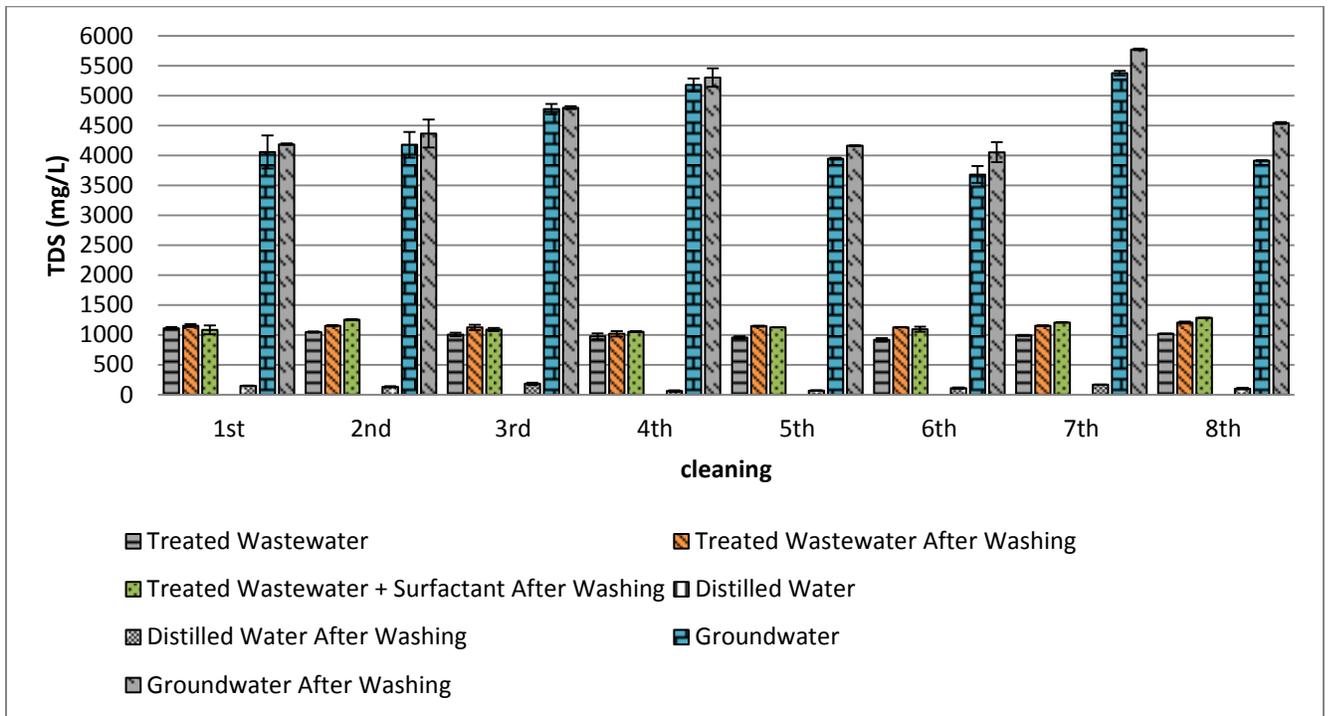
Figure 20. Total dissolved solids before and after washing the PV panels located at the West Maintenance Yard of the City of Las Vegas

Figure 20 shows the TDS before and after washing the panels. Distilled water was the only type of water utilized in this study with less than 100 mg/L. The treated wastewater and groundwater had a range of 915 to 1110 mg/L, and 3680 to 5375 mg/L, respectively. The distilled water after washing the panels presented a TDS lower than 100 mg/L only in the fourth (60 mg/L) and fifth (67.5 mg/L) wash.

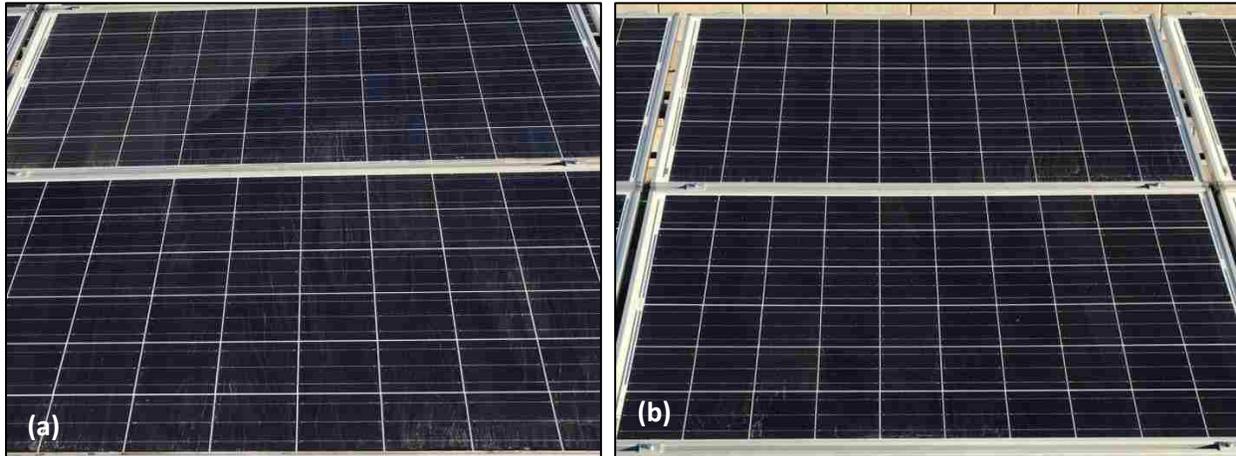
Figure 21. Presence of residuals after cleaning. (a) Groundwater. (b) Treated wastewater with surfactant

the fact that the water types previously contained different types of particles. Therefore, the washing process resulted in particle removal, but it also resulted in particle addition. The water reuse process may have aggravated this problem.

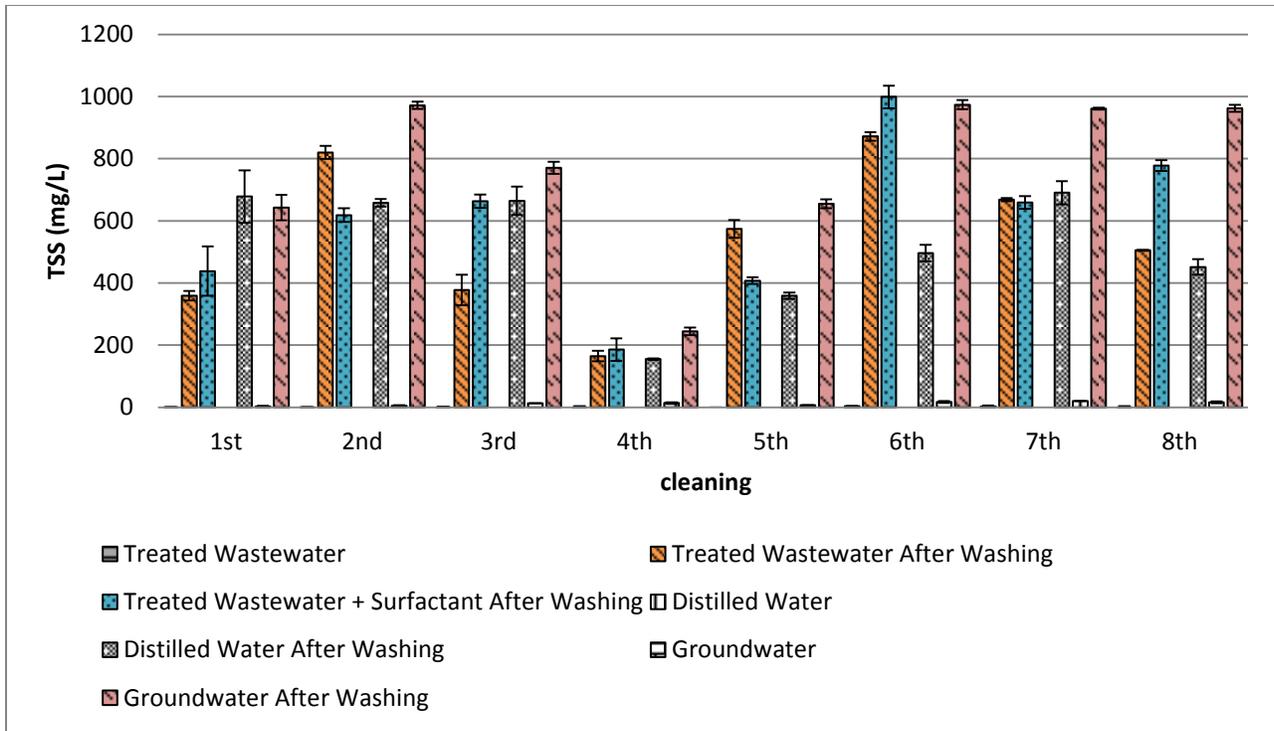
Figure 22. Total suspended solids before and after washing the panels

Figure 22 shows the TSS before and after washing the panels. The treated wastewater and groundwater presented a TSS concentration lower than 3.1 mg/L and 20.1 mg/L, respectively, while the distilled water did not show any amount of suspended solids. However, after washing the panels, these concentrations increased considerably, as shown in Figure 22.

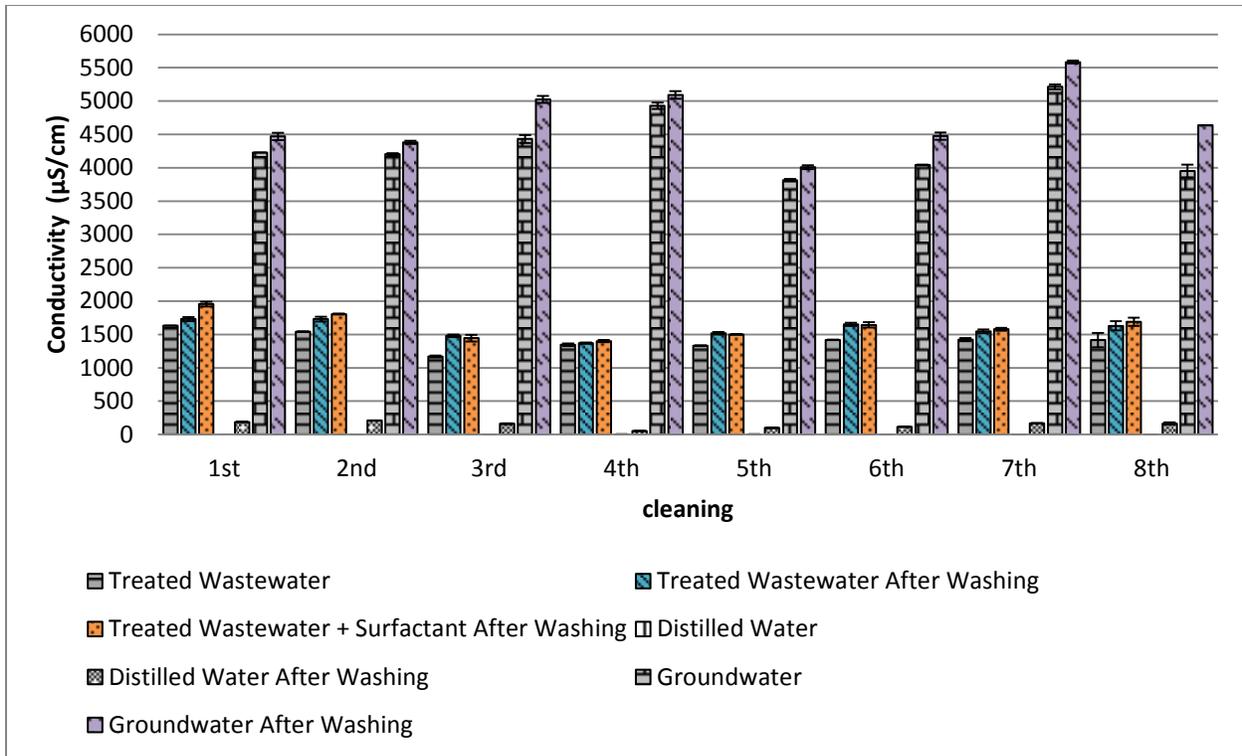
Figure 23. Conductivity before and after washing the panels

The findings revealed that all water types increased the conductivity after washing the solar panels. Therefore, this increase in conductivity indicates the dissolution of solids that were present as dust in the panels, promoting a higher concentration of ions in each sample.

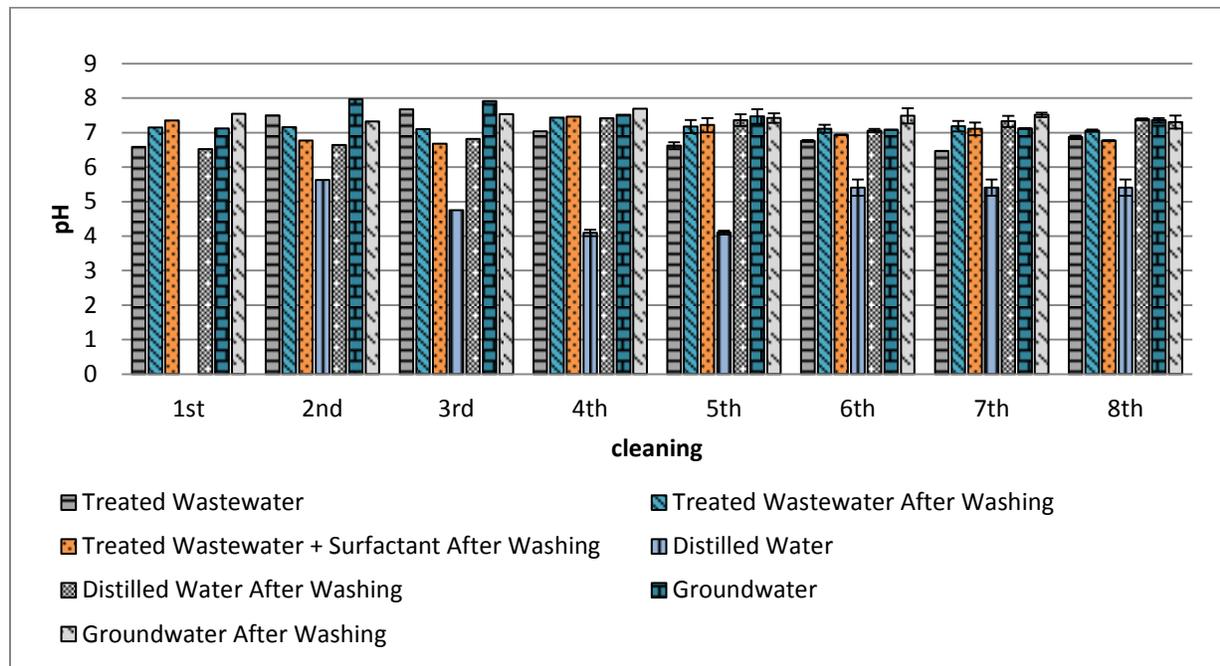
Figure 24. pH of water before and after washing the panels

Yilbas et al. (2015) indicated that dust particles containing alkali (NaOH) and alkaline earth metals (CaCO₃) compounds might increase the pH when dissolved into the water. The presence of alkaline and alkali metals were observed in the dust and water samples by the EDS and Thermo iCap 6300 – ICP analyses, respectively. The pH for distilled water in the first wash was not measured.

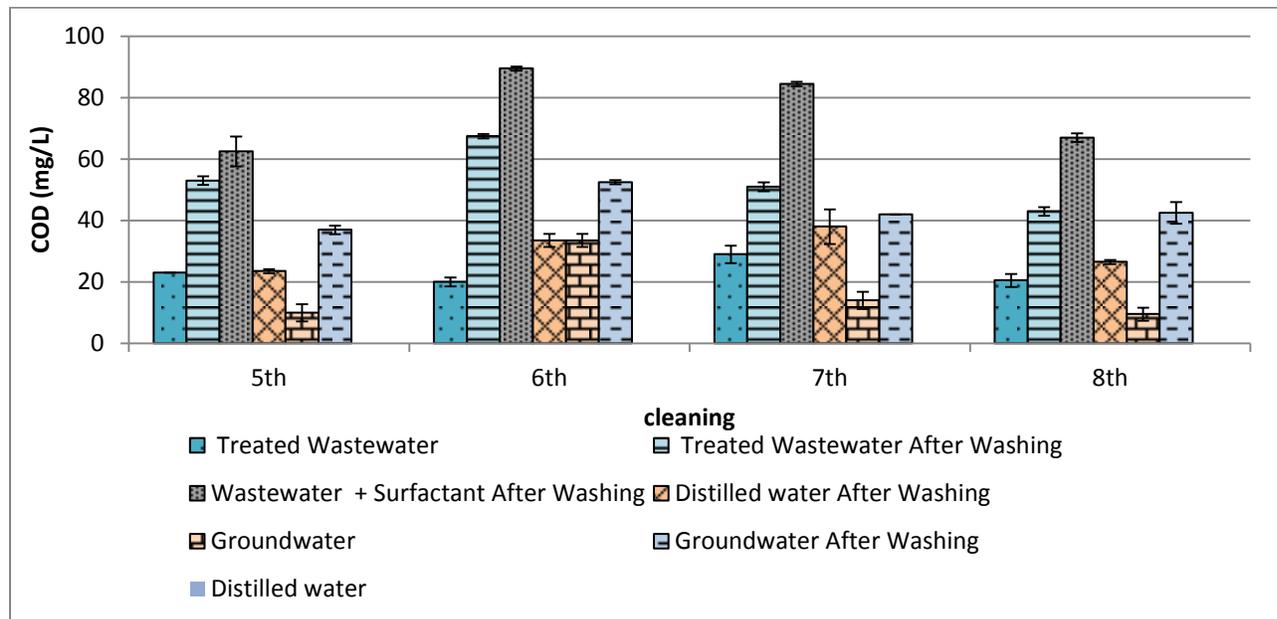
Figure 25. COD before and after washing the PV panels

After washing the surface of the solar panels, all cleaning solutions presented a higher COD. This result revealed that part of the organic matter present on the panels was removed with the cleaning. Higher COD concentrations detected after washing the PV panels were found in the treated wastewater with surfactant, followed by the treated wastewater, groundwater, and distilled water. The wash water from the panel washed with distilled water presented a COD range from 23 to 38 mg/L.

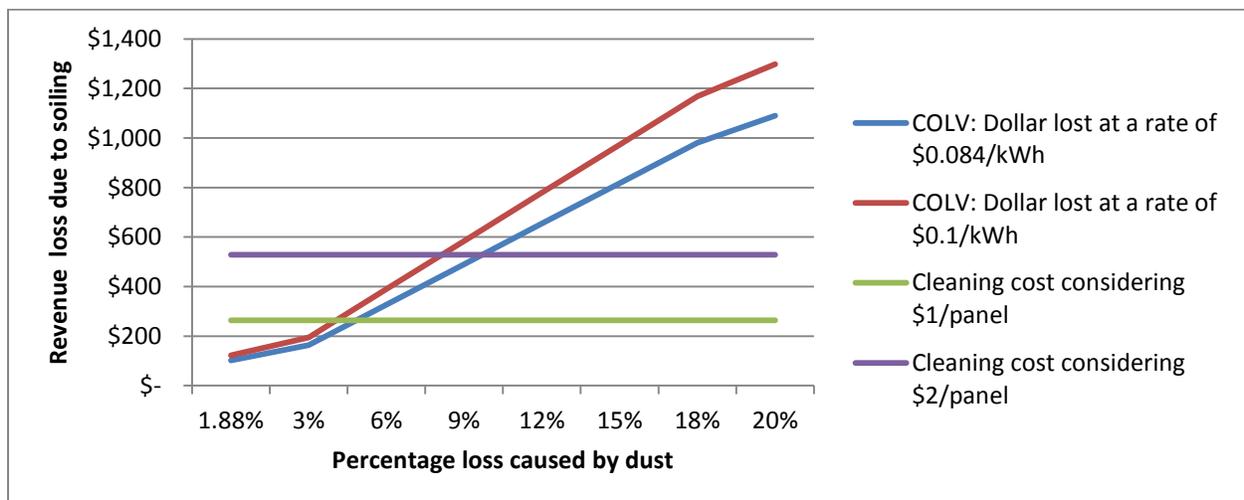
Figure 26. Simulation of different percentage loss caused by dust considering when it is cost effective to wash the solar panels located at COLV

Figure 26-27 simulates different percentage loss caused by dust and the costs for this research (COLV) and for the Copper Mountain Solar 1. After analyzing the three different prices for cleaning, it was possible to conclude that a cleaning schedule for this research would be recommended only if a loss of 6% caused by dust was observed and the price for cleaning were \$1 per panel. When considering the cleaning price of \$2 per panel, a cleaning schedule would be recommended after a loss of 9% for a rate of \$0.1/kWh, and after a loss of 12% for a rate of \$0.084/kWh. For the large solar plant at Sempra, cleaning schedule would be recommended for a loss of 20% due to the large amount of panels in this solar site.

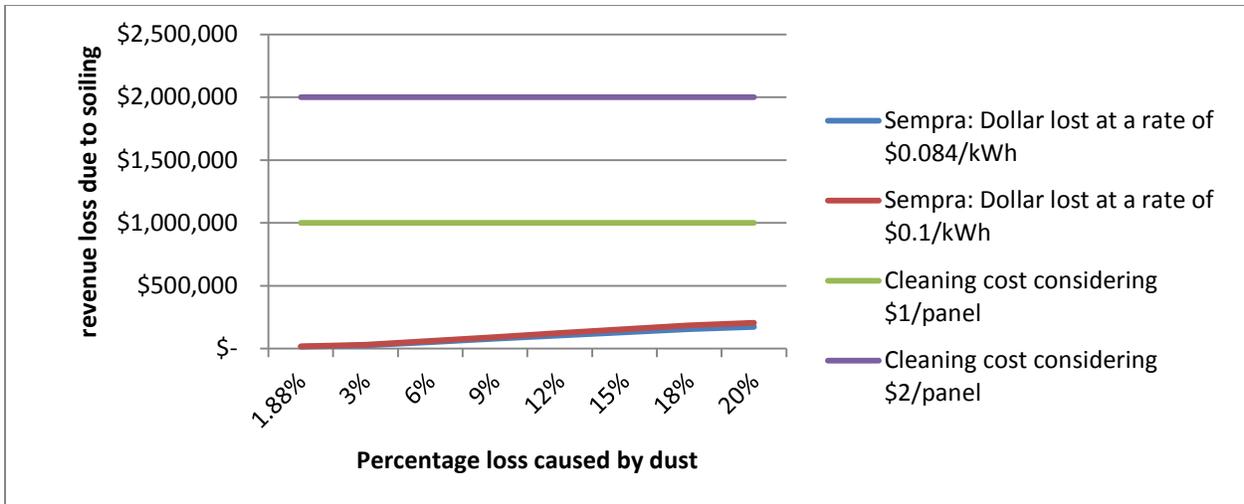
Figure 27. Simulation of different percentage loss caused by dust considering when it is cost effective to wash the solar panels located at Sempra

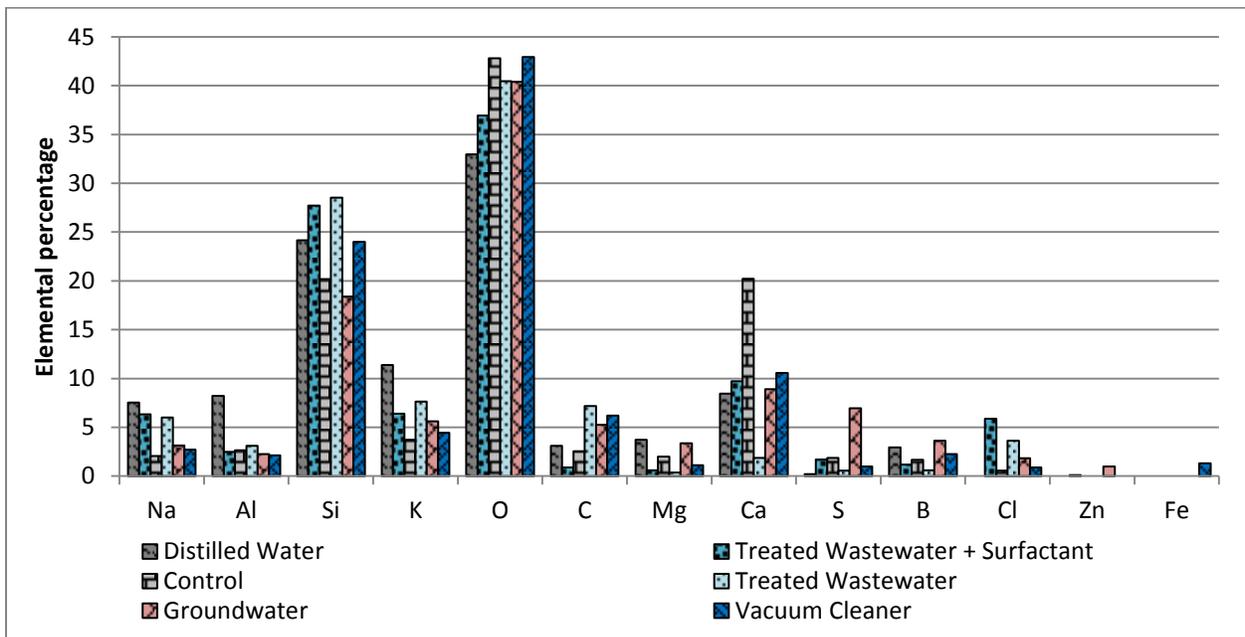
Figure 28. SEM-EDS elements remaining on the surface tempered glass after washing with various water types

The results from the SEM-EDS revealed that most of the dust accumulated on the surface of the panels is composed of sodium (Na), aluminum (Al), silicon (Si), potassium (K), oxygen (O), carbon (C), magnesium (Mg), calcium (Ca), sulfur (S), boron (B), chloride (Cl), zinc (Zn), and iron (Fe). The analysis shows that the elemental composition of remaining elements on the glass surface was different for different water types used to clean the panels. The group of panels cleaned with the vacuum cleaner was the only group where the presence of iron was detected (fifth and seventh wash). A logical explanation for this finding cannot be provided. The group cleaned with treated wastewater and surfactant was the only group where the presence of zinc (sixth wash) was noticed, although at small levels. As expected, chloride was not identified in the group washed with distilled water, but it was detected in all other groups.

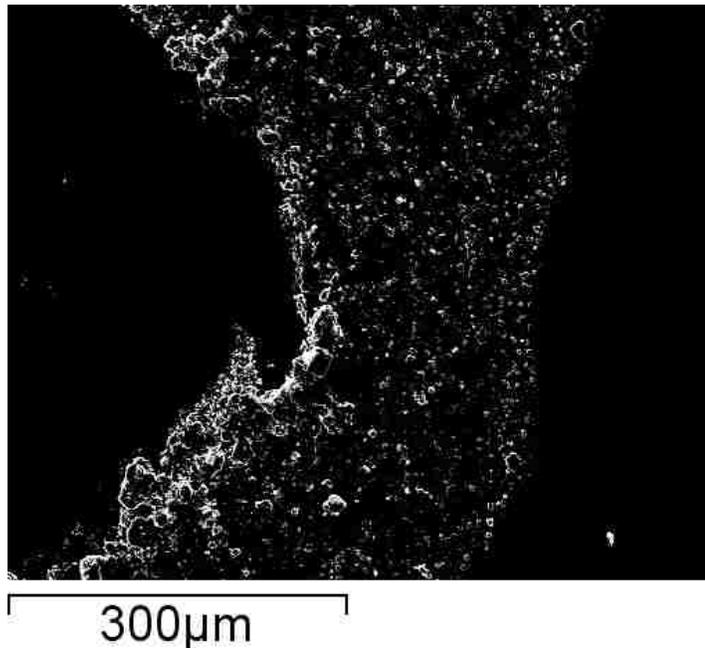
Figure 29. Agglomeration of particles observed when washing solar panels with treated wastewater and sodium dodecyl sulfate surfactant

The wastewater used contains high levels of calcium, magnesium, potassium, sodium, and sulfur. And, the groundwater used contains high levels of calcium, potassium, magnesium, sodium, sulfur, and silicon. The higher presence of these elements was detected on SEM-EDS results on the surface of the tempered glass.

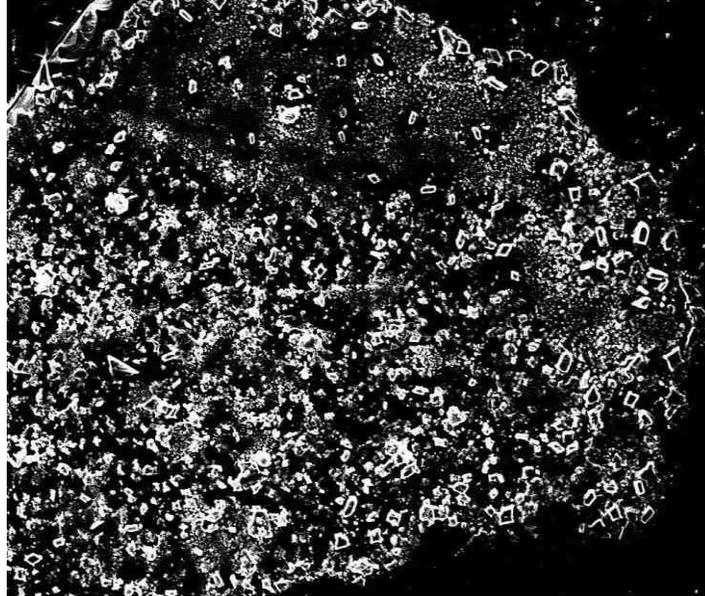
Figure 30. Presence of different particles on tempered glass sample after washing solar panels with groundwater

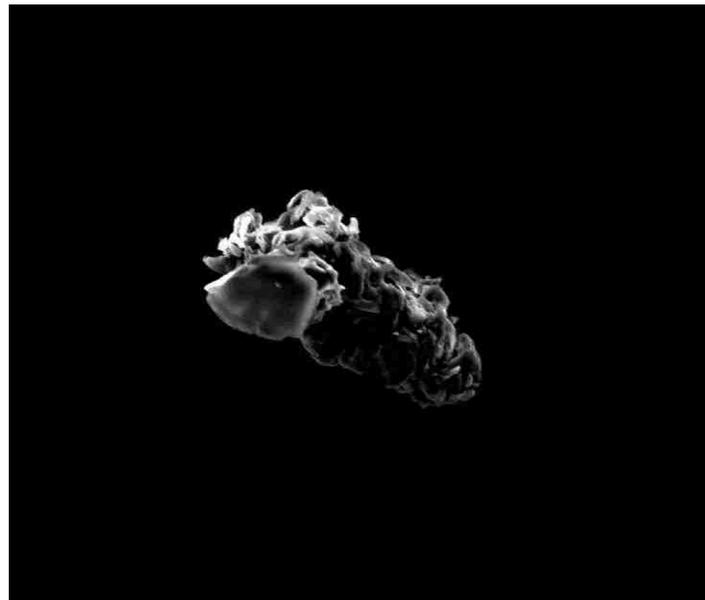
Figure 31. Particle on glass sample from solar panels washed with distilled water
