THE IMPACT OF WATERS OF LOW QUALITY ON SOILING
REMOVAL FROM PHOTOVOLTAIC PANELS

Master of Science in Engineering - Civil and Environmental Engineering

University of Nevada, Las Vegas

May 2018

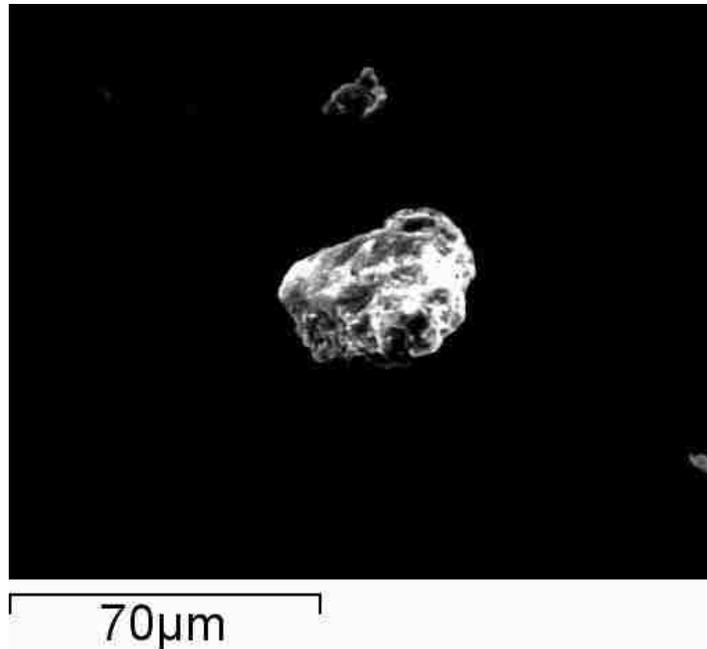
Figure 32. Particle on glass surface from solar panels cleaned with a vacuum

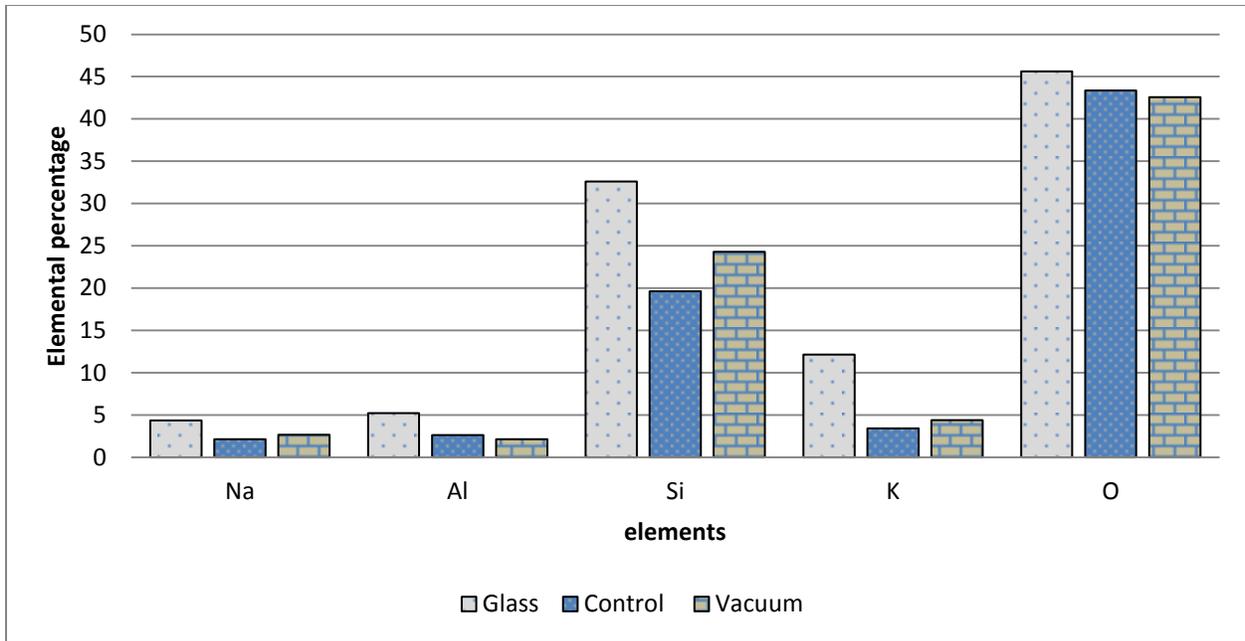
Figure 33. The mean chemical composition of the tempered glass compared with the mean dust composition found in the control group and the vacuum cleaned panel group

Figure 33 compares the mean chemical composition of the tempered glass utilized in this study with the mean dust composition found in the control and the vacuum cleaned panel groups. The graph shows that sodium, aluminum, silicon, potassium, and oxygen are higher in the glass samples than the control and vacuum cleaner group. Aluminum and oxygen are slightly higher in the control group when comparing with the vacuum cleaner group.

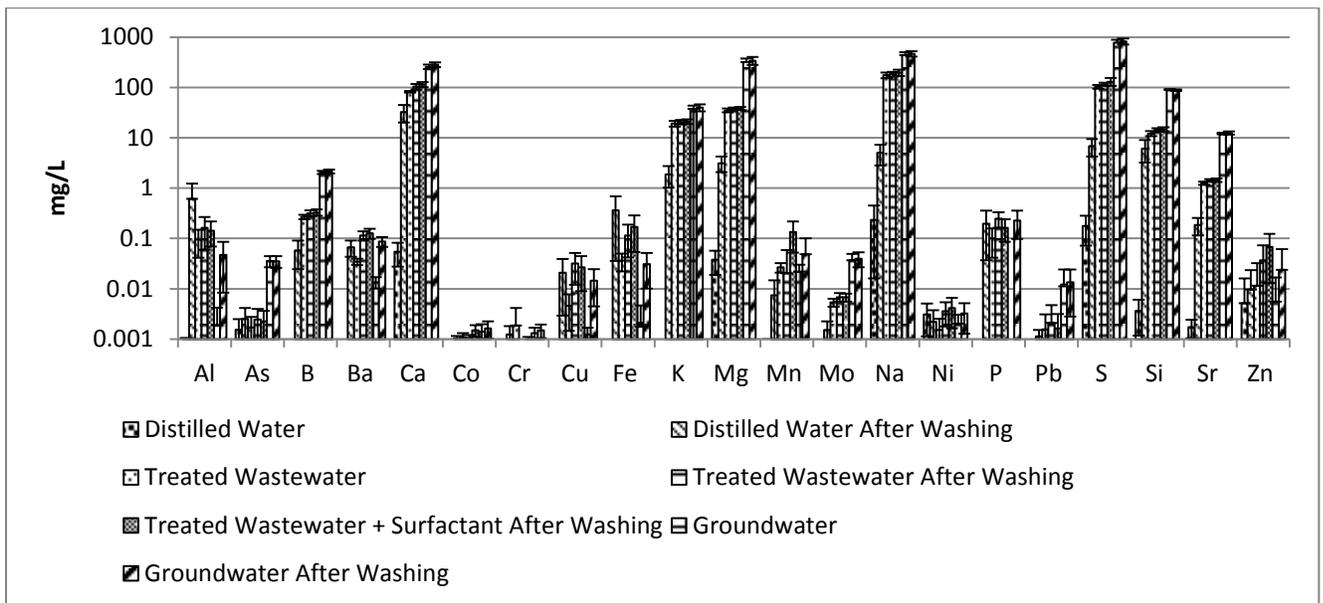
Figure 34. Mean trace concentration of 21 metals from the second to the eighth panel washes

Figure 34 shows the mean trace concentration of 21 metals from the second to the eighth panel washes. Cadmium and selenium were not identified at detection limits of 0.001 and 0.025 mg/L, respectively. Table 18 shows the mean trace concentration of 21 metals for the wash water before washing the PV panels.

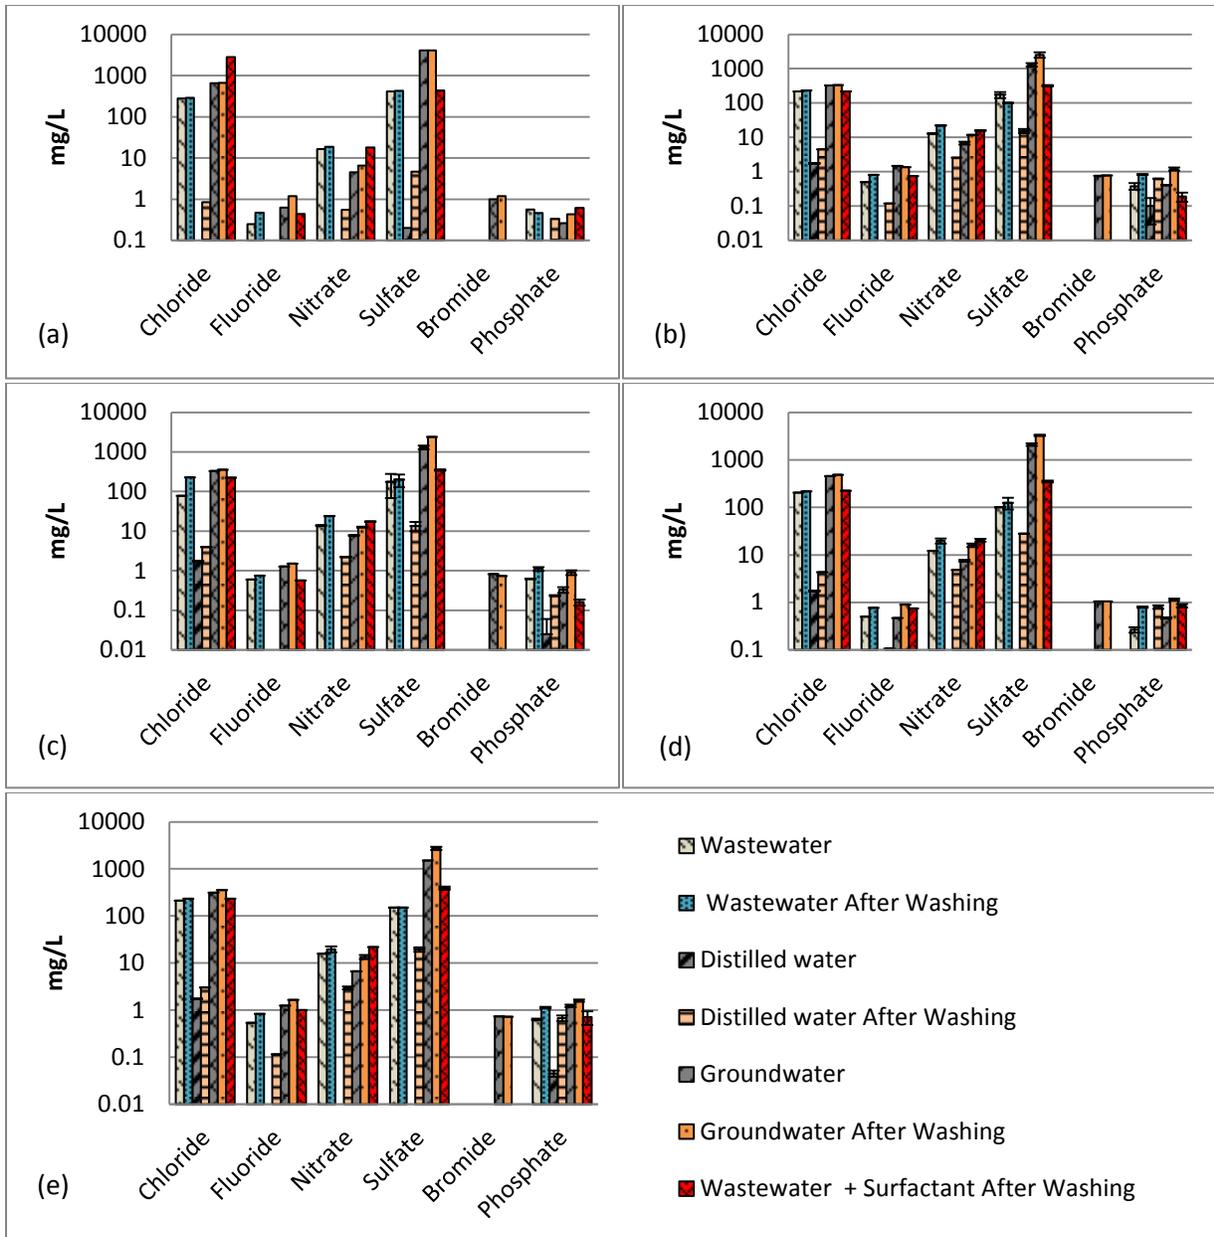
Figure 35. Anions (a) 4th wash (b) 5th wash (c) 6th wash (d) 7th wash (e) 8th wash

The anions analyzed in this research were chloride, fluoride, nitrate, sulfate, bromide, and phosphate. Figure 35 presents the anion concentration from the fourth to the eighth wash. These samples showed a variation on the anions concentration for each time the surface of the panels was cleaned. This variation can be described by the prior presence of anions in some types of water such as the treated wastewater or groundwater. Another relevant reason could be related with the quantity of dirt accumulated on the panels, influenced by the wind, rainfalls or the cleaning process.

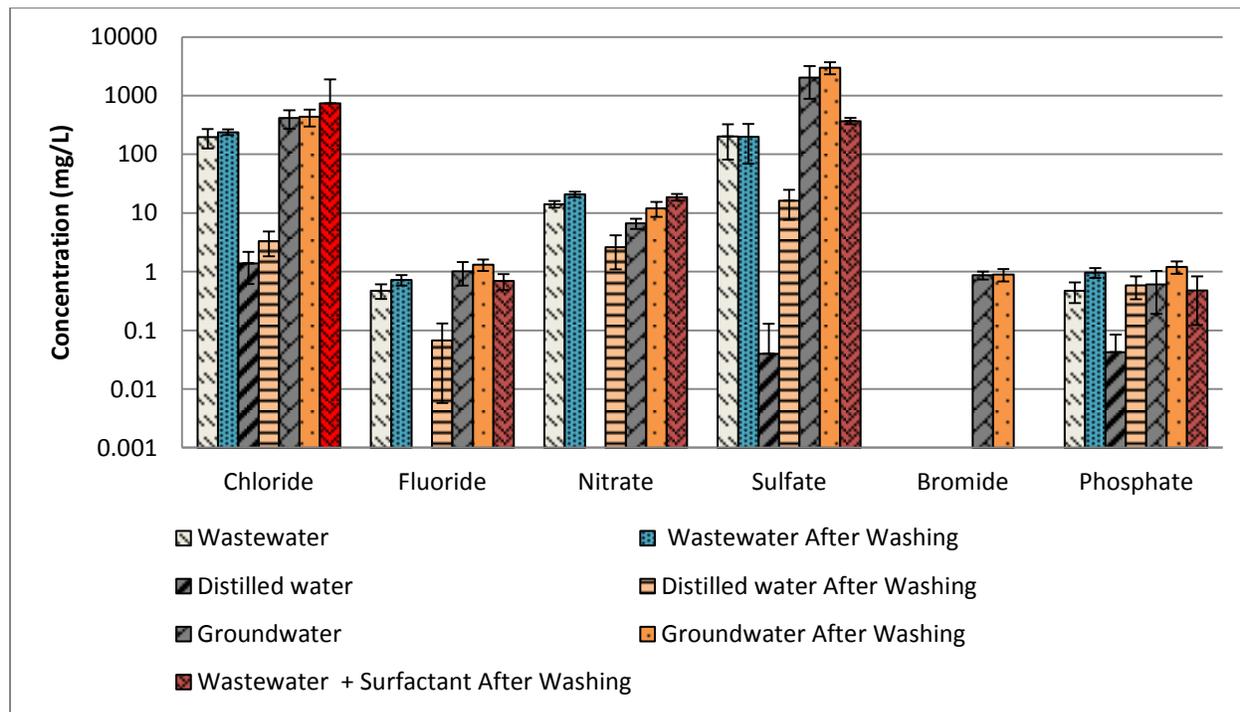
Figure 36. Mean anion concentration (mg/L) for each type of wash water

Since total phosphate was performed in the fourth wash, it was not included in the mean of orthophosphate (fifth, sixth, seventh, and eight wash) represented in Figure 34.
