Cost Comparison of Cement Concrete and Polymer Concrete Manholes in Sewer Systems

Master of Science – Construction Management

University of Nevada, Las Vegas

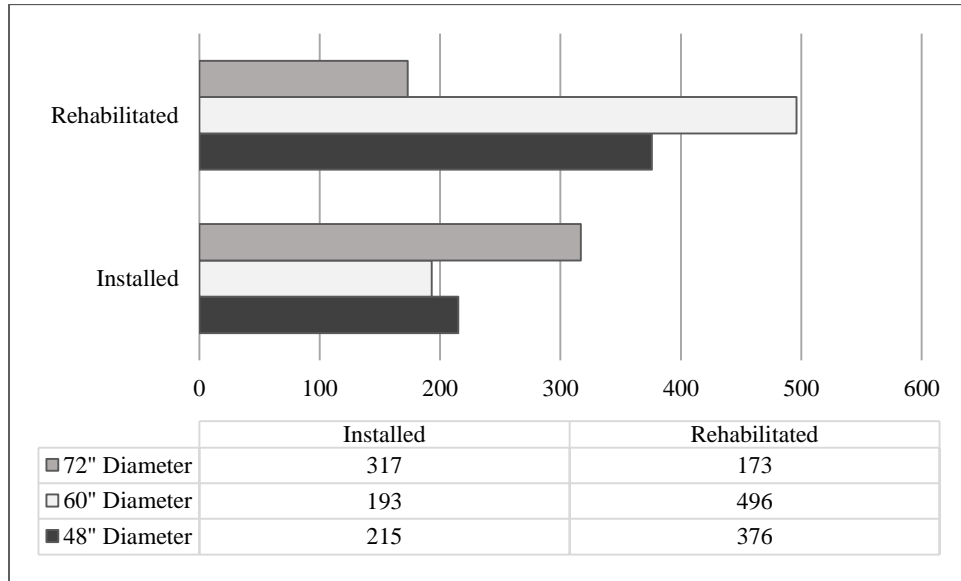
distribution of the number of different diameters of manholes are represented in the following figure:

Fig. 2: Number of Cement Concrete Manholes of different diameters for Comparison between Installation cost per feet and Rehabilitation cost per feet (2006-2017)

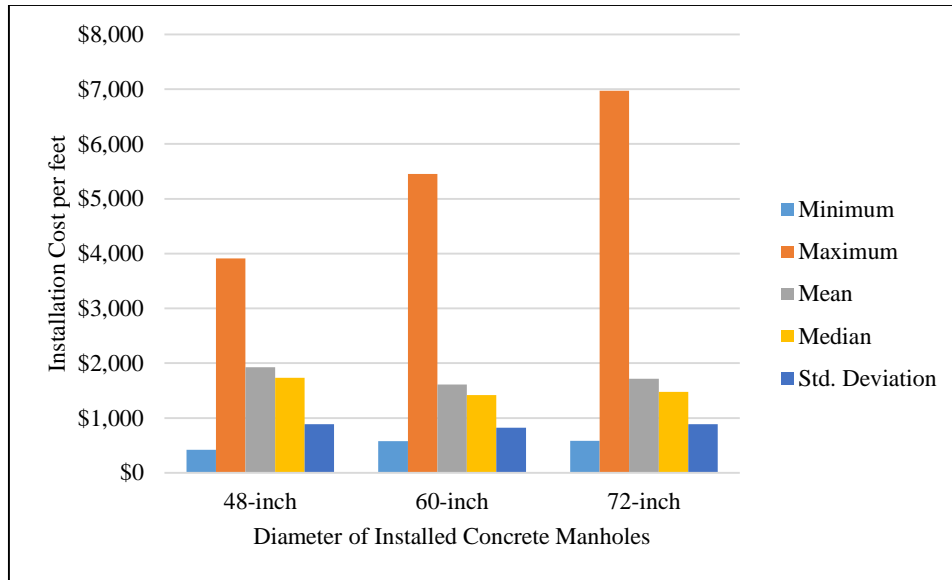
Fig. 3: Descriptive Statistics of Installation Cost per feet of Cement Concrete Manholes (2006-2017)

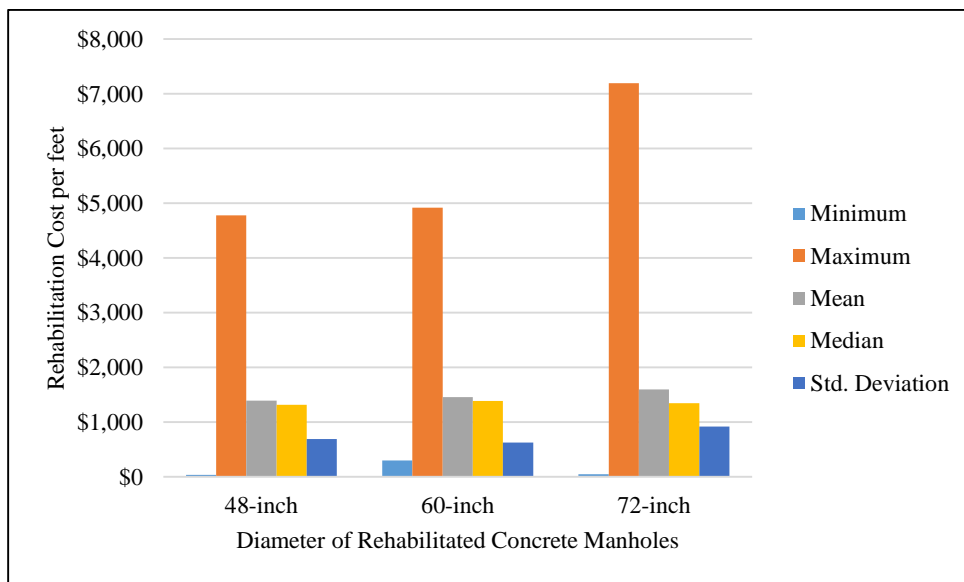
Fig. 4 Descriptive Statistics of Rehabilitation Cost per feet of Cement Concrete Manholes (2006-2017)

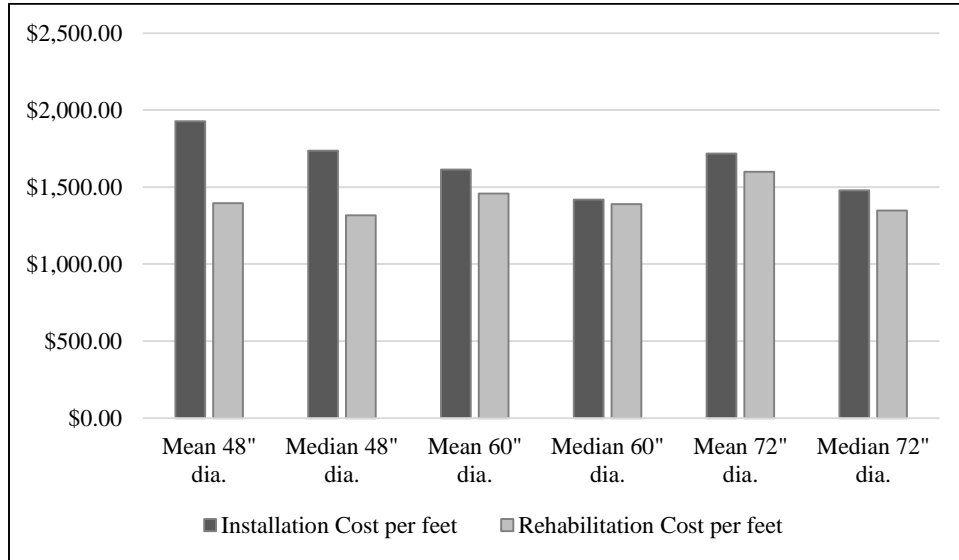
The comparison of mean and median costs of installation and rehabilitation of cement concrete manholes of different diameters show that the rehabilitation costs are slightly lower than the installation costs. The comparison is shown in the figure below:

Fig. 5: Comparison between Installation Cost and Rehabilitation Cost (Mean and Median) of Cement Concrete Manholes (2006-2017)

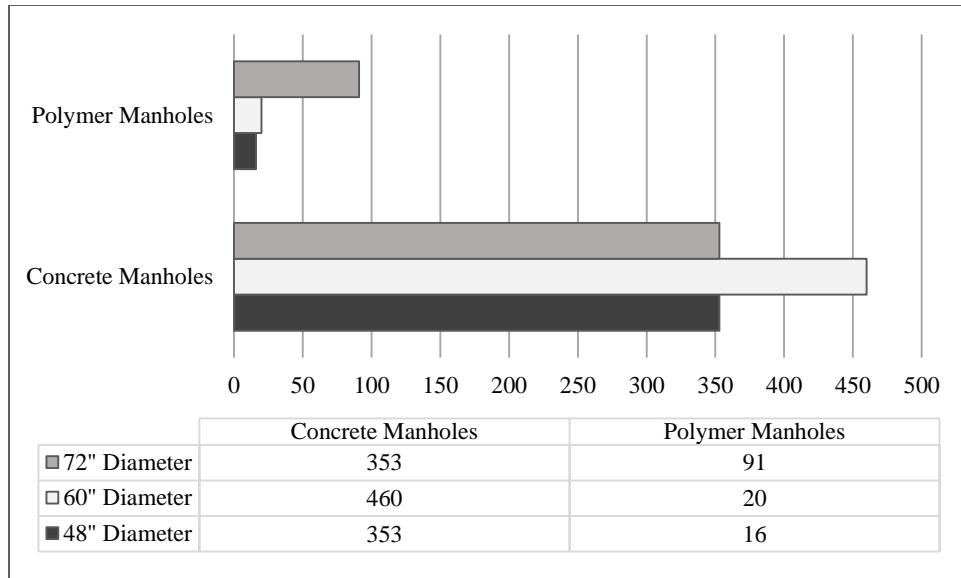
Fig. 6: Number of Cement Concrete and Polymer Concrete Manholes of different diameters for Comparison of Installation Cost per feet (1977-2017)

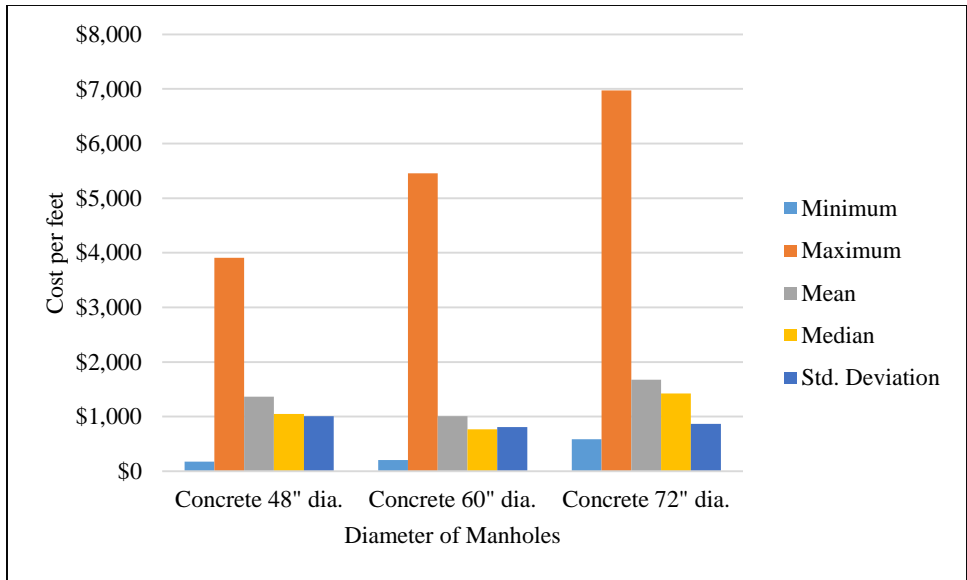
Further, the following charts show the descriptive statistics of both cement concrete and polymer concrete manholes. The descriptive statistics show a uniform increment of different statistics values of the installation cost per feet for both types of manholes.

Fig. 7: Descriptive Statistics of Installation Cost per feet of Cement Concrete Manholes (1977-2017)

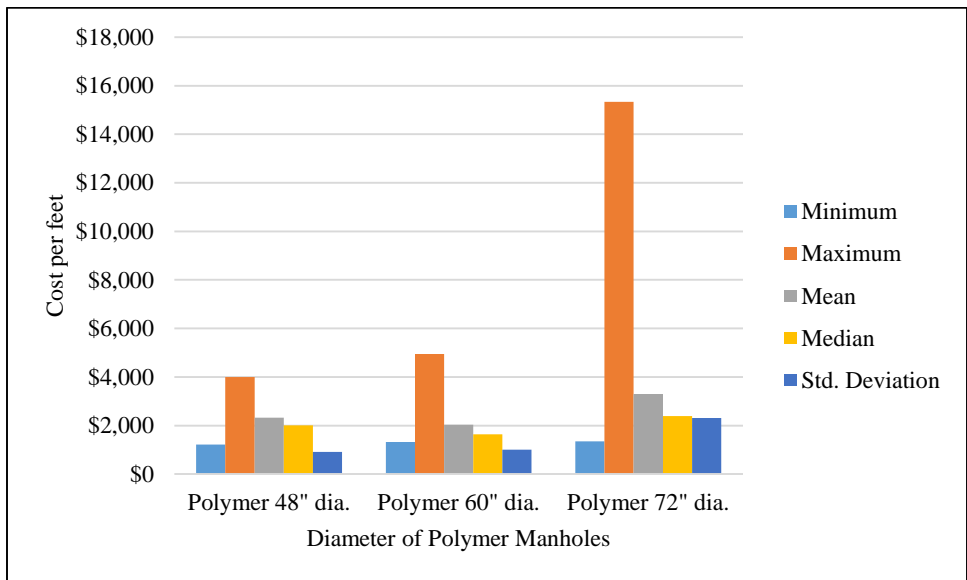
Fig. 8: Descriptive Statistics of Installation Cost per feet of Polymer Concrete Manholes (1977-2017)

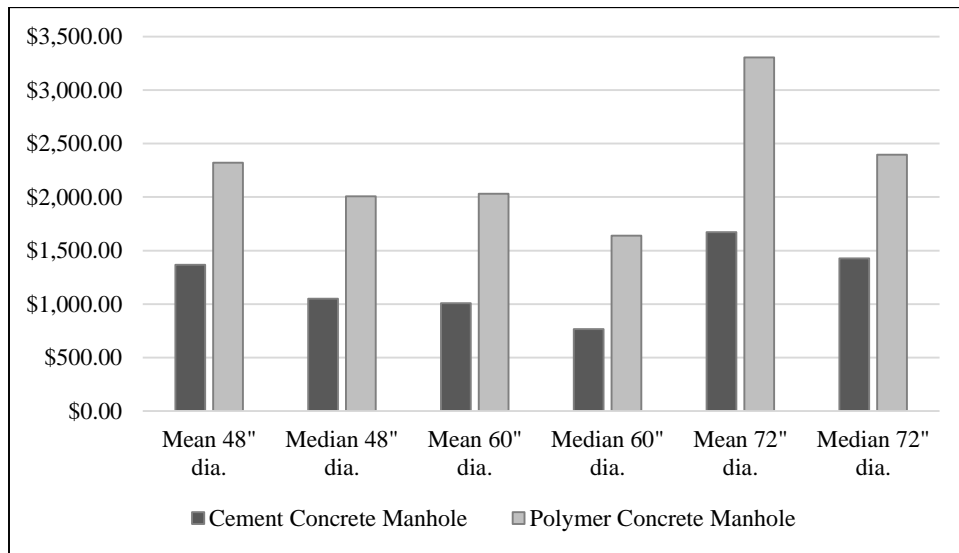
The comparison of mean and median values of the installation costs per feet between the cement concrete and polymer concrete manholes of different diameters, for the duration 1977-

2017, show the higher cost of polymer concrete manholes. The comparison is shown in the figure below:

Fig. 9: Comparison of Installation Costs per feet (Mean and Median) between Cement Concrete and Polymer Concrete Manholes (1977-2017)

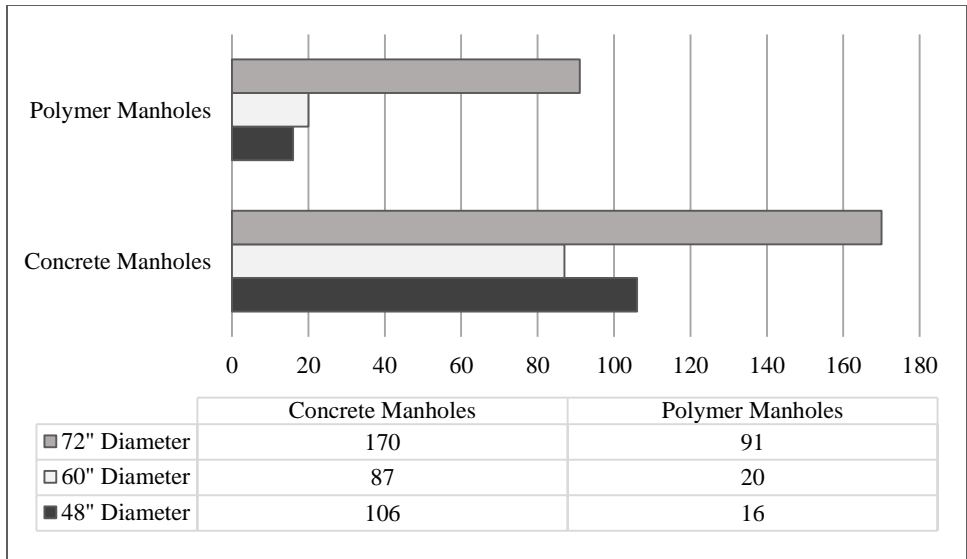
Fig. 10: Number of Cement Concrete and Polymer Concrete Manholes of different diameters for Comparison of Installation Cost per feet (2015-2017)

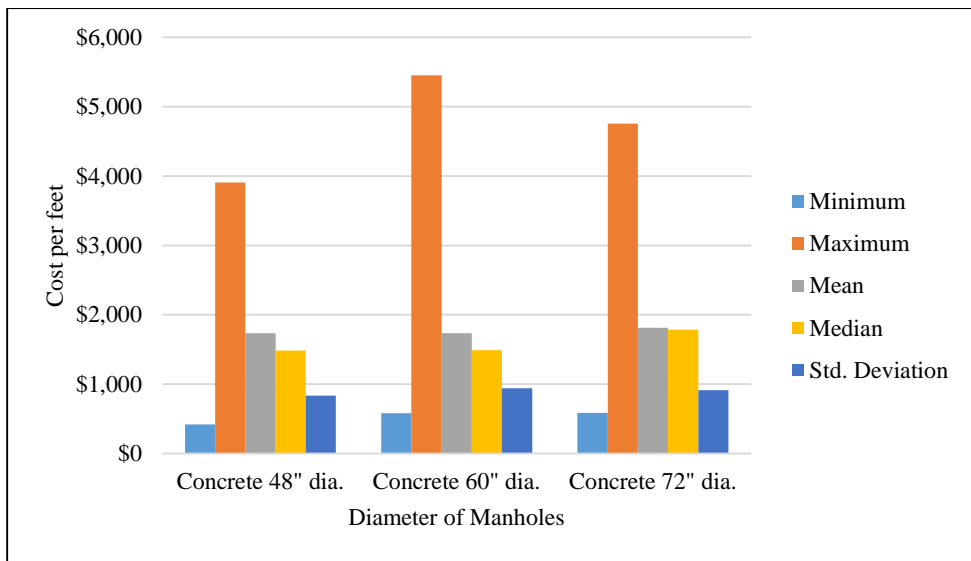
Fig. 11: Descriptive Statistics of Installation Cost per feet of Concrete Manholes (2015-2017)

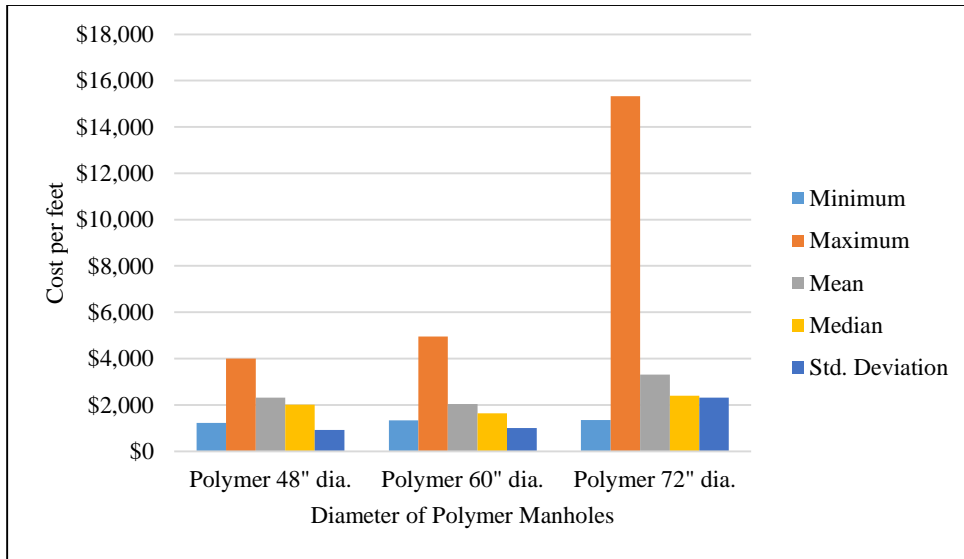
Fig. 12: Descriptive Statistics of Installation Cost per feet of Polymer Concrete Manholes (2015-2017)

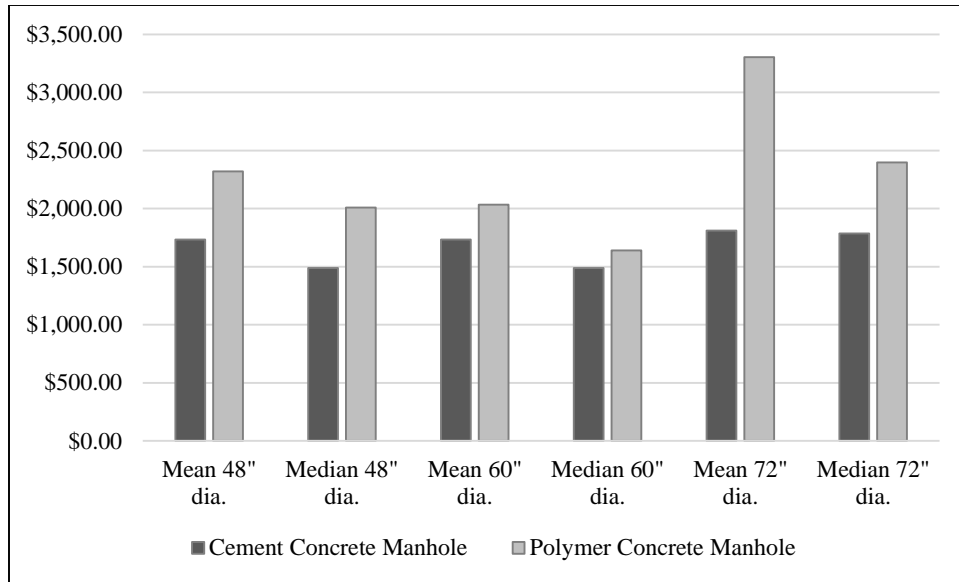
The comparison of mean and median values of the installation costs per feet between the cement concrete and polymer concrete manholes of different diameters, for the duration 2015-2017, shows the higher cost of polymer concrete manholes. The comparison is shown in the figure below:

Fig. 13: Comparison of Installation Costs per feet (Mean and Median) between Cement Concrete and Polymer Concrete Manholes (2015-2017)

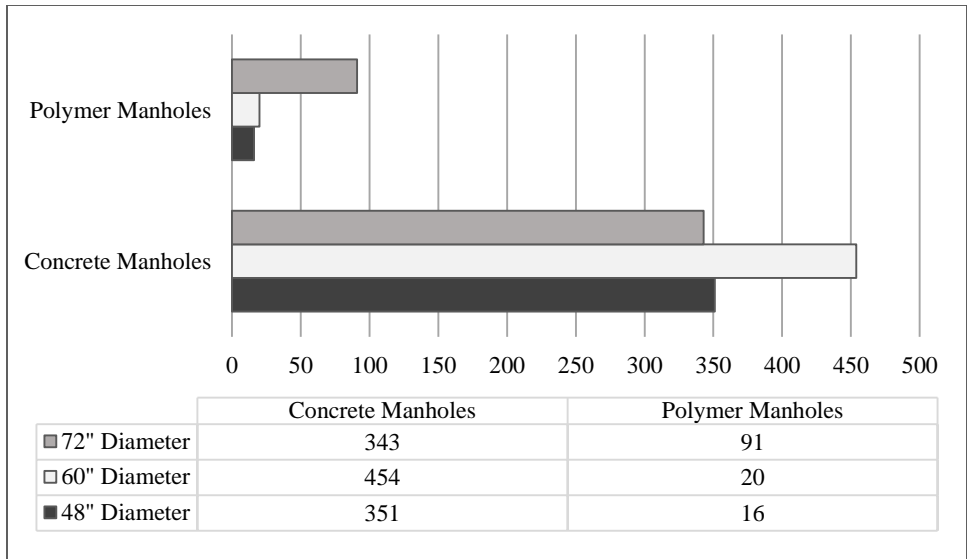
Fig. 14: Number of Cement Concrete and Polymer Concrete Manholes of different diameters for Comparison of Installation and Rehabilitation Costs per feet per year with a service life of polymer manholes as 50 years (1977-2017)

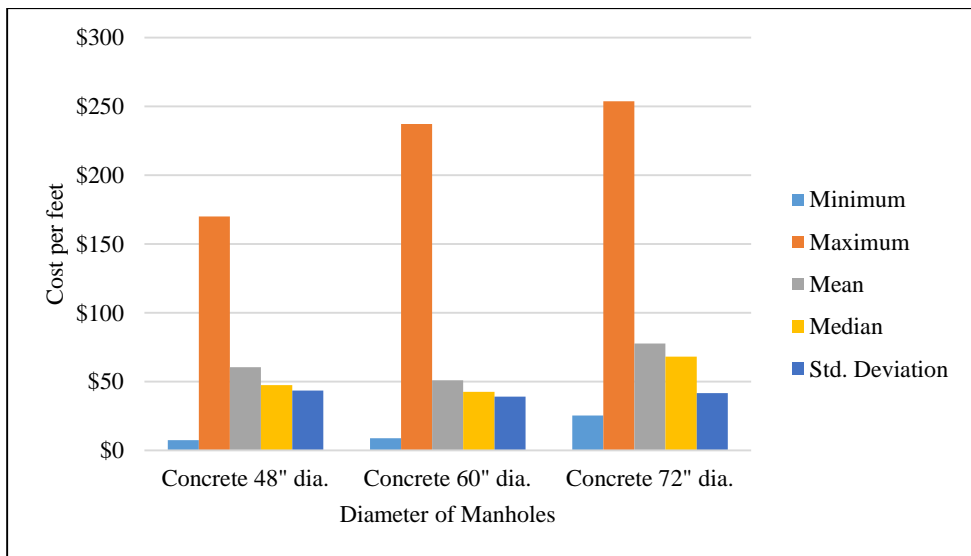
Fig. 15: Descriptive Statistics of Installation and Rehabilitation Costs per feet per year of Cement Concrete Manholes (1977-2017)

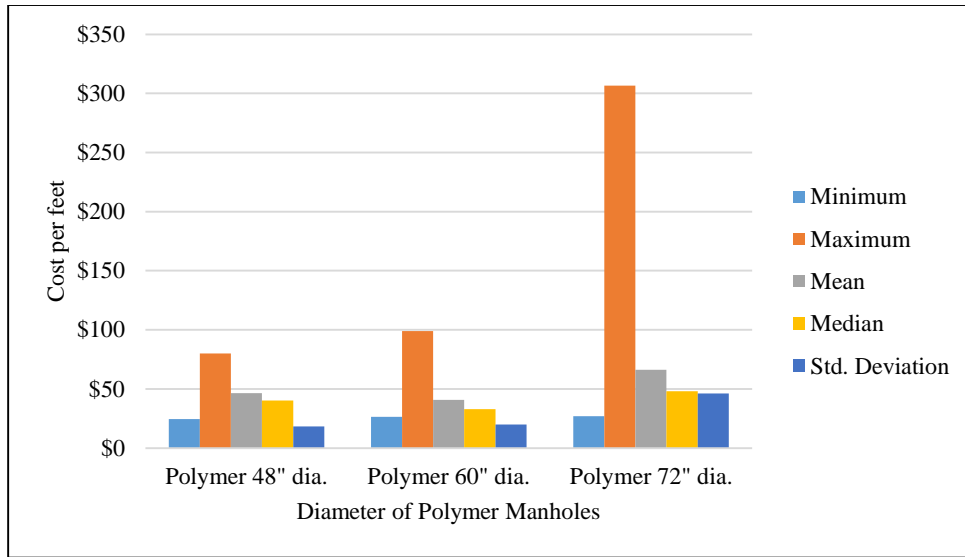
Fig. 16: Descriptive Statistics of Installation and Rehabilitation Costs per feet per year of Polymer Concrete Manholes (1977-2017)

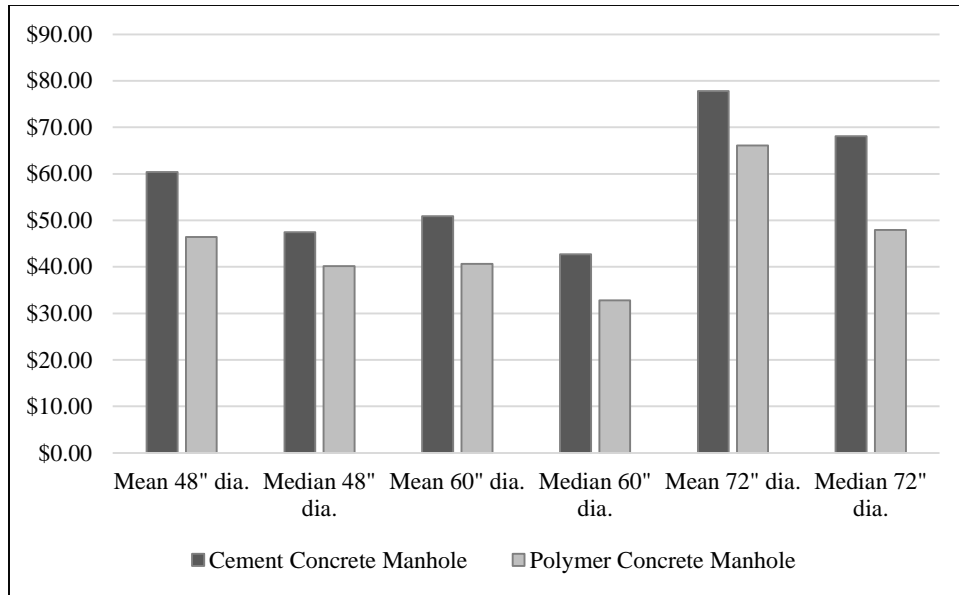
The comparison of mean and median values of installation and rehabilitation costs of the cement concrete and polymer concrete manholes of different diameters, for the duration 1977-2017, with a service life of polymer concrete manhole as 50 years, show the comparatively lower cost of polymer concrete manholes. The comparison is shown in the figure below:

Fig. 17: Comparison of Installation and Rehabilitation Costs (Mean and Median) between Cement Concrete and Polymer Concrete Manholes (1977-2017), the service life of polymer concrete manhole as 50 years

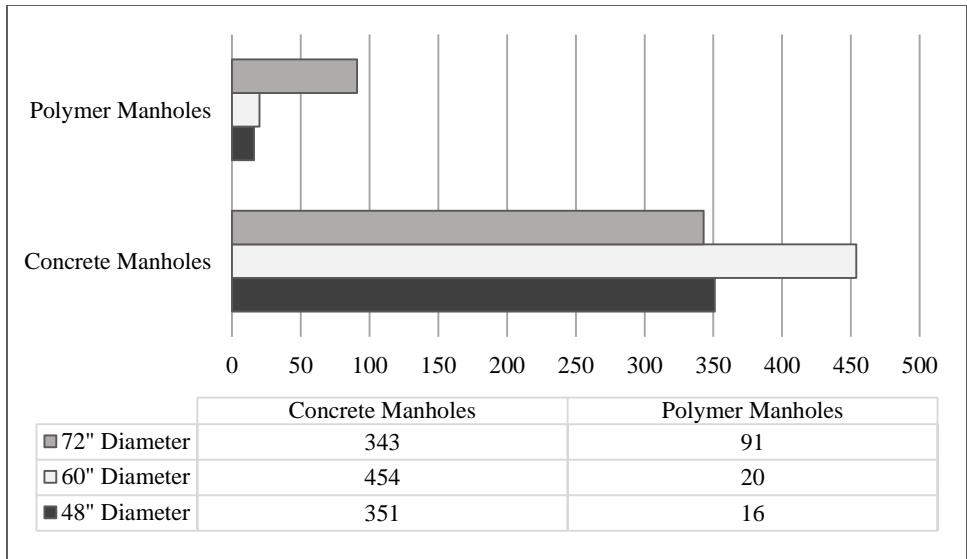
Fig. 18: Number of Cement Concrete and Polymer Concrete Manholes of different diameters for Comparison of Installation and Rehabilitation Costs per feet per year with a service life of polymer manholes as 25 years (1977-2017)

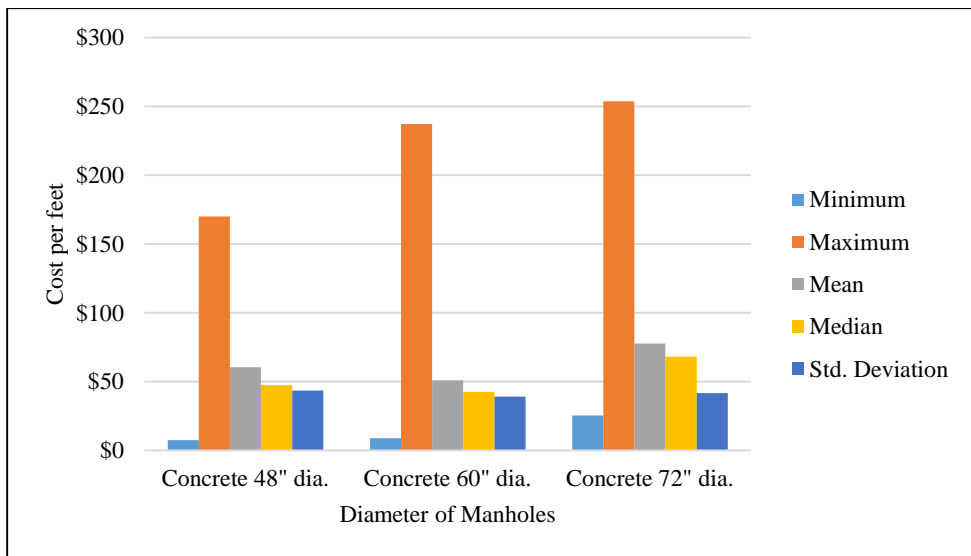
Fig. 19: Descriptive Statistics of Installation and Rehabilitation Costs per feet per year of Cement Concrete Manholes (1977-2017)

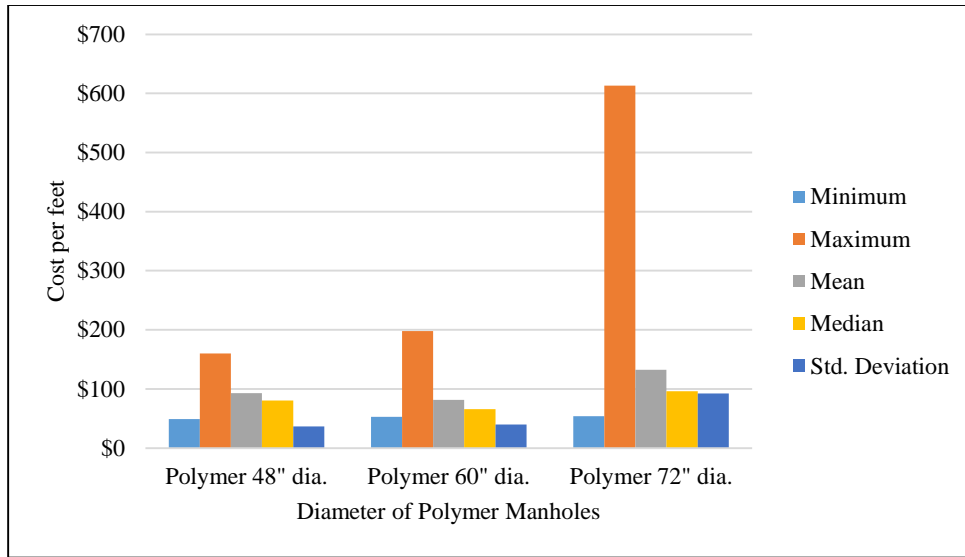
Fig. 20: Descriptive Statistics of Installation and Rehabilitation Costs per feet per year of Polymer Concrete Manholes (1977-2017)

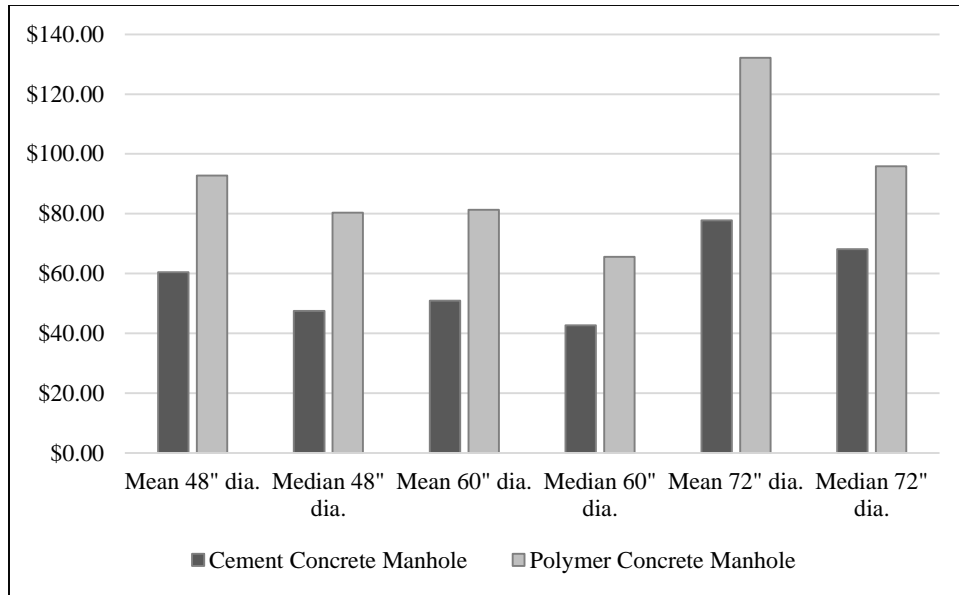
The comparison of mean and median values of installation and rehabilitation costs between the cement concrete and polymer concrete manholes of different diameters, for the duration 1977-2017, with a service life of polymer concrete manhole as 25 years, show the comparatively higher cost of polymer concrete manholes. The comparison is shown in the figure below:

Fig. 21: Comparison of Installation and Rehabilitation Costs (Mean and Median) between Cement Concrete and Polymer Concrete Manholes (1977-2017), the service life of polymer concrete manhole as 25 years

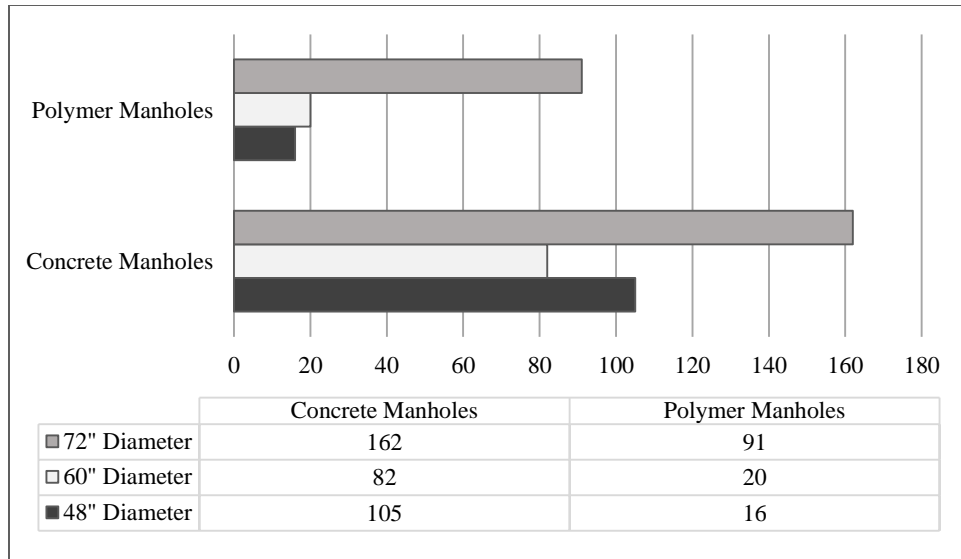
Fig. 22: Number of Cement Concrete and Polymer Concrete Manholes of different diameters for Comparison of Installation and Rehabilitation Costs per feet per year with a service life of polymer concrete manholes as 50 years (2015-2017)

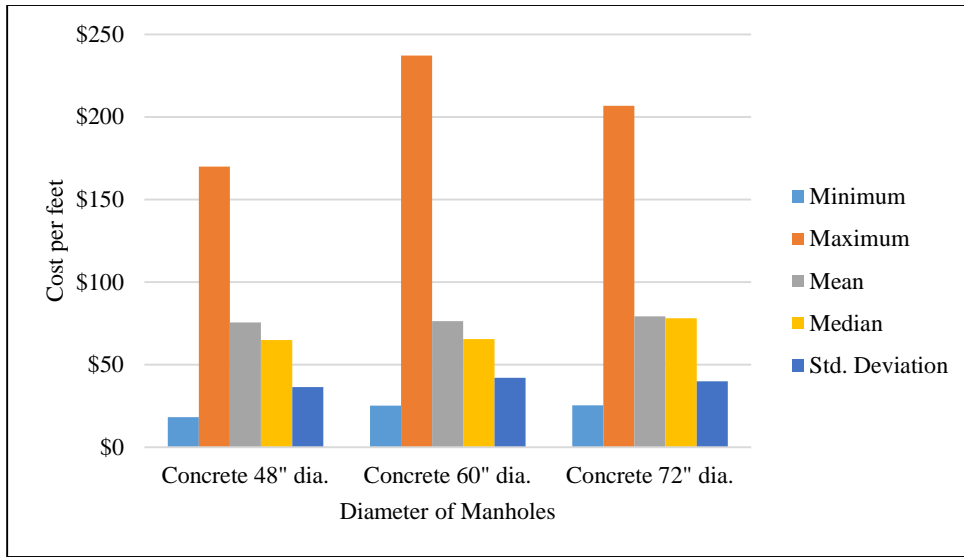
Further, the following charts show the descriptive statistics of both cement concrete and polymer concrete manholes. The descriptive statistics show a uniform increment of different statistics values for both types of manholes.

Fig. 23: Descriptive Statistics of Installation and Rehabilitation Costs per feet per year of Cement Concrete Manholes (2015-2017)

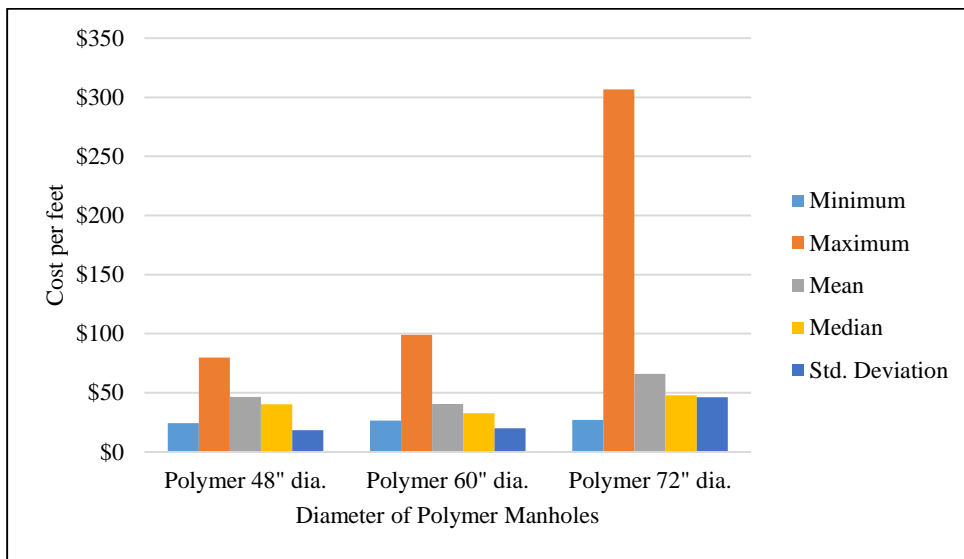
Fig. 24: Descriptive Statistics of Installation and Rehabilitation Costs per feet per year of Polymer Concrete Manholes (2015-2017)

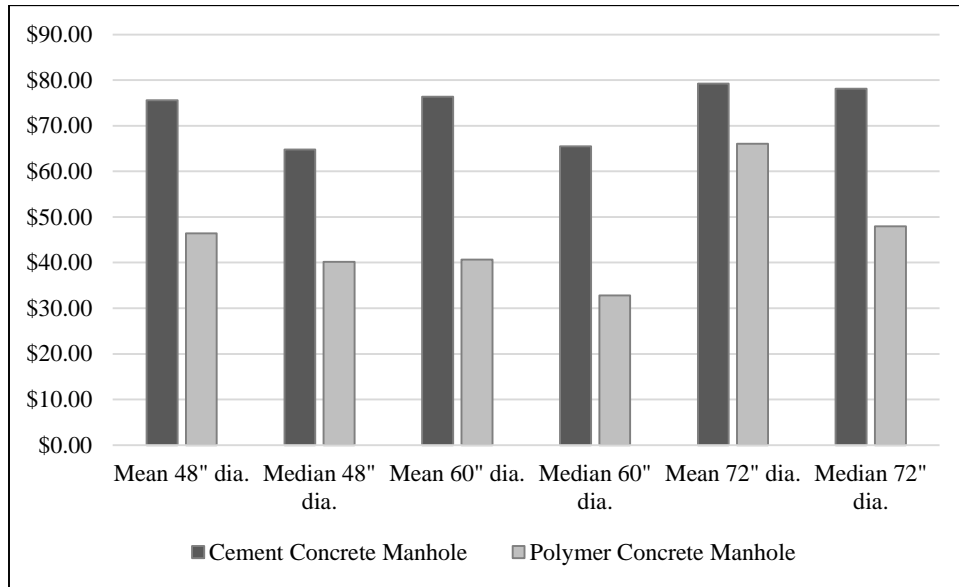
The comparison of mean and median values of installation and rehabilitation costs between the cement concrete and polymer concrete manholes of different diameters, for the duration 2015-2017 with a service life of polymer concrete manhole as 50 years, show the

comparatively lower cost of polymer concrete manholes. The comparison is shown in the figure below:

Fig. 25: Comparison of Installation and Rehabilitation Costs (Mean and Median) between Cement Concrete and Polymer Concrete Manholes (2015-2017), the service life of polymer concrete manhole as 50 years

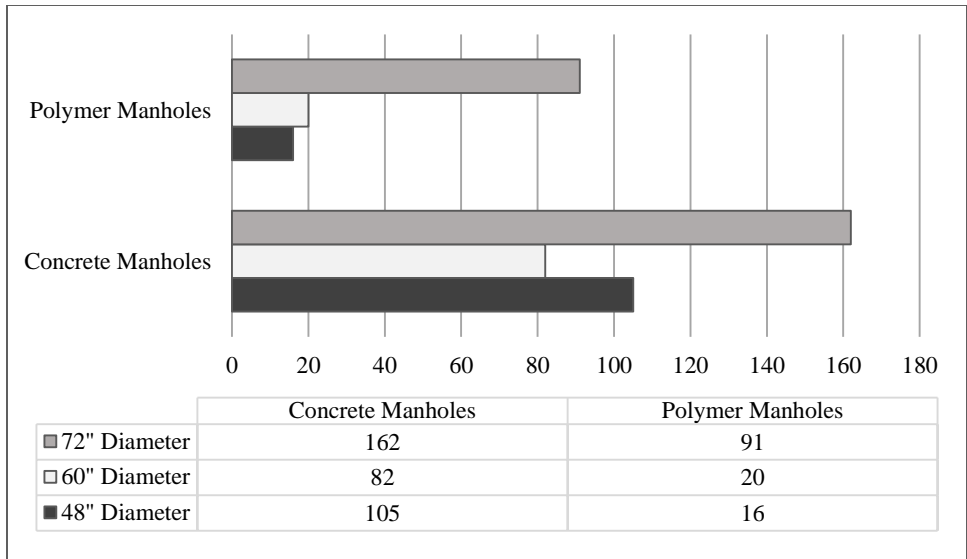
Fig. 26: Number of Cement Concrete and Polymer Concrete Manholes of different diameters for Comparison of Installation and Rehabilitation Costs per feet per year with a service life of polymer concrete manholes as 25 years (2015-2017)

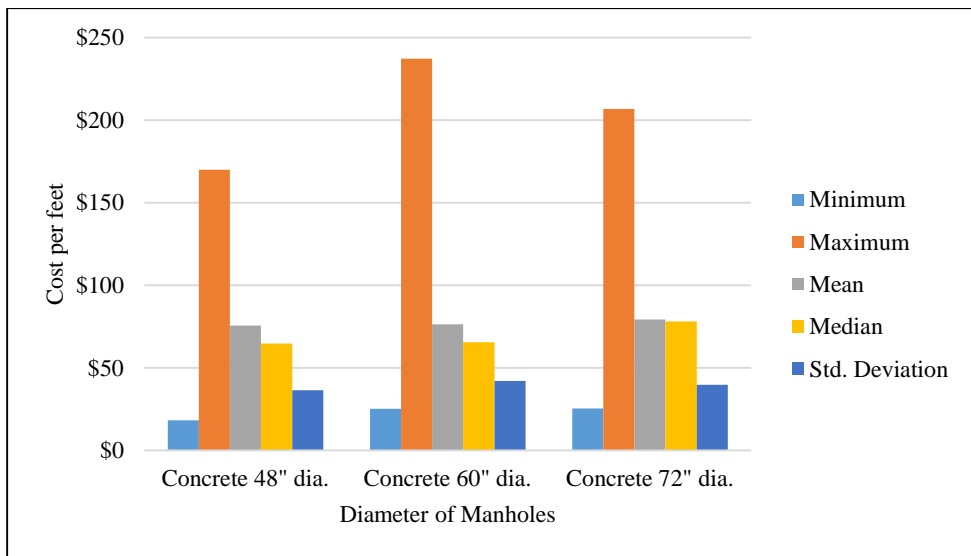
Fig. 27: Descriptive Statistics of Installation and Rehabilitation Costs per feet per year of Cement Concrete Manholes (2015-2017)

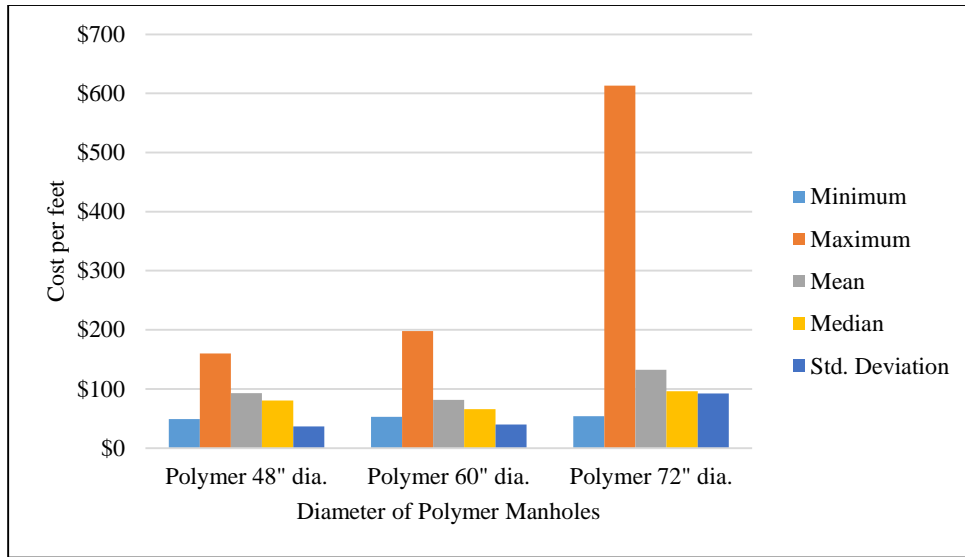
Fig. 28: Descriptive Statistics of Installation and Rehabilitation Costs per feet per year of Polymer Concrete Manholes (2015-2017)

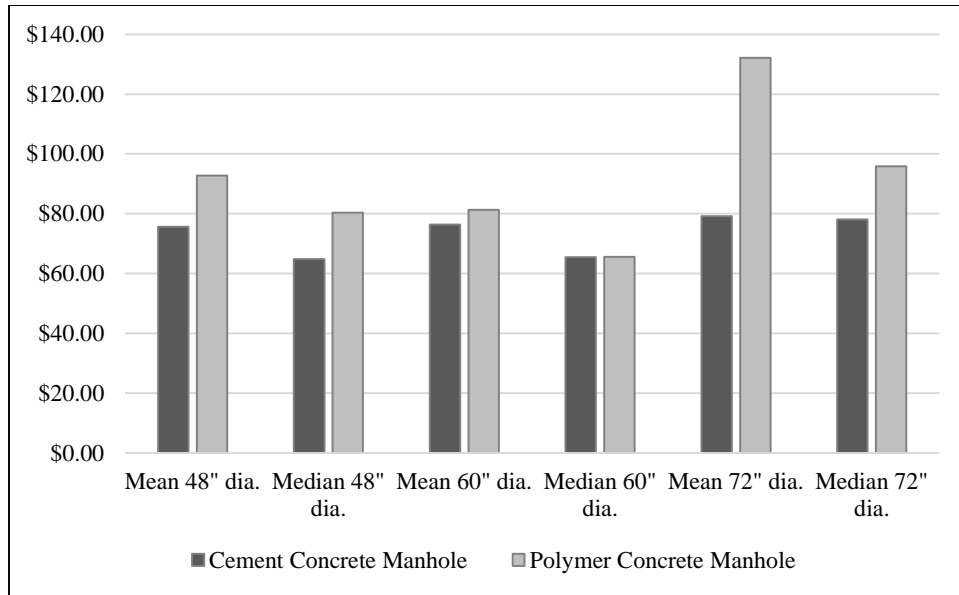
The comparison of mean and median values of installation and rehabilitation costs of the cement concrete and polymer concrete manholes of different diameters, for the duration 2015-2017 with a service life of polymer concrete manhole as 25 years, show the comparatively higher cost of polymer concrete manholes except for the manhole of diameter 60-inch. In case of the 60-inch manholes, the costs are almost equal. The comparison is shown in the figure below:

Fig. 29: Comparison of Installation and Rehabilitation Costs (Mean and Median) between Cement Concrete and Polymer Concrete Manholes (2015-2017), the service life of polymer concrete manhole as 25 years
