SEISMIC EVALUATION OF HOLLOW CORE PRESTRESSED CONCRETE
BRIDGE COLUMN-PILES IN WASHINGTON STATE

A thesis

Master of Science in Civil Engineering

University of Washington

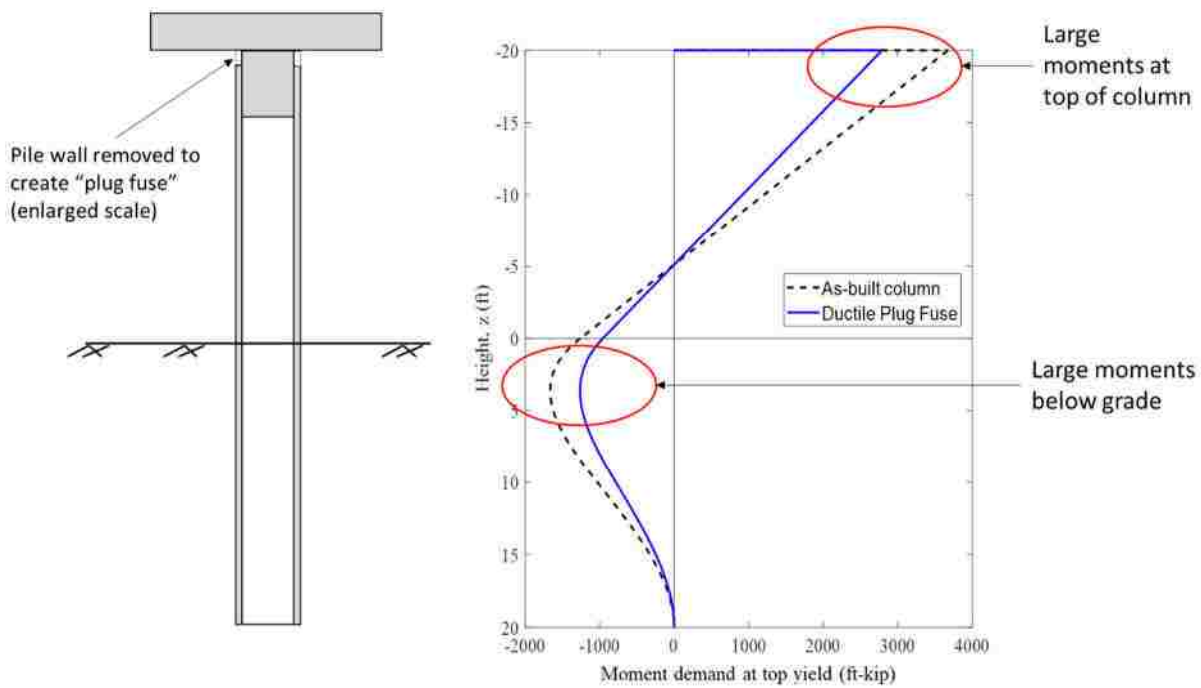
Figure 1-5. Moment demand for as-built vs. “plug fuse” retrofit conditions.

be to cut and remove the outer wall over a short distance directly below the cap beam and to confine the left behind plug with a jacket in order to provide a ductile fuse (See Figure 1-5). However, this requires the plug to carry the axial load from the superstructure and transfer it to the column through the action of interface shear friction, the feasibility of which would need to be investigated. This is especially true given the unknown surface roughness conditions of the field columns.

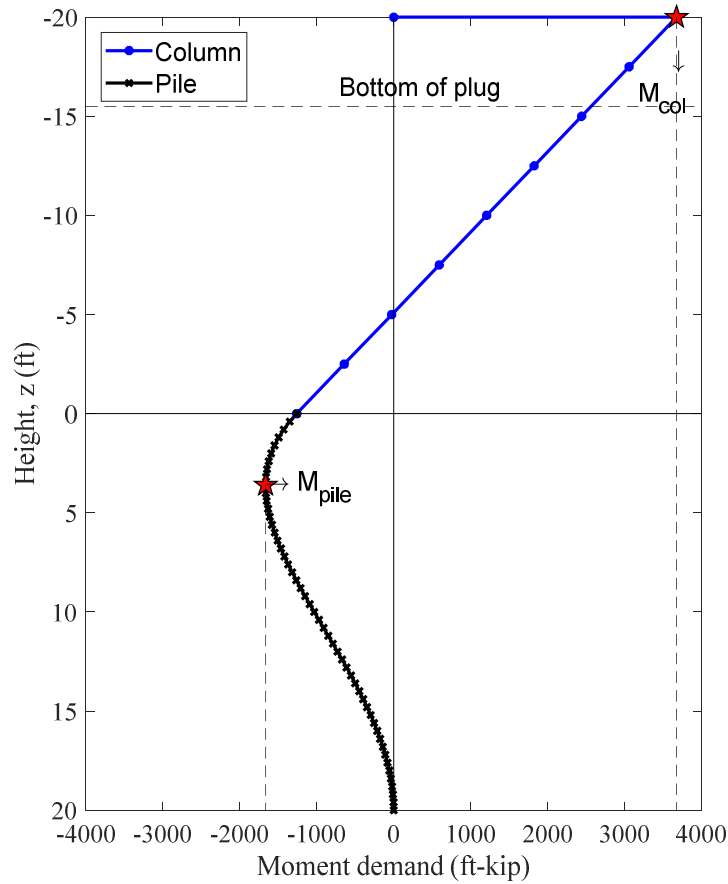
Figure 3-5. Moment Demand for As-built Column-Pile using Reference Conditions

strength and that the moment along the length of the column, below the plug, never reached the moment strength of the hollow pile. These two conclusions are illustrated in Figure 3-5 which shows the moment demand along the length of the column for the reference conditions, and Figure 3-6 which shows the ratio of the maximum moment demand above ground at the cap beam (M_{col}) to the maximum moment demand below grade (M_{pile}) with respect to the parameter, β_{soil} .

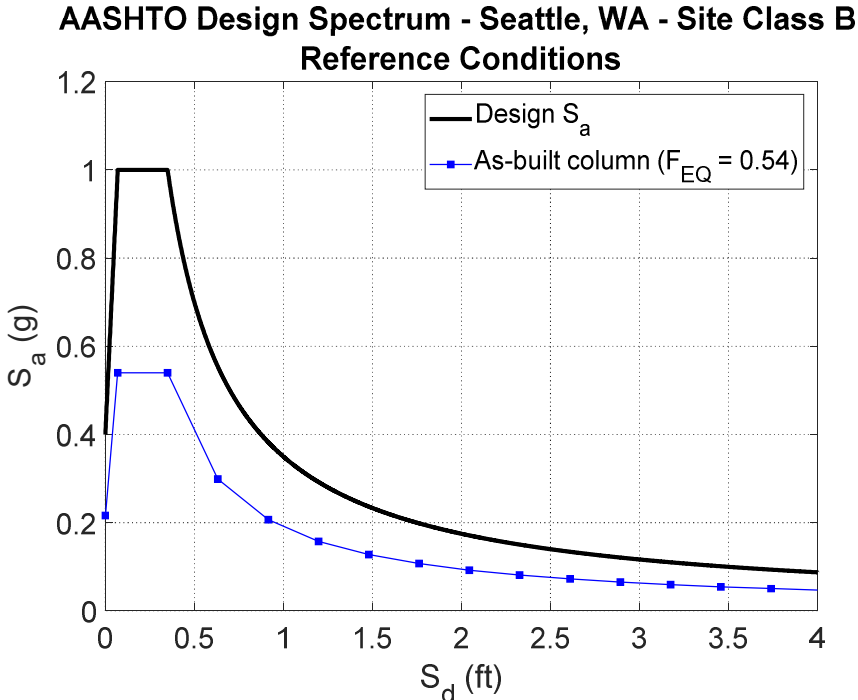
Figure 3-9. Scaled AASHTO Response Spectrum for As-built conditions

Figure 3-9 shows the scaled response spectrum that would be expected to cause failure of the as-built column reference condition. The scale factor indicates that a smaller earthquake, or an earthquake with a smaller return period than the 1000-year design earthquake could cause failure of the existing columns. The failure considered here is at the top of the column, where the plug is present, and not in the hollow region. The column is assumed to be non-ductile, based on the low proportion of spiral steel, in which case it is assumed to fail when it reaches first yield.

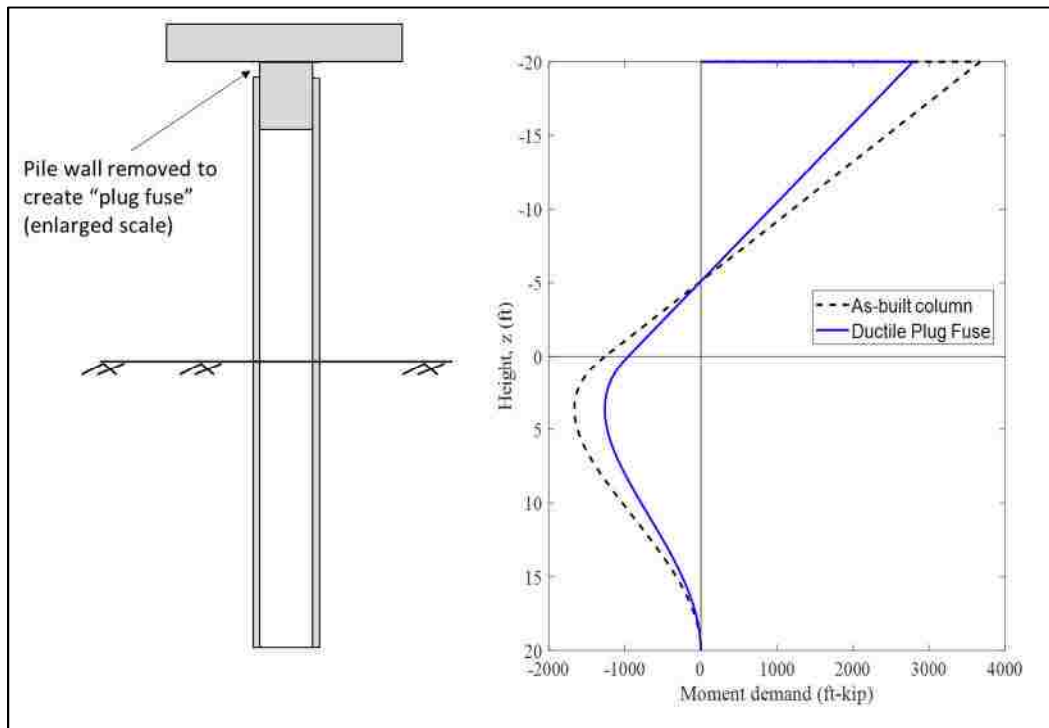
Figure 3-10. Illustration of "plug fuse" retrofit concept

The results of the as-built condition led to the development of the retrofit concept that is illustrated in Figure 3-10 below.

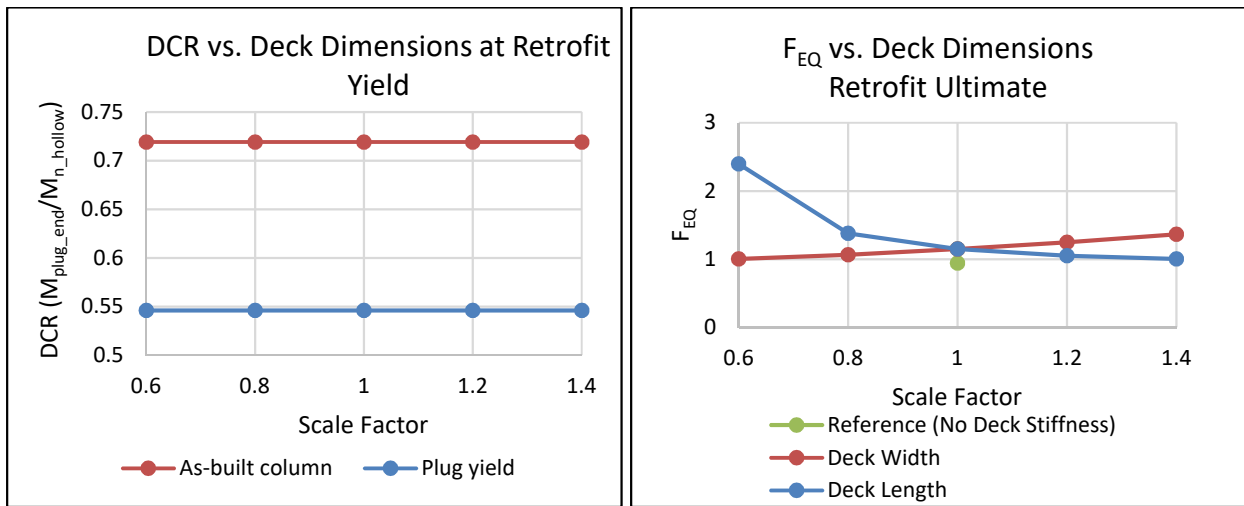
Figure 3-19. Effect of Scaling Deck Dimensions

Increasing the deck width or decreasing the deck length have, as expected, the same positive effect on the earthquake amplitude factor F_{EQ} , but to different extents. Of particular importance, the presence of the deck increases the value of the PGA at which the pile reaches its flexural capacity below-grade to be at or above the PGA of the 1000-year return period design earthquake. It should be noted that these analyses presuppose checking the strength of the deck and the abutments which may limit the practical behavior of the deck. Also, the Maximum Considered Earthquake (MCE) would occur at an F_{EQ} factor of 1.5 so any values above this are theoretical only.

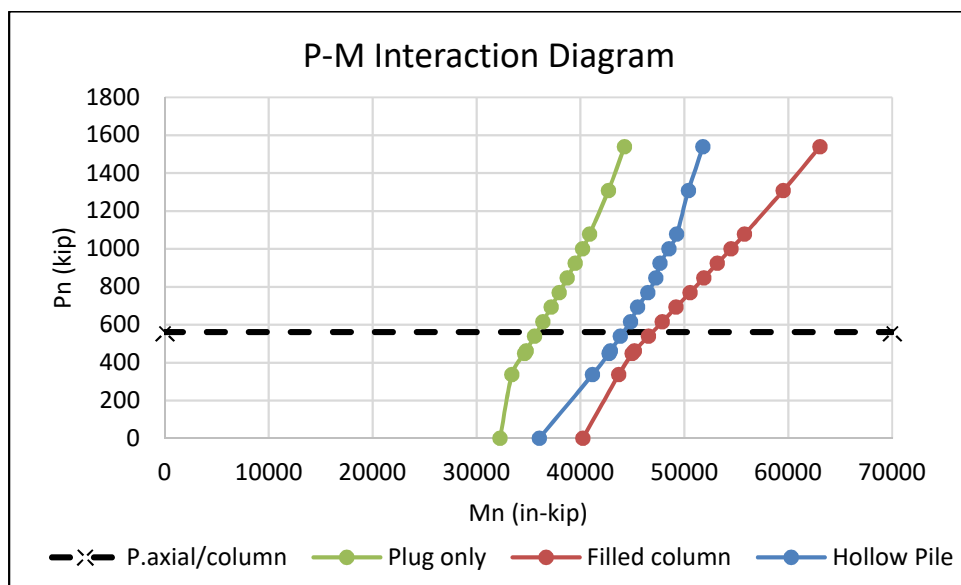
Figure 3-22. P-M Interaction Diagram for the different failure modes

As shown in Figure 3-22, at the expected reference axial load, the moment capacity for all three failure conditions lies on the ascending branch of the interaction diagram. Therefore, a higher vertical stress on the column will also increase its moment capacity. Furthermore, since the slope of the “plug only” interaction is steeper than that of the hollow pile, the DCR of the hollow section at plug yield should remain below 1.0 at higher axial loads, even with the increased moment demand.

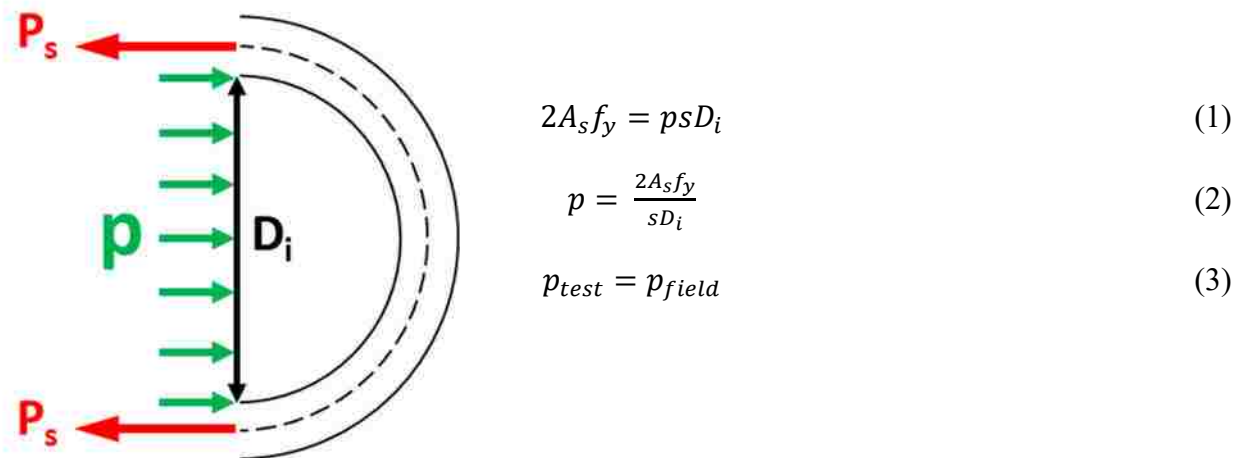
Figure 4-1. Hoop force equilibrium for hoop reinforcement

The testing program consisted of twelve (12) concrete pipe specimens each of length 36 inches with an outer diameter of 30 inches and a wall thickness of 3 inches (See Figure 4-2). The pipes were reinforced circumferentially with D2.1 Grade 65 wire at a 2-inch pitch, with an 11 inch splice, and longitudinally with W1.7 Grade 65 wire at an 8-inch spacing. The concrete nominal 28-day strength for the pipe wall was 6,000 psi. The circumferential reinforcement area and spacing was designed so that the hoop force equilibrium would be the same as in the field (See Figure 4-1, Equations 1-3).

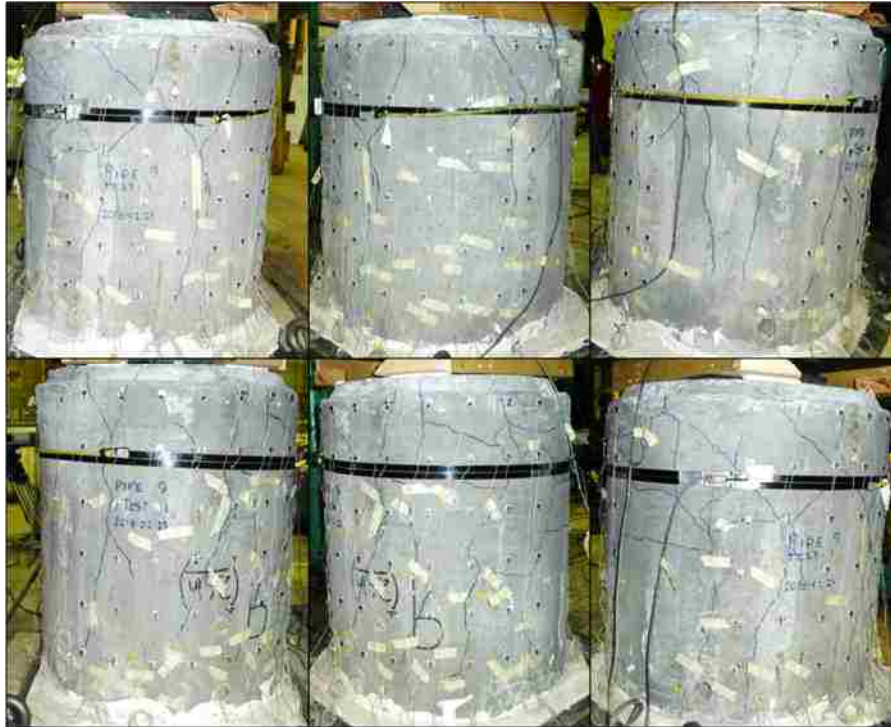
Figure 5-5. Crack formation at peak load for Test ep24-1 (L-R: N-NW-SW; S-SE-NE)

In the sliding region, the failure occurred between the pipe wall and the epoxy, which remained firmly attached to the plug concrete. This was observed for all tests where epoxy mortar was applied.

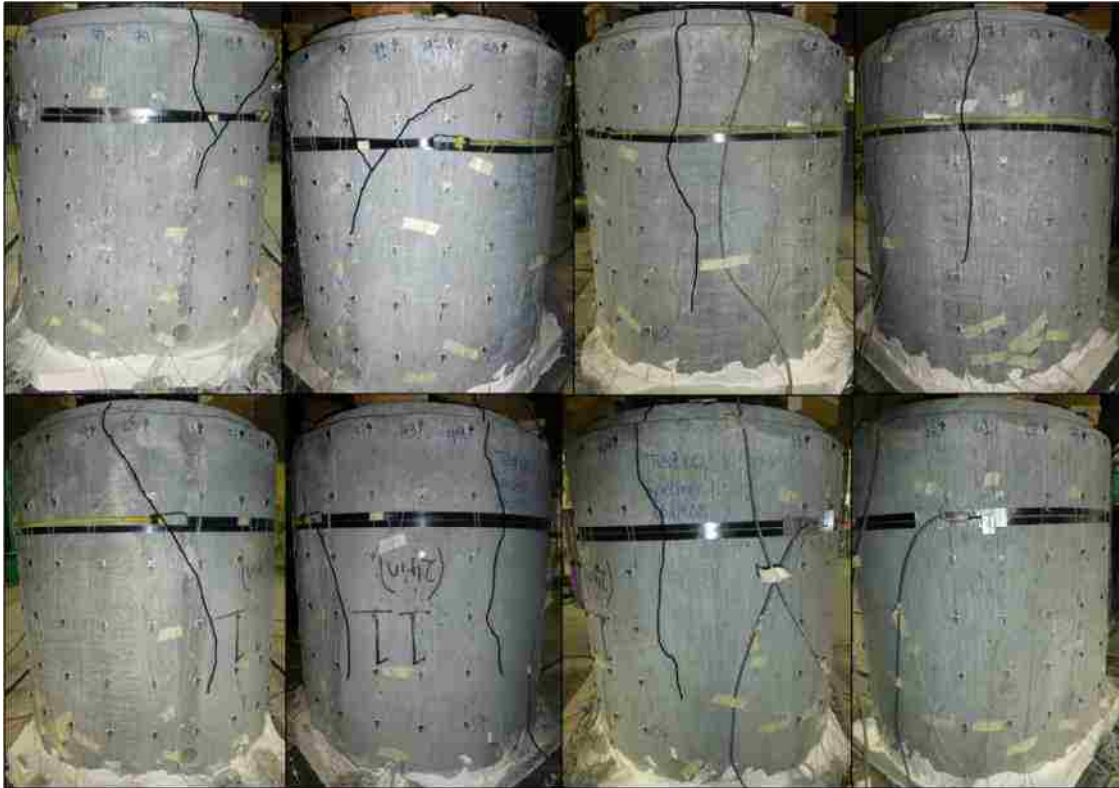
Figure 5-6. Crack formation at peak load for Test ep24-2 (L-R: N-NW-W-SW; S-SE-E-NE)

This test was done as a repeat of the first test that is, keeping all of the variable conditions the same in order to corroborate the results being used for the baseline condition. The peak load for this test was 320 kips, which is approximately 75% of that of test ep24-1, and the number of vertical cracks that formed around the specimen was less than that of the first test. Additionally, there was not a similar cluster of horizontal or diagonal cracks (See Figure 5-6). Unlike test ep21-1, all of the plug displacement was a result of sliding at the interface.

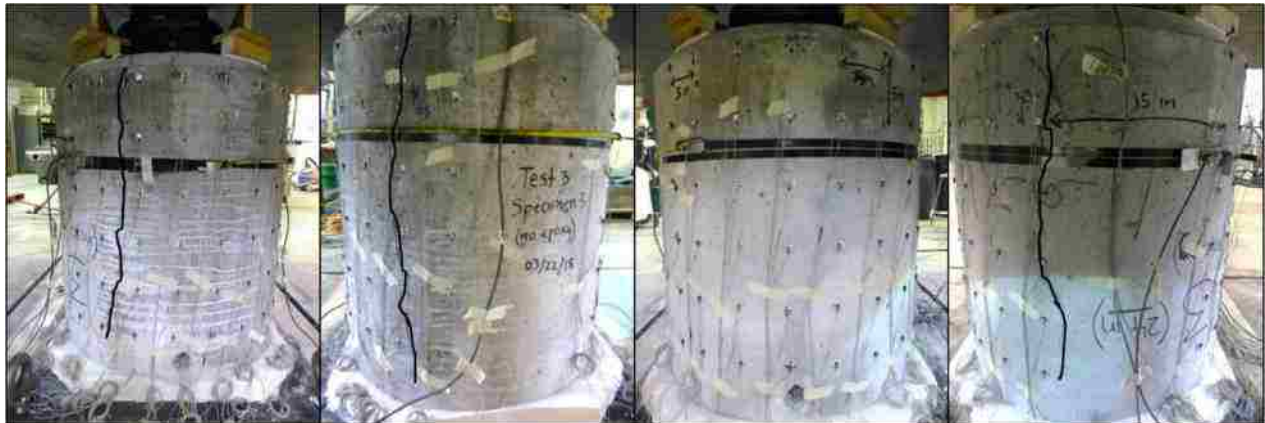
Figure 5-9. Crack formation at peak load for Test ep0-2 (L-R: N-W-S-E)

This was a repeat of the previous test and similar results were observed. The peak load was recorded at 147 kips, less than 10% different from the companion test, and only 3 longitudinal cracks formed at this load (See Figure 5-9). Additionally, the plug displacement was only due to sliding along the interface (See Figure 5-10). At the end of testing some additional cracks had formed except there was no large-scale horizontal crack as in the former test.

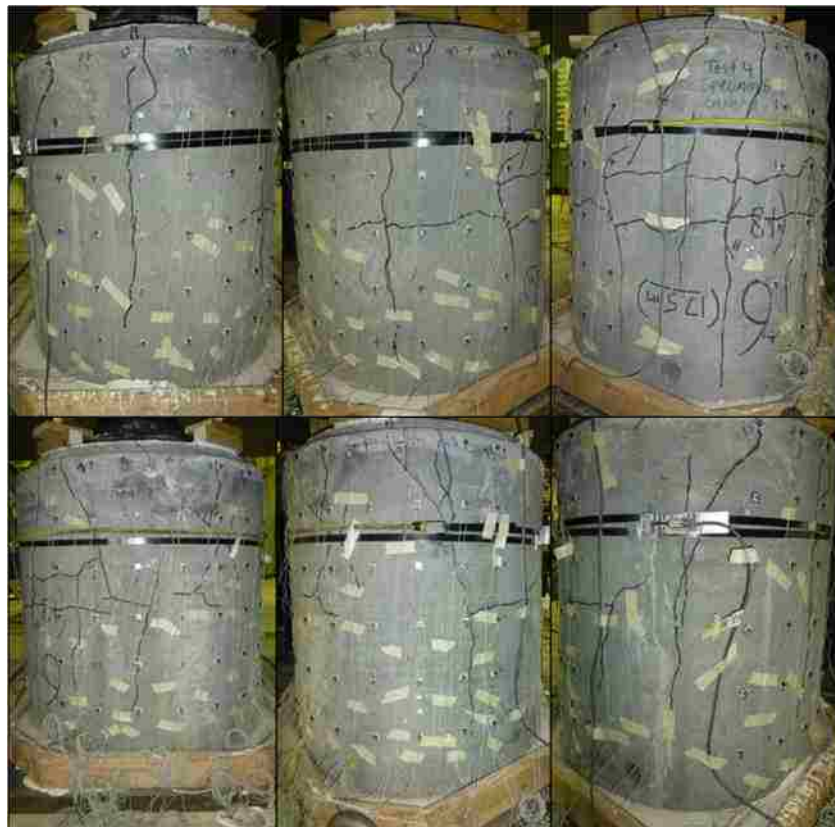
Figure 5-11. Crack formation at end of testing for Test ep18-1 (L-R: N-NW-SW; S-SE-NE)

For this test, the inner plug was cast 18 inches deep instead of 24 inches deep, and the pipe wall was treated with epoxy mortar. The peak load was 364 kips at which point, many longitudinal cracks formed as well as a small number of little horizontal cracks. However, at the end of testing a large horizontal crack that spanned about 75% of the circumference was marked at approximately 18 inches from the top of the specimen (i.e. at the bottom of the plug) (See Figure 5-11).

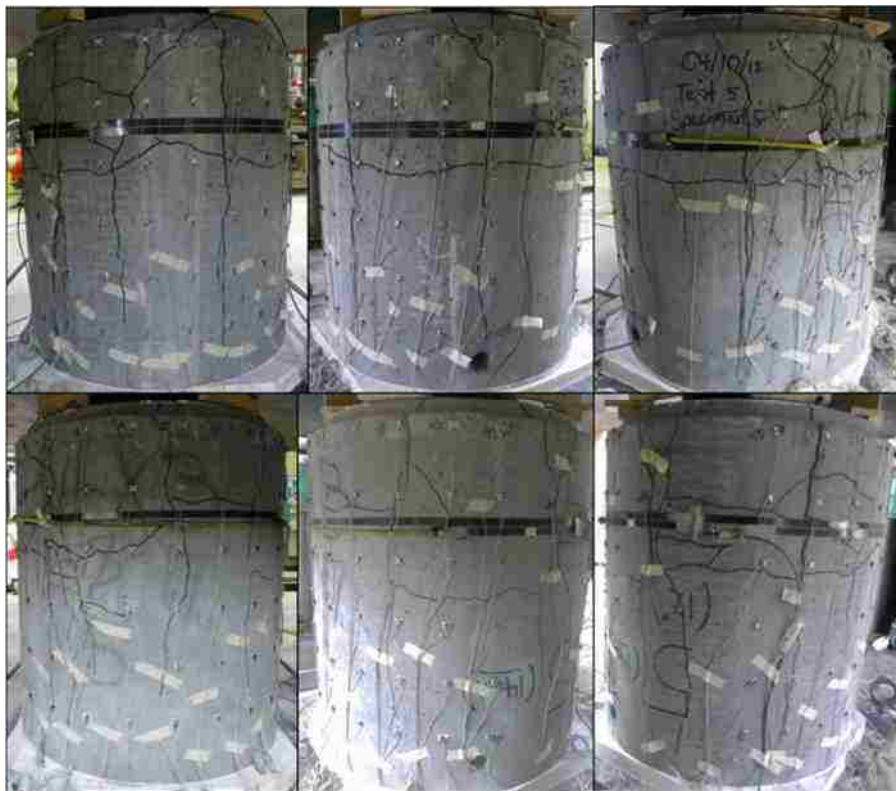
Figure 5-12. Crack formation at end of testing for Test ep14-1 (L-R: N-NW-SW; S-SE-NE)

Similar to the previous test, this plug was cast at 14 inches deep, instead of the typical 24 inches. The peak load was 284 kips, which is less than that for the 24 inches and the 18 inches plug specimens. As observed for the previous experiment, at the end of testing a large horizontal crack was marked around the circumference at approximately 14 inches from the top of the specimen, that is, at the base of the plug (See Figure 5-12). For both tests with the shorter plug length, the large horizontal cracks appeared sometime during the second phase of testing.

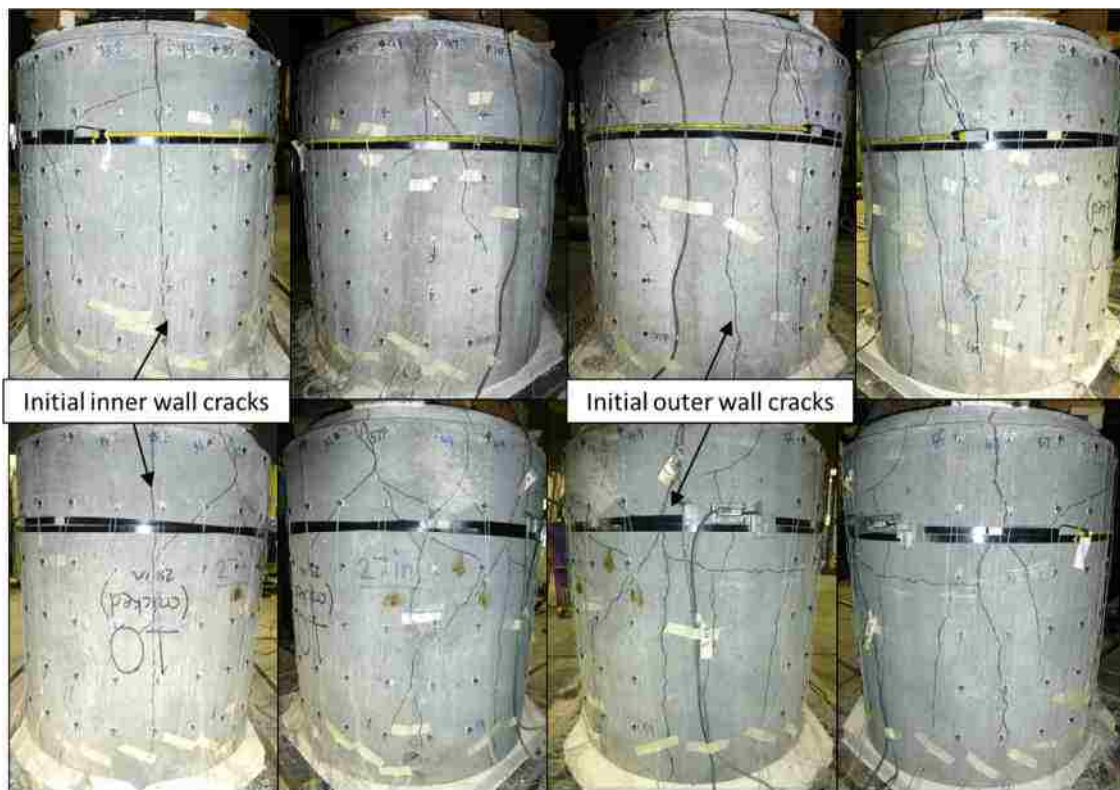
Figure 5-13. Crack Formation at Peak Load for Test 6-ep24-cr (L-R: N-NW-W-SW; S-SE-E-NE)

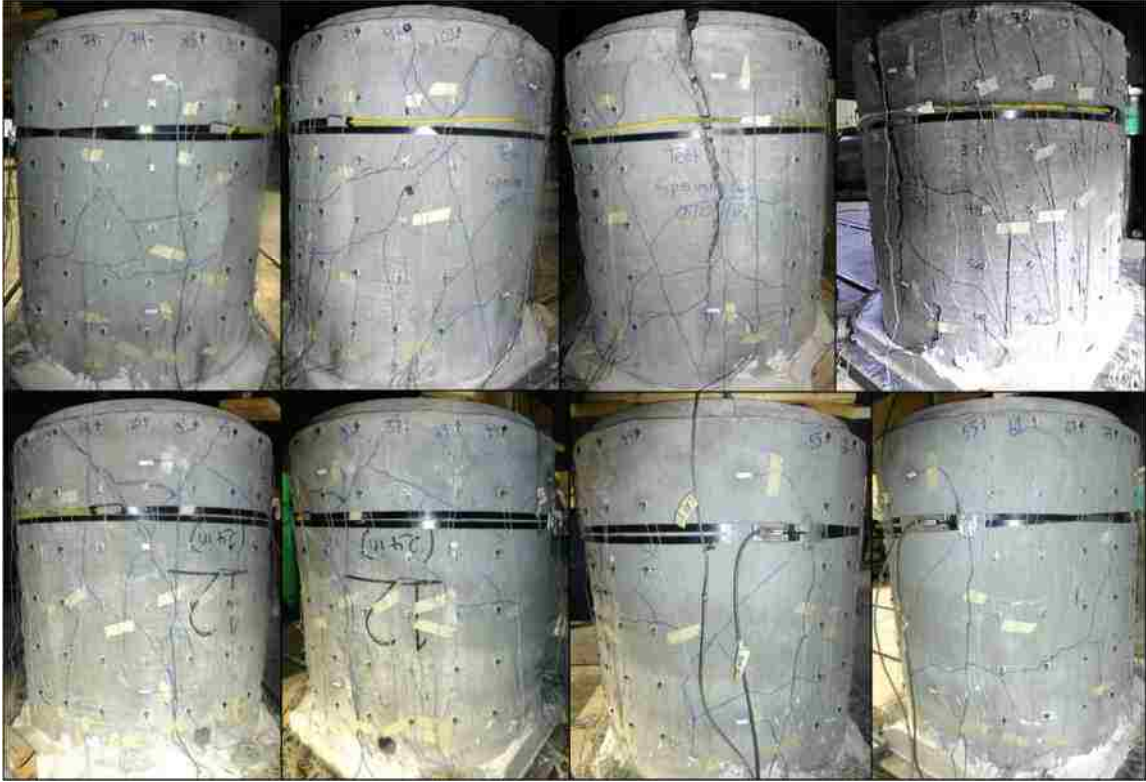
Figure 5-15. Crack formation at Peak Load for Test 9-ep24-ecc showing large crack on west side (L-R: N-NW-W-SW; S-SE-E-NE)

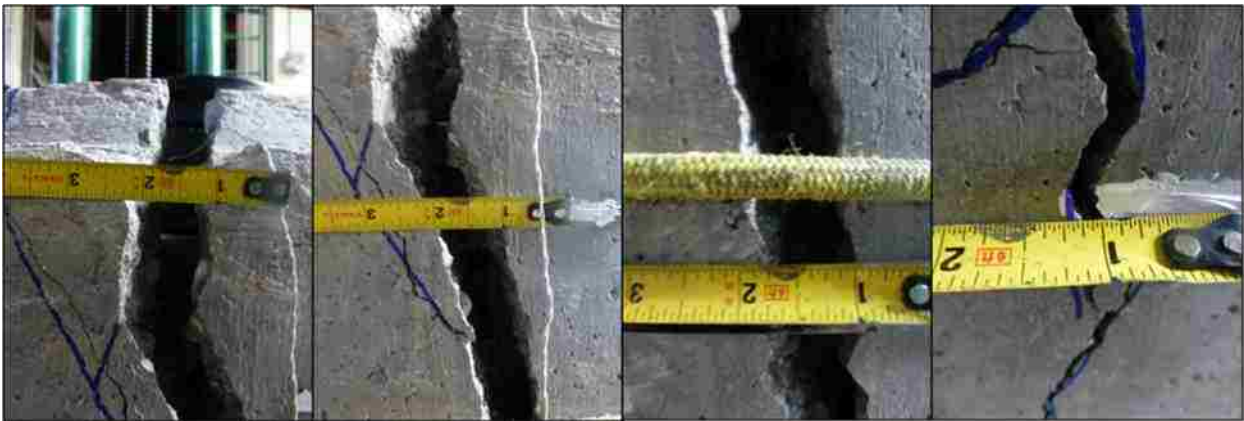
Figure 5-16. Width of large crack on west side of specimen (top to bottom)

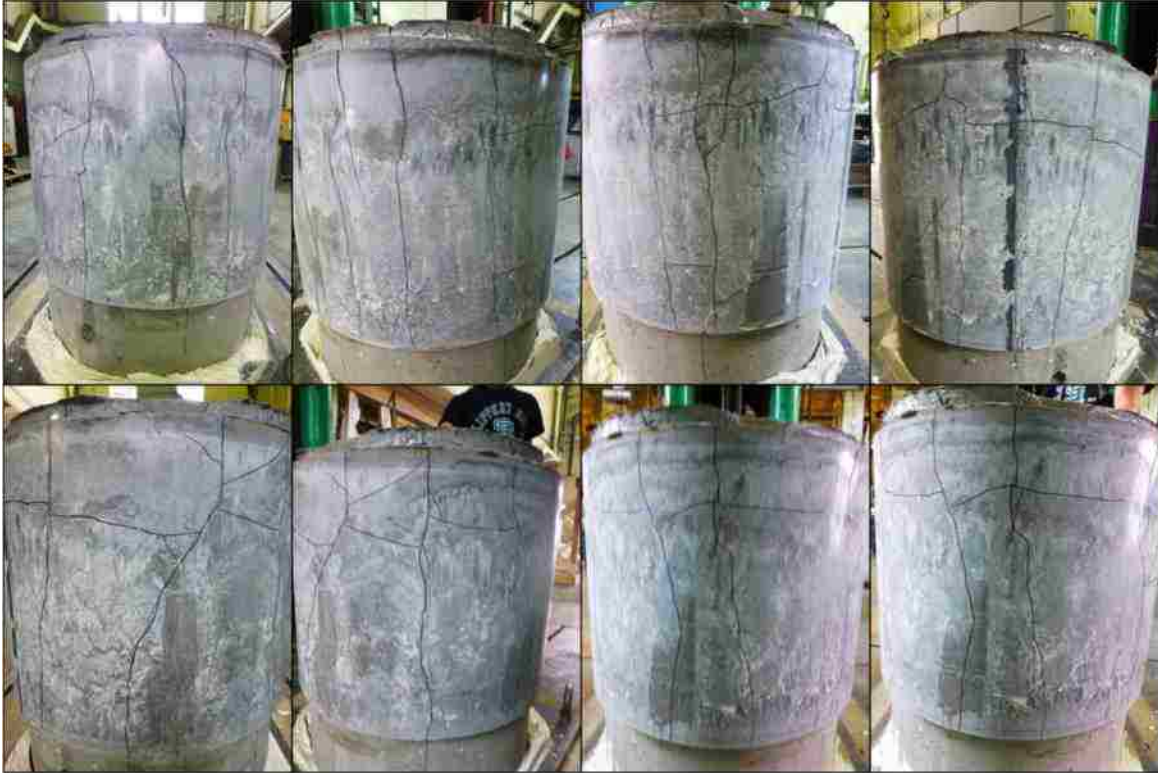
Figure 5-17. Crack Formation at end of testing for Test ep24s1-1 (L-R: N-NW-W-SW; S-SE-E-NE)

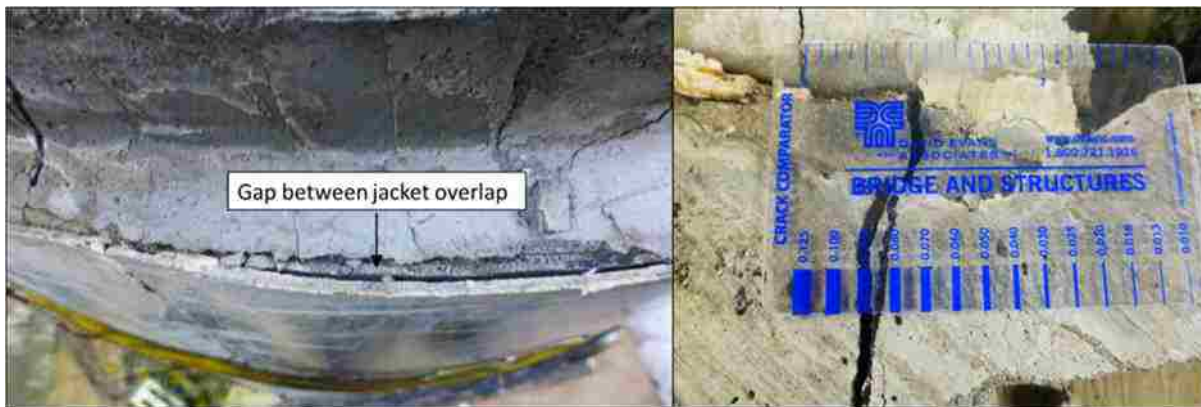
Figure 5-18. Observations at the end of Test 12-ep24s1-1 including gap opening and crack width at the top of the specimen

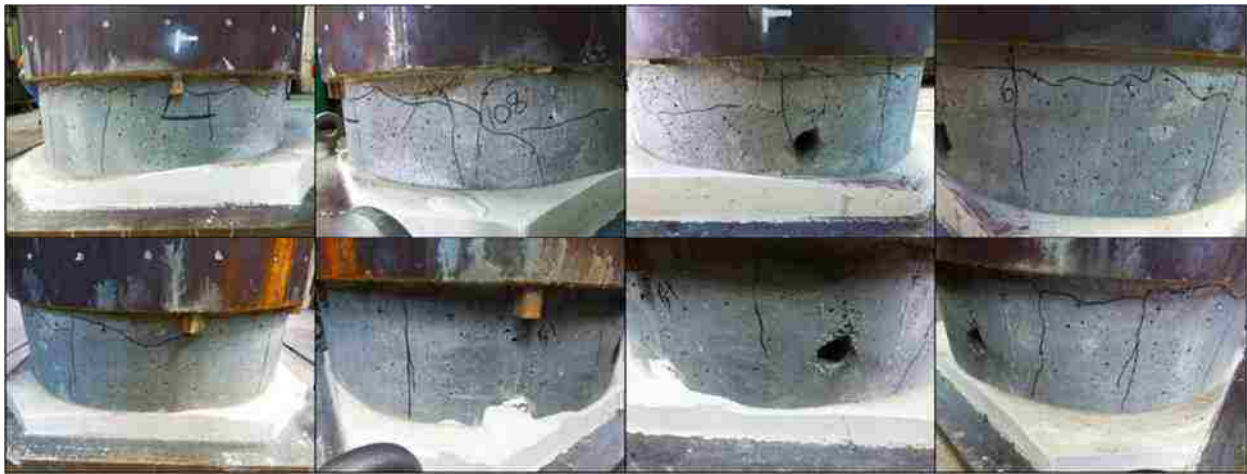
Figure 5-19. Crack formation at end of testing for Test ep24s4-1 (L-R: N-NW-W-SW; S-SE-E-NE)

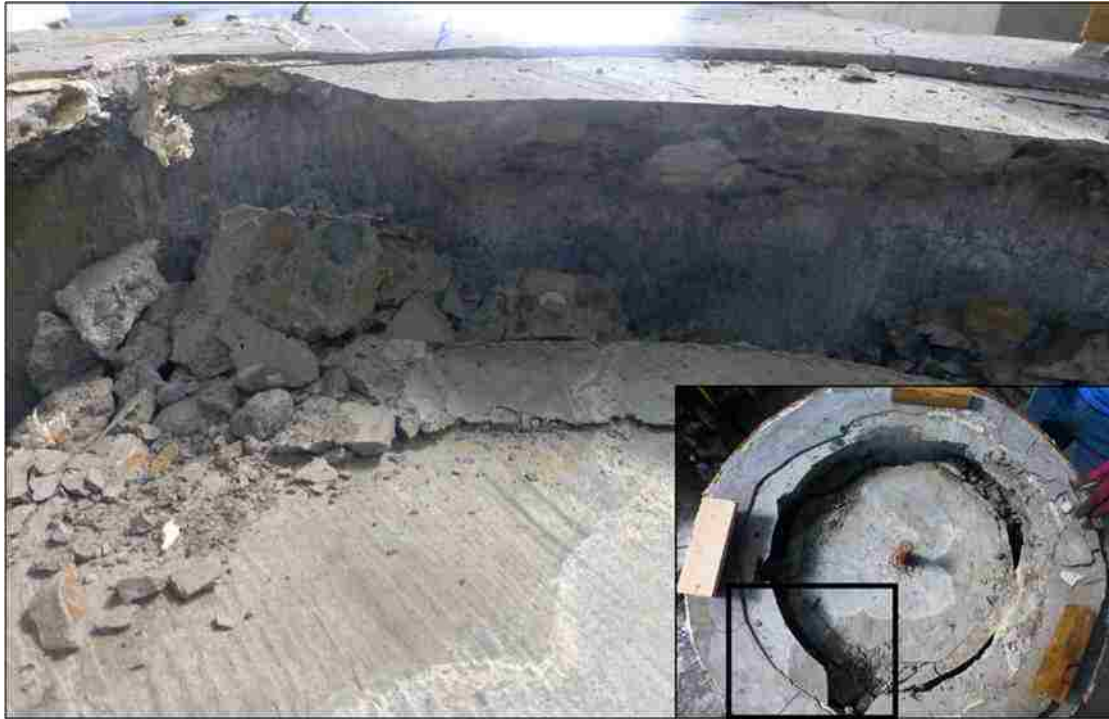
Figure 5-20. Plan View of Test ep24s4-1 at the end of testing showing "punching" displacement of plug

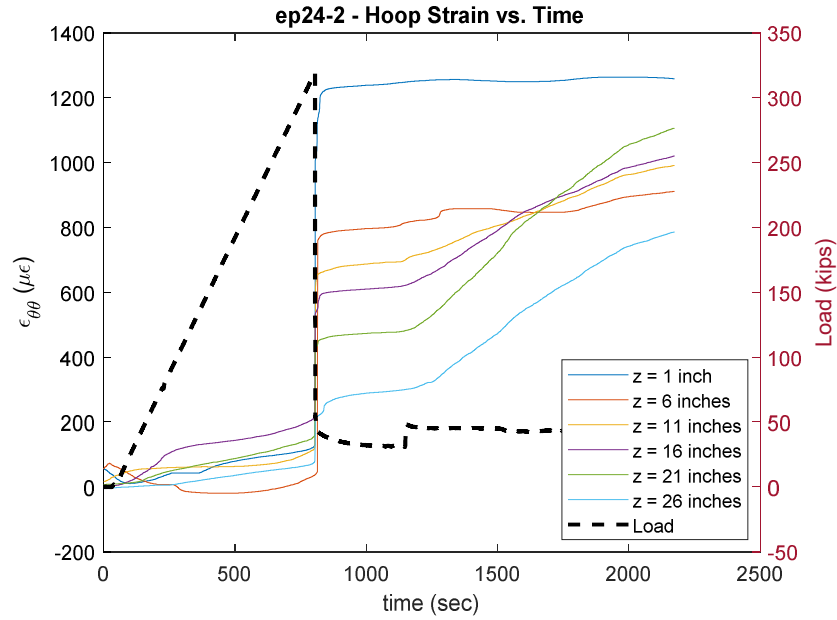
Figure 5-25. Hoop Strain vs. Time, with Axial Load for test ep24-2

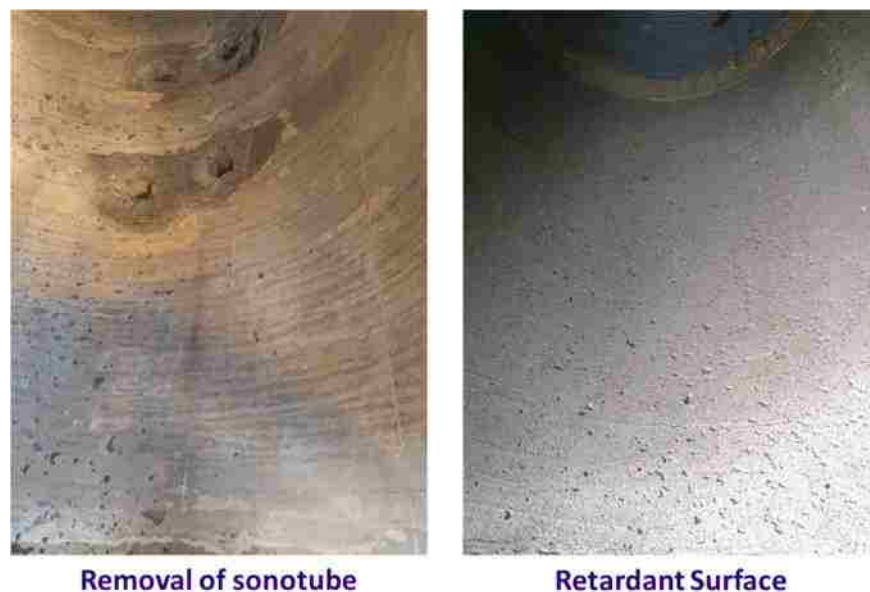
Figure 7-12. Comparison of surface roughness after removal of sonotube, with and without retardant

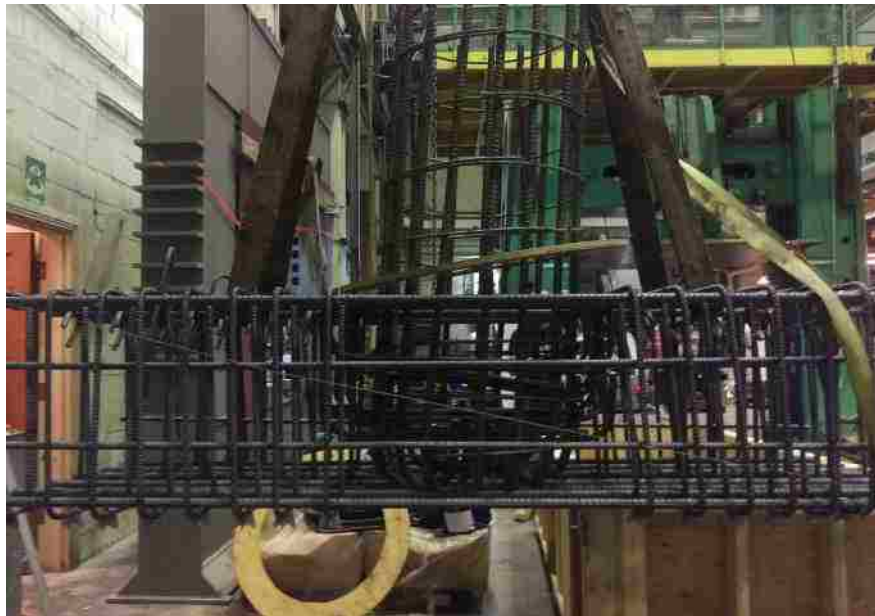
Figure 7-14. Reinforcement cage for cap beam being lifted into formwork for casting

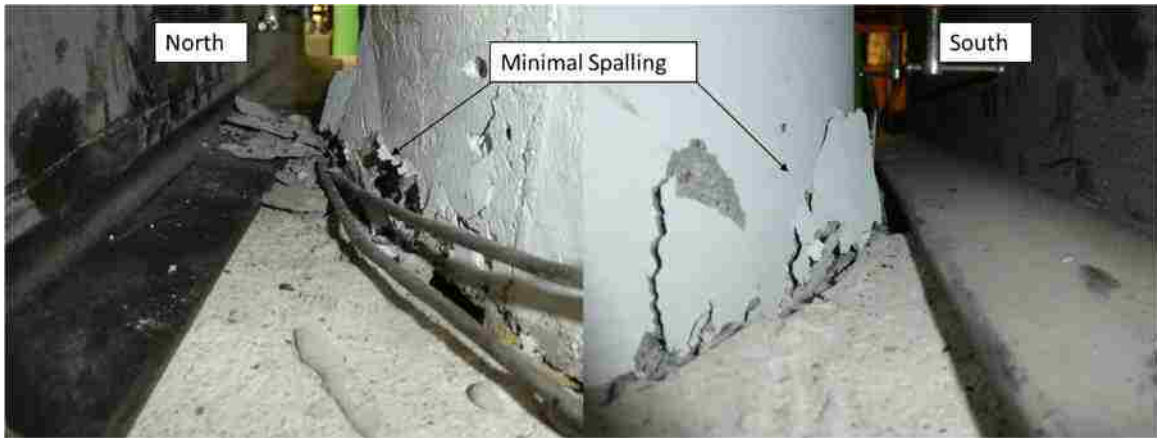
Figure 8-6. Minimal Spalling at base of column, Series 4

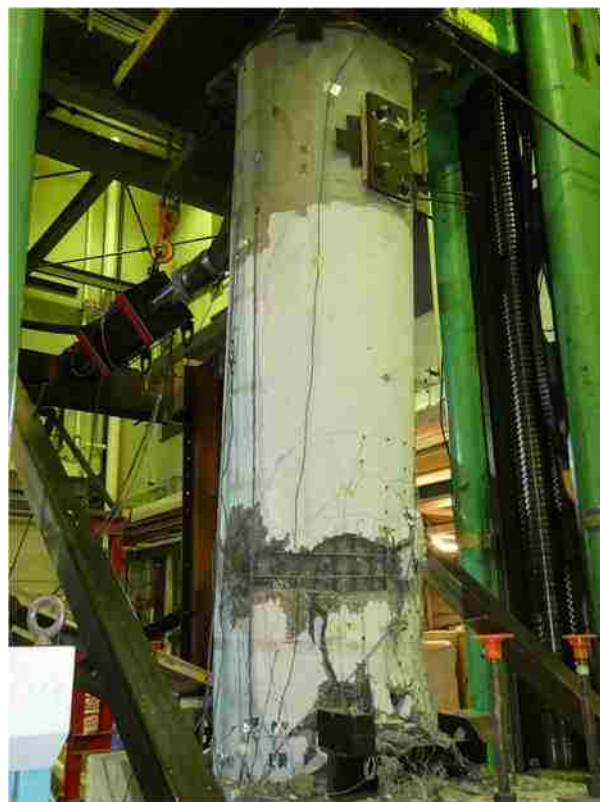
Figure 8-16. Final position of specimen at failure

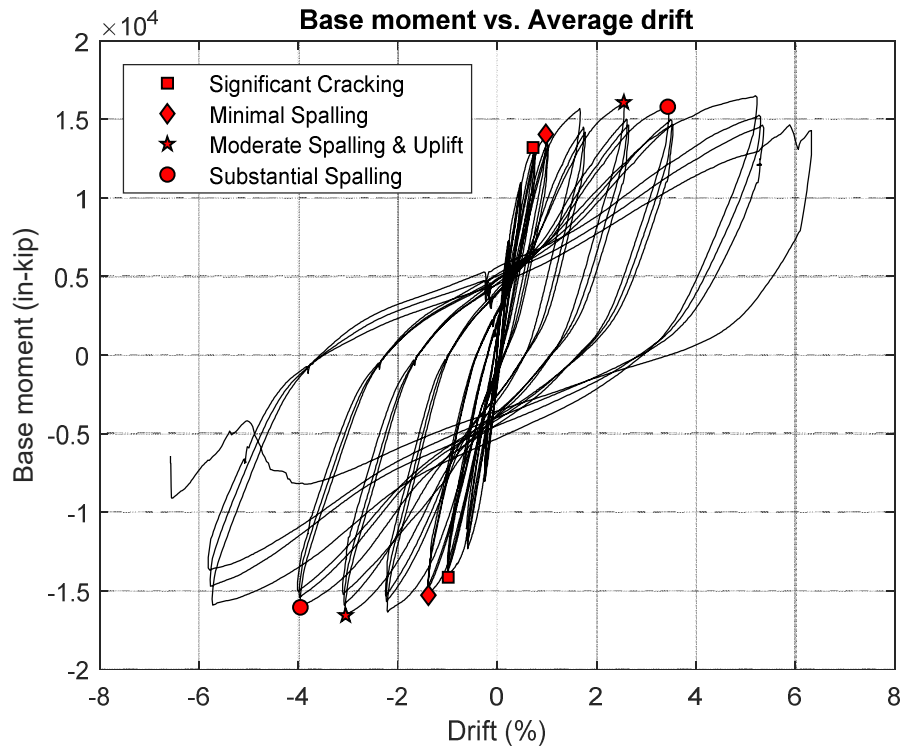
Figure 8-20. Base moment vs first peak drift with key damage states identified

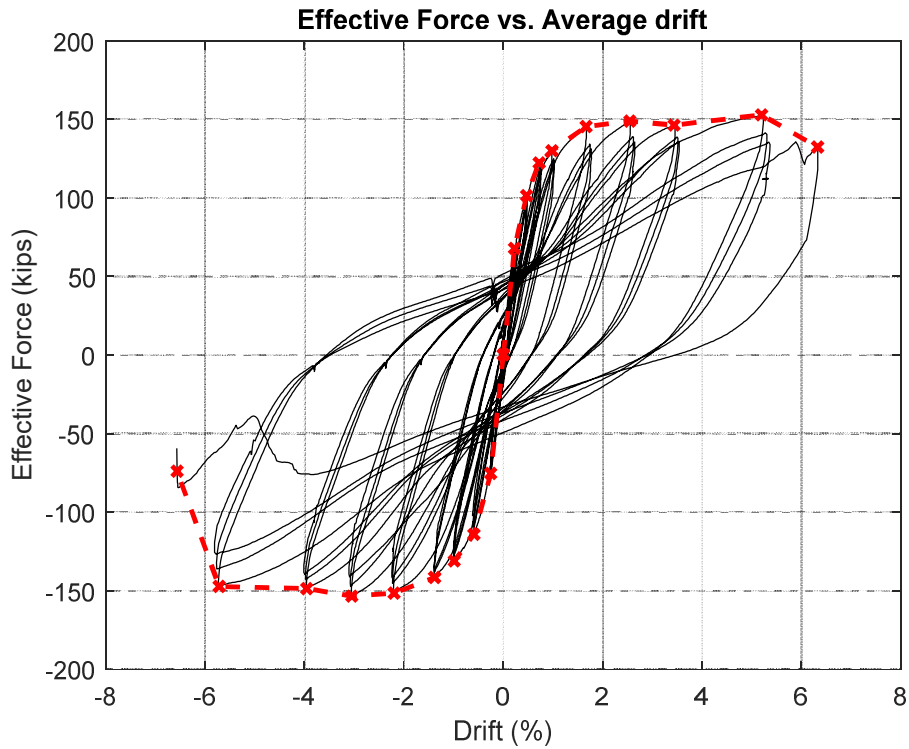
Figure 8-21. Effective force vs. Average drift with cycle 1 backbone behavior

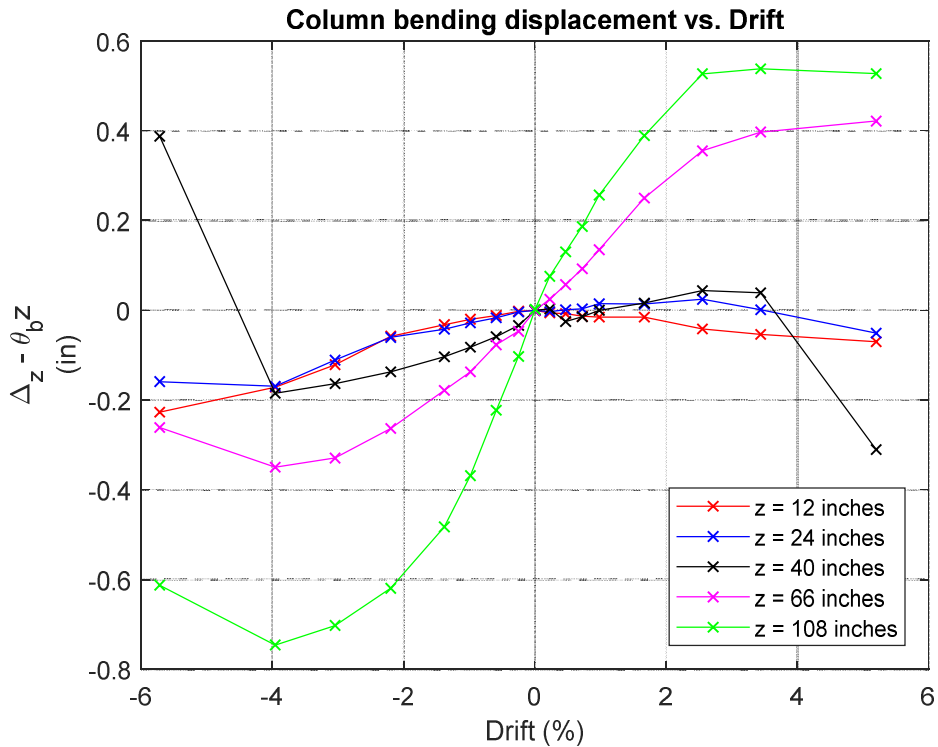
Figure 8-28. Extent of Column Bending Deformation in terms of Local Lateral Displacements

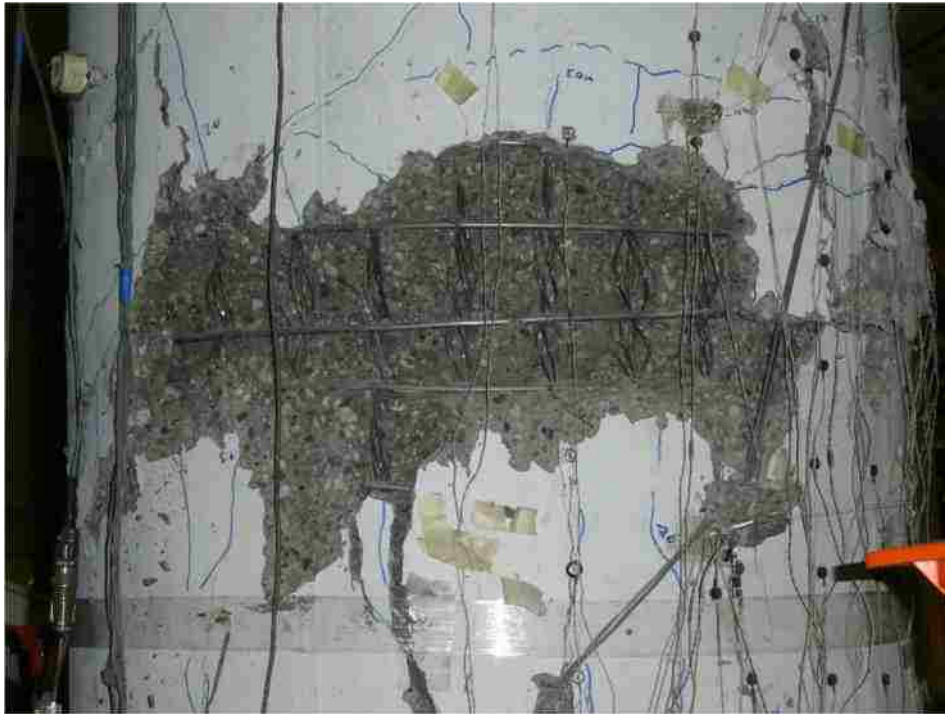
Figure 9-3. "Damaged Area" at end of testing showing concrete spalling, buckled strands and spiral deformation
