DAM REGULATIONS EFFECTS ON SAND BAR MIGRATION ON THE MISSOURI RIVER: SOUTHEASTERN SOUTH DAKOTA

**DAM REGULATION EFFECTS ON SAND BAR MIGRATION ON THE
MISSOURI RIVER: SOUTHEASTERN SOUTH DAKOTA**

Masters of Arts
in Geography, GIS/Cartography

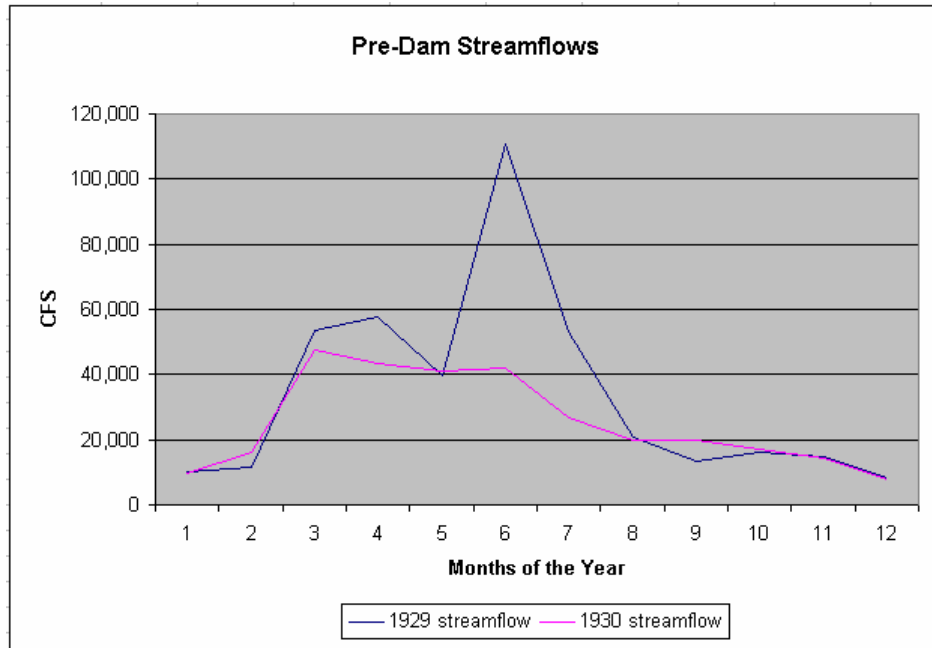
Figure 4: Historical Streamflow Data for the Missouri River at Sioux City, Iowa, pre-dam.

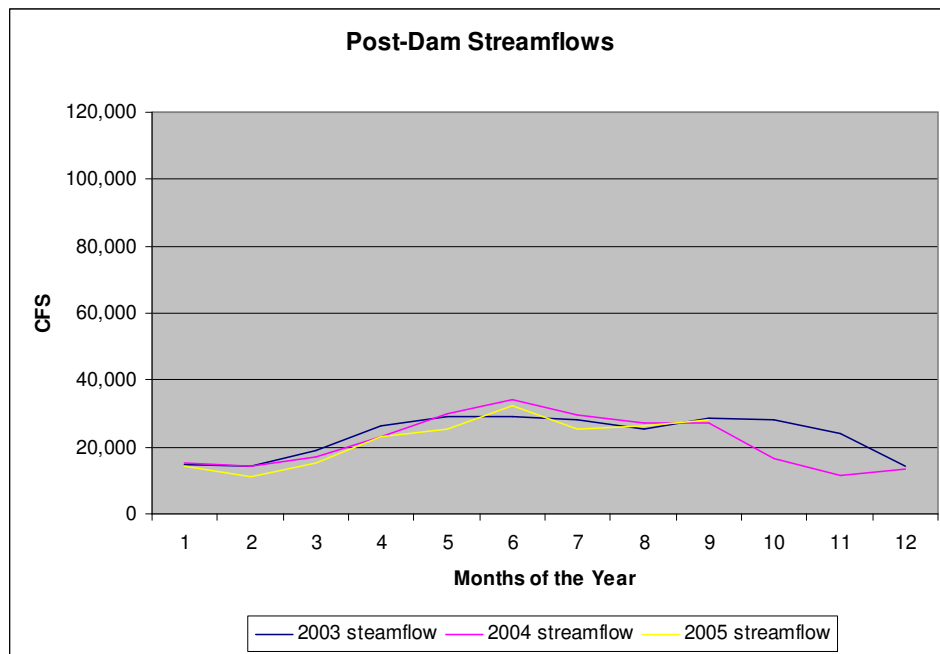
Figure 5: Streamflows for the Missouri River from Sioux City, Iowa, post-dam.

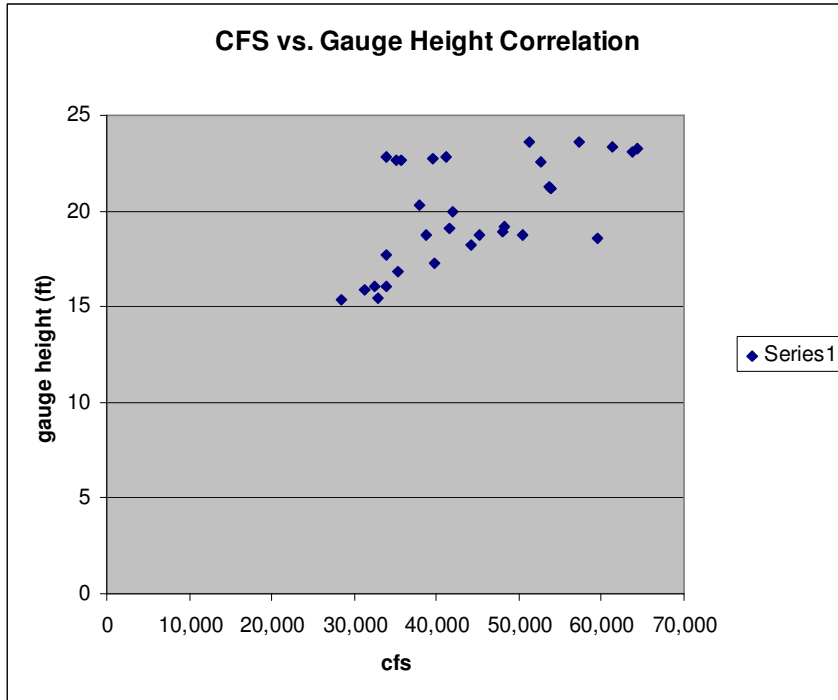
Figure 8. Graph displaying gauge height to cfs correlations.

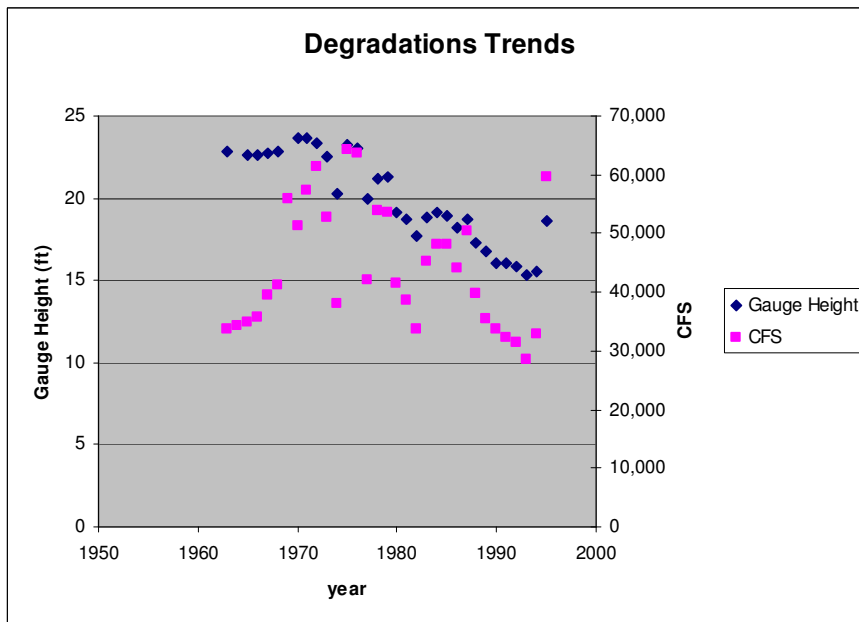
Figure 9. Graph showing bed degradation trends in the Missouri River.

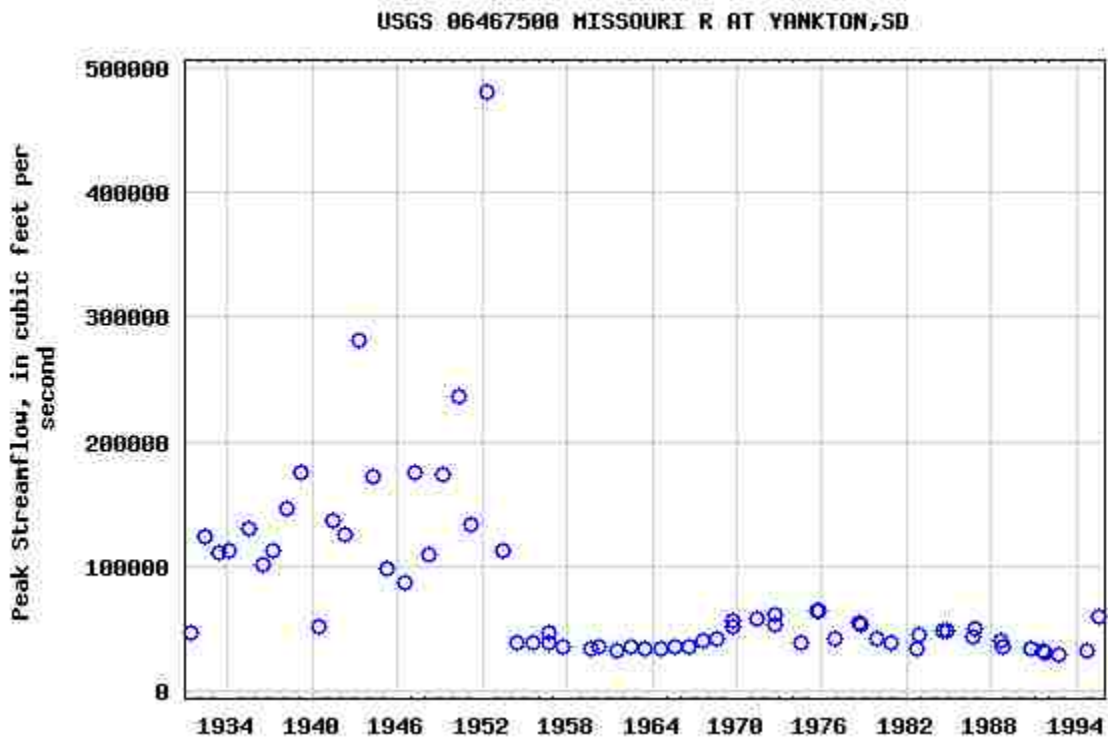
Figure 10. Graph showing mean annual peak flow discharges for the Missouri River at Yankton S.D. (USGS, 2006).

the amount of snow pack and precipitation, but also depend on reservoir levels and the water needed downriver for barge traffic. According to Figure 10, the times slices used in this project are from 1940-1941 and 2004-2005. These are representatives of both pre- and post-dam conditions respectively.

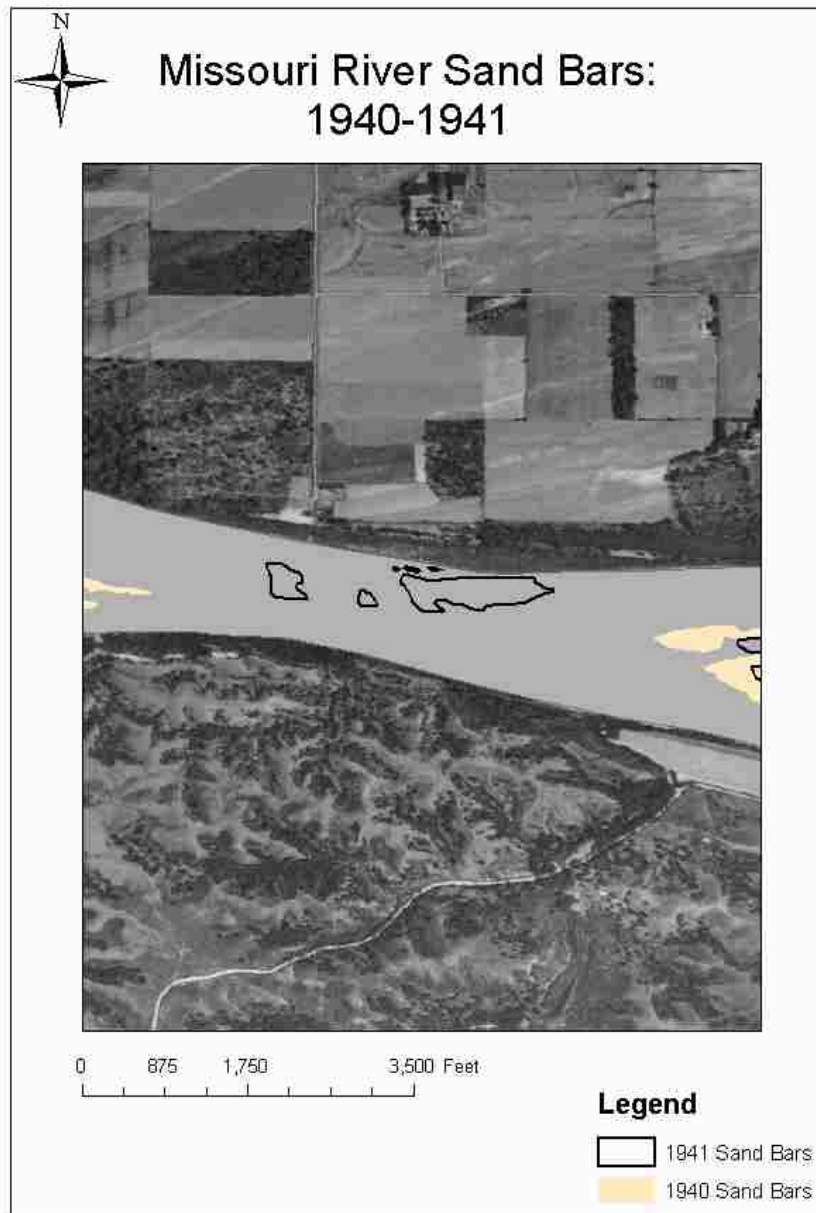
Figure 28: Map showing open water in 1940, sand bars in 1941.

All of the bars showed considerably more change between 1940 and 1941 than did the bars between 2004 and 2005. In many cases bars that were present in 1940 were not present in 1941 (Figure 27). The opposite was also found, areas that contained no bars in 1940 had bars present in 1941 (Figure 28). Many similar cases could have been selected like those in Figures 27 and 28. Some of the bars fragmented such that one

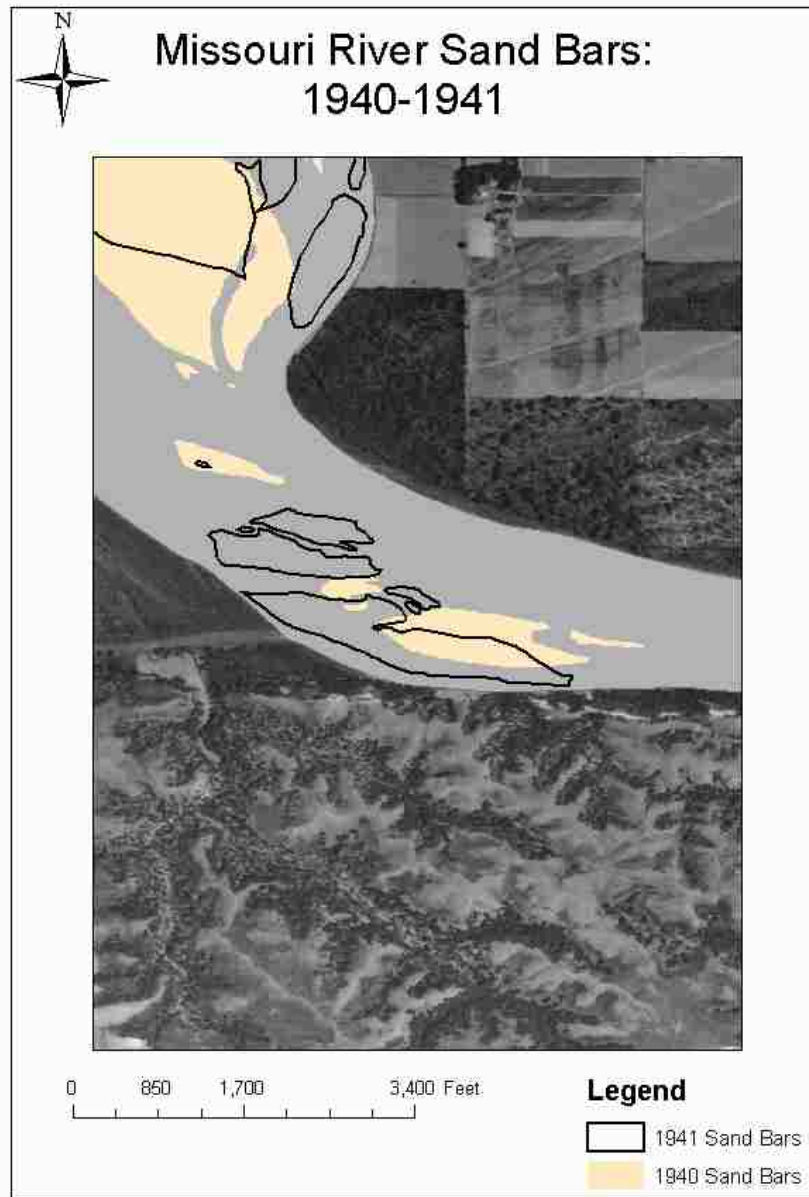
Figure 29: Map depicting difficulty in finding bar pairs in 1940-1941.

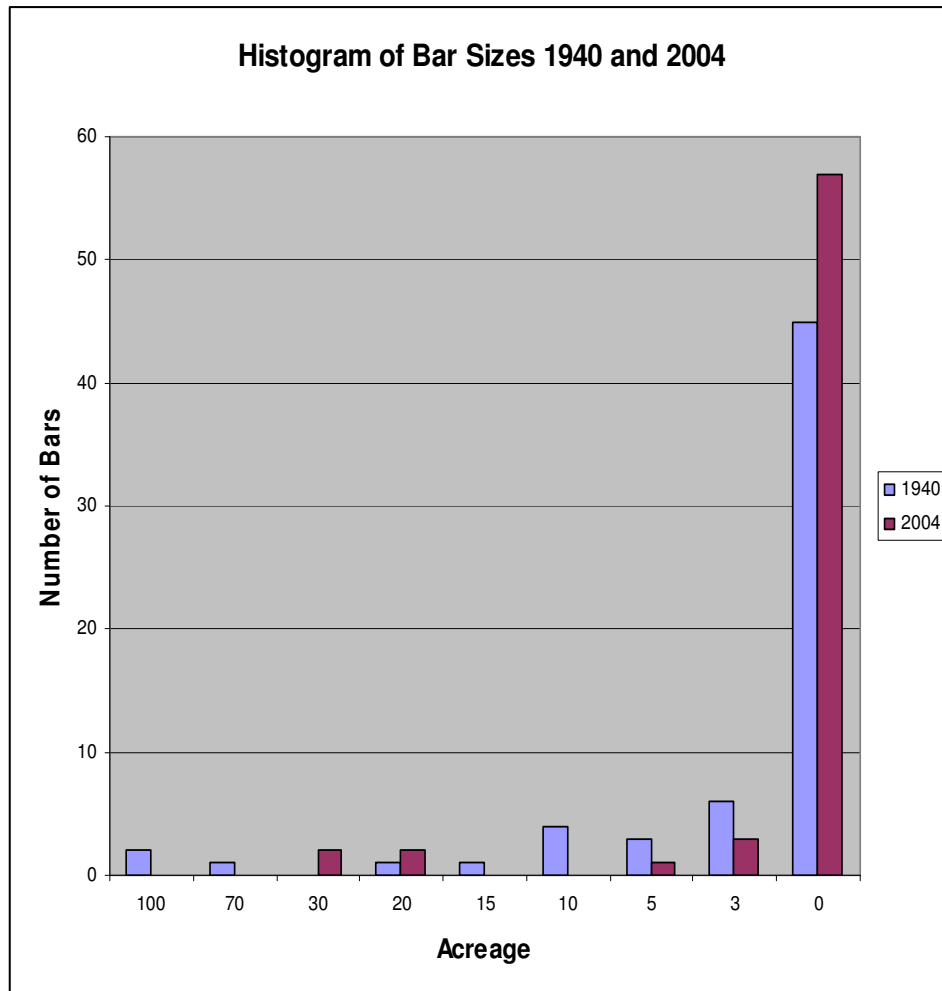
Figure 32. Histogram showing ranges in sand bar sizes comparing the years 1940 and 2004. Acreage indicates the minimum size of the bar in that category.

distances below the dam. According to Williams and Wolman (1986), the study area for this project is in the reach of degradation that has developed below Gavins Point Dam. The low sediment water and resulting degradation has caused a reduction in the acreage and distribution of the sand bars currently present in this reach of the Missouri River (Figure 32).
