Effects of Surface Treatments on National Bridge Inventory Condition Ratings for Concrete Bridge Decks in Utah

A thesis submitted to the faculty of
Brigham Young University
in partial fulfillment of the requirements for the degree of
Master of Science

Department of Civil and Environmental Engineering
Brigham Young University

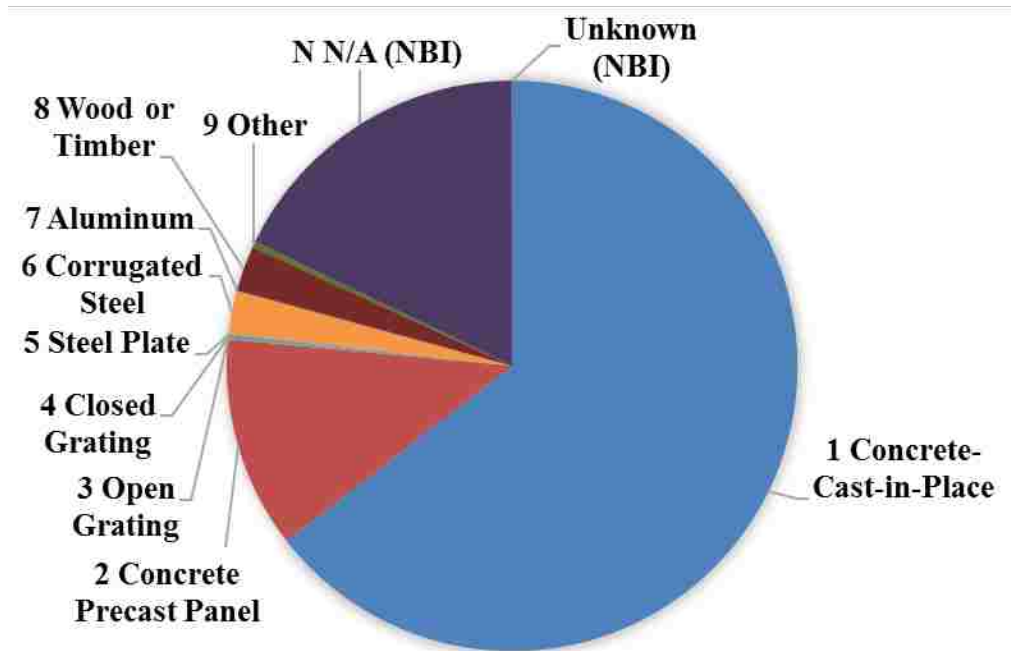
Figure 3-1: Example pie chart of a categorical characteristic (bridge deck material).

The categorical characteristics of the bridges were analyzed using pie charts. From the charts, the most common classes were visually identified for each characteristic. The pie chart used to determine the most common bridge deck materials used in construction is shown as an example in Figure 3-1. The most common bridge deck materials, based on this pie chart, are cast-in-place concrete and concrete precast panels. In the charts, “N/A” indicates that the data were not available. Of the 10 categorical bridge characteristics, five had classes that were clearly

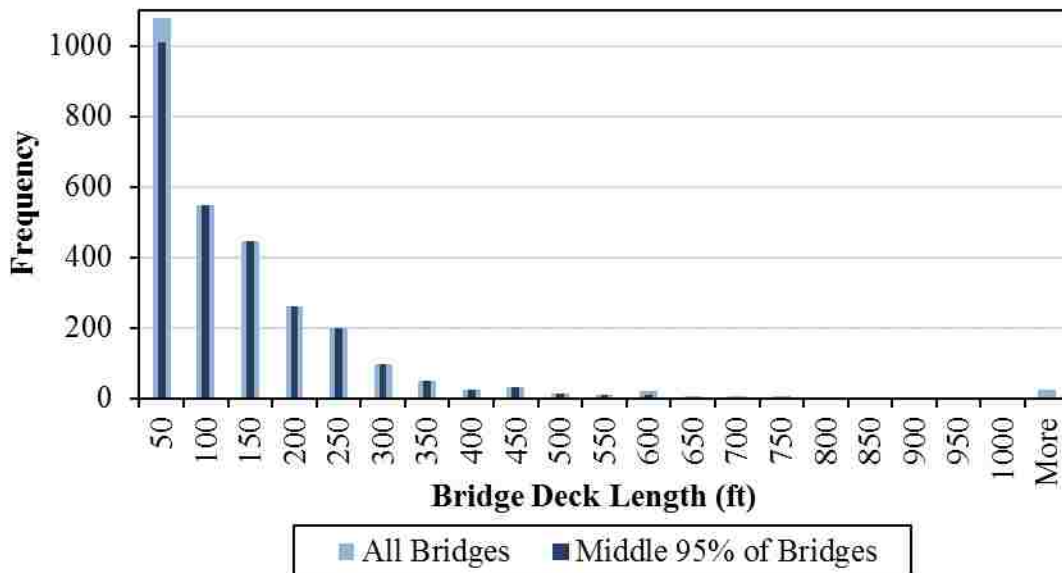
Figure 3-2: Example histogram of a numerical characteristic (bridge deck length).

The numerical characteristics of the bridges were analyzed using histograms and statistics. In this process, outliers as well as a typical range of values for each characteristic were identified. The histogram showing a typical range for the numerical characteristic of bridge length is shown as an example in Figure 3-2. The typical range, which is generally indicated by striped bars in the histogram, encompassed the middle 95 percent of the values for a particular bridge characteristic. The typical range of bridge deck length was calculated to range from 20 ft to 600 ft. Numerical characteristics for which data were missing for several bridges were excluded from the process of determining typical bridges. Of the 11 numerical characteristics, seven had easily identifiable typical ranges that were determined from the maximum and minimum values associated with the middle 95 percent of the values. All of the histograms used

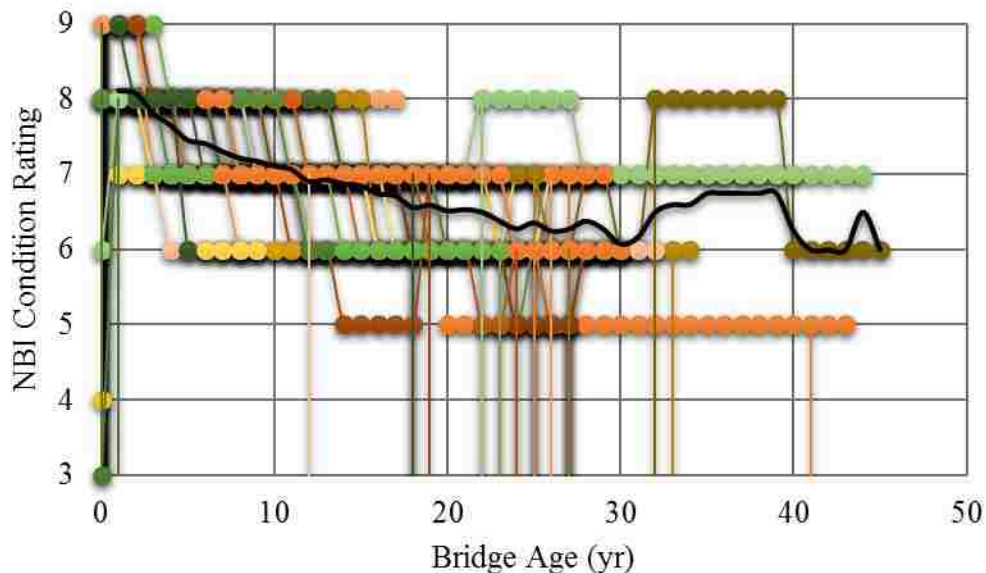
Figure 3-5: NBI ratings aligned by deck construction time for bridge decks with a bituminous overlay in Region 2.

Visual Basic code was written to extract deterioration curves for individual bridges from a particular workbook (this workbook could contain all the bridges with bituminous overlays in Region 1 or all the bridges with monolithic concrete decks in Region 3, for example), and combine them into one graph, with the deck construction times aligned at a value of 0 on the x-axis. As illustrated in Figure 3-5, which shows individual deterioration curves for bridges with bituminous overlays in Region 1 as an example, an average deterioration curve, which is shown as a black line, was then calculated. Greater variability occurs in the average deterioration curve as the number of available bridge decks for a given age decreases. Beyond displaying the NBI ratings with age for each bridge deck, Figure 3-5 also indicates with a vertical line the age at which the surface type changed for each bridge deck.

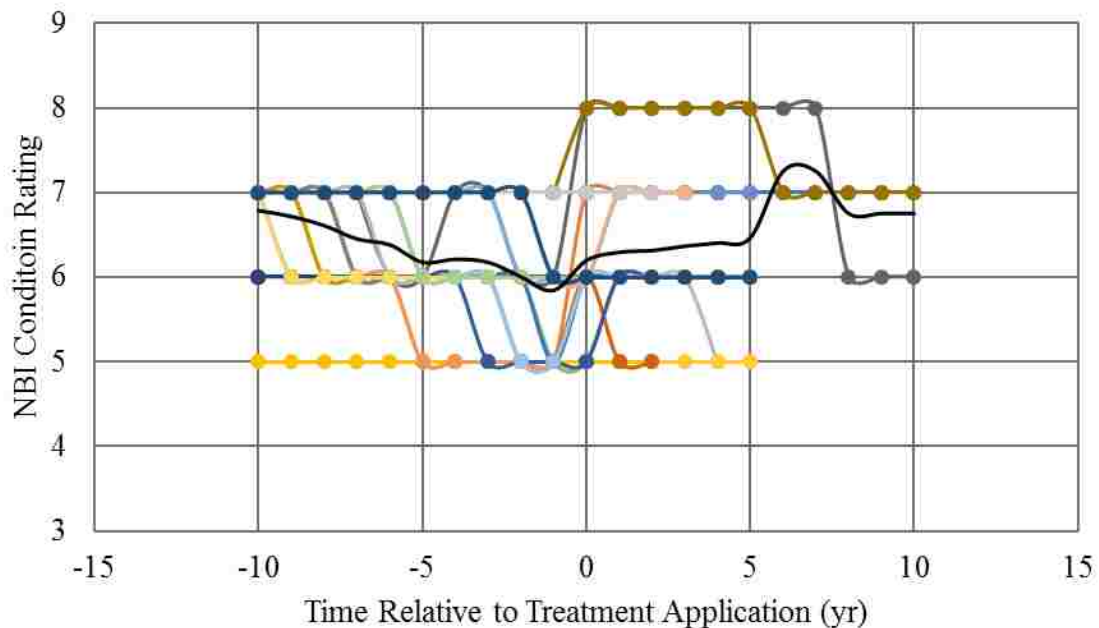
Figure 3-7: NBI ratings aligned by deck treatment time for bridge decks with late application of a bituminous overlay in Region 2.

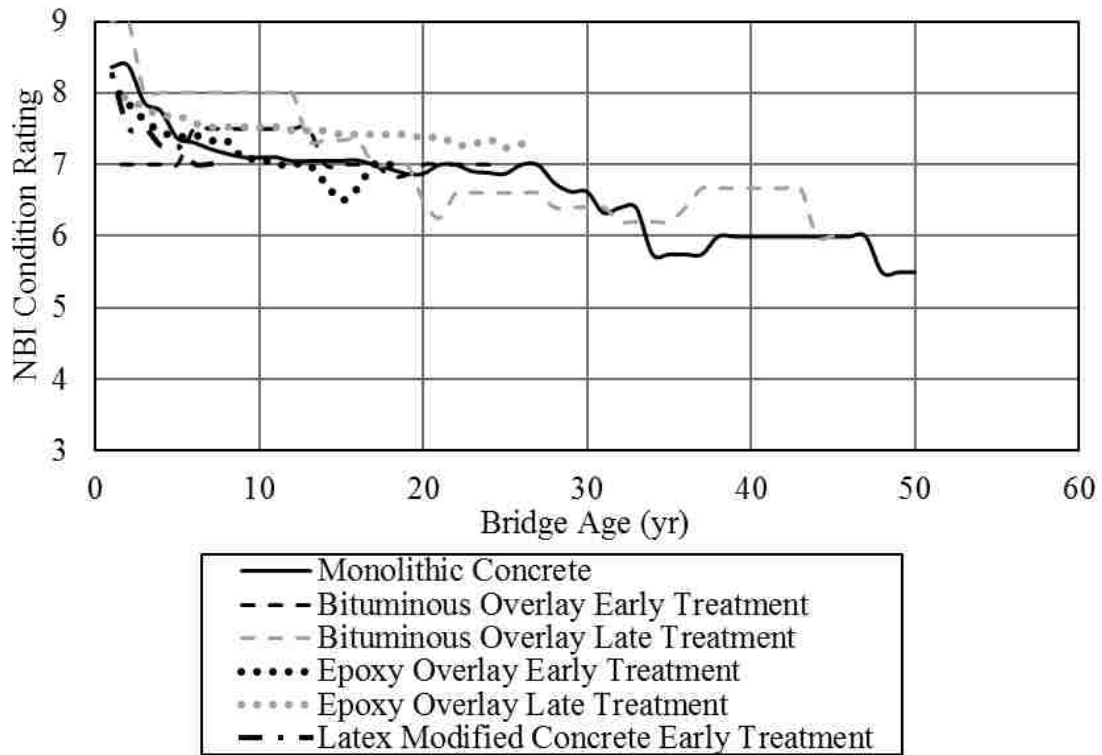
Figure 4-1: Average deterioration curves aligned by deck construction time for Region 1.

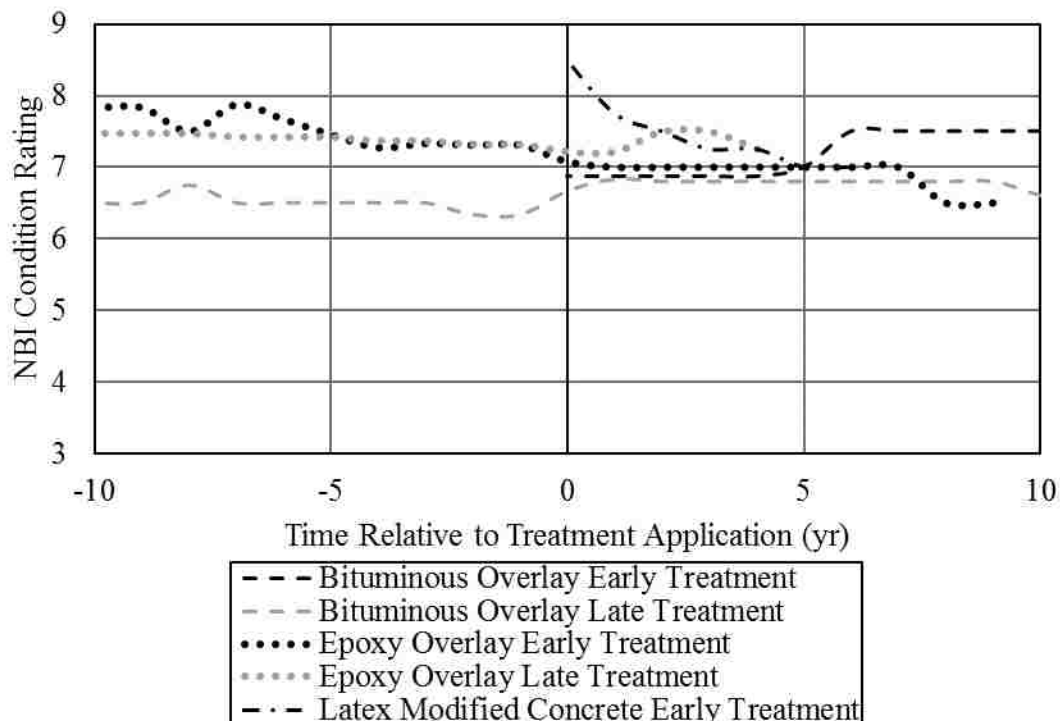
Figure 4-6: Average deterioration curves aligned by deck treatment time for Region 1.

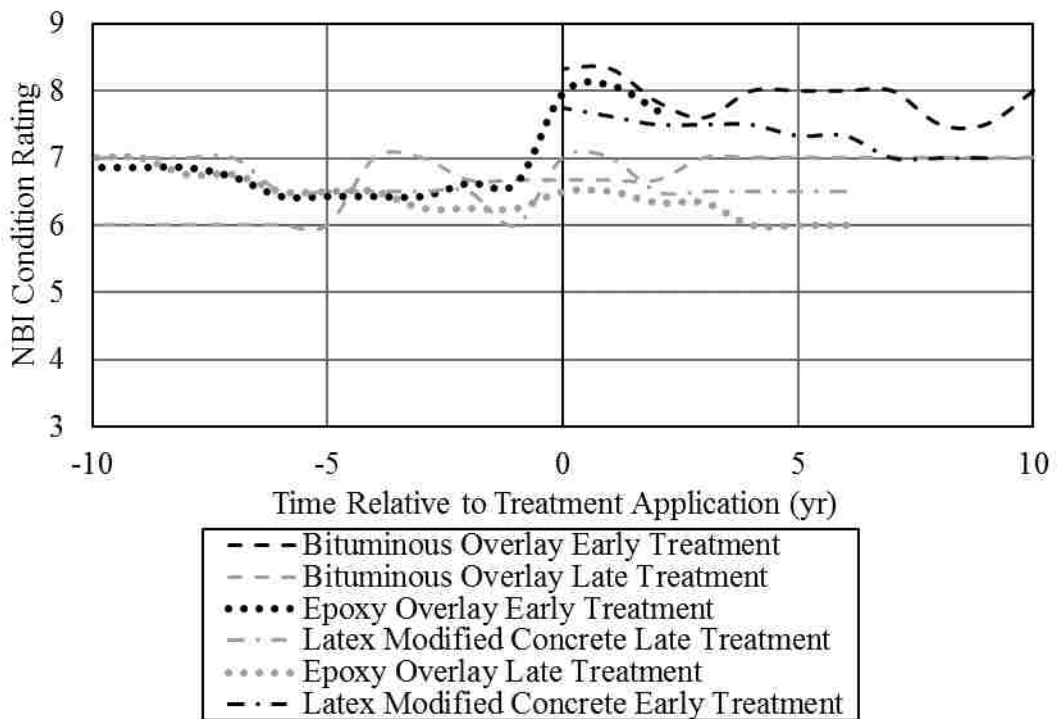
Figure 4-8: Average deterioration curves aligned by deck treatment time for Region 3.

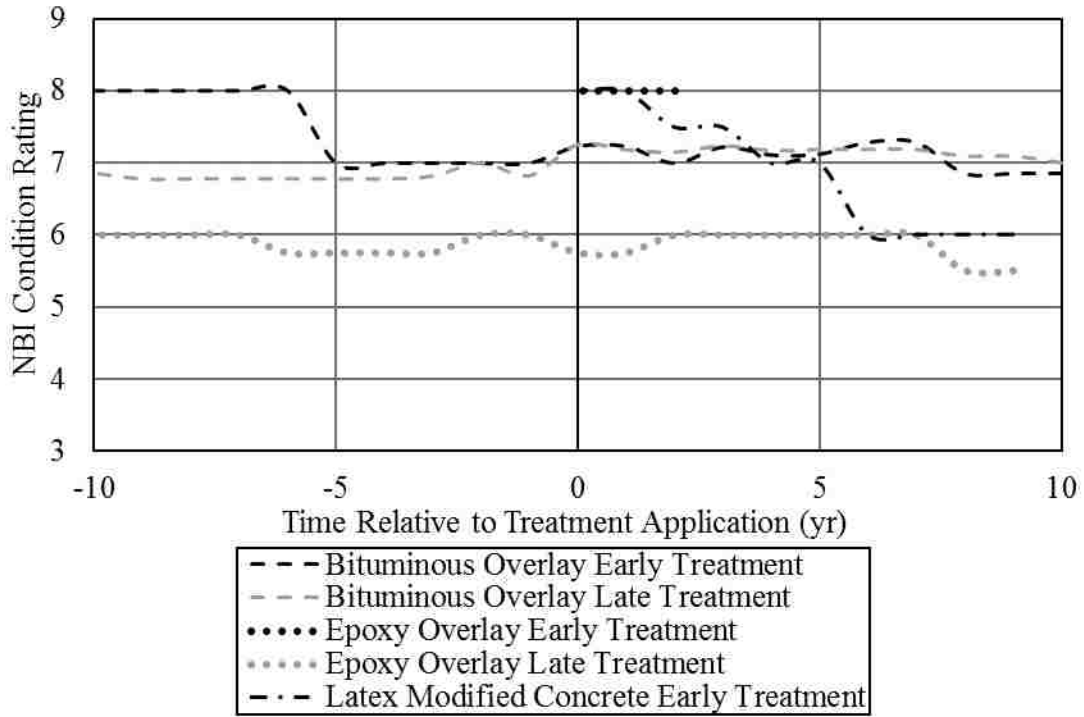
Figure 4-9: Average deterioration curves aligned by deck treatment time for Region 4.

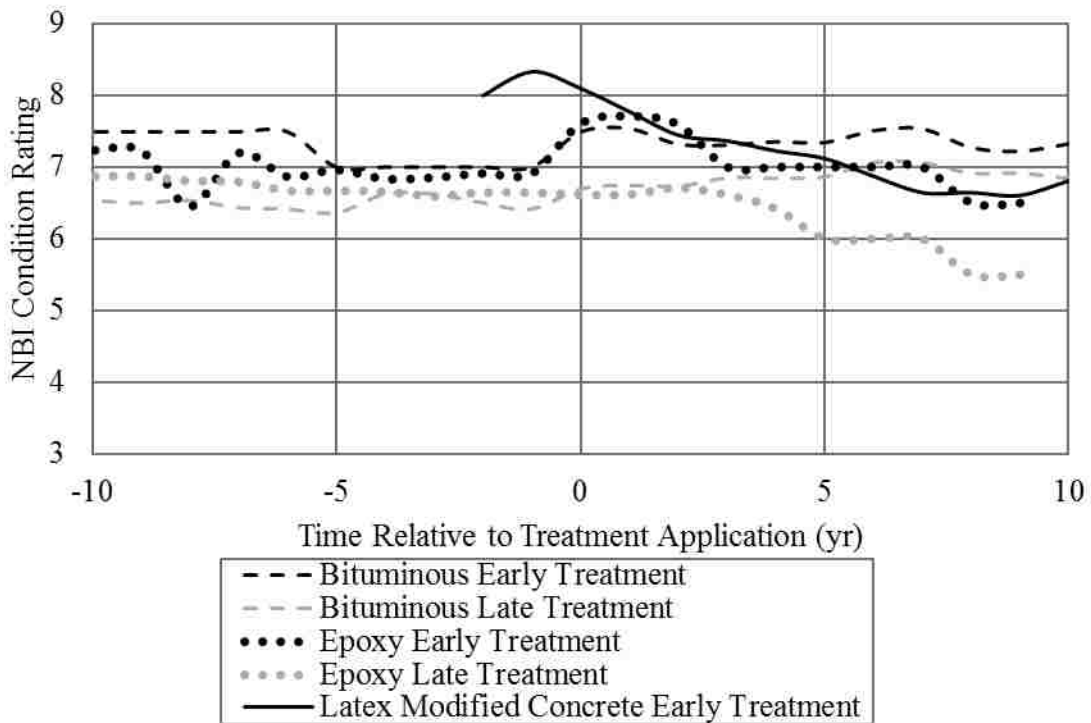
Figure 4-10: Statewide average deterioration curves aligned by deck treatment time.

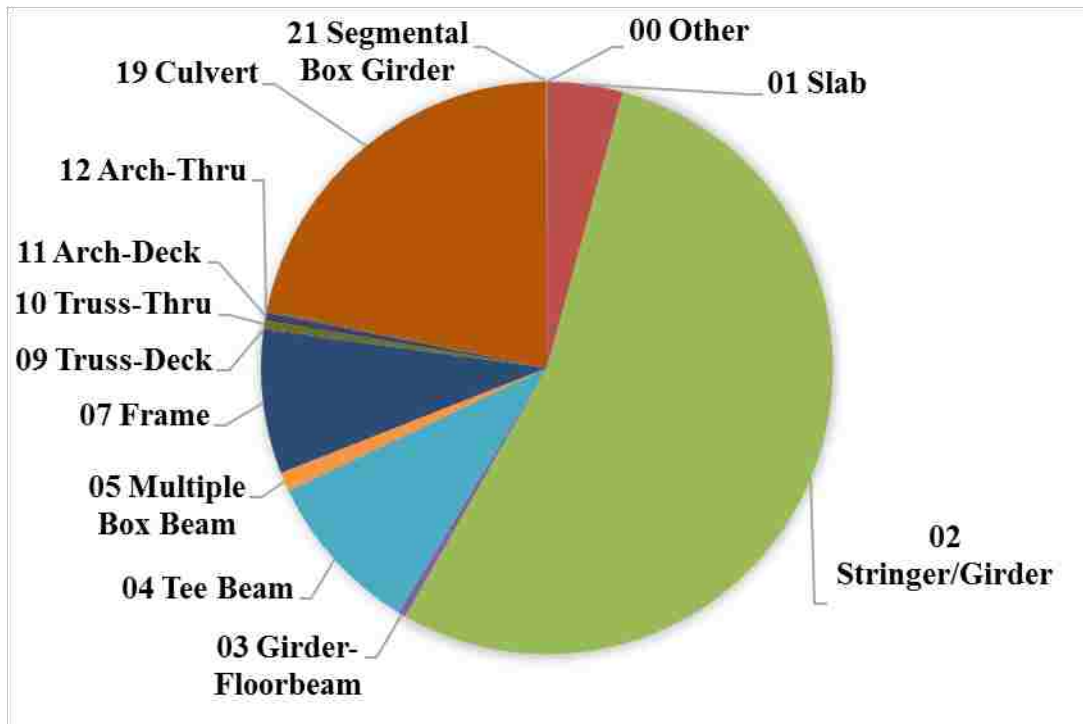
Figure A.2 Pie chart of bridges in Utah grouped by span design.

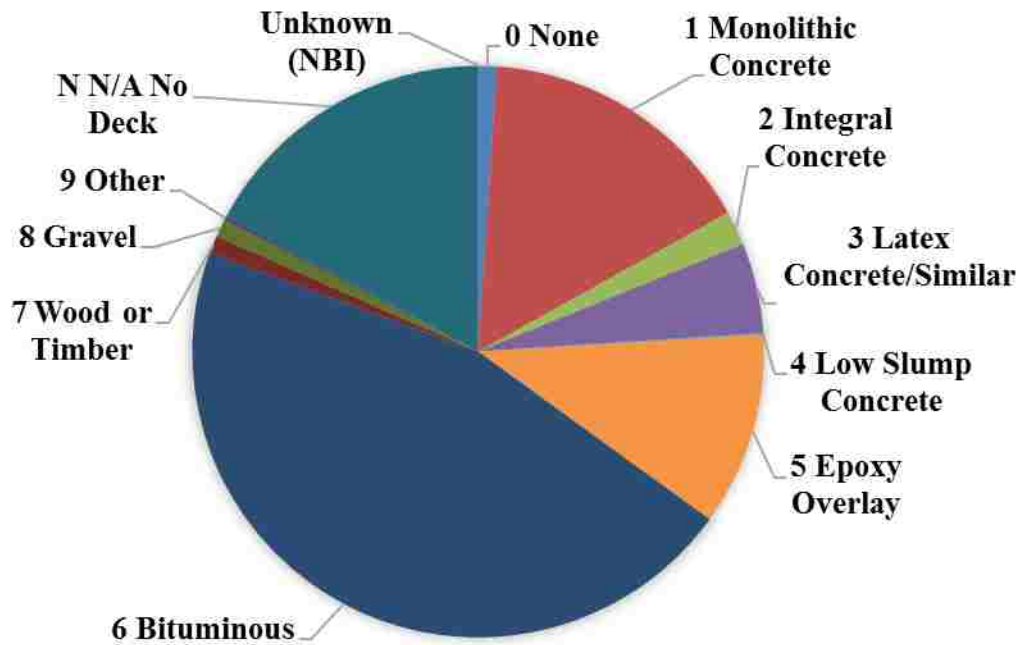
Figure A.5 Pie chart of bridges in Utah grouped by surface type based on FHWA classifications.

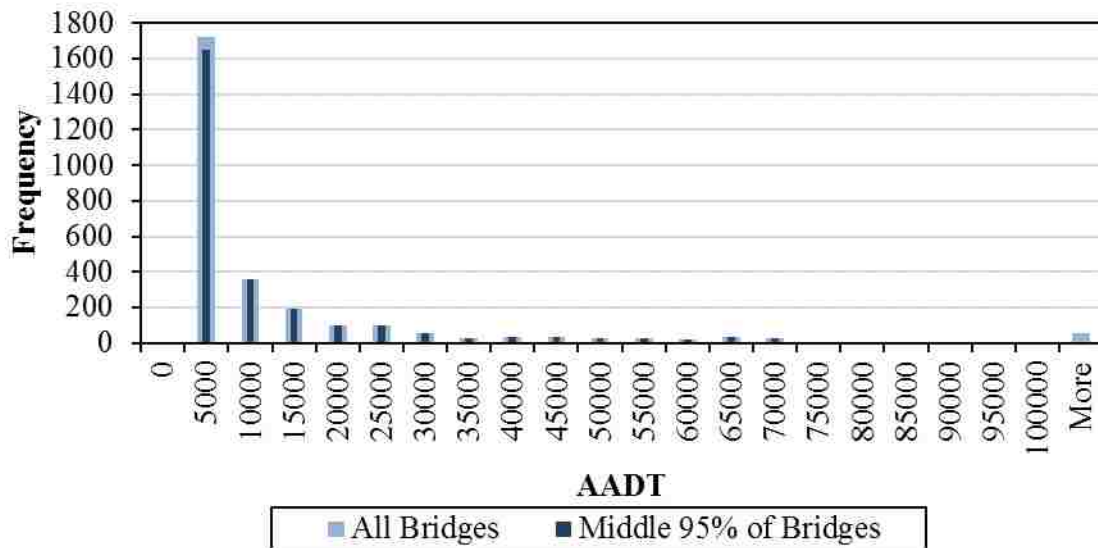
Figure A.10 Histogram of bridges in Utah grouped by AADT.

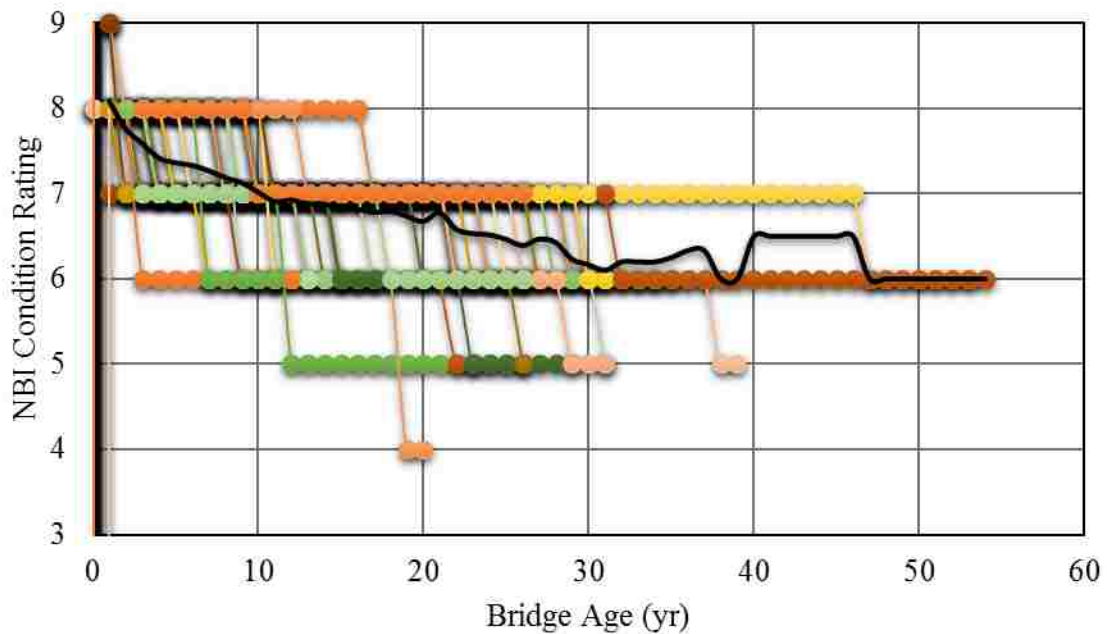
Figure B-7: Individual deterioration curves and average curve aligned by deck construction time for monolithic concrete bridge decks in Region 2.
