Environmentally Friendly and Sustainable Stream Stability in the Vicinity of Bridges

A thesis submitted to the faculty of
Brigham Young University
in partial fulfillment of the requirements for the degree of

Master of Science

Department of Civil and Environmental Engineering

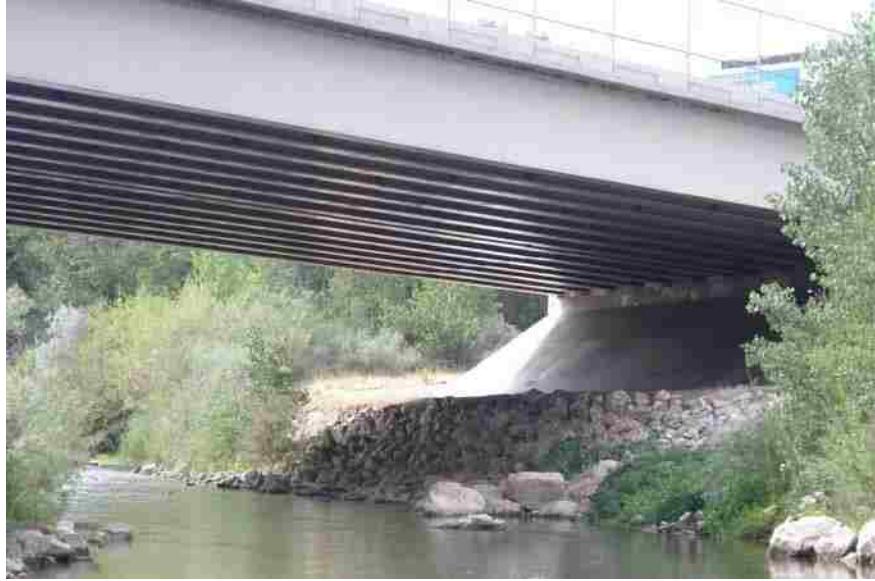
Figure 2-3: Riprap Used to Protect a Bridge Abutment. Flow From Top to Bottom (Picture Taken by Evan Cope).

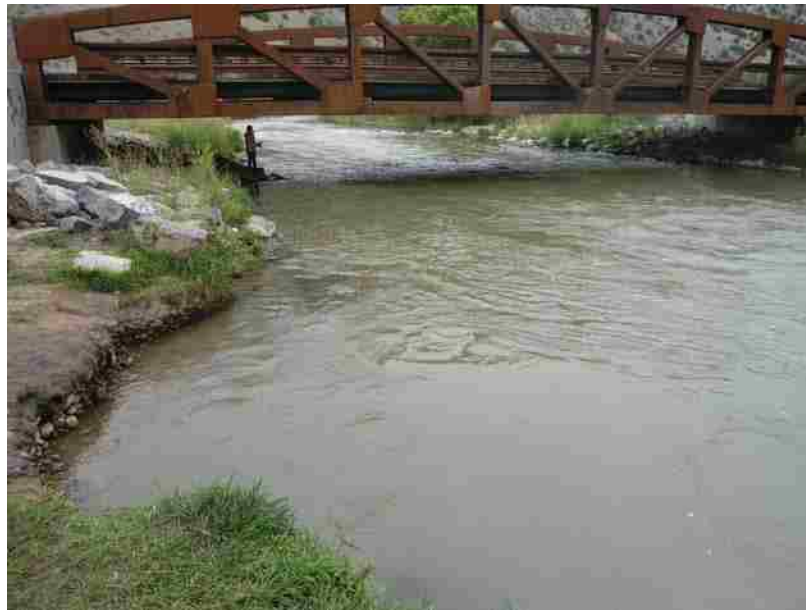
When using riprap, it is important to armor the bank to a depth that is deeper than the maximum scour near the toe of the riprap revetment. If scour occurs and undermines the toe of the riprap revetment, the riprap will begin to slide down the slope of the streambank into the scour hole and will eventually fail. The riprap must also have a smooth transition from native streambank to riprap revetment. An abrupt change can cause scour to occur at the transition's location and will begin to undermine the riprap (Figure 2-4), causing failure (Grinderland, 2013).

Figure 2-4: Abrupt Change from Riprap to Streambank, Causing Downstream Scour. Flow from Top to Bottom (picture taken by Evan Cope).

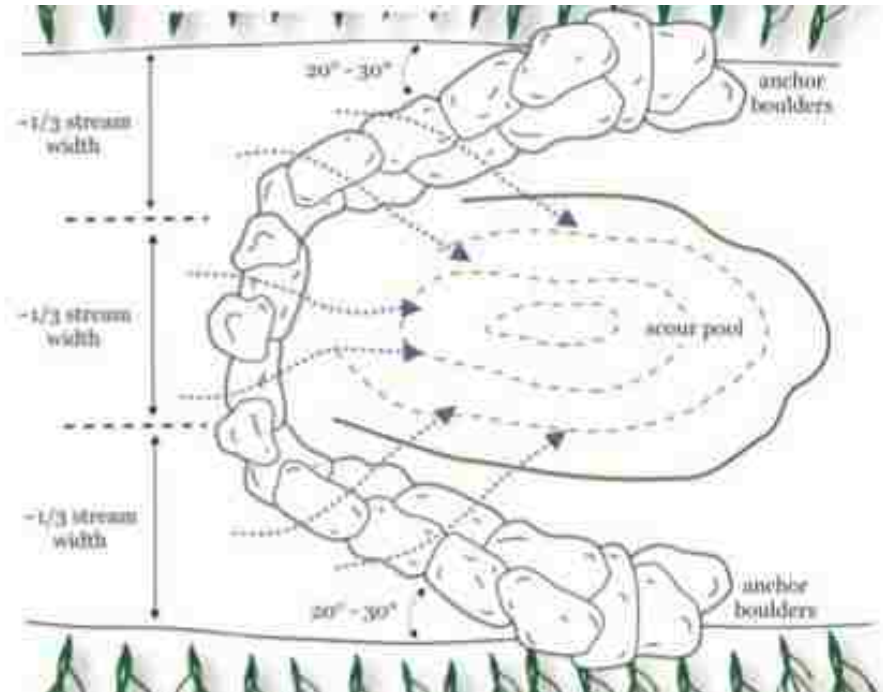
The Cross-Vane consists of two vanes, one on each side of a stream each extending into 1/3 of the channel width that connect together in the center third of the channel (Figure 2-8). Cross-Vanes are effective when the streambanks on each side of the stream must be protected

Figure 2-8: Cross-Vane (Sotiropoulos, 2013).

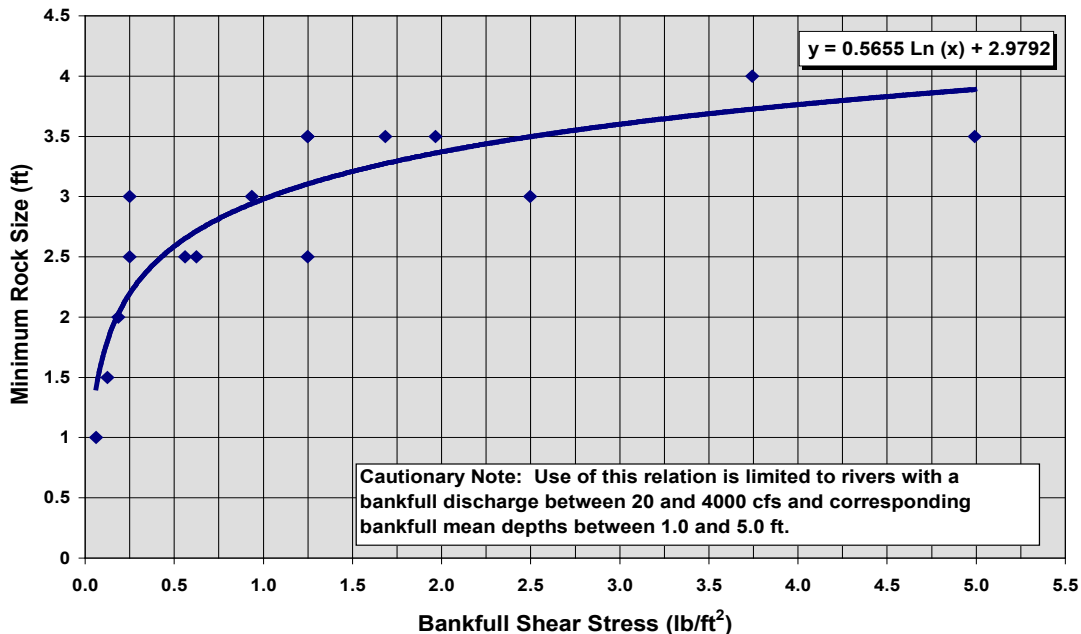
David Rosgen used empirical data to relate shear stress to rock size and then created a best-fit equation for rock size (Figure 3-3).

Figure 3-3: Rock Sizing Based off of Shear Stress (Chart Provided by David Rosgen).

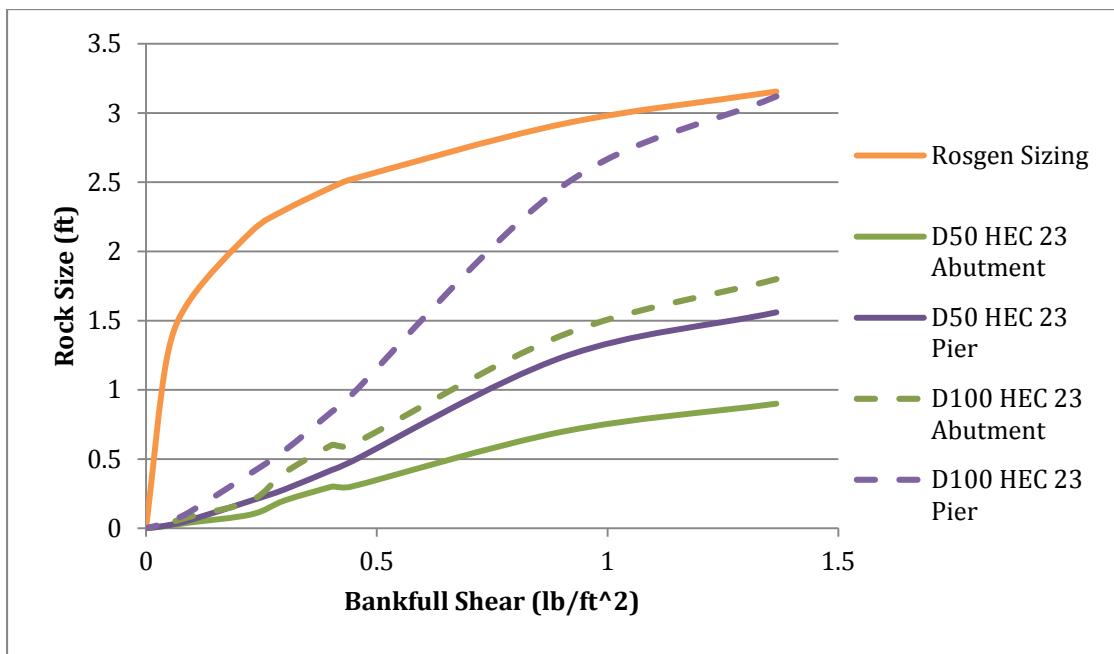
To demonstrate that the Rosgen structures require larger rock than the HEC-23 equations, data were analyzed from the Division of Natural Resources (DNR). Cross-sections, slopes and Manning's coefficients were provided for the Spanish Fork River near Thistle, Utah. The provided data were used for sizing rock with HEC-23 and Rosgen's equations. The results for all equations were plotted (Figure 3-4) and show clearly that Rosgen structures require larger rock.

Figure 3-4: Rock Sizing Equations vs. Shear Stress.

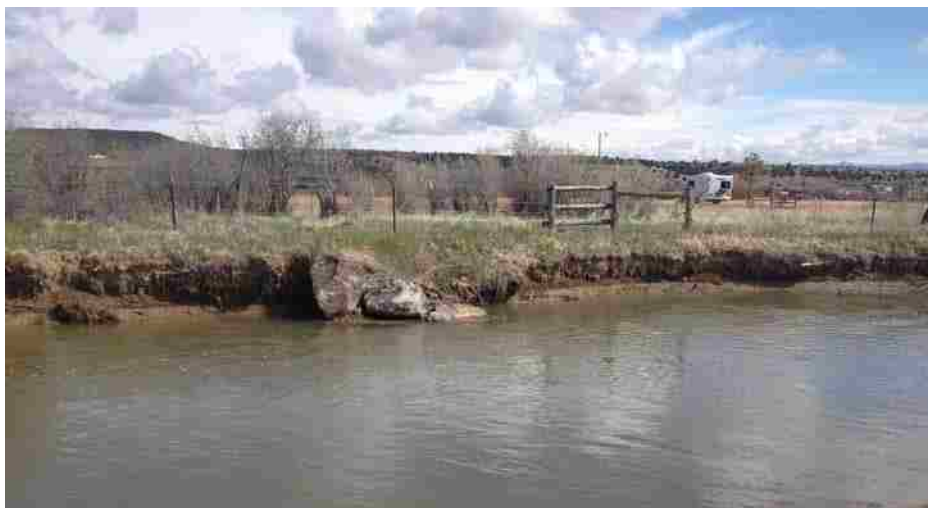
Figure 3-5: Large Vane Angle that Created a Recirculating Eddy and has Actually Increased Streambank Erosion. Flow from Right to Left. (Picture taken by Evan Cope).

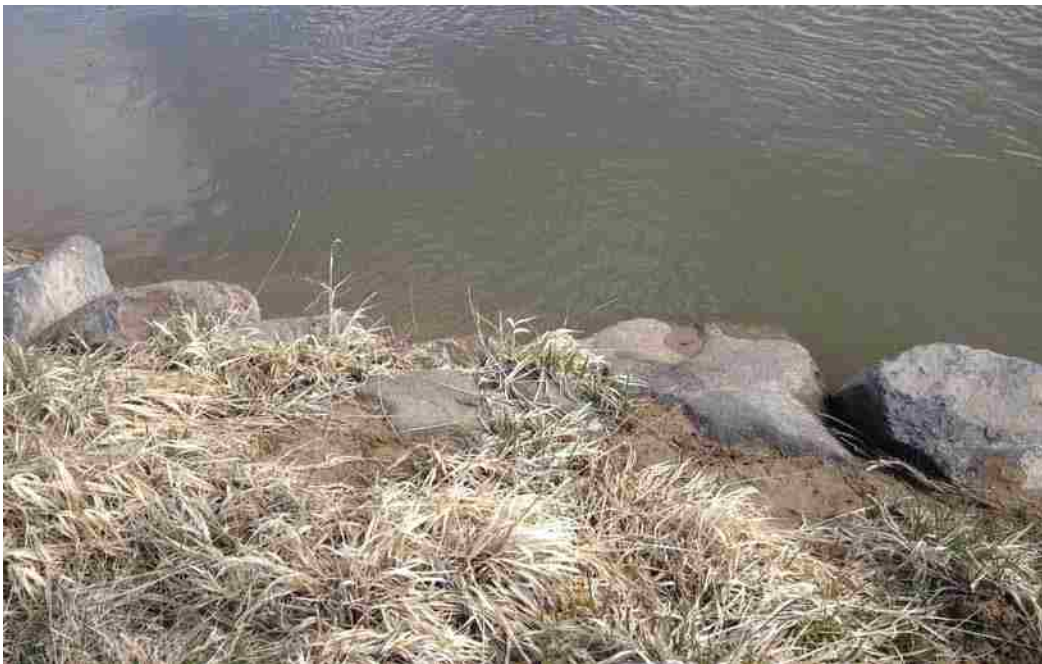
Figure 3-7: Tight Vane Angle Protected and Stabilized the Streambank. Flow from Right to Left (Picture Taken by Evan Cope).

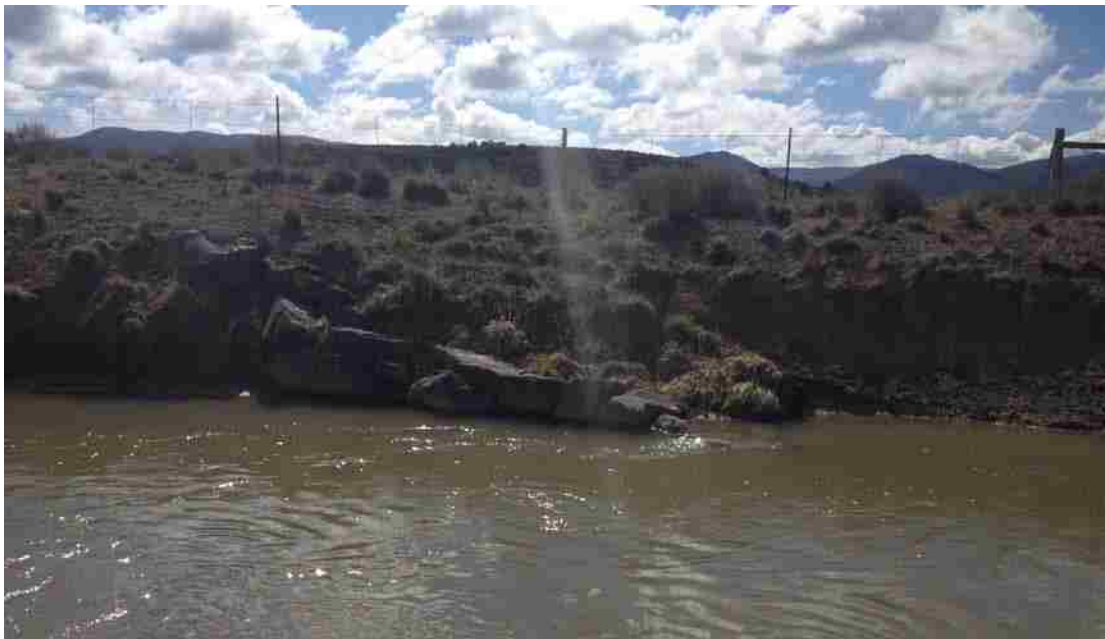
To best redirect flow to the center of the channel, the vane must slope upstream. The adverse slope help force the flow away from streambanks. The vane slope should be between 2 and 7 percent (Figure 3-8, Rosgen, 2006). If slopes are too steep, the vane can actually cause greater streambank erosion (Figure 3-9).

Figure 3-9: Steep Vane Slope has Increased Steambank Erosion. Flow from Right to Left. (Picture Taken by Evan Cope)

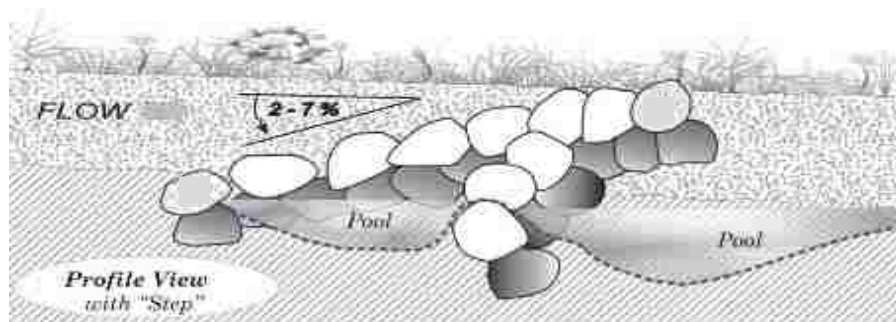
To prevent the downstream scour hole from getting too deep for Cross-Vanes and W-Weirs, a rock step can be installed within the vane arms (Figure 3-11 and Figure 3-12). This creates a series of structures; that reduces the size of the scour hole (Sotiropoulos, 2013). This provides additional protection so that the structure's footers will not be undermined and also to contain lateral scour (Rosgen, 2006).

Figure 3-12: Profile View of Rock Step (Rosgen, 2006).

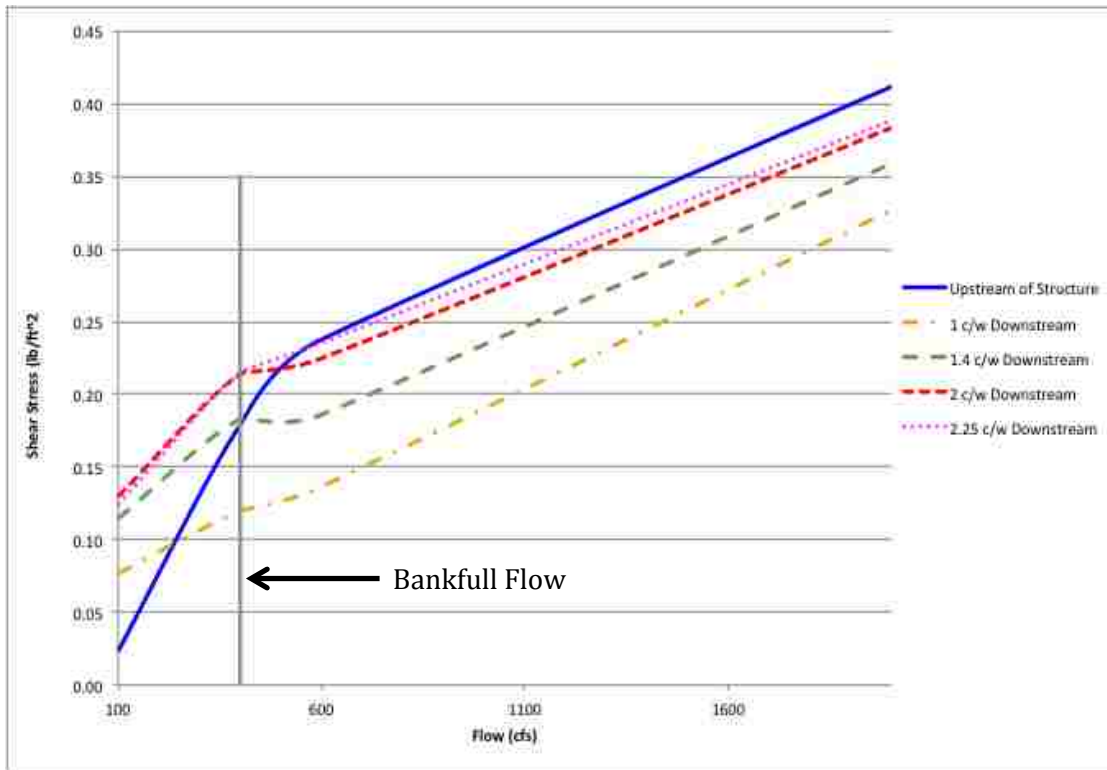
To determine how far downstream the structure has an impact on streambank erosion, the calculated shear stress along the streambank was examined for various flows with a bankfull flow of 400 cubic feet per second (cfs). Streambank shear was plotted for different channel widths downstream from the Cross-Vane (Figure 3-15).

Figure 3-15: Bank Shear vs. Flow for Different Channel Widths Away from Cross-vane.

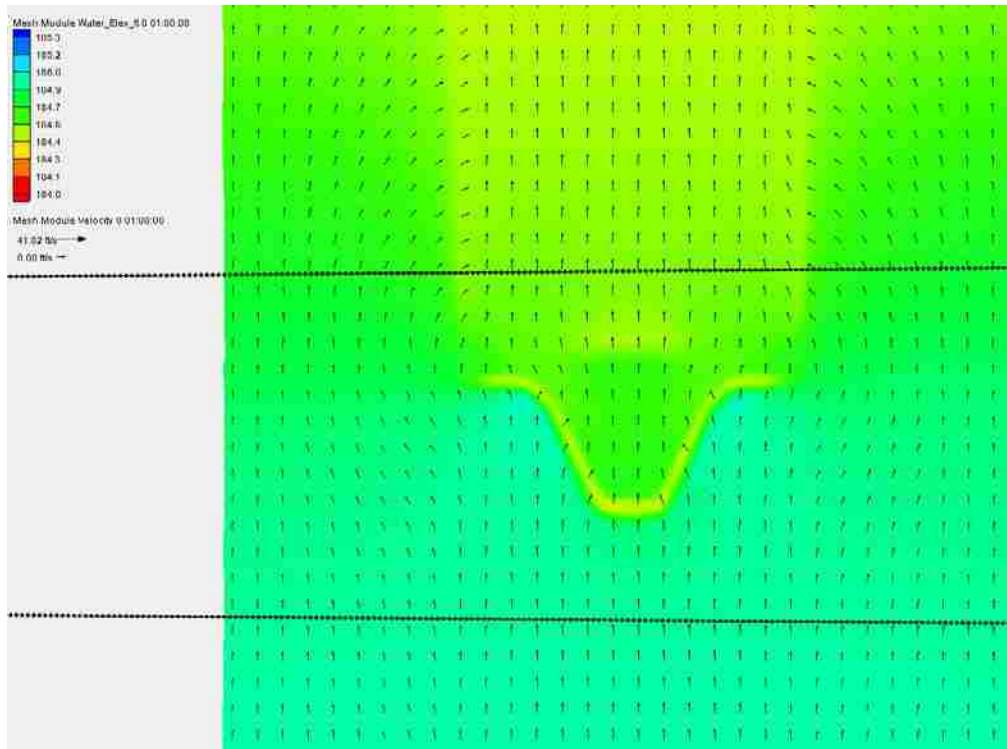
Figure 4-9: Water Surface Elevations for Bankfull Flow. Flow Depth = 2.5 Feet (Image from SMS).

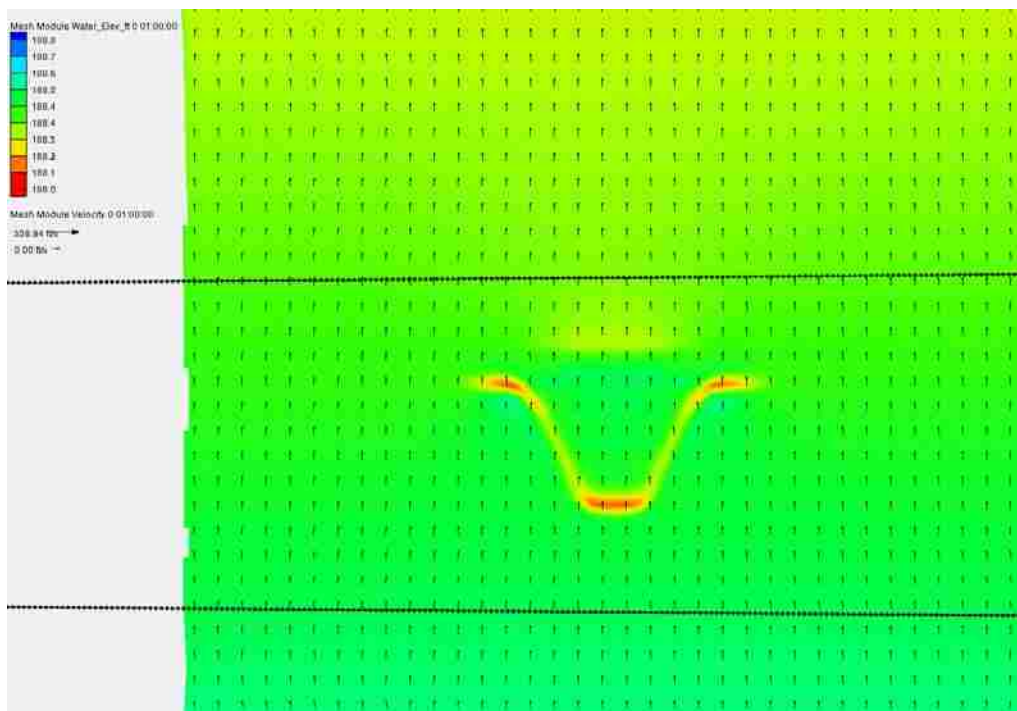
Figure 4-10: Water Surface Elevations for Above Bankfull Flow. Flow Depth = 6.5 Feet (Image from SMS).

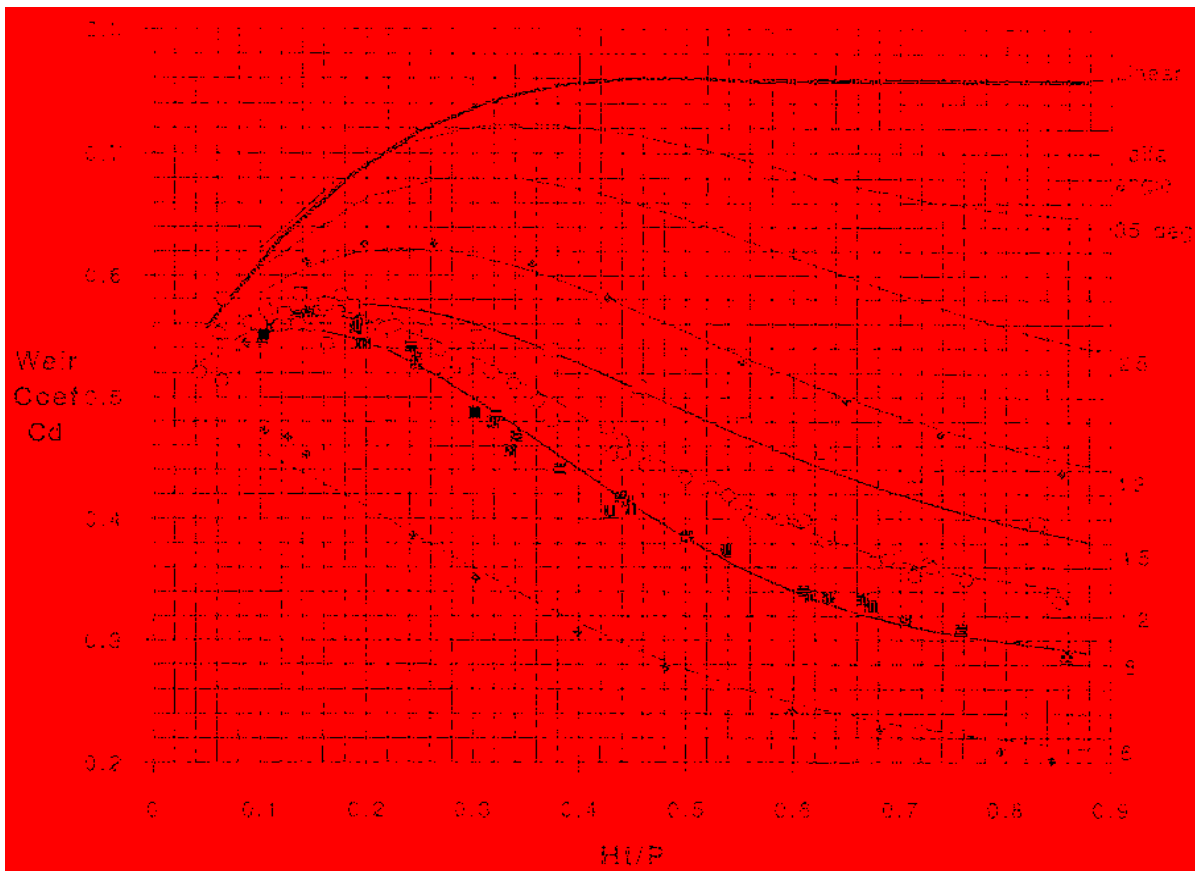
Weir coefficients are used to compensate for viscosity, energy, momentum, weir geometry and crest shape (Crookston, 2010). Weir coefficients are provided for several different types of weirs and have been established with laboratory testing. As the total upstream head increases for a labyrinth weir, the weir coefficient begins to decrease, showing that the overall performance of the weir decreases (Figure 4-15). The effectiveness of a labyrinth weir is correlated with the ratio of the total upstream head (H_T) divided by the weir height (P) (Figure 4-14). Labyrinth weirs are more efficient when the headwater ratio is less than 0.9 (Crookston, 2010).

Figure 4-15: Weir Coefficients for Headwater Ratios Lower than 0.9 (Tullis et al., 1995).

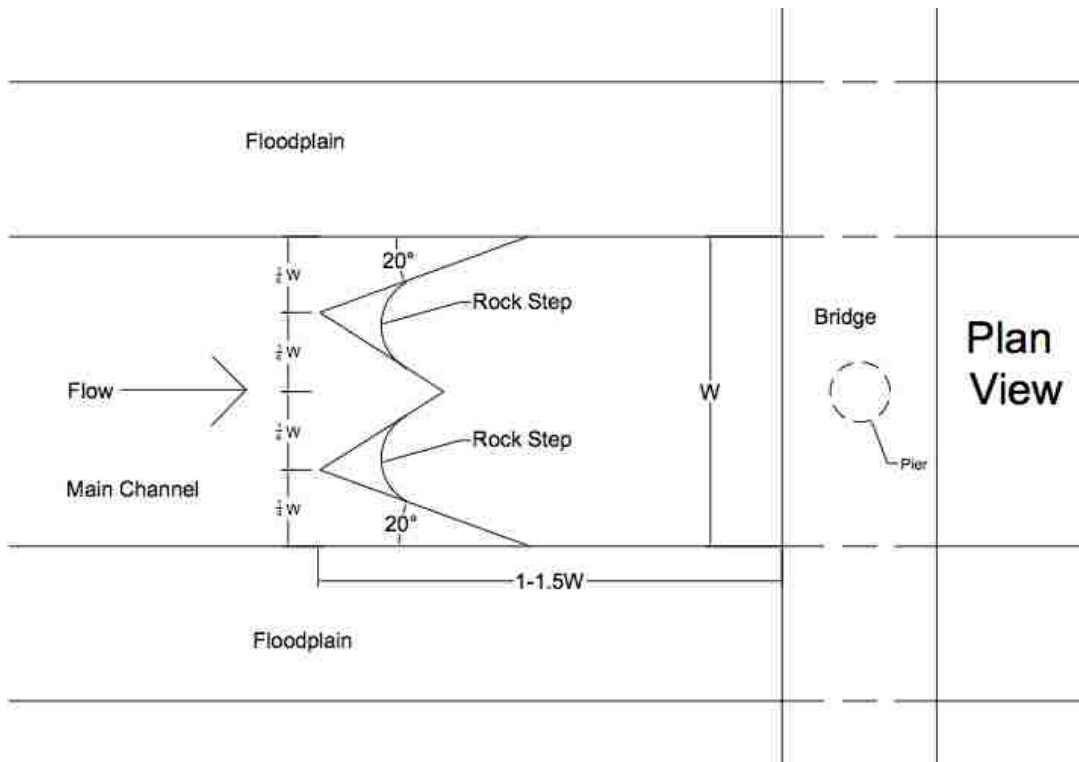
Figure 5-2: Plan View for Implementing a W-Weir Near Bridges.
