Low velocity impact damage assessment in IM7/977-3 cross-ply composites using 3D computed tomography

A thesis submitted in partial fulfillment
of the requirements for the Master of
Science degree in Mechanical Engineering
in the Graduate College of
The University of Iowa

Thesis Supervisor: Associate Professor Olesya I. Zhupanska

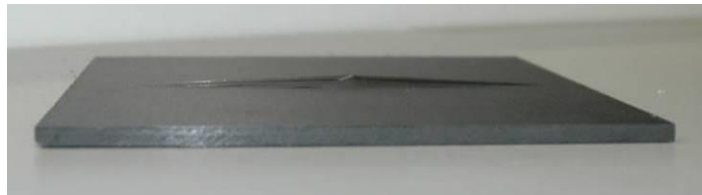
To reduce the amount of damage produced during impact, the impact energy was decreased to half of the initial value, resulting in an impact energy of 37.76 J. To achieve this, the same mass was used (12.831 kg) and the height was decreased to 0.30 m. Specimen 2 was clamped into the impact testing machine and impacted at this energy. The specimen damage, seen in Figure 3.4 through Figure 3.6, was moderate in scope with a large dent on the top surface and raised delamination on the back surface. While the damage was less than that for specimen 1, it was still more severe than desired.

Figure 3.6: Side View of Impact Damage on the Bottom Surface of Specimen 2

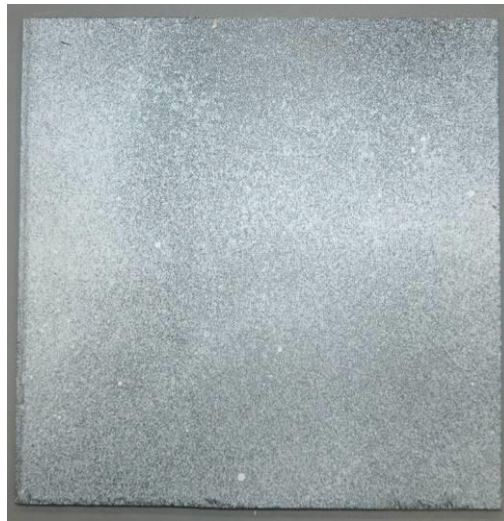
Figure 3.31: Impact Damage on the Bottom Surface of Specimen 9

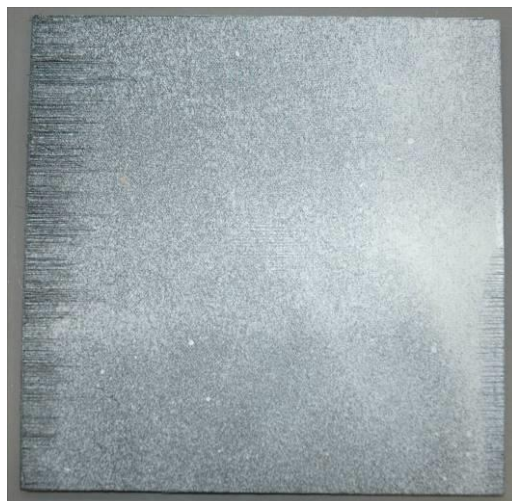
Figure 3.35: Impact Damage on the Bottom Surface of Specimen 11

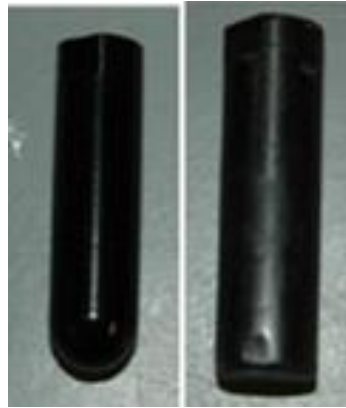
Figure 3.41: Tool Steel (left) and DELRIN® (right) Tup Insert (Zantout 2009)

In addition to material differences, the tup inserts also had different tip geometries, seen in Figure 3.41. The tool steel tup insert had a hemispherical tip and the DELRIN® tup insert had a flat end. The flat end would distribute the impact force over a larger contact area, and the decreased stress concentration at the center could contribute to the decreased level of damage. The effect of geometry and impactor size was studied by Icten (2013), who noted that damage increased with decreased impactor contact area. In other words, it was found that an impactor with a smaller contact area, measured by Icten in terms of diameter, produced a larger amount of damage for a given impact energy. Moreover, the density of steel is larger than the density of DELRIN®, and therefore the kinetic energy was larger in the case of the steel impactor compared to the DELRIN® impactor. This provided a slight contribution to the larger amount of damage produced in the impact of a composite plate by a steel impactor. The results obtained from the present study are consistent with the previous research.
