# Evaluating CFRP-Masonry Bond Using Thermal Imaging

Joseph Christopher Ross

A thesis submitted in partial fulfillment  
of the requirements for the degree of  
Master of Science in Civil Engineering  
Department of Civil and Environmental Engineering  
College of Engineering  
University of South Florida

Date of Approval:  
October 18, 2013

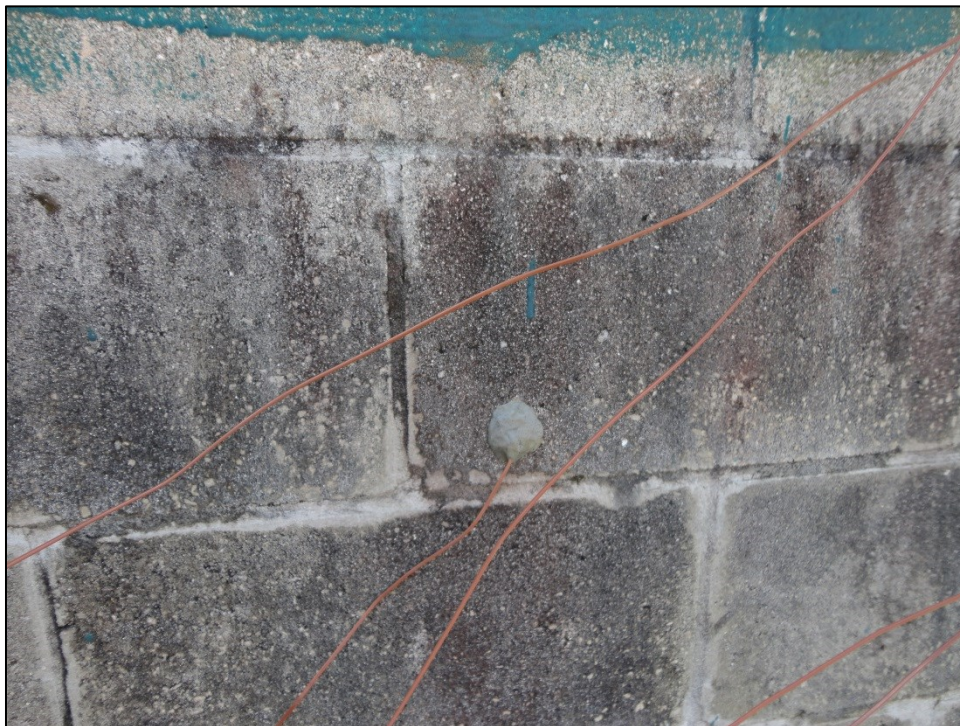
**Figure A66: Photo at Location 21 (North Side of Wall 2)**

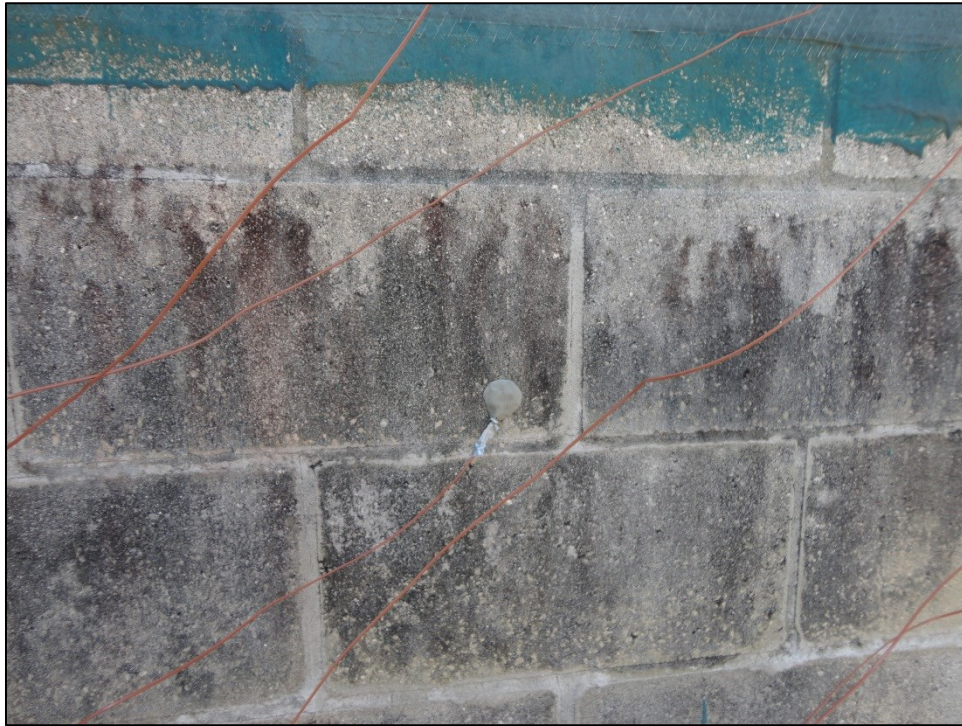
**Figure A69: Photo at Location 22 (North Side of Wall 2)**

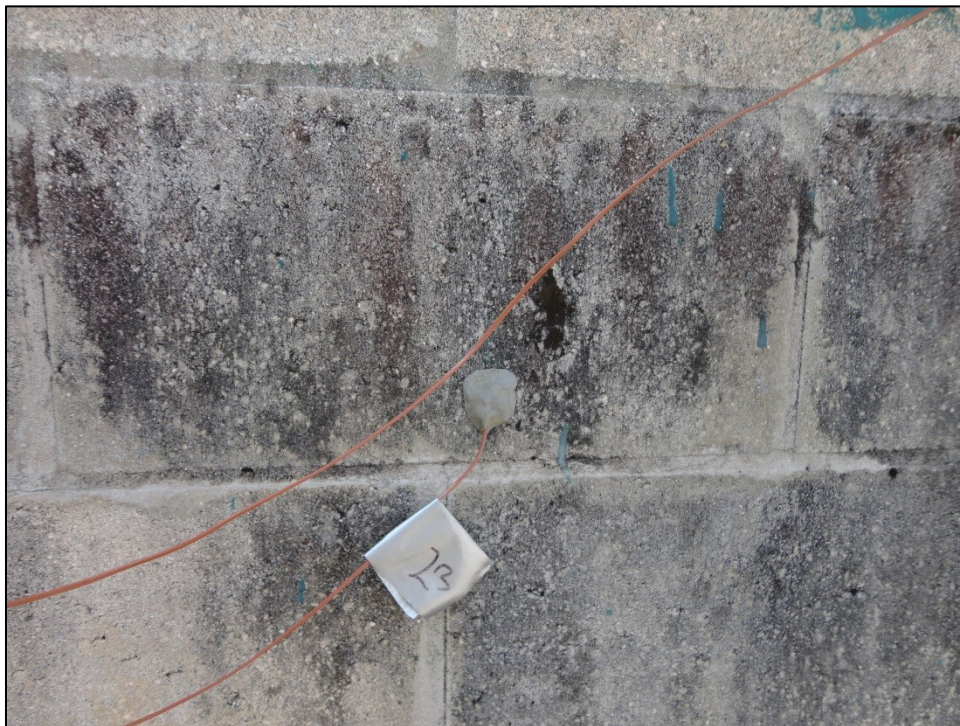
**Figure A72: Photo at Location 23 (North Side of Wall 2)**
